Inspection Report (On-Highway Dump Truck)

Year	2011
Make	Peterbilt
Model	367
Serial Number	1NP - TLUOX - 2 - BD127975
Truck Odometer Reading	423,441
Previous Application (e.g., earth moving, mining, demolition, etc)	Asphalt Construction

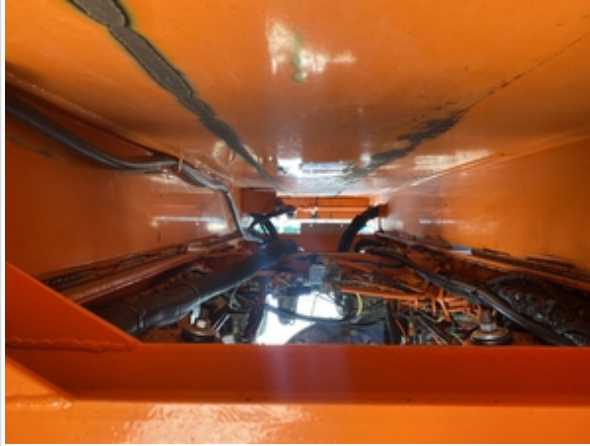
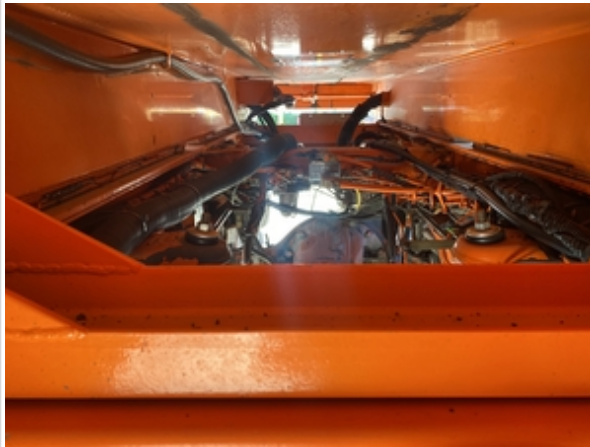
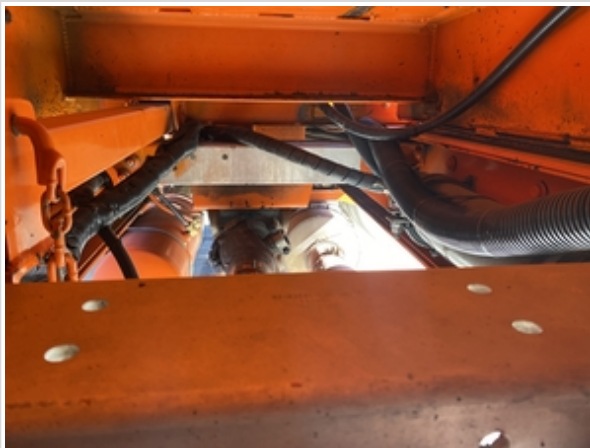
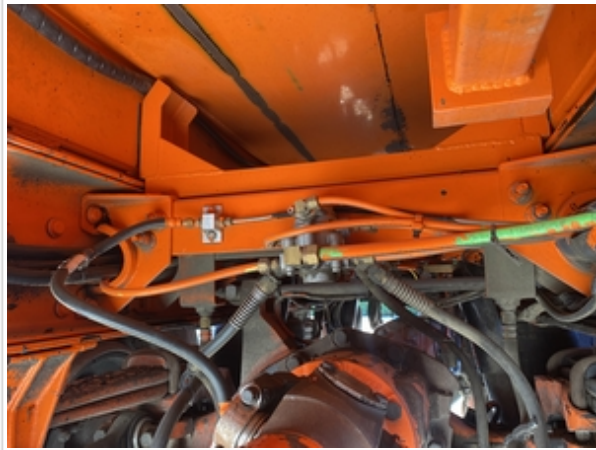
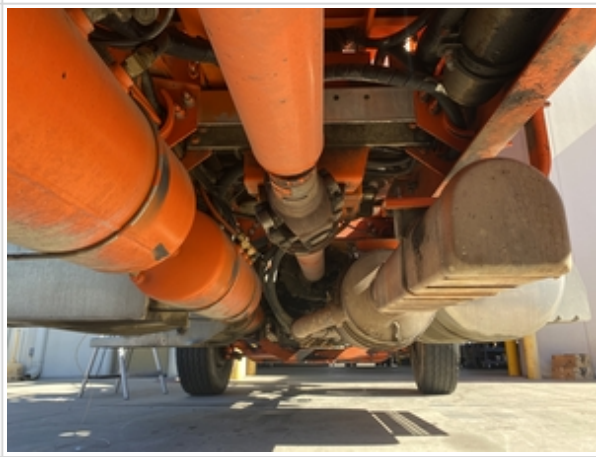
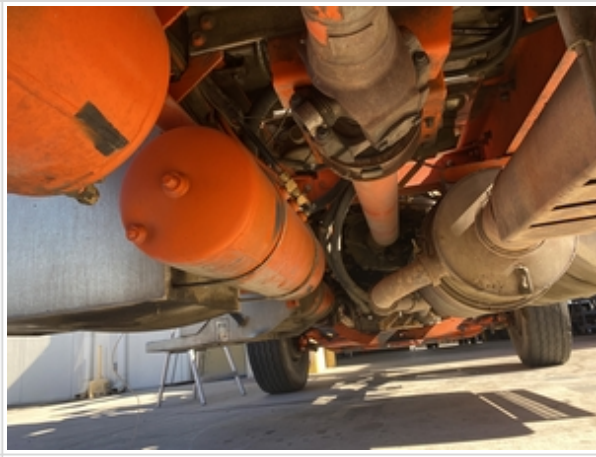
Overall Chassis & Undercarriage
Photos

Overall Chassis	3
Overall Chassis Comments	Overall chassis in good condition with no obvious major problems found.

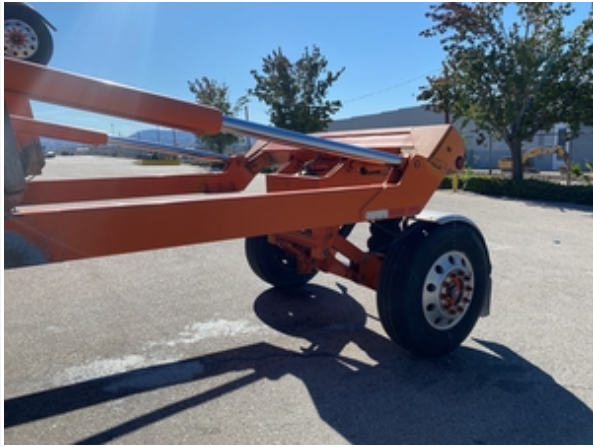
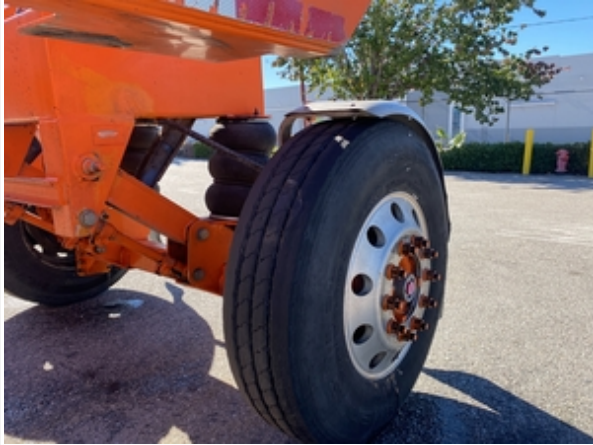
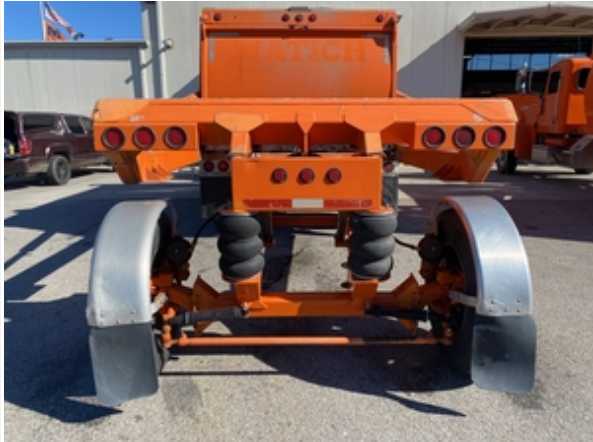
Drop Axle?	Yes
Super Dump?	Yes
Weight Rating	12,0000 Lbs.
Axle Condition	3 - Normal Wear & Tear
Axle Condition Photos

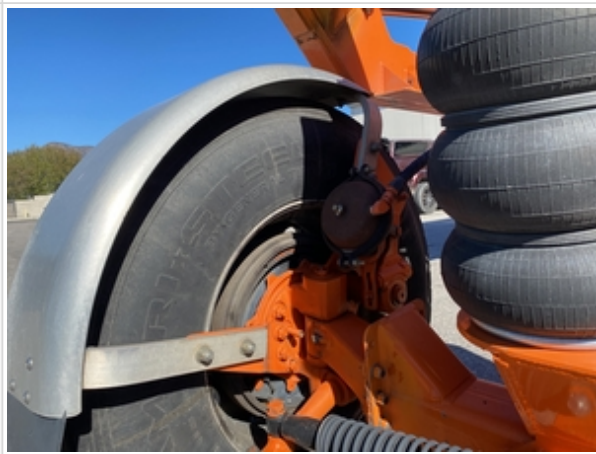
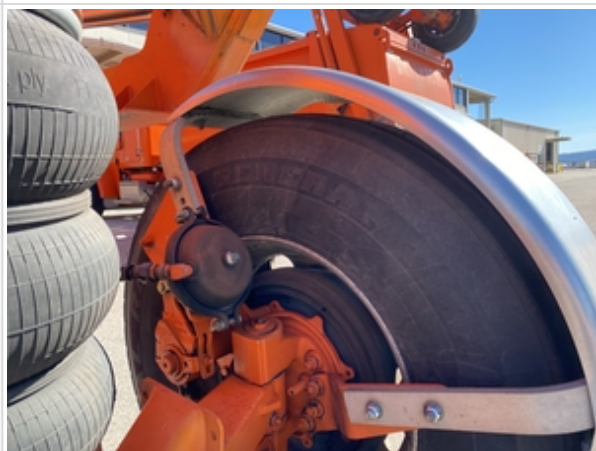
<p>Wheels & Tires</p>	<p>3 - Normal Wear & Tear</p>	
<p>Wheels & Tires Photos</p>

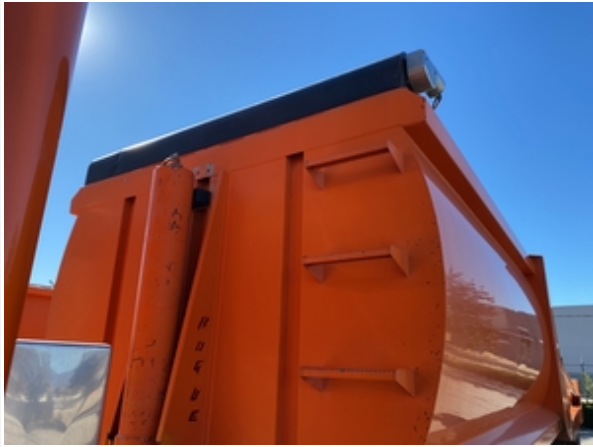
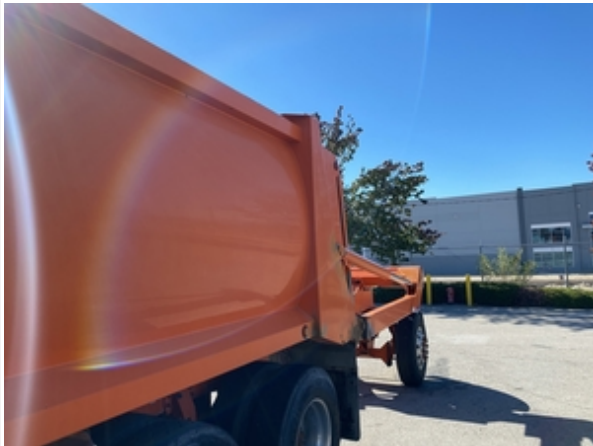
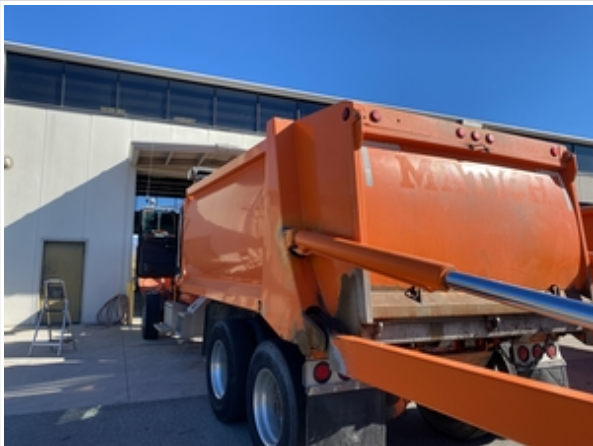
Dump Body Make & Material	Rogue
Dump Body Length (ft and inches)	15'
Dump Body Height (ft and inches)	5'3"
Bed Body	3 - Normal Wear & Tear
Bed Body Photos

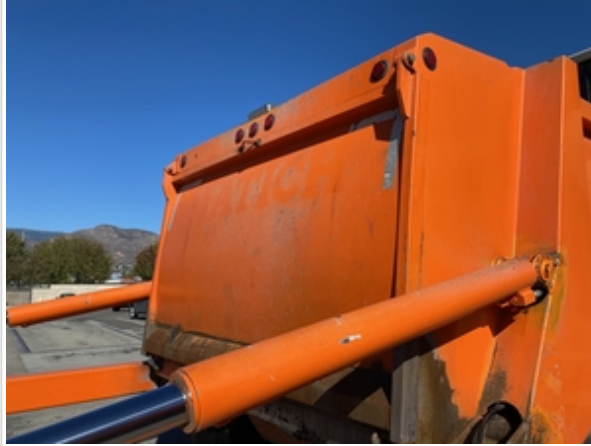
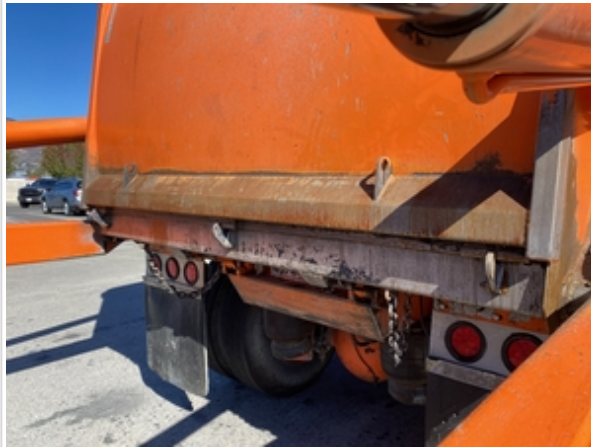
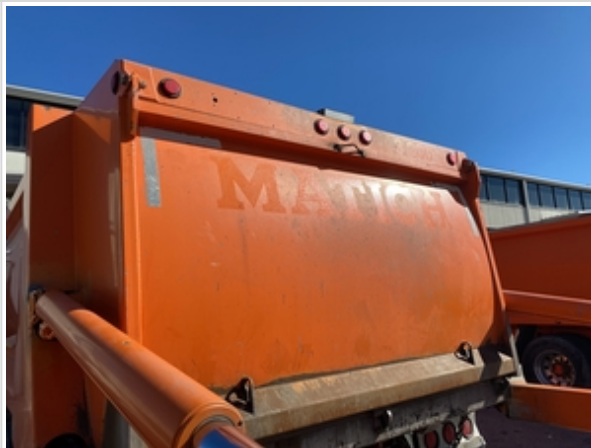
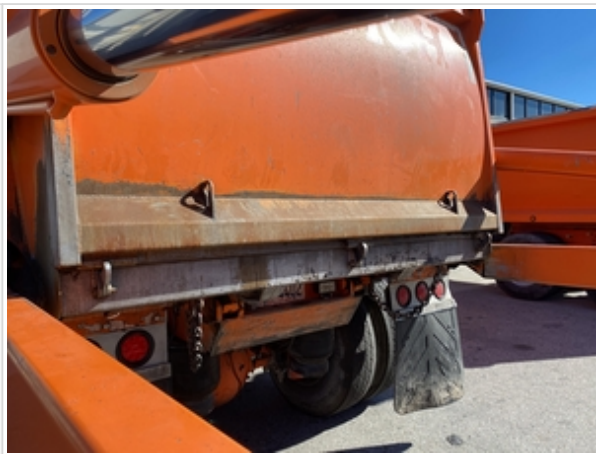
Tailgate Photos

<p>Tailgate</p>	<p>3 - Normal Wear & Tear</p>

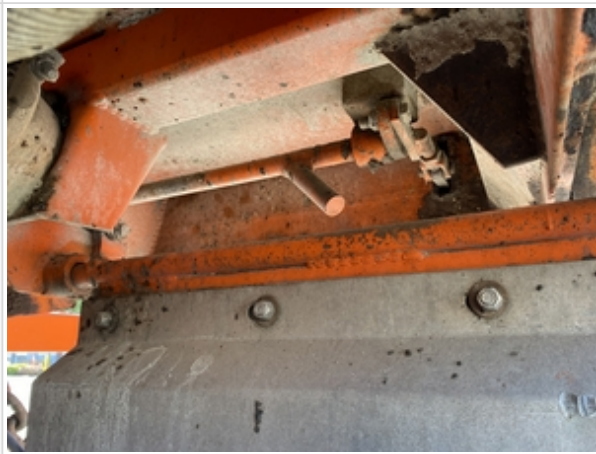
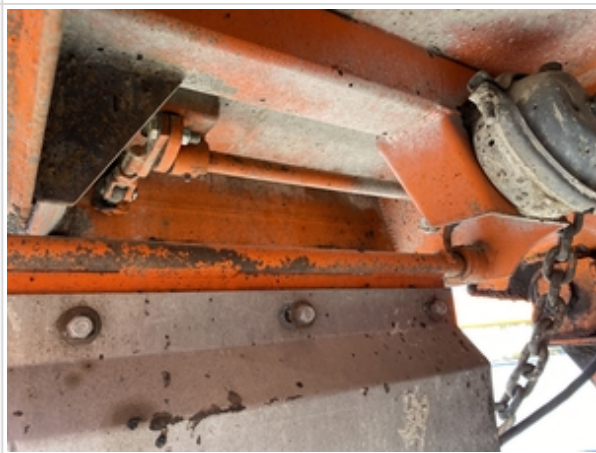
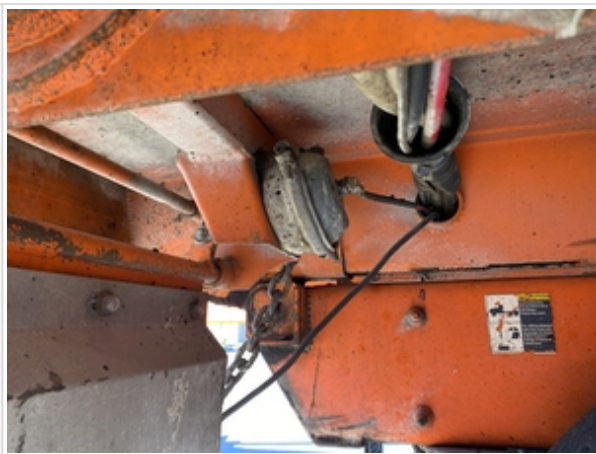
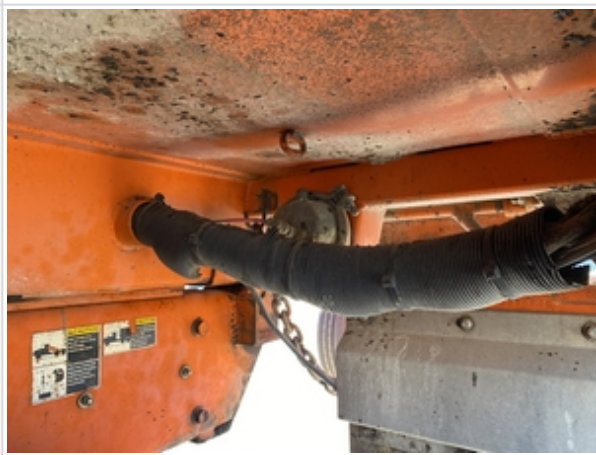
<p>Tailgate Latch</p>	<p>3 - Normal Wear & Tear</p>	
<p>Tailgate Latch Photos</p>

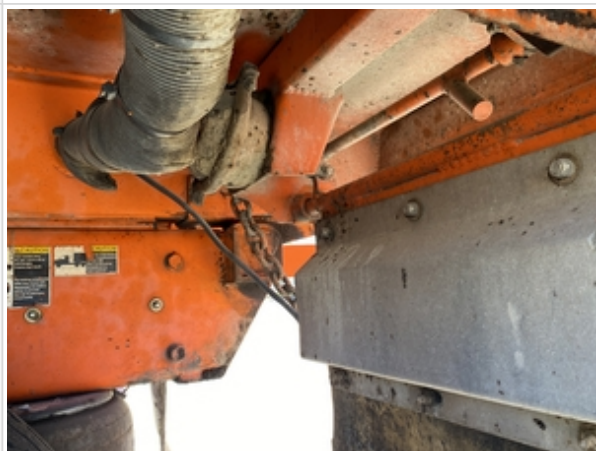
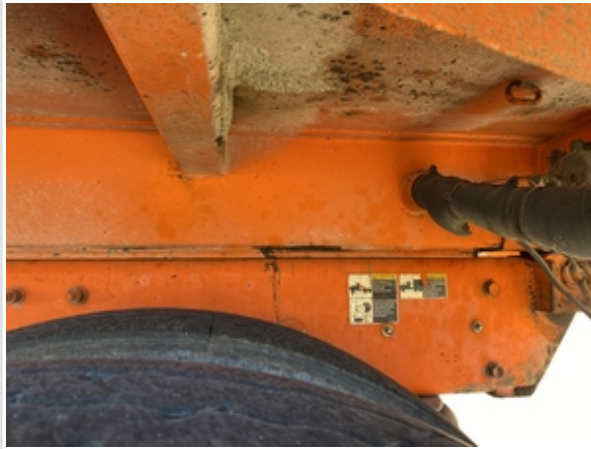
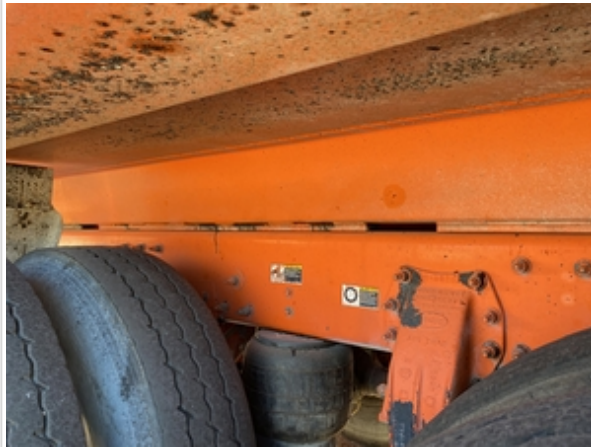
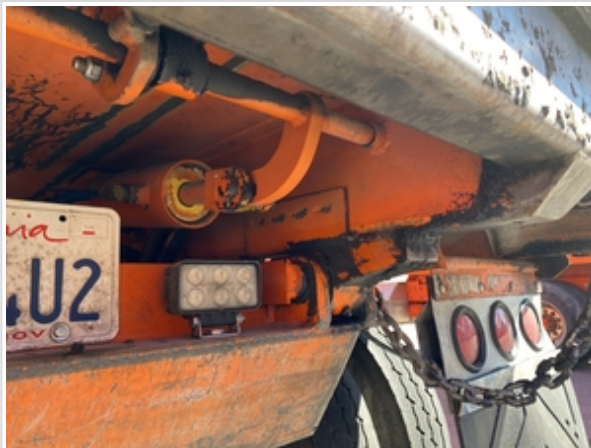
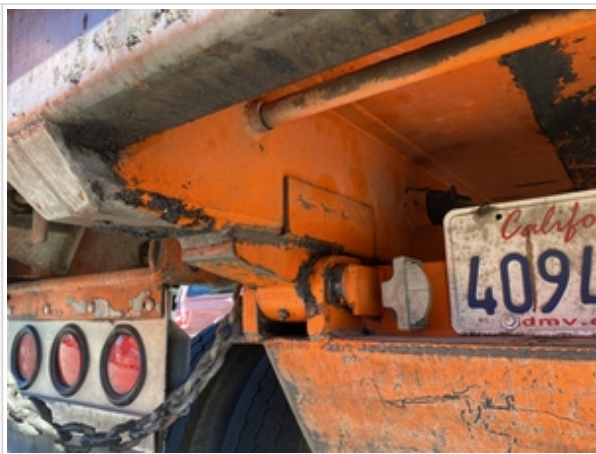
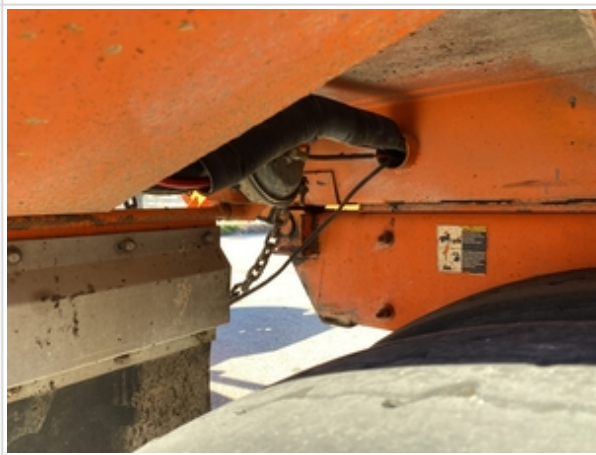
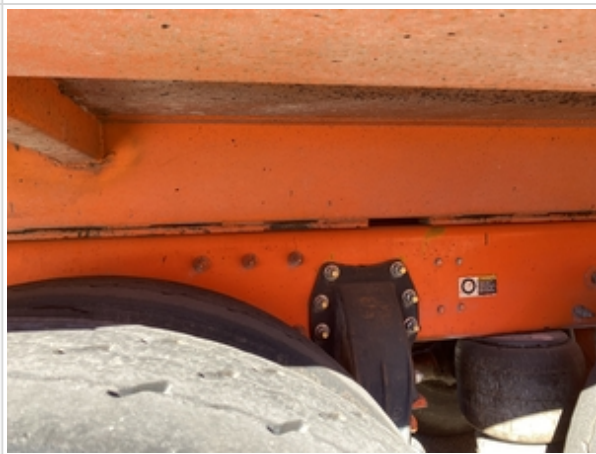
<p>Support Frame</p>	<p>3 - Normal Wear & Tear</p>	
<p>Support Frame Photos</p>

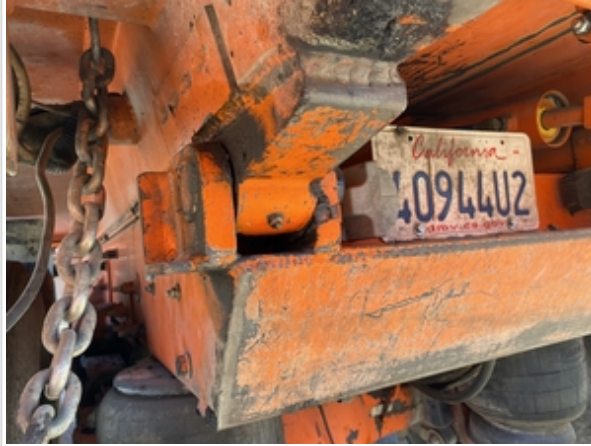
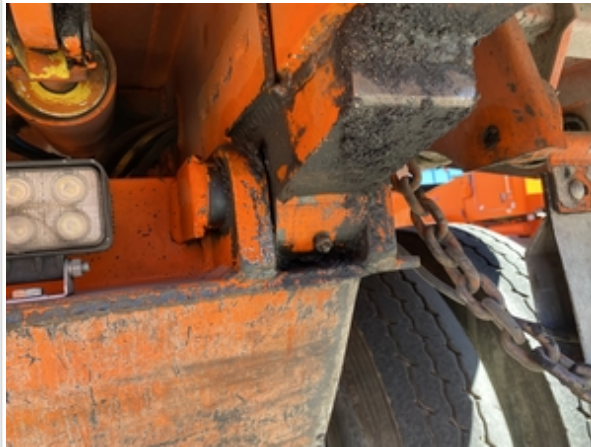
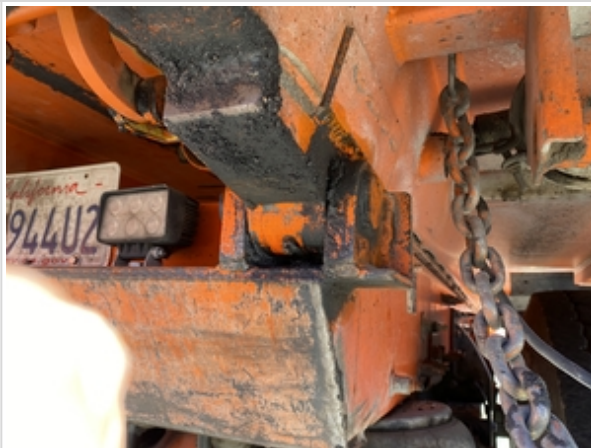
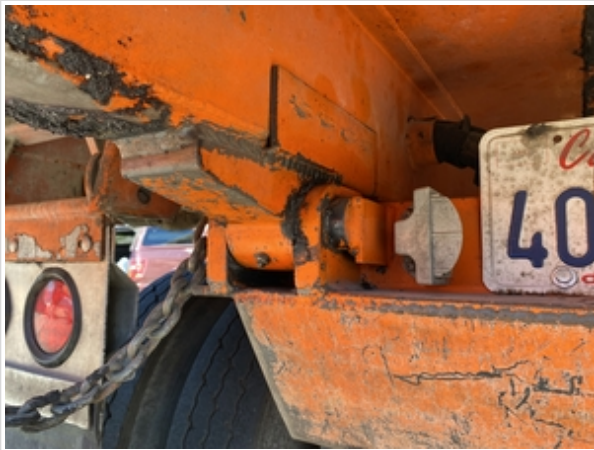
Hinge Point Photos

<p>Hinge Points</p>	<p>3 - Normal Wear & Tear</p>

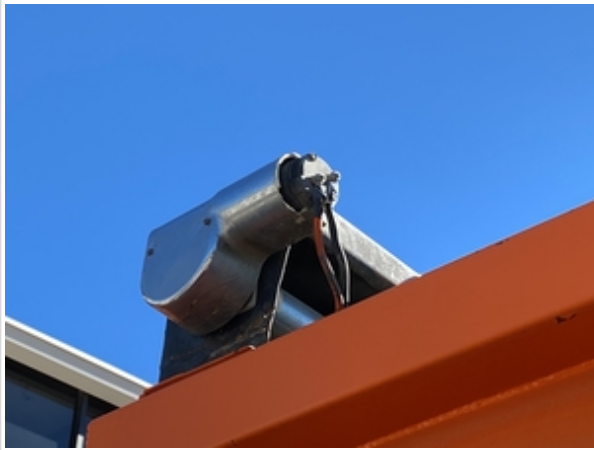
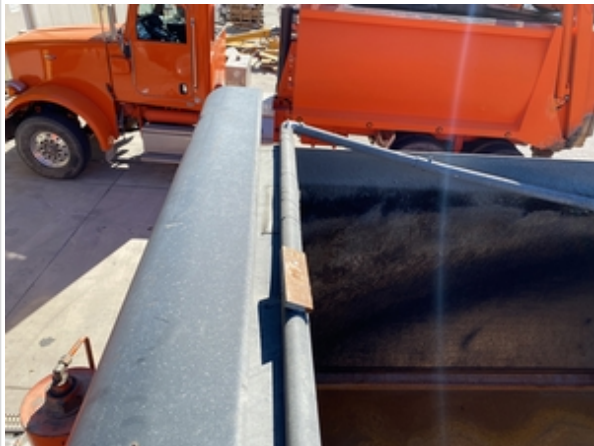
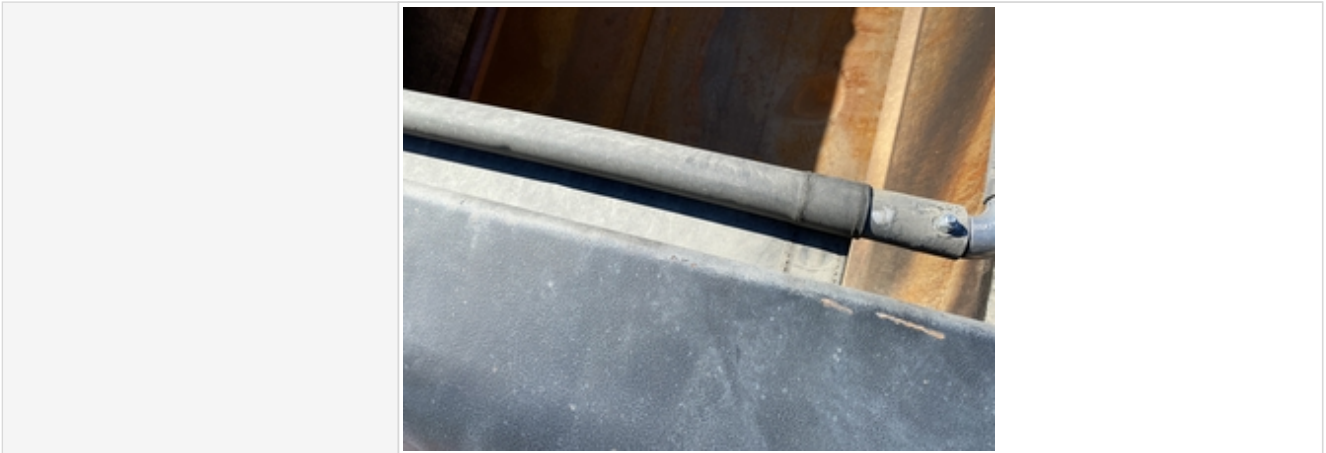
<p>Tarp</p>	<p>3 - Normal Wear & Tear</p>	
<p>Tarp Photos</p>

Controls	3 - Normal Wear & Tear
Overall Functional Test Comments	Truck operates well. Dump body and strong arm axle operate normal. Tarp may need to be adjusted (tarp retract hesitation observed)
Operating Video	Click to Download

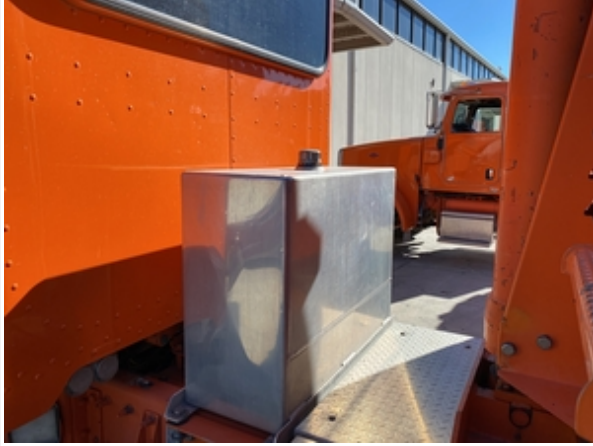
Hydraulics	Check the condition of the hydraulics. Check lines, hoses, fittings, leaks, function, etc. Note any damage or wear. Take photos.
Hydraulic Tank	3 - Normal Wear & Tear
Hydraulic Tank Photos

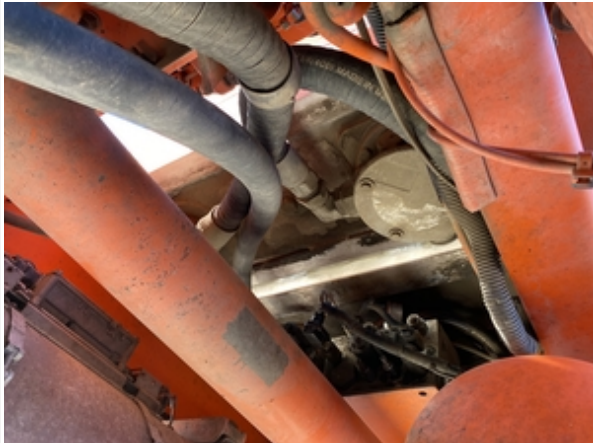
A photograph of a white, rectangular hydraulic tank mounted on the side of an orange dump truck. The tank is situated on a metal platform, and the surrounding area shows the orange body panels of the truck.
Hoses	3 - Normal Wear & Tear
Hose Photos

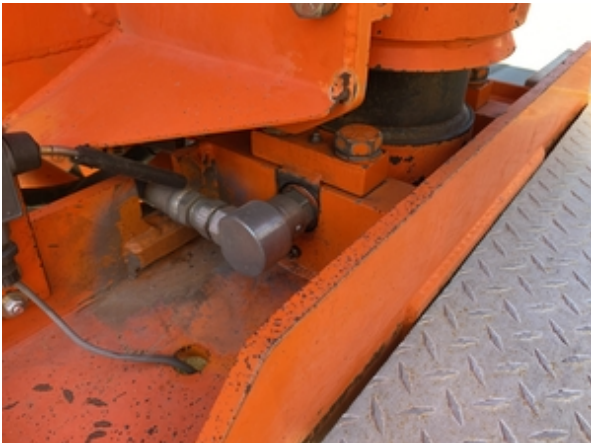
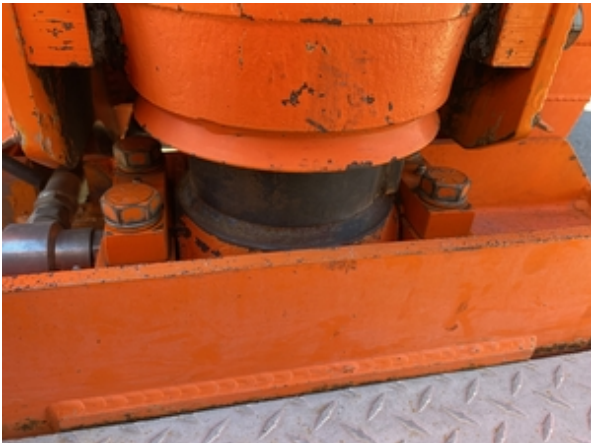
Cylinder Pins and Bushings	3 - Normal Wear & Tear
Cylinder Pins and Bushings Photos
