Inspection Report (Material Handler)

Year	2019
Make	Sennebogen
Model	718E
Serial Number	718.0.2072
Hour Meter Reading	655 Hrs.
Previous Application (e.g., earth moving, mining, demolition, etc)	General Tree Services

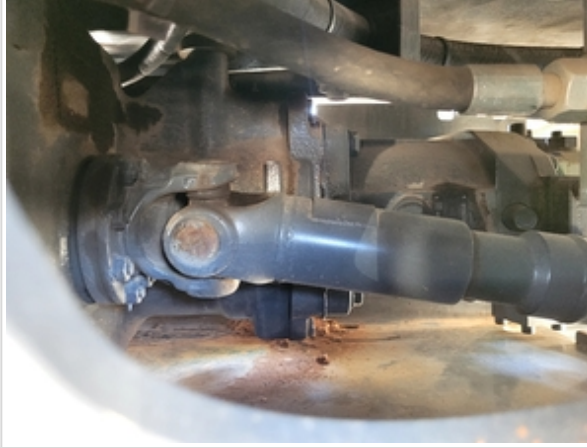
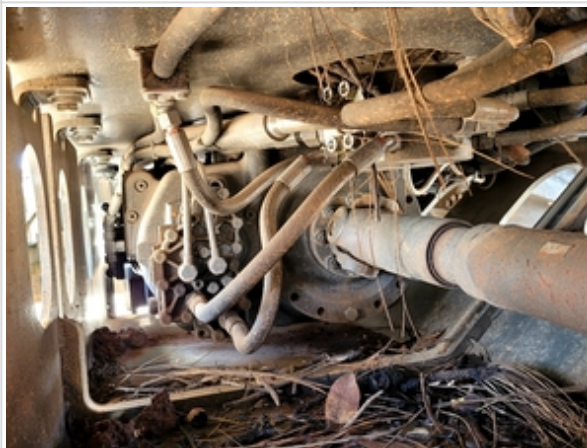
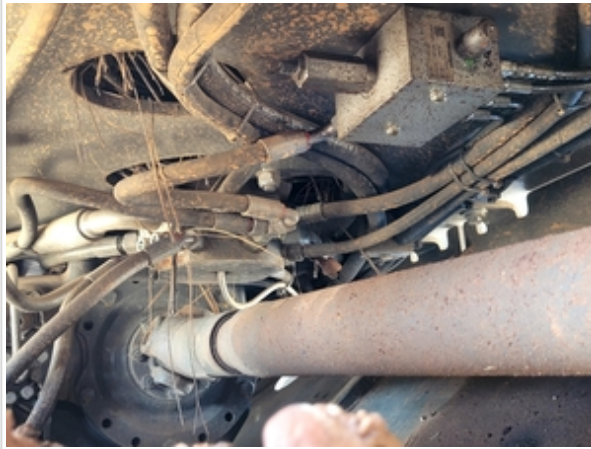
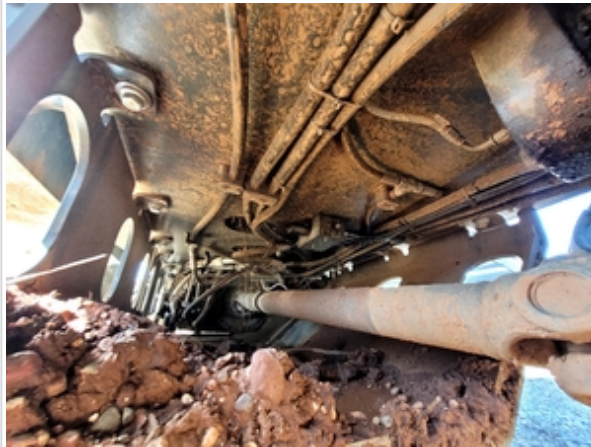
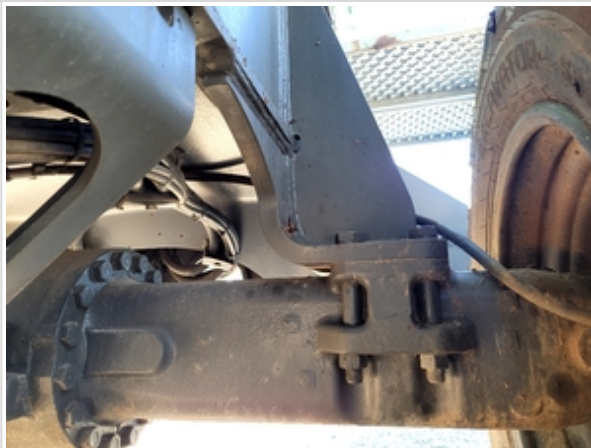
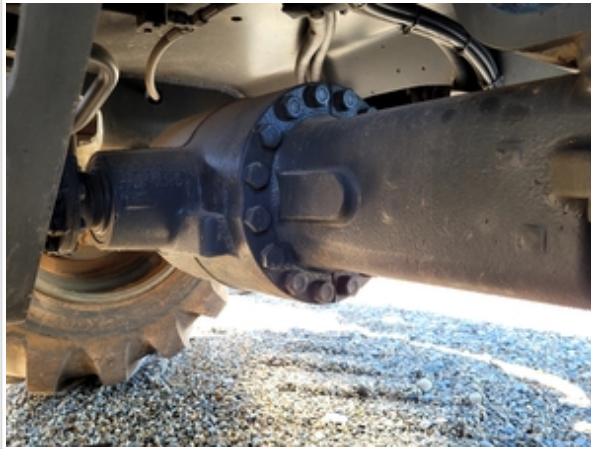
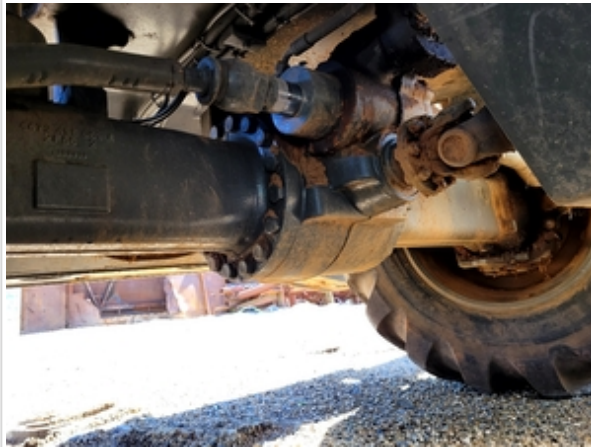
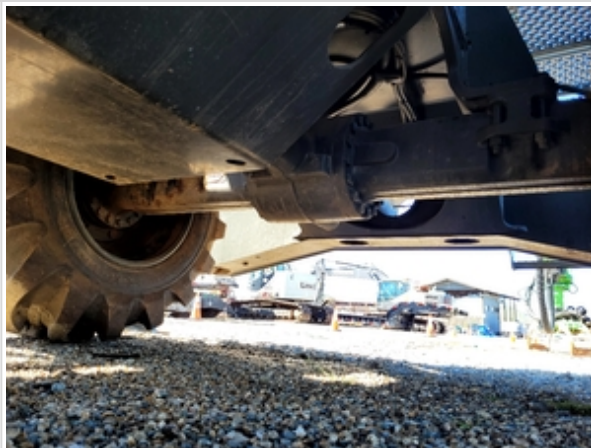
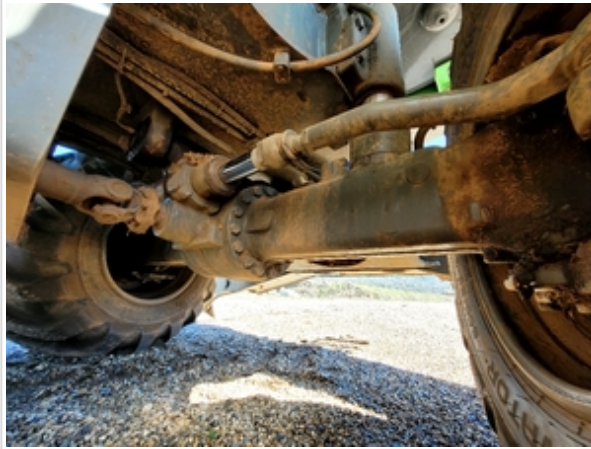
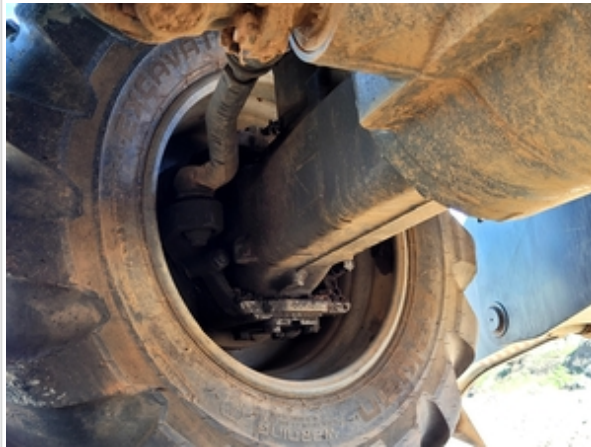
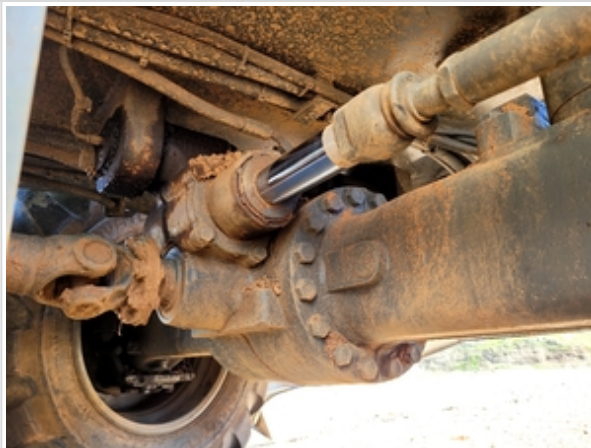
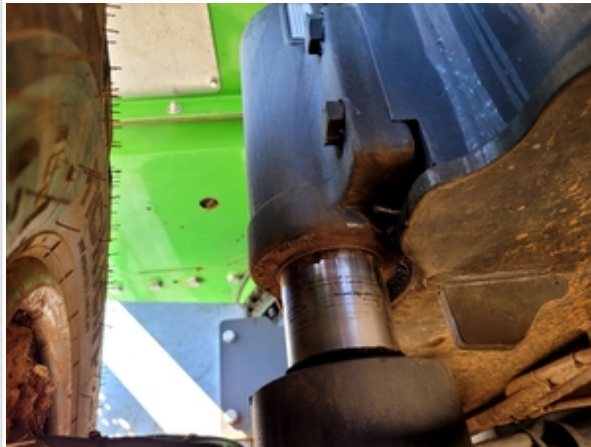
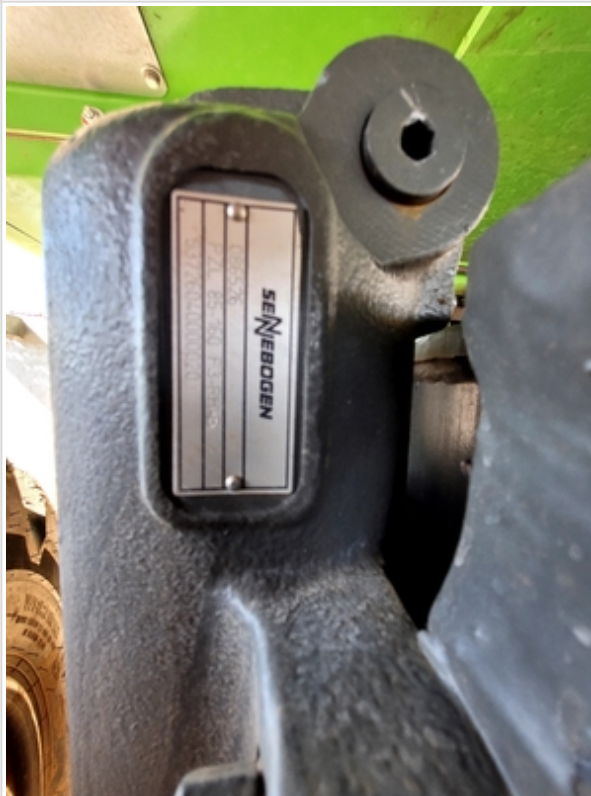
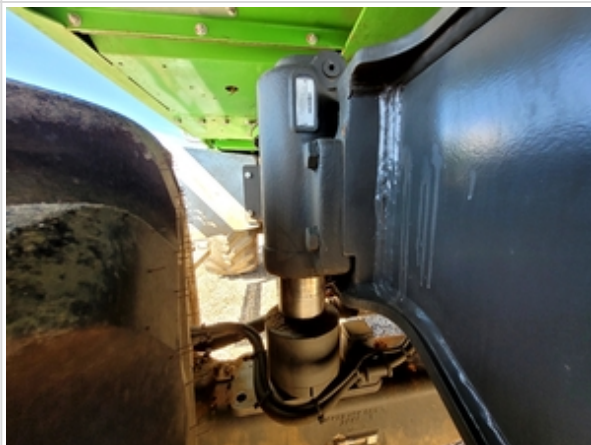
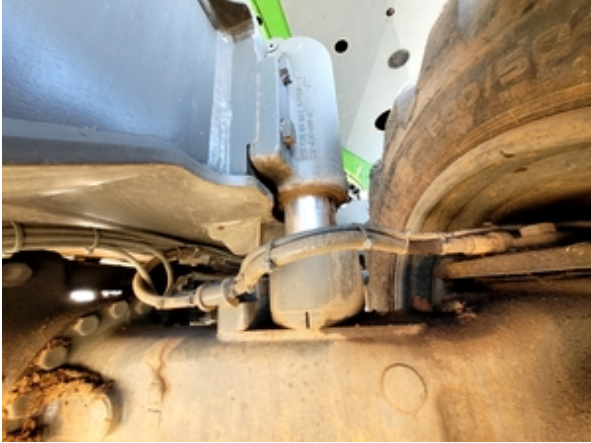
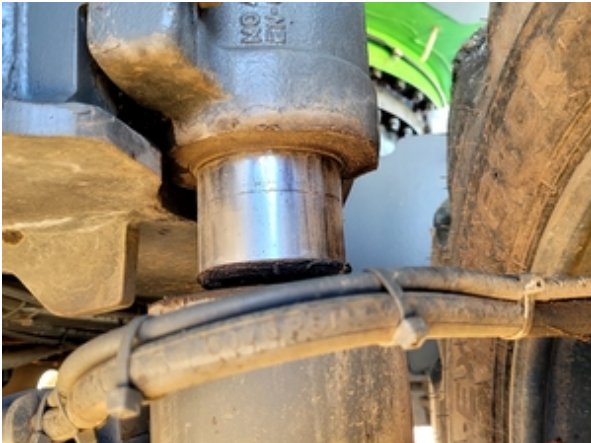
Drivetrain Photos

Hydrostatic Transmission?	Yes
2 Speed?	Yes
Hydrostatic Drive Configuration	Split Transmission
Transmission Components	4 - Like New, Recently Replaced
Transmission Condition	Good forward and reverse function
Drive Motors	0
Parking Brake	4 - Operating Within Factory Specs
Parking Brake Function	Good brake function
Overall Drivetrain Comments	Drivetrain function well and have healthy maintained appearance.

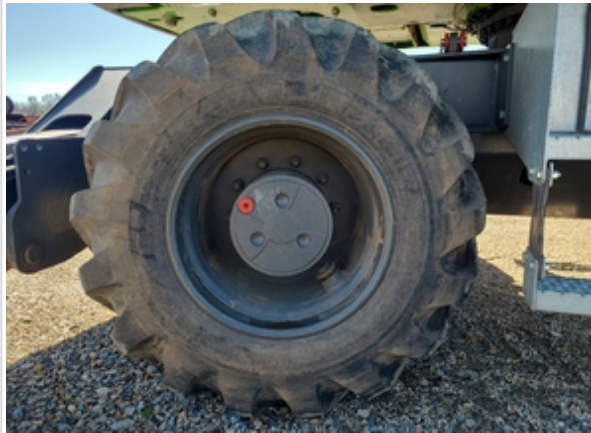
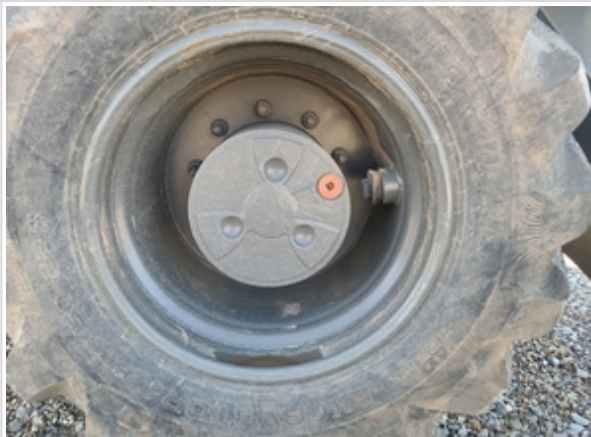
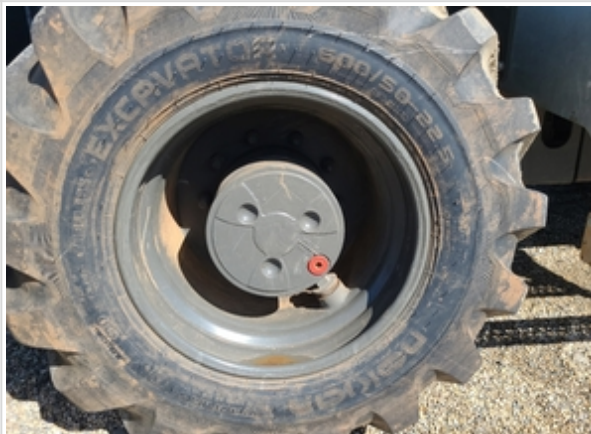
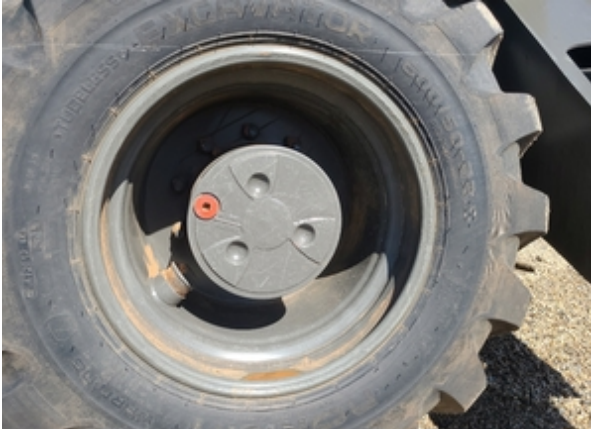
Wheels & Hub Condition	4
Comments	Tires are above 90%
Wheels & Hub Photos

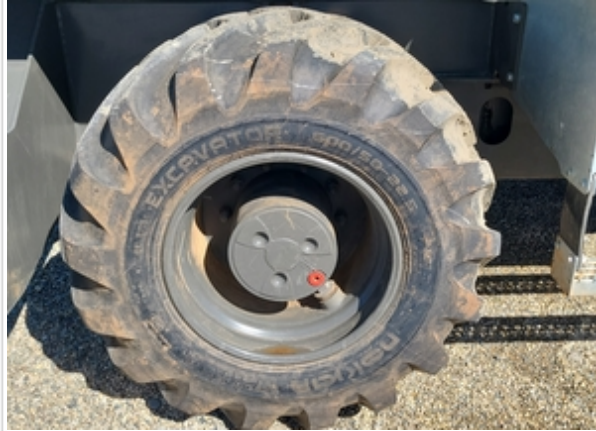
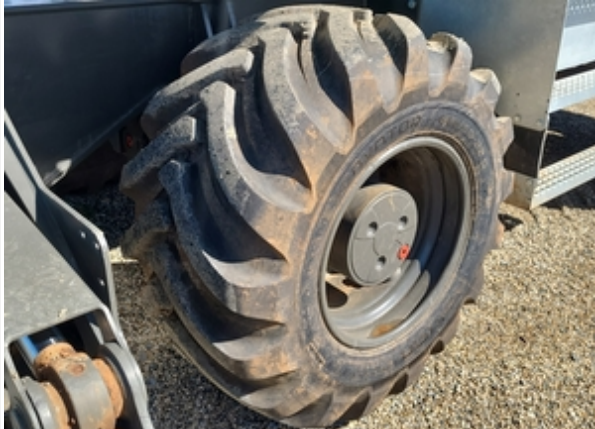
<p>Rear Right Tire - Ratio Remaining</p>	<p>90%</p>
<p>Rear Right Tire Photos</p>

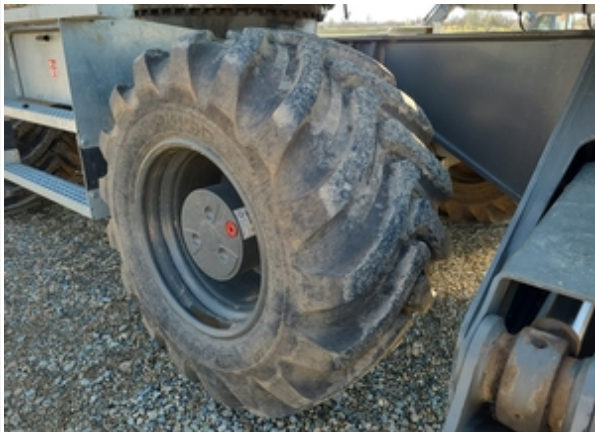
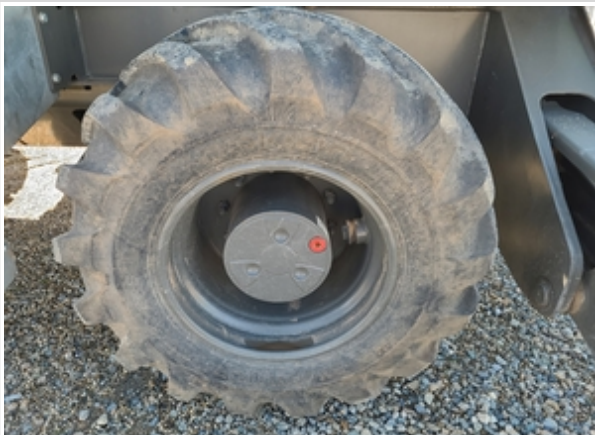
Rear Left Tire - Ratio Remaining	90%
Rear Left Tire Photos

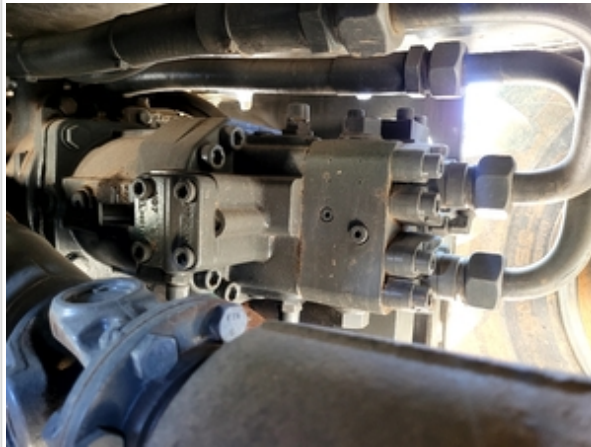
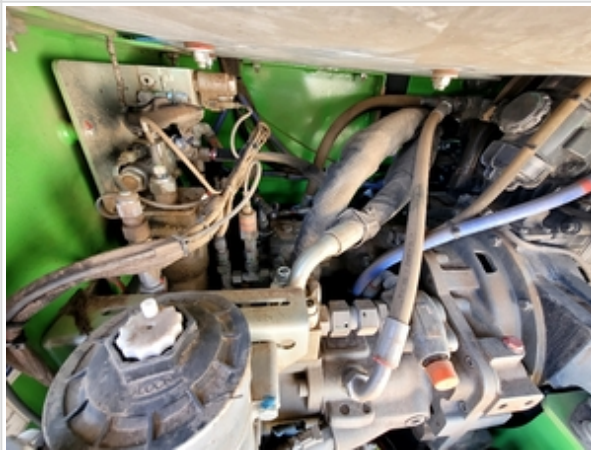
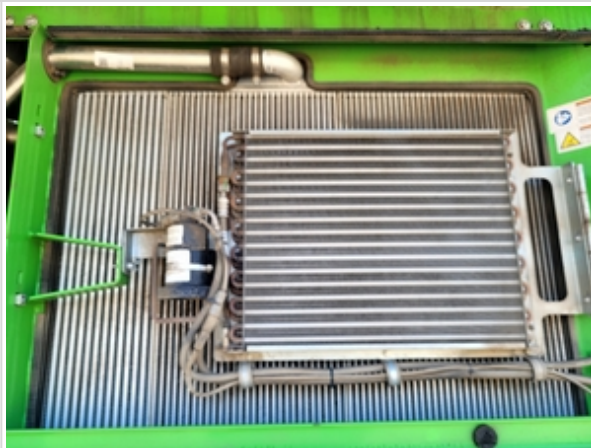
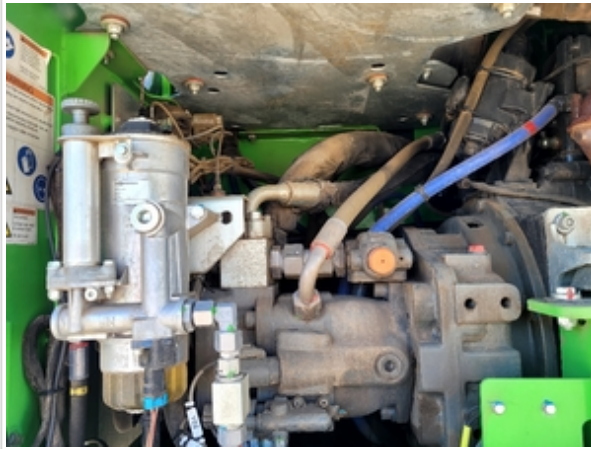
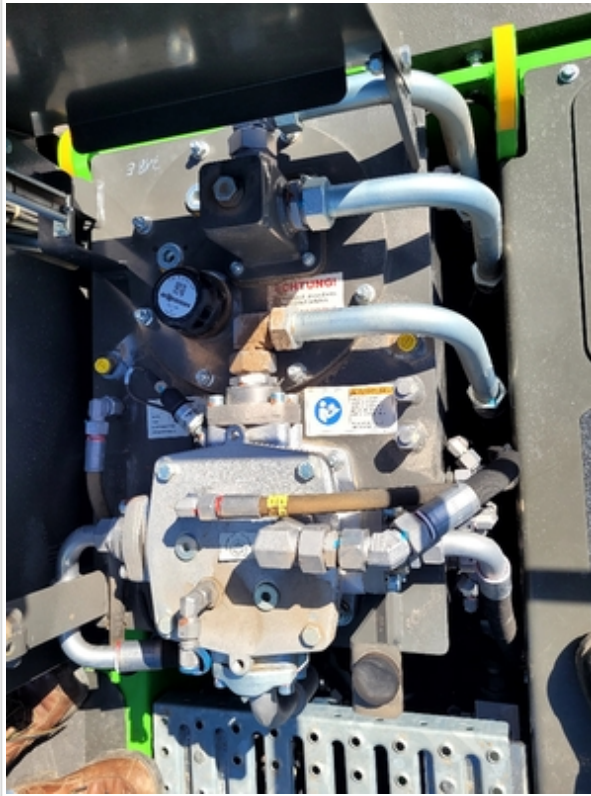
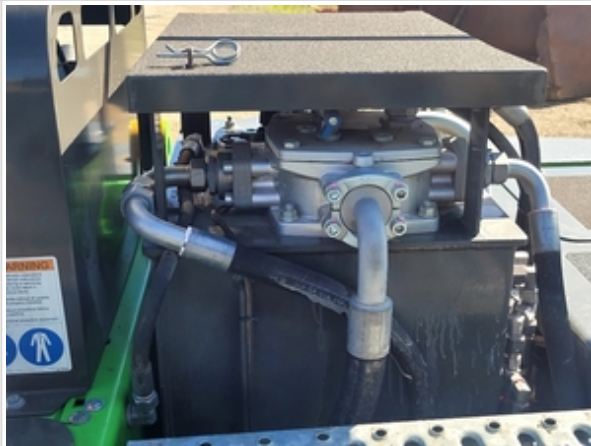
Hydraulic System Photos

Wet or Damp Hydraulic Lines / Fittings	No
Appearance of Hydraulic Lines / Fittings	4 - Like New, Recently Replaced
Hydraulic Lines / Fittings Condition	Hydraulic lines & fittings are clean and in good condition
Unusual Noises (Hydraulic Pump)	No
Hydraulic Pump Notes	No unusual noises heard during operation
Comments	Hydraulic pumps works great under load and sound healthy under load.
Swing Motor	4 - Like New, Recently Replaced
Hydraulic Swivel Center	4 - Like New, Recently Replaced

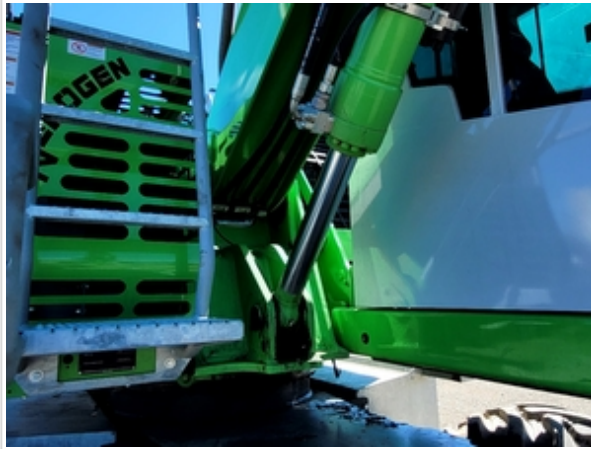
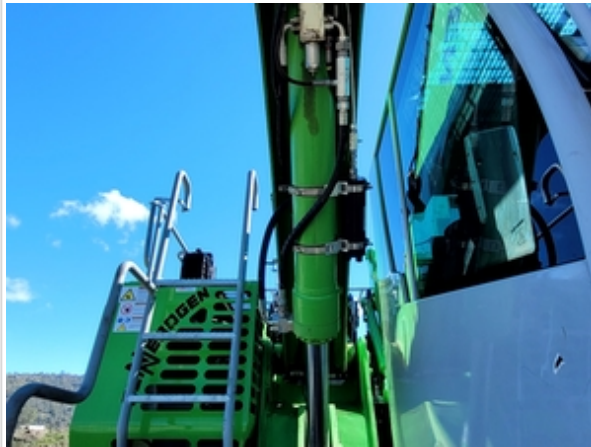
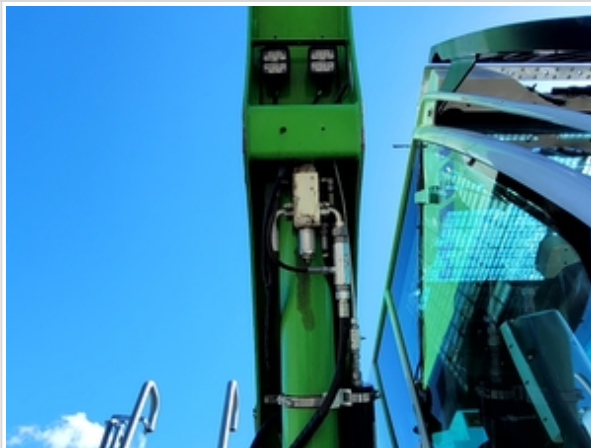
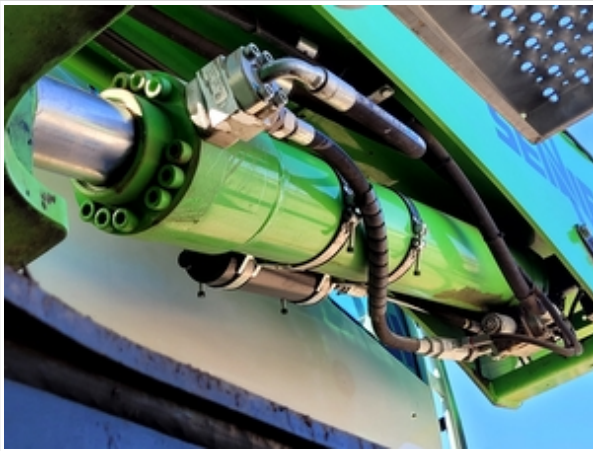
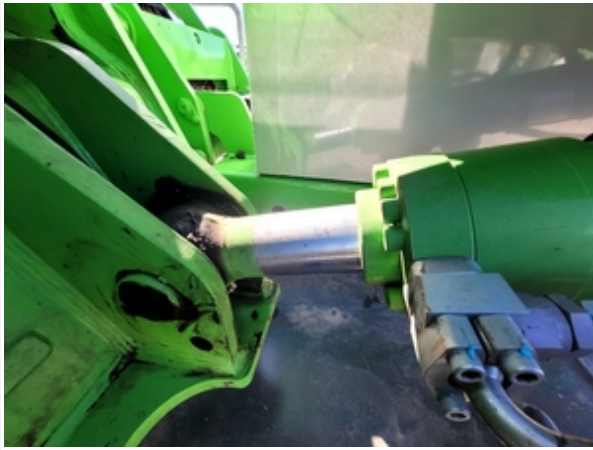
Boom Cylinder: Mounting Pins	4 - Like New, Recently Replaced
Boom Cylinder: Oil Leaks	No
Boom Cylinder Photos

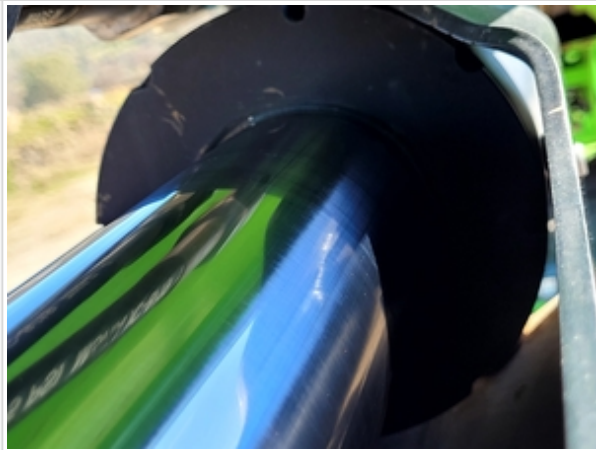
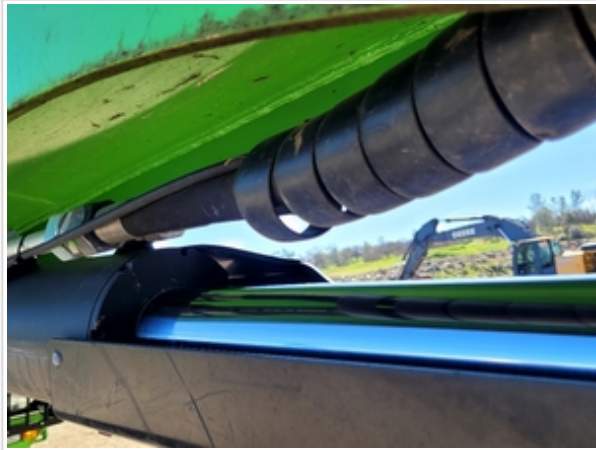
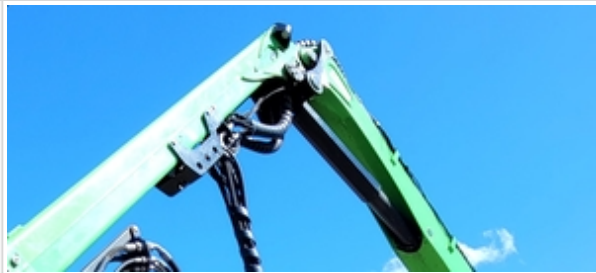
Stick Cylinder: Mounting Pins	4 - Like New, Recently Replaced	
Stick Cylinder: Oil Leaks	No	
Stick Cylinder Photos

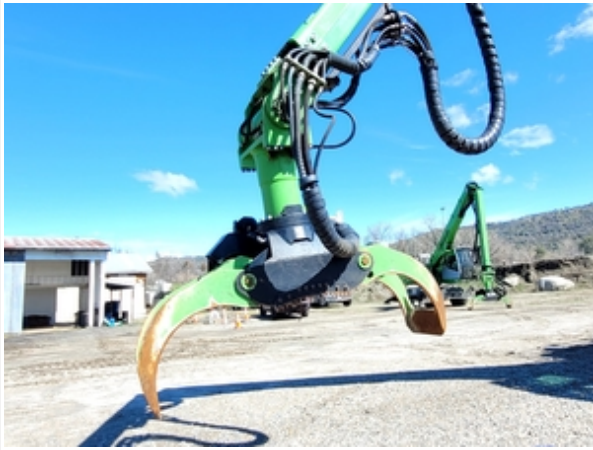
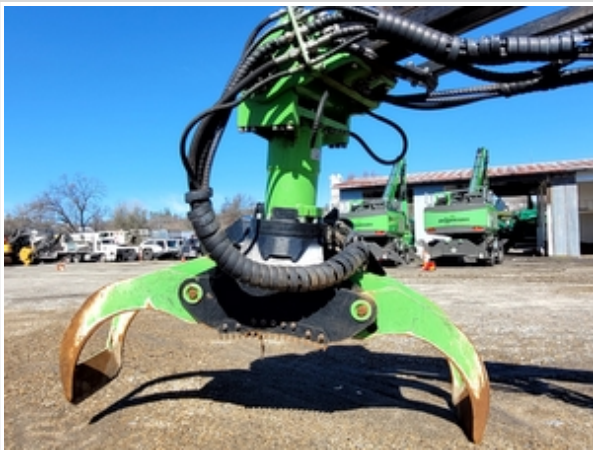
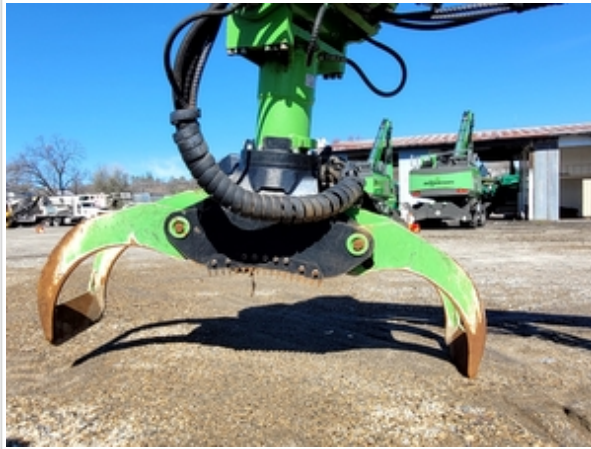
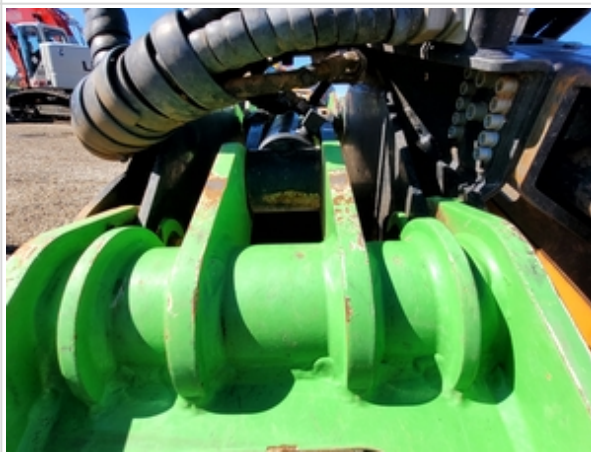
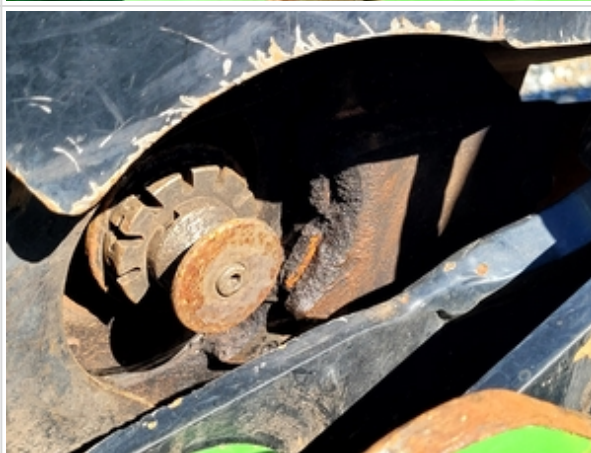
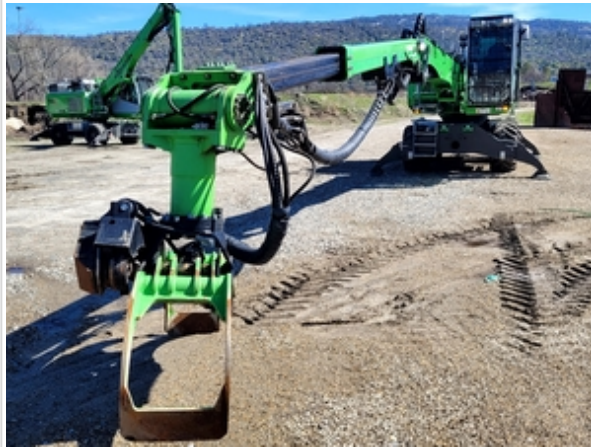
Attachment Photos

Grapple	4 - Like New, Recently Replaced	
Shear	3 - Normal Wear & Tear
