Inspection Report (Mini Excavator)

Year	2019
Make	Kubota
Model	KX033-4
Serial Number	KBCK0334PK3G13787
Hour Meter Reading	1,088 Hrs.
Previous Application (e.g., earth moving, mining, demolition, etc)	Equipment Rental

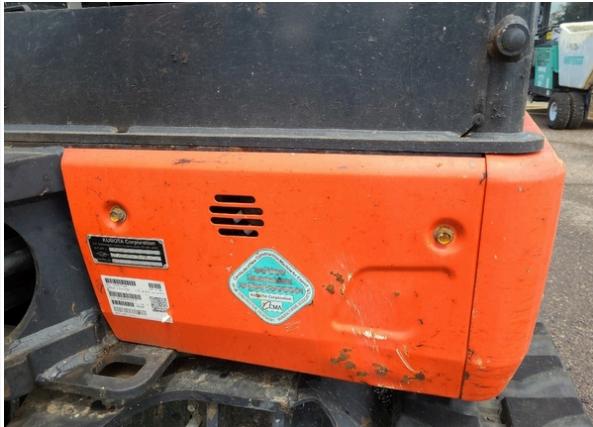
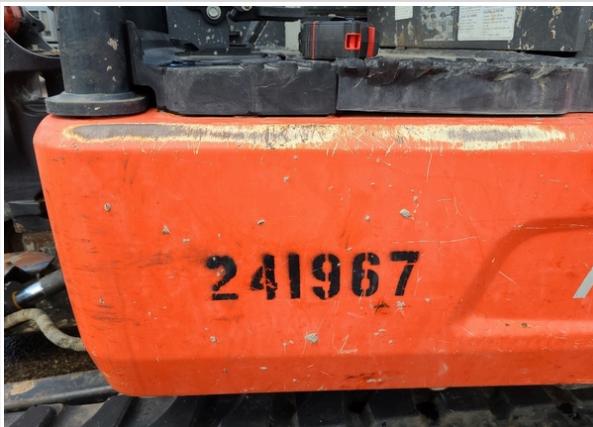
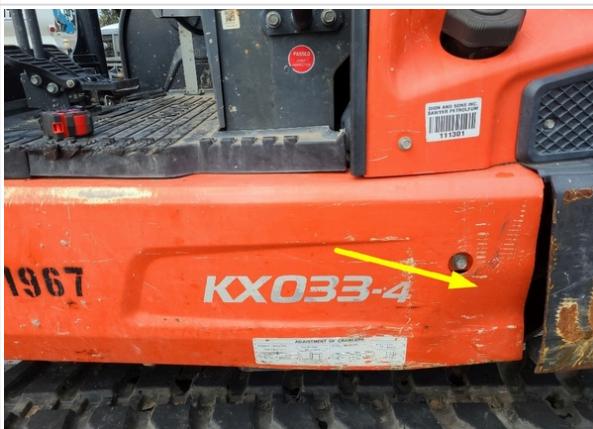
Small dent

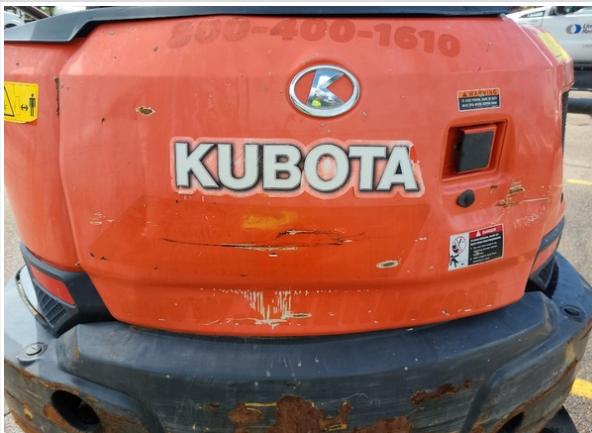
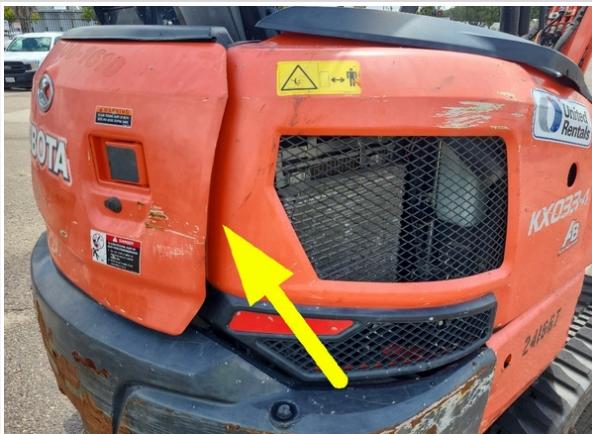
Engine Compartment Door misaligned but still closes and opens with no major issues.

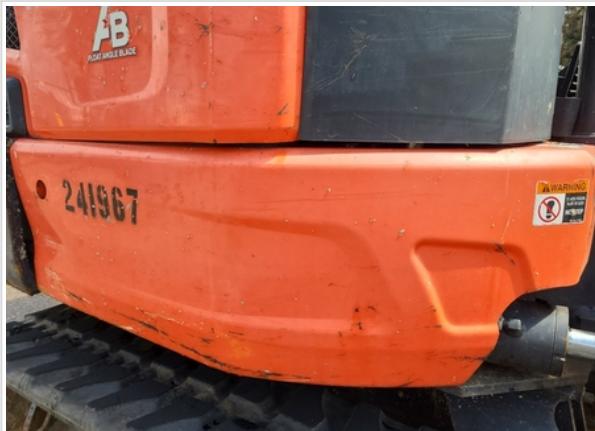
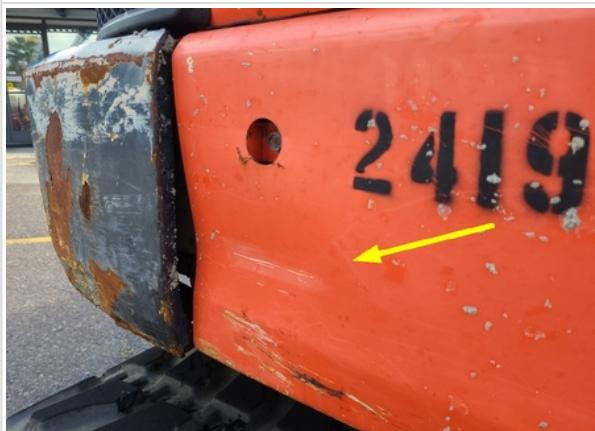
small dent present

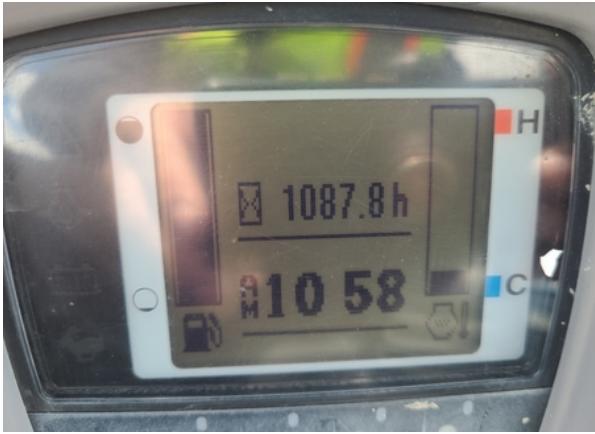
Hour Meter Activity Photos

Operator Cabin Overall	3 - Normal Wear & Tear
Operator Cabin Overall Condition	Good cabin appearance, solid floors, panels, and ceiling, Minor cosmetic wear to cabin surfaces, floors, panels, and ceiling
Operator Seat	3 - Normal Wear & Tear
Operator Seat Condition	Seat(s) in good condition, no stains or tears in upholstery
Cabin Lights	0
Safety Lock Out / Stop	3 - Normal Wear & Tear
Safety Lock Out / Stop Condition	Safety lock out device is present, in good condition, and functional
Controls & Switches	3 - Normal Wear & Tear
Controls & Switches Condition	All switches are installed and functional
Hour Meter Activity	3 - Normal Wear & Tear
Hour Meter Condition	Hour meter is functional and in good condition

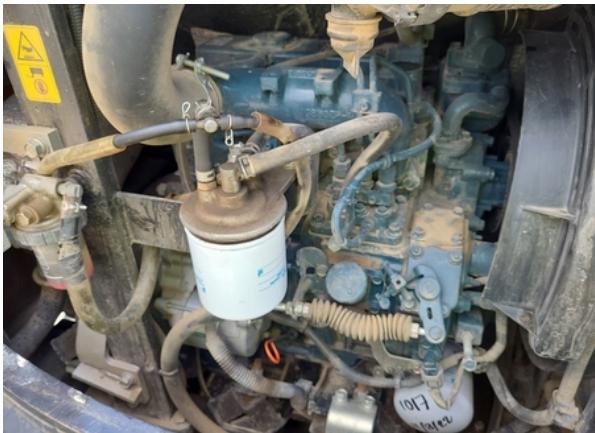
Requires DEF (Diesel Exhaust Fluid)	No
Overall Engine Appearance	Dusty & dry
Overall Engine Comments	Overall Engine in well maintained condition with no active leaks observed. Engine oil last service in October of 2022.

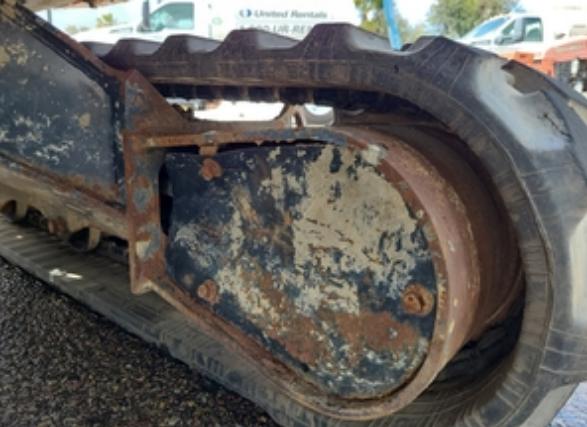
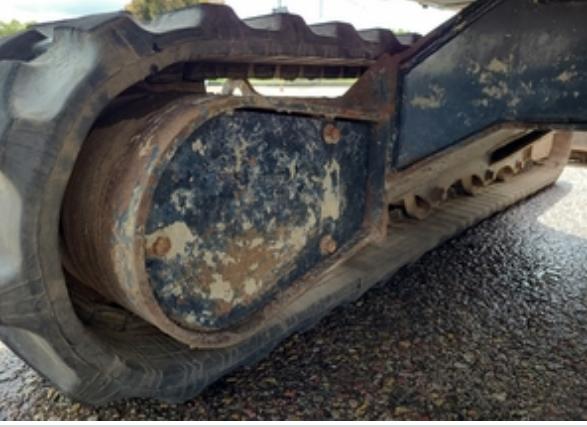
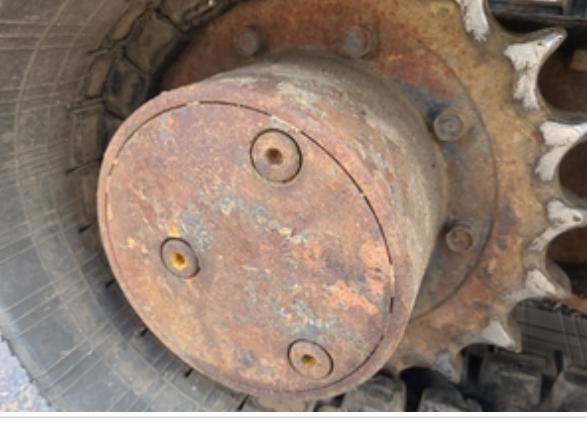
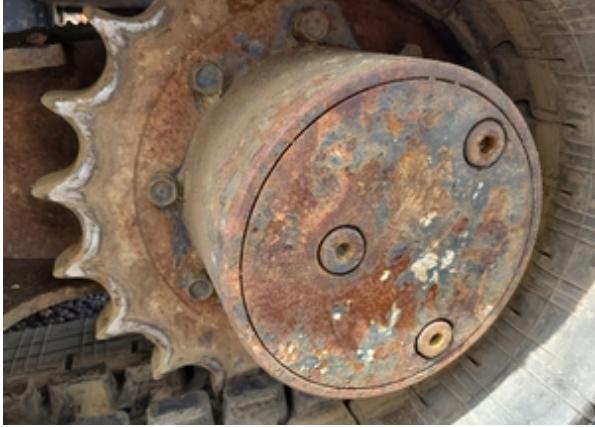
Hydrostatic Transmission?	Yes
2 Speed?	No
Hydrostatic Drive Configuration	Split Transmission
Drive Motors	2 - Above Average Wear
Hydrostatic Parking Brake	3 - Normal Wear & Tear
Hydrostatic Parking Brake Condition	Good brake function
Overall Drivetrain Comments	Drivetrain operating well in all directions. No obvious issues observed during the inspection.

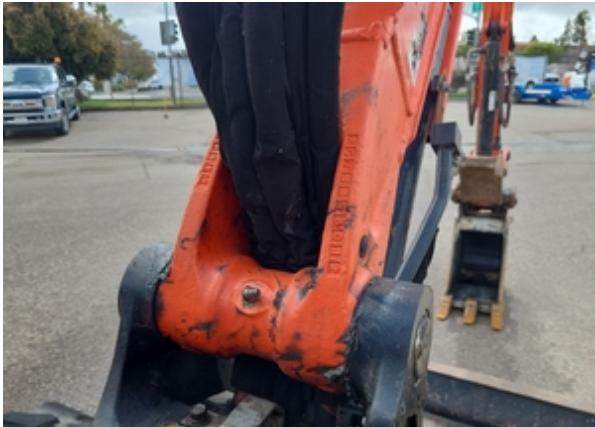
Boom Condition	3 - Normal Wear & Tear
Boom Photos

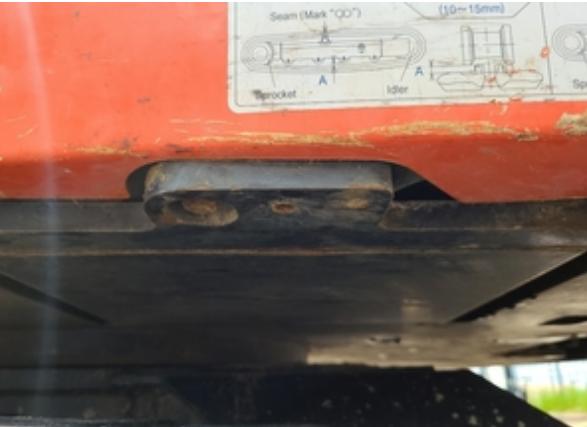
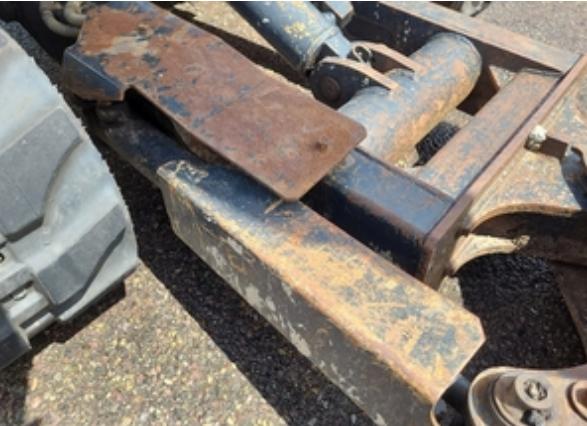
Boom Base Pin & Bushings	3 - Normal Wear & Tear
Boom to Stick Pin & Bushings	3 - Normal Wear & Tear
Stick to Bucket Pin & Bushings	3 - Normal Wear & Tear
Turntable Bearing	3 - Normal Wear & Tear

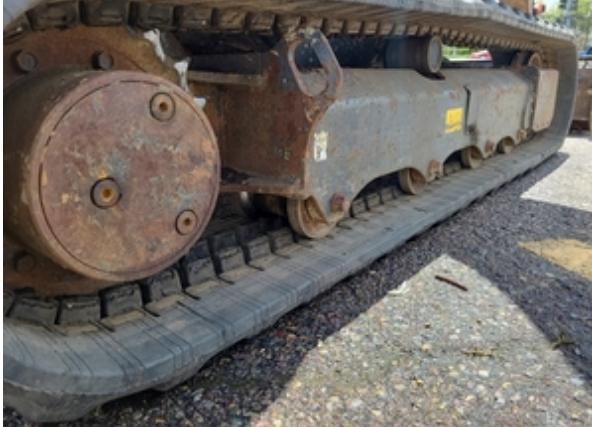
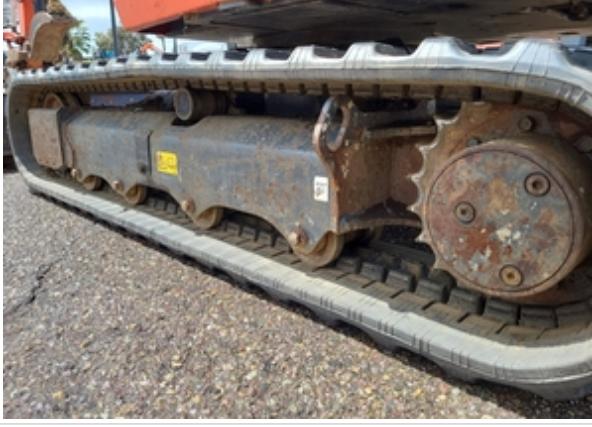
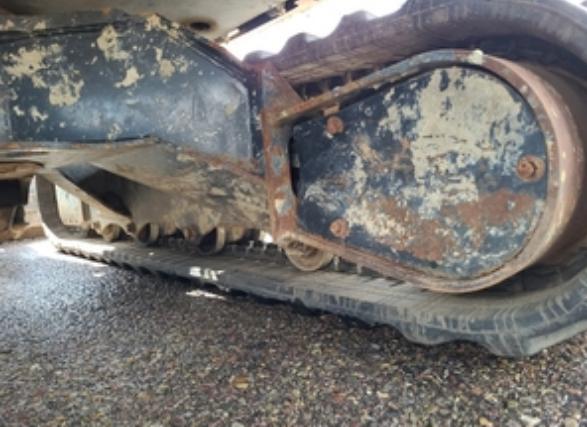
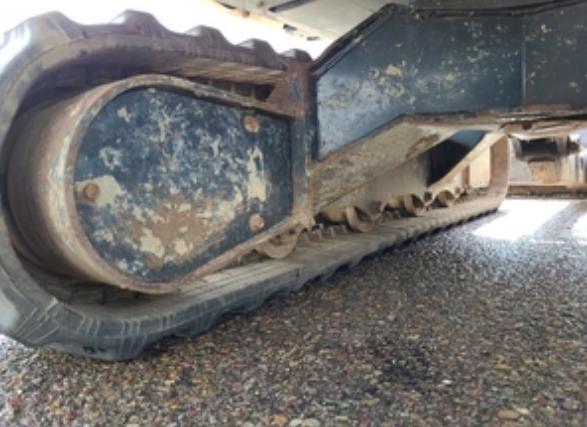
Track Width (inches)	12
Roller Frames	3 - Normal Wear & Tear
Roller Frames Photos

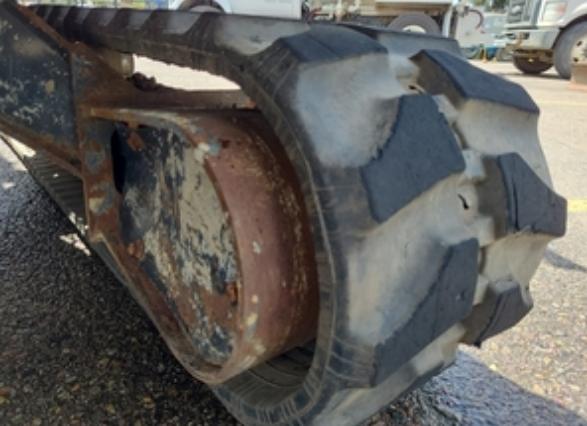
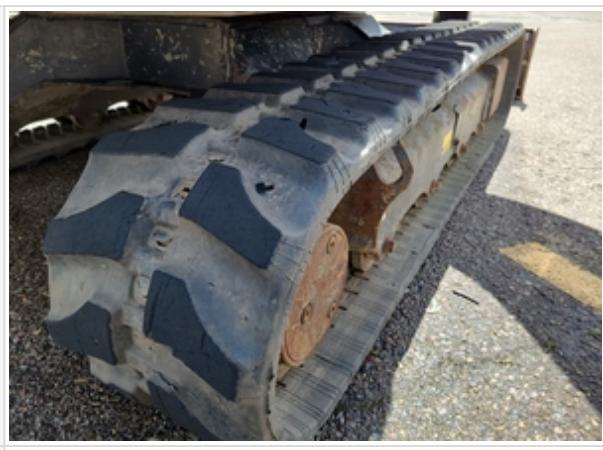
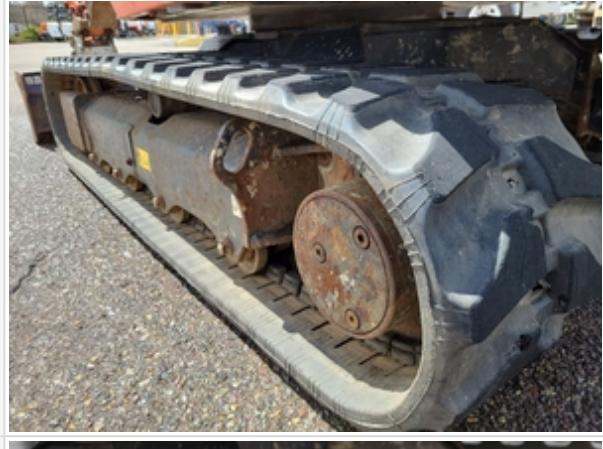
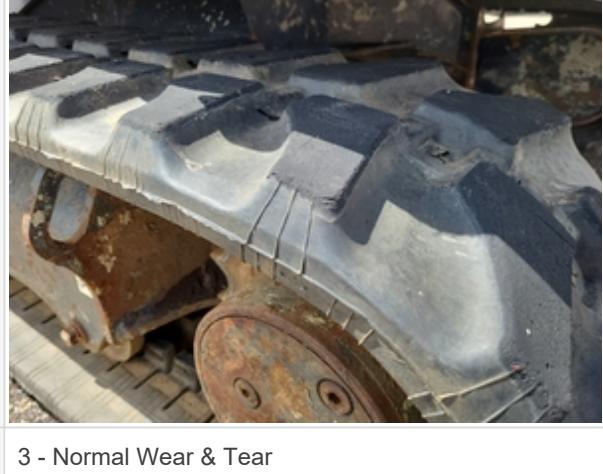
Track Belt	3 - Normal Wear & Tear
Track Belt Photos

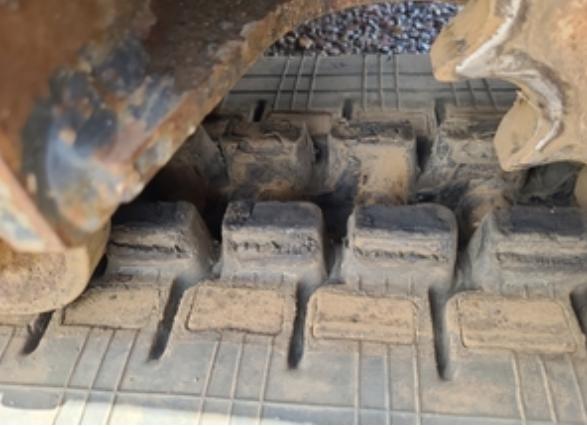
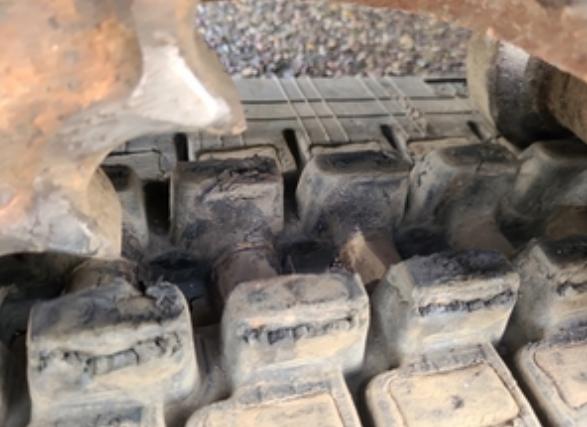
Rubber Belt Drive Lugs Photos

Rubber Belt Drive Lugs

3 - Normal Wear & Tear

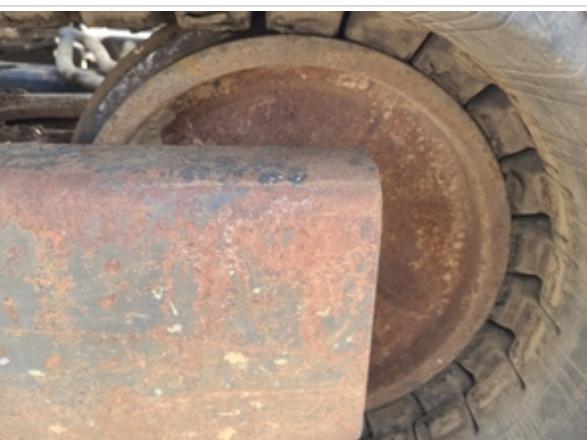
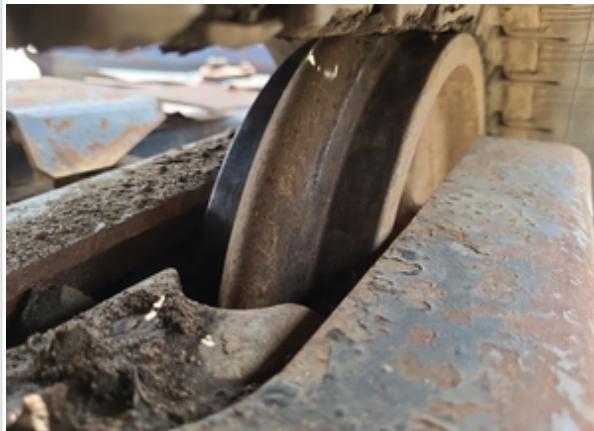
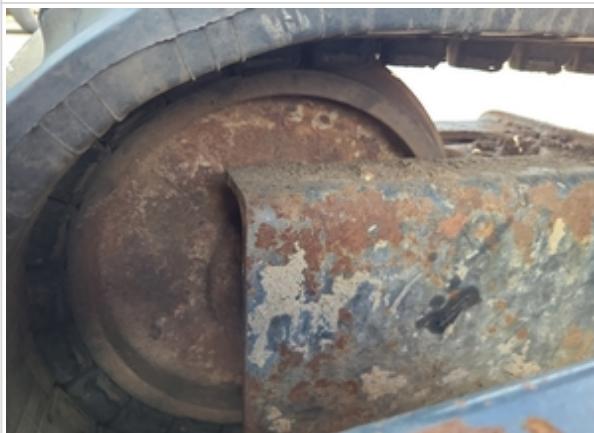
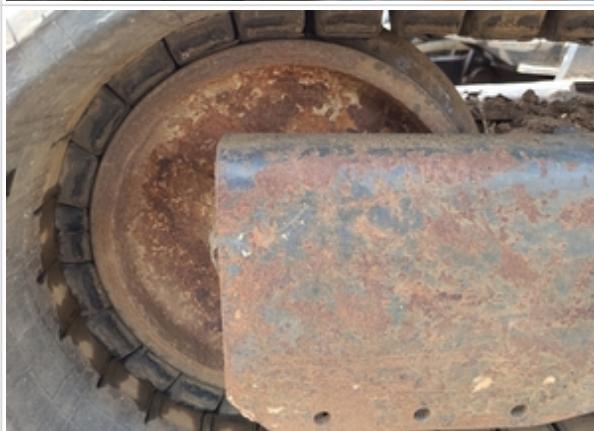
Track Tensioners	3 - Normal Wear & Tear
Front Idlers	3 - Normal Wear & Tear
Front Idlers Photos

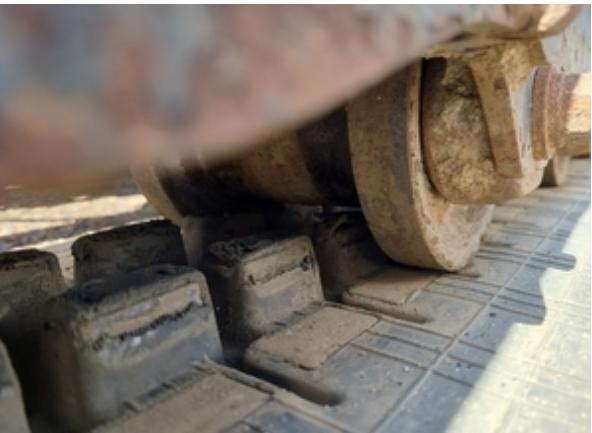
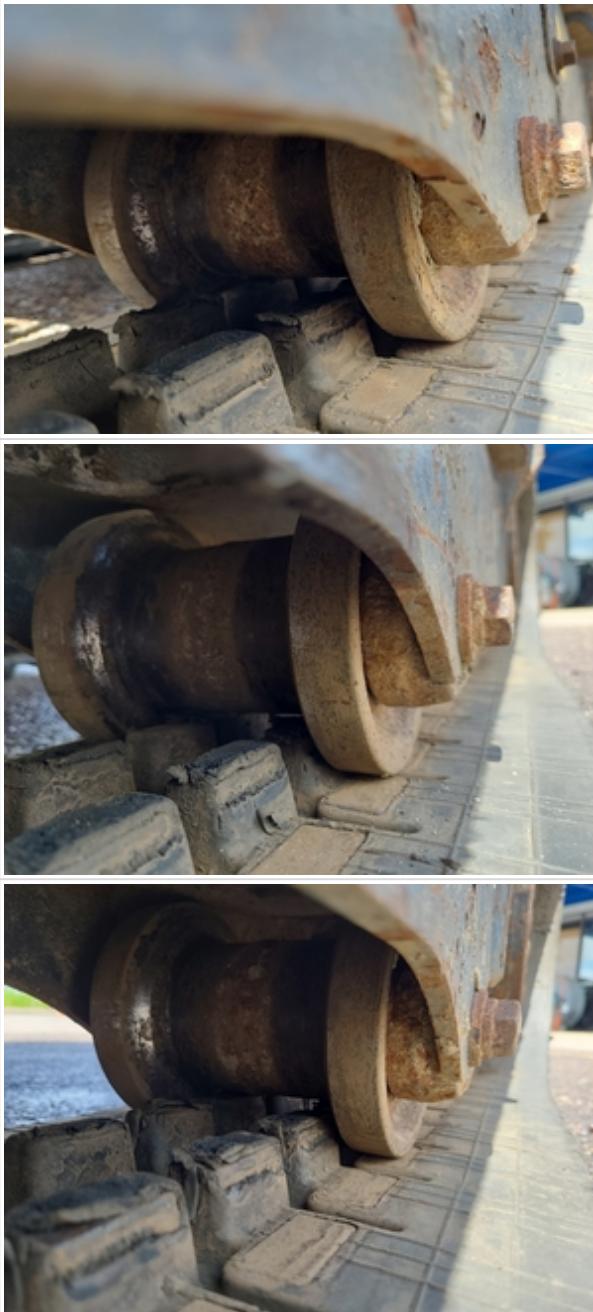
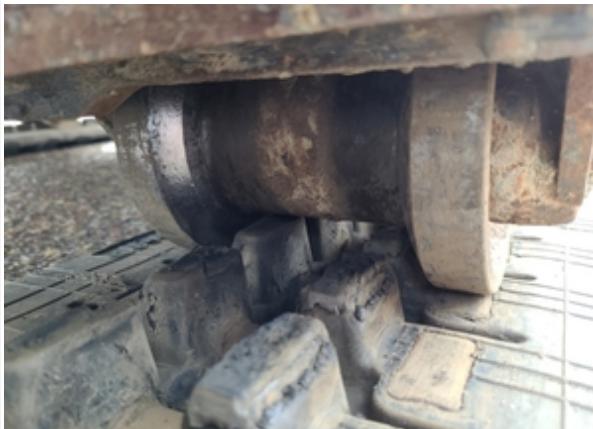
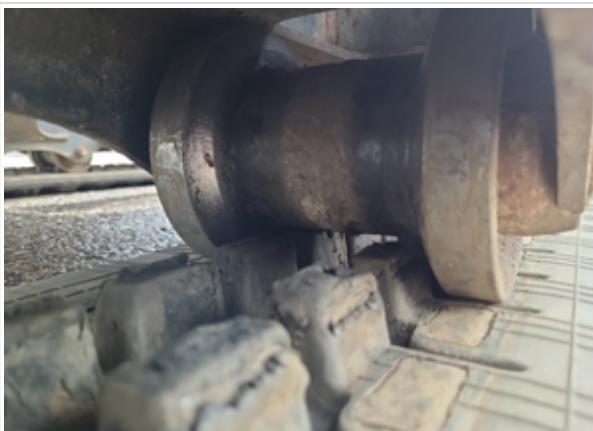
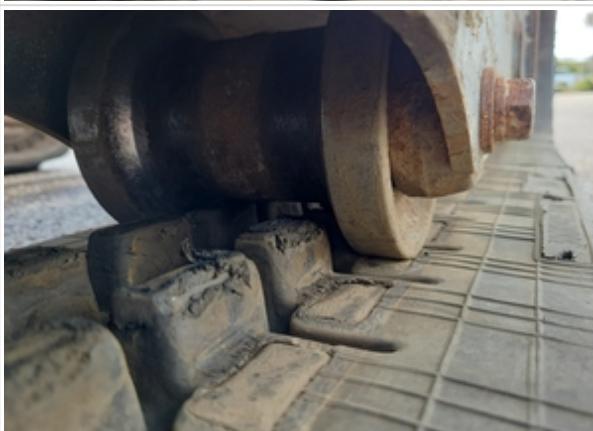
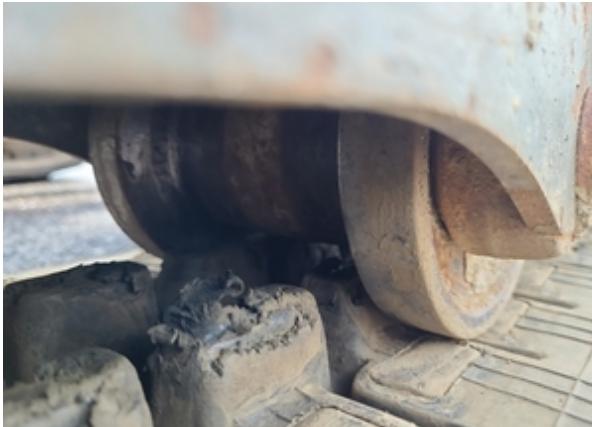
A close-up photograph of a track roller, showing significant rust and wear on the metal frame.
Rear Idlers	0
Track Rollers	3 - Normal Wear & Tear
Track Rollers Photos

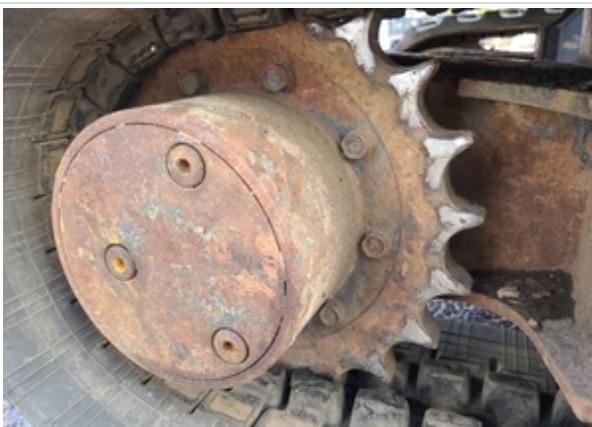
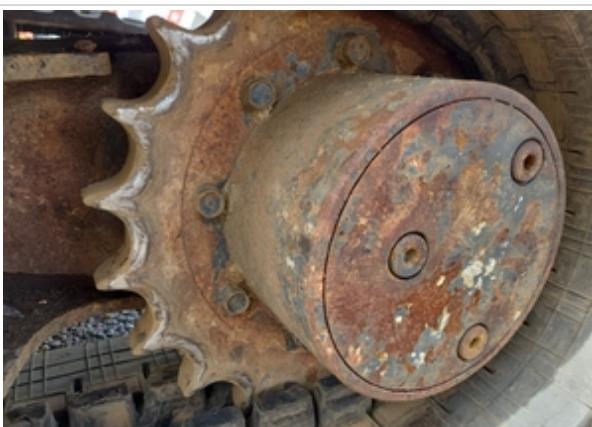
Sprockets	3 - Normal Wear & Tear
Sprockets Photos

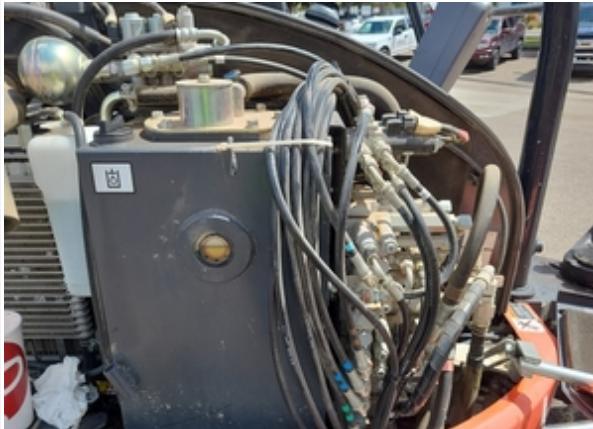
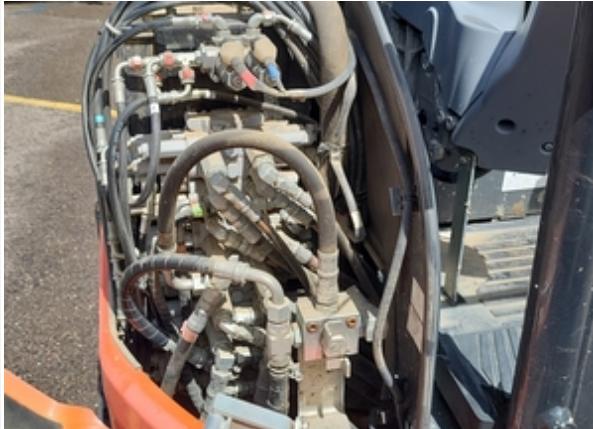
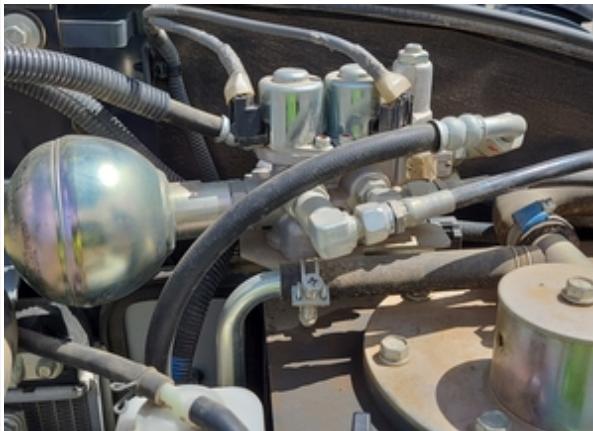
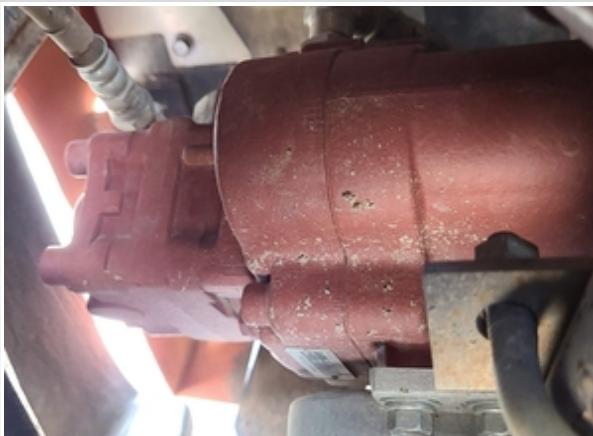
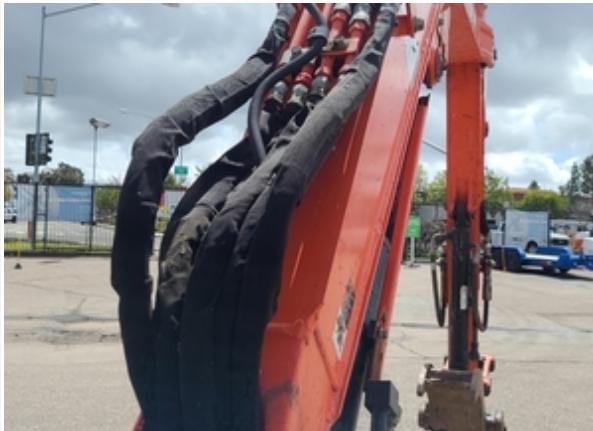
Hydraulic System Photos

Wet or Damp Hydraulic Lines / Fittings	No
Appearance of Hydraulic Lines / Fittings	3 - Normal Wear & Tear
Hydraulic Lines / Fittings Condition	Hydraulic lines & fittings are clean and in good condition
Unusual Noises (Hydraulic Pump)	No
Hydraulic Pump Notes	No unusual noises heard during operation
Comments	Hydraulic System has healthy appearance and no active leaks observed.

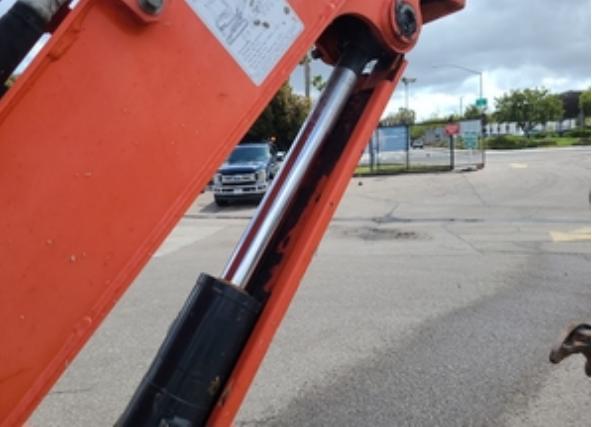
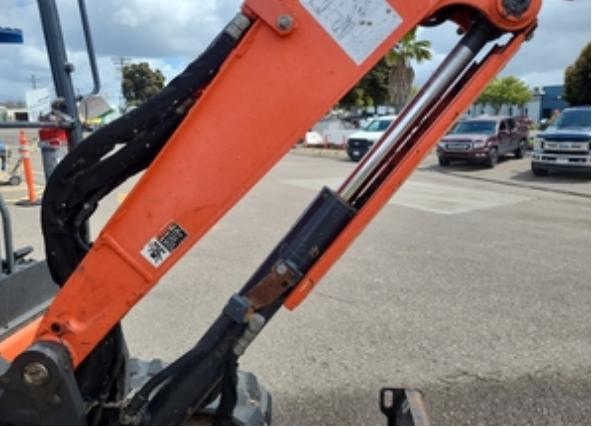
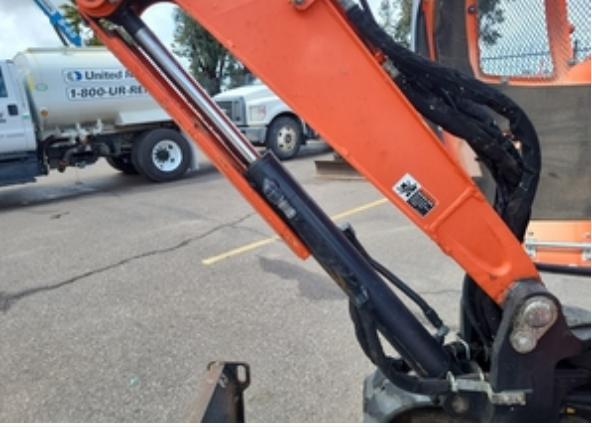
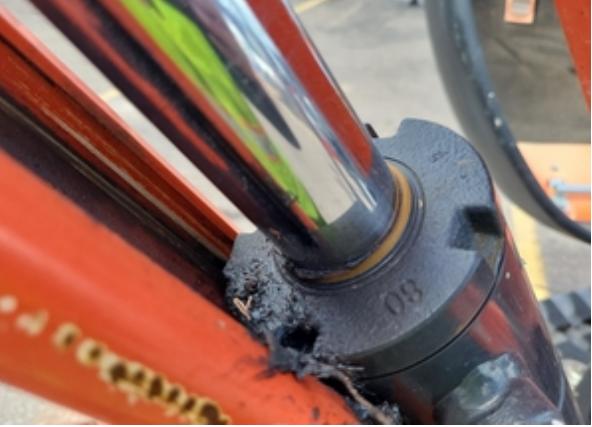
Boom Cylinder Photos

Boom Cylinder: Mounting Pin	3 - Normal Wear & Tear
Boom Cylinder: Oil Leaks	No

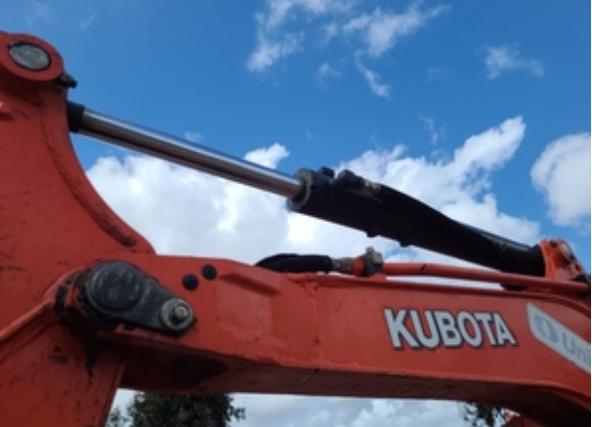
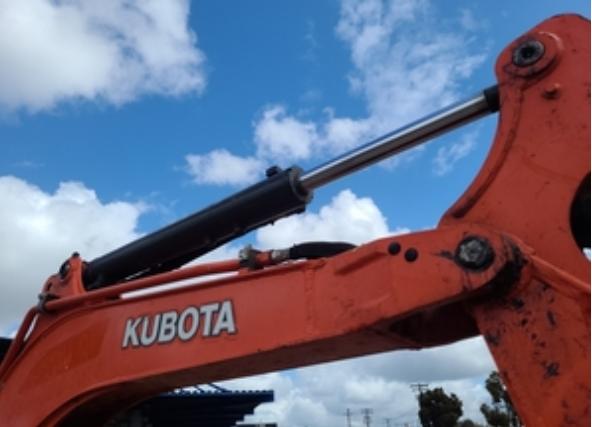
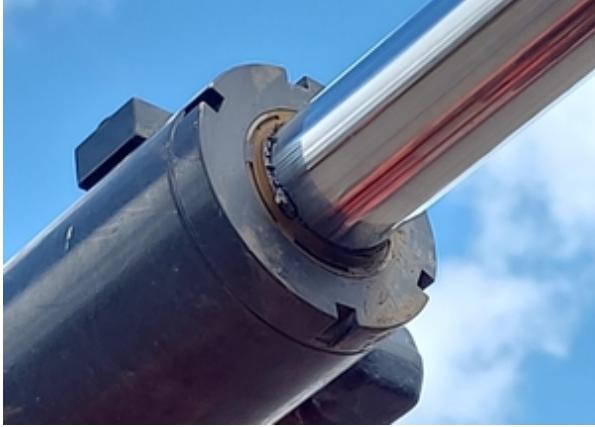
Stick Cylinder: Mounting Pin	3 - Normal Wear & Tear
Stick Cylinder: Oil Leaks	No
Stick Cylinder Photos

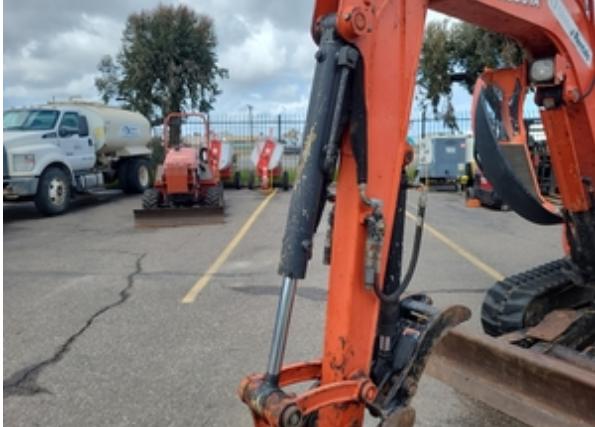
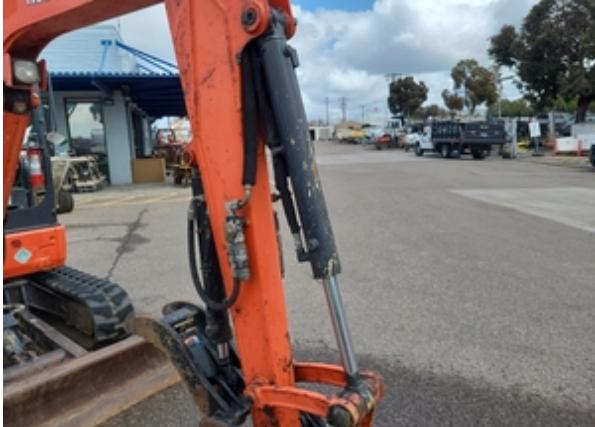
Bucket Cylinder: Mounting Pin	3 - Normal Wear & Tear
Bucket Cylinder: Oil Leaks	No
Bucket Cylinder Photos

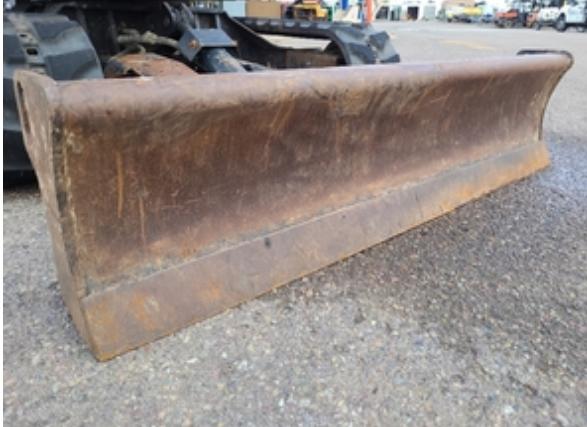
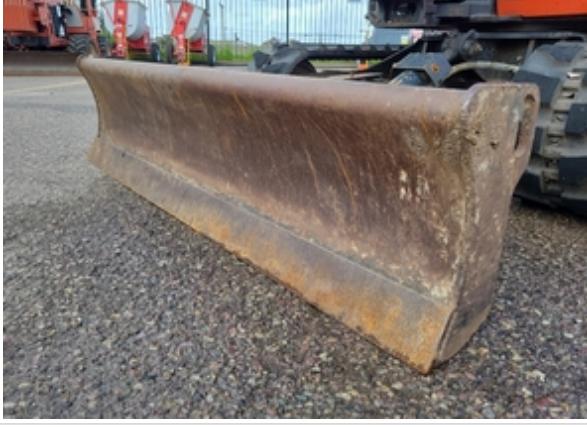
Blade	3 - Normal Wear & Tear
Comments	61" blade with Tilt Option Included
Blade Photos

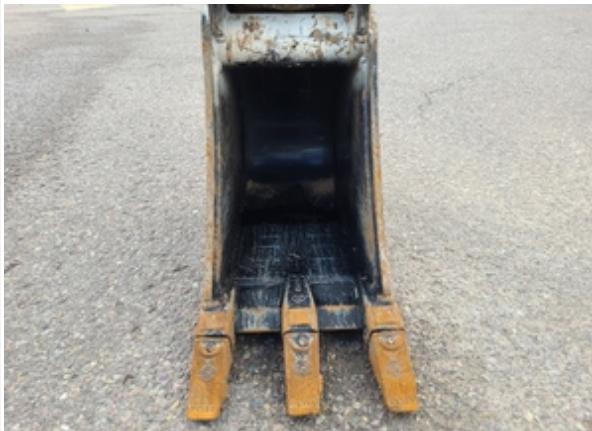
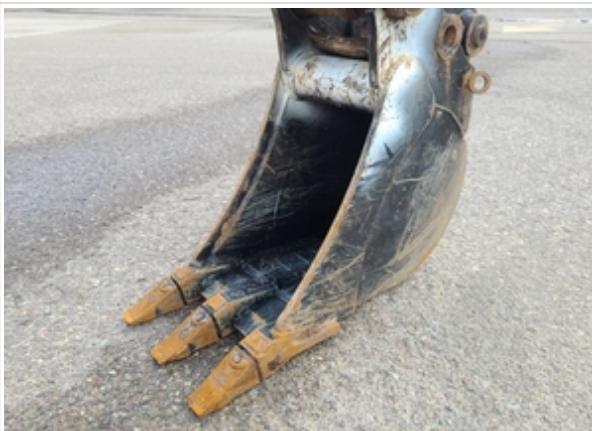
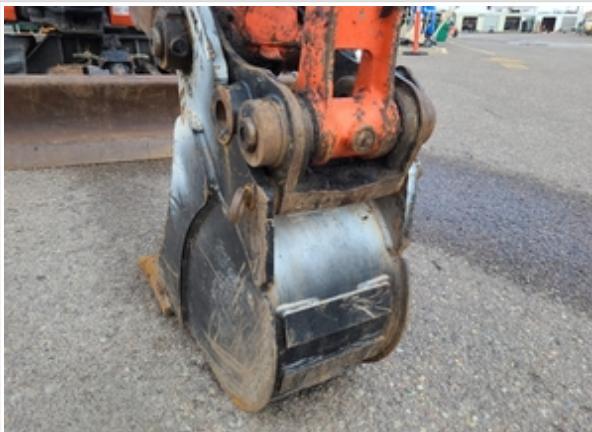
Bucket Condition	3 - Normal Wear & Tear
Comments	Bucket pin has improper retaining hardware
Bucket Photos	A photograph of a mini excavator's bucket, showing the metal digging edge and the hydraulic arm it is attached to. The bucket is positioned on a paved surface.

Pin retainer missing nut or should be replaced	
Bucket Hose & Fittings	3 - Normal Wear & Tear

What's Great About the Machine	Machine has well maintained appearance and no active leaks observed. Machine is equipped with lift and angle Tilt for front blade. Machine also has a hydraulic thumb with a 12" bucket in great condition. Low hours on this Machine and plenty of work life left.
What Needs Work	Cosmetic damage all around the main body of the machine. Bucket coupler pin retainer should be repaired.
Date/Time	03-30-2023

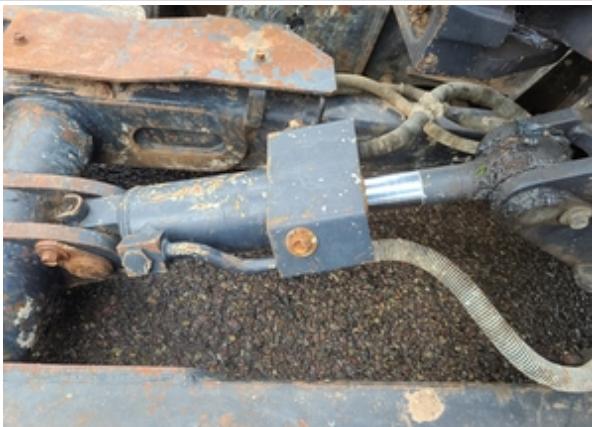
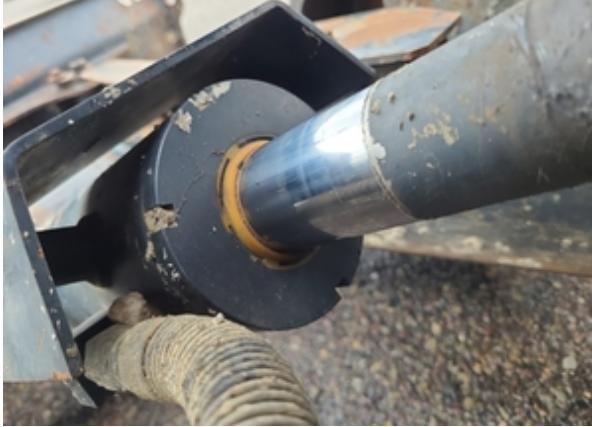
Blade Cylinder	3 - Normal Wear & Tear
Blade Cylinder Photos

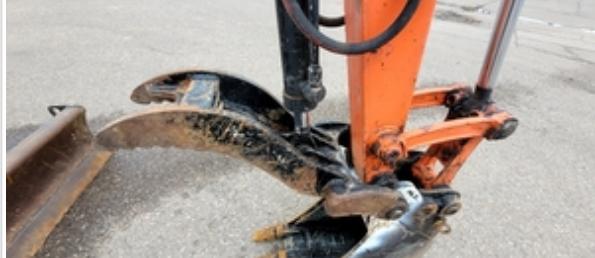
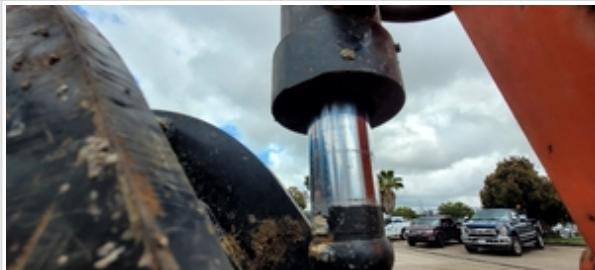
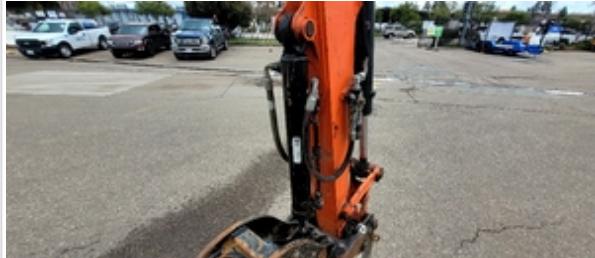
Attachment Type	Hydraulic Thumb
Attachment Make	N/A
Attachment Size / Specs	8" Wide
Attachment Condition	3 - Normal Wear & Tear
Attachment Photos
