## Inspection Report (Generator)

Year	2002
Make	300kW Kohler Generator (Enclosed Portable Trailer)
Model	30OREOZD-RT
Serial Number	O749039
Hour Meter Reading	3,870 Hrs.
Previous Application (e.g., earth moving, mining, demolition, etc)	N/A

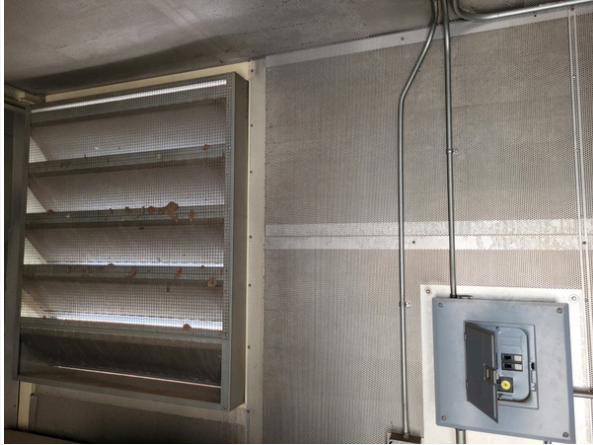
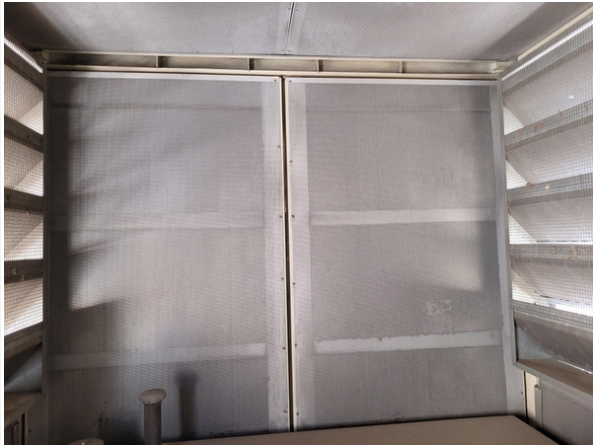
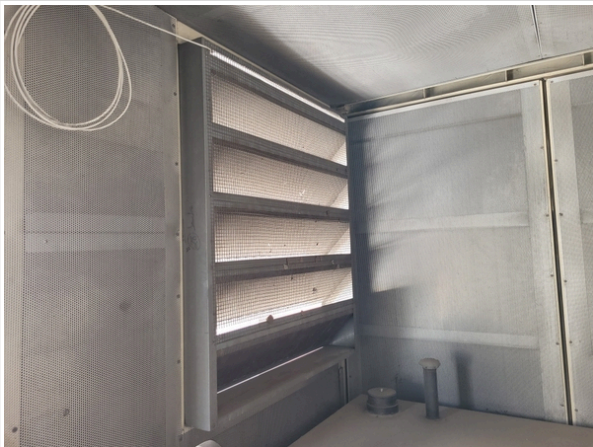
<b>Doors / Canopy Latches</b>	3 - Normal Wear & Tear	
<b>Doors / Canopy Latches Condition</b>	No visible damage	
<b>Steps / Ladders</b>	3 - Normal Wear & Tear	
<b>Steps / Ladders Condition</b>	Steps/ladders are fully intact and appear structurally sound	
<b>Handrails</b>	3 - Normal Wear & Tear	
<b>Handrails Condition</b>	Handrails are fully intact and appear structurally sound	
<b>Glass</b>	0

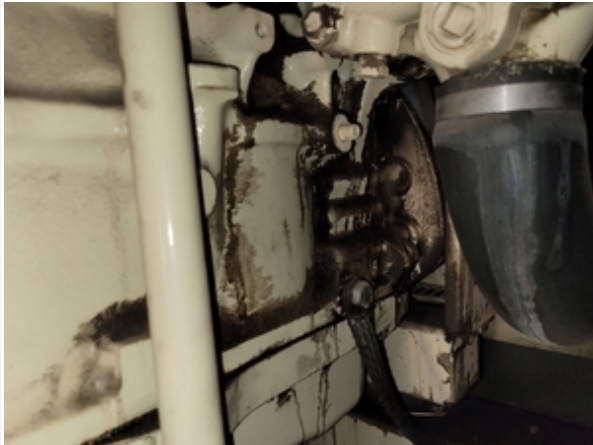
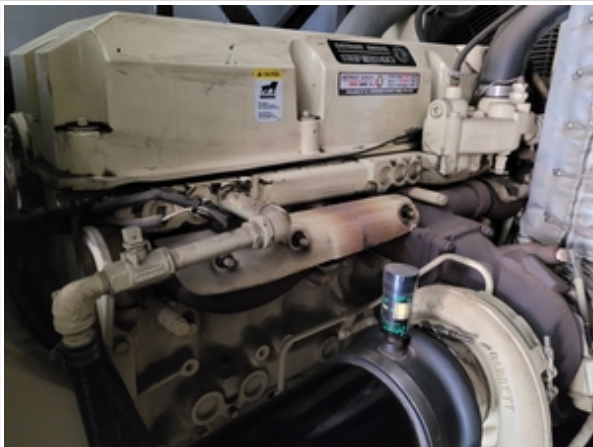
Belt Condition	Other (see comments)
Comments	Belts looked okay but fan shields obstructed clear view
Hoses	3 - Normal Wear & Tear
Hose Condition	Firm, pliant hoses with no signs of wear or leaks
Water Pump	3 - Normal Wear & Tear
Water Pump Condition	No unusual pump noises heard
Cooling System Leaks	No
Coolant Color / Appearance	3 - Normal Wear & Tear
Coolant Color/Appearance Notes	Normal Translucent appearance, no visual signs of contamination
Oil Leaks	Yes
Oil Leak Notes	Wetness & discoloration observed, Other (see comments)
Comments	Signs of active oil leaks seen at both sides of front engine cover and also around valve cover gasket
Oil Leak Photos

Overall Engine Comments	Signs of possible front engine oil leak seen. Oil pressure sensor not displaying on monitor panel.
-------------------------	--

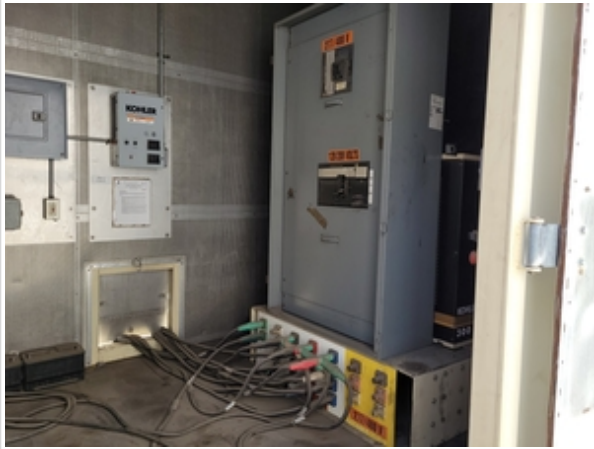
Electrical Connections	3 - Normal Wear & Tear

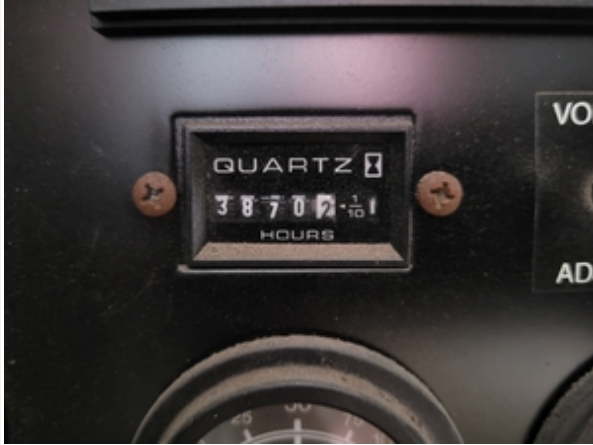
Hour Meter	3 - Normal Wear & Tear
------------	------------------------
