Inspection Report (Generator)

Year	2008
Make	L3 OFNW8
Model	MEP-805B
Serial Number	HX36952
Hour Meter Reading	840 Hrs.
Previous Application (e.g., earth moving, mining, demolition, etc)	U.S.A. Military Generator

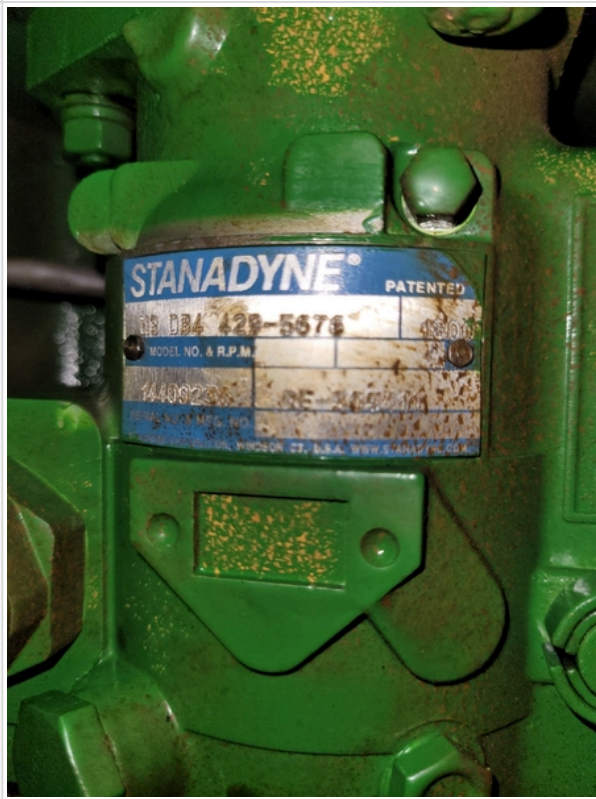
Engine Fuel Type	Diesel
Engine Photos

Engine Type (Make, Model, Cylinders, Hp)	John Deere - 4045TF - 4Cyl. - 4.5L - 111Hp.
Emissions Tier	Tier 3
Engine Serial Number	748228 (Last 6)

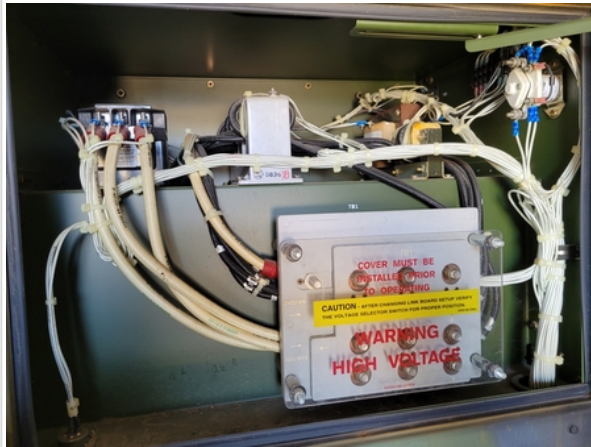
Wire Harness Photos

Wire Harness	3 - Normal Wear & Tear
--------------	------------------------

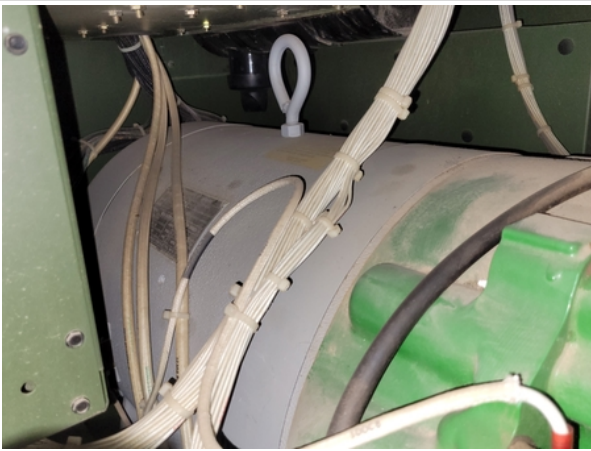
Cables & Fittings	3 - Normal Wear & Tear	
Cables & Fittings Photos

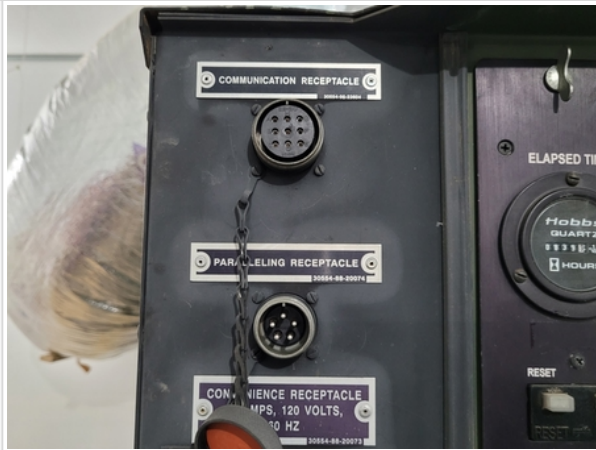
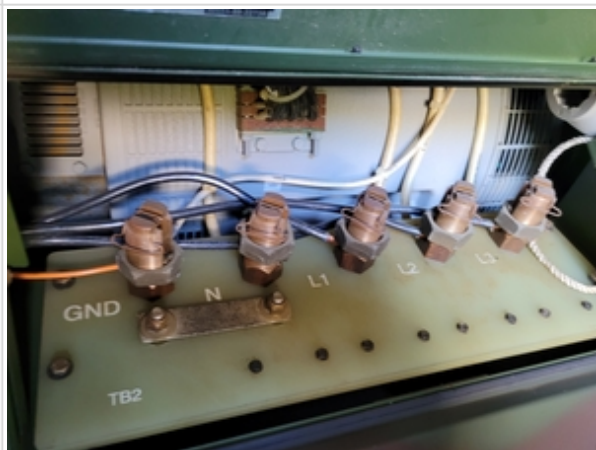
<p>Electrical Connections Photos</p>

Electrical Connections	3 - Normal Wear & Tear

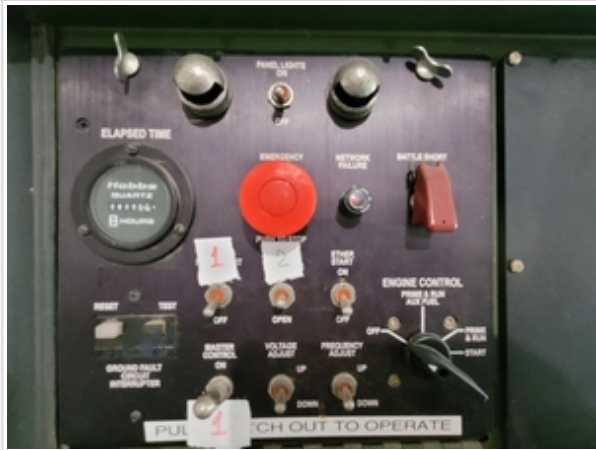
Disconnect Switch	3 - Normal Wear & Tear
Disconnect Switch Photos

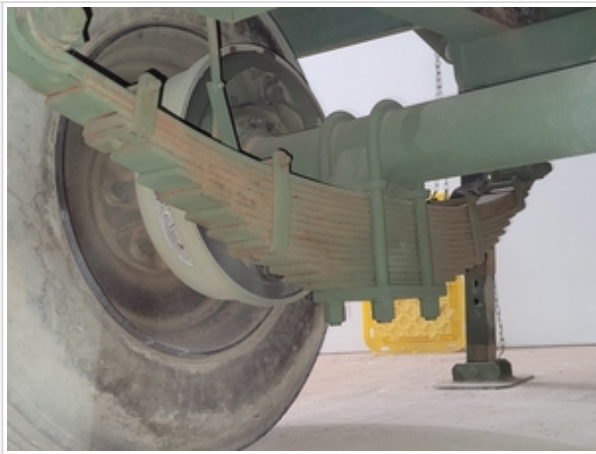
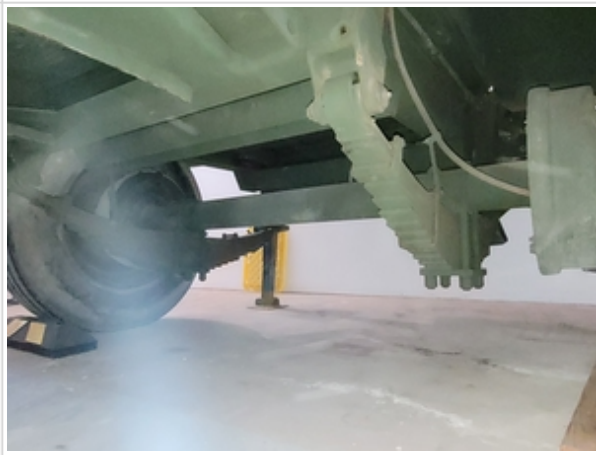
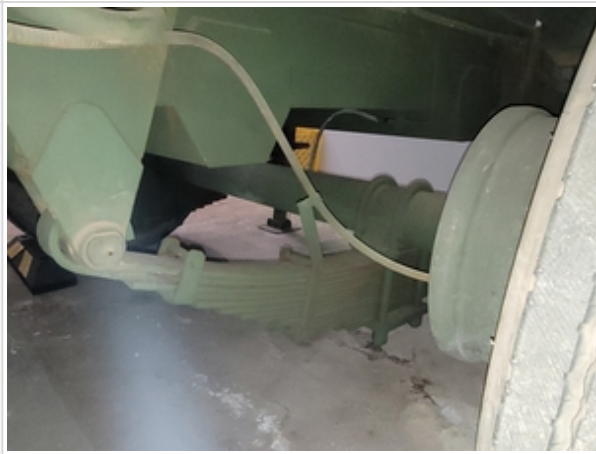
Brake Type	Air Brakes, Other (see comments)	
Comments	Air/Mechanical, brake chamber to mechanical cable to brake drums	
Air Brake System Leaks	N/A	
Air Lines Condition (Between Trailers, Gladhands, Rubbers)	3 - Normal Wear & Tear	
Brake Shoe Thickness	70%	
Comments	Drum brakes covered, Estimated percentage based on hours and years	
Brake Shoe Photos
