Inspection Report (On-Highway Truck Cab + Chassis)

Year	2013
Make	Chevrolet
Model	2500HD
Serial Number	1GC2CXCG8DZ289731
Truck Odometer Reading	195,618
Previous Application (e.g., earth moving, mining, demolition, etc)	Equipment Rental

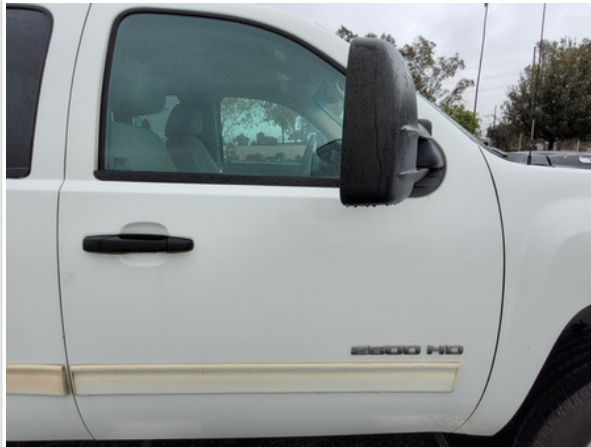
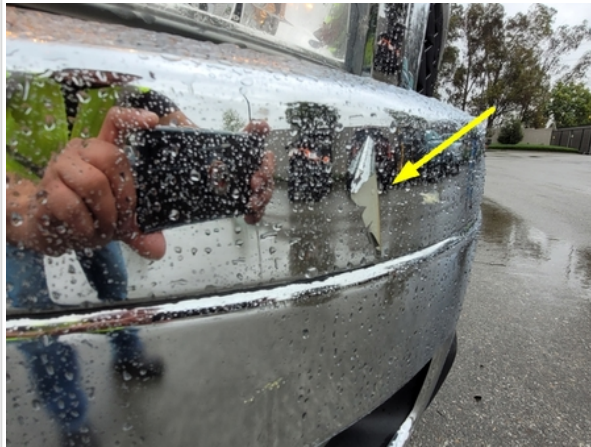
Small Chrome Film Peeling Off

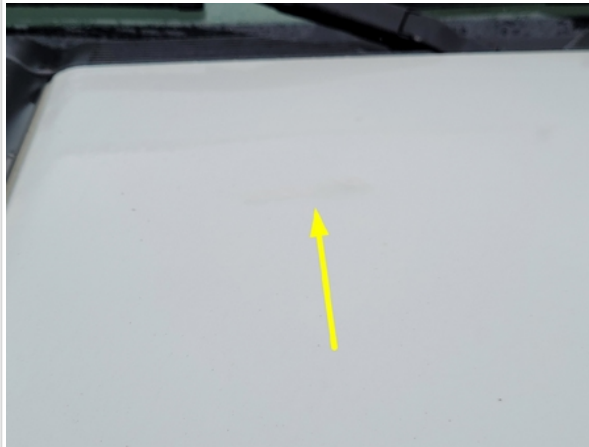
Small dent at pointed area

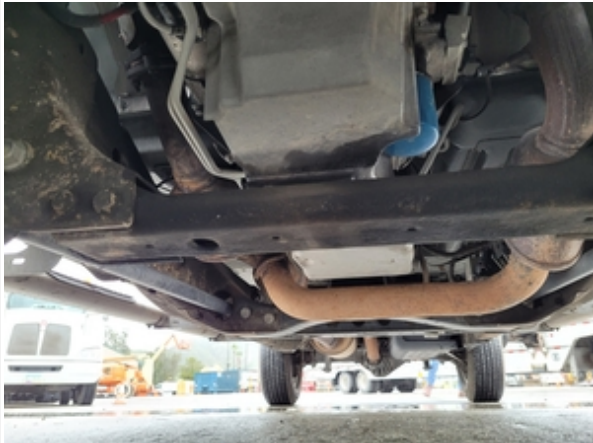
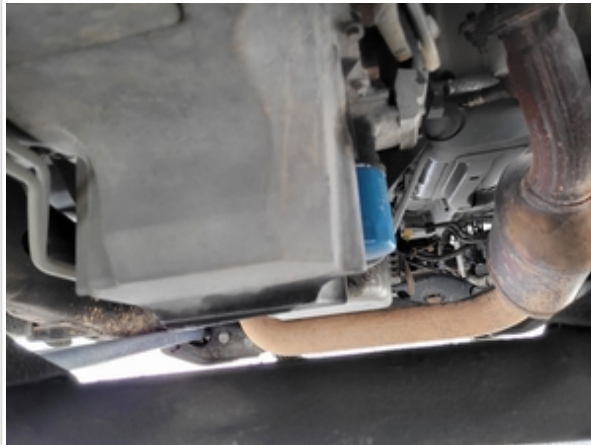
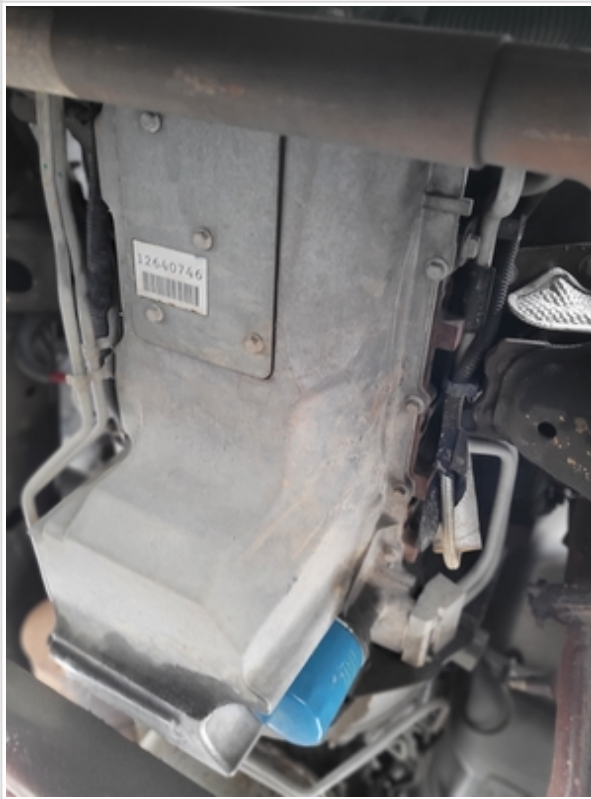
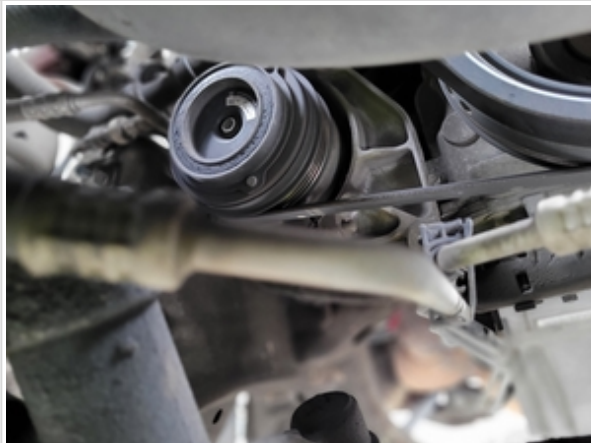
Engine Type (Make, Model, Cylinders, Hp)	Chevy Vortec - 6.0L - V8 - 360HP
Emissions Tier	Other (see comments)
Comments	Engine setup for FlexFuel Gasoline/E85
Engine Serial Number	N/A
Engine Fuel Type	Gasoline
Engine Photos

Blow-by (Visual Observation Check)	N/A	
Unusual Noises (Upon Start-up, Idle, Shutdown)	Yes	
Unusual Noise Notes	Other (see comments)	
Comments	Front engine sound observed at initial startup and went away after a few minutes of running. This may be related to front serpentine belt and/or pulley system and should be further inspected for proper diagnosis.	
Engine Smoke (Upon Start-up, Idle, Shutdown)	No	
Engine Smoke Notes	No engine smoke issues observed	
Engine Exhaust Color	Clear	
Battery	3 - Normal Wear & Tear	
Battery Condition	Dusty & dirty appearance, Clean & dry appearance, tight connections	
Radiator	3 - Normal Wear & Tear	
Radiator Condition	Radiator fins & components appear to be in good working order, no signs of damage or leaks	
Belts	3 - Normal Wear & Tear	
Belt Condition	Belts appear in good condition & alignment with proper tension

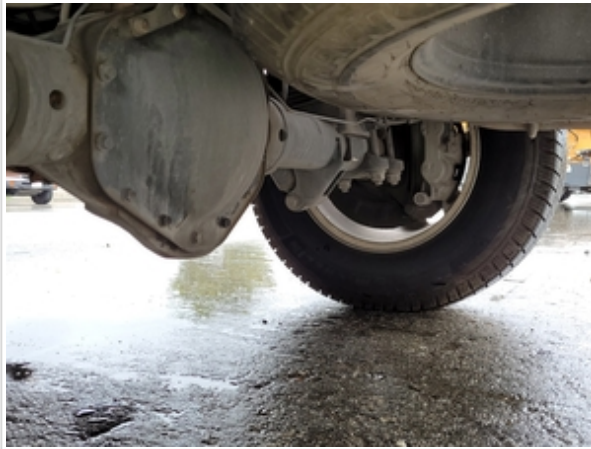
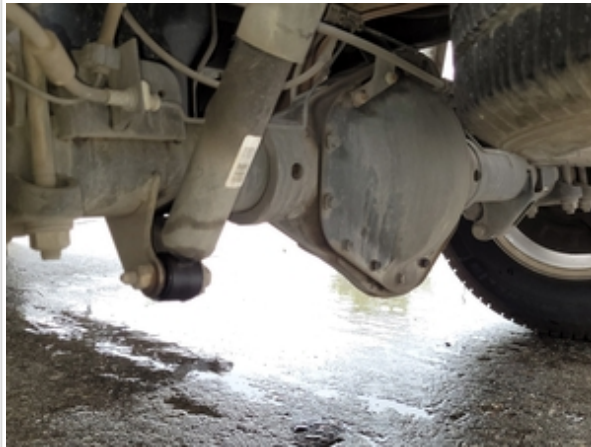
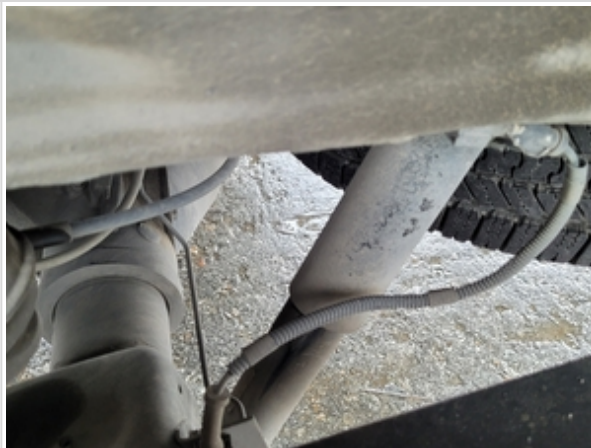
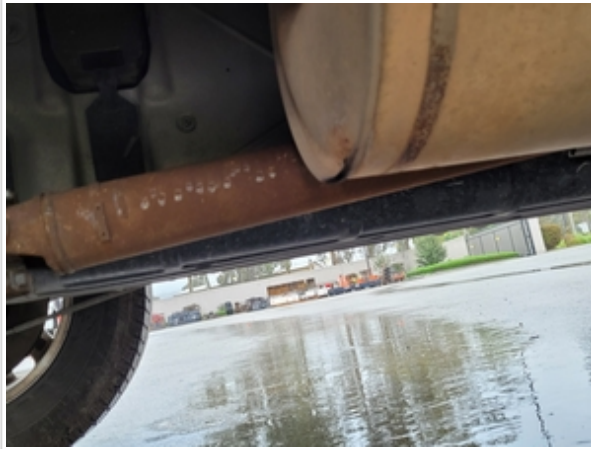
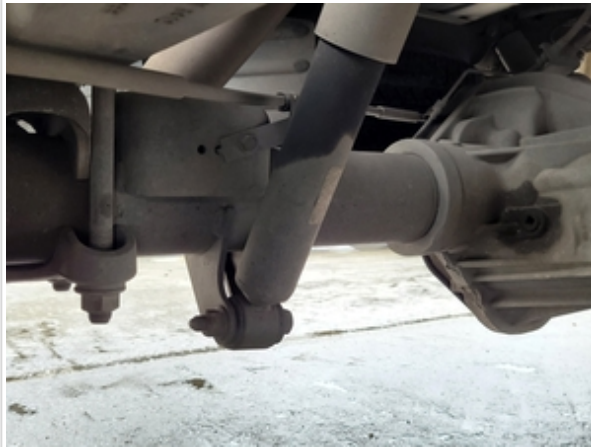
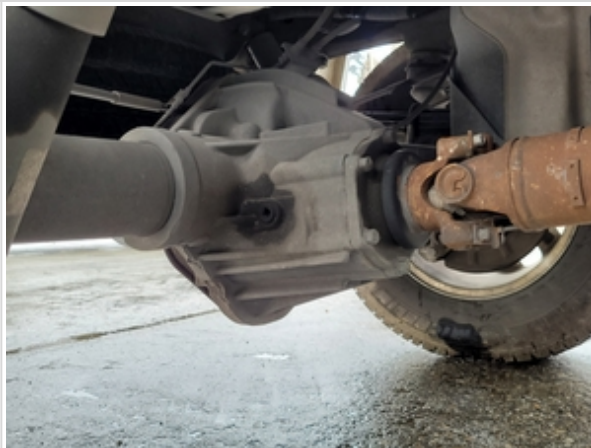
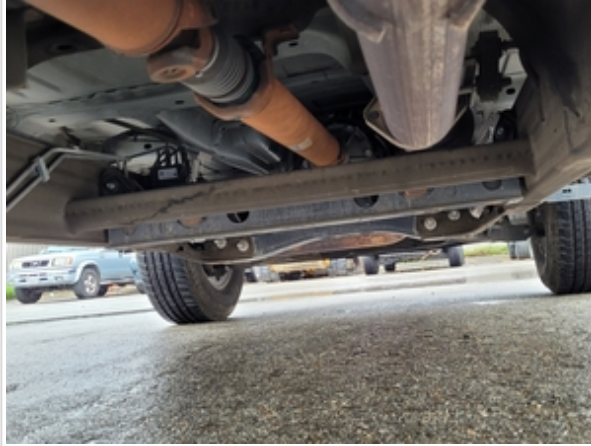
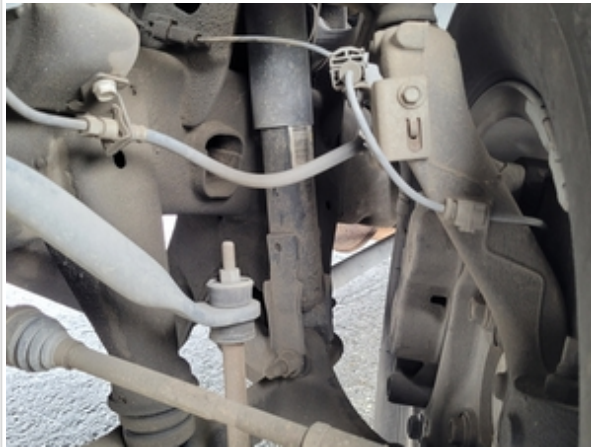
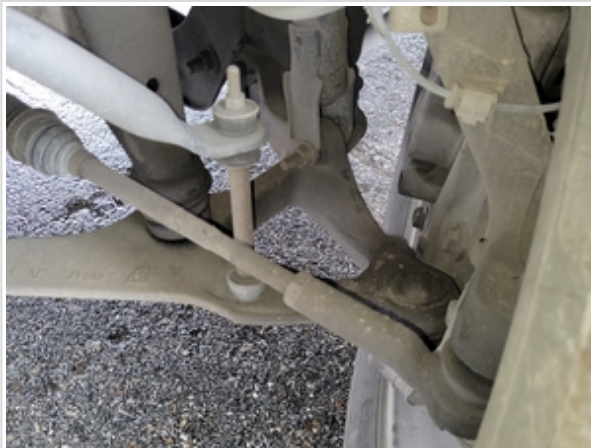
Frame	3 - Normal Wear & Tear	
Suspension	3 - Normal Wear & Tear	
Comments	Rear shocks oil seepage observed and should be replaced for optimal performance.	
Steer Axle Condition	3 - Normal Wear & Tear	
Steering Components	3 - Normal Wear & Tear	
Steering Component Photos

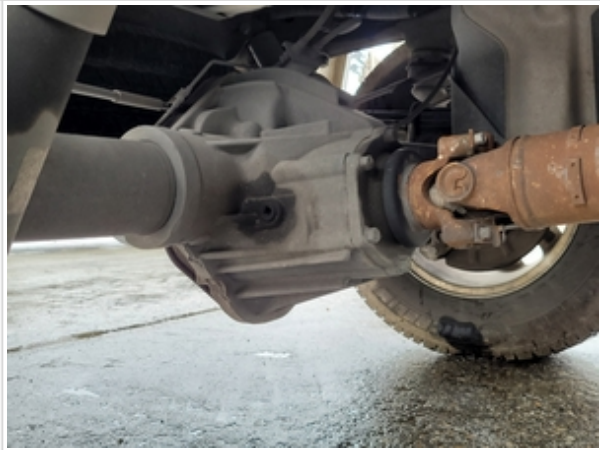
Transmission Info (Make/Model)	Automatic - 6 Speed	
Transmission	3 - Normal Wear & Tear	
Transmission Condition	No unusual noises or vibrations	
PTO	0	
Differential	Check condition of the differential(s). Take photos and notes as relevant.	
Rear Differential	3 - Normal Wear & Tear	
Rear Differential Condition	Dry housing appearance, no unusual noises heard during operation	
Rear Differential Photos

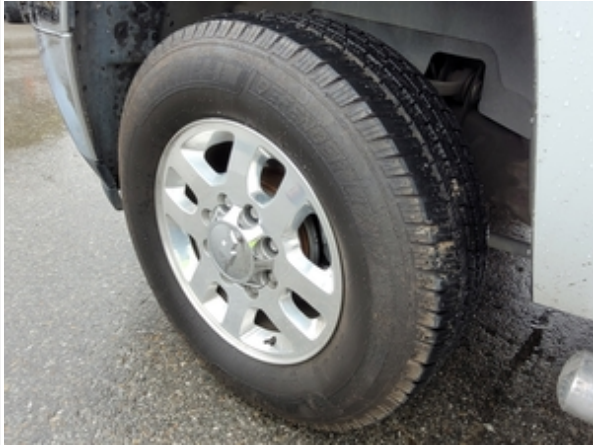
Wheels & Hub Condition	3
Wheel Seal Leaks	No
Tire Brand	Michelin
Tire Size	LT265/70R18
Front Left Tire - Ratio Remaining	90%
Front Left Tire Photos

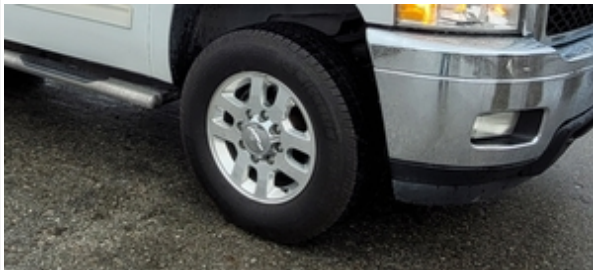
Front Right Tire - Ratio Remaining	90%
Front Right Tire Photos

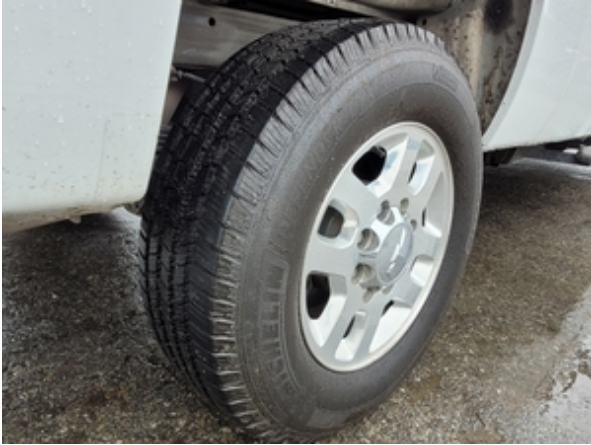
Rear Right Tire Photos

Rear Right Tire - Ratio Remaining	90%

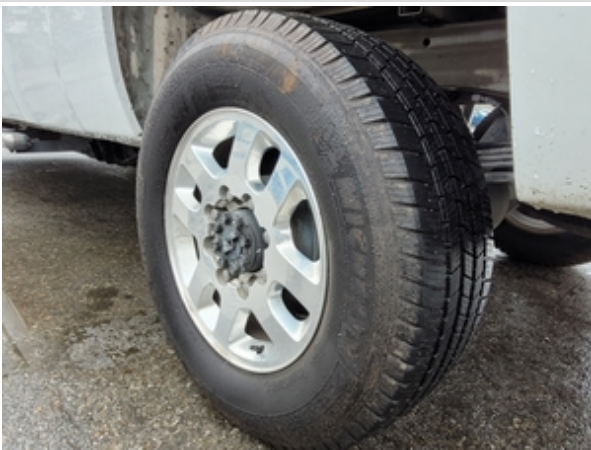
Rear Left Tire - Ratio Remaining	90%
Rear Left Tire Photos
