Inspection Report (Backhoe Loader)

| Make | CAT |
| Model | 420F |
| Serial Number | SKR00900 |

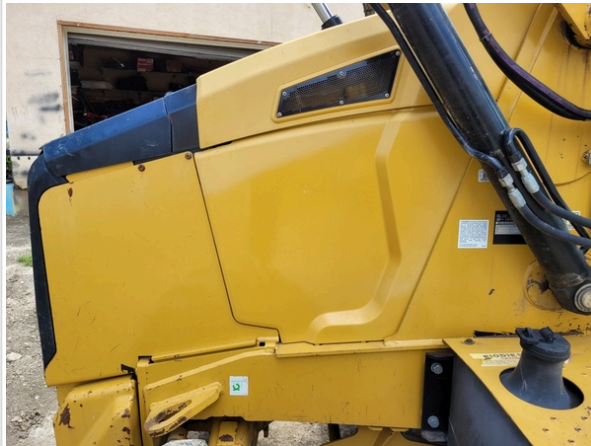
Fiberglass crack

| Comments | Right side engine panel has small crack, Front Top Side of hood has dent. Minor scuff marks all around |

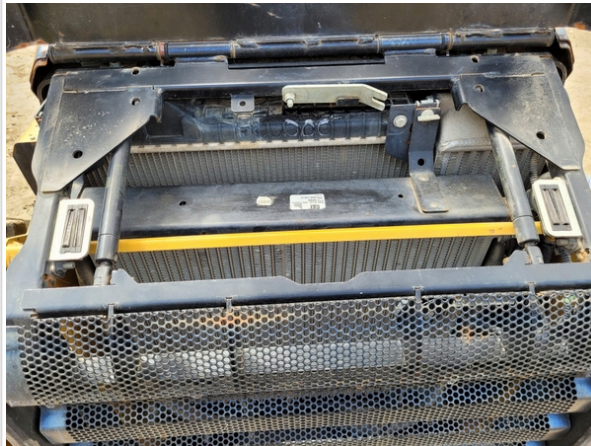
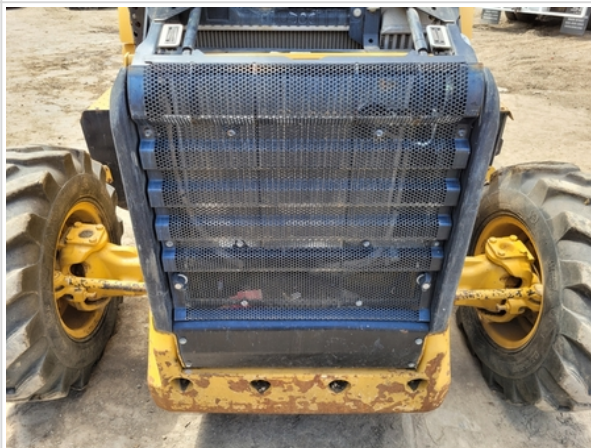
Top hood dented

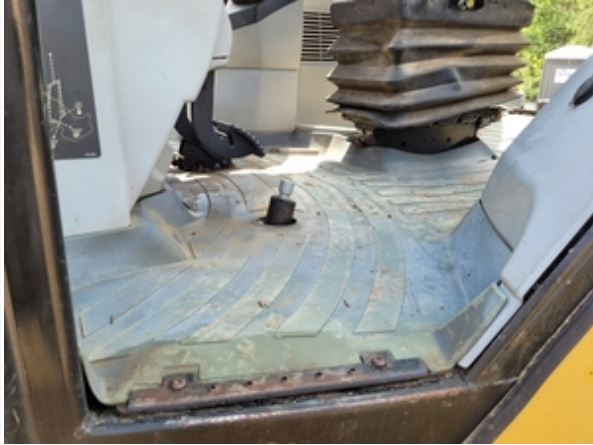
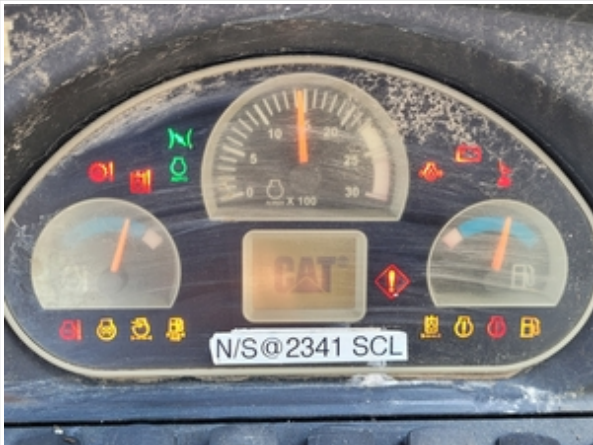
| Operator Seat | 2 - Above Average Wear | |
| Operator Seat Condition | Seat(s) has major surface staining or tears, Seat belt secures properly | |
| | Seat Torn | |

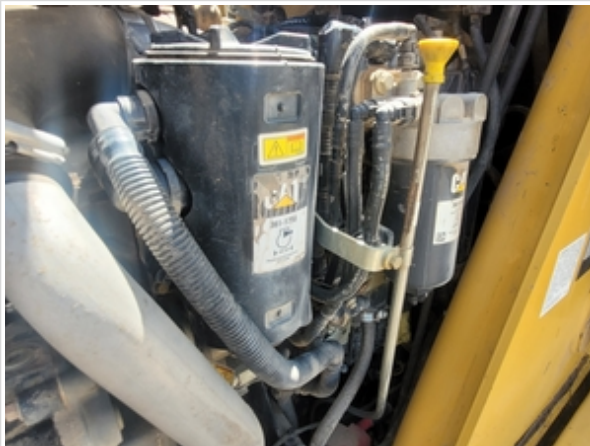
Engine sensor wiring damaged

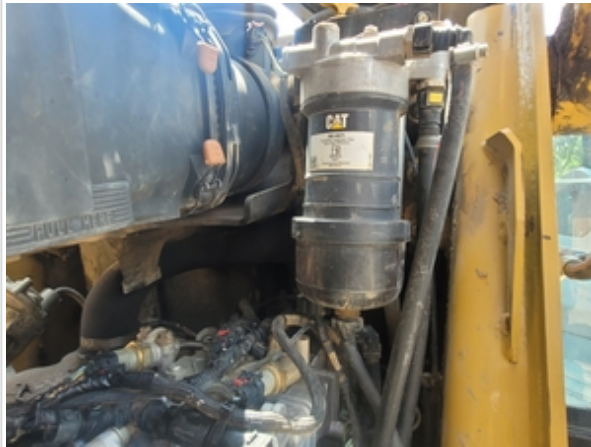
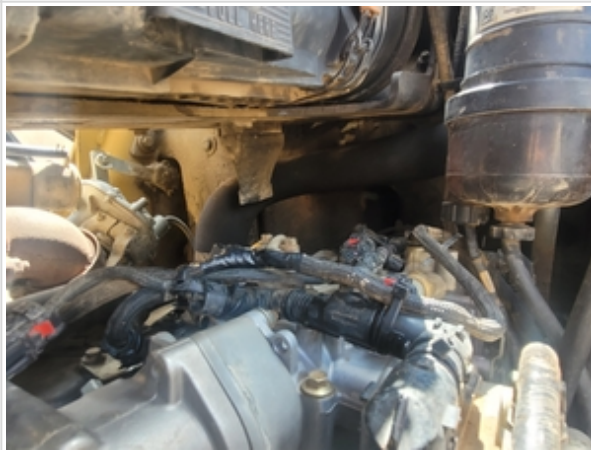
Residual oil buildup on valve cover. No active leak seen

| Overall Engine Comments | Engine in good shape and no active leaks observed. Top of valve cover has some residual oil/dirt buildup and should be further inspected for possible engine oil seepage or leak. |

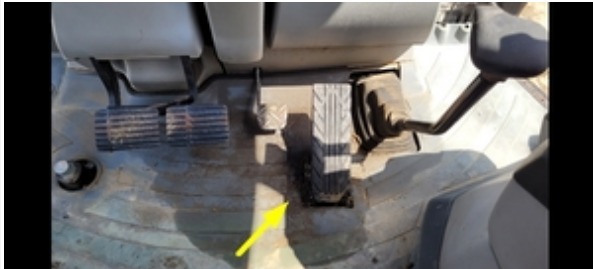
| Foot Brake Condition | Good brake function, Other (see comments) |
| Comments | Possible minor leak around foot brake valve |
| Foot Brake Photos | <p>Residual oil around brake pedal (may be slightly leaking)</p> |

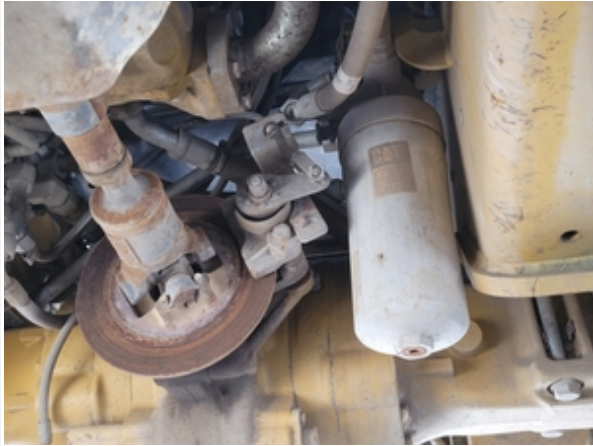
| Parking Brake Condition | Good brake function | |

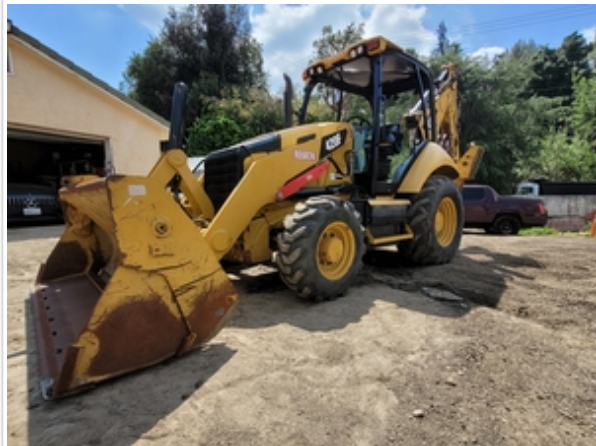
| Stance | 3 - Normal Wear & Tear |

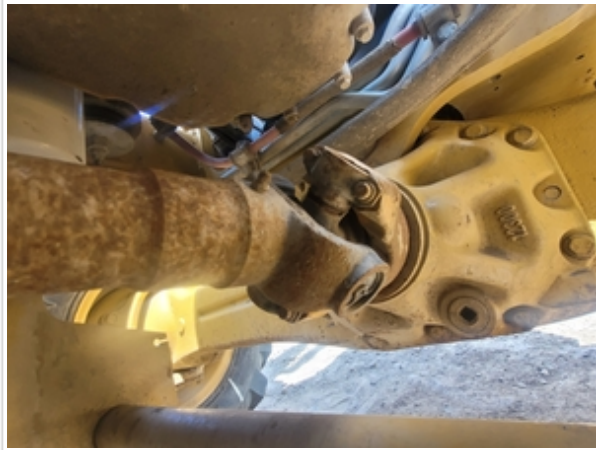
| Front Axle Appearance | 3 - Normal Wear & Tear |

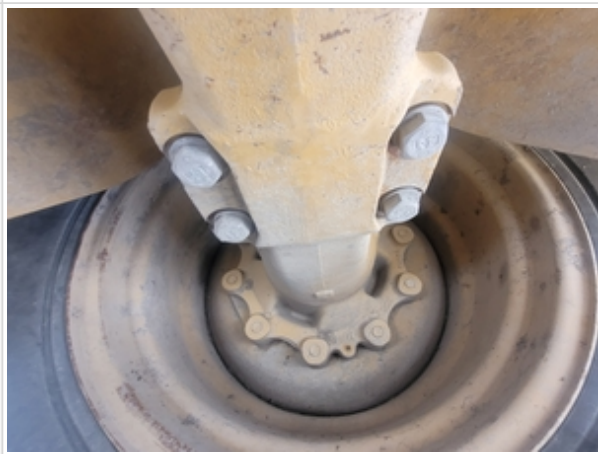
| Rear Axle Appearance | 3 - Normal Wear & Tear | |

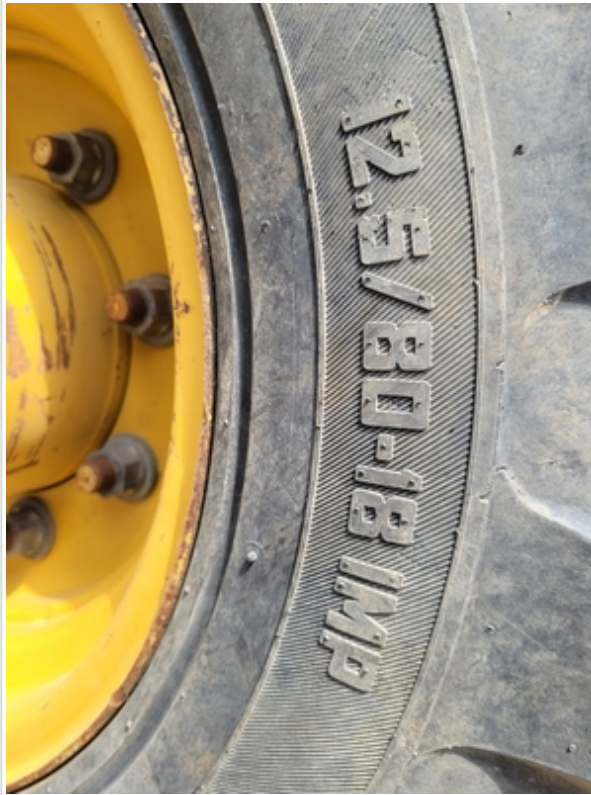
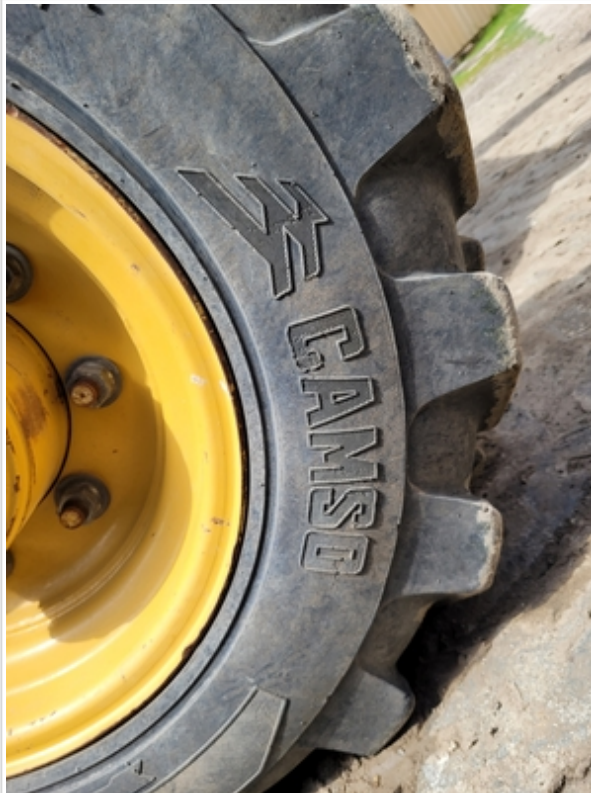
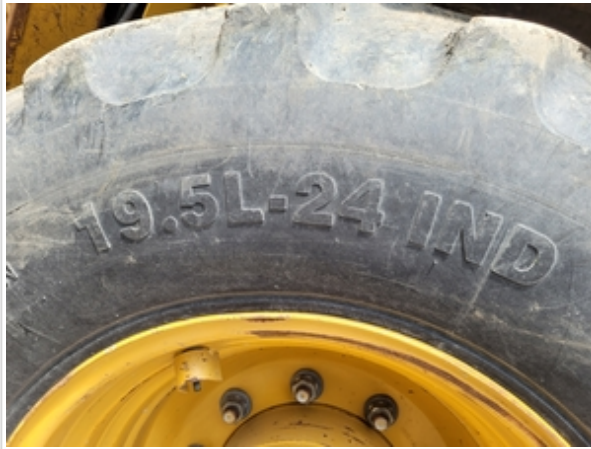
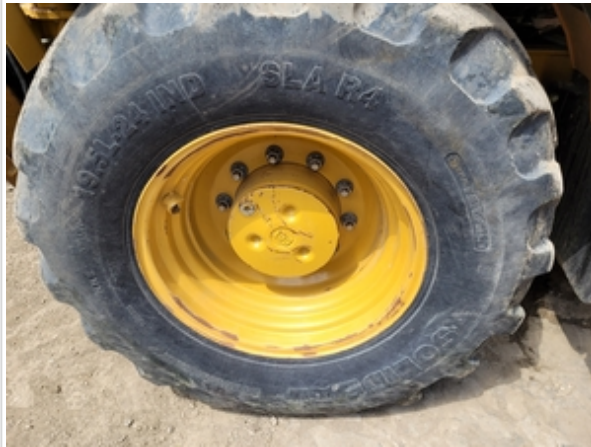
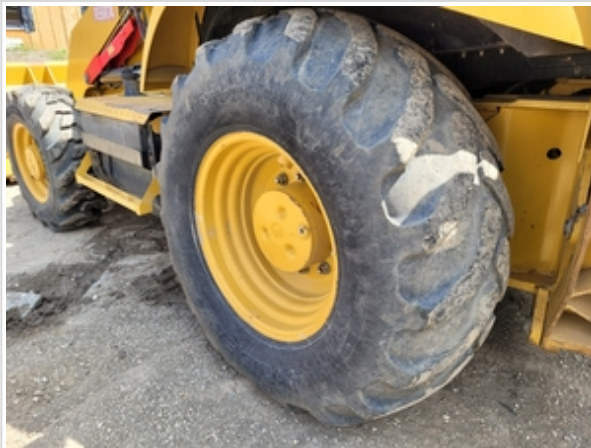
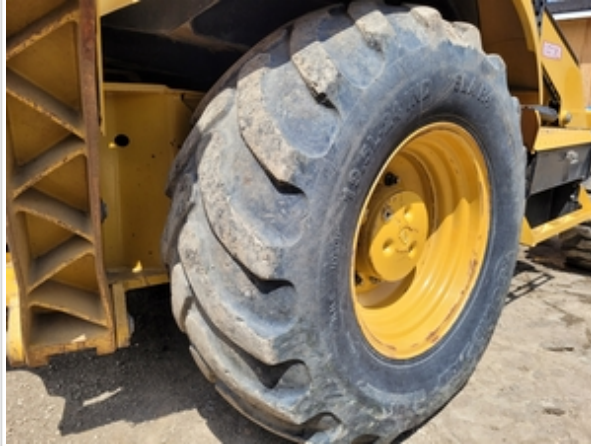
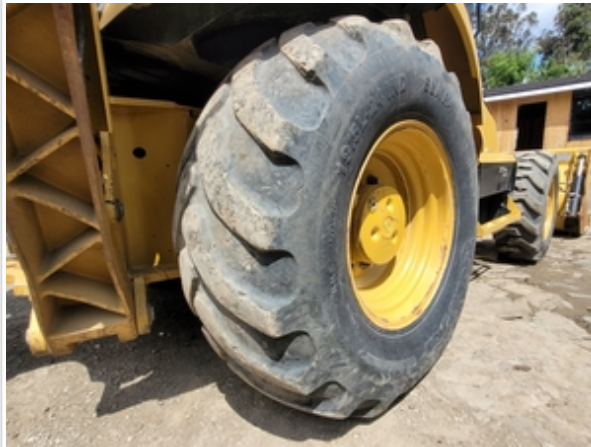
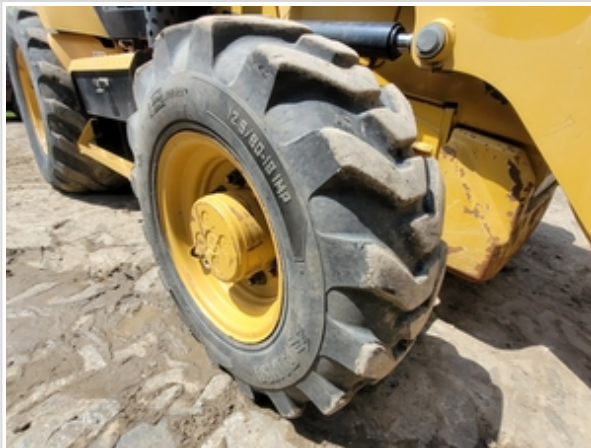
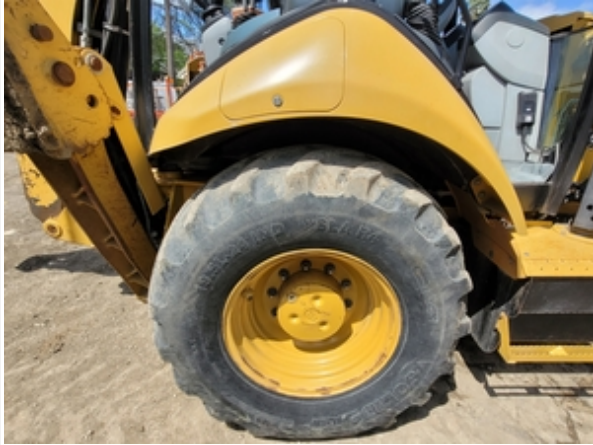
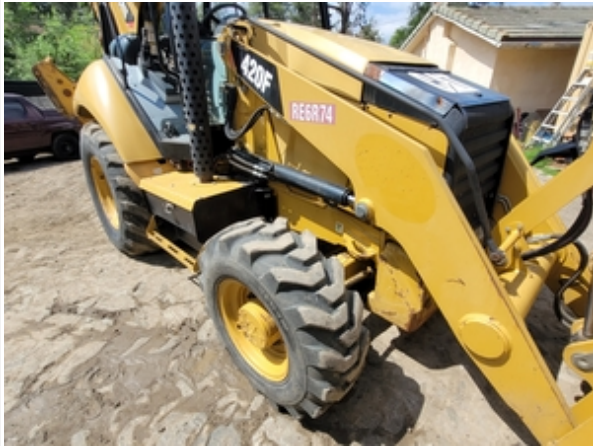
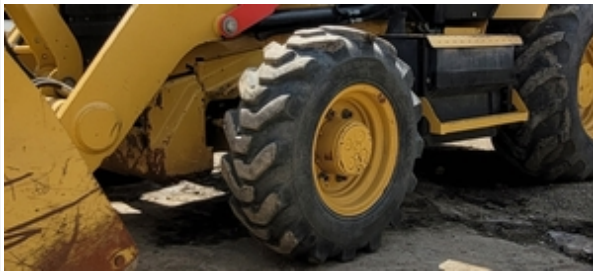
Wheels & Tires Photos

| Wheels & Tires | 3 - Normal Wear & Tear |

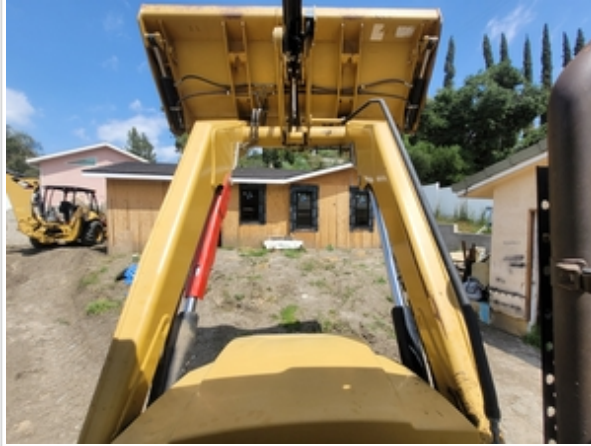
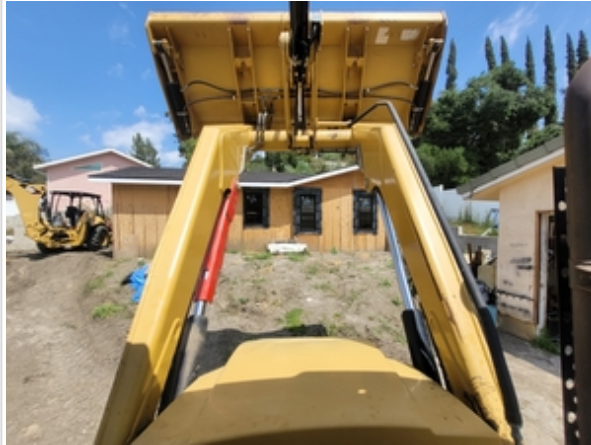
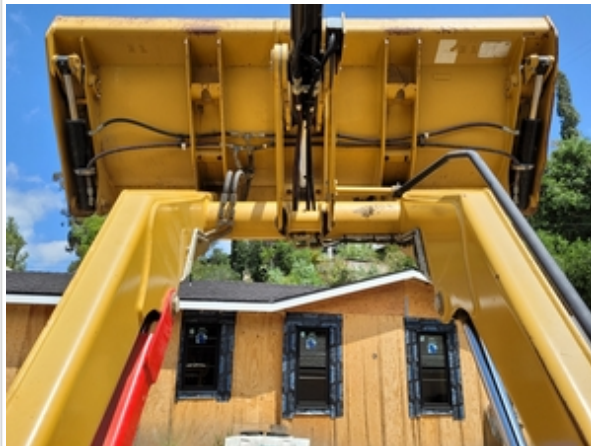
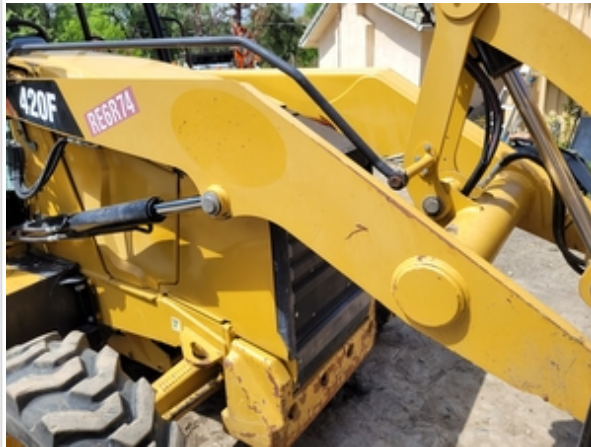
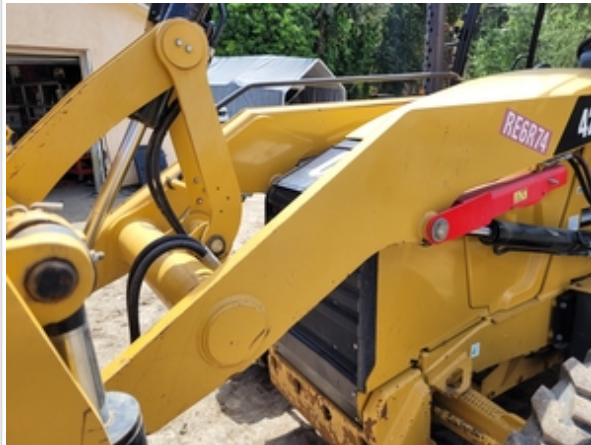
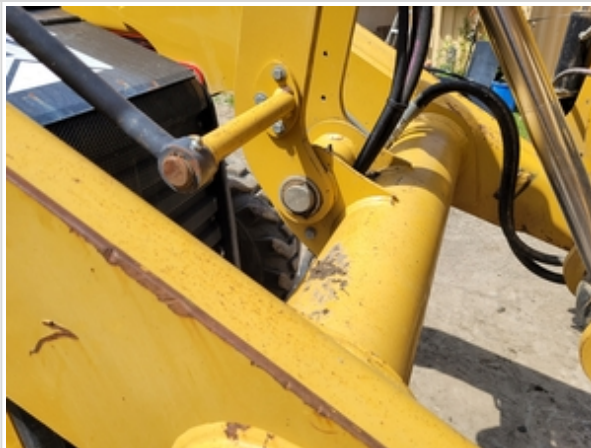
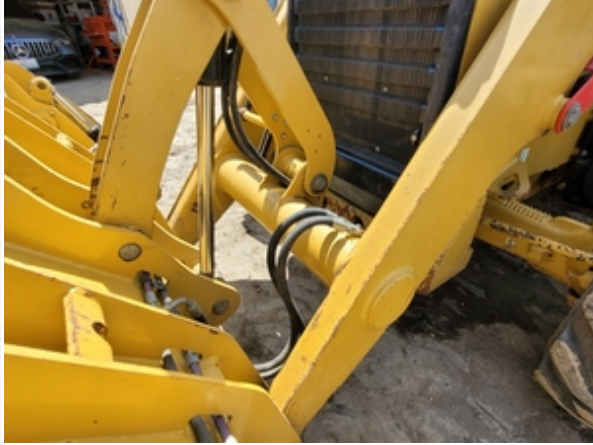
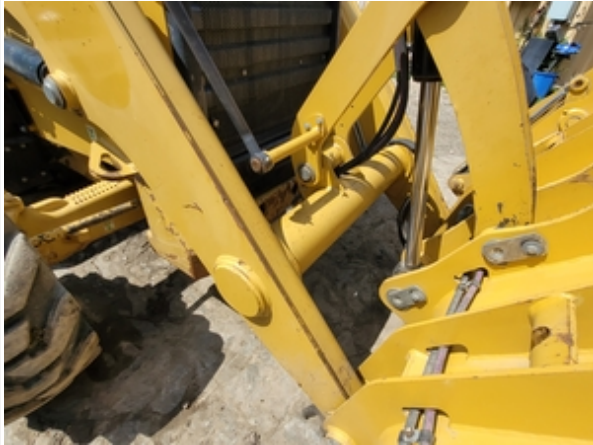
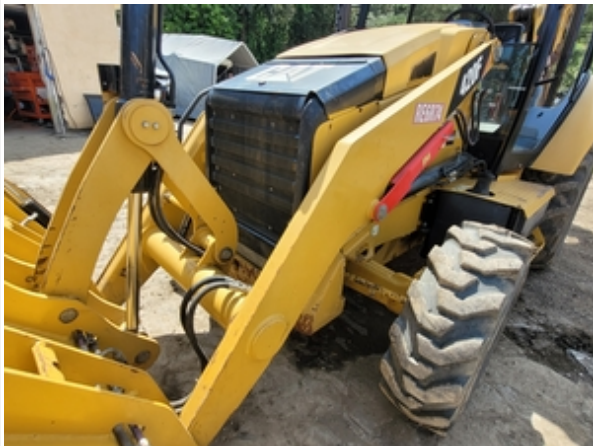
Lift Arm Photos

| Lift Arm | 3 - Normal Wear & Tear | |

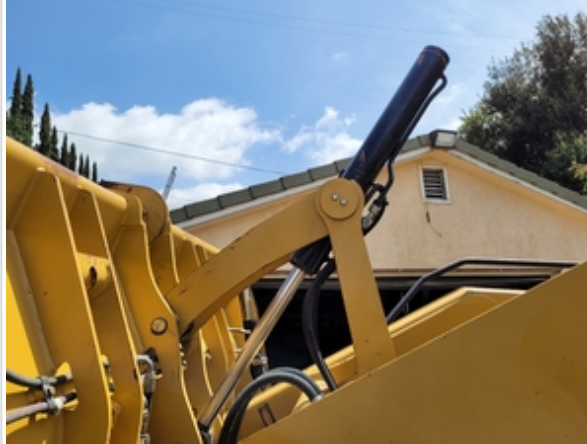
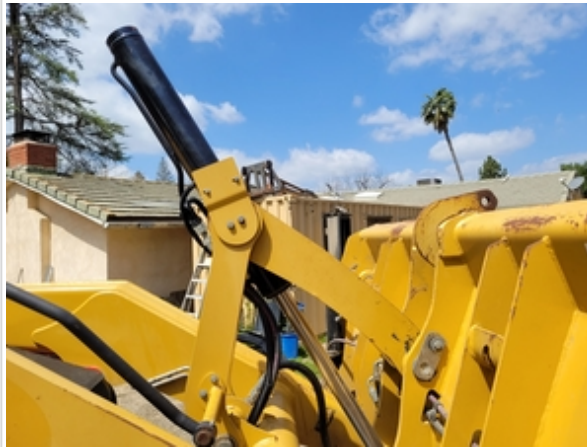
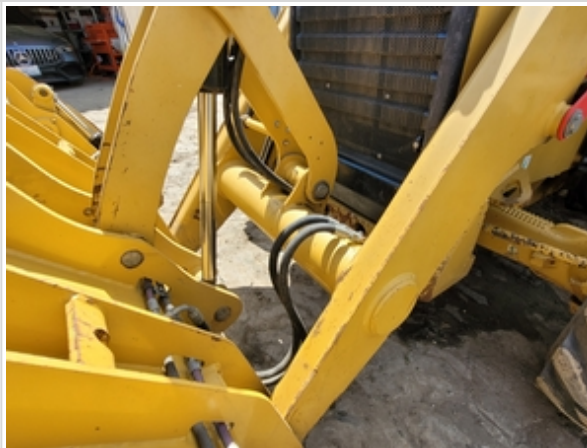
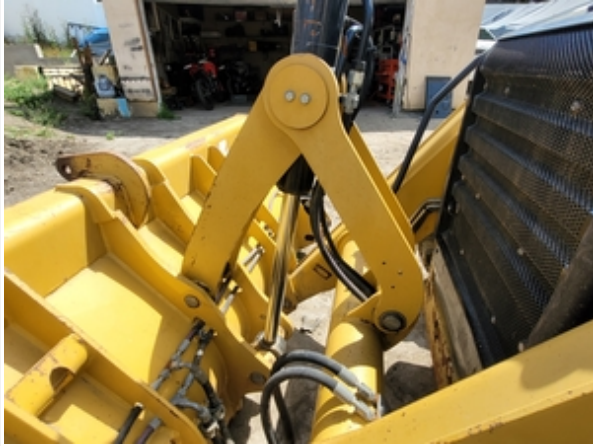
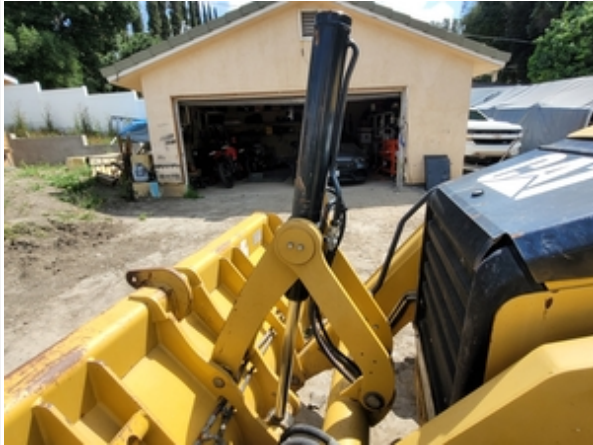
Tilt Linkage Photos

| Tilt Linkage | 3 - Normal Wear & Tear | |

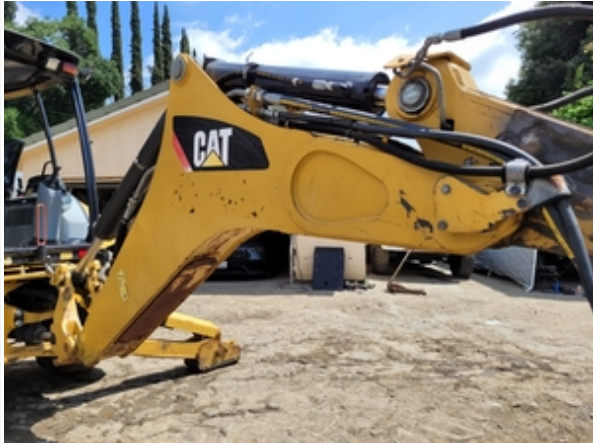
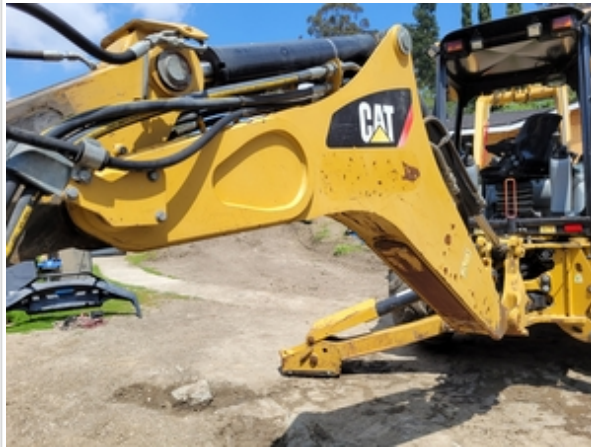
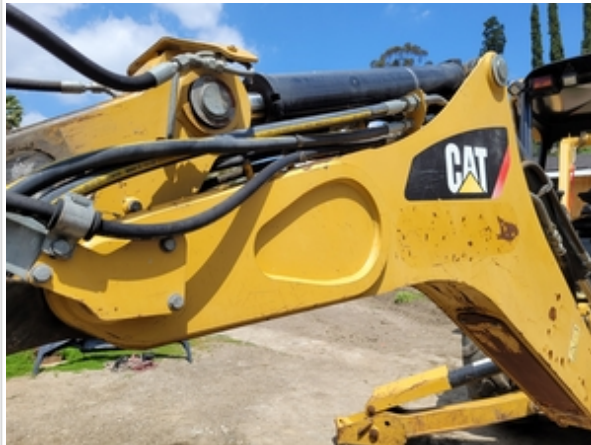
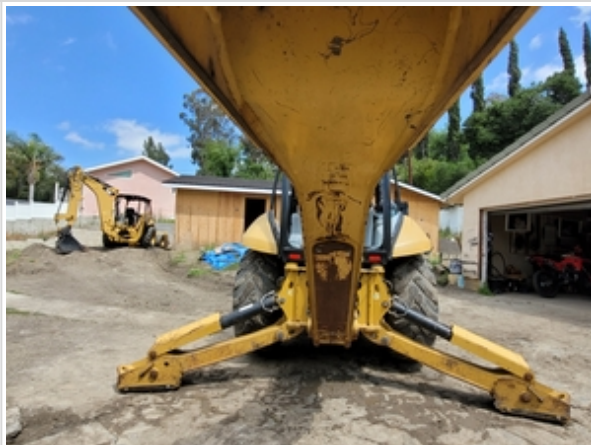
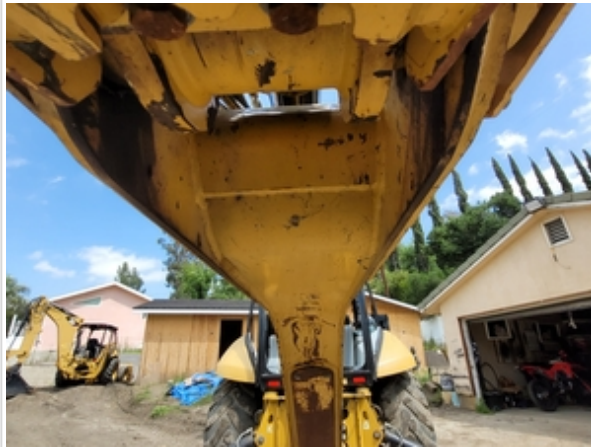
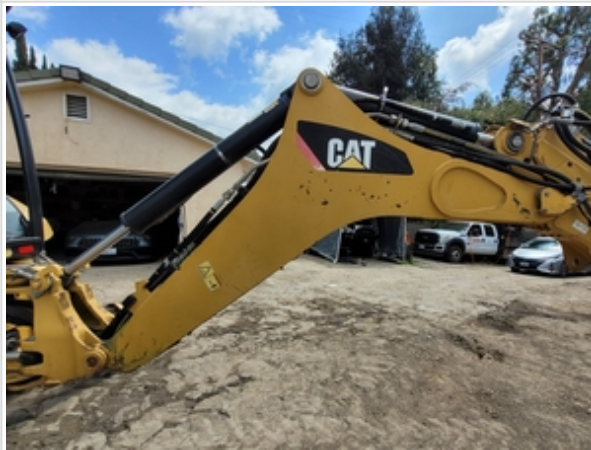
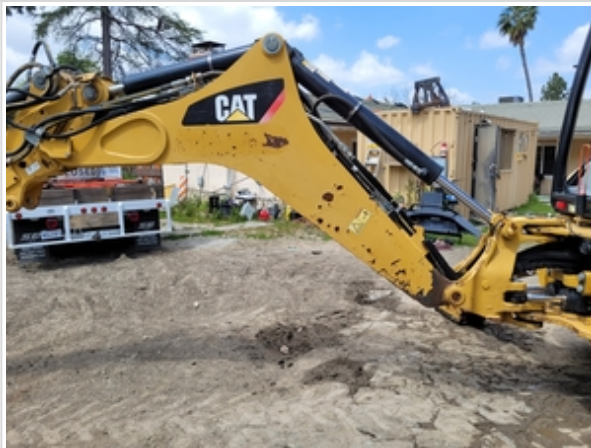
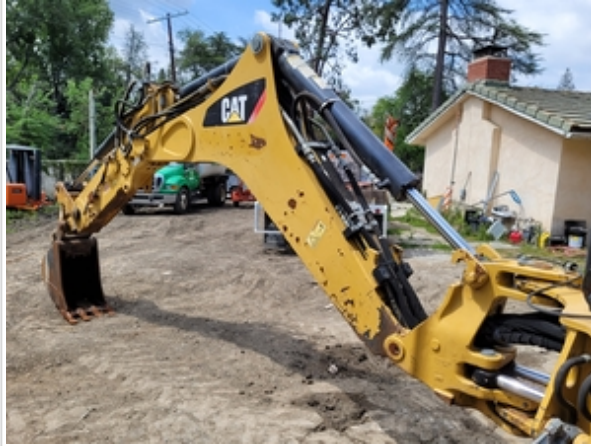
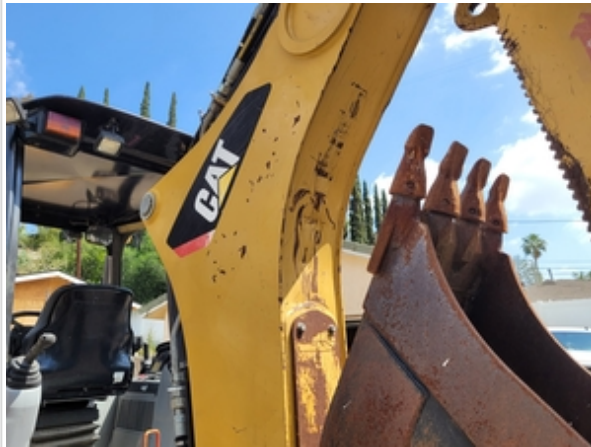
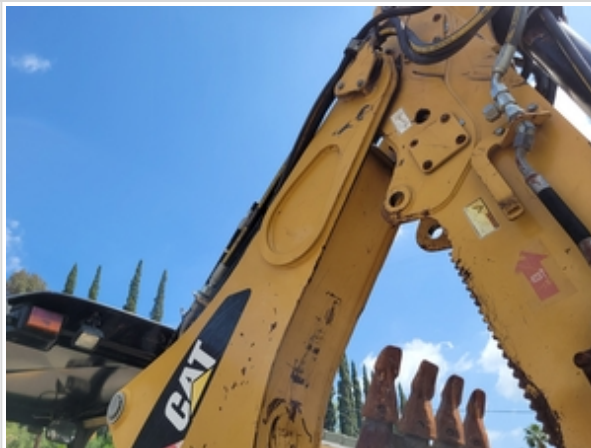
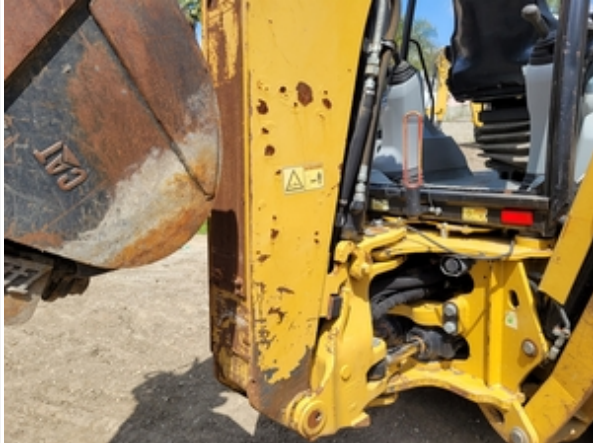
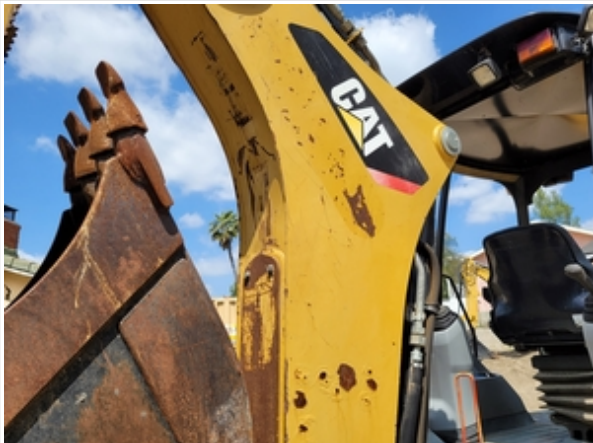
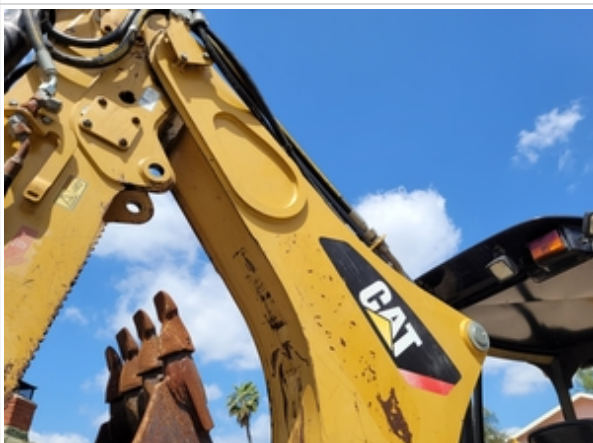
| Boom Condition Photos | | |

| Boom Condition | 3 - Normal Wear & Tear | |

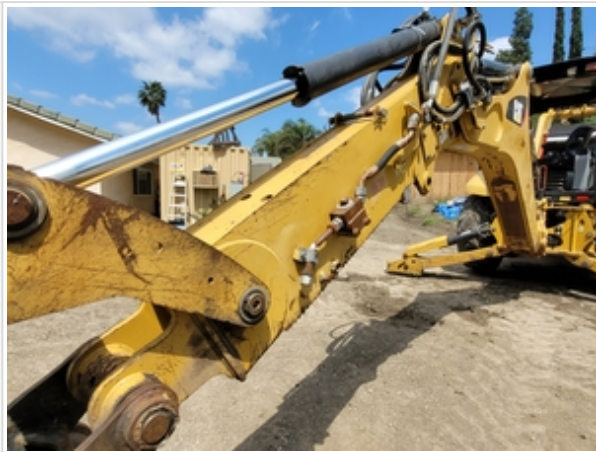
| Stick Condition Photos | |

| Stick Condition | 3 - Normal Wear & Tear | |

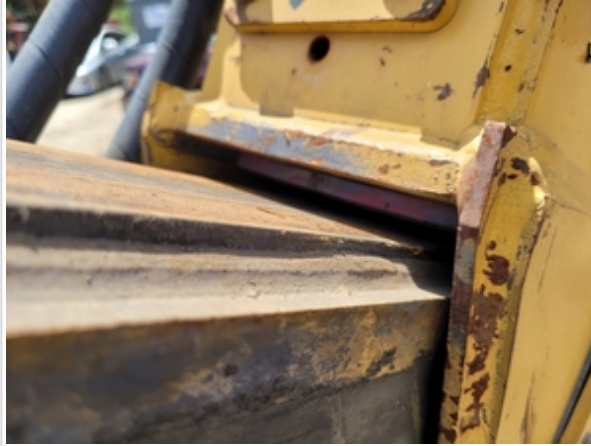
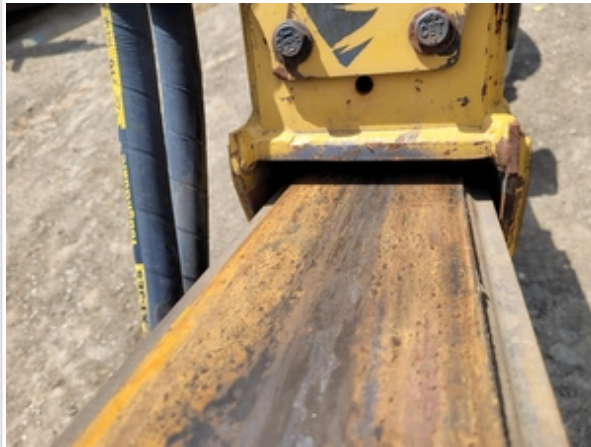
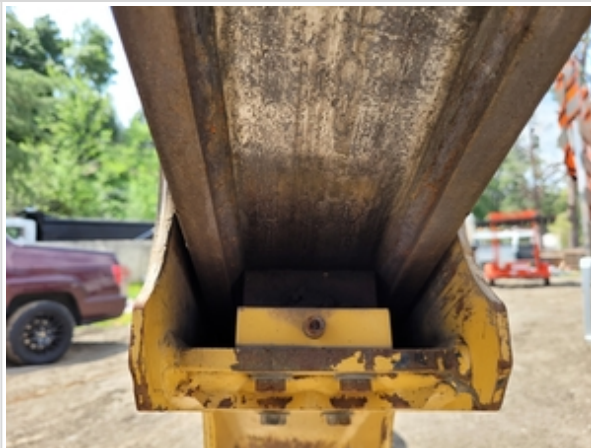
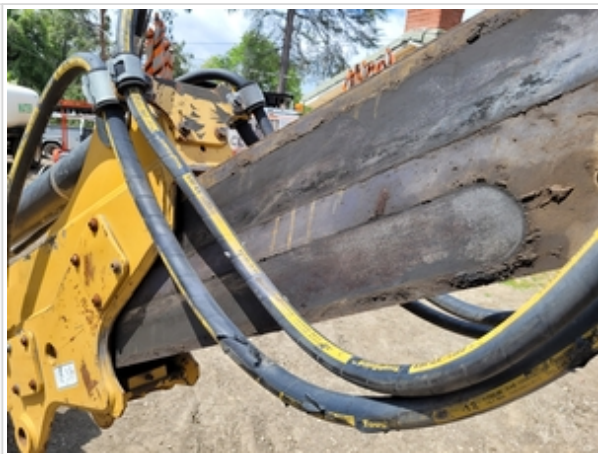
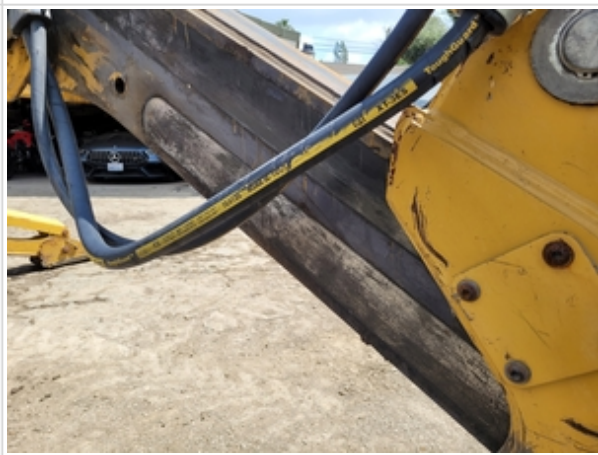
Stick Extension Wear Guides
Photos

| Stick Extension Wear Guides | 3 - Normal Wear & Tear |

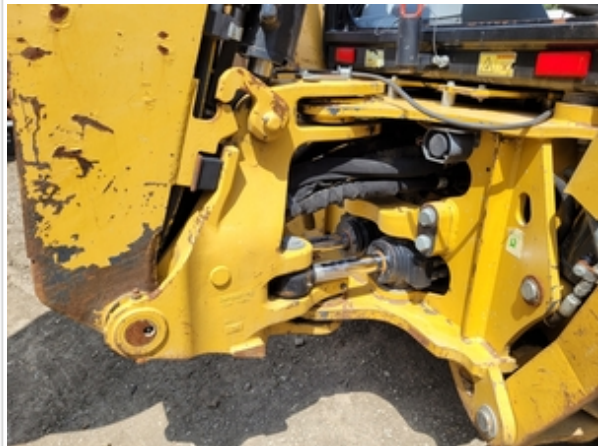
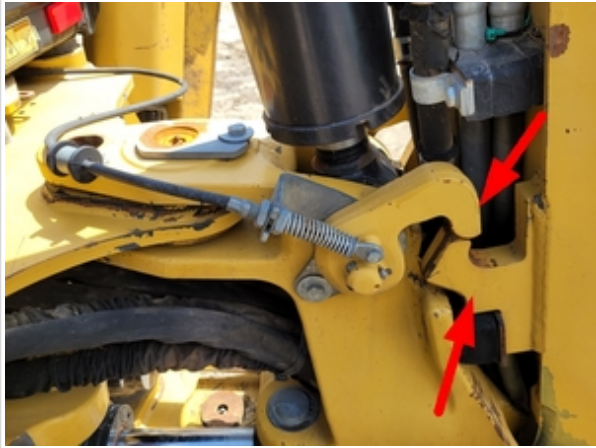
| Boom Lock Photos | | |

| Boom Lock | 3 - Normal Wear & Tear | |

| | | <p>Boom lock working well</p> |

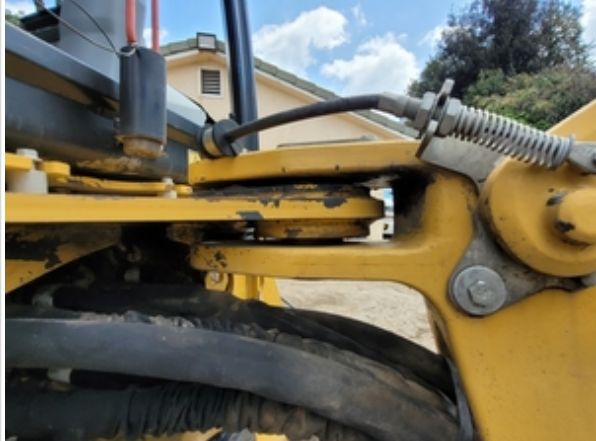
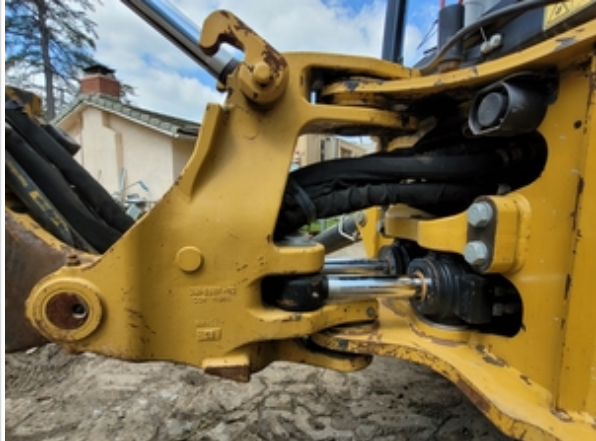
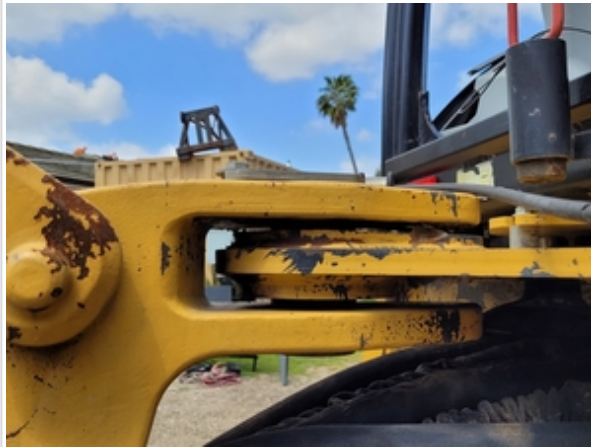
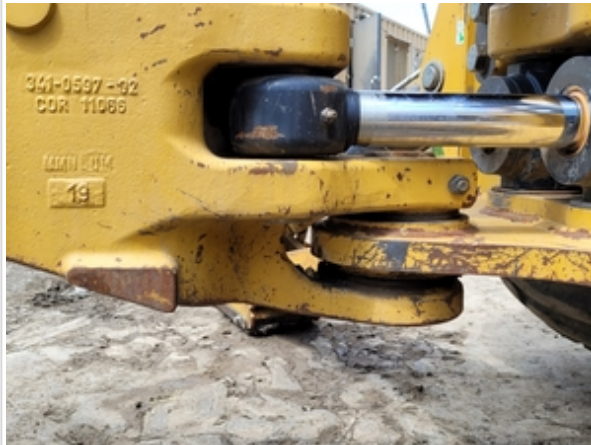
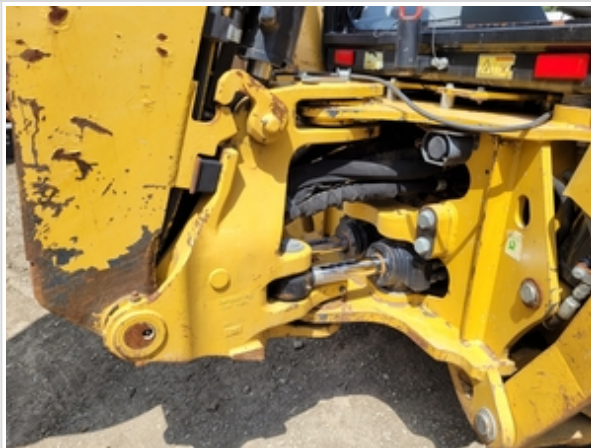
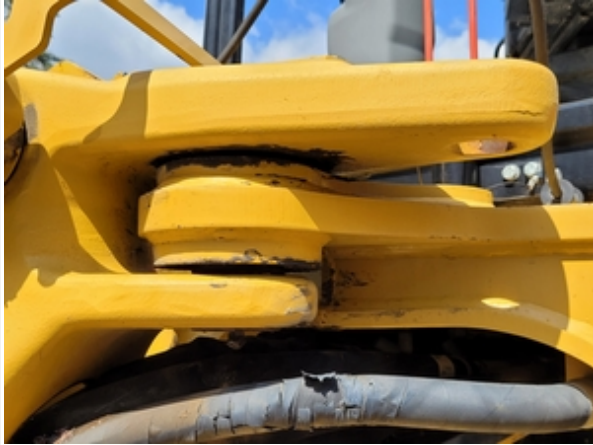
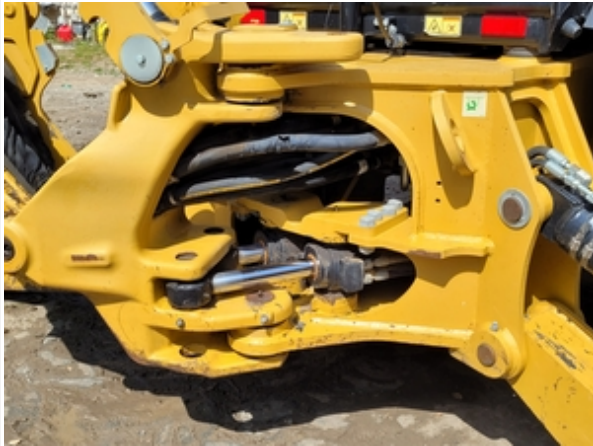
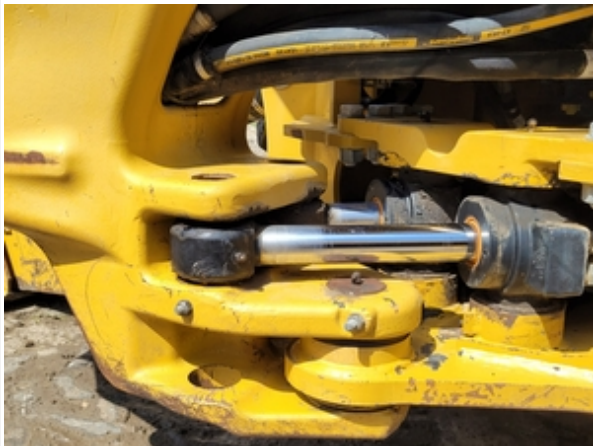
| <p>Swing Tower Pivot Photos</p> | | |

| <p>Swing Tower Pivot</p> | <p>3 - Normal Wear & Tear</p> | |

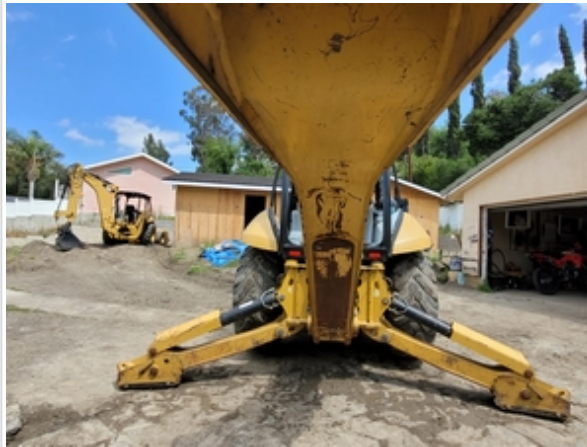
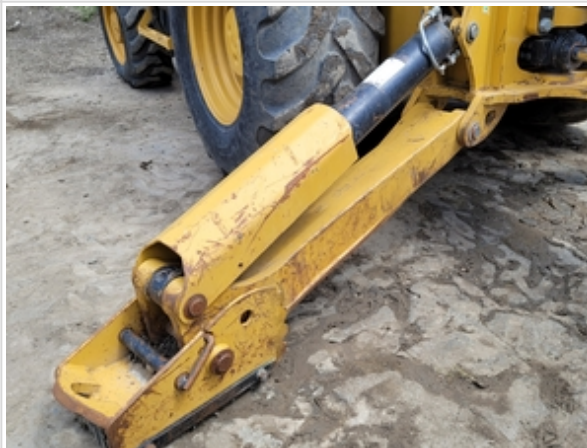
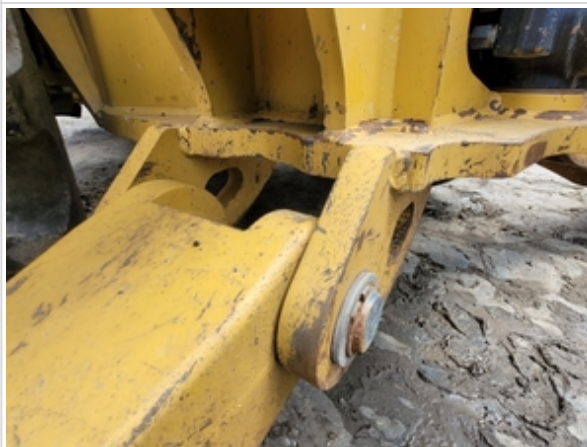
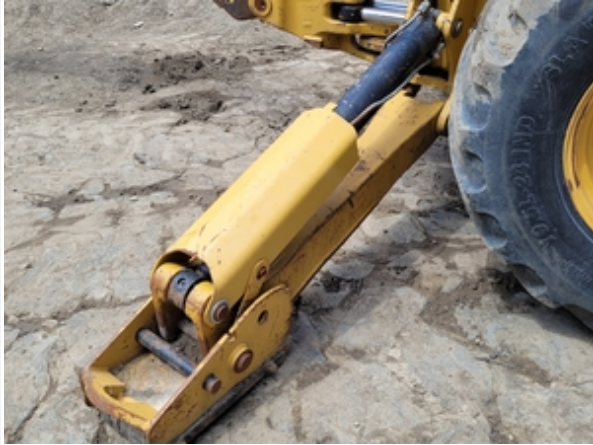
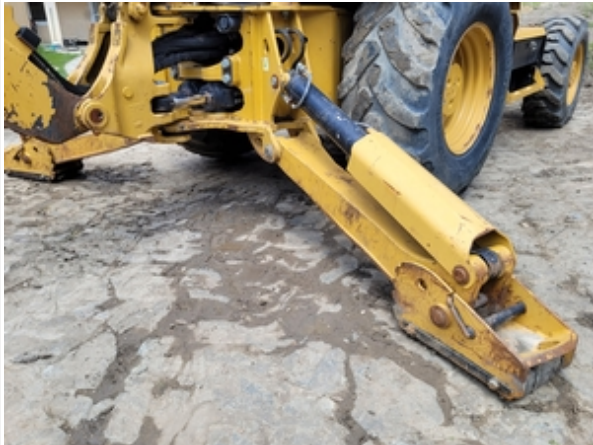
Outriggers Photos

| Outriggers | 3 - Normal Wear & Tear | |

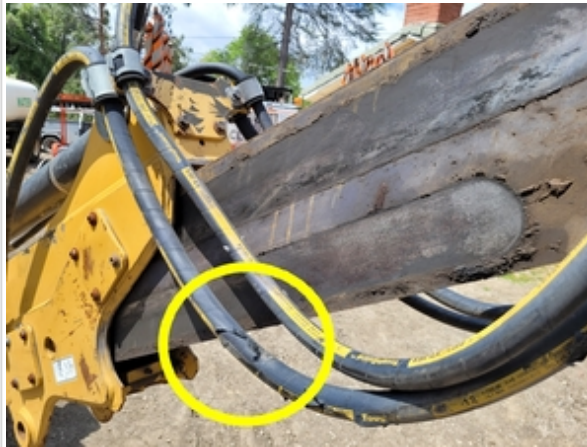
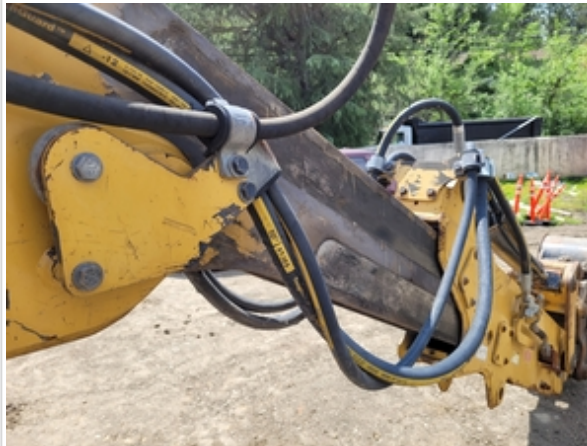
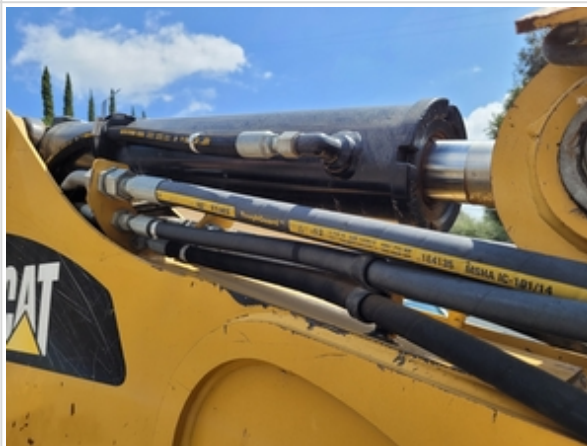
Hydraulic hose damaged (Not leaking)

| Comments | A few hydraulic hoses have surface damage | |

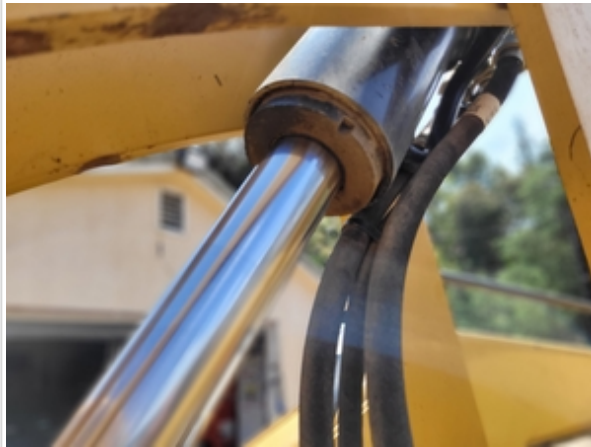
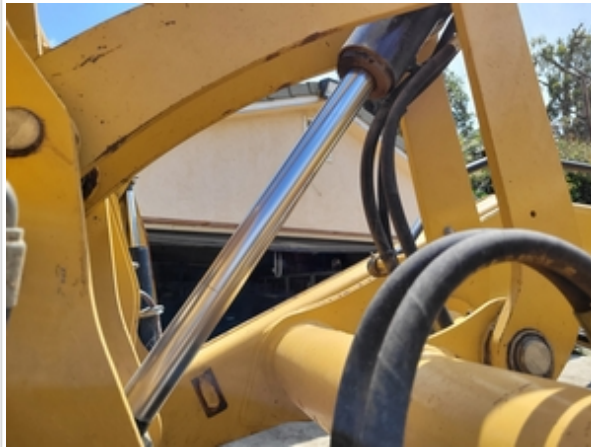
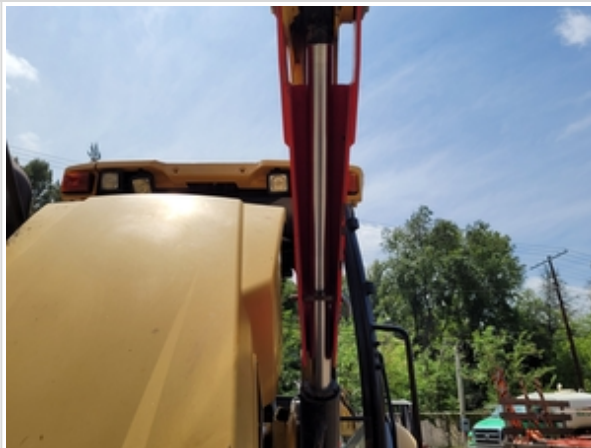
Loader Lift / Tilt Cylinders Photos

| Loader Lift / Tilt Cylinders: Oil Leaks | No |

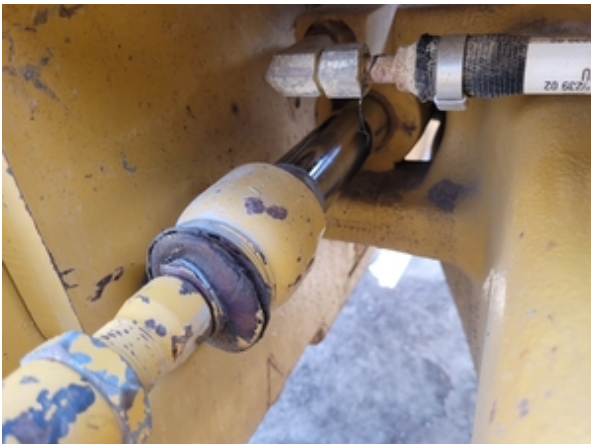
| Comments | Right side steer cylinder has minor oil/dirt buildup around rod seal. Further inspection recommended to determine if minor leak exist | |

| What Needs Work | A few possible seepage (not active leaks) may eventually become leaks @ brake pedal valve and steer cylinder. Minor cosmetic damage on hood. Seat is torn and should be replaced soon for operator comfort. Rear tires will need to be replaced soon. |

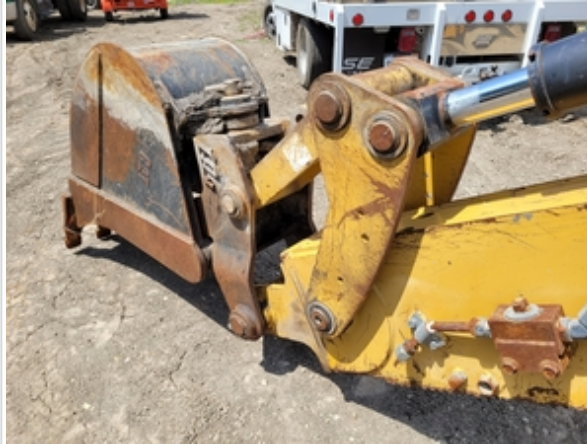
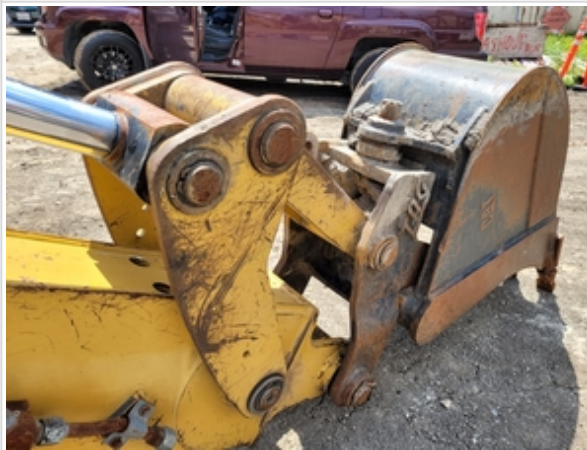
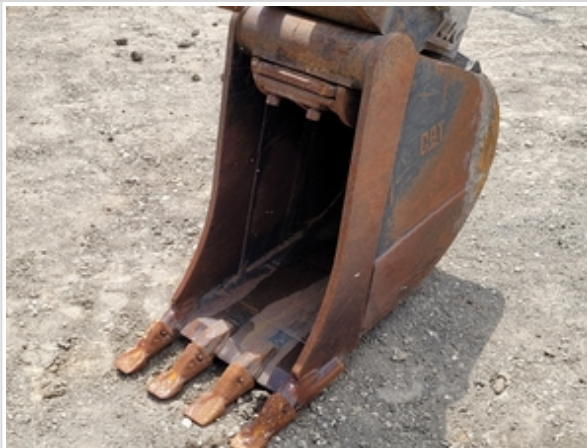
Backhoe Bucket Photos

| Backhoe Bucket | 3 - Normal Wear & Tear |
