Inspection Report (Trailer)

Year	2006
Make	Trailking
Model	TK70HT - 482
Serial Number	ITKA0482X7M087662
Current Inspection / State Cert / DOT	N/A
Previous Application (e.g., earth moving, mining, demolition, etc)	Demolition General Construction

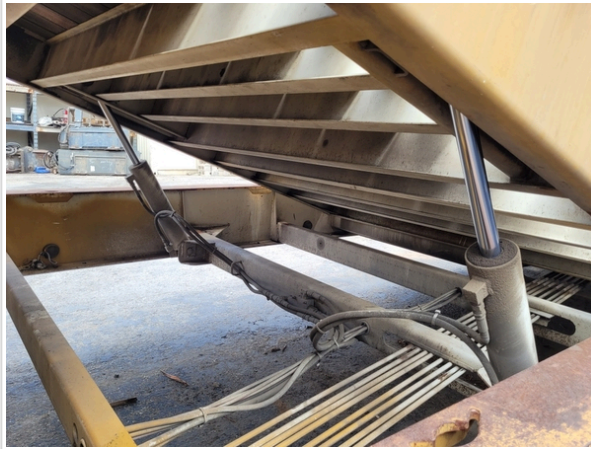
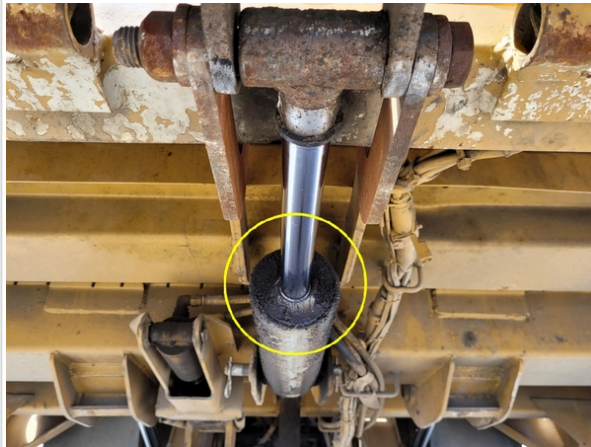
Cylinder has residual oil and may be leaking

Hydraulic System	Take close-up photos of the hydraulic components including the pump, lines, fittings, controls, and levers. Note any damage, wear, or leaks.
Hydraulic Cylinder(s)	3 - Normal Wear & Tear
Cylinder(s): Oil Leaks	Yes
Comments	Some cylinders may be leaking at rear ramps

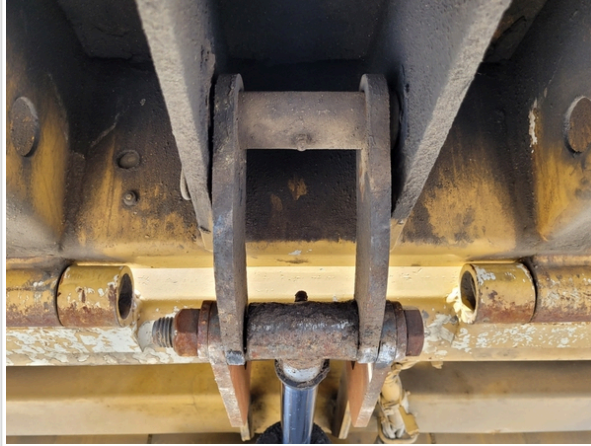
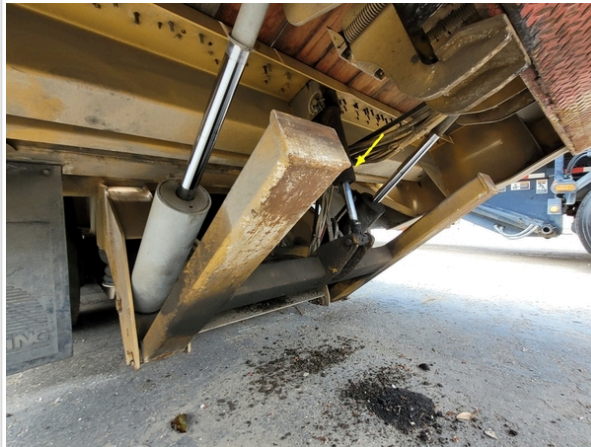
Cylinder may be leaking

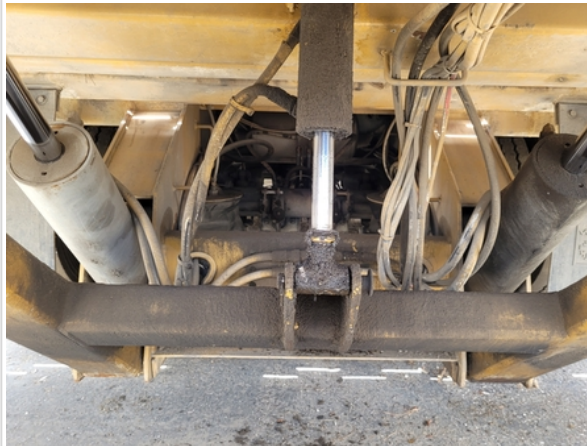
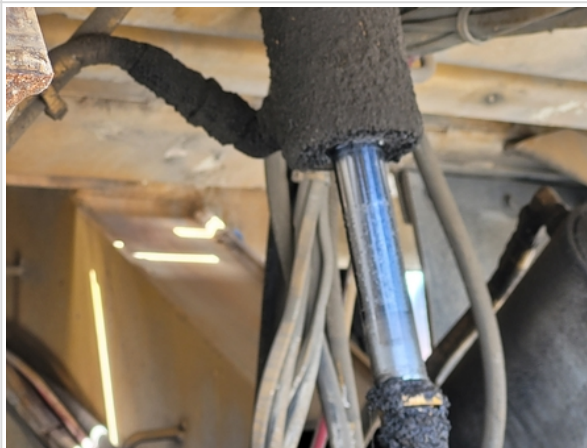
Cylinder may be leaking

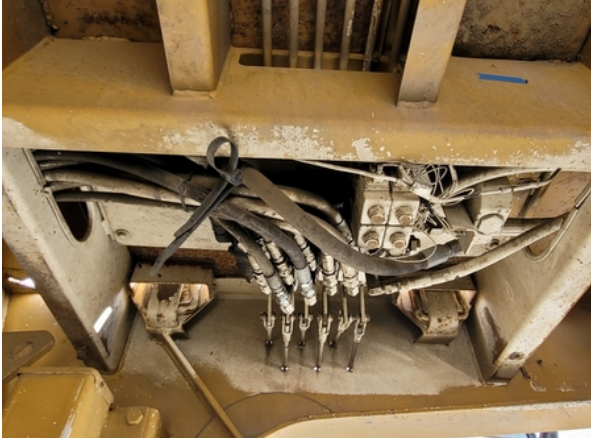
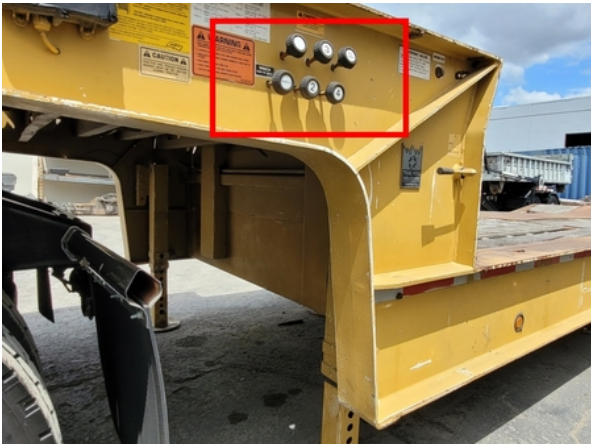
<p>Minor seepage buildup on Main Control Valve (No active leak observed)</p>

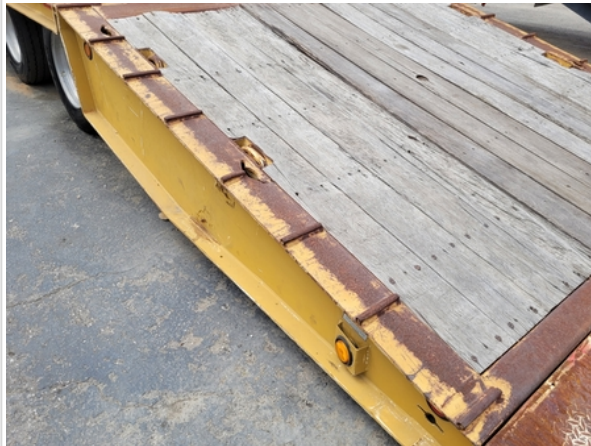
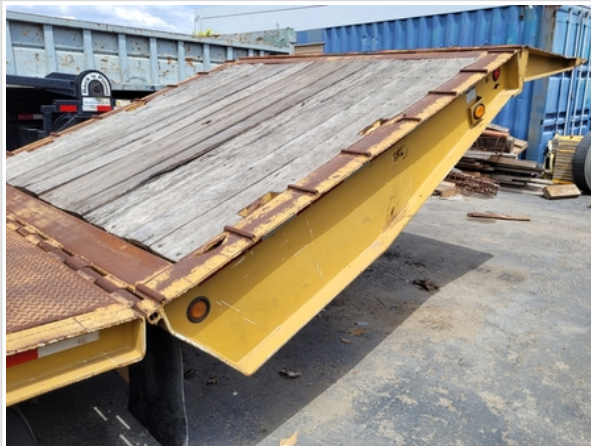
Flatbed Body	Check the condition of the flat bed body. Note any damage or wear. Take photos.
Bed Details (Deck Type, Additional Features)	Top Deck Has Hydraulic winch and has 8' of surface space available for loads. Hydraulic Ramp equipped to top deck
Flatbed Body	3
Comments	Some floor boards missing and some have damage

Floor board missing wood piece

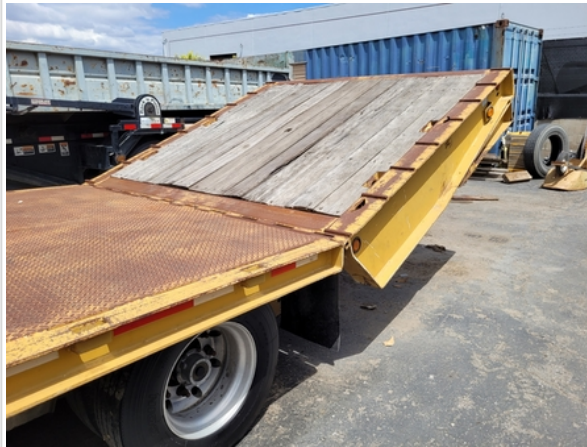
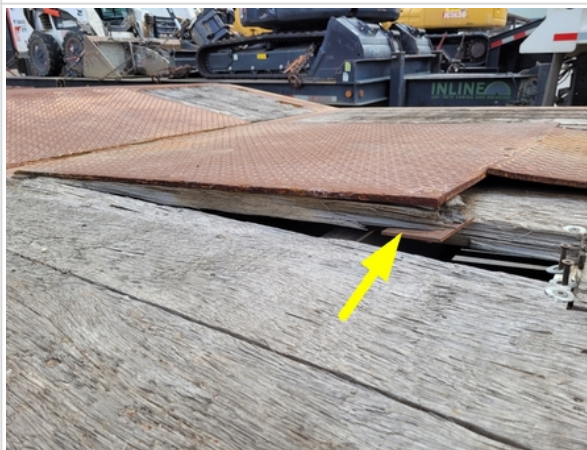
Wood damaged at front part of deck

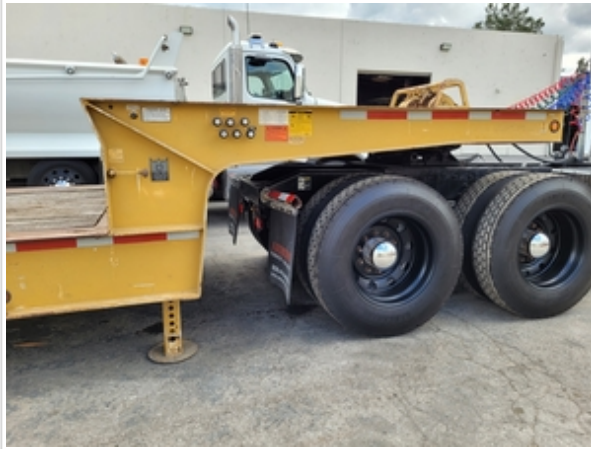
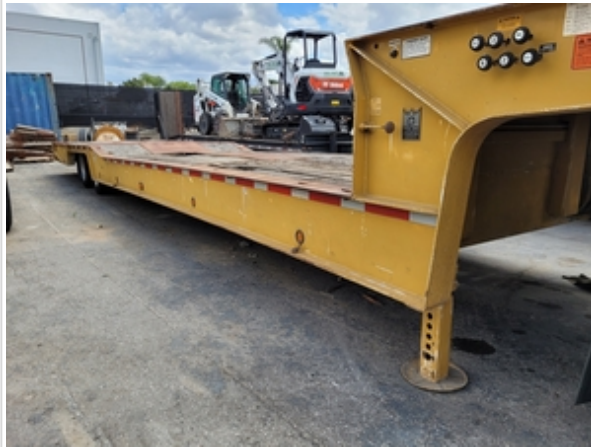
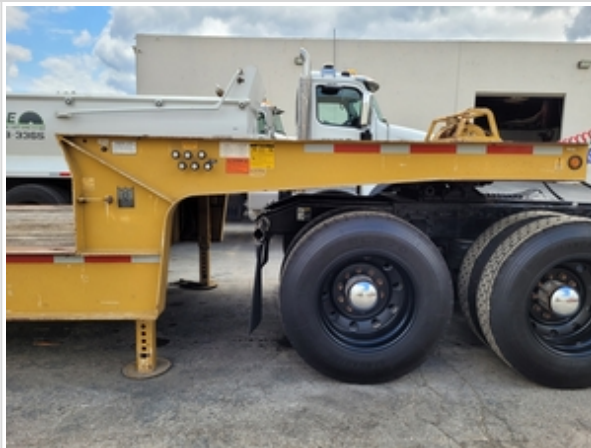
Support Frame Photos

Tailgate Latch	0
Support Frame	3

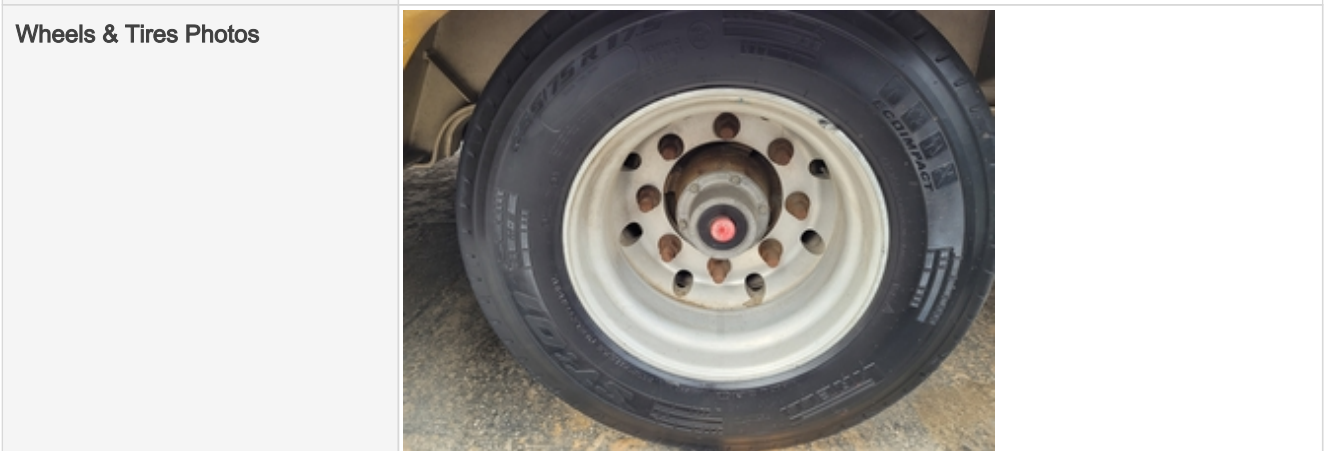
Instructions	Check the condition of additional axle(s), wheels & tires. Note any damage or wear. Take photos.
Axle Description & Position	Dual Fixed Axles
Steerable?	No
Drop Axle?	No
Super Dump?	N/A
Axle Condition	3 - Normal Wear & Tear
Wheels & Tires	3 - Normal Wear & Tear
Comments	Most tires below 50% worn

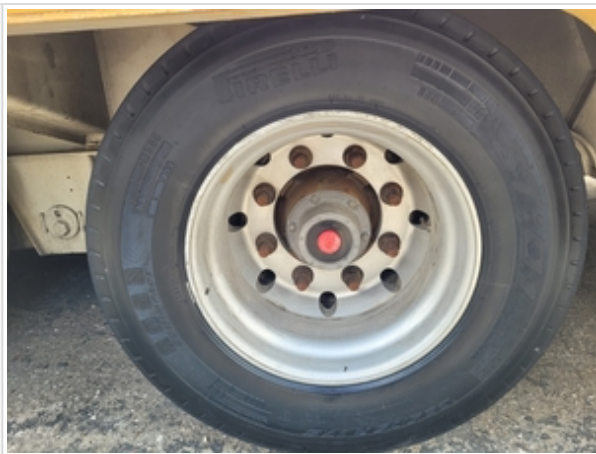
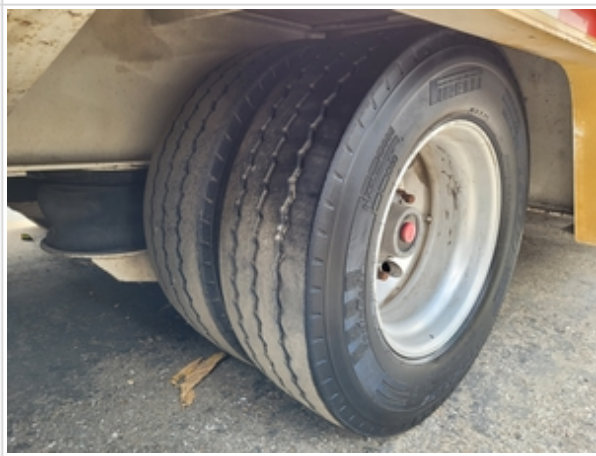
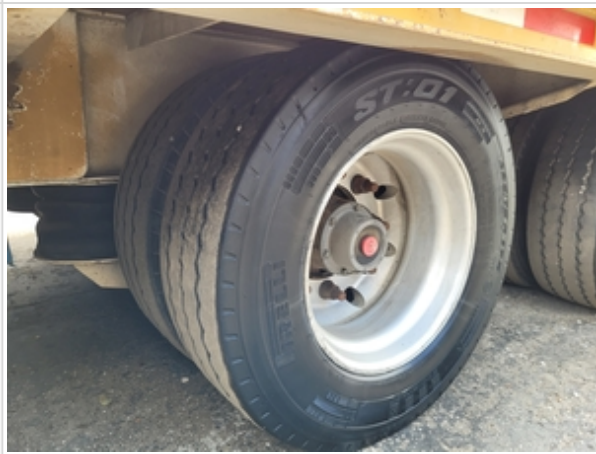
Tire Brand	Pirelli	
Tire Size	235/75R/17.5	
Left Tire(s) Ratio Remaining	30%	
Right Tire(s) Ratio Remaining	30%
