Inspection Report (Excavator)

Year	2008
Make	Hitachi
Model	ZX270LC-3
Serial Number	1FFASROXPAO820124
Hour Meter Reading	10,070 Hrs.
Previous Application (e.g., earth moving, mining, demolition, etc)	General Construction

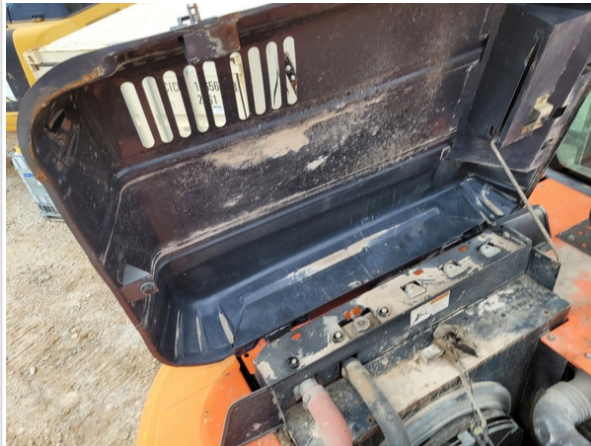
Cracked Sun Visor

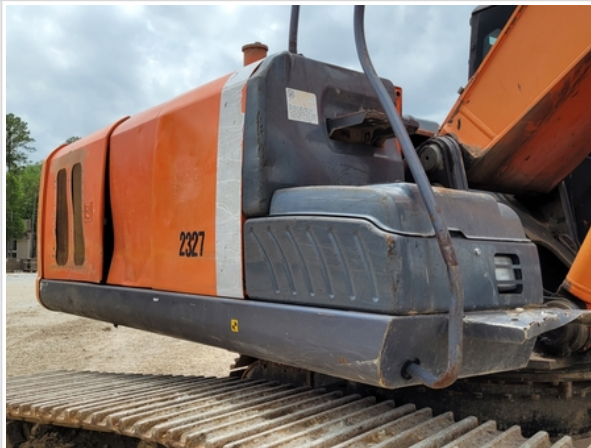
Panels Bent

Body Panels	2 - Above Average Wear
Body Panel Condition	Some panel misalignment observed, Large dents or cracks, Other (see comments)
Doors / Canopy Latches	3 - Normal Wear & Tear
Doors / Canopy Latches Condition	No visible damage
Steps / Ladders	2 - Above Average Wear
Steps / Ladders Condition	Steps/ladders are fully intact and appear structurally sound, Bent or broken steps or rungs
Handrails	3 - Normal Wear & Tear

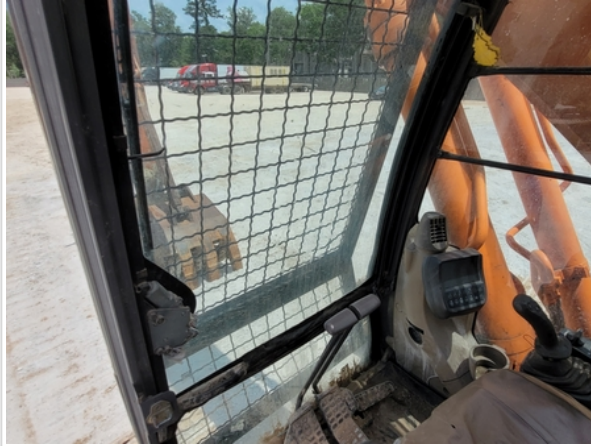
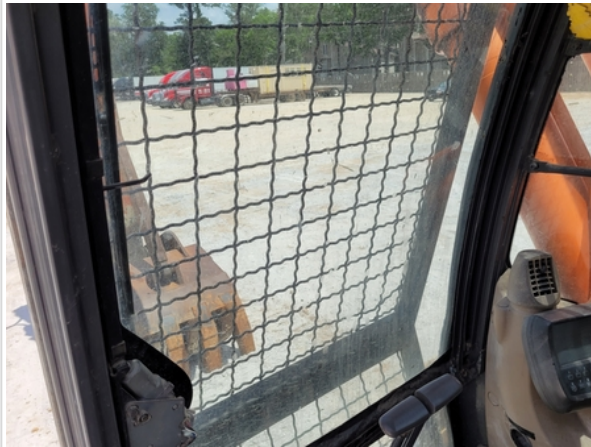
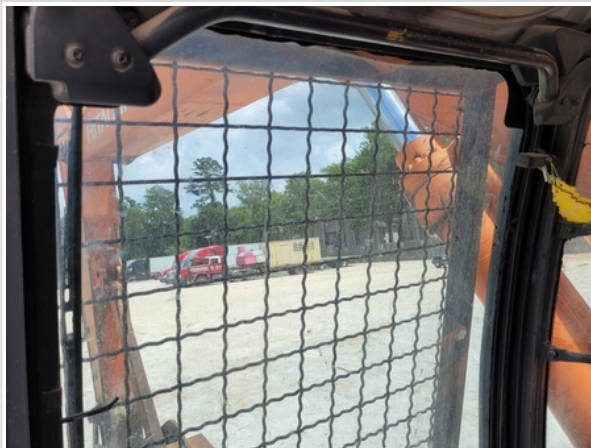
Handrails Condition	Handrails are fully intact and appear structurally sound
Glass	2 - Above Average Wear
Glass Condition	Major chips or cracks observed, Other (see comments)
Comments	Left Side Cab window broken
Glass Condition Photos

<p data-bbox="536 1921 866 1953">Top Sun Roof view obstructed</p>

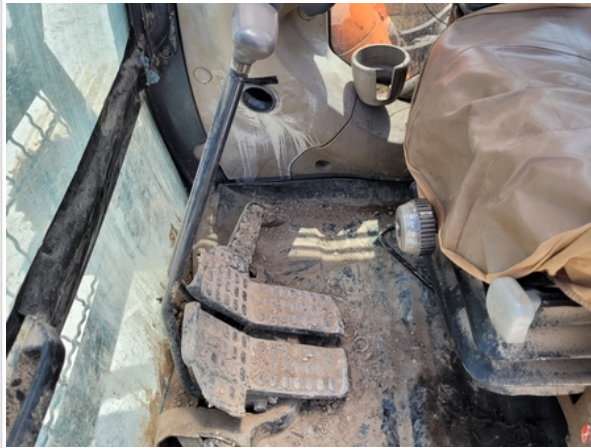
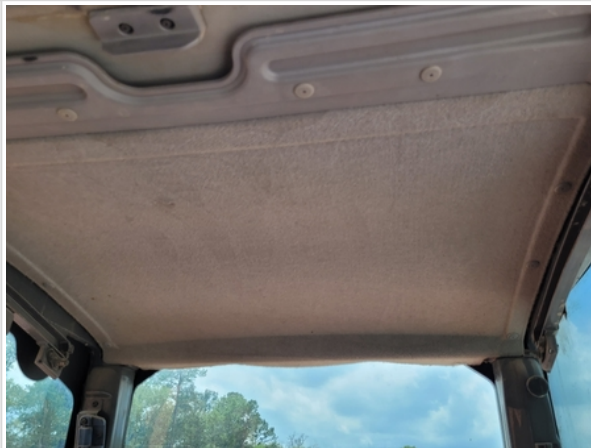
Residual oil at floormat

Control Station Overall Rating	2 - Above Average Wear
Control Station Overall Condition	Significant wear and tear to cabin floor, panels, and ceiling, Other (see comments)
Comments	Oil leaks seen at left side joystick console area
Operator Seat	3 - Normal Wear & Tear
Operator Seat Condition	Seat(s) has major surface staining or tears
Cabin Lights	2 - Above Average Wear
Cabin Lights Condition	Cabin lights are installed with all light covers in place, bulbs are installed and working properly
Safety Lock Out / Stop	3 - Normal Wear & Tear
Safety Lock Out / Stop Condition	Safety lock out device is present, in good condition, and functional
Controls & Switches	3 - Normal Wear & Tear
Controls & Switches Condition	All switches are installed and functional
Hour Meter Activity	3 - Normal Wear & Tear
Hour Meter Condition	Hour meter is functional and in good condition

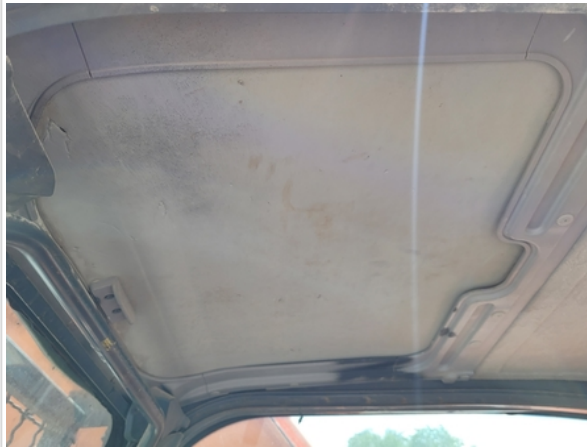
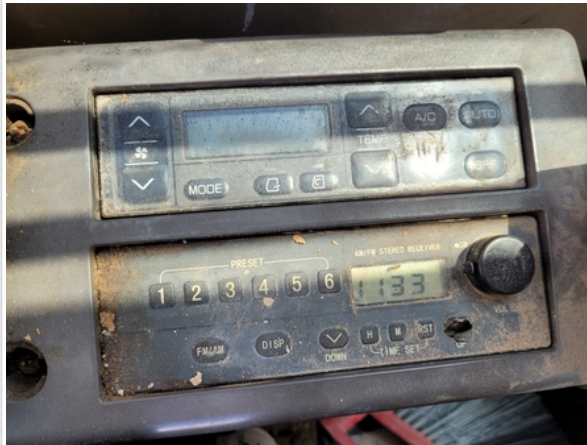
Behind seat are these main machines computers & electrical wire harnesses.
(Covers Missing)

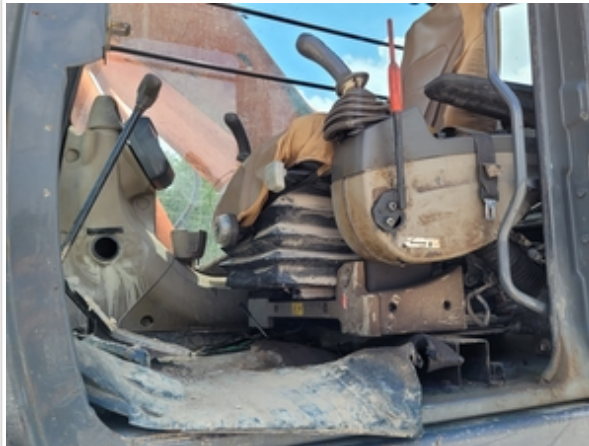
Hydraulic Pilot Control Hoses Leaking

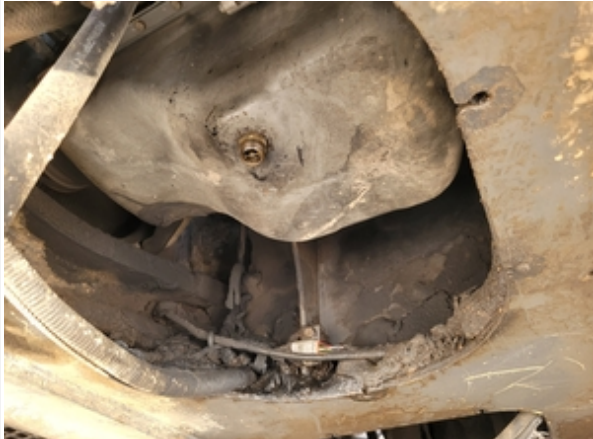
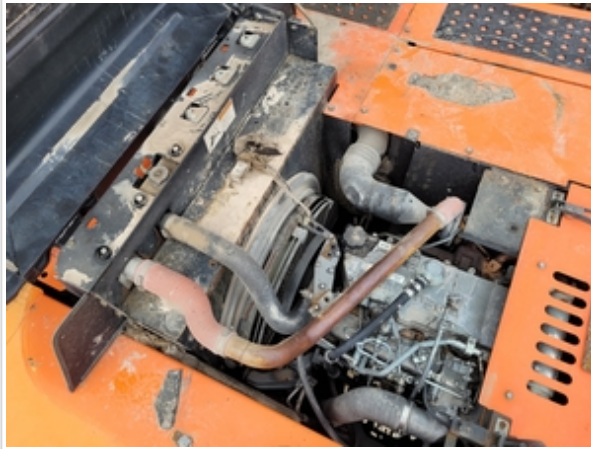
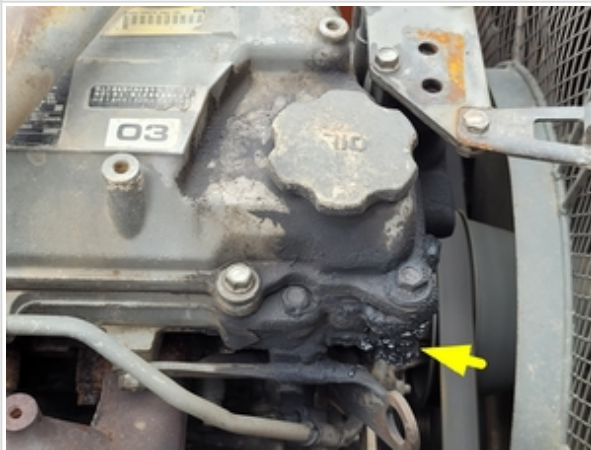
Active Engine Oil Leak

Belt Condition	Belts appear in good condition & alignment with proper tension
Hoses	3 - Normal Wear & Tear
Hose Condition	Firm, pliant hoses with no signs of wear or leaks
Water Pump	3 - Normal Wear & Tear
Water Pump Condition	No unusual pump noises heard
Cooling System Leaks	No
Coolant Color / Appearance	3 - Normal Wear & Tear
Coolant Color/Appearance Notes	Normal Translucent appearance, no visual signs of contamination
Oil Leaks	Yes
Oil Leak Notes	Wetness & discoloration observed
Comments	Engine leak observed at valve cover area
Oil Color / Appearance	3 - Normal Wear & Tear
Oil Color / Appearance Notes	Clean oil appearance, no signs of cross contamination, Appropriate oil level
Fuel Leaks	No
Equipped with DPF (Diesel Particulate Filter)	No
Requires DEF (Diesel Exhaust Fluid)	No
Overall Engine Appearance	Active leaks/pooling observed in & around engine compartment, Dusty & dry
Overall Engine Comments	Engine fires right up and sounds okay under load. A few active leaks observed around topside of engine.

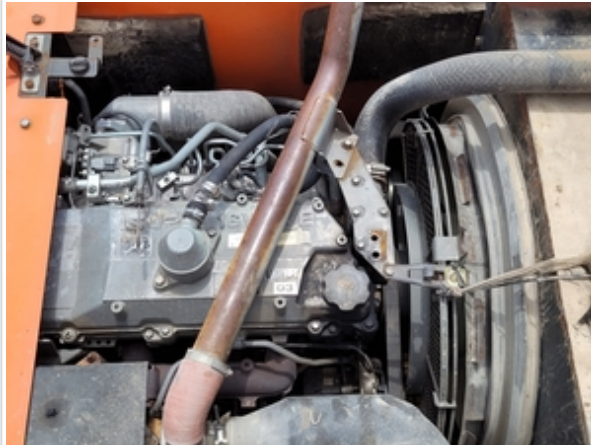
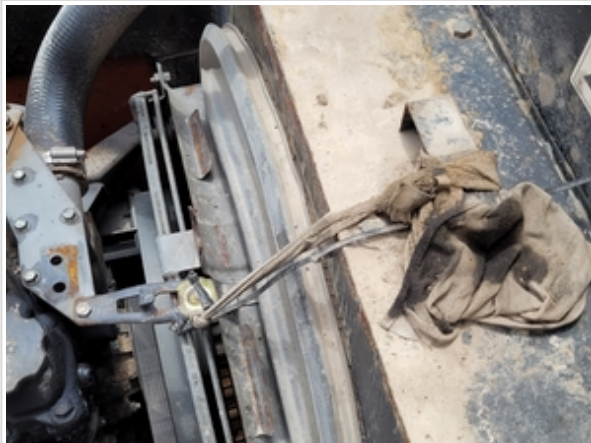
Helping support Radiator Mount

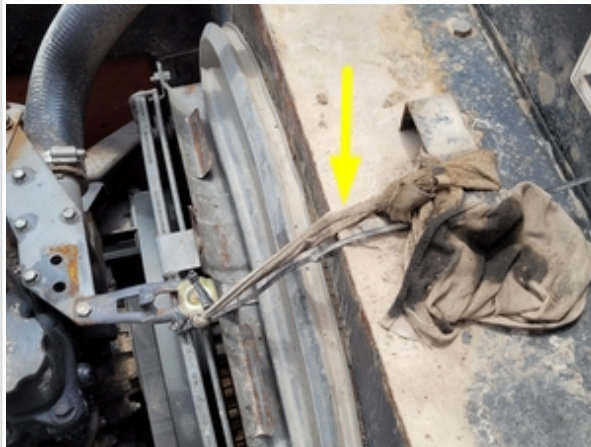
Helping Support Fan Guard

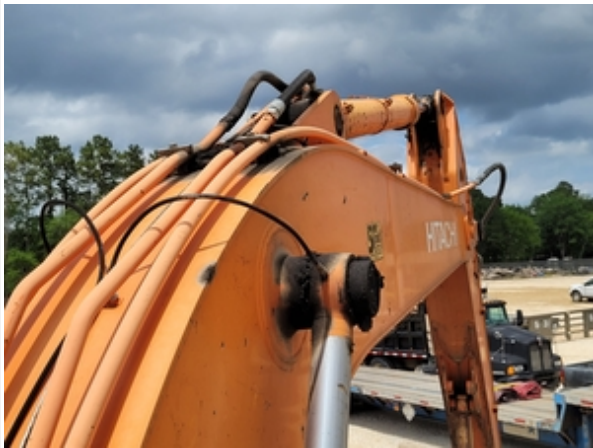
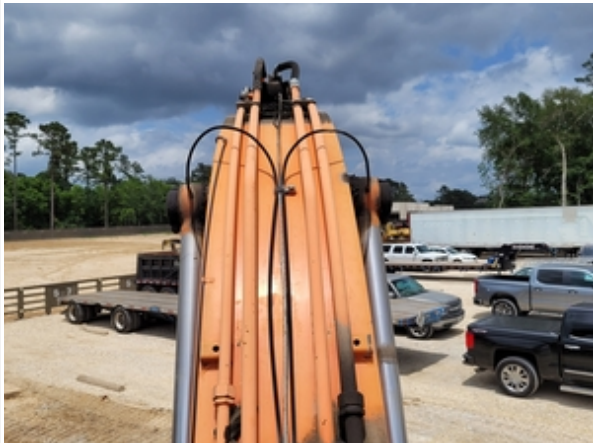
Boom Condition	3 - Normal Wear & Tear
Boom Photos

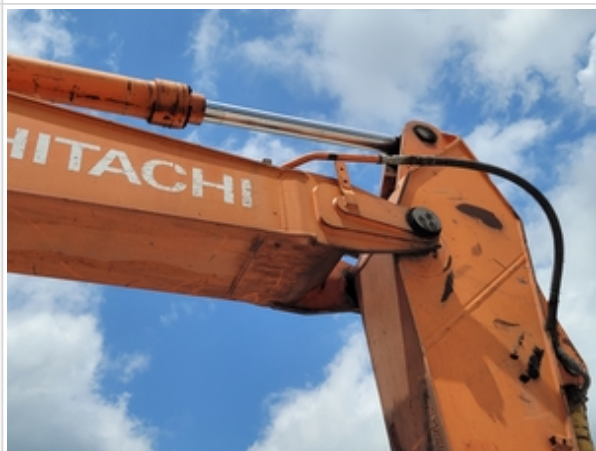
<p>Stick Condition</p>	<p>3 - Normal Wear & Tear</p>	
<p>Stick Photos</p>

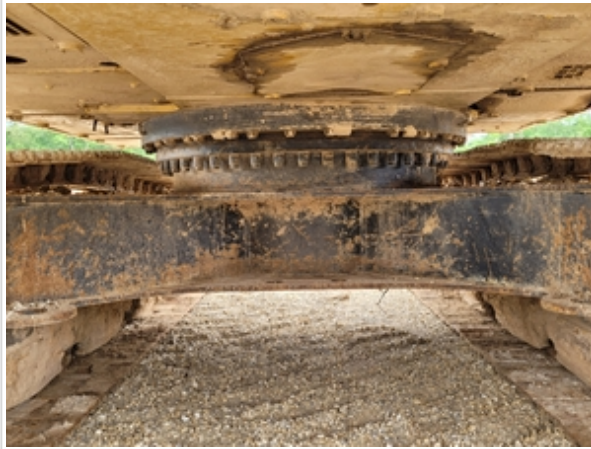
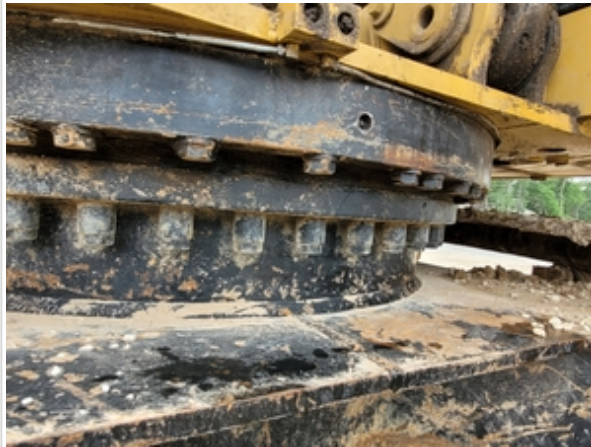
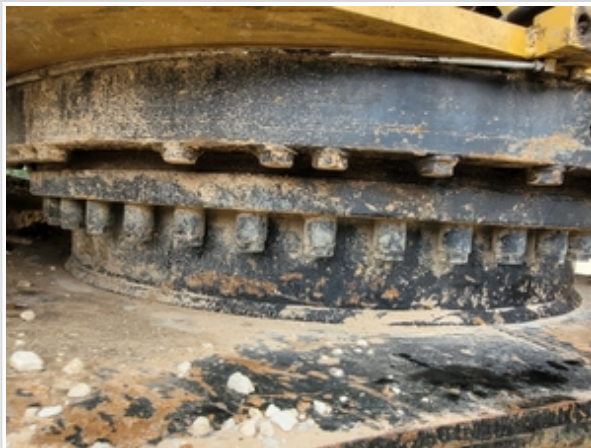
Turntable Bearing Photos

Boom Base Pin & Bushings	3 - Normal Wear & Tear
Boom to Stick Pin & Bushings	3 - Normal Wear & Tear
Stick to Bucket Pin & Bushings	3 - Normal Wear & Tear
Turntable Bearing	3 - Normal Wear & Tear

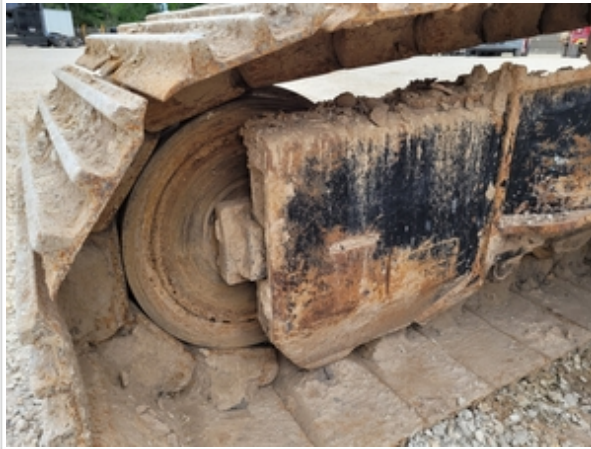
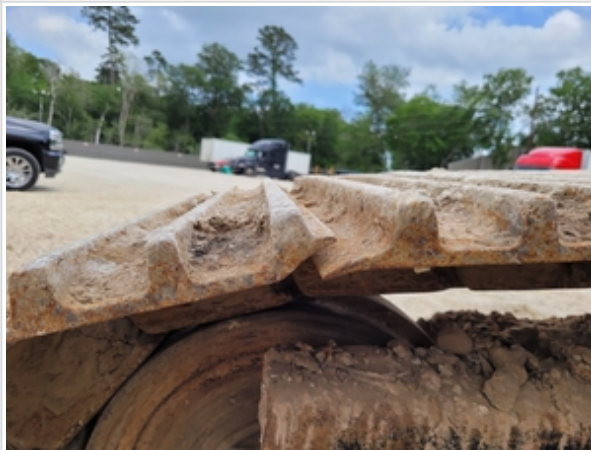
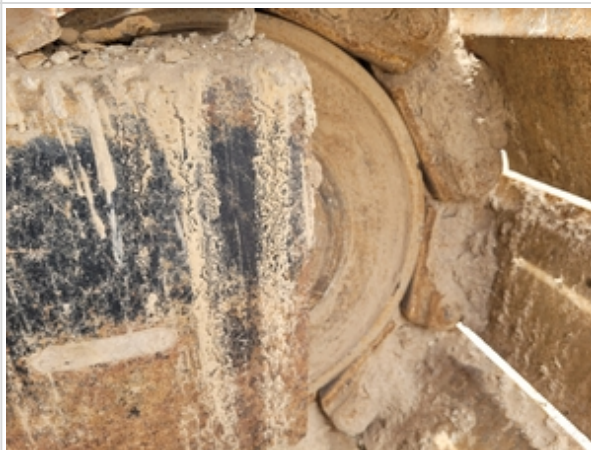
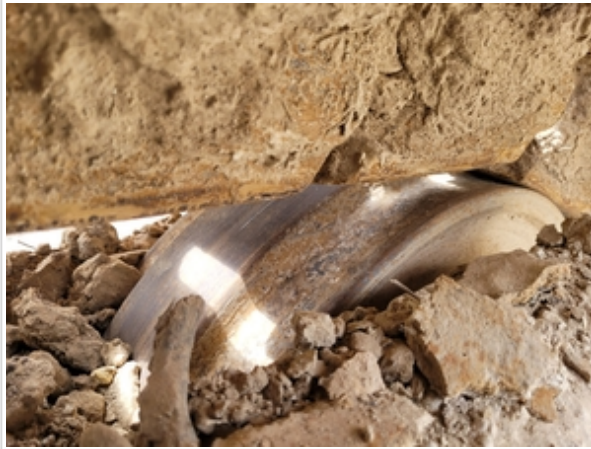
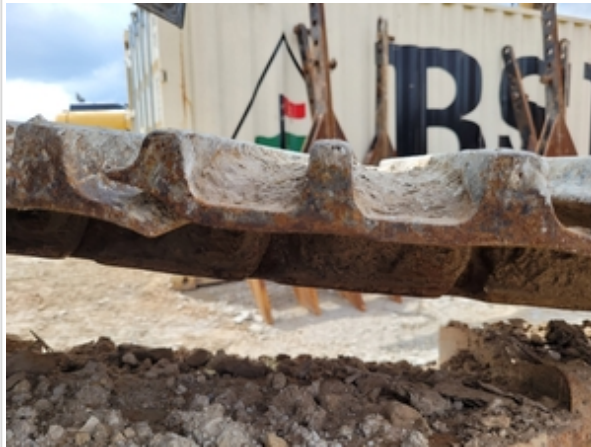
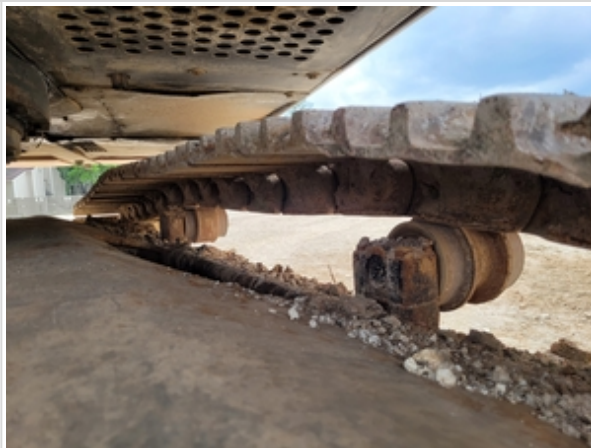
Undercarriage Overall Condition	3 - Normal Wear & Tear	
Comments	Sprocket segments worn and upper rollers worn past 50%	
Undercarriage Overall Photos

Pin & Bushings	3 - Normal Wear & Tear	
Tracks	3 - Normal Wear & Tear	
Comments	Track pads in good condition.	
Left Side: Link Bushings / Drive Sprocket / Shoe Condition	3 - Normal Wear & Tear	
Left Side: Upper & Lower Roller / Front Idler Condition	2 - Above Average Wear	
Comments	Front idlers look okay. Bottom rollers covered with mud/debris and difficult to see

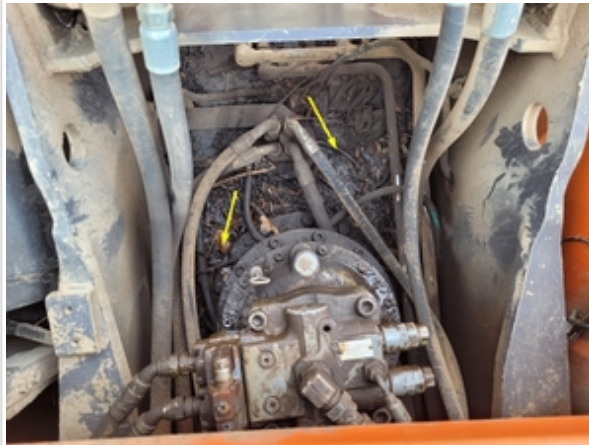
Hydraulic residual buildup around swing drive

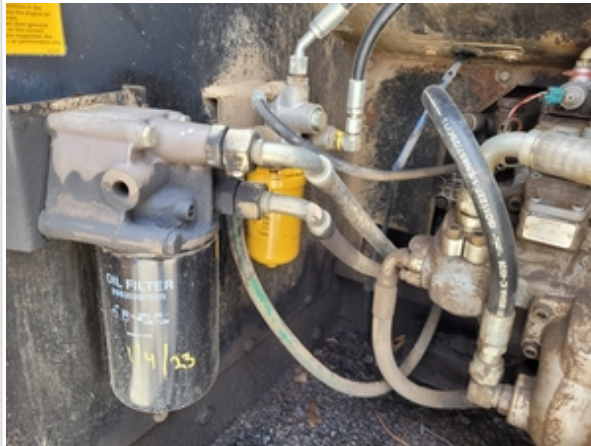
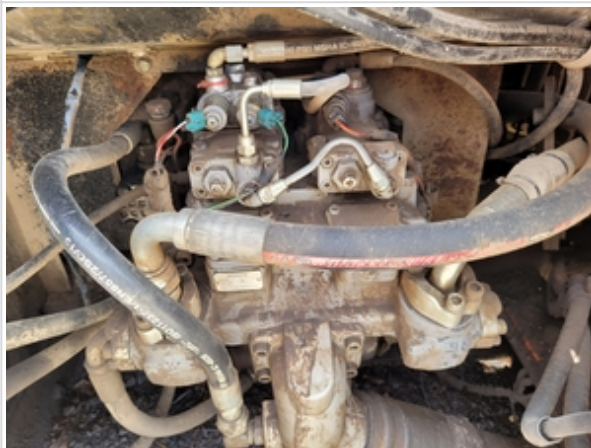
Active Leak

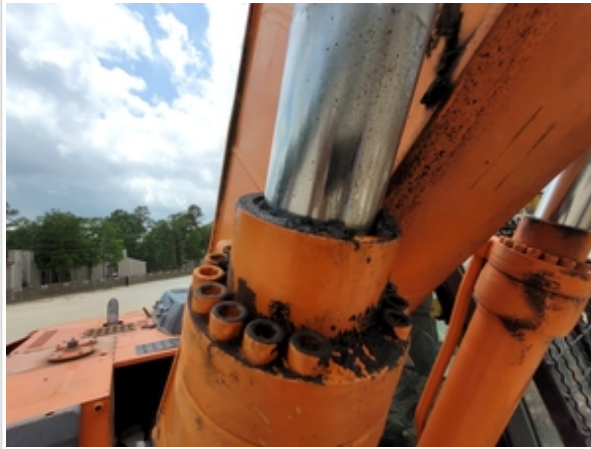
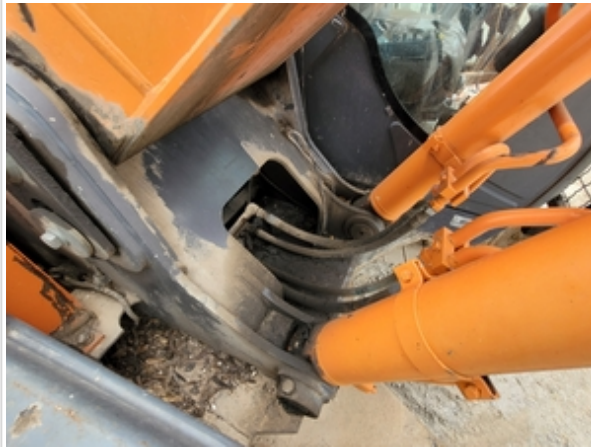
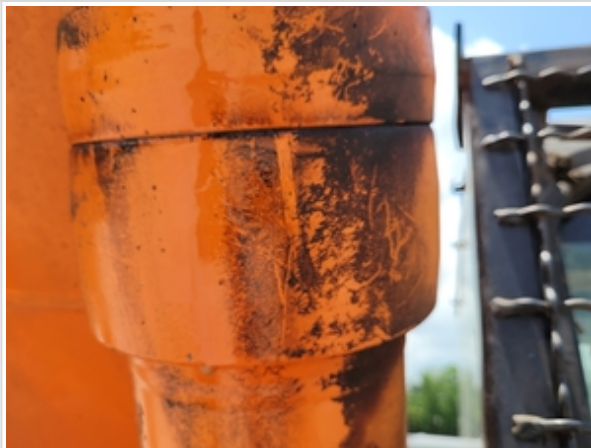
Boom Cylinder	Check the boom cylinder. Note any wear, pitting, discoloration, etc. Take photos.
Boom Cylinder: Mounting Pin	3
Boom Cylinder: Oil Leaks	Yes
Comments	Both Cylinders may be leaking at rod seals

Minor oil leakage seen at both boom cylinders

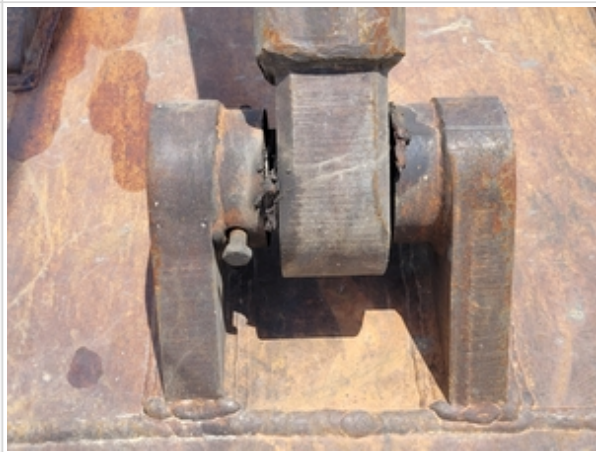
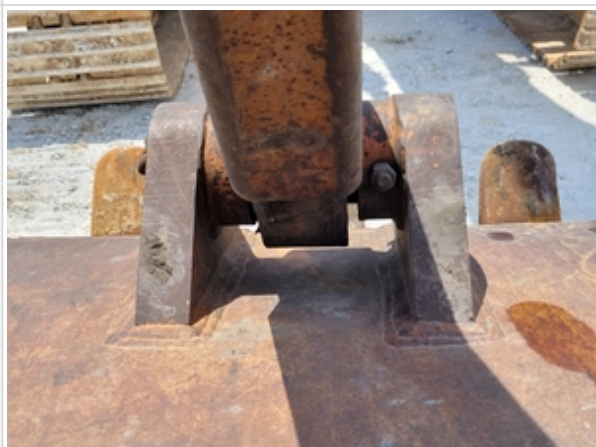
Attachment Type	Manual Grapple assembly
Attachment Condition	3 - Normal Wear & Tear
Attachment Photos
