General Info

General Info		
Category	Bulldozer	
Travel System	Track Undercarriage	
Comments		
Year	1987	
Make	CAT	
Model	D3B	
Fleet ID	N/A	
Serial Number	23Y02174	
Serial Number Plate	MODEL NUMBER ARRANGEMENT NUMBER MACHINE P SERIAL ENGINE TRANSMISSION CATERPILLAR MITSUBISHI LTD. SAGAMIHARA, KANAGAWA. ADE IN JAPAN SVS847	
Hour Meter Reading	32070

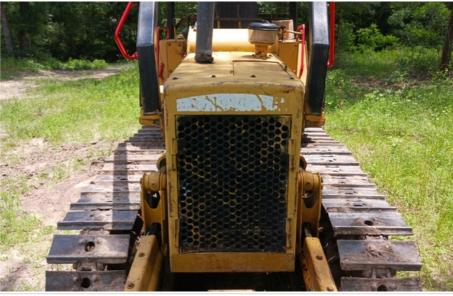
area of rust

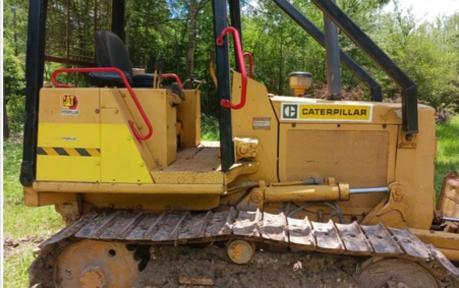
small scratch/missing paint

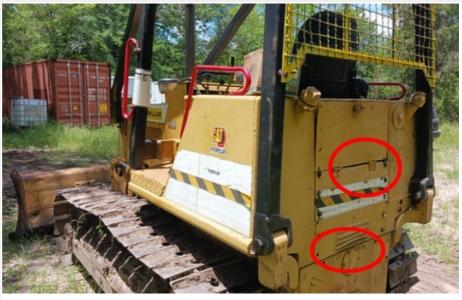
minor misalignment/small dent

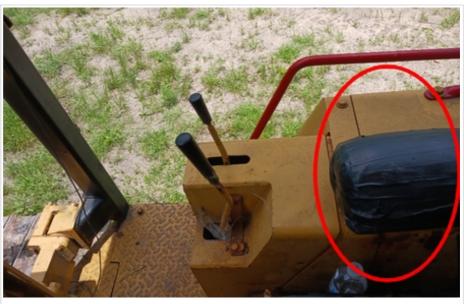
electrical tape on arm rest

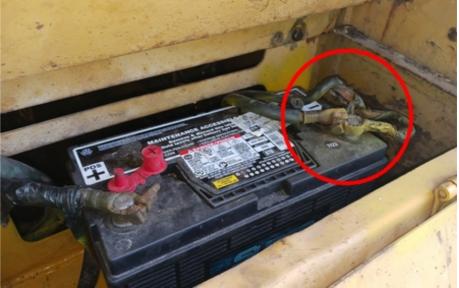
exposed wires on negative battery cable

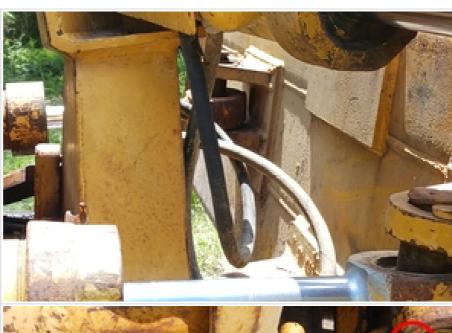
leak from under hose guard on left hand side arm cylinder

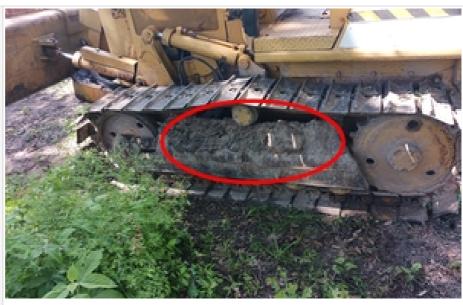
dirt build up

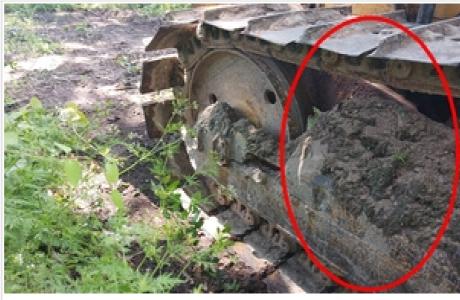
dirt build up

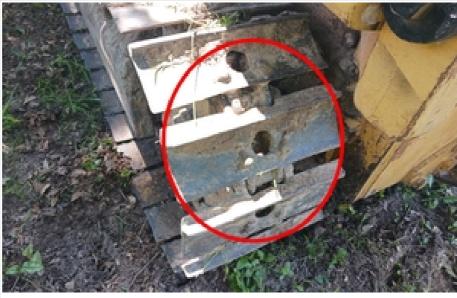
worn tracks

Undercarriage Rating	2 - Above Average Wear & Tear
Undercarriage Comments	Tracks have above normal wear and tear but the system works just fine

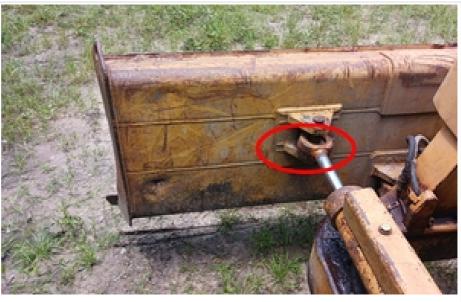
area is a little lose

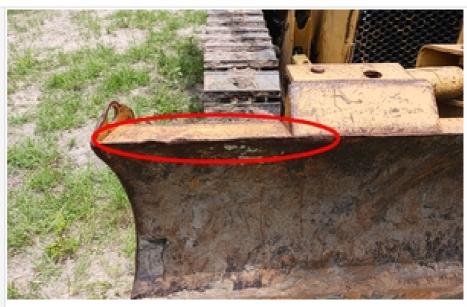
minor dents

Attachment Rating	2 - Above Average Wear & Tear	
Attachment Comments	Attachment has minor dents and shows above normal wear and tear

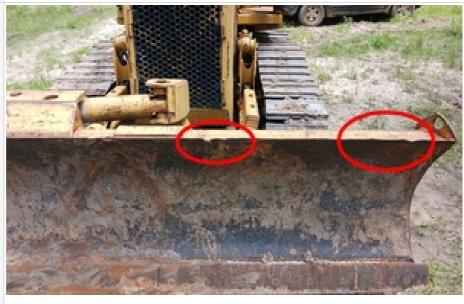
minor dents

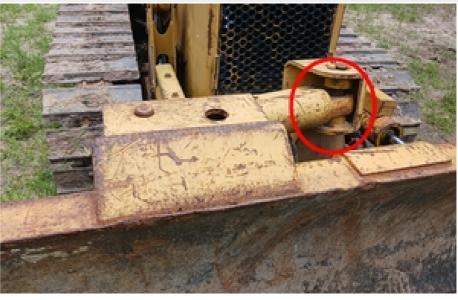
area has some play
