Inspection Report (Vibratory Compactor)

Year	2012
Make	Hamm
Model	HD12
Serial Number	H20Q1545
Hour Meter Reading	859.6
Previous Application (e.g., earth moving, mining, demolition, etc)	asphalt roller

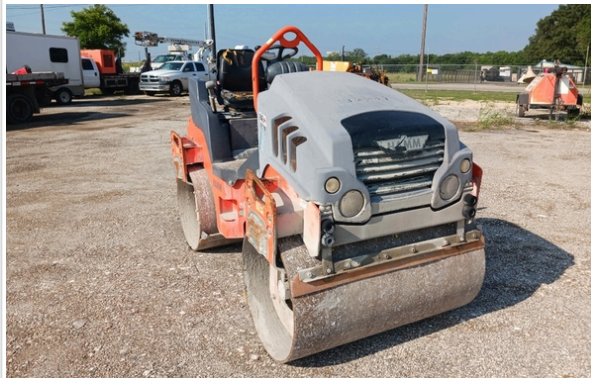
area of rust/missing paint, and faded hood

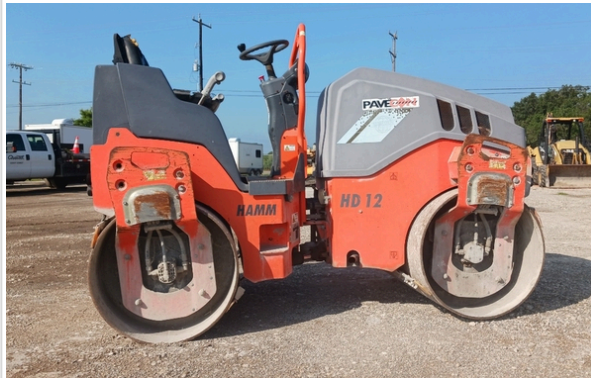
small areas of rust/missing paint

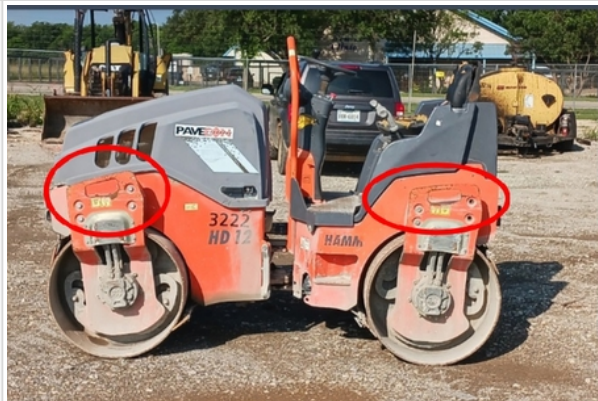
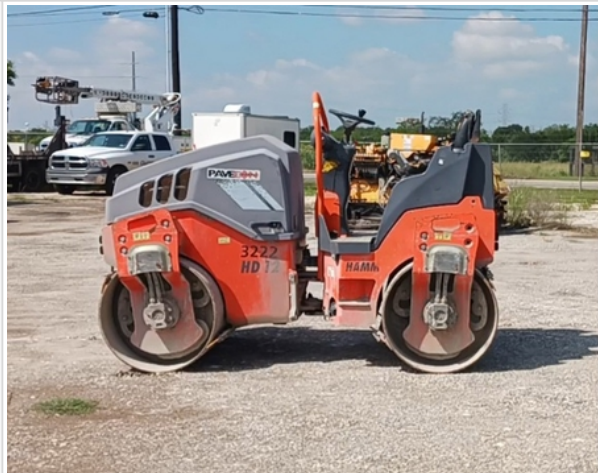
Body Panels	3 - Normal Wear & Tear	
Body Panel Condition	Visible chipped paint or dents	
Body Panels Photos

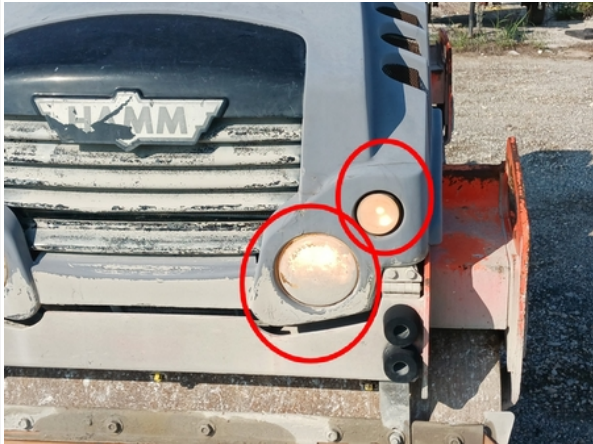
<p>lights work, they are just dirty</p>

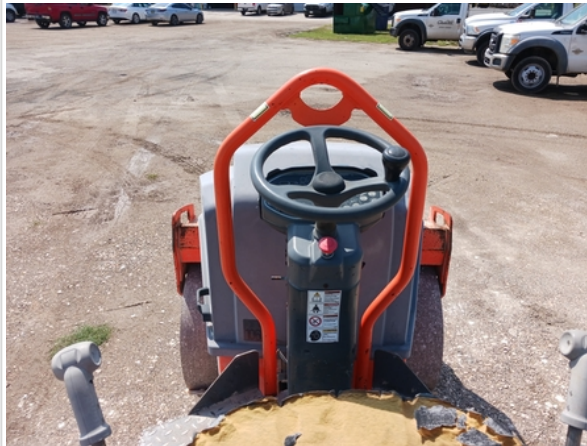
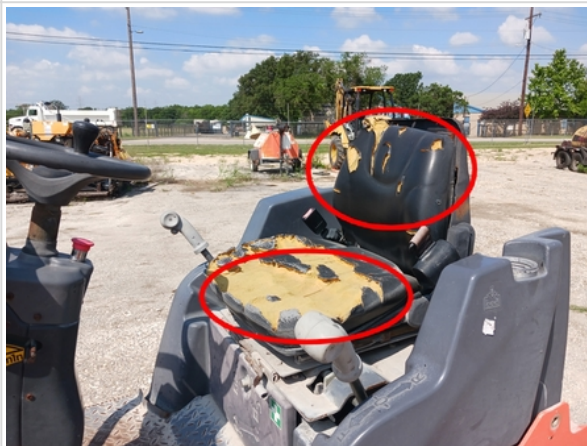
big tears on the seat

Operator Cabin Overall	3 - Normal Wear & Tear	
Operator Cabin Overall Condition	Minor cosmetic wear to cabin surfaces, floors, panels, and ceiling	
Operator Seat	2 - Above Average Wear	
Operator Seat Condition	Seat(s) is damaged due to sun exposure; fading, cracking observed, Seat(s) has major surface staining or tears, Seat belt secures properly, Seat belt is intact and in good condition	
Operator Seat Photos

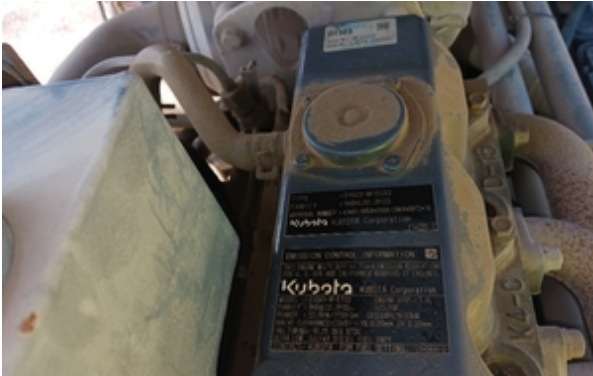
<p data-bbox="536 1361 770 1391">normal wear and tear</p>

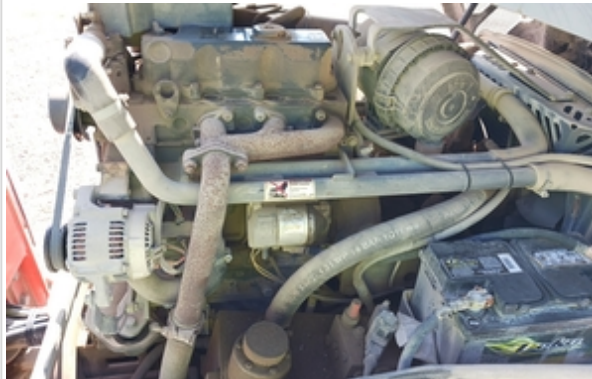
gunky/dirty area

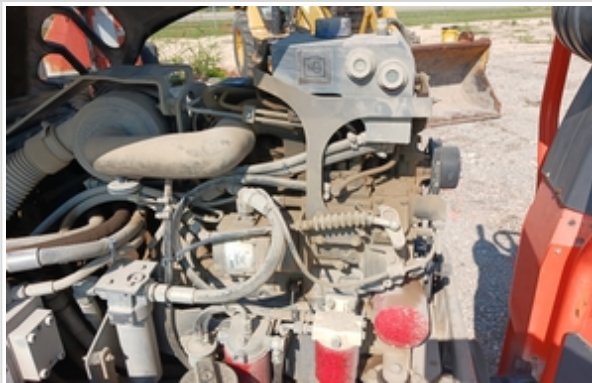
dirty/gunk area and area was moist

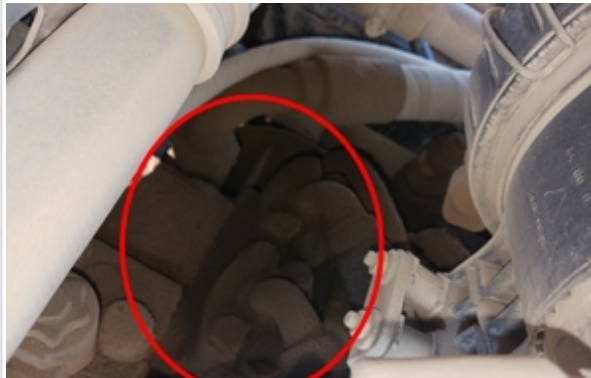
dirty/gunky area

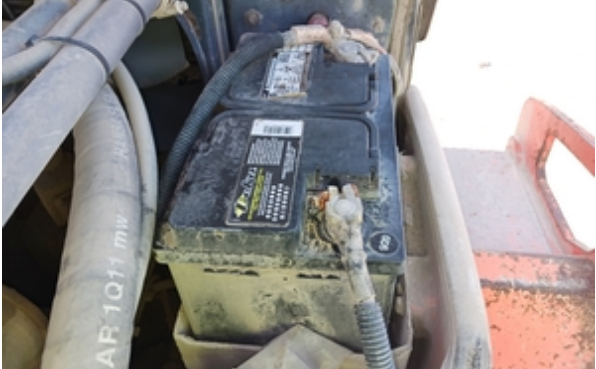
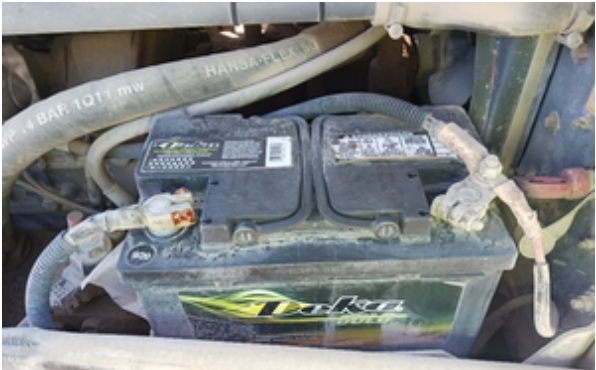
Blow-by (Visual Observation Check)	N/A
Unusual Noises (Upon Start-up, Idle, Shutdown)	No
Unusual Noise Notes	No unusual noises heard
Engine Smoke (Upon Start-up, Idle, Shutdown)	No
Engine Smoke Notes	No engine smoke issues observed
Engine Exhaust Color	Clear
Battery	3 - Normal Wear & Tear
Battery Condition	Dusty & dirty appearance
Comments	normal amount of wear and tear
Battery Condition Photos

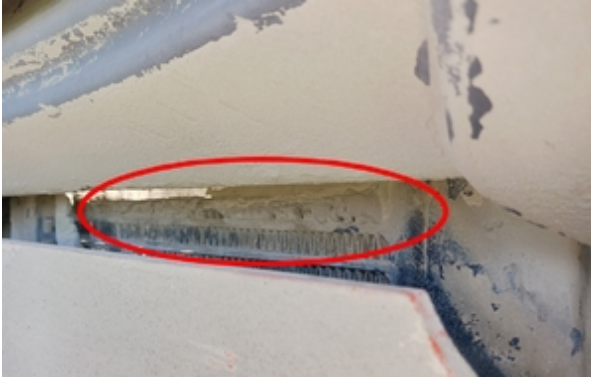
Radiator	3 - Normal Wear & Tear	
Radiator Condition	Signs of defects, chips, or contamination buildup seen on cooling fan	
Radiator Photos

<p>clogged/dirty areas</p>

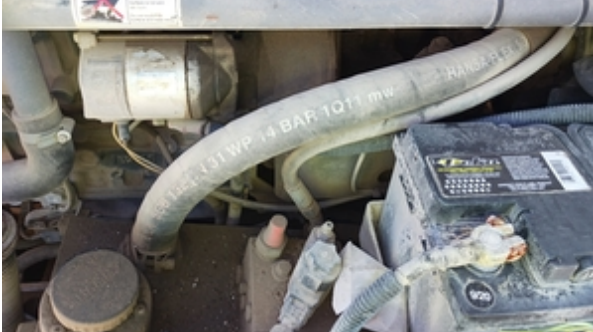
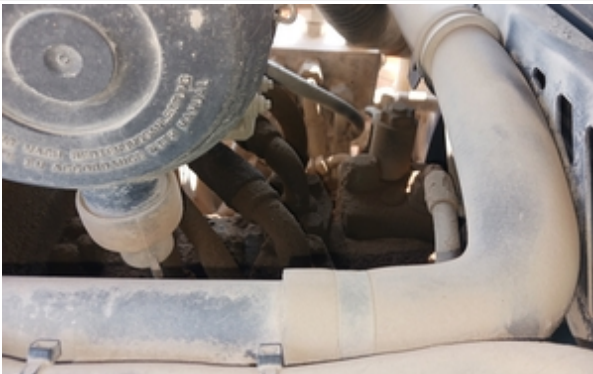
<p>clogged/dirty areas</p>	
Belts	<p>3 - Normal Wear & Tear</p>	
Belt Condition	<p>Belts appear in good condition & alignment with proper tension</p>	
Hoses	<p>3 - Normal Wear & Tear</p>	
Hose Condition	<p>Dried seepages observed, Other (see comments)</p>	
Comments	<p>some hoses have a moist appearance</p>	
Hose Photos

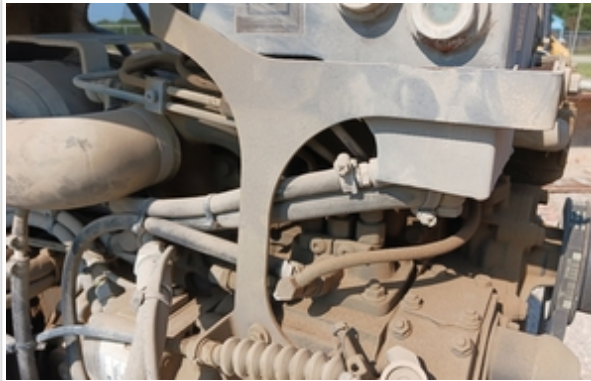
moist area with dirty/gunky residue on the hose

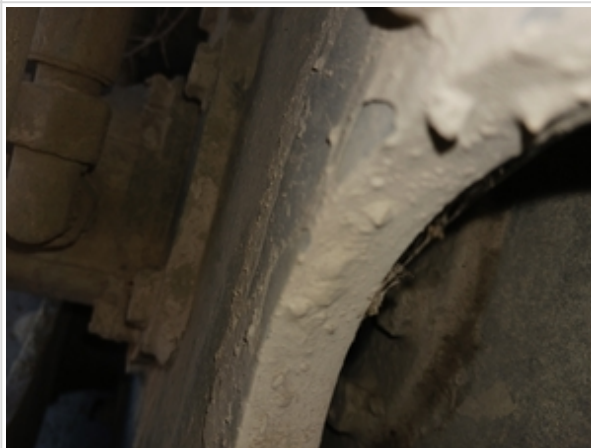
piece of grass/twig not a crack

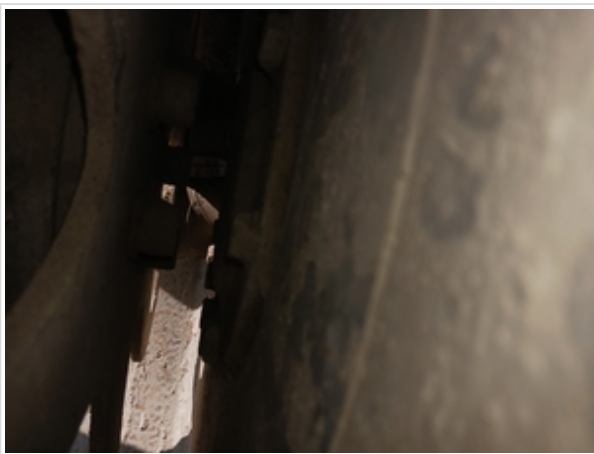
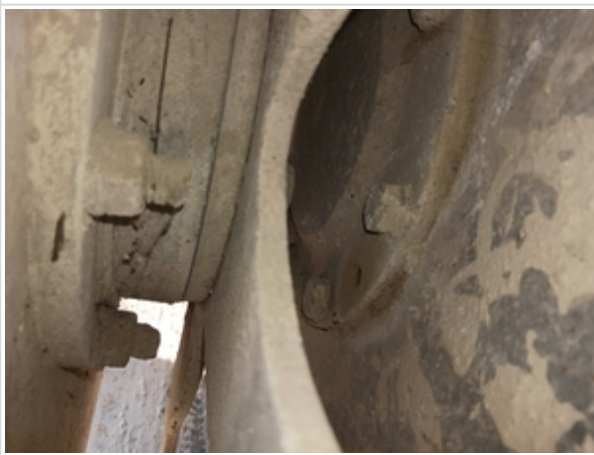
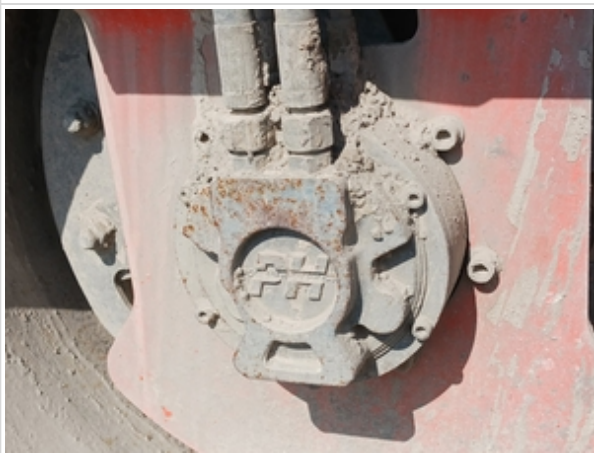
Hydrostatic Transmission?	Yes
2 Speed?	No
Hydrostatic Drive Configuration	Close Coupled Transmission
Drive Motors	3 - Normal Wear & Tear
Comments	transmission is an infinitely variable one

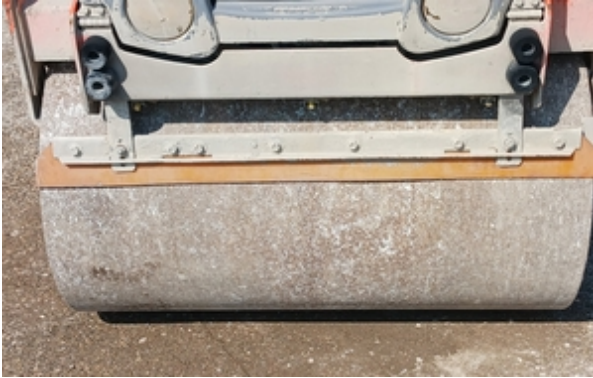
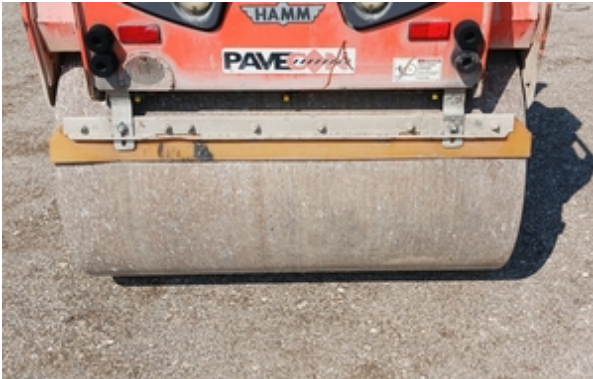
Comments	drums have a normal amount of wear in tear
Drum(s) Photos

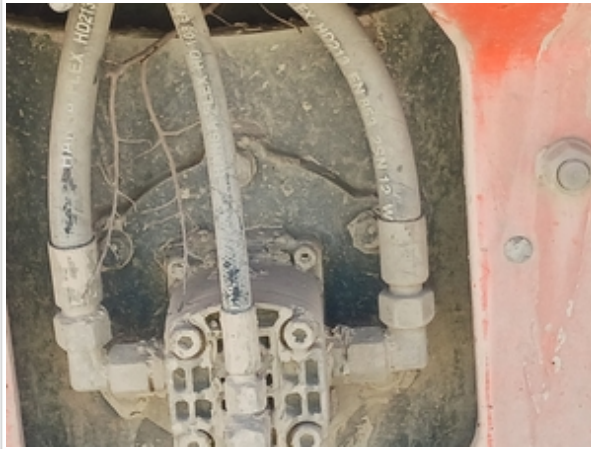
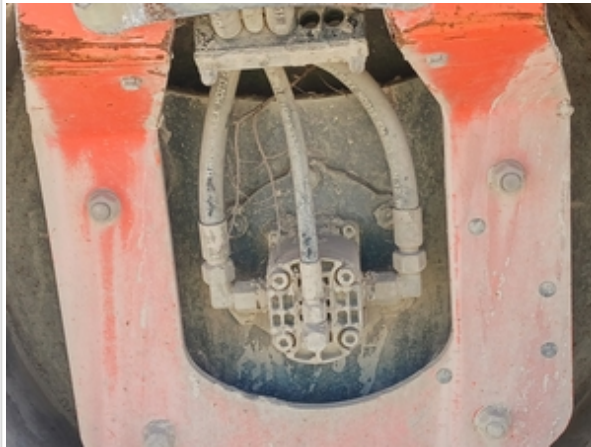
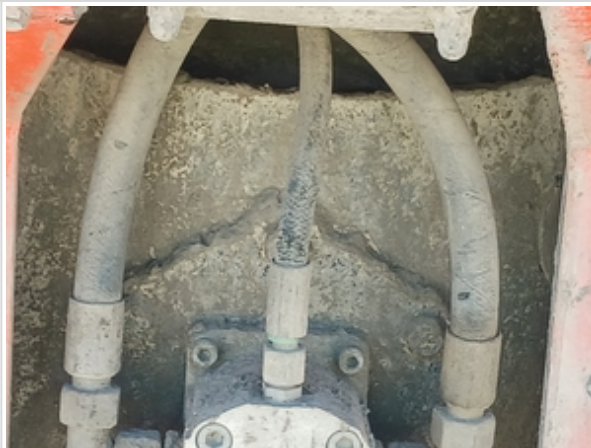
Hydraulic System Photos

Wet or Damp Hydraulic Lines / Fittings	Yes
Appearance of Hydraulic Lines / Fittings	3 - Normal Wear & Tear
Hydraulic Lines / Fittings Condition	Hydraulic lines & fittings are clean and in good condition
Unusual Noises (Hydraulic Pump)	No
Hydraulic Pump Notes	No unusual noises heard during operation

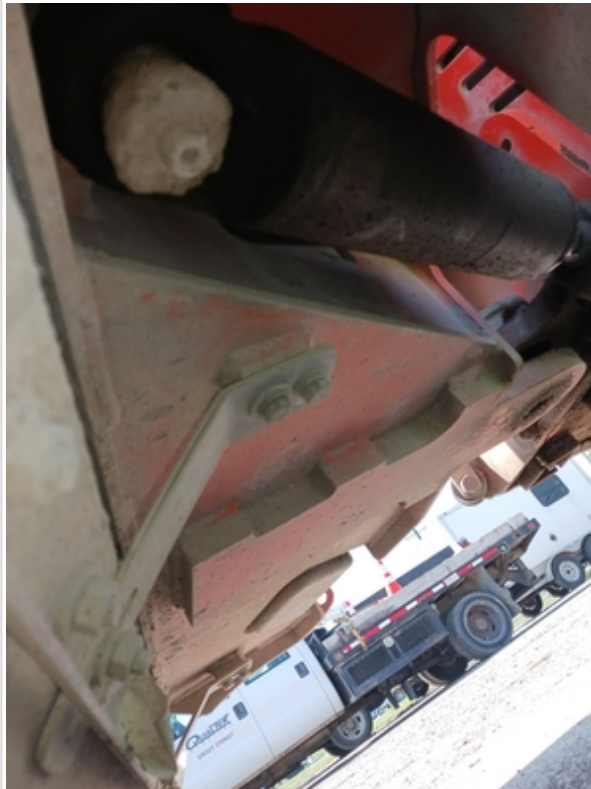
damp/moist area

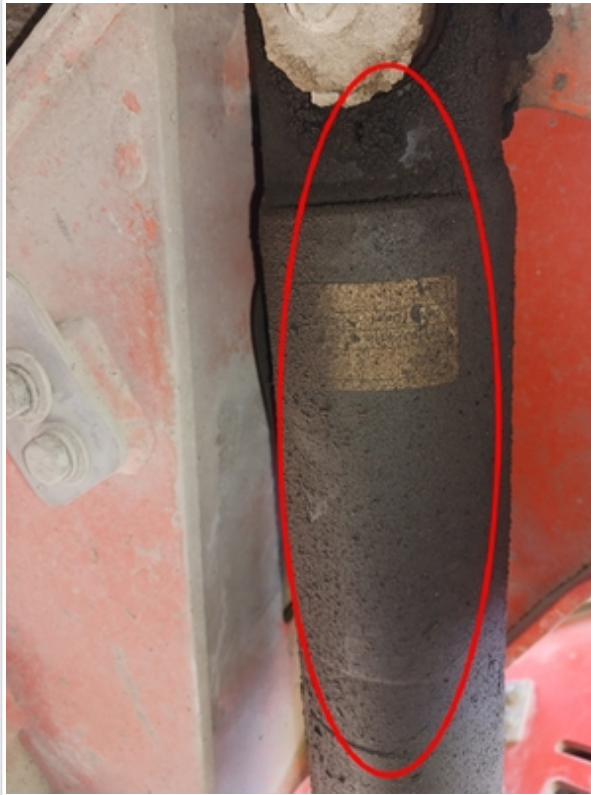
damp/dirty area
