Inspection Report (Motor Grader)

Year	2014
Make	CAT
Model	140 M3
Serial Number	N9J00126
Hour Meter Reading	11,131 Hrs.
Previous Application (e.g., earth moving, mining, demolition, etc)	Grading

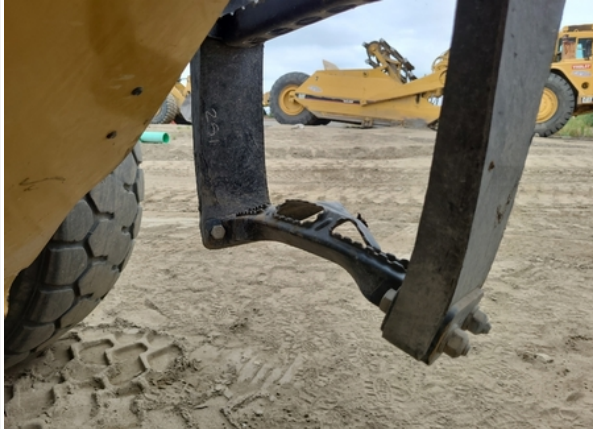
Steps / Ladders Photos

Body Panels	3 - Normal Wear & Tear
Body Panel Condition	No visible damage, good paint condition and panel fitment
Doors / Canopy Latches	3 - Normal Wear & Tear
Doors / Canopy Latches Condition	No visible damage
Steps / Ladders	3 - Normal Wear & Tear
Steps / Ladders Condition	Bent or broken steps or rungs, Other (see comments)
Comments	L/S Operator Cab Step Assembly bottom bent. R/S bottom slightly bent

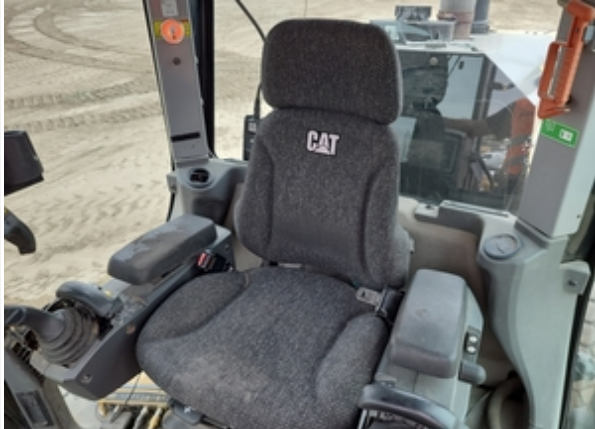
Operator Seat Photos

Control Station Overall Rating	3 - Normal Wear & Tear	
Control Station Overall Condition	Good cabin appearance, solid floors, panels, and ceiling	
Operator Seat	3 - Normal Wear & Tear	
Operator Seat Condition	Seat(s) in good condition, no stains or tears in upholstery

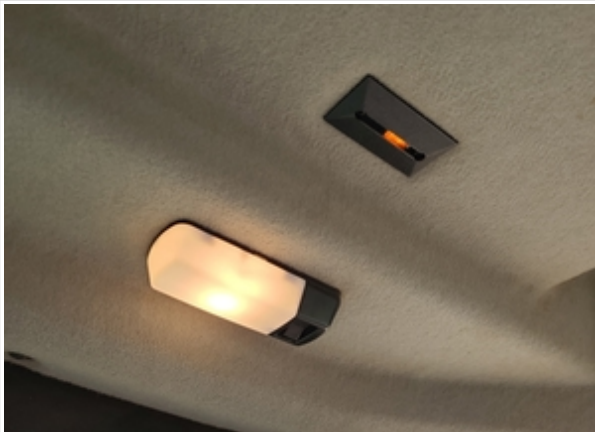
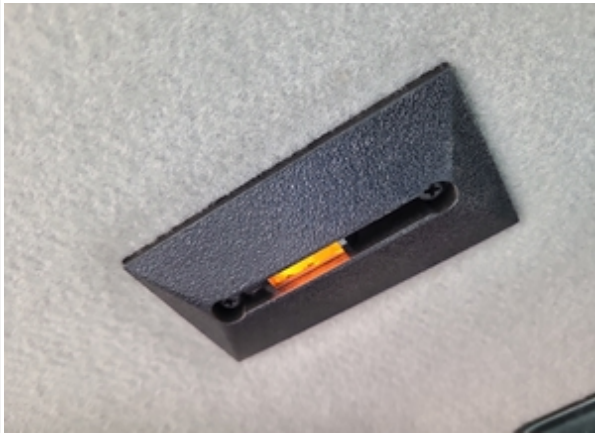
Cabin Lights	3 - Normal Wear & Tear
Cabin Lights Condition	Cabin lights are installed with all light covers in place, bulbs are installed and working properly
Cabin Lights Photos

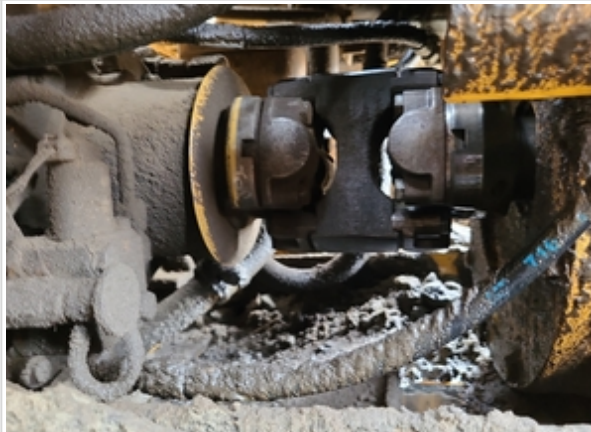
Residual oil buildup on rear axle area

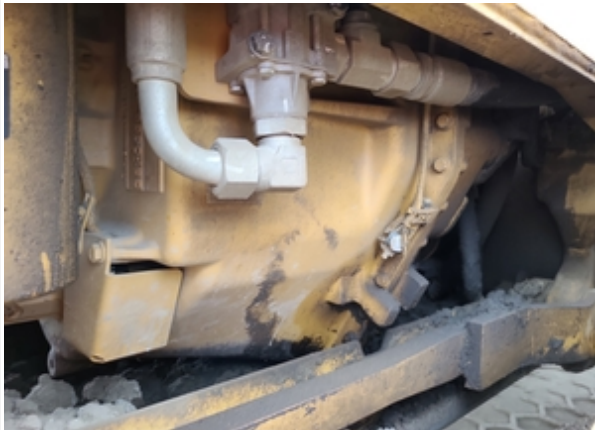
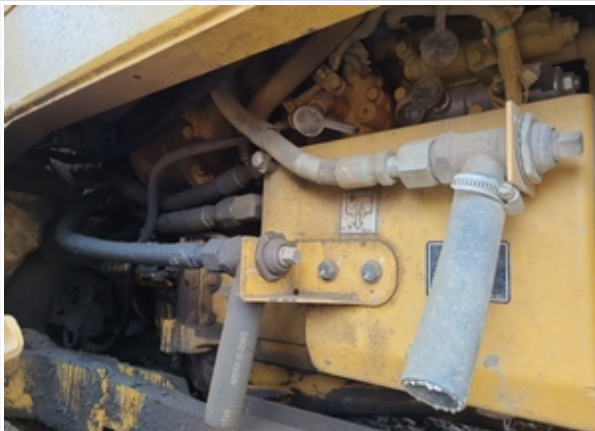
Hydrostatic Transmission?	No	
2 Speed?	No	
Hydrostatic Drive Configuration	Split Transmission	
Transmission Info (Make/Model/Speeds)	Powershift 8 Speed Fwd/6 Speed Reverse/ Front is Hydrostatic AWD	
Transmission Components	3 - Normal Wear & Tear	
Transmission Condition	Good forward and reverse function, Leaking transmission fluid observed, Other (see comments)	
Comments	Rear transmission housing is half covered in residual oil that may relate to active Trans., Hyd., & or Engine fluid leaks.	
Transmission Photos

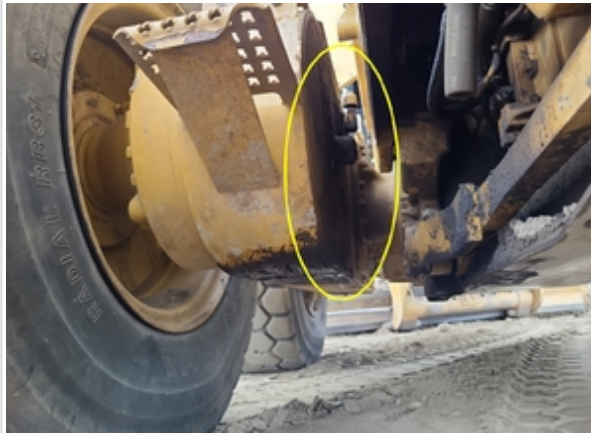
L/S Tandem has residual oil buildup

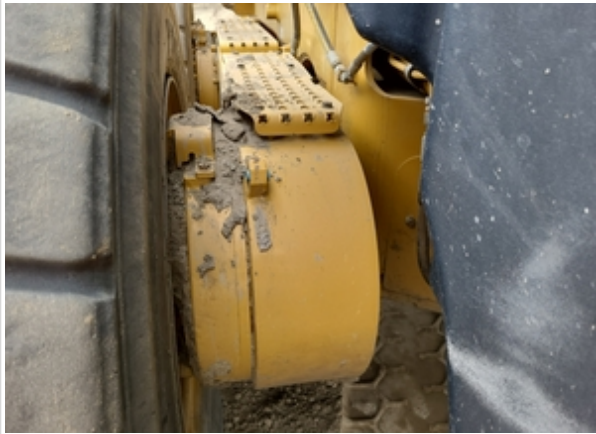
Rear Drive Axle	3 - Normal Wear & Tear
Comments	Has residual oil buildup around rear axle

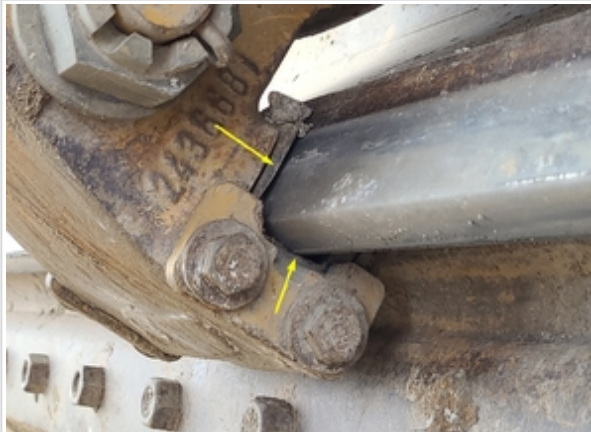
Large Gap, worn wearpads all around

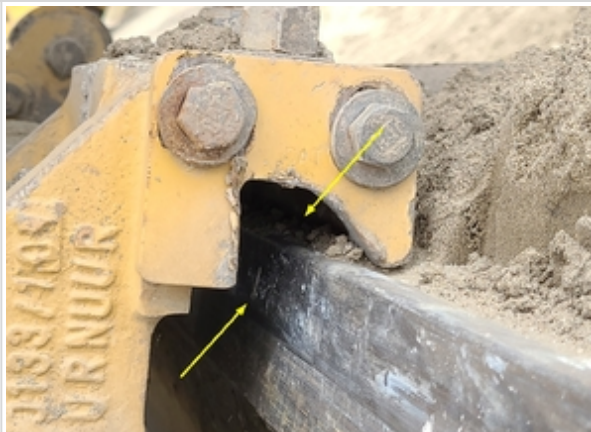
Blade slide rail Bushings/wear plates worn and some missing

Large gap = worn bushings

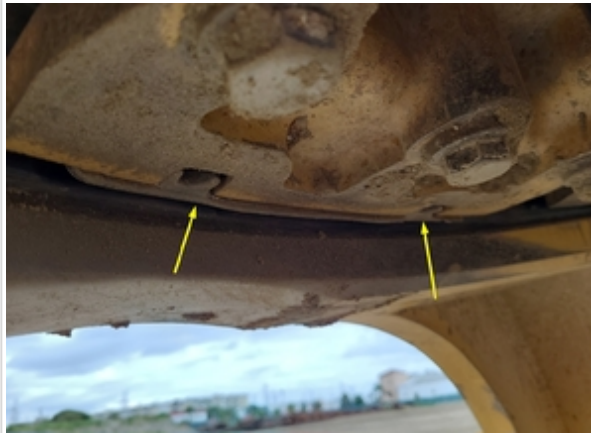
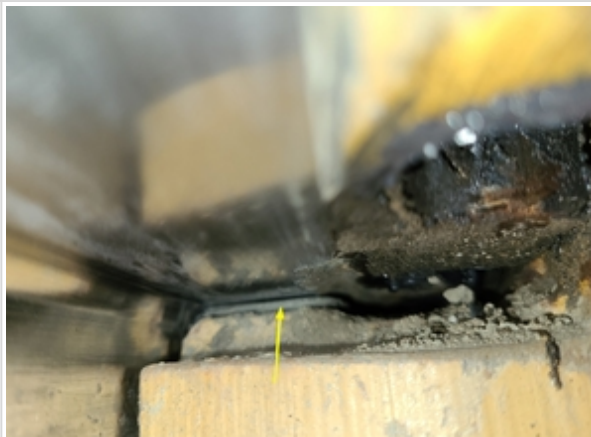
Inside of circle wear pad to top

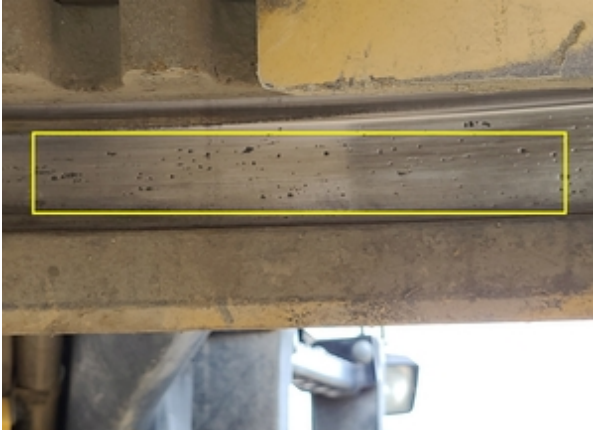
<p>Circle rotational wear pads worn</p>

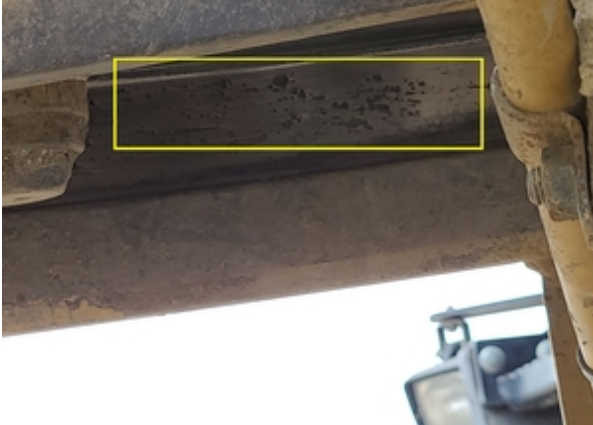
<p>inside circle wall showing minor pitting</p>

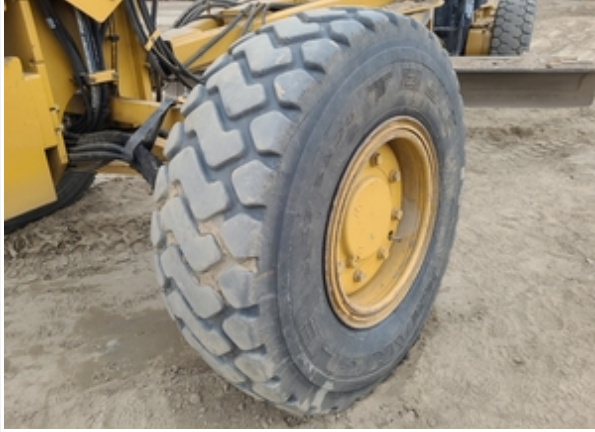
Front Left Tire Photos

Tire Brand	Qty5 - YOKOHAMA Qty1. (Triangle)	
Tire Size	17.5R25	
Front Left Tire - Ratio Remaining	10%

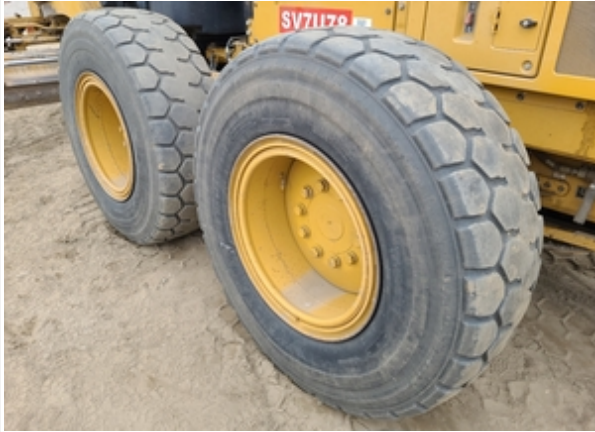
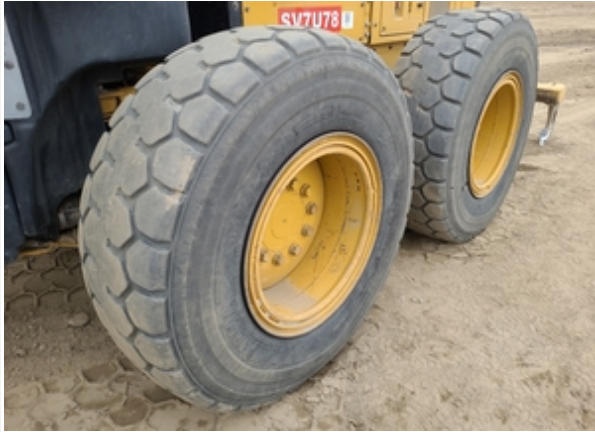
Rear Left Tires - Ratio Remaining	10%	
Rear Left Tire Photos

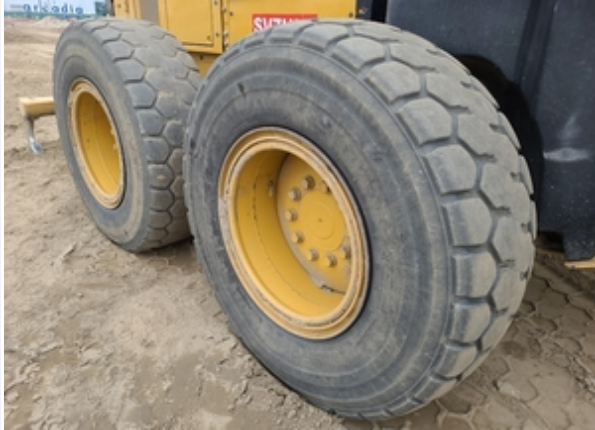
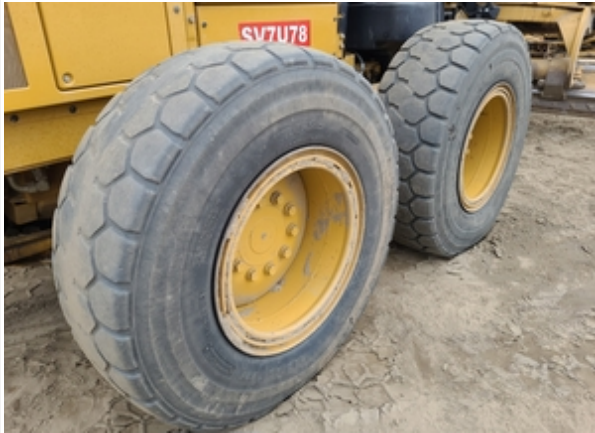
Rear Right Tire Photos

Rear Right Tires - Ratio Remaining	10%

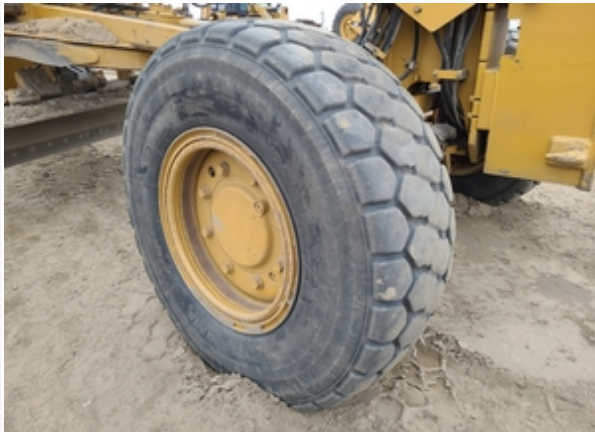
Front Right Tire - Ratio Remaining	10%	
Front Right Tire Photos

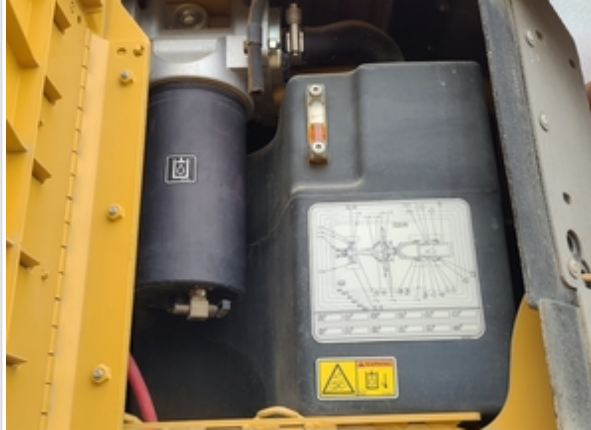
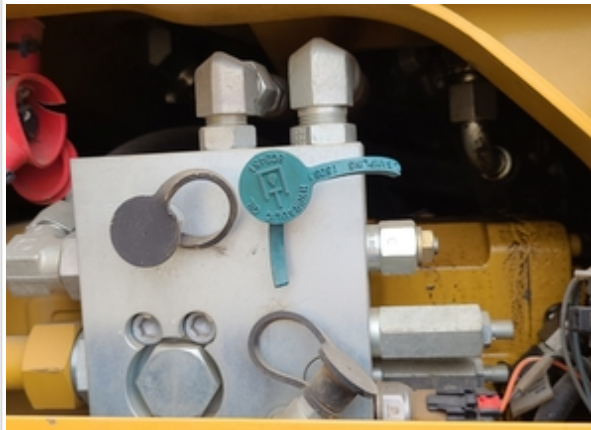
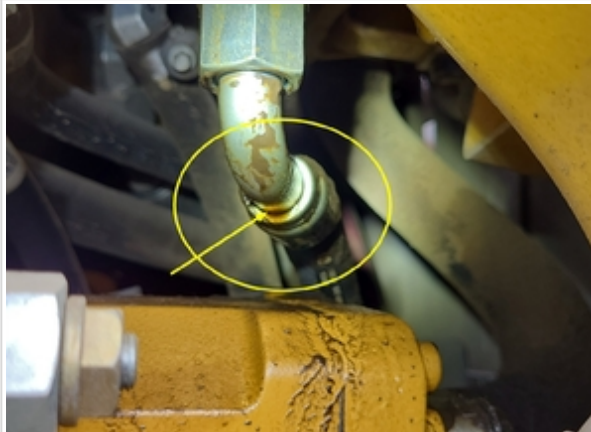
Hydraulic System Photos

Active minor hydraulic leak

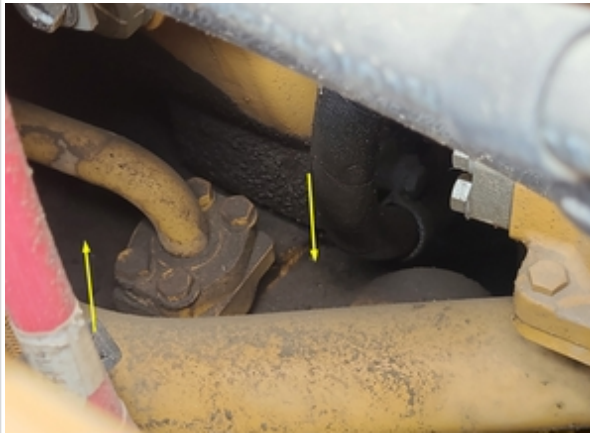
Residual oil buildup on bottom r/s pump

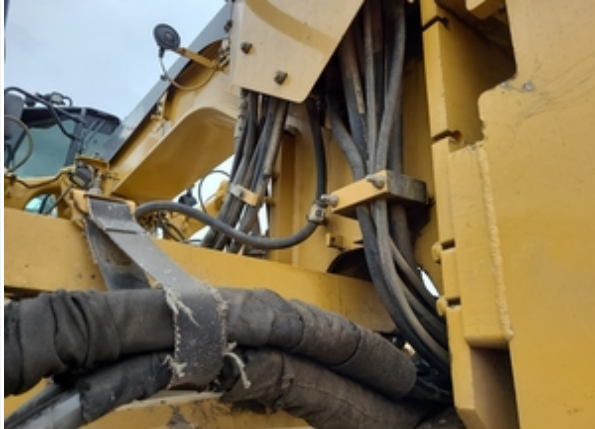
Wet or Damp Hydraulic Lines / Fittings	Yes
Appearance of Hydraulic Lines / Fittings	3 - Normal Wear & Tear
Hydraulic Lines / Fittings Condition	Hydraulic lines & fittings are clean and in good condition, Active leaks in hoses or fittings observed, Other (see comments)
Comments	Active leak at rear left side under hyd. tank hoses area. Front drive motors have residual oil/grease buildup. May be leaking or just grease.
Unusual Noises (Hydraulic Pump)	No
Hydraulic Pump Notes	No unusual noises heard during operation
Comments	Hydraulics work well and sound healthy under pressure.

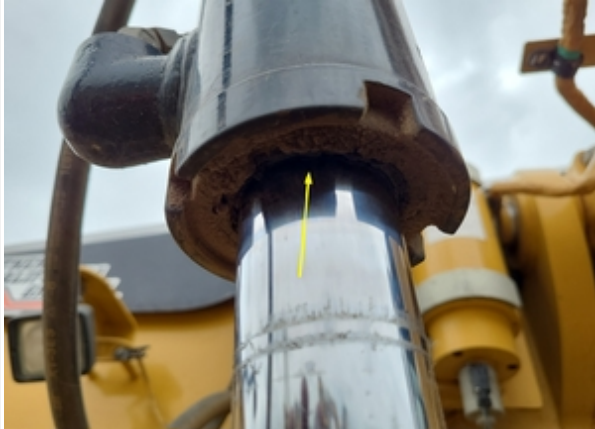
<p>very minor residual oil buildup at rod seal</p>

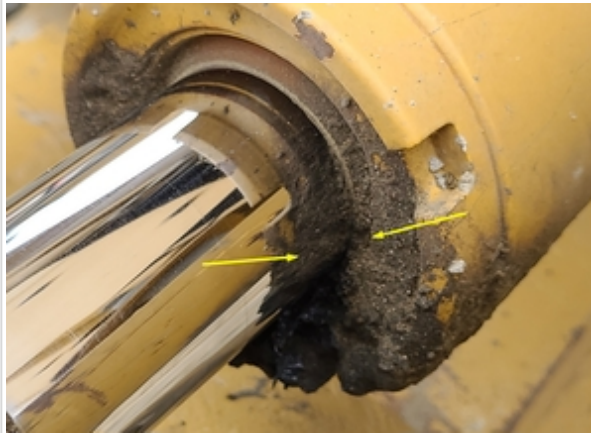
Wheel Lean Cylinders	Check the cylinders and mounting pins. Note any wear, pitting, discoloration, etc. Take photos.
Wheel Lean Cylinder: Mounting Pin	3
Wheel Lean Cylinder: Oil Leaks	No
Comments	Wheel Lean Cylinder not leaking just grease buildup from suspension
Wheel Lean Cylinder Photos

Grease buildup from nearby grease point area on wheel

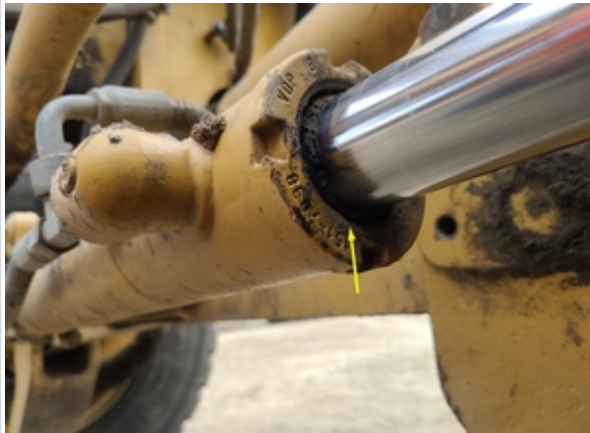
Minor Residual Oil seen at brood seal (R/S Steer Cylinder)

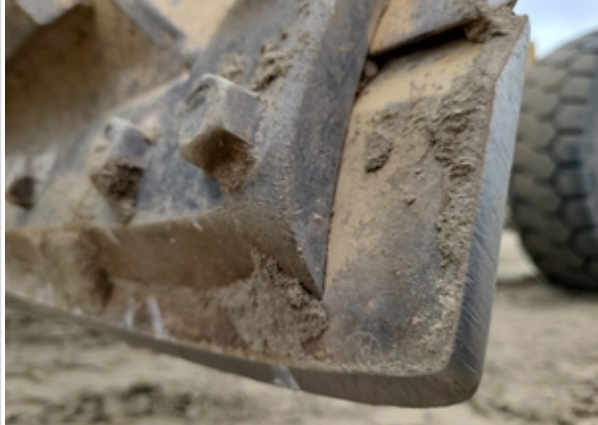
Blade Cutting Edge Condition	2 - Above Average Wear	
Comments	Bottom edge blade can be flipped to extend life.	
Blade Edge Photos
