# Inspection Report

## Hydraulics

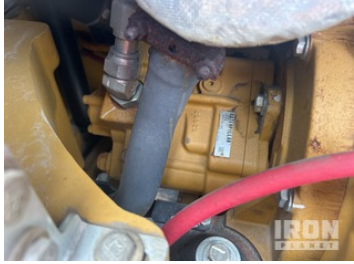
| Item | Assessment | Photo |
|---|---|---|
| Pumps (Hydraulics) | ★★★★ | |

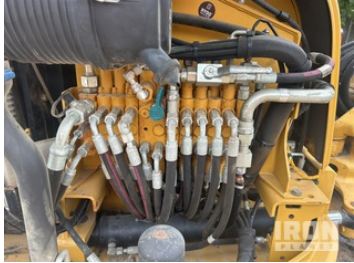
| Item | Assessment | Photo |
|---|---|---|
| Valves | ★★★★ | |

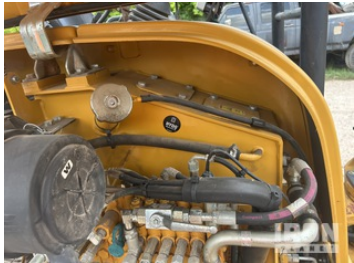
| Item | Assessment | Photo |
|---|---|---|
| Hydraulic Tank | ★★★★ | |

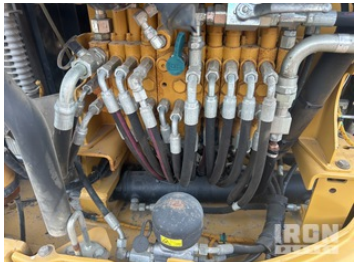
| Item | Assessment | Photo |
|---|---|---|
| Hoses (Hydraulics) | ★★★★ | |

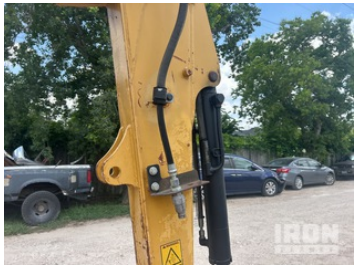
| Auxiliary Hydraulic Plumbing | Not operationally checked, End of stick | |

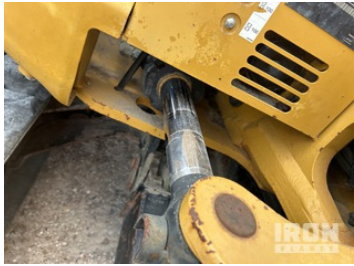
| Boom Swing Cylinders | ★★★★☆ | |

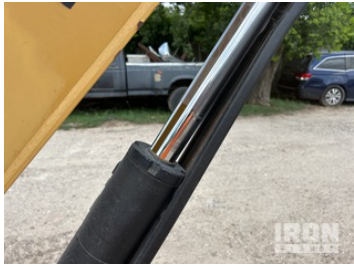
| Boom Lift Cylinder(s) | ★★★★☆ | |

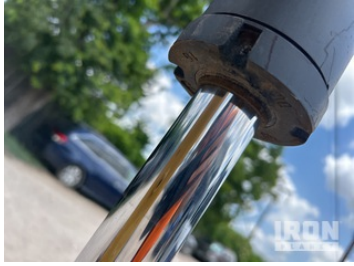
| Bucket Cylinder | ★★★★☆ | |

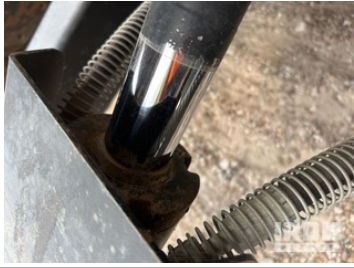
| Blade Lift Cylinder | ★★★★☆ | |

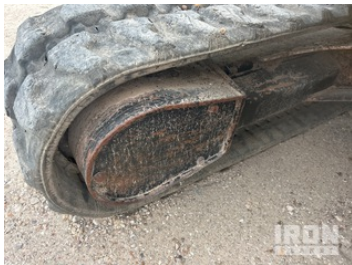
| Item | Assessment | Photo |
|---|---|---|
| Left Drive Motor | ★★★★☆ | |

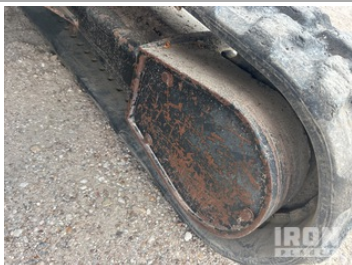
| Item | Assessment | Photo |
|---|---|---|
| Right Drive Motor | ★★★★☆ | |

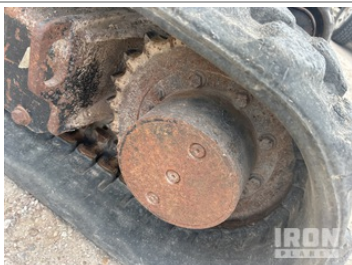
| Item | Assessment | Photo |
|---|---|---|
| Left Final Drive | ★★★★☆ | |

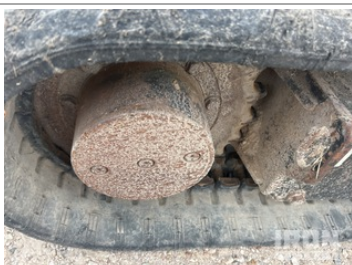
| Item | Assessment | Photo |
|---|---|---|
| Right Final Drive | ★★★★☆ | |

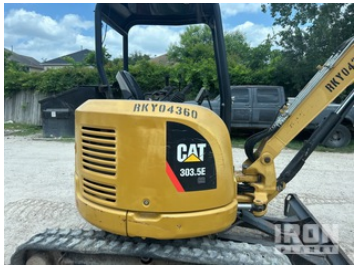
| Body Panels* | No visible damage or missing components | |

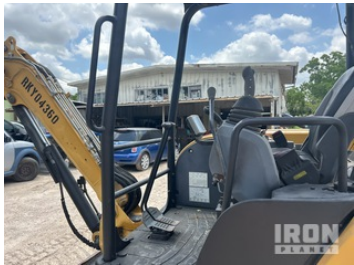
| Hand Rails` | No visible damage or missing components | |

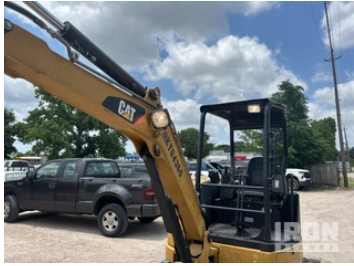
| Lights* | All lights operational | |

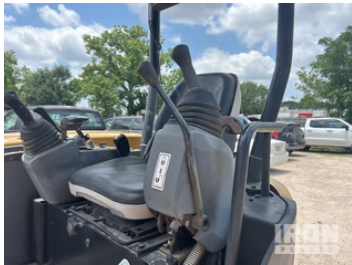
| Safety | | |
|---|---|---|
| Safety Lock Out/Stop | Operational | |

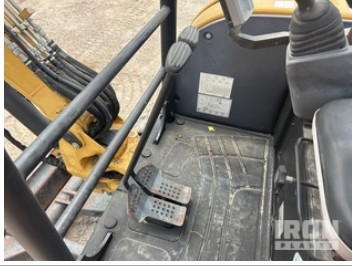
| Control Station - CE Excavator* | | |
|---|---|---|
| Steering Controls | ★★★★☆ | |

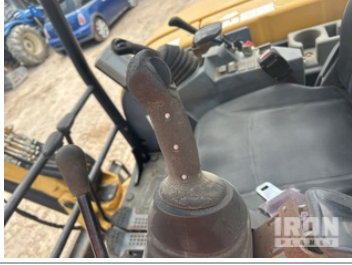
| Control Station - CE Excavator* | | |
|---|---|---|
| Hydraulic Controls | ★★★★☆ | |

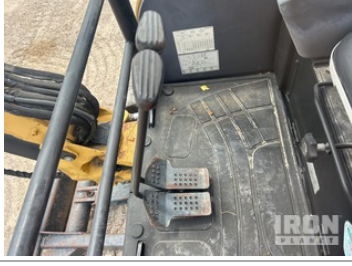
| Control Station - CE Excavator* | | |
|---|---|---|
| Drivetrain Controls | ★★★★☆ | |

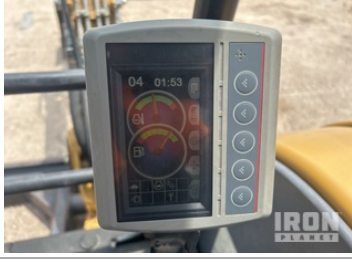
| Control Station - CE Excavator* | | |
|---|---|---|
| Dash Console | ★★★★☆ | |

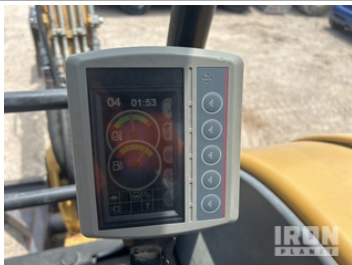
| Control Station - CE Excavator* | | |
|---|---|---|
| Fault Indicator Lights | Operational | |

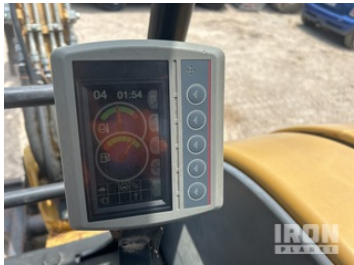
| Gauges | Operational | |

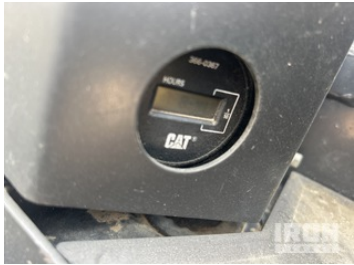
| Hour Meter / Odometer | 833 hrs | |

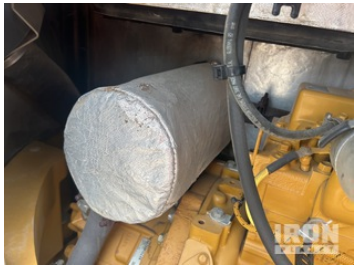
| Engine - CE* | | |
|---|---|---|
| Exhaust System** | No visible damage or missing components | |

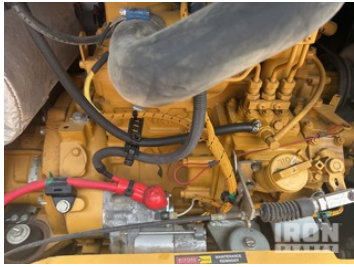
| Engine - CE* | | |
|---|---|---|
| Oil Leaks | No dripping leaks | |

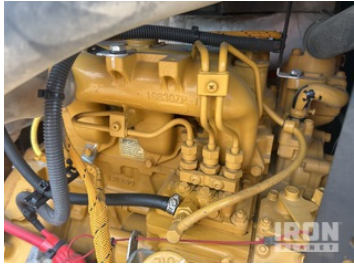
| Engine - CE* | | |
|---|---|---|
| Fuel Leaks | No dripping leaks | |

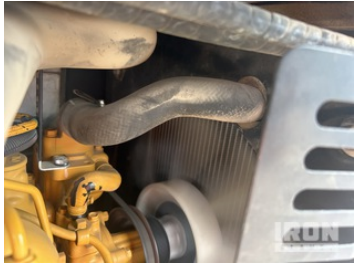
| Engine - CE* | | |
|---|---|---|
| Cooling System Leaks | No dripping leaks | |

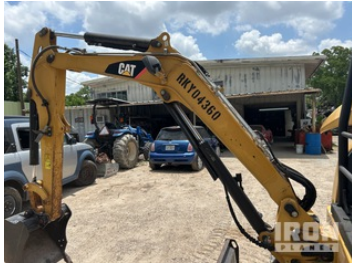
| Excavator Chassis* | | |
|---|---|---|
| Boom Condition | ★★★★☆ | |

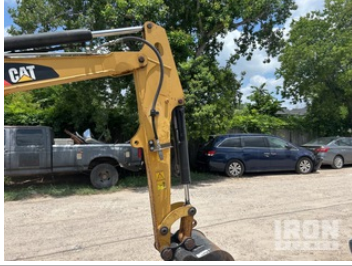
| Excavator Chassis* | | |
|---|---|---|
| Stick Condition | ★★★★☆ | |

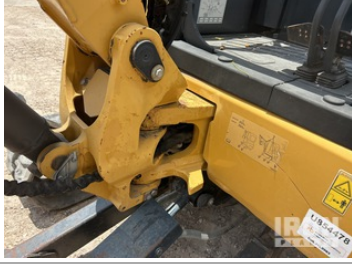
| Excavator Chassis* | | |
|---|---|---|
| Swing Tower Pivot | ★★★★☆ | |

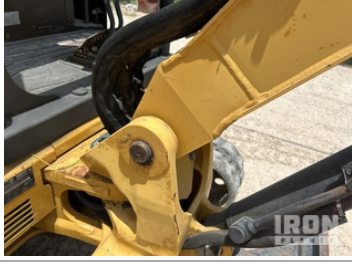
| Excavator Chassis* | | |
|---|---|---|
| Boom Base Pin and Bushings | ★★★★☆ | |

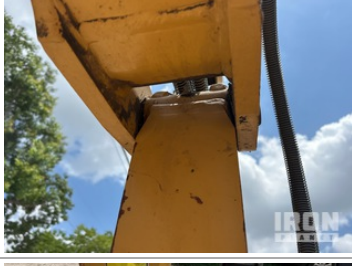
| Excavator Chassis* | | |
|---|---|---|
| Pin and Bushings Boom to Stick | ★★★★☆ | |

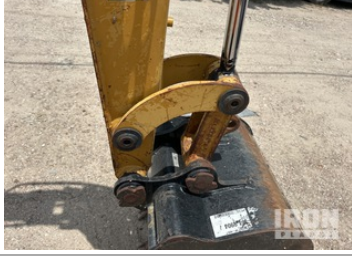
| Excavator Chassis* | | |
|---|---|---|
| Pin and Bushings Stick to Bucket | ★★★★☆ | |

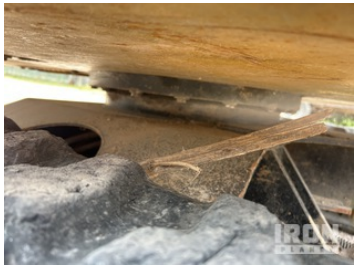
| Turntable Bearing | ★★★★☆ | |

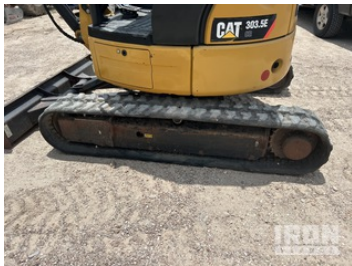
| Item | Assessment | Photo |
|---|---|---|
| Roller Frames | ★★★★☆ | |

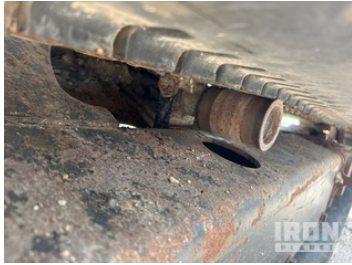
| Item | Assessment | Photo |
|---|---|---|
| Rubber Belt Drive Lugs | No visible damage | |

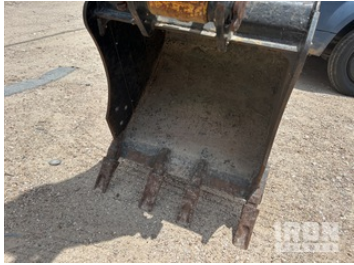
| Specialty - Excavator* | | |
|---|---|---|
| Excavator Bucket Condition | ★★★★☆ | |

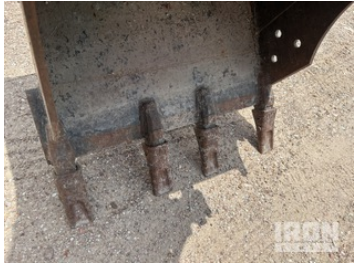
| Specialty - Excavator* | | |
|---|---|---|
| Bucket Cutting Edge/Shanks/Teeth* | ★★★★☆ | |

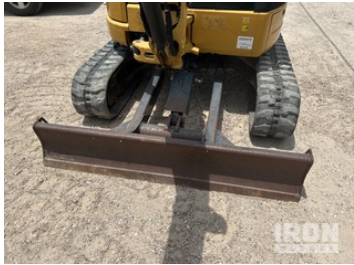
| Specialty - Excavator* | | |
|---|---|---|
| Blade Condition | ★★★★☆ | |
