## Inspection Report (On-Highway Flatbed Truck)

| Make | Kenworth |
| Model | T800 |
| Serial Number | 1XKDDP9X7CJ300183 |

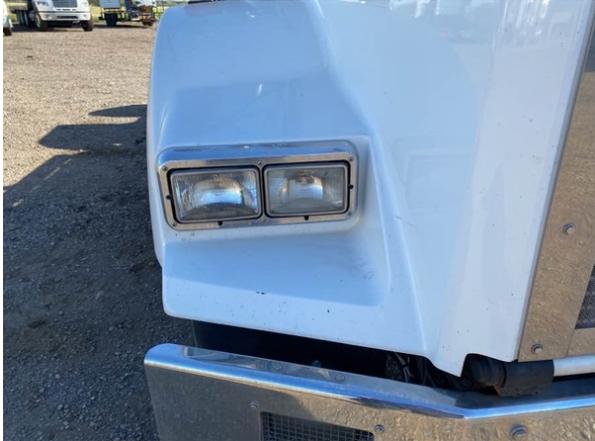
| Front Photos | |

| Front | 3 - Normal Wear & Tear |
| Front Condition | No visible damage, Other (see comments) |
| Comments | Normal paint wear, front tires 11r22.5 have 40 to 50 % tread life left |

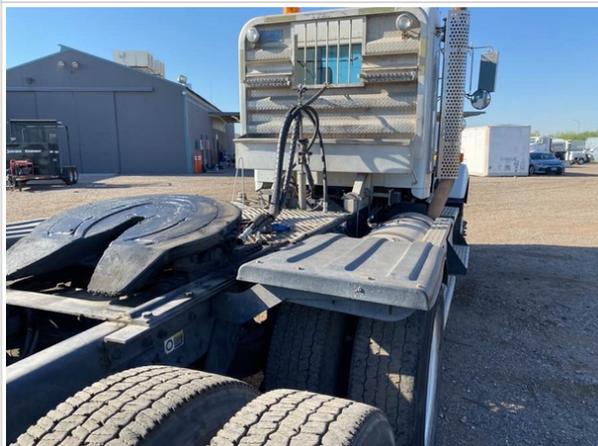
| <b>Rear Photos</b> | |

| <b>Rear</b> | 3 - Normal Wear & Tear |
| <b>Rear Condition</b> | No visible damage, Other (see comments) |
| <b>Comments</b> | Rear tires are 11r22.5 have 40 to 50 % tread life left |

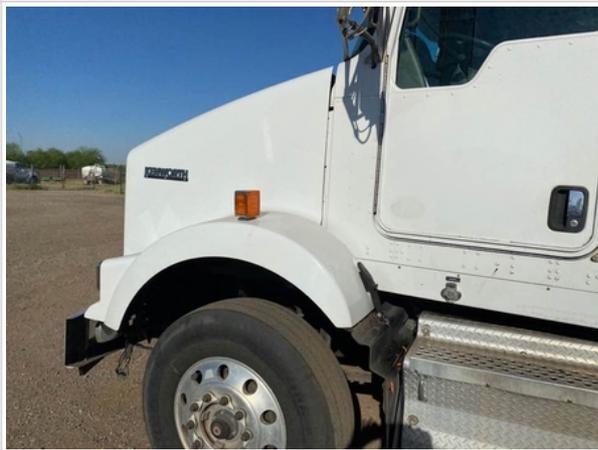
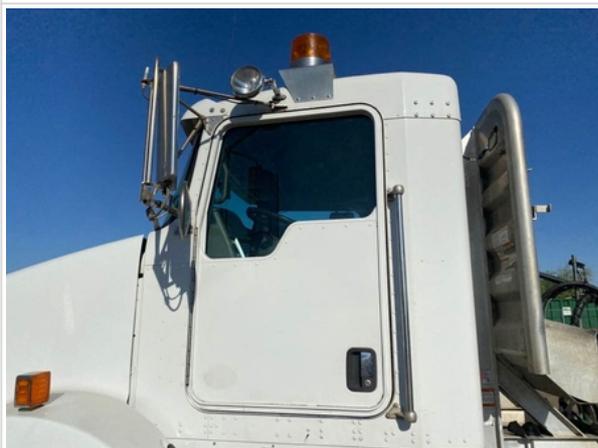
| <b>Left Photos</b> | | |

| <b>Left</b> | 3 - Normal Wear & Tear | |
| <b>Left Condition</b> | No visible damage | |

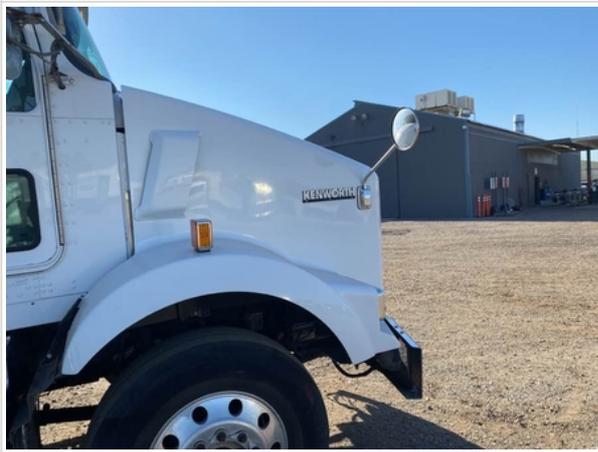
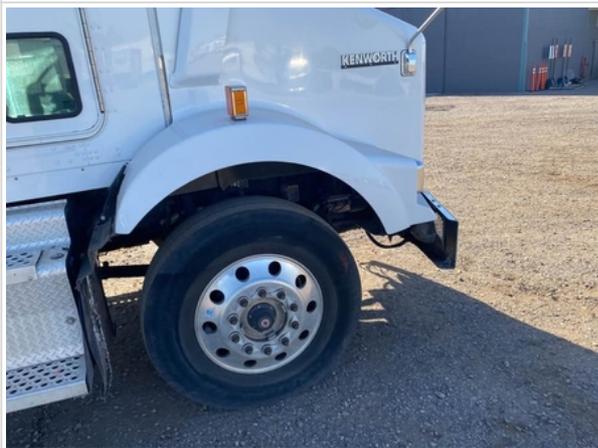
| <p>Right Photos</p> | | |

| <p>Right</p> | <p>3 - Normal Wear &amp; Tear</p> | |

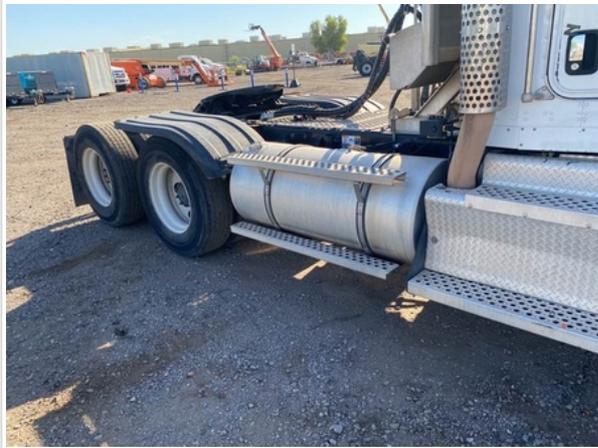
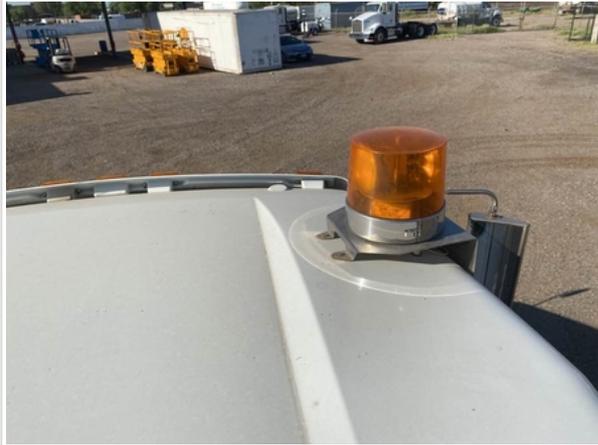
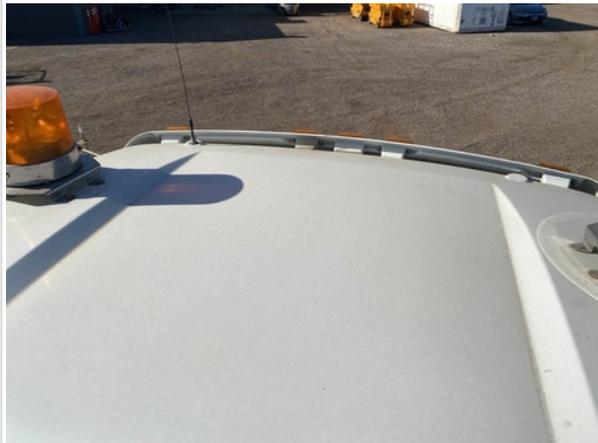
| Upper Photos | |

| Upper | 3 - Normal Wear & Tear |
| Upper Condition | No visible damage |

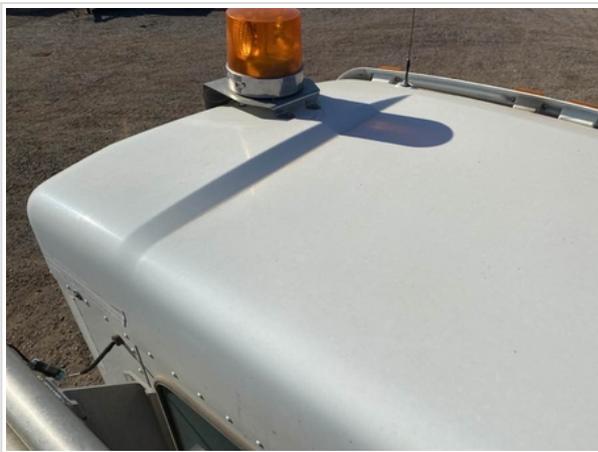
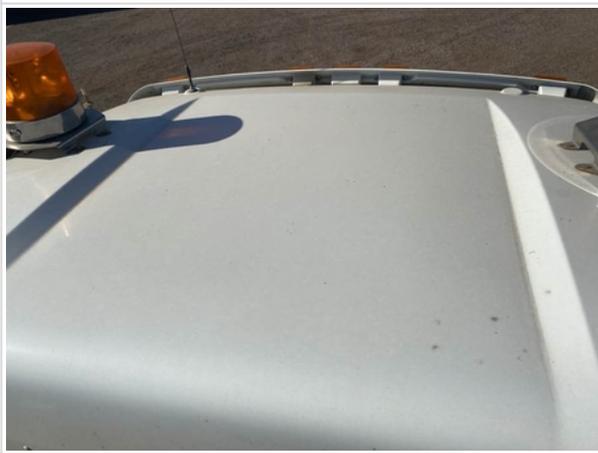
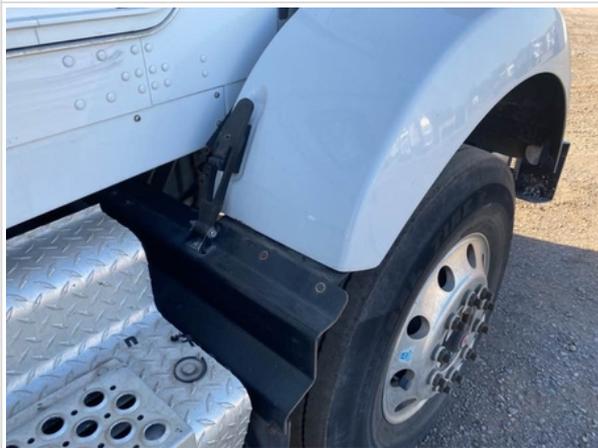
| <p><b>Body Panels Photos</b></p> | | |

| <p><b>Body Panels (Any Rust Damage?)</b></p> | <p>3 - Normal Wear &amp; Tear</p> | |

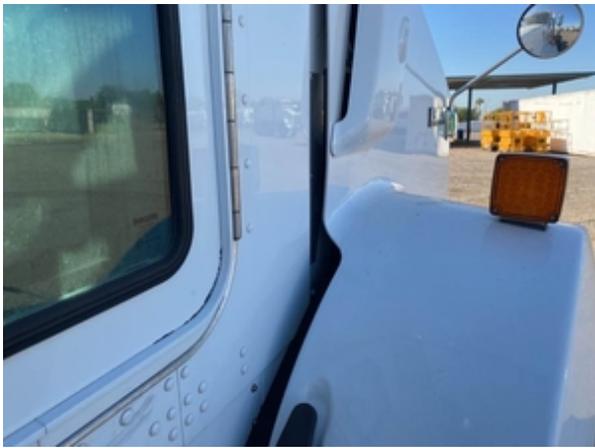
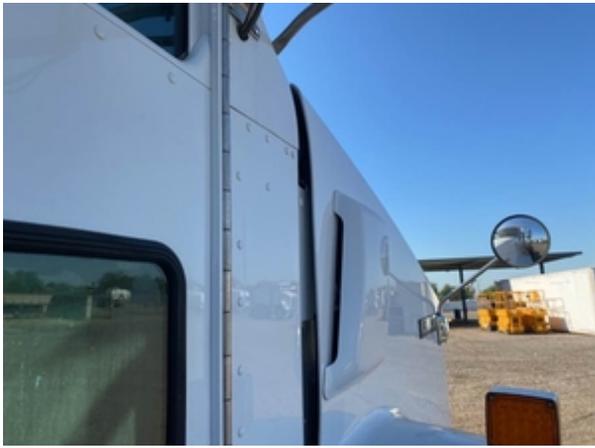
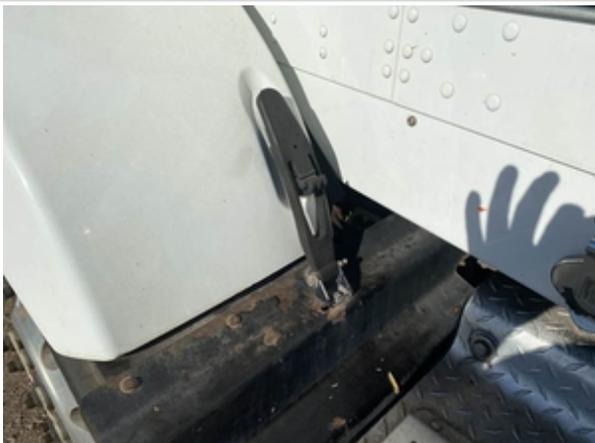
| <b>Doors / Canopy Latches Photos</b> | | |

| <b>Doors / Canopy Latches</b> | 3 - Normal Wear & Tear | |
| <b>Doors / Canopy Latches Condition</b> | No visible damage | |

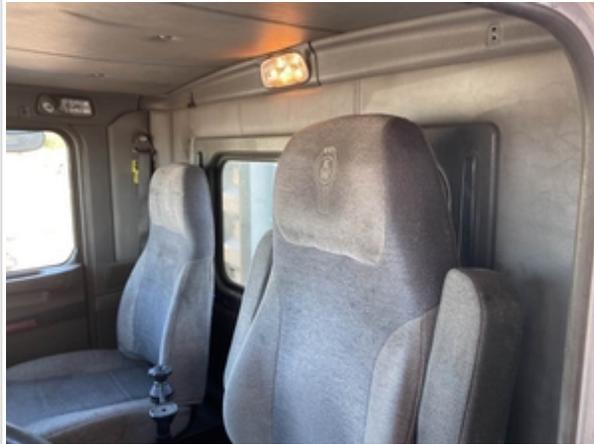
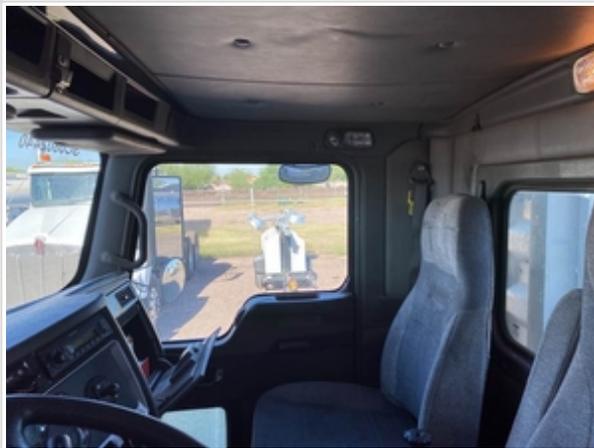
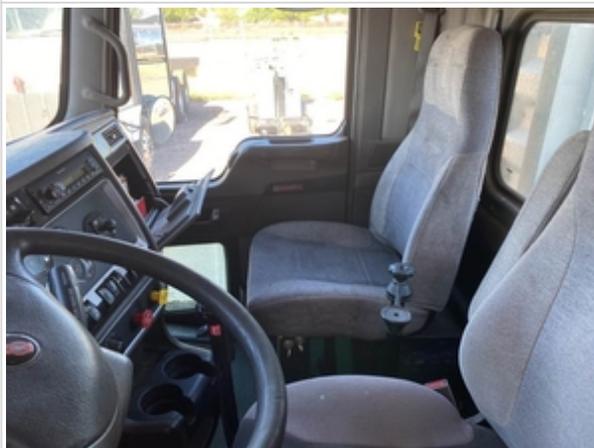
Operator Cabin Photos

| <b>Operator Cabin</b> | 3 - Normal Wear & Tear |

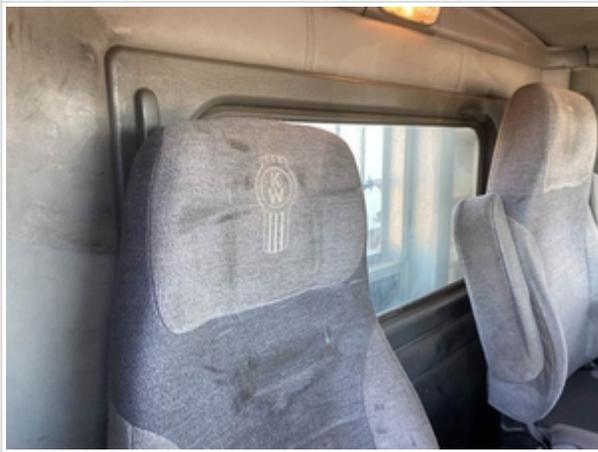
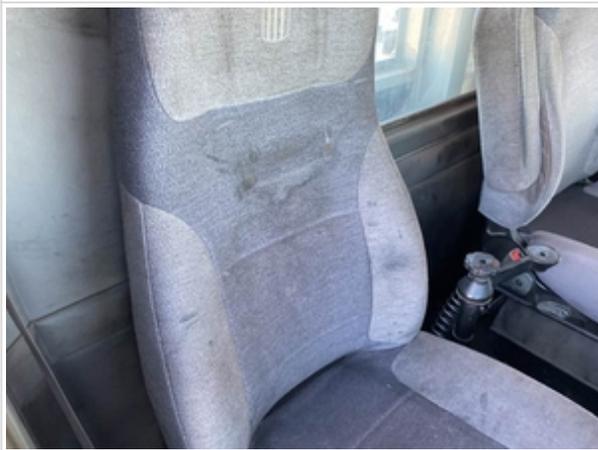
| <p><b>Operator's Seat &amp; Arm Rests Photos</b></p> | | |

| <p><b>Operator's Seat &amp; Arm Rests</b></p> | <p>3 - Normal Wear &amp; Tear</p> | |

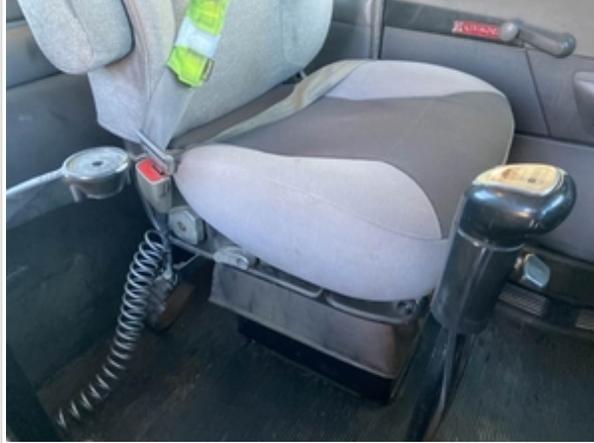
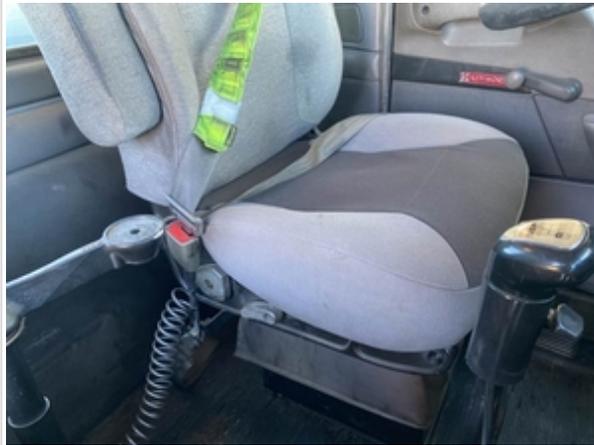
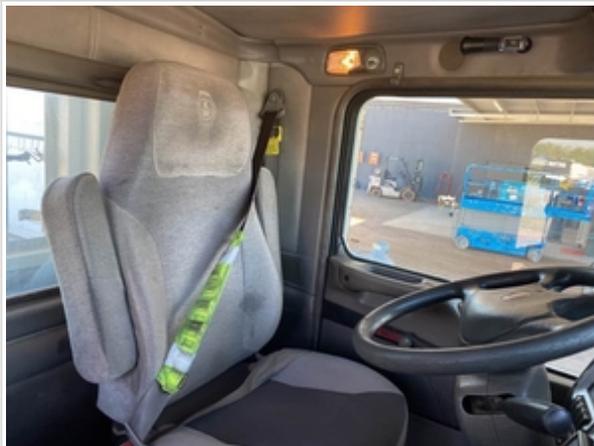
Seat Belt Photos

| <b>Seat Belt</b> | 3 - Normal Wear & Tear | |

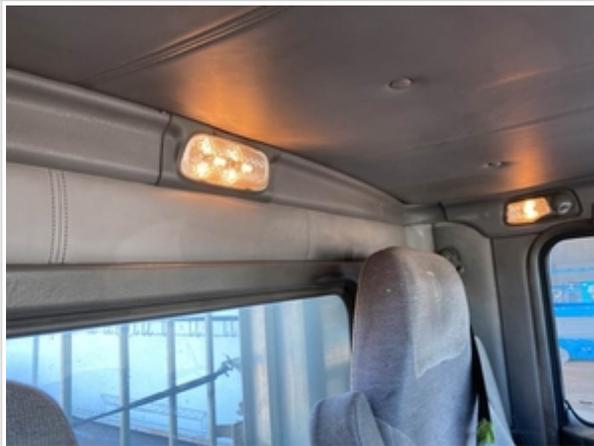
Cabin Lights Photos

3 - Normal Wear & Tear

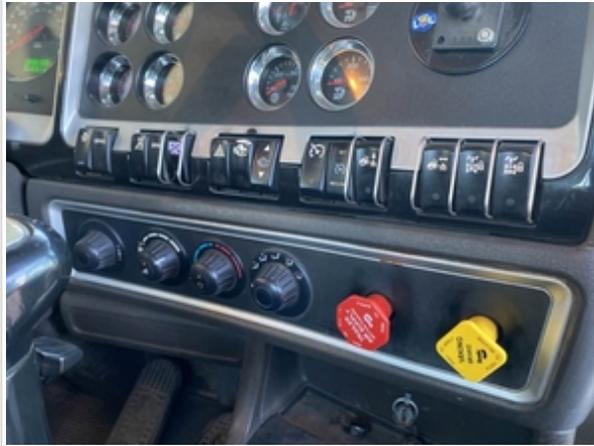
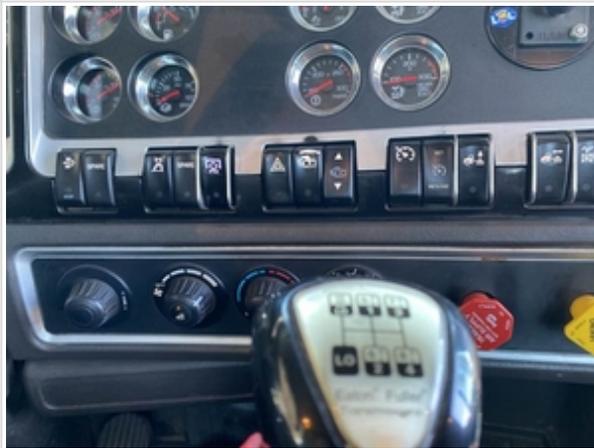
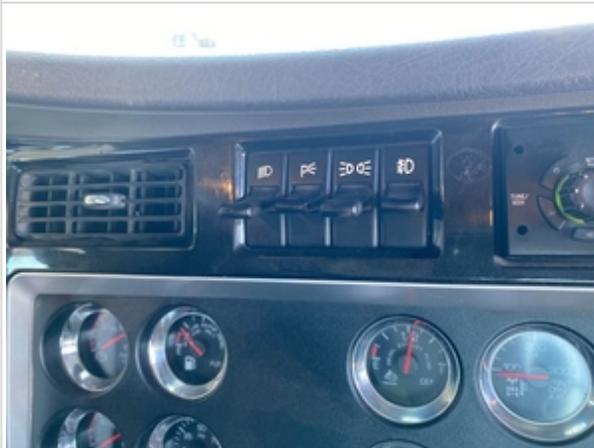
Controls & Switches Photos

| <p><b>Controls &amp; Switches</b></p> | <p>3 - Normal Wear &amp; Tear</p> | |

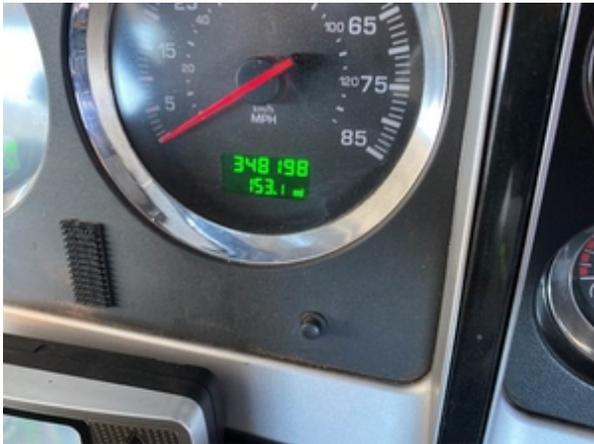
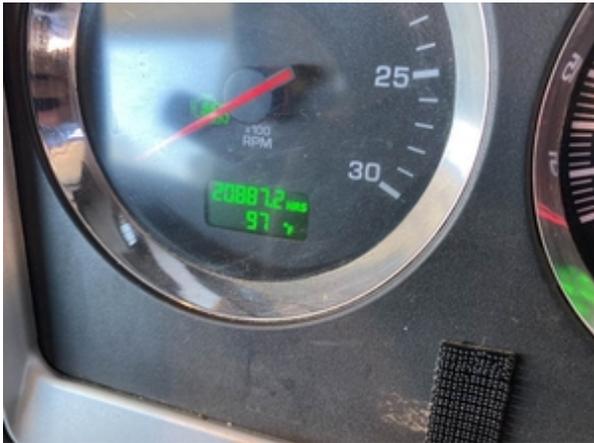
| <b>Odometer Activity Photos</b> | | |

| <b>Odometer Activity</b> | 3 - Normal Wear & Tear | |

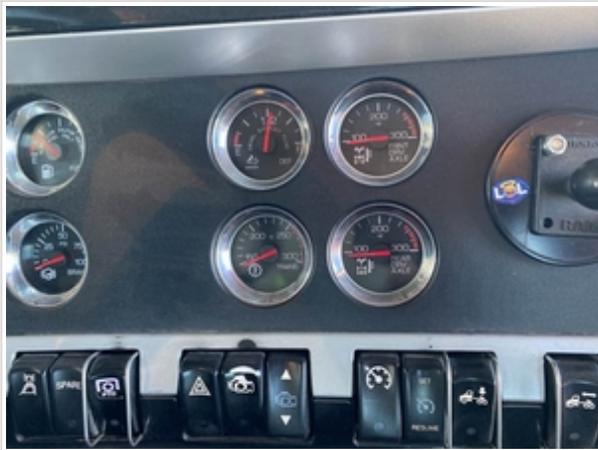
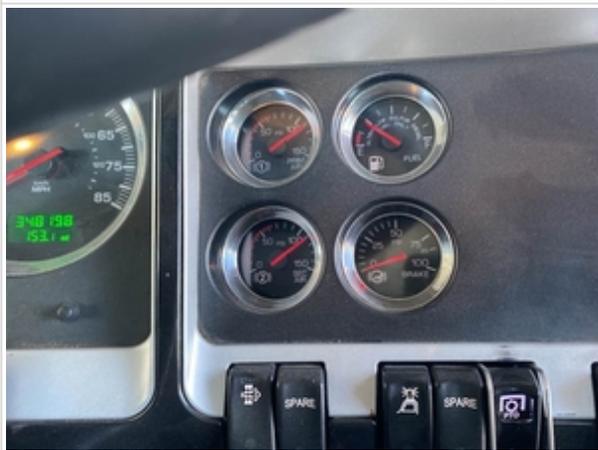
| <p>Other Gauge Activity Photos</p> | |

| <b>Other Gauge Activity</b> | 3 - Normal Wear & Tear | |

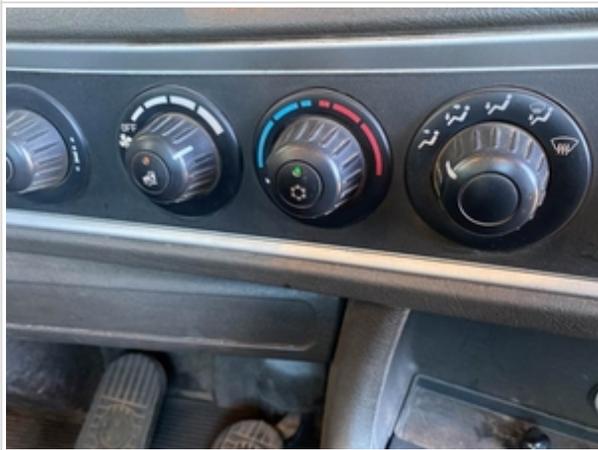
| <p>Heater &amp; A/C Photos</p> | |

| <p>Heater &amp; A/C</p> | <p>3 - Normal Wear &amp; Tear</p> |

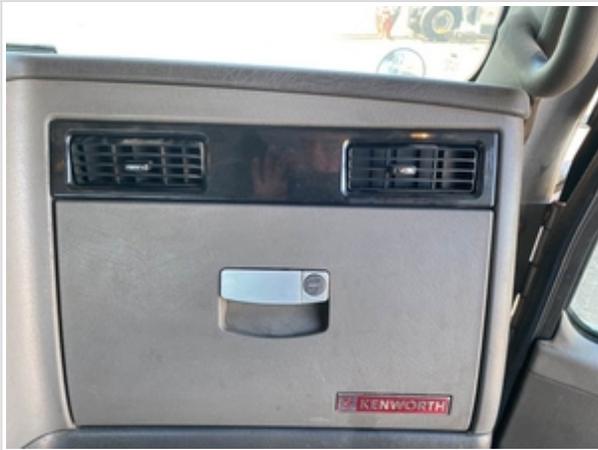
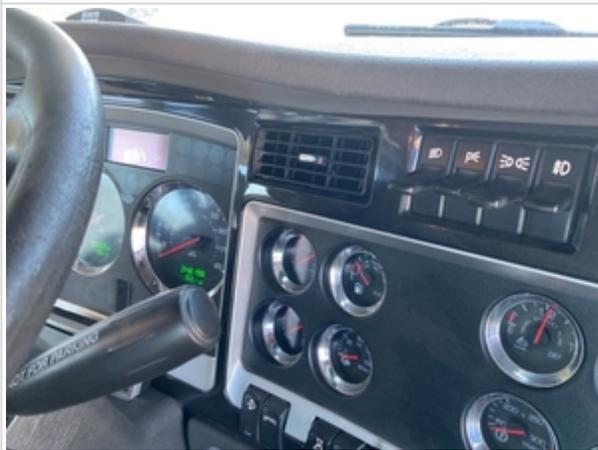
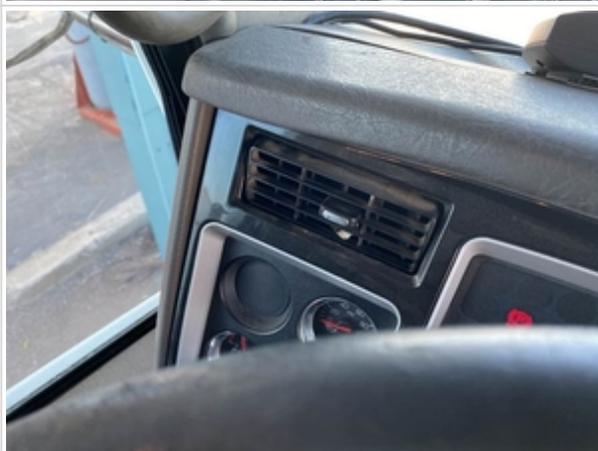
| Fans / Vents Photos | |

| <p>Fans / Vents</p> | <p>3 - Normal Wear &amp; Tear</p> |

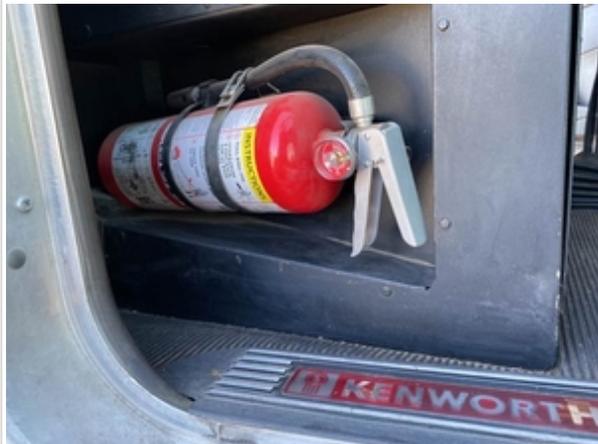
| Fire Extinguisher Photos | |

| Fire Extinguisher | 3 - Normal Wear & Tear |

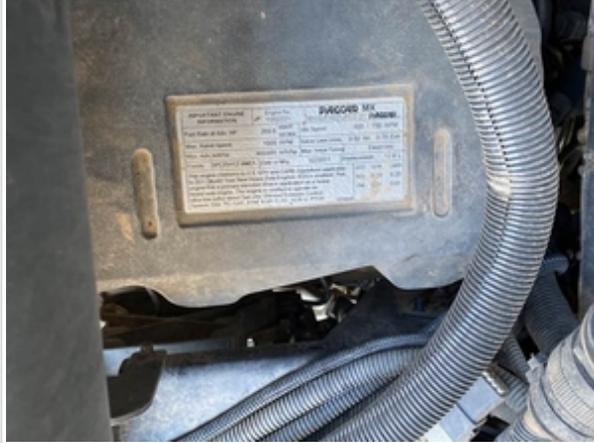
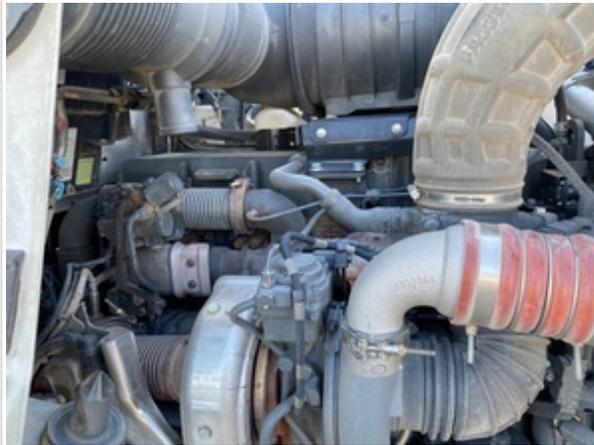
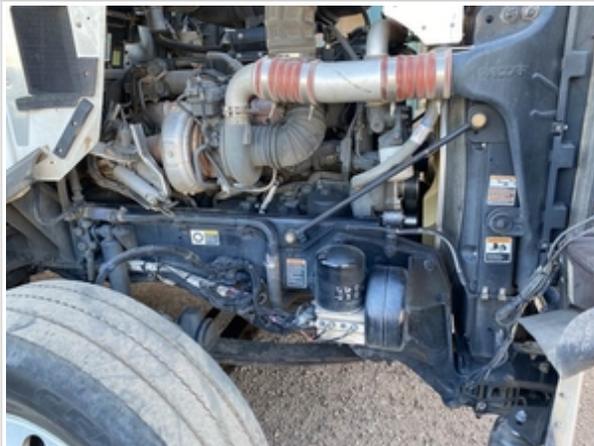
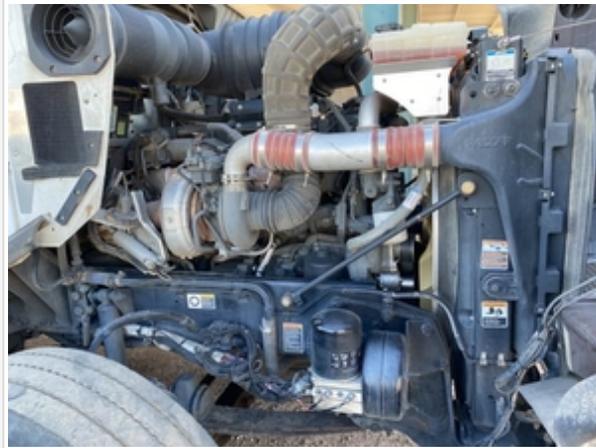
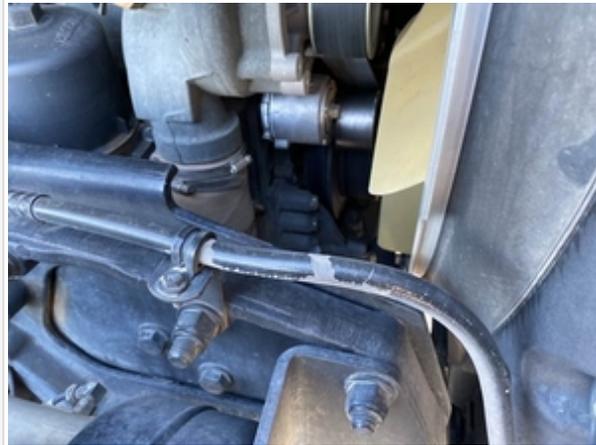
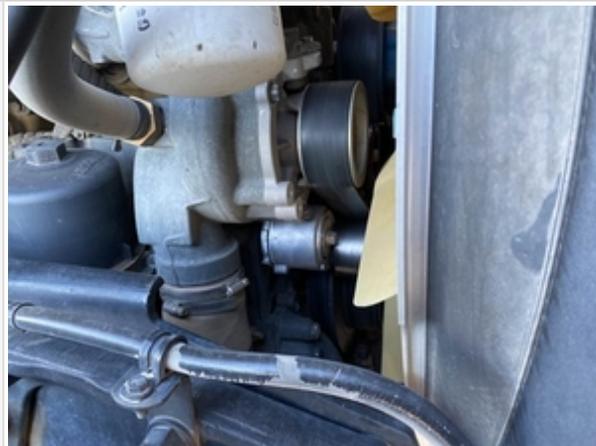
Engine Photos

| Overall Engine Comments | Engine looks well serviced and unkept. Signs of various components replaced to keep the engine running strong and healthy. No fluid leaks or obvious, major repairs needed from a visual standpoint. |

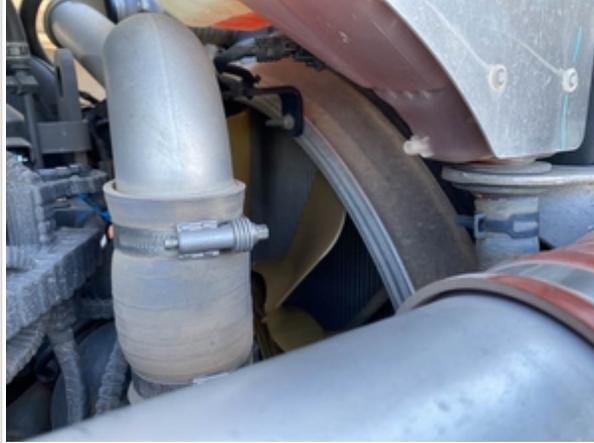
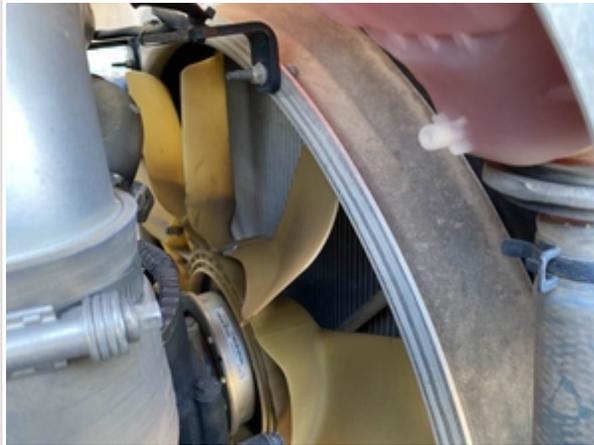
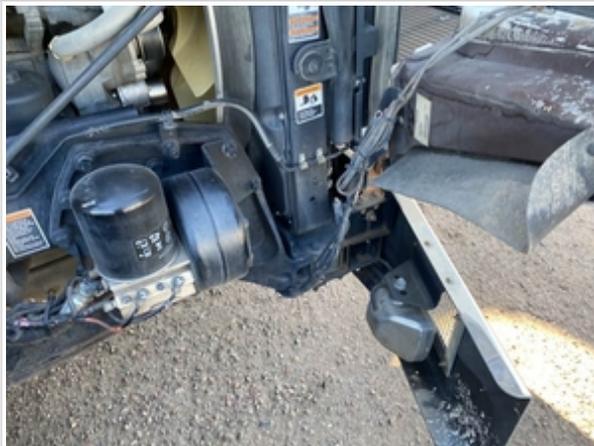
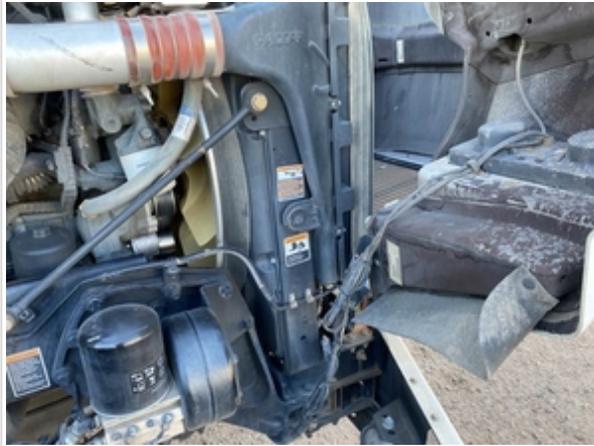
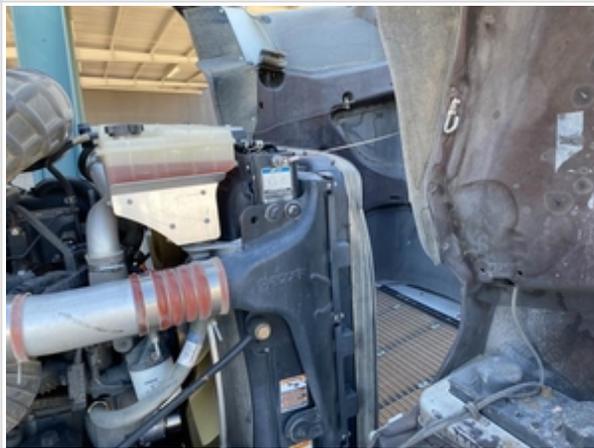
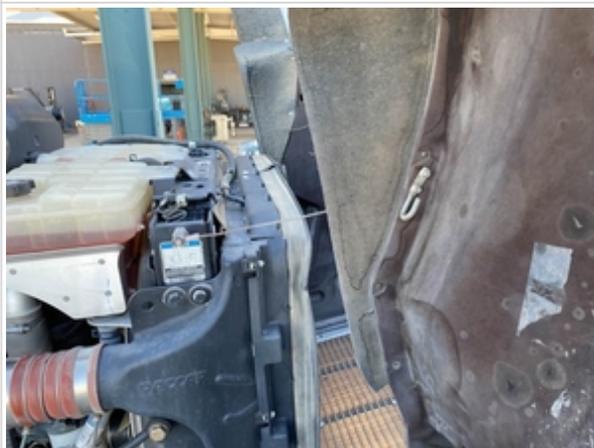
Radiator Photos

| <p>Radiator</p> | <p>3 - Normal Wear &amp; Tear</p> |

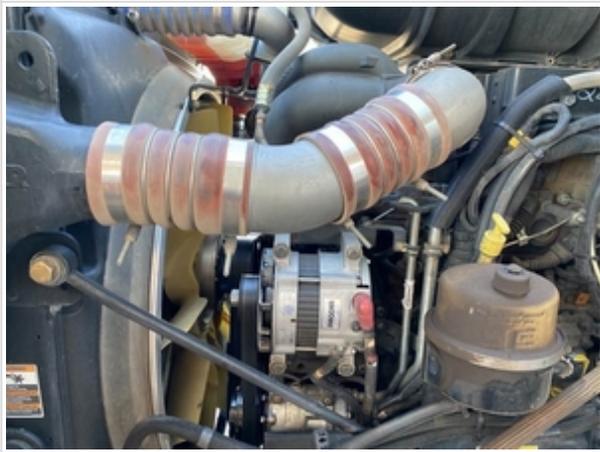
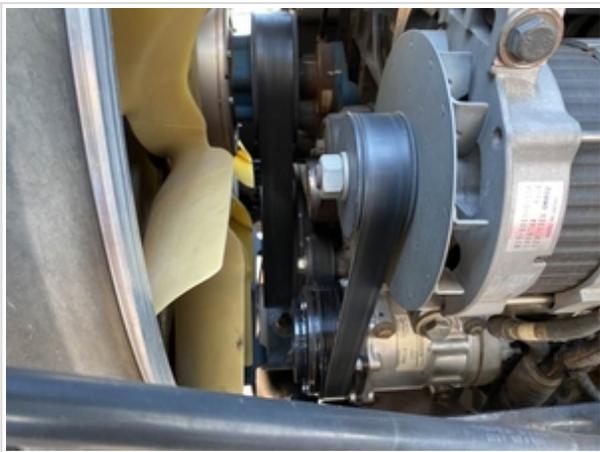
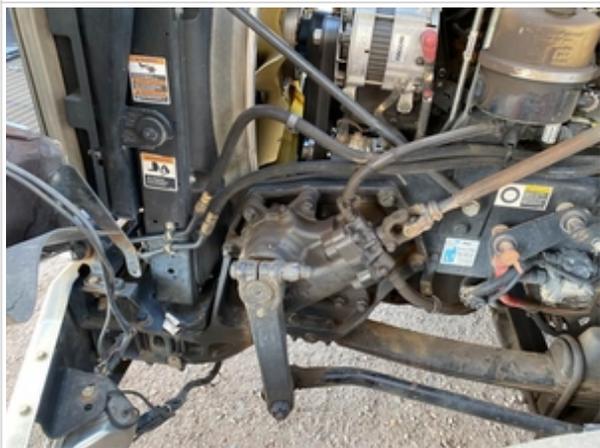
| <p>Hose Photos</p> | | |

| <p>Hoses</p> | <p>3 - Normal Wear &amp; Tear</p> | |

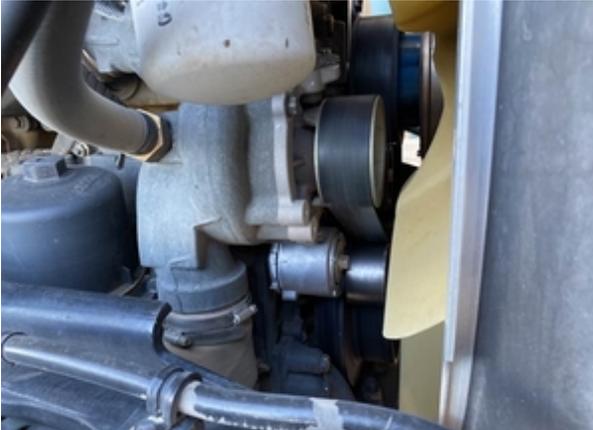
| <b>Water Pump Photos</b> | |

| <b>Water Pump</b> | 3 - Normal Wear & Tear |
| <b>Water Pump Condition</b> | No unusual pump noises heard, Other (see comments |
| <b>Comments</b> | Recently replaced |

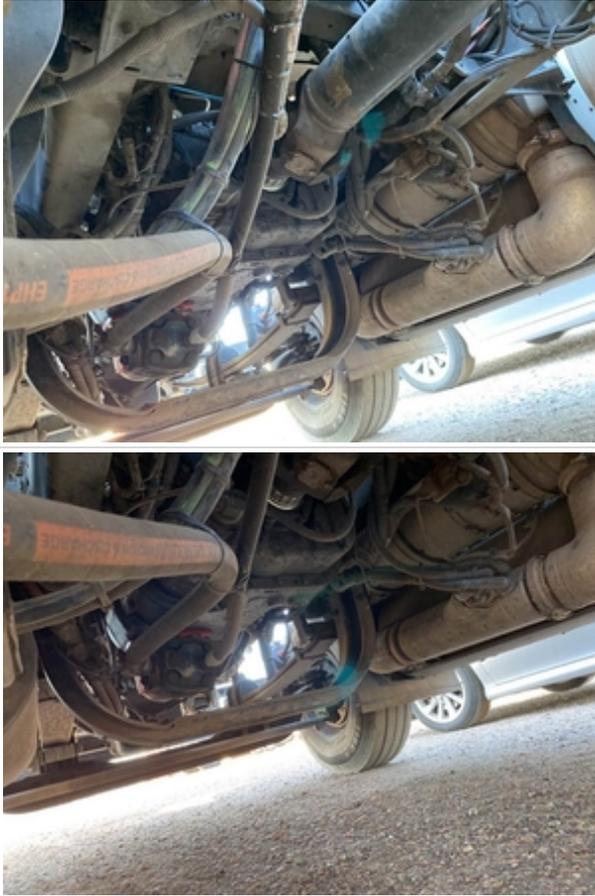
| <b>Transmission Condition Photos</b> | |

| <b>Transmission</b> | 3 - Normal Wear & Tear |

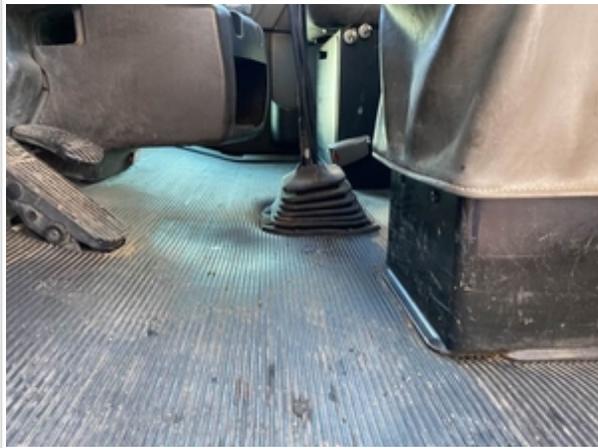
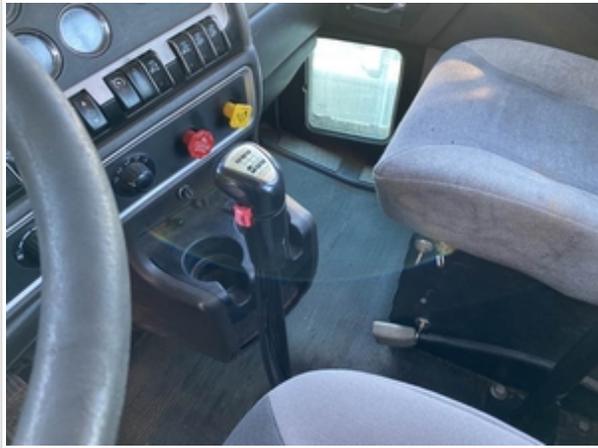
| <b>Shift Lever Photos</b> | |

| <b>Shift Lever</b> | 3 - Normal Wear & Tear |

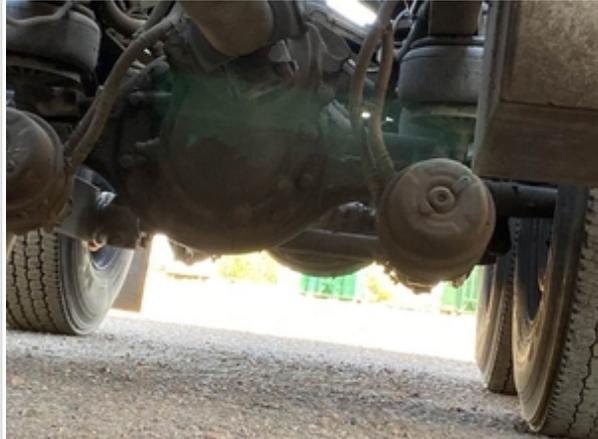
| <b>Rear Differential Photos</b> | |

| <b>Rear Differential</b> | 3 - Normal Wear & Tear |
| <b>Rear Differential Condition</b> | Dry housing appearance, no unusual noises heard during operation |

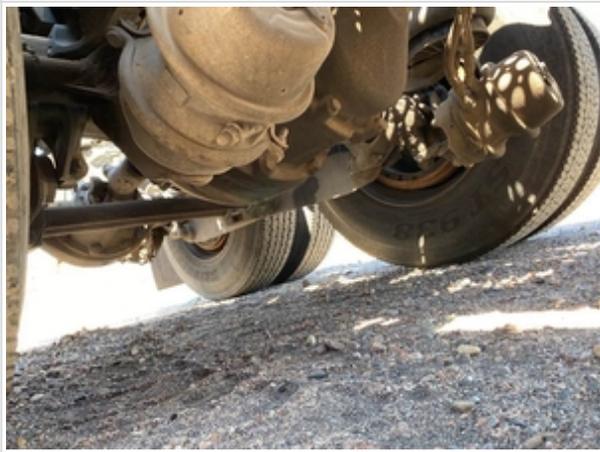
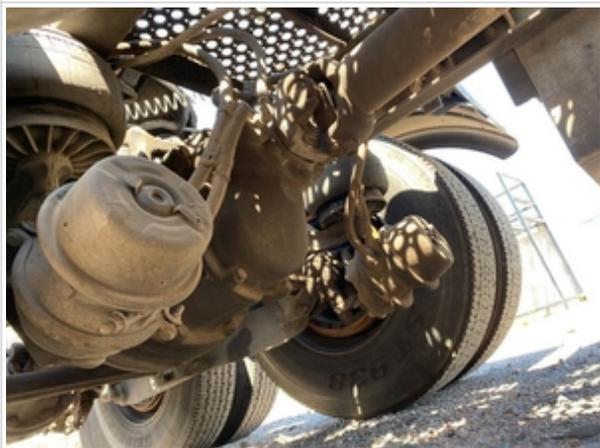
| <p>Front Differential Photos</p> | | |

| <p>Front Differential</p> | <p>3 - Normal Wear &amp; Tear</p> | |

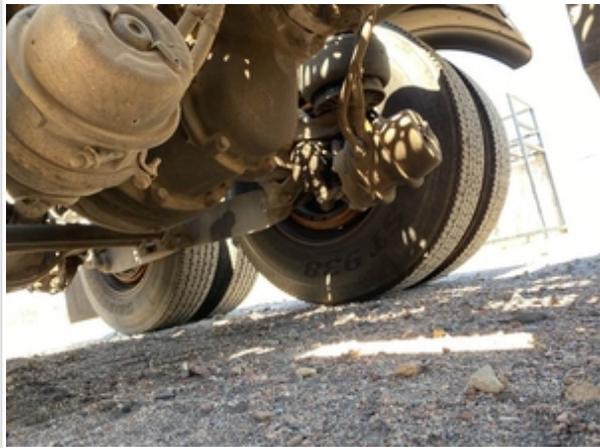
| <b>Brake System Type</b> | Air Brakes | |
| <b>Air Brakes Build Correct Pressure</b> | Yes | |
| <b>Air Brake System Leaks</b> | No | |
| <b>Comments</b> | Brake shoes look recently replaced | |

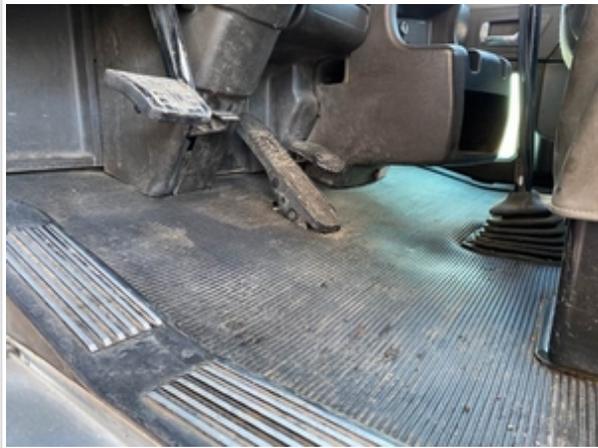
| Foot Brake Photos | |

| <p>Foot Brake</p> | <p>3 - Normal Wear &amp; Tear</p> | |

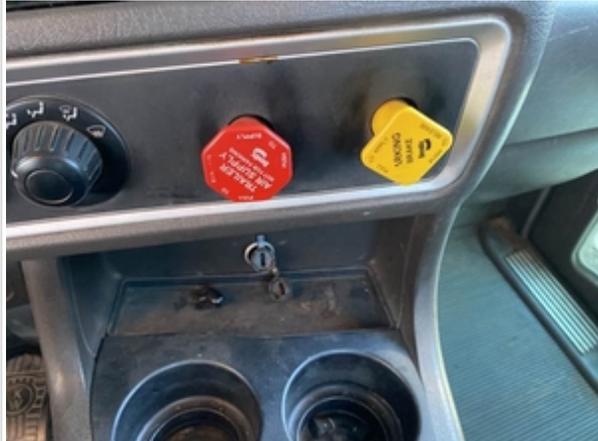
| Parking Brake Photos | |

| Parking Brake | 3 - Normal Wear & Tear |
