## Inspection Report (Skid Steer)

Year	2017
Make	Bobcat
Model	S770
Serial Number	AT5A12197
Hour Meter Reading	2673 hours
Previous Application (e.g., earth moving, mining, demolition, etc)	Asphalt Paving General Construction

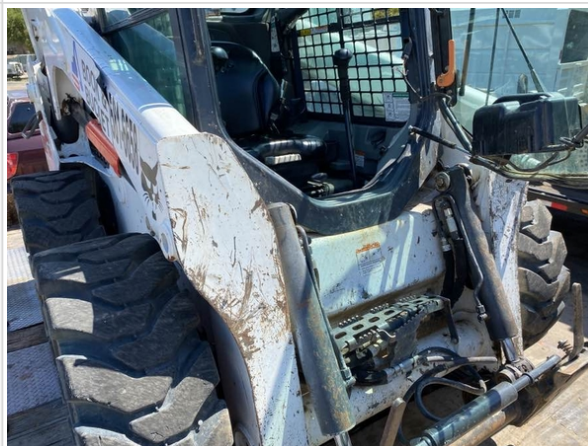
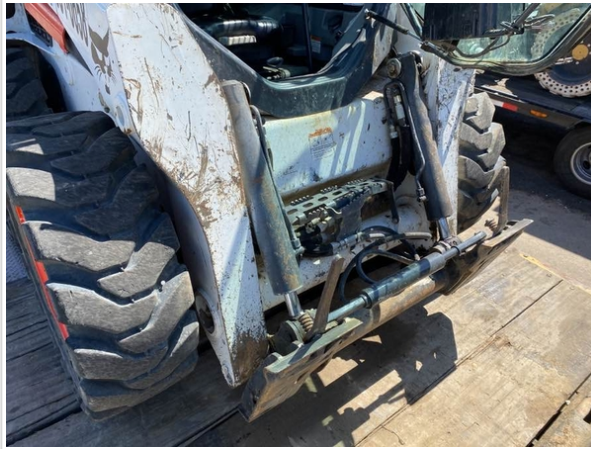
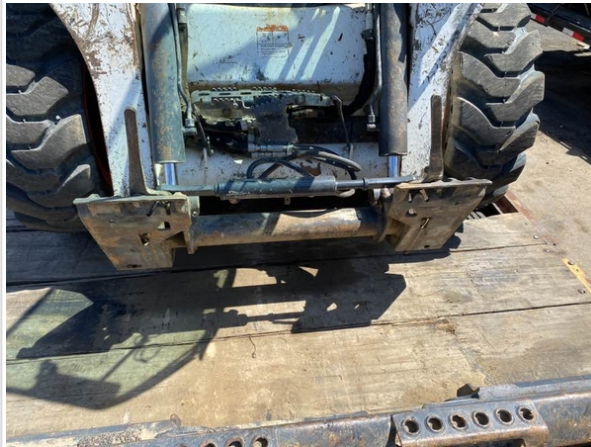
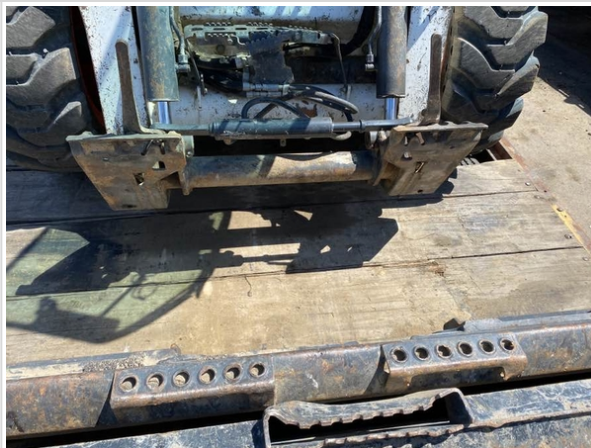
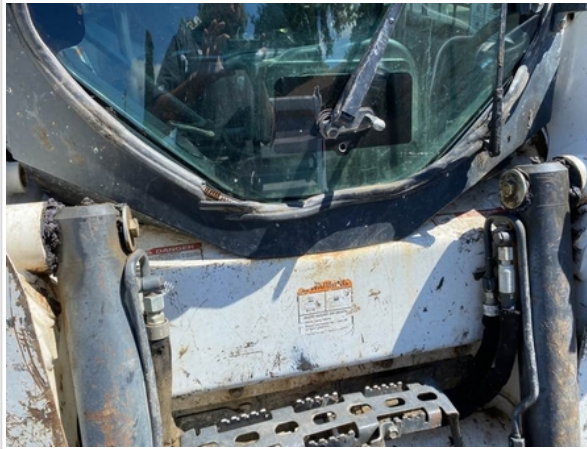
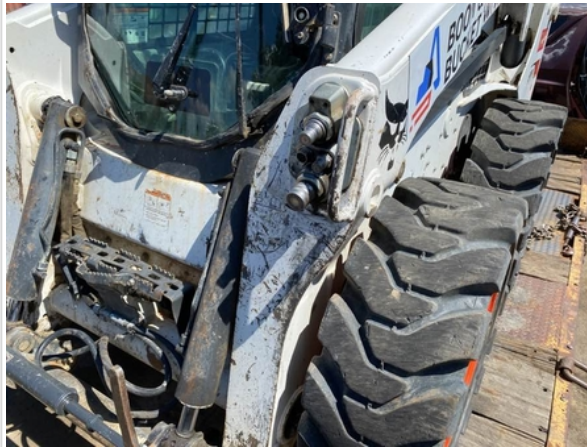
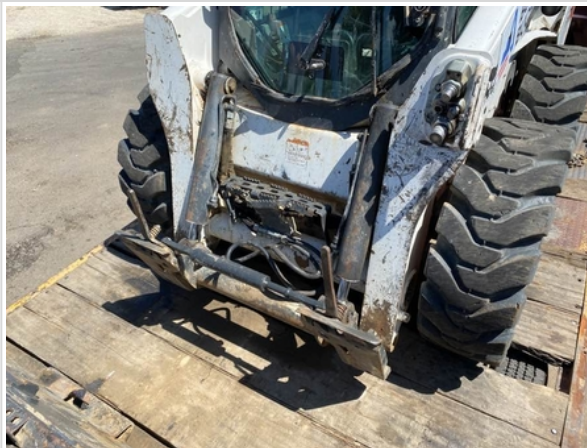
<b>Instructions</b>	<p>Evaluate the following on a 4 point scale (leave comments where an explanation is appropriate):</p> <p>4 = Like New, Recently Replaced  3 = Normal Wear &amp; Tear  2 = Above Average Wear  1 = Service Required</p> <p>Things to look for:</p> <ul style="list-style-type: none"> <li>- cosmetic damage</li> <li>- minor surface rust</li> <li>- repaint (and overspray)</li> <li>- cracked or damage glass</li> <li>- major rust (cancer)</li> <li>- cracks / visible welds</li> </ul>
<b>Front</b>	3 - Normal Wear & Tear
<b>Comments</b>	No major dents just various scratches on front loader arms
<b>Front Photos</b>

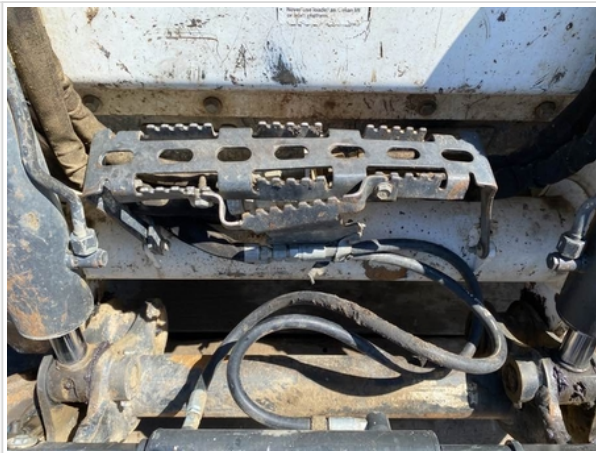
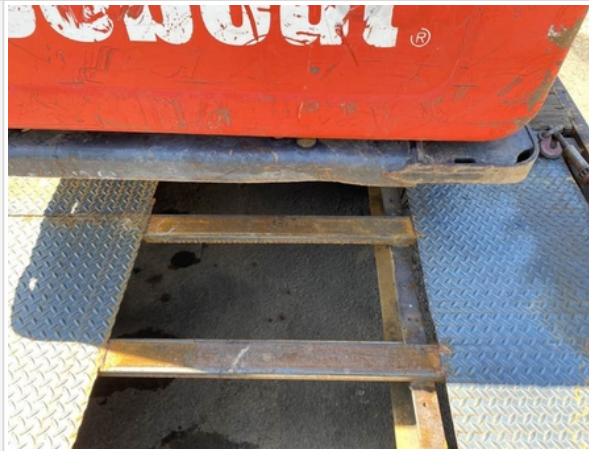
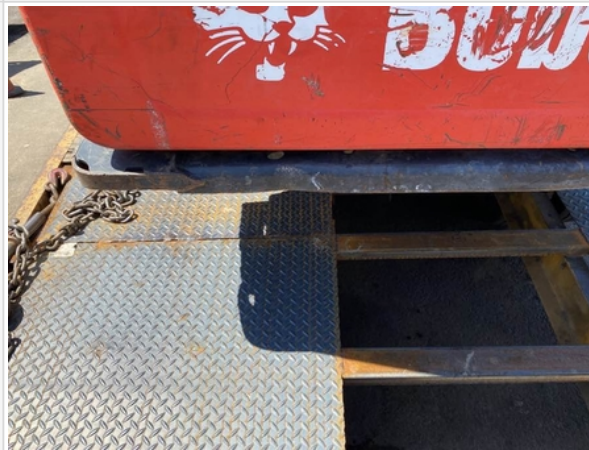
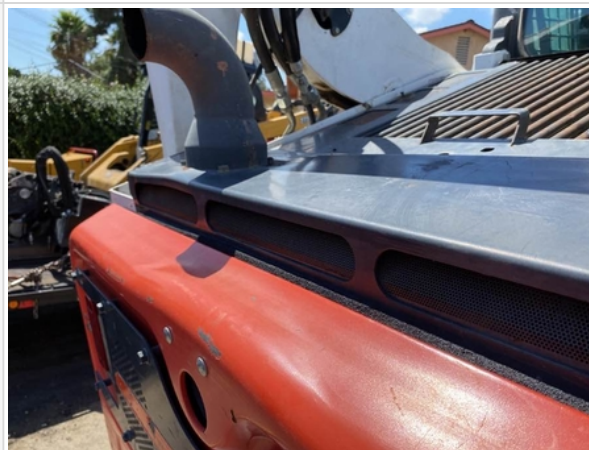
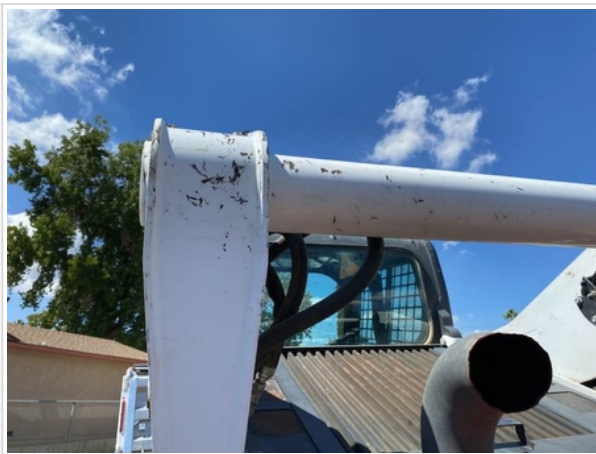
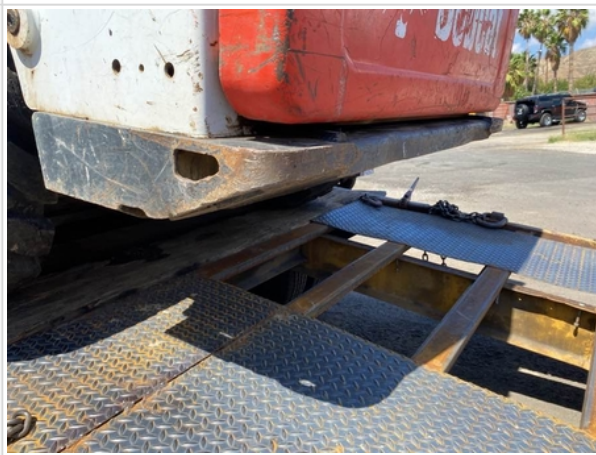
Rear	3 - Normal Wear & Tear
Comments	Small dent in rear door vent cover
Rear Photos

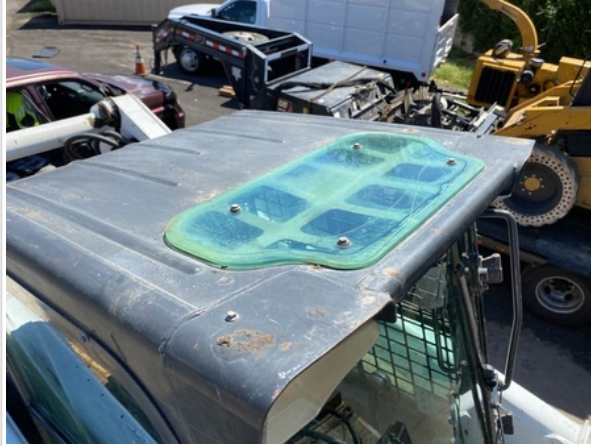
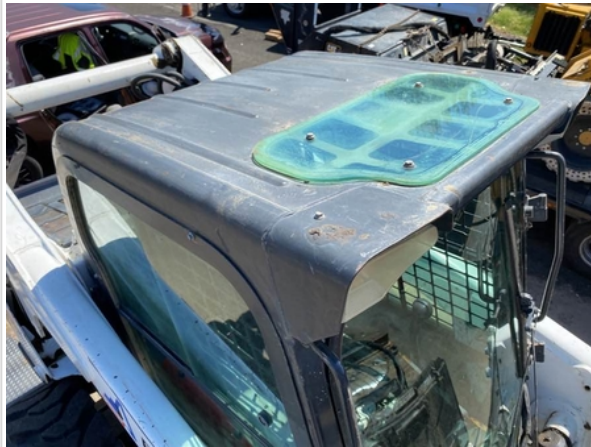
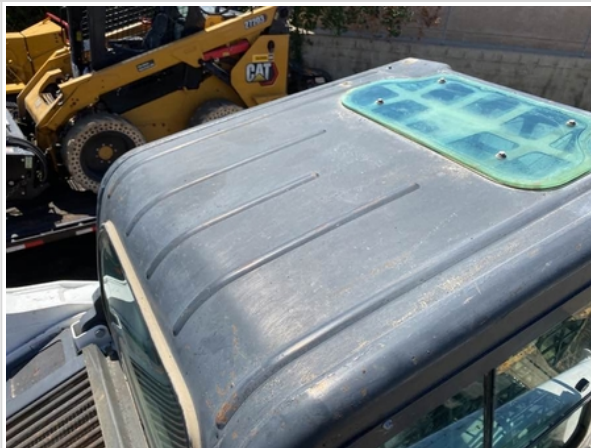
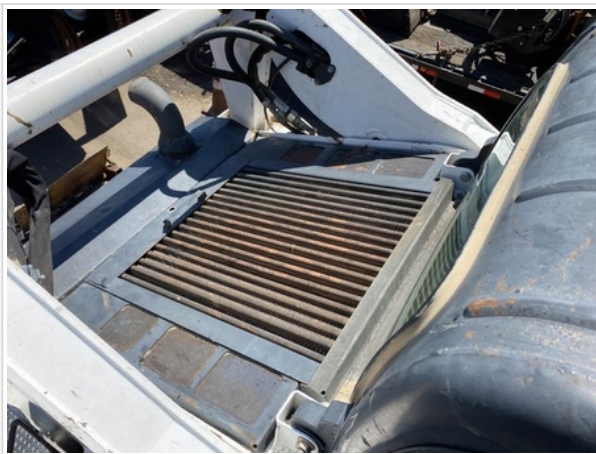
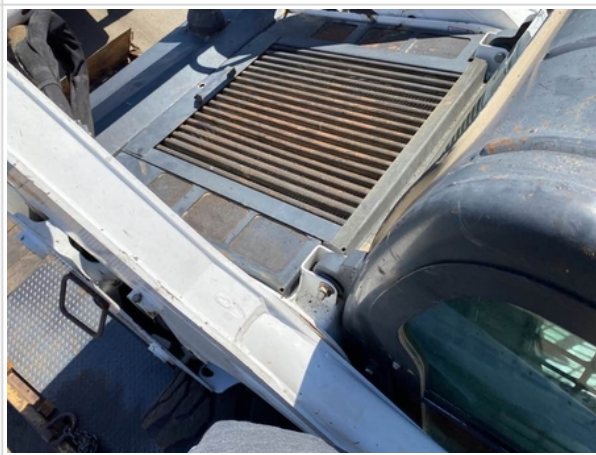
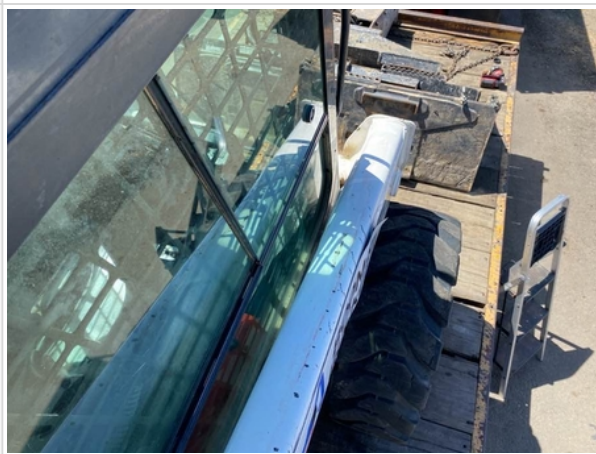
Upper Photos

3 - Normal Wear & Tear

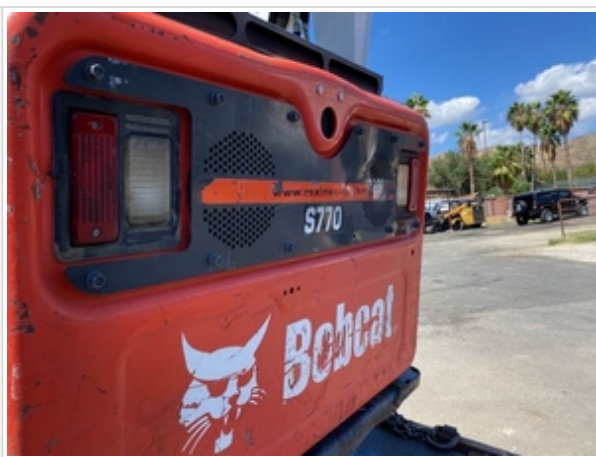
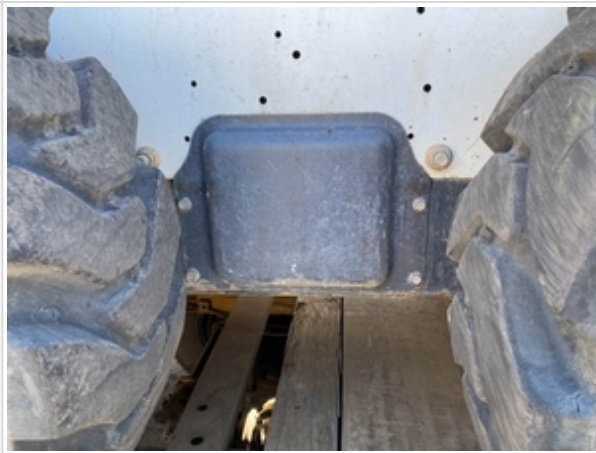
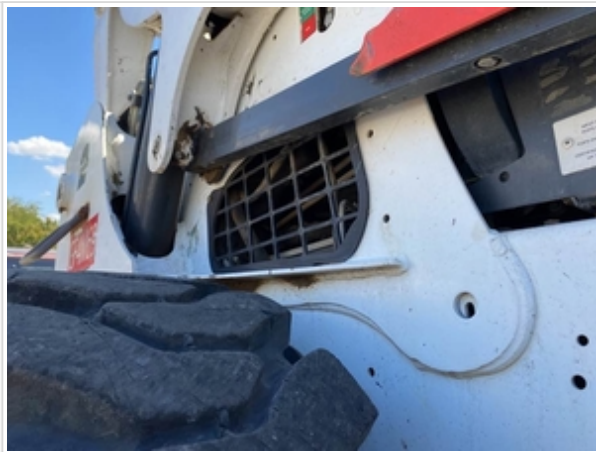
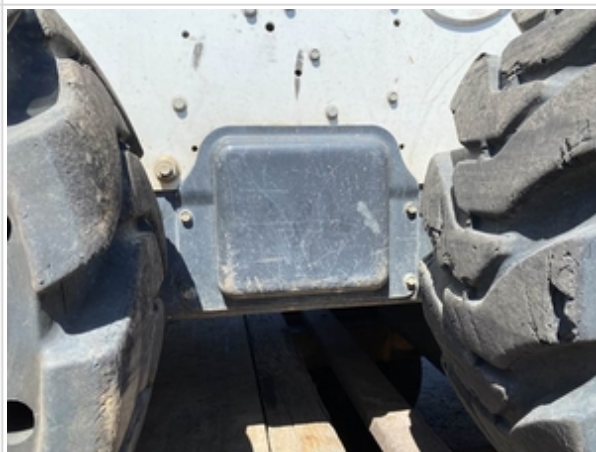
<p>Body Panels Photos</p>

<p>Body Panels (Any Rust Damage?)</p>	<p>3 - Normal Wear &amp; Tear</p>

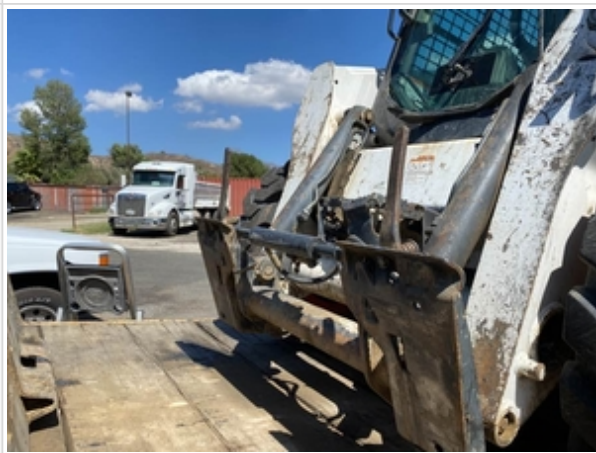
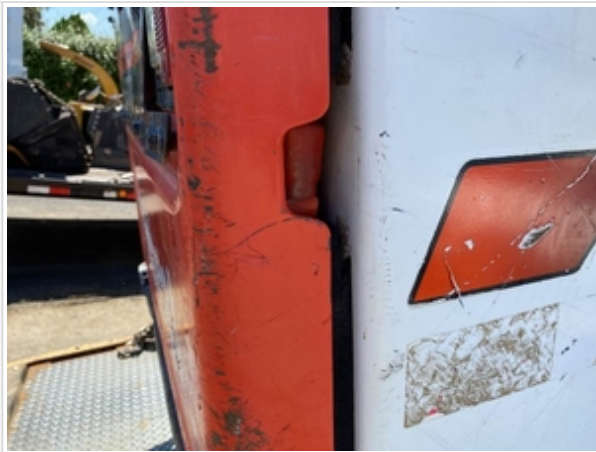
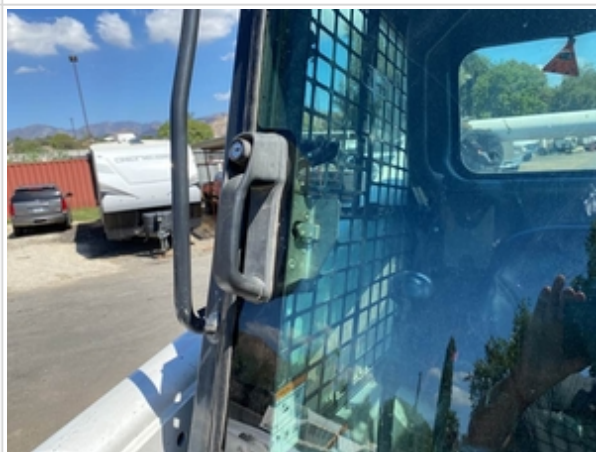
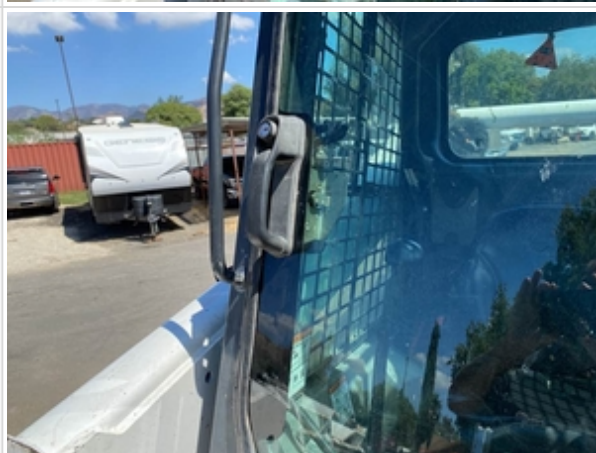
<p><b>Doors / Canopy Latches</b></p>	<p>3 - Normal Wear &amp; Tear</p>
<p><b>Doors / Canopy Latches Photos</b></p>

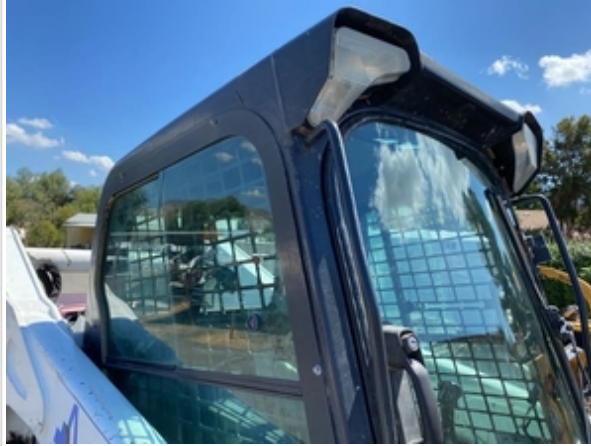
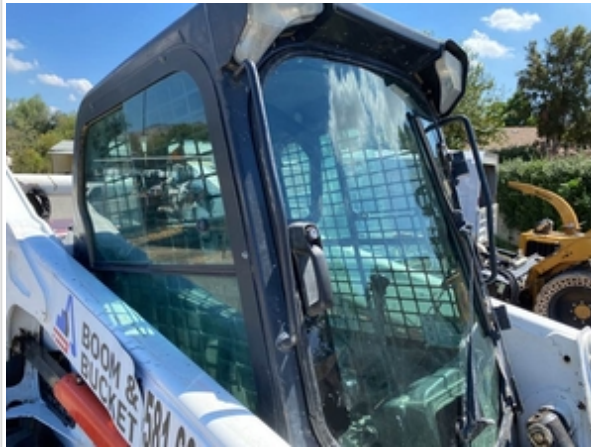
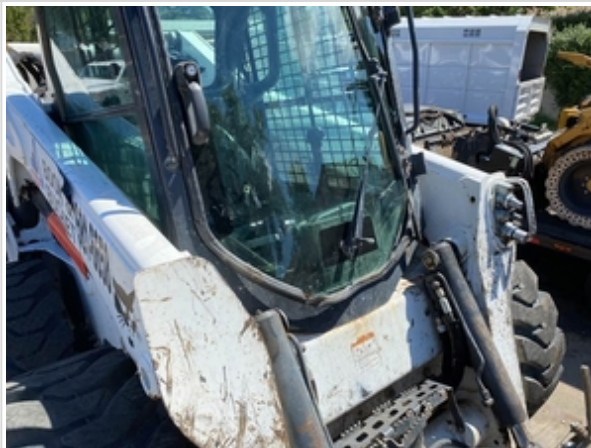
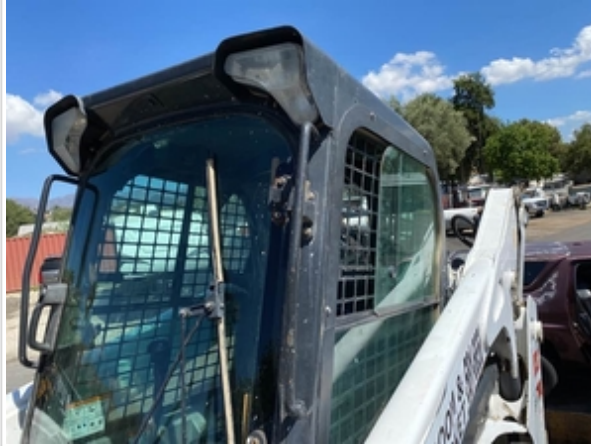
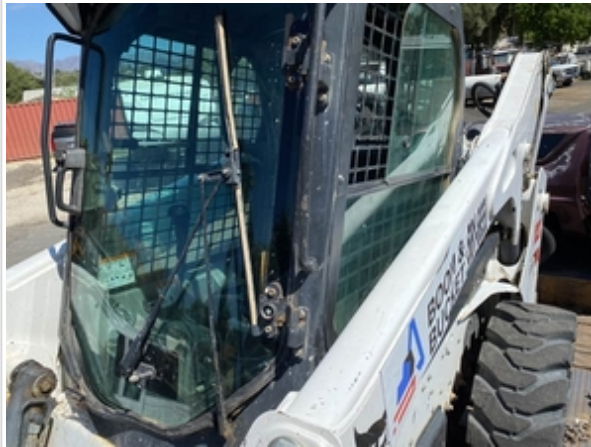
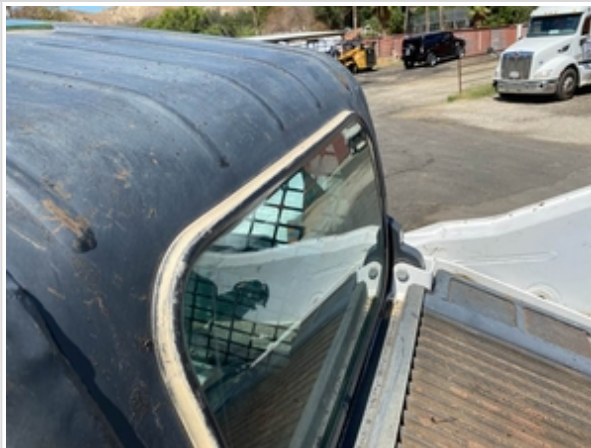
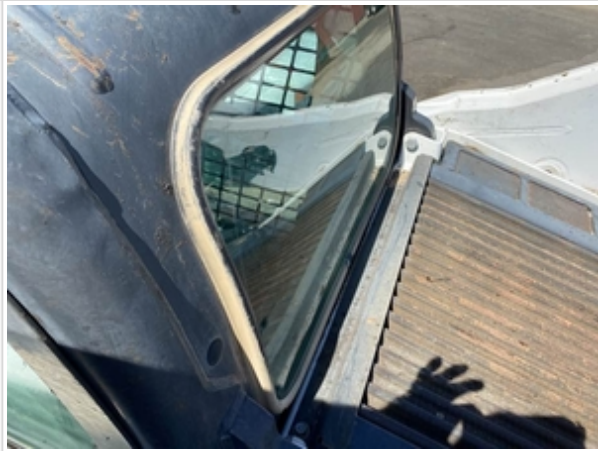
Glass Condition Photos

<p><b>Glass Condition</b></p>	<p>3 - Normal Wear &amp; Tear</p>

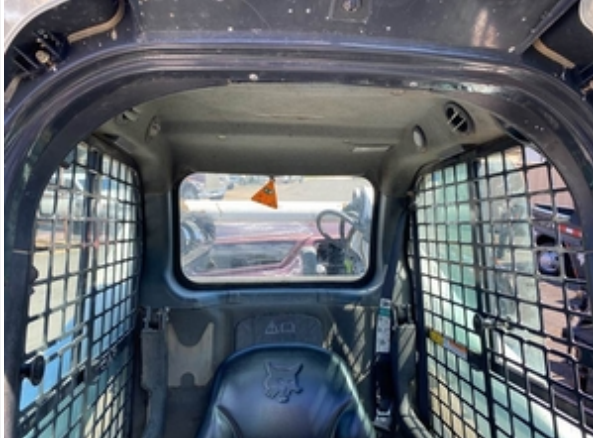
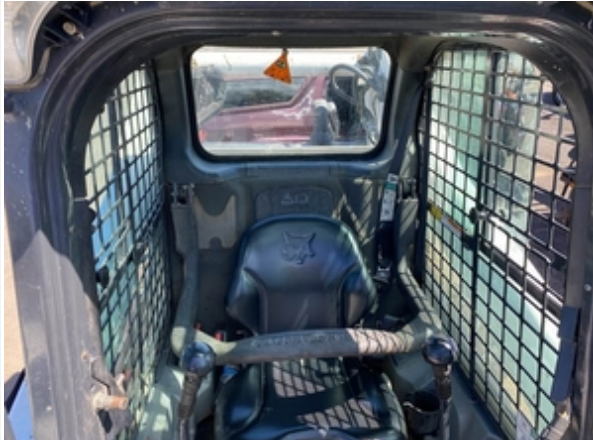
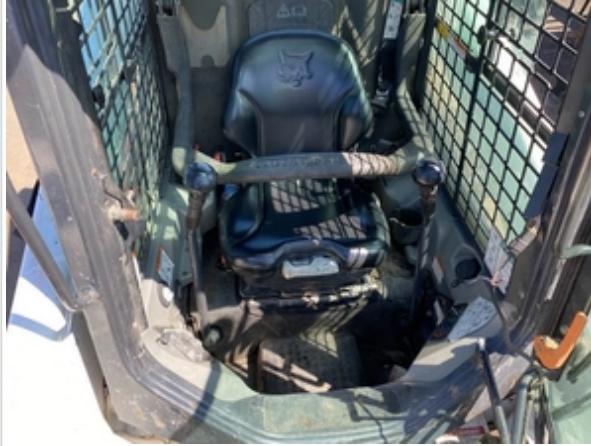
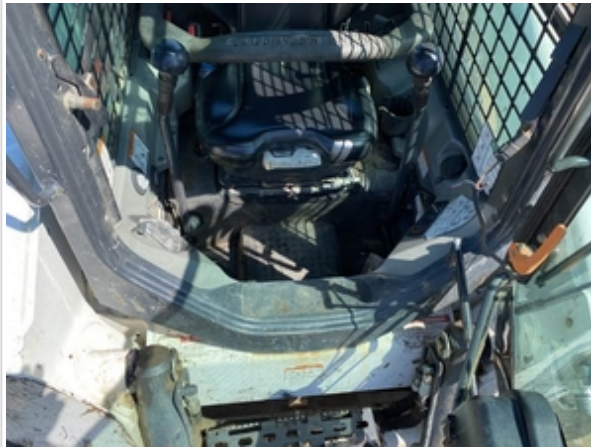
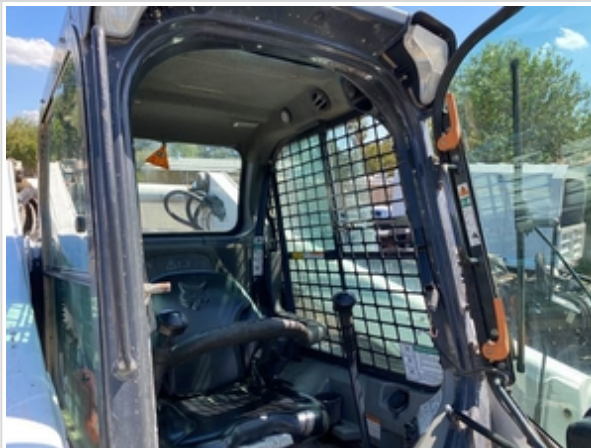
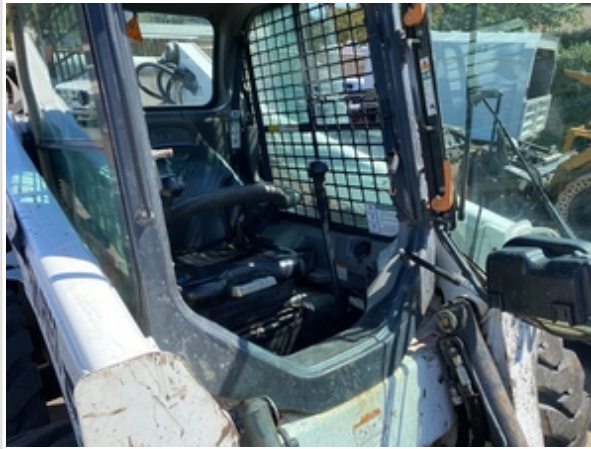
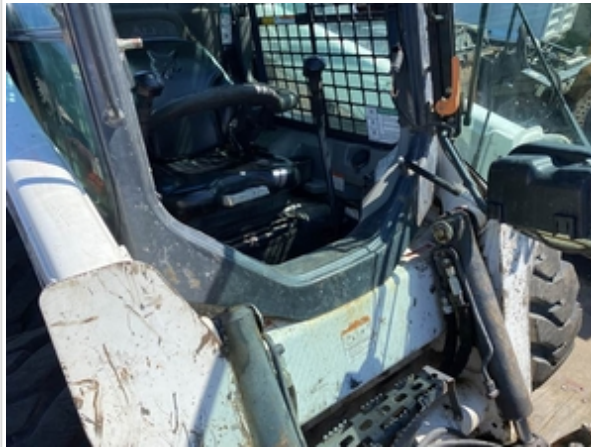
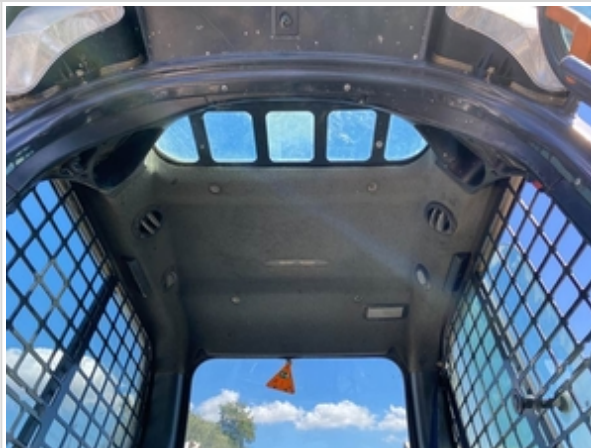
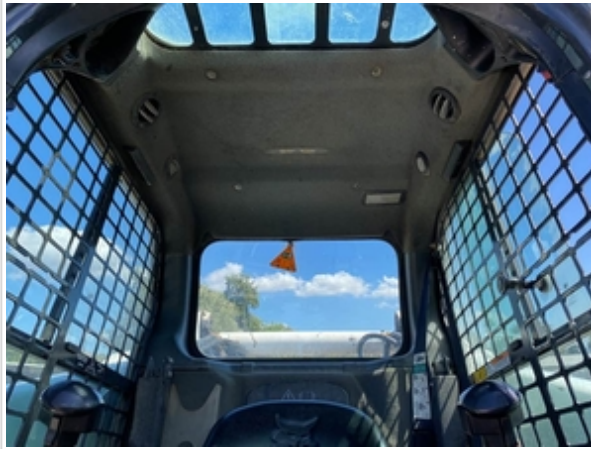
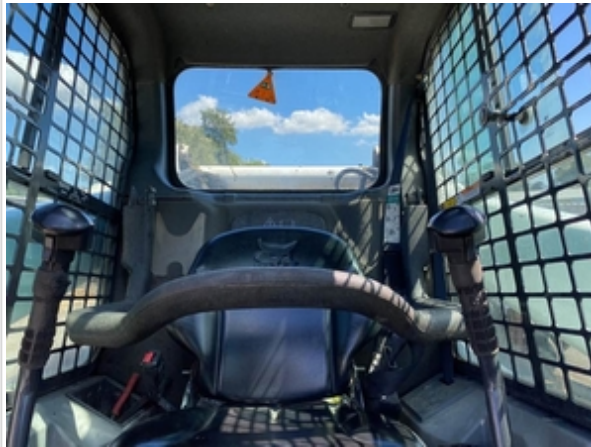
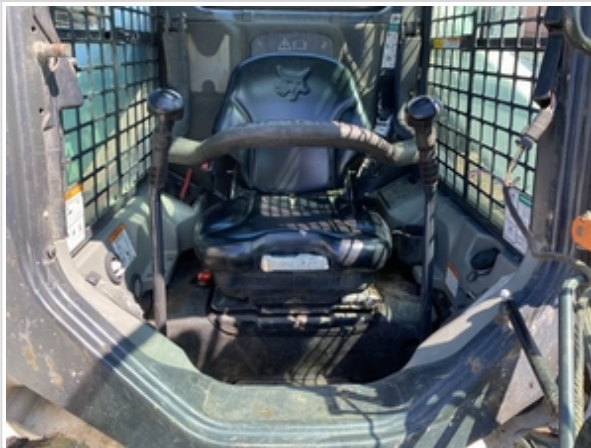
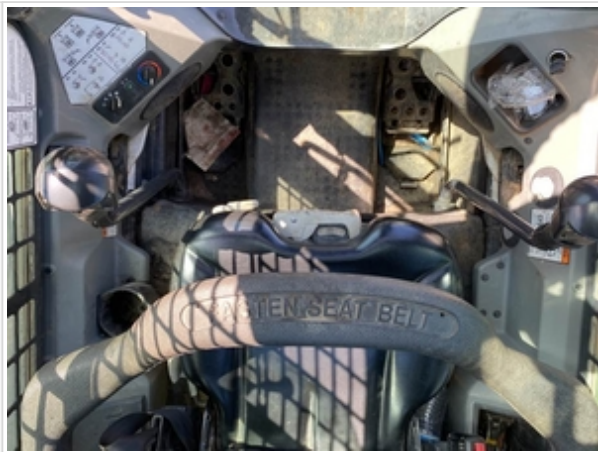
<b>Operator Cabin Photos</b>

<p>A black metal serial number plate for a Bobcat. The plate features the Bobcat logo at the top. Below the logo, it reads "COMPACT SKID STEER TRACK LOADER MODEL". To the right, there is a box containing the number "S770". In the center, a box contains the product identification number "*AT5A12197*". Below this is a barcode. At the bottom left, it says "MADE IN USA". At the bottom center, there is a box with the year "2017" and the text "MODEL YEAR". At the very bottom, it lists "Bobcat Company", "West Fargo, ND 58078 USA", and "www.bobcat.com".</p>
<b>Operator Cabin</b>	<p>3 - Normal Wear &amp; Tear</p>

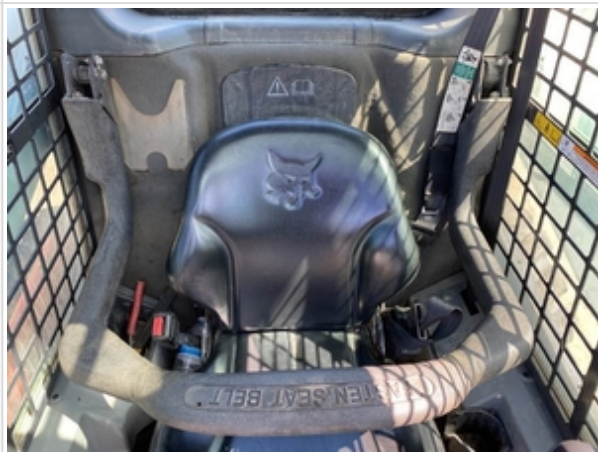
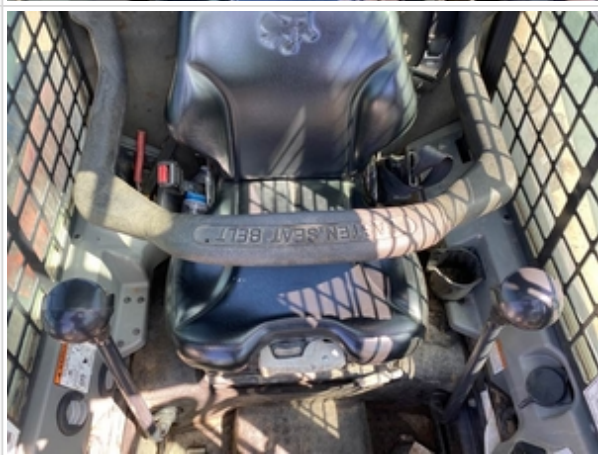
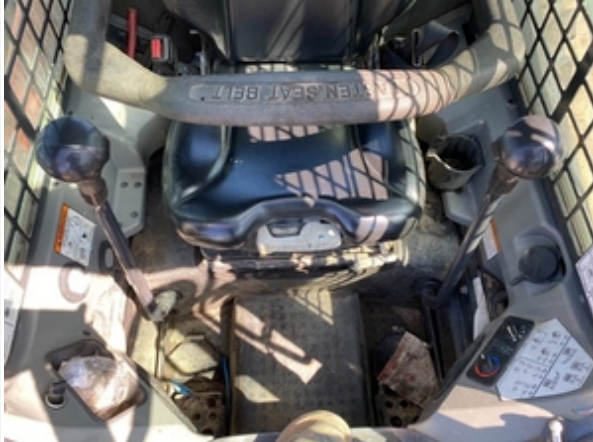
<p>Operator's Seat &amp; Arm Rests</p>	<p>3 - Normal Wear &amp; Tear</p>	
<p>Operator's Seat &amp; Arm Rests Photos</p>

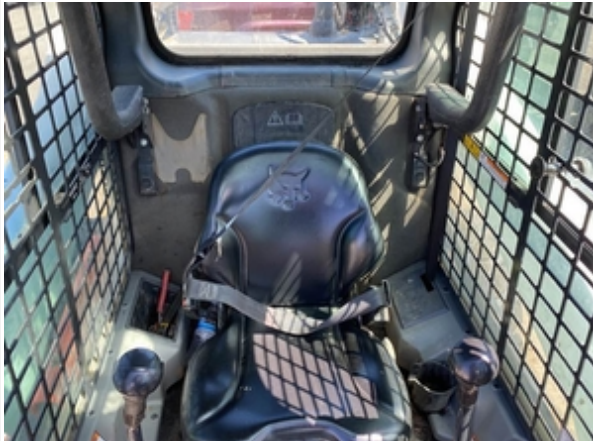
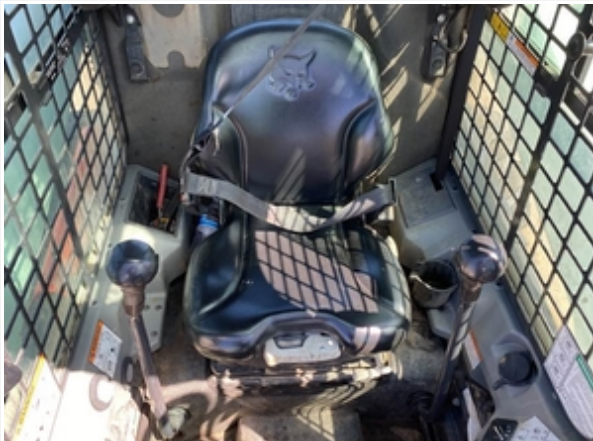
<b>Seat Belts</b>	2 - Above Average Wear
<b>Comments</b>	Bottom retractable seat belt inop, top part and seat belt lock okay
<b>Seat Belt Photos</b>

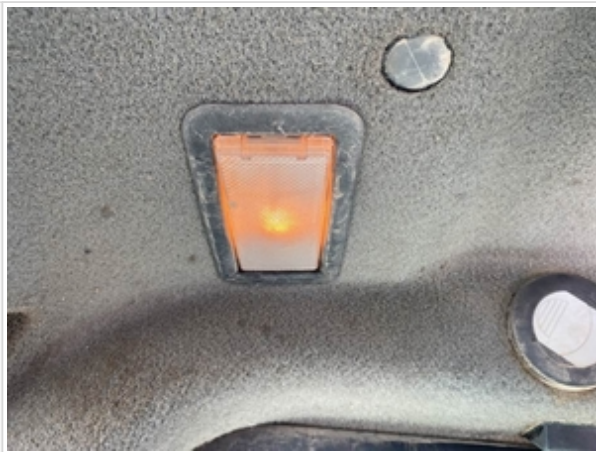
Cabin Lights Photos

<b>Cabin Lights</b>	3 - Normal Wear & Tear

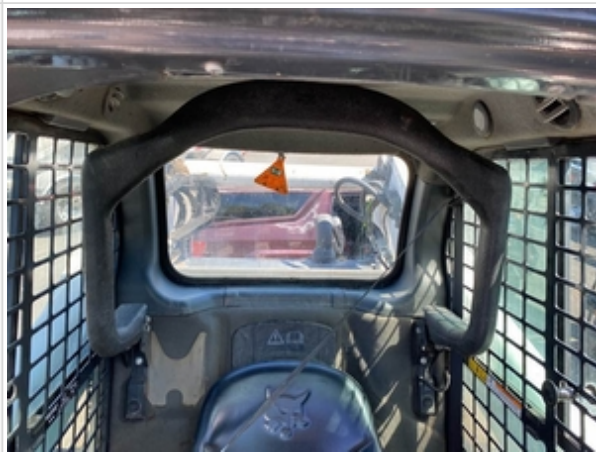
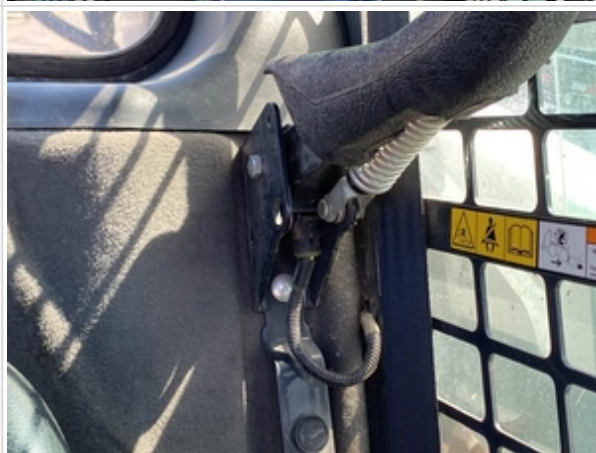
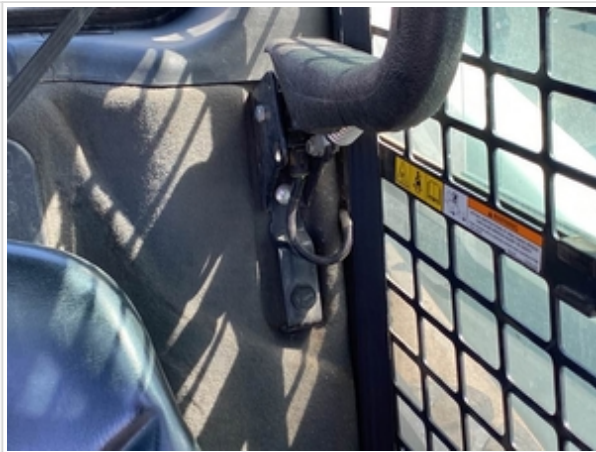
Safety Lock Out / Stop	3 - Normal Wear & Tear
Safety Lock Out / Stop Photos

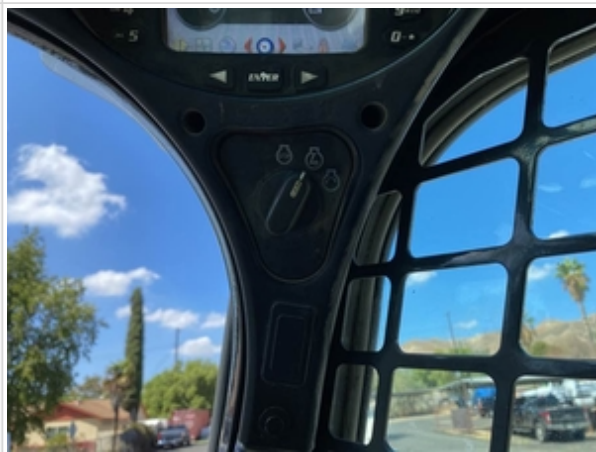
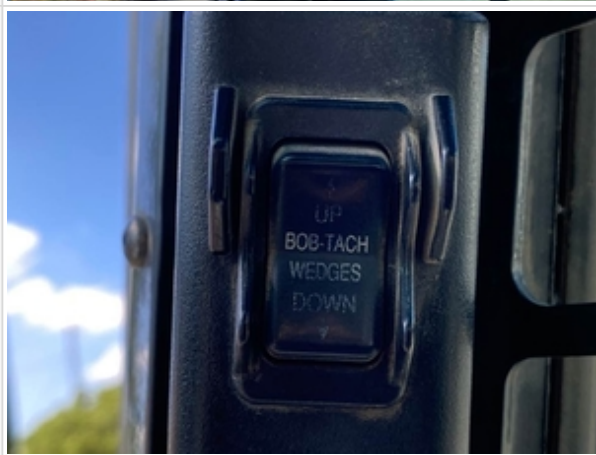
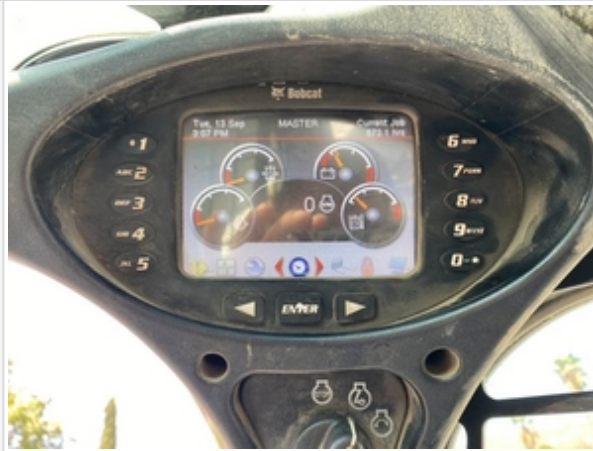
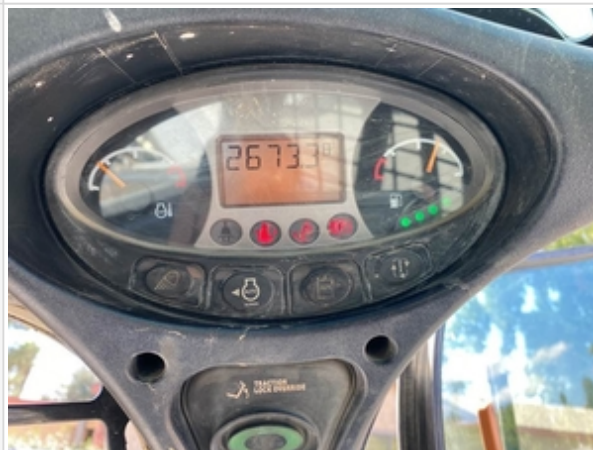
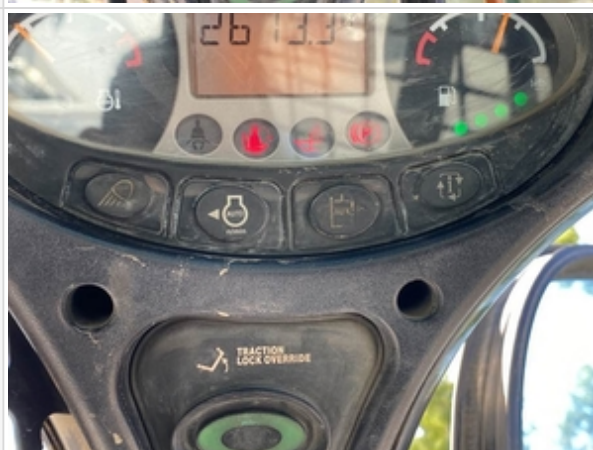
<p><b>Controls &amp; Switches</b></p>	<p>3 - Normal Wear &amp; Tear</p>	
<p><b>Controls &amp; Switches Photos</b></p>

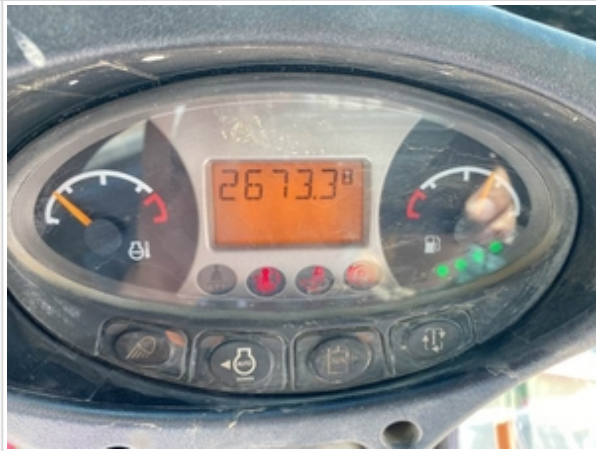
<p>Hour Meter Activity</p>	<p>3 - Normal Wear &amp; Tear</p>

Hour Meter Activity Photos

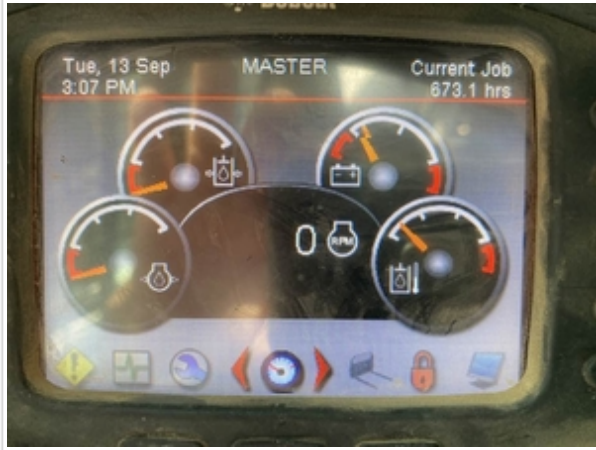
Other Gauge Activity	3 - Normal Wear & Tear
Other Gauge Activity Photos

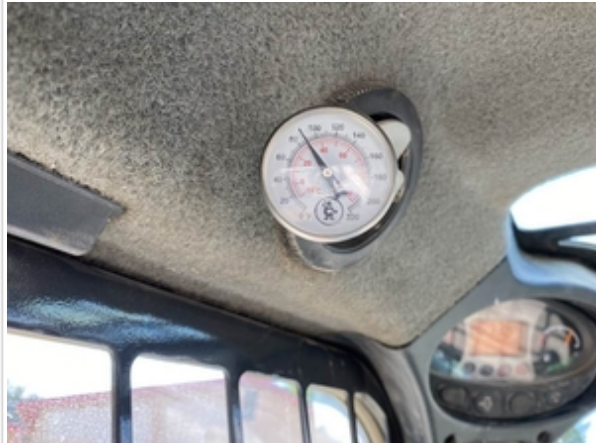
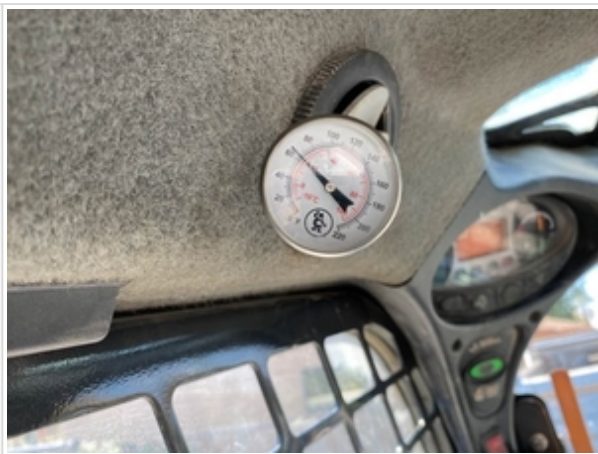
Heater & A/C	4 - Like New, Recently Replaced
Heater & A/C Photos

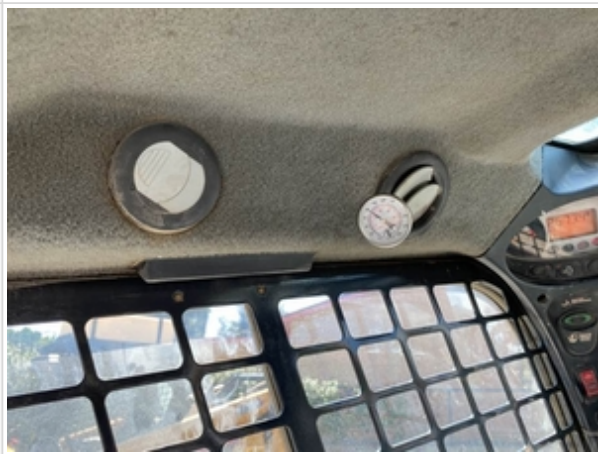
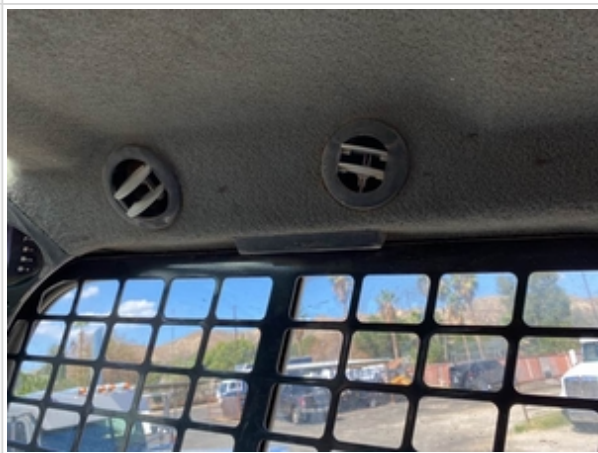
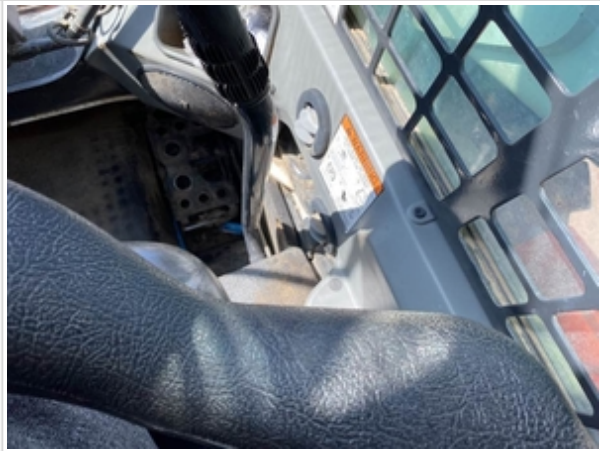
<p>Fans / Vents</p>	<p>3 - Normal Wear &amp; Tear</p>	
<p>Fans / Vents Photos</p>

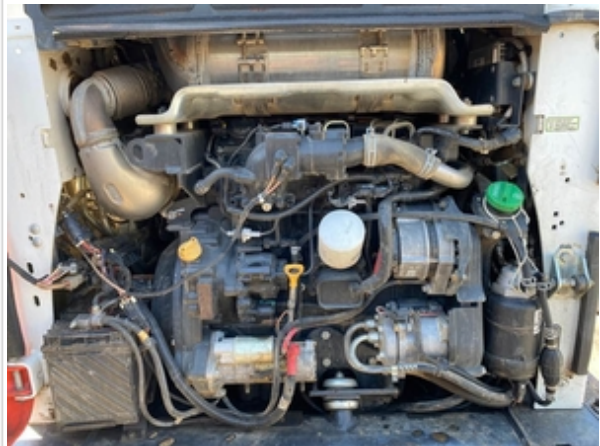
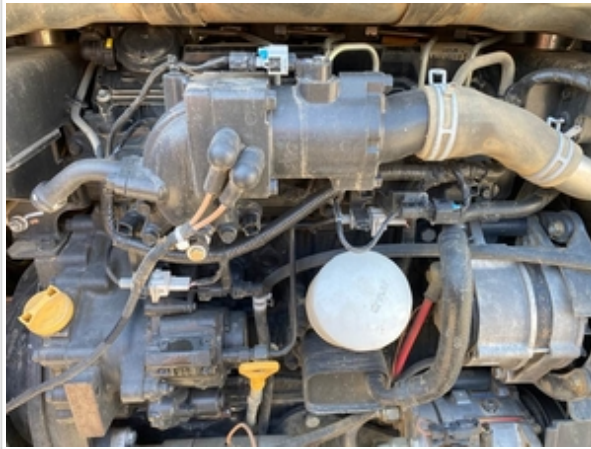
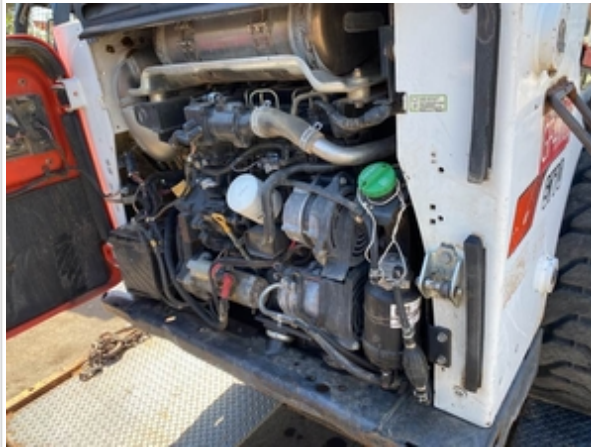
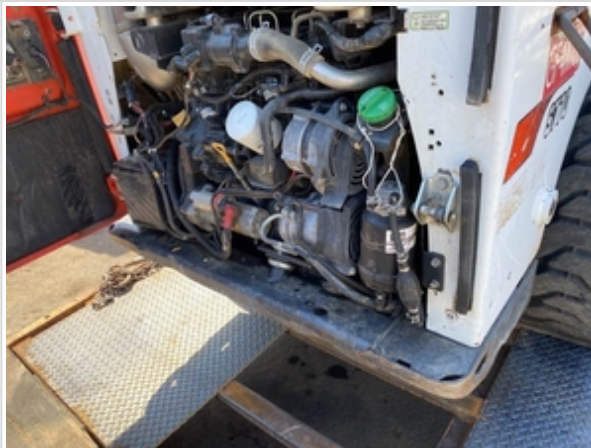
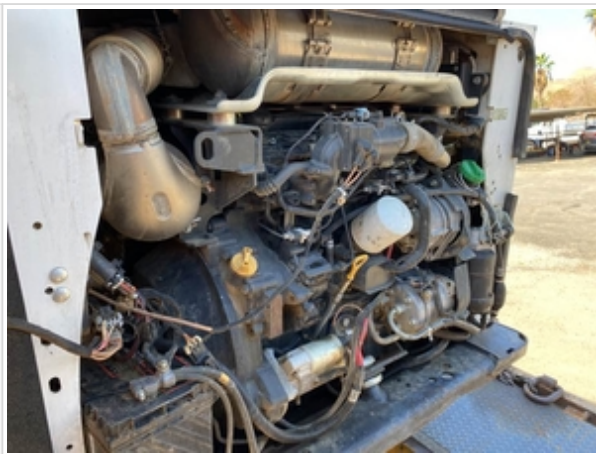
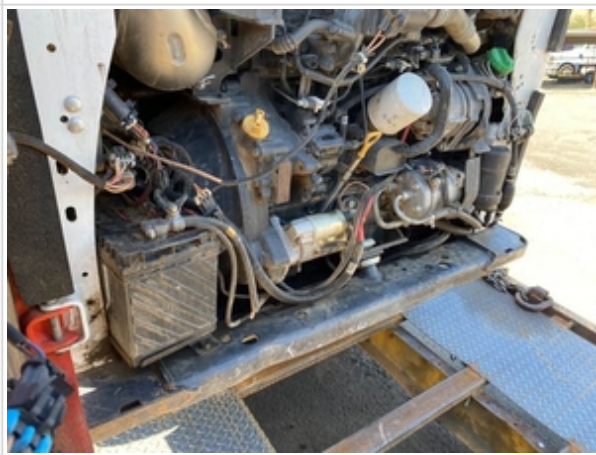
<b>Instructions</b>	<p>Assess the condition of the engine / power unit.</p> <p>For items on a 4 point scale, evaluate using the following criteria:</p> <p>4 = Like New, Recently Replaced  3 = Normal Wear &amp; Tear  2 = Above Average Wear  1 = Service Required</p>
<b>Engine Type (Make, Model, Cylinders, Hp)</b>	Bobcat 3.4 L - 4 Cyl. - 92HP
<b>Emissions Tier</b>	Tier 4
<b>Engine Photos</b>

<b>Blow-by (Visual Observation Check)</b>	No
<b>Unusual Noises (Upon Start-up, Idle, Shutdown)</b>	No
<b>Engine Smoke (Upon Start-up, Idle, Shutdown)</b>	No
<b>Engine Exhaust Color</b>	Clear
<b>Comments</b>	Engine runs well and sounds healthy.
<b>Battery Condition</b>	3 - Normal Wear & Tear
<b>Battery Photos</b>

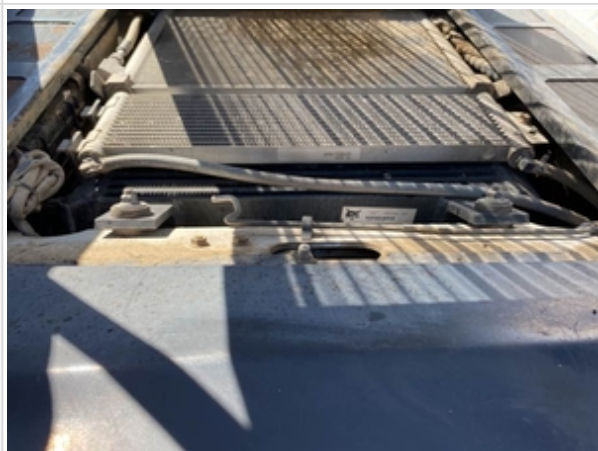
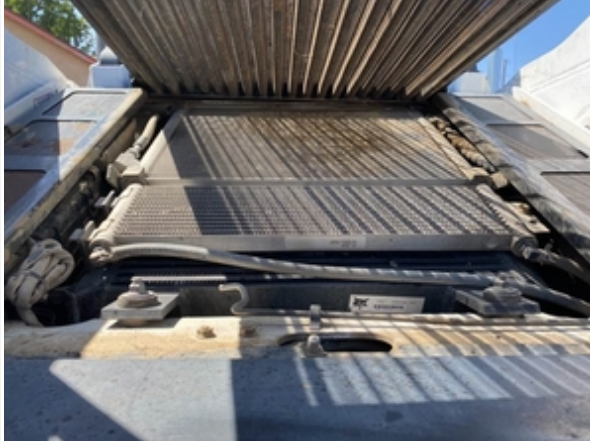
<p>Radiator</p>	<p>3 - Normal Wear &amp; Tear</p>	
<p>Radiator Photos</p>

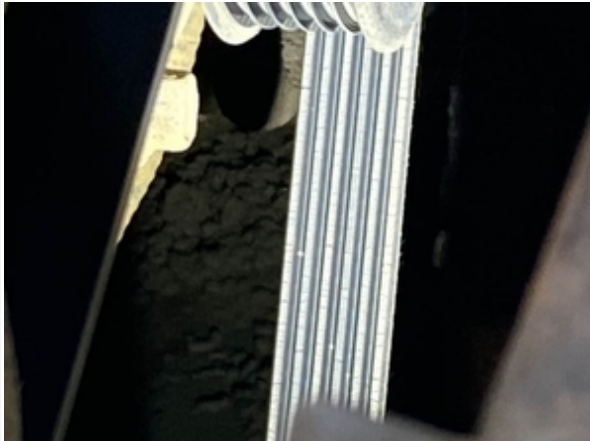
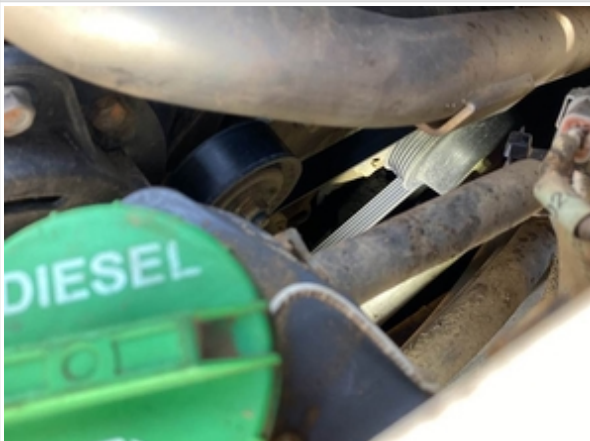
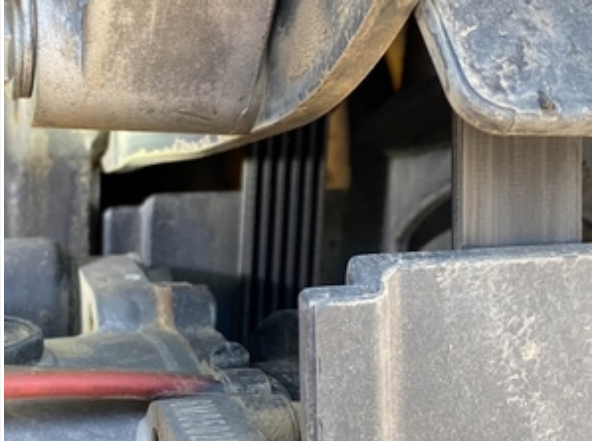
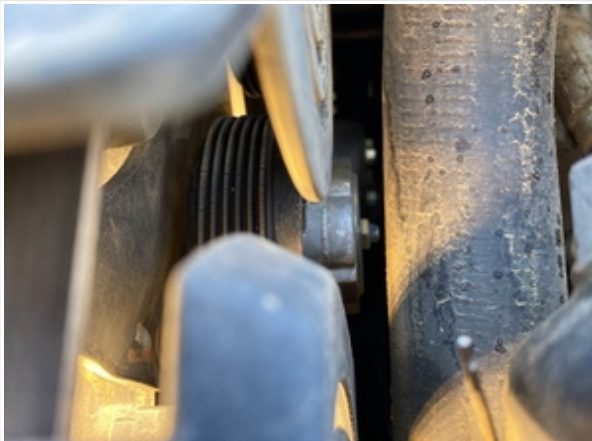
<b>Belts &amp; Hoses</b>	3 - Normal Wear & Tear	
<b>Comments</b>	Showing small cracks should be replaced soon	
<b>Belts &amp; Hoses Photos</b>

<b>Water Pump</b>	3 - Normal Wear & Tear	
<b>Cooling System Leaks</b>	No	
<b>Coolant Color / Appearance</b>	3 - Normal Wear & Tear	
<b>Oil Leaks</b>	No	
<b>Oil Color / Appearance</b>	3 - Normal Wear & Tear	
<b>Fuel Leaks</b>	No	
<b>Overall Engine Appearance</b>	Clean	
<b>Overall Engine Comments</b>	Overall engine sounds healthy with no leaks found. Recommend an engine service and replacing serpentine belts.
