## Inspection Report (Skid Steer)

Year	2017
Make	Bobcat
Model	S770
Serial Number	AT5A12197
Hour Meter Reading	2673 hours
Previous Application (e.g., earth moving, mining, demolition, etc)	Asphalt Paving General Construction

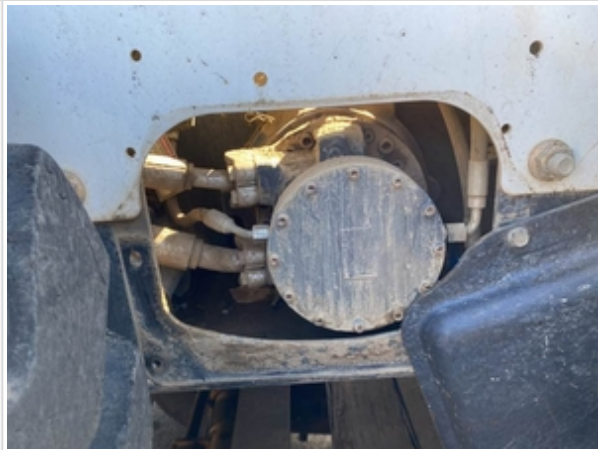
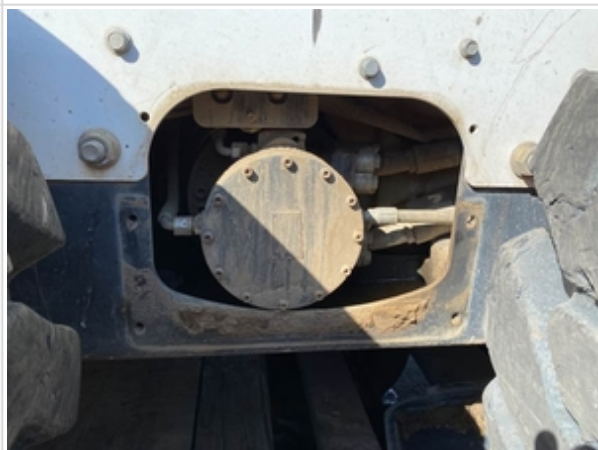
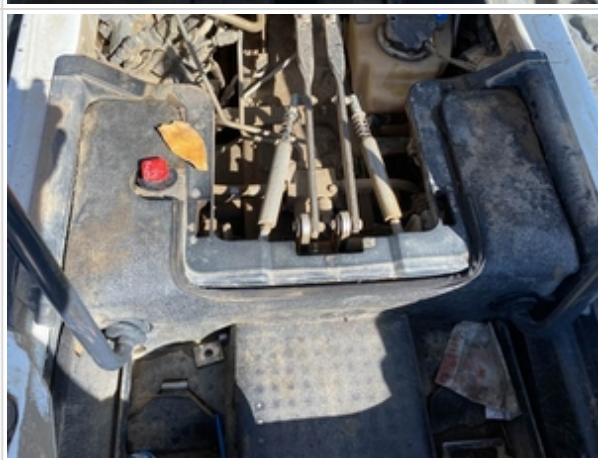
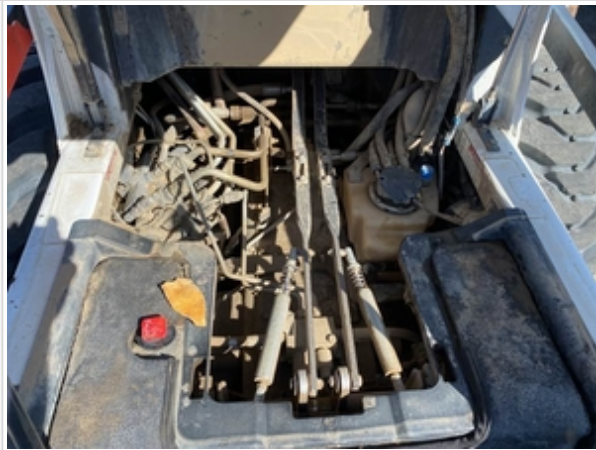
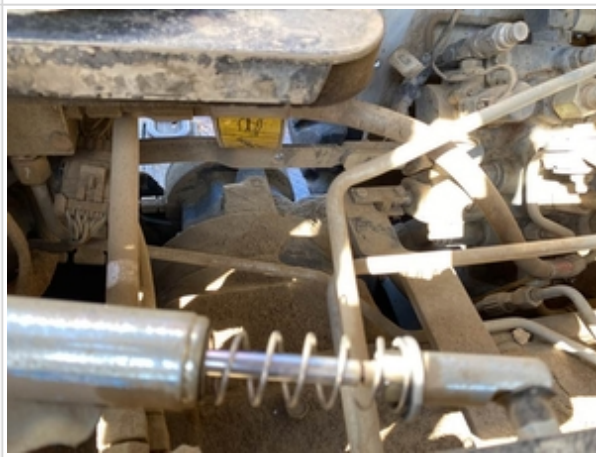
<b>Instructions</b>	<p>Evaluate the following on a 4 point scale (leave comments where an explanation is appropriate):</p> <p>4 = Like New, Recently Replaced  3 = Normal Wear &amp; Tear  2 = Above Average Wear  1 = Service Required</p>	
<b>Transmission Info</b>	Hydrostatic	
<b>Transmission Condition</b>	3 - Normal Wear & Tear

<p>Transmission Condition Photos</p>

<b>Parking Brake</b>	3 - Normal Wear & Tear
<b>Overall Drivetrain Comments</b>	Overall machine operates great in all directions with no unusual sounds from hydrostatic system.

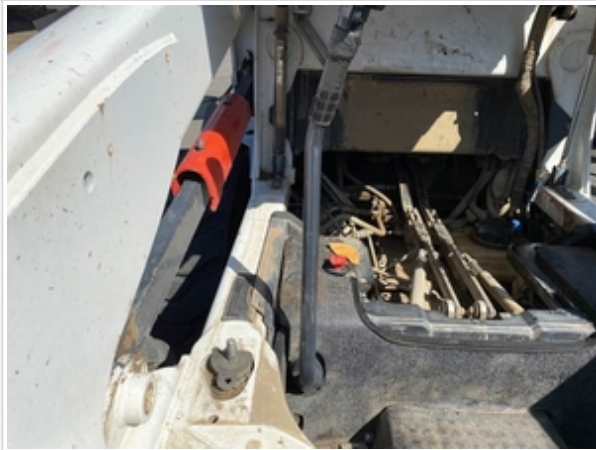
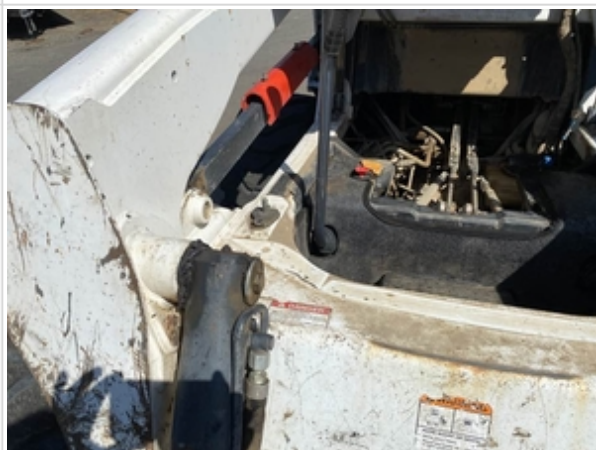
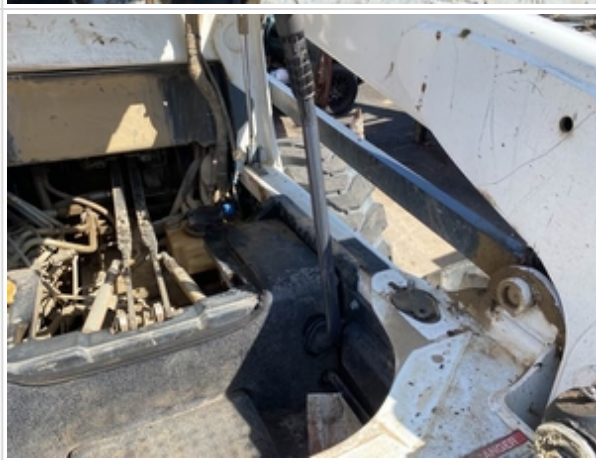
<b>Instructions</b>	<p>Evaluate the following on a 4 point scale (leave comments where an explanation is appropriate):</p> <p>4 = Like New, Recently Replaced  3 = Normal Wear &amp; Tear  2 = Above Average Wear  1 = Service Required</p>
<b>Frame</b>	3 - Normal Wear & Tear

Frame Photos

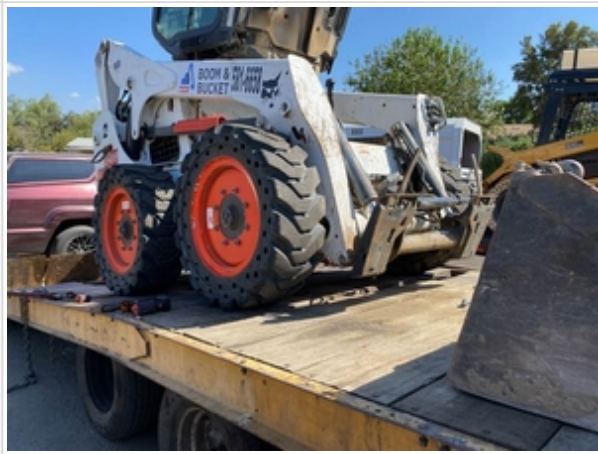
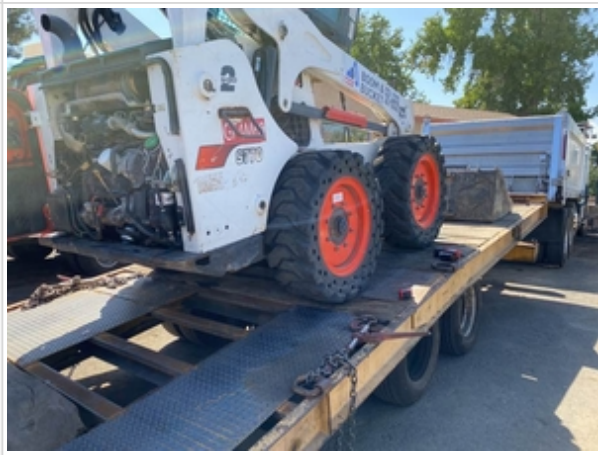
<b>Stance</b>	3 - Normal Wear & Tear	
<b>Stance Photos</b>

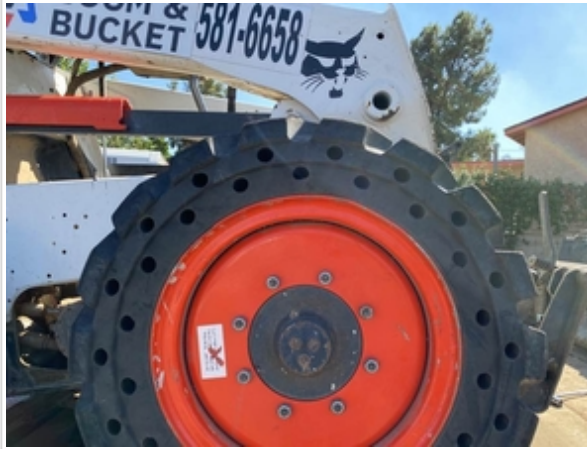
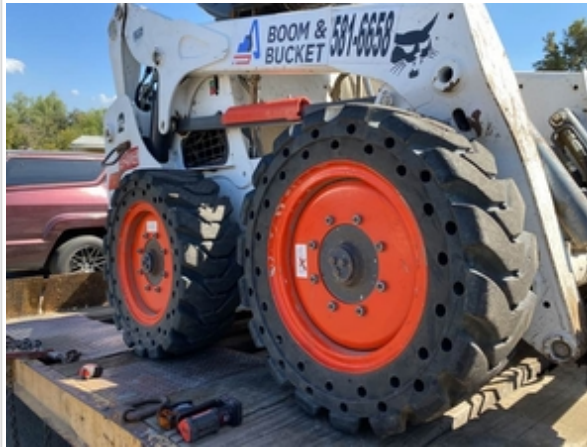
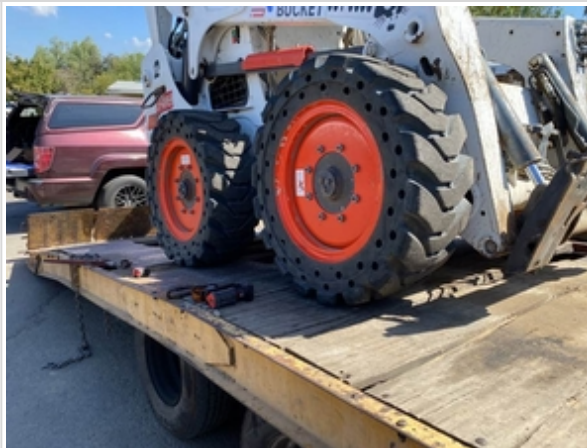
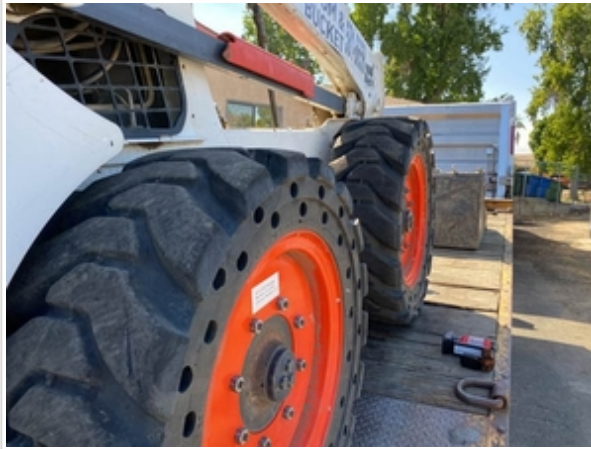
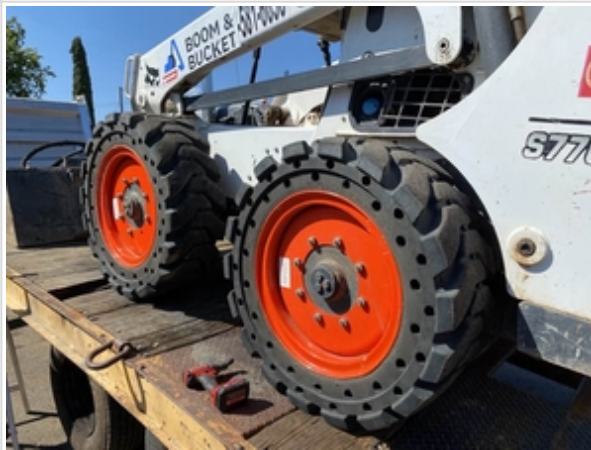
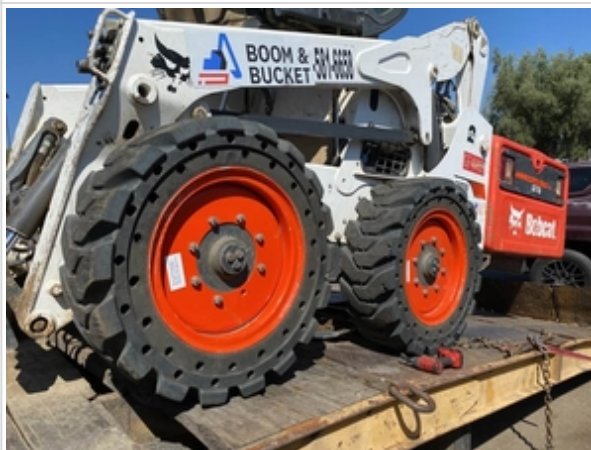
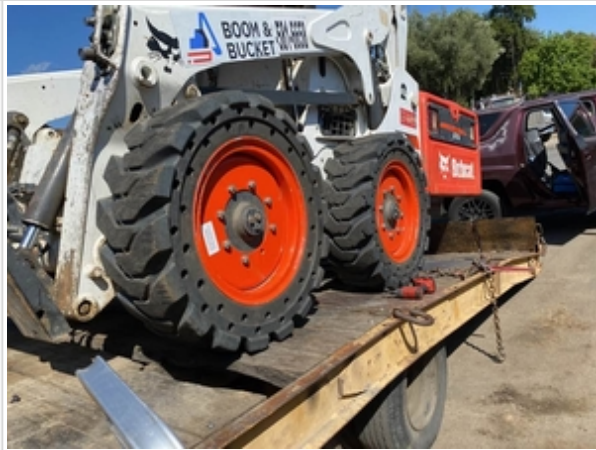
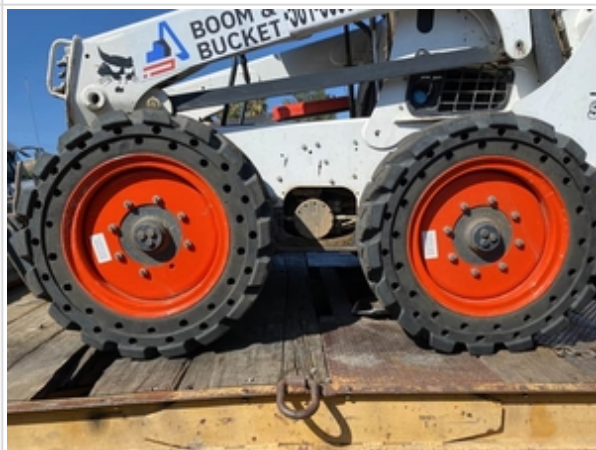
Wheels & Tires Photos

<b>Wheels &amp; Tires</b>	4 - Like New, Recently Replaced	
<b>Comments</b>	About 100 hours on these

Tire Brand	Tongyong Solid Flex Rubber Flat Proof	
Tire Size	36x12-20	
Front Left Tire - Ratio Remaining	90%	
Rear Left Tire - Ratio Remaining	90%	
Front Right Tire - Ratio Remaining	90%	
Rear Right Tire - Ratio Remaining	90%	
Lift Arm	3 - Normal Wear & Tear	
Lift Arm Photos

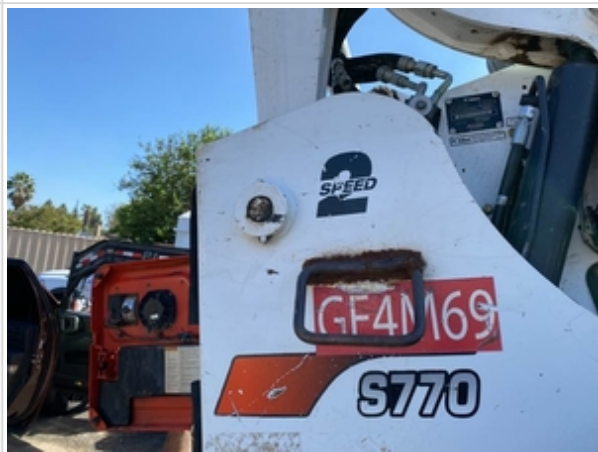
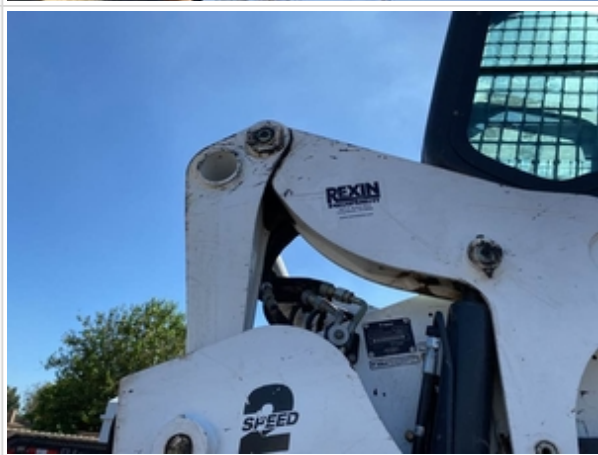
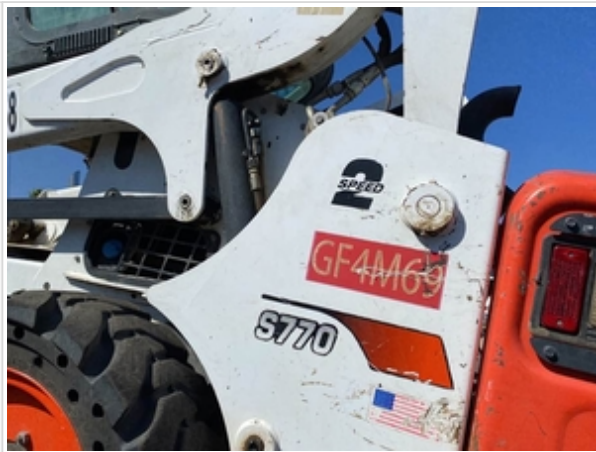
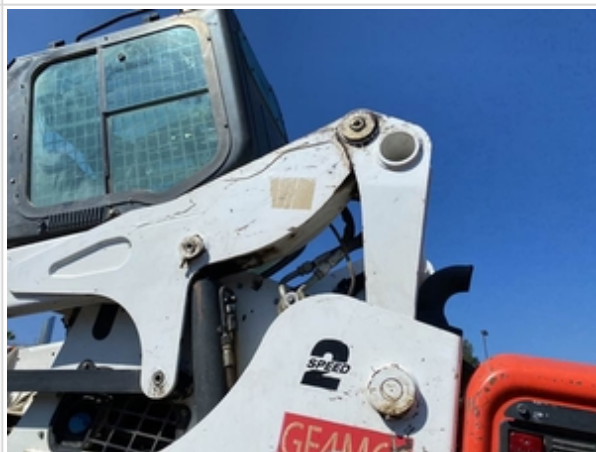
<p>Chassis to Arm Pins</p>	<p>3 - Normal Wear &amp; Tear</p>	
<p>Chassis to Arm Pins Photos</p>

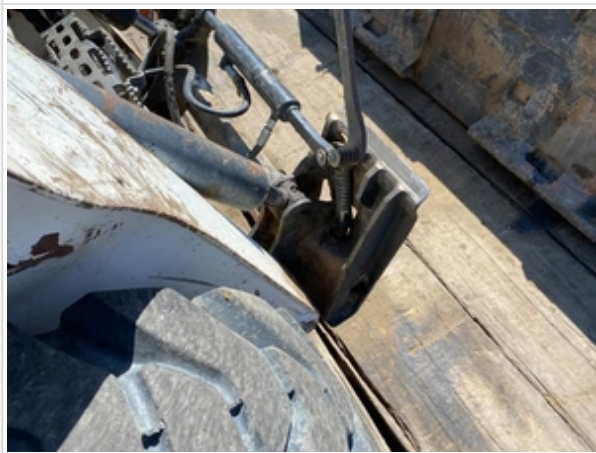
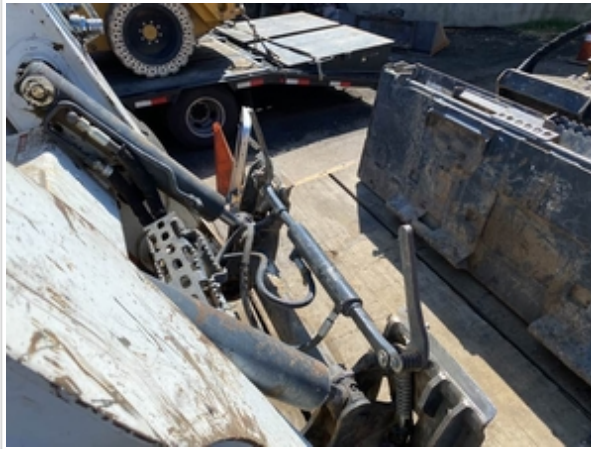
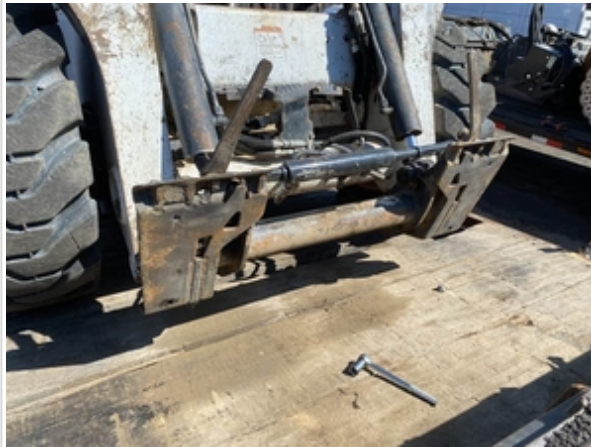
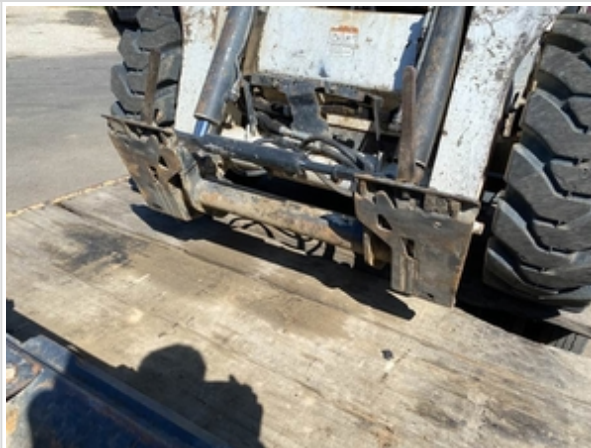
<p>Quick Coupler</p>	<p>3 - Normal Wear &amp; Tear</p>	
<p>Quick Coupler Photos</p>

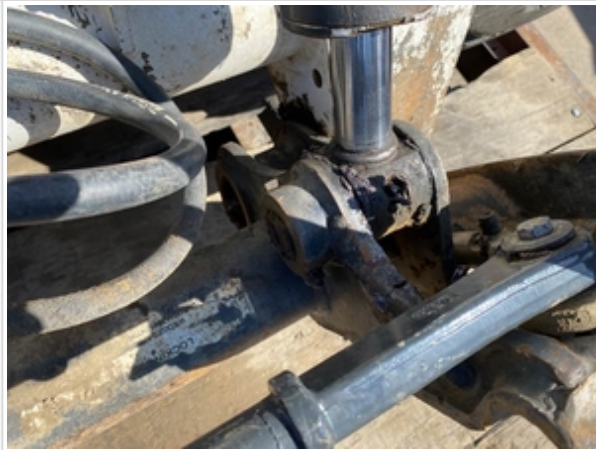
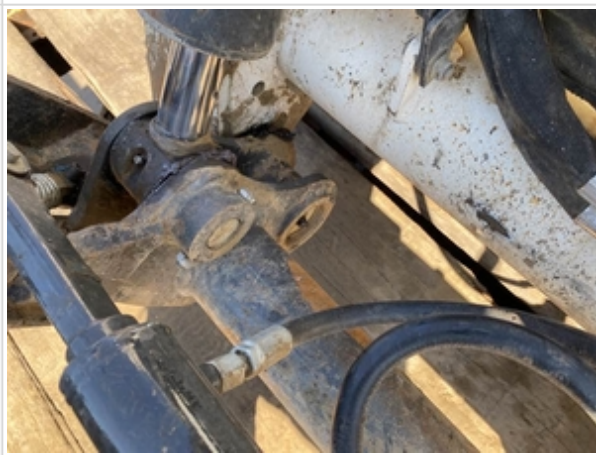
<p>Quick Coupler to Arms Pins Photos</p>

**Quick Coupler to Arms Pins**

3 - Normal Wear & Tear

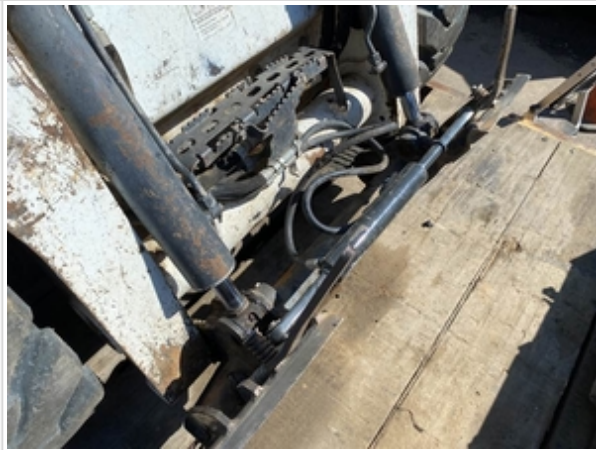
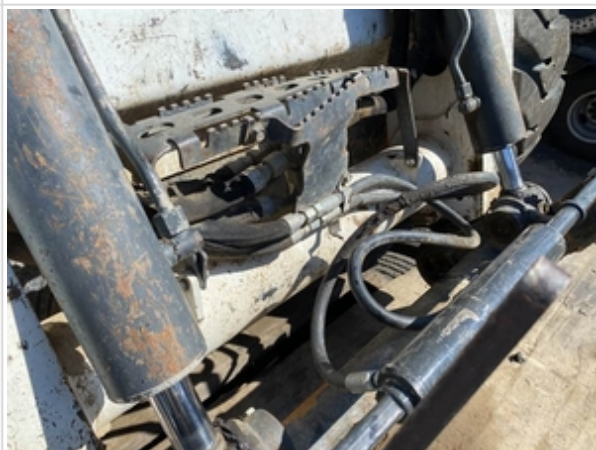
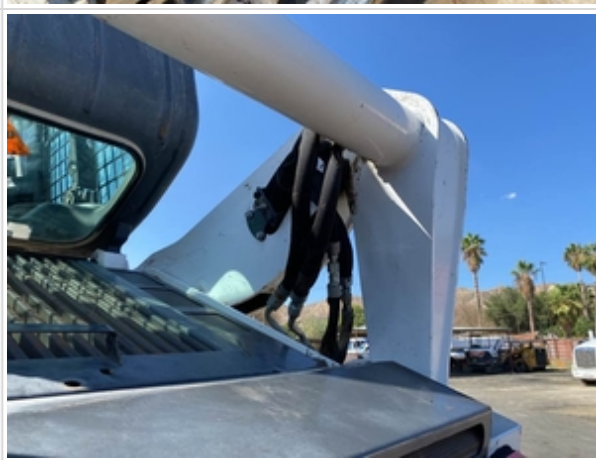
Hydraulic Lines Photos

<p><b>Instructions</b></p>	<p>Evaluate the following on a 4 point scale (leave comments where an explanation is appropriate):</p> <p>4 = Like New, Recently Replaced 3 = Normal Wear &amp; Tear 2 = Above Average Wear 1 = Service Required</p> <p>Things to look for:</p> <ul style="list-style-type: none"> <li>- All hydraulic lines</li> <li>- All hydraulic cylinders</li> <li>- All mounting pins</li> <li>- Leaks</li> <li>- Wet/damp lines</li> </ul> <p>Take close-up photos and leave comments.</p>
<p><b>Overall Appearance of Hydraulic Lines / Fittings</b></p>	<p>3</p>
<p><b>Comments</b></p>	<p>A few lines on inside left side of engine compartment may be seeping oil</p>

<b>Overall Hydraulics Comments</b>	Overall hydraulics work well and only found 2 seepage leaks from hydraulic tank hose and left side hydraulic hoses

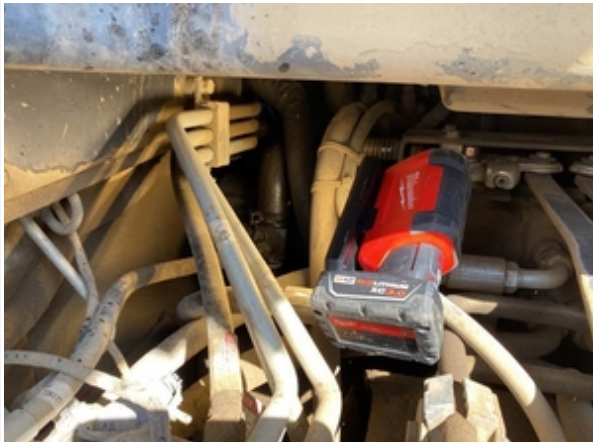
<b>Wet or Damp Hydraulic Lines / Fittings</b>	Yes	
<b>Comments</b>	Hard to see but 1 hose from hydraulic tank seeping oil out	
<b>Hydraulic Line Leak Photos</b>

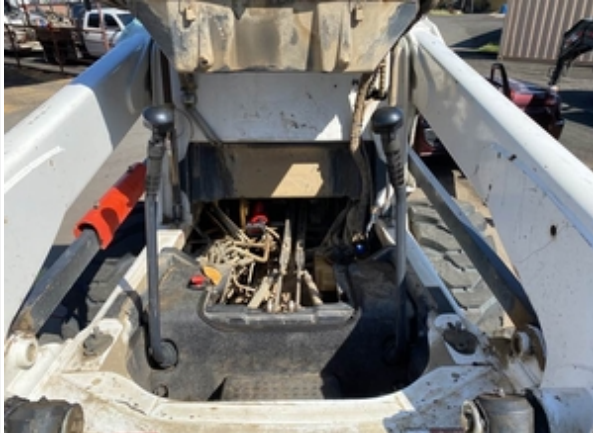
<b>Unusual Noises (Hydraulic Pump)</b>	No	
<b>External Controls / Levers</b>	3	
<b>External Controls / Levers Photos</b>

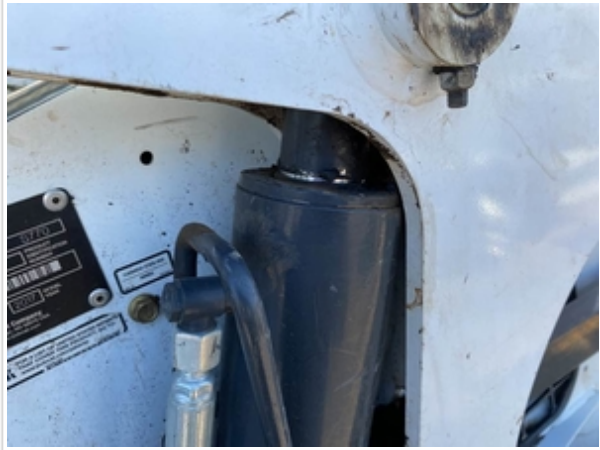
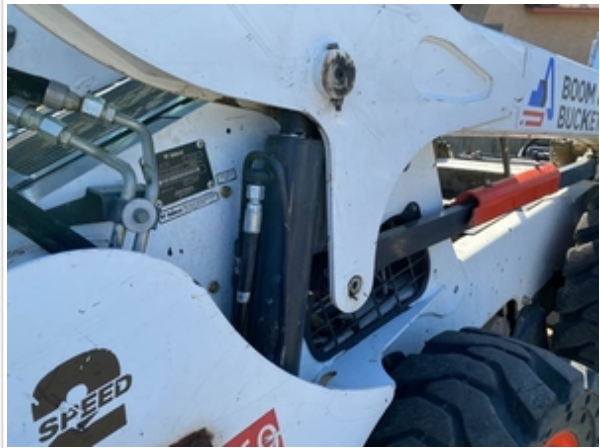
<b>Lift Cylinder</b>	Check the lift cylinder. Note any wear, pitting, discoloration, etc. Take photos.	
<b>Lift Cylinder: Mounting Pin</b>	3	
<b>Lift Cylinder: Oil Leaks</b>	No	
<b>Lift Cylinder Photos</b>

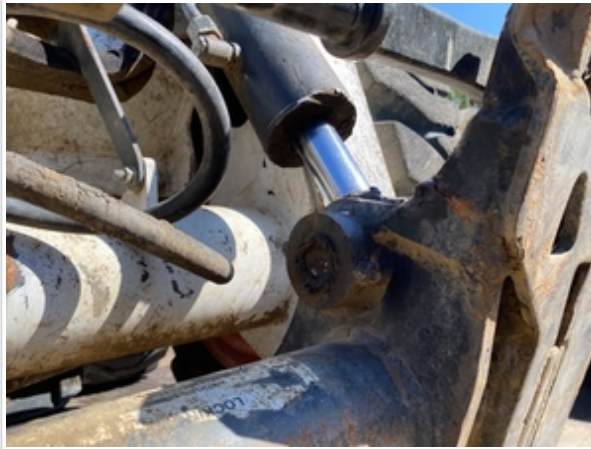
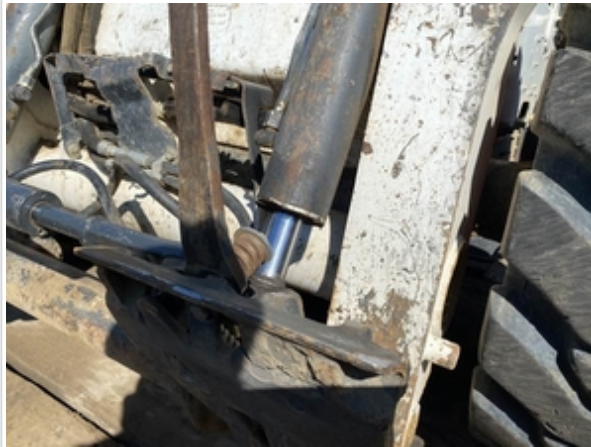
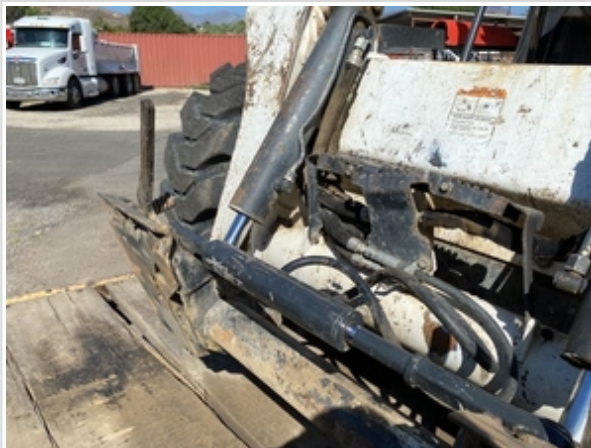
<b>Bucket Cylinder</b>	Check the bucket cylinder. Note any wear, pitting, discoloration, etc. Take photos.
<b>Bucket Cylinder: Mounting Pin</b>	3
<b>Bucket Cylinder: Oil Leaks</b>	No
<b>Comments</b>	Slight damage to left side bucket tilt cylinder barrel nut but not leaking
<b>Bucket Cylinder Photos</b>

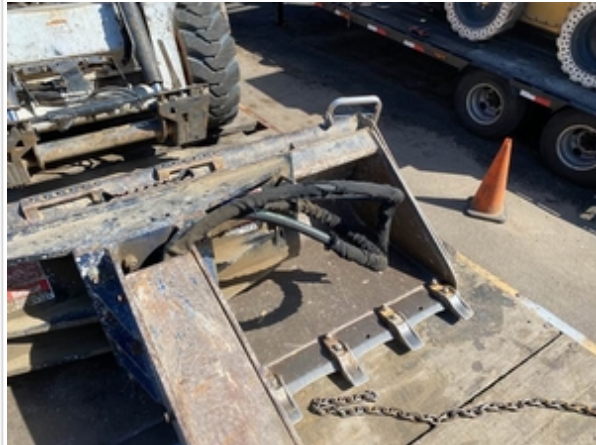
<b>Instructions</b>	Evaluate the following on a 4 point scale (leave comments where an explanation is appropriate):  4 = Like New, Recently Replaced 3 = Normal Wear & Tear 2 = Above Average Wear 1 = Service Required	
<b>Bucket Condition</b>	3 - Normal Wear & Tear	
<b>Bucket Photos</b>

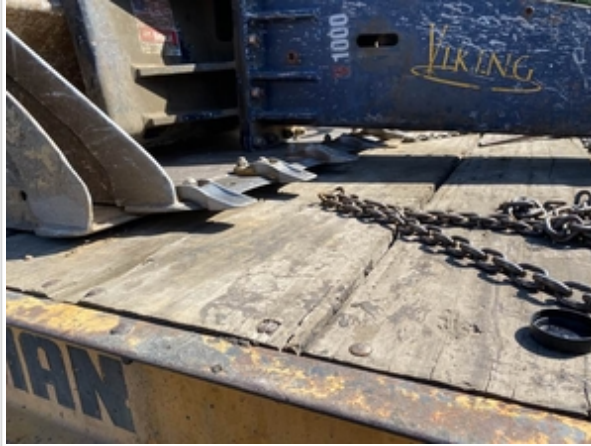
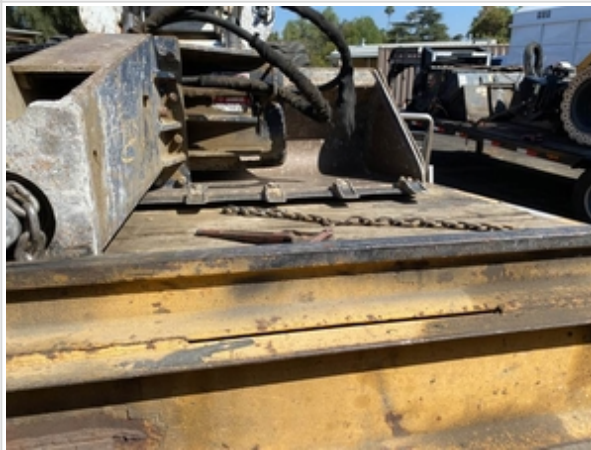
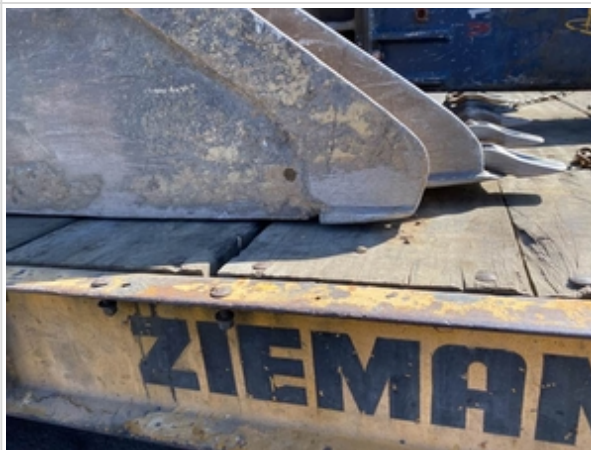
Bucket Edge / Deflectors

<b>Bucket Edge / Deflectors</b>	2 - Above Average Wear
<b>Comments</b>	Cutting edge bucket missing cutting edge, smaller bucket teeth in good condition

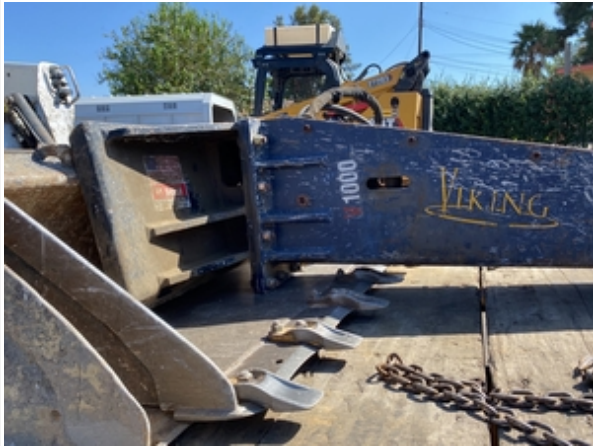
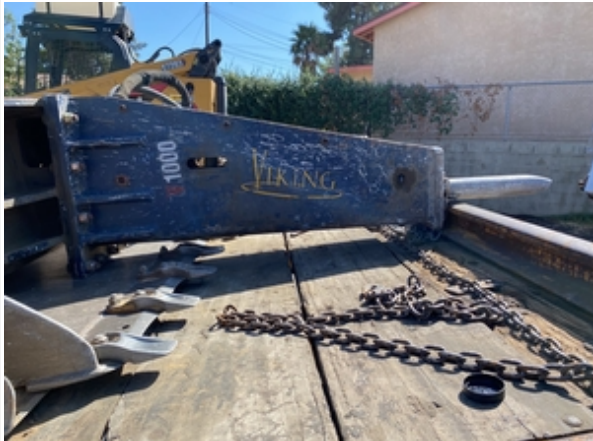
Attachment Type	Hydraulic breaker
Attachment Make	Viking
Attachment Size / Specs	V1000
Attachment Condition	3 - Normal Wear & Tear
Attachment Photos
