Inspection Report (On-Highway Dump Truck)

Year	2013
Make	International
Model	4300
Serial Number	3HAMMAAL4DL198252
Truck Odometer Reading	281,798
Current Inspection / State Cert / DOT	N/A
Previous Application (e.g., earth moving, mining, demolition, etc)	General Construction

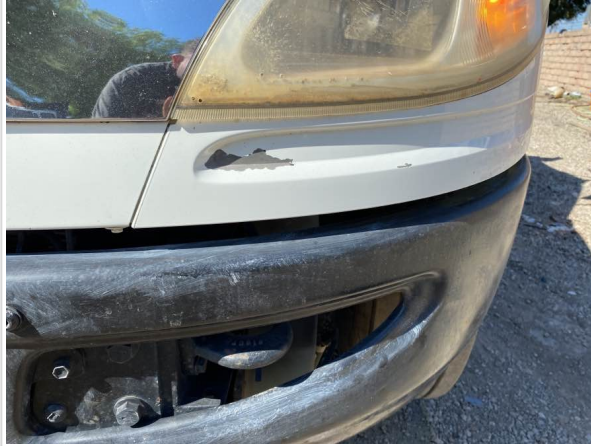
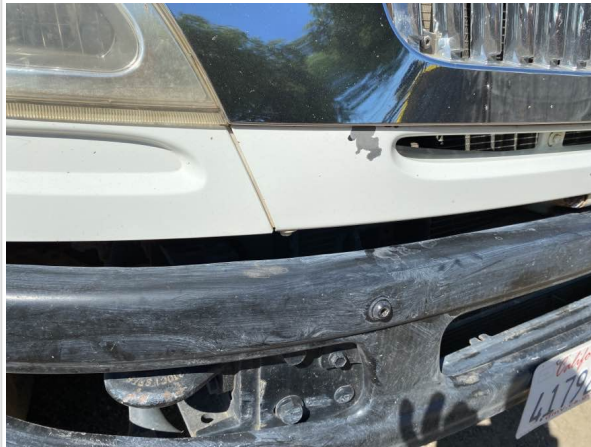
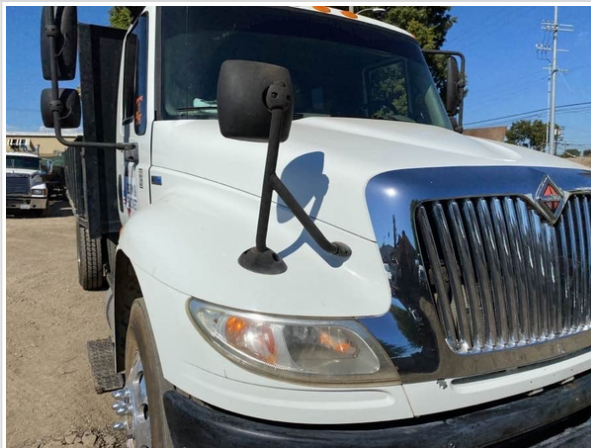
Front Photos

Front	3 - Normal Wear & Tear
Front Condition	No visible damage, Other (see comments)
Comments	Small paint chips lower hood area

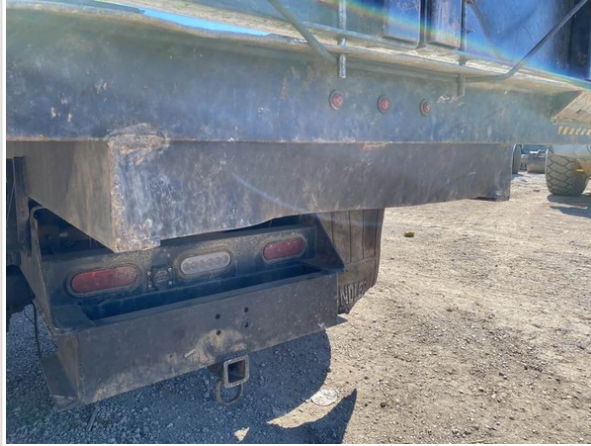
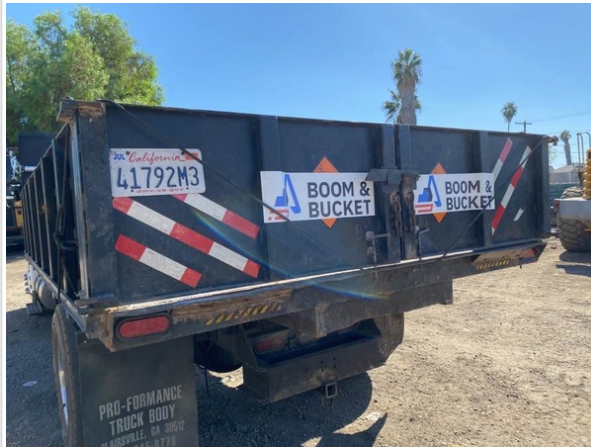
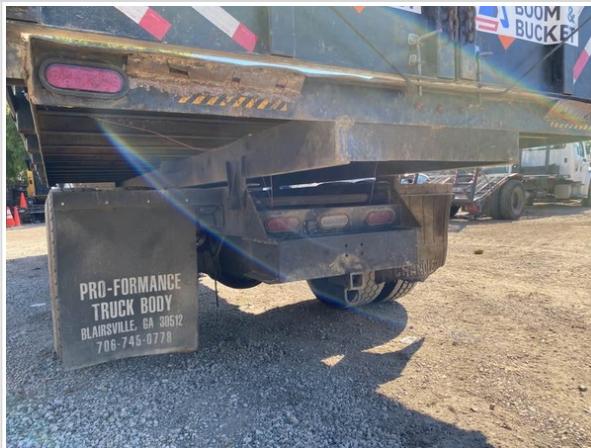
Rear Photos

Rear	3 - Normal Wear & Tear
Rear Condition	No visible damage, Other (see comments)
Comments	Small dent bottom of dump body

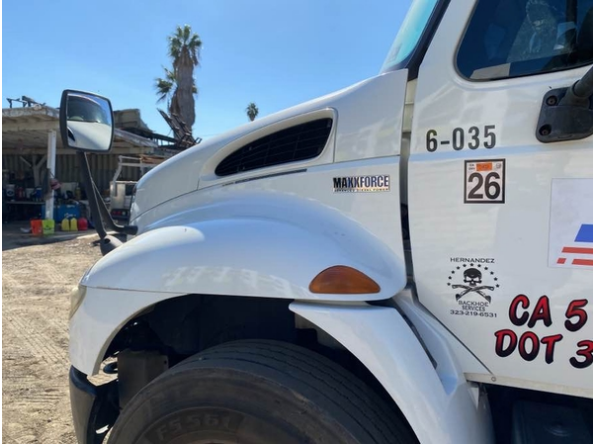
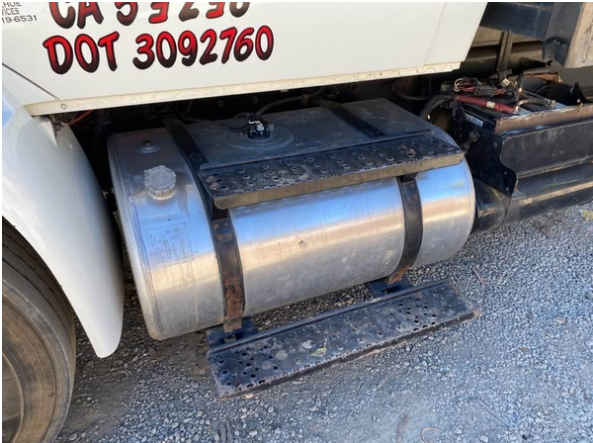
Left	3 - Normal Wear & Tear	
Left Condition	No visible damage	
Left Photos

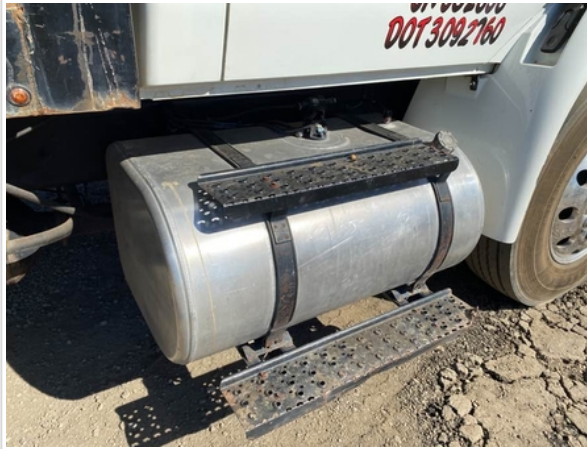
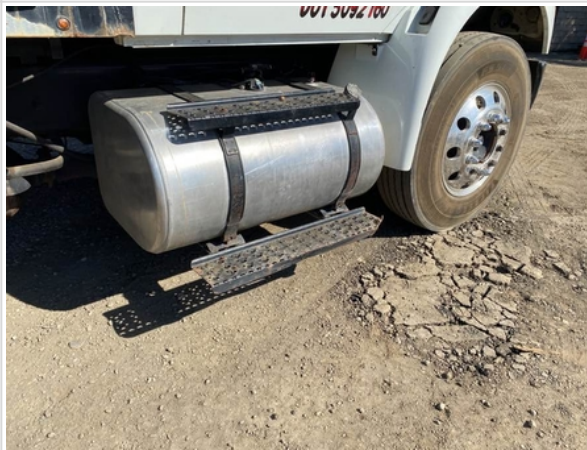
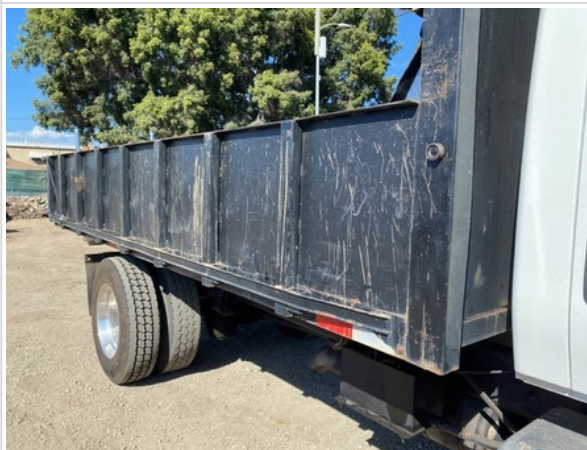
Right Photos

Right	3 - Normal Wear & Tear
Right Condition	No visible damage

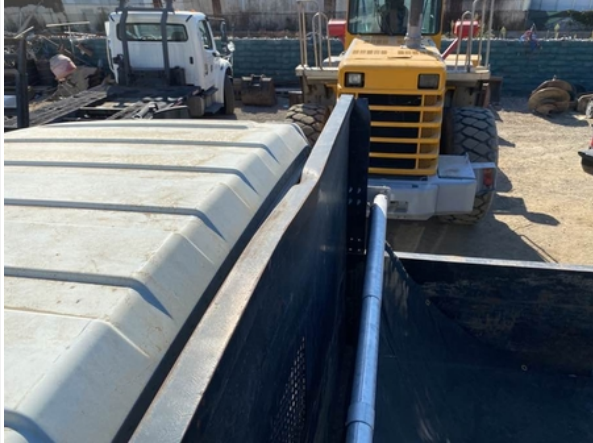
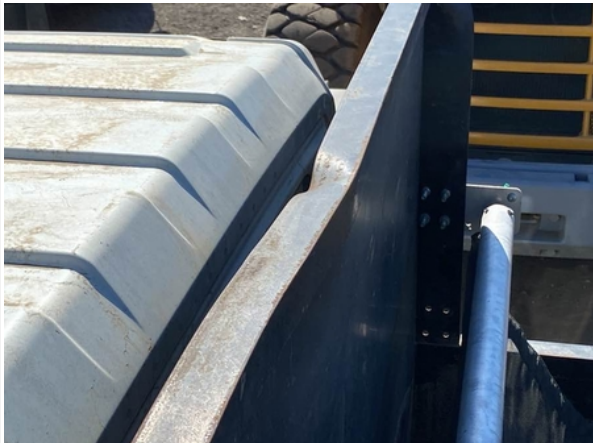
Upper	3 - Normal Wear & Tear	
Upper Condition	No visible damage, Other (see comments)	
Comments	Small dent on dump body	
Upper Photos

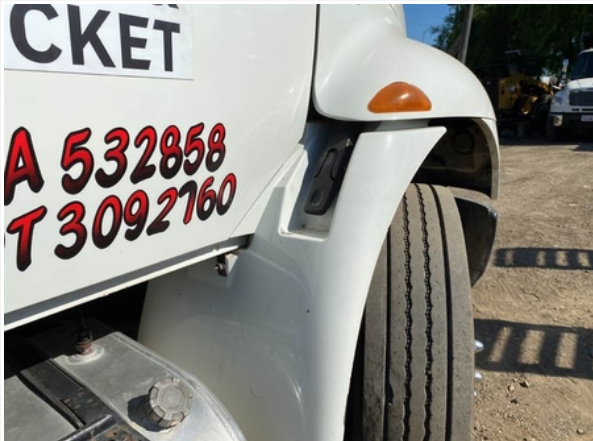
Body Panels (Any Rust Damage?)	3 - Normal Wear & Tear
Body Panel Condition	No visible damage, good paint condition and panel fitment
Body Panels Photos

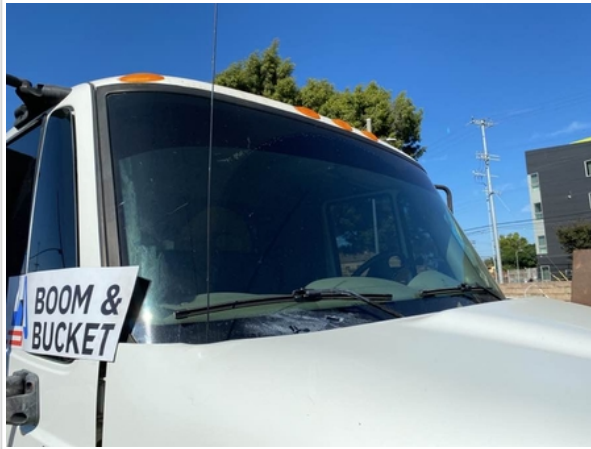
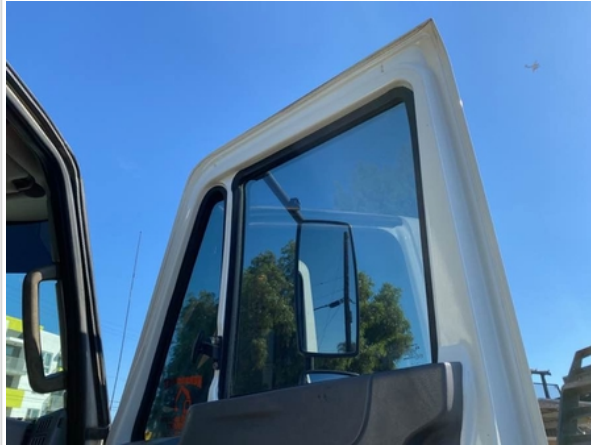
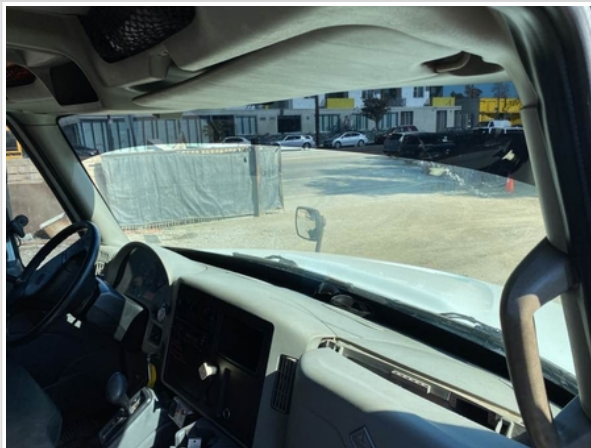
Glass Condition	3 - Normal Wear & Tear
Glass Condition Notes	Glass intact, no visible damage
Glass Condition Photos

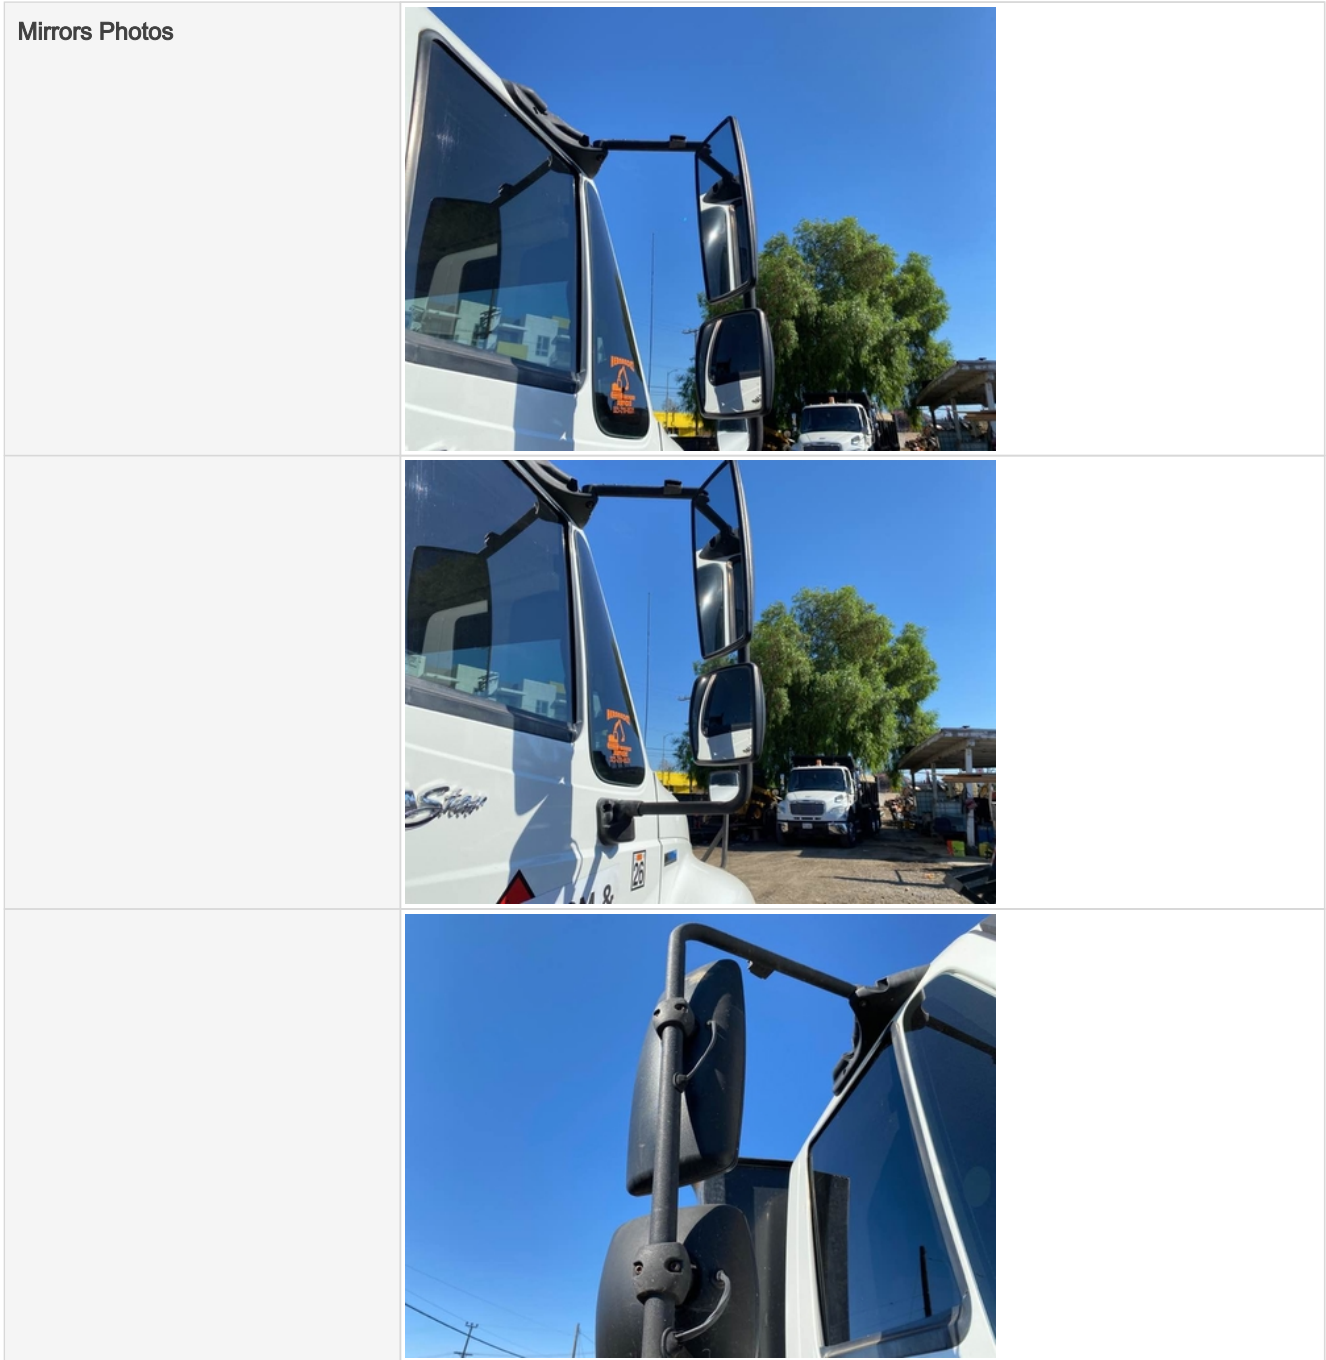
Mirrors	3 - Normal Wear & Tear
Mirror Condition Notes	Mirrors present and intact, no visible damage

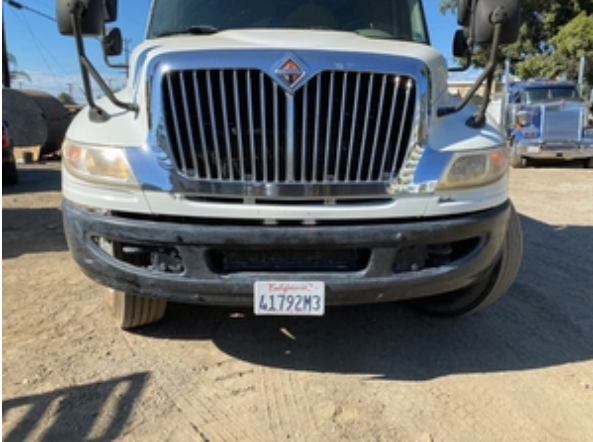
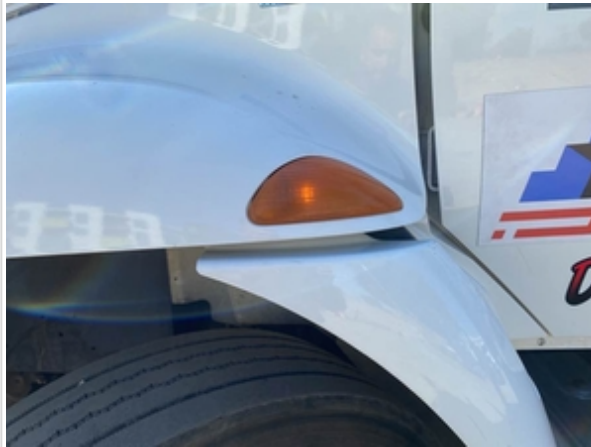
Lighting System	3 - Normal Wear & Tear
Lighting System Condition	No visible damage, lighting system is operational, One or more exterior lights are non-operational, Other (see comments)
Comments	Front l/s headlight inop
Lighting System Photos

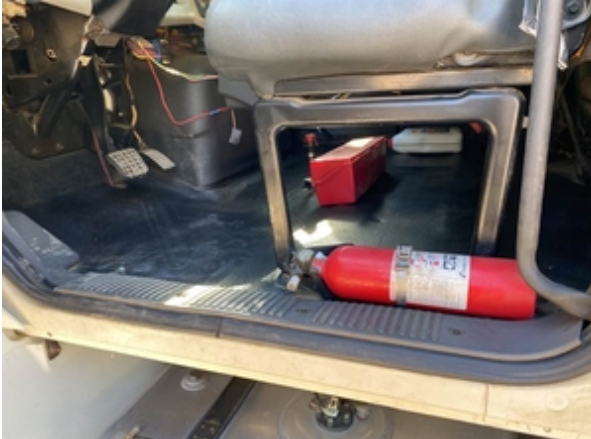
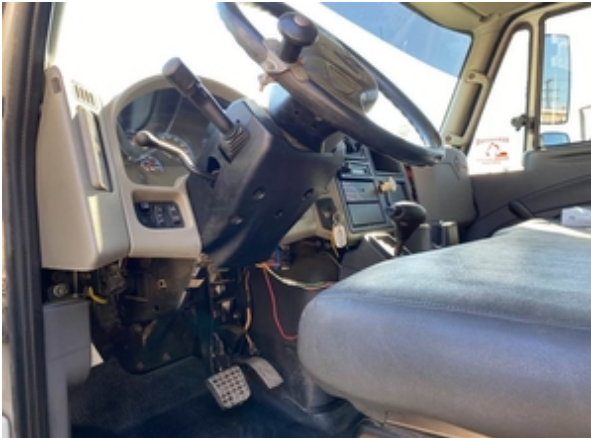
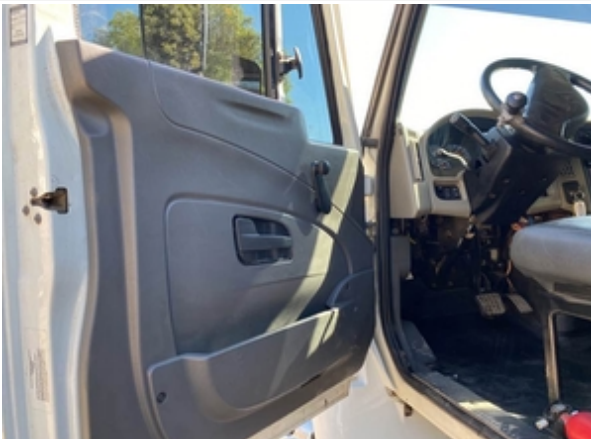
Operator Cabin	3 - Normal Wear & Tear
Comments	R/S Dash Fuse Panel Cover Loose
Operator Cabin Photos

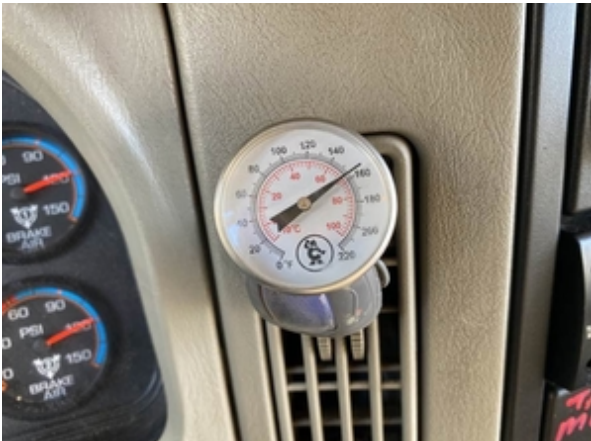
Heater & A/C	2 - Above Average Wear
Comments	A/C inop Heater operation okay
Heater & A/C Photos

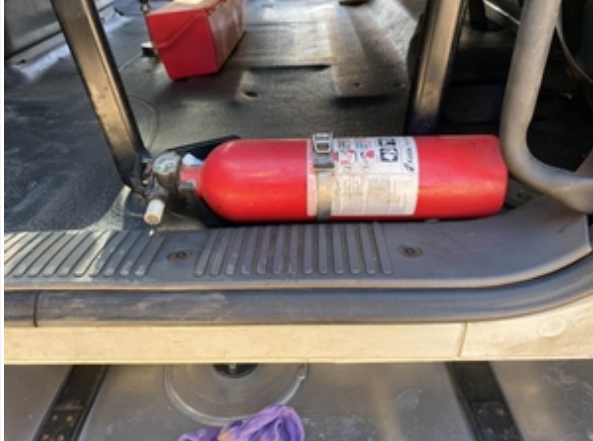
Horn	3 - Normal Wear & Tear	
Reverse Alarm / Backup Signal	0	
Comments	No back up alarm heard	
Backup Camera	0	
Other Electronic Devices	0	
Fire Extinguisher	1 - Service Required	
Comments	2&1/2lbs extinguisher empty	
Fire Extinguisher Photos

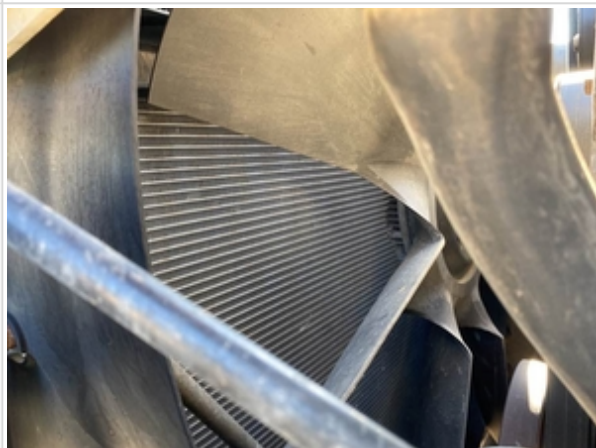
Radiator	3 - Normal Wear & Tear
Radiator Condition	Radiator fins & components appear to be in good working order, no signs of damage or leaks
Radiator Photos

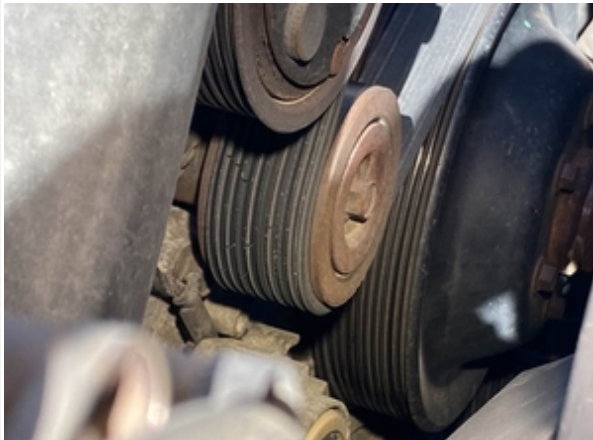
Belts	3 - Normal Wear & Tear
Belt Condition	Belts appear in good condition & alignment with proper tension, Other (see comments)
Comments	Slight worn cracks starting to appear
Belt Photos

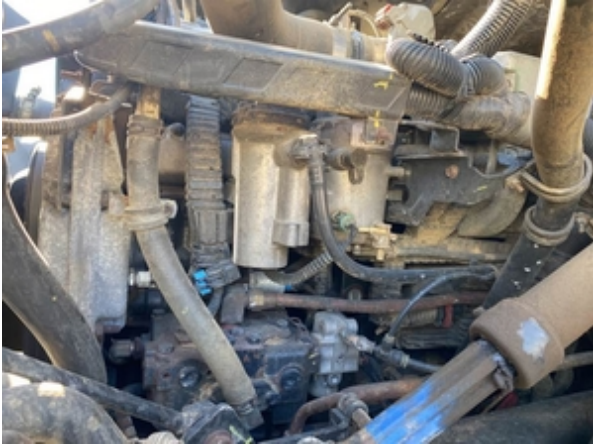
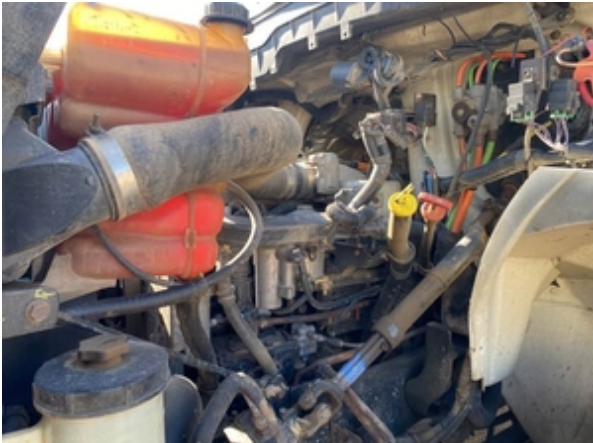
Hoses	3 - Normal Wear & Tear	
Hose Condition	Firm, pliant hoses with no signs of wear or leaks	
Hose Photos

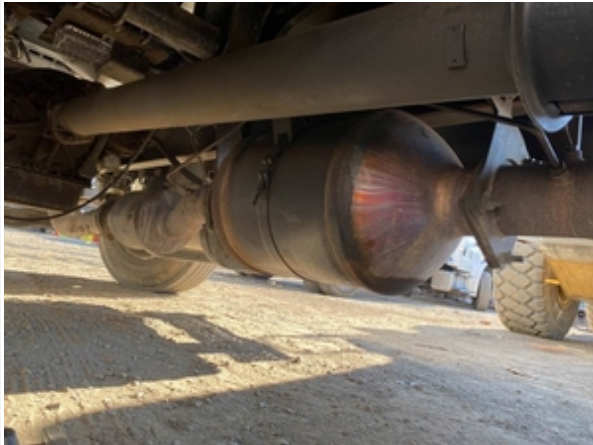
Oil Color / Appearance Notes	Clean oil appearance, no signs of cross contamination, Appropriate oil level
Fuel Leaks	No
Equipped with DPF (Diesel Particulate Filter)	Yes
DPF Condition	3 - Normal Wear & Tear
DPF Condition Notes	Filter housing is intact with no signs of damage or malfunction, DPF indicator is not illuminated
DPF Photos

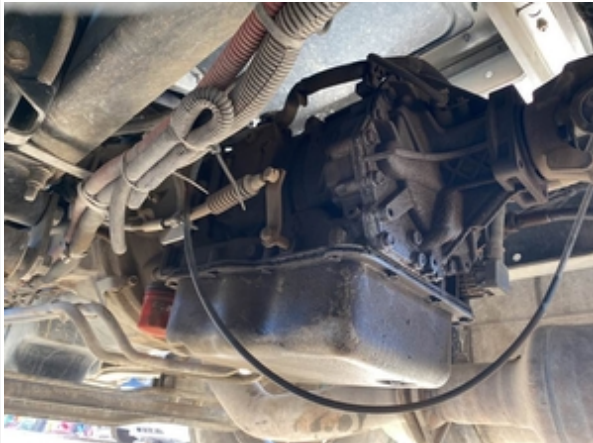
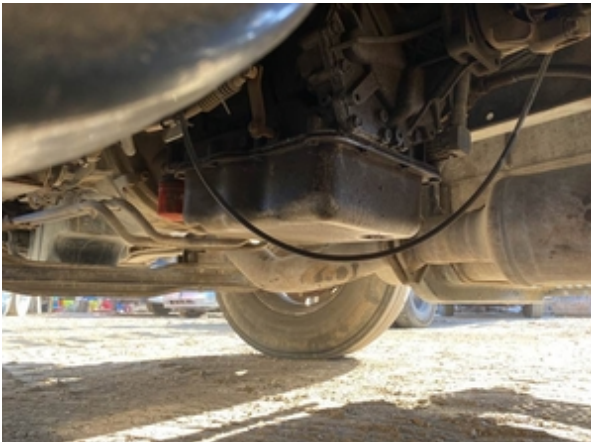
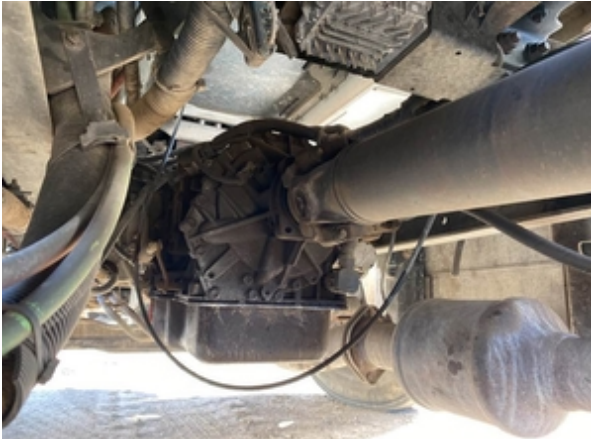
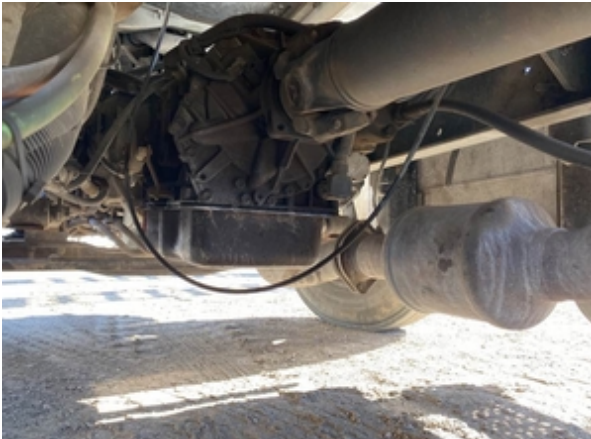
Drivetrain	
Transmission Info (Make/Model)	Allison Automatic
Drive Type	4X2
Overdrive	No
Transmission	3 - Normal Wear & Tear
Transmission Condition	No unusual noises or vibrations
Transmission Condition Photos

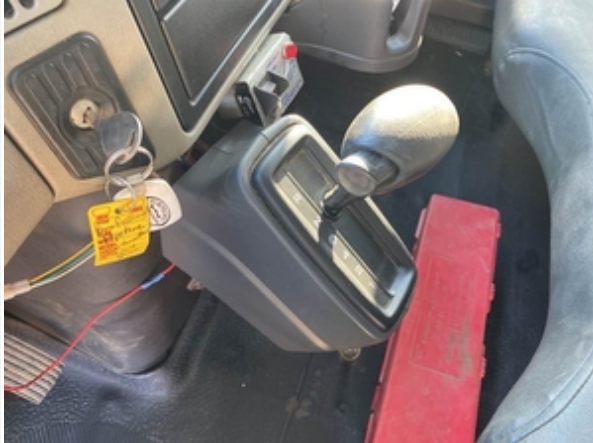
Shift Lever Photos

Clutch	0
Shift Lever	3 - Normal Wear & Tear
Shift Lever Condition	Good forward and reverse function

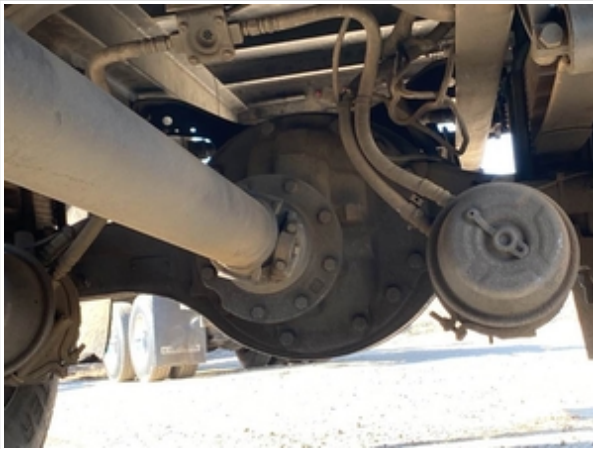
Differential	Check condition of the differential(s). Take photos and notes as relevant.
Rear Differential	3 - Normal Wear & Tear
Rear Differential Condition	Dry housing appearance, no unusual noises heard during operation
Rear Differential Photos

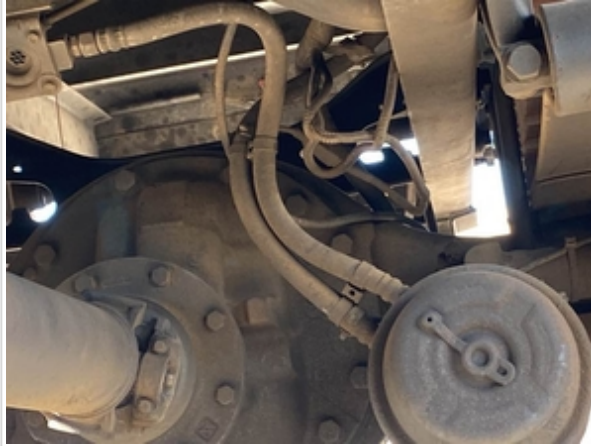
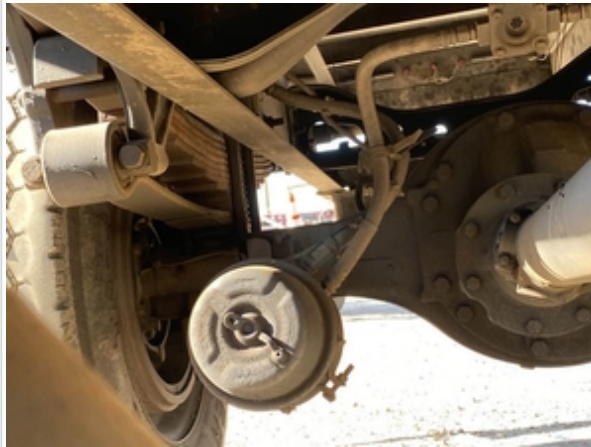
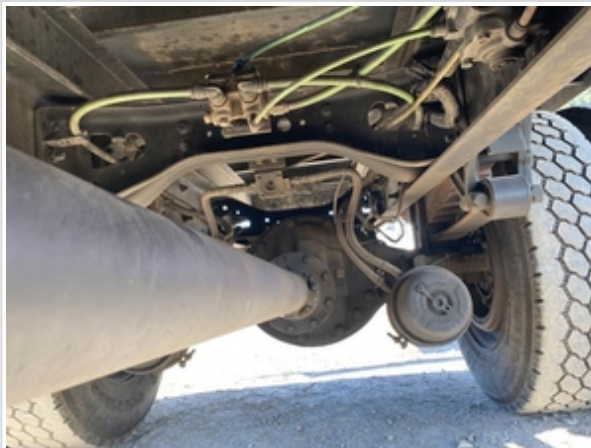
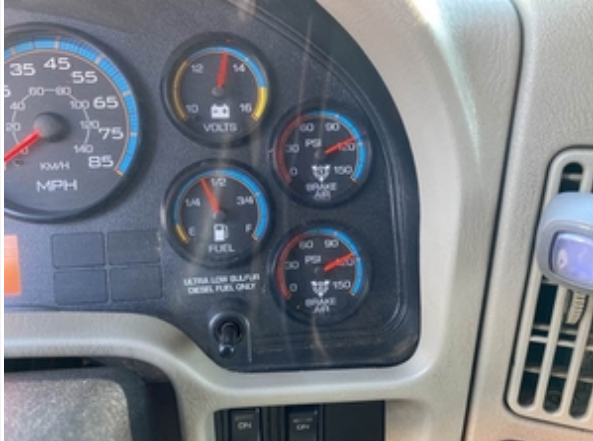
Air Brake System Photos

Front Differential	0
Brake System Type	Air Brakes
Air Brakes Build Correct Pressure	No
Air Brake System Leaks	No
Air Brake Hose Condition	3 - Normal Wear & Tear
Comments	Air brake stops building psi at 118psi should be 120

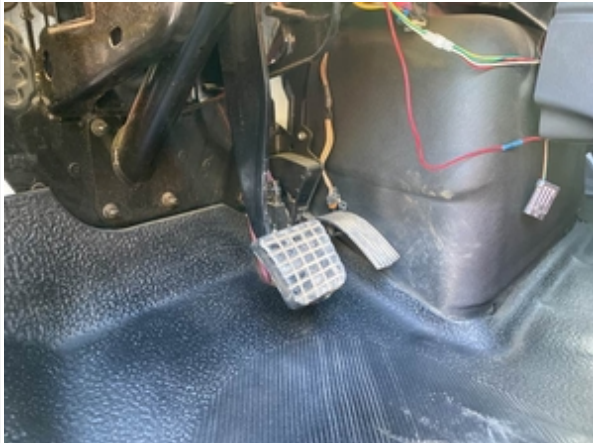
Foot Brake	3 - Normal Wear & Tear
Foot Brake Condition	Good brake function
Foot Brake Photos

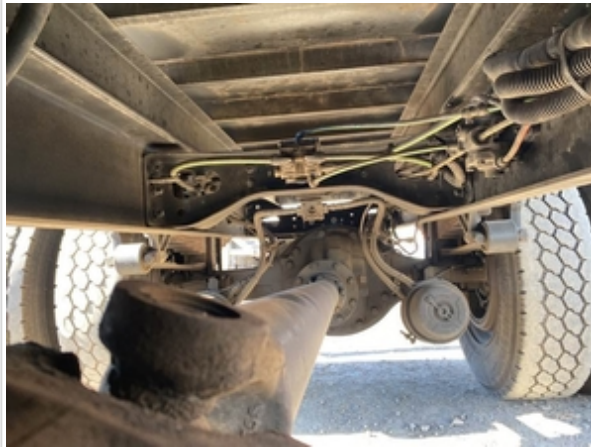
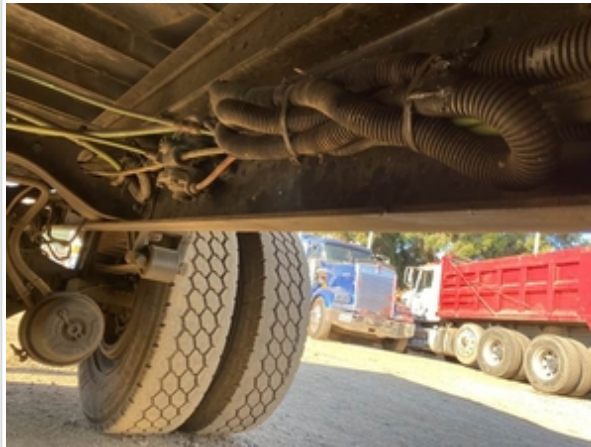
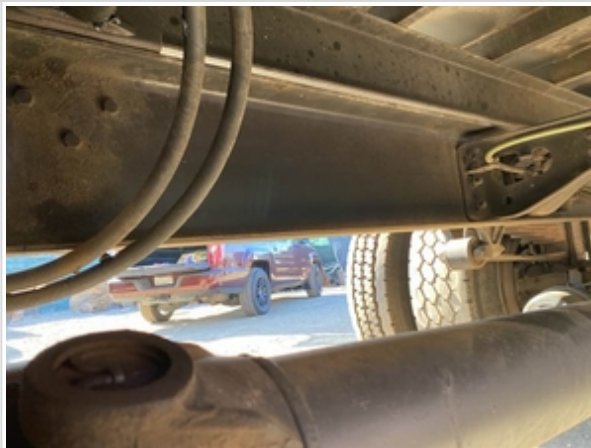
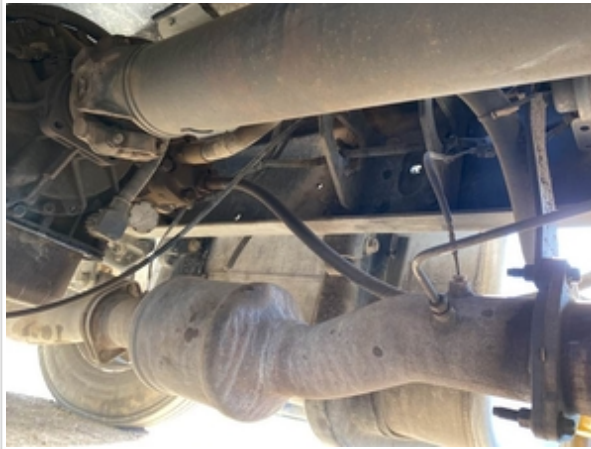
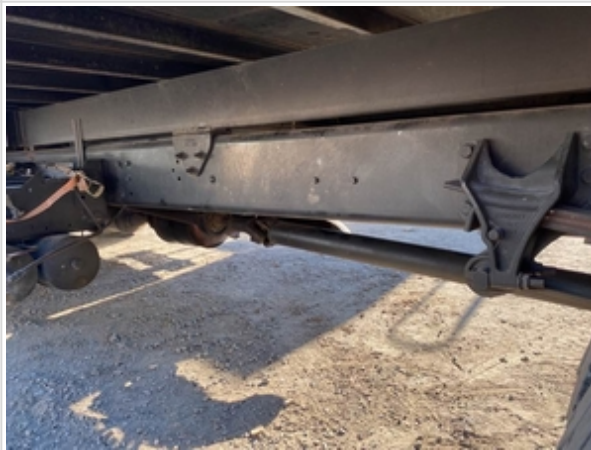
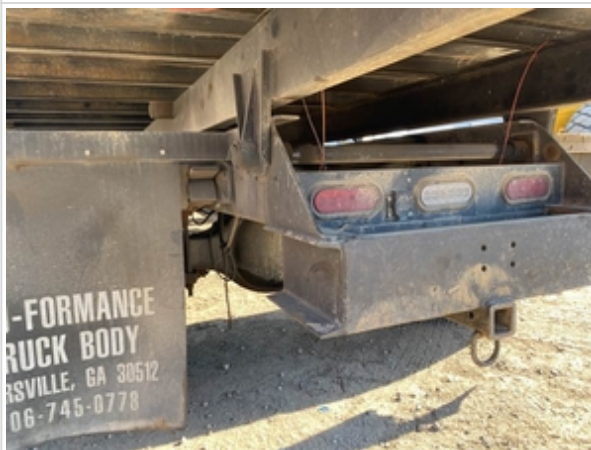
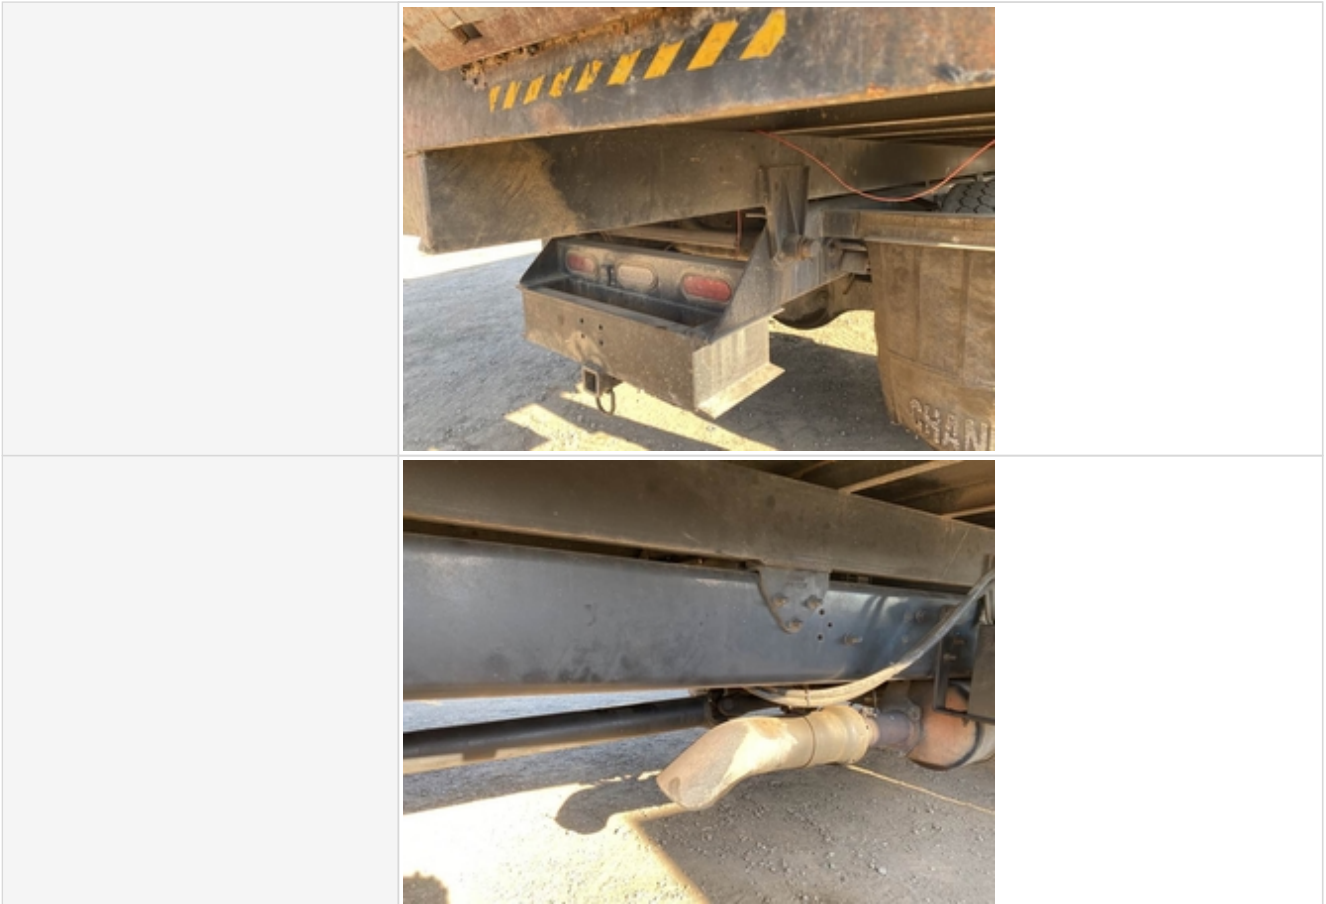
Frame Photos

Frame Condition	3
-----------------	---

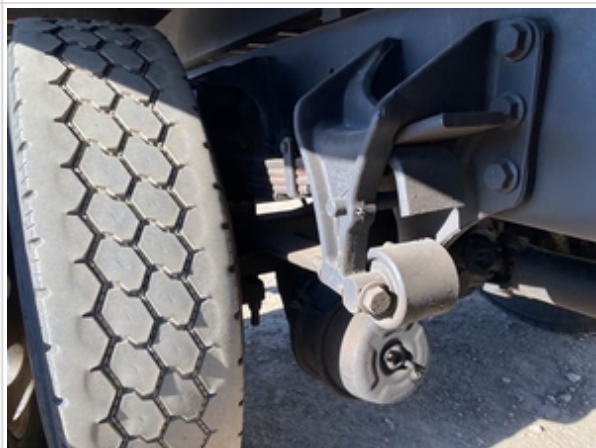
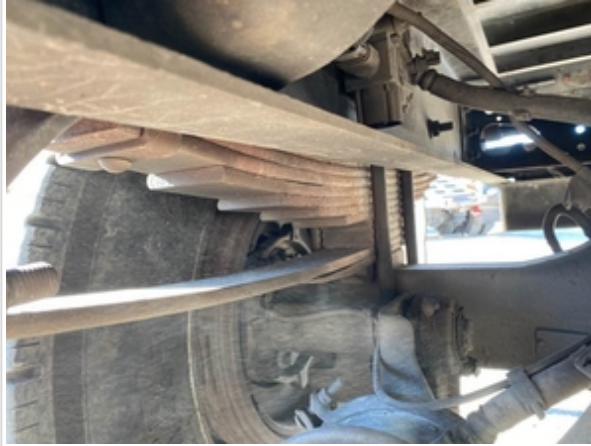
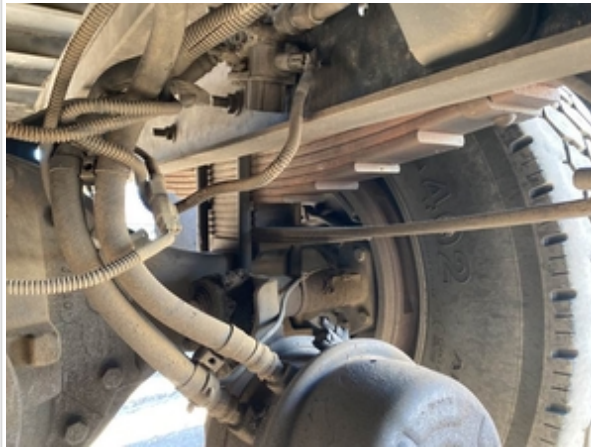
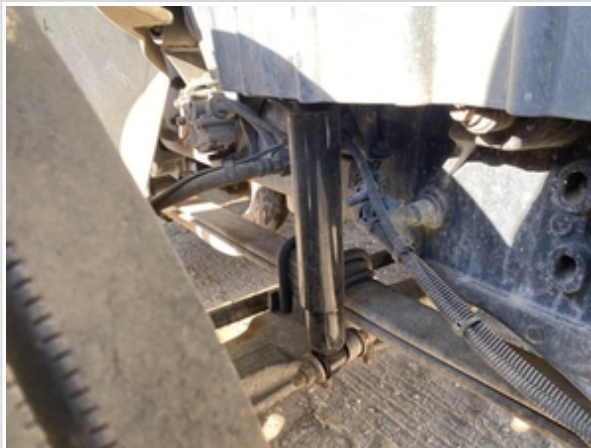
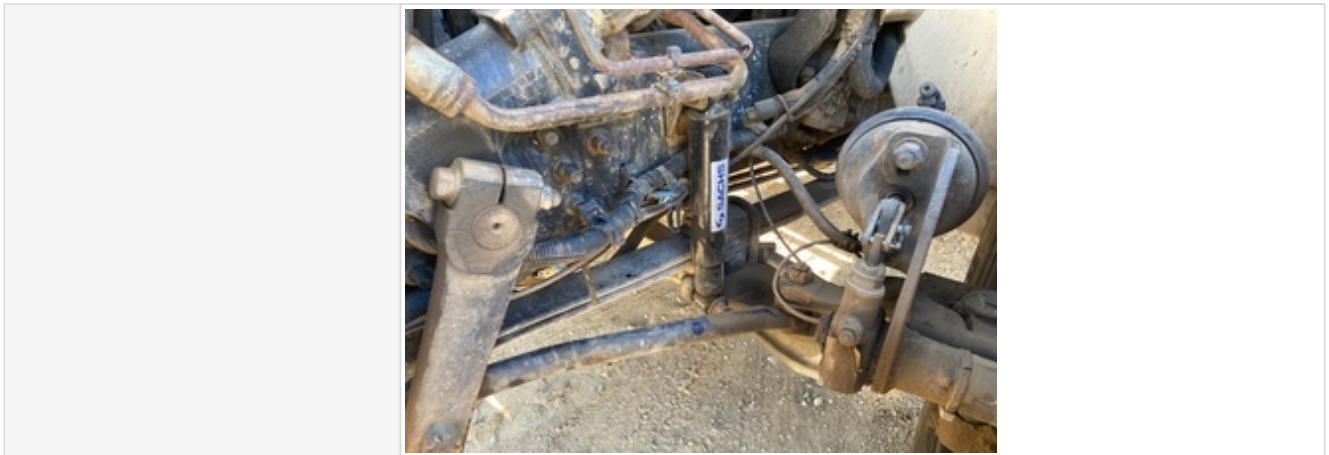
Suspension	3
Suspension Photos

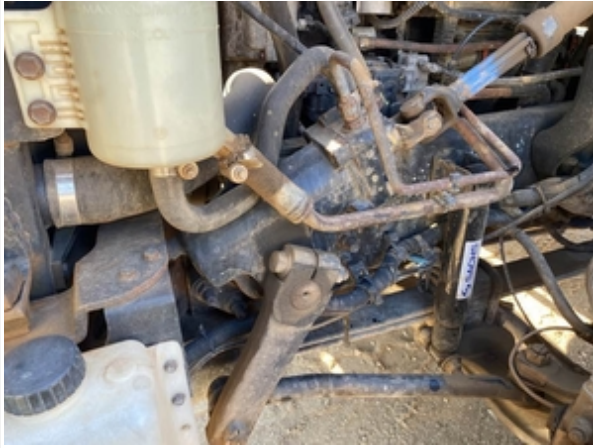
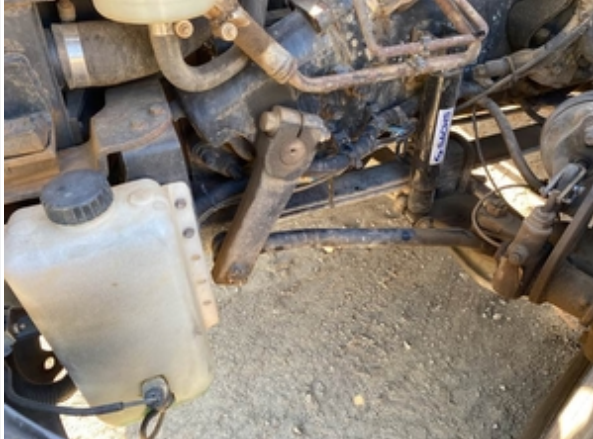
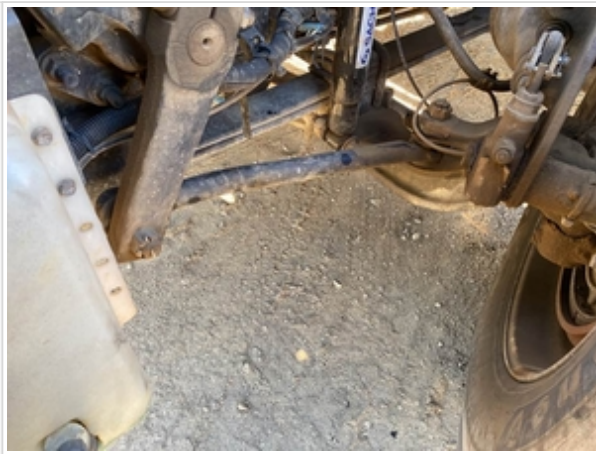
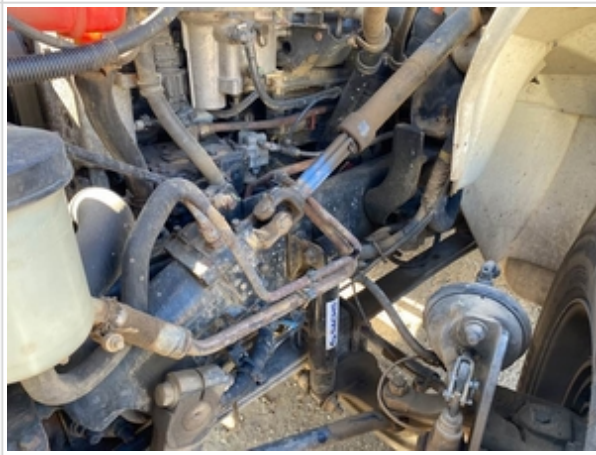
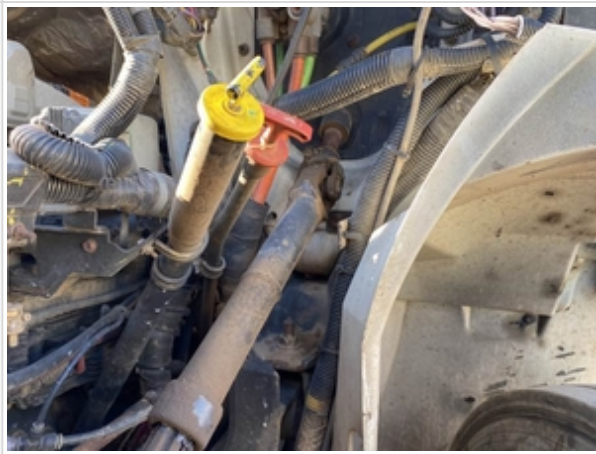
Steering Components	3
Steering Components Photos

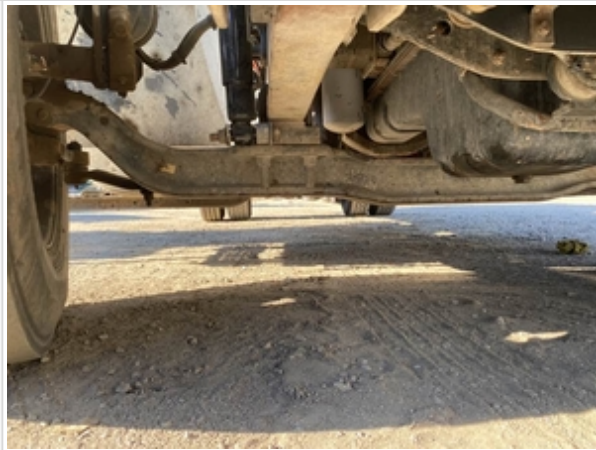
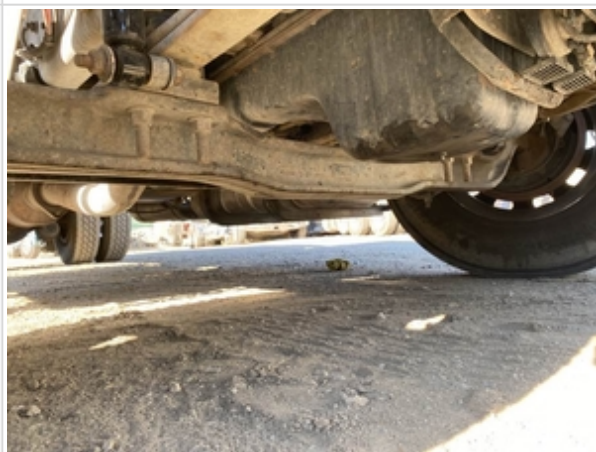
Steer Axle Photos

<p>Steer Axle Condition</p>	<p>3</p>

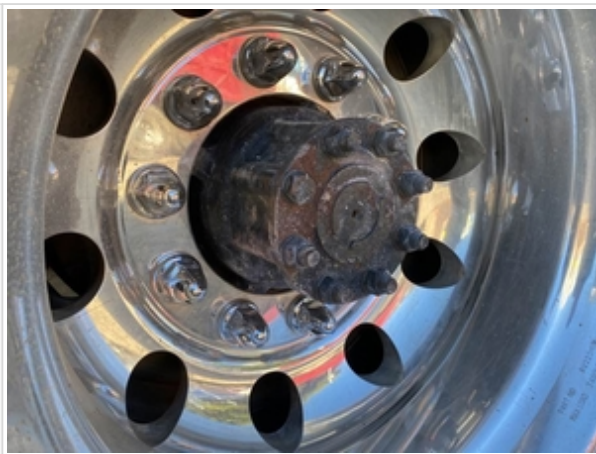
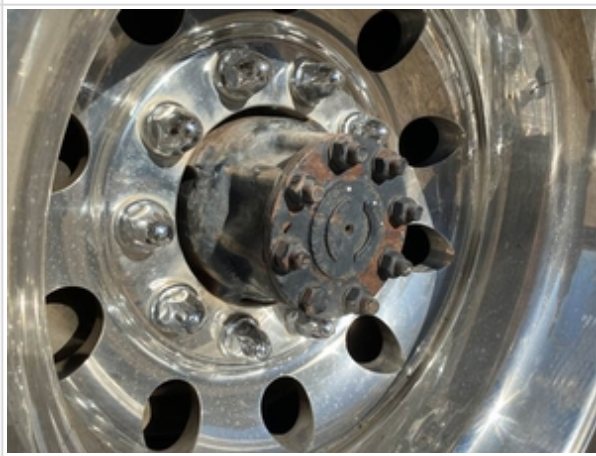
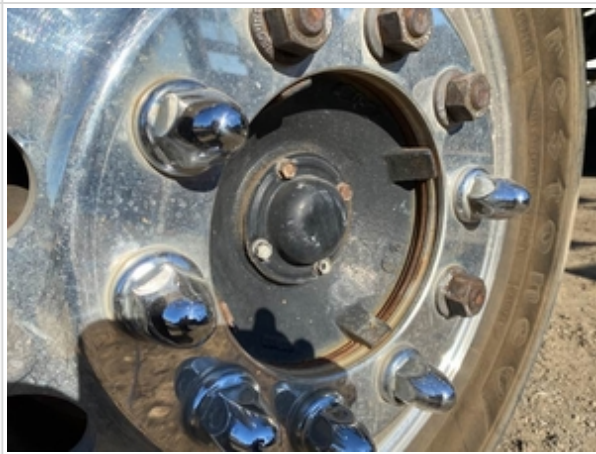
Wheels & Hub Condition	3	
Wheels & Hub Photos

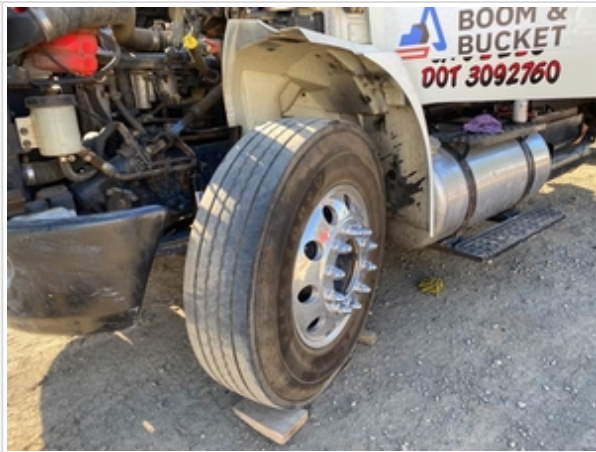
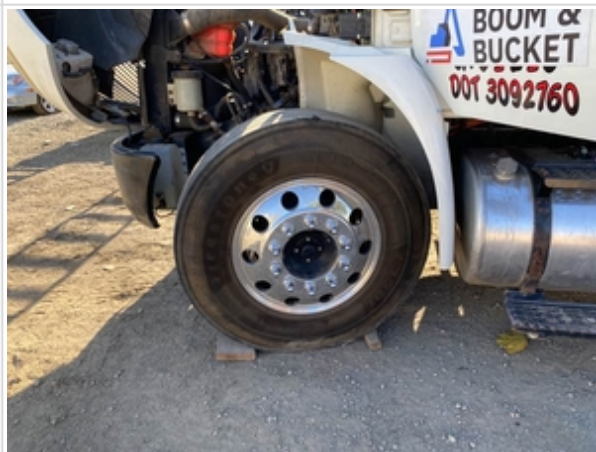
<p>Front Left Tire Photos</p>

Wheel Seal Leaks	No
Tire Brand	(Front) Firestone (rear) Generic recap brands
Tire Size	11r 22.5
Front Left Tire - Ratio Remaining	50%

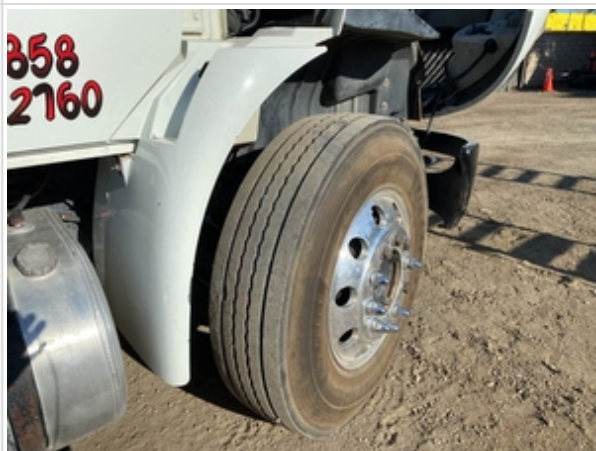
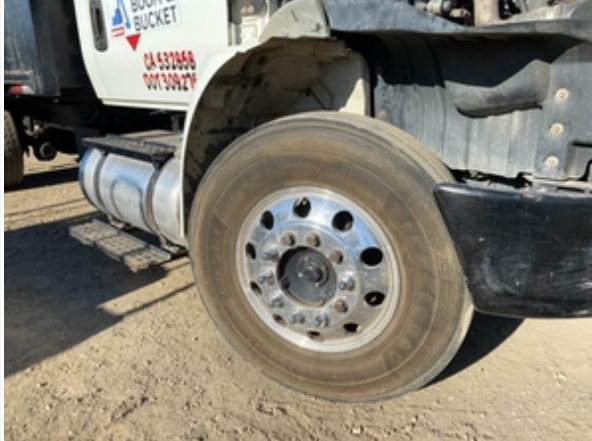
<p>Front Right Tire - Ratio Remaining</p>	<p>70%</p>
<p>Front Right Tire Photos</p>

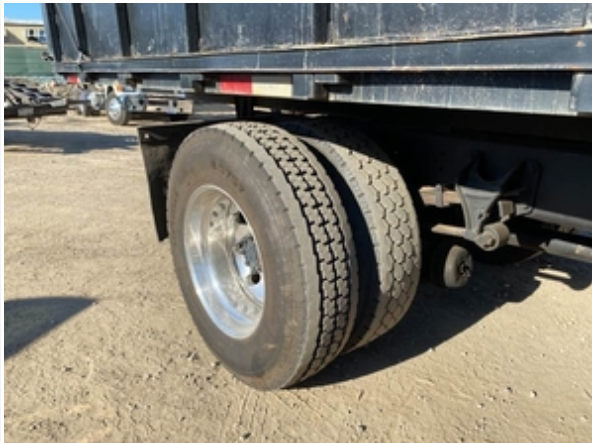
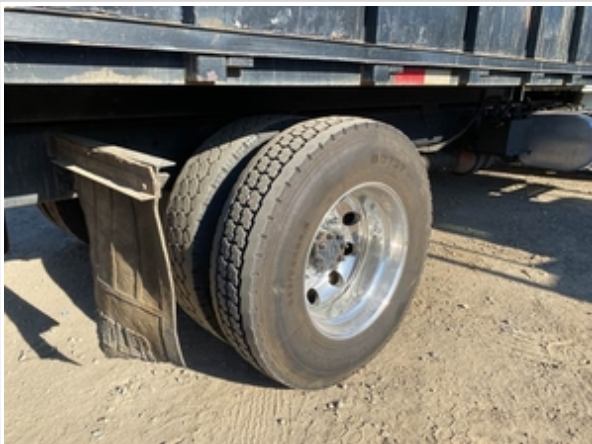
Rear Right Tire - Ratio Remaining	70%	
Rear Right Tire Photos

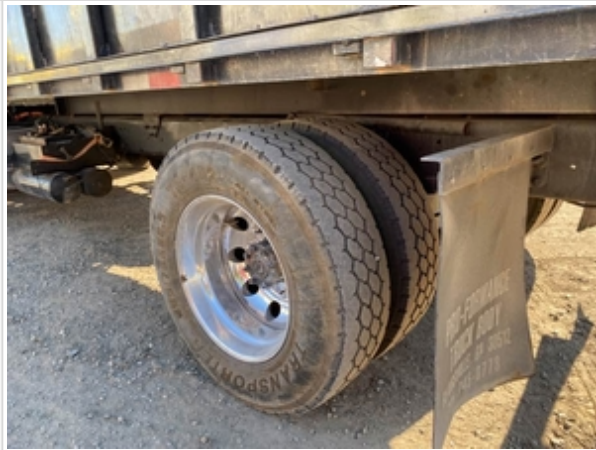
Rear Left Tire Photos

Rear Left Tire - Ratio Remaining	50%
