Inspection Report (On-Highway Dump Truck)

Year	2013
Make	International
Model	4300
Serial Number	3HAMMAAL4DL198252
Truck Odometer Reading	281,798
Current Inspection / State Cert / DOT	N/A
Previous Application (e.g., earth moving, mining, demolition, etc)	General Construction

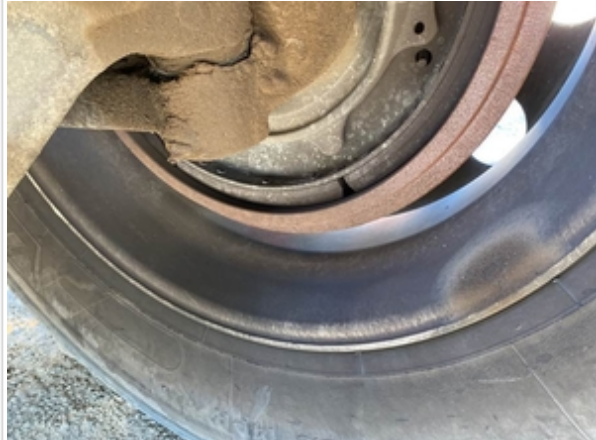
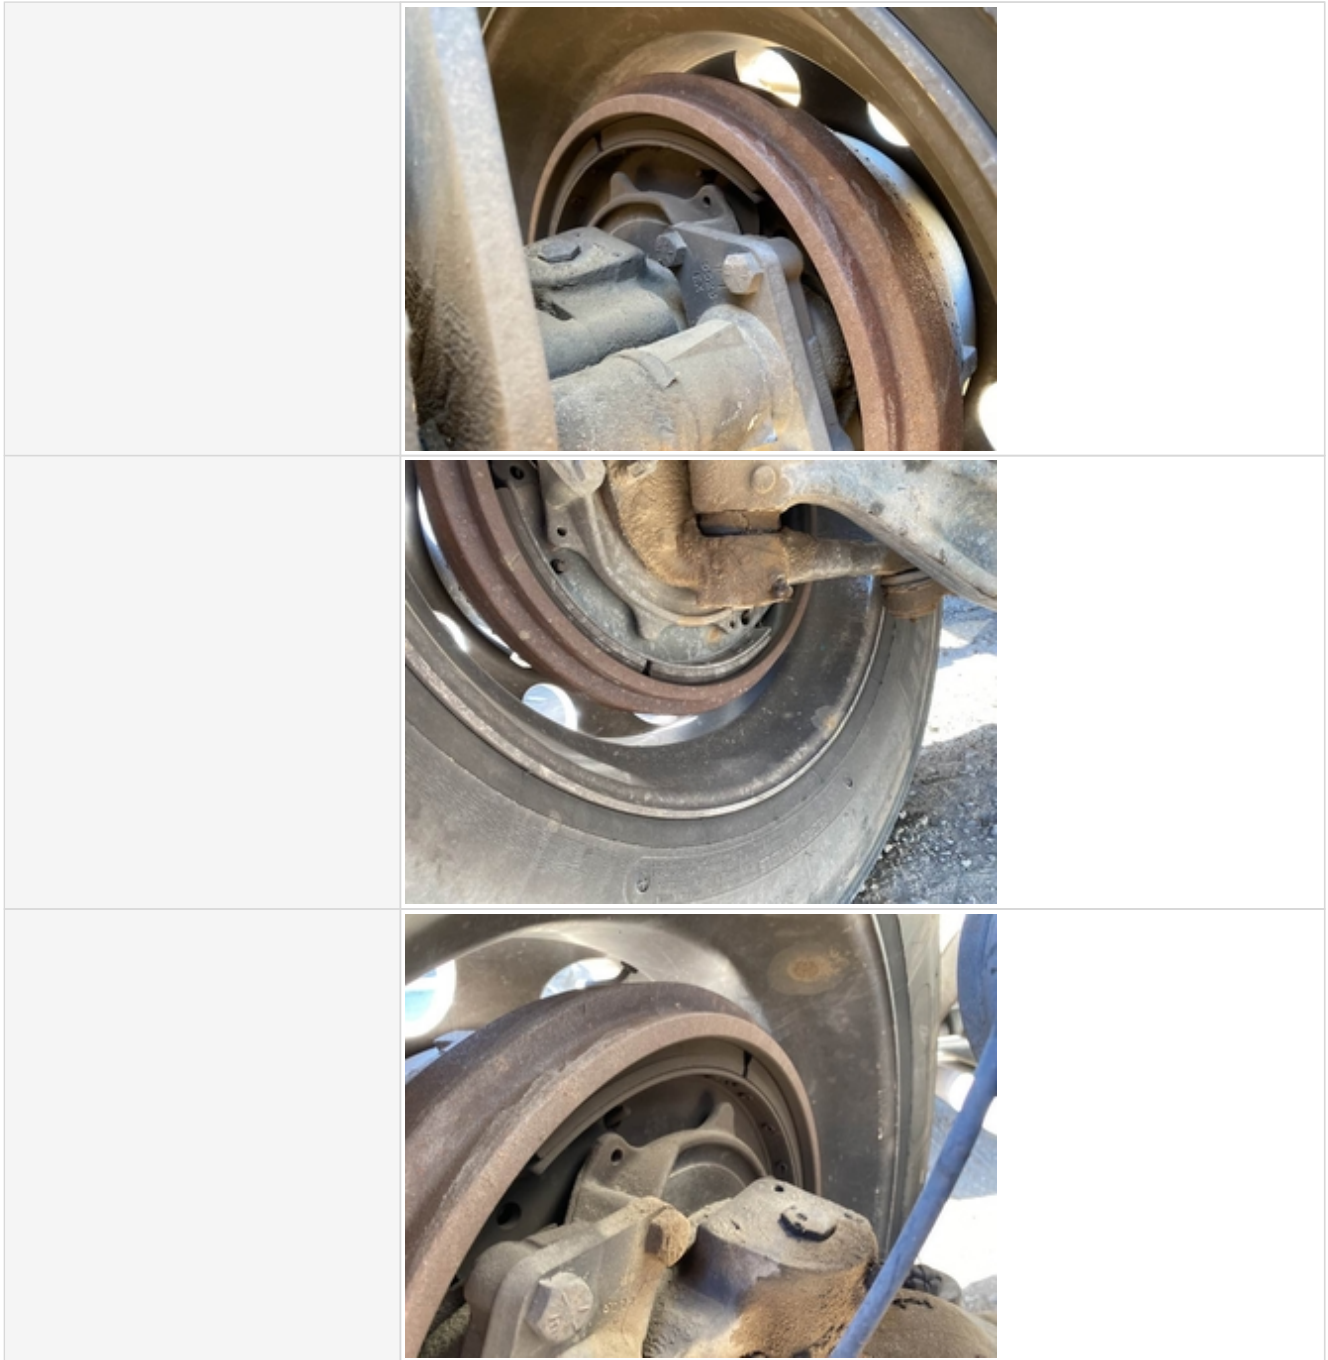
Brake Shoe Thickness	70%
Comments	Rear shoes have 50% of material left front have 70% left
Brake Shoe Photos

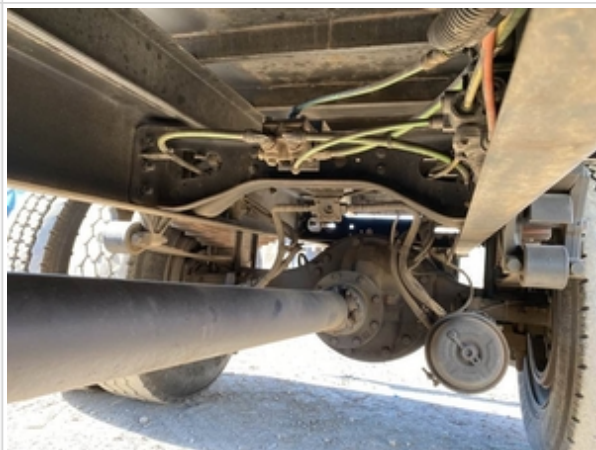
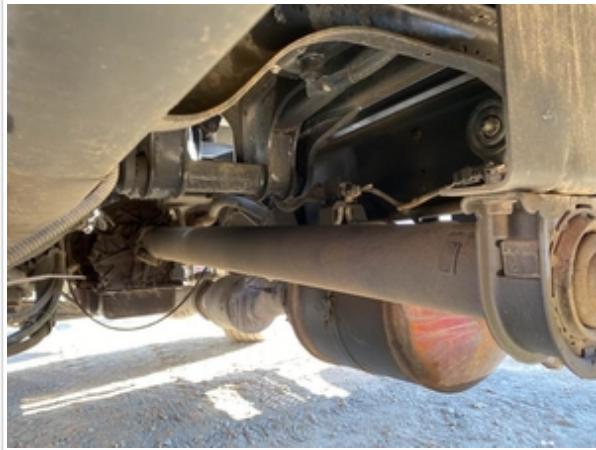
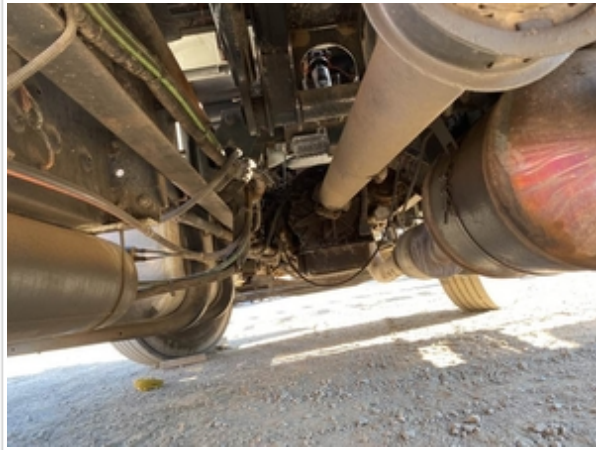
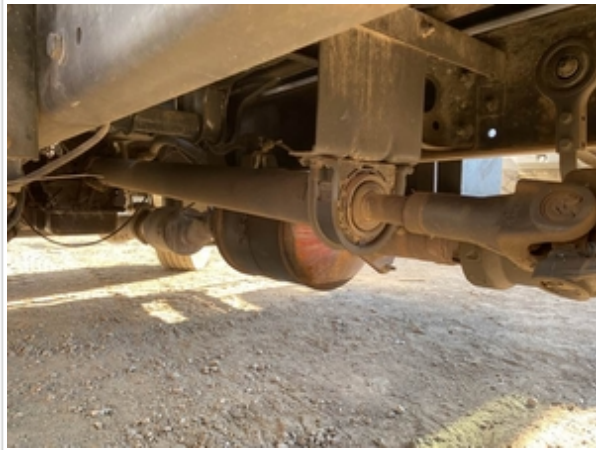
Overall Chassis	3
Overall Chassis & Undercarriage Photos

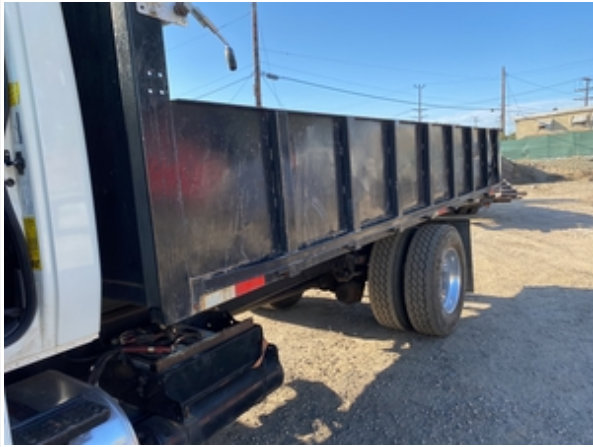
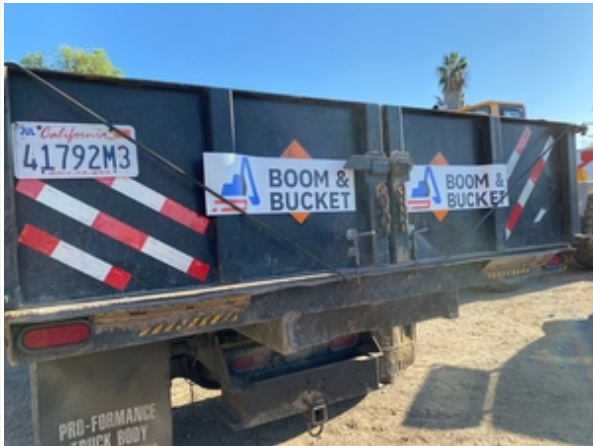
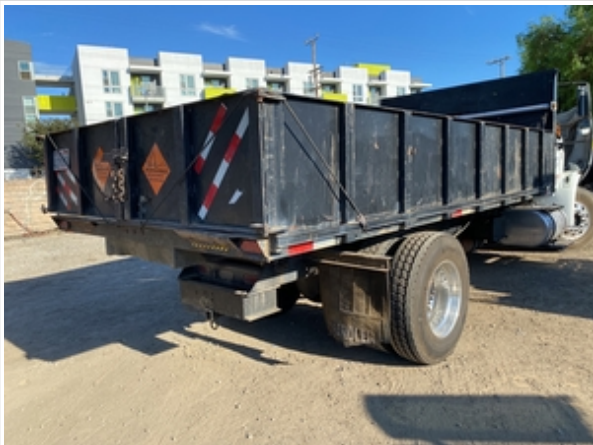
Dump Body Length (ft and inches)	16'
Dump Body Height (ft and inches)	6'
Bed Body	3 - Normal Wear & Tear
Comments	Dump body in good condition
Bed Body Photos

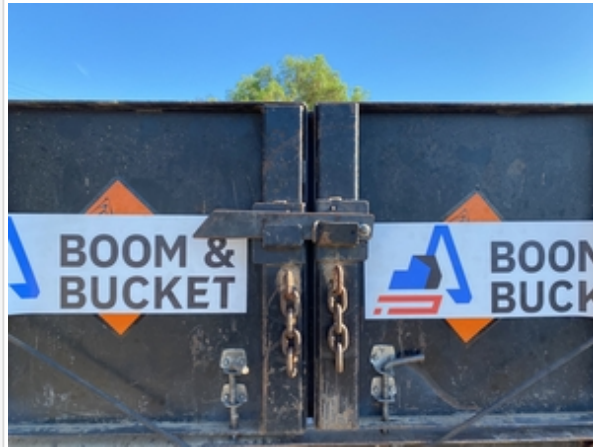
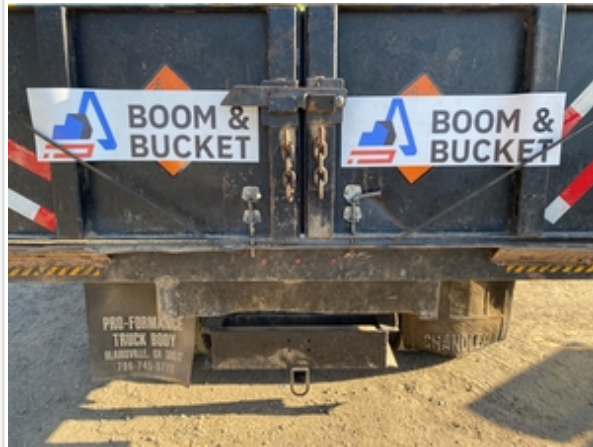
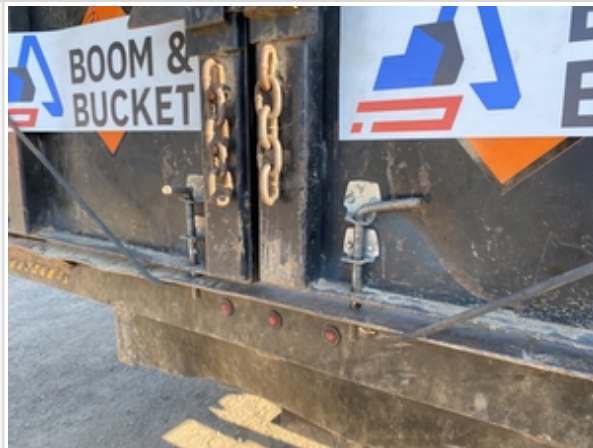
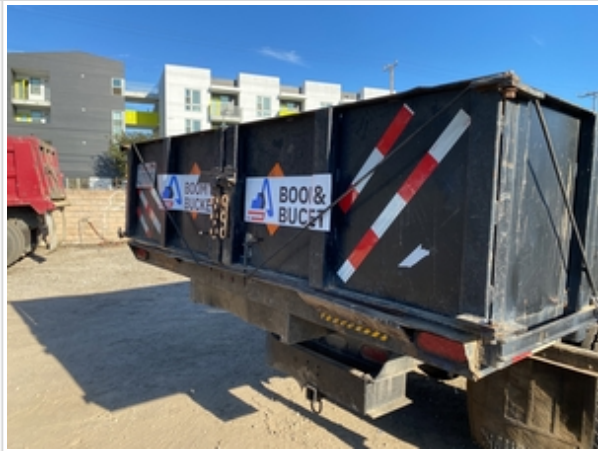
Tailgate Photos

Tailgate	3 - Normal Wear & Tear

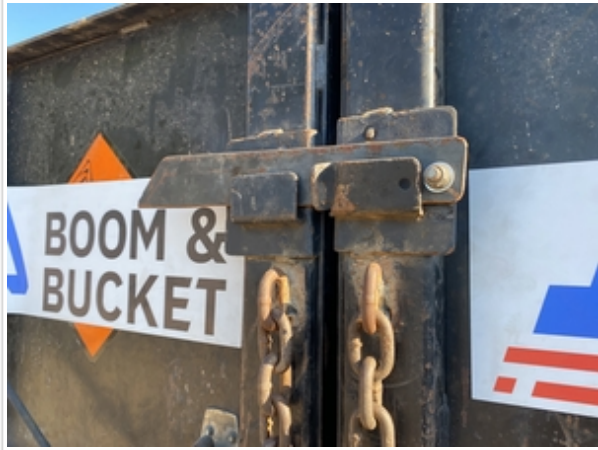
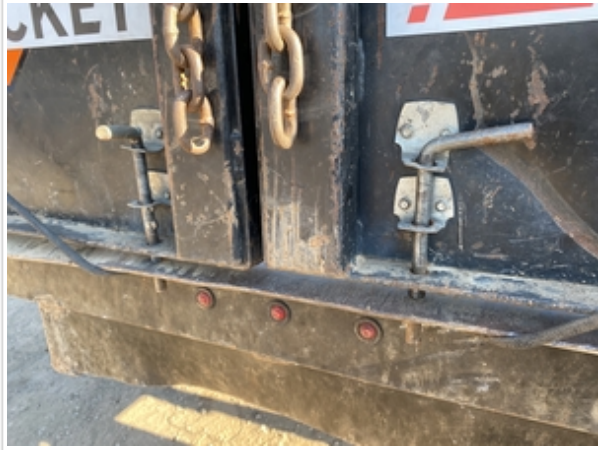
<p>Tailgate Latch</p>	<p>3 - Normal Wear & Tear</p>	
<p>Tailgate Latch Photos</p>

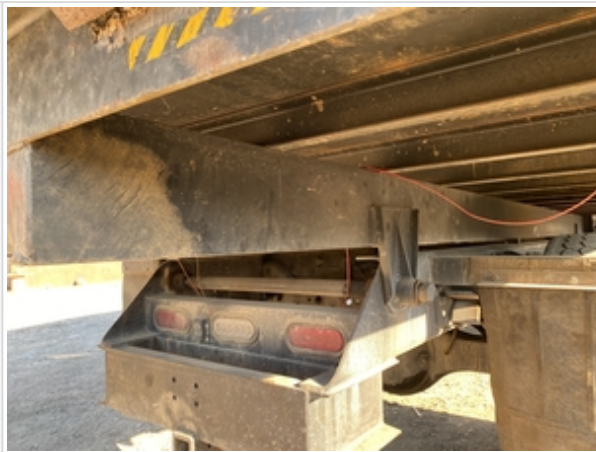
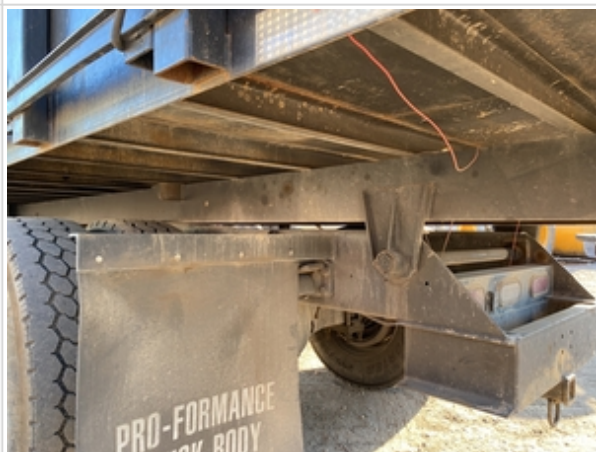
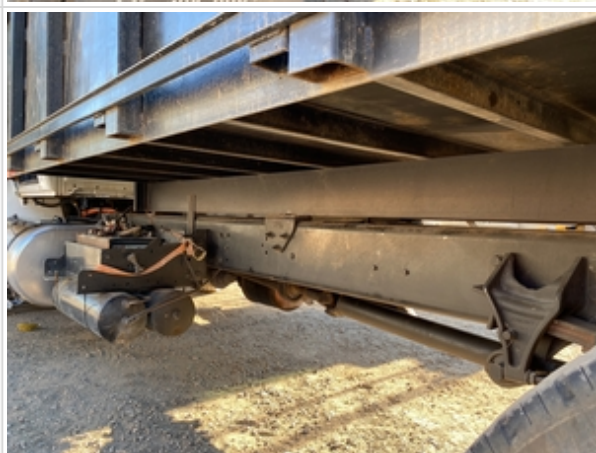
<p>Support Frame Photos</p>

<p>Support Frame</p>	<p>3 - Normal Wear & Tear</p>

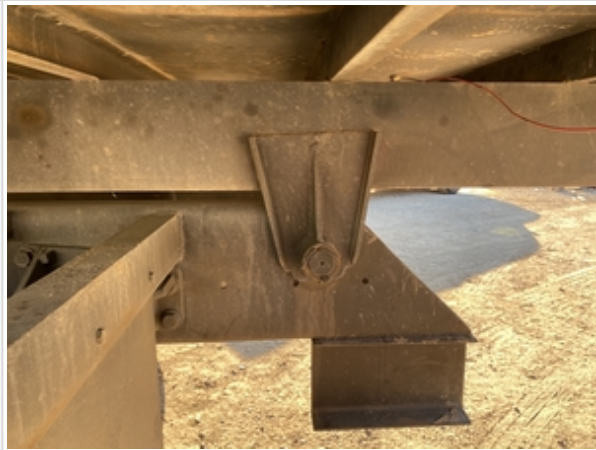
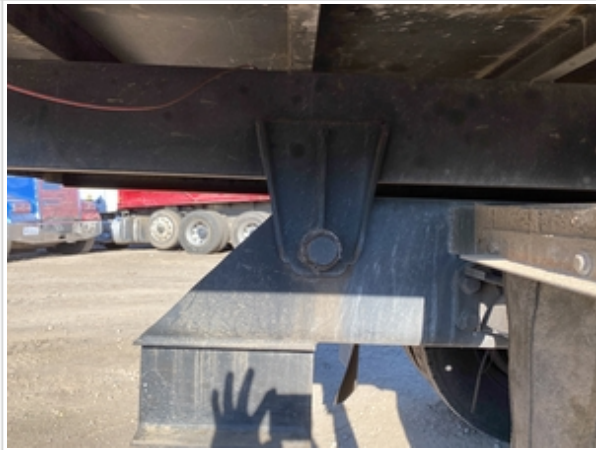
Hinge Point Photos

<p>Hinge Points</p>	<p>3 - Normal Wear & Tear</p>

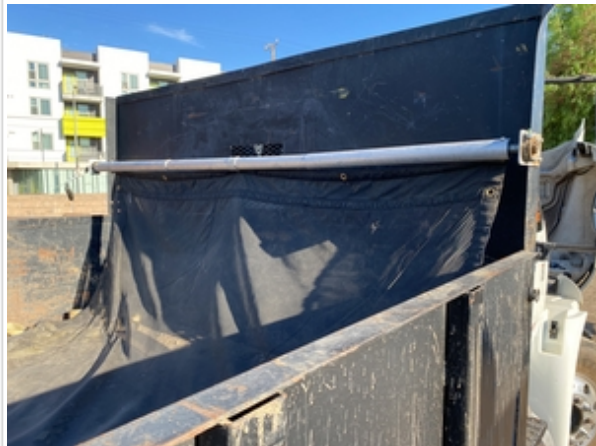
Tarp	3 - Normal Wear & Tear
Tarp Photos

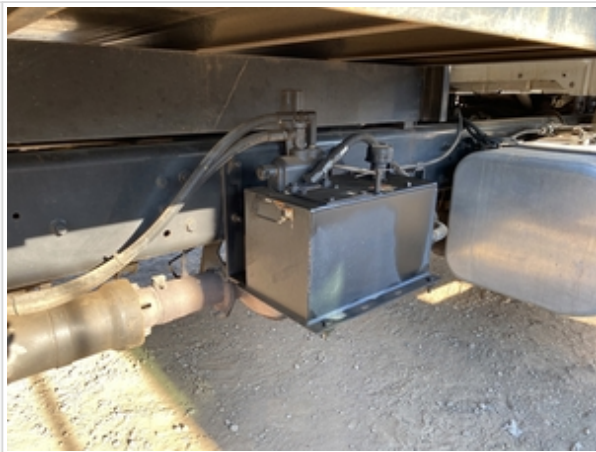
Hydraulic Tank Photos

Hydraulics	Check the condition of the hydraulics. Check lines, hoses, fittings, leaks, function, etc. Note any damage or wear. Take photos.
Hydraulic Tank	3 - Normal Wear & Tear

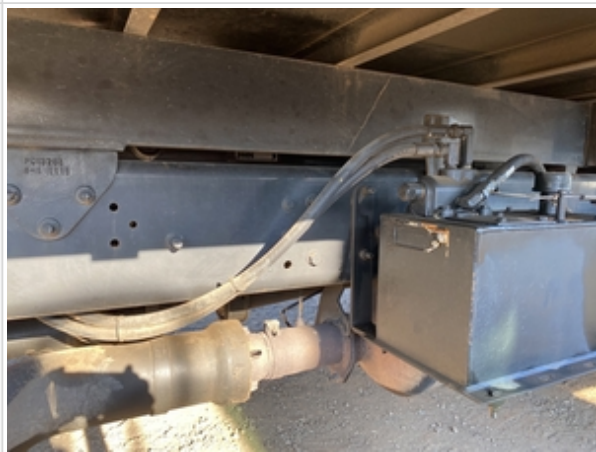
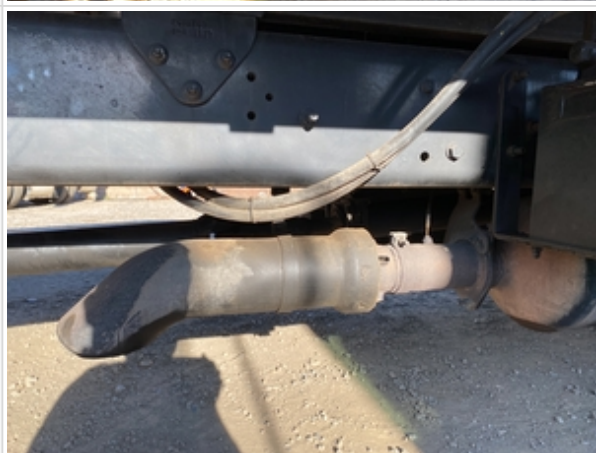
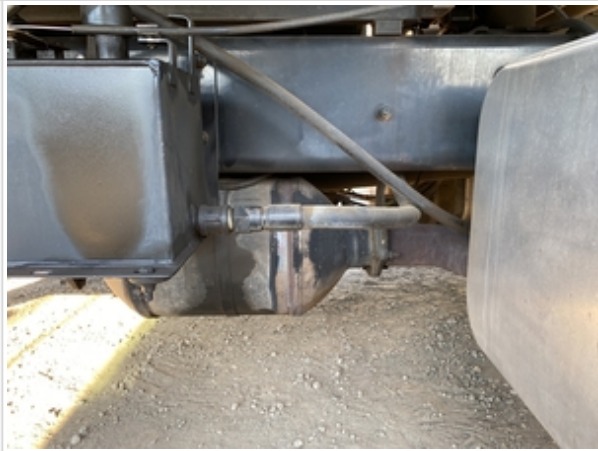
Hoses	3 - Normal Wear & Tear
Hose Photos

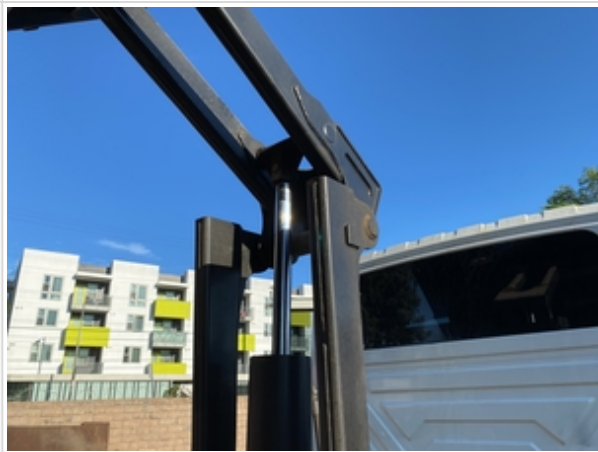
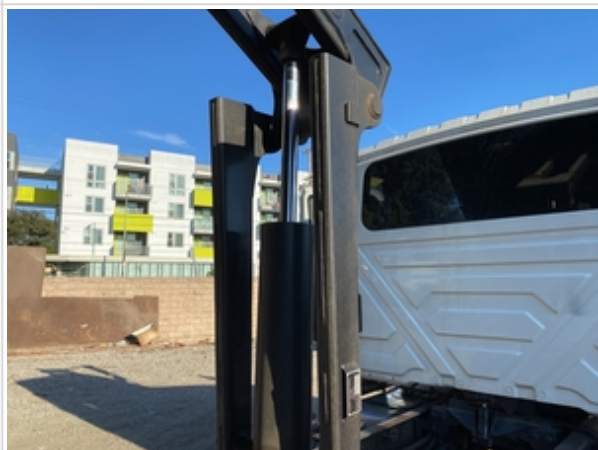
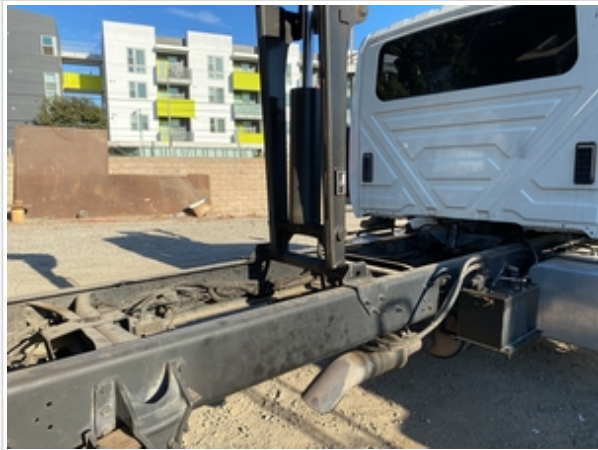
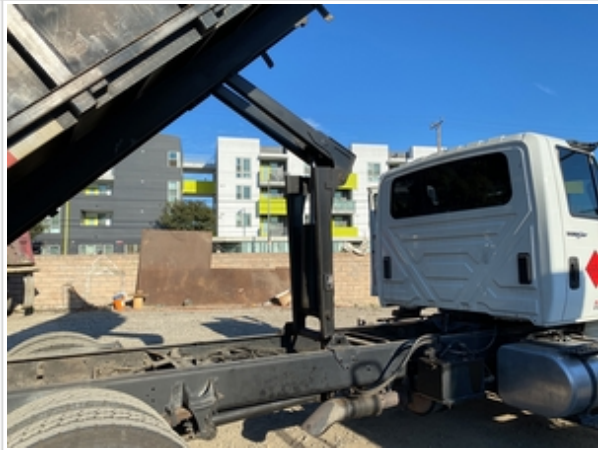
Hydraulic Cylinders	3 - Normal Wear & Tear	
Cylinder Pins and Bushings	3 - Normal Wear & Tear	
Cylinder Pins and Bushings Photos
