## Inspection Report (Generator)

Year	2013
Make	PECO
Model	0YTT1-101655-501
Serial Number	8995-004
Hour Meter Reading	13,502
Previous Application (e.g., earth moving, mining, demolition, etc)	General Construction

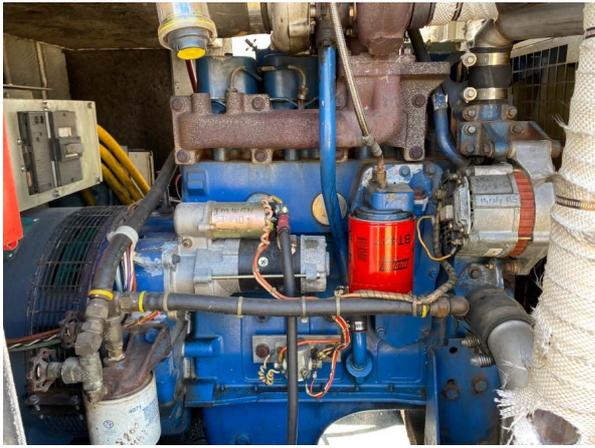
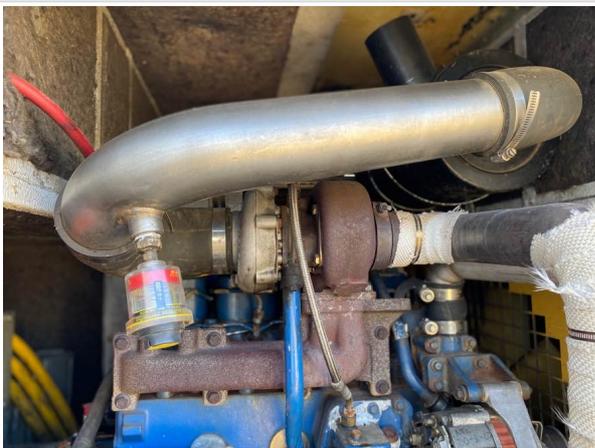
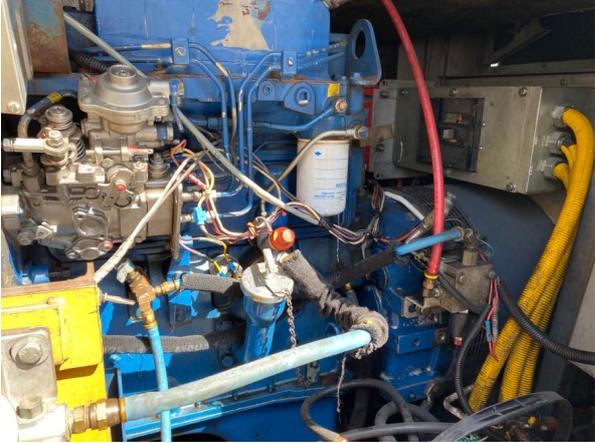
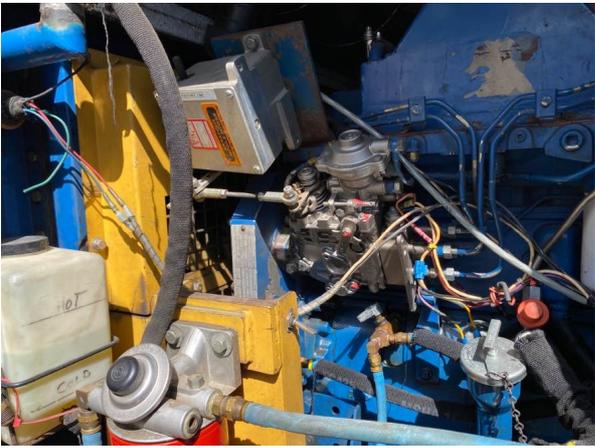
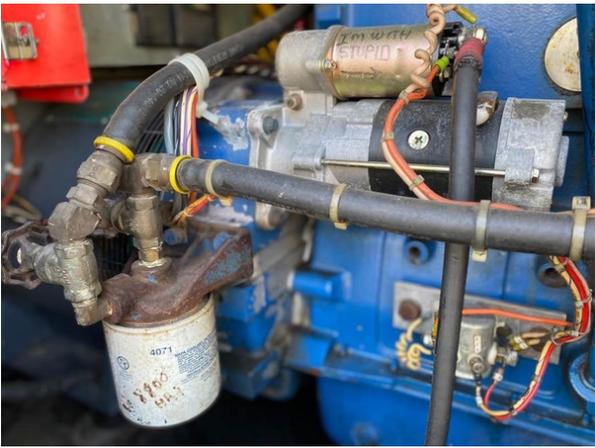
### Engine

Engine Type (Make, Model, Cylinders, Hp)	Cummins - 4BTA3.9 - 4CYL. - 116HP - 3.9L
Emissions Tier	Tier 3
Engine Serial Number	44429025
Engine Fuel Type	Diesel
Engine Photos

<b>Water Pump</b>	3 - Normal Wear & Tear
<b>Water Pump Condition</b>	No unusual pump noises heard
<b>Cooling System Leaks</b>	No
<b>Coolant Color / Appearance</b>	3 - Normal Wear & Tear
<b>Coolant Color/Appearance Notes</b>	Normal Translucent appearance, no visual signs of contamination
<b>Oil Leaks</b>	No
<b>Oil Color / Appearance</b>	3 - Normal Wear & Tear
<b>Oil Color / Appearance Notes</b>	Clean oil appearance, no signs of cross contamination, Appropriate oil level
<b>Fuel Leaks</b>	No
<b>Equipped with DPF (Diesel Particulate Filter)</b>	No
<b>Requires DEF (Diesel Exhaust Fluid)</b>	No
<b>Overall Engine Appearance</b>	Clean & dry
<b>Overall Engine Comments</b>	Overall engine in good condition, well maintained and sounds healthy.

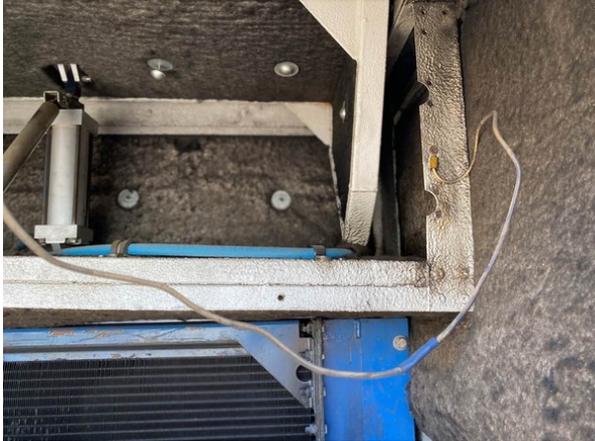
Radiator	3 - Normal Wear & Tear
Radiator Condition	Radiator fins & components appear to be in good working order, no signs of damage or leaks
Radiator Photos

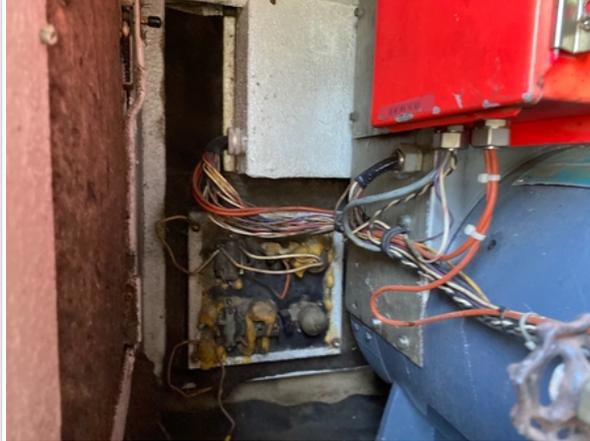
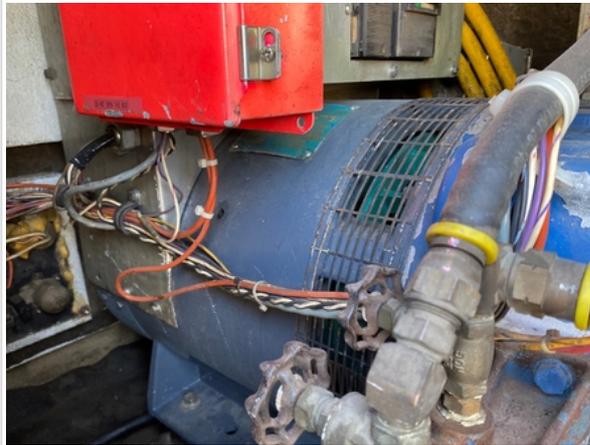
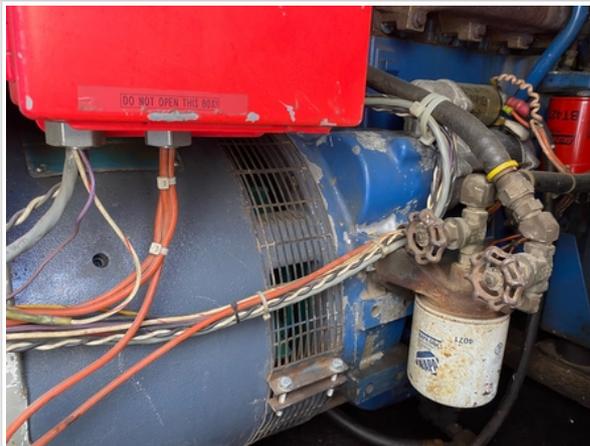
Wire Harness Photos

<b>Wire Harness</b>	2 - Above Average Wear
<b>Comments</b>	Wire harness missing wire loom

Exterior Rating	3
Interior Rating	3
Safety Rating	3
Quality Rating	3
Functionality Rating	3
Overall Rating	3
What's Great About the Machine	Unit is in good condition and generator has recently been replaced. Engine is well maintained and visually all functions operate well.
What Needs Work	Tires may need to be replaced soon. Wire harness needs to be secured in some areas.

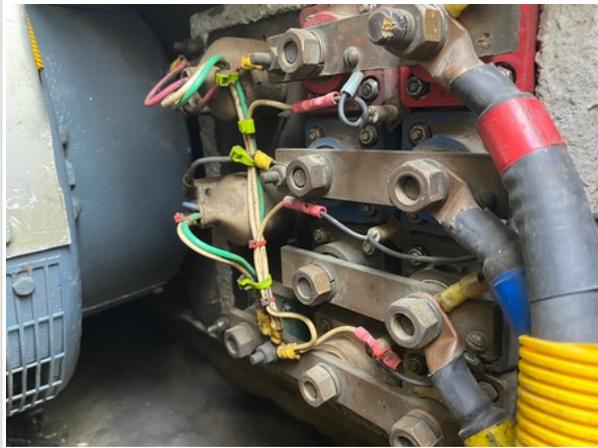
<p>Cables &amp; Fittings Photos</p>

3 - Normal Wear & Tear

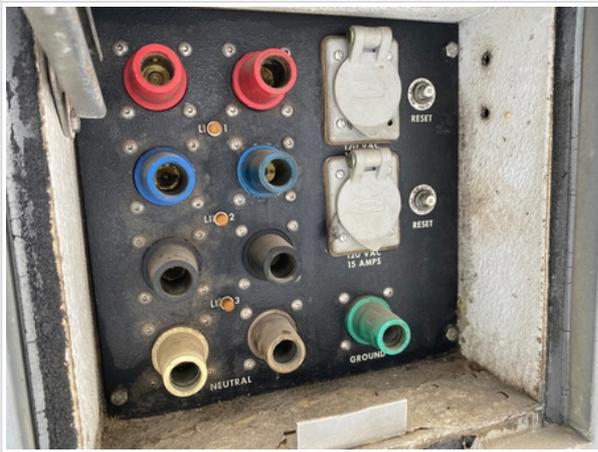
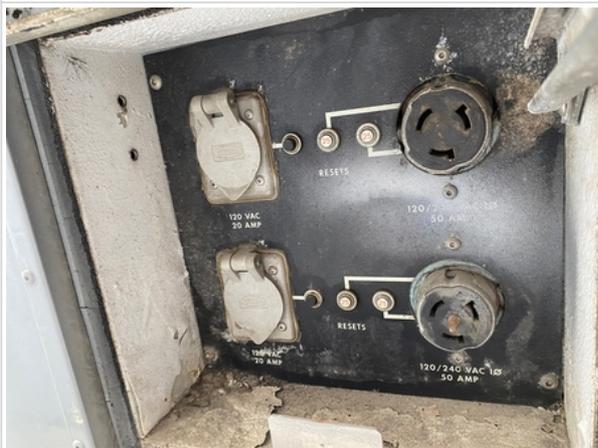
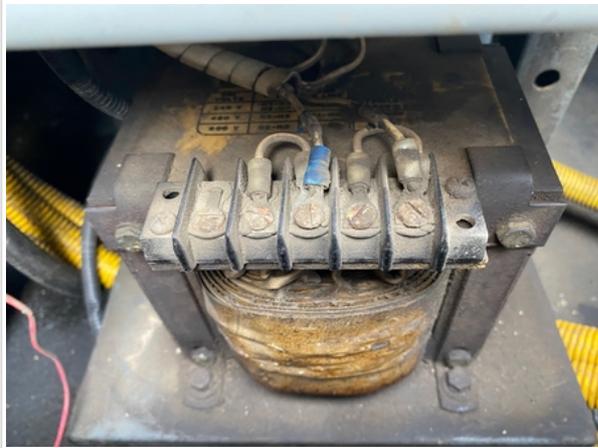
<p>Electrical Connections</p>	<p>3 - Normal Wear &amp; Tear</p>
<p>Electrical Connections Photos</p>

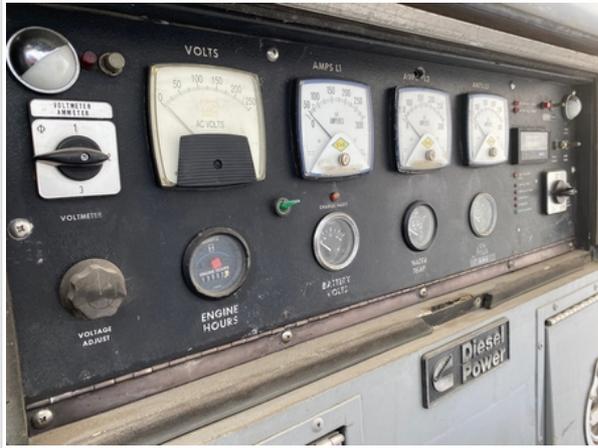
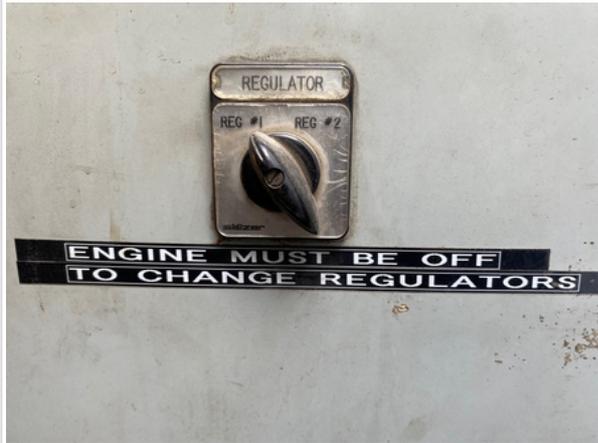
<p><b>Controls &amp; Switches</b></p>	<p>3 - Normal Wear &amp; Tear</p>	
<p><b>Controls &amp; Switches Photos</b></p>

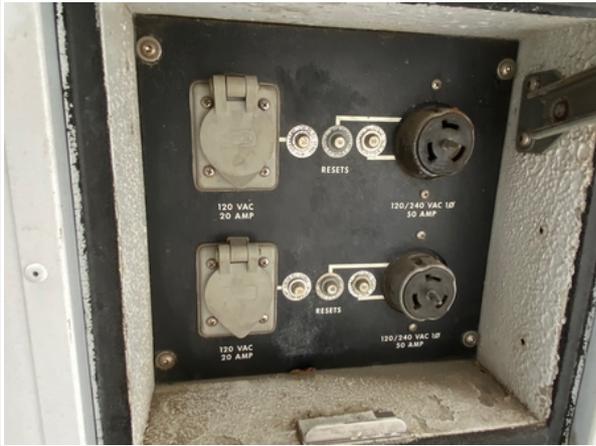
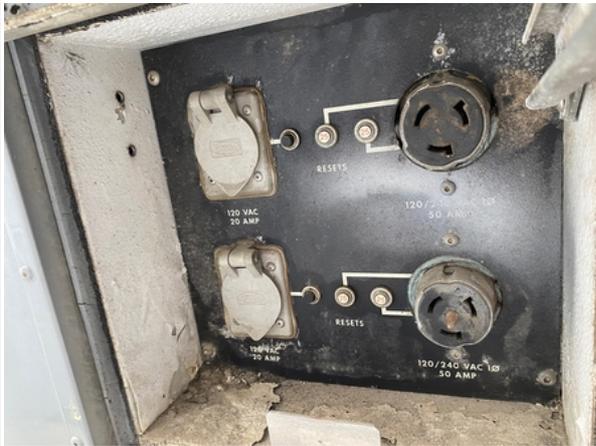
110V	Yes
Number of Outlets	2
110V Outlet Condition	3 - Normal Wear & Tear
110V Outlet Photos

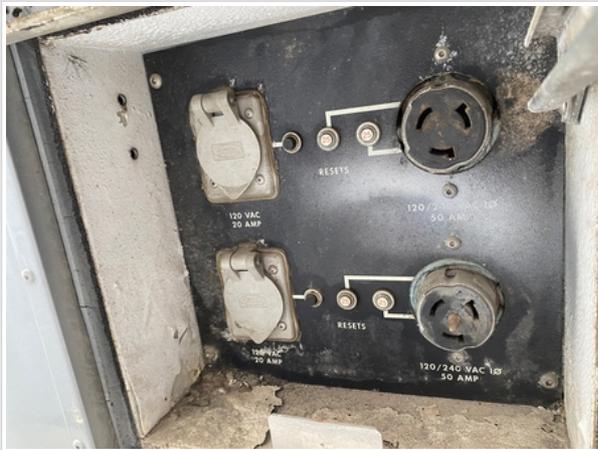
240V Outlet Photos

240V	Yes
Number of Outlets	2
240V Outlet Condition	2 - Above Average Wear

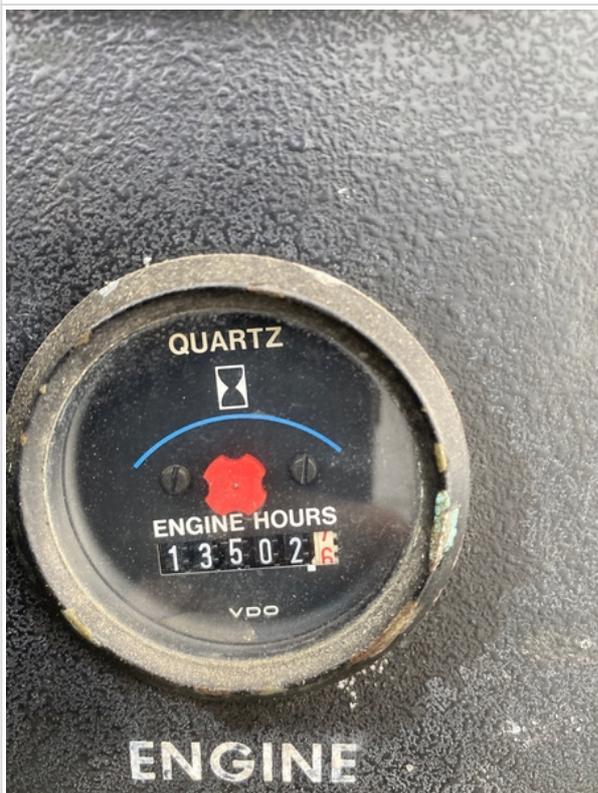
Hour Meter	3 - Normal Wear & Tear
Hour Meter Photos

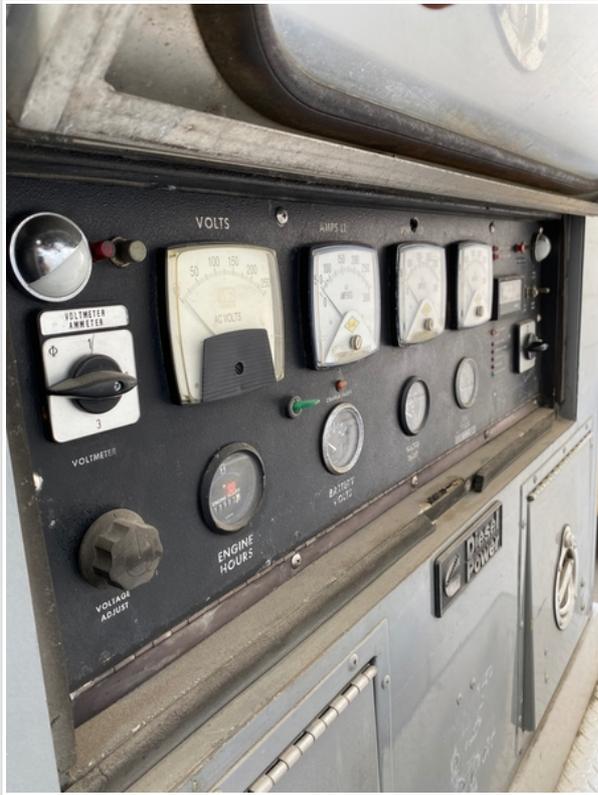
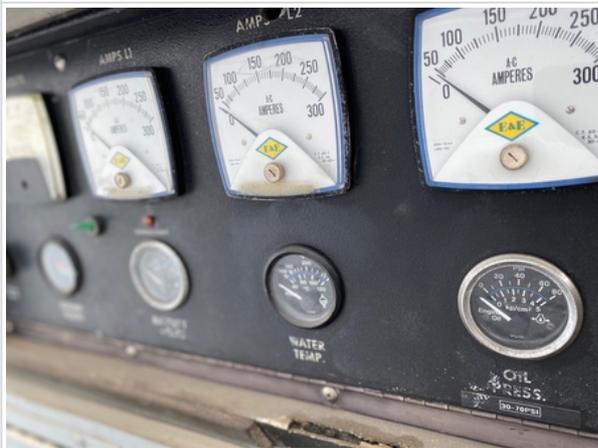
RPM Display	0
Volt Display	3 - Normal Wear & Tear
Volt Display Photos

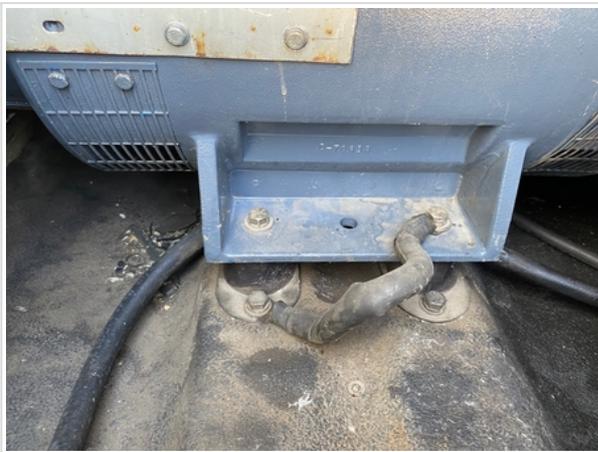
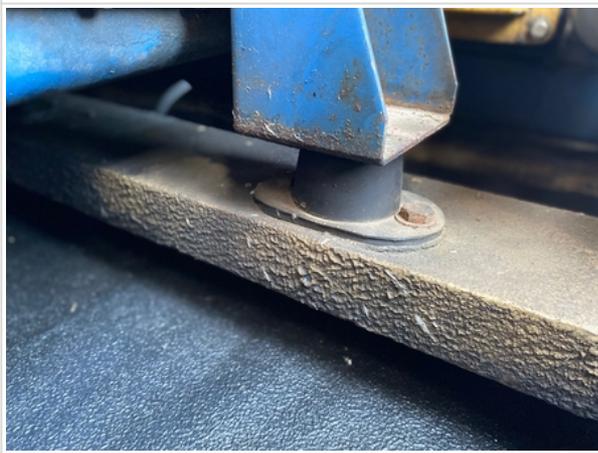
<p>Mounting Plate Photos</p>

Display Screen Appearance	3 - Normal Wear & Tear
<h3>Mounting Plate</h3>	
Overall Mounting Plate Appearance	3 - Normal Wear & Tear

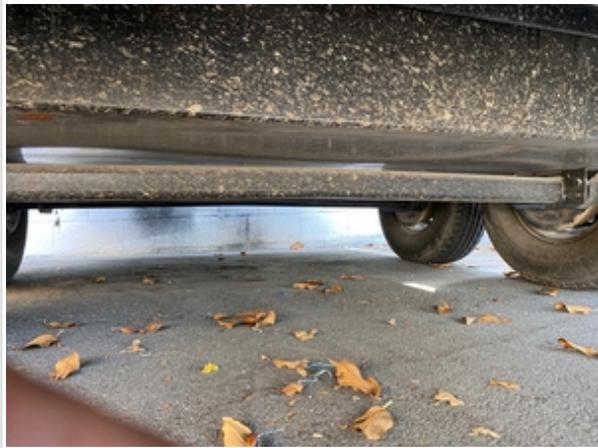
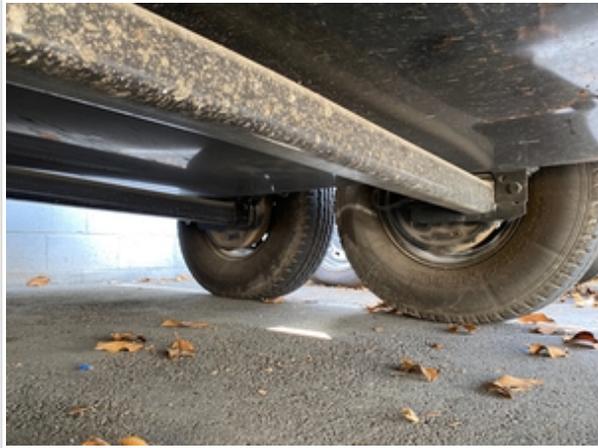
Bottom Surface Photos

<p>Bottom Surface</p>	<p>3 - Normal Wear &amp; Tear</p>

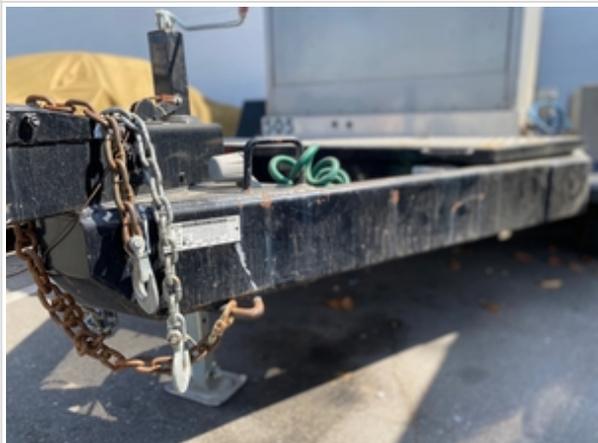
Frame Condition	3 - Normal Wear & Tear
Frame Photos

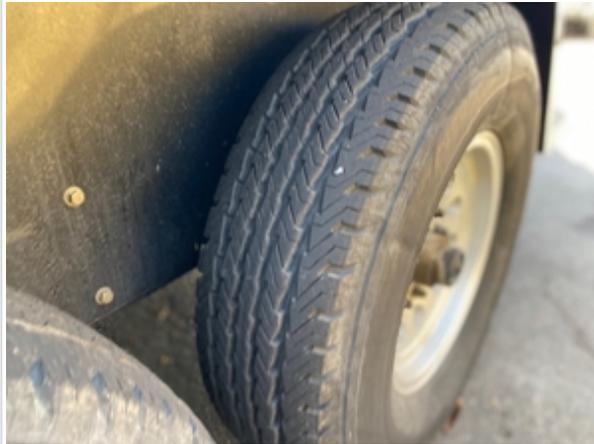
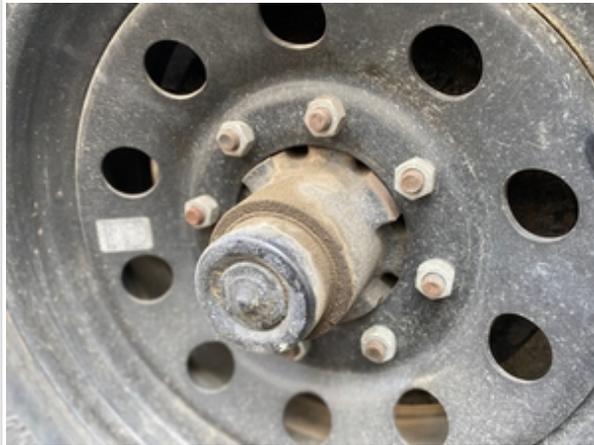
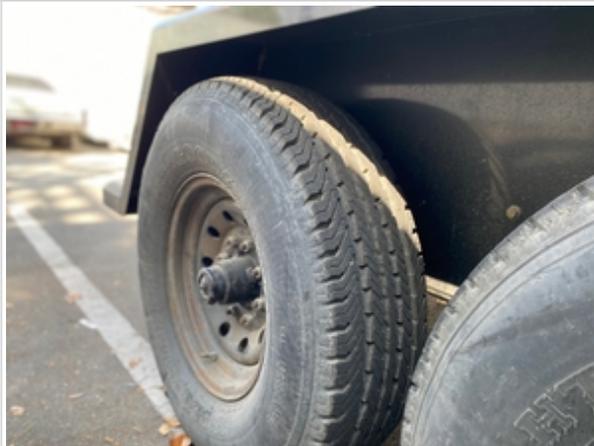
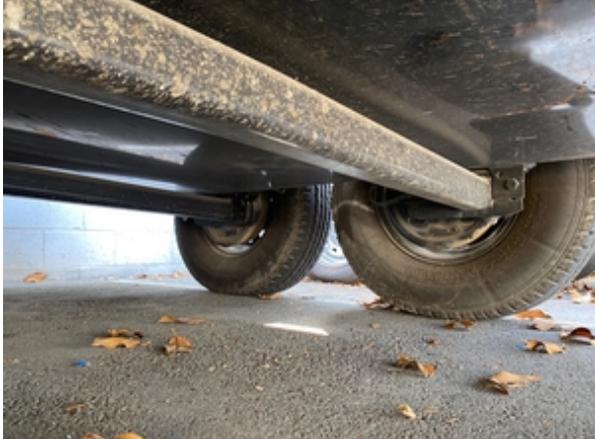
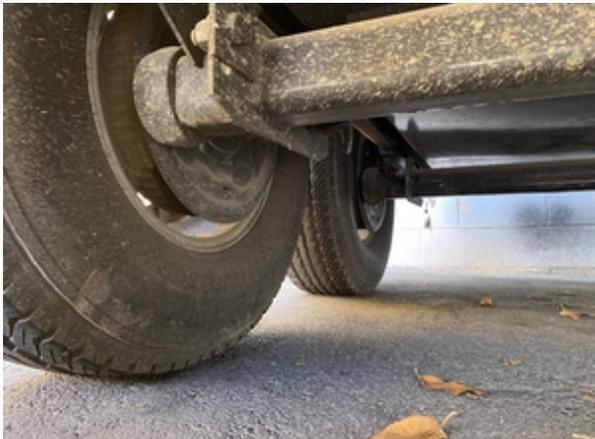
Wheels & Hub Condition	3 - Normal Wear & Tear	
Comments	Both front tires & rear l/s tire ok, rear r/s tire has sidewall cracks appearing	
Wheels & Hub Photos

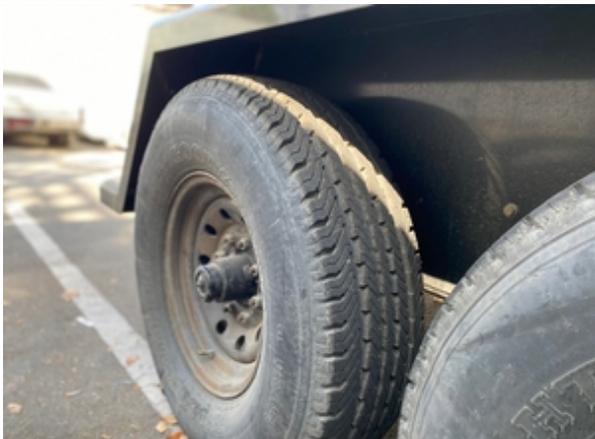
Loose Lugs	No	
Tire Brand	Goodyear	
Tire Size	LT235/85R16	
Front Left Tire - Ratio Remaining	50%	
Front Left Tire Photos

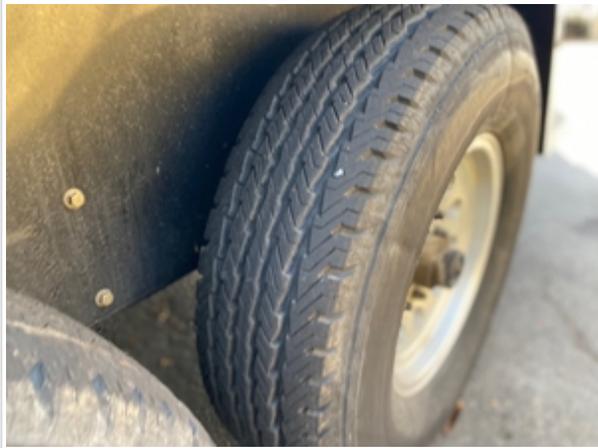
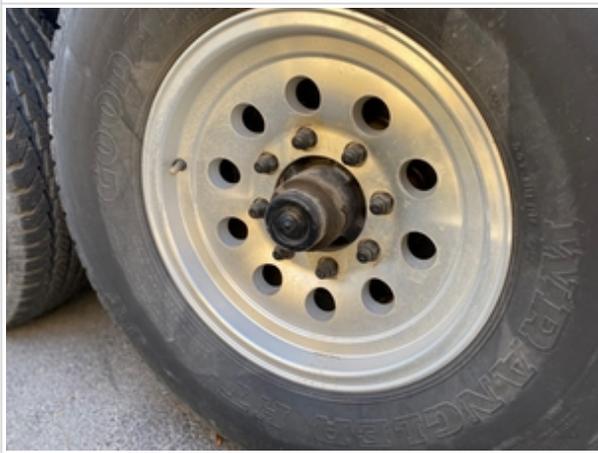
Front Right Tire Photos

Front Right Tire - Ratio Remaining	50%
