Inspection Report (Wheel Loader)

| Make | CAT |
| Model | 930B unit 15-104 |
| Serial Number | 41K9005 |

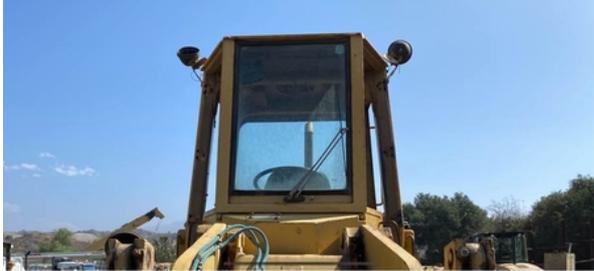
| Glass Condition Photos | |

| Glass Condition | 3 - Normal Wear & Tear |
| Glass Condition Notes | Glass intact, no visible damage |

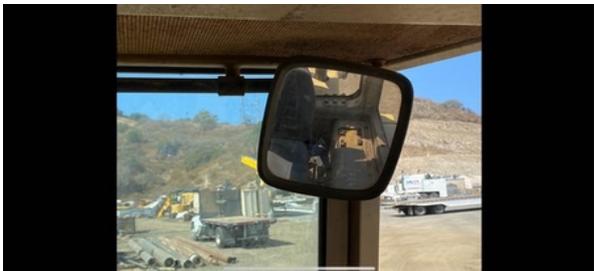
| Mirrors Photos | |

| Mirrors | 3 - Normal Wear & Tear |
| Mirror Condition Notes | Mirrors present and intact, no visible damage |

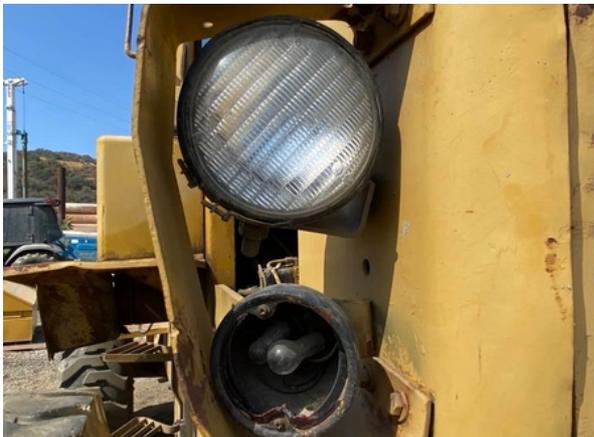
| Lighting System | 1 - Service Required |
| Lighting System Condition | Overall lighting system is non-operational |

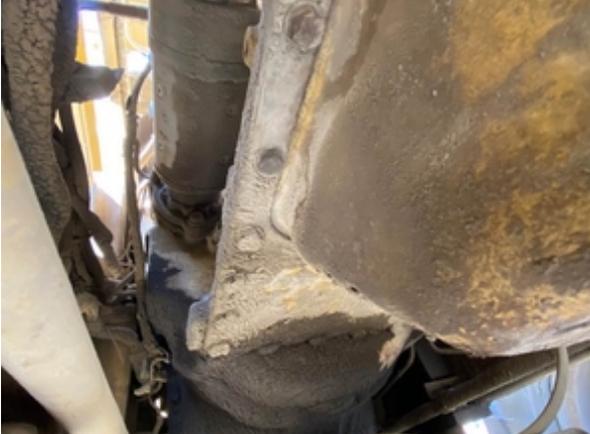
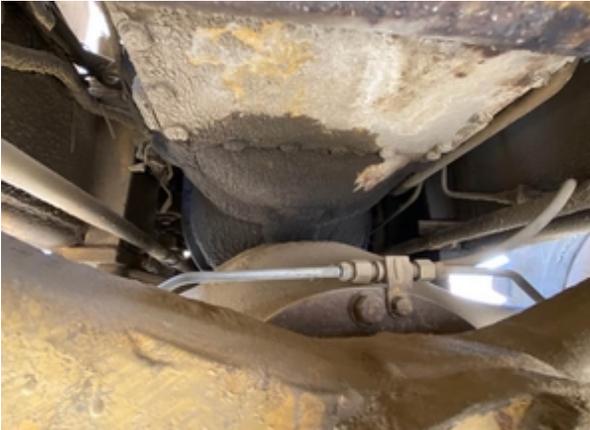
| Blow-by (Visual Observation Check) | Yes | |
| Comments | Minor blowby | |

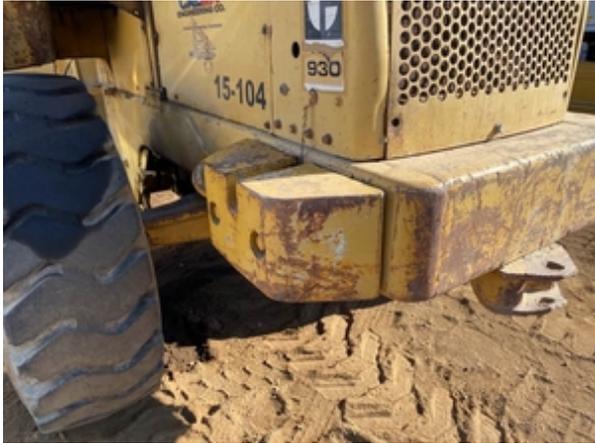
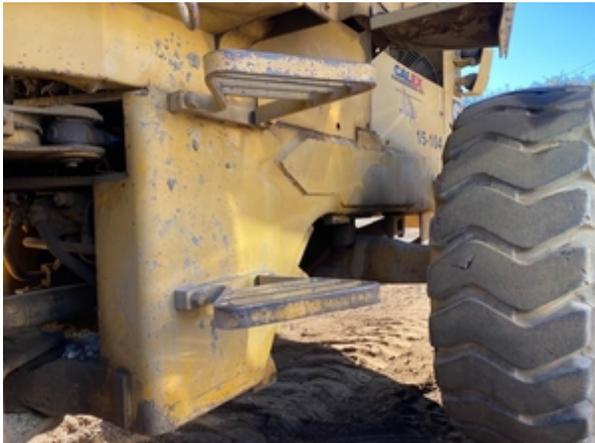
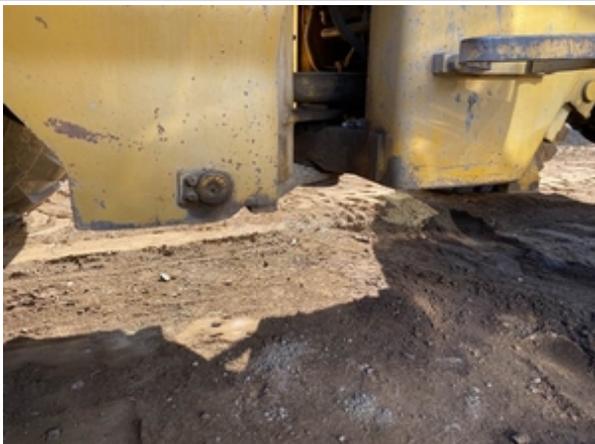
| Frame Photos | |

| Frame | 3 - Normal Wear & Tear |

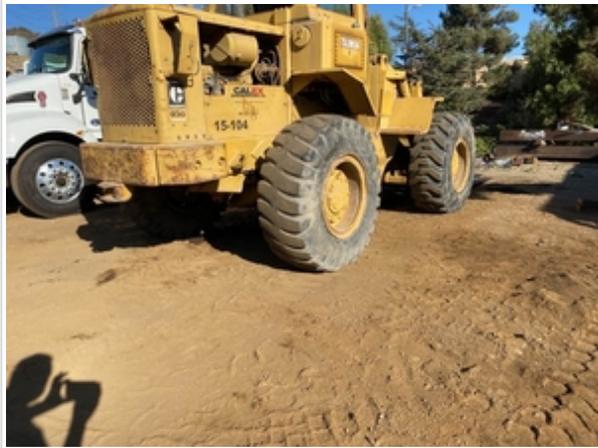
| Stance Photos | |

| <p>Stance</p> | <p>3 - Normal Wear & Tear</p> |

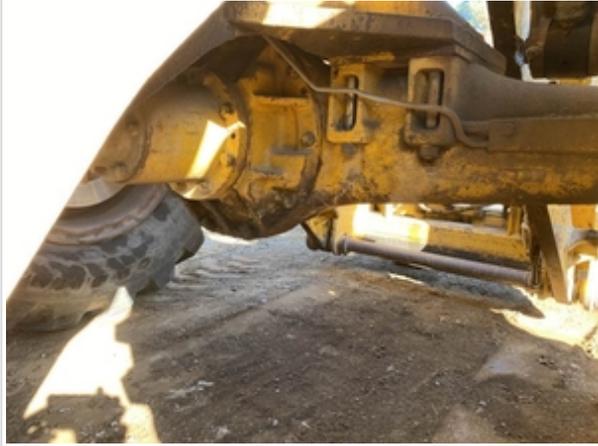
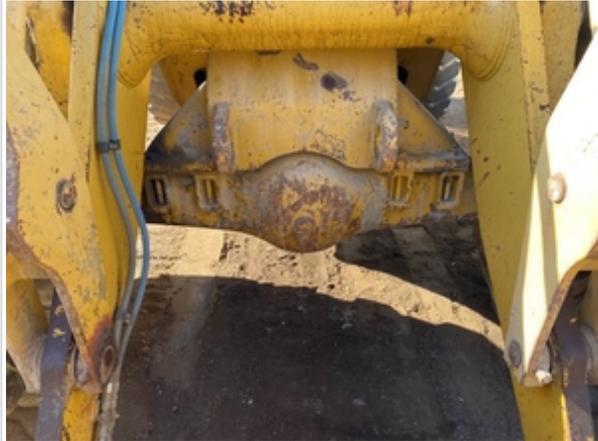
| Front Axle Appearance Photos | |

| Front Axle Appearance | 3 - Normal Wear & Tear |

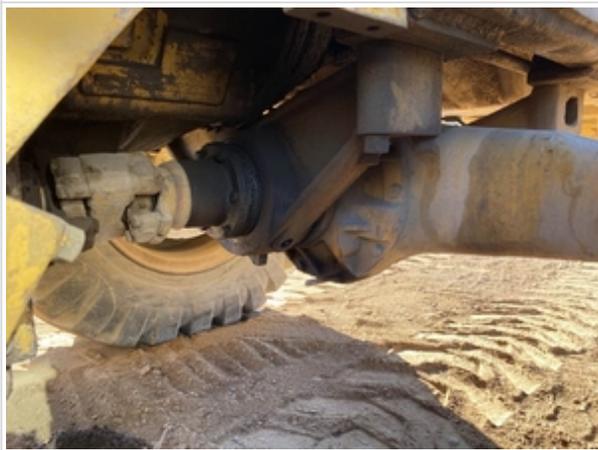
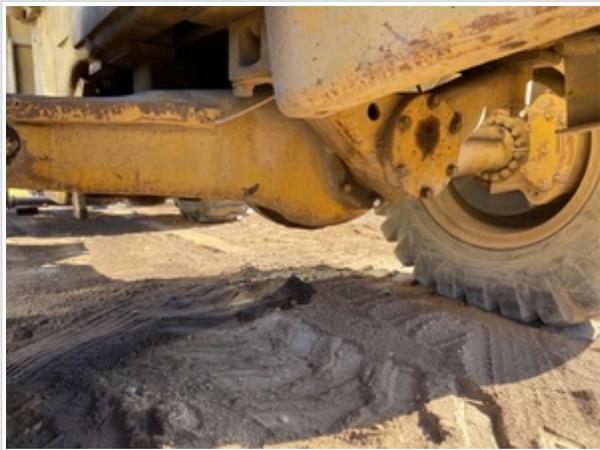
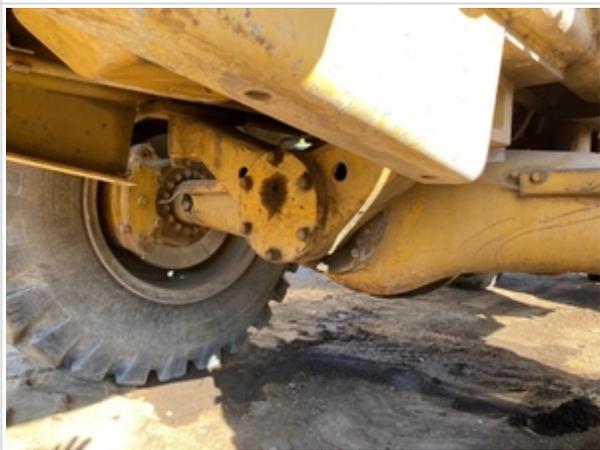
| <p>Rear Axle Appearance Photos</p> | | |

| <p>Rear Axle Appearance</p> | <p>3 - Normal Wear & Tear</p> | |

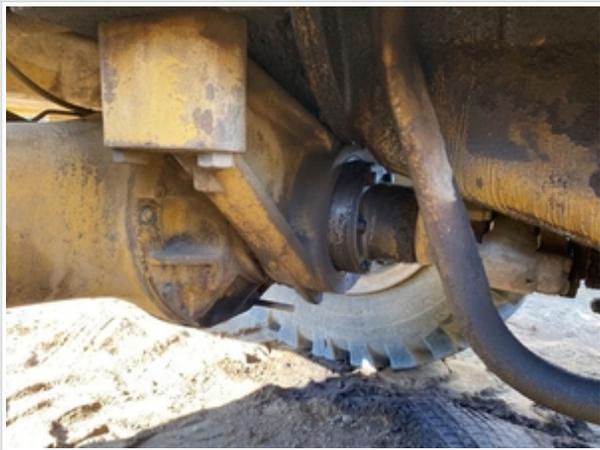
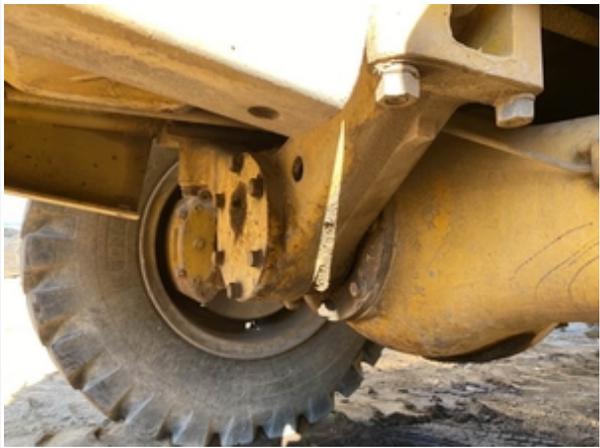
| <p>Articulating Center Pin Appearance Photos</p> | | |

| <p>Articulating Center Pin Appearance</p> | <p>3 - Normal Wear & Tear</p> | |

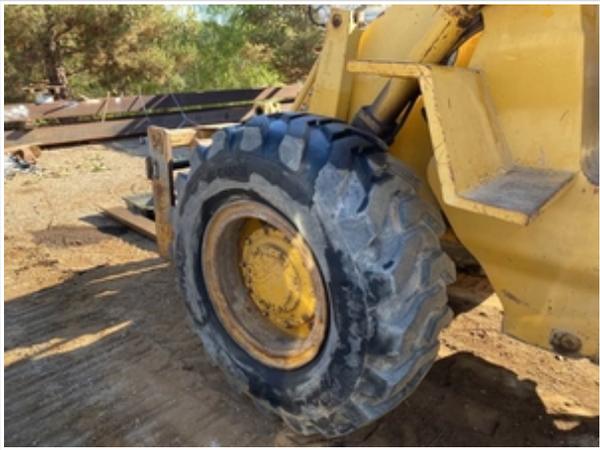
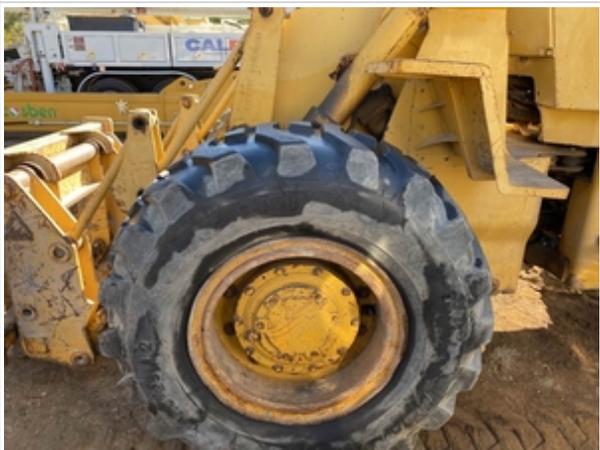
| Front Left Tire Photos | | |

| Front Left Tire - Ratio Remaining | 70% | |

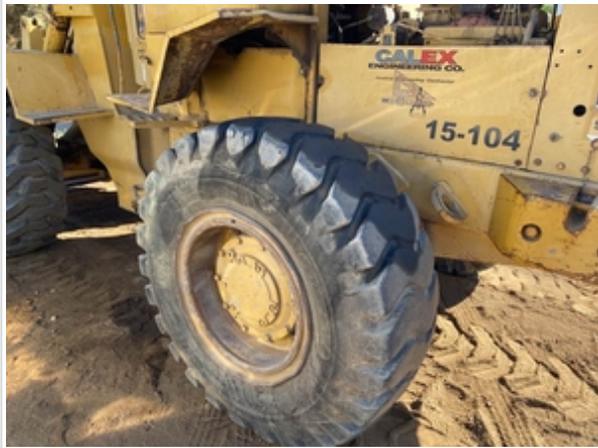
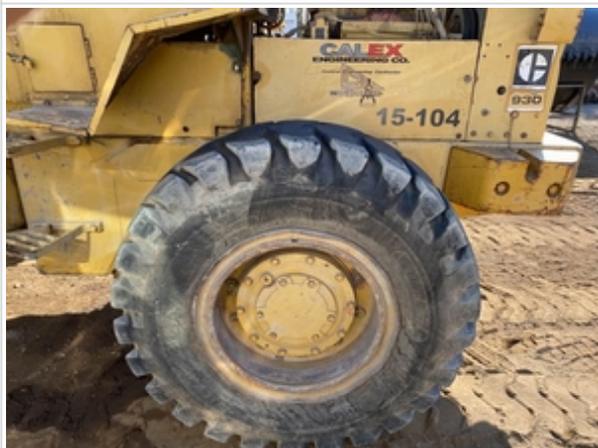
| <p>Rear Left Tire Photos</p> | |

| Rear Left Tire - Ratio Remaining | 50% | |

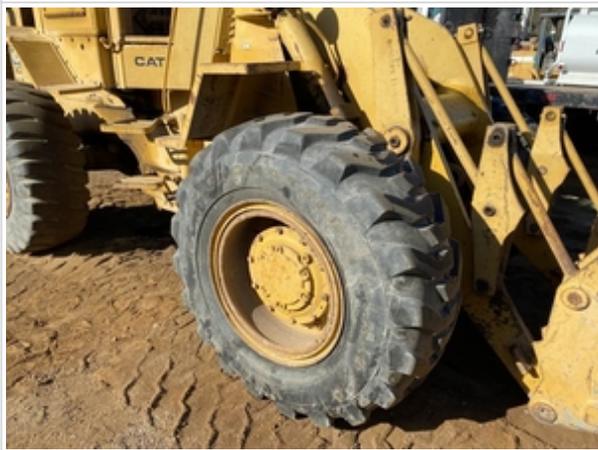
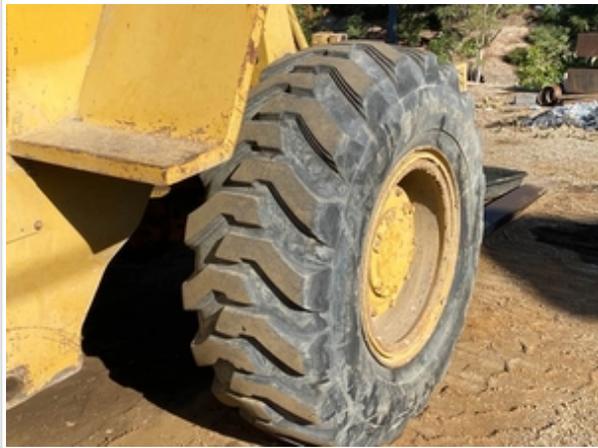
| <p>Front Right Tire Photos</p> | |

| <p>Front Right Tire - Ratio Remaining</p> | <p>30%</p> |

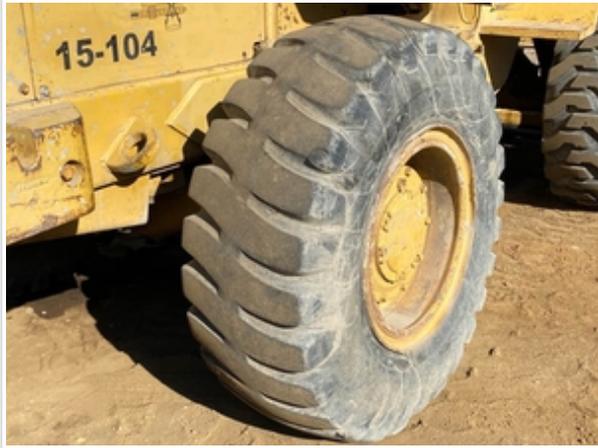
| <p>Rear Right Tire Photos</p> | | |

| <p>Rear Right Tire - Ratio Remaining</p> | <p>30%</p> | |

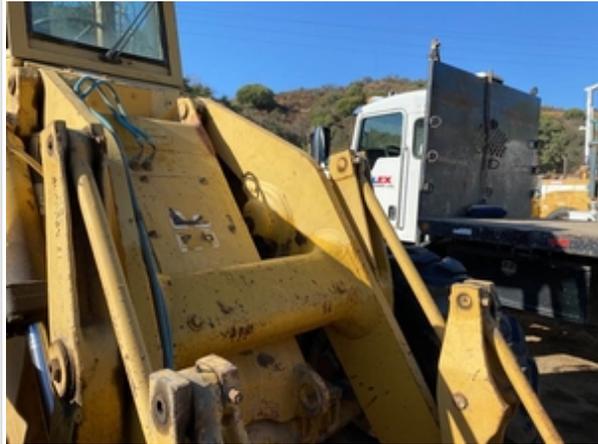
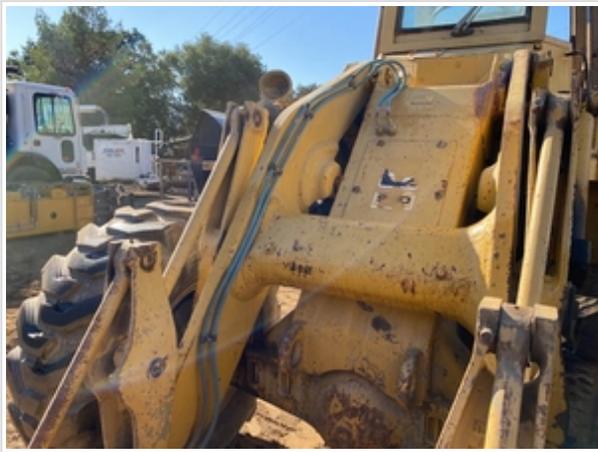
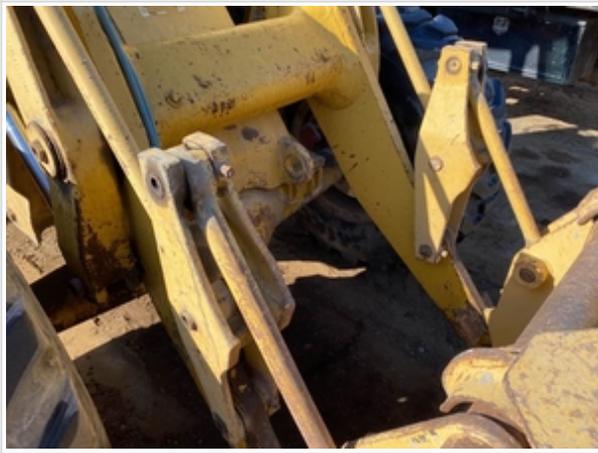
| <p>Lift Arm Photos</p> | | |

| <p>Lift Arm</p> | <p>3 - Normal Wear & Tear</p> | |

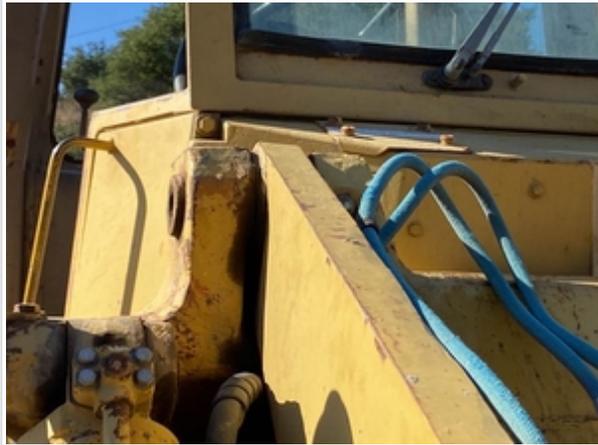
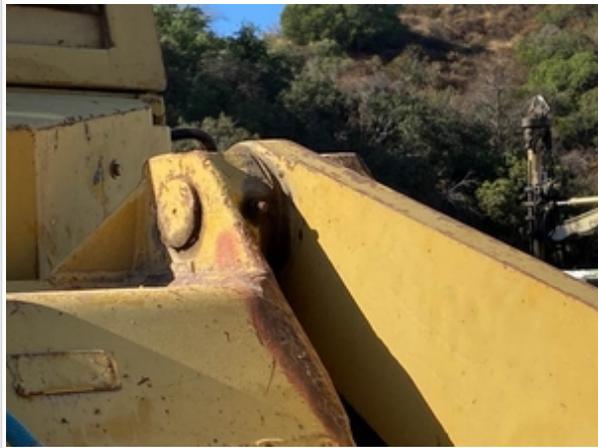
| <p>Chassis to Arm Pins Photos</p> | |

| <p>Chassis to Arm Pins</p> | <p>3 - Normal Wear & Tear</p> |

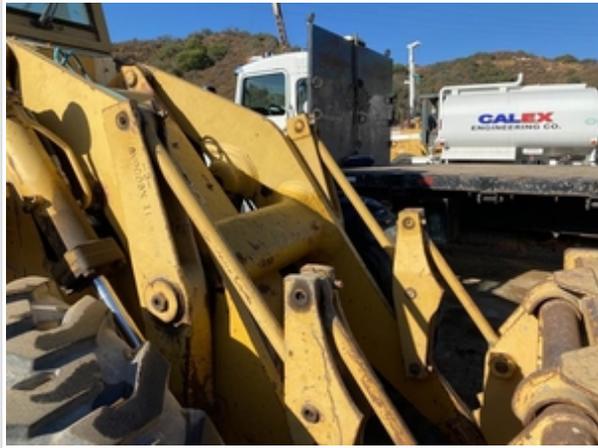
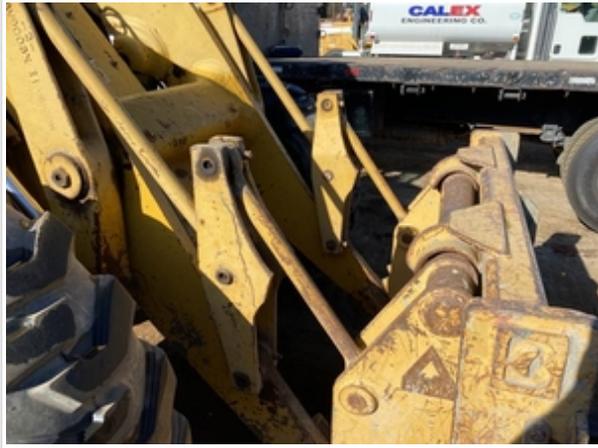
| <p>Tilt Linkage Photos</p> | | |

| <p>Tilt Linkage</p> | <p>3 - Normal Wear & Tear</p> | |

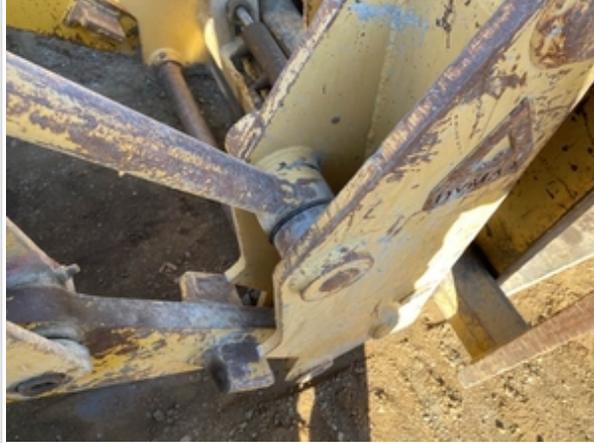
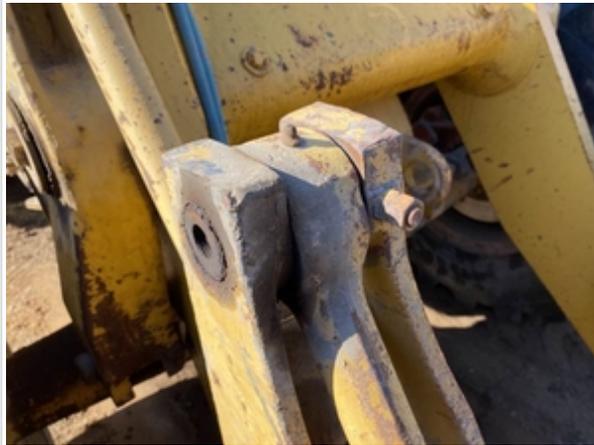
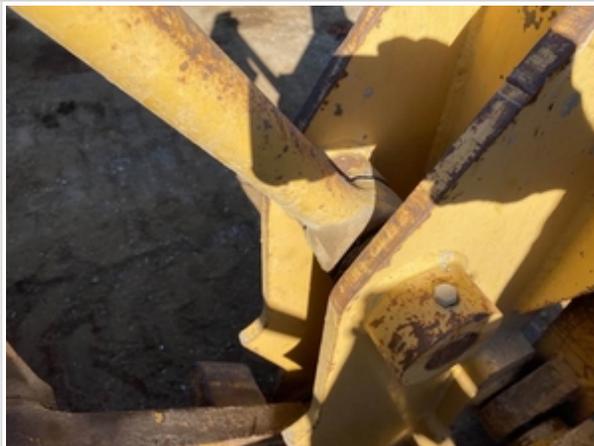
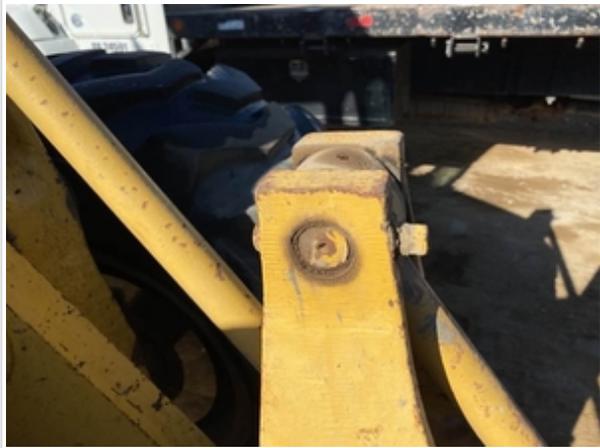
Tilt Linkage Pins and Bushings
Photos

| <p>Tilt Linkage Pins and Bushings</p> | <p>3 - Normal Wear & Tear</p> | |

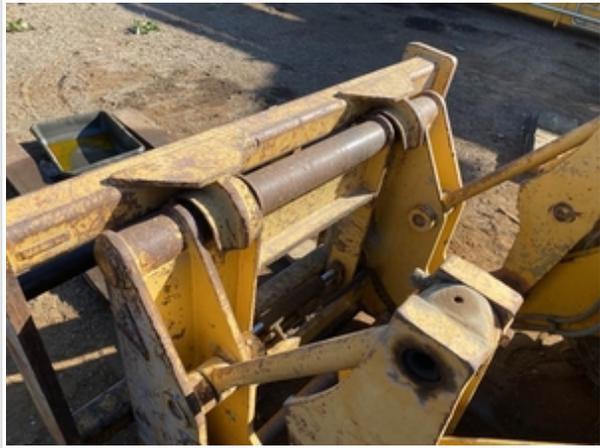
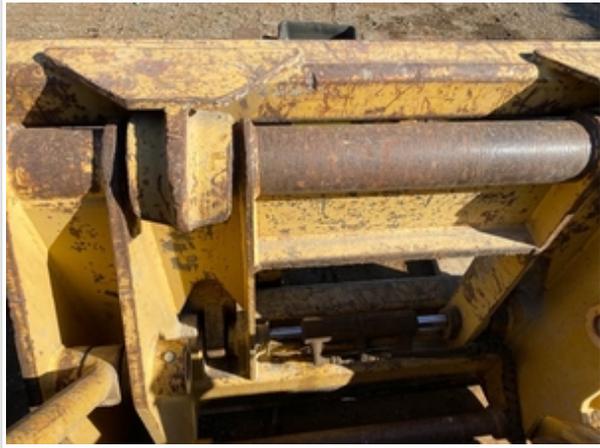
| <p>Quick Coupler Photos</p> | | |

| <p>Quick Coupler</p> | <p>3 - Normal Wear & Tear</p> | |

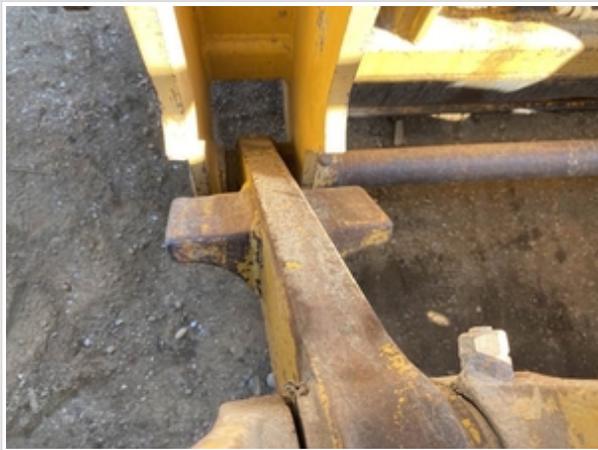
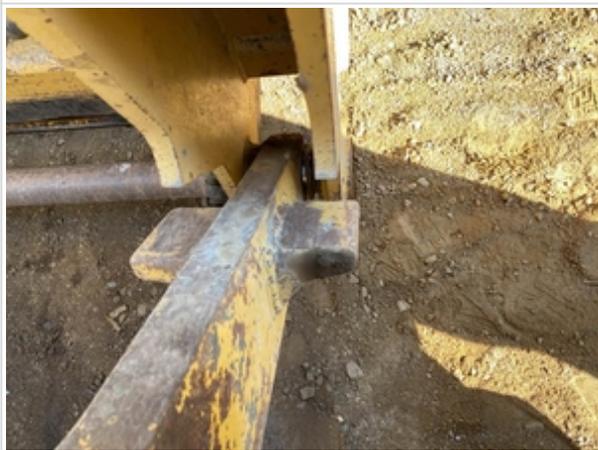
| <p>Quick Coupler to Arms Pins Photos</p> | | |

| <p>Quick Coupler to Arms Pins</p> | <p>3 - Normal Wear & Tear</p> | |

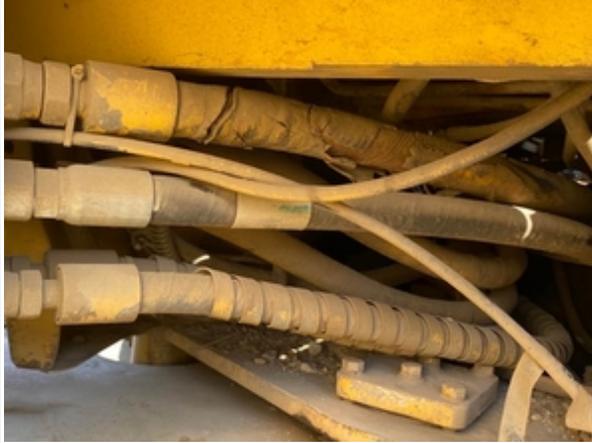
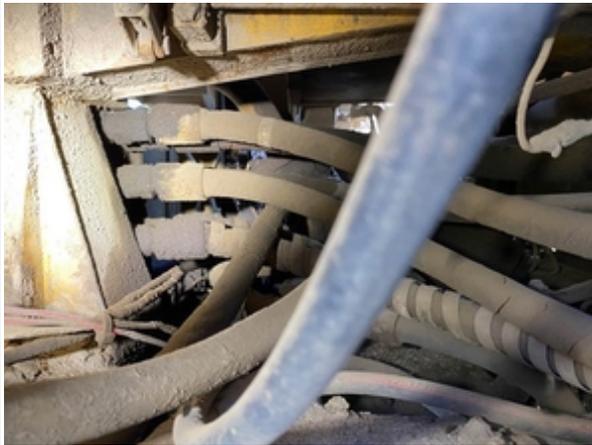
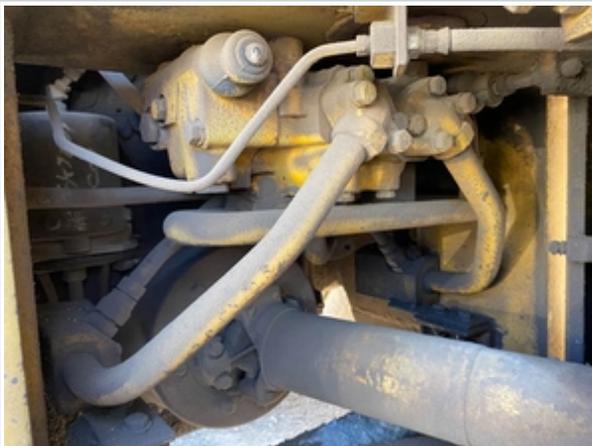
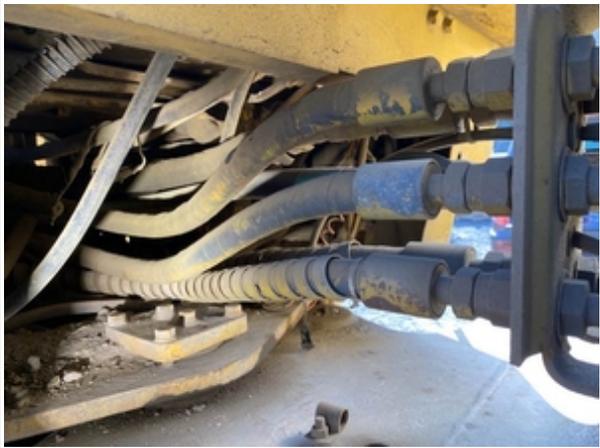
Appearance of Hydraulic Lines /
Fittings Photos

| <h3>Hydraulics Overall</h3> | |
|---|---|
| <p>Hydraulic Lines / Fittings Condition</p> | <p>Hydraulic lines & fittings are clean and in good condition</p> |

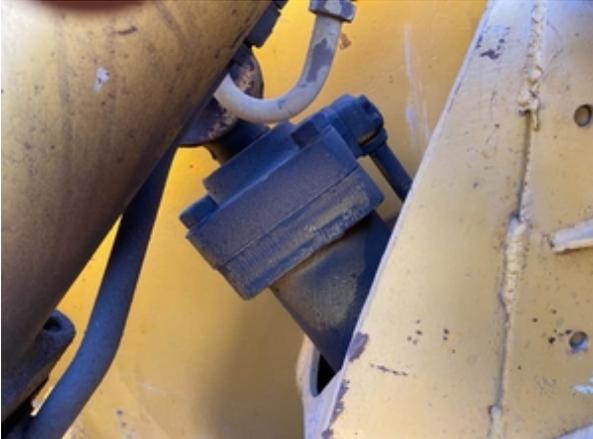
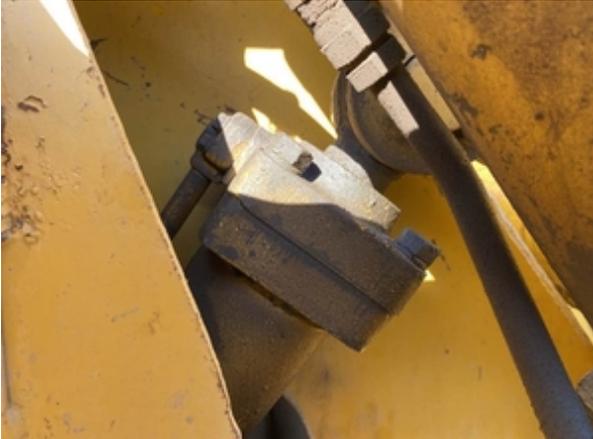
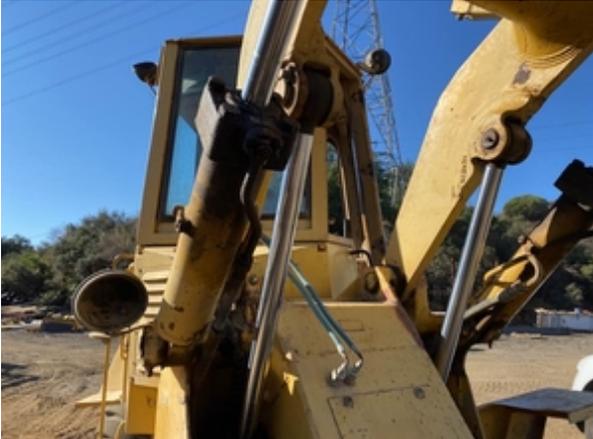
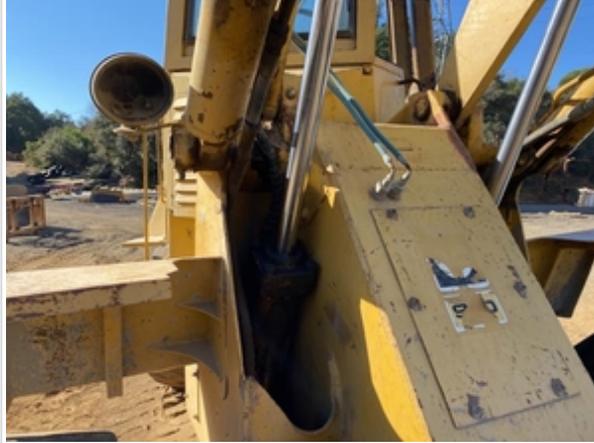
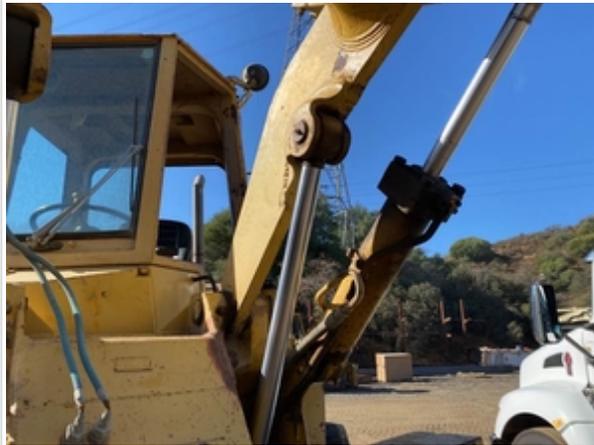
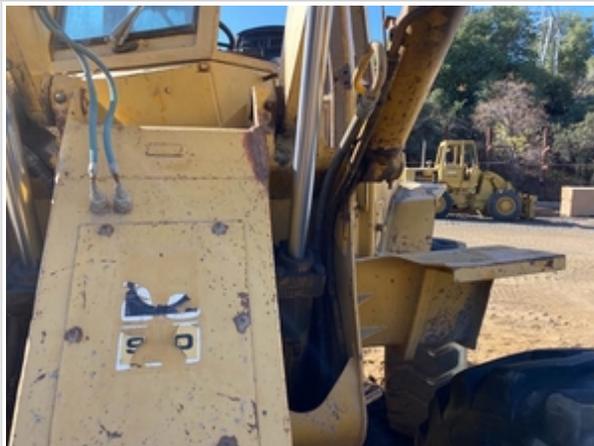
| Lift Cylinder Photos | |

| Lift Cylinder: Oil Leaks | Yes |
| Comments | Seepage leaks at rod seal |

| What Needs Work | Possible engine oil leak at l/s of oil pan. Most cylinders have seepage oil leaks at rod seals. |

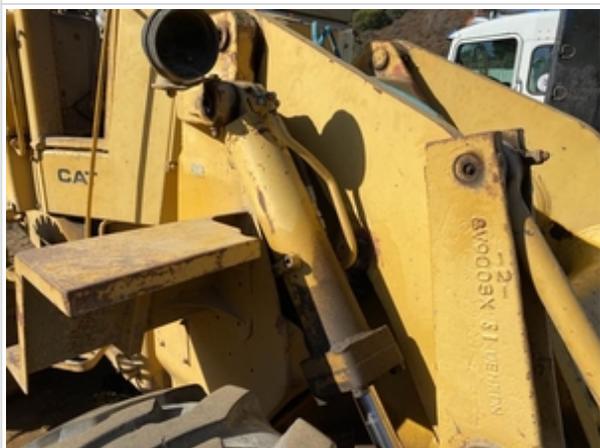
| Bucket Cylinder: Oil Leaks | Yes | |
| Comments | Oil seepage at rod seals | |
