Inspection Report (Compact Track Loader)

Year	2016
Make	John Deere
Model	333E
Serial Number	296619
Hour Meter Reading	1,335
Previous Application (e.g., earth moving, mining, demolition, etc)	Pipeline / Electrical Construction

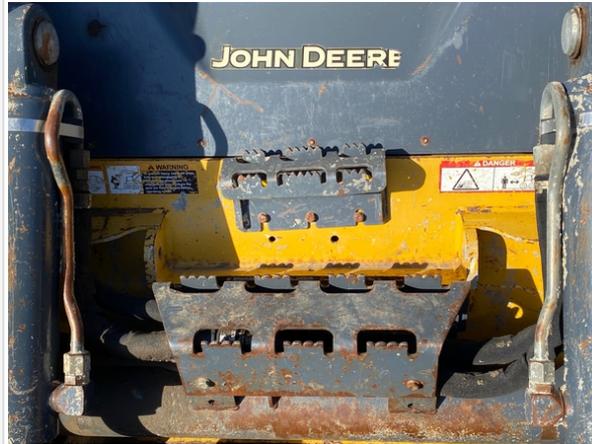
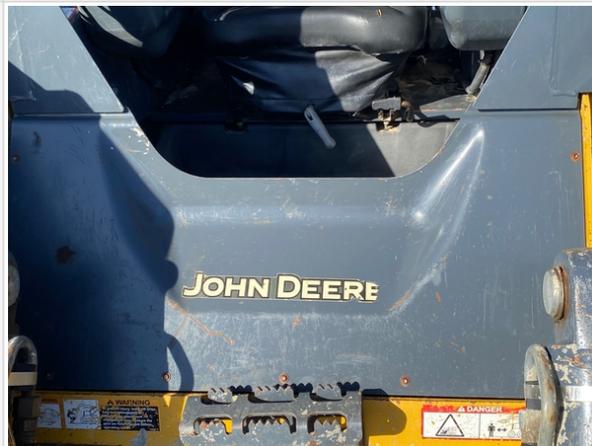
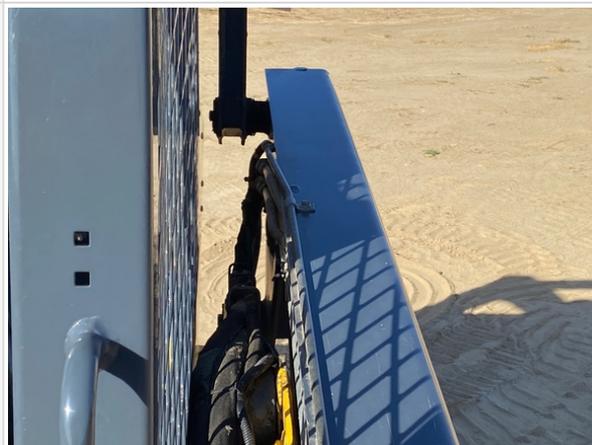
Front Photos

Front	3 - Normal Wear & Tear
Front Condition	No visible damage

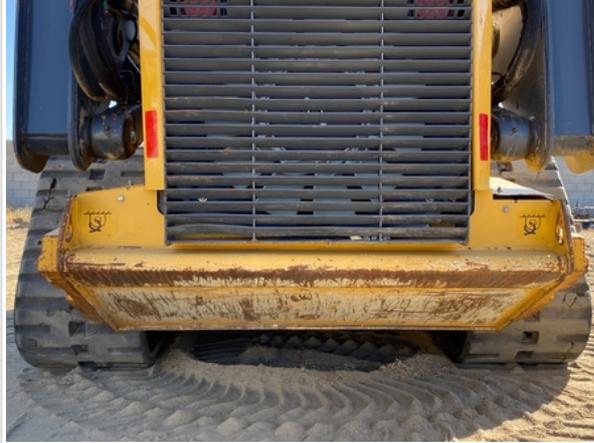
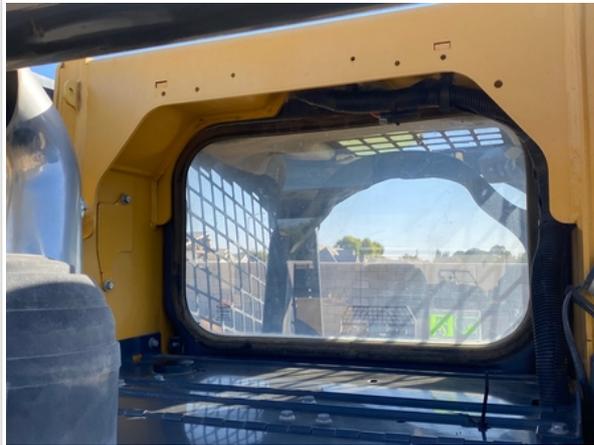
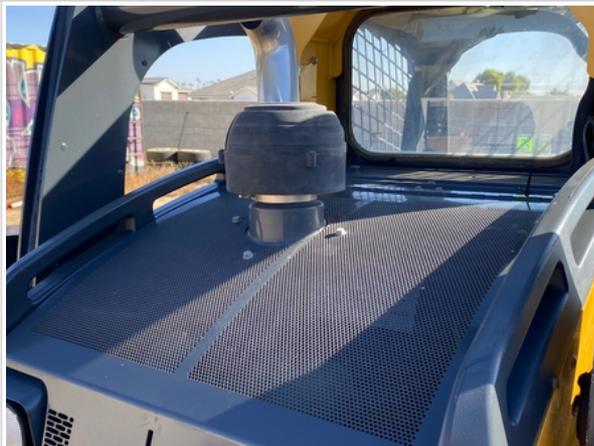
Rear Photos

Rear	3 - Normal Wear & Tear
Rear Condition	No visible damage

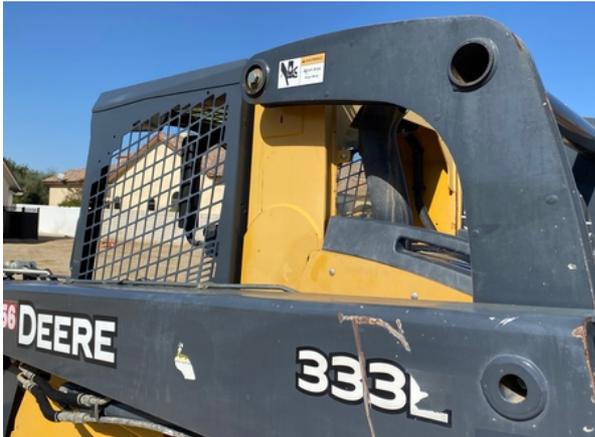
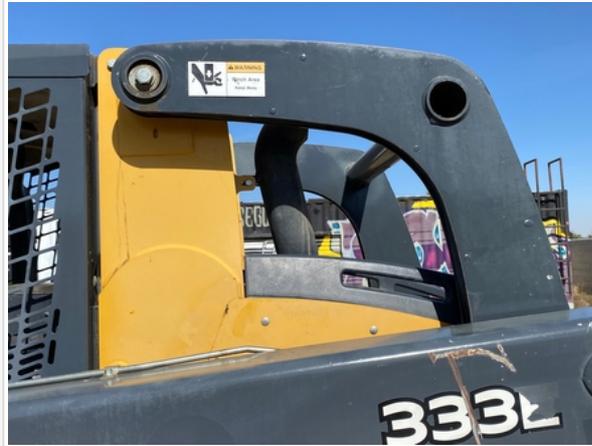
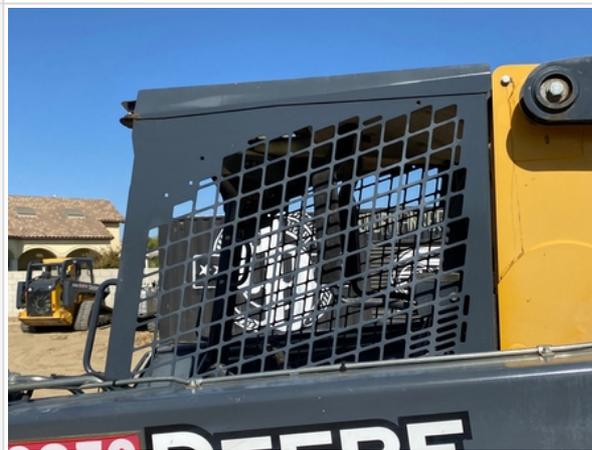
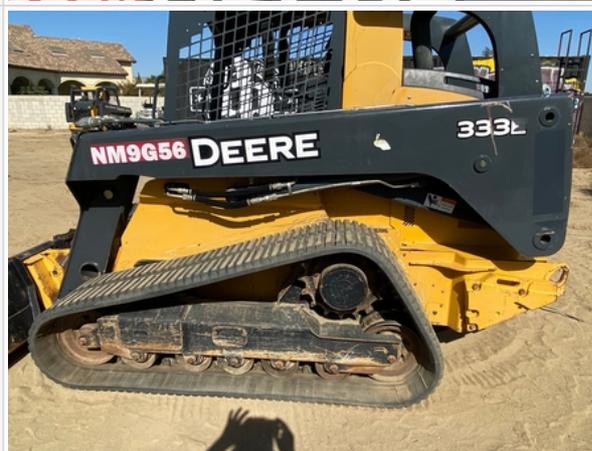
Left	3 - Normal Wear & Tear
Left Condition	No visible damage
Left Photos

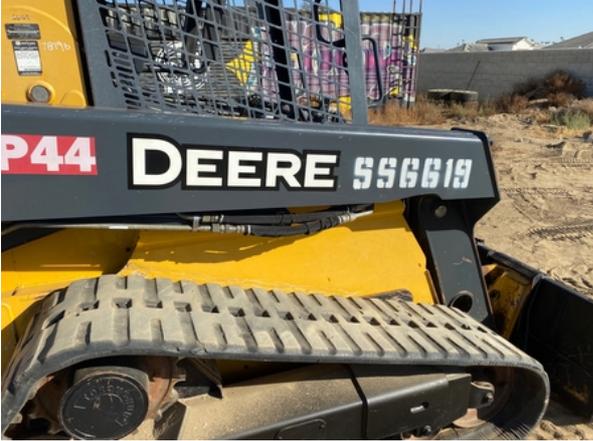
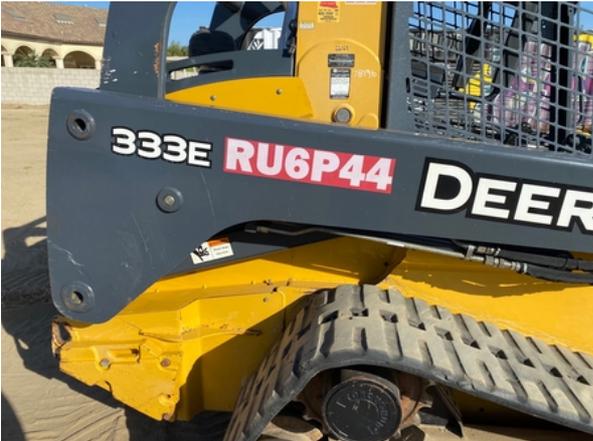
Right	3 - Normal Wear & Tear
Right Condition	No visible damage
Right Photos

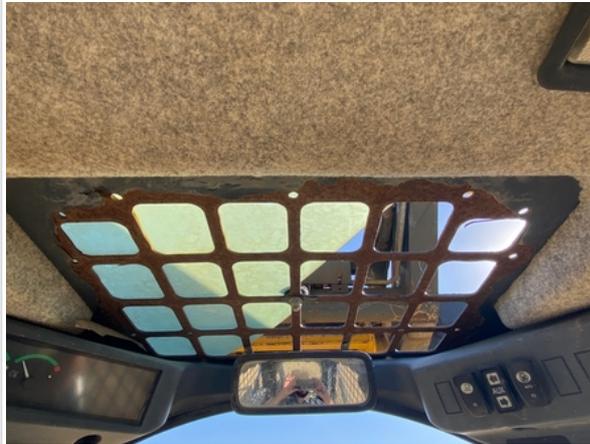
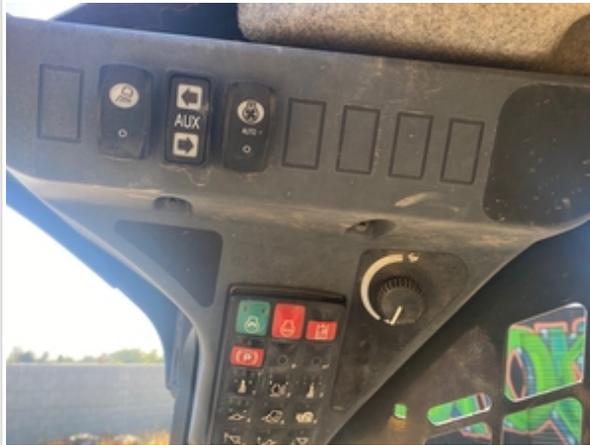
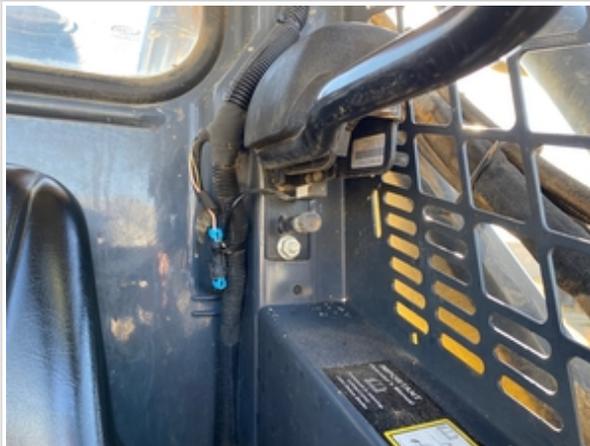
Operator Cabin Photos

Operator Cabin Overall	3 - Normal Wear & Tear
Operator Cabin Overall Condition	Good cabin appearance, solid floors, panels, and ceiling, Other (see comments)
Comments	Top cabin sunroof window missing half (broken)

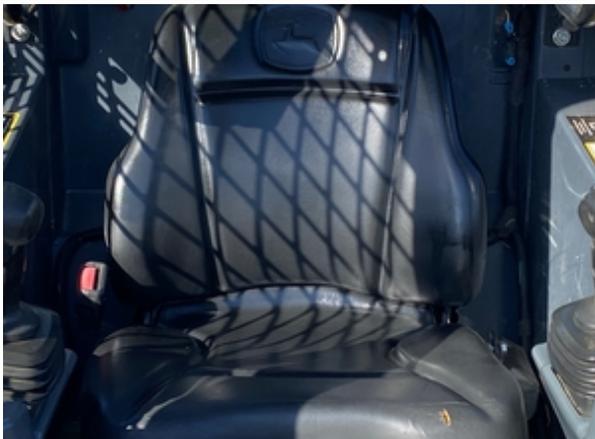
Operator's Seat & Arm Rests	3 - Normal Wear & Tear
Operator's Seat & Arm Rests Condition	Seat(s) have minor surface staining or small tears, Other (see comments)
Comments	Seat in good shape minor tear
Operator's Seat & Arm Rests Photos

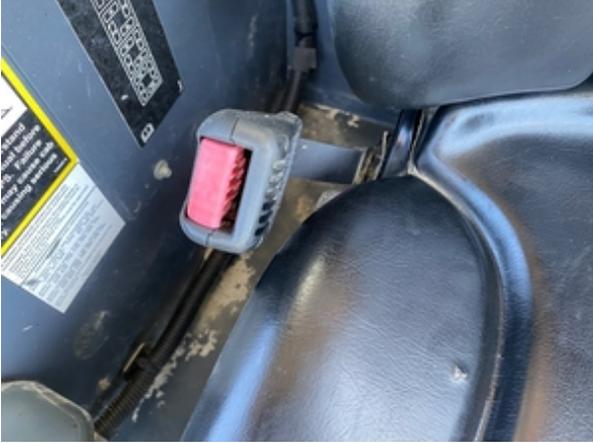
Seat Belt Photos

Seat Belt	3 - Normal Wear & Tear
Seat Belt Condition	Seat belt shows limited functionality or does not secure properly

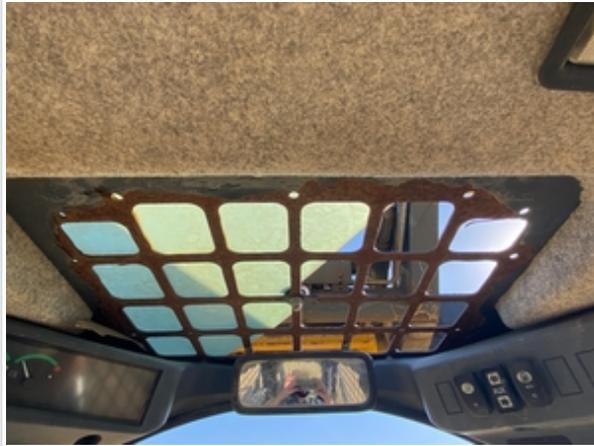
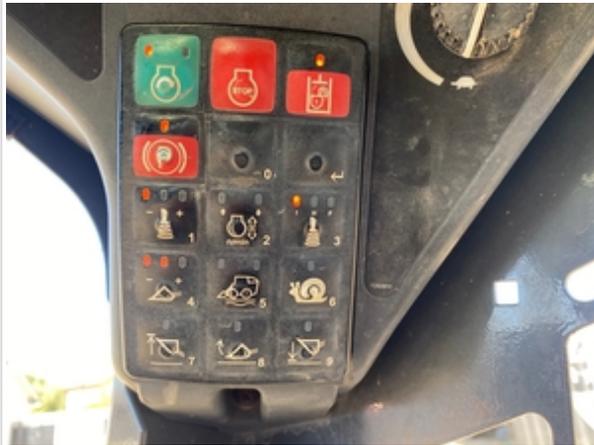
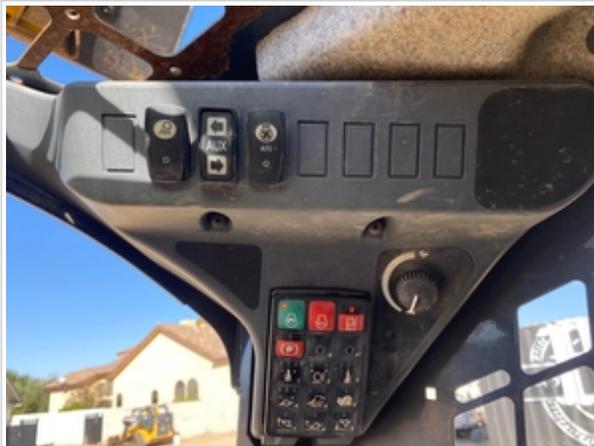
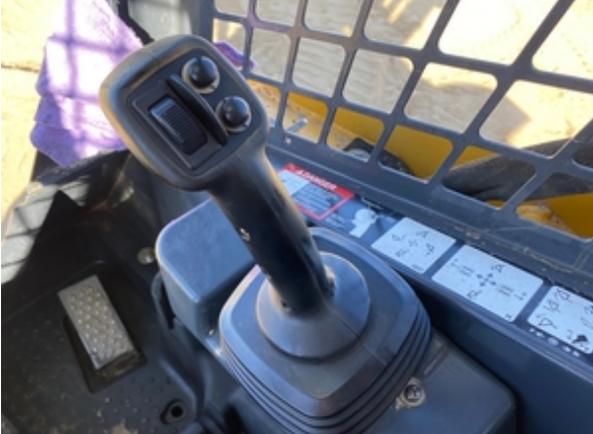
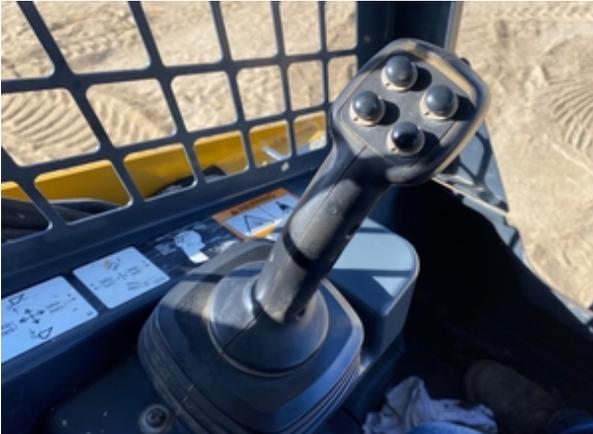
<p>Controls & Switches</p>	<p>3 - Normal Wear & Tear</p>
<p>Controls & Switches Condition</p>	<p>All switches are installed and functional</p>
<p>Controls & Switches Photos</p>

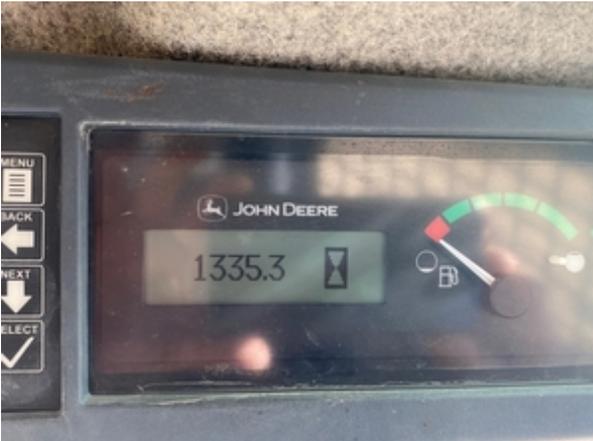
Hour Meter Activity	3 - Normal Wear & Tear
Hour Meter Condition	Hour meter is functional and in good condition
Hour Meter Activity Photos

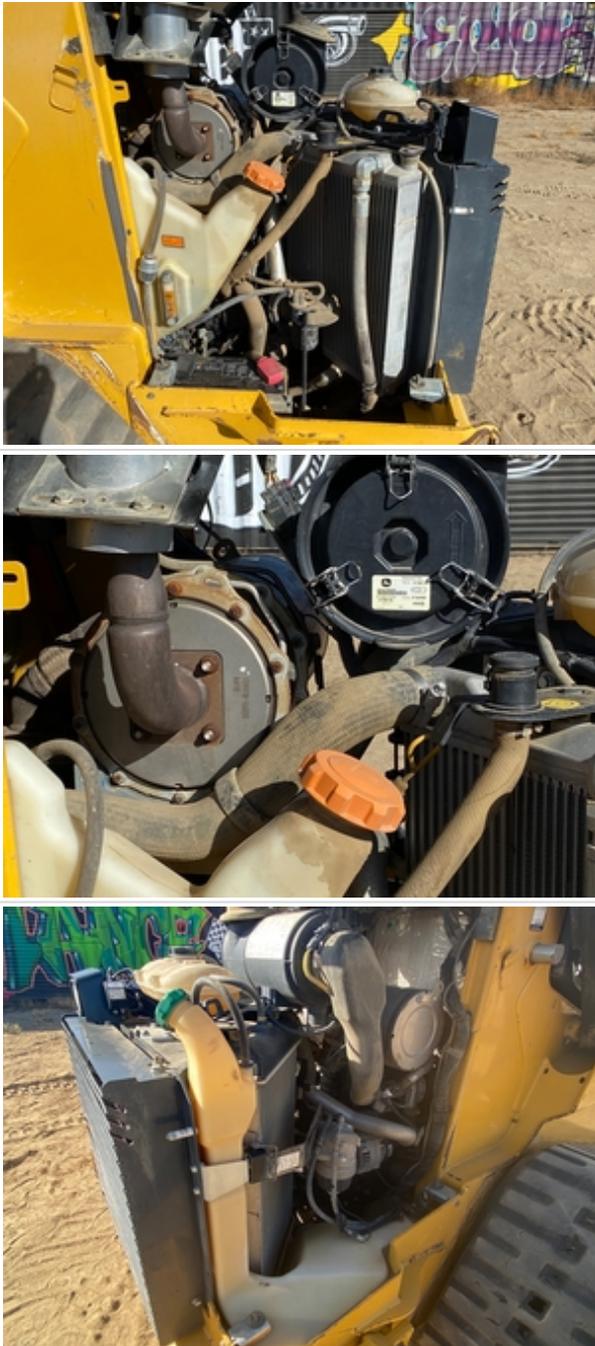
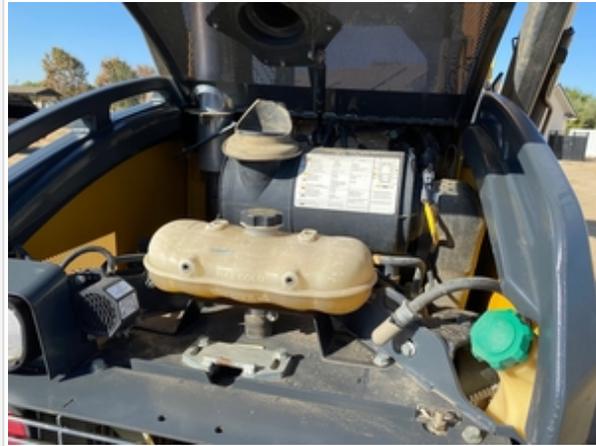
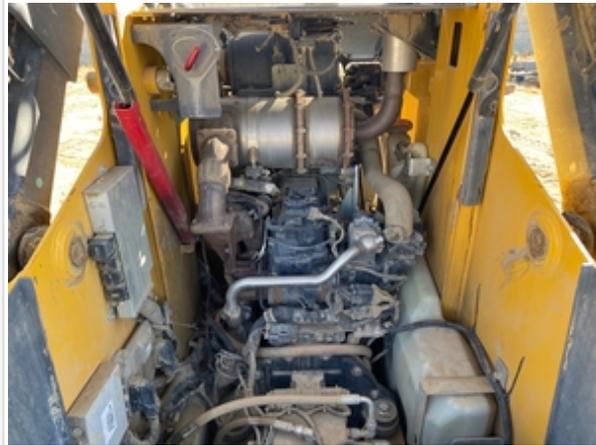
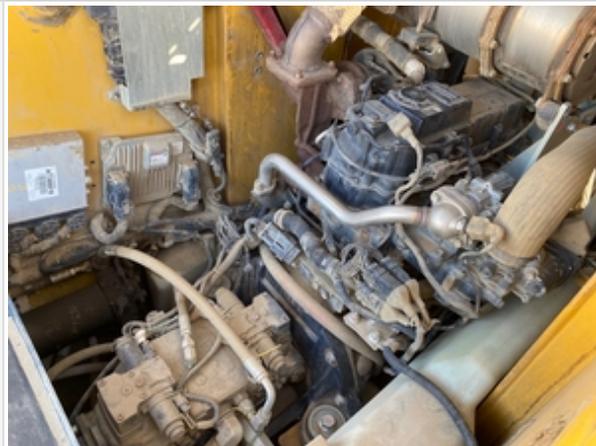
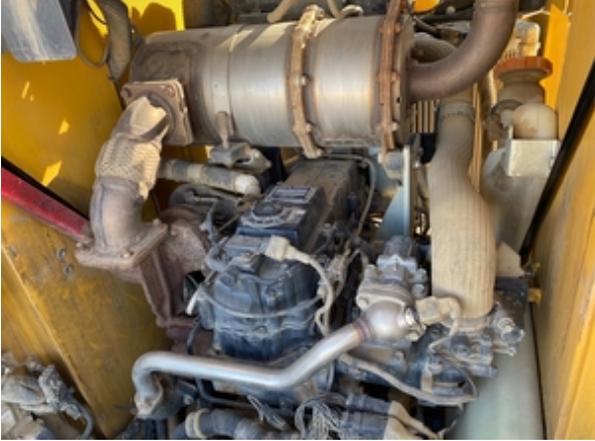
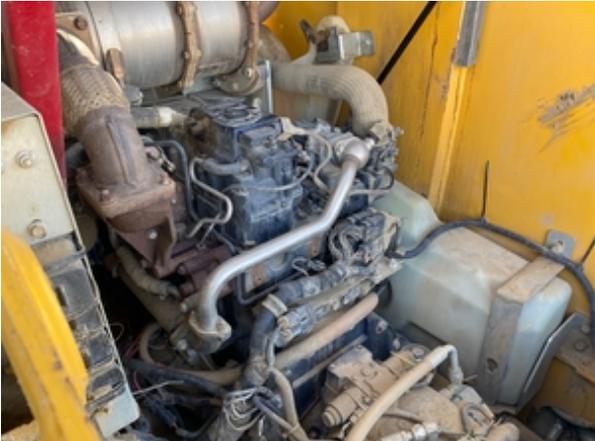
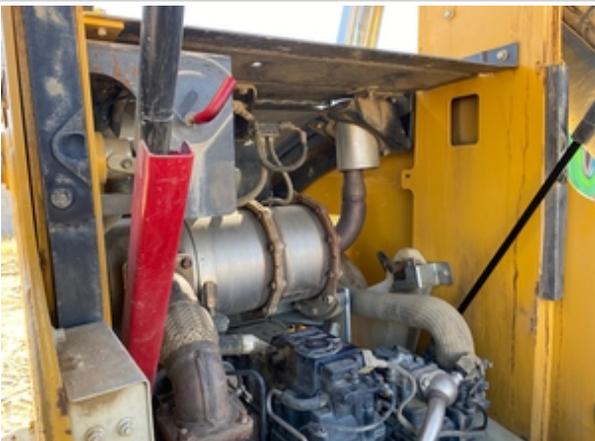
Engine Type (Make, Model, Cylinders, Hp)	Yanmar- 4TNV94CHT - 4 Cyl. - 96 HP.
Emissions Tier	Tier 4i
Engine Fuel Type	Diesel
Engine Photos

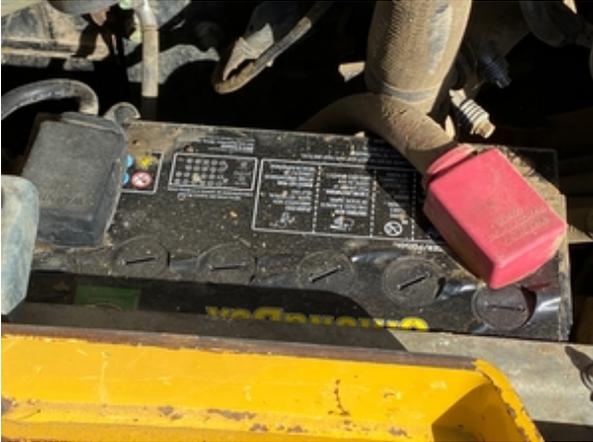
Battery	3 - Normal Wear & Tear
Battery Condition	Like new, recently replaced
Battery Condition Photos

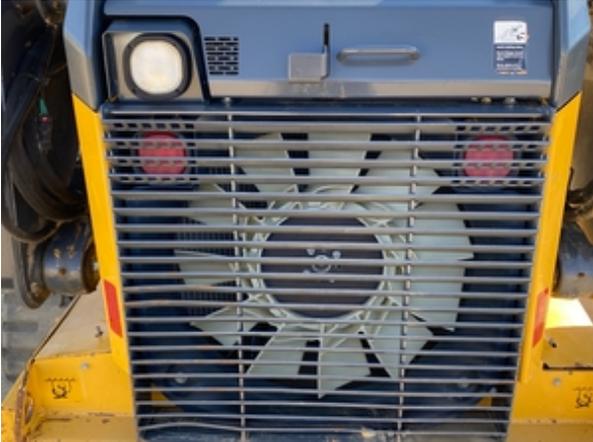
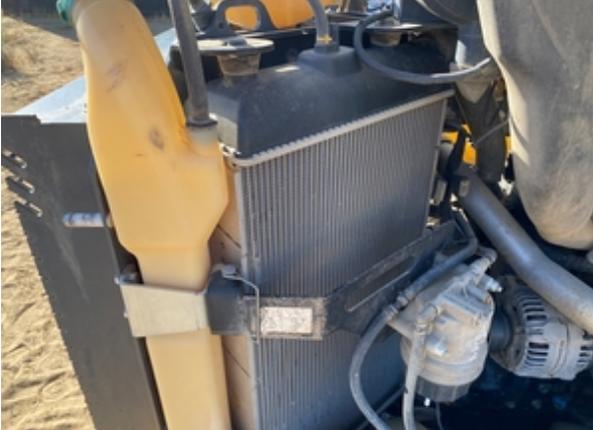
Radiator	3 - Normal Wear & Tear
Radiator Condition	Radiator fins & components appear to be in good working order, no signs of damage or leaks
Radiator Photos

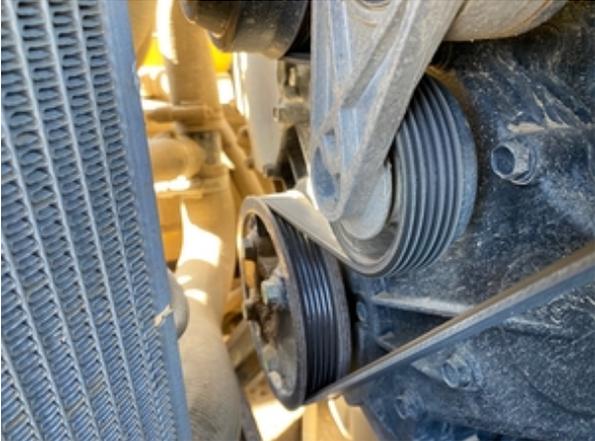
Belts	3 - Normal Wear & Tear	
Belt Condition	Belts appear in good condition & alignment with proper tension	
Belt Photos

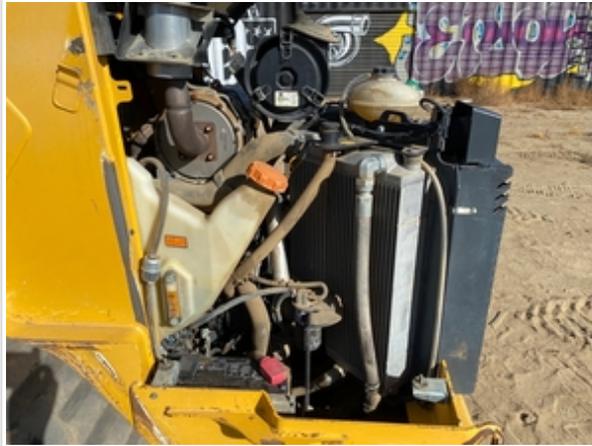
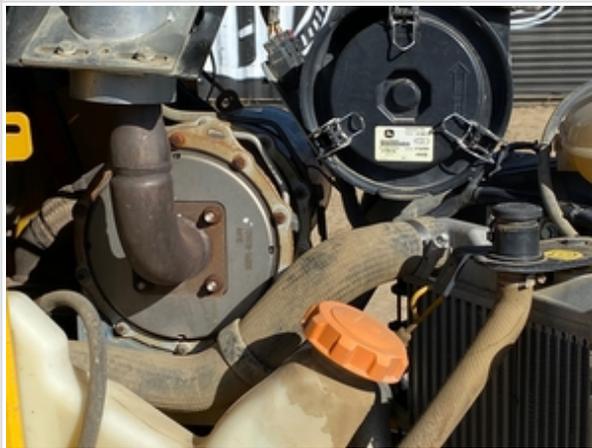
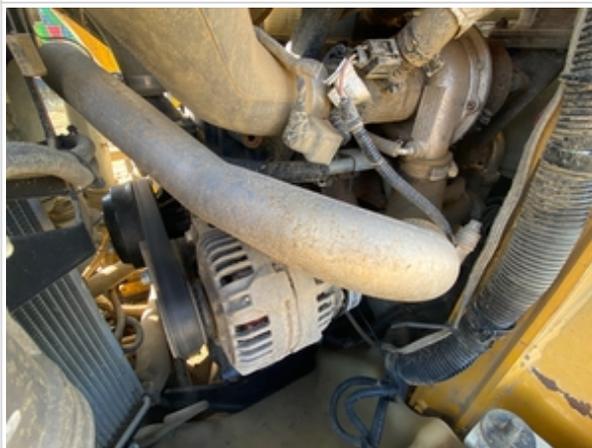
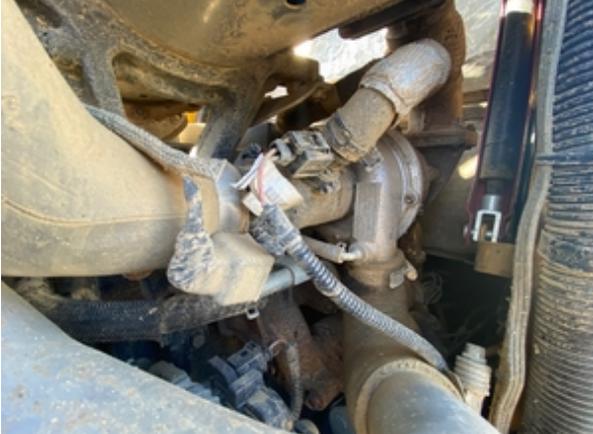
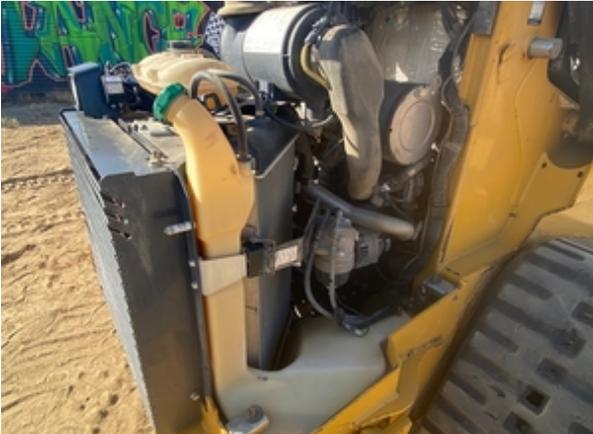
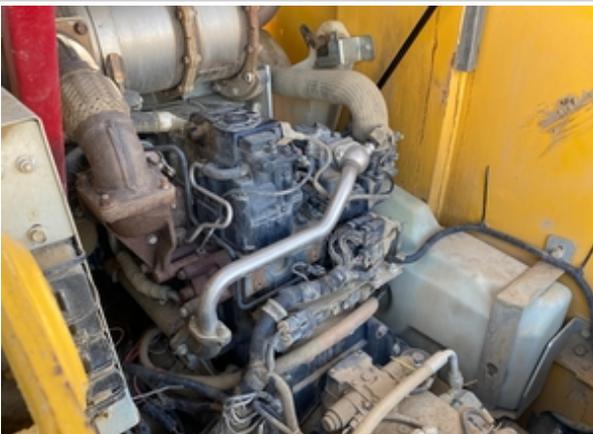
Hose Photos

Hoses	3 - Normal Wear & Tear	
Hose Condition	Firm, pliant hoses with no signs of wear or leaks

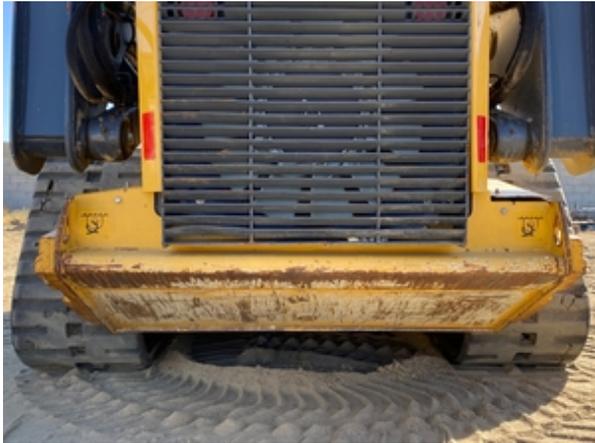
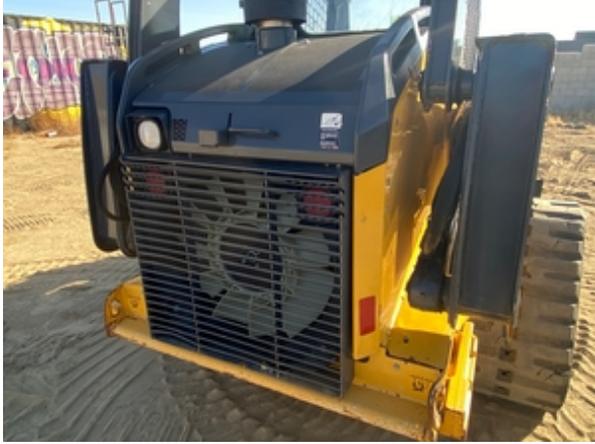
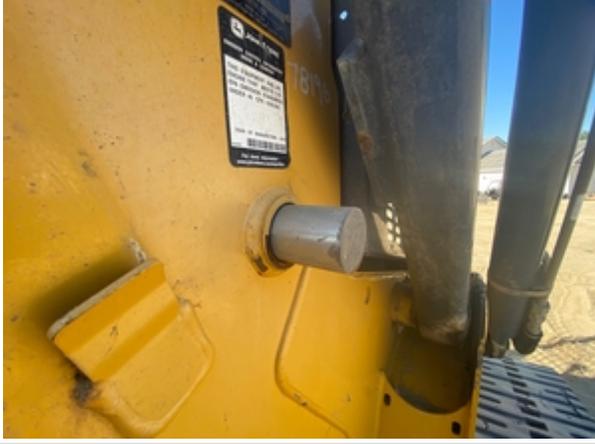
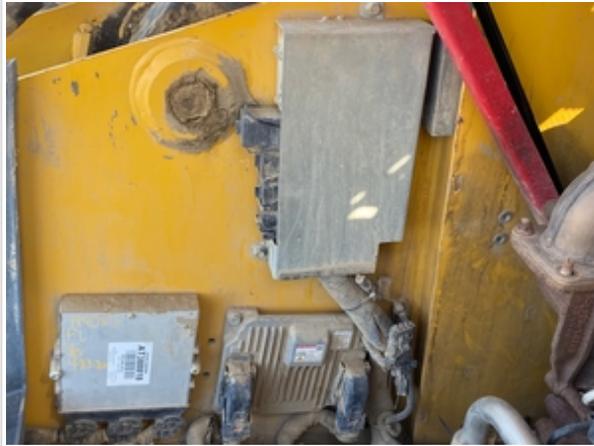
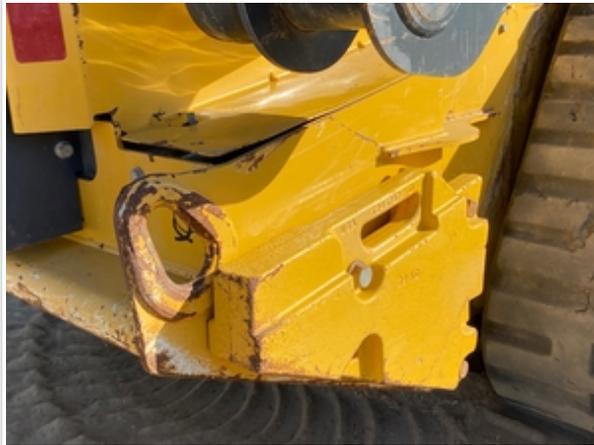
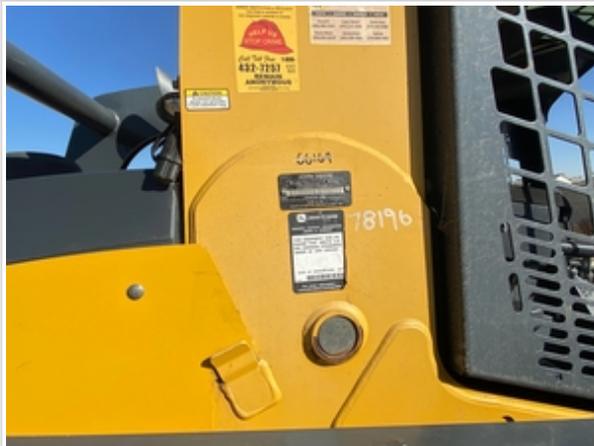
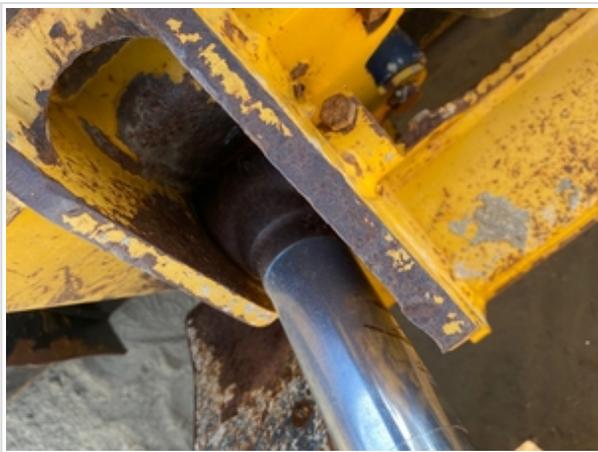
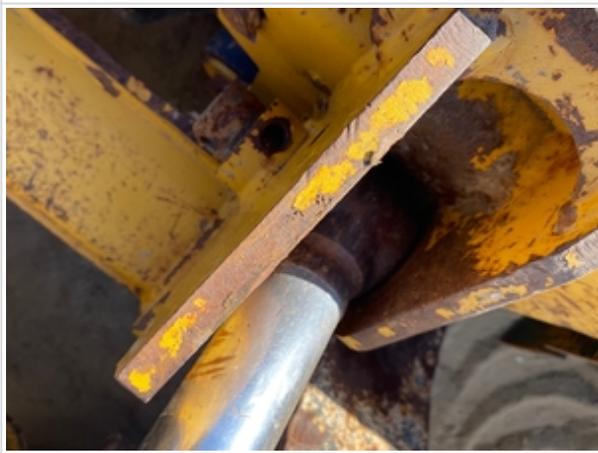
Frame	3 - Normal Wear & Tear
Frame Photos

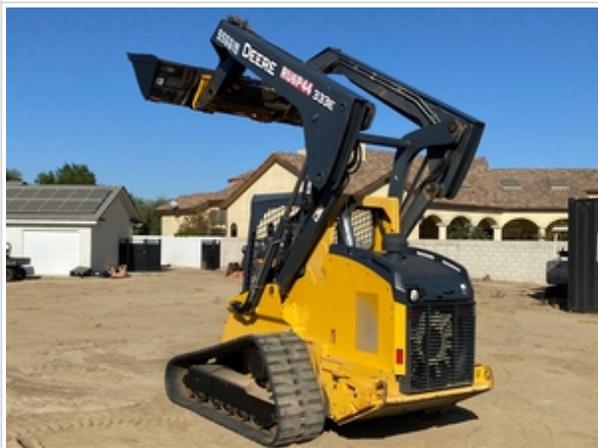
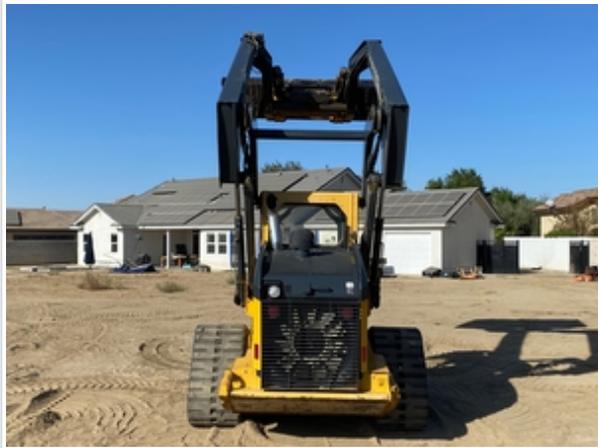
<p>Stance</p>	<p>3 - Normal Wear & Tear</p>	
<p>Stance Photos</p>

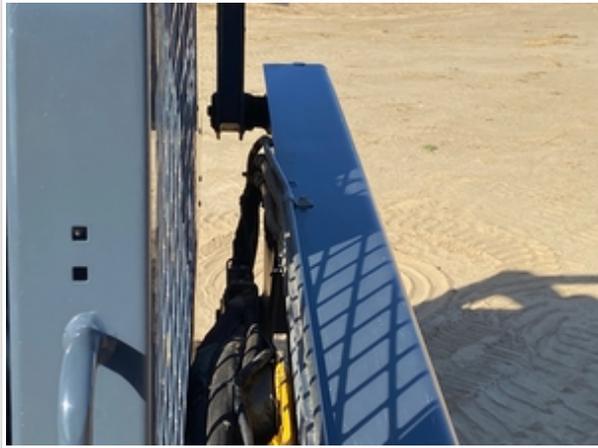
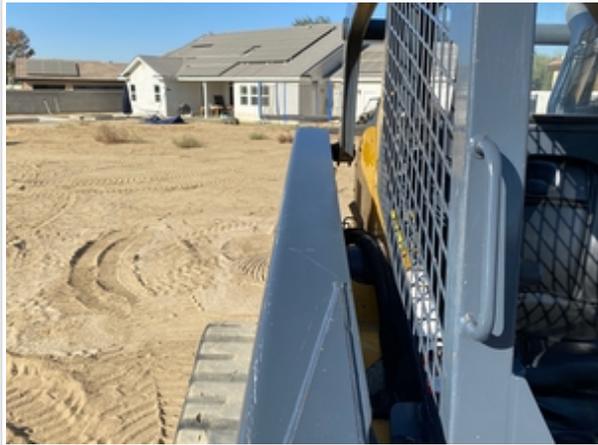
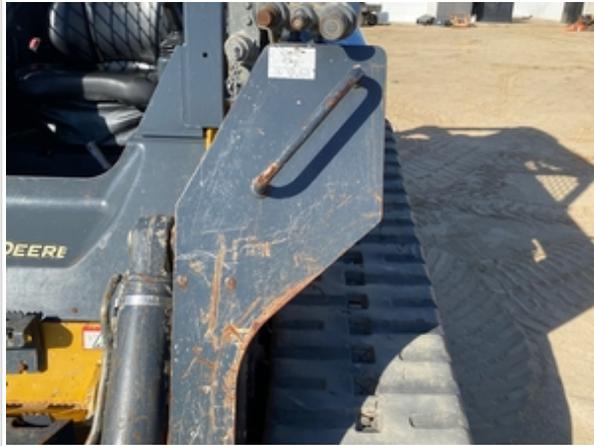
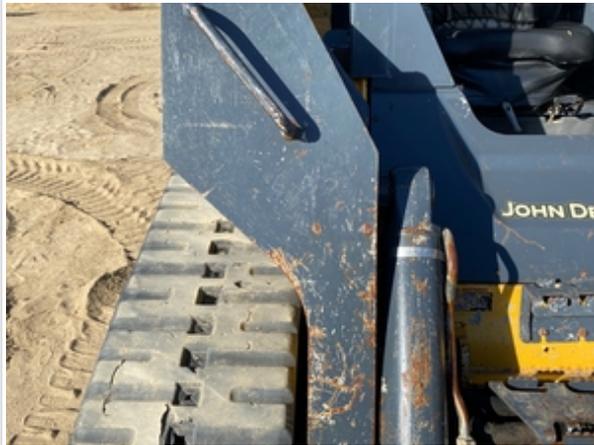
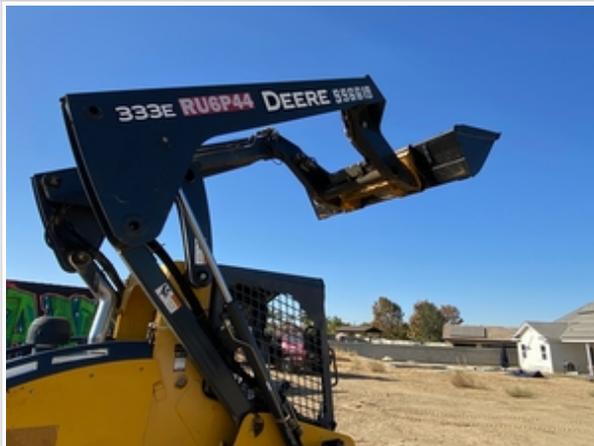
Lift Arm	3 - Normal Wear & Tear	
Lift Arm Photos

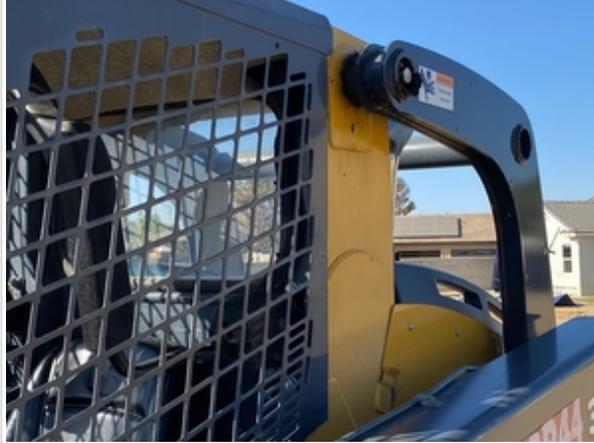
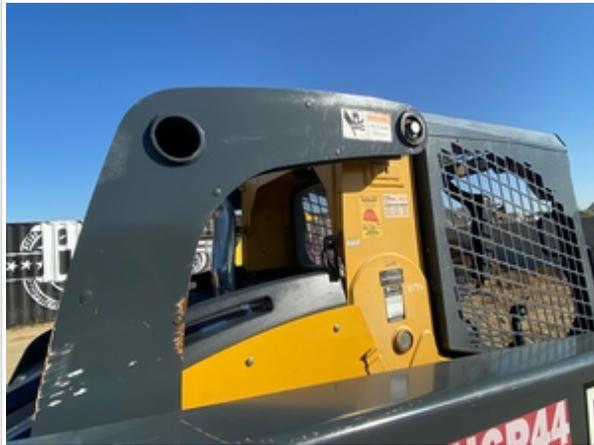
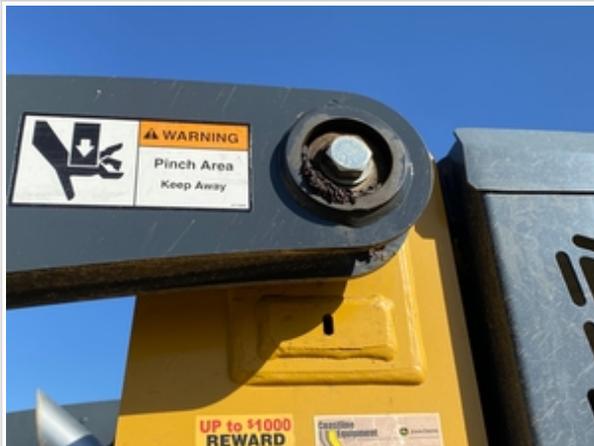
Chassis to Arm Pins Photos

Chassis to Arm Pins

3 - Normal Wear & Tear

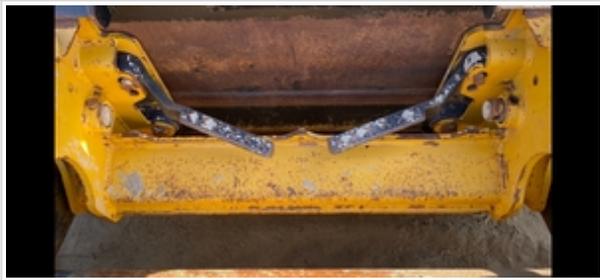
Quick Coupler	3 - Normal Wear & Tear	
Comments	Right side tilt cylinder pin to quick coupler loose	
Quick Coupler Photos

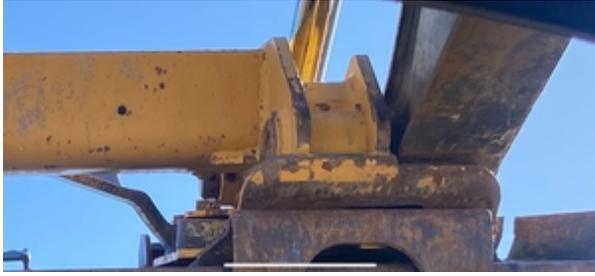
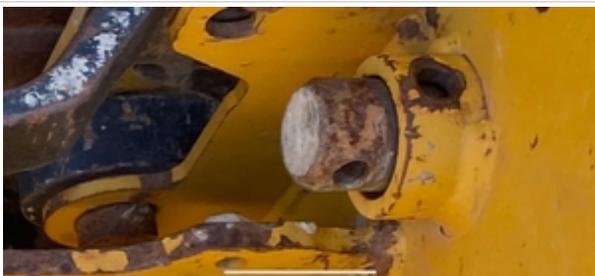
Quick Coupler to Arms Pins	2 - Above Average Wear
Comments	Right side pin needs attention
Quick Coupler to Arms Pins Photos

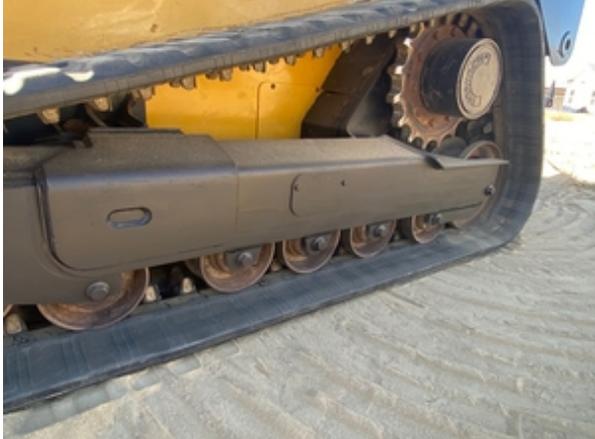
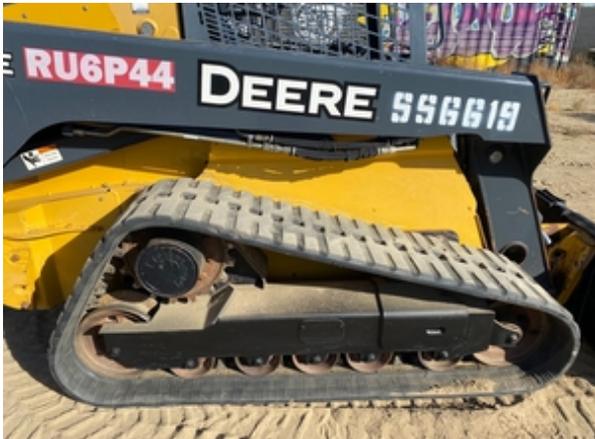
Roller Frames Photos

Roller Frames	3 - Normal Wear & Tear
---------------	------------------------

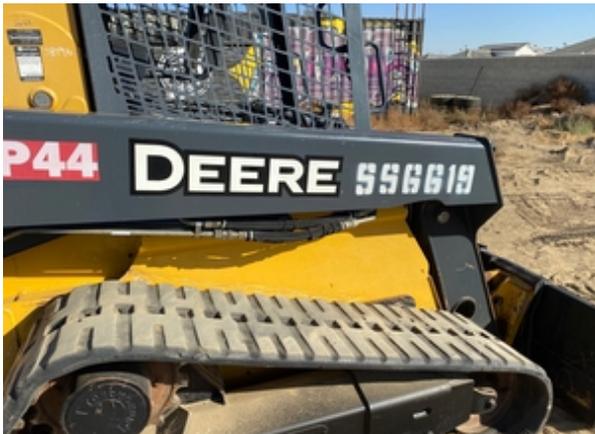
Track Belt	3 - Normal Wear & Tear
Comments	Track belts have less than 50% tread left
Track Belt Photos

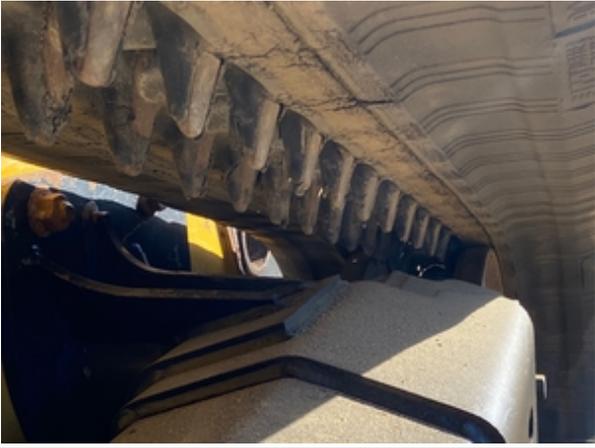
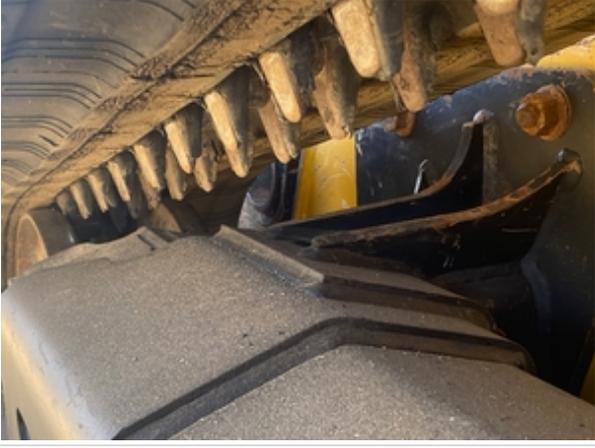
Rubber Belt Drive Lugs	3 - Normal Wear & Tear	
Rubber Belt Drive Lugs Photos

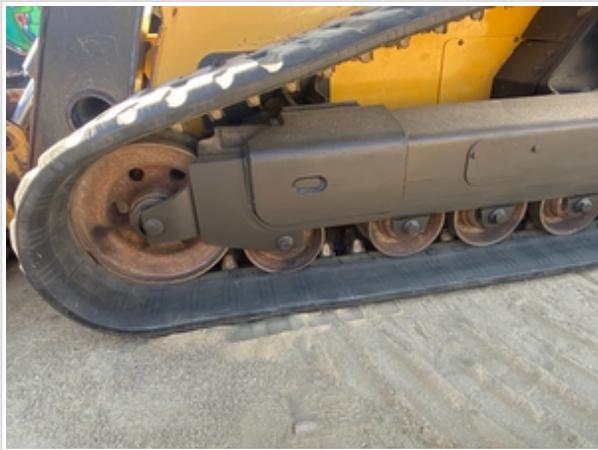
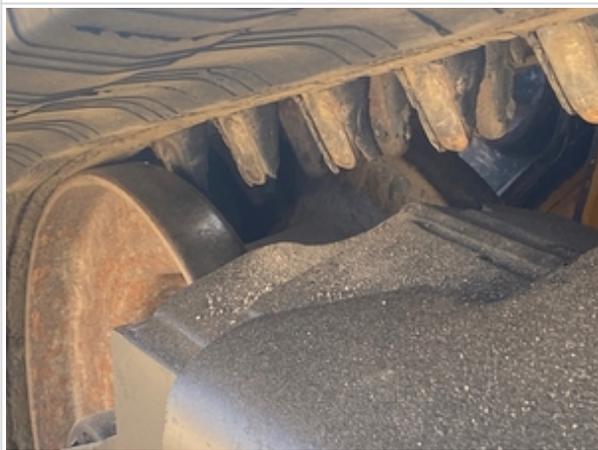
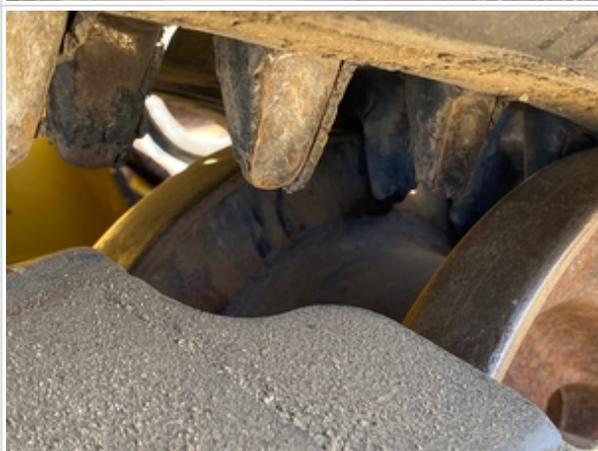
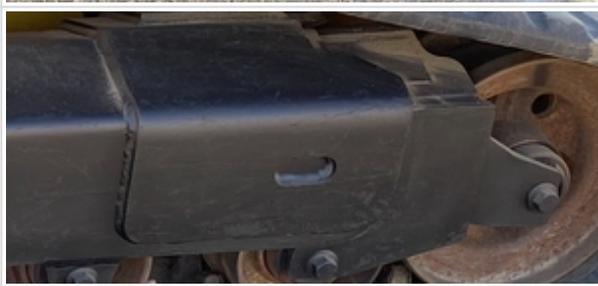
<p>Front Idlers Photos</p>

Track Tensioners	3 - Normal Wear & Tear	
Front Idlers	3 - Normal Wear & Tear

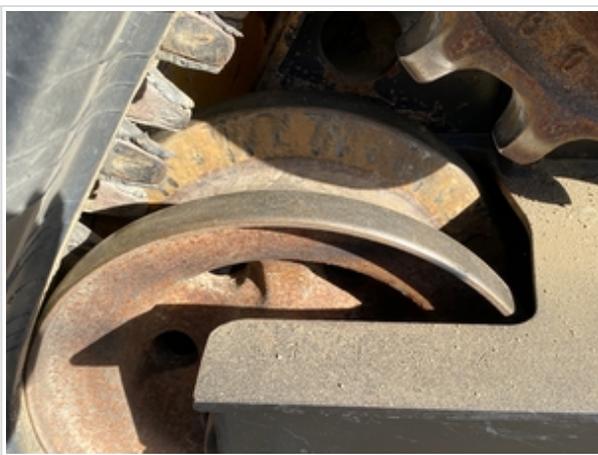
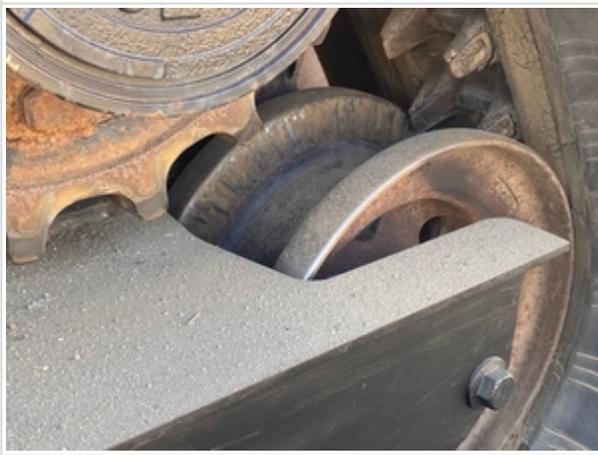
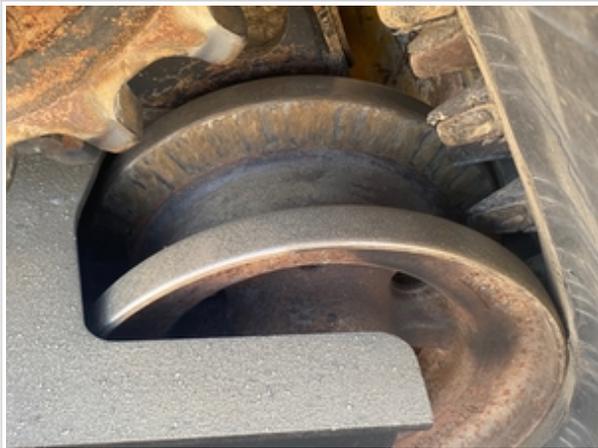
<p>Rear Idlers Photos</p>

<p>Rear Idlers</p>	<p>3 - Normal Wear & Tear</p>

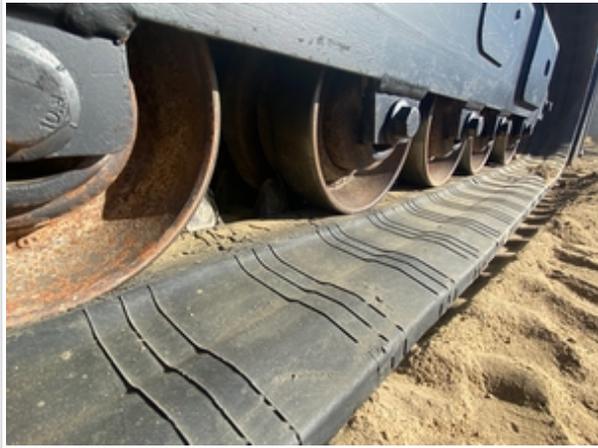
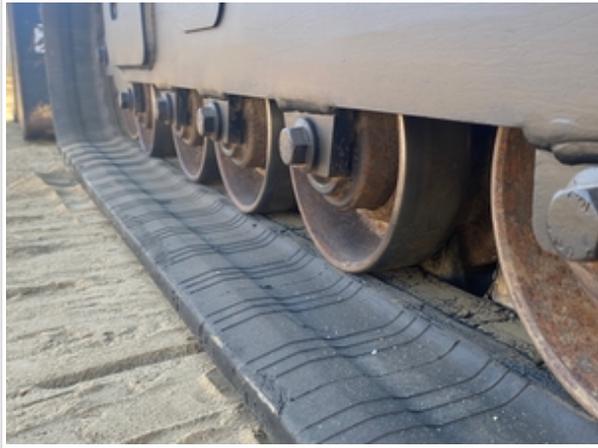
<p>Track Rollers</p>	<p>3 - Normal Wear & Tear</p>	
<p>Track Rollers Photos</p>

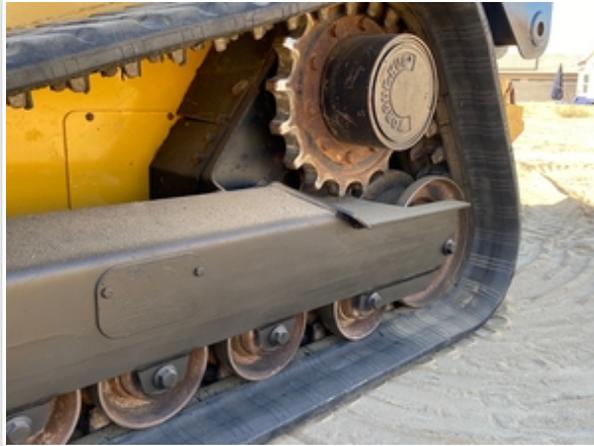
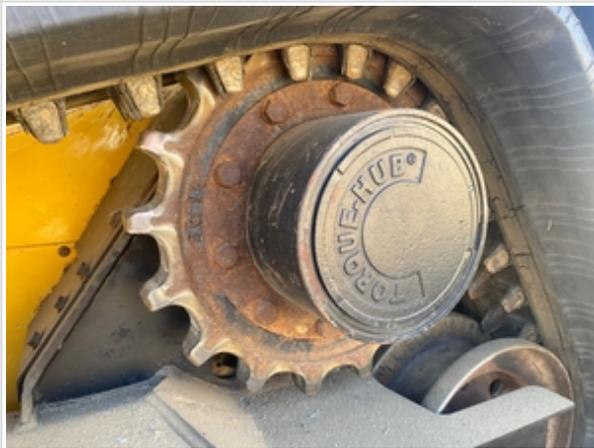
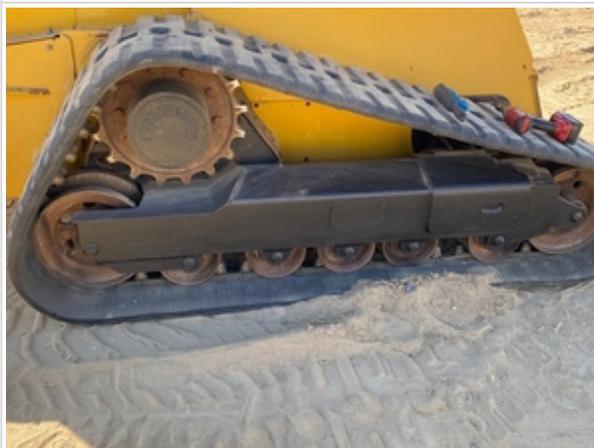
Sprockets Photos

<p>Sprockets</p>	<p>3 - Normal Wear & Tear</p>

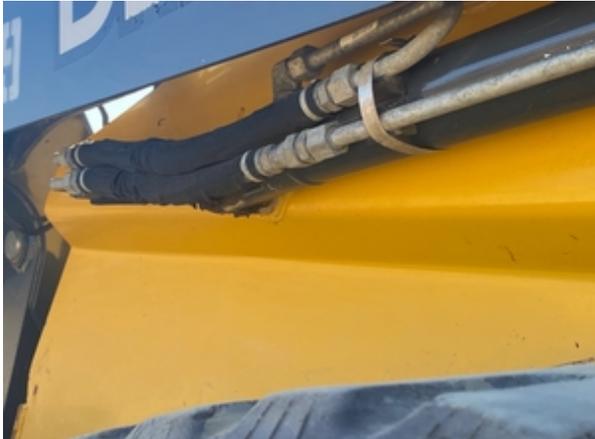
Wet or Damp Hydraulic Lines / Fittings	Yes
Appearance of Hydraulic Lines / Fittings	3
Hydraulic Lines / Fittings Condition	Hydraulic lines & fittings are clean and in good condition
Appearance of Hydraulic Lines / Fittings Photos

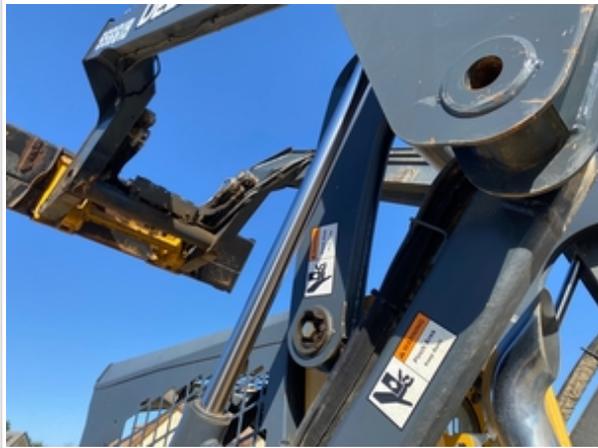
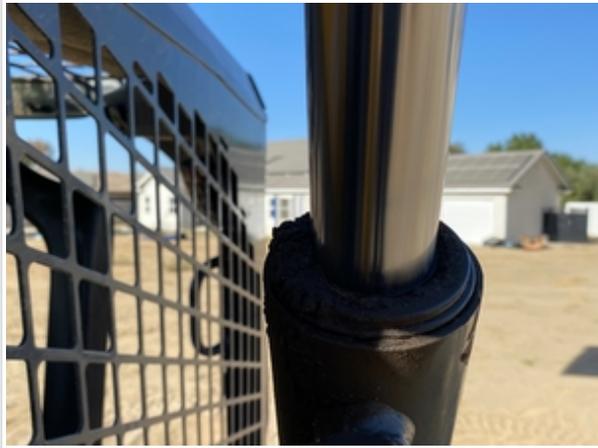
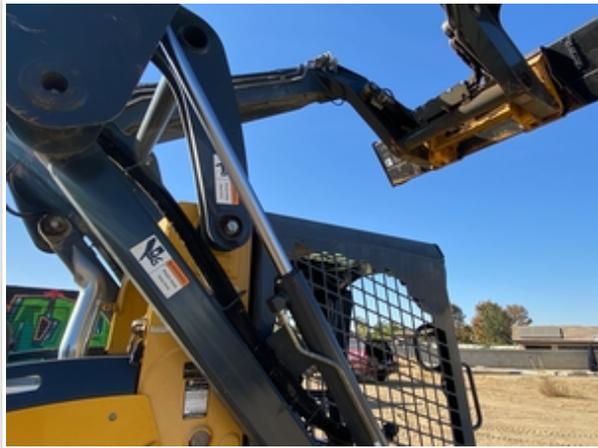
Lift Cylinder	Check the lift cylinder. Note any wear, pitting, discoloration, etc. Take photos.
Lift Cylinder: Mounting Pin	3
Lift Cylinder: Oil Leaks	Yes
Comments	Right side lift cylinder showing signs of seepage, oil dirt buildup, (no active leaks seen)
Lift Cylinder Photos
