Inspection Report (Compact Track Loader)

Year	2016
Make	John Deere
Model	333E
Serial Number	296619
Hour Meter Reading	1,335
Previous Application (e.g., earth moving, mining, demolition, etc)	Pipeline / Electrical Construction

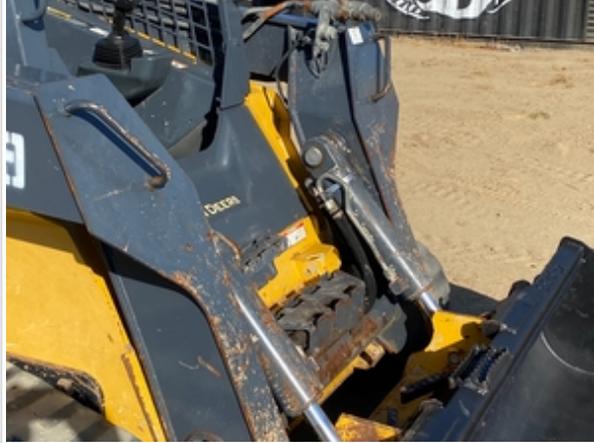
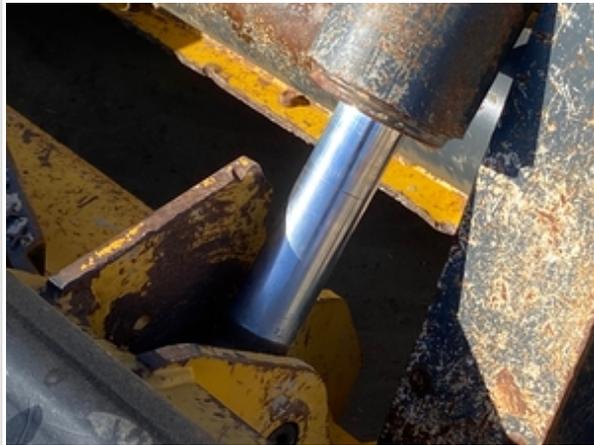
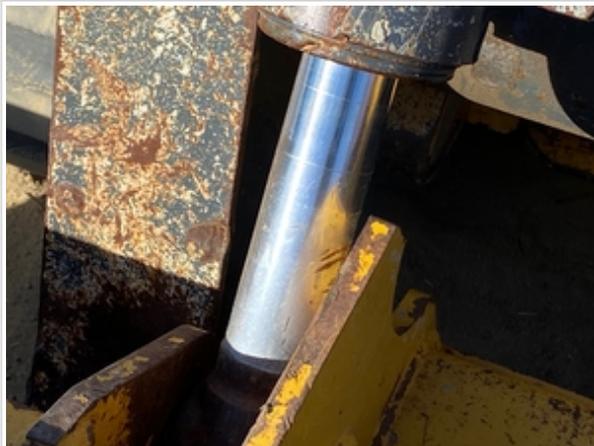
Bucket Cylinder Photos

Bucket Cylinder	Check the bucket cylinder. Note any wear, pitting, discoloration, etc. Take photos.
Bucket Cylinder: Mounting Pin	3
Bucket Cylinder: Oil Leaks	No

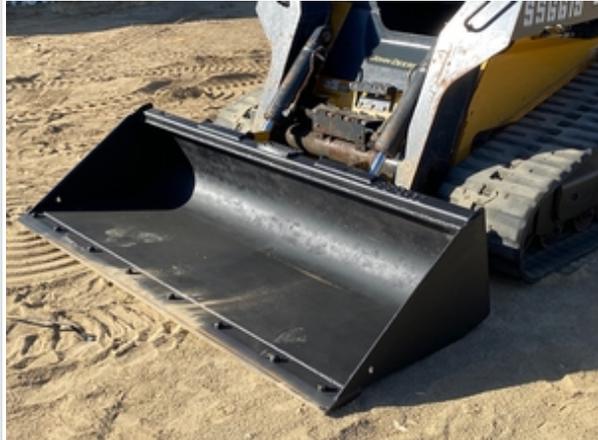
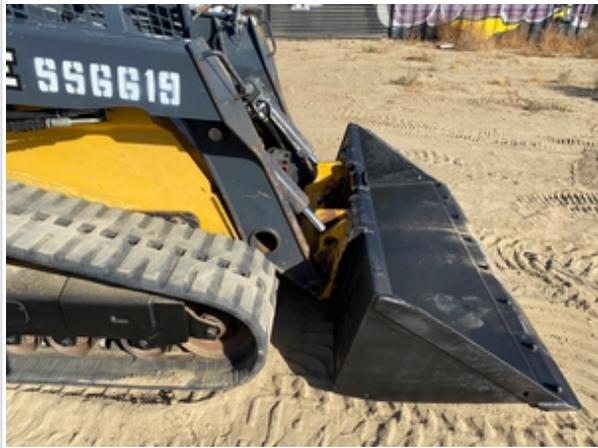
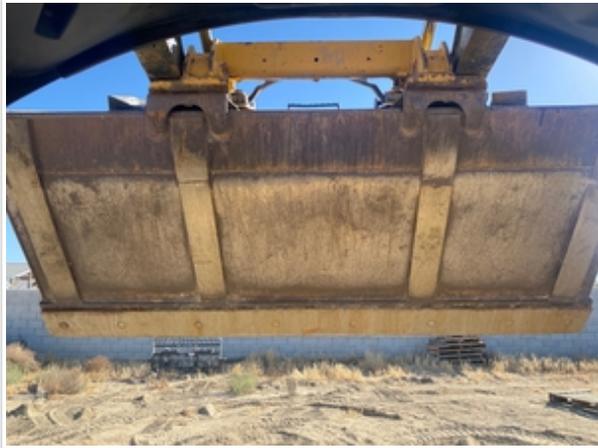
Bucket	3 - Normal Wear & Tear
Bucket Photos
