## Inspection Report (Compact Track Loader)

Year	2015
Make	John Deere
Model	333E
Serial Number	279331
Hour Meter Reading	1,704
Previous Application (e.g., earth moving, mining, demolition, etc)	Pipeline / Electrical Construction

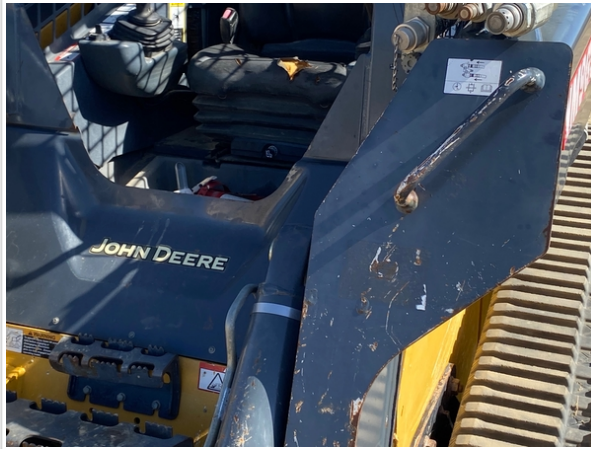
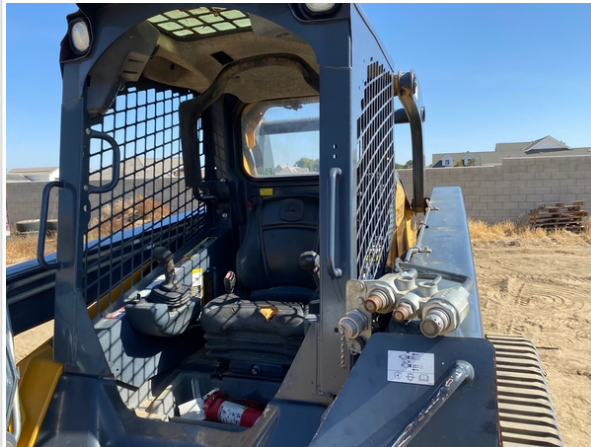
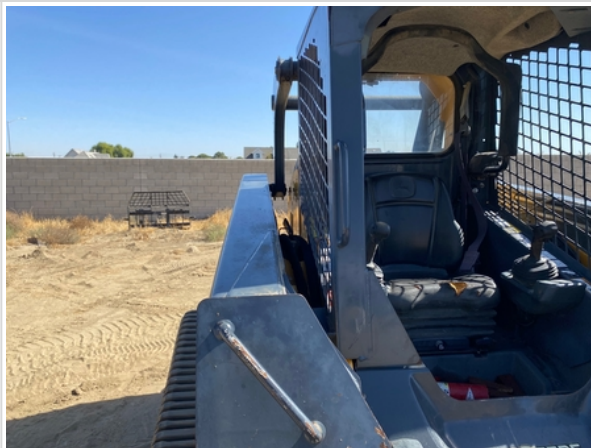
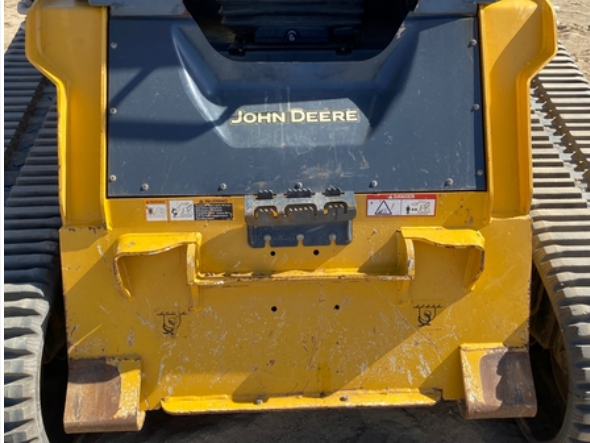
Front	3 - Normal Wear & Tear
Front Condition	No visible damage
Front Photos

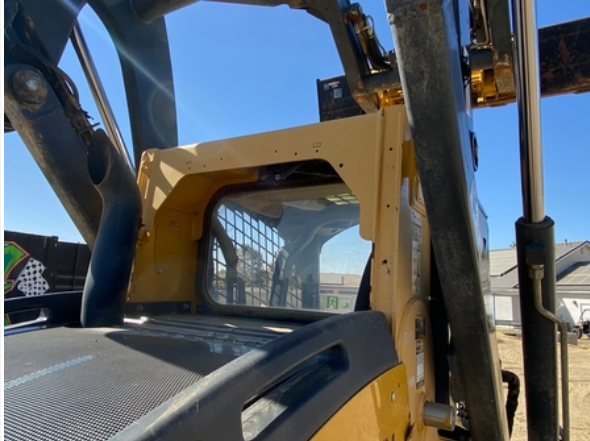
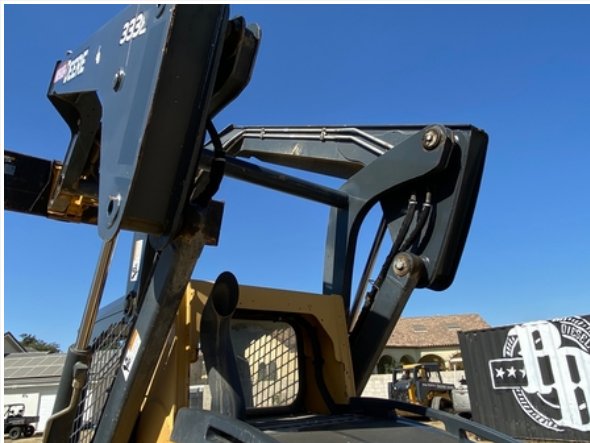
Rear	3 - Normal Wear & Tear	
Rear Condition	No visible damage	
Rear Photos

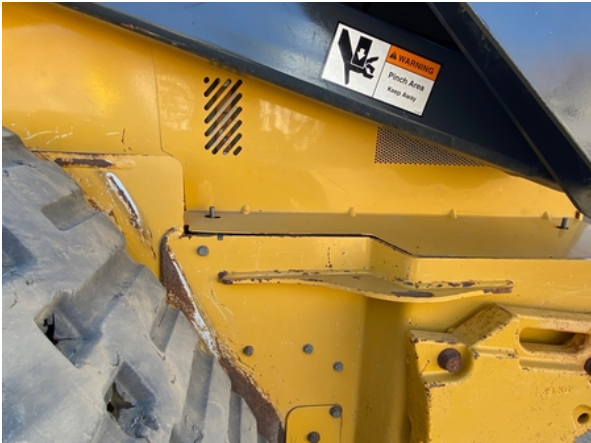
<b>Left</b>	3 - Normal Wear & Tear
<b>Left Condition</b>	No visible damage
<b>Left Photos</b>

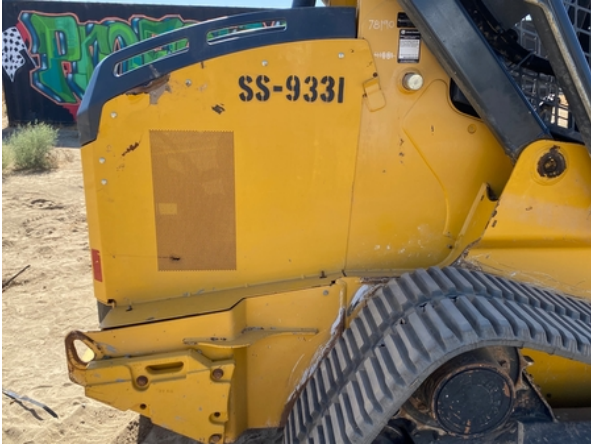
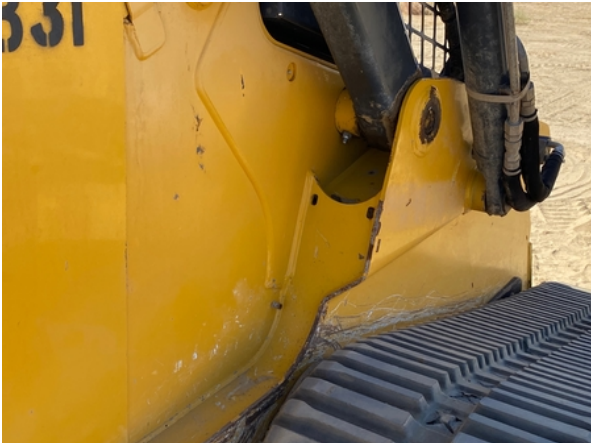
<b>Right</b>	3 - Normal Wear & Tear
<b>Right Condition</b>	No visible damage
<b>Right Photos</b>

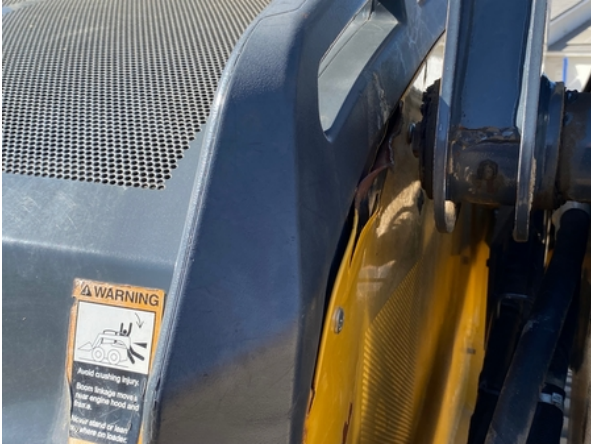
<b>Body Panels (Any Rust Damage?)</b>	3 - Normal Wear & Tear
<b>Body Panel Condition</b>	Some panel misalignment observed, Visible chipped paint or dents, Other (see comments)
<b>Comments</b>	Rear engine body panels bent on top side and slightly misaligned
<b>Body Panels Photos</b>

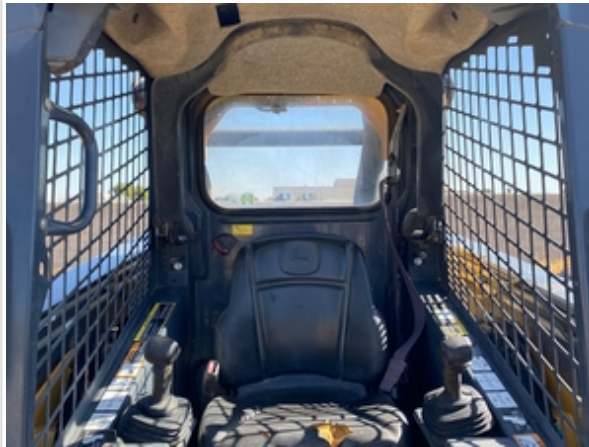
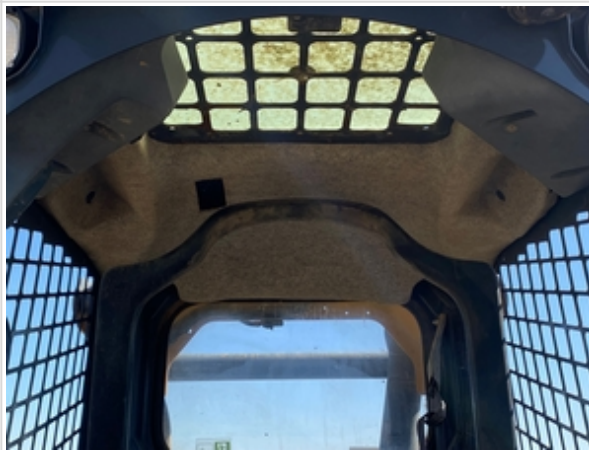
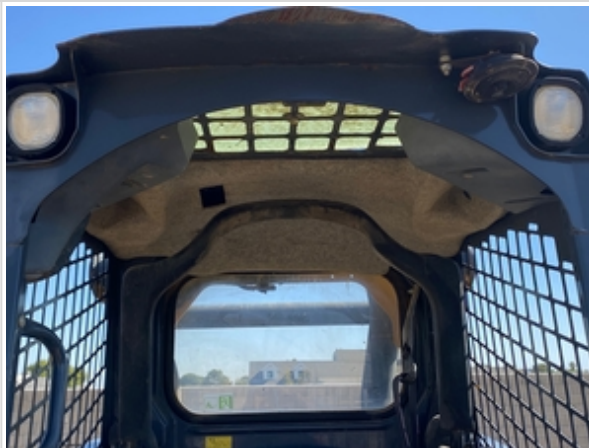
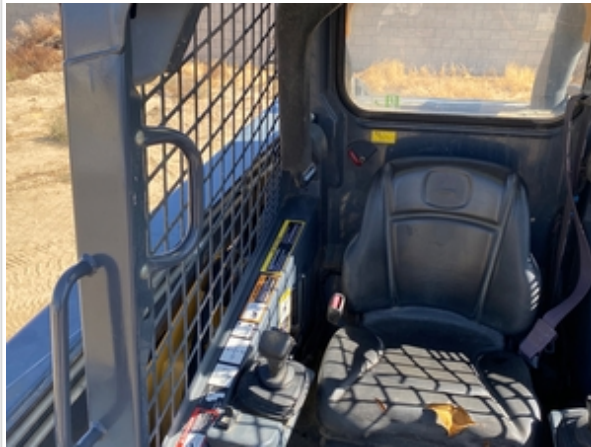
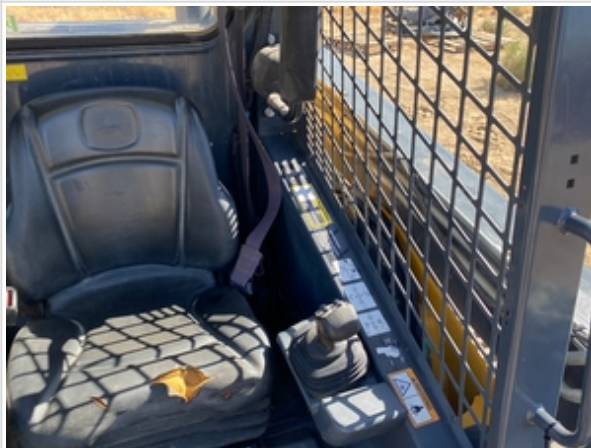
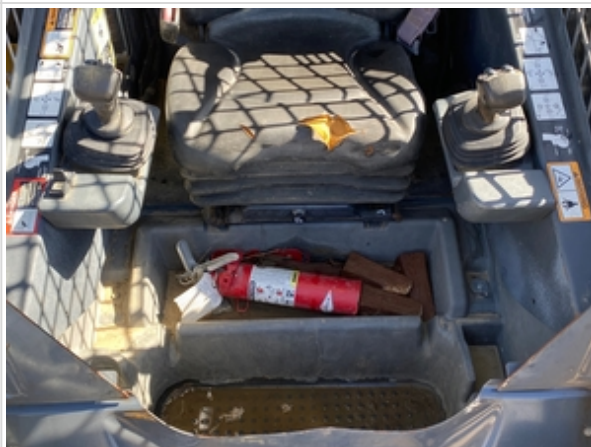
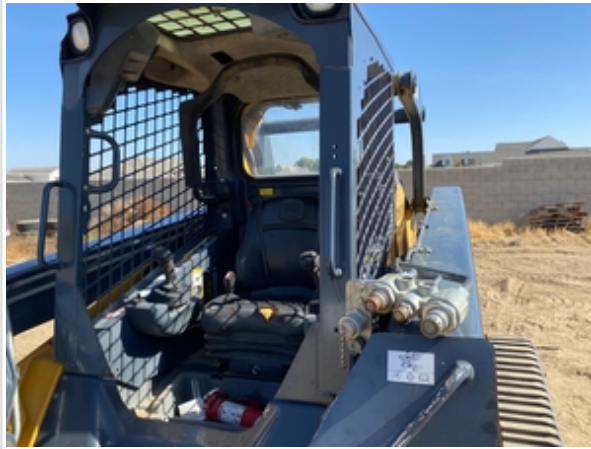
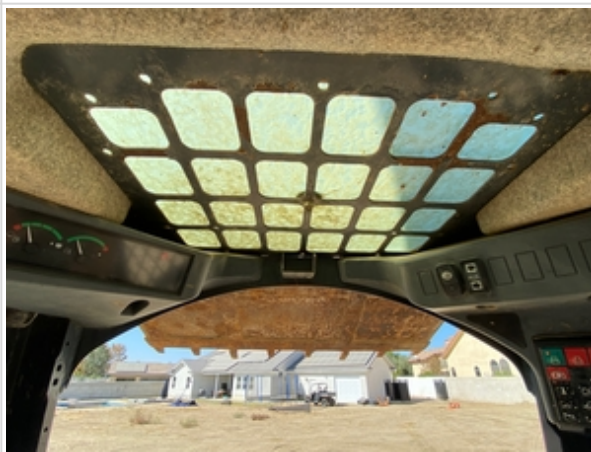
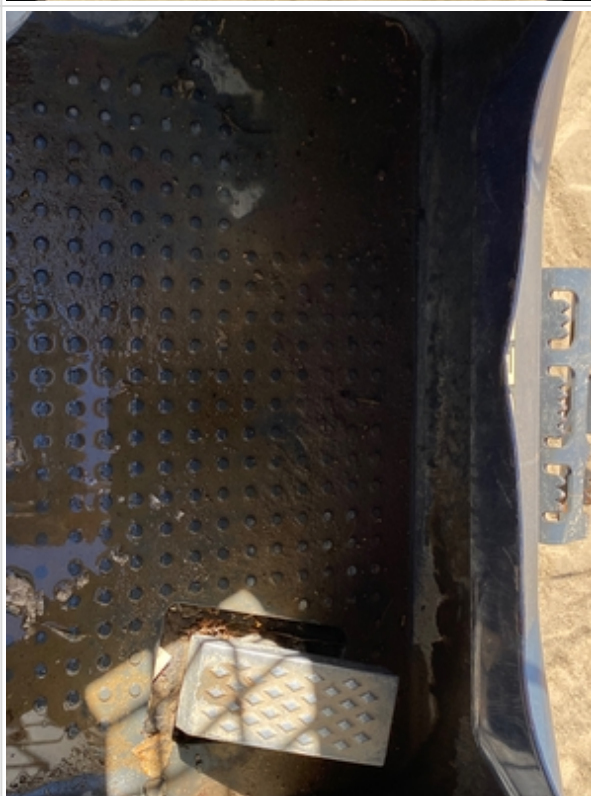
Operator Cabin Photos

Serial Number Plate Photo	 
Operator Cabin Overall	3 - Normal Wear & Tear
Operator Cabin Overall Condition	Good cabin appearance, solid floors, panels, and ceiling

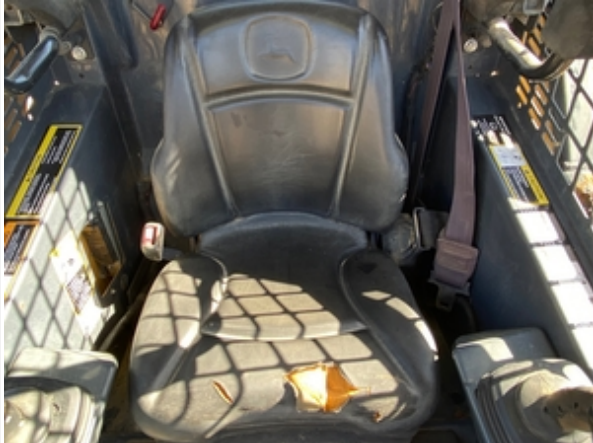
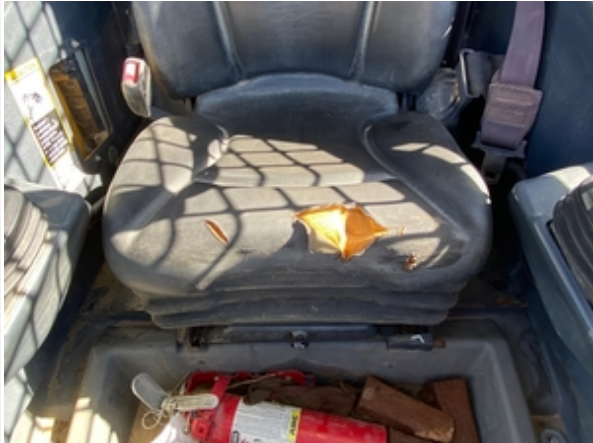
Operator's Seat & Arm Rests	3 - Normal Wear & Tear
Operator's Seat & Arm Rests Condition	Seat(s) have minor surface staining or small tears
Operator's Seat & Arm Rests Photos

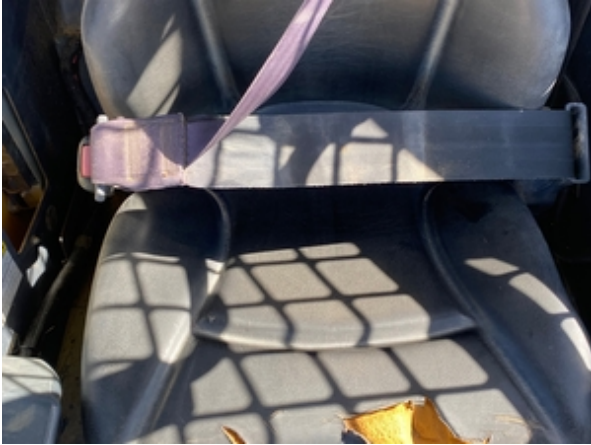
<b>Seat Belt Photos</b>

Seat Belt	3 - Normal Wear & Tear
Seat Belt Condition	Seat belt secures properly. Belt is intact and in good condition

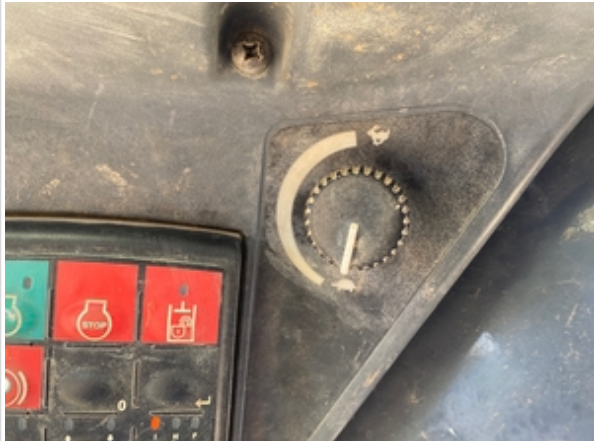
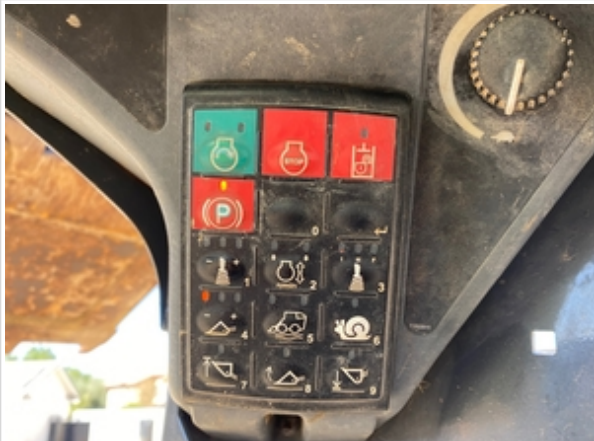
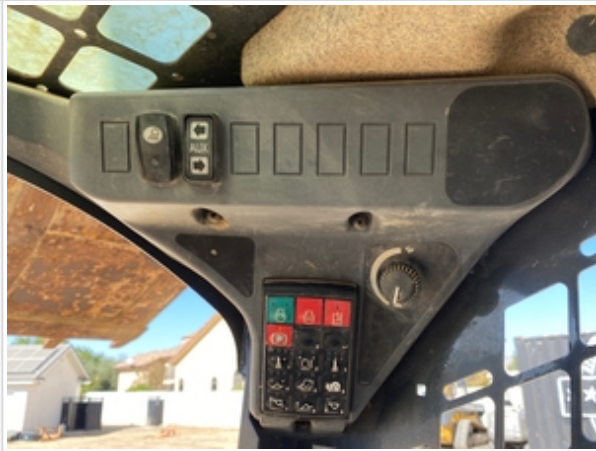
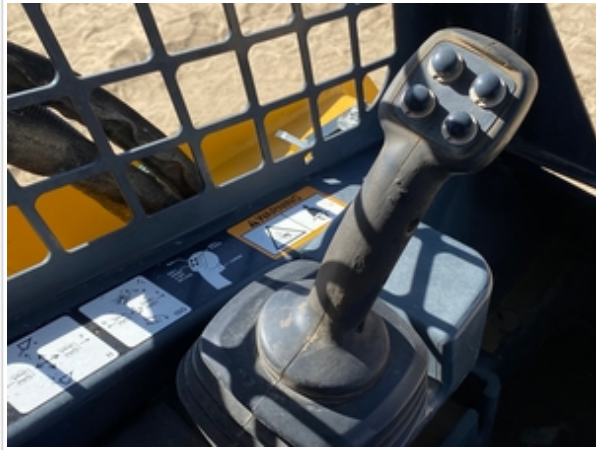
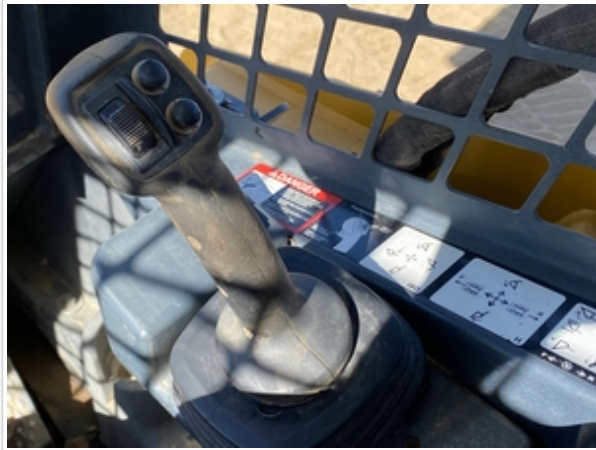
<b>Controls &amp; Switches</b>	3 - Normal Wear & Tear
<b>Controls &amp; Switches Condition</b>	All switches are installed and functional
<b>Controls &amp; Switches Photos</b>

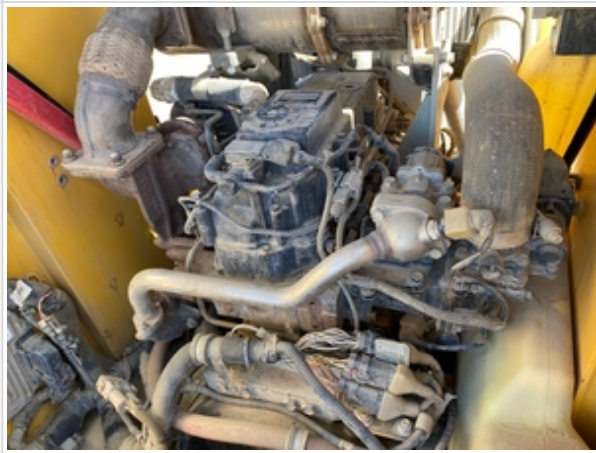
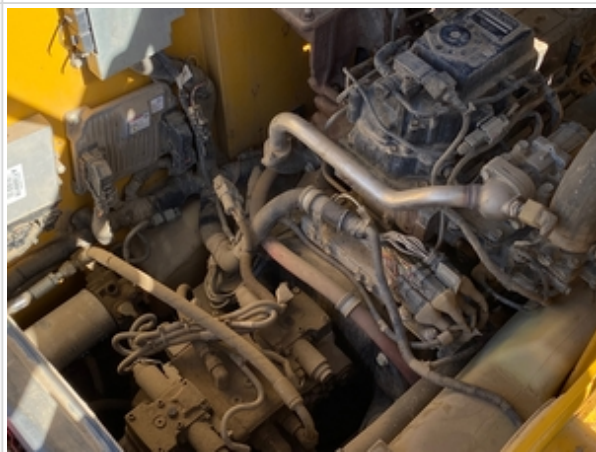
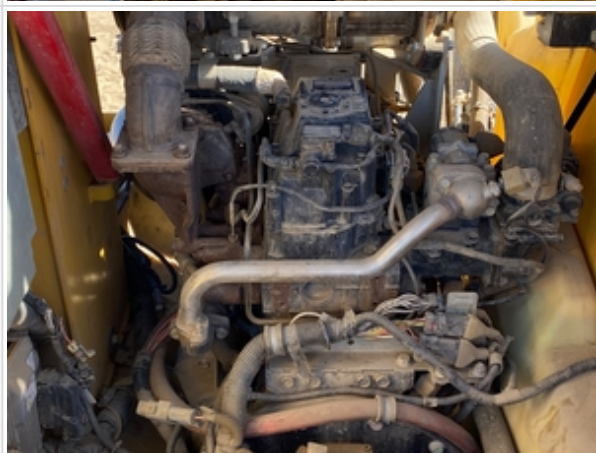
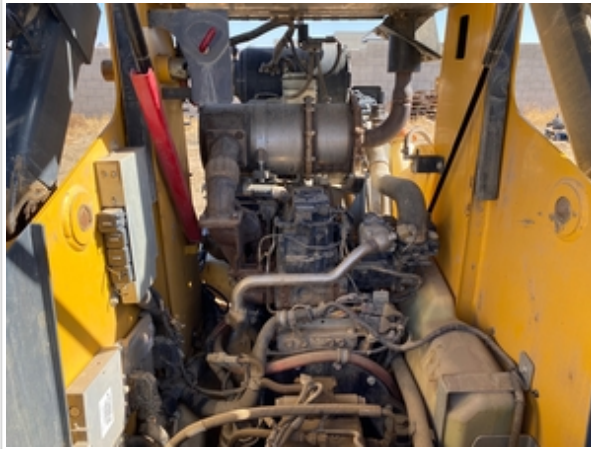
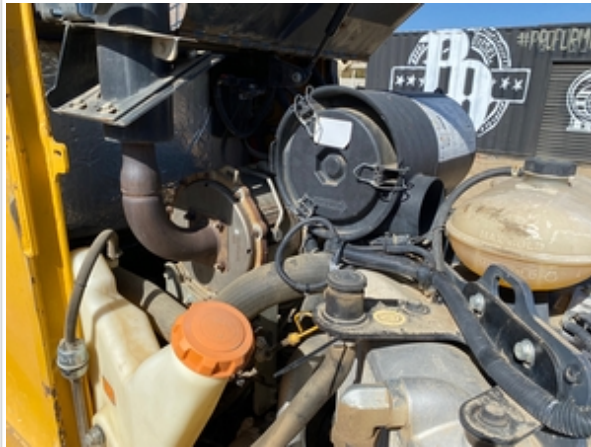
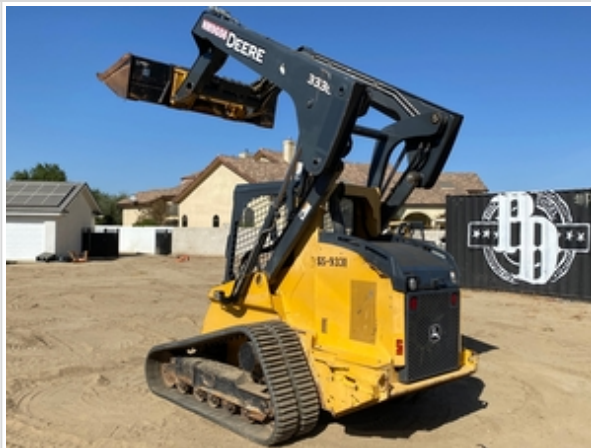
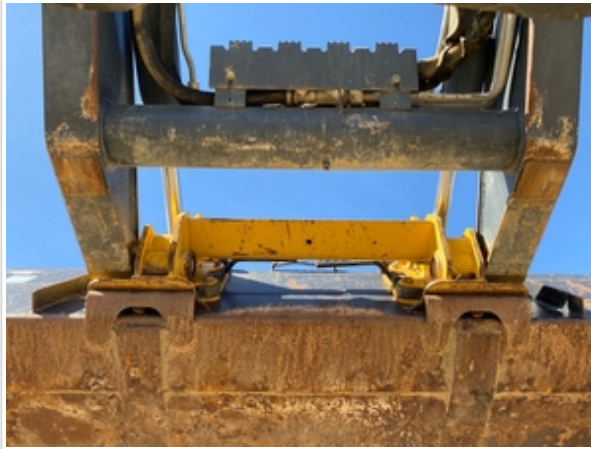
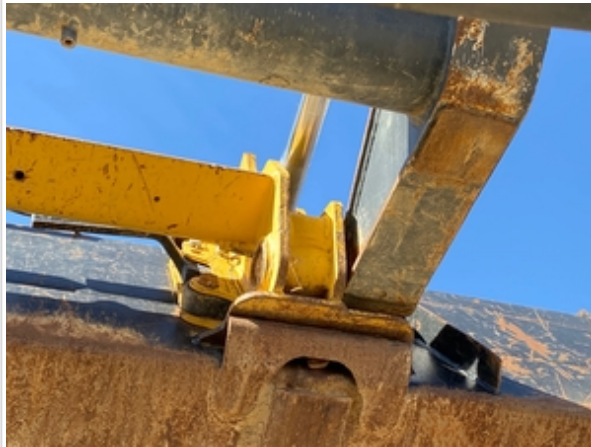
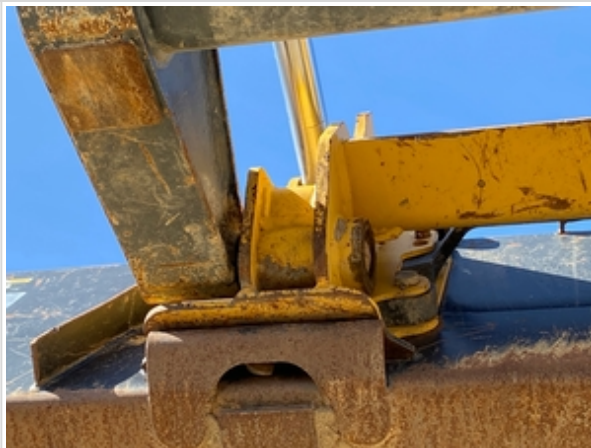
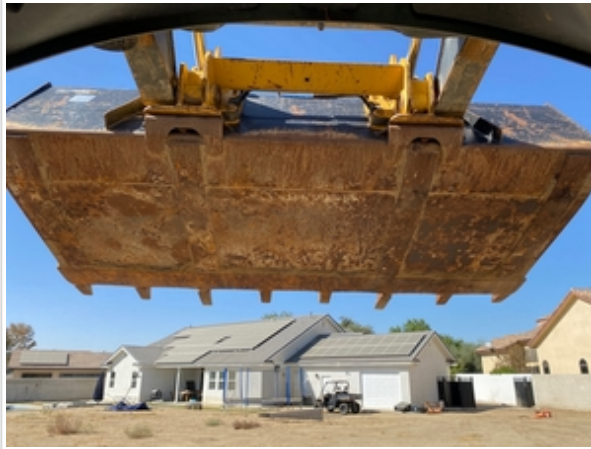
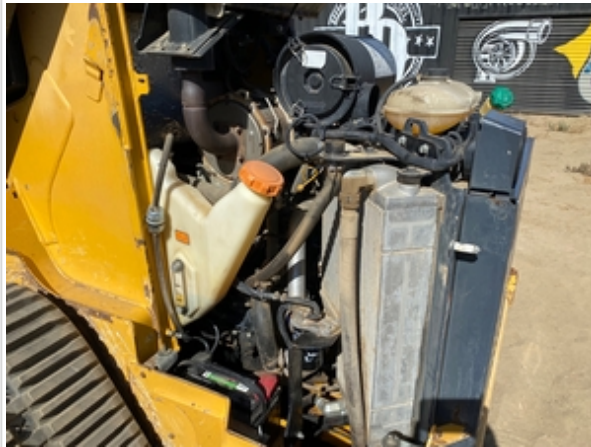
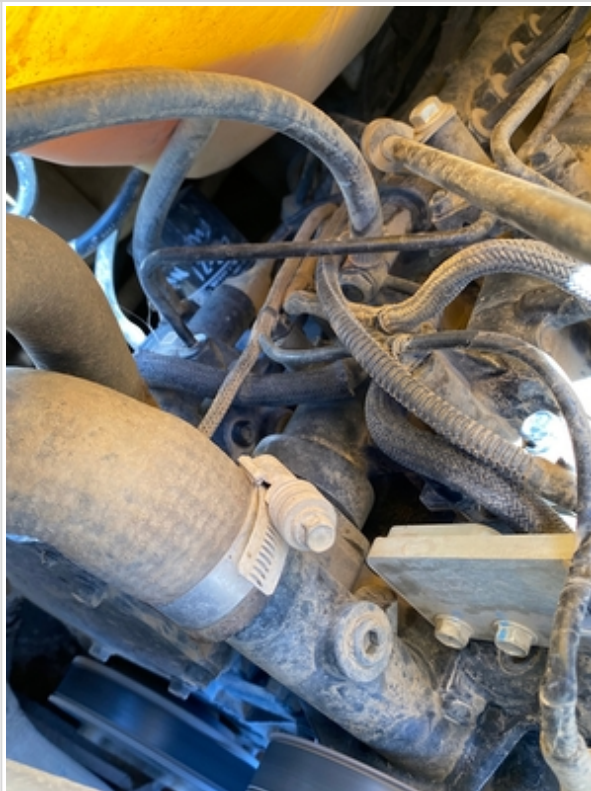
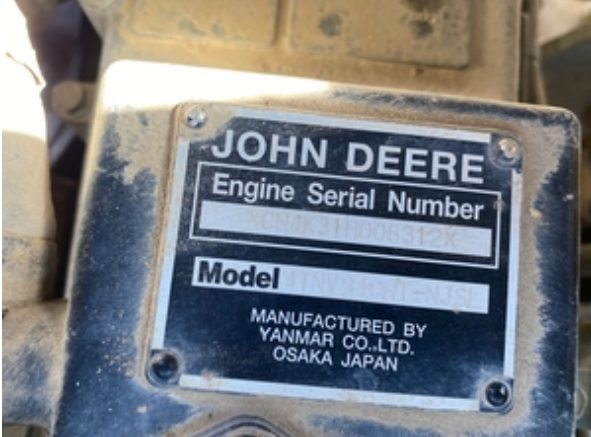
Engine Fuel Type	Diesel
Engine Photos

<b>Overall Engine Comments</b>	Overall engine well maintained, sounds healthy and no active leaks found. Engine has been serviced periodically as needed. Check engine light observed 3719.16, related to DPF filter being restricted.
--------------------------------	---

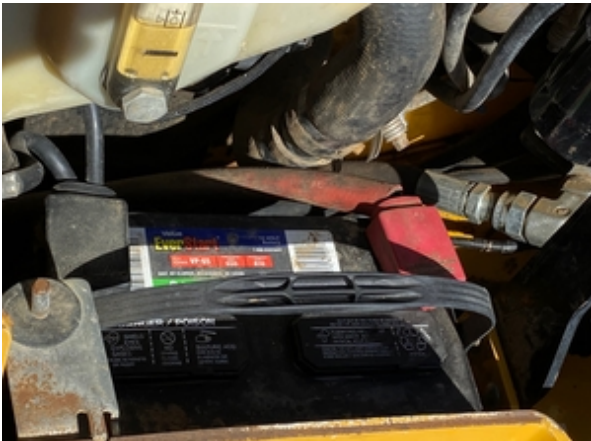
Blow-by (Visual Observation Check)	No
Unusual Noises (Upon Start-up, Idle, Shutdown)	No
Unusual Noise Notes	No unusual noises heard
Engine Smoke (Upon Start-up, Idle, Shutdown)	No
Engine Smoke Notes	No engine smoke issues observed
Engine Exhaust Color	Clear
Battery	3 - Normal Wear & Tear
Battery Condition	Like new, recently replaced
Battery Condition Photos

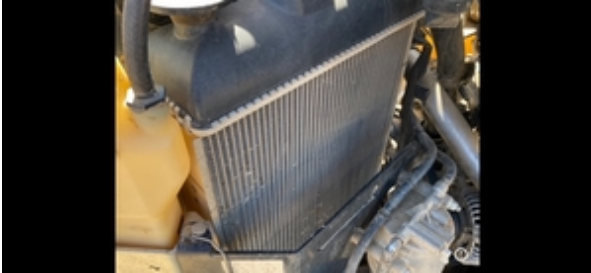
Radiator Photos

Radiator	3 - Normal Wear & Tear
Radiator Condition	Radiator fins & components appear to be in good working order, no signs of damage or leaks

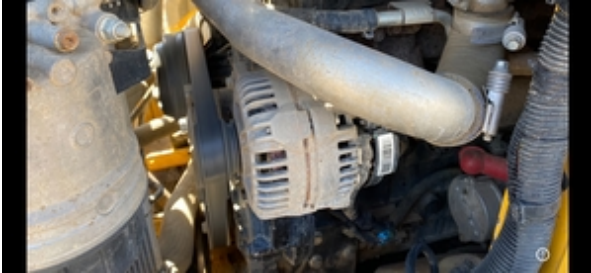
Belts	3 - Normal Wear & Tear
Belt Condition	Belts appear in good condition & alignment with proper tension
Belt Photos

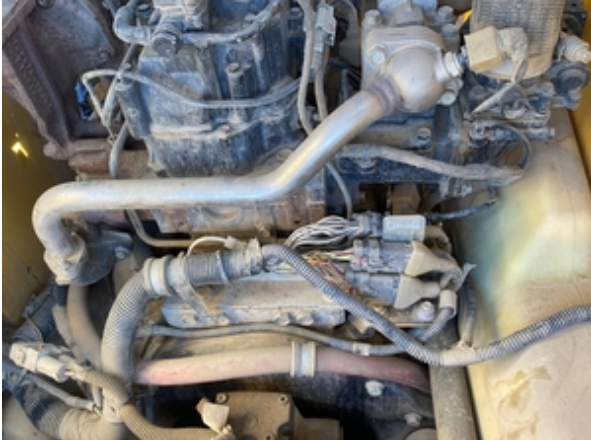
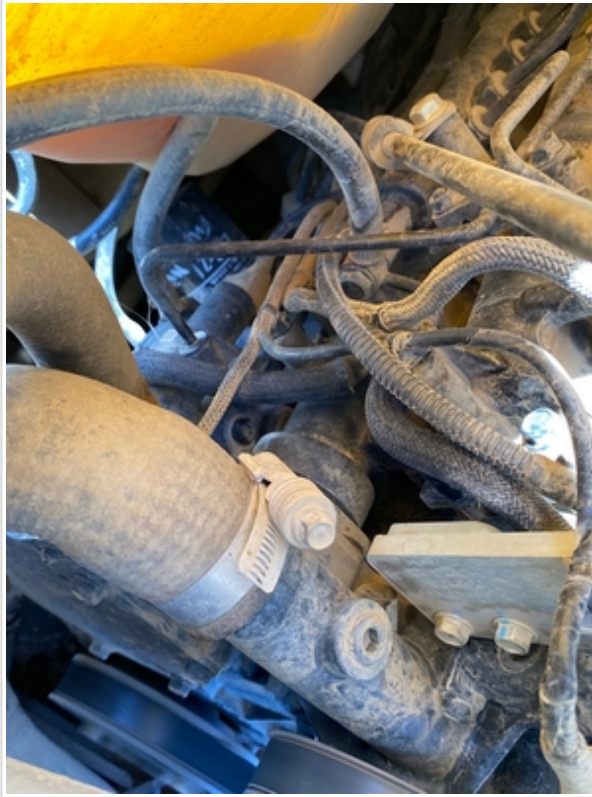
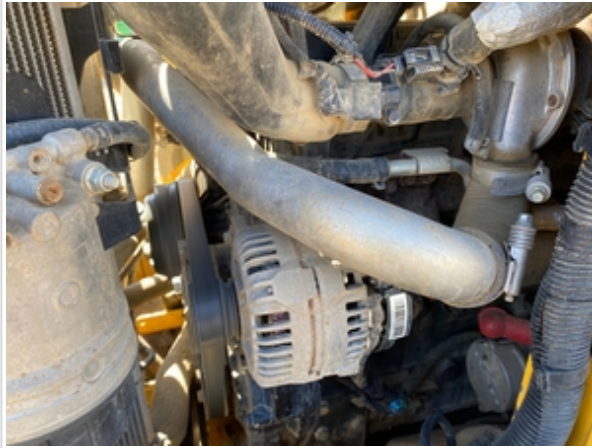
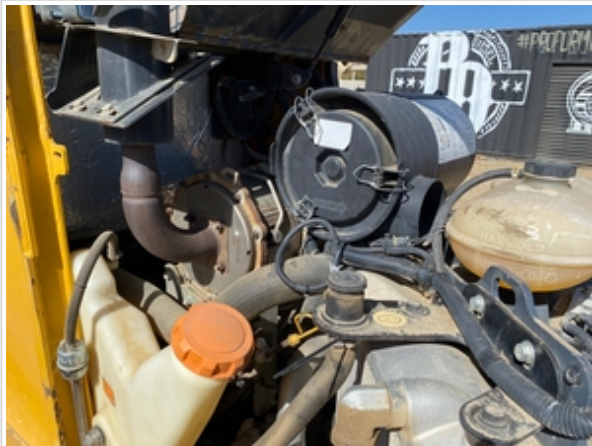
Hoses	3 - Normal Wear & Tear
Hose Condition	Firm, pliant hoses with no signs of wear or leaks
Hose Photos

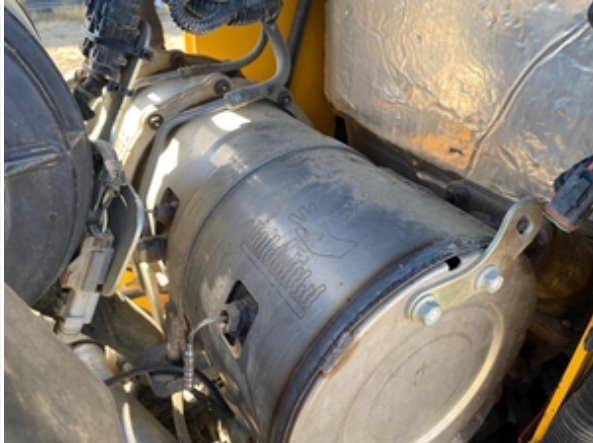
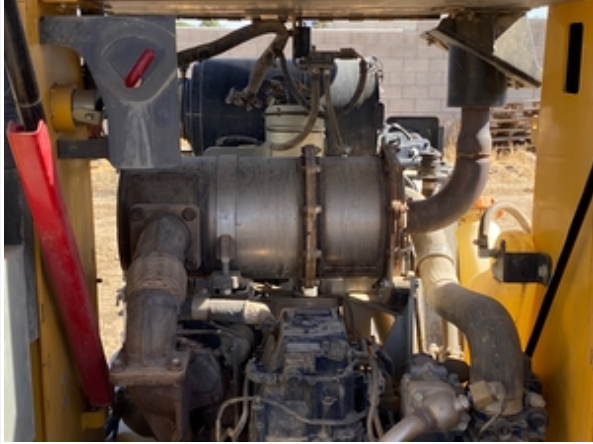
Water Pump	3 - Normal Wear & Tear
Water Pump Condition	No unusual pump noises heard
Cooling System Leaks	No
Coolant Color / Appearance	3 - Normal Wear & Tear
Coolant Color/Appearance Notes	Normal Translucent appearance, no visual signs of contamination
Oil Leaks	No
Oil Color / Appearance	3 - Normal Wear & Tear
Oil Color / Appearance Notes	Clean oil appearance, no signs of cross contamination, Appropriate oil level
Fuel Leaks	No
Equipped with DPF (Diesel Particulate Filter)	Yes
DPF Condition	3 - Normal Wear & Tear
DPF Condition Notes	Filter housing is intact with no signs of damage or malfunction, DPF indicator is not illuminated
DPF Photos

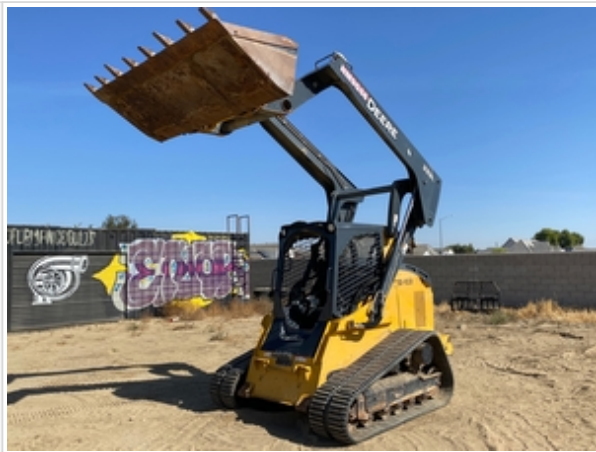
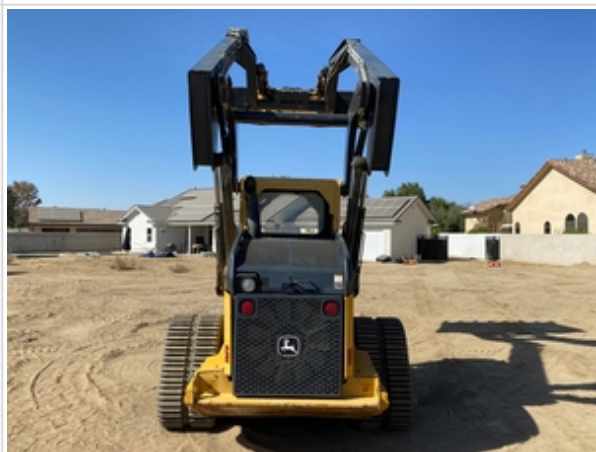
<p>Stance Photos</p>

<p><b>Stance</b></p>	<p>3 - Normal Wear &amp; Tear</p>

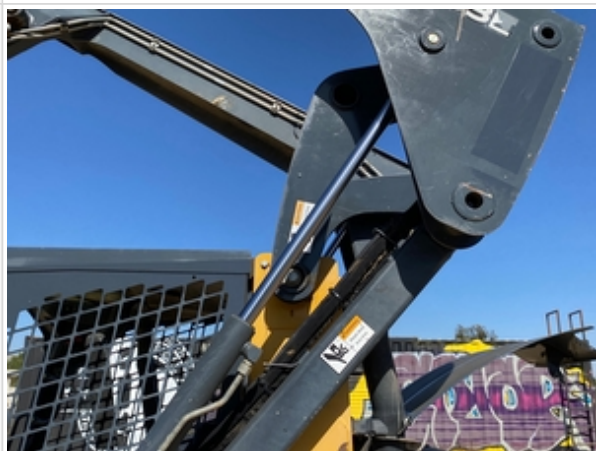
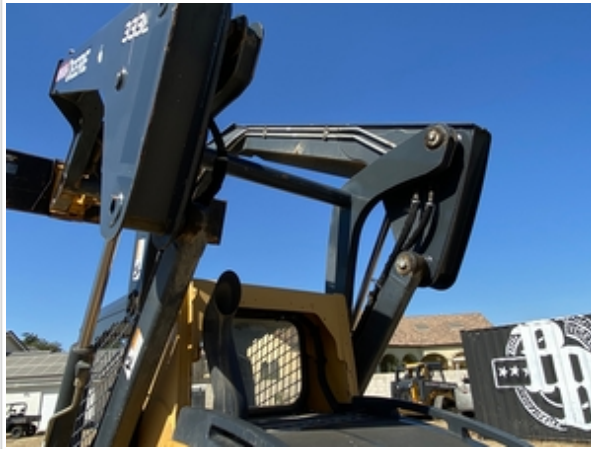
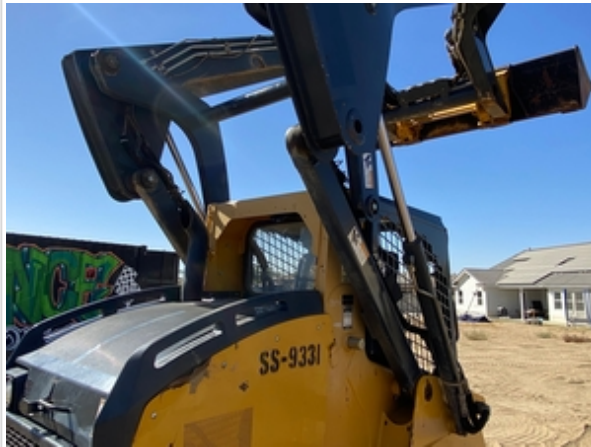
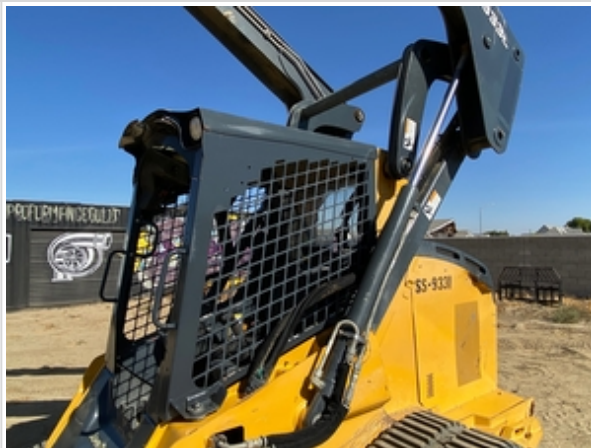
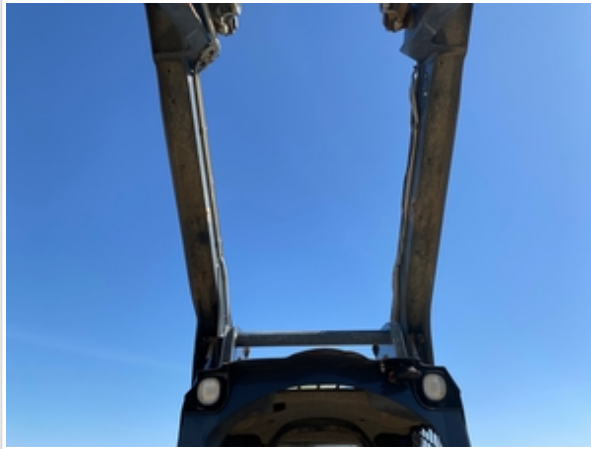
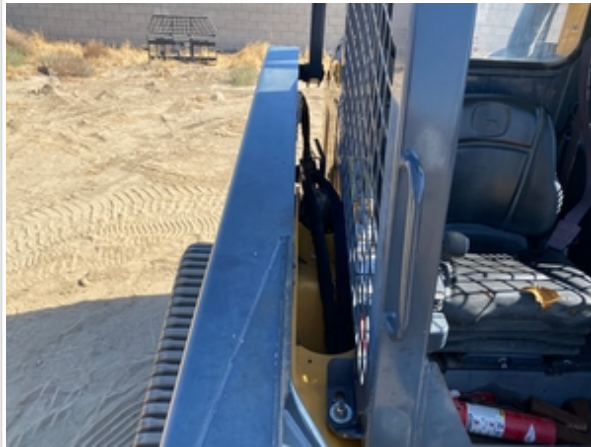
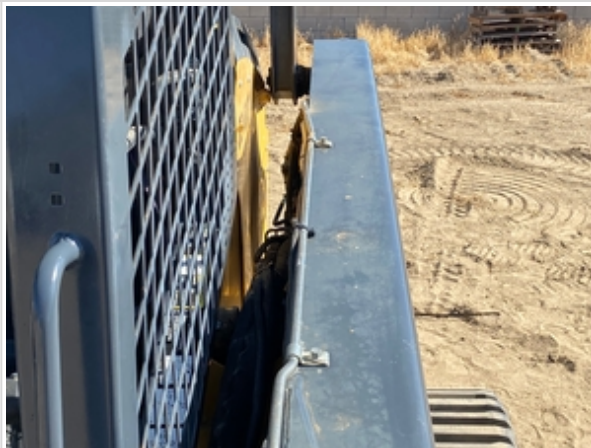
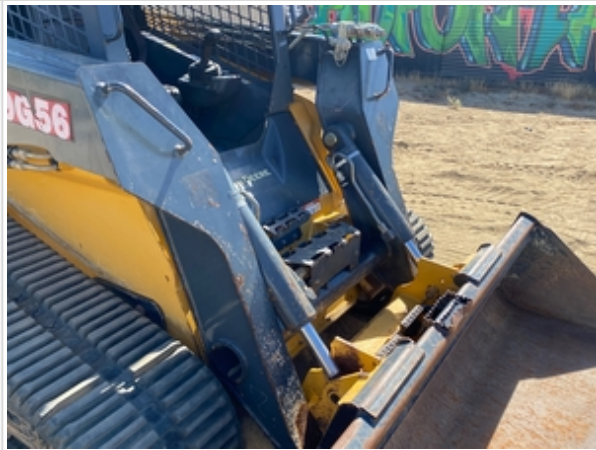
<p>Lift Arm</p>	<p>3 - Normal Wear &amp; Tear</p>
<p>Lift Arm Photos</p>

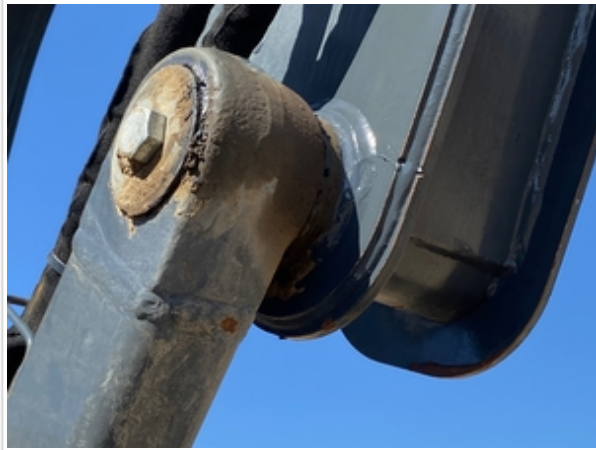
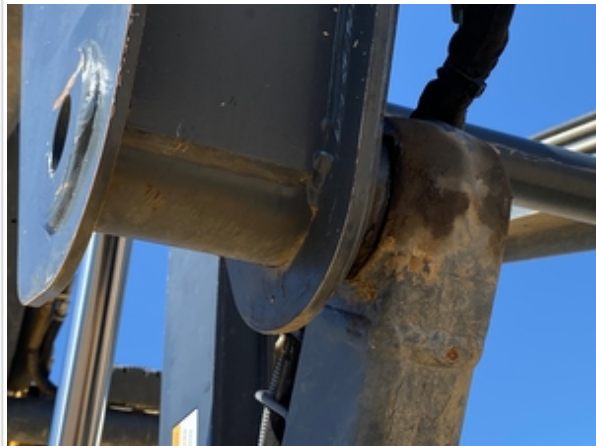
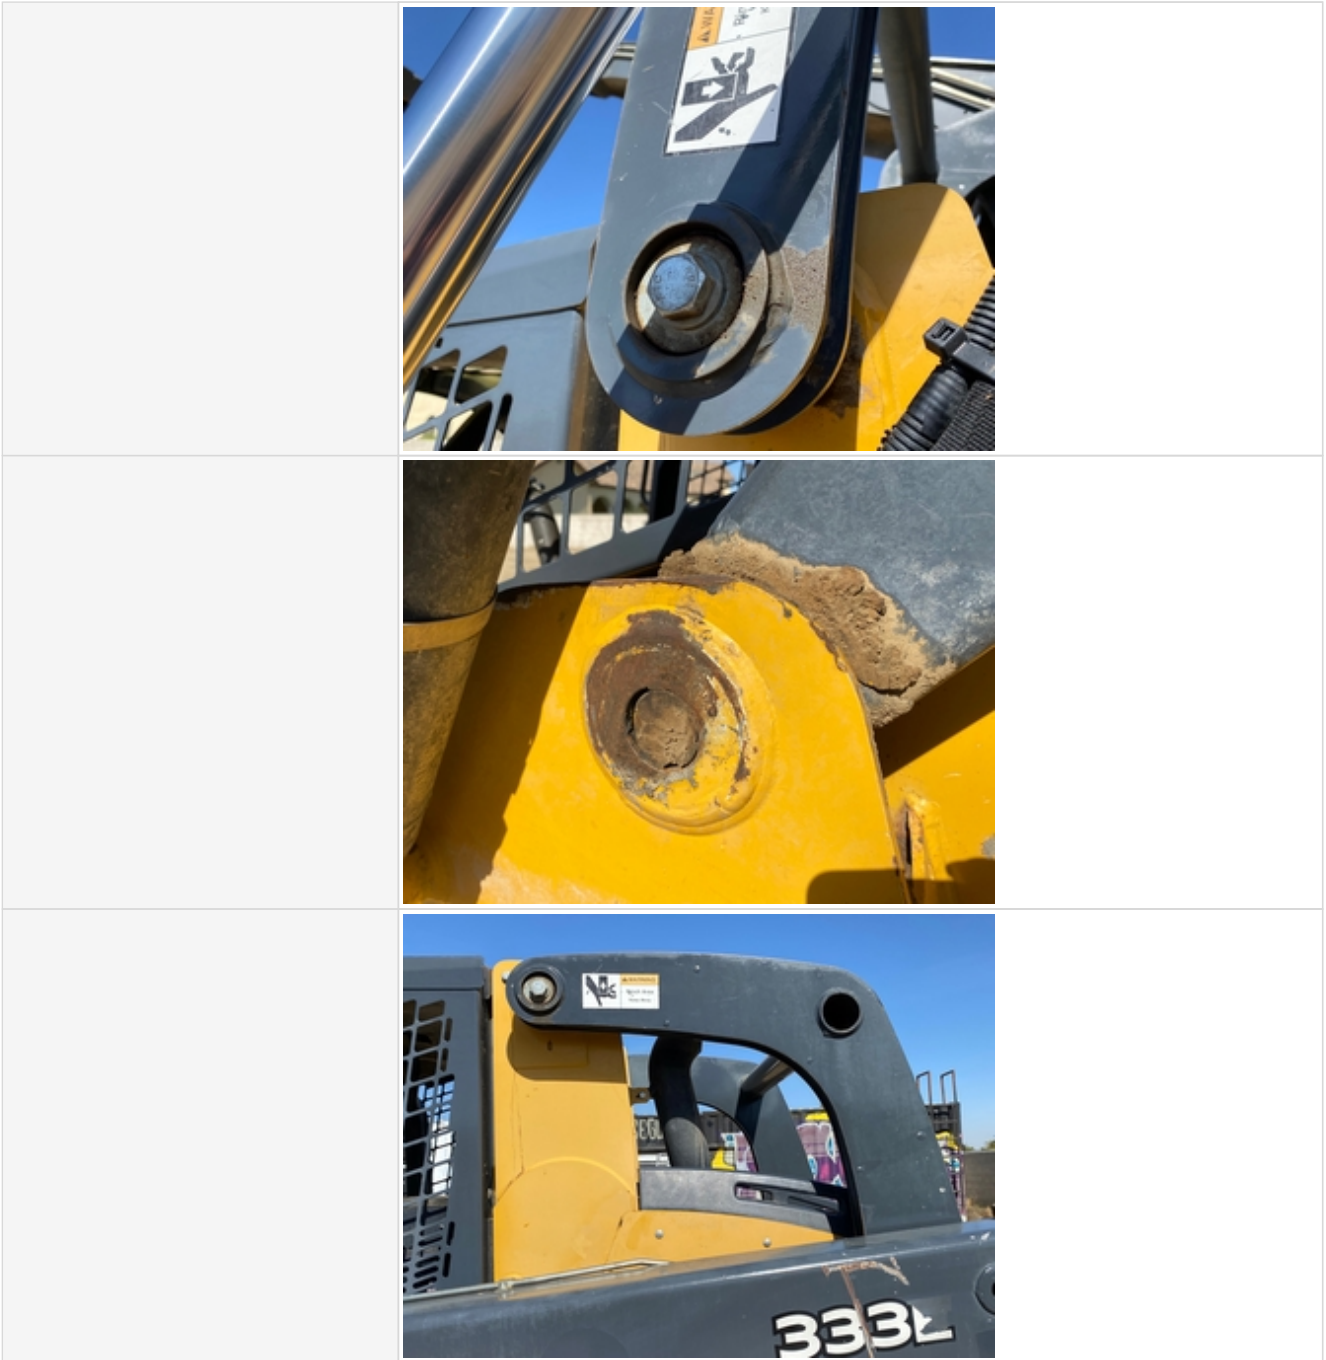
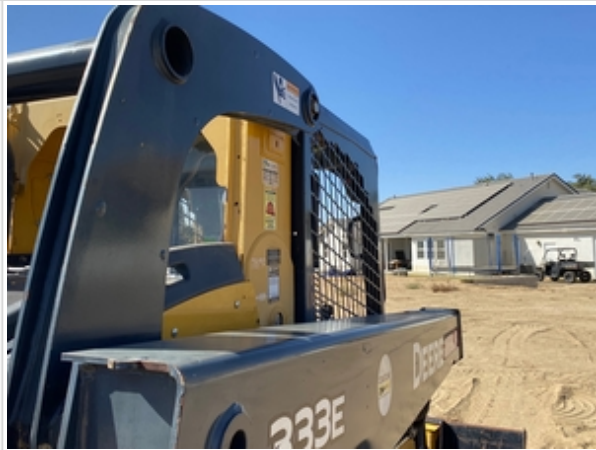
<p>Chassis to Arm Pins</p>	<p>3 - Normal Wear &amp; Tear</p>
<p>Chassis to Arm Pins Photos</p>

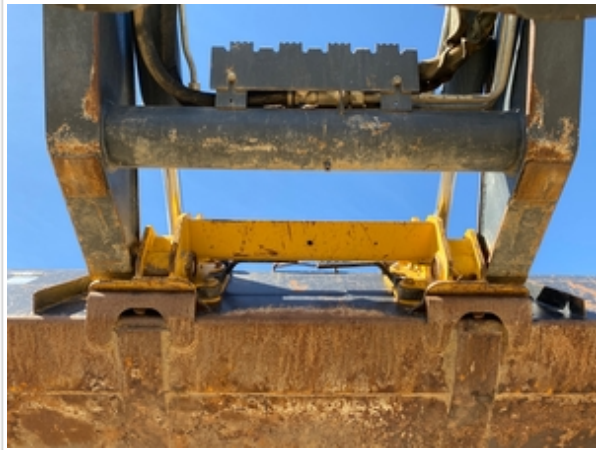
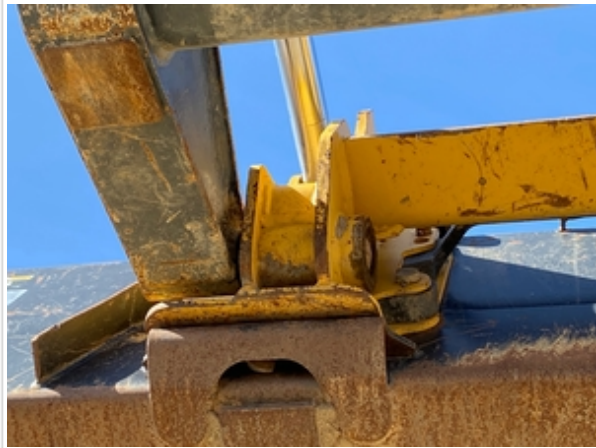
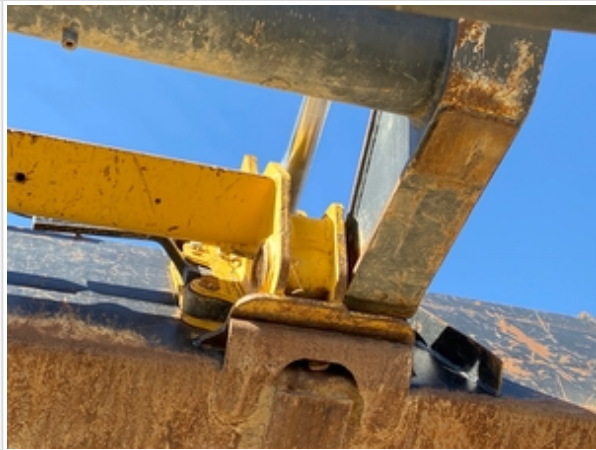
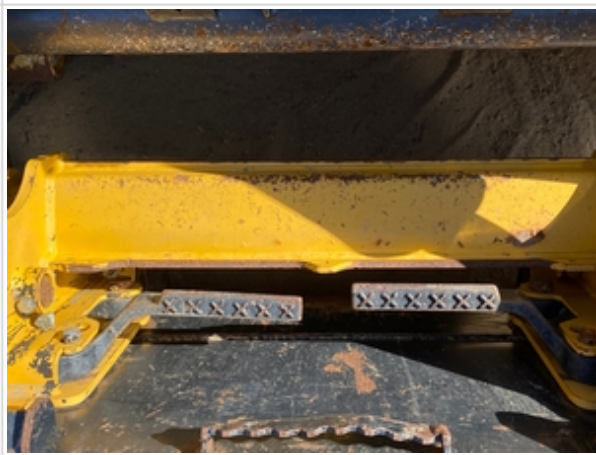
<p><b>Quick Coupler</b></p>	<p>3 - Normal Wear &amp; Tear</p>	
<p><b>Quick Coupler Photos</b></p>

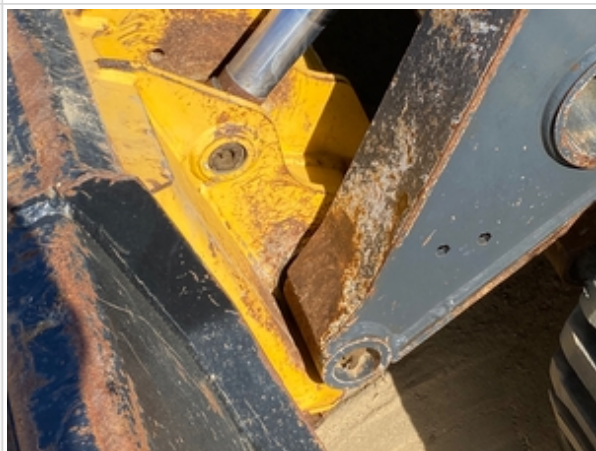
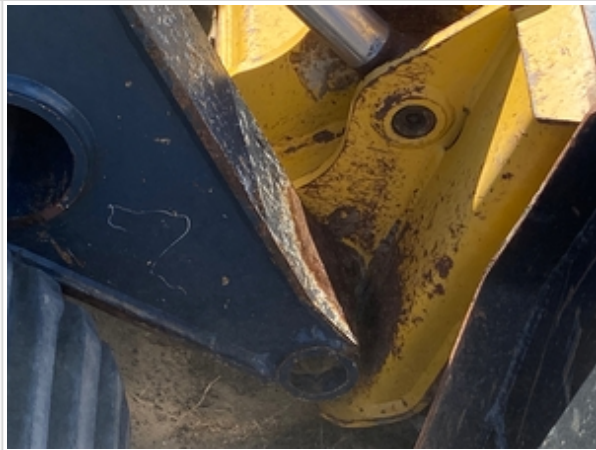
<p><b>Quick Coupler to Arms Pins</b></p>	<p>3 - Normal Wear &amp; Tear</p>	
<p><b>Quick Coupler to Arms Pins Photos</b></p>

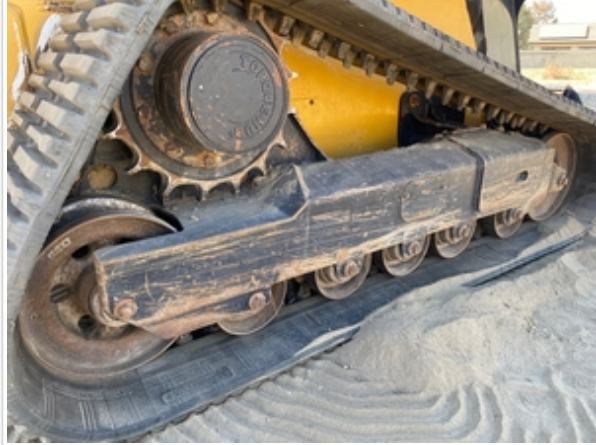
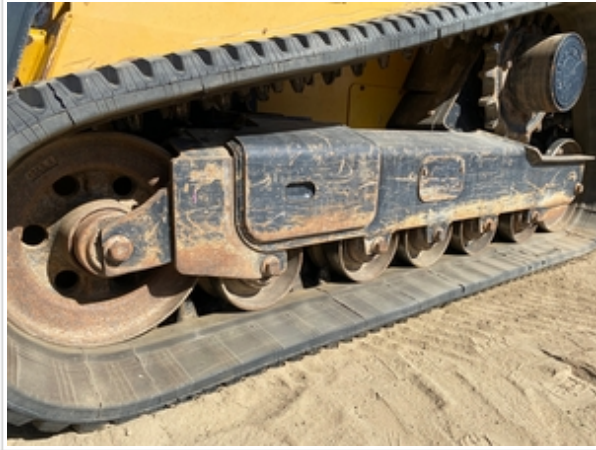
<b>Roller Frames</b>	3 - Normal Wear & Tear
<b>Roller Frames Photos</b>
