## Inspection Report (Compact Track Loader)

Year	2015
Make	John Deere
Model	333E
Serial Number	279331
Hour Meter Reading	1,704
Previous Application (e.g., earth moving, mining, demolition, etc)	Pipeline / Electrical Construction

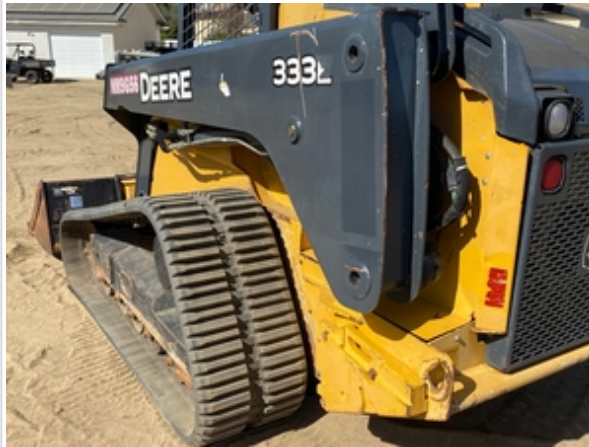
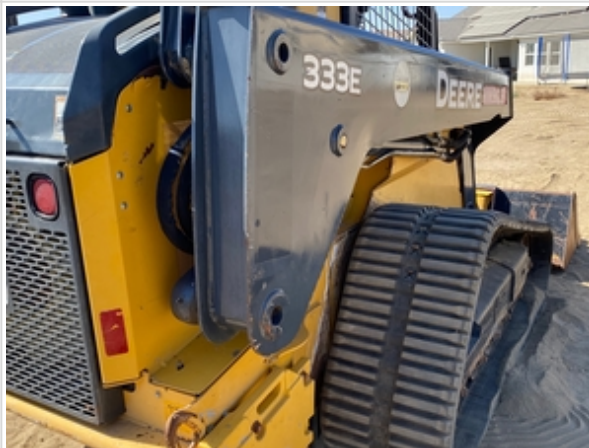
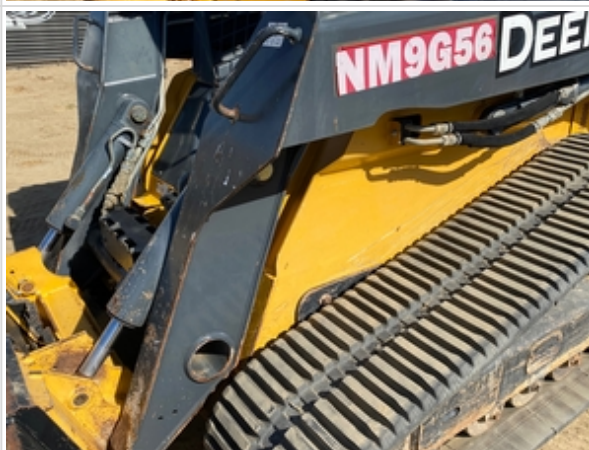
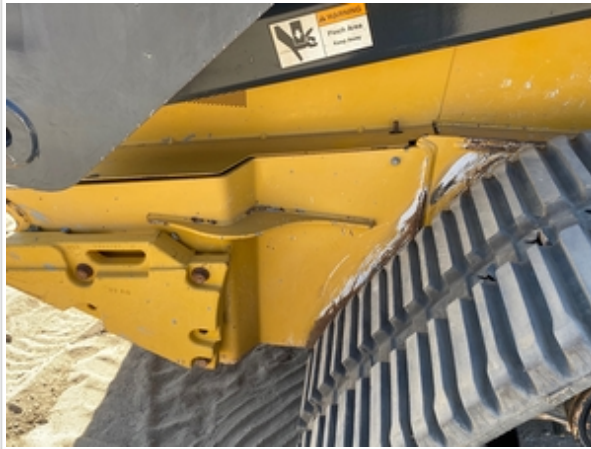
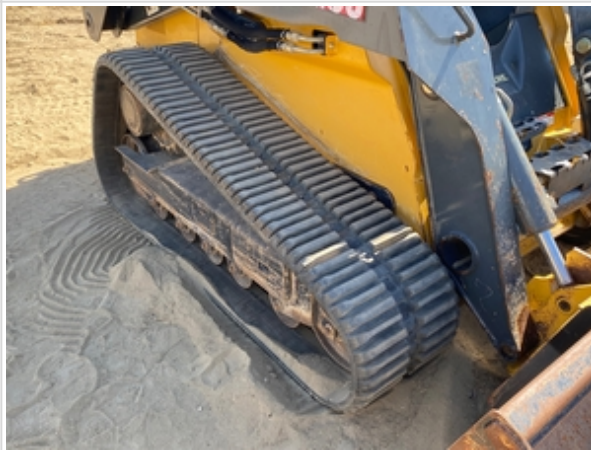
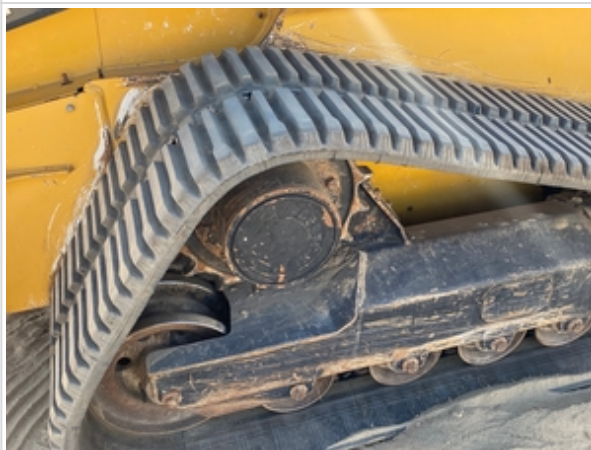
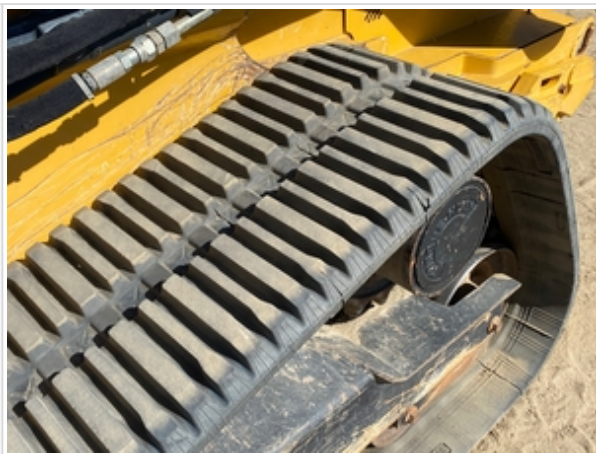
Track Belt Photos

<b>Track Belt</b>	3 - Normal Wear & Tear
<b>Comments</b>	Tracks like new

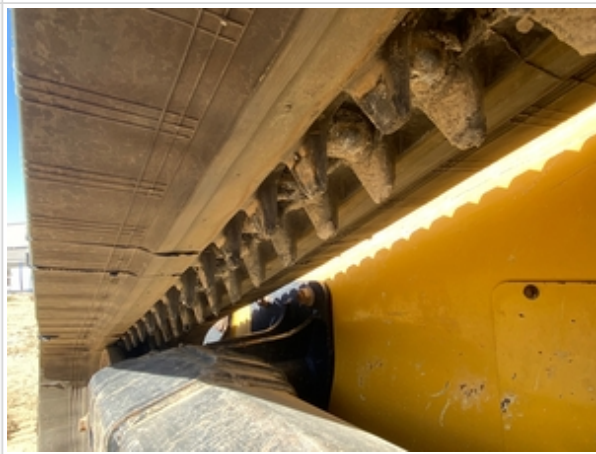
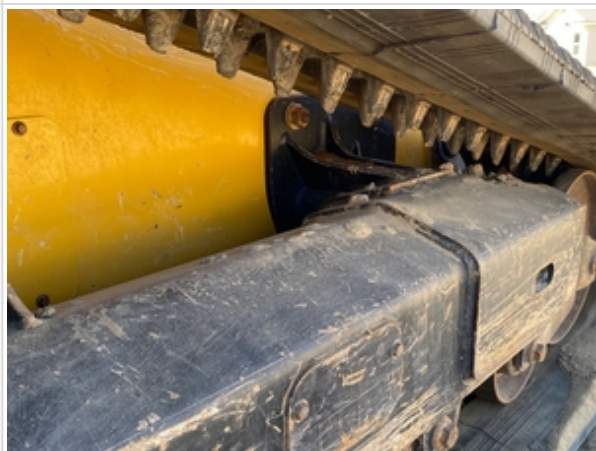
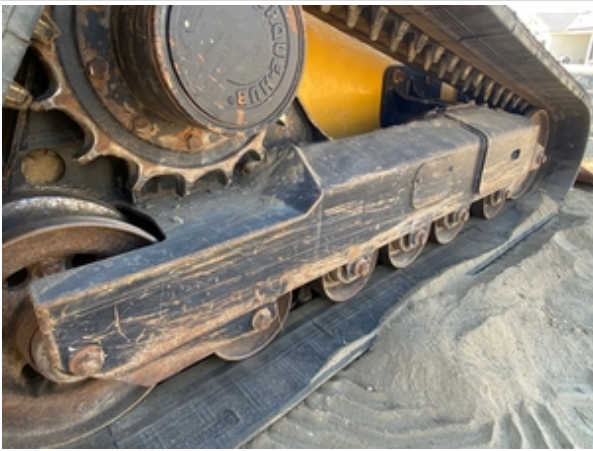
<p>Rubber Belt Drive Lugs</p>	<p>3 - Normal Wear &amp; Tear</p>
<p>Rubber Belt Drive Lugs Photos</p>

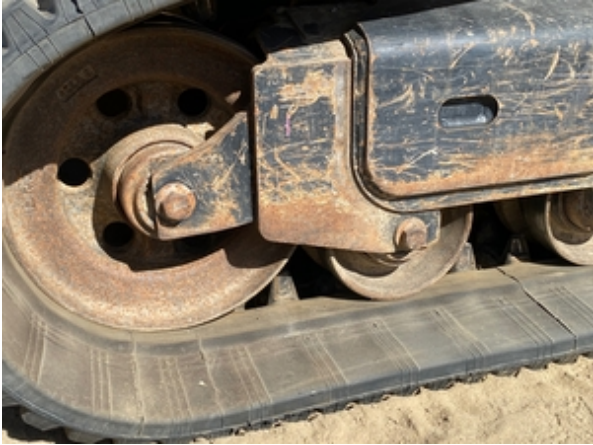
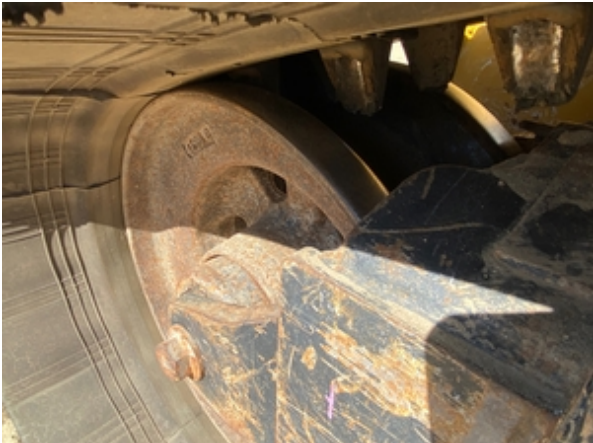
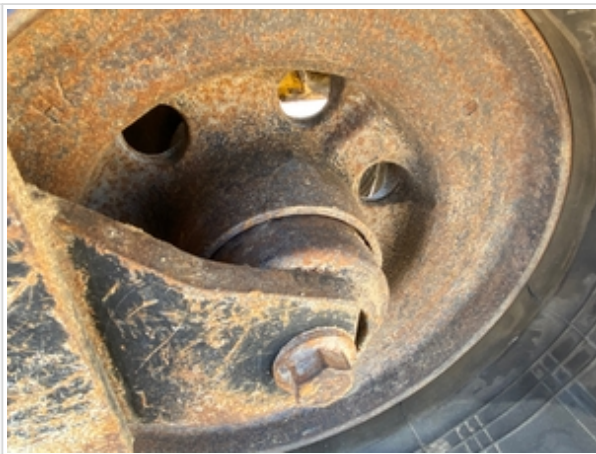
<b>Track Tensioners</b>	3 - Normal Wear & Tear	
<b>Front Idlers</b>	3 - Normal Wear & Tear	
<b>Front Idlers Photos</b>

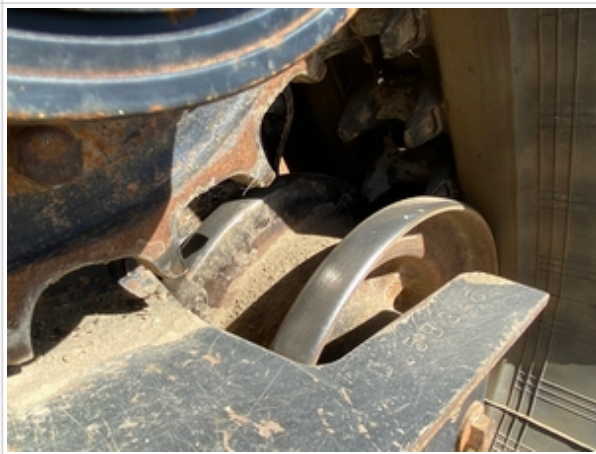
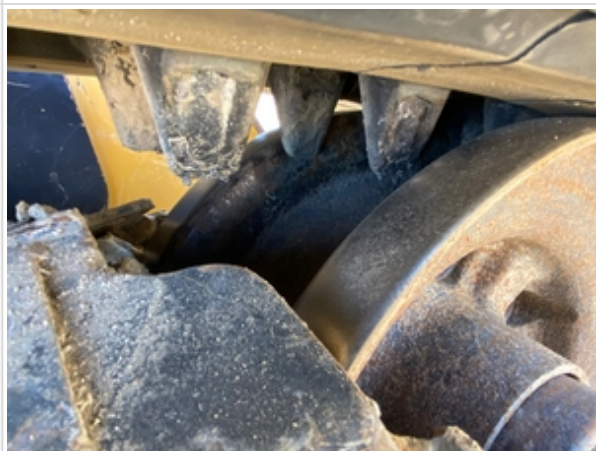
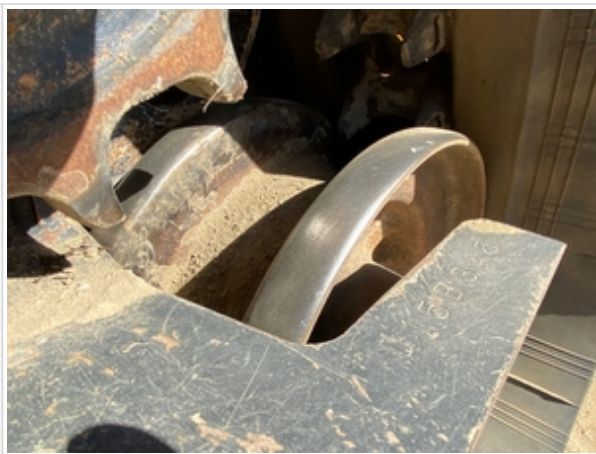
<p>Rear Idlers</p>	<p>3 - Normal Wear &amp; Tear</p>	
<p>Rear Idlers Photos</p>

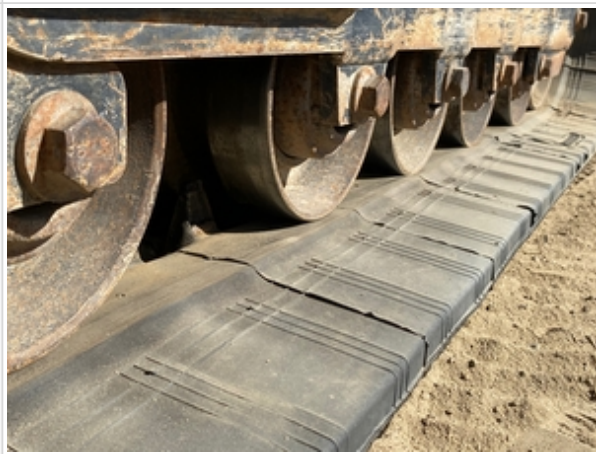
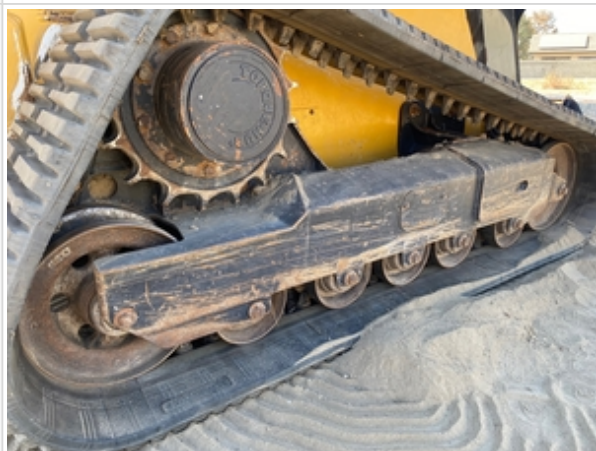
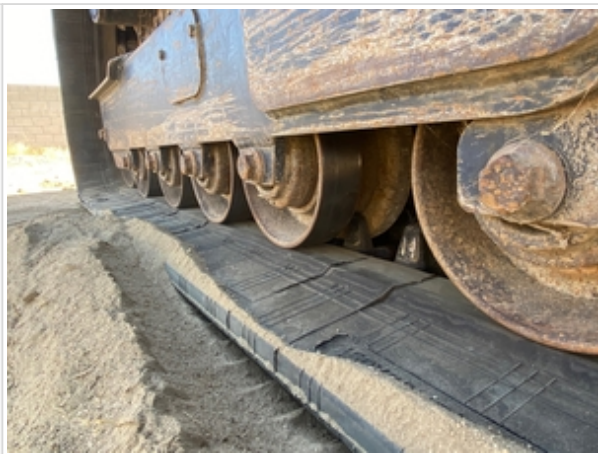
<p>Track Rollers</p>	<p>3 - Normal Wear &amp; Tear</p>	
<p>Track Rollers Photos</p>

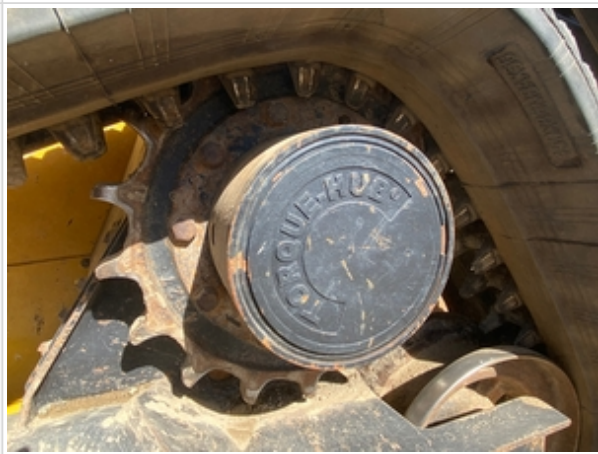
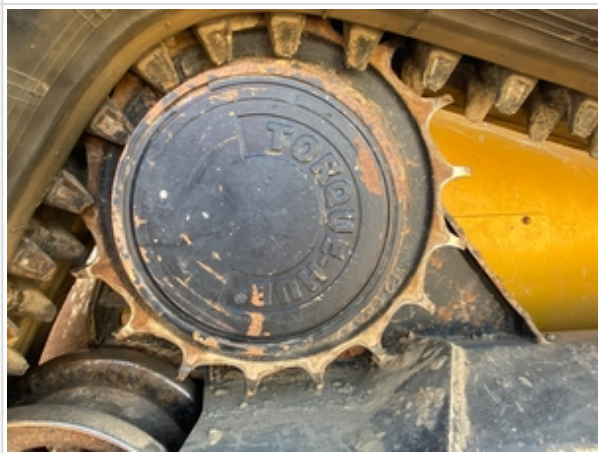
<p>Sprockets</p>	<p>3 - Normal Wear &amp; Tear</p>	
<p>Sprockets Photos</p>

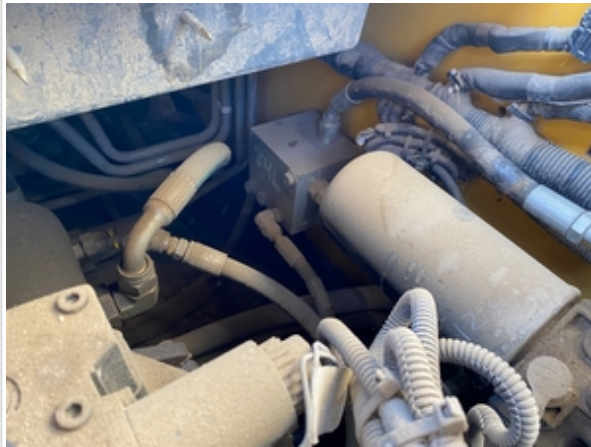
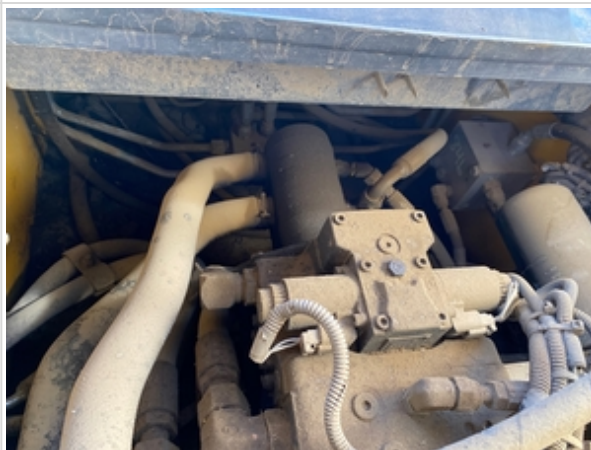
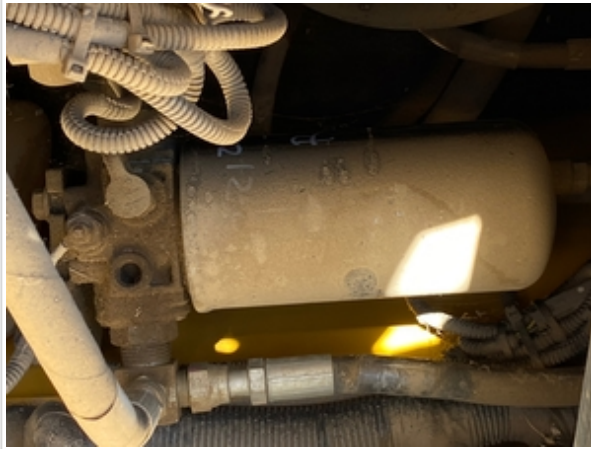
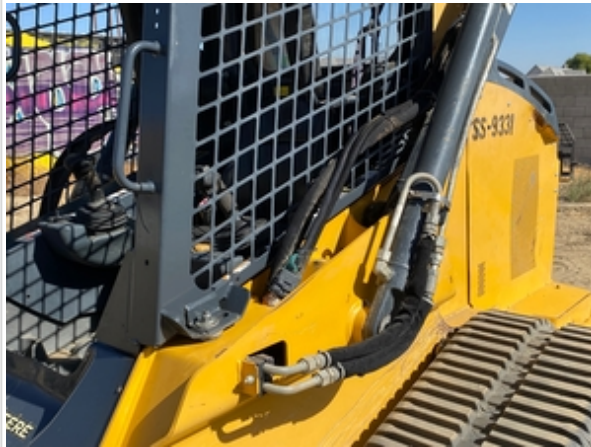
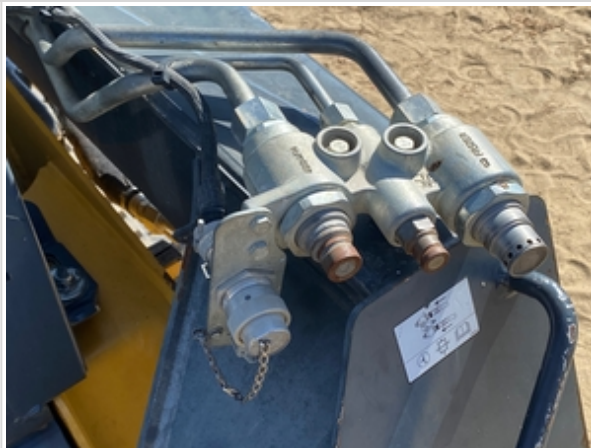
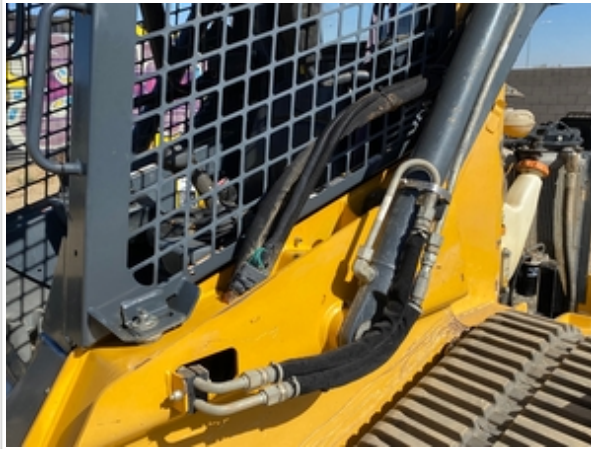
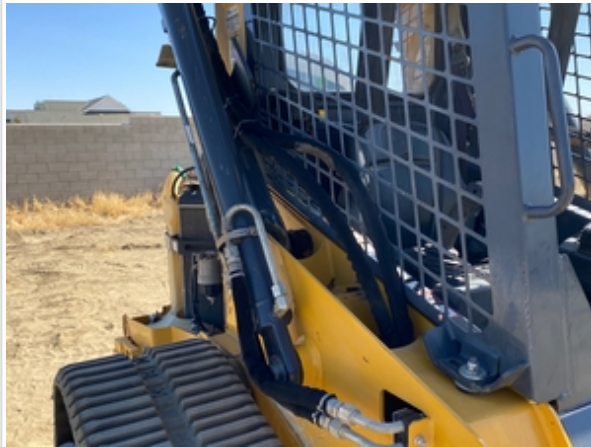
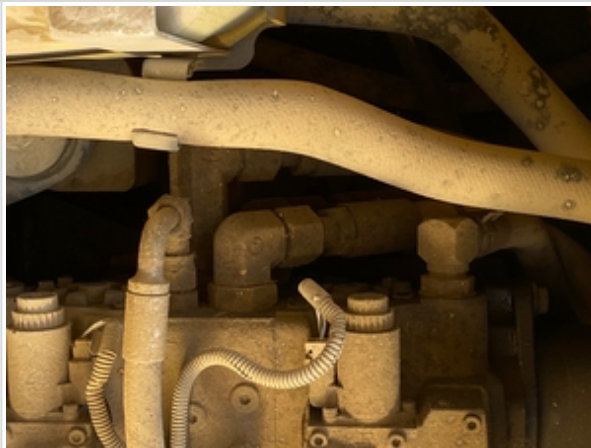
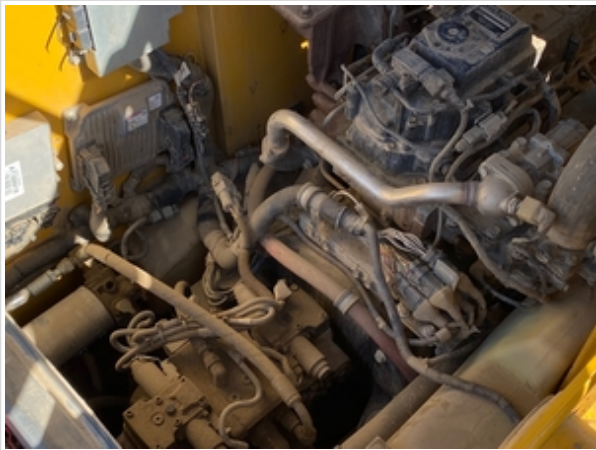
Appearance of Hydraulic Lines /  
Fittings Photos

Wet or Damp Hydraulic Lines / Fittings	No
Appearance of Hydraulic Lines / Fittings	3
Hydraulic Lines / Fittings Condition	Hydraulic lines & fittings are clean and in good condition

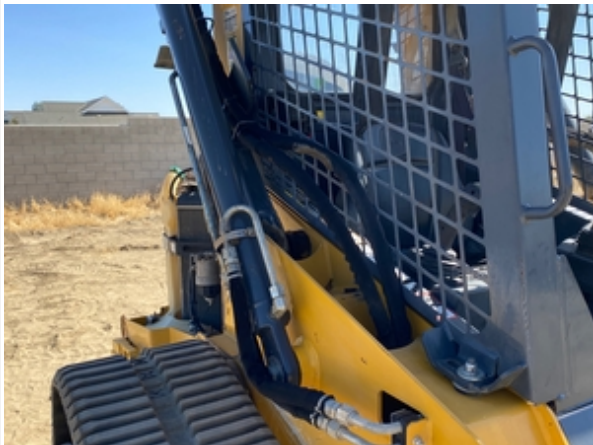
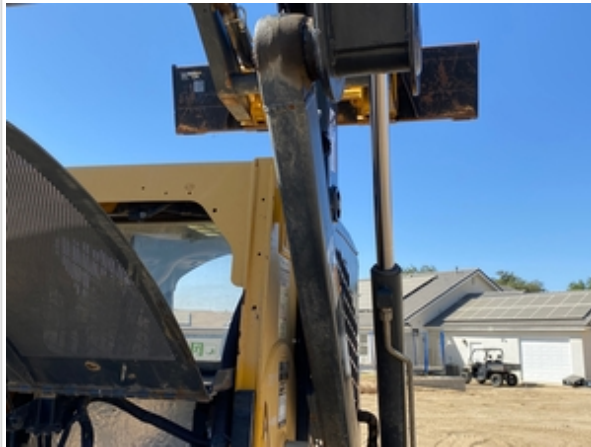
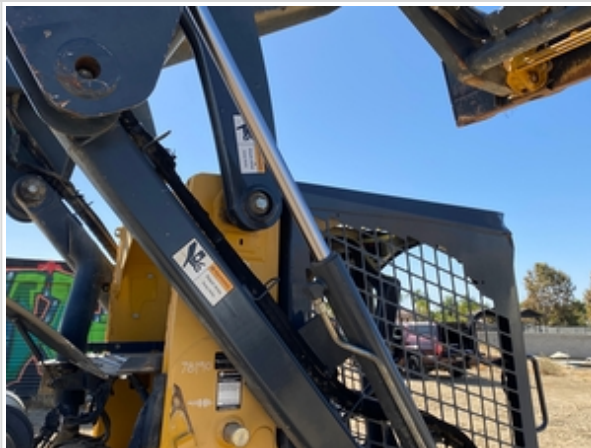
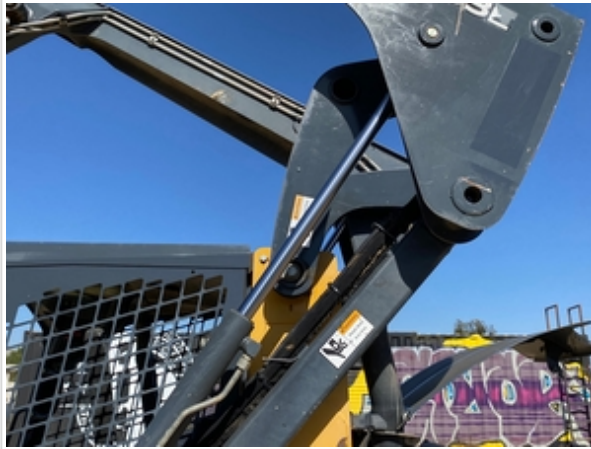
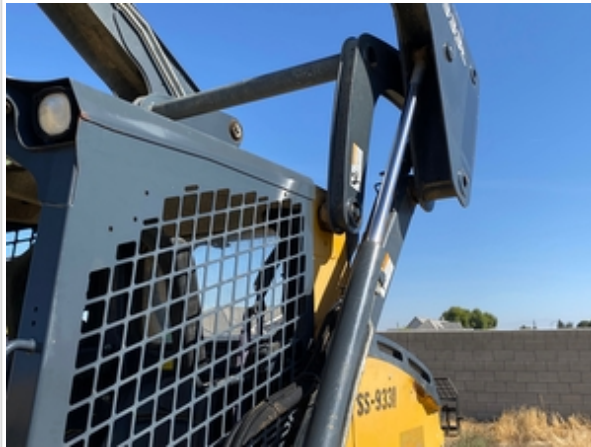
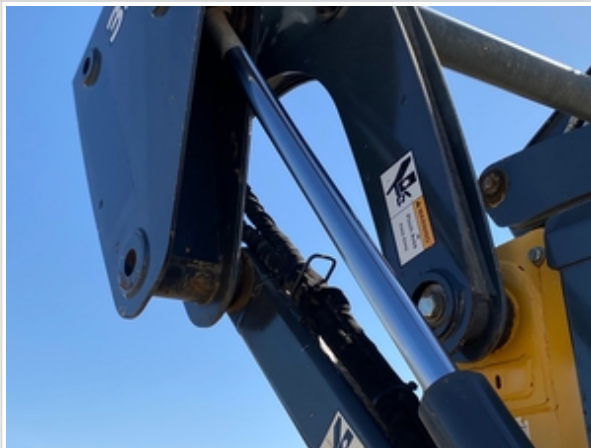
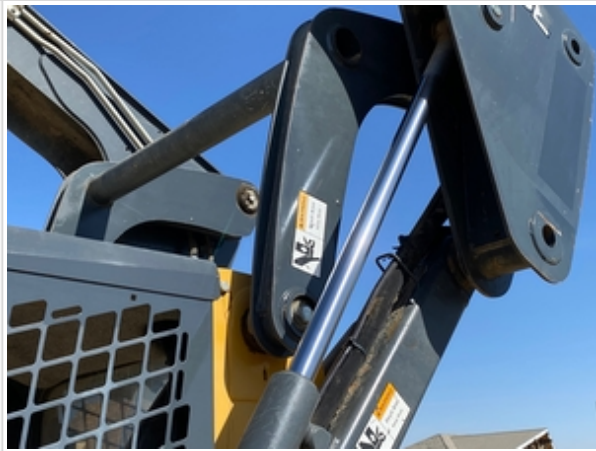
Lift Cylinder	Check the lift cylinder. Note any wear, pitting, discoloration, etc. Take photos.
Lift Cylinder: Mounting Pin	3
Lift Cylinder: Oil Leaks	No
Lift Cylinder Photos

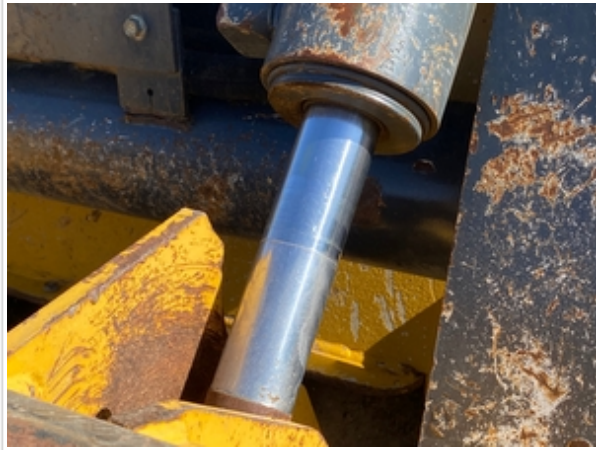
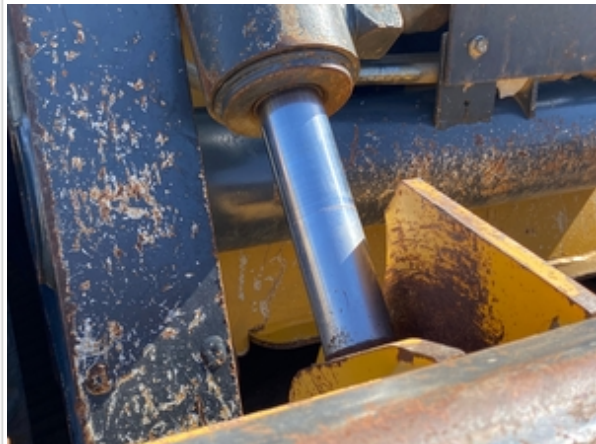
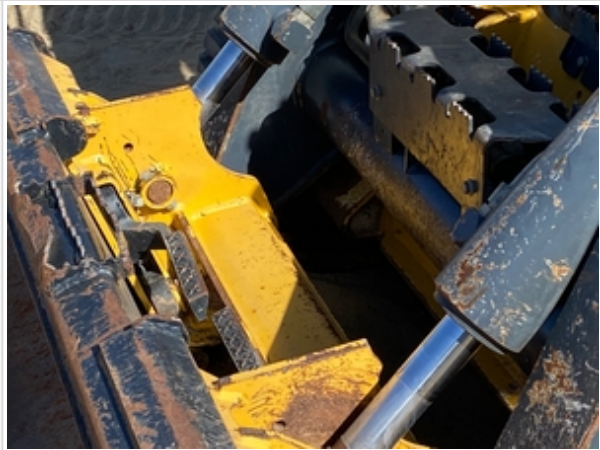
<b>Bucket Cylinder</b>	Check the bucket cylinder. Note any wear, pitting, discoloration, etc. Take photos.
<b>Bucket Cylinder: Mounting Pin</b>	3
<b>Bucket Cylinder: Oil Leaks</b>	No
<b>Bucket Cylinder Photos</b>

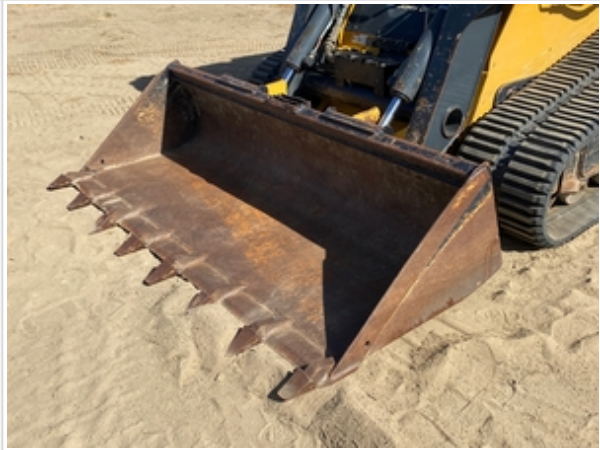
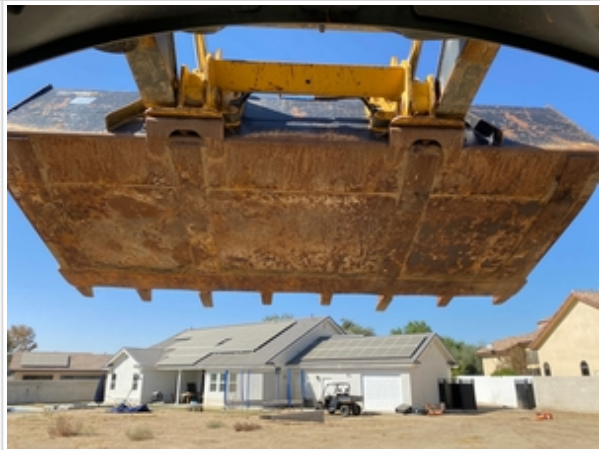
Bucket	3 - Normal Wear & Tear	
Bucket Photos
