## Inspection Report (Generator)

Year	2001
Make	Weber
Model	177KW Studio Generator
Serial Number	101113177A39824
Hour Meter Reading	8,976
Previous Application (e.g., earth moving, mining, demolition, etc)	Generator Rentals

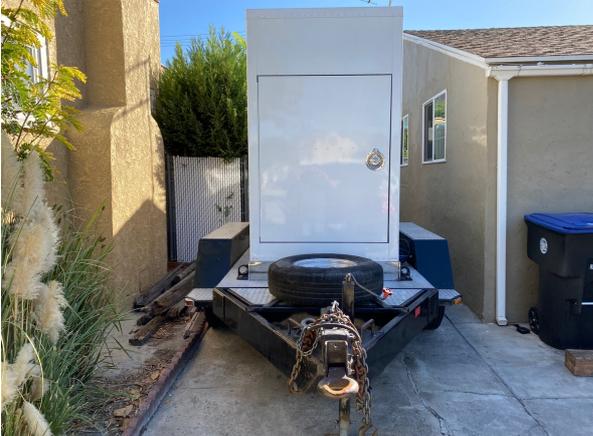
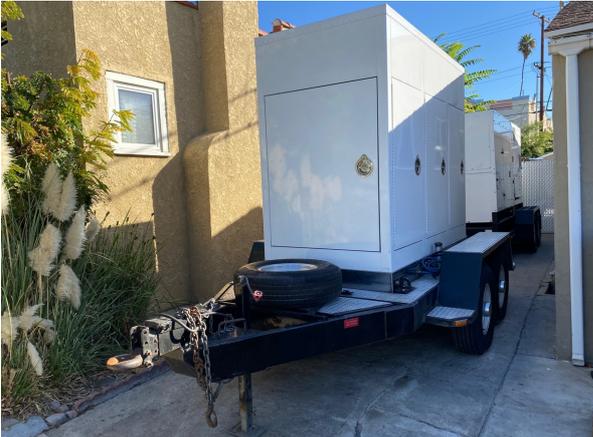
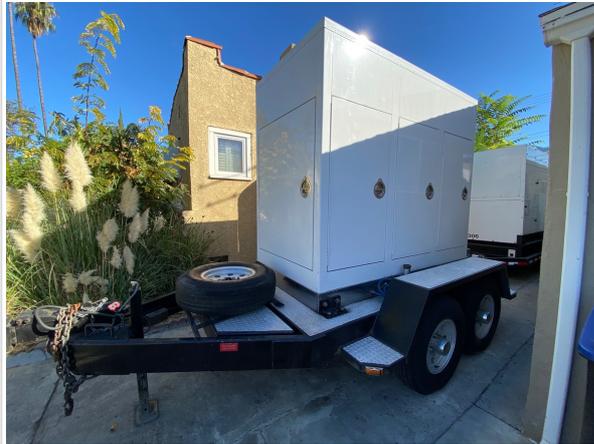
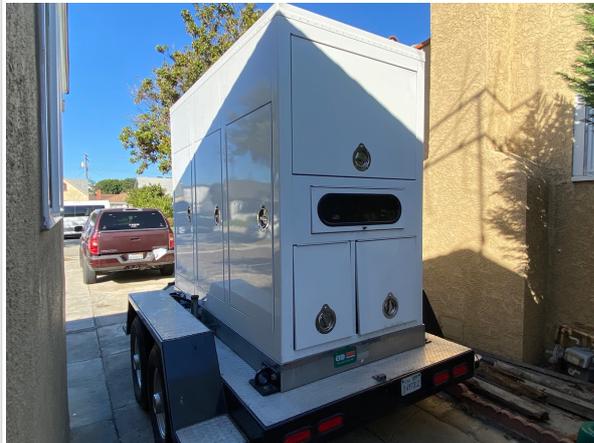
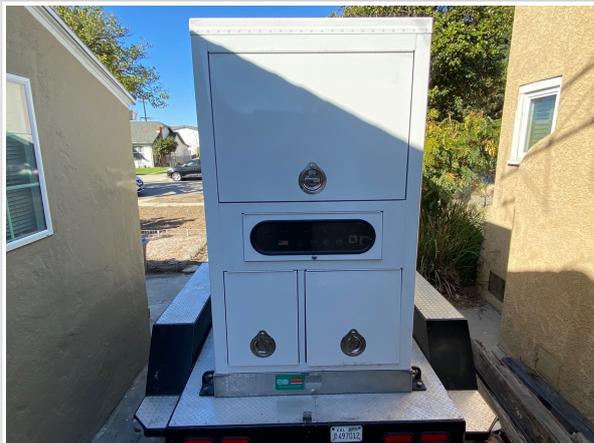
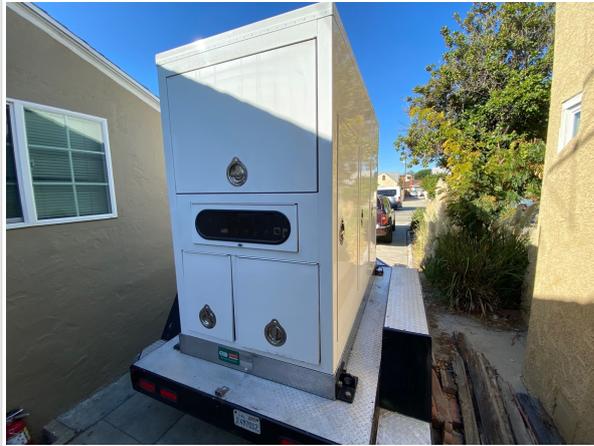
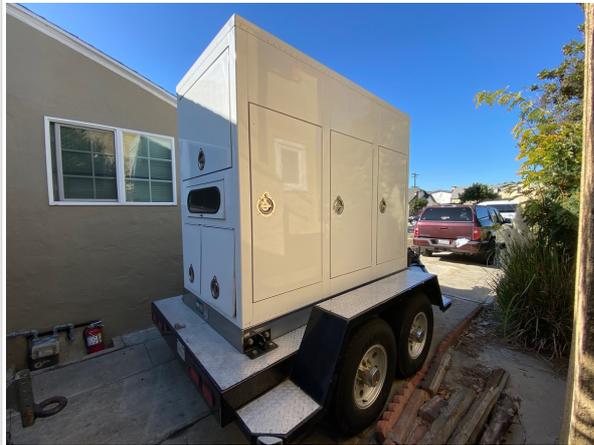
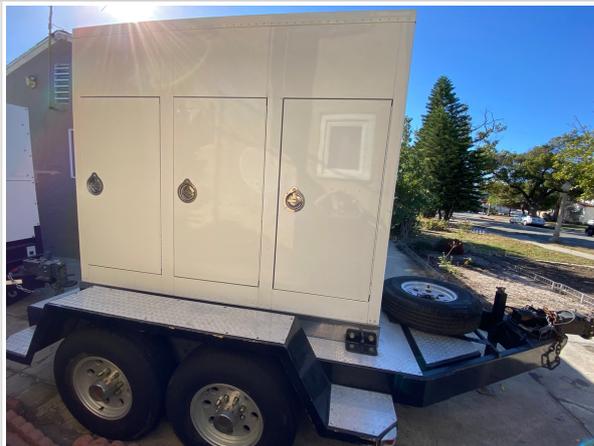
<b>Instructions</b>	<p>Take photos of the exterior of the piece of equipment. Capture a full 360 degree walk around and all major components.</p> <p>Must have shots to capture:</p> <ul style="list-style-type: none"> <li>- Front</li> <li>- 45 degree corner shot of left front</li> <li>- 45 degree corner shot of right front</li> <li>- Left side</li> <li>- Right side</li> <li>- Rear</li> <li>- 45 degree corner shot of left rear</li> <li>- 45 degree corner shot of right rear</li> </ul> <p>Tips for good photos:</p> <ul style="list-style-type: none"> <li>- Move the equipment into a open area without any visual distractions or other equipment in the background</li> </ul>
<b>Exterior Walkaround Photos</b>

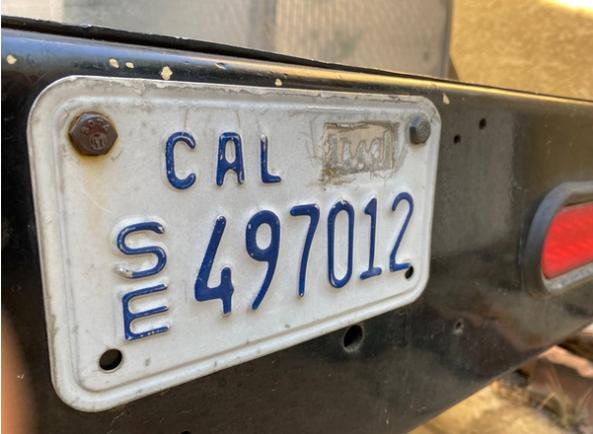
<p>Rear</p>	<p>3 - Normal Wear &amp; Tear</p>
<p>Rear Condition</p>	<p>No visible damage</p>
<p>Rear Photos</p>

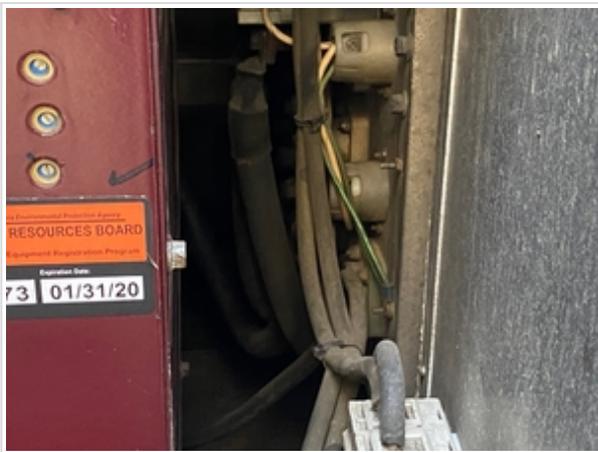
<p>Comments</p>	<p>Wire harness has been repaired in some areas</p>
<p>Wire Harness Photos</p>

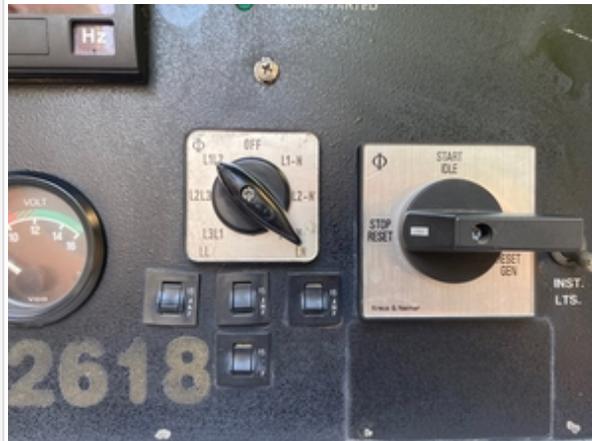
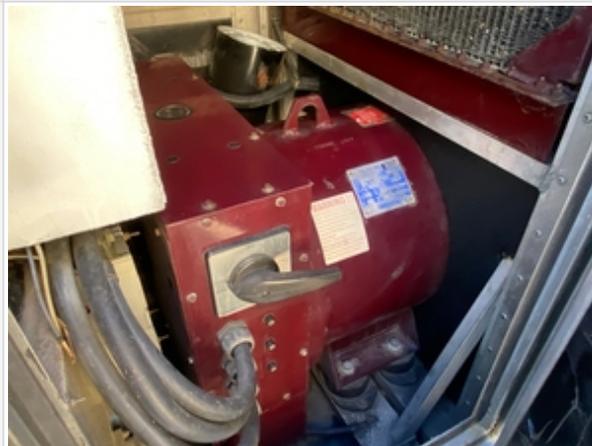
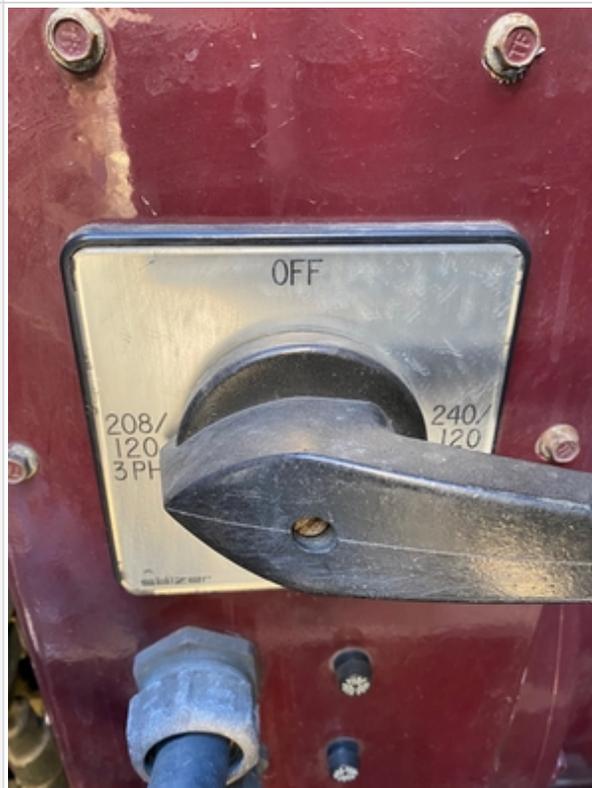
Controls & Switches Photos

<b>Controls &amp; Switches</b>	3 - Normal Wear & Tear

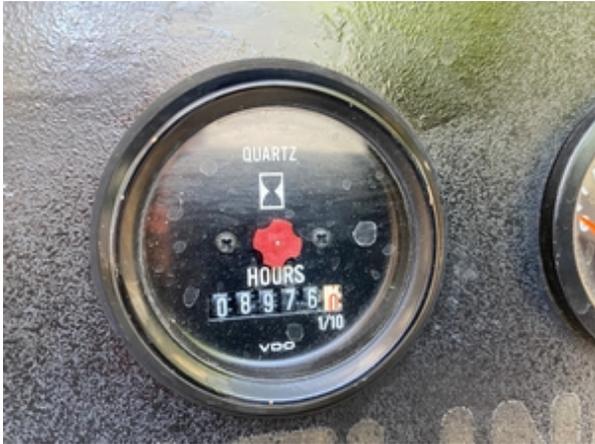
Hour Meter Photos

Hour Meter	3 - Normal Wear & Tear
------------	------------------------

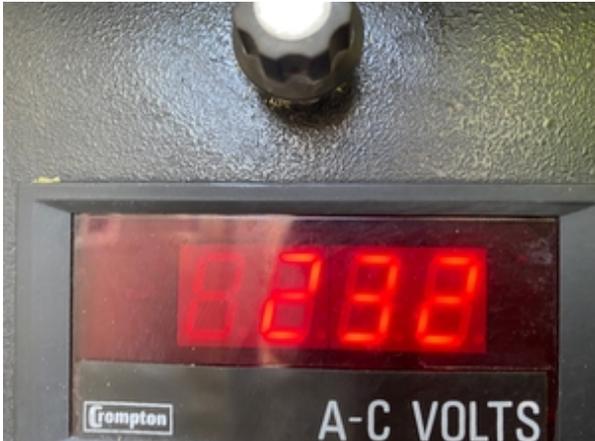
Volt Display Photos

Volt Display	3 - Normal Wear & Tear
--------------	------------------------

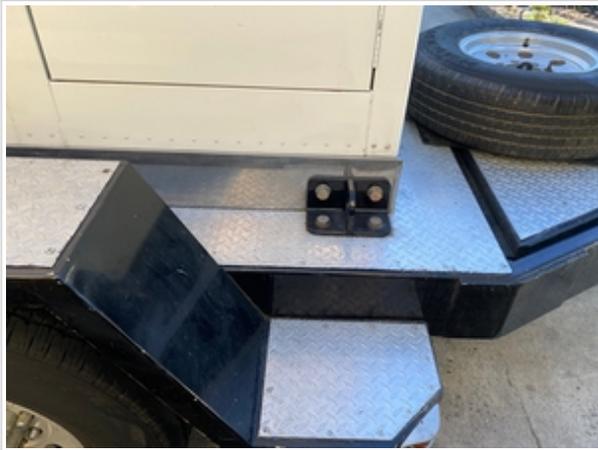
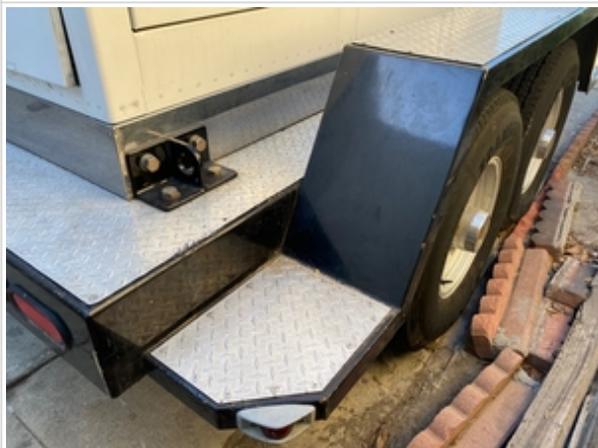
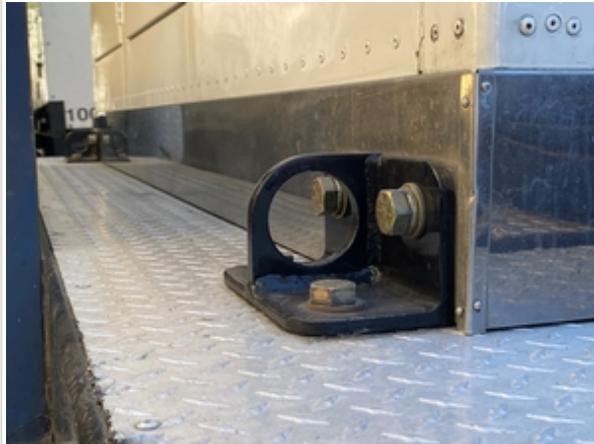
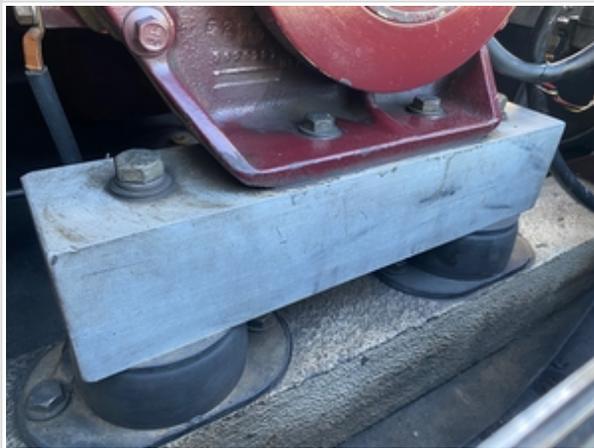
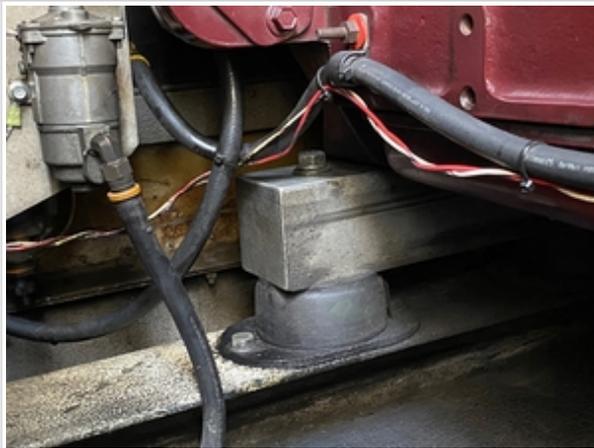
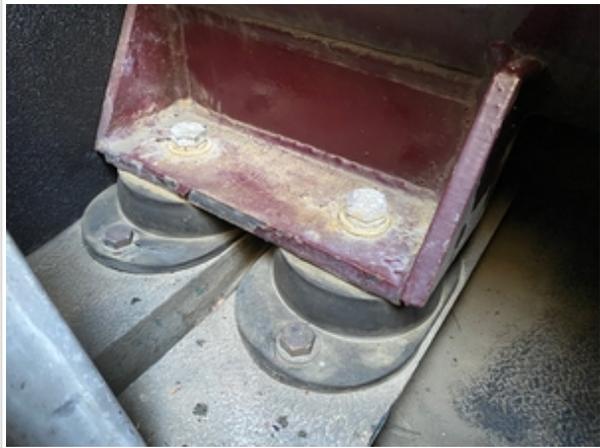
Overall Mounting Plate Appearance	3 - Normal Wear & Tear
Mounting Plate Photos

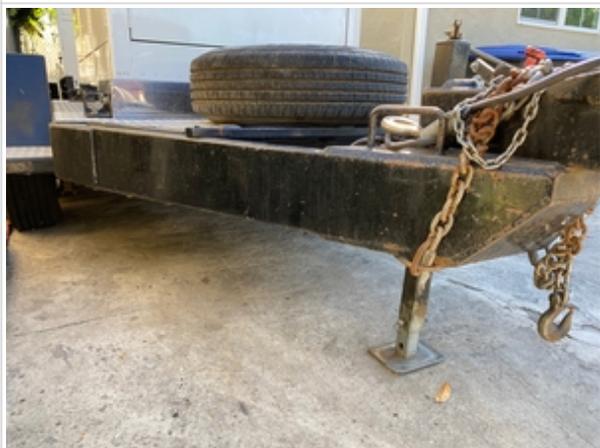
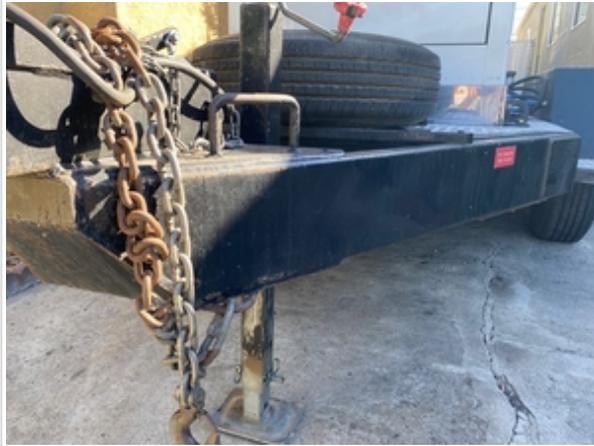
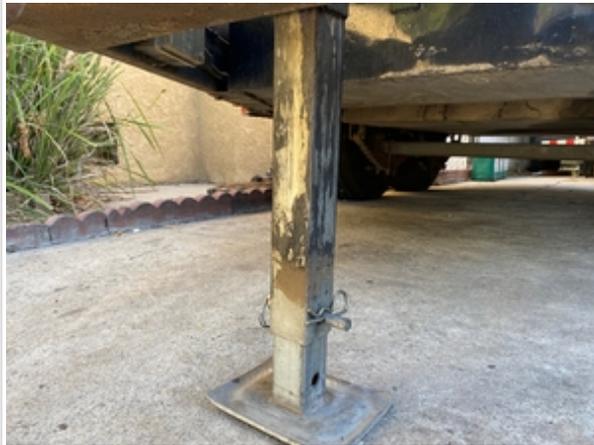
<b>Frame Condition</b>	3 - Normal Wear & Tear	
<b>Frame Photos</b>

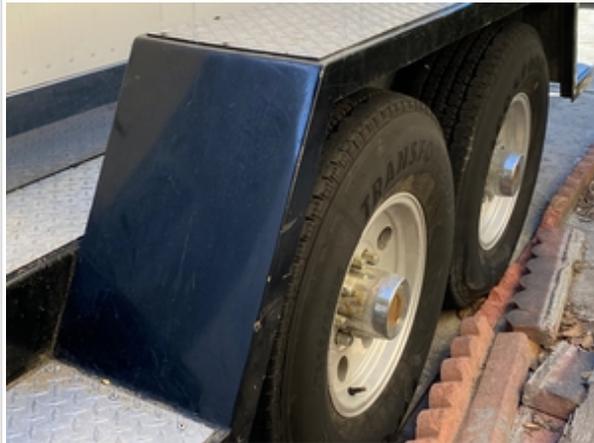
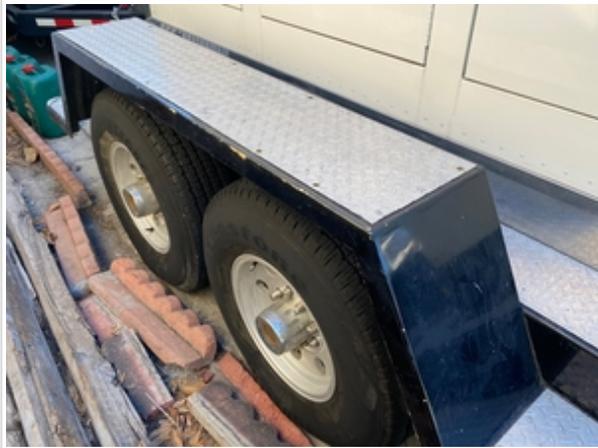
**Fender Photos**

3 - Normal Wear & Tear

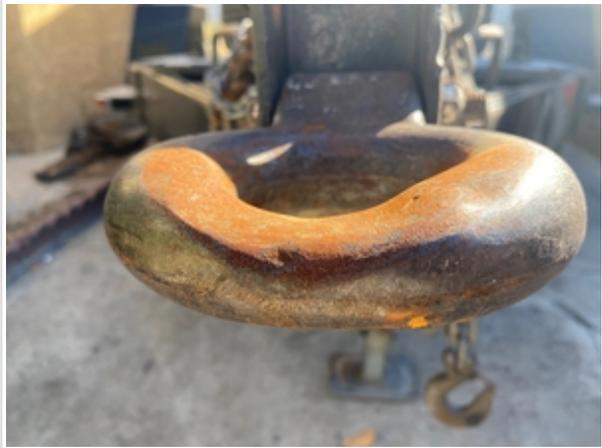
Hitch Type	Pintle
Hitch Condition	2 - Above Average Wear
Comments	Pintle hitch needs to be replaced (worn)
Hitch Photos

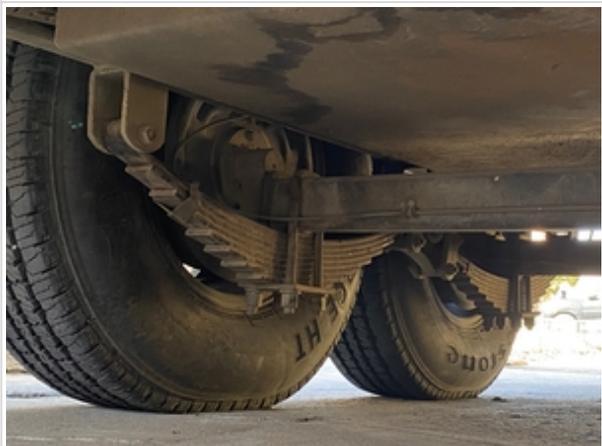
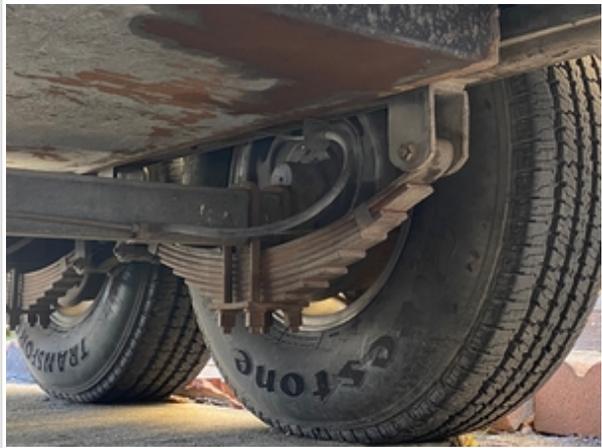
<b>Springs</b>	3 - Normal Wear & Tear	
<b>Springs Photos</b>

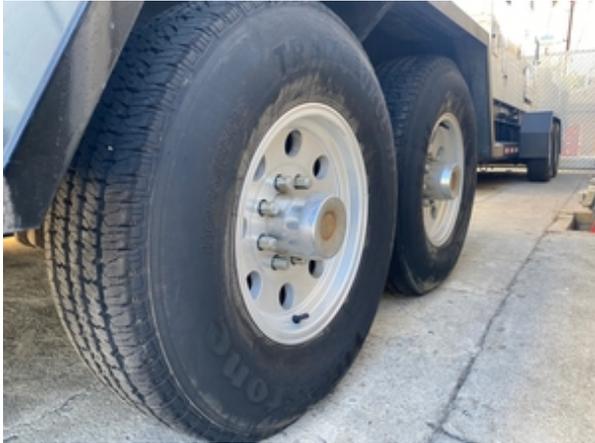
Tire Brand	Firestone (Transforce)
Tire Size	LT235/85/R16
Front Left Tire - Ratio Remaining	70%
Front Left Tire Photos

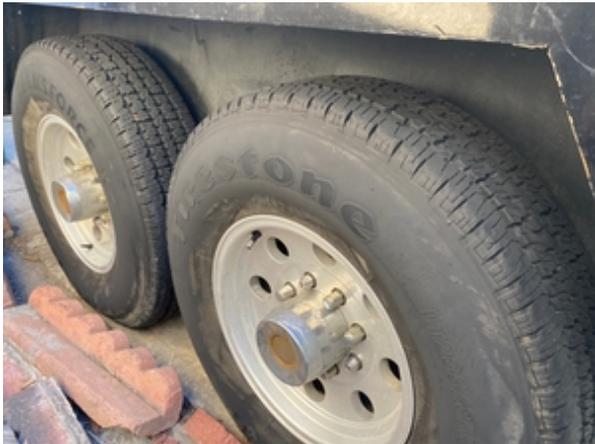
Front Right Tire - Ratio Remaining	70%
Front Right Tire Photos

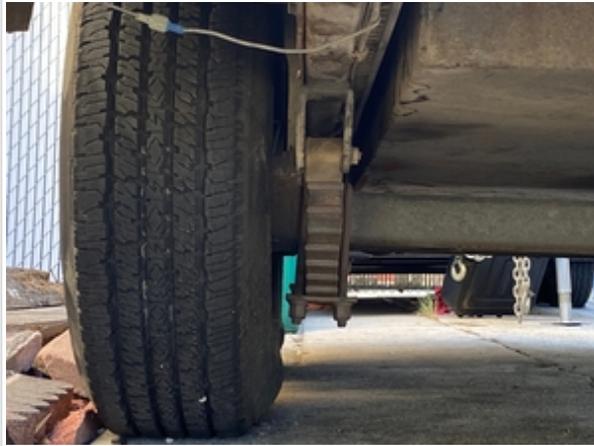
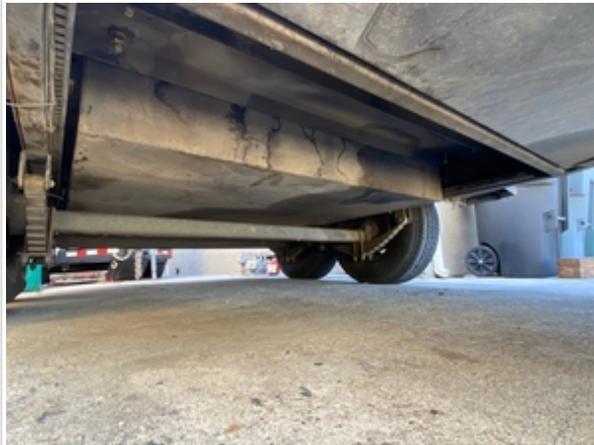
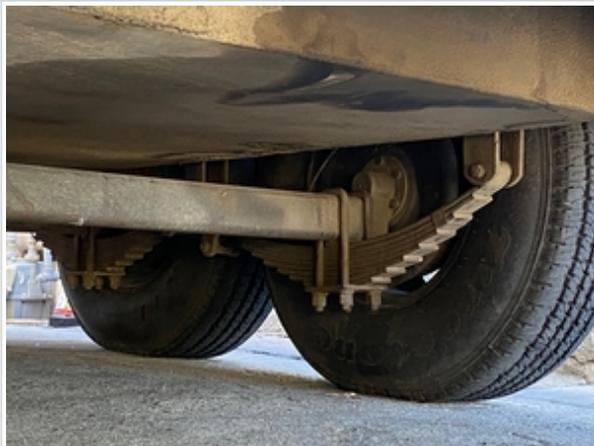
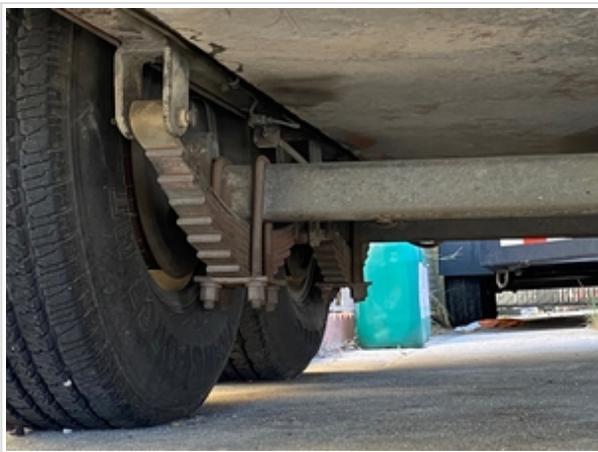
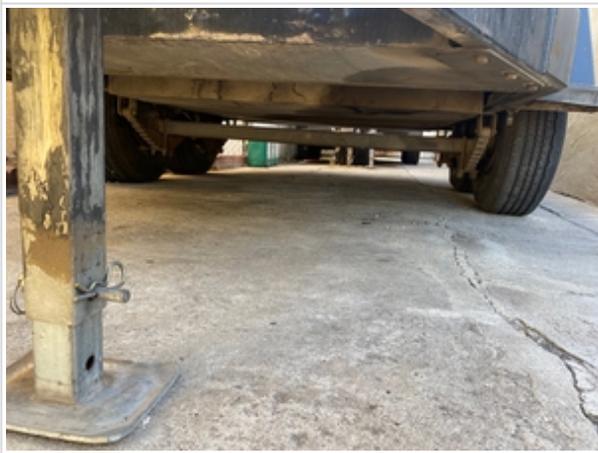
Overall Trailer	3 - Normal Wear & Tear
Overall Trailer Comments	Overall, visually, the trailer in good condition. Brakes need to be tested for proper operation. Covers on and unable to see brake shoes.
Overall Trailer & Undercarriage Photos

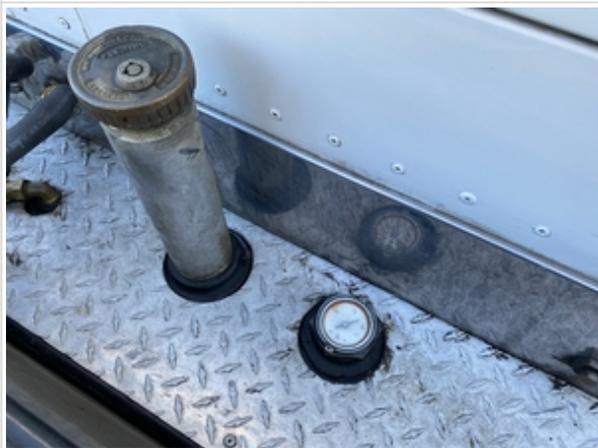
<p><b>Fuel Tank Condition</b></p>	<p>3 - Normal Wear &amp; Tear</p>	
<p><b>Fuel Tank Photos</b></p>
