Inspection Report (Telehandler)

Year	2014
Make	Genie
Model	GTH-5519
Serial Number	2237
Hour Meter Reading	1,416
Previous Application (e.g., earth moving, mining, demolition, etc)	Equipment Rentals

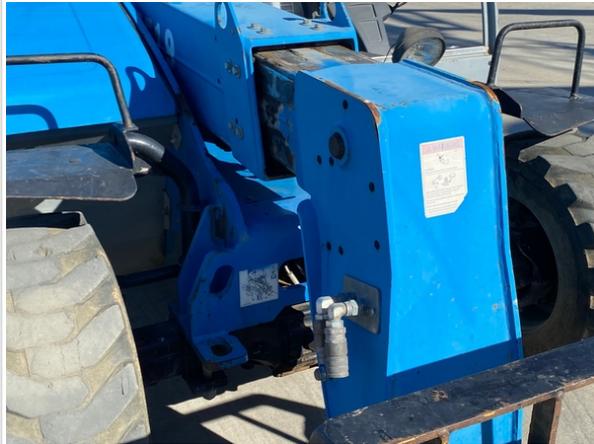
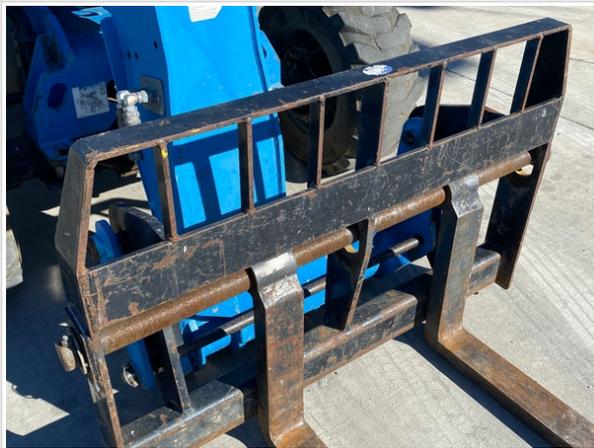
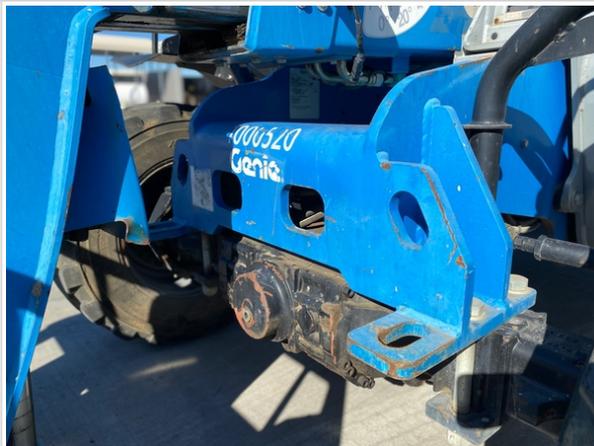
Front Photos

Front	3 - Normal Wear & Tear
Front Condition	No visible damage

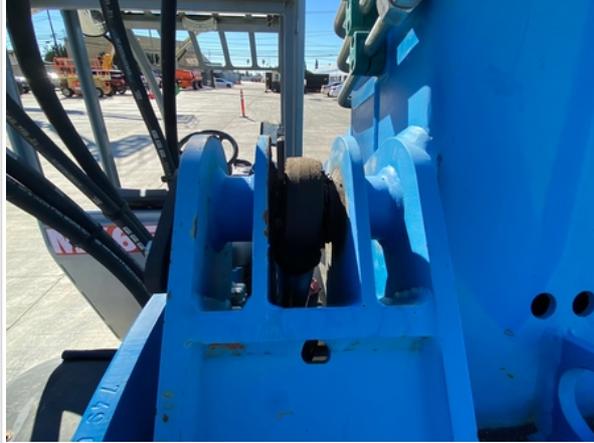
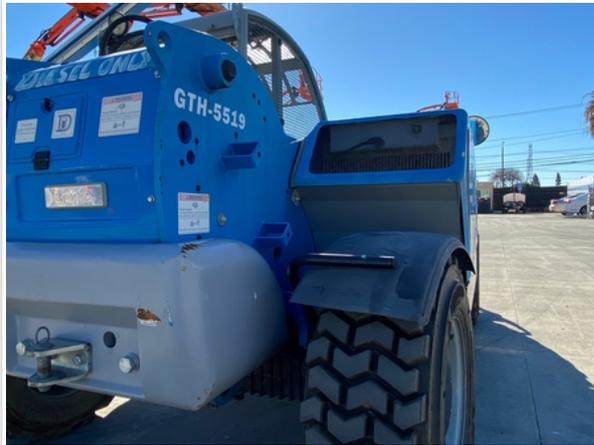
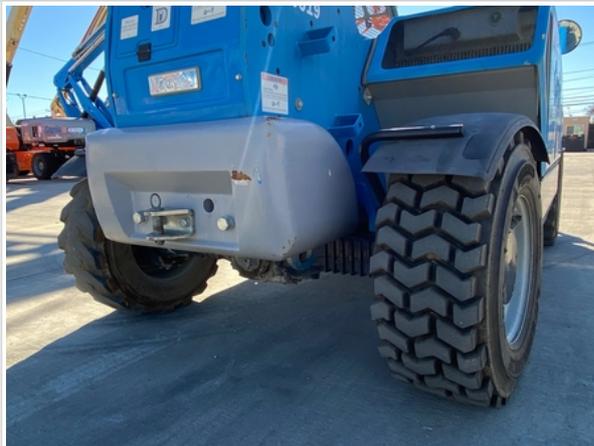
Rear	3 - Normal Wear & Tear	
Rear Condition	No visible damage	
Rear Photos

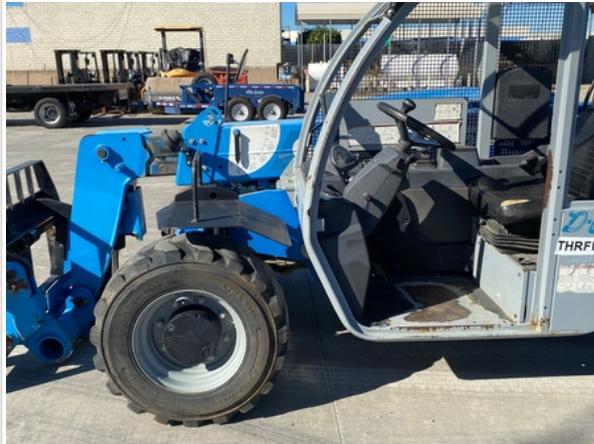
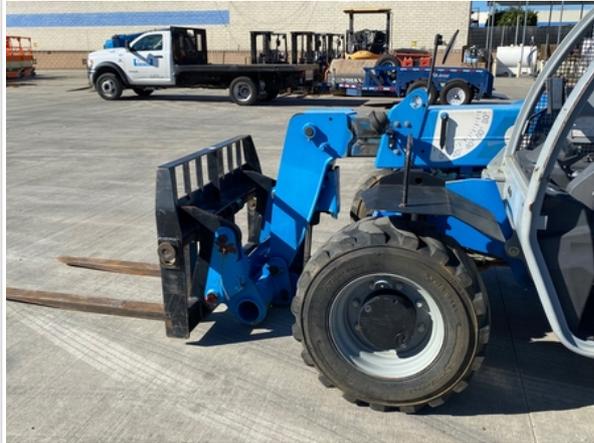
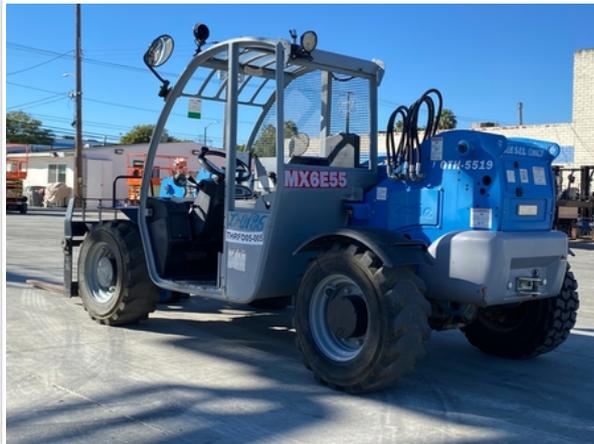
Left	3 - Normal Wear & Tear
Left Condition	No visible damage
Left Photos

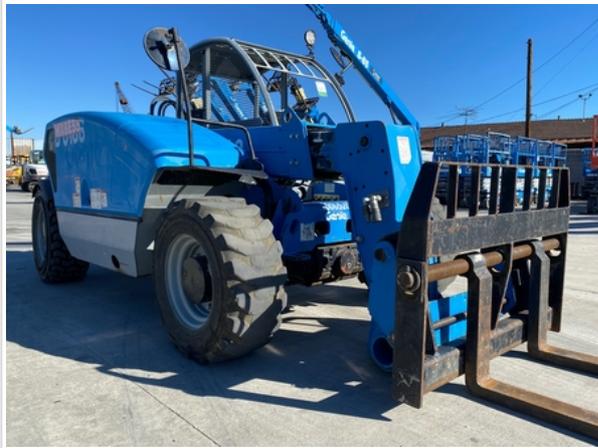
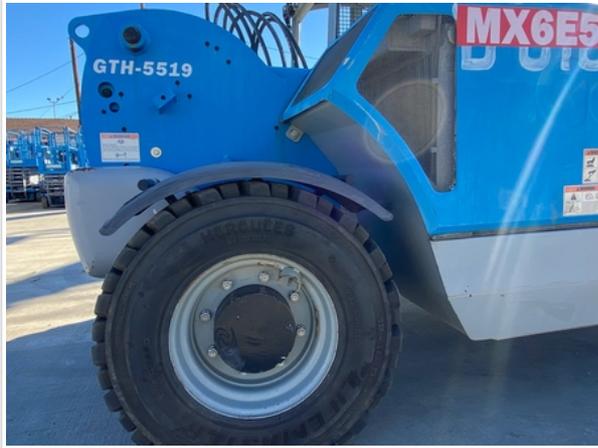
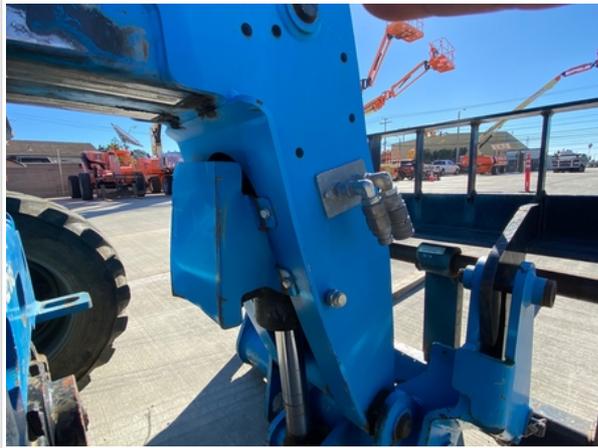
Right	3 - Normal Wear & Tear	
Right Condition	No visible damage	
Right Photos

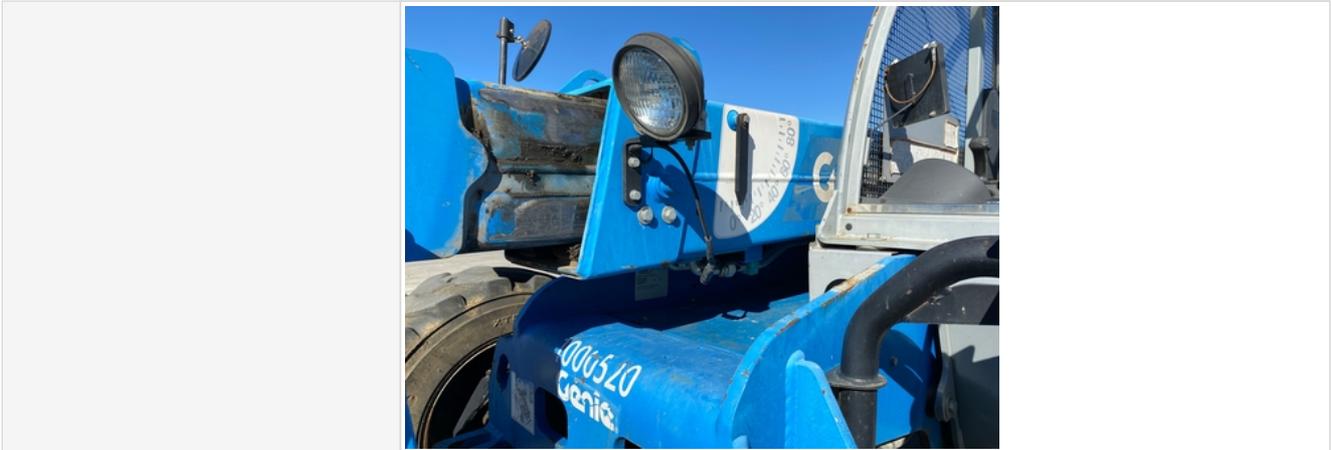
Lighting System	3 - Normal Wear & Tear
Lighting System Condition	No visible damage, lighting system is operational
Lighting System Photos

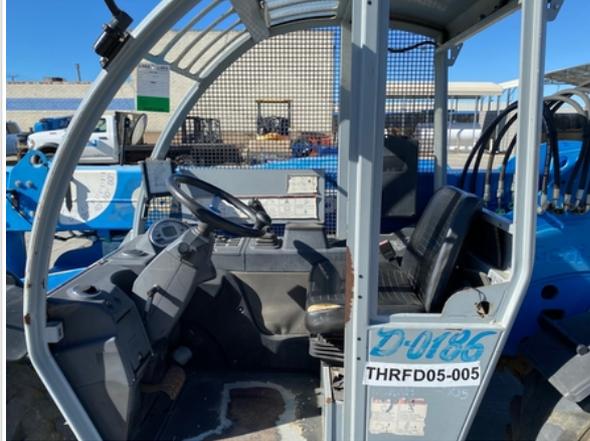
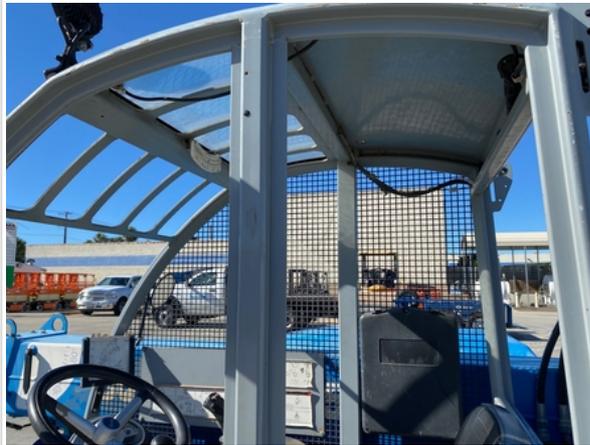
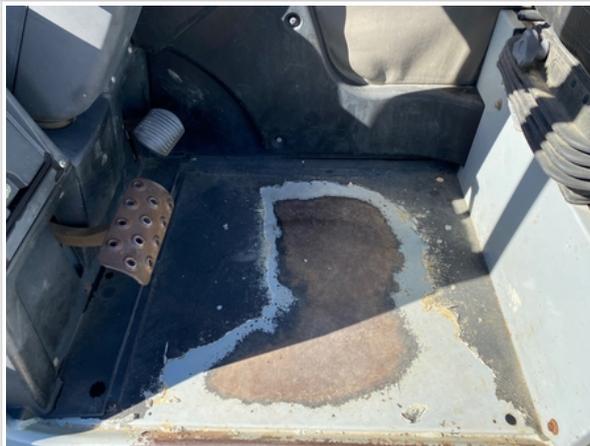
Operator Cabin Photos

Operator Cabin Overall	3 - Normal Wear & Tear
Operator Cabin Overall Condition	Good cabin appearance, solid floors, panels, and ceiling

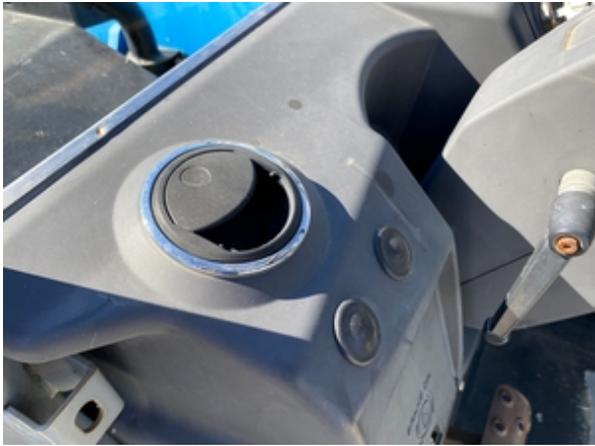
Heater & A/C	0
Fans / Vents	2 - Above Average Wear
Fans / Vents Condition	Fan vents are installed but one or more is restricted in movement or functionality
Comments	Fan inoperable
Fans / Vents Photos

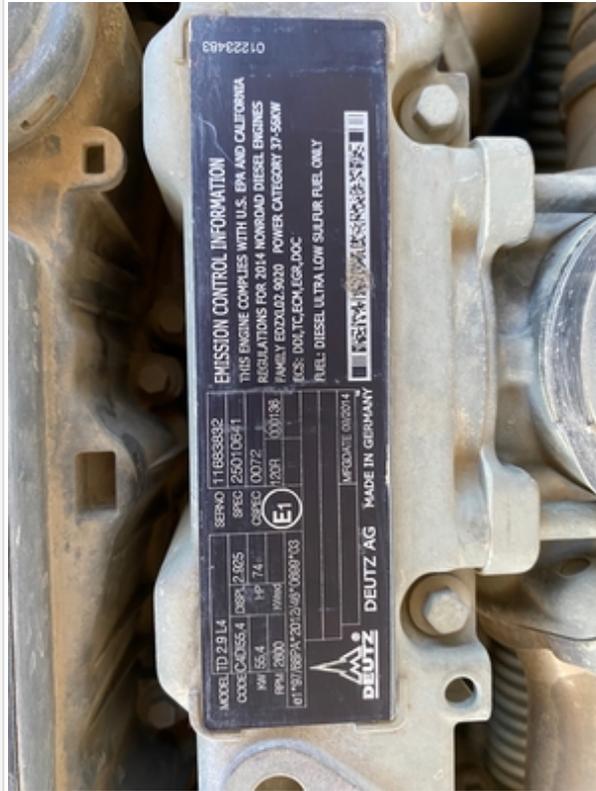
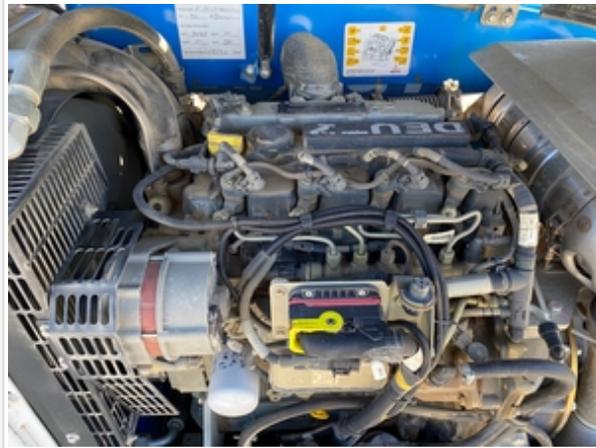
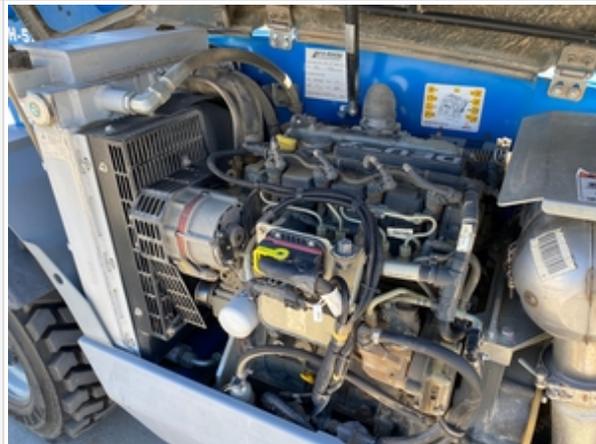
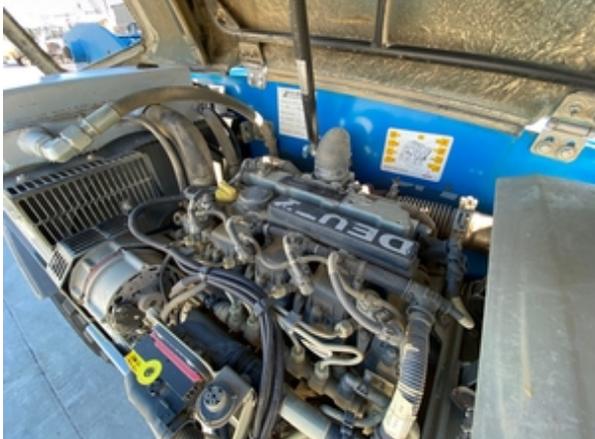
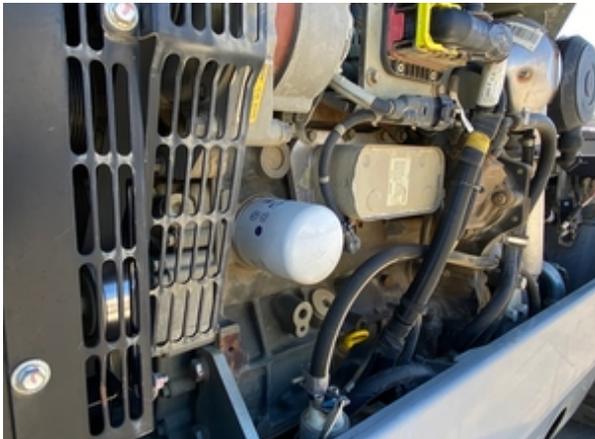
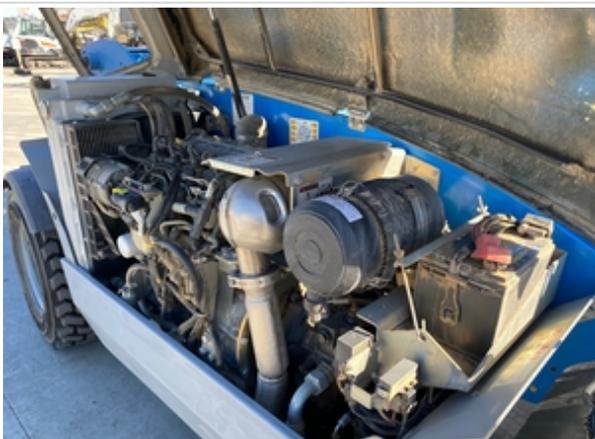
Engine Photos

Blow-by (Visual Observation Check)	No
Unusual Noises (Upon Start-up, Idle, Shutdown)	No
Unusual Noise Notes	No unusual noises heard
Engine Smoke (Upon Start-up, Idle, Shutdown)	No
Engine Smoke Notes	No engine smoke issues observed
Engine Exhaust Color	Clear

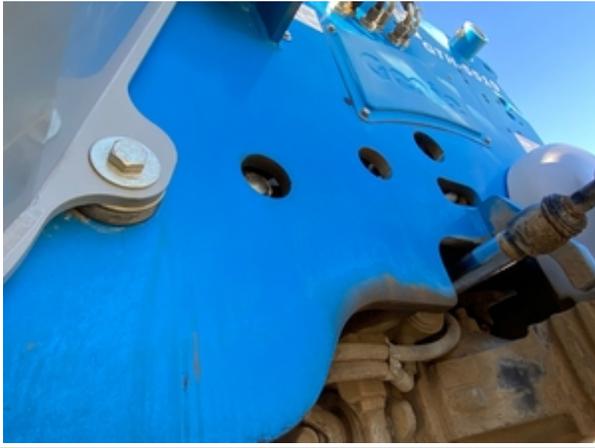
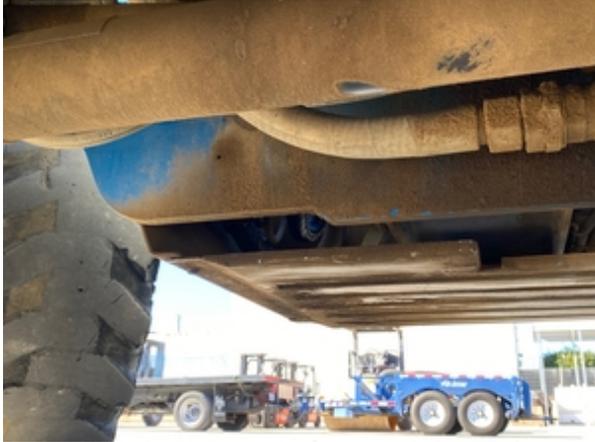
Frame	3 - Normal Wear & Tear
Frame Photos

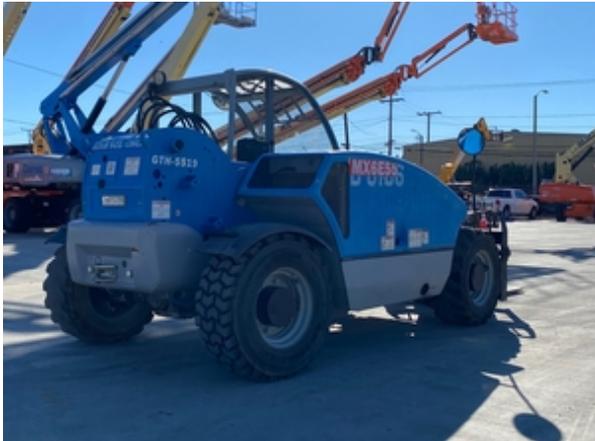
Stance	3 - Normal Wear & Tear
Stance Photos

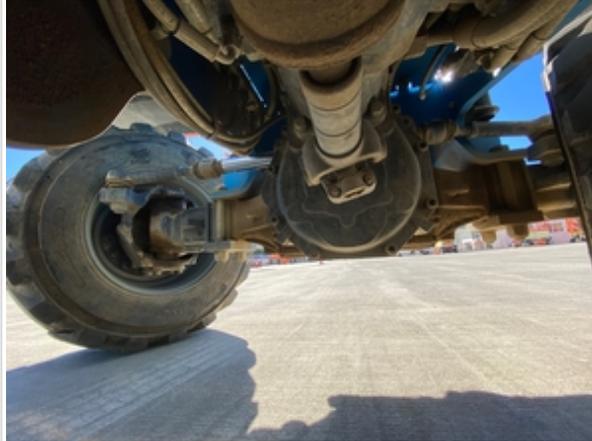
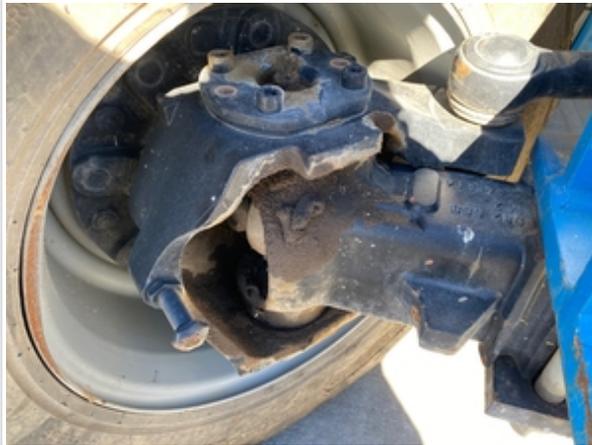
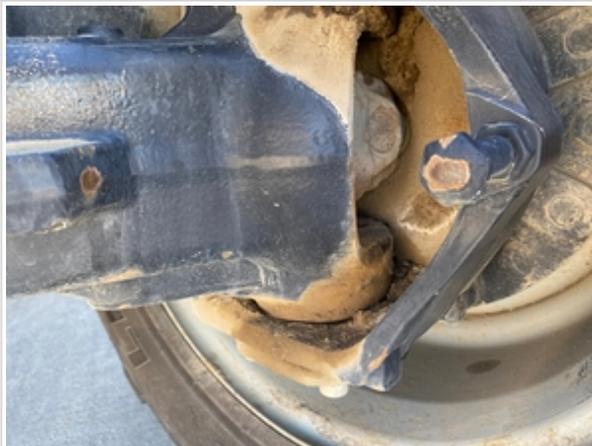
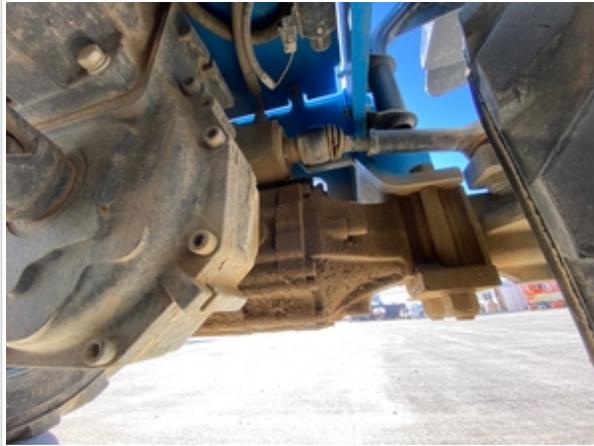
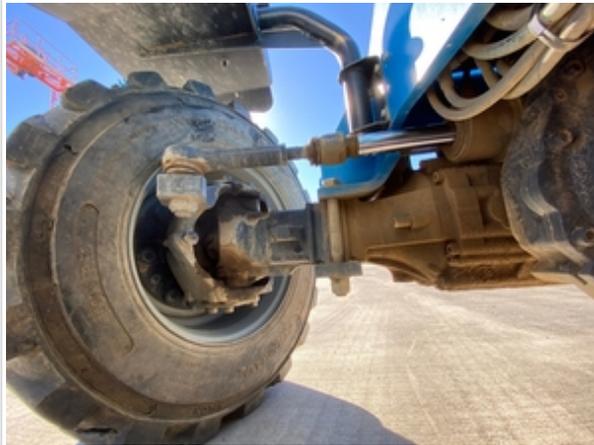
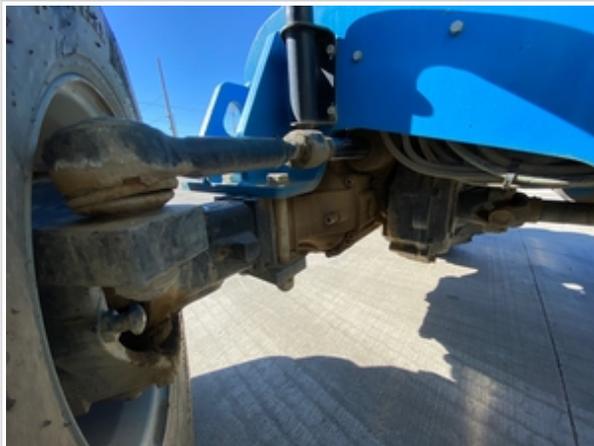
Front Axle Appearance Photos

Front Axle Appearance	3 - Normal Wear & Tear

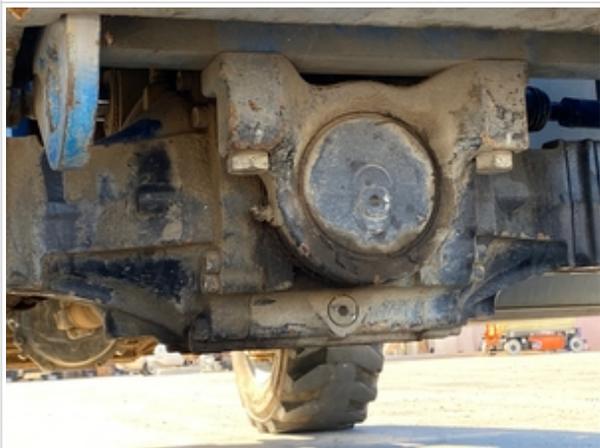
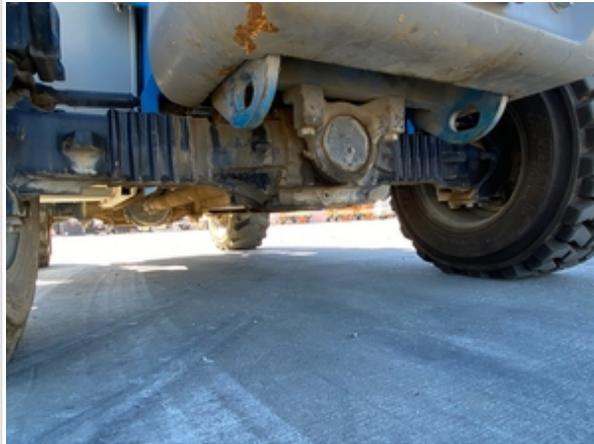
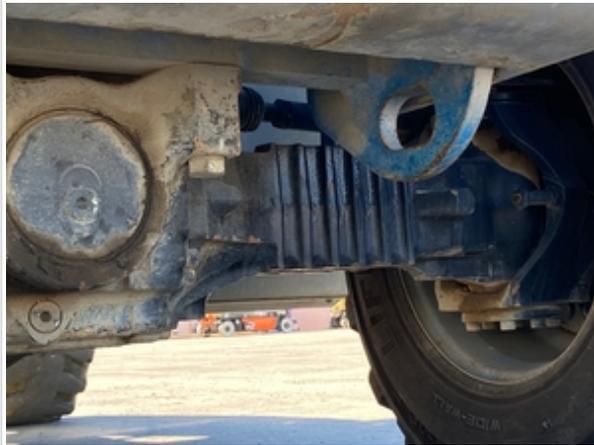
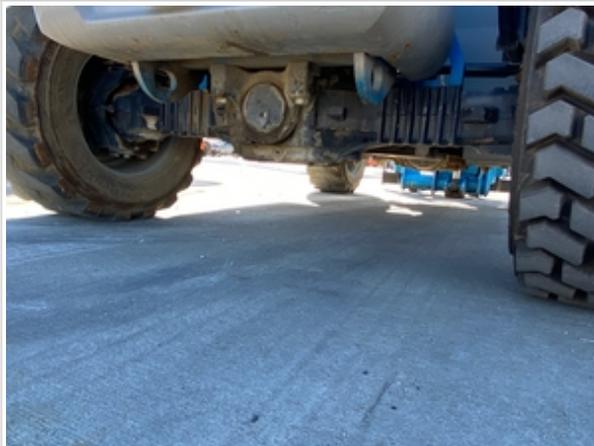
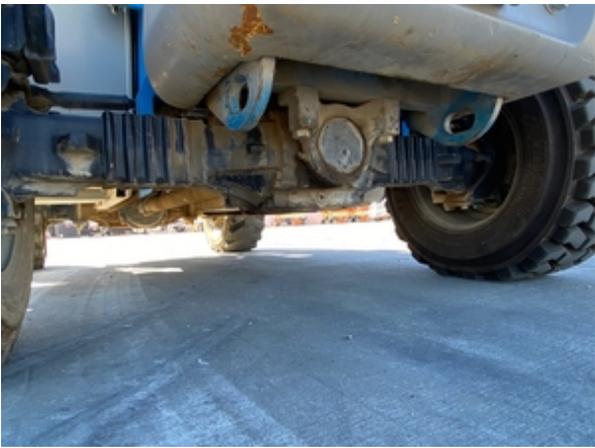
<p>Rear Axle Appearance</p>	<p>3 - Normal Wear & Tear</p>	
<p>Rear Axle Appearance Photos</p>

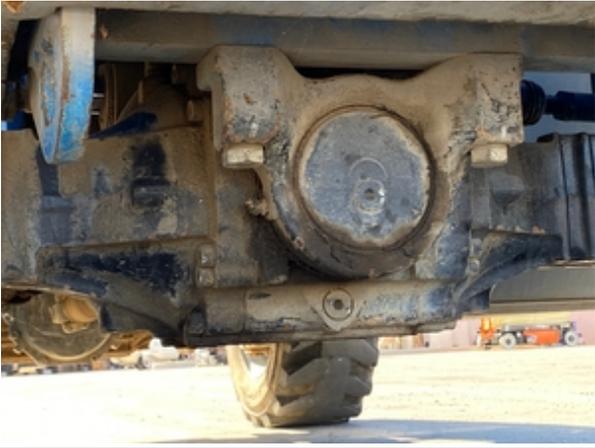
Oscillating Pin Appearance	3 - Normal Wear & Tear	
Oscillating Pin Appearance Photos

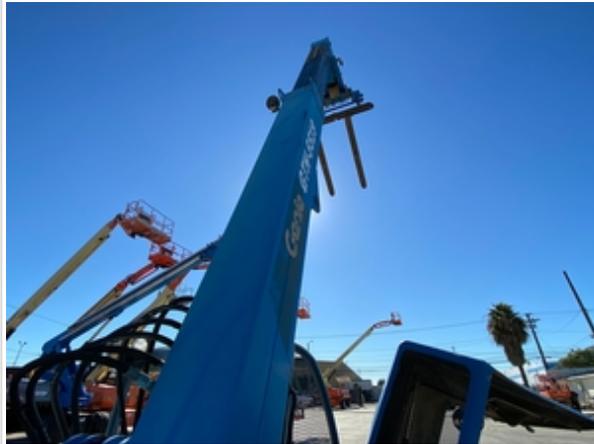
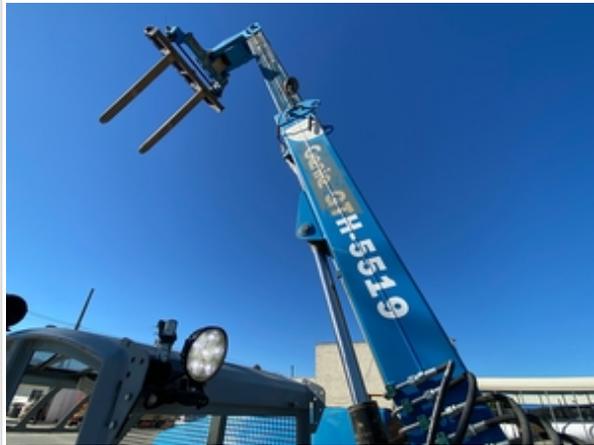
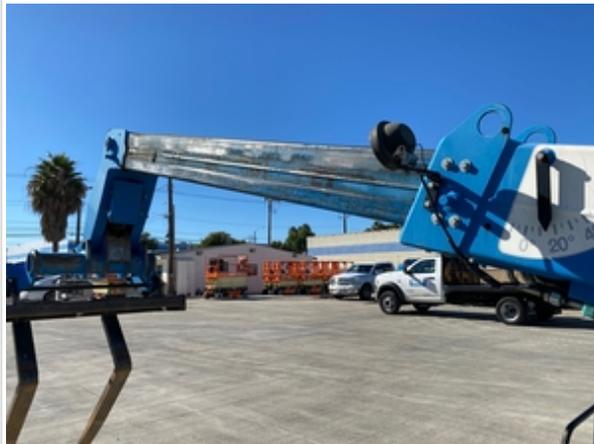
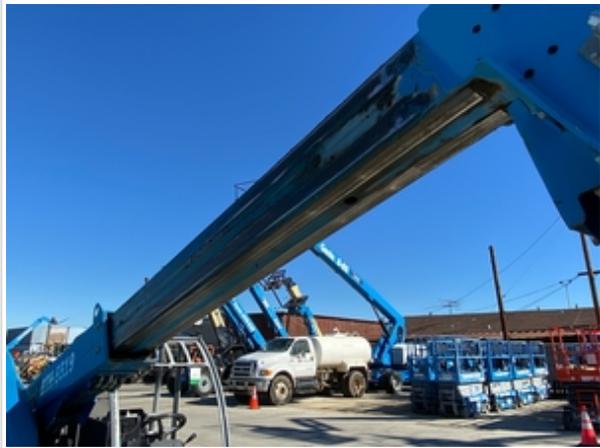
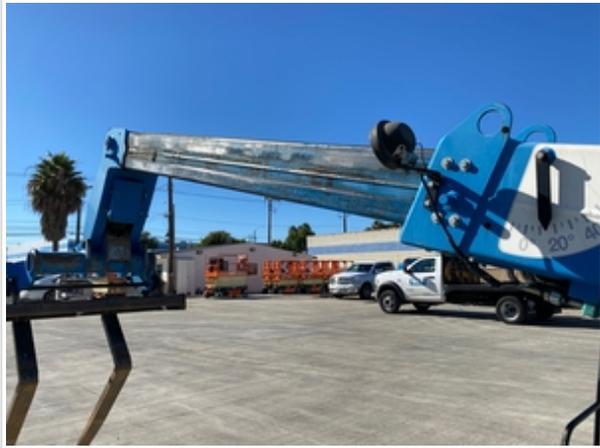
Boom Condition Photos

Tire Brand	Hercules life master
Tire Size	12 - 16.5
Front Left Tire - Ratio Remaining	30%
Rear Left Tire - Ratio Remaining	30%
Front Right Tire - Ratio Remaining	30%
Rear Right Tire - Ratio Remaining	90%
Boom Condition	3 - Normal Wear & Tear

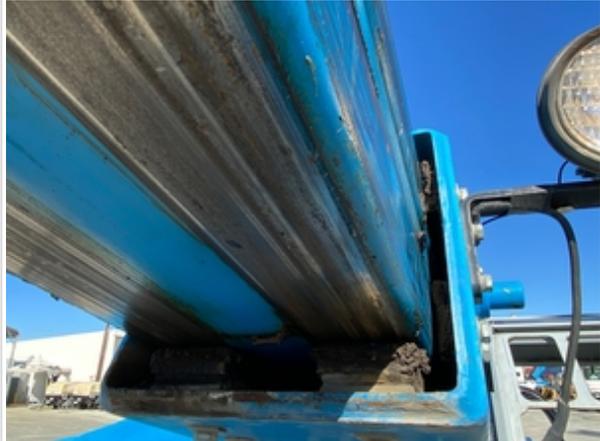
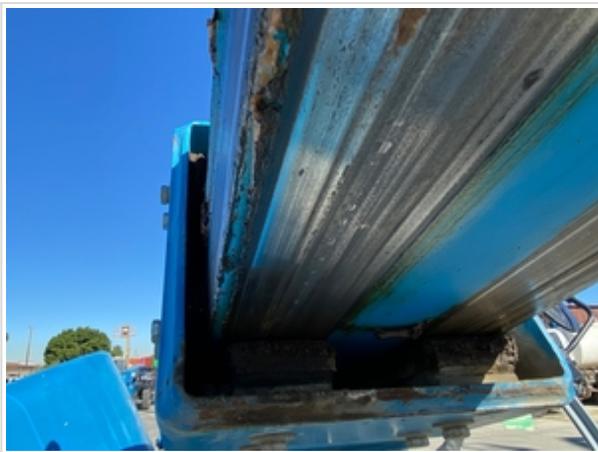
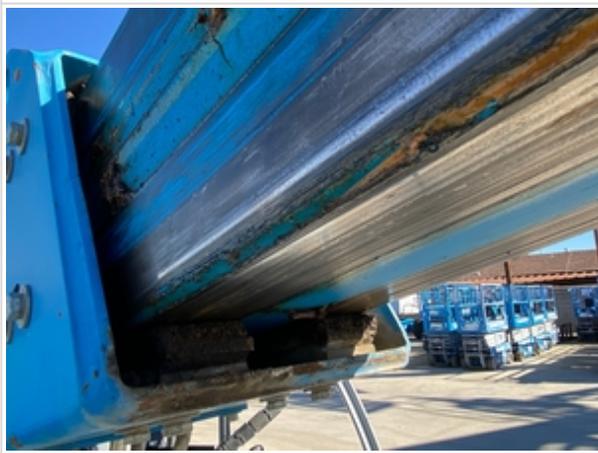
Chain / Tensioners	3 - Normal Wear & Tear	
Rollers & Guides	3 - Normal Wear & Tear	
Boom Wear Guides	3 - Normal Wear & Tear	
Boom Wear Guides Photos

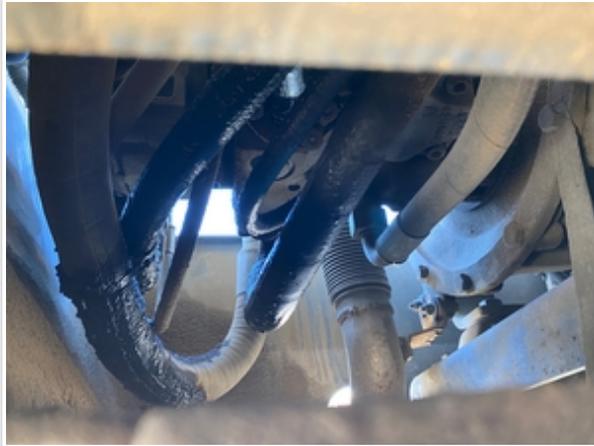
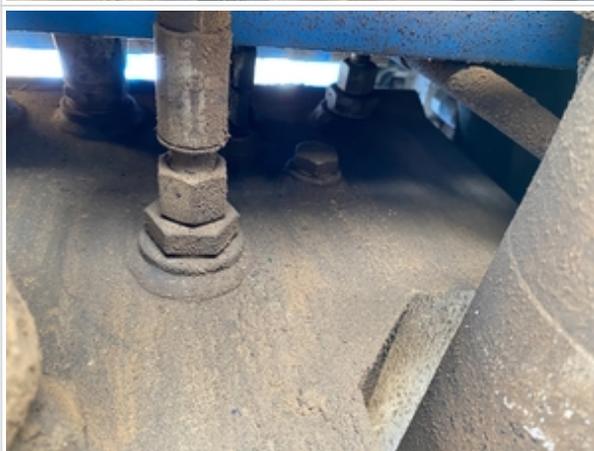
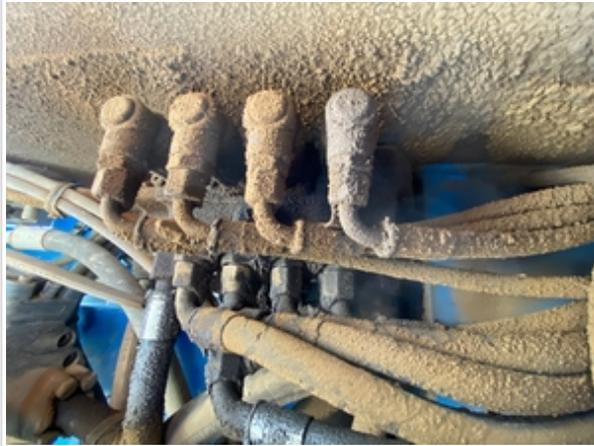
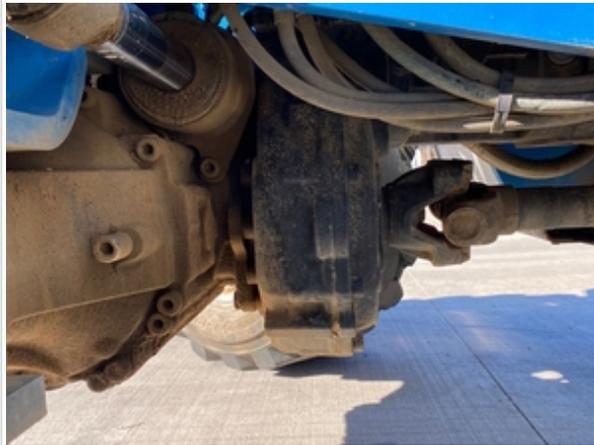
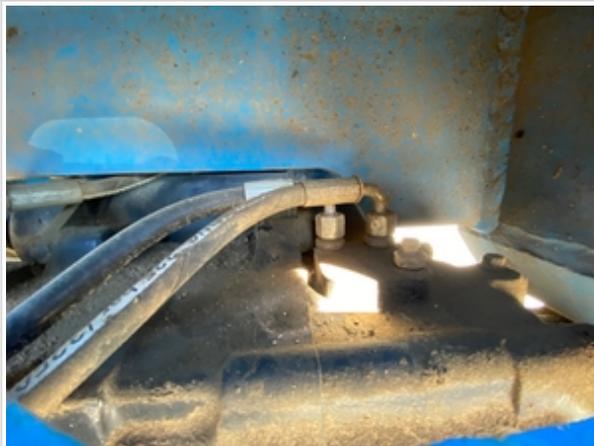
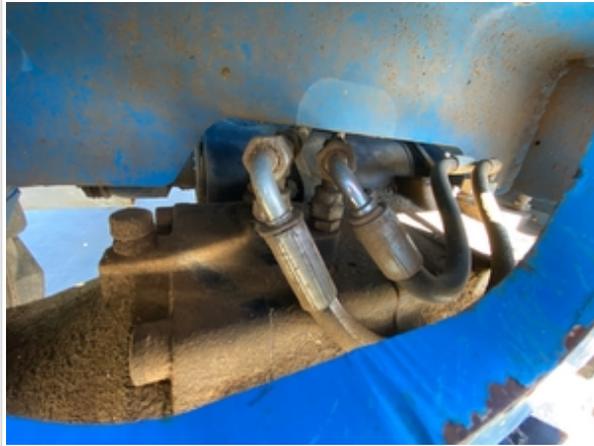
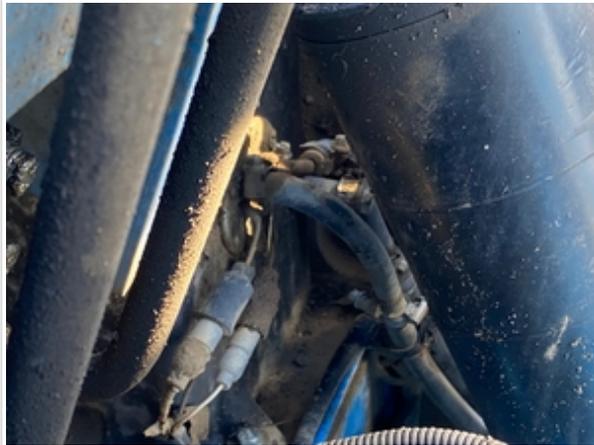
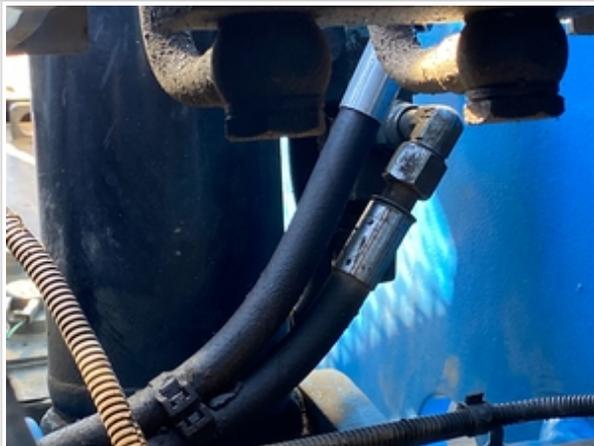
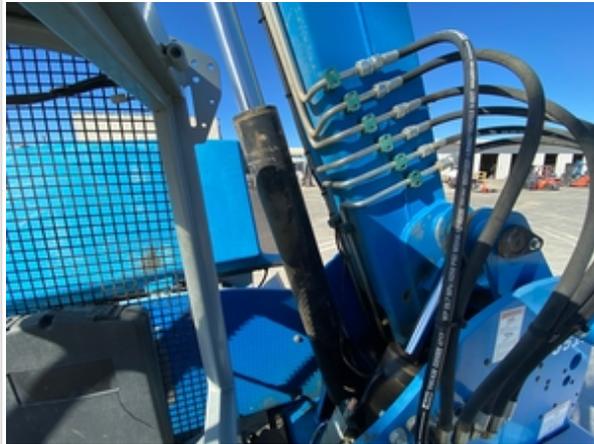
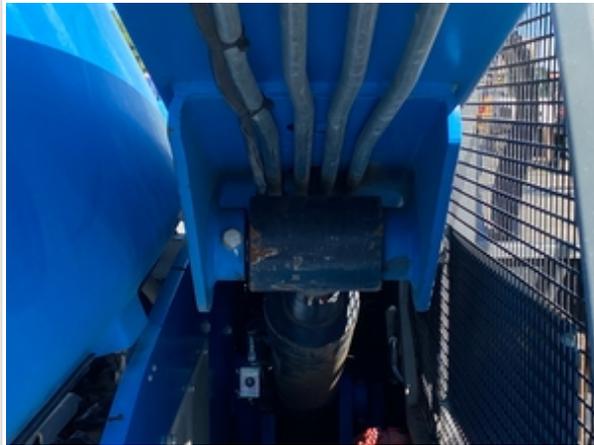
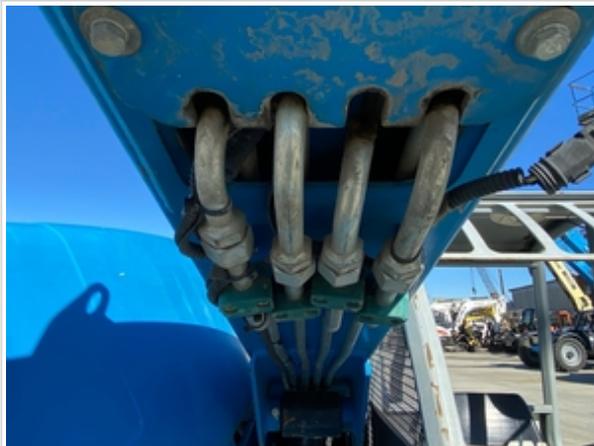
Appearance of Hydraulic Lines /
Fittings Photos

<h3>Hydraulics Overall</h3>	
Wet or Damp Hydraulic Lines / Fittings	Yes
Appearance of Hydraulic Lines / Fittings	3
Hydraulic Lines / Fittings Condition	Hydraulic lines & fittings are clean and in good condition, Active leaks in hoses or fittings observed, Other (see comments)
Comments	Some hydraulic hoses starting to leak. No active fluid drips seen only wet hoses

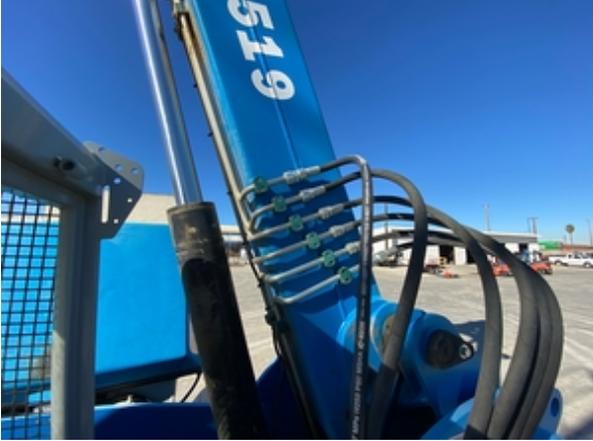
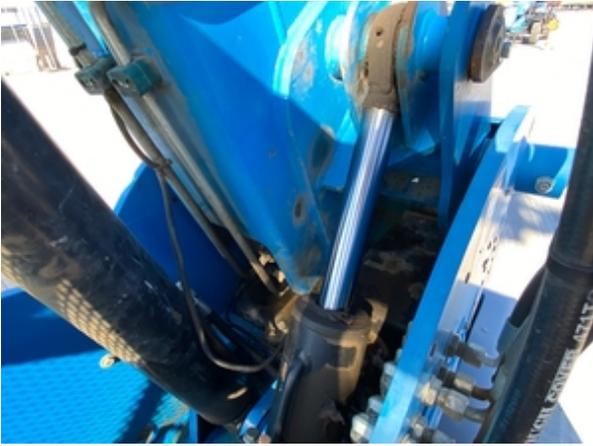
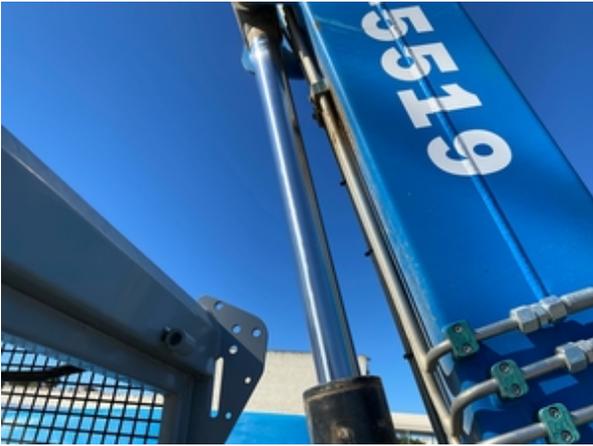
Boom Lift Cylinders Photos

Boom Lift Cylinders	Check the boom lift cylinders. Note any wear, pitting, discoloration, etc. Take photos.
Boom Lift Cylinders: Mounting Pin	3
Boom Lift Cylinders: Oil Leaks	No

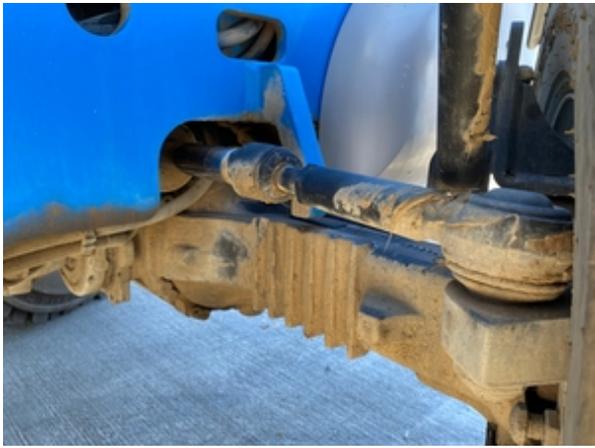
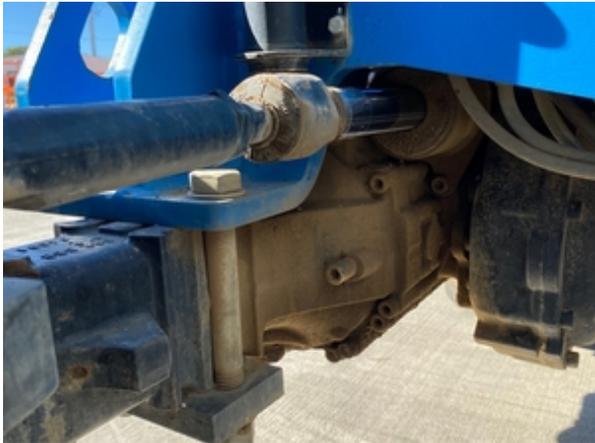
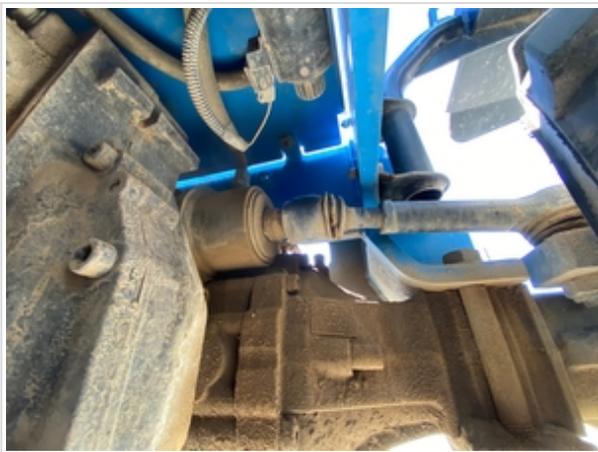
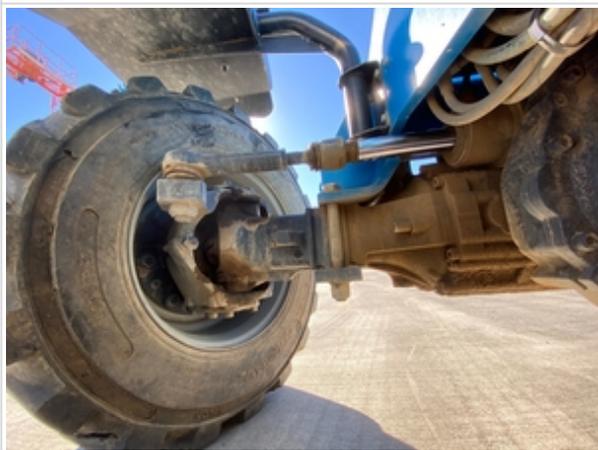
Carriage Tilt Cylinder: Mounting Pin	0
Carriage Tilt Cylinder: Oil Leaks	No
Side Shift Cylinder	Check the side shift cylinder. Note any wear, pitting, discoloration, etc. Take photos.
Outrigger Cylinders	Check the outrigger cylinders. Note any wear, pitting, discoloration, etc. Take photos.
Steering Cylinders	Check the steering cylinders. Note any wear, pitting, discoloration, etc. Take photos.
Steering Cylinders: Mounting Pin	3
Steering Cylinders: Oil Leaks	No
Steering Cylinders Photos

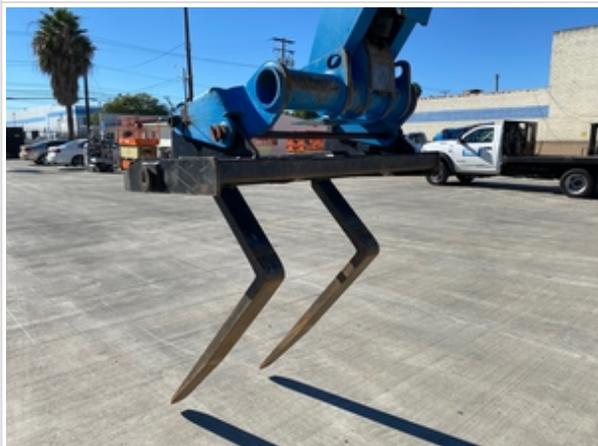
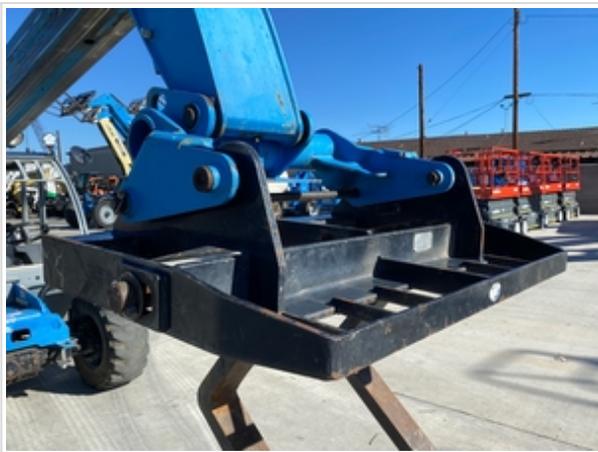
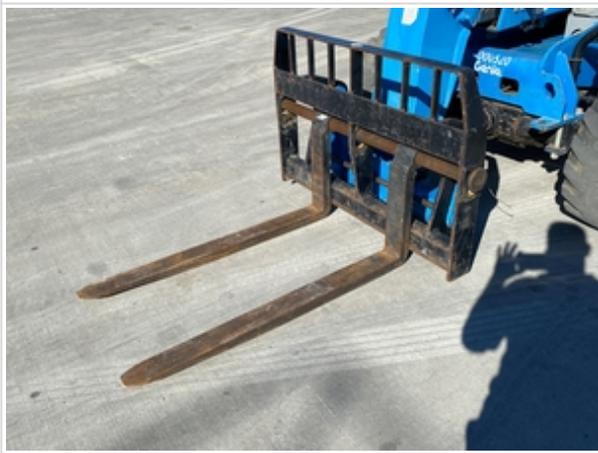
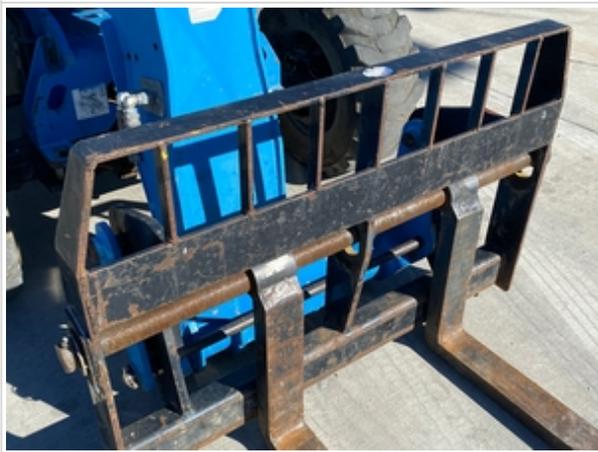
Forks / Work Tool Condition	3 - Normal Wear & Tear
Forks / Work Tool Photos
