Inspection Report (On-Highway Dump Truck)

Year	2011
Make	Peterbilt
Model	367
Serial Number	1NP - TLUOX - 6 - BD127980
Truck Odometer Reading	408,807
Previous Application (e.g., earth moving, mining, demolition, etc)	Asphalt Construction

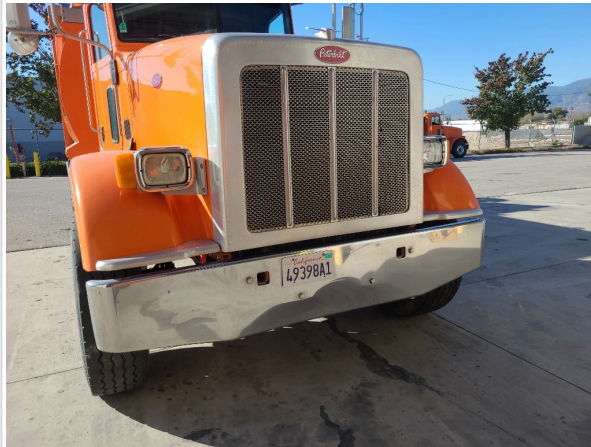
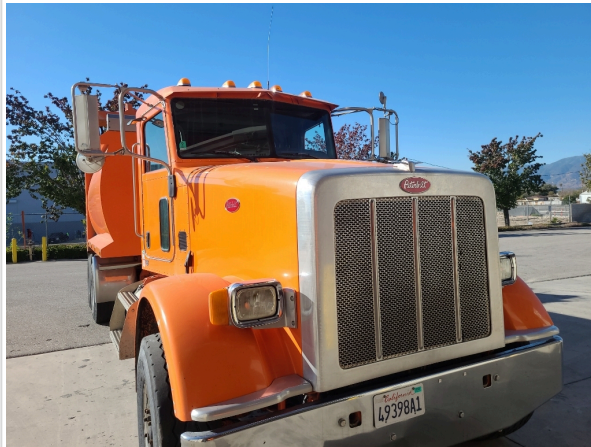
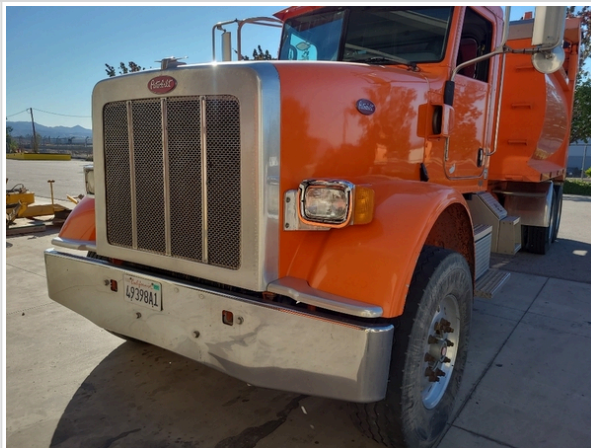
Front Photos

Front	3 - Normal Wear & Tear
Front Condition	No visible damage, Other (see comments)
Comments	Small front bumper dent at center

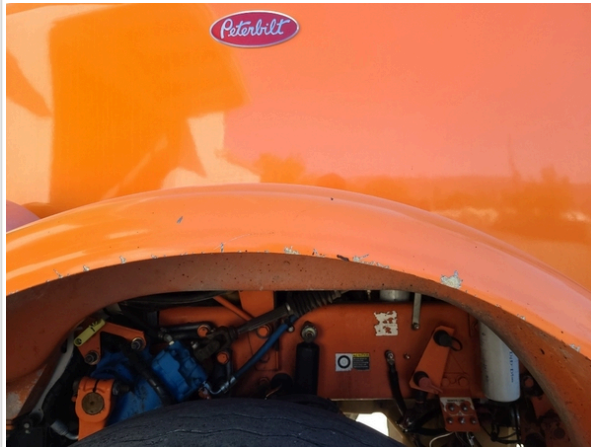
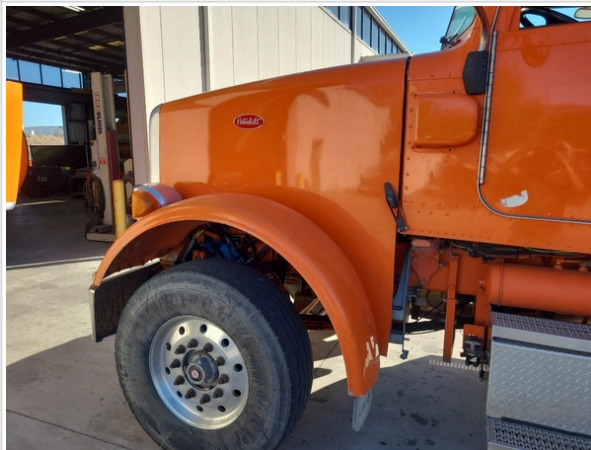
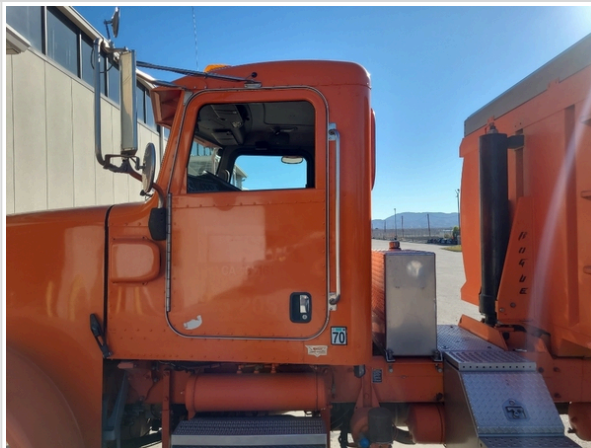
Left Photos

Left	3 - Normal Wear & Tear	
Left Condition	No visible damage, Other (see comments)	
Comments	a few paint chipping at front fender

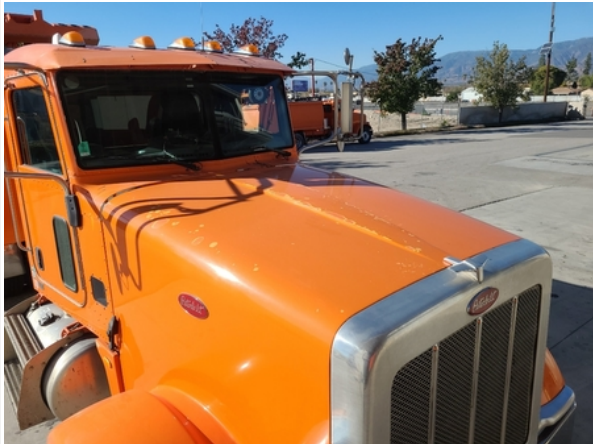
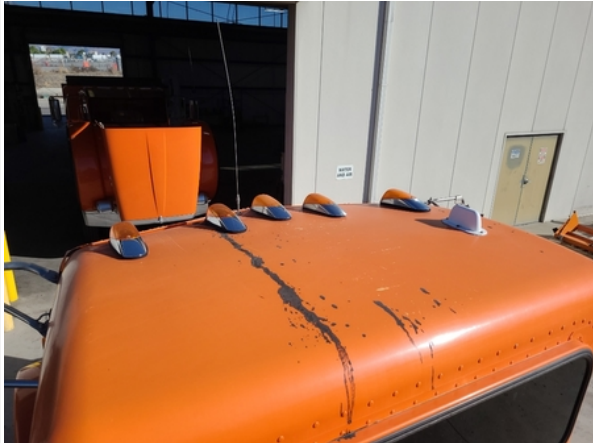
Upper	3 - Normal Wear & Tear	
Upper Condition	No visible damage, Other (see comments)	
Comments	asphalt slurry stained	
Upper Photos

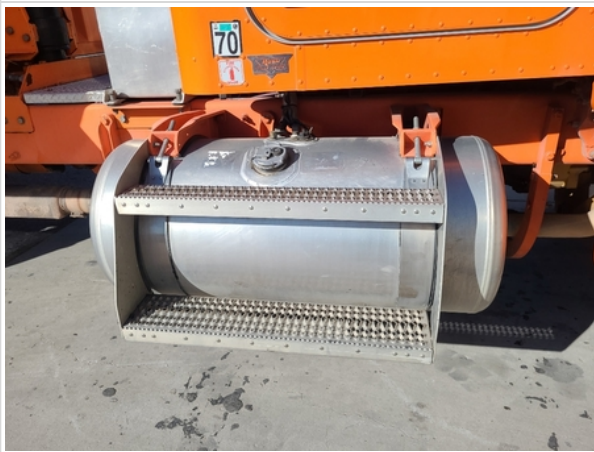
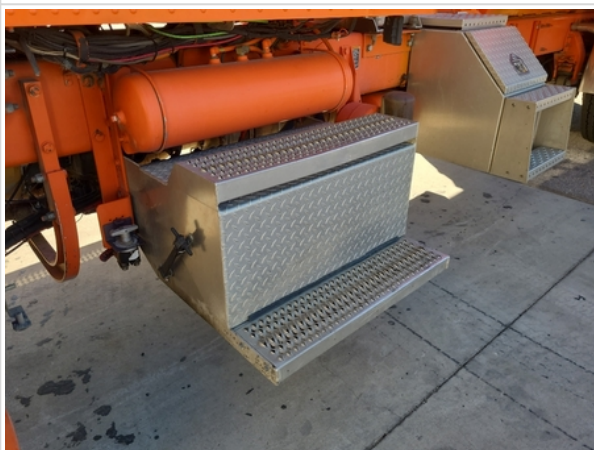
Steps / Ladders	3 - Normal Wear & Tear
Steps / Ladders Condition	Steps/ladders are fully intact and appear structurally sound
Steps / Ladders Photos

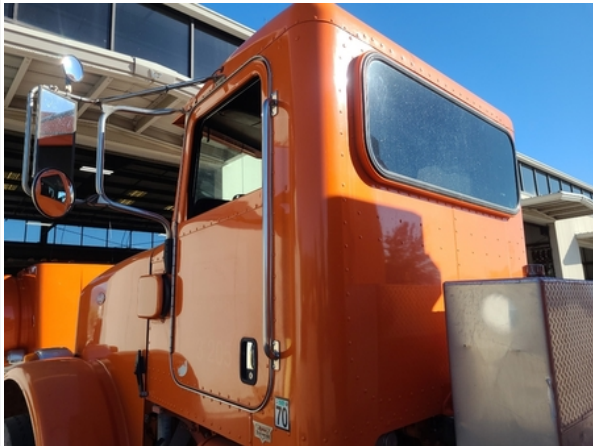
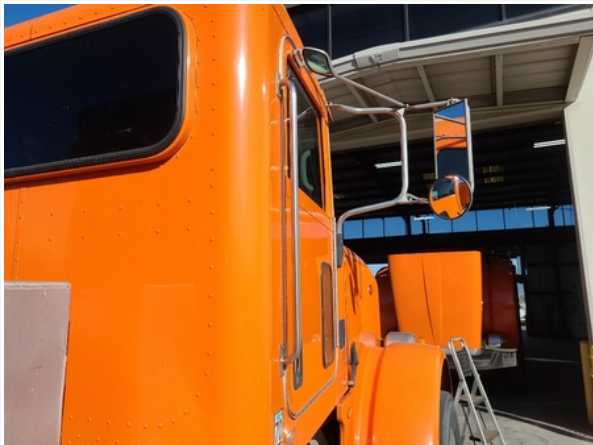
Handrails	3 - Normal Wear & Tear
Handrails Condition	Handrails are fully intact and appear structurally sound
Handrail Photos

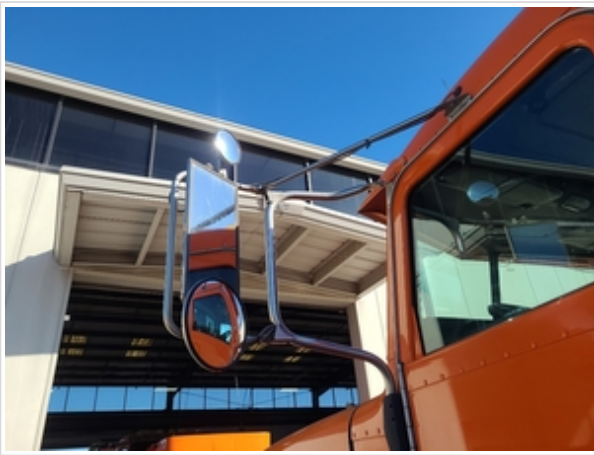
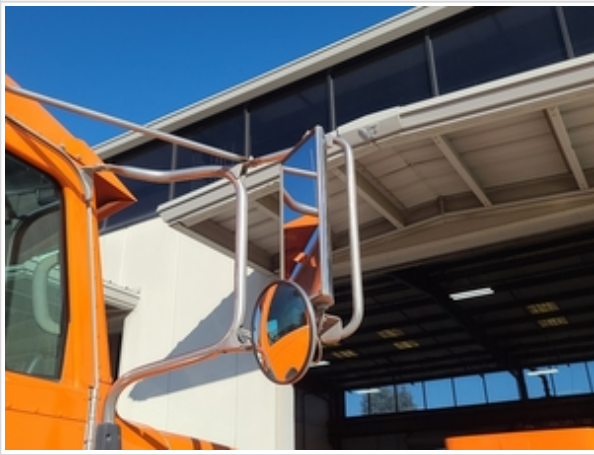
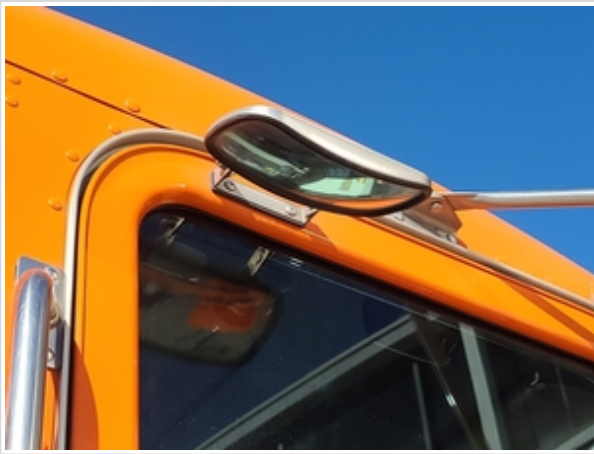
Mirrors Photos

Mirrors	3 - Normal Wear & Tear
Mirror Condition Notes	Mirrors present and intact, no visible damage

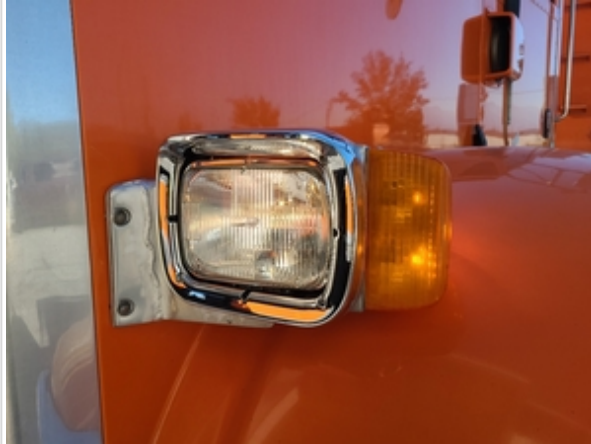
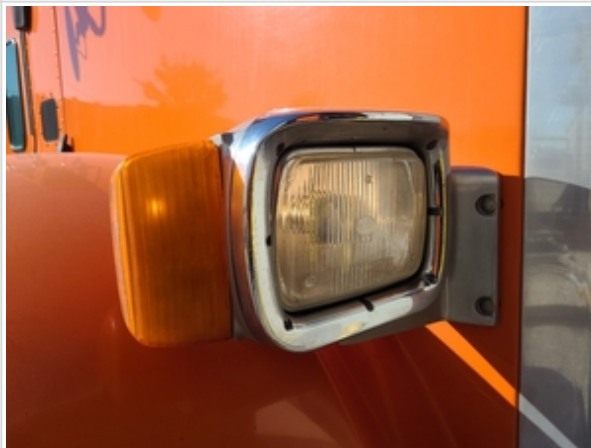
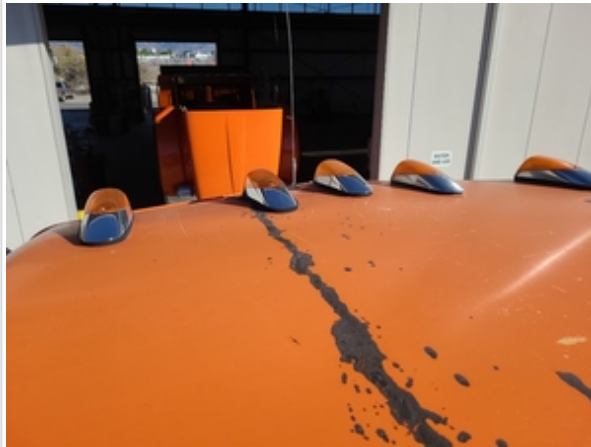
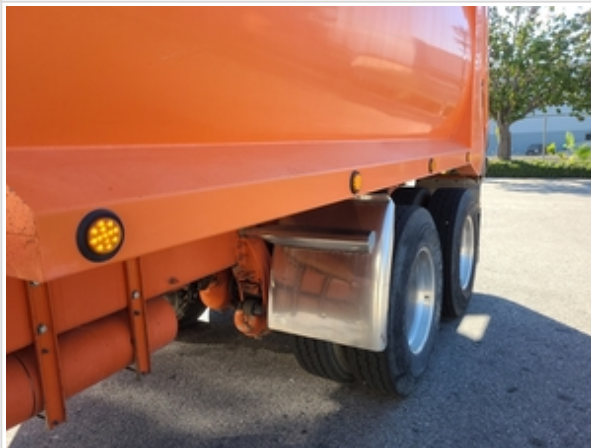
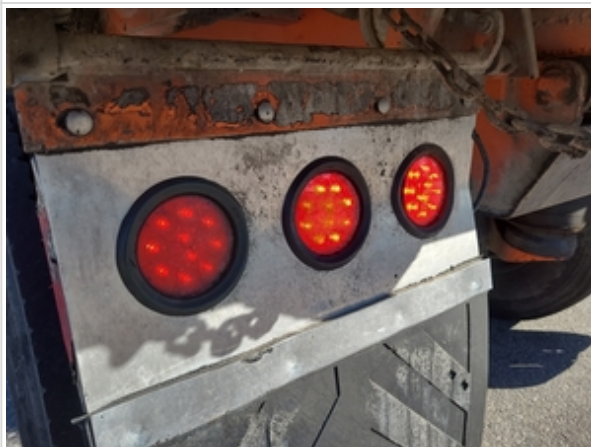
Lighting System Photos

Lighting System	3 - Normal Wear & Tear
Lighting System Condition	No visible damage, lighting system is operational

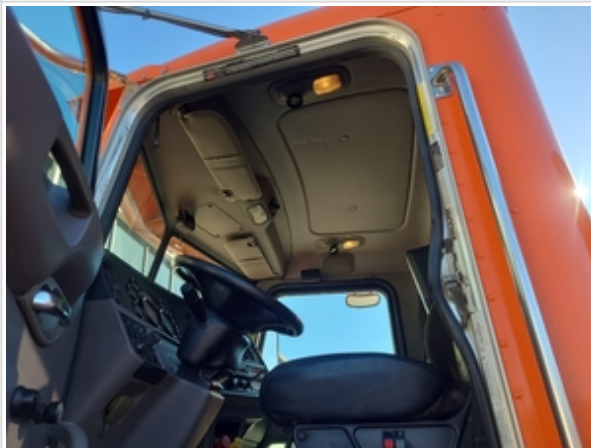
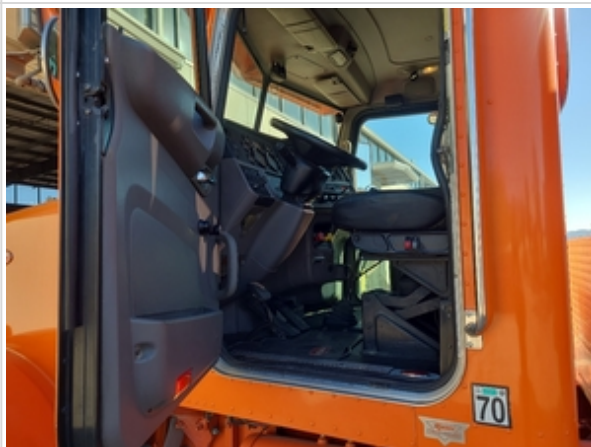
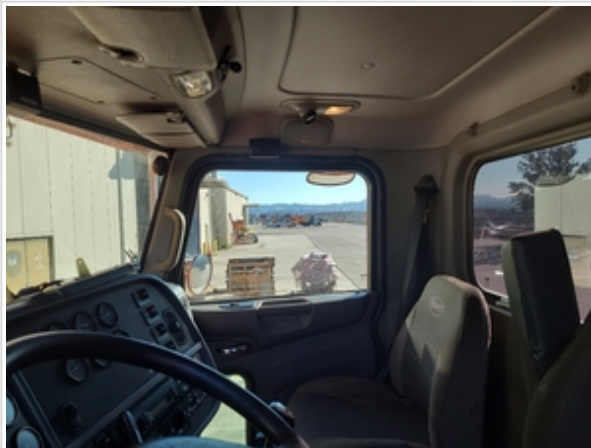
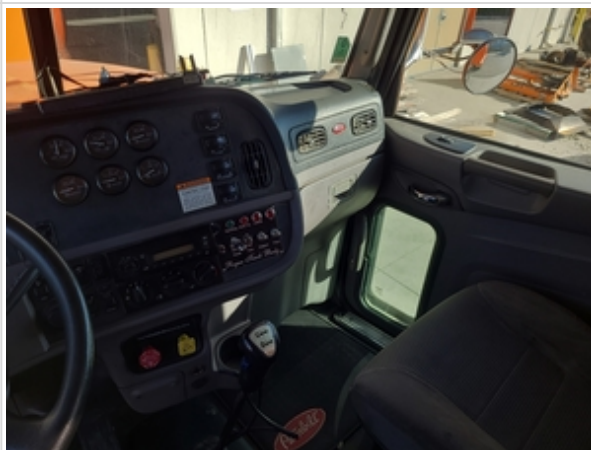
Operator Cabin Photos

3 - Normal Wear & Tear

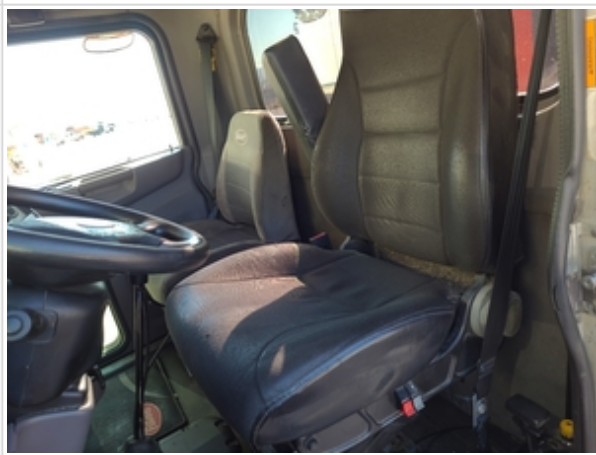
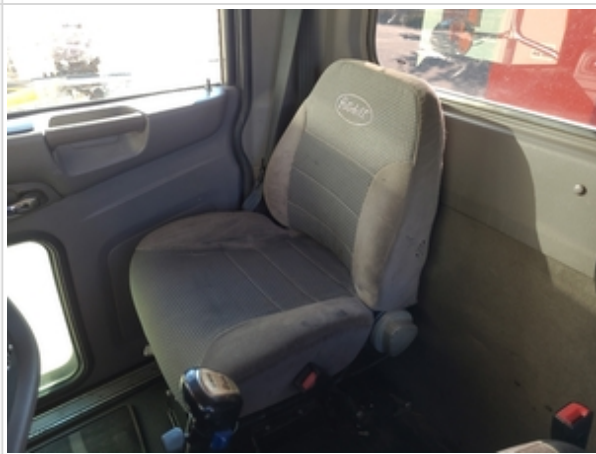
<p>Operator's Seat & Arm Rests Photos</p>

Operator's Seat & Arm Rests	3 - Normal Wear & Tear

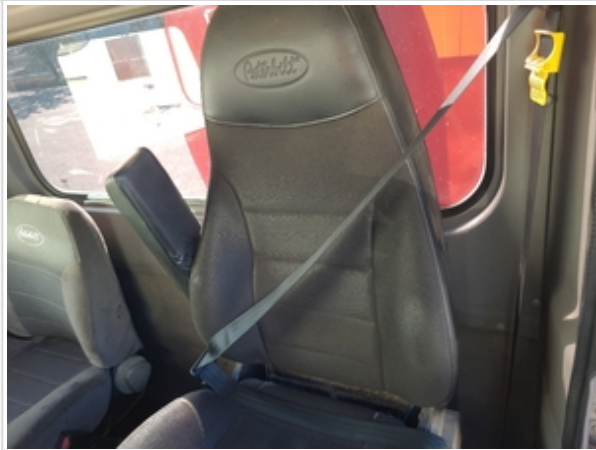
<p>Seat Belt Photos</p>

<p>Seat Belt</p>	<p>3 - Normal Wear & Tear</p>

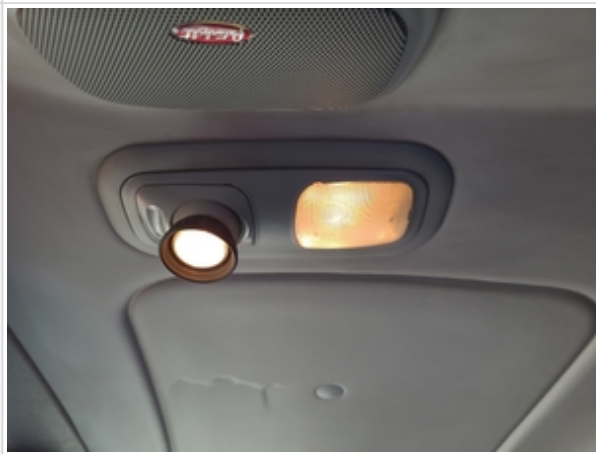
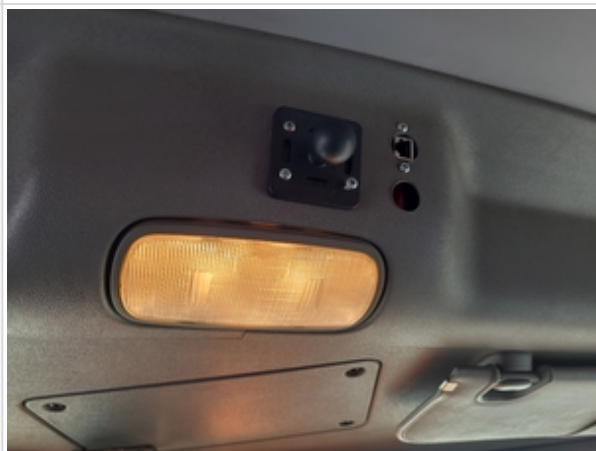
<p>Cabin Lights</p>	<p>3 - Normal Wear & Tear</p>
<p>Cabin Lights Photos</p>

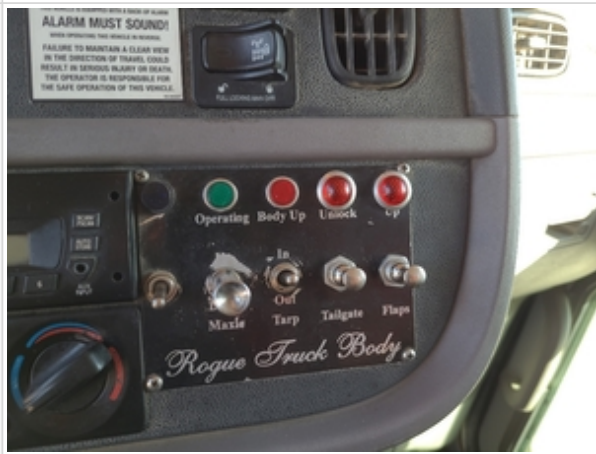
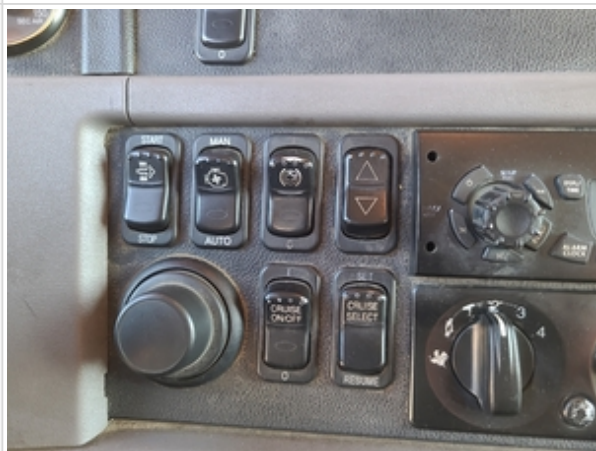
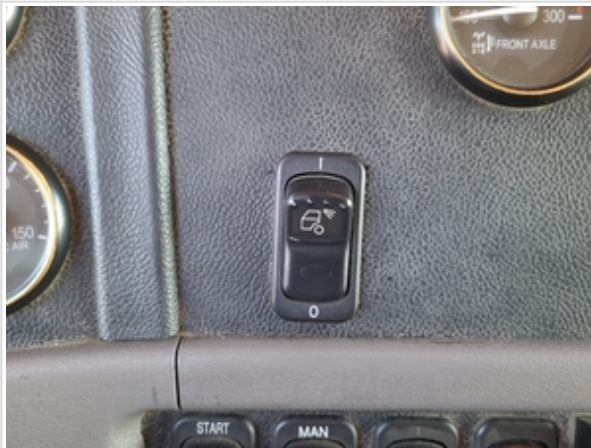
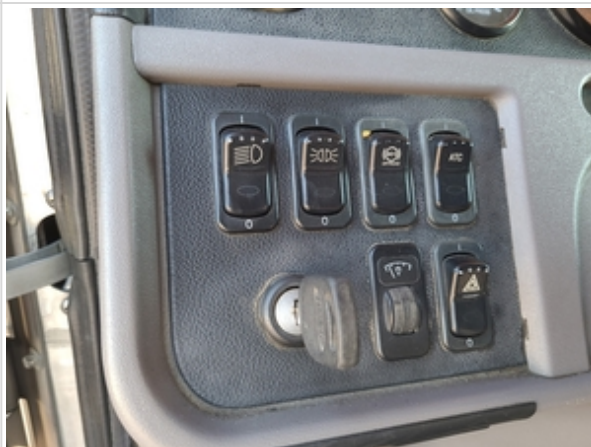
Controls & Switches	3 - Normal Wear & Tear
Controls & Switches Photos

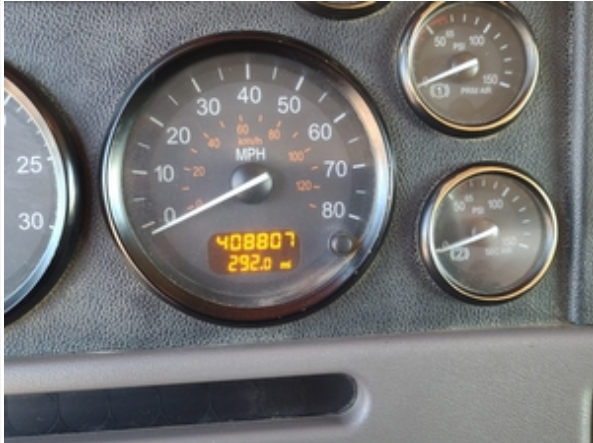
Other Gauge Activity	3 - Normal Wear & Tear

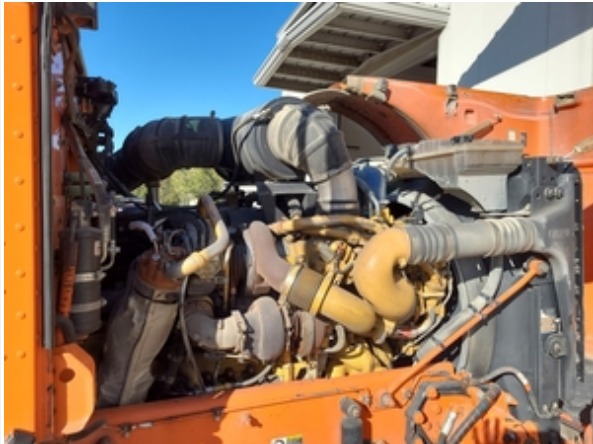
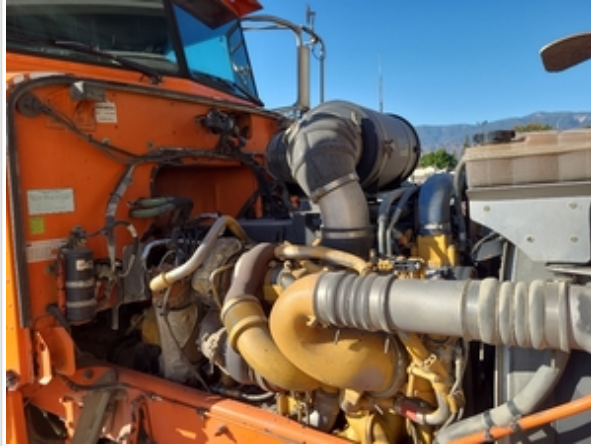
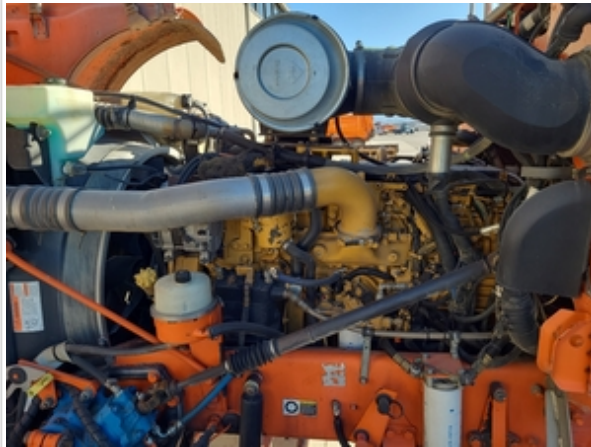
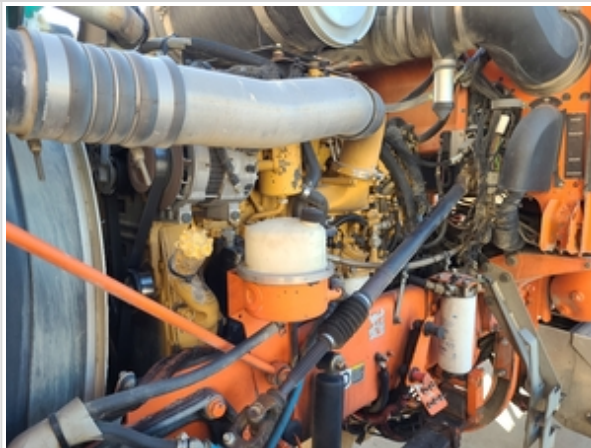
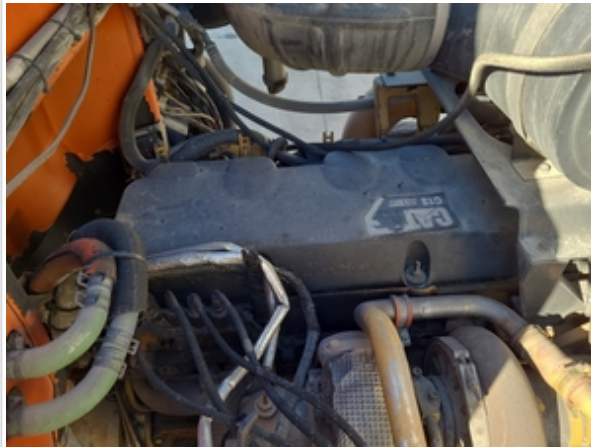
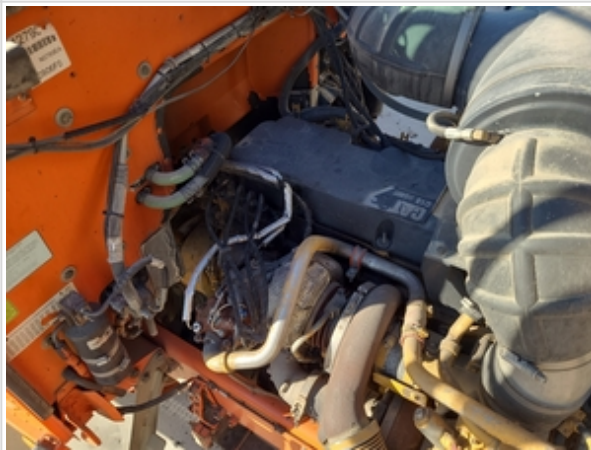
Engine Type (Make, Model, Cylinders, Hp)	CAT - C13 - 6CYL. - 450HP - 12.5L	
Emissions Tier	Tier 4i	
Engine Serial Number	N/A	
Engine Fuel Type	Diesel	
Engine Photos

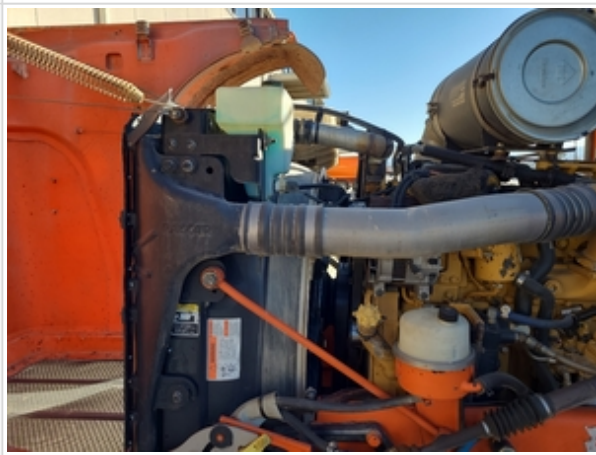
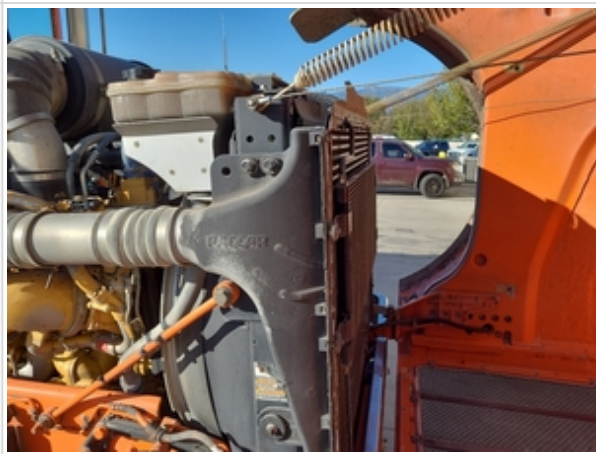
Battery Condition Photos	 
Radiator	3 - Normal Wear & Tear
Radiator Condition	Radiator fins & components appear to be in good working order, no signs of damage or leaks
Radiator Photos

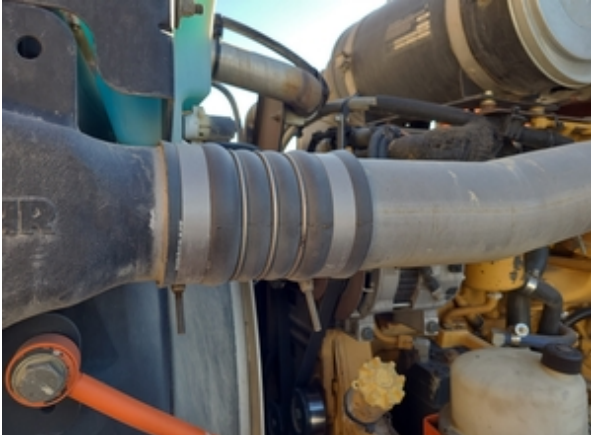
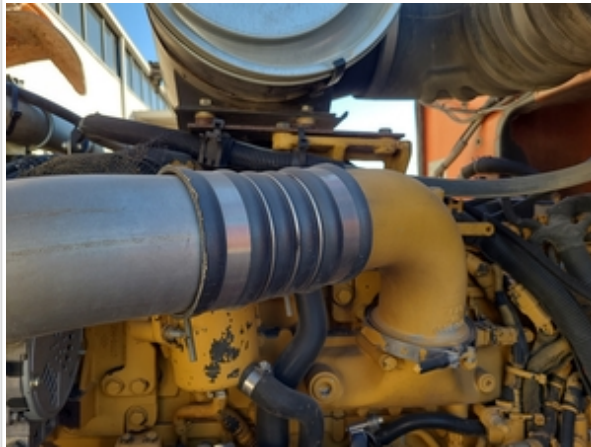
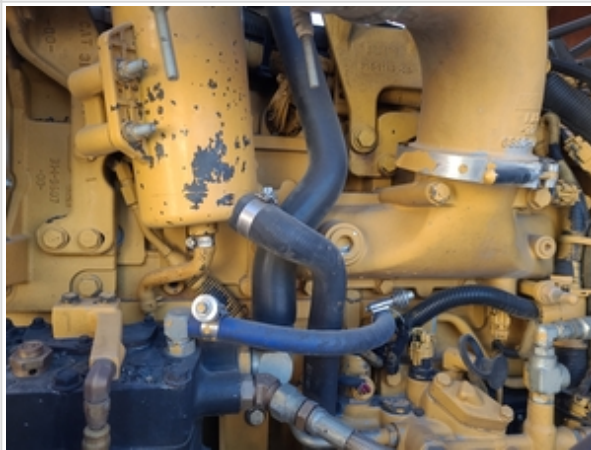
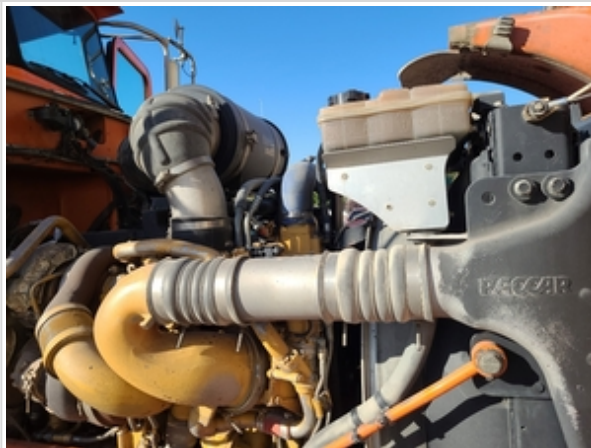
Hoses	3 - Normal Wear & Tear
Hose Condition	Firm, pliant hoses with no signs of wear or leaks
Hose Photos

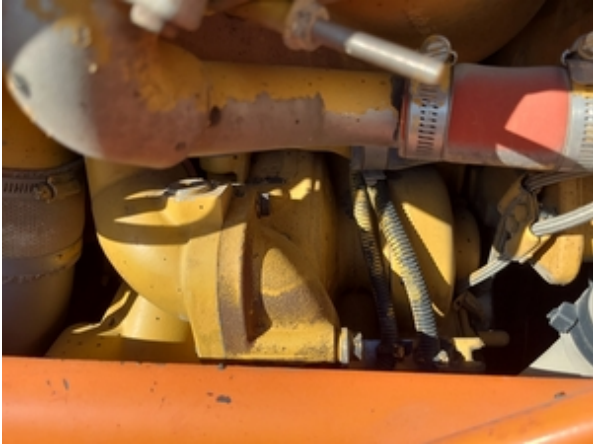
Water Pump Photos

Water Pump	3 - Normal Wear & Tear
Water Pump Condition	No unusual pump noises heard

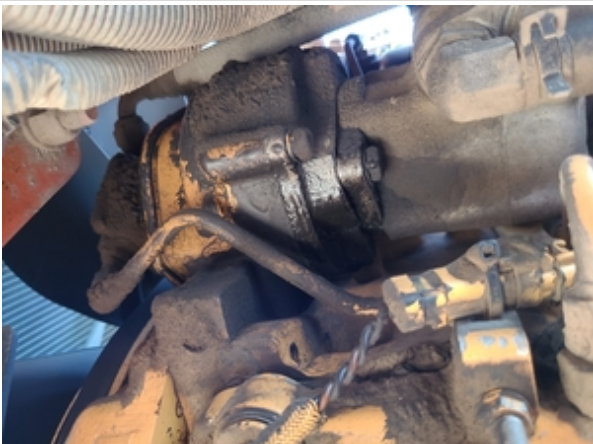
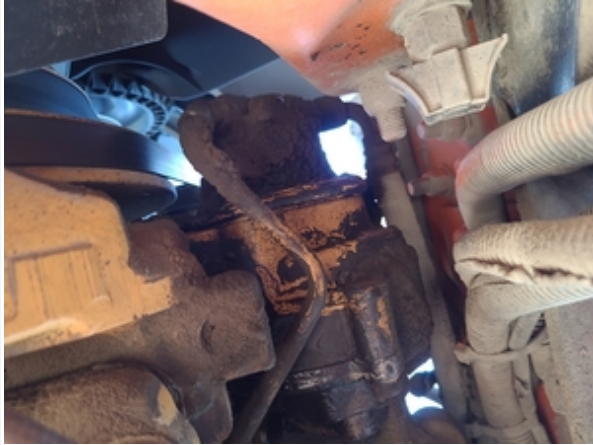
Cooling System Leaks	No
Coolant Color / Appearance	3 - Normal Wear & Tear
Coolant Color/Appearance Notes	Normal Translucent appearance, no visual signs of contamination
Oil Leaks	Yes
Oil Leak Notes	Wet areas with drops forming due to oil leakage, Other (see comments)
Comments	small oil leak observed around bell housing & Small oil leak at front left side of engine
Oil Leak Photos

Requires DEF (Diesel Exhaust Fluid)	No
Overall Engine Appearance	Clean & dry, Areas of dried seepage seen on engine hoses & components
Overall Engine Comments	Overall engine well maintained. A few small leaks observed.

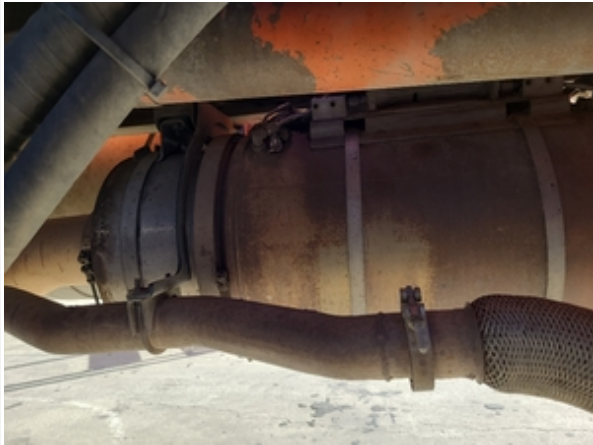
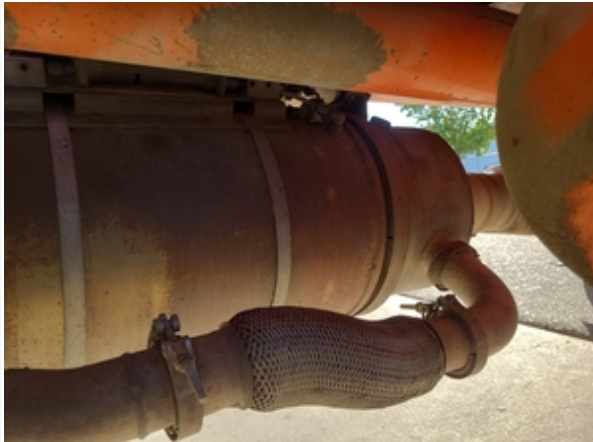
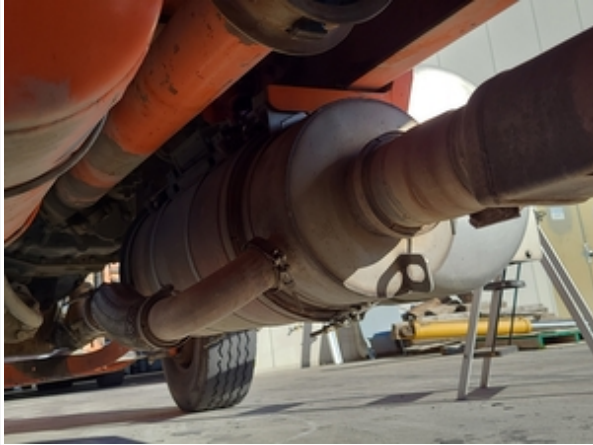
Oil Color / Appearance	3 - Normal Wear & Tear	
Oil Color / Appearance Notes	Clean oil appearance, no signs of cross contamination, Appropriate oil level	
Fuel Leaks	No	
Equipped with DPF (Diesel Particulate Filter)	Yes	
DPF Condition	3 - Normal Wear & Tear	
DPF Condition Notes	Filter housing is intact with no signs of damage or malfunction, DPF indicator is not illuminated	
DPF Photos

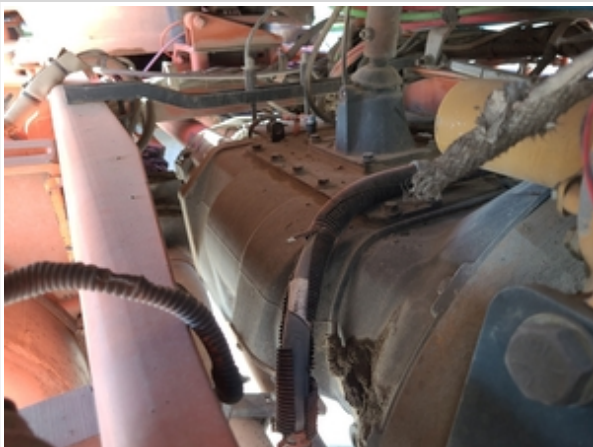
Transmission Info (Make/Model)	Eaton 10 Speed Manual Transmission
Drive Type	4X2
Overdrive	N/A
Transmission	3 - Normal Wear & Tear
Transmission Condition	No unusual noises or vibrations
Transmission Condition Photos

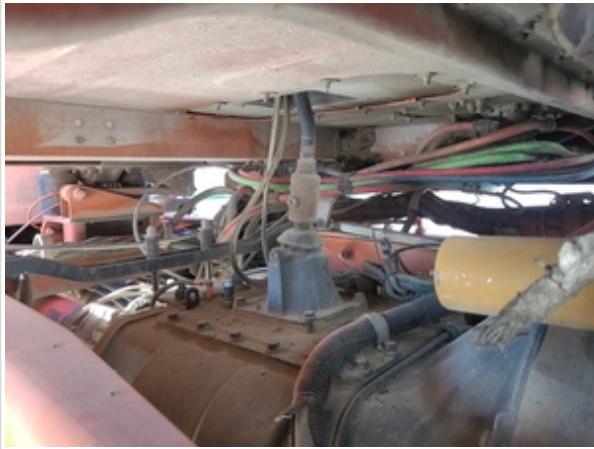
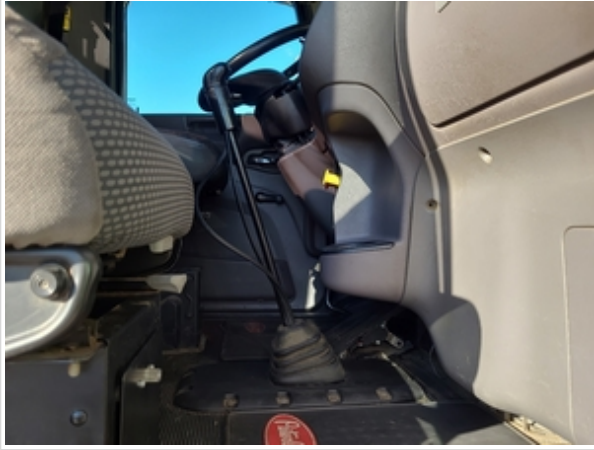
Shift Lever Photos

Clutch	3 - Normal Wear & Tear	
Clutch Condition	Clutch is functioning as expected	
Shift Lever	3 - Normal Wear & Tear	
Shift Lever Condition	Good forward and reverse function

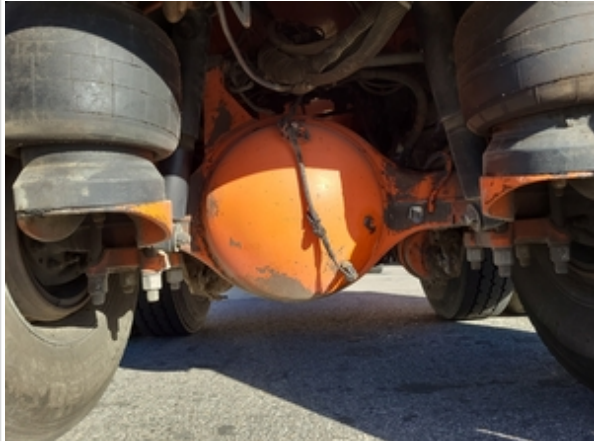
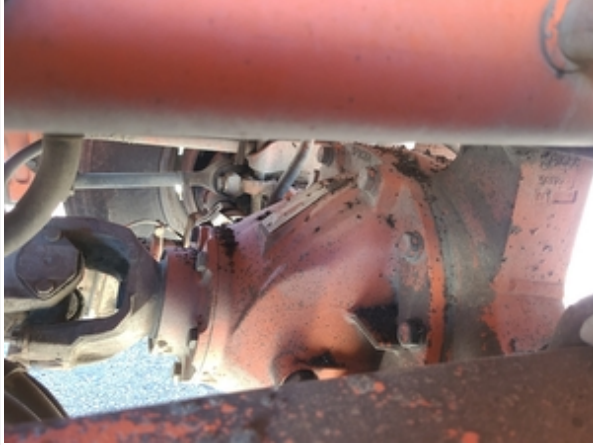
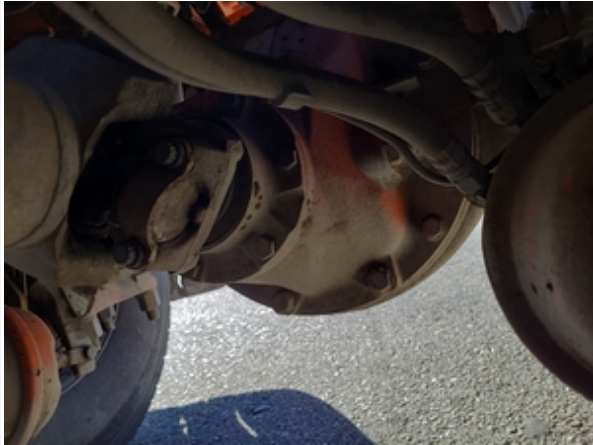
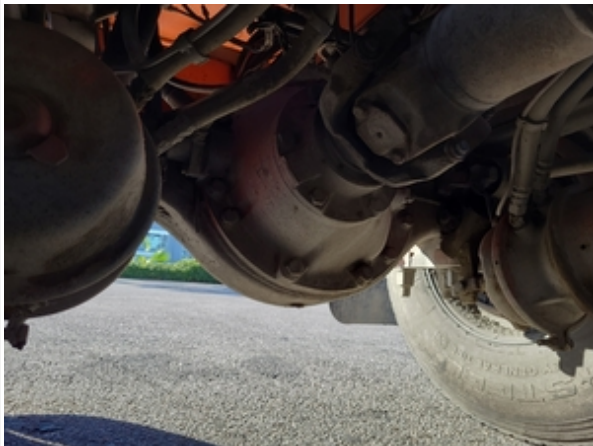
Differential	Check condition of the differential(s). Take photos and notes as relevant.
Rear Differential	3 - Normal Wear & Tear
Rear Differential Condition	Dry housing appearance, no unusual noises heard during operation
Rear Differential Photos

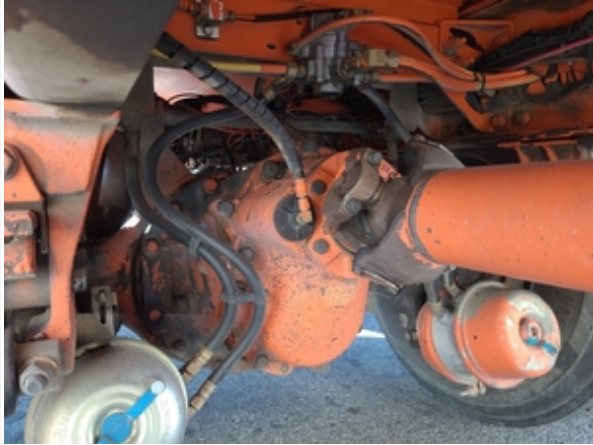
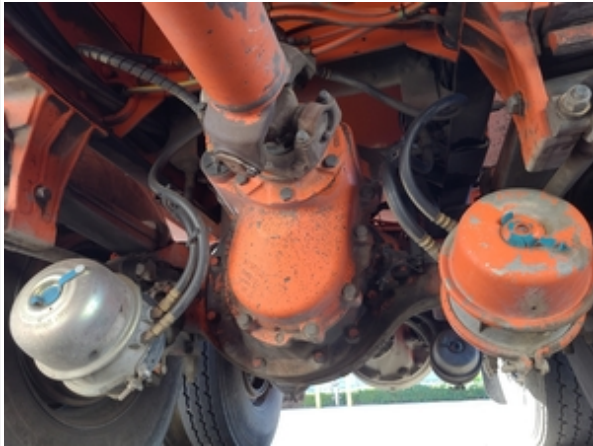
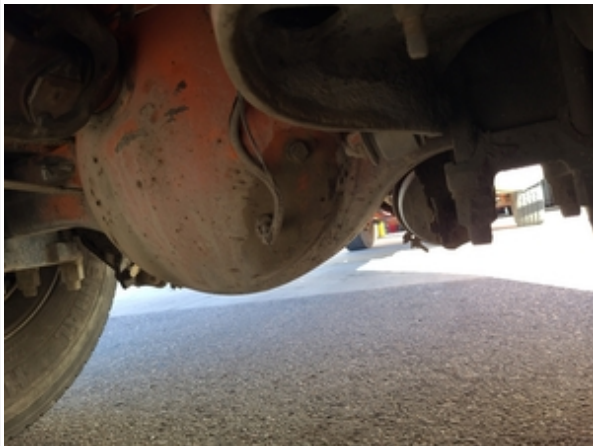
Front Differential Photos

Front Differential	3 - Normal Wear & Tear	
Front Differential Condition	Dry housing appearance, no unusual noises heard during operation

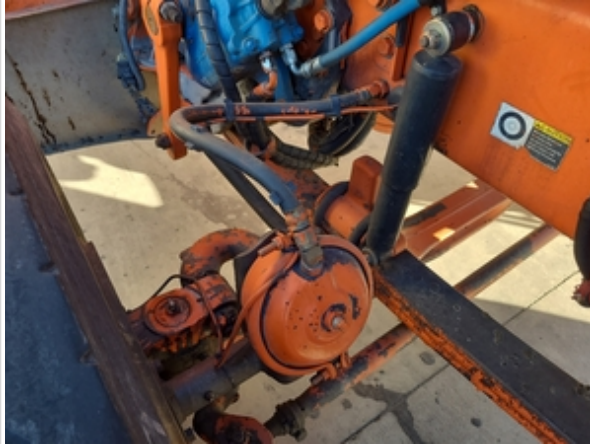
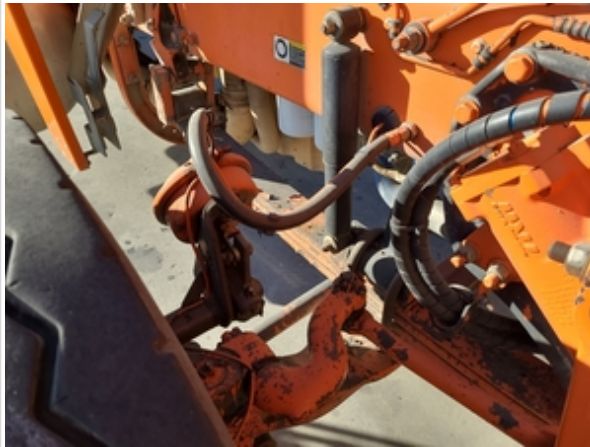
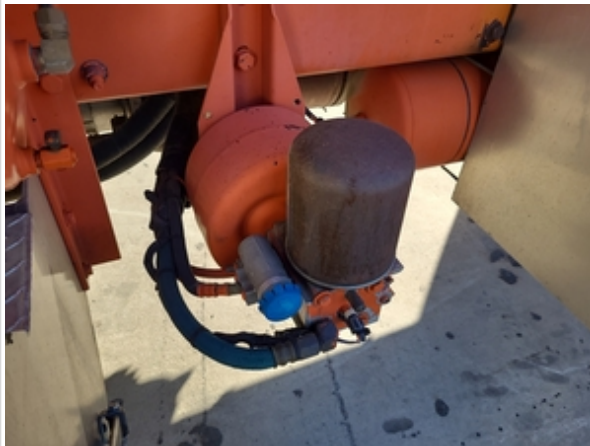
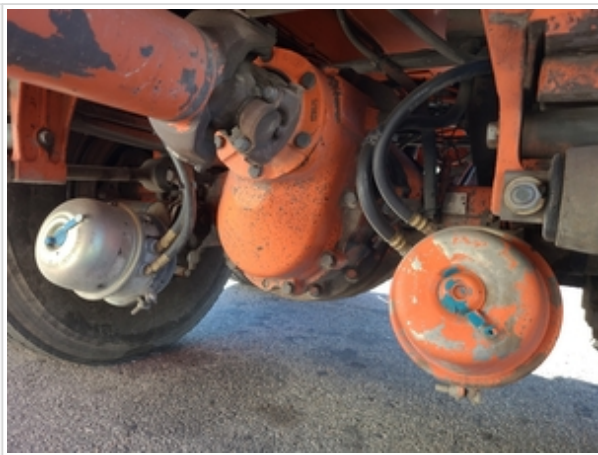
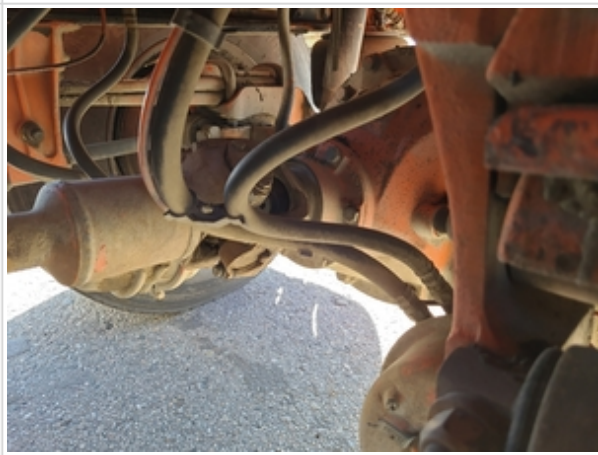
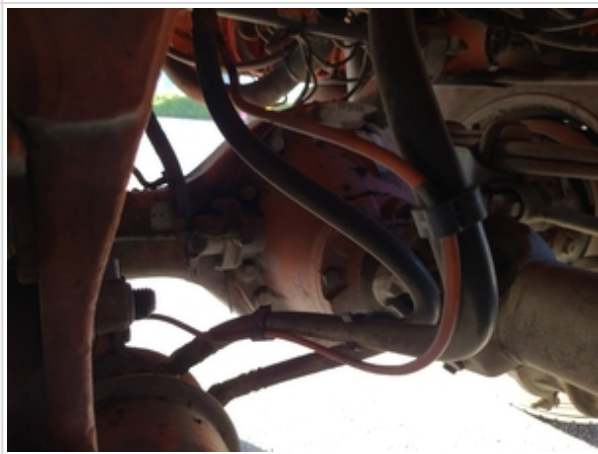
Air Brake System Photos

Brake System Type	Air Brakes	
Air Brakes Build Correct Pressure	Yes	
Air Brake System Leaks	No	
Air Brake Hose Condition	3 - Normal Wear & Tear

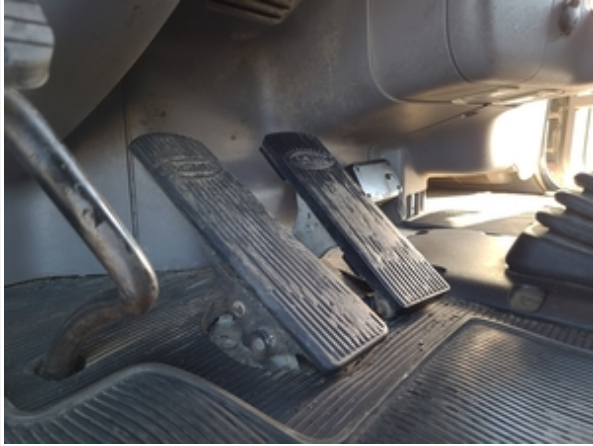
Foot Brake Photos

Foot Brake	3 - Normal Wear & Tear	
Foot Brake Condition	Good brake function

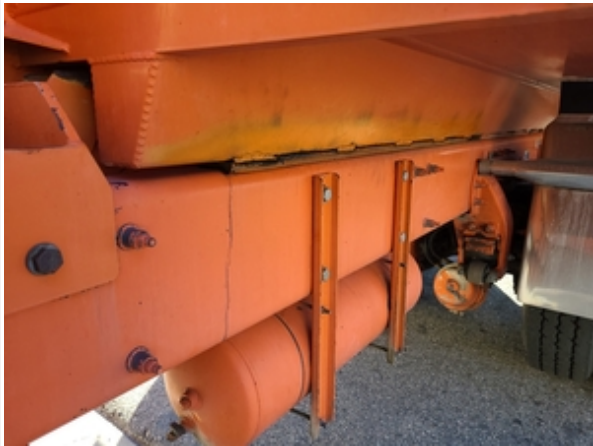
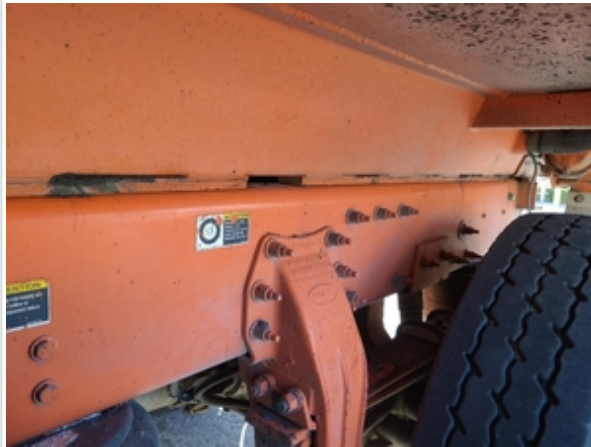
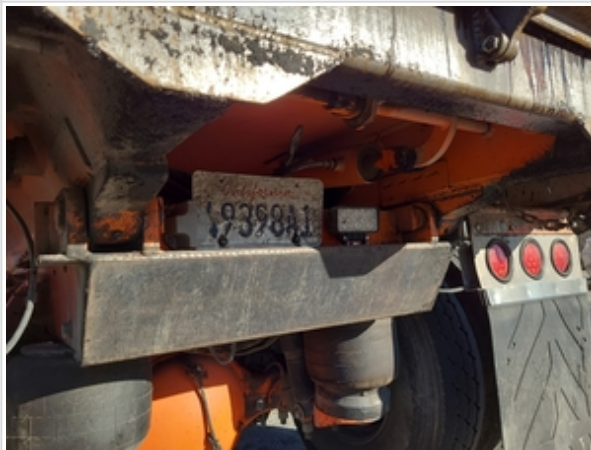
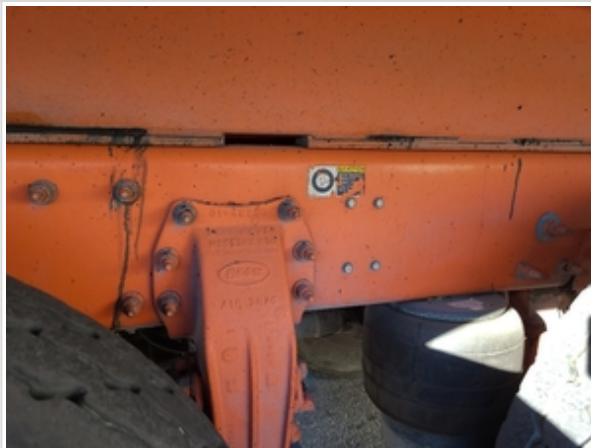
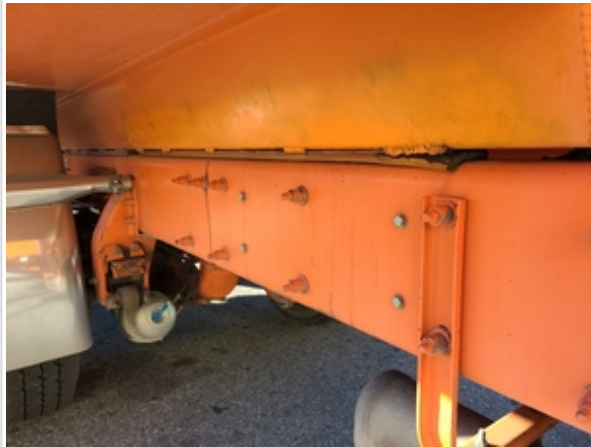
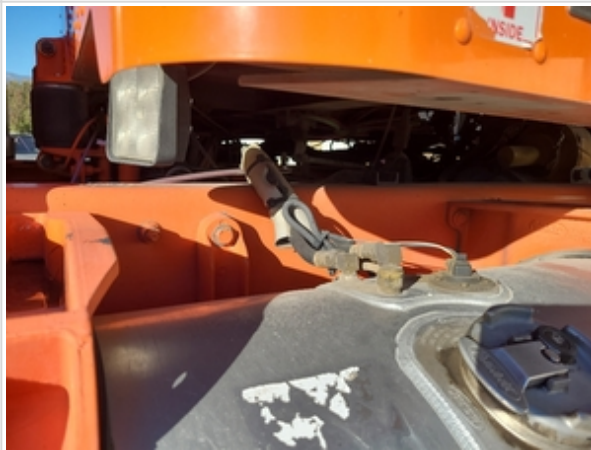
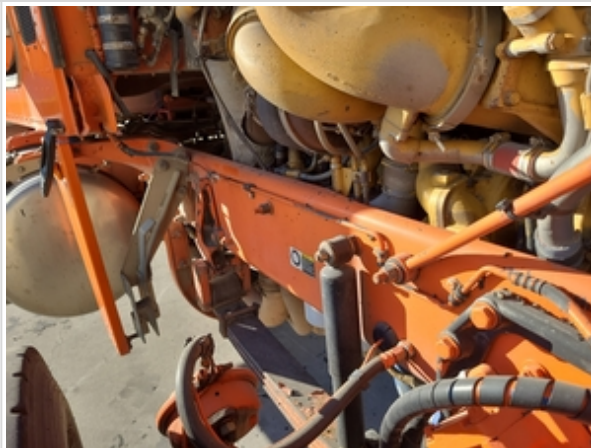
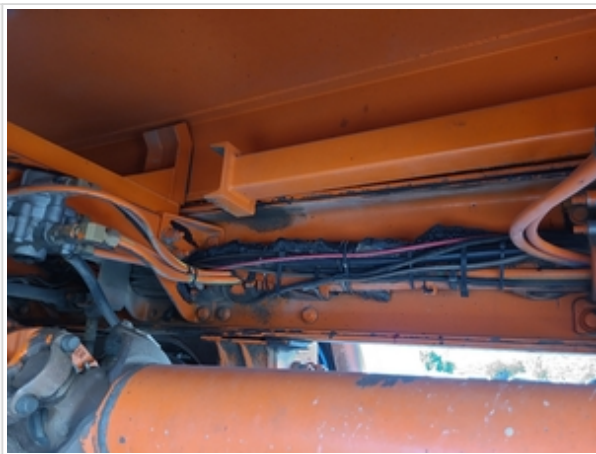
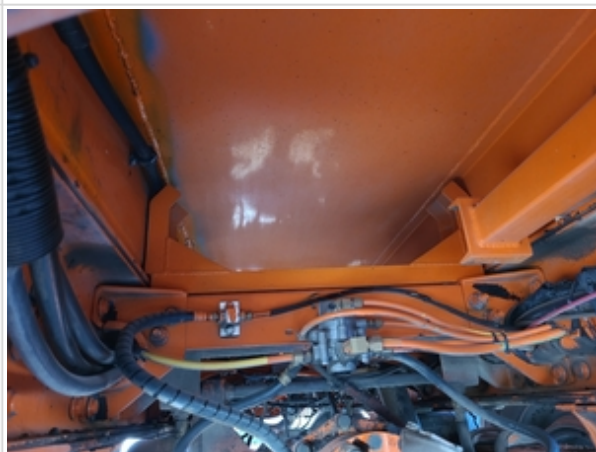
Frame Condition	3
Frame Photos

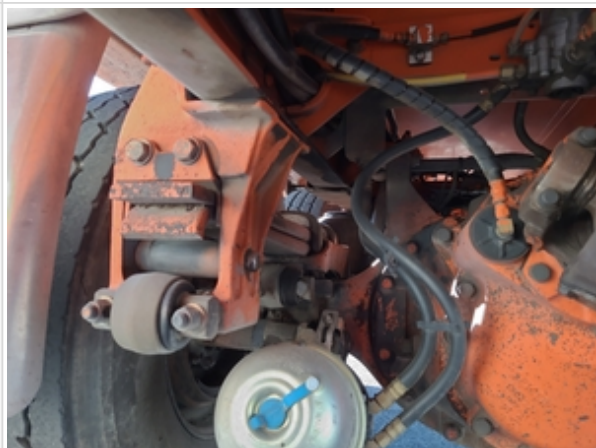
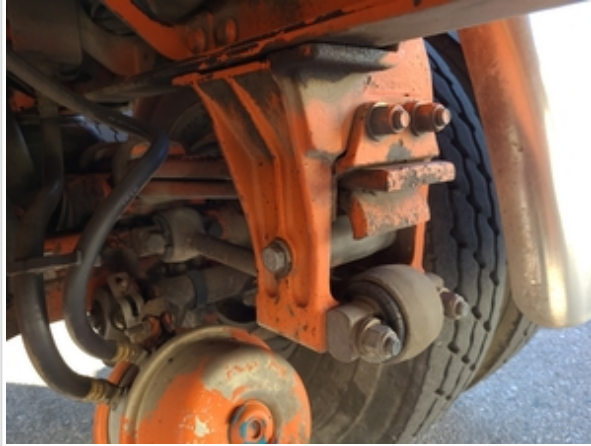
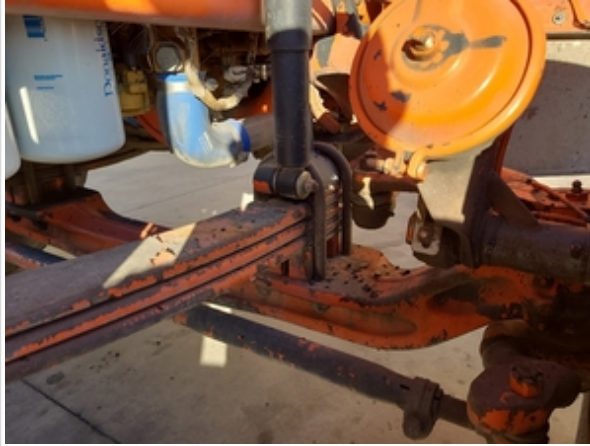
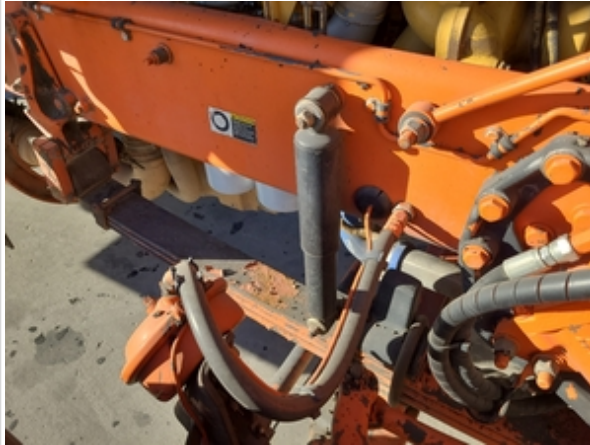
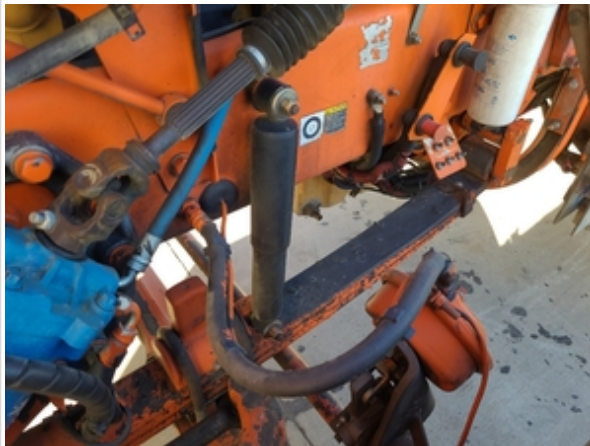
Suspension	3
Suspension Photos
