Inspection Report (On-Highway Dump Truck)

Year	2011
Make	Peterbilt
Model	367
Serial Number	1NP - TLUOX - 6 - BD127980
Truck Odometer Reading	408,807
Previous Application (e.g., earth moving, mining, demolition, etc)	Asphalt Construction

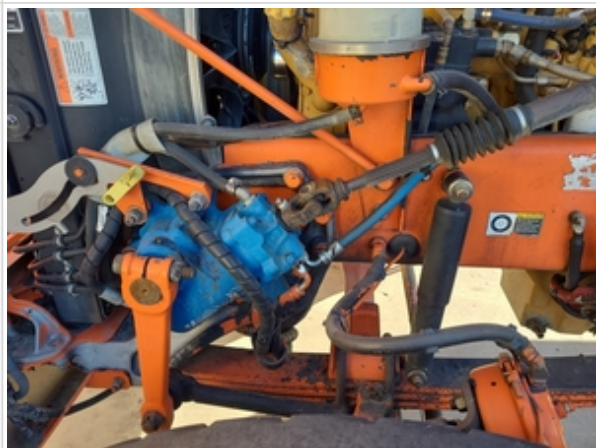
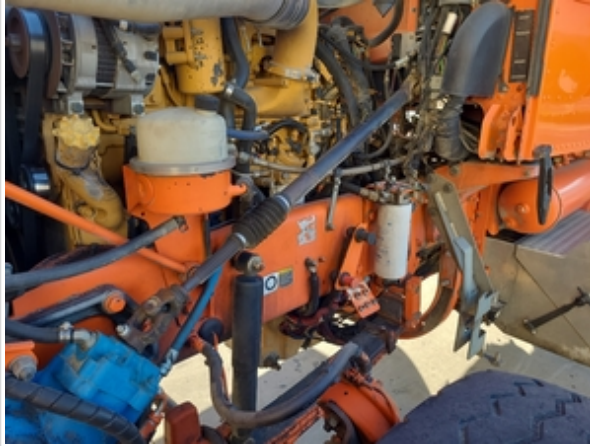
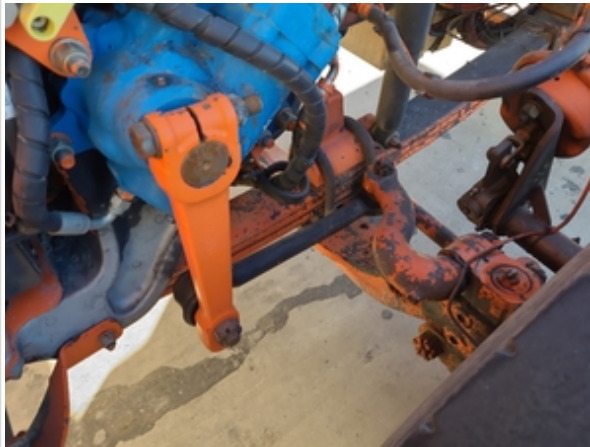
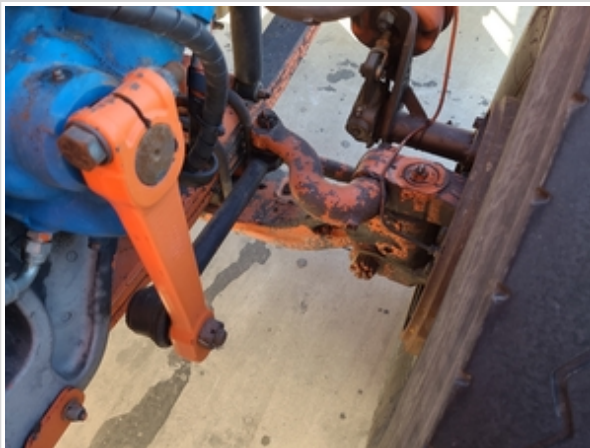
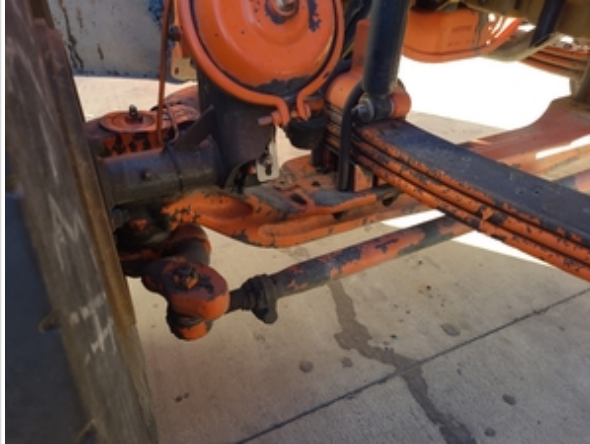
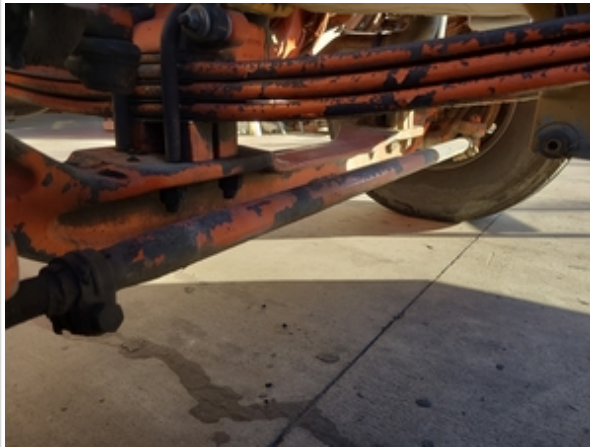
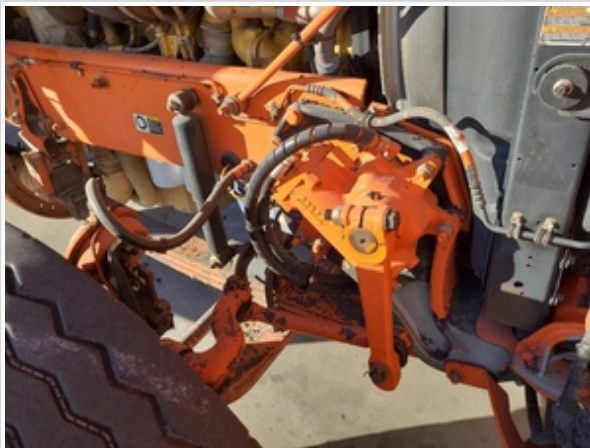
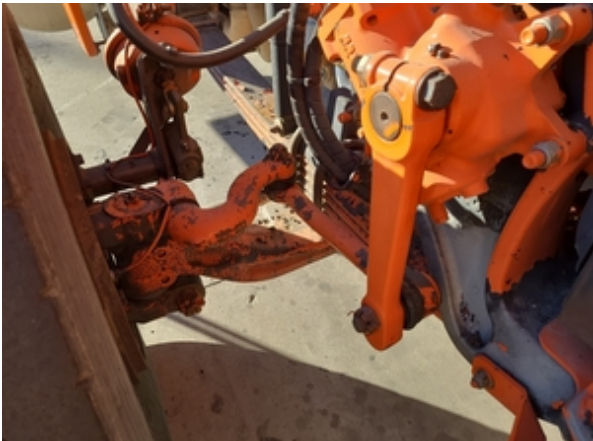
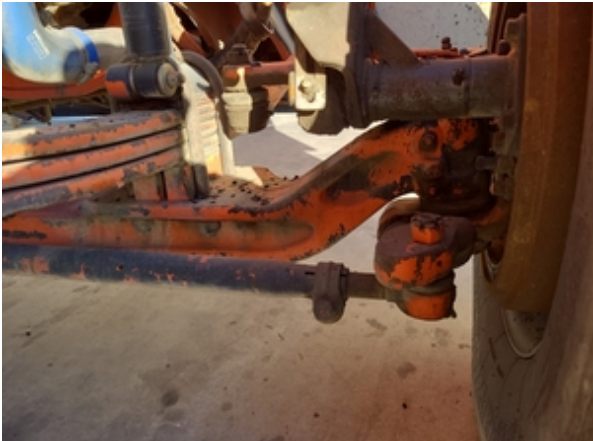
Steering Components	3
Steering Components Photos

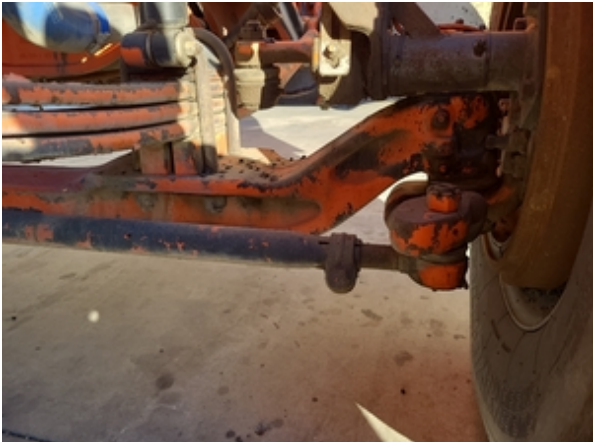
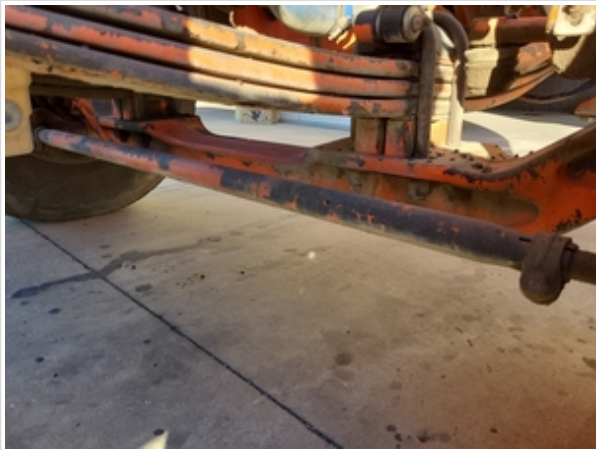
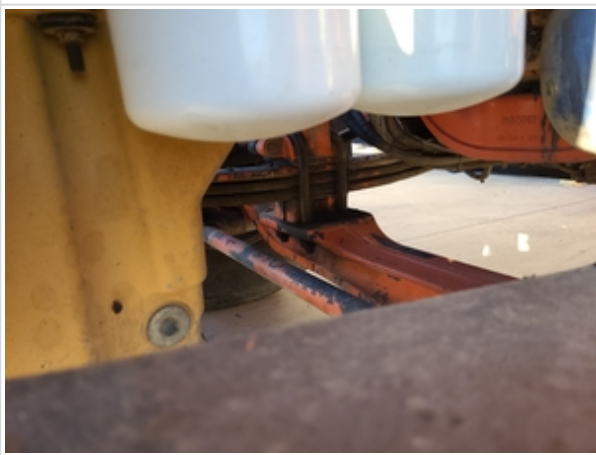
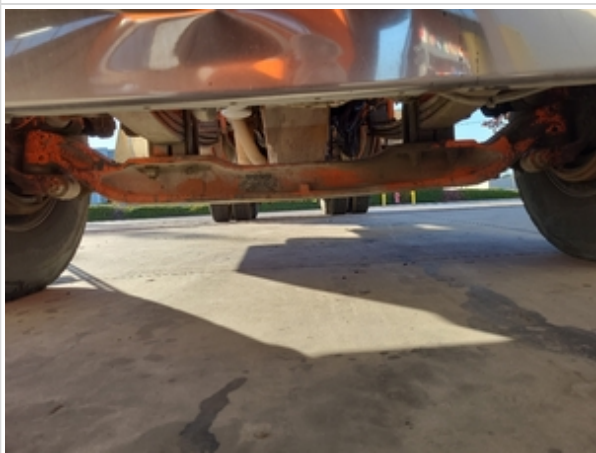
Steer Axle Condition	3
Steer Axle Photos

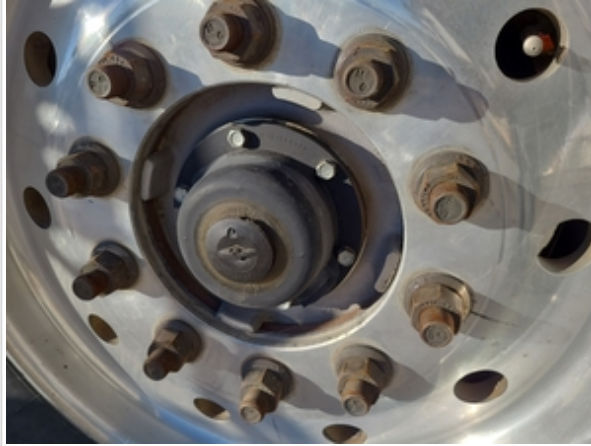
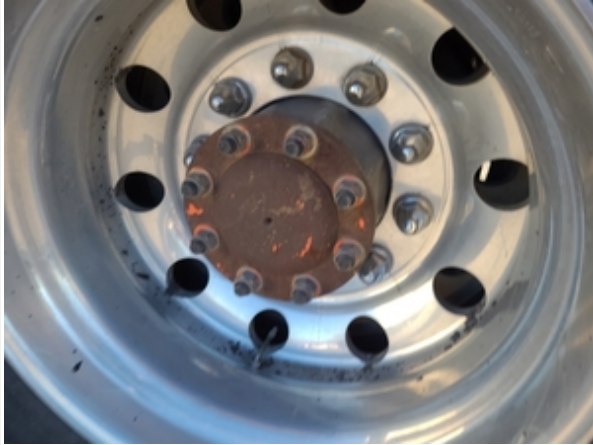
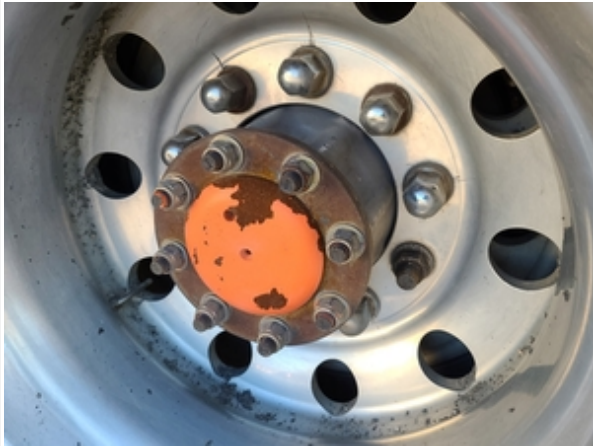
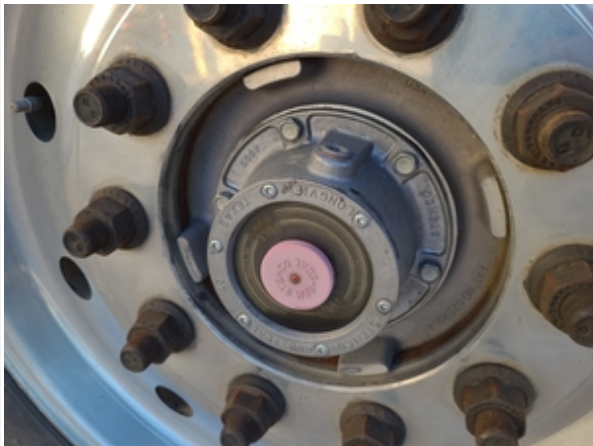
Wheels & Hub Photos

Wheels & Hub Condition	3
------------------------	---

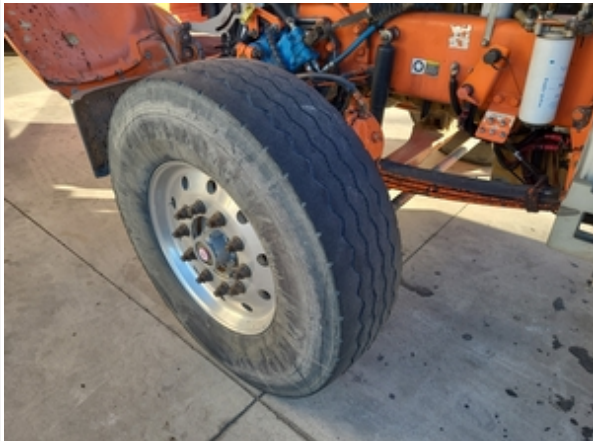
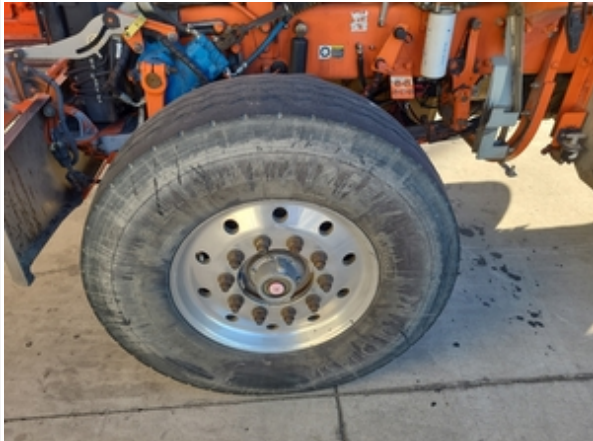
Front Left Tire Photos

Wheel Seal Leaks	No	
Tire Brand	(Front) Yokohama (Rear) generic recaps	
Tire Size	(Front) 315/80R/22.5 (Rear) 11R22.5	
Front Left Tire - Ratio Remaining	10%

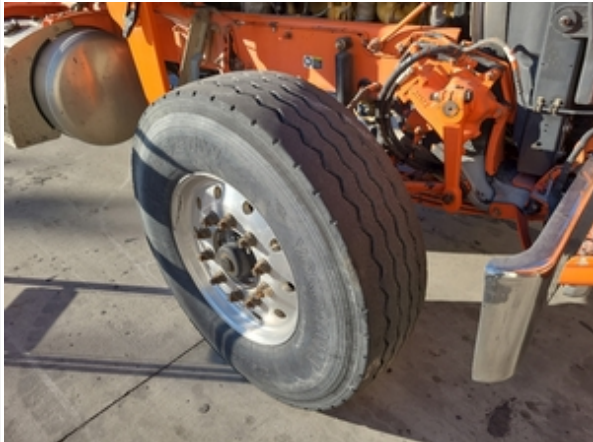
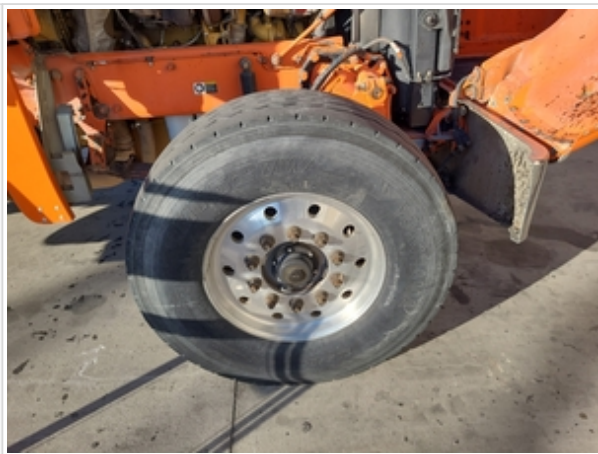
Front Right Tire - Ratio Remaining	30%
Front Right Tire Photos

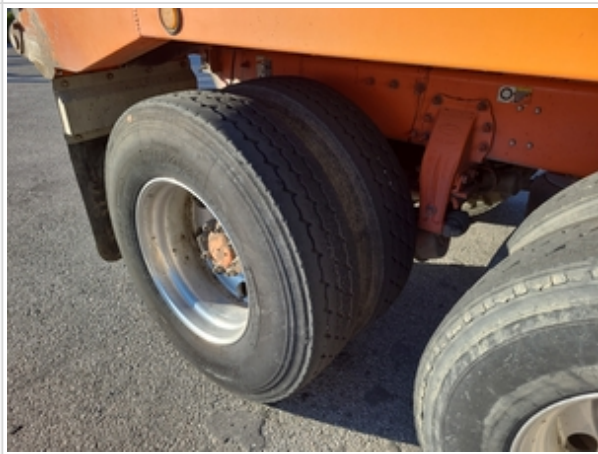
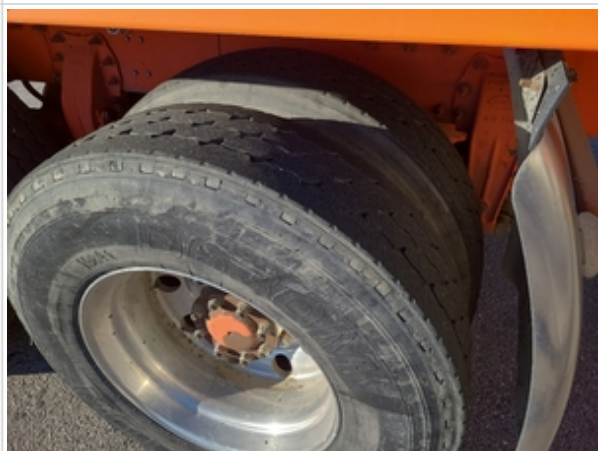
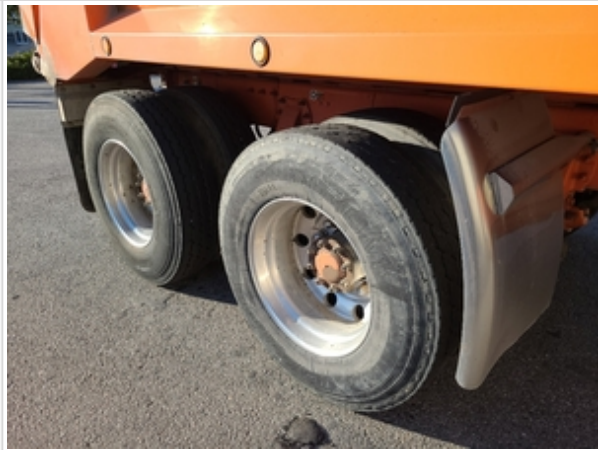
Rear Right Tire - Ratio Remaining	50%	
Rear Right Tire Photos

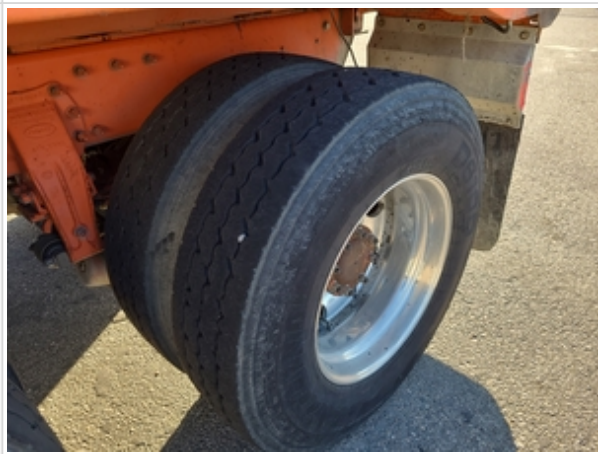
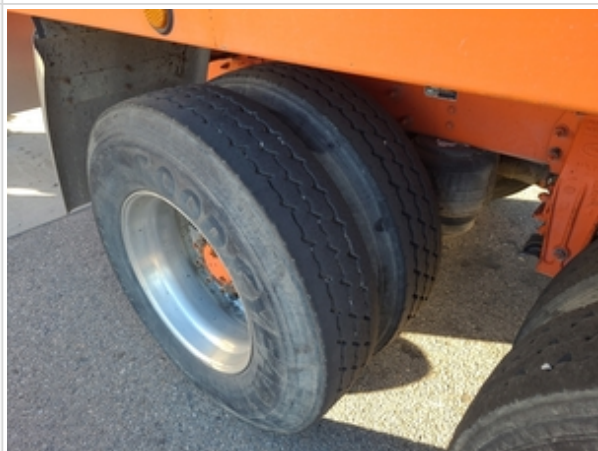
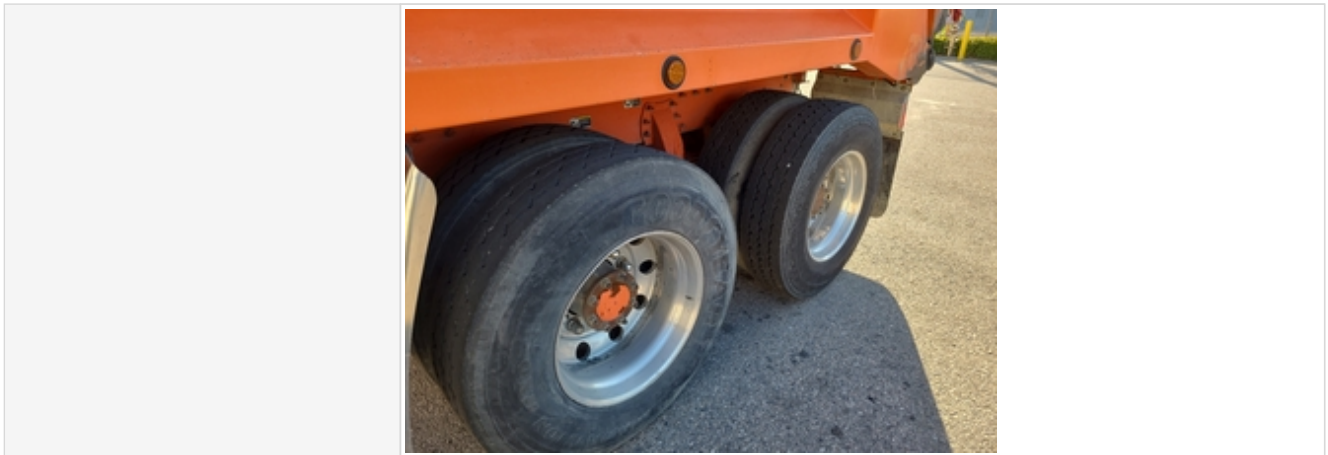
Rear Left Tire - Ratio Remaining	50%	
Rear Left Tire Photos

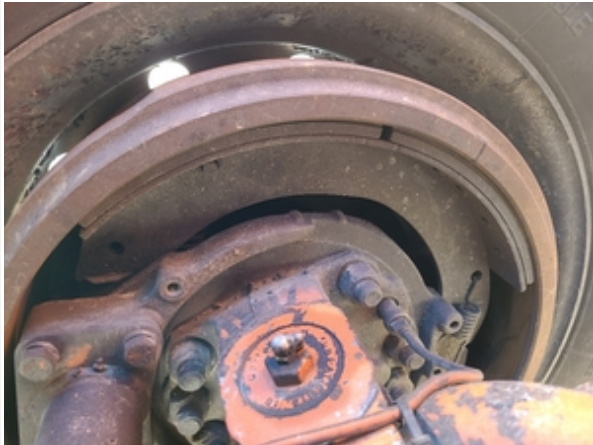
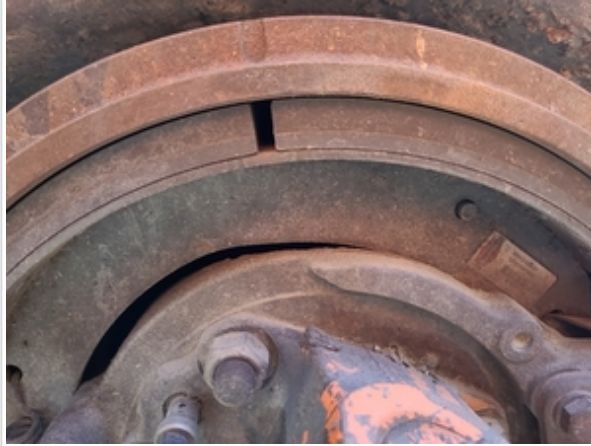
Brake Shoe Thickness	50%
Comments	front left side low rest okay
Brake Shoe Photos

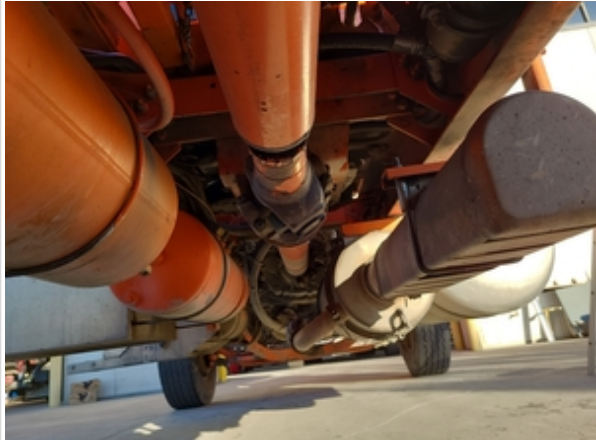
Overall Chassis	3
Overall Chassis Comments	Overall all in good condition
Overall Chassis & Undercarriage Photos

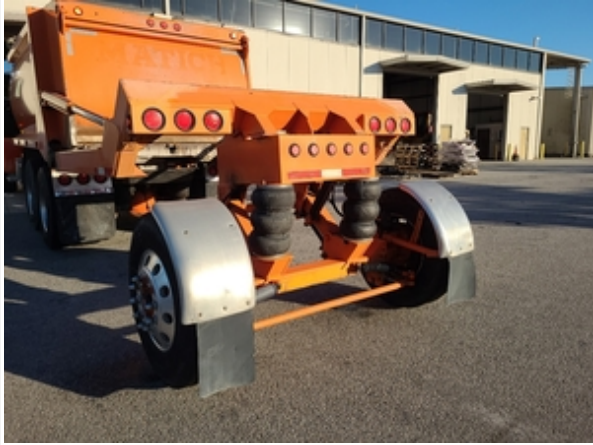
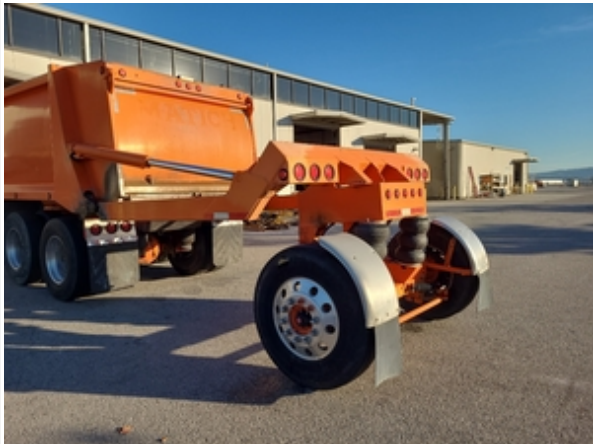
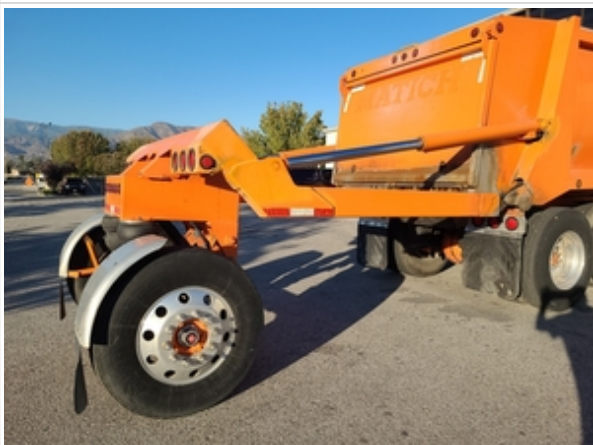
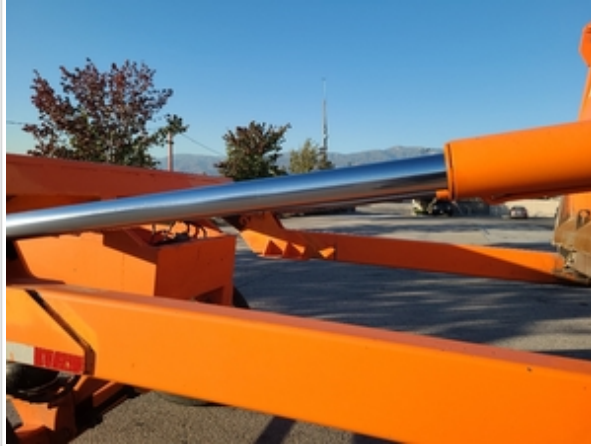
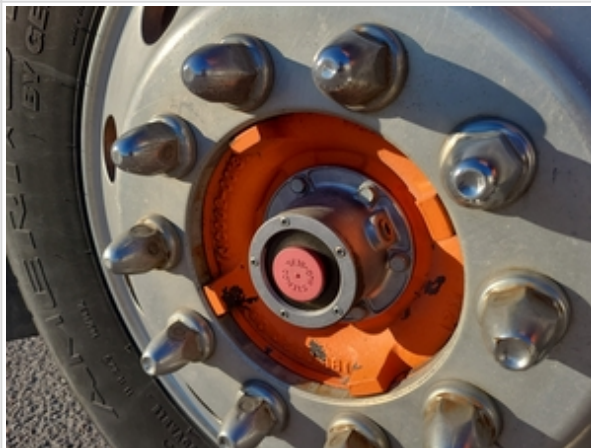
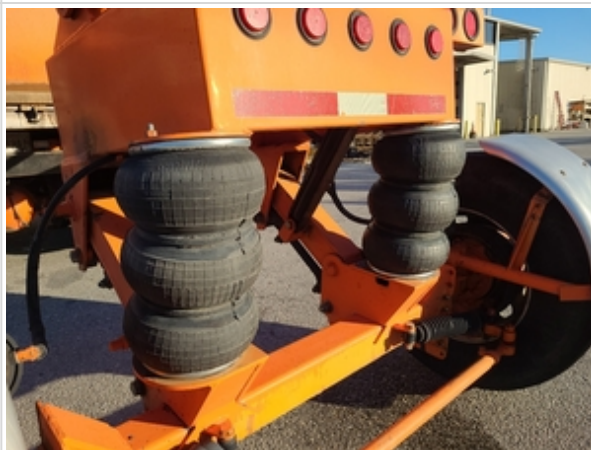
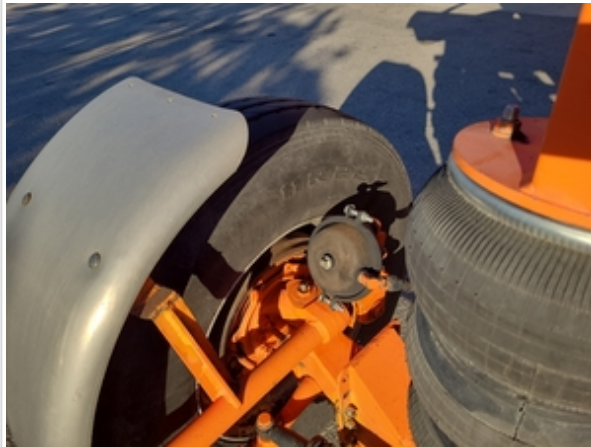
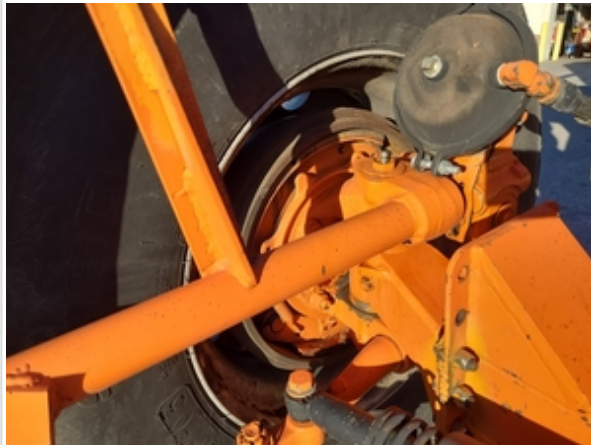
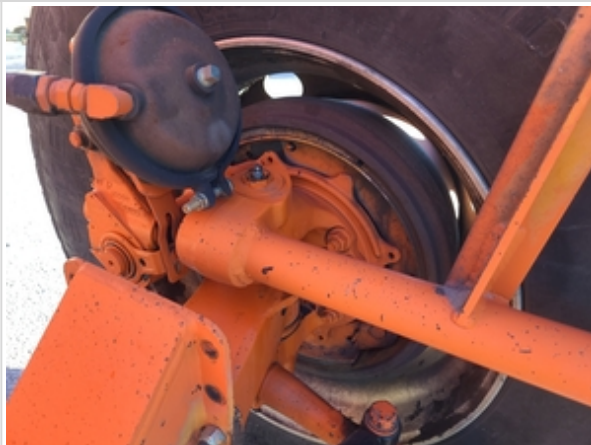
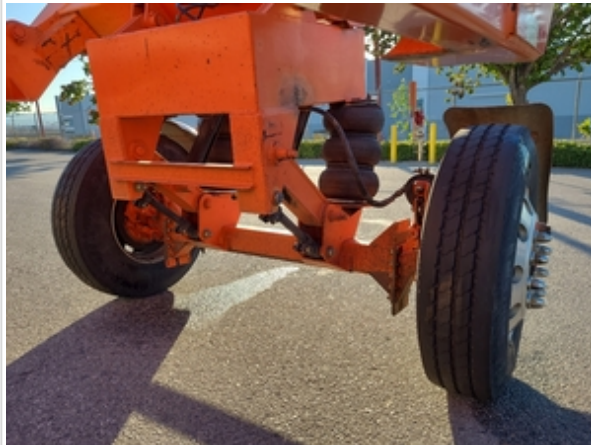
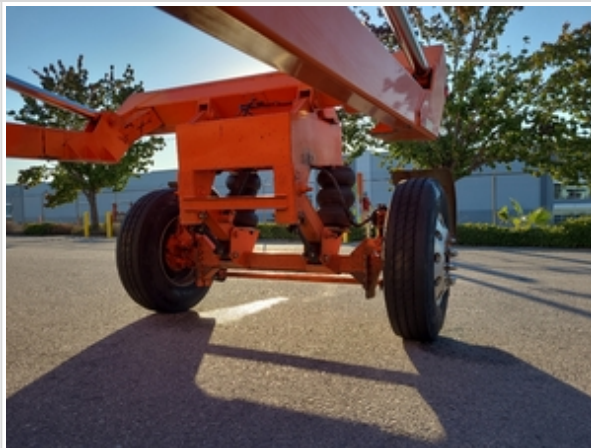
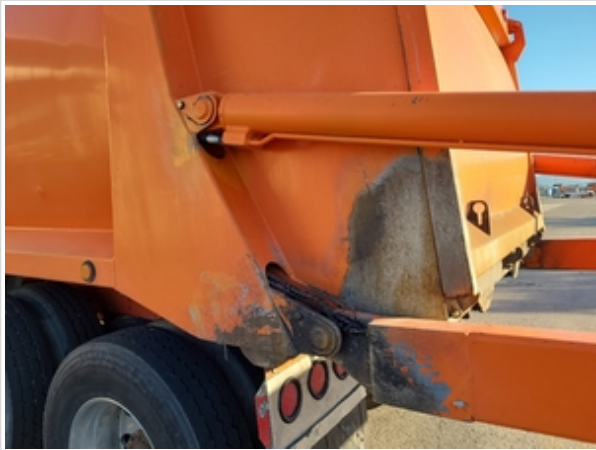
Drop Axle?	Yes
Super Dump?	Yes
Weight Rating	12,000Lbs
Axle Condition	3 - Normal Wear & Tear
Axle Condition Photos

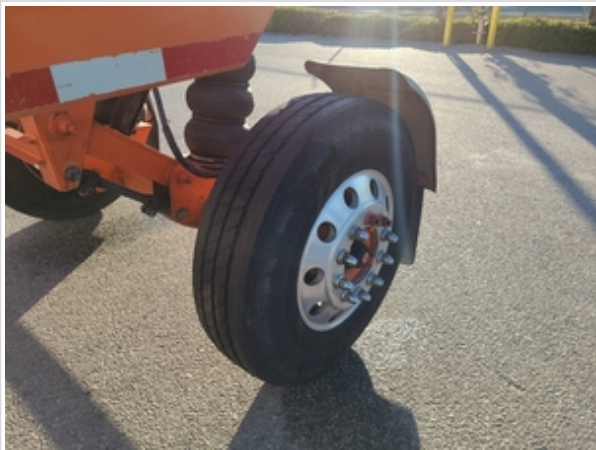
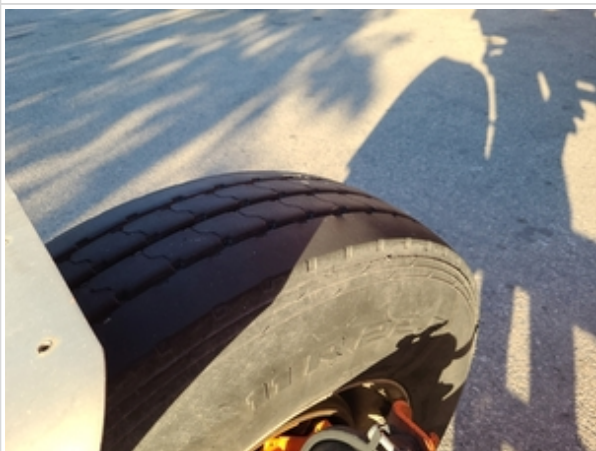
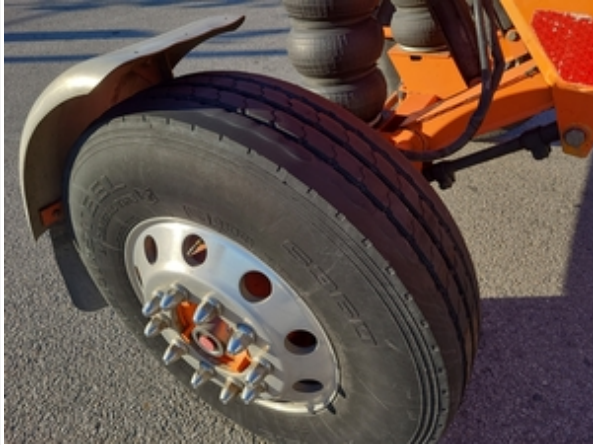
Wheels & Tires	3 - Normal Wear & Tear	
Wheels & Tires Photos

Tire Brand	AmeriSteel
Tire Size	11R22.5
Left Tire(s) Ratio Remaining	50%
Right Tire(s) Ratio Remaining	50%

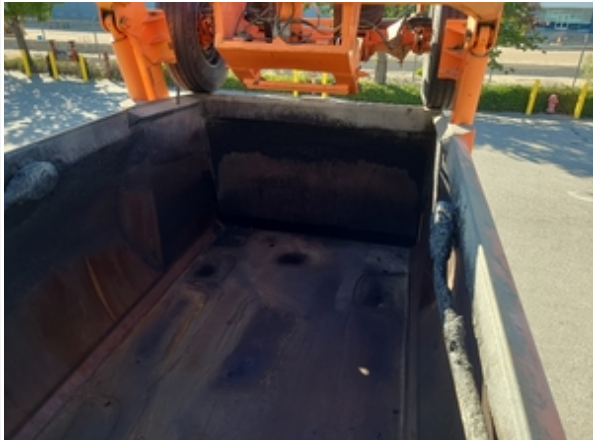
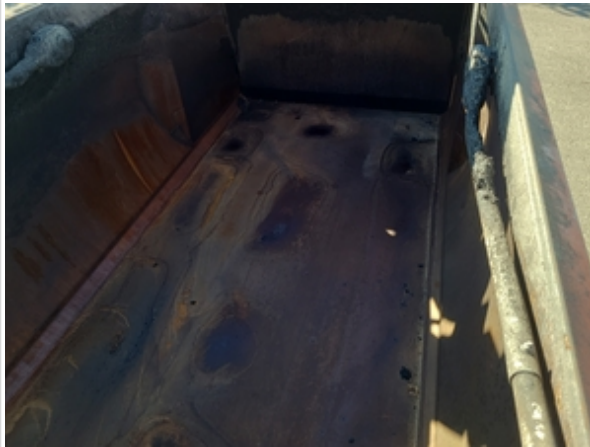
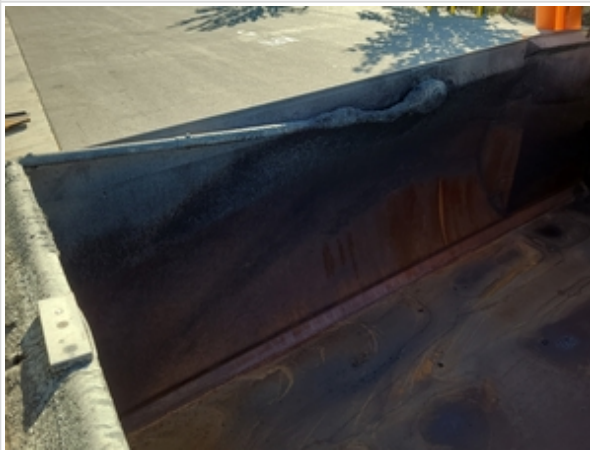
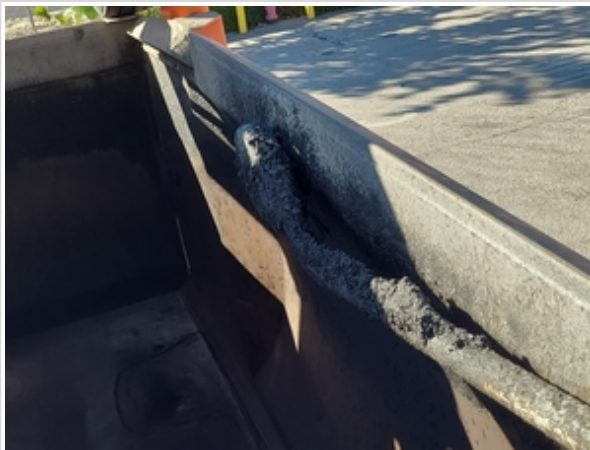
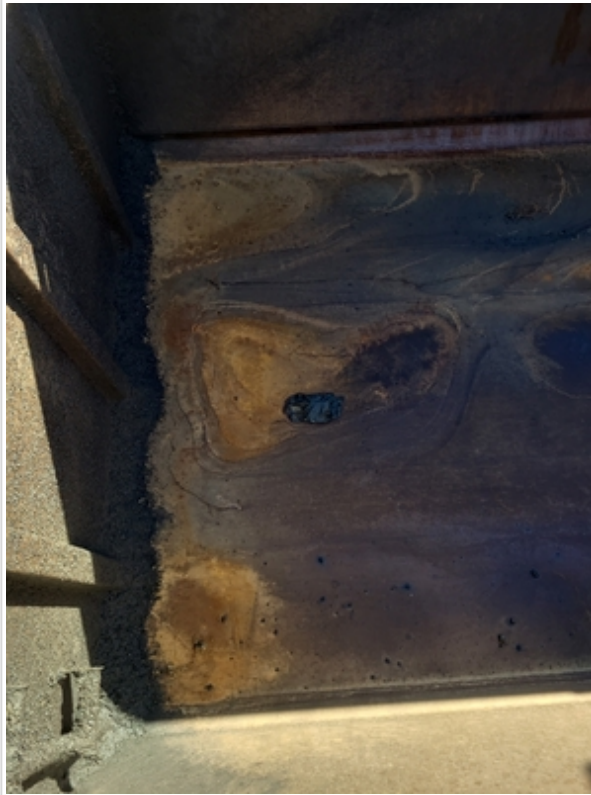
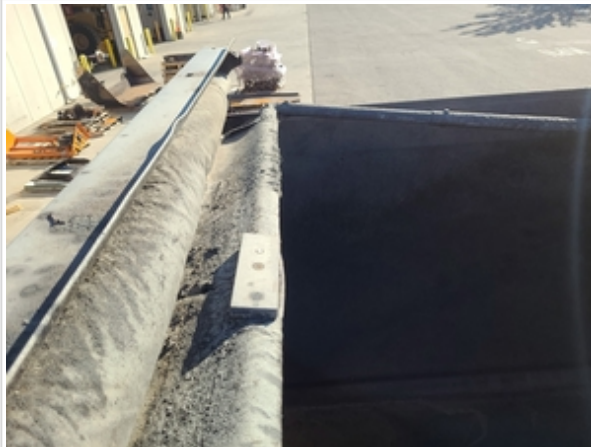
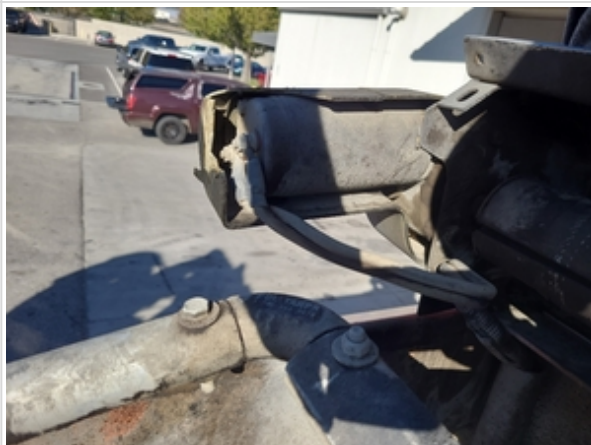
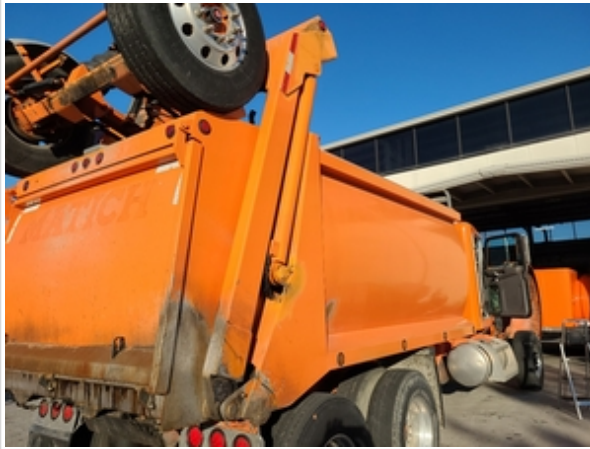
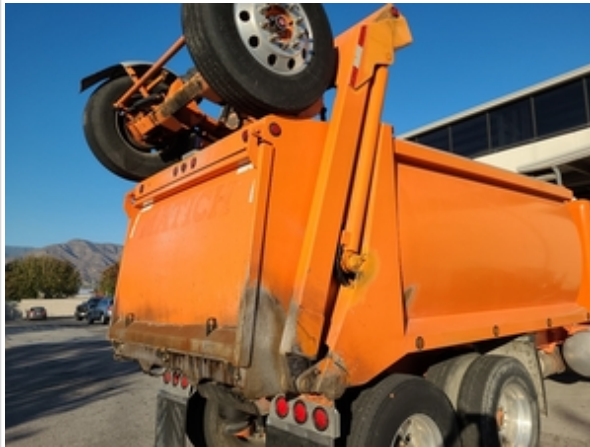
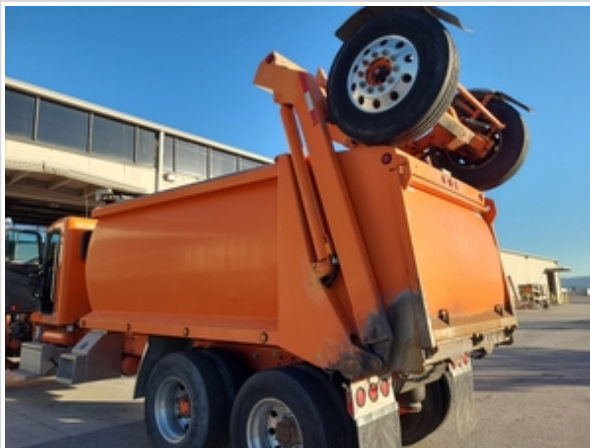
Dump Body Make & Material	Rogue
Dump Body Length (ft and inches)	15'
Dump Body Height (ft and inches)	5'3"
Bed Body	3 - Normal Wear & Tear
Bed Body Photos

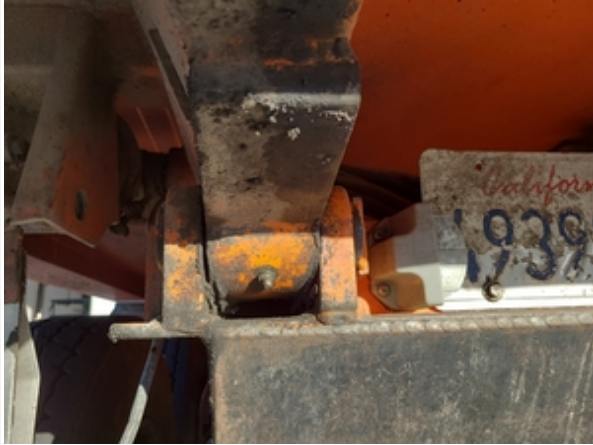
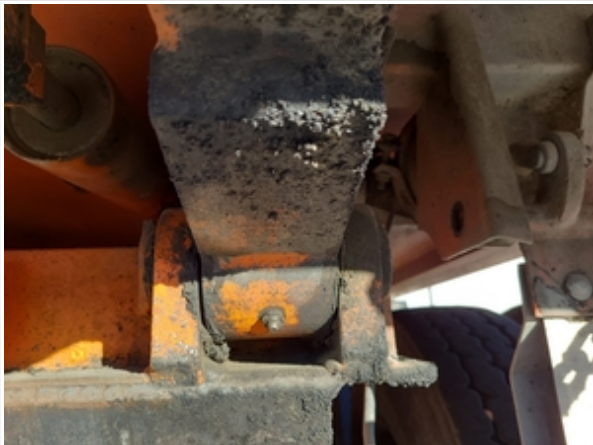
Hinge Point Photos

Tailgate Latch	3 - Normal Wear & Tear	
Support Frame	3 - Normal Wear & Tear	
Hinge Points	3 - Normal Wear & Tear

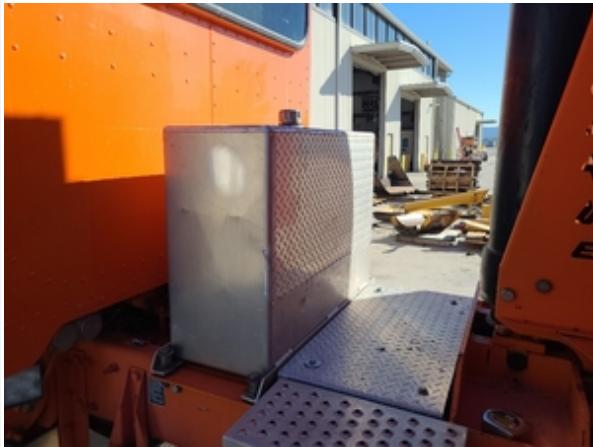
Hydraulics	Check the condition of the hydraulics. Check lines, hoses, fittings, leaks, function, etc. Note any damage or wear. Take photos.	
Hydraulic Tank	3 - Normal Wear & Tear	
Hydraulic Tank Photos

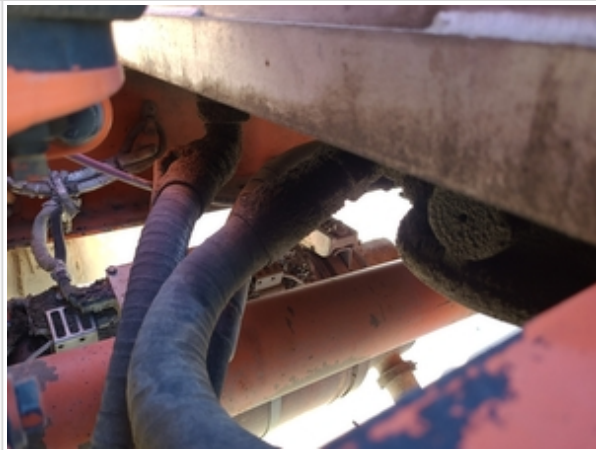
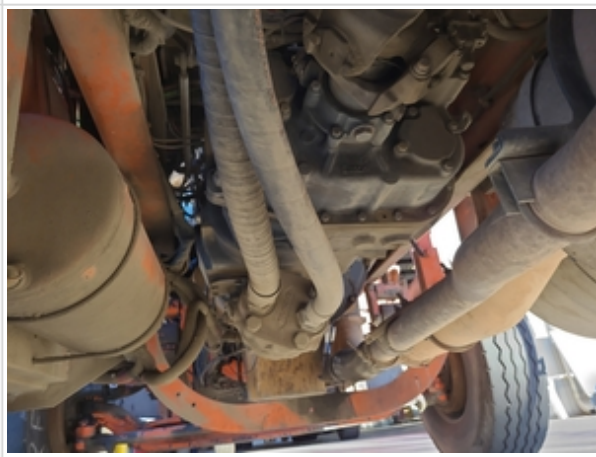
Hose Photos

Hoses	3 - Normal Wear & Tear

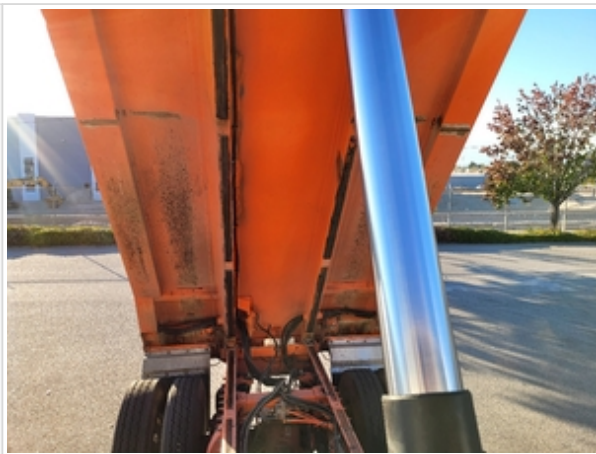
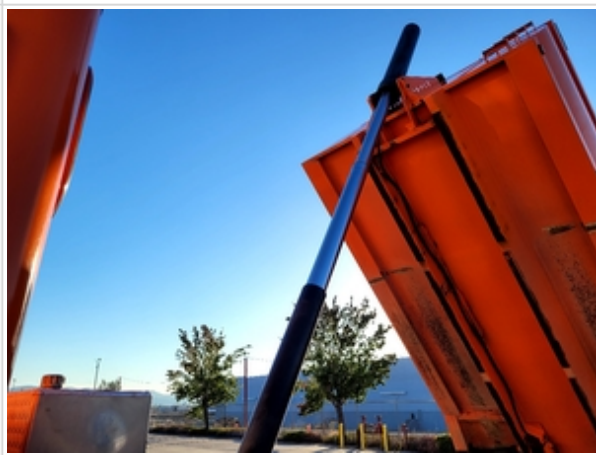
Hydraulic Cylinders	3 - Normal Wear & Tear
Hydraulic Cylinder Photos

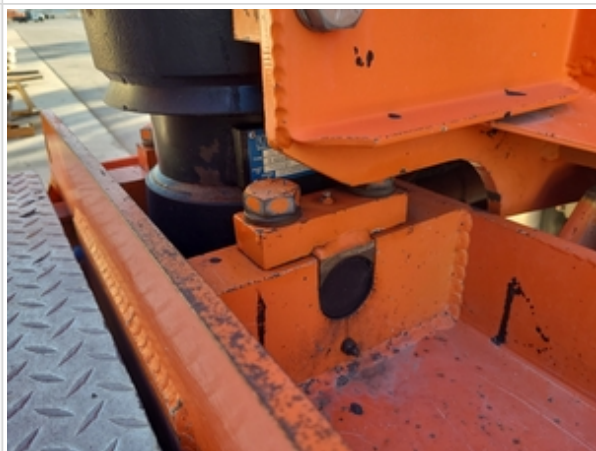
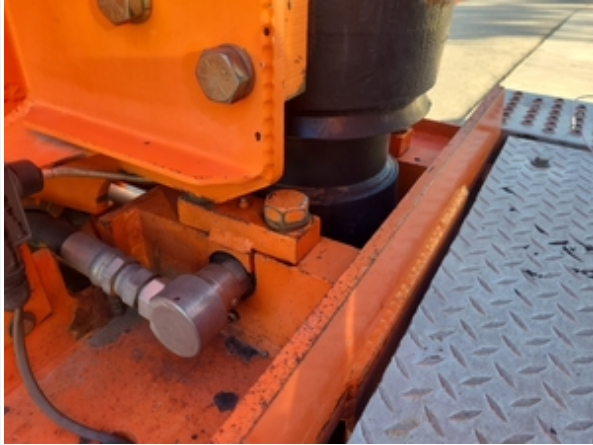
Cylinder Pins and Bushings	3 - Normal Wear & Tear
Cylinder Pins and Bushings Photos

Hydraulic Function	3 - Normal Wear & Tear
Comments	Dump bed lift cylinder retract abnormal

Exterior Rating	3
Interior Rating	3
Safety Rating	3
Quality Rating	3
Functionality Rating	3
Overall Rating	3
What's Great About the Machine	This truck is in excellent condition simply because it has been well maintained bumper to bumper. No obvious major repairs found in powertrain or suspension. The interior is super clean and the exterior looks great.
What Needs Work	Most tires need to be replaced soon. Front brake shoes need to be replaced soon. Dump body lift cylinder should be further inspected to determine possible hydraulic retract problem.
Date/Time	11-14-2022
