Inspection Report (On-Highway Dump Truck)

Year	2011
Make	Peterbilt
Model	367
Serial Number	1NP - TLUOX - 2 - BD127975
Truck Odometer Reading	423,441
Previous Application (e.g., earth moving, mining, demolition, etc)	Asphalt Construction

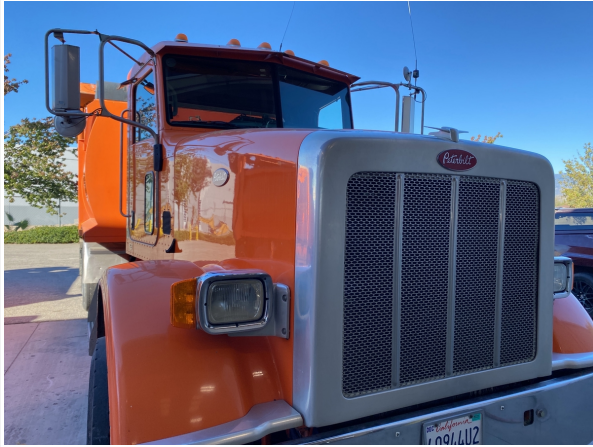
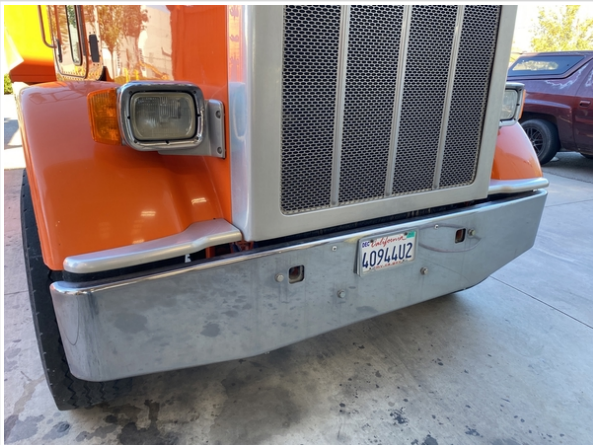
Front	3 - Normal Wear & Tear
Front Condition	No visible damage
Front Photos

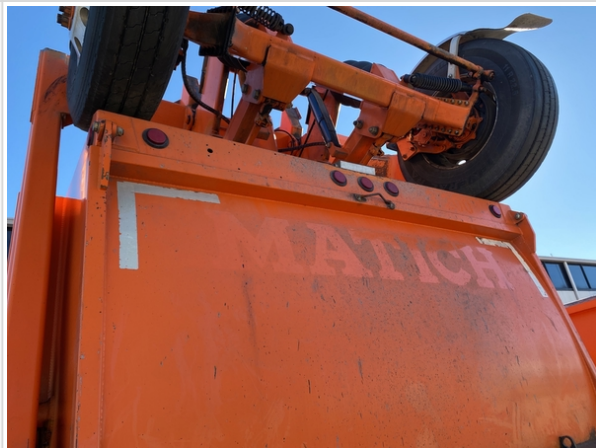
Rear	3 - Normal Wear & Tear
Rear Condition	No visible damage, Visible chipped paint or dents, Other (see comments)
Comments	Rear body straight and solid, normal wear
Rear Photos

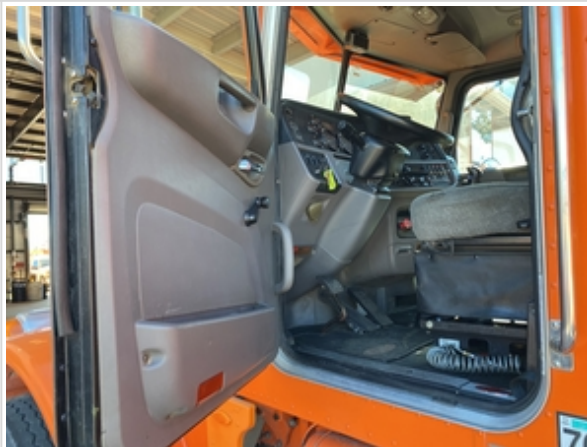
Operator Cabin Photos

3 - Normal Wear & Tear

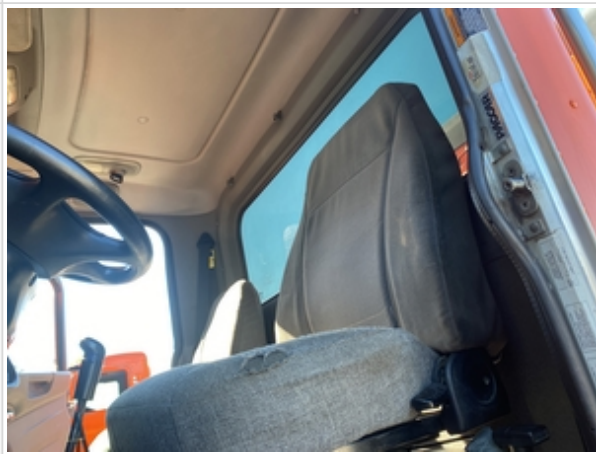
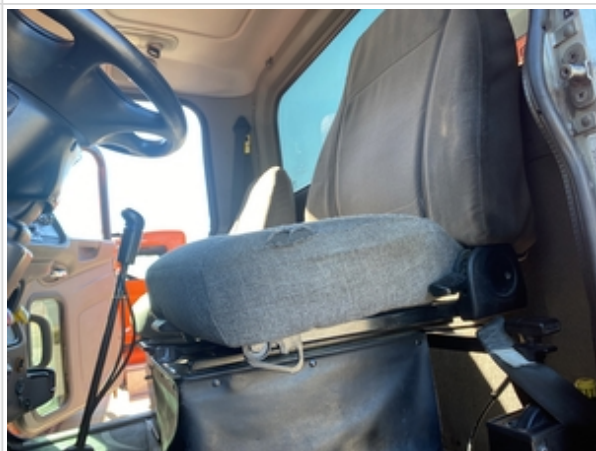
<p>Operator's Seat & Arm Rests</p>	<p>3 - Normal Wear & Tear</p>	
<p>Operator's Seat & Arm Rests Photos</p>

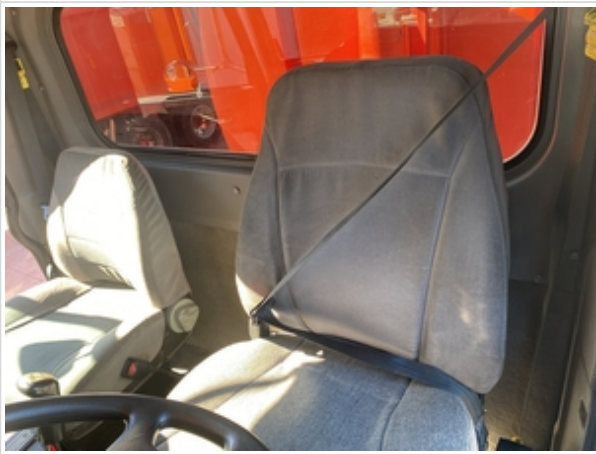
Seat Belt	3 - Normal Wear & Tear	
Seat Belt Photos

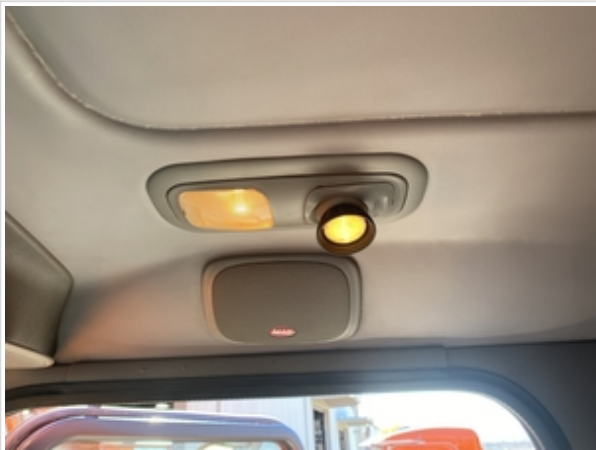
Cabin Lights	3 - Normal Wear & Tear	
Cabin Lights Photos

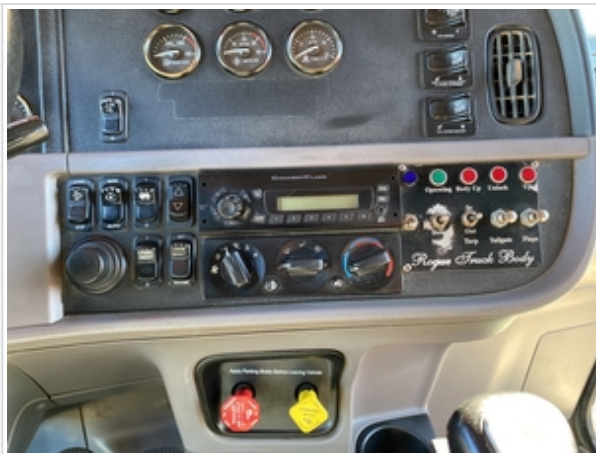
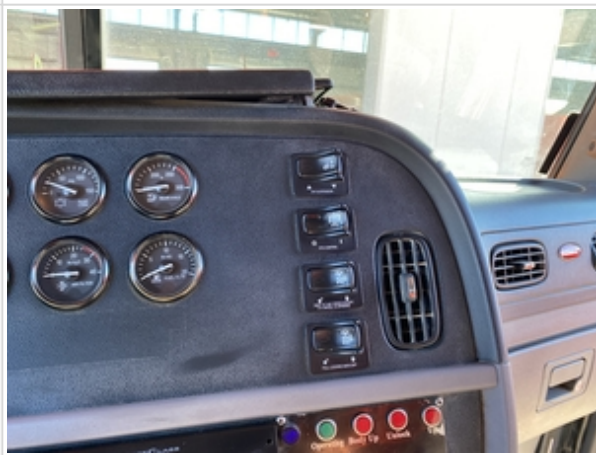
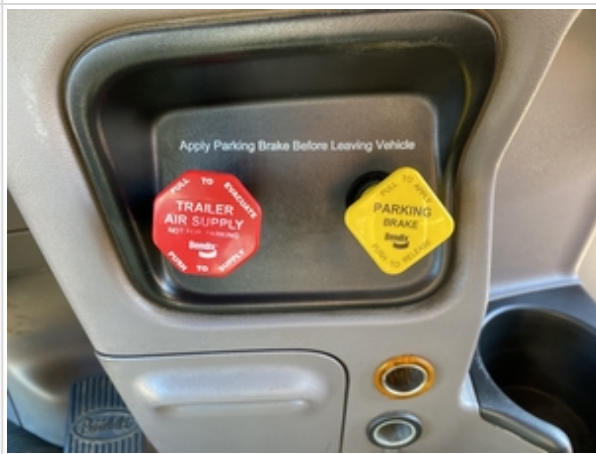
<p>Controls & Switches</p>	<p>3 - Normal Wear & Tear</p>	
<p>Controls & Switches Photos</p>

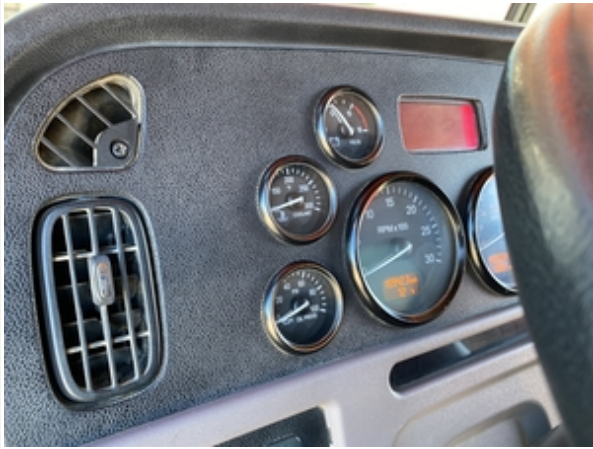
Heater & A/C	3 - Normal Wear & Tear
Heater & A/C Photos

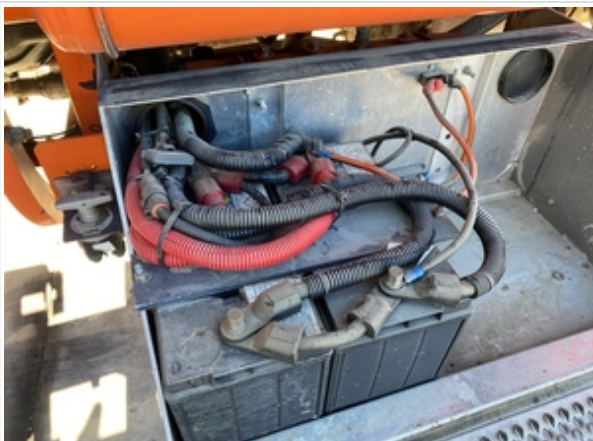
Blow-by (Visual Observation Check)	No	
Unusual Noises (Upon Start-up, Idle, Shutdown)	No	
Unusual Noise Notes	No unusual noises heard	
Engine Smoke (Upon Start-up, Idle, Shutdown)	No	
Engine Smoke Notes	No engine smoke issues observed	
Engine Exhaust Color	Clear	
Battery	2 - Above Average Wear	
Battery Condition	Needs charge or replacement	
Comments	Engine starter hesitation observed	
Battery Condition Photos

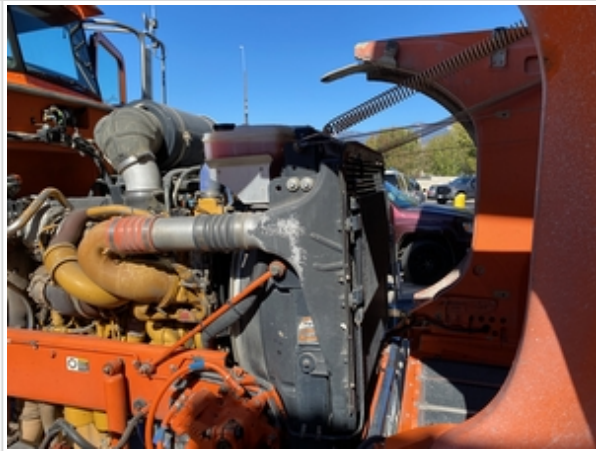
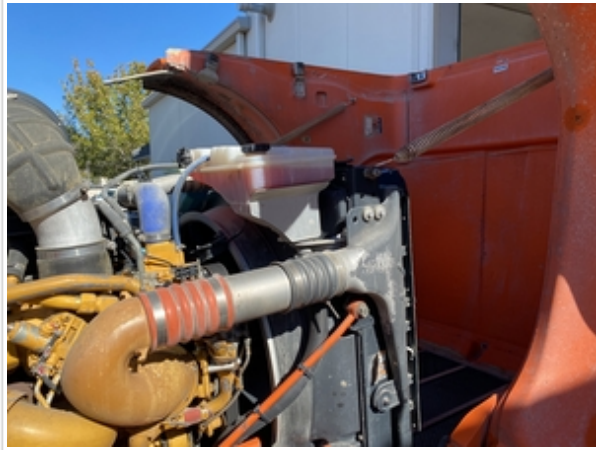
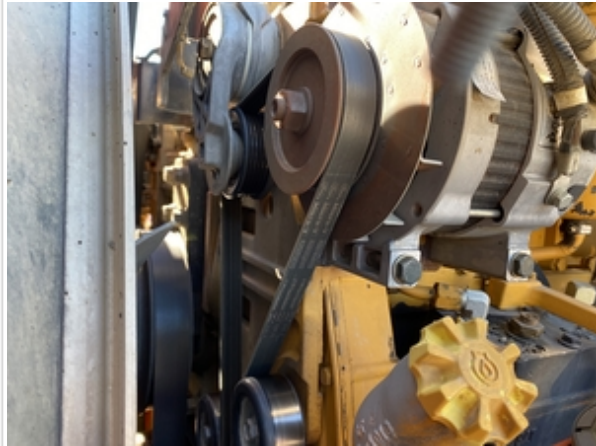
Belts	3 - Normal Wear & Tear
Belt Condition	Belts appear in good condition & alignment with proper tension
Belt Photos

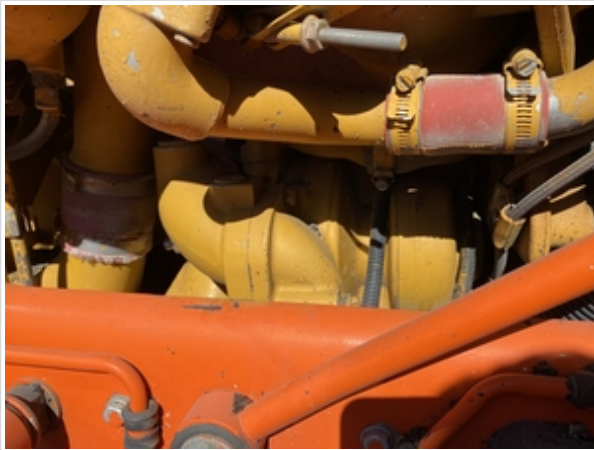
Water Pump	3 - Normal Wear & Tear
Water Pump Condition	No unusual pump noises heard

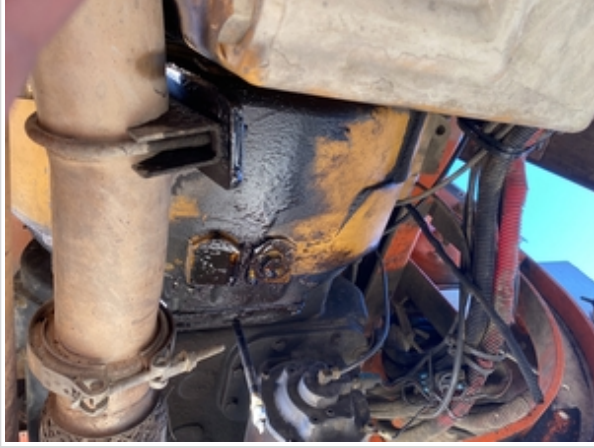
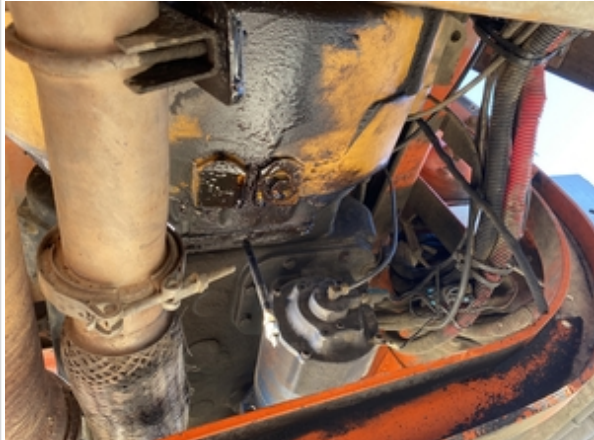
Cooling System Leaks	No
Coolant Color / Appearance	3 - Normal Wear & Tear
Coolant Color/Appearance Notes	Normal Translucent appearance, no visual signs of contamination
Oil Leaks	Yes
Oil Leak Notes	Wet areas with drops forming due to oil leakage, Other (see comments)
Comments	Oil leak at rear top side of oil pan and around bell housing
Oil Leak Photos

Requires DEF (Diesel Exhaust Fluid)	No
Overall Engine Appearance	Clean & dry, Areas of dried seepage seen on engine hoses & components
Overall Engine Comments	Minor oil leak may be coming from engine oil pan and around bell housing.

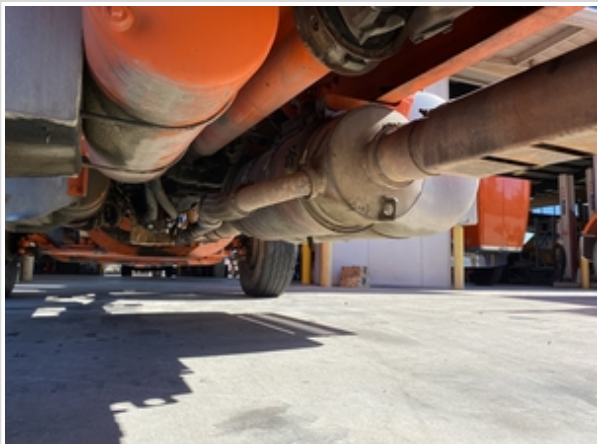
Oil Color / Appearance	3 - Normal Wear & Tear	
Oil Color / Appearance Notes	Clean oil appearance, no signs of cross contamination, Appropriate oil level	
Fuel Leaks	No	
Equipped with DPF (Diesel Particulate Filter)	Yes	
DPF Condition	3 - Normal Wear & Tear	
DPF Condition Notes	Filter housing is intact with no signs of damage or malfunction, DPF indicator is not illuminated	
DPF Photos

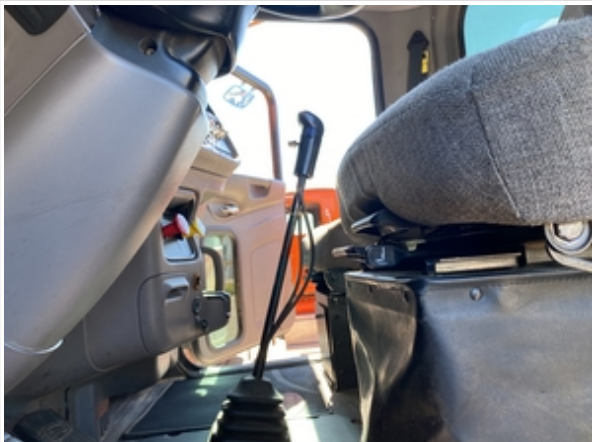
Clutch	3 - Normal Wear & Tear	
Clutch Condition	Clutch is functioning as expected	
Shift Lever	3 - Normal Wear & Tear	
Shift Lever Condition	Good forward and reverse function	
Shift Lever Photos

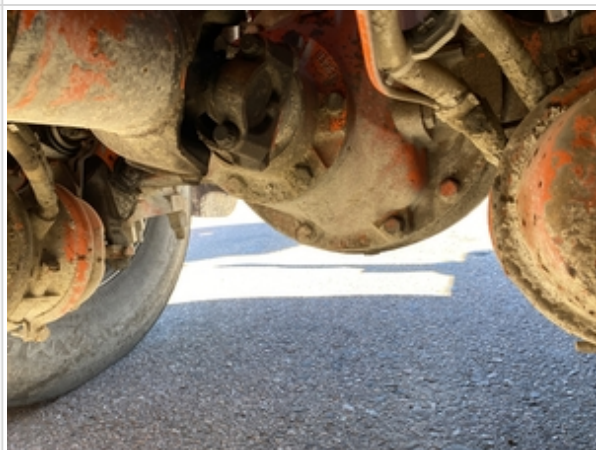
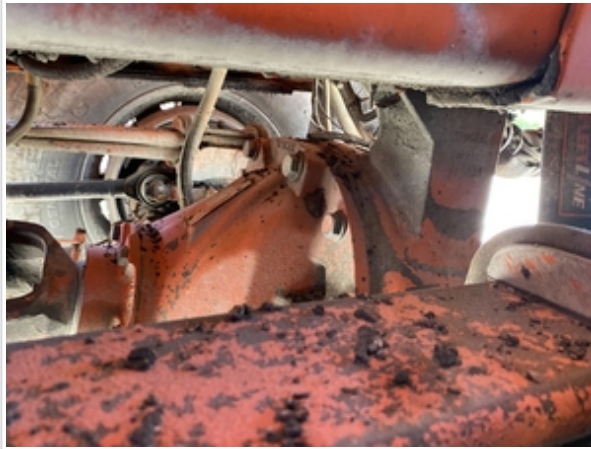
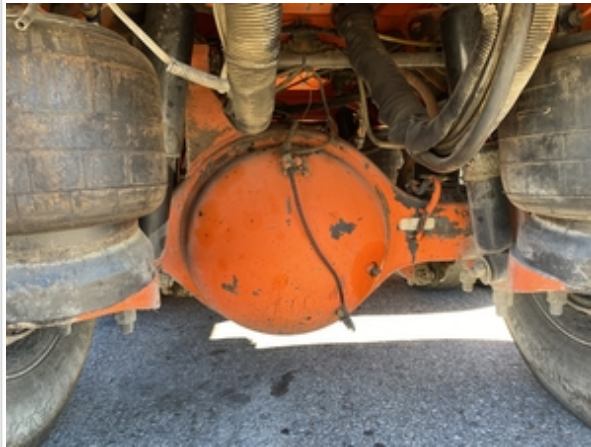
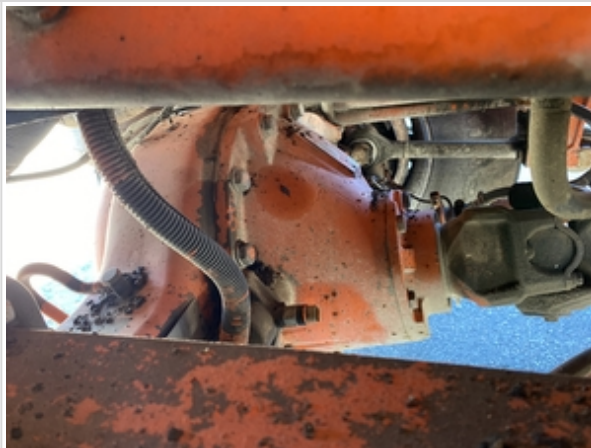
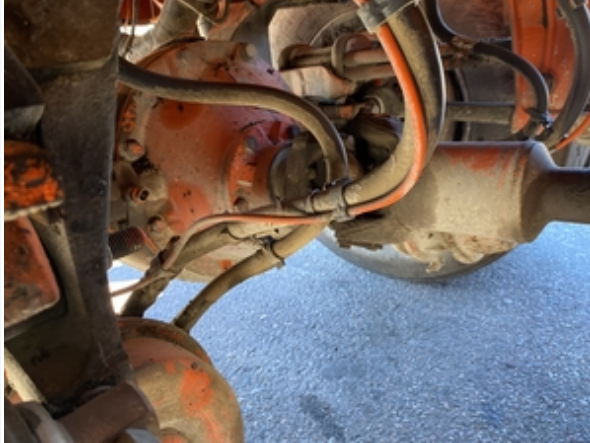
Differential	Check condition of the differential(s). Take photos and notes as relevant.
Rear Differential	3 - Normal Wear & Tear
Rear Differential Condition	Dry housing appearance, no unusual noises heard during operation
Rear Differential Photos

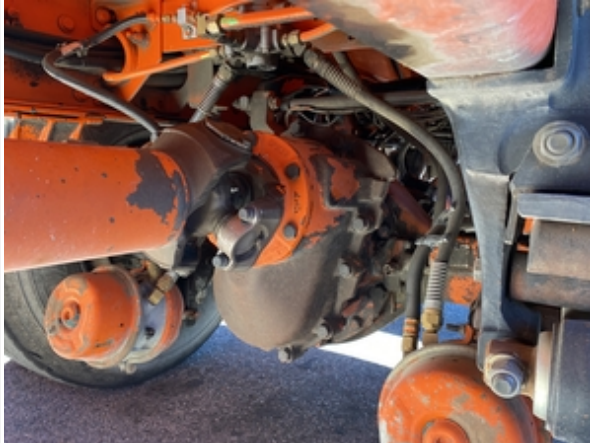
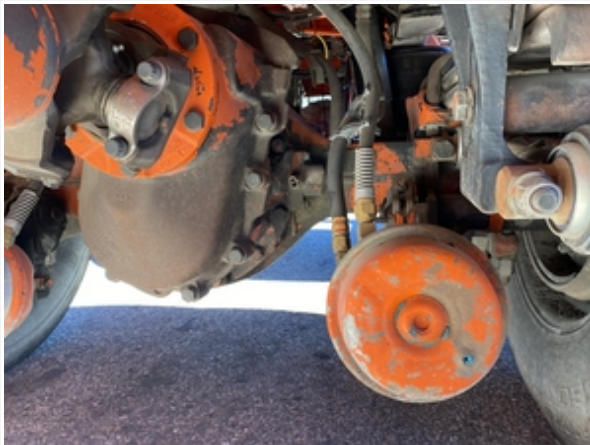
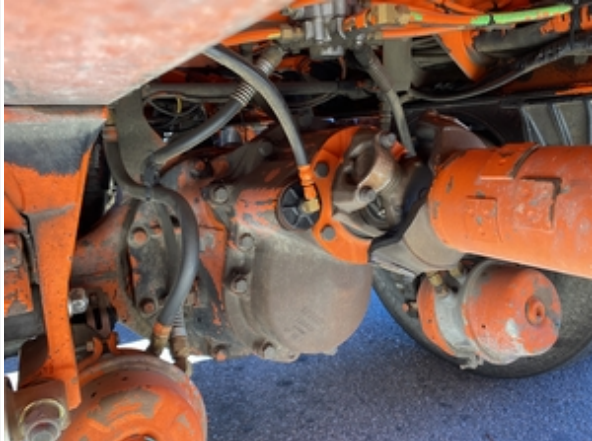
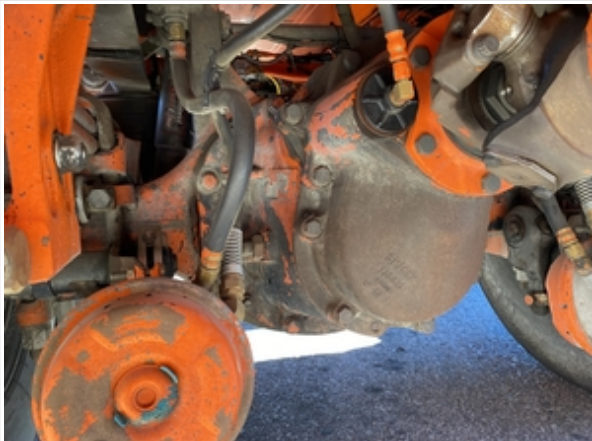
Front Differential	3 - Normal Wear & Tear	
Front Differential Condition	Dry housing appearance, no unusual noises heard during operation	
Front Differential Photos

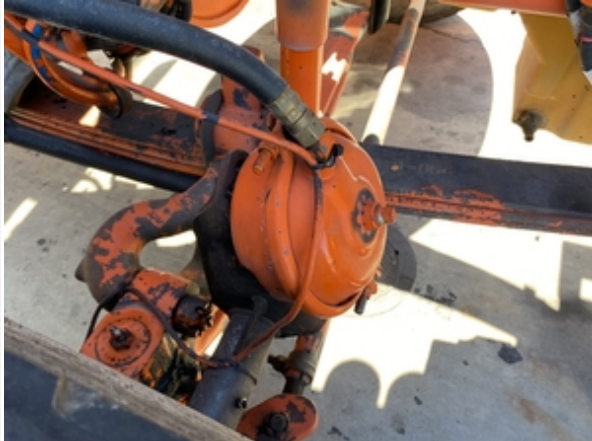
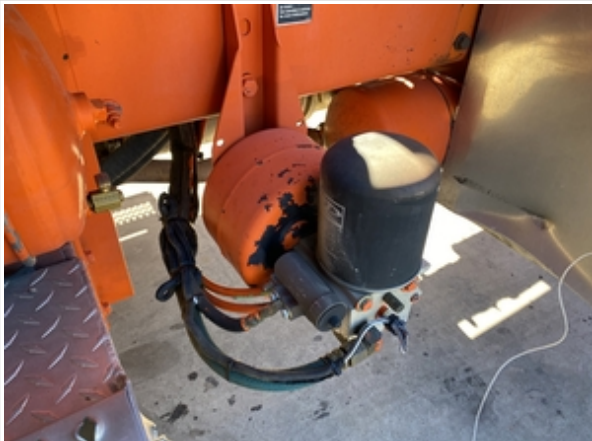
Brake System Type	Air Brakes	
Air Brakes Build Correct Pressure	Yes	
Air Brake System Leaks	Yes	
Comments	Minor air leak observed beneath cab	
Air Brake Hose Condition	3 - Normal Wear & Tear	
Air Brake System Photos

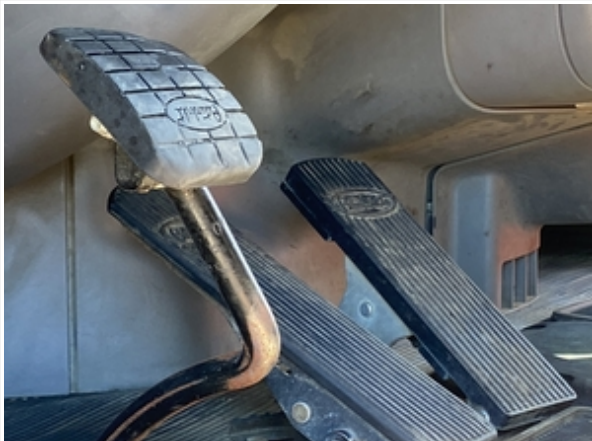
Foot Brake	3 - Normal Wear & Tear	
Foot Brake Condition	Good brake function	
Foot Brake Photos

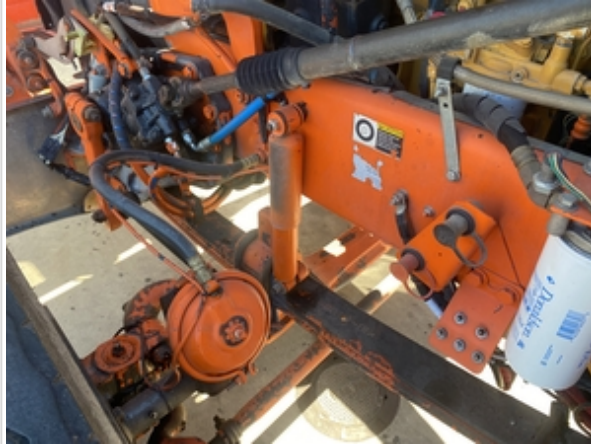
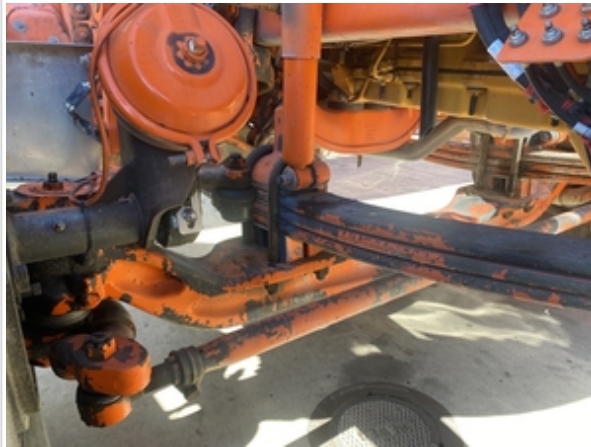
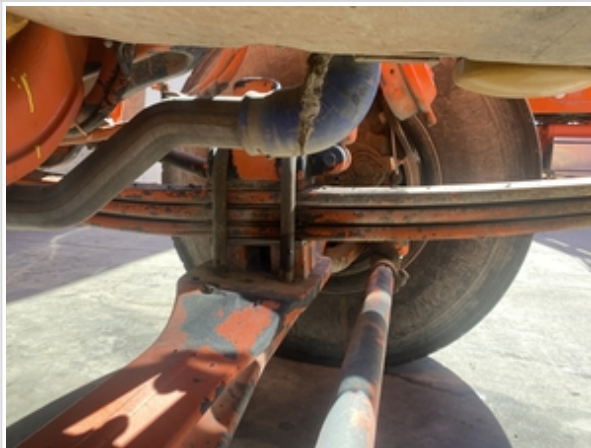
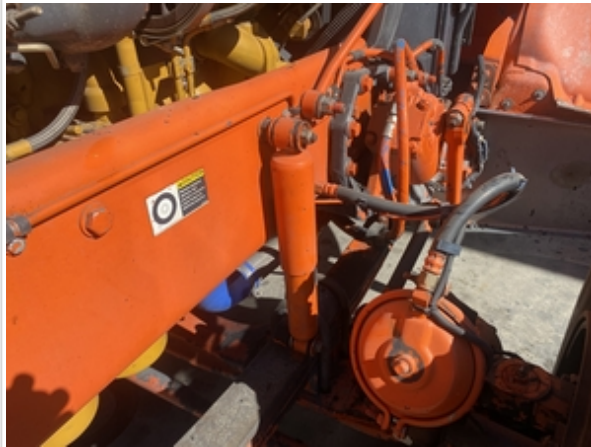
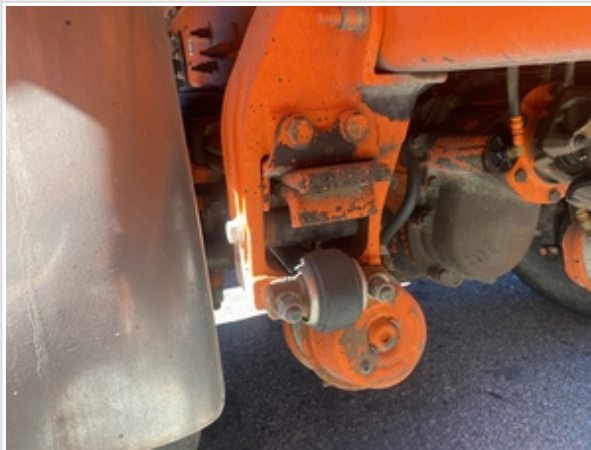
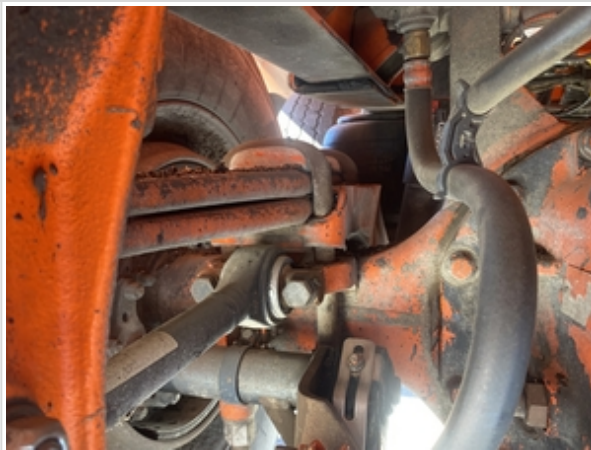
Suspension Photos

Suspension	3
------------	---

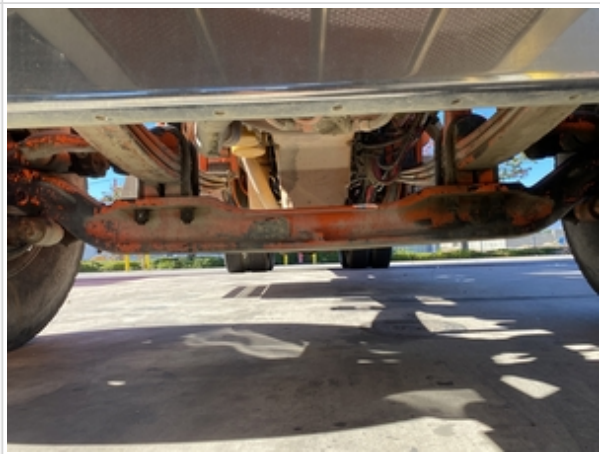
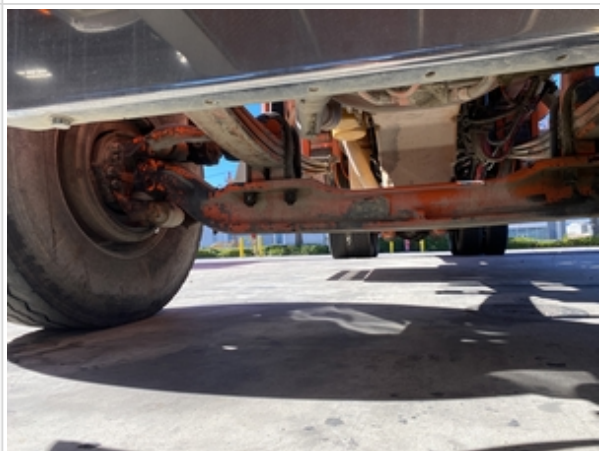
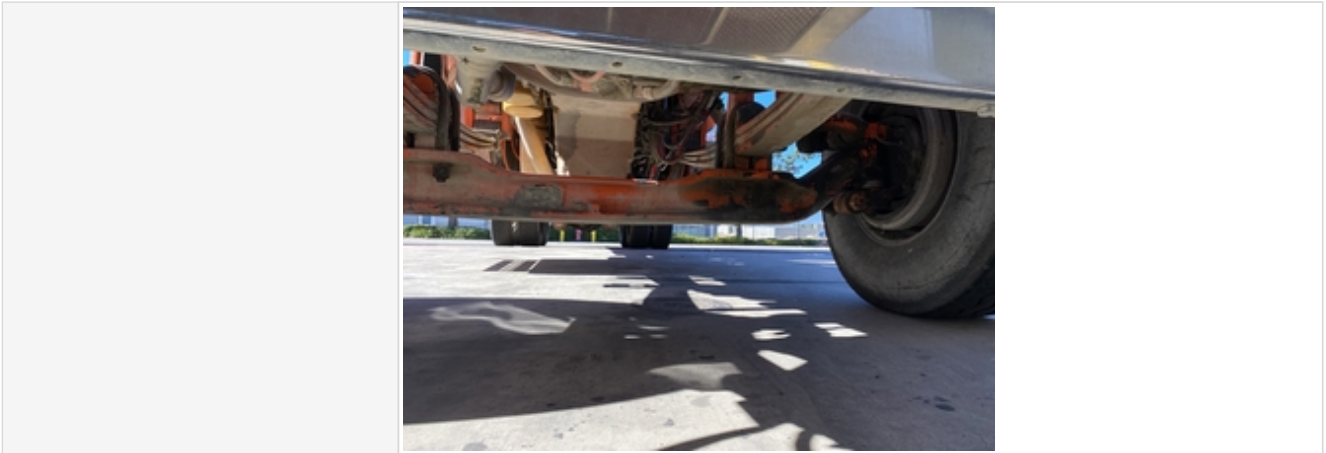
Steer Axle Condition	3	
Steer Axle Photos

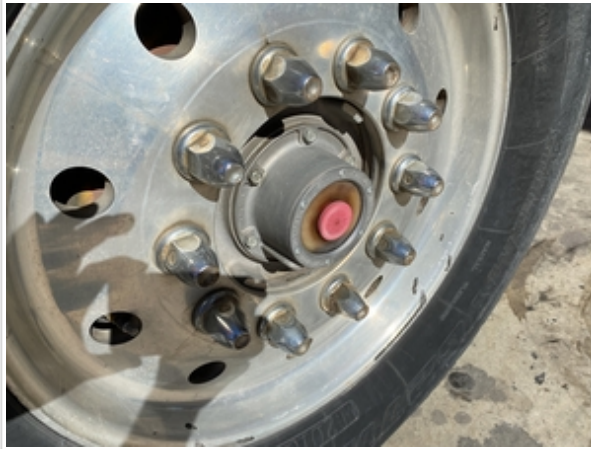
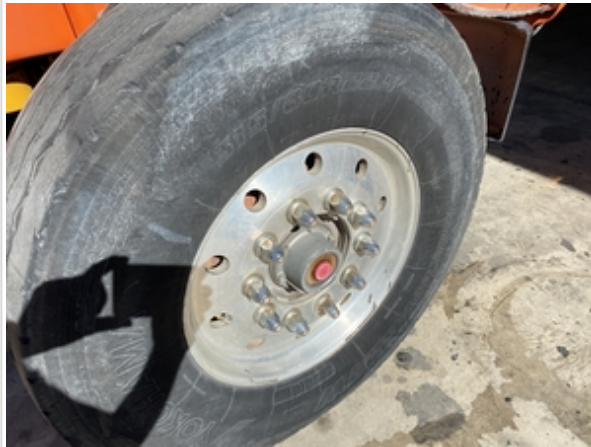
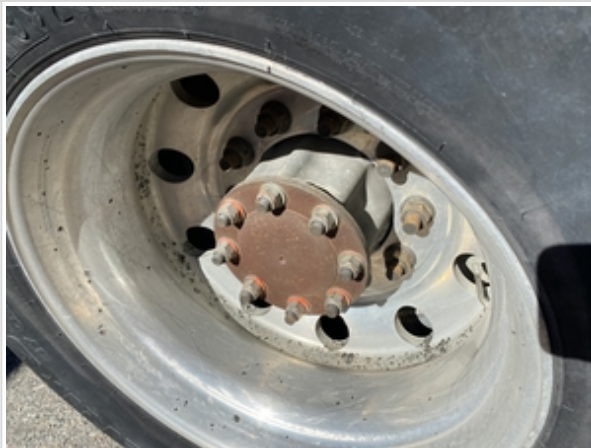
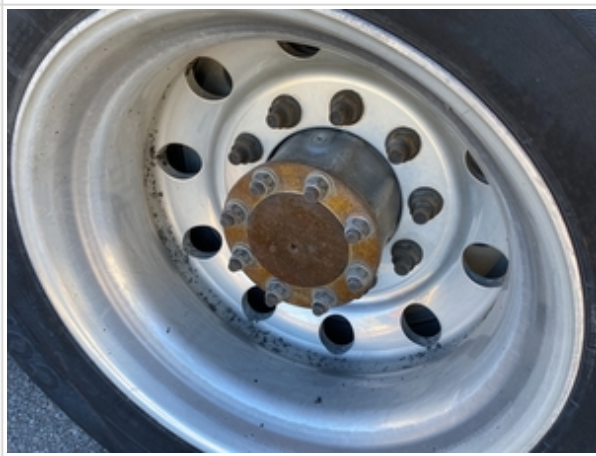
Wheels & Hub Condition	3
Wheels & Hub Photos

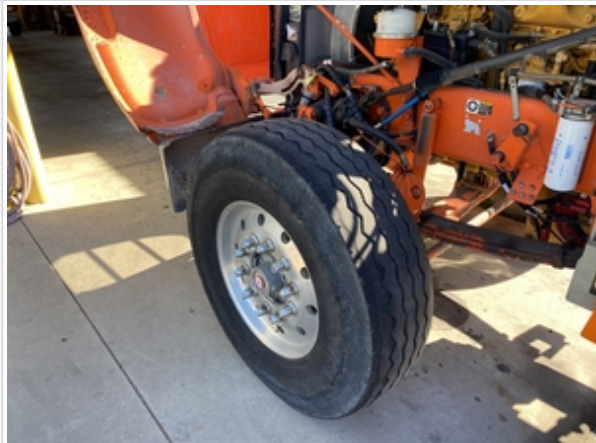
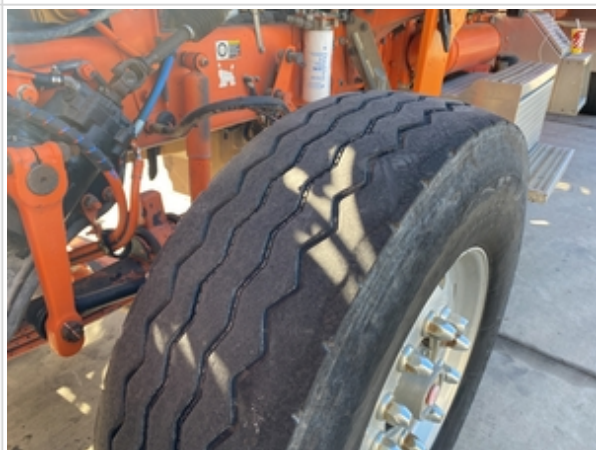
Front Left Tire Photos

Wheel Seal Leaks	No	
Tire Brand	(Front) Yokohama (Rear) generic recaps	
Tire Size	315/80R/22.5 (Rear) 11R22.5	
Front Left Tire - Ratio Remaining	10%

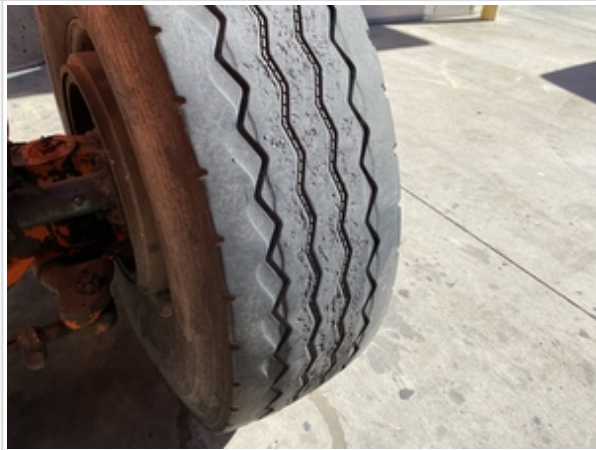
Front Right Tire - Ratio Remaining	10%
Front Right Tire Photos

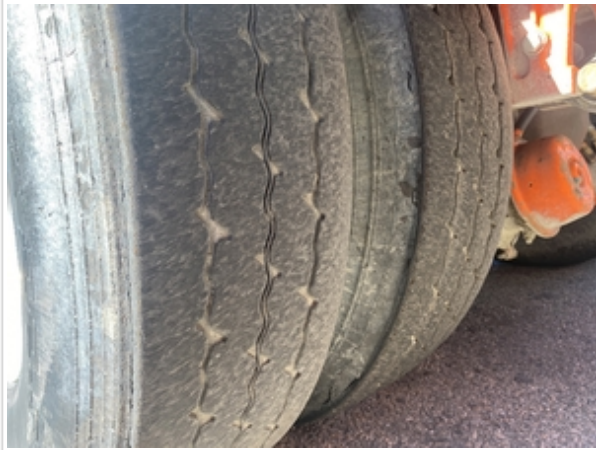
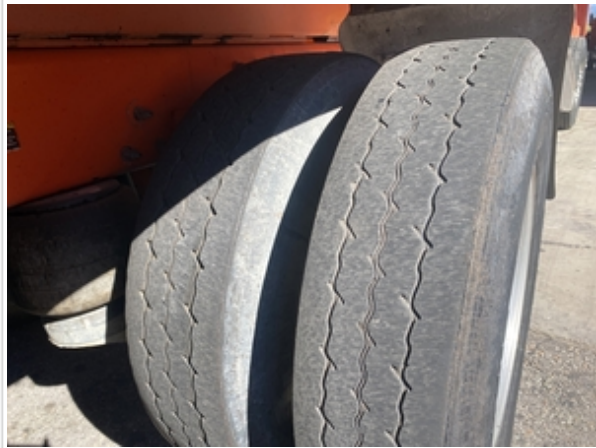
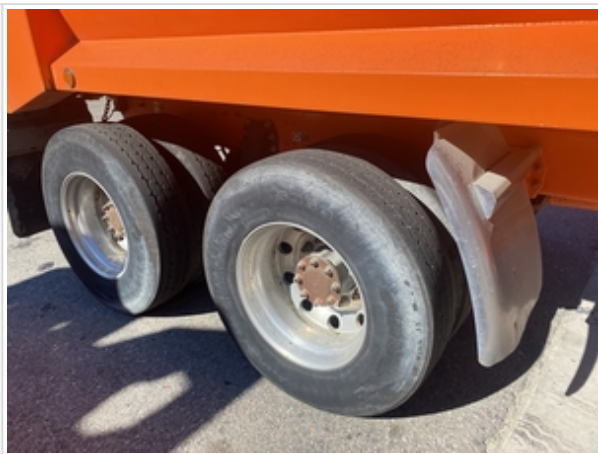
<p>Rear Right Tire - Ratio Remaining</p>	<p>10%</p>
<p>Rear Right Tire Photos</p>

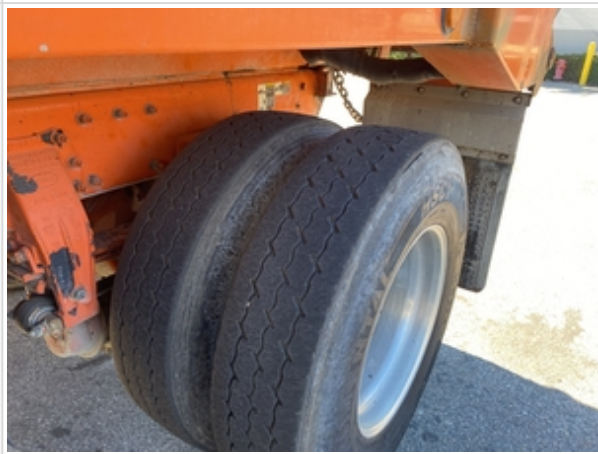
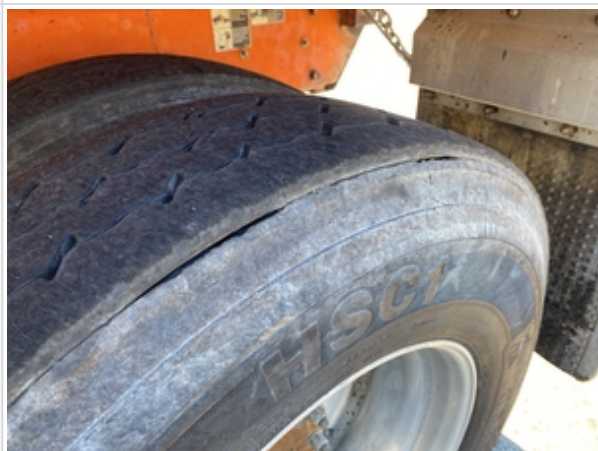
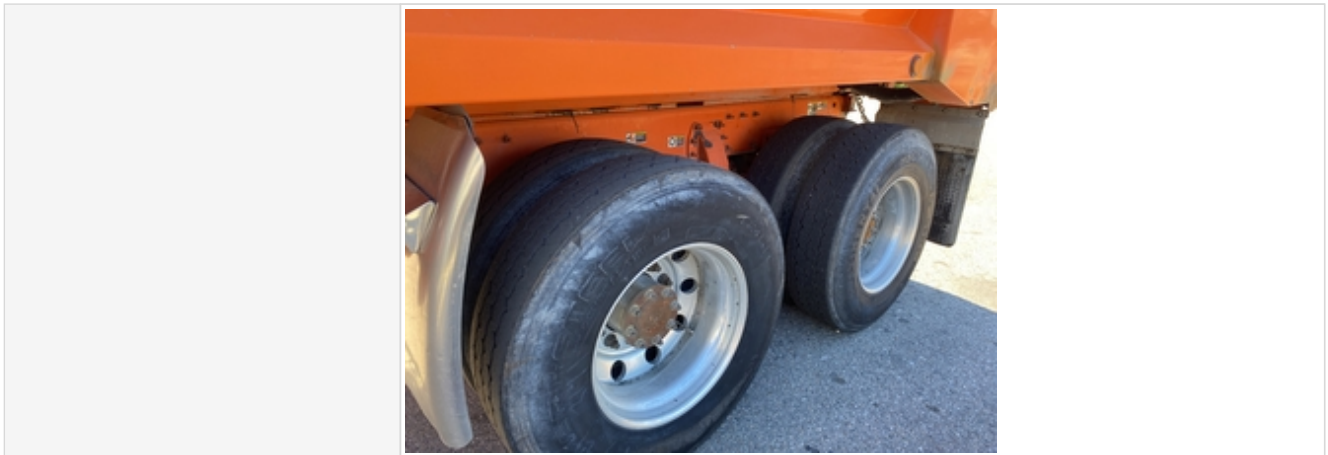
Rear Left Tire - Ratio Remaining	10%	
Rear Left Tire Photos

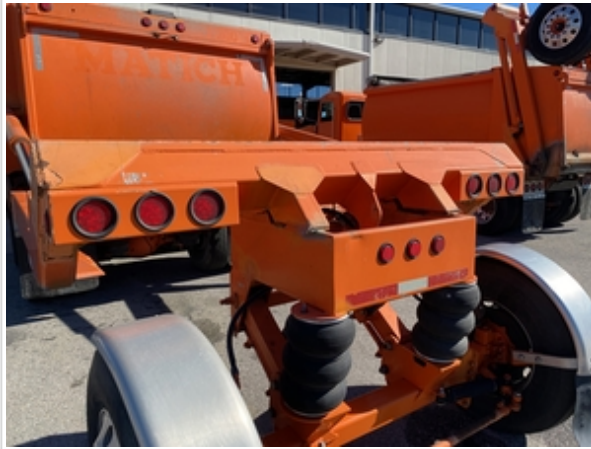
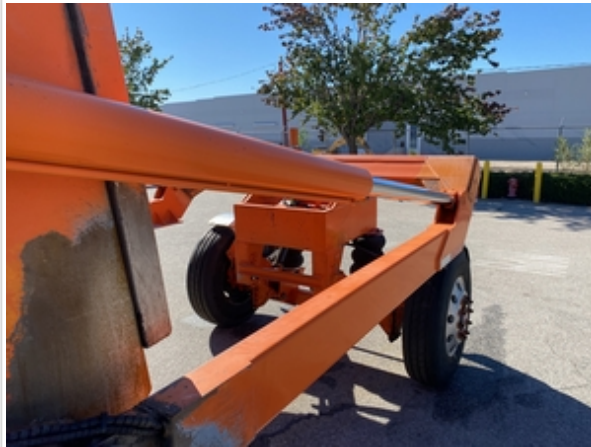
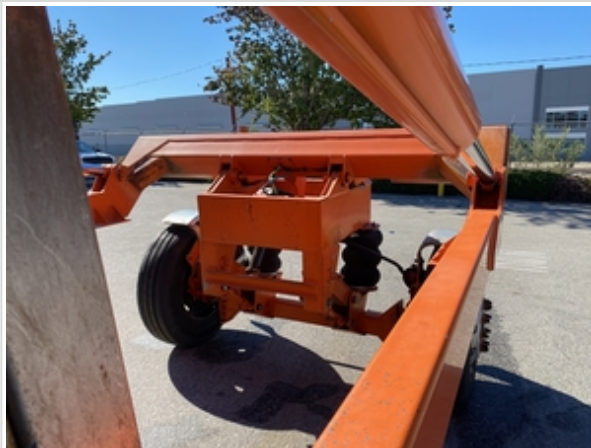
Drop Axle?	Yes
Super Dump?	Yes
Weight Rating	12,0000 Lbs.
Axle Condition	3 - Normal Wear & Tear
Axle Condition Photos

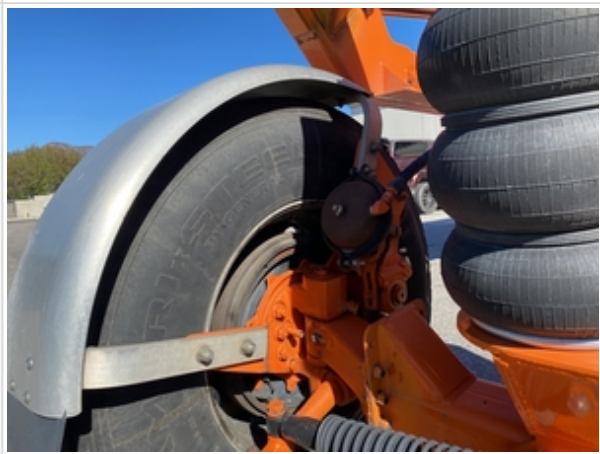
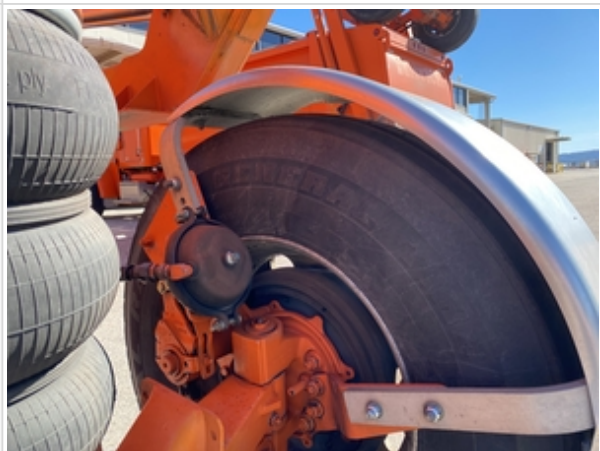
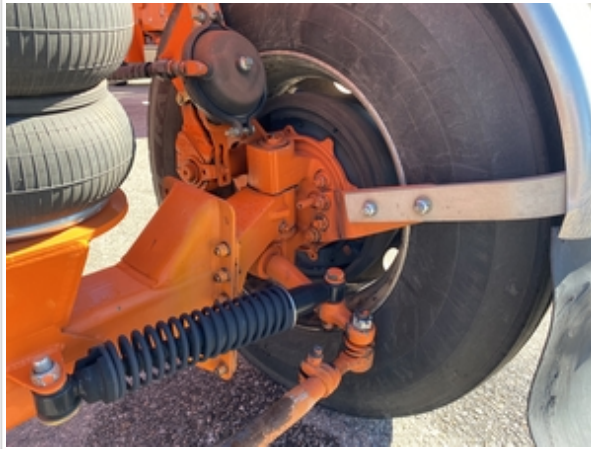
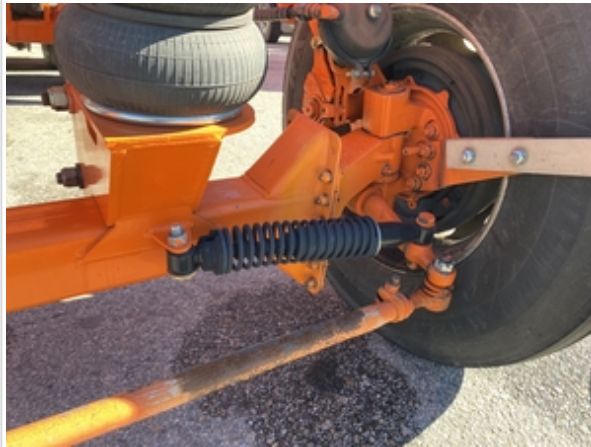
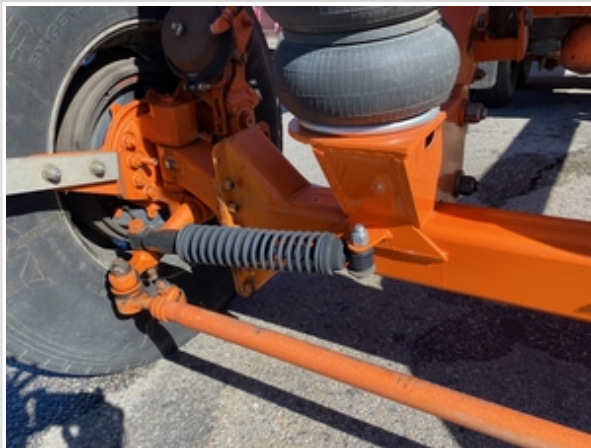
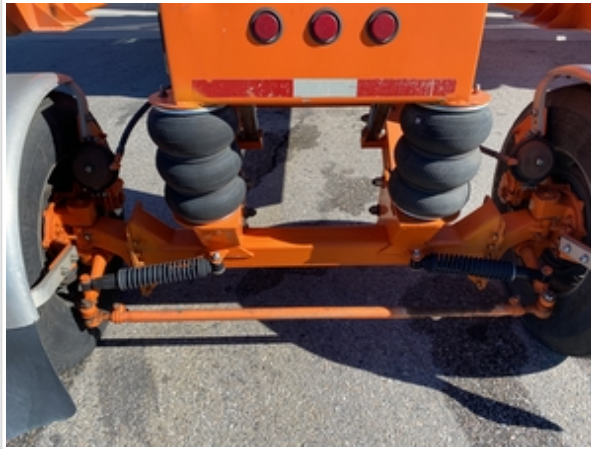
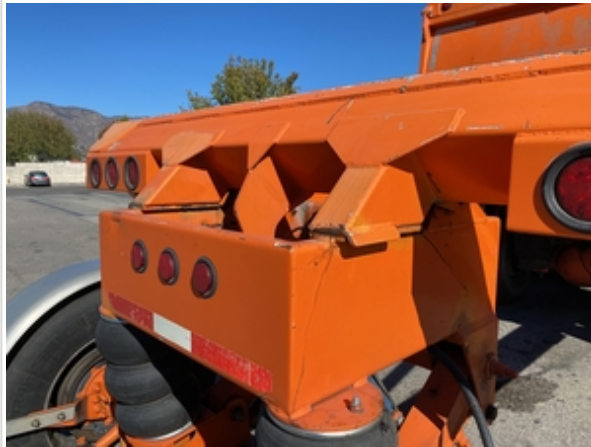
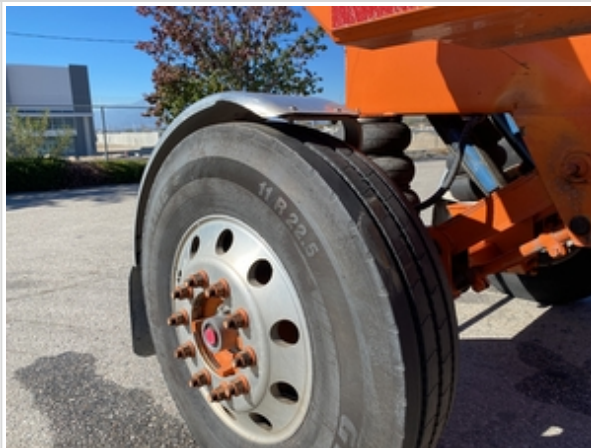
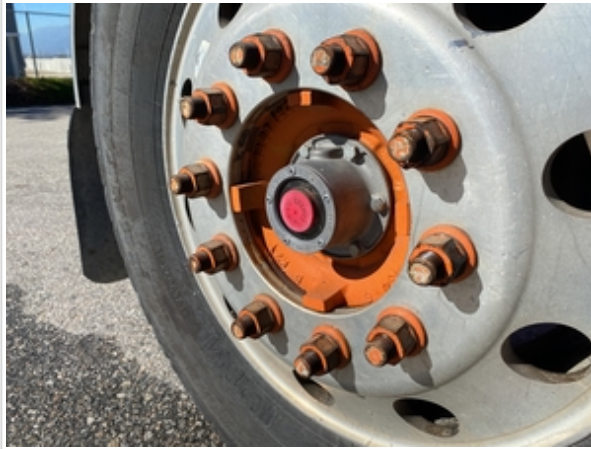
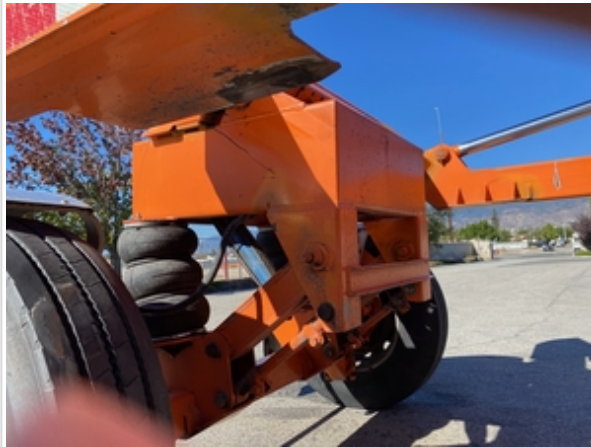
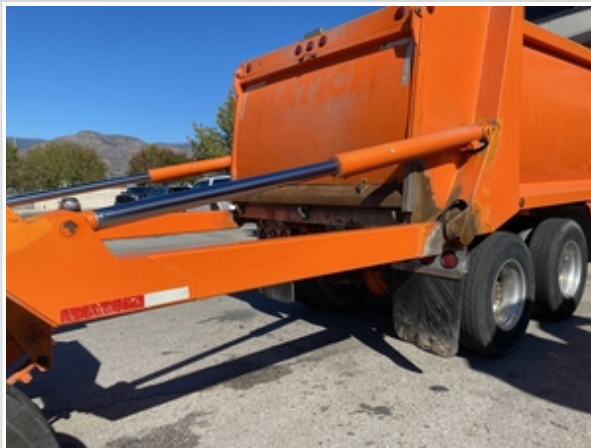
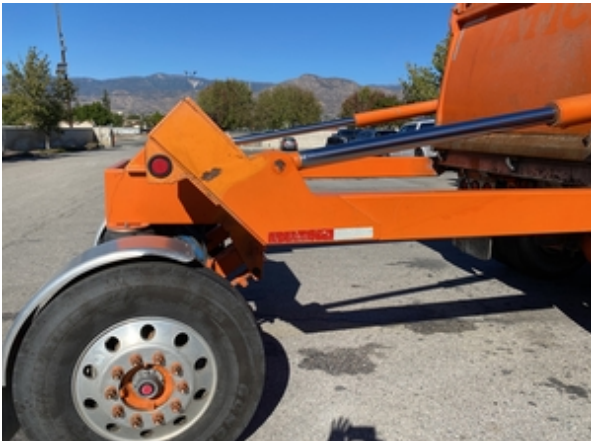
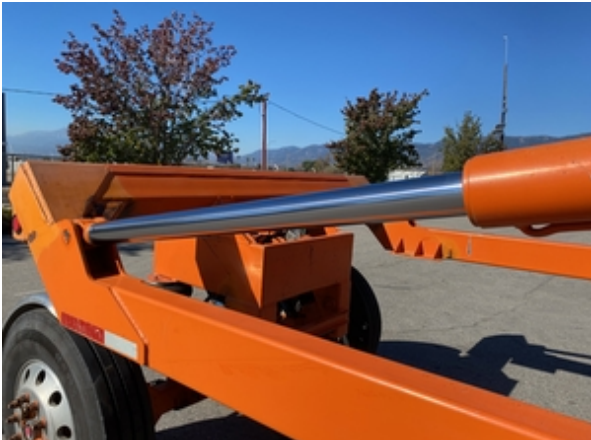
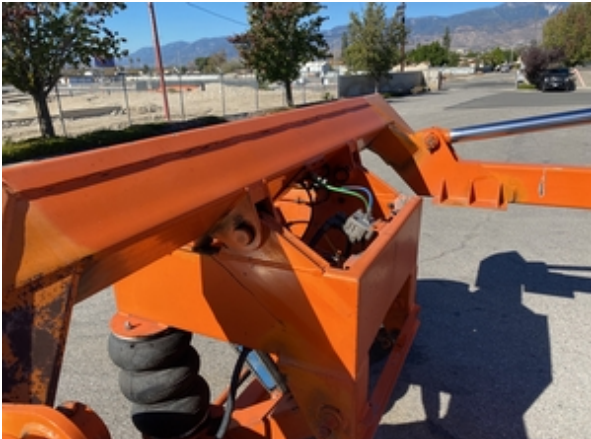
<p>Wheels & Tires</p>	<p>3 - Normal Wear & Tear</p>	
<p>Wheels & Tires Photos</p>

Tire Brand	Ameristeel
Tire Size	11R22.5
Left Tire(s) Ratio Remaining	70%
Right Tire(s) Ratio Remaining	70%
