Inspection Report (On-Highway Dump Truck)

Year	2011
Make	Peterbilt
Model	367
Serial Number	1NP - TLUOX - 2 - BD127975
Truck Odometer Reading	423,441
Previous Application (e.g., earth moving, mining, demolition, etc)	Asphalt Construction

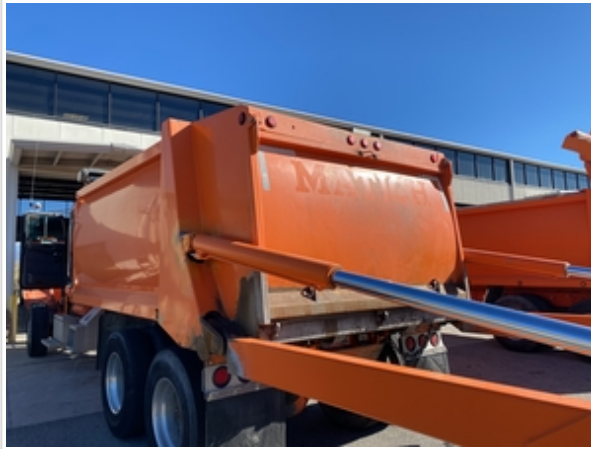
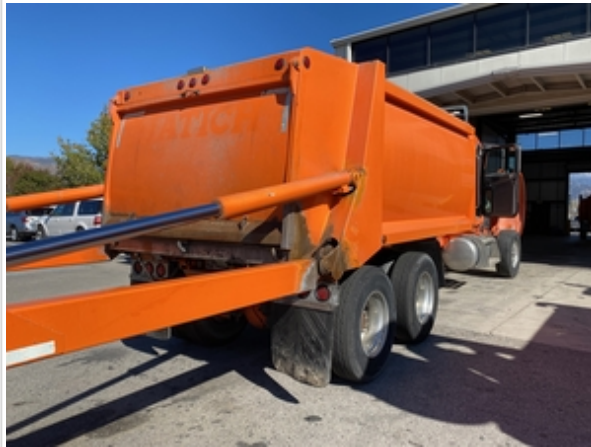
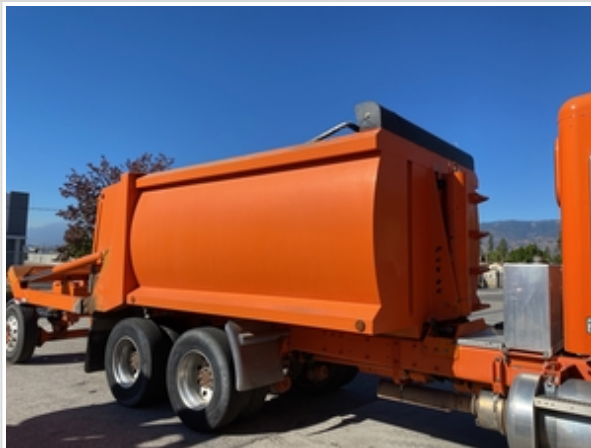
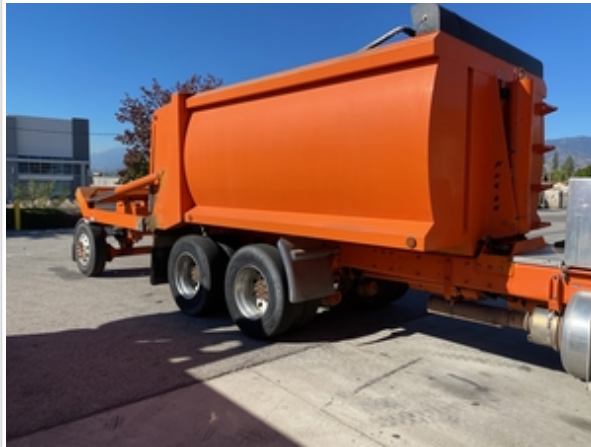
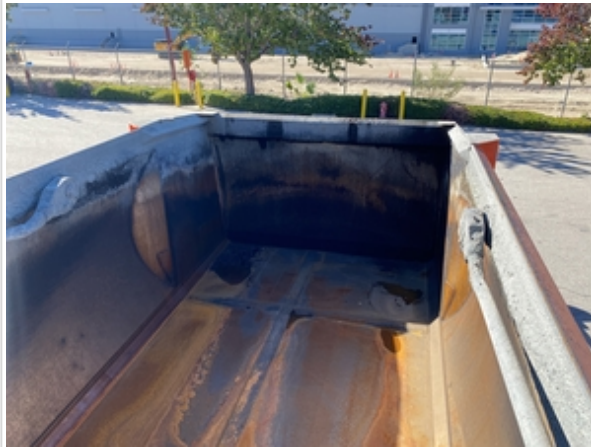
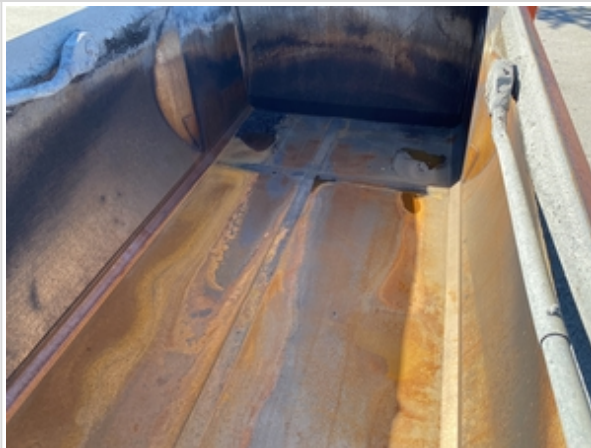
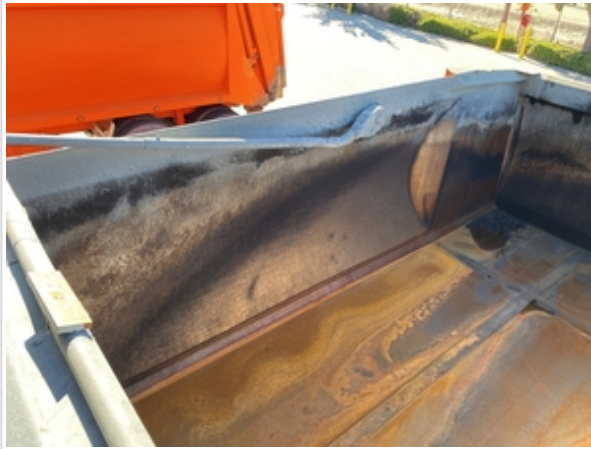
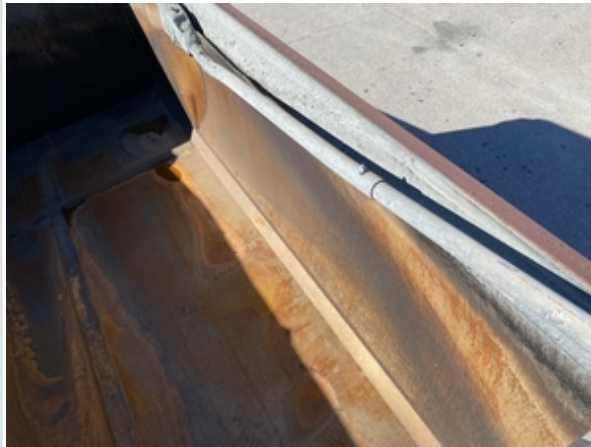
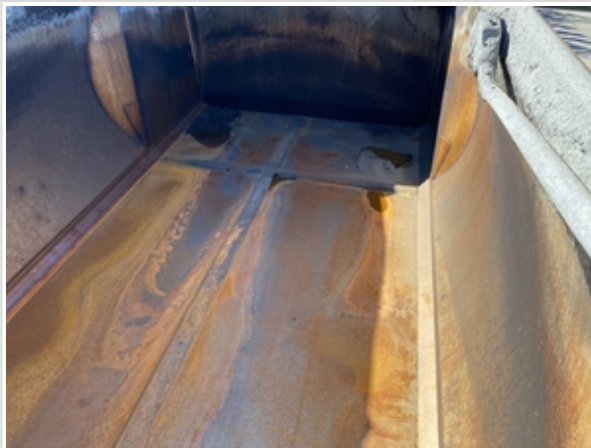
Dump Body Make & Material	Rogue
Dump Body Length (ft and inches)	15'
Dump Body Height (ft and inches)	5'3"
Bed Body	3 - Normal Wear & Tear
Bed Body Photos

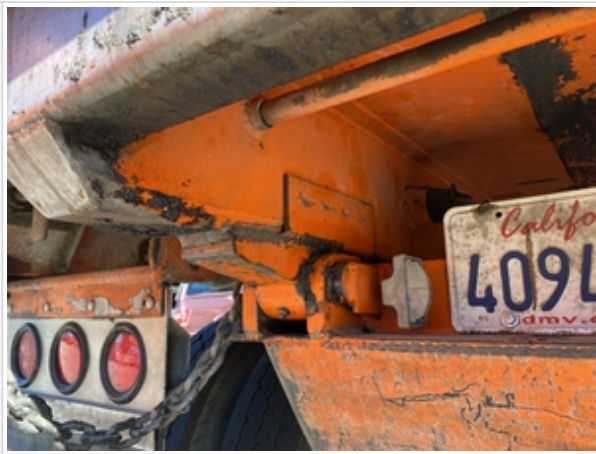
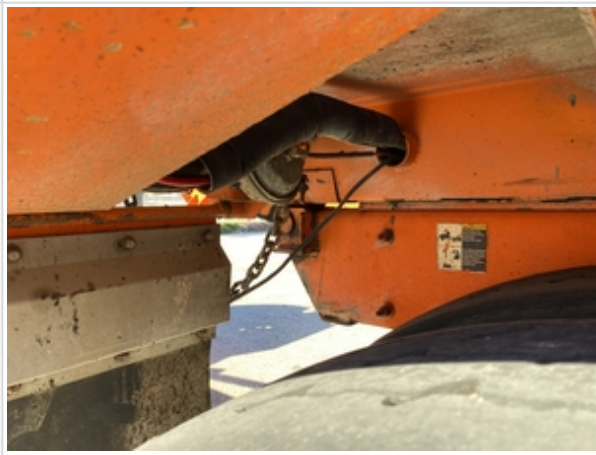
<p>Support Frame</p>	<p>3 - Normal Wear & Tear</p>	
<p>Support Frame Photos</p>

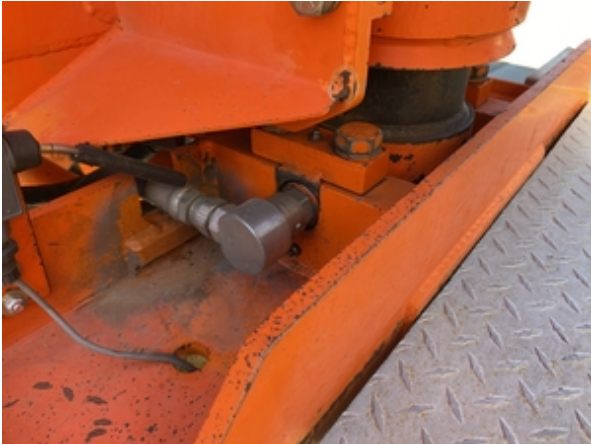
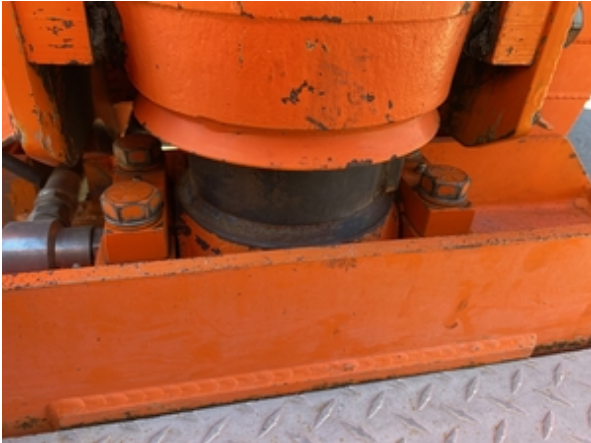
Cylinder Pins and Bushings	3 - Normal Wear & Tear
Cylinder Pins and Bushings Photos
