## Inspection Report (On-Highway Dump Truck)

Year	2011
Make	Peterbilt
Model	367
Serial Number	1NP - TLUOX - 6 - BD127977
Truck Odometer Reading	443,015
Previous Application (e.g., earth moving, mining, demolition, etc)	Asphalt Construction

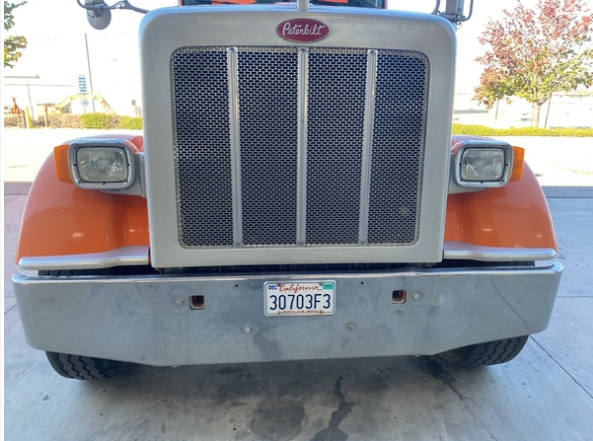
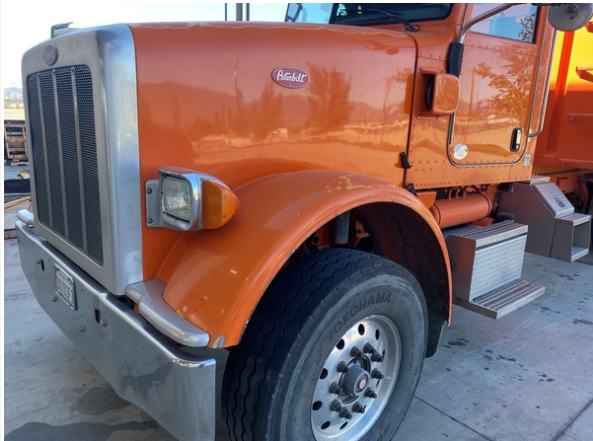
Front Photos

Front	3 - Normal Wear & Tear
Front Condition	No visible damage

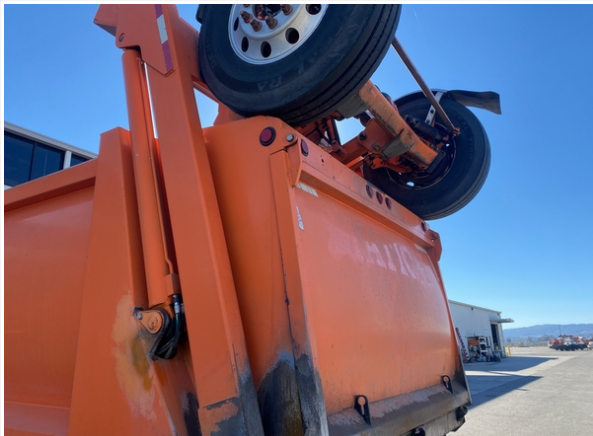
<b>Rear</b>	3 - Normal Wear & Tear
<b>Rear Condition</b>	No visible damage, Other (see comments)
<b>Rear Photos</b>

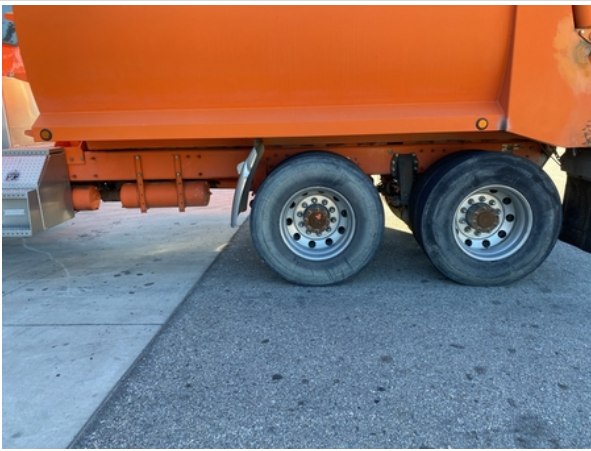
<b>Left</b>	3 - Normal Wear & Tear	
<b>Left Condition</b>	No visible damage	
<b>Left Photos</b>

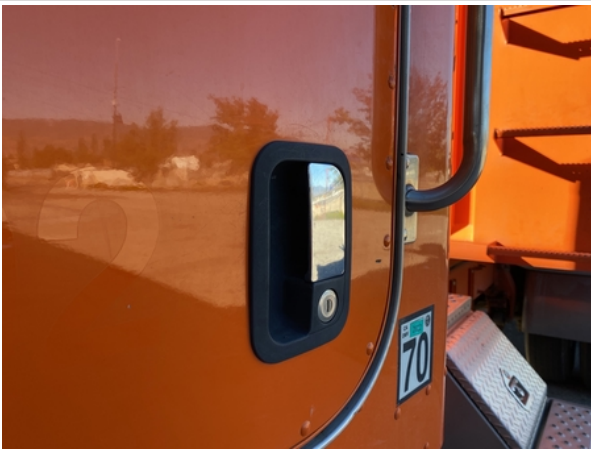
<b>Body Panels (Any Rust Damage?)</b>	3 - Normal Wear & Tear	
<b>Body Panel Condition</b>	No visible damage, good paint condition and panel fitment	
<b>Doors / Canopy Latches</b>	3 - Normal Wear & Tear	
<b>Doors / Canopy Latches Condition</b>	No visible damage	
<b>Doors / Canopy Latches Photos</b>

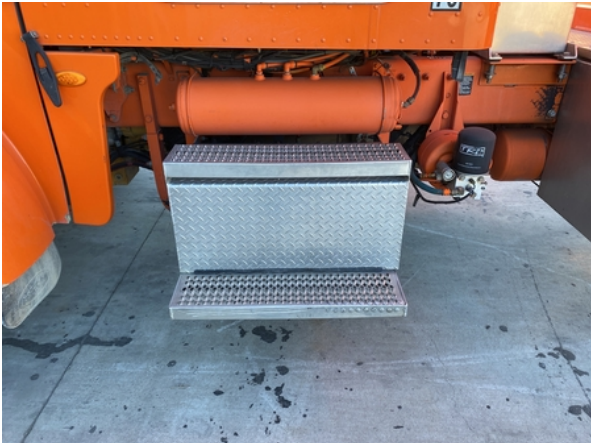
<b>Steps / Ladders</b>	3 - Normal Wear & Tear
<b>Steps / Ladders Condition</b>	Steps/ladders are fully intact and appear structurally sound
<b>Steps / Ladders Photos</b>

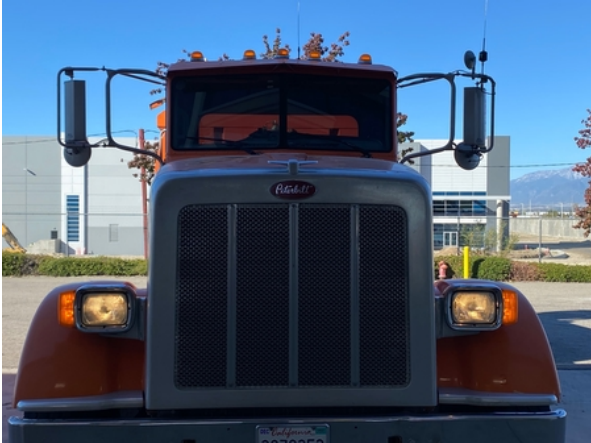
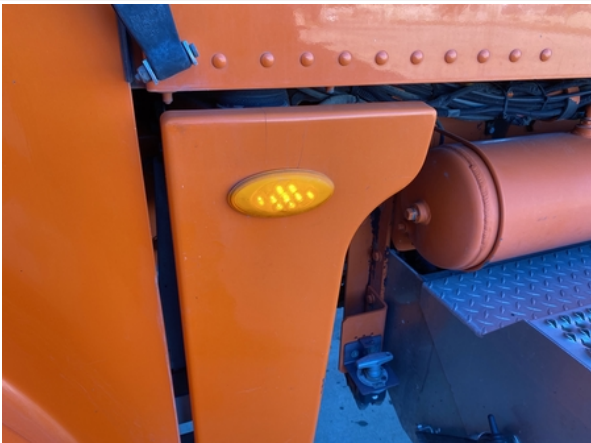
<b>Lighting System</b>	3 - Normal Wear & Tear	
<b>Lighting System Condition</b>	No visible damage, lighting system is operational	
<b>Lighting System Photos</b>

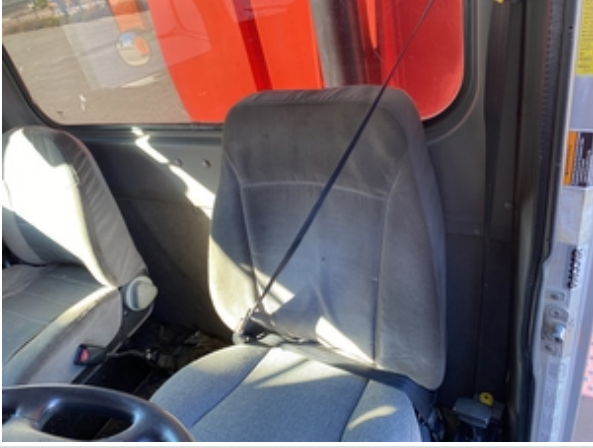
<b>Seat Belt</b>	3 - Normal Wear & Tear
<b>Seat Belt Photos</b>

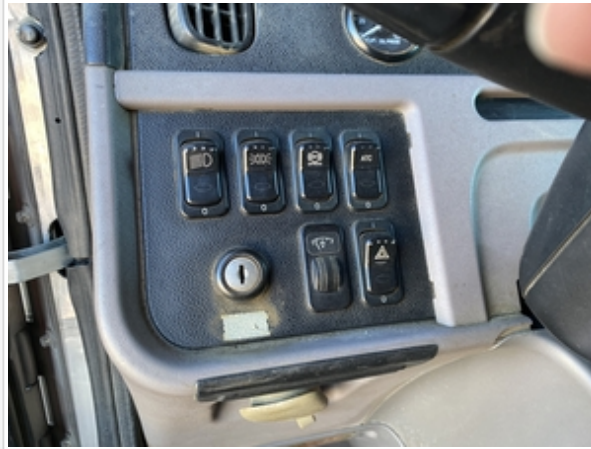
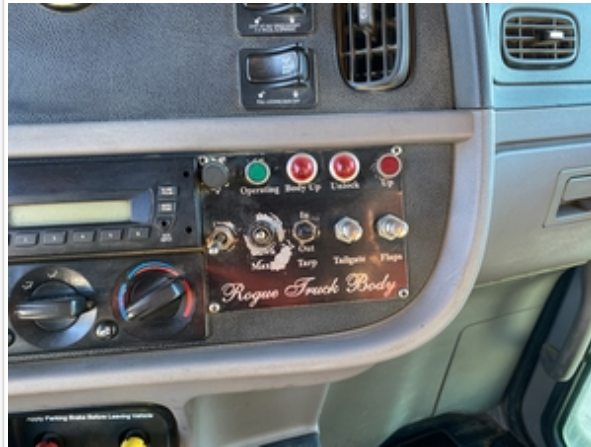
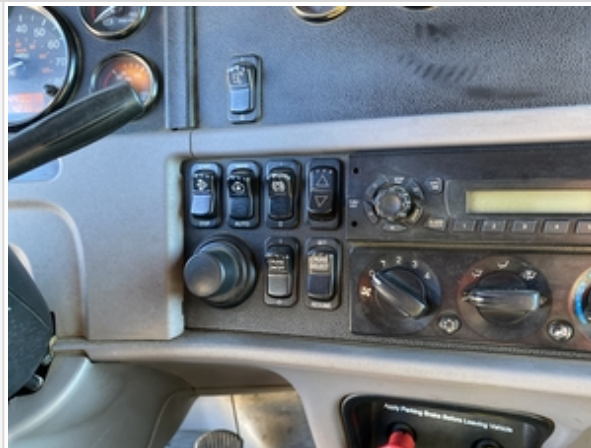
Controls & Switches Photos

Controls & Switches	3 - Normal Wear & Tear

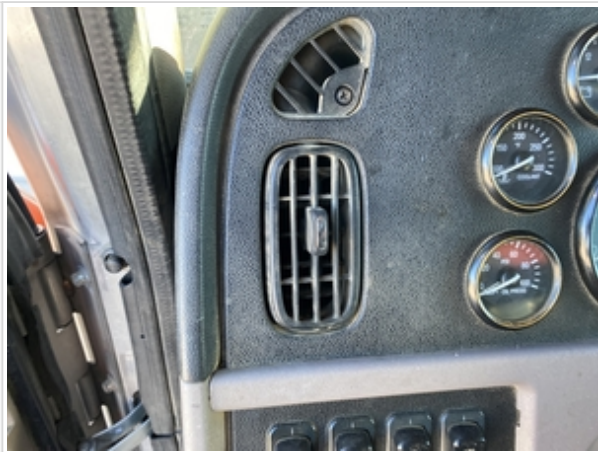
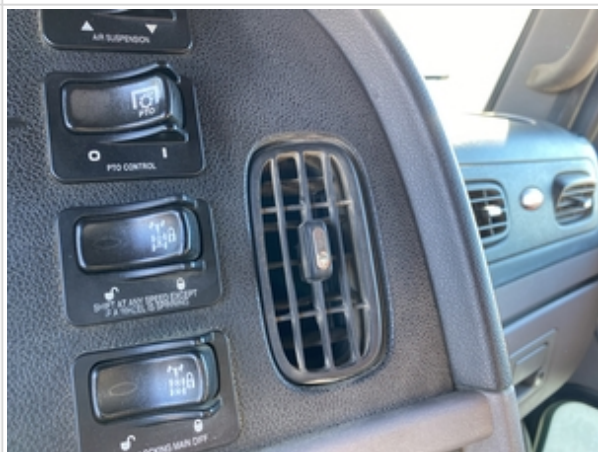
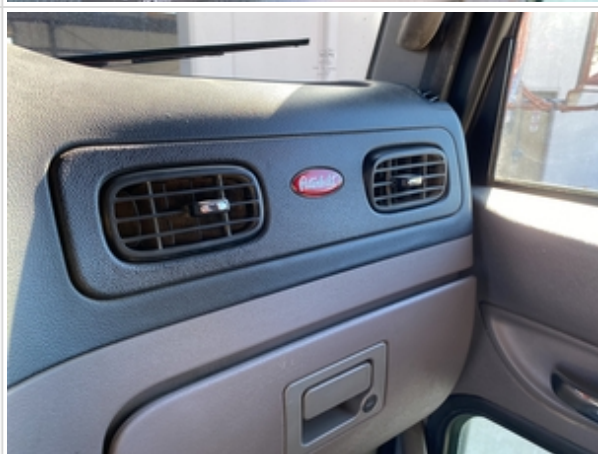
Fans / Vents Photos

<p>Fans / Vents</p>	<p>3 - Normal Wear &amp; Tear</p>

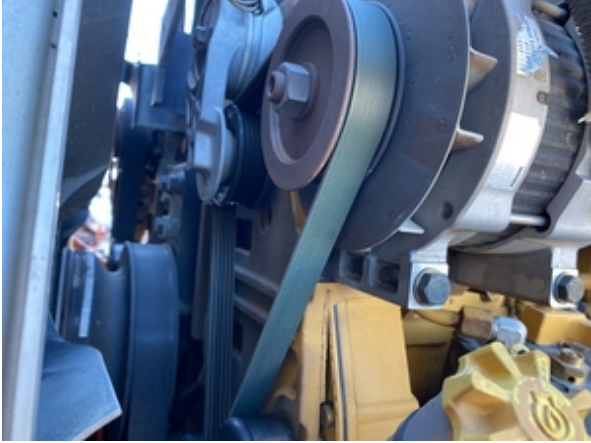
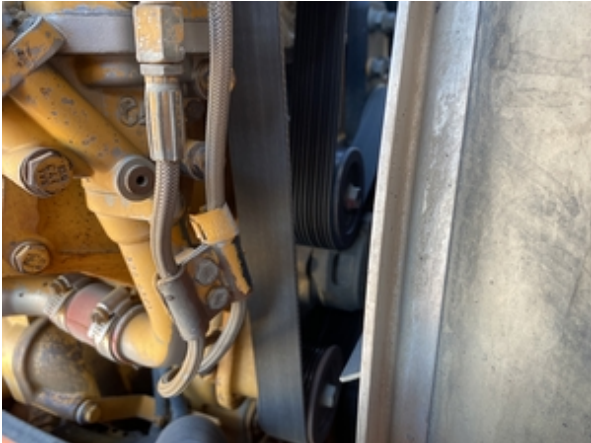
<b>Belt Photos</b>

<b>Belts</b>	3 - Normal Wear & Tear
<b>Belt Condition</b>	Belts appear in good condition & alignment with proper tension

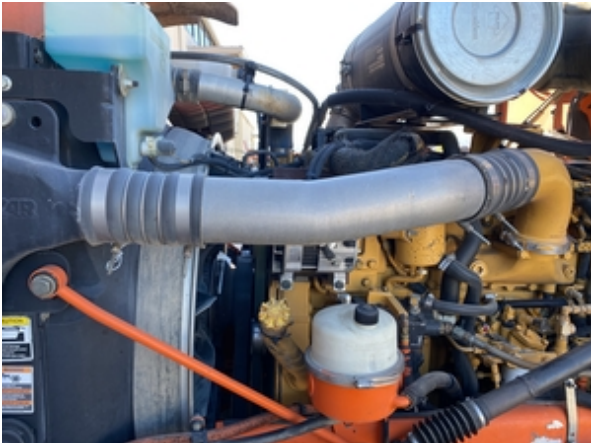
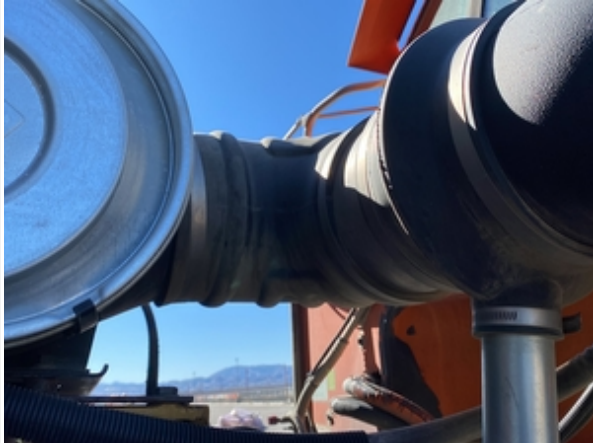
<b>Hoses</b>	3 - Normal Wear & Tear
<b>Hose Condition</b>	Firm, pliant hoses with no signs of wear or leaks
<b>Hose Photos</b>

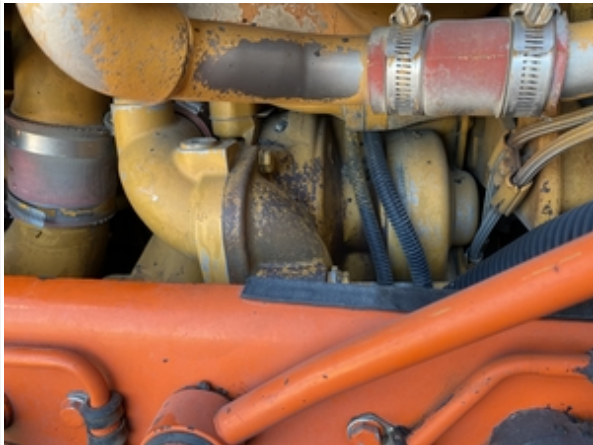
<b>Water Pump</b>	3 - Normal Wear & Tear
<b>Water Pump Condition</b>	No unusual pump noises heard
<b>Water Pump Photos</b>

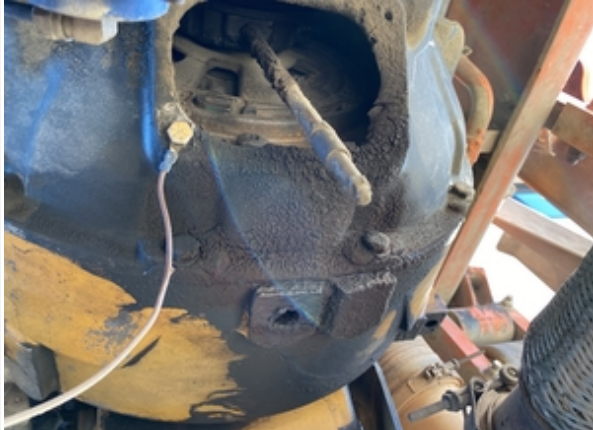
<b>Cooling System Leaks</b>	No
<b>Coolant Color / Appearance</b>	3 - Normal Wear & Tear
<b>Coolant Color/Appearance Notes</b>	Normal Translucent appearance, no visual signs of contamination
<b>Oil Leaks</b>	Yes
<b>Oil Leak Notes</b>	No oil leaks seen, Dried oil seepages seen
<b>Oil Leak Photos</b>

Requires DEF (Diesel Exhaust Fluid)	No
Overall Engine Appearance	Clean & dry, Areas of dried seepage seen on engine hoses & components
Overall Engine Comments	Engine clean, minor leakage at oil pan, rear housing area

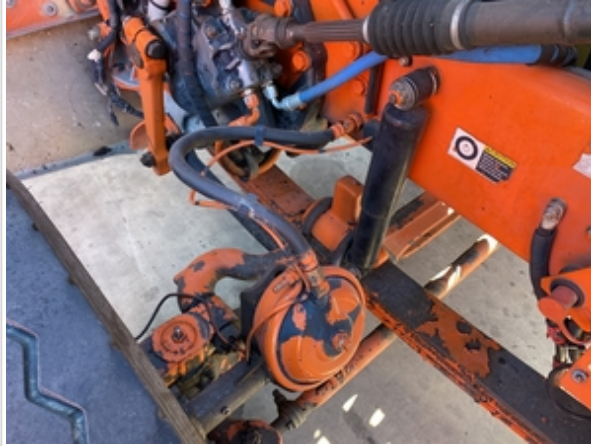
Air Brake System Photos

<b>Brake System Type</b>	Air Brakes
<b>Air Brakes Build Correct Pressure</b>	Yes
<b>Air Brake System Leaks</b>	No
<b>Air Brake Hose Condition</b>	3 - Normal Wear & Tear

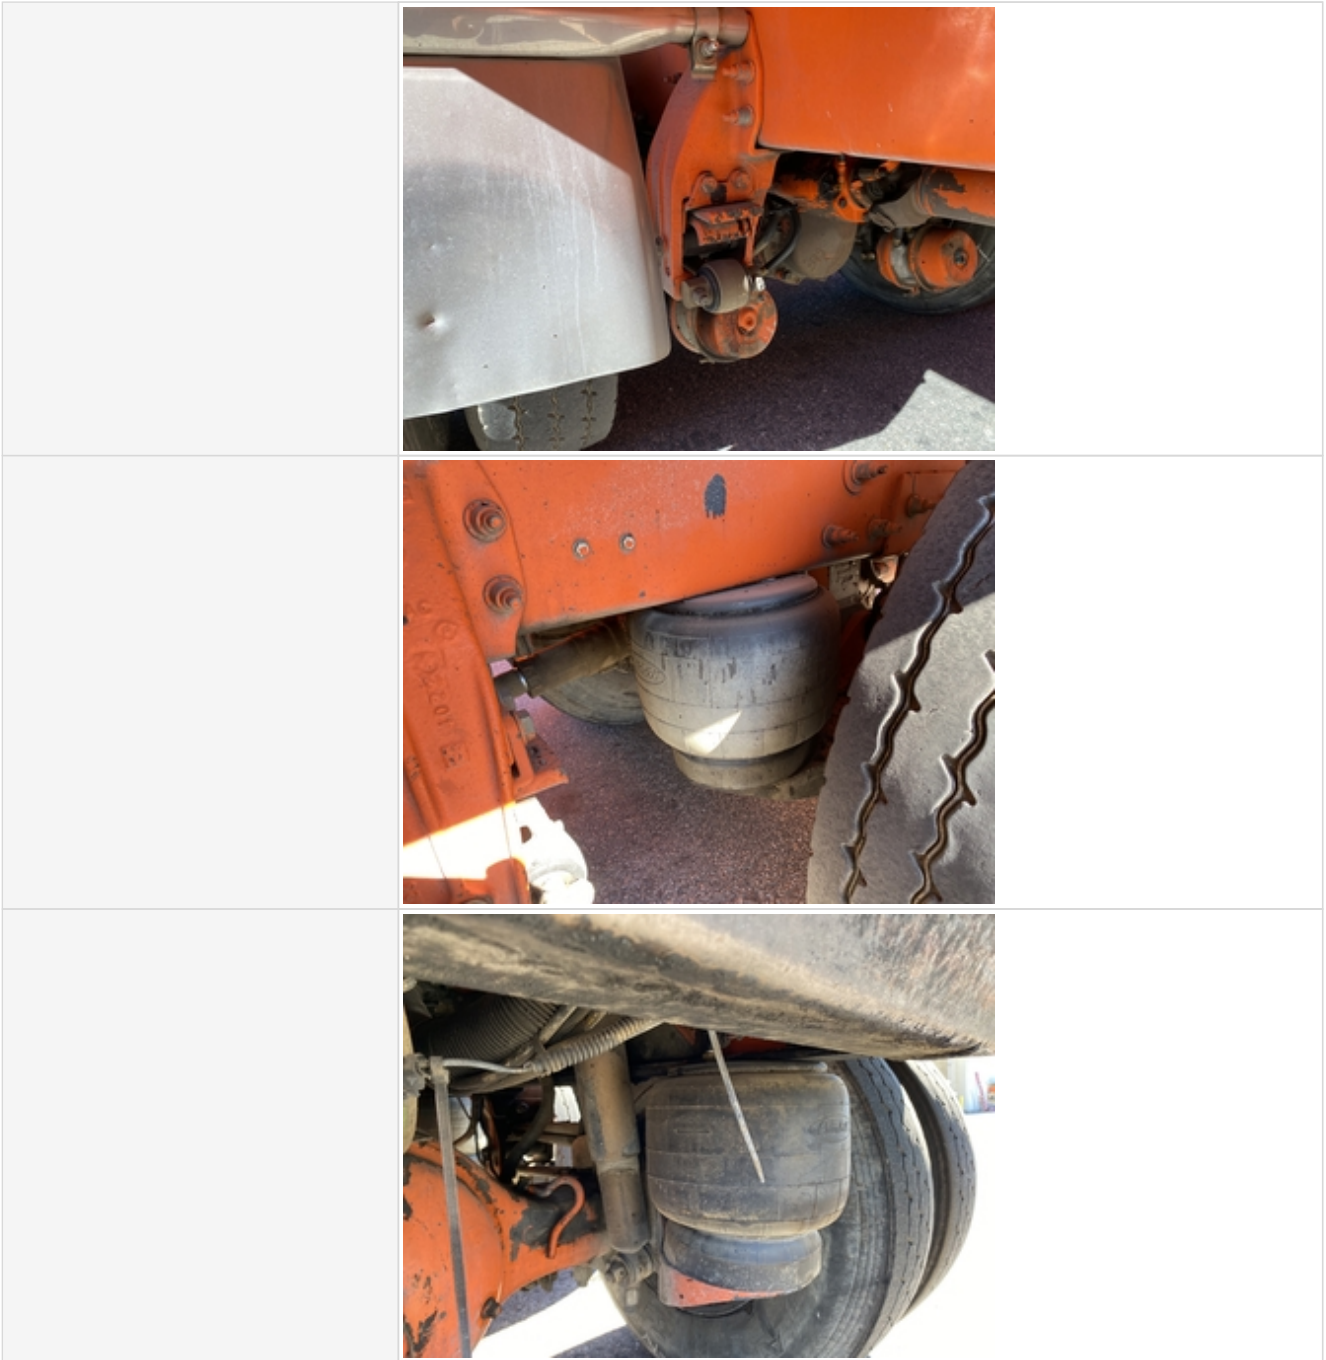
Suspension Photos

Suspension	3
------------	---

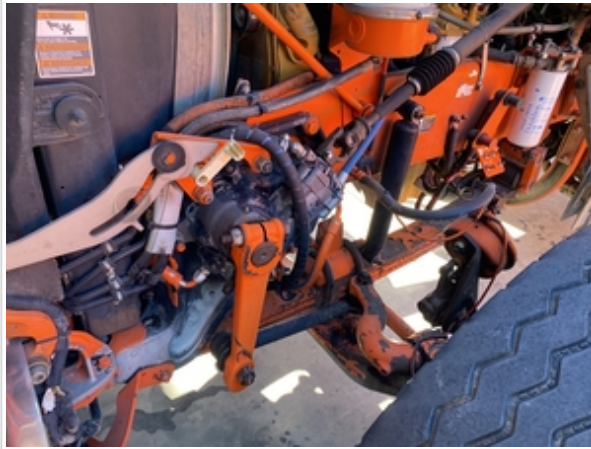
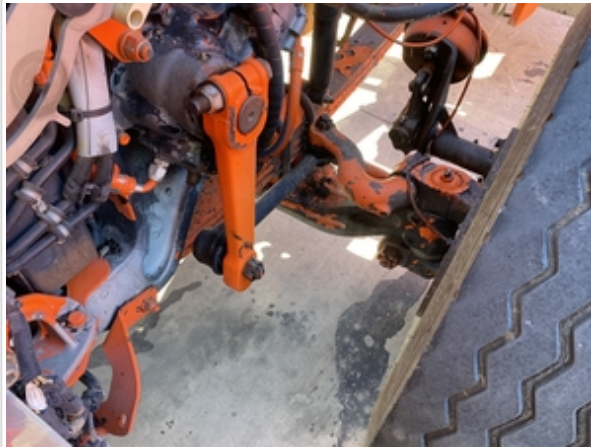
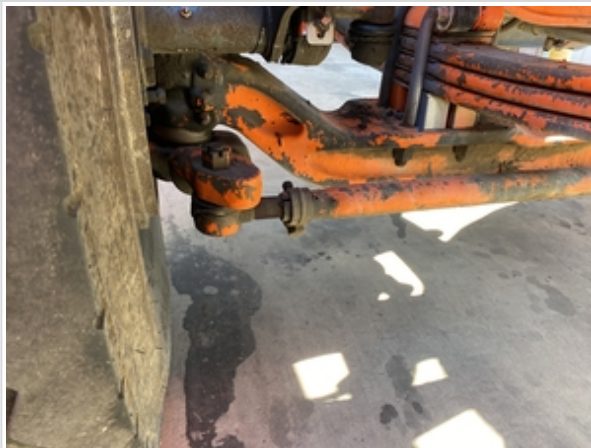
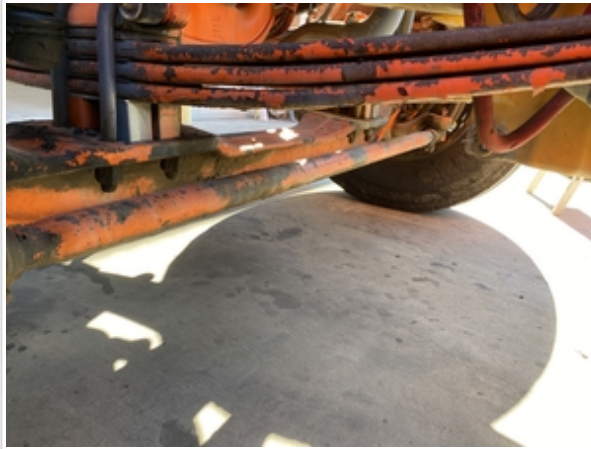
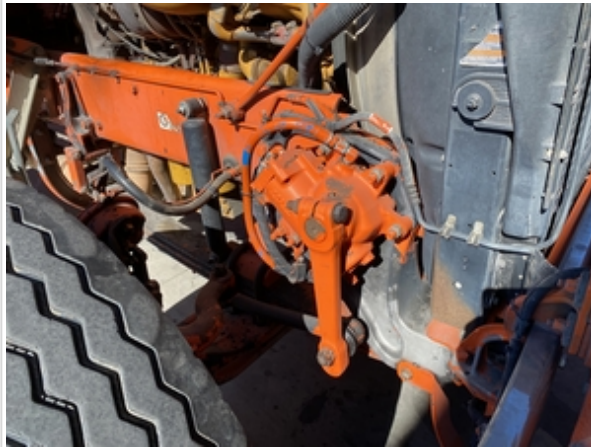
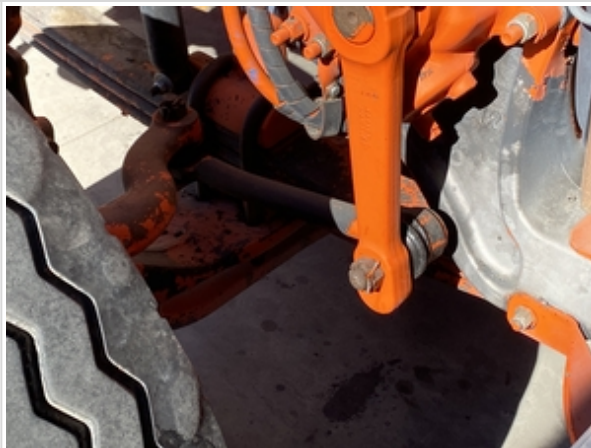
Steering Components	3
Steering Components Photos

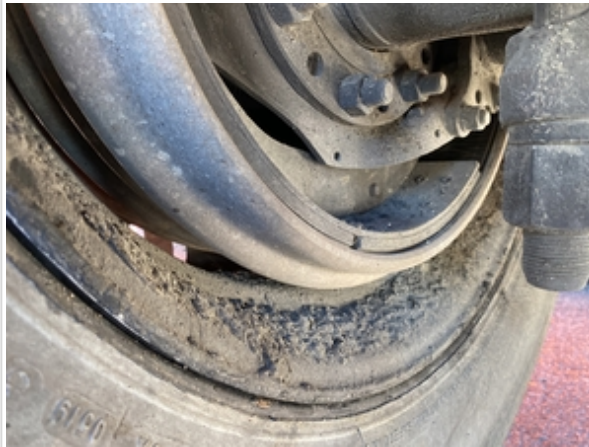
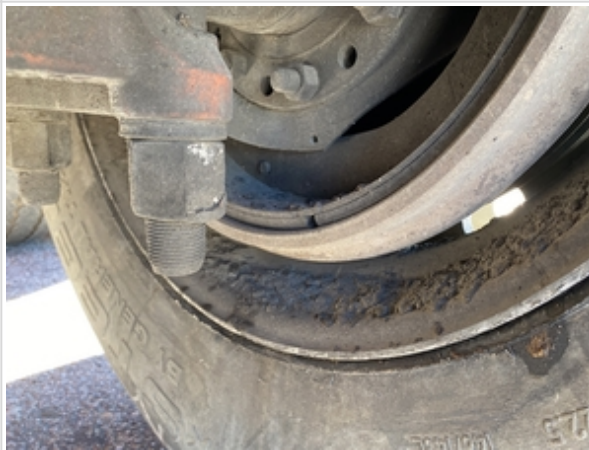
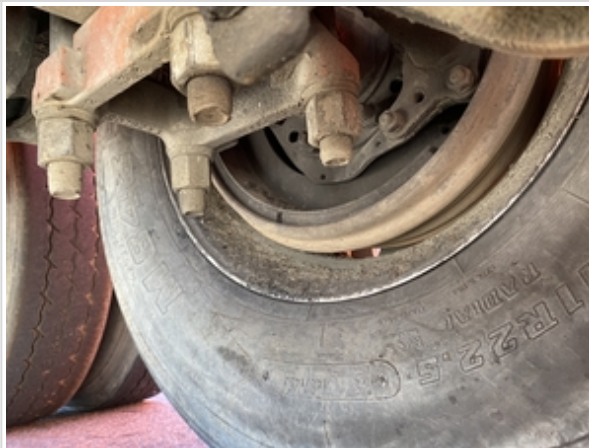
Brake Shoe Photos

<p>Brake Shoe Thickness</p>	<p>10%</p>
-----------------------------	------------

Exterior Rating	3
Interior Rating	3
Safety Rating	3
Quality Rating	3
Functionality Rating	3
Overall Rating	3
What's Great About the Machine	This truck is well maintained by a professional, experienced shop that does not cut corners. All their trucks are treated the same and it shows. Very few issues found.
What Needs Work	Few cosmetic issues with clearcoat. Tires need to be replaced soon and some brake shoes getting low.
Date/Time	11-15-2022

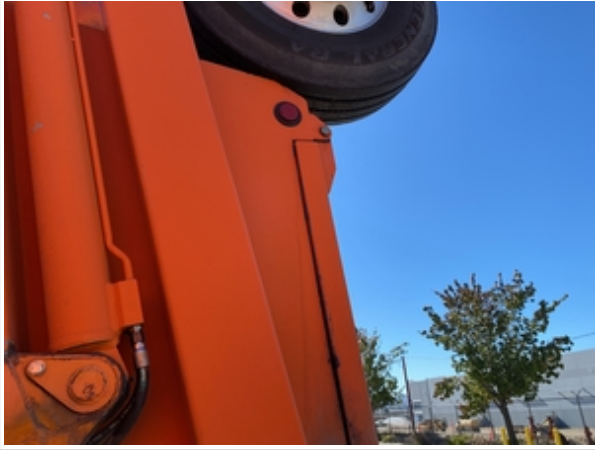
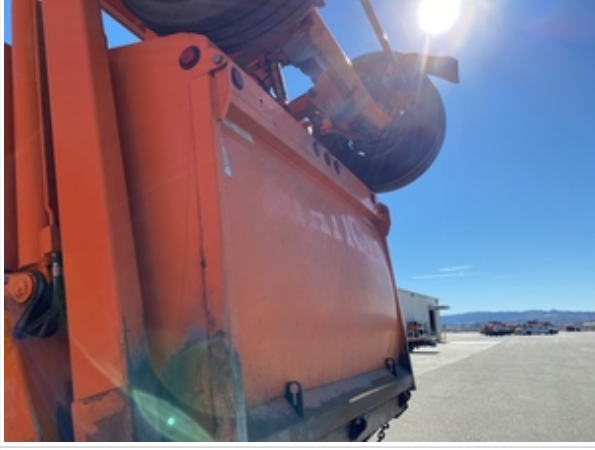
<b>Tailgate</b>	3 - Normal Wear & Tear	
<b>Tailgate Photos</b>
