## Inspection Report (Boom Lift)

Year	2008
Make	JLG
Model	AJ 800
Serial Number	0300119325
Hour Meter Reading	3,827
Previous Application (e.g., earth moving, mining, demolition, etc)	Equipment Rental

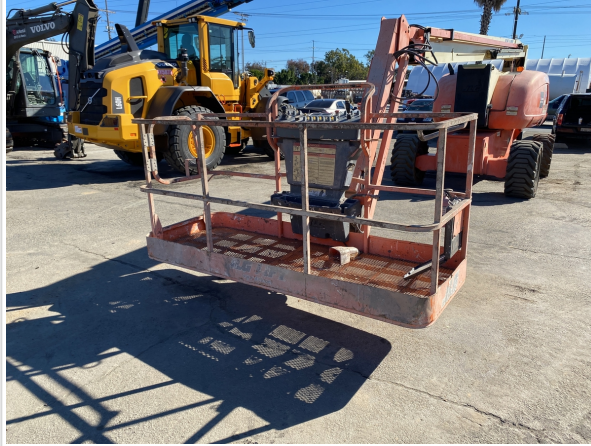
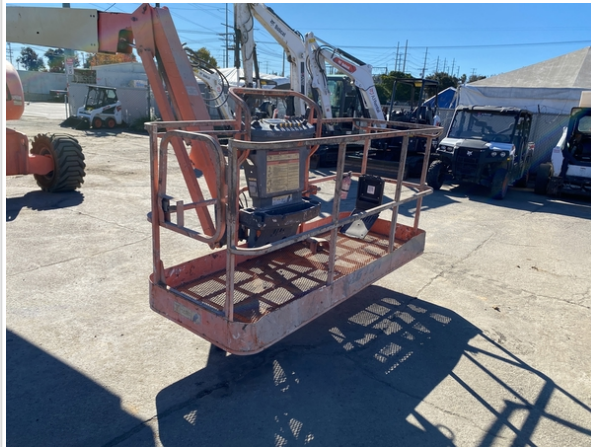
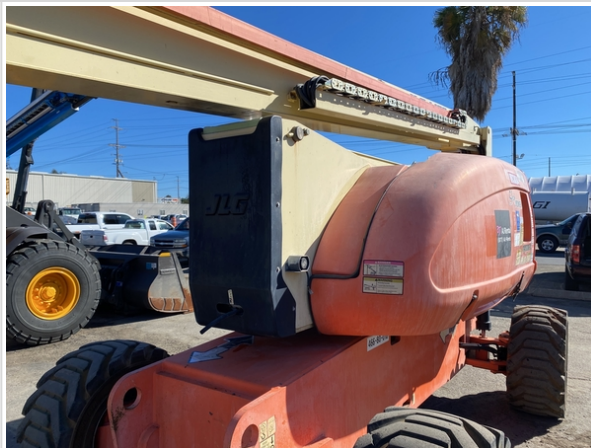
Front Photos

Front	3 - Normal Wear & Tear
-------	------------------------

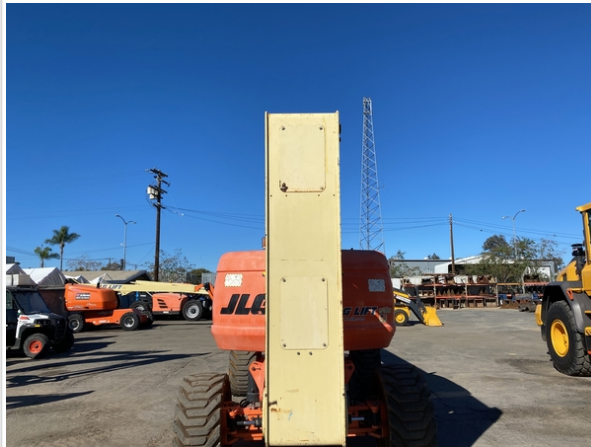
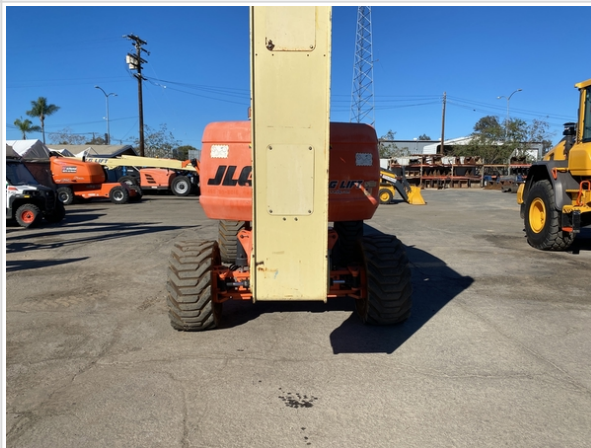
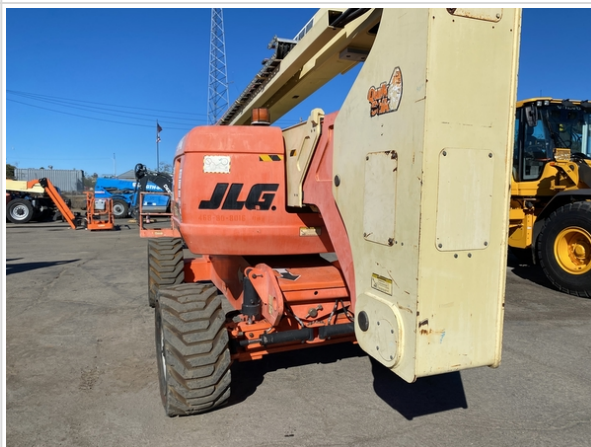
Rear Photos

Rear

3 - Normal Wear & Tear

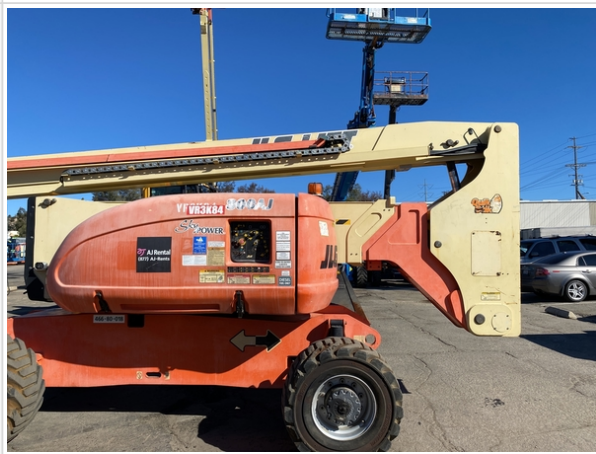
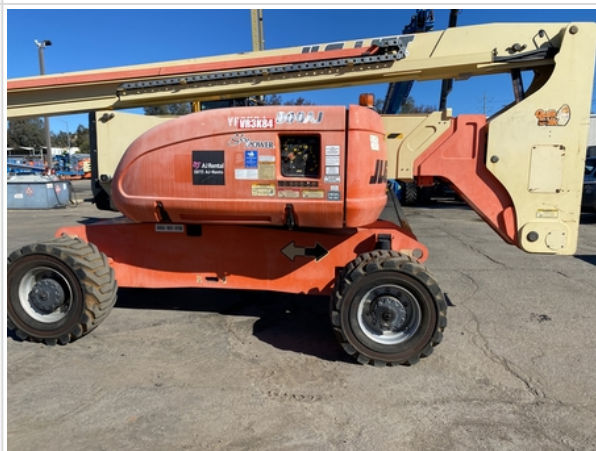
<p>Left</p>	<p>3 - Normal Wear &amp; Tear</p>	
<p>Left Photos</p>

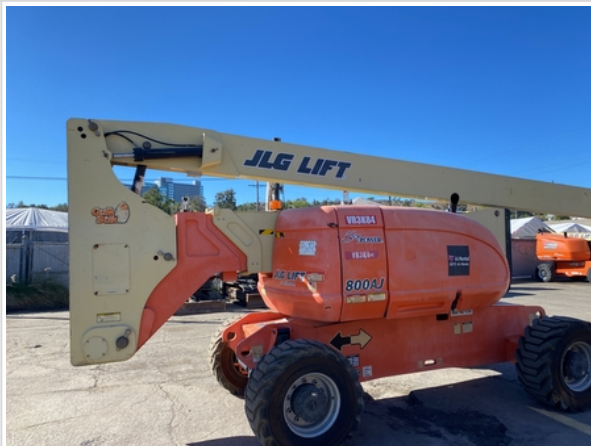
Right Photos

Right

3 - Normal Wear & Tear

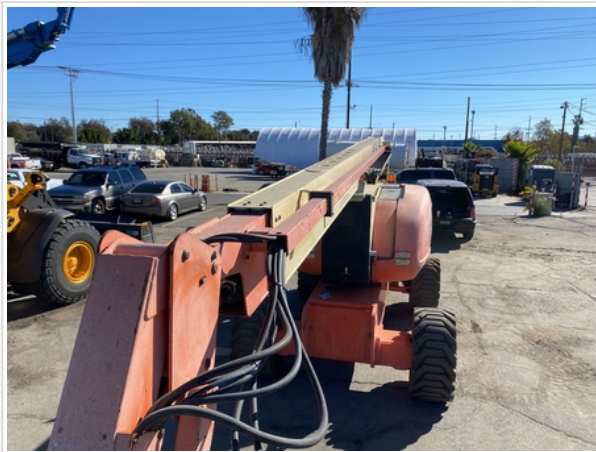
<p>Upper Photos</p>

Upper

3 - Normal Wear & Tear

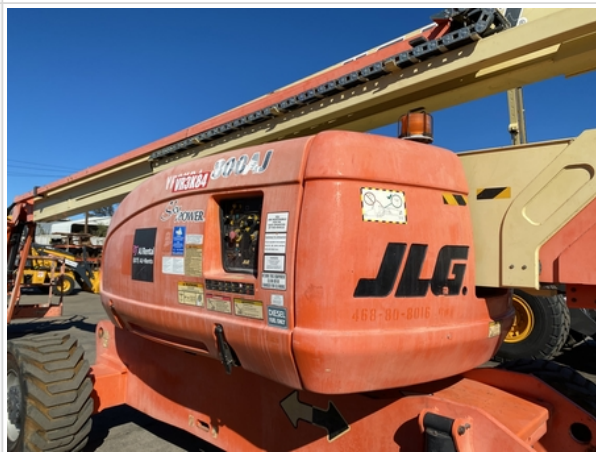
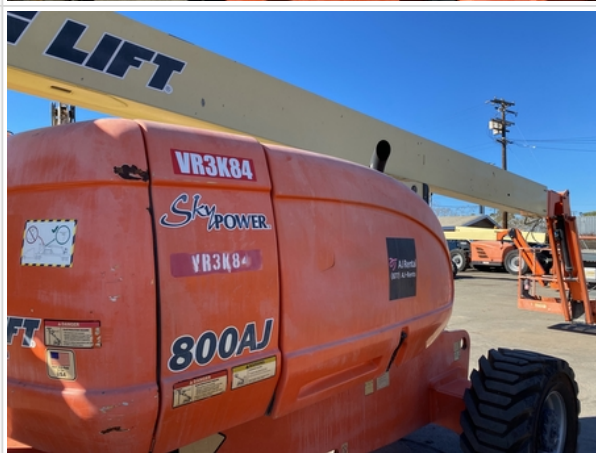
<p>Body Panels (Any Damage?)</p>	<p>3 - Normal Wear &amp; Tear</p>
<p>Body Panels Photos</p>

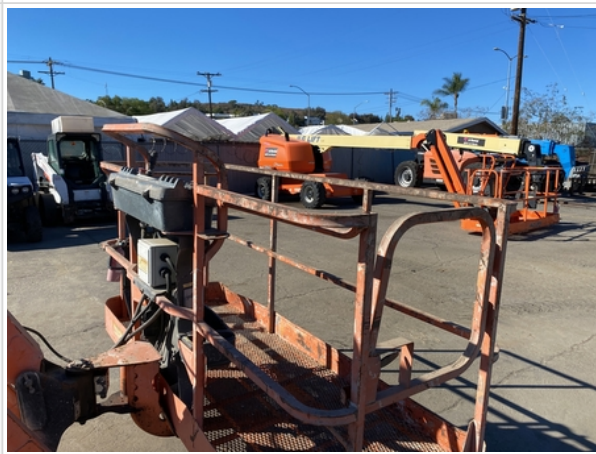
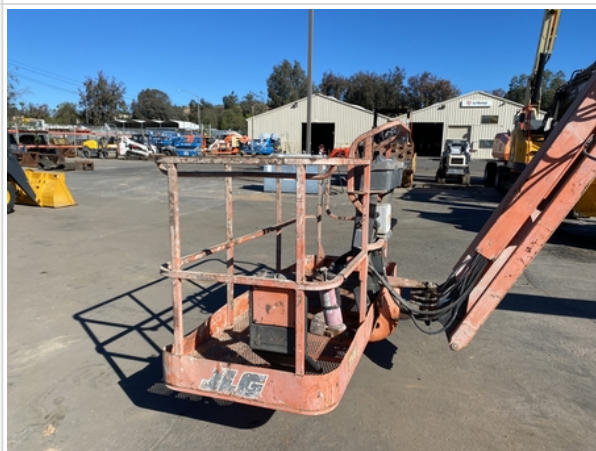
<p><b>Hand Rails</b></p>	<p>3 - Normal Wear &amp; Tear</p>
<p><b>Hand Rails Photos</b></p>

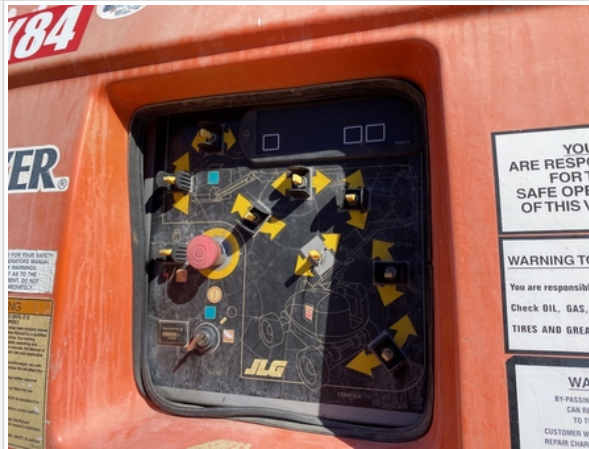
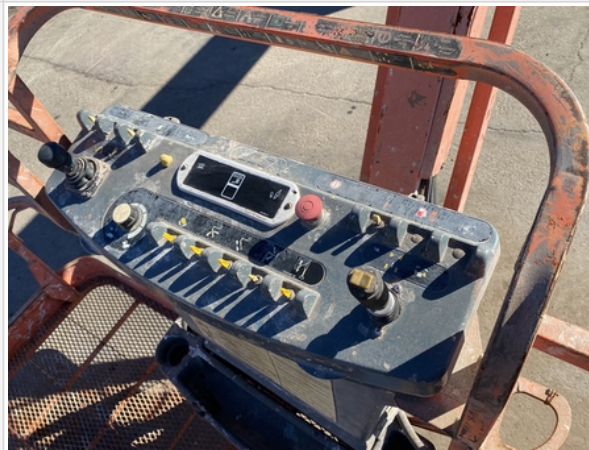
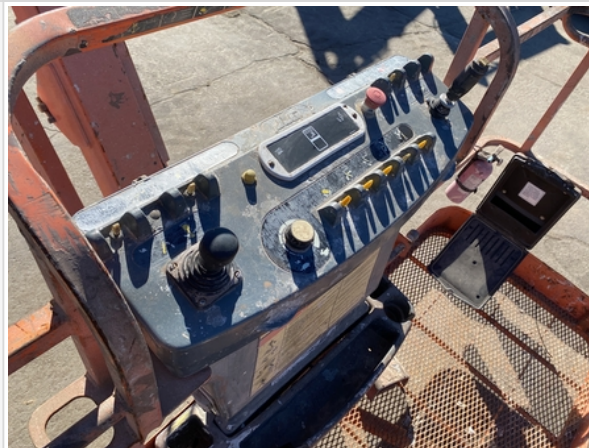
### Controls & Switches Photos

<p>Hour Meter Activity</p>	<p>3 - Normal Wear &amp; Tear</p>
<p>Hour Meter Activity Photos</p>	 
<p>Other Gauge Activity</p>	<p>3 - Normal Wear &amp; Tear</p>
<p>Other Gauge Activity Photos</p>	 
<p>Controls &amp; Switches</p>	<p>3 - Normal Wear &amp; Tear</p>

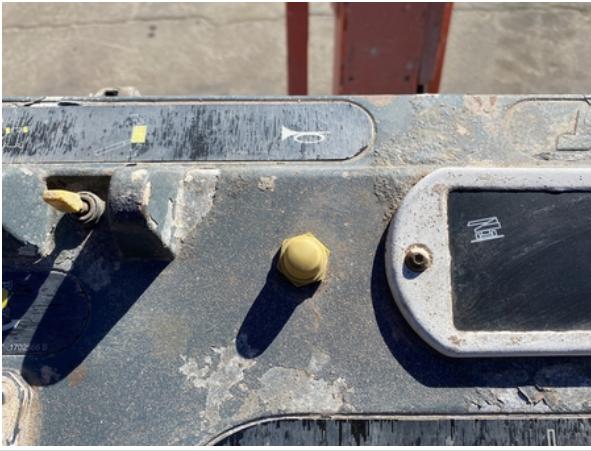
<b>Horn</b>	3 - Normal Wear & Tear	
<b>Horn Photos</b>

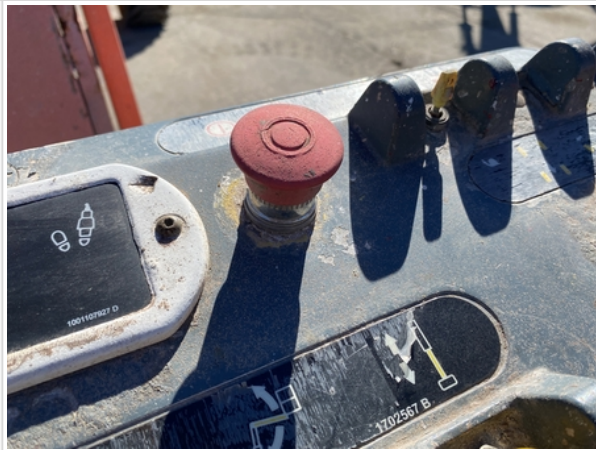
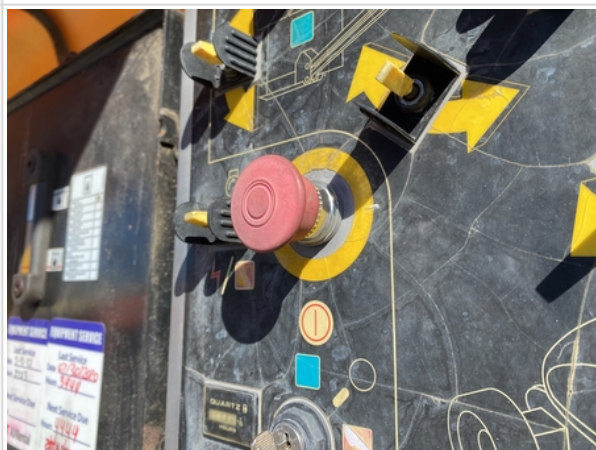
<p>Safety Lock Out / Stop Photos</p>

<b>Safety Lock Out / Stop</b>	3 - Normal Wear & Tear

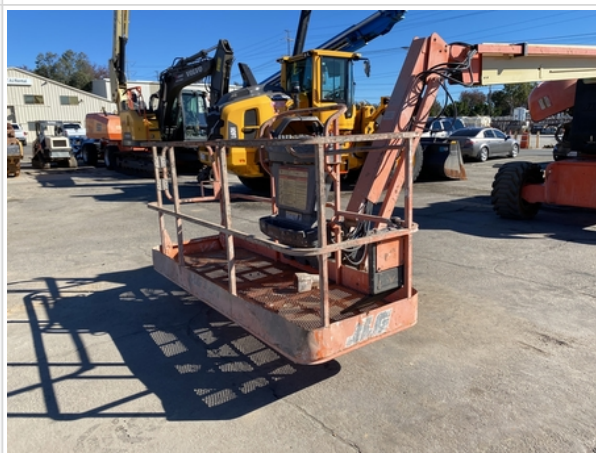
<p>Platform Safety Rails &amp; Appearance</p>	<p>3 - Normal Wear &amp; Tear</p>
<p>Platform Safety Rails &amp; Appearance Photos</p>

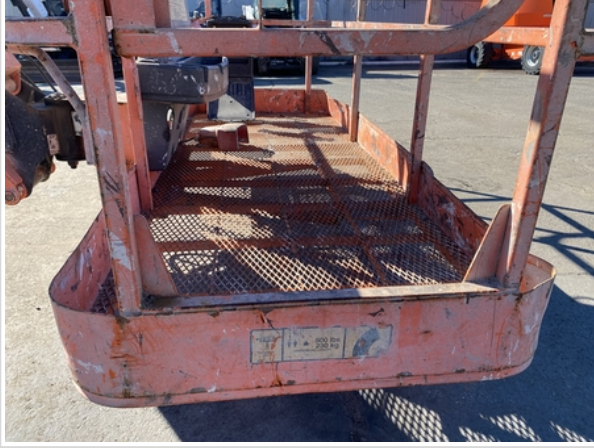
<b>Platform Floor</b>	3 - Normal Wear & Tear	
<b>Platform Floor Photos</b>

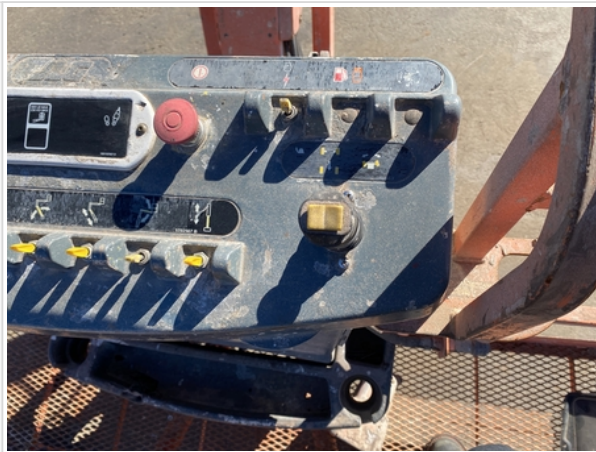
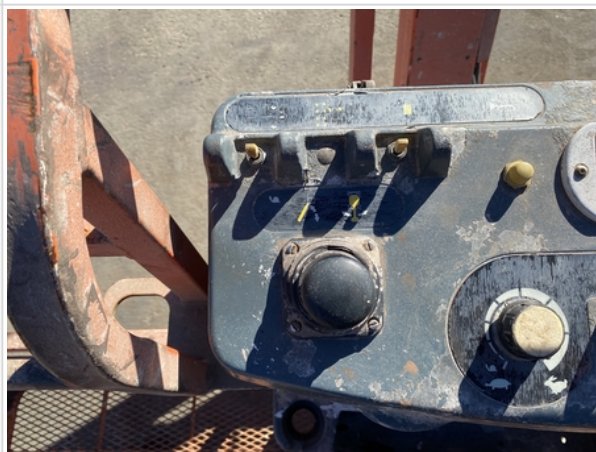
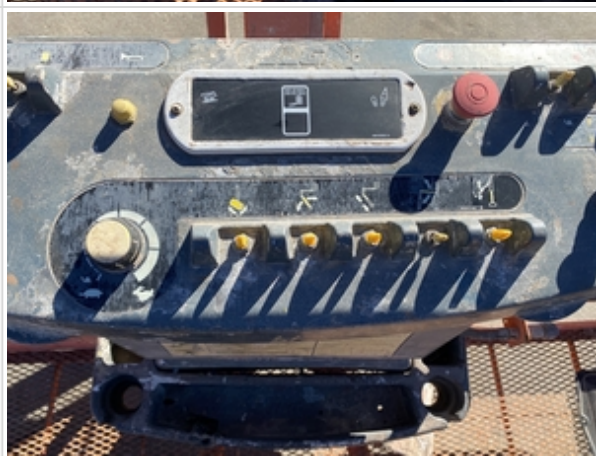
Platform Controls Photos

<b>Platform Controls</b>	3 - Normal Wear & Tear

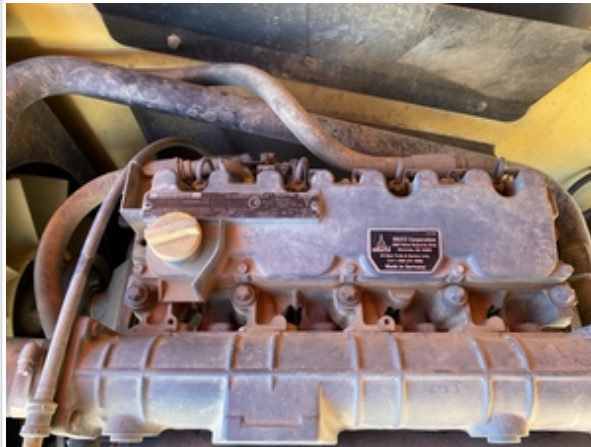
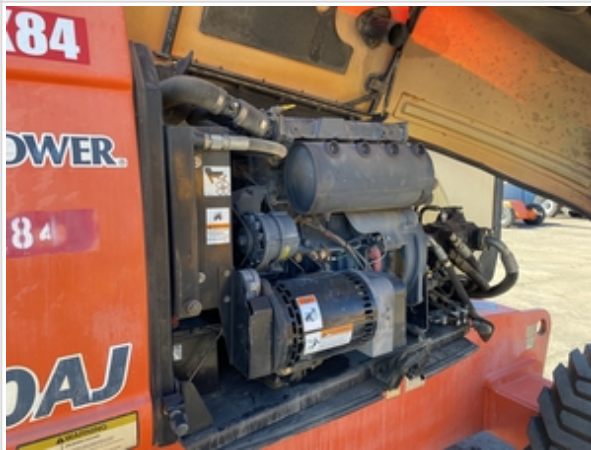
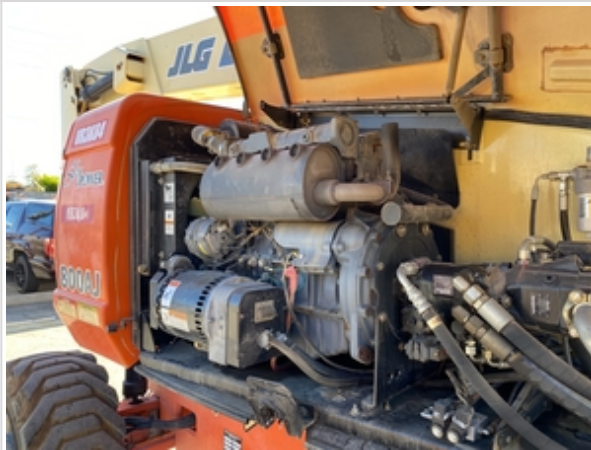
Engine Photos

Engine Type (Make, Model, Cylinders, Hp)	Deutz - 4Cyl. - 2.9L - 65 HP - (Model # F 4M 2011)
Emissions Tier	Tier 4F
Engine Serial Number	10457632
Engine Fuel Type	Diesel

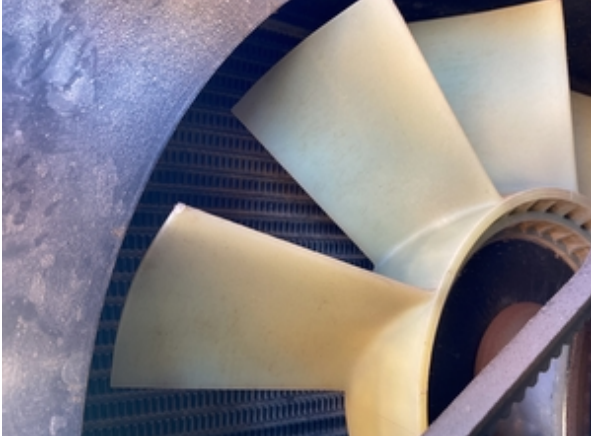
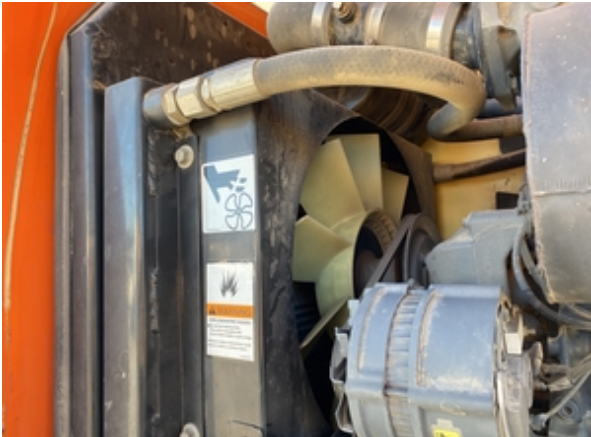
<b>Radiator Photos</b>

Blow-by (Visual Observation Check)	No
Unusual Noises (Upon Start-up, Idle, Shutdown)	No
Unusual Noise Notes	No unusual noises heard
Engine Smoke (Upon Start-up, Idle, Shutdown)	No
Engine Smoke Notes	No engine smoke issues observed
Engine Exhaust Color	Clear
Battery	3 - Normal Wear & Tear
Battery Condition	Clean & dry appearance, tight connections
Radiator	3 - Normal Wear & Tear
Radiator Condition	Radiator fins & components appear to be in good working order, no signs of damage or leaks

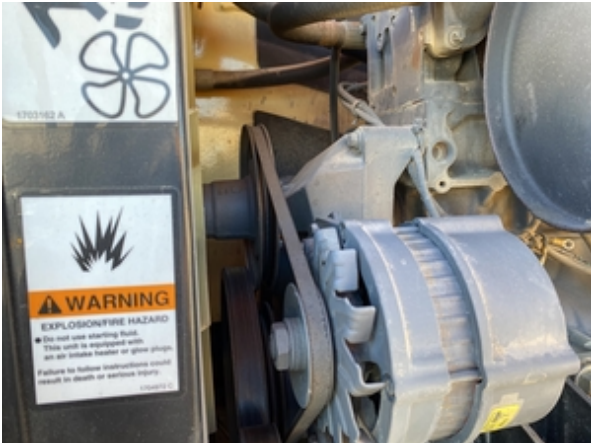
<b>Belts</b>	3 - Normal Wear & Tear
<b>Belt Condition</b>	Belts appear in good condition & alignment with proper tension
<b>Belt Photos</b>

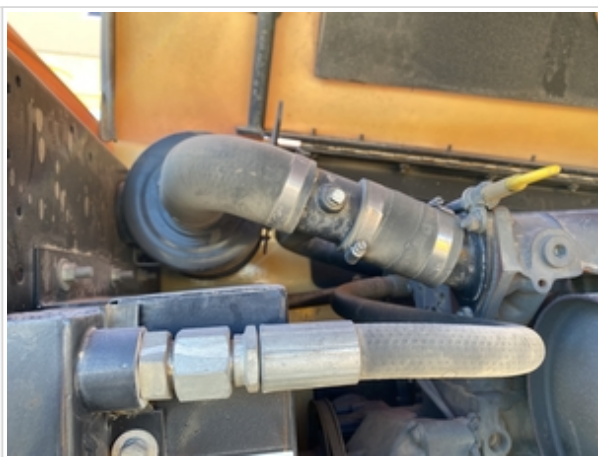
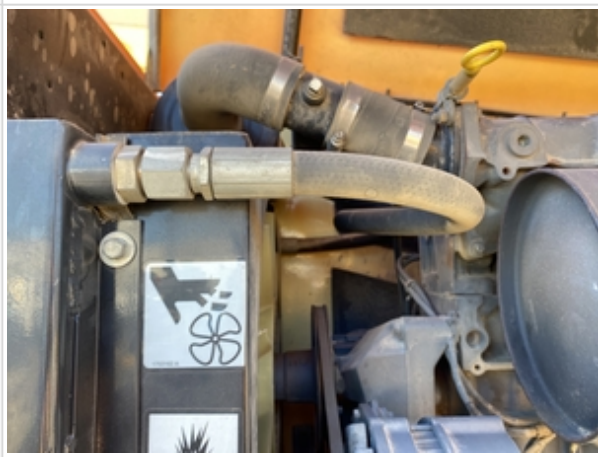
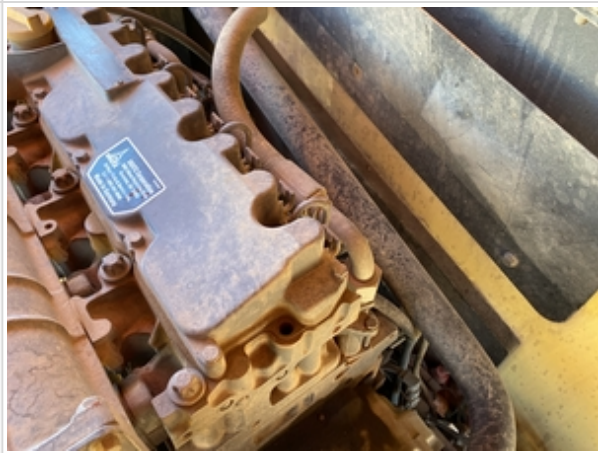
<p>Hose Photos</p>

<b>Hoses</b>	3 - Normal Wear & Tear
<b>Hose Condition</b>	Firm, pliant hoses with no signs of wear or leaks

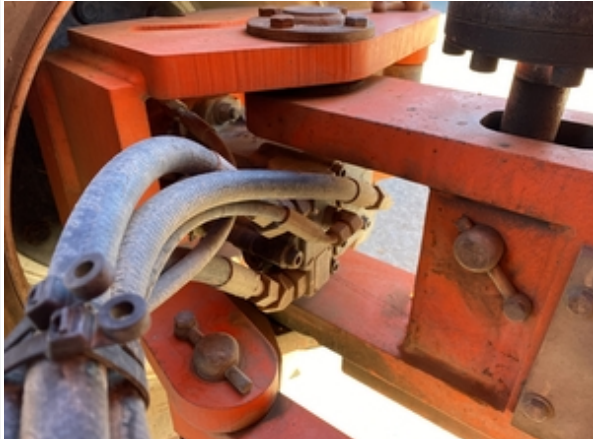
Hydrostatic Transmission?	Yes
2 Speed?	Yes
Hydrostatic Drive Configuration	Split Transmission
Drive Motors	4 - Like New, Recently Replaced
Comments	Rear left drive motor showing signs of active leak
Drive Motor Photos

<b>Hydrostatic Parking Brake</b>	3 - Normal Wear & Tear	
<b>Hydrostatic Parking Brake Condition</b>	Good brake function	
<b>Overall Drivetrain Comments</b>	Overall drivetrain in great condition. Left side rear hydraulic motor showing signs of active hydraulic leak.

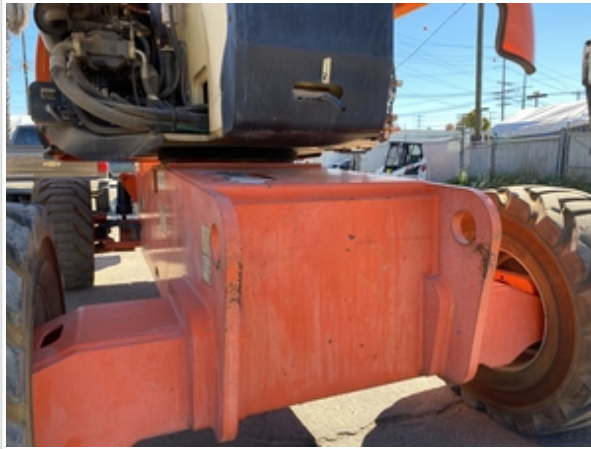
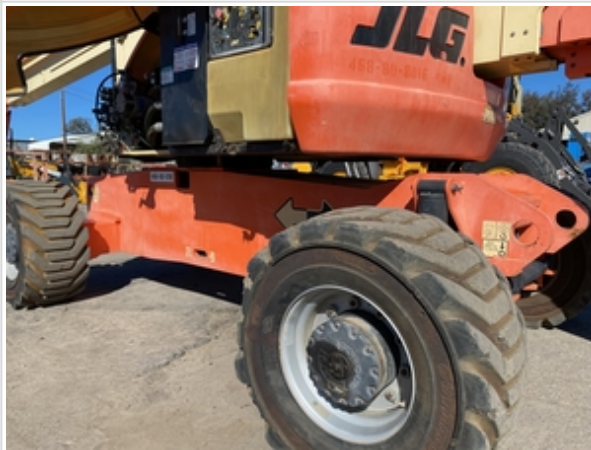
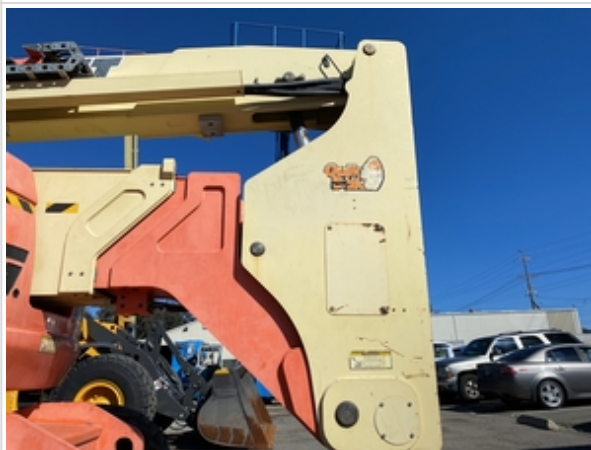
Frame Photos

<b>Frame</b>	3 - Normal Wear & Tear
--------------	------------------------

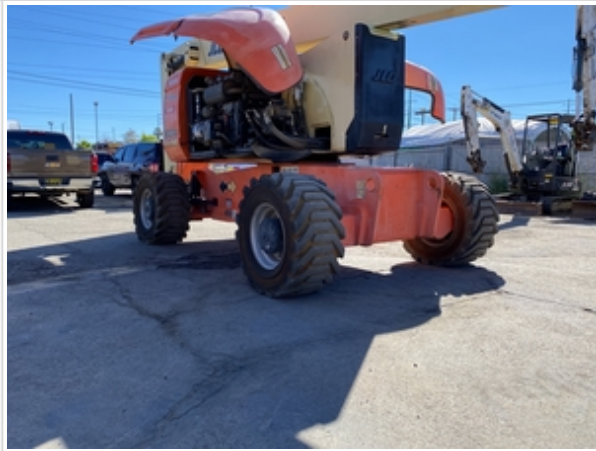
<p>Stance Photos</p>

3 - Normal Wear & Tear

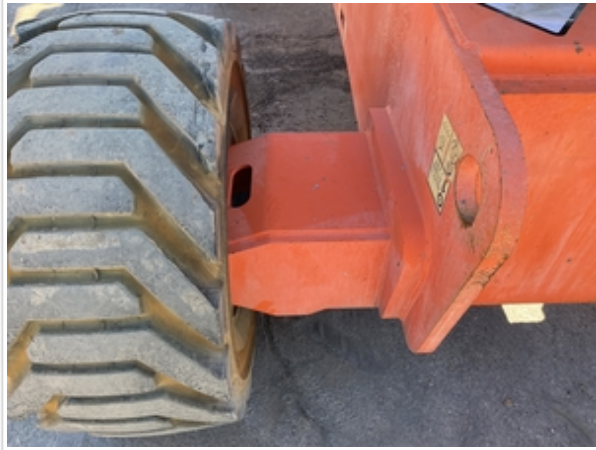
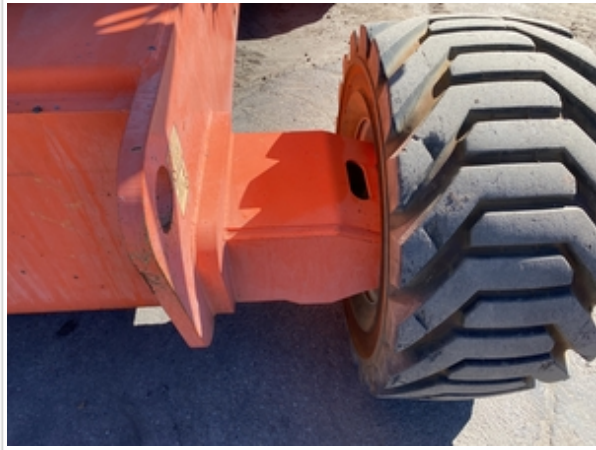
<p>Front Axle Appearance</p>	<p>3 - Normal Wear &amp; Tear</p>
<p>Front Axle Appearance Photos</p>

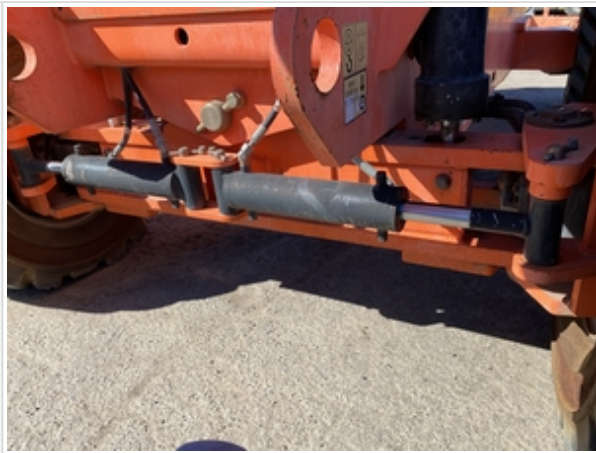
<b>Rear Axle Appearance Photos</b>

<p>Rear Axle Appearance</p>	<p>3 - Normal Wear &amp; Tear</p>

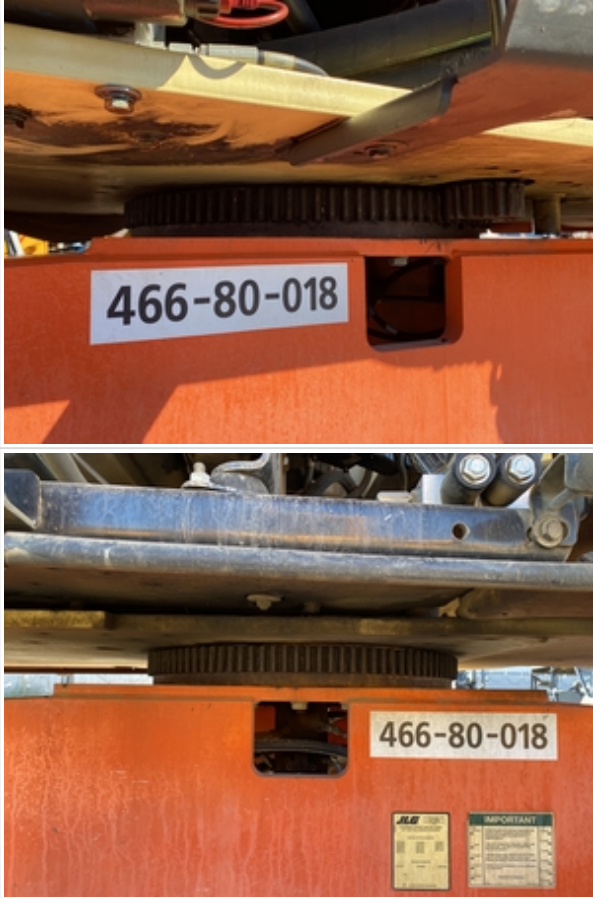
Tire Brand	OTR Outrigger
Tire Size	IN445/55D19.5
Front Left Tire - Ratio Remaining	70%
Rear Left Tire - Ratio Remaining	70%
Front Right Tire - Ratio Remaining	70%
Rear Right Tire - Ratio Remaining	70%
Swivel Bearing	3 - Normal Wear & Tear
Swivel Bearing Photos

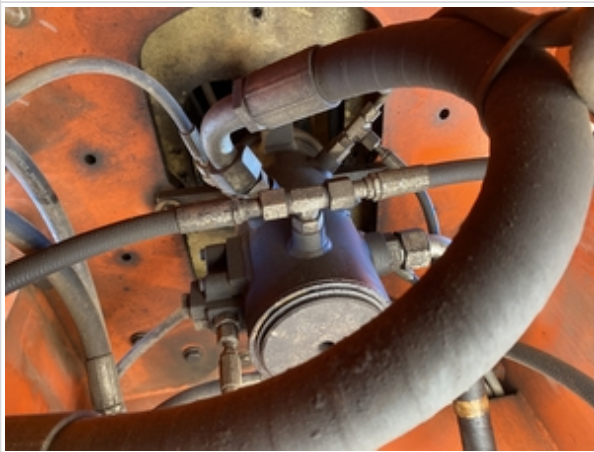
Swivel Joint	3 - Normal Wear & Tear
Swivel Joint Photos

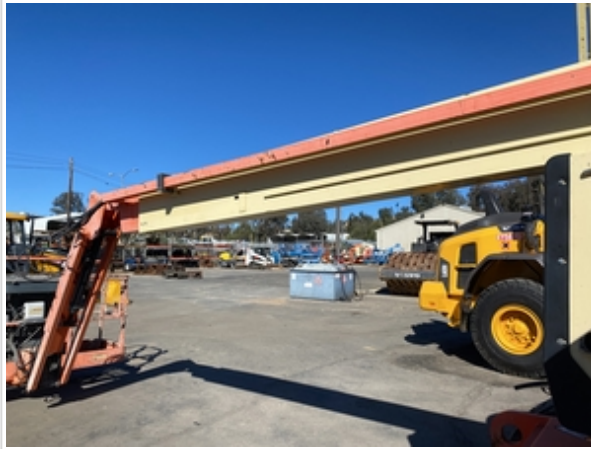
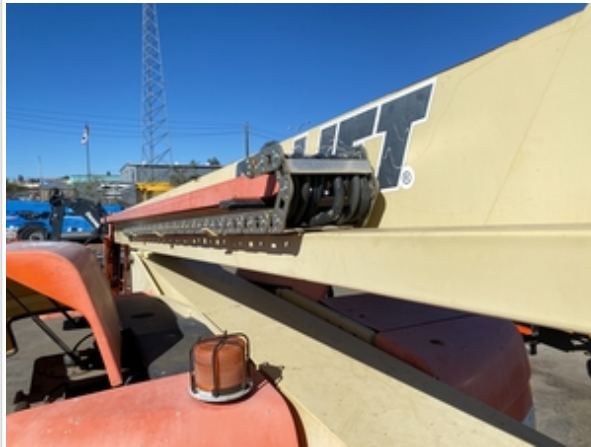
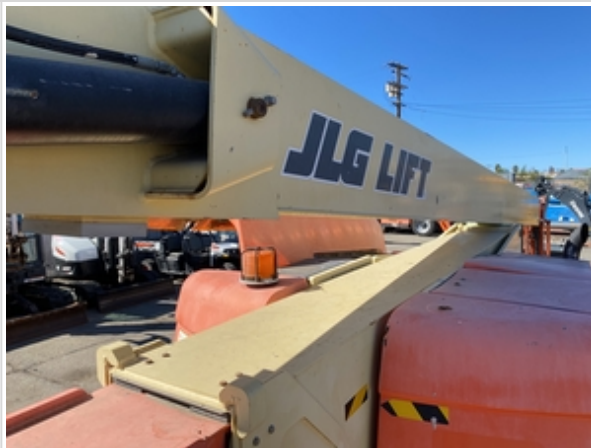
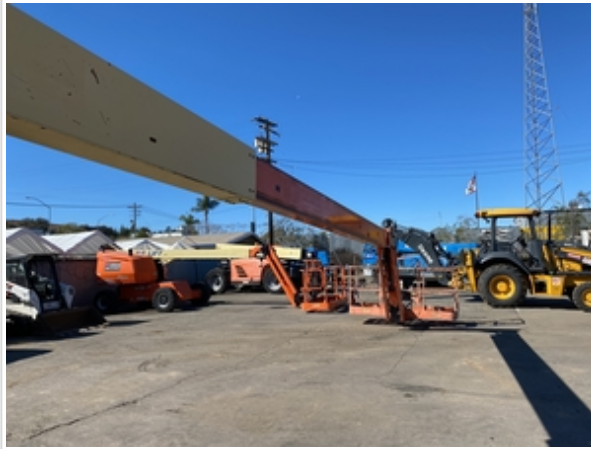
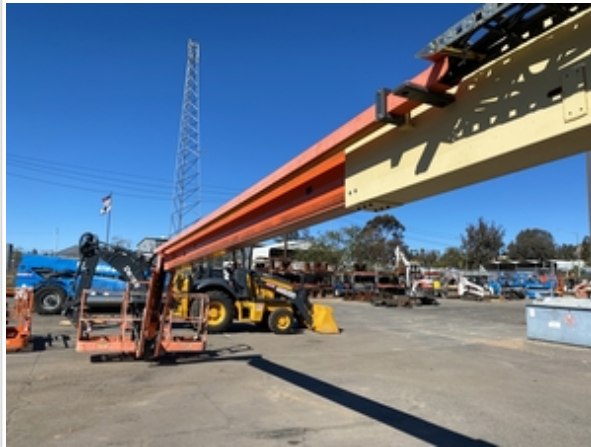
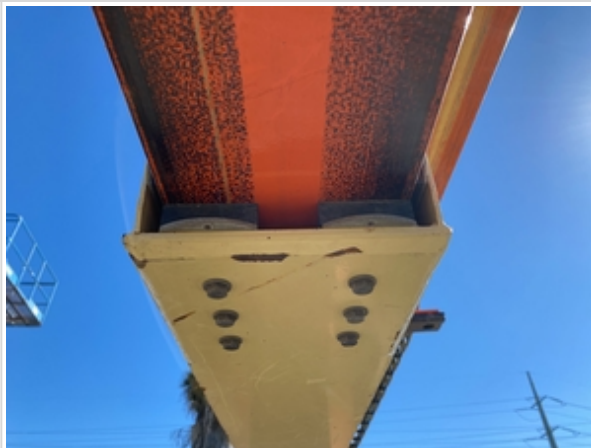
Boom Condition	3 - Normal Wear & Tear
Comments	Really good condition, wear pads like new
Boom Condition Photos

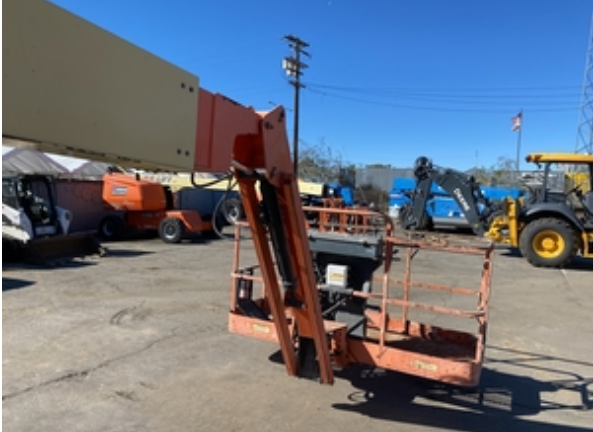
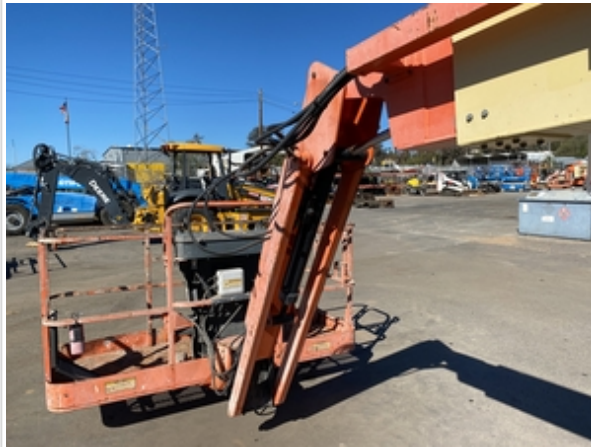
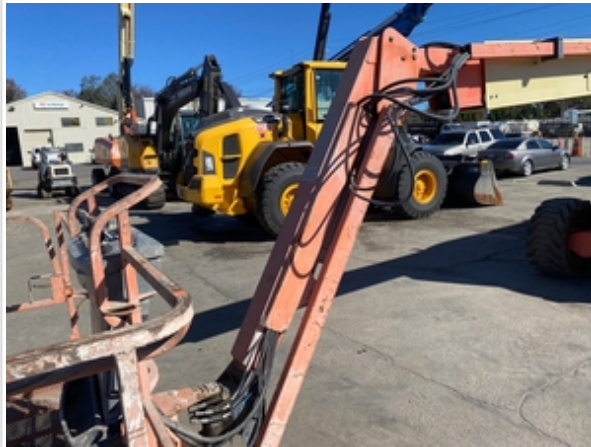
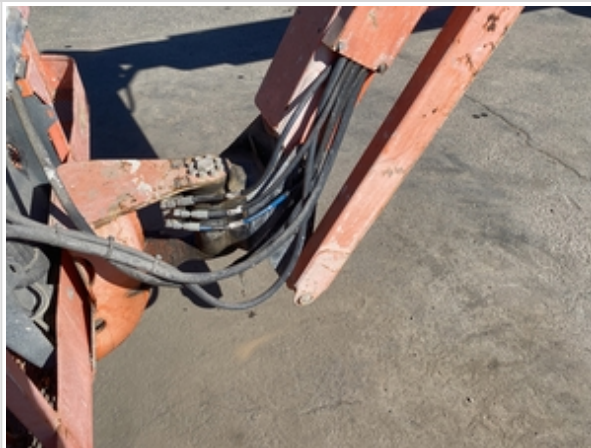
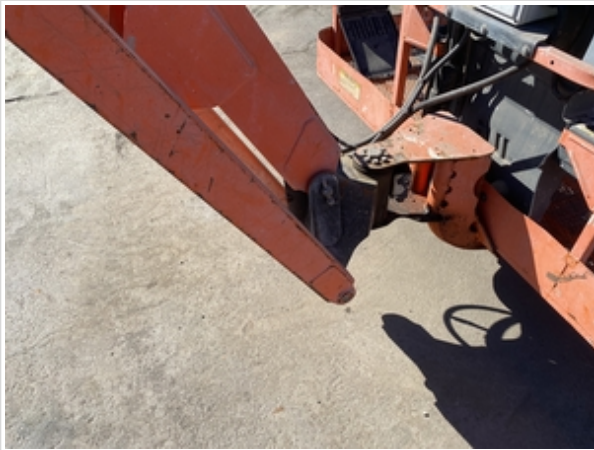
<b>Boom Wear Guides</b>	3 - Normal Wear & Tear	
<b>Comments</b>	Pictures seen in boom condition photos, like new	
<b>Jib Condition</b>	3 - Normal Wear & Tear	
<b>Jib Condition Photos</b>

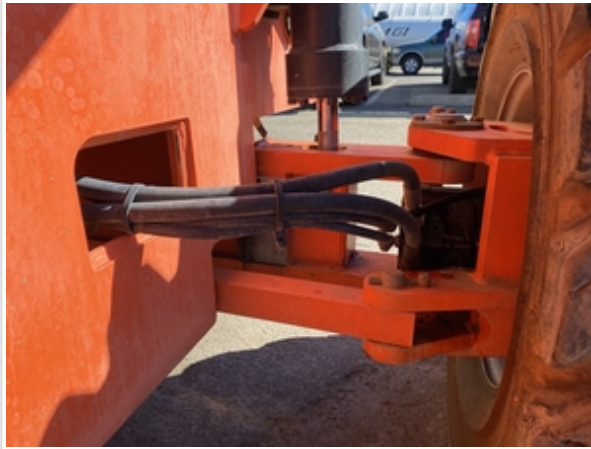
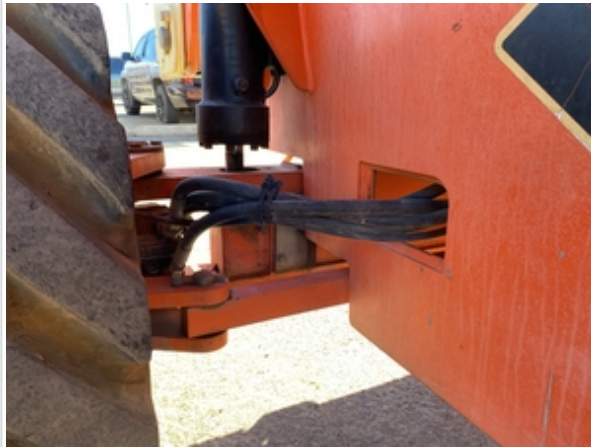
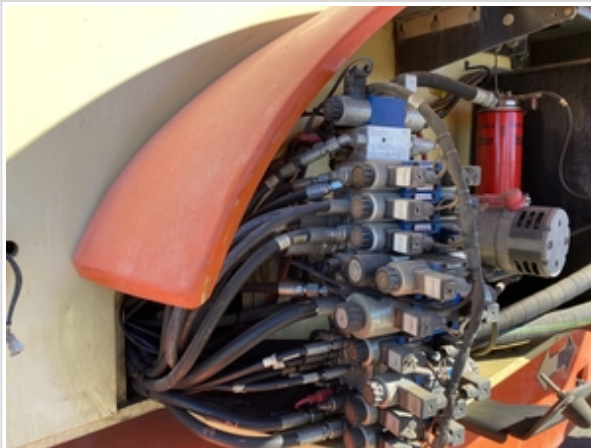
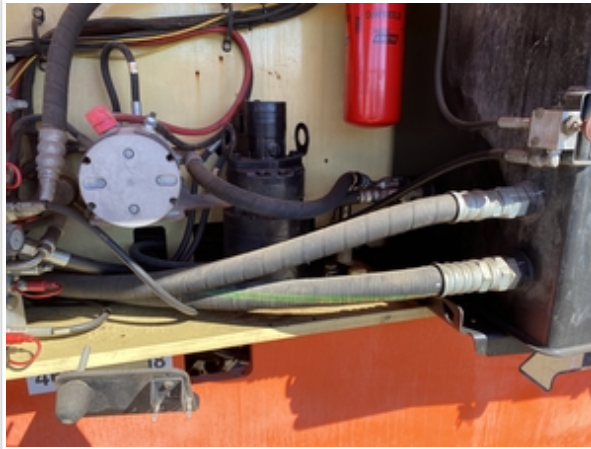
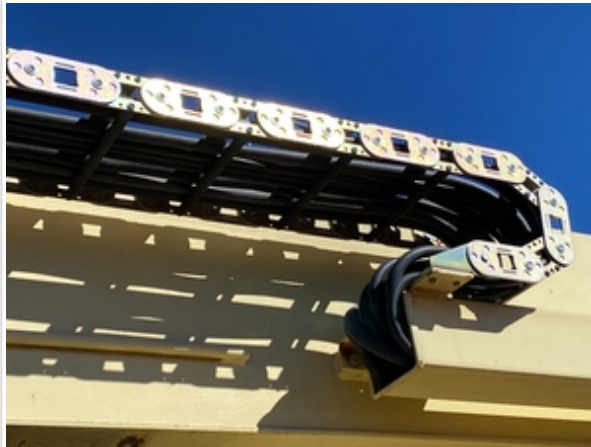
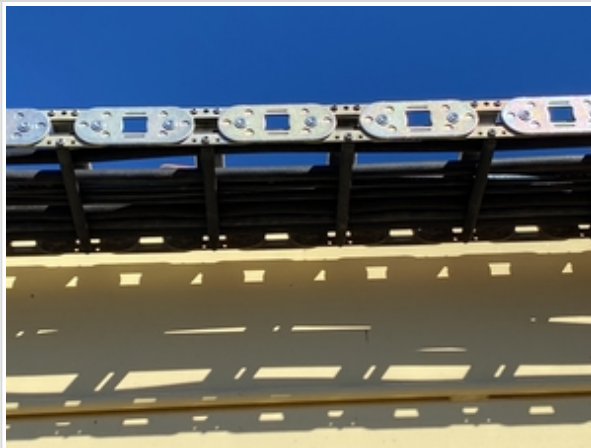
<b>Wet or Damp Hydraulic Lines / Fittings</b>	No
<b>Appearance of Hydraulic Lines / Fittings</b>	3
<b>Hydraulic Lines / Fittings Condition</b>	Hydraulic lines & fittings are clean and in good condition, Active leaks in hoses or fittings observed
<b>Comments</b>	Active leaks seen coming from rear hoses under boom cylinder and possibly from underneath front body
<b>Appearance of Hydraulic Lines / Fittings Photos</b>

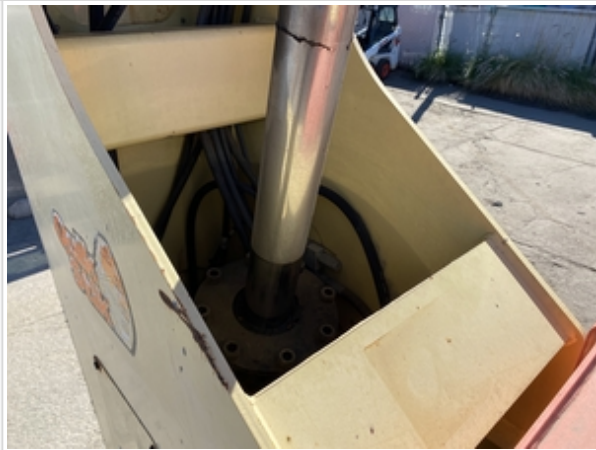
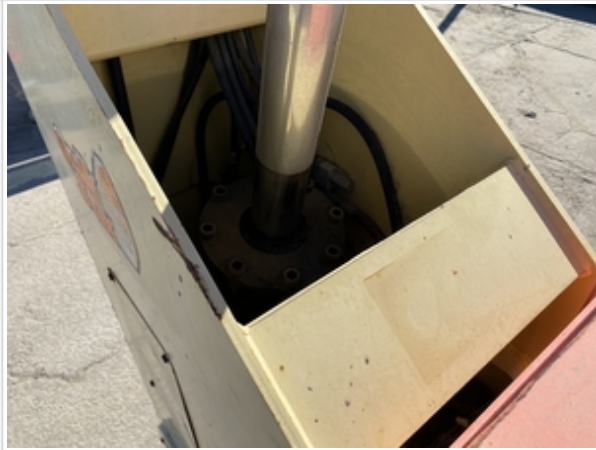
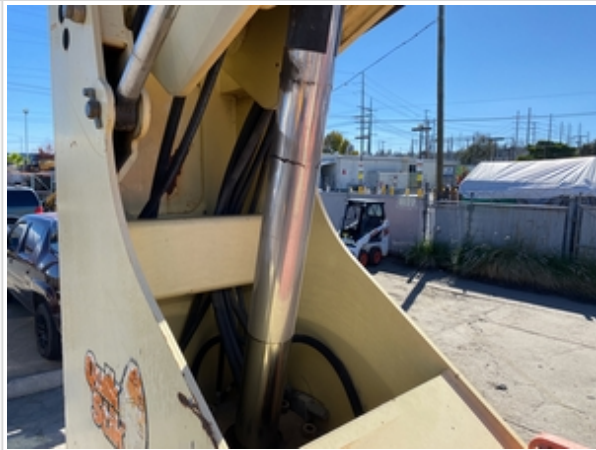
Boom Lift Cylinders: Mounting Pin	4
Boom Lift Cylinders: Oil Leaks	No
Boom Lift Cylinders Photos

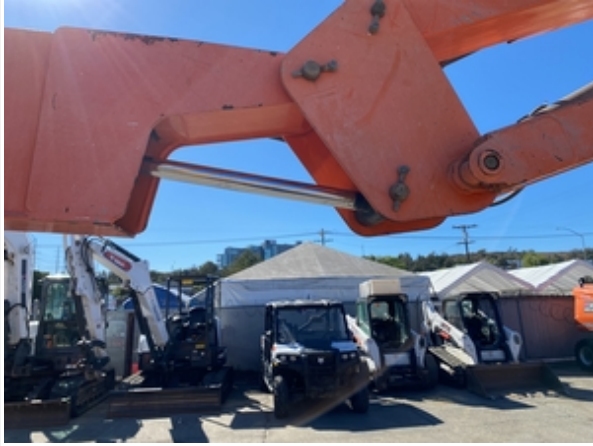
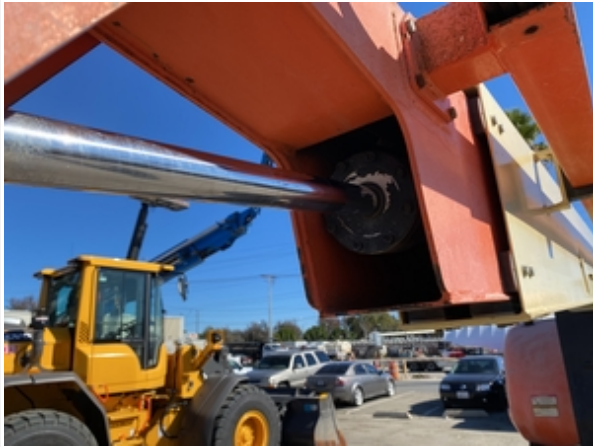
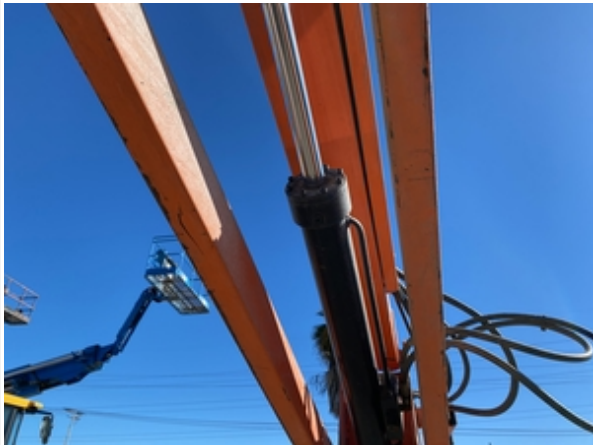
Jib Cylinder: Mounting Pin	3
Jib Cylinder Photos

<b>Boom Extension Cylinder</b>	Check the boom extension cylinder. Note any wear, pitting, discoloration, etc. Take photos.
<b>Boom Extension Cylinder: Mounting Pin</b>	3
<b>Boom Extension Cylinder: Oil Leaks</b>	No
<b>Comments</b>	No leaks observed, unable to get a picture
<b>Jib Cylinder</b>	Check the jib cylinder. Note any wear, pitting, discoloration, etc. Take photos.
<b>Jib Cylinder: Oil Leaks</b>	No

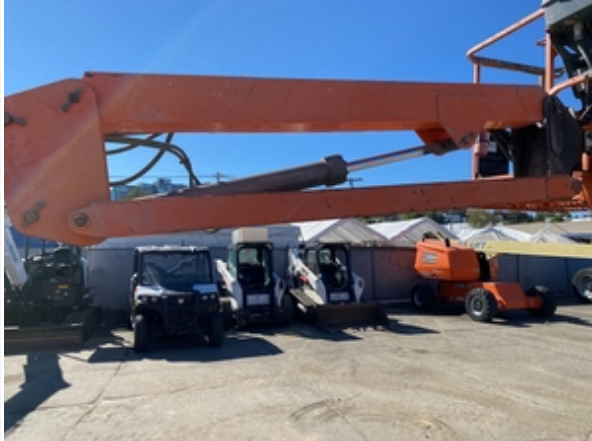
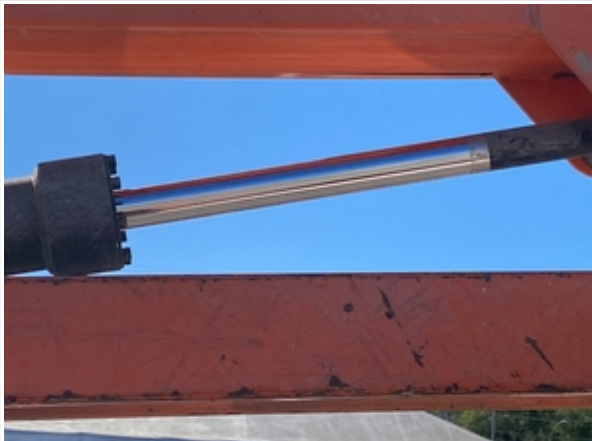
<b>Basket Tilt Cylinder Photos</b>

Basket Tilt Cylinder	Check the basket tilt cylinders. Note any wear, pitting, discoloration, etc. Take photos.
Basket Tilt Cylinder: Mounting Pin	3
Basket Tilt Cylinder: Oil Leaks	No

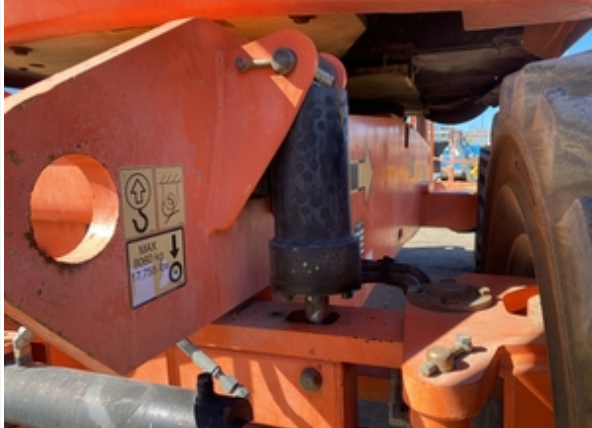
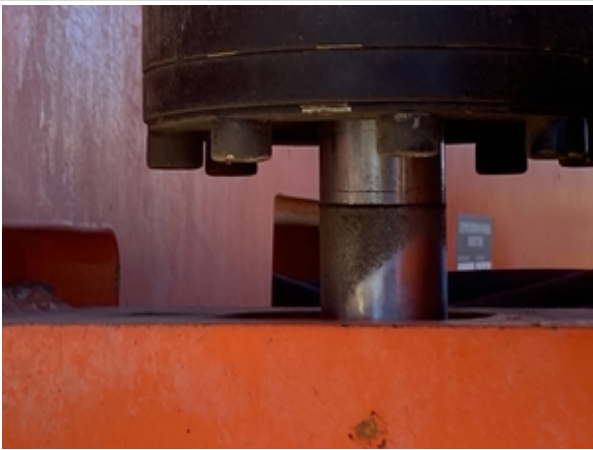
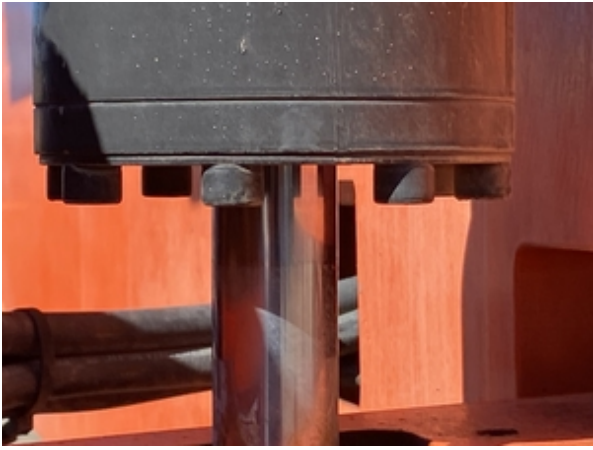
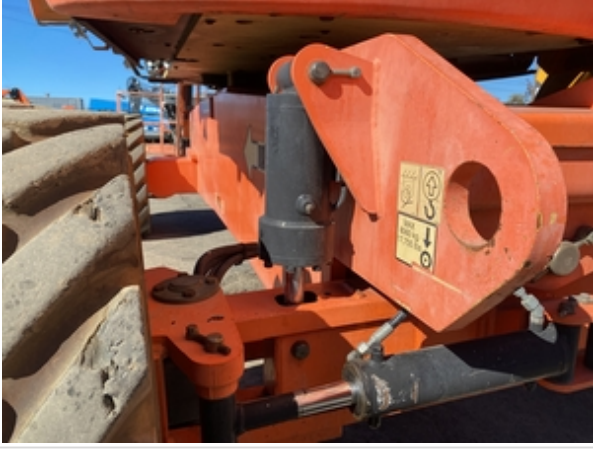
<b>Frame Leveling Cylinders</b>	Check the frame leveling cylinders. Note any wear, pitting, discoloration, etc. Take photos.	
<b>Frame Leveling Cylinders: Mounting Pin</b>	3	
<b>Frame Leveling Cylinders: Oil Leaks</b>	No	
<b>Frame Leveling Cylinders Photos</b>

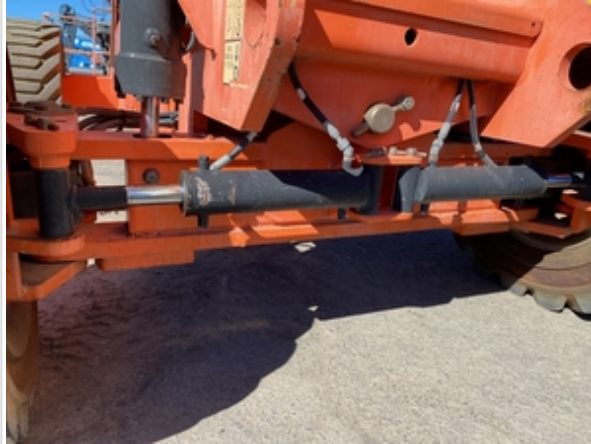
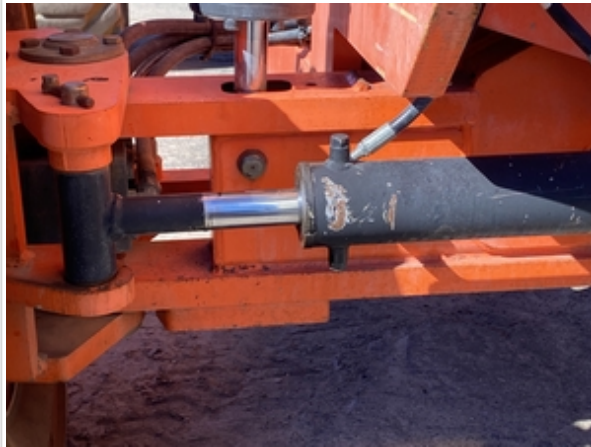
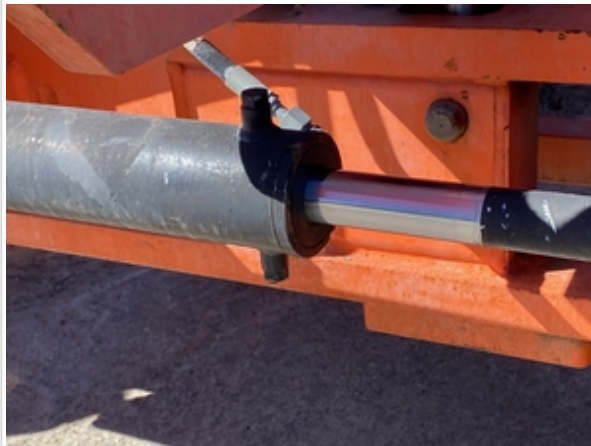
Steering Cylinders Photos

<b>Outrigger Cylinders</b>	Check the outrigger cylinders. Note any wear, pitting, discoloration, etc. Take photos.	
<b>Steering Cylinders</b>	Check the steering cylinders. Note any wear, pitting, discoloration, etc. Take photos.	
<b>Steering Cylinders: Mounting Pin</b>	3	
<b>Steering Cylinders: Oil Leaks</b>	No
