Inspection Report (Mini Excavator)

Year	2005
Make	Bobcat
Model	435 HAG
Serial Number	563211071
Hour Meter Reading	3,070
Previous Application (e.g., earth moving, mining, demolition, etc)	General Construction

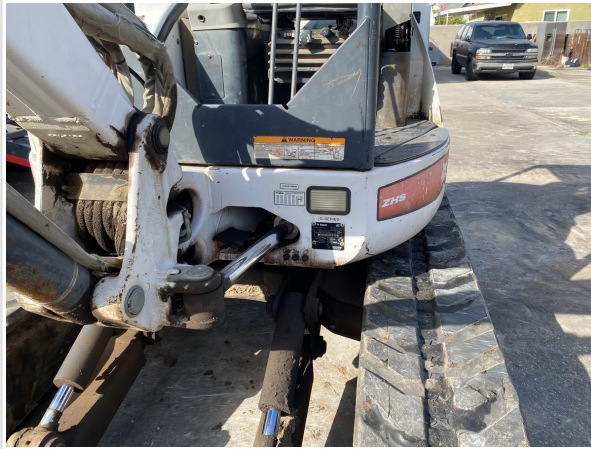
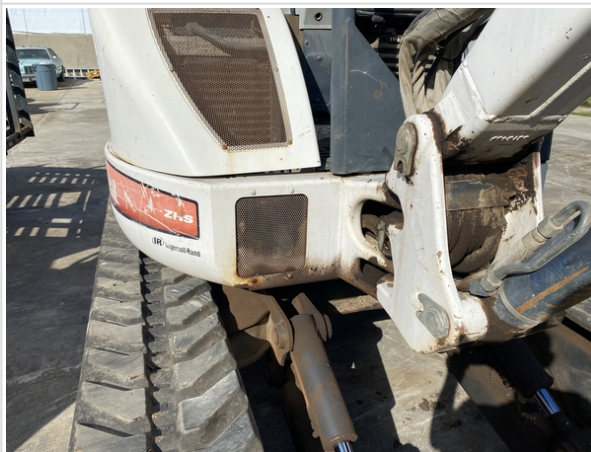
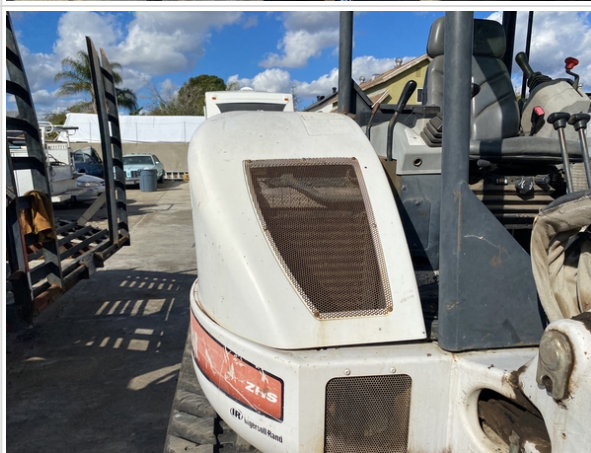
Front Photos

Front	3 - Normal Wear & Tear
Front Condition	No visible damage

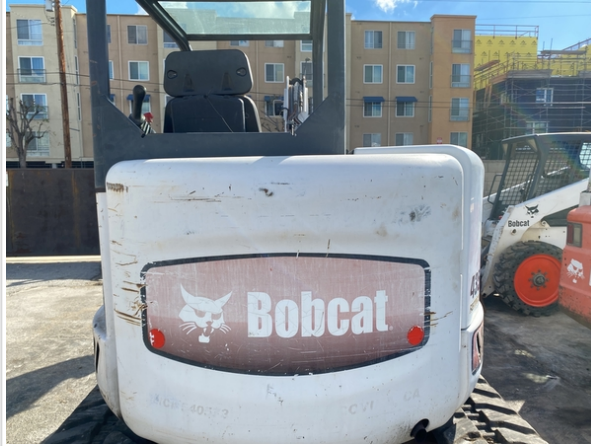
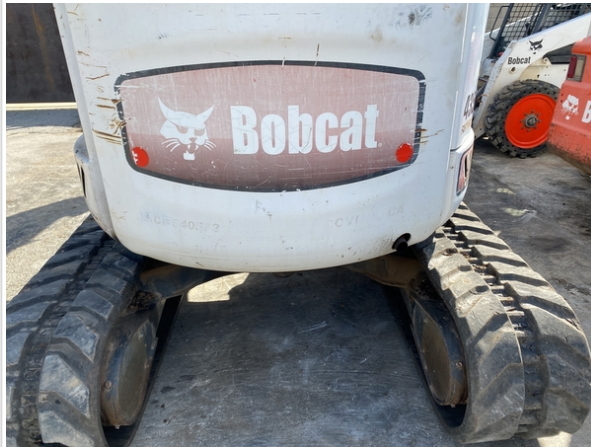
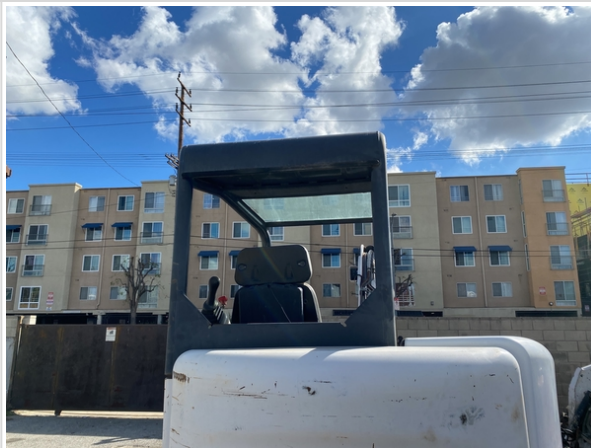
Rear Photos

Rear	3 - Normal Wear & Tear
Rear Condition	No visible damage

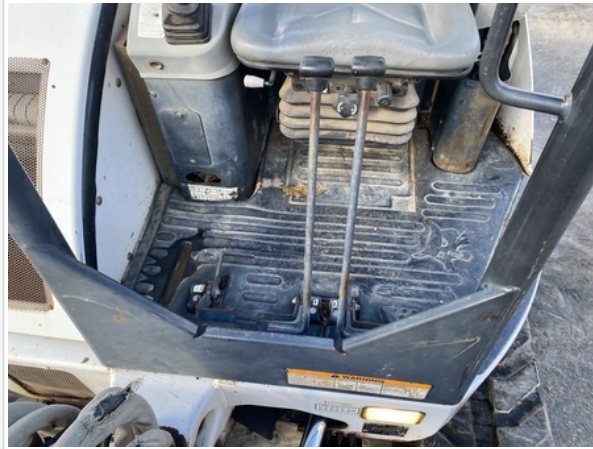
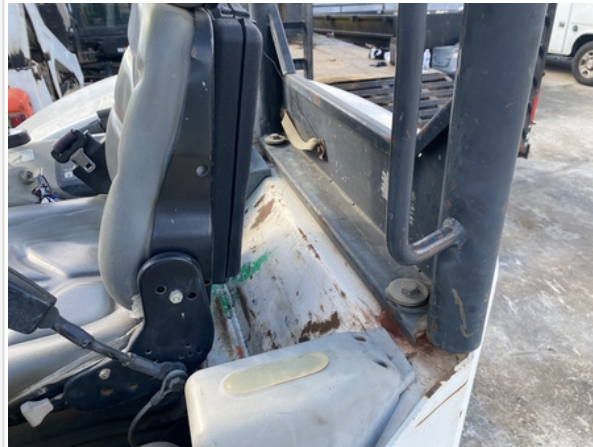
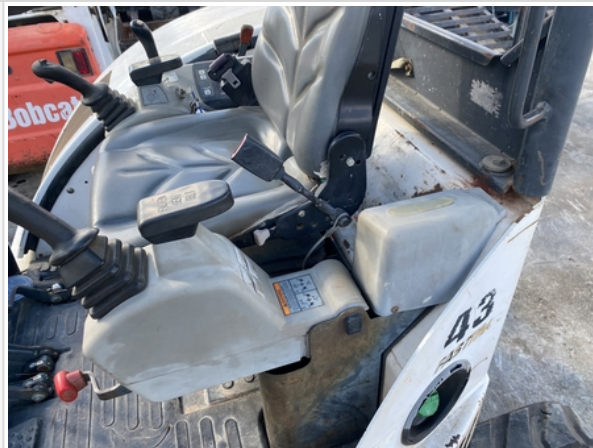
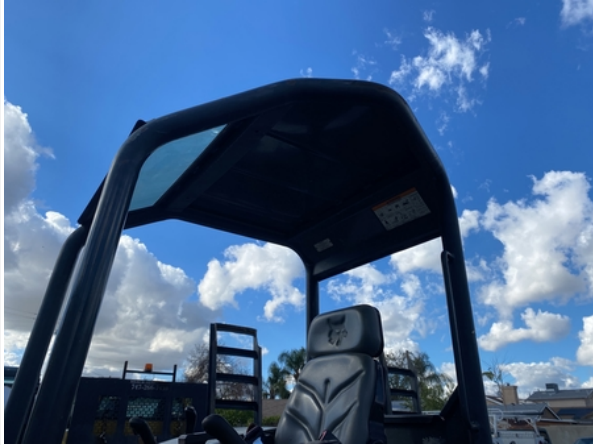
Operator Cabin Overall Condition	Good cabin appearance, solid floors, panels, and ceiling
Operator Cabin Photos

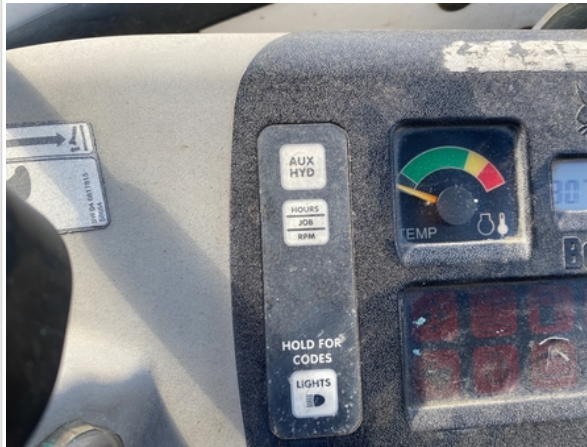
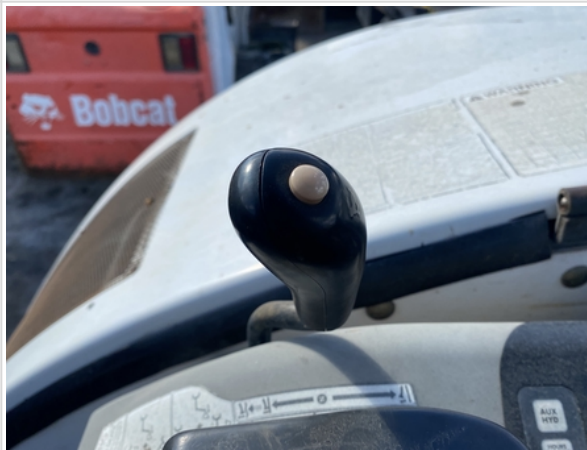
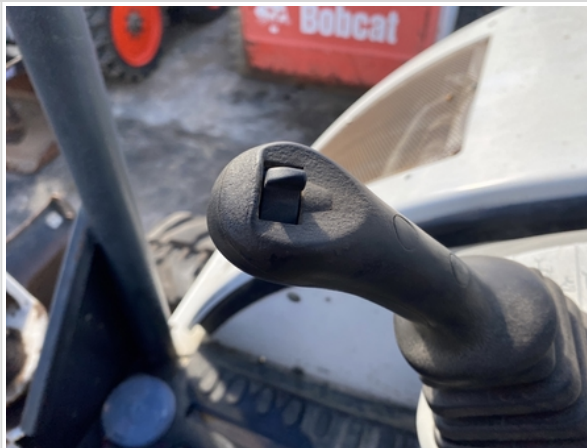
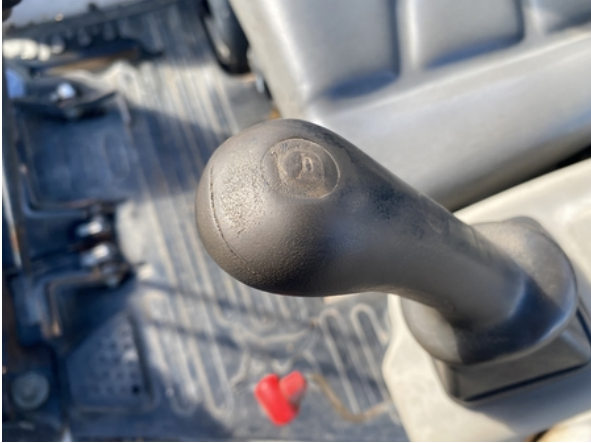
Controls & Switches Photos

Seat Belt	3 - Normal Wear & Tear
Seat Belt Condition	Seat belt secures properly. Belt is intact and in good condition
Cabin Lights	0
Safety Lock Out / Stop	3 - Normal Wear & Tear
Safety Lock Out / Stop Condition	Safety lock out device is present, in good condition, and functional
Controls & Switches	3 - Normal Wear & Tear
Controls & Switches Condition	All switches are installed and functional

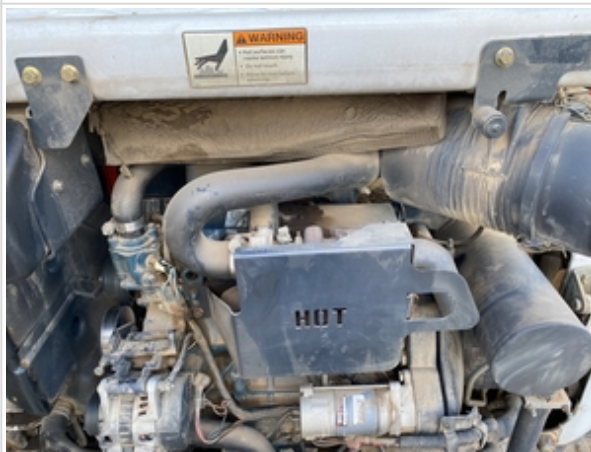
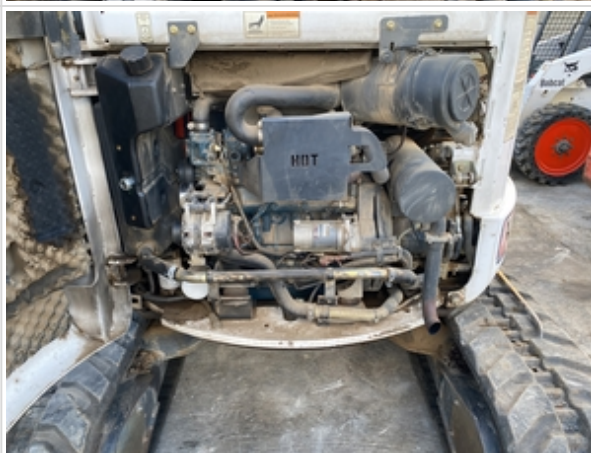
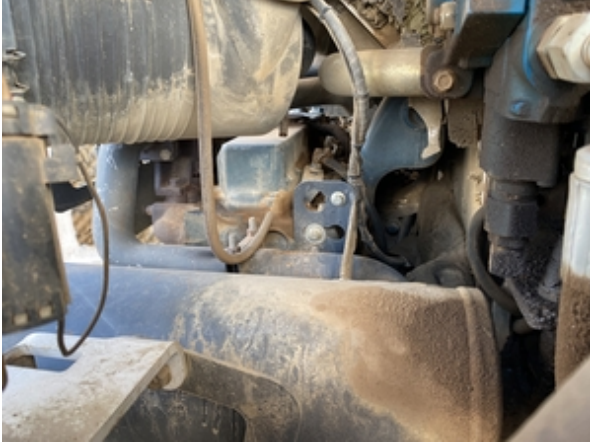
Engine Type (Make, Model, Cylinders, Hp)	Kubota - V2003MDITE2BBC1 - 4CYL - 49HP - 2.0L
Emissions Tier	Tier 2
Engine Serial Number	N/A
Engine Fuel Type	Diesel
Engine Photos

Oil Color / Appearance Notes	Clean oil appearance, no signs of cross contamination, Appropriate oil level
Fuel Leaks	No
Equipped with DPF (Diesel Particulate Filter)	No
Requires DEF (Diesel Exhaust Fluid)	No
Overall Engine Appearance	Dusty & dry
Overall Engine Comments	Overall engine in good condition. No active leaks seen and no obvious major problems seen.

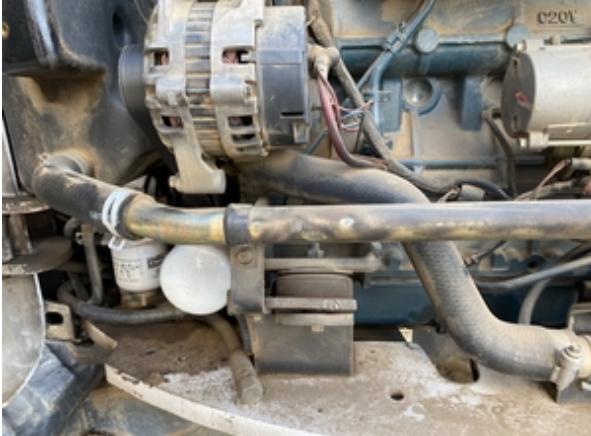
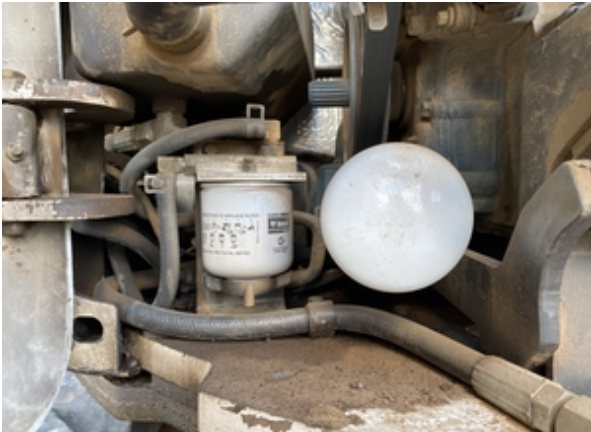
Hoses	3 - Normal Wear & Tear
Hose Condition	Firm, pliant hoses with no signs of wear or leaks
Hose Photos

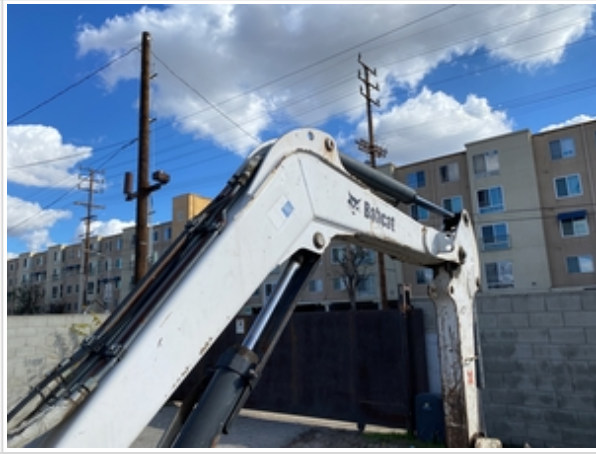
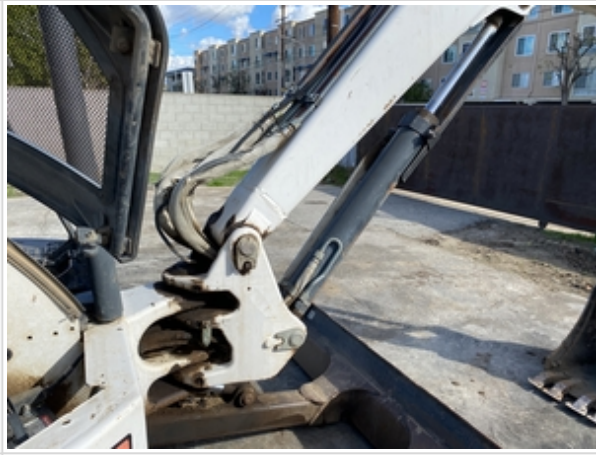
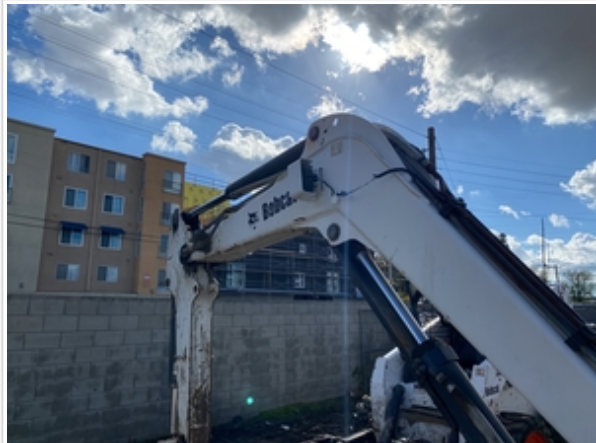
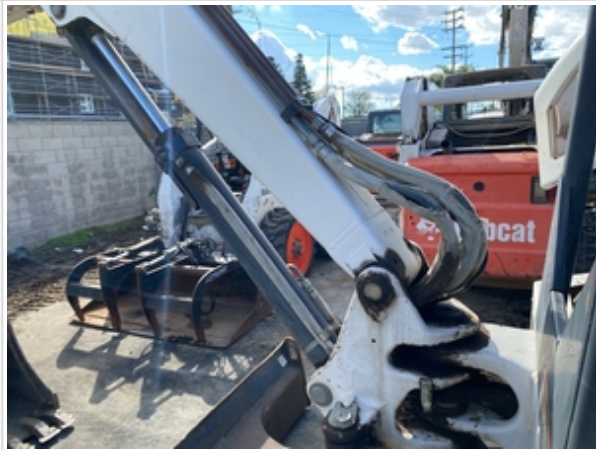
Boom Condition	3 - Normal Wear & Tear
Boom Photos

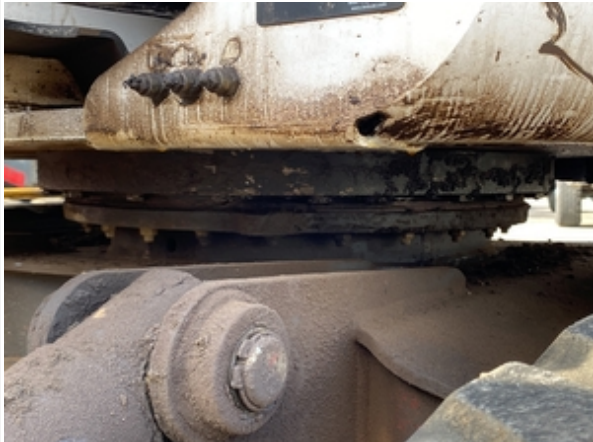
Boom Base Pin & Bushings	3 - Normal Wear & Tear	
Boom to Stick Pin & Bushings	3 - Normal Wear & Tear	
Stick to Bucket Pin & Bushings	3 - Normal Wear & Tear	
Comments	Stick to bucket coupler has some play (may need bushings or spacers)	
Turntable Bearing	3 - Normal Wear & Tear	
Turntable Bearing Photos

Overall Chassis Comments	Overall chassis in good condition. The excess play from stick to bucket coupler should be addressed.
--------------------------	--

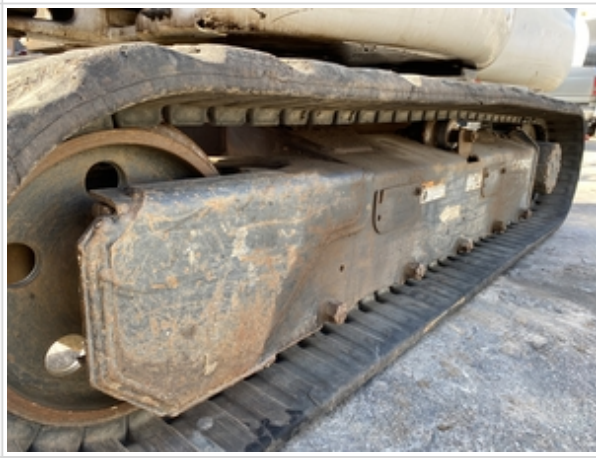
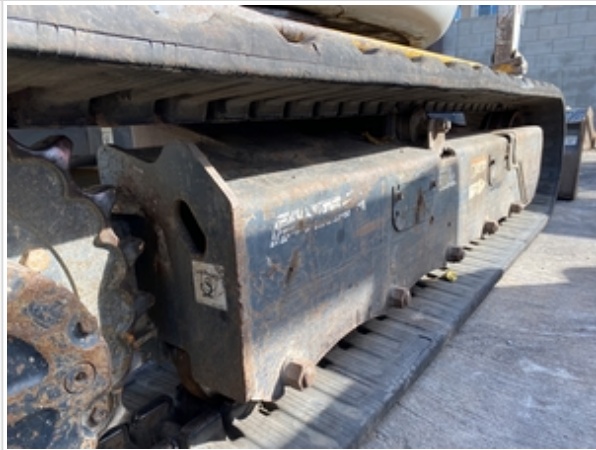
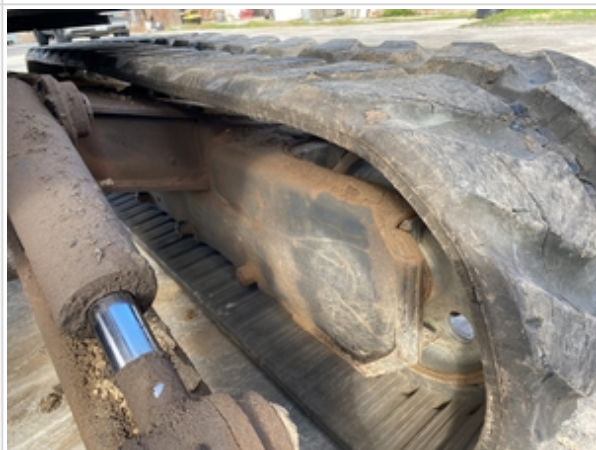
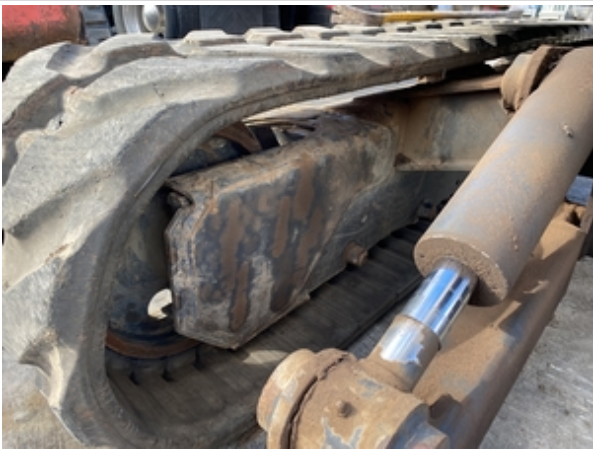
Roller Frames	3 - Normal Wear & Tear
Roller Frames Photos

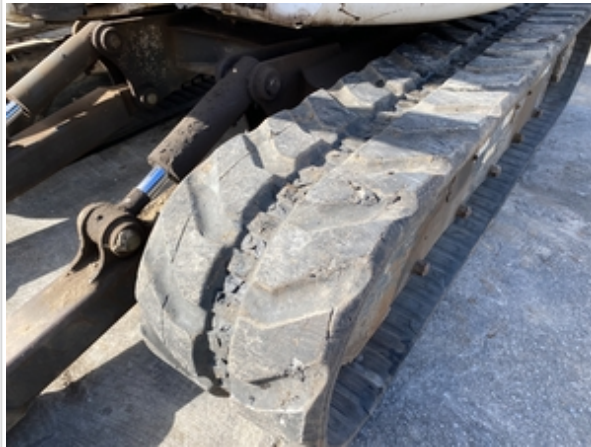
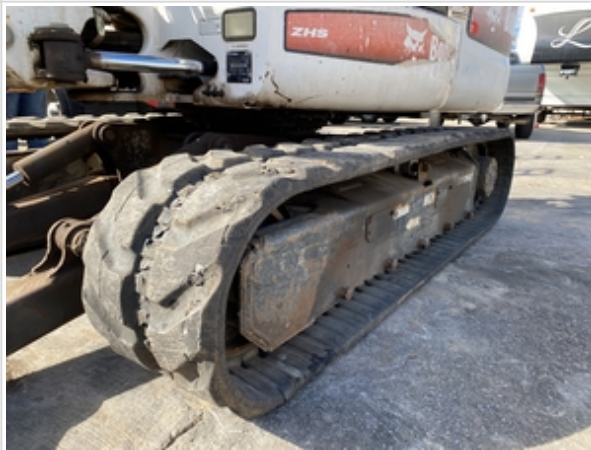
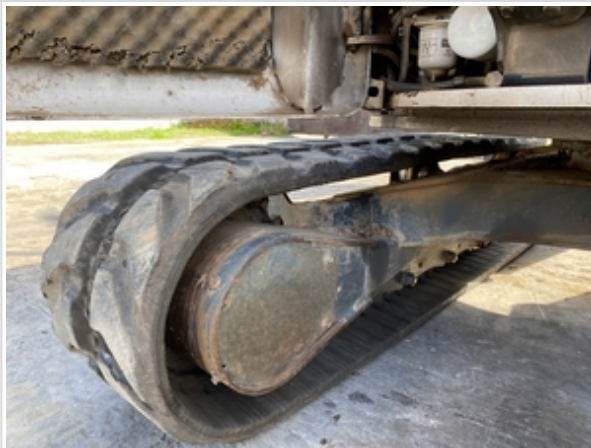
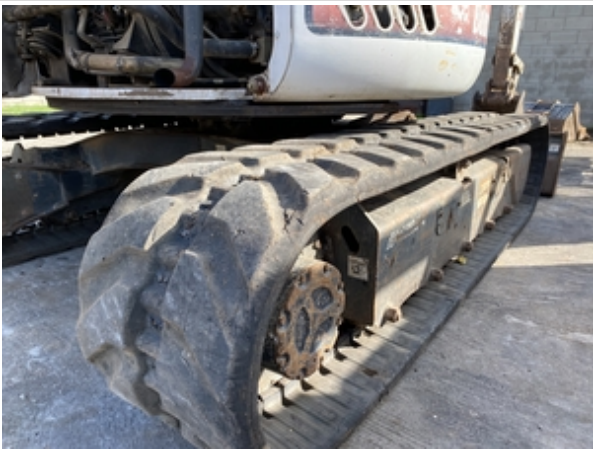
Track Belt	3 - Normal Wear & Tear	
Comments	About 30% to 40%	
Track Belt Photos

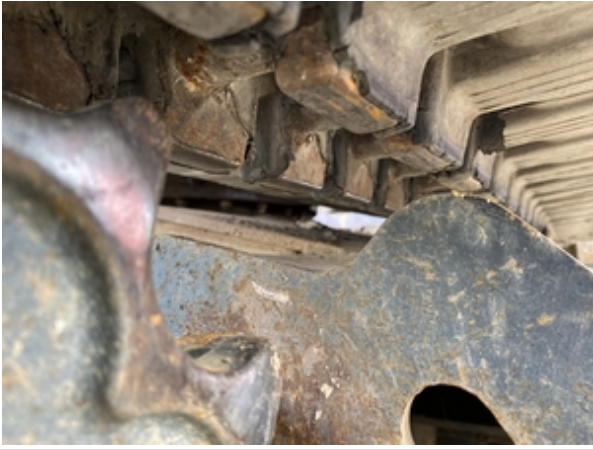
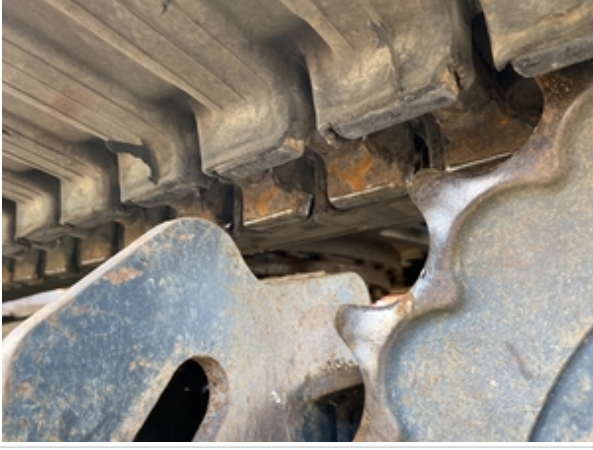
Rubber Belt Drive Lugs	3 - Normal Wear & Tear	
Rubber Belt Drive Lugs Photos

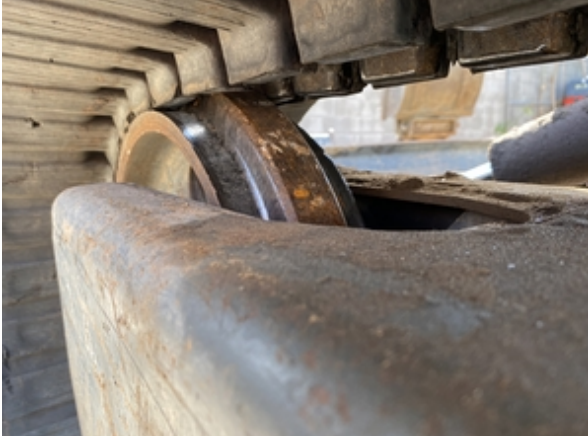
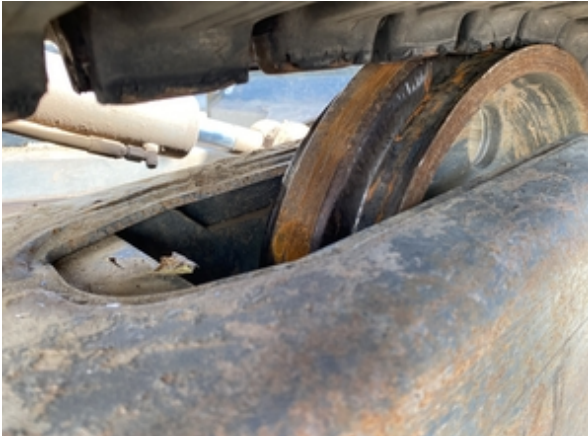
<p>Front Idlers Photos</p>

Track Tensioners	3 - Normal Wear & Tear	
Front Idlers	3 - Normal Wear & Tear

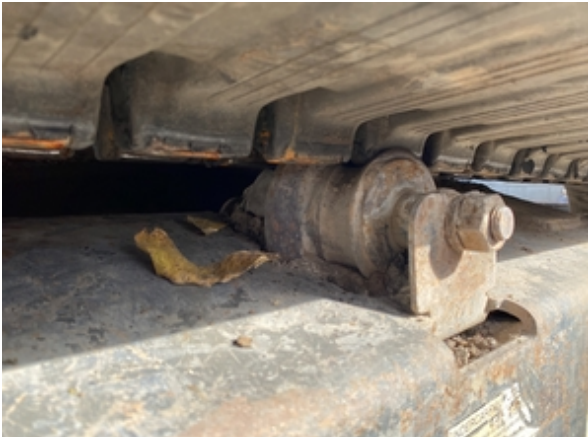
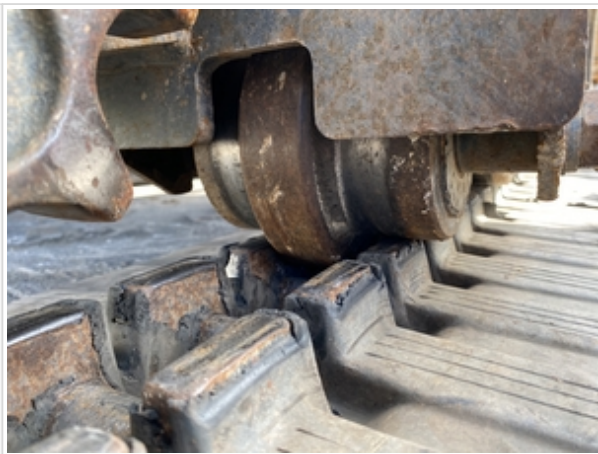
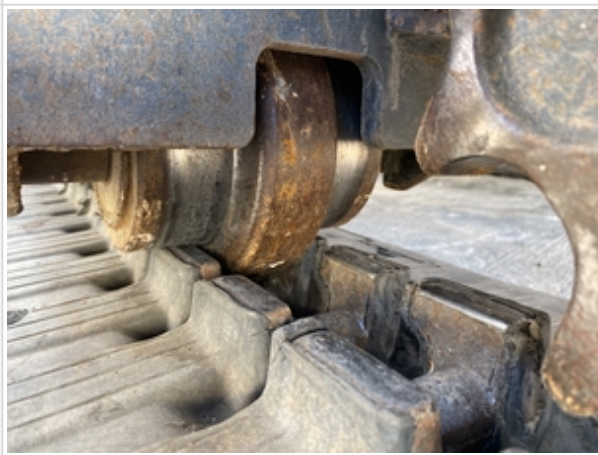
<p>Rear Idlers</p>	<p>0</p>	
<p>Track Rollers</p>	<p>3 - Normal Wear & Tear</p>	
<p>Track Rollers Photos</p>

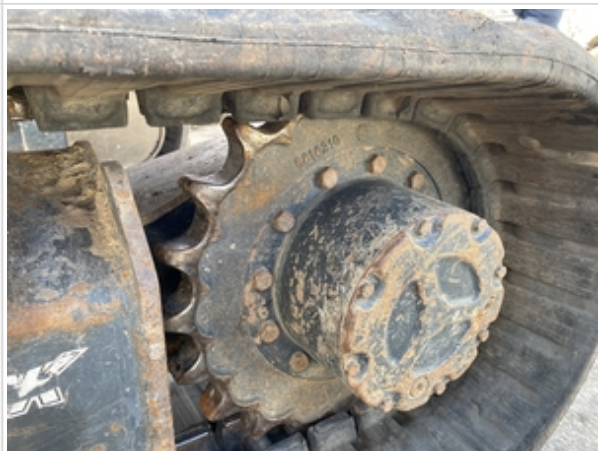
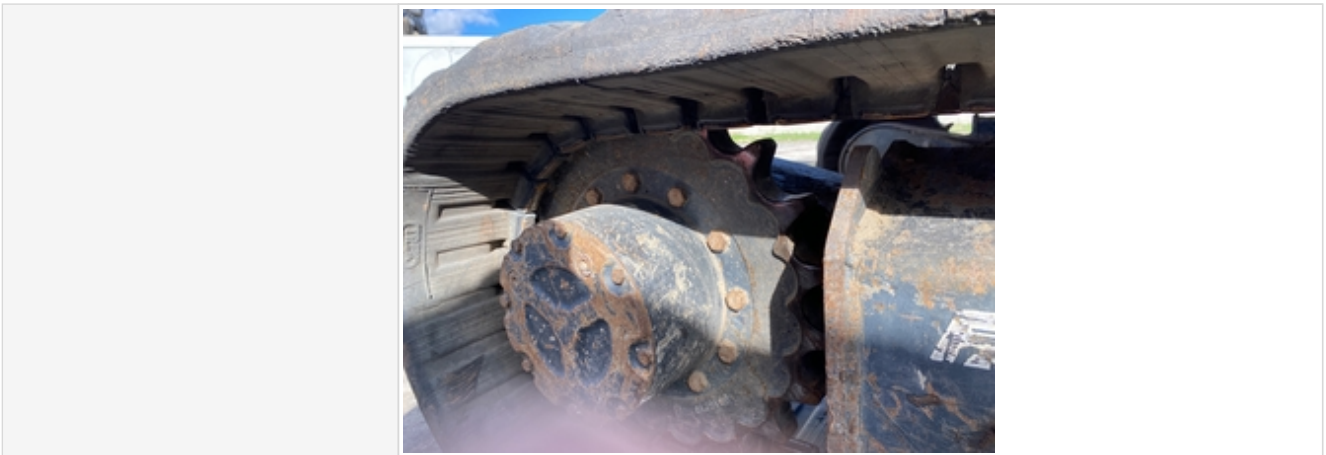
<p>Sprockets</p>	<p>3 - Normal Wear & Tear</p>	
<p>Sprockets Photos</p>

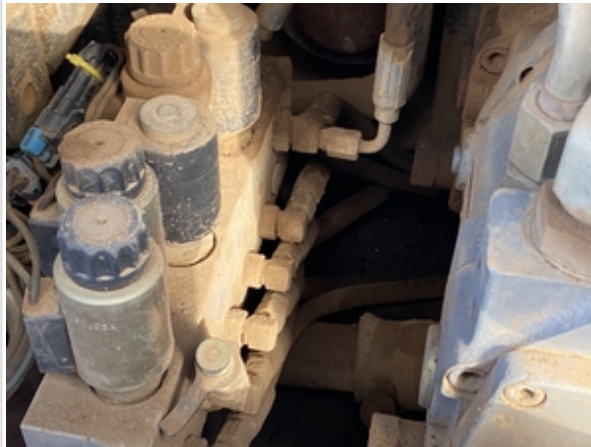
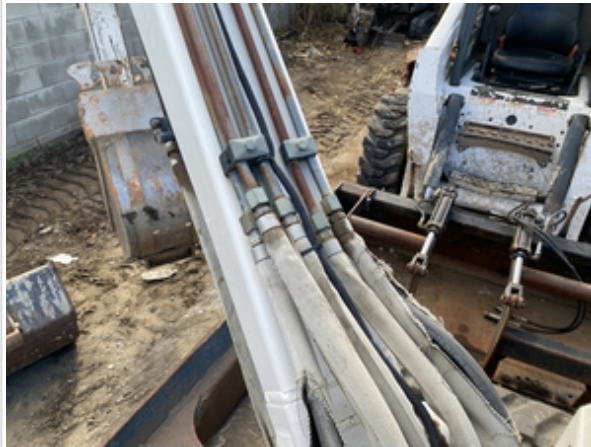
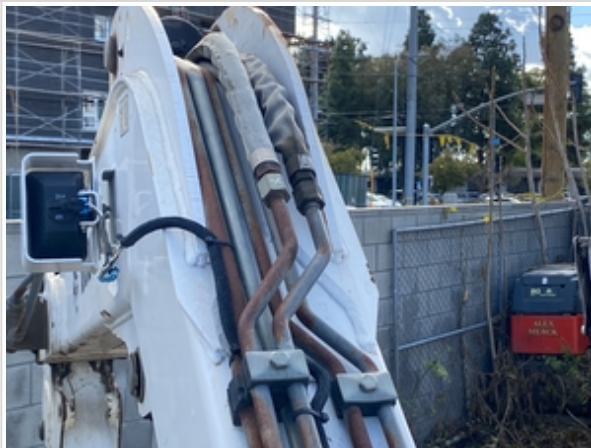
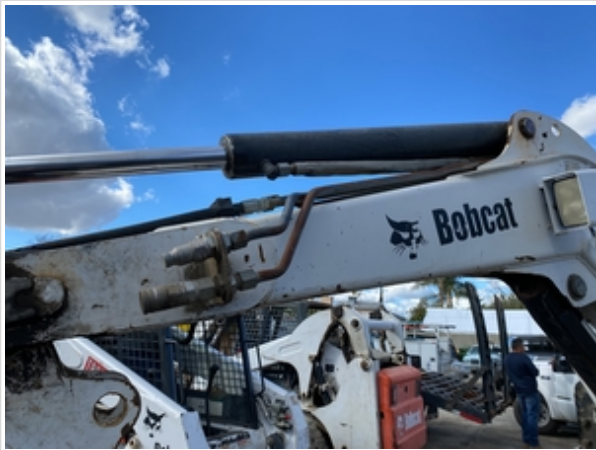
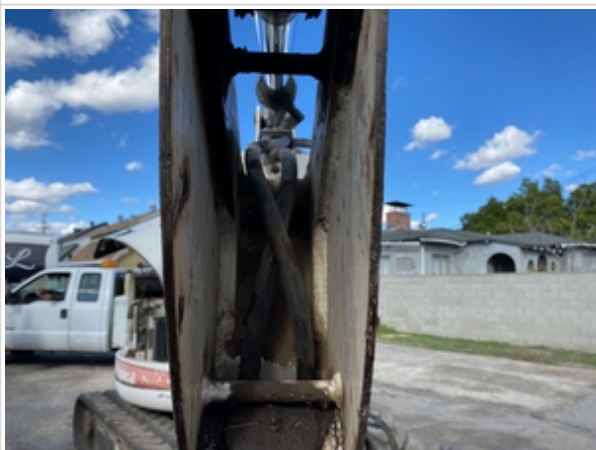
Wet or Damp Hydraulic Lines / Fittings	Yes
Appearance of Hydraulic Lines / Fittings	3 - Normal Wear & Tear
Hydraulic Lines / Fittings Condition	Hydraulic lines & fittings are clean and in good condition, Active leaks in hoses or fittings observed, Other (see comments)
Comments	Observed signs of small hydraulic leaks at main control valve

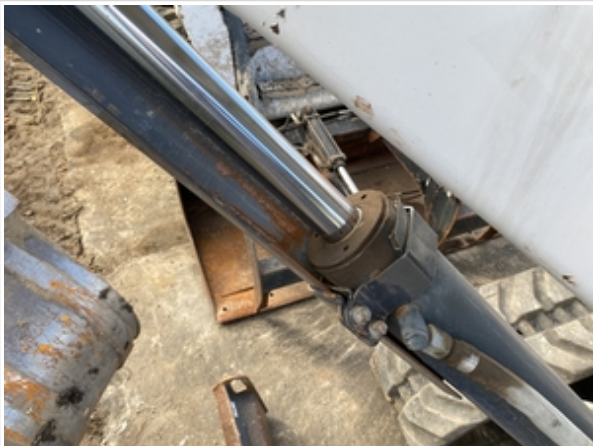
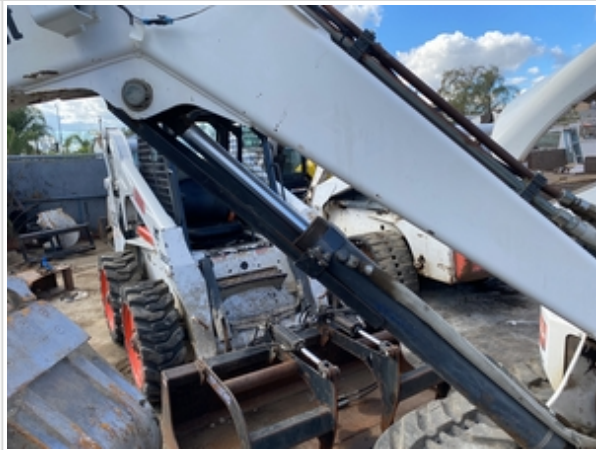
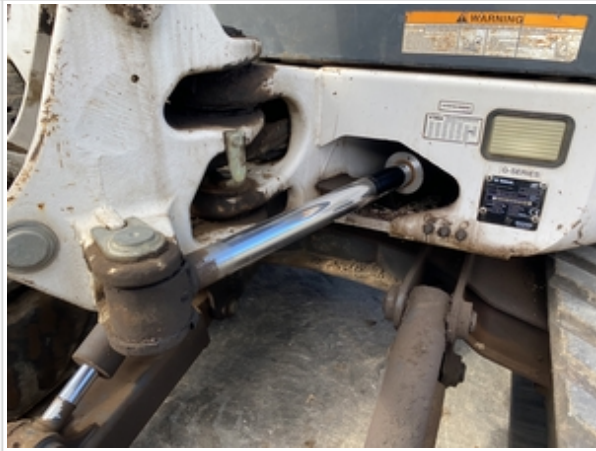
Boom Cylinder: Mounting Pin	3 - Normal Wear & Tear
Boom Cylinder: Oil Leaks	No
Boom Cylinder Photos

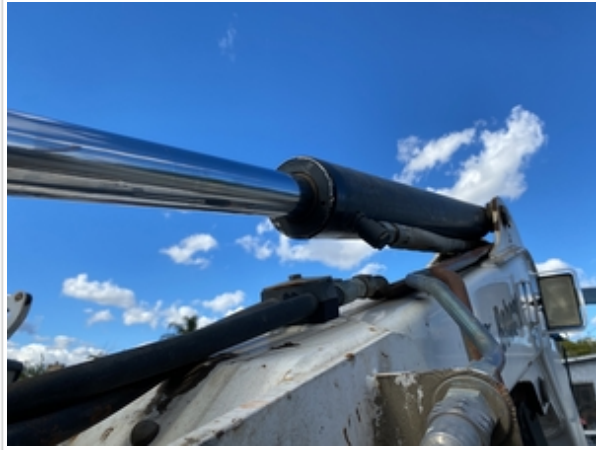
Stick Cylinder: Mounting Pin	3 - Normal Wear & Tear
Stick Cylinder: Oil Leaks	No
Stick Cylinder Photos

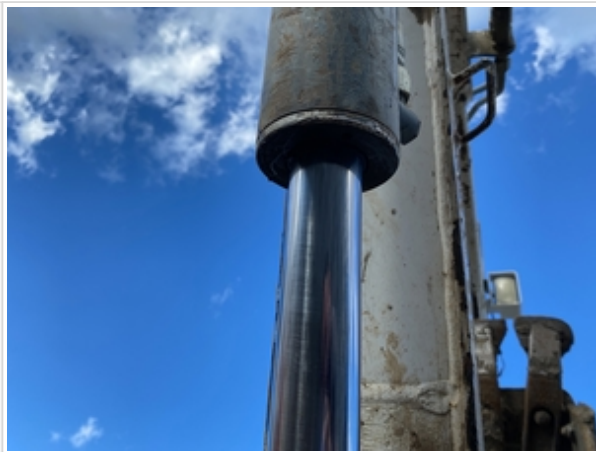
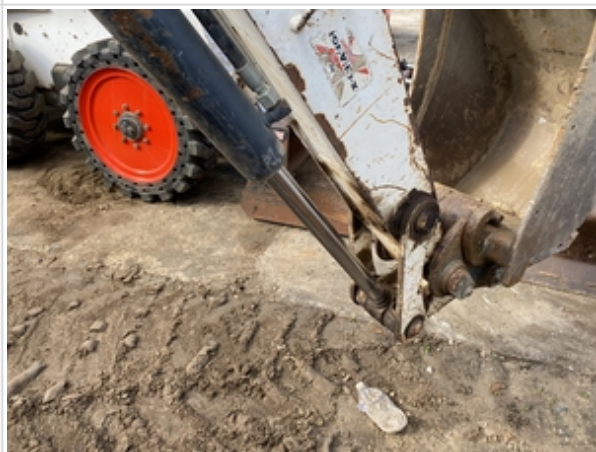
Bucket Cylinder Photos

Bucket Cylinder: Mounting Pin	3 - Normal Wear & Tear
Bucket Cylinder: Oil Leaks	No

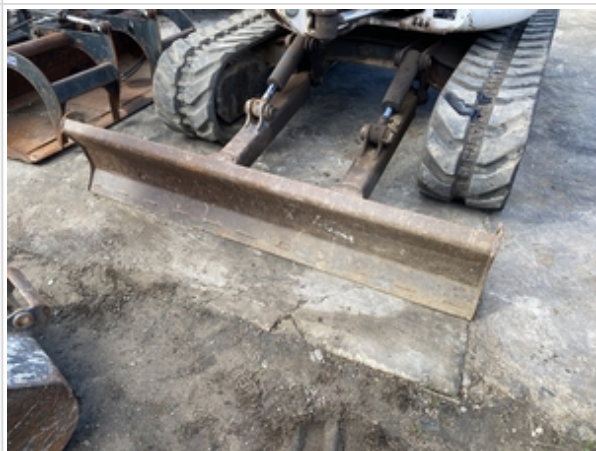
Blade	3 - Normal Wear & Tear
Blade Photos

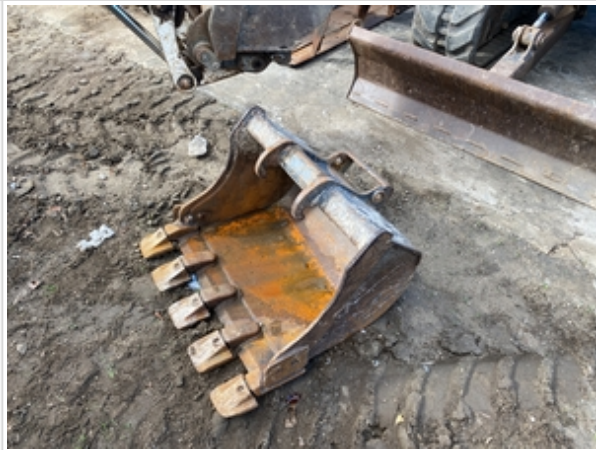
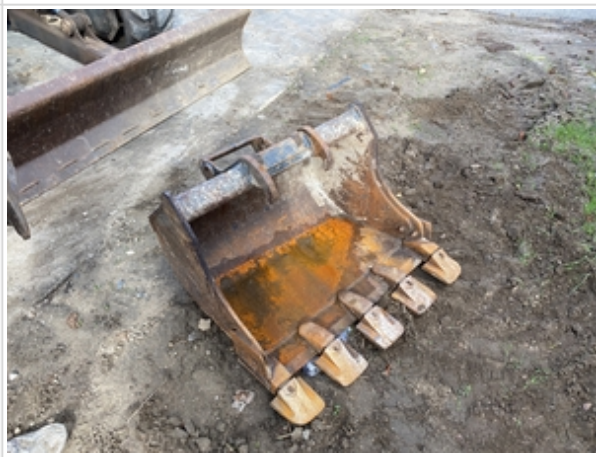
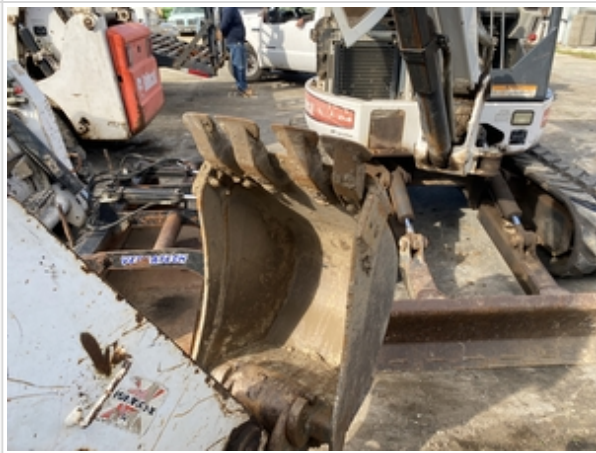
<p>Bucket Photos</p>

Bucket Condition	3 - Normal Wear & Tear
Comments	18" and 30"

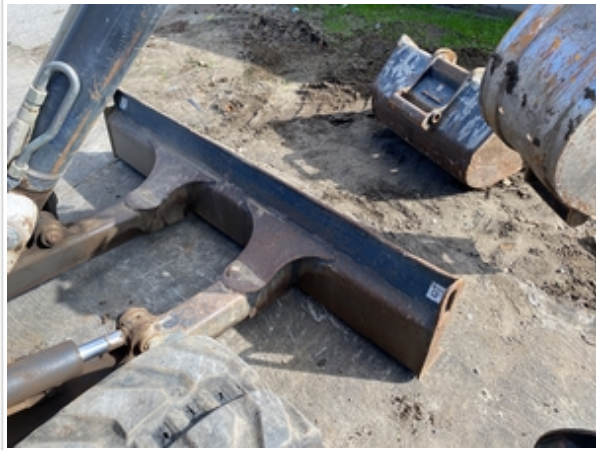
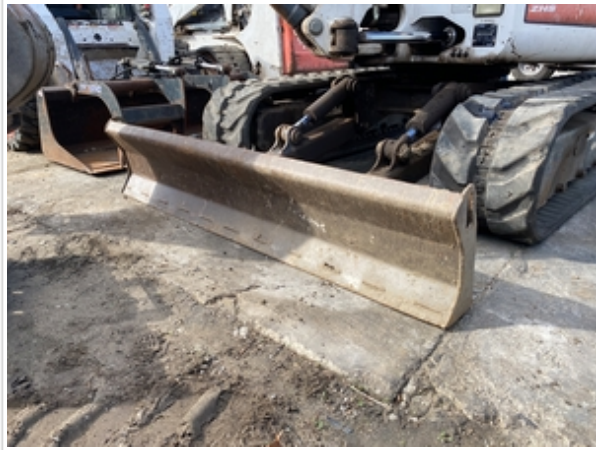
Blade Condition	3 - Normal Wear & Tear
Blade Photos
