Inspection Report (On-Highway Flatbed Truck)

Year	2013
Make	Ford
Model	F750
Serial Number	3FRWF7FG1DV019792
Truck Odometer Reading	29,140
Current Inspection / State Cert / DOT	N/A
Previous Application (e.g., earth moving, mining, demolition, etc)	General Construction

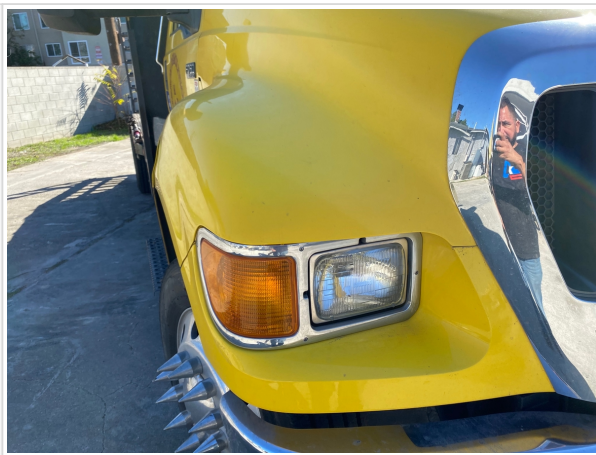
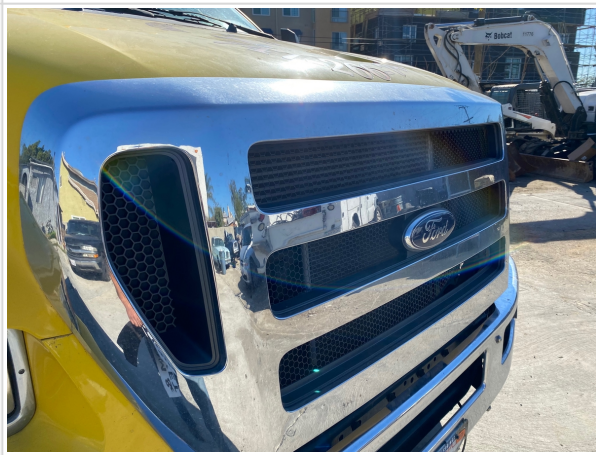
Front	3 - Normal Wear & Tear
Front Condition	No visible damage
Front Photos

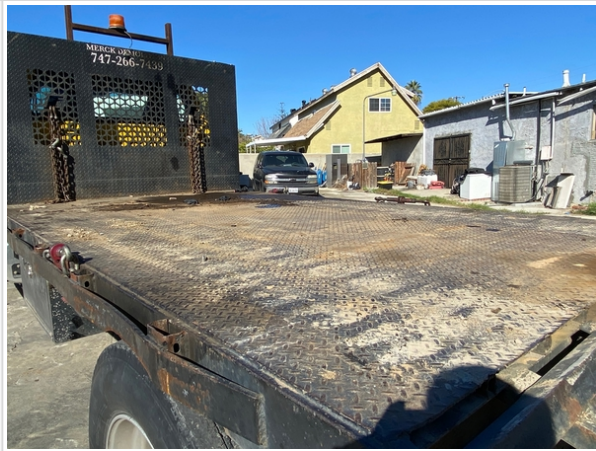
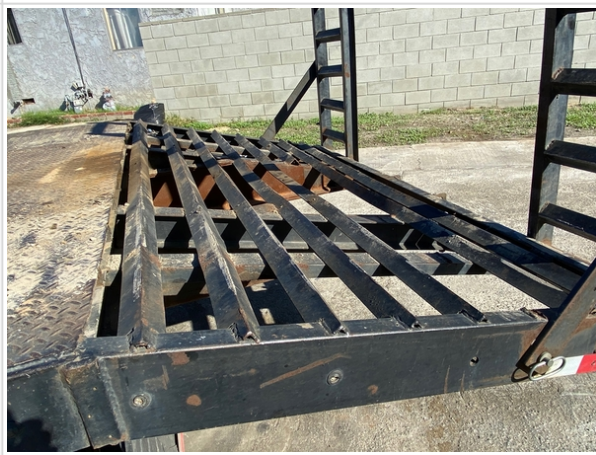
Rear	3 - Normal Wear & Tear	
Rear Condition	No visible damage	
Rear Photos

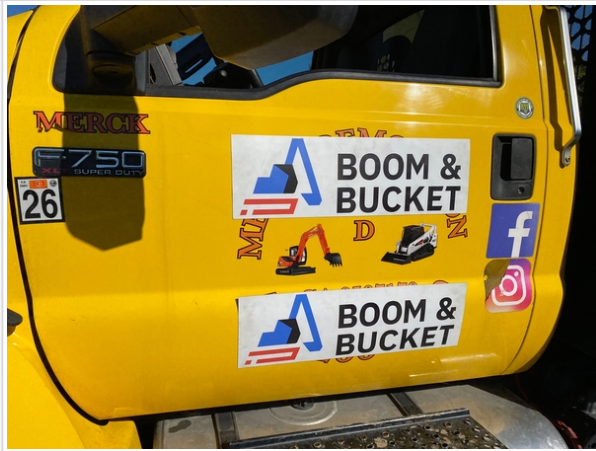
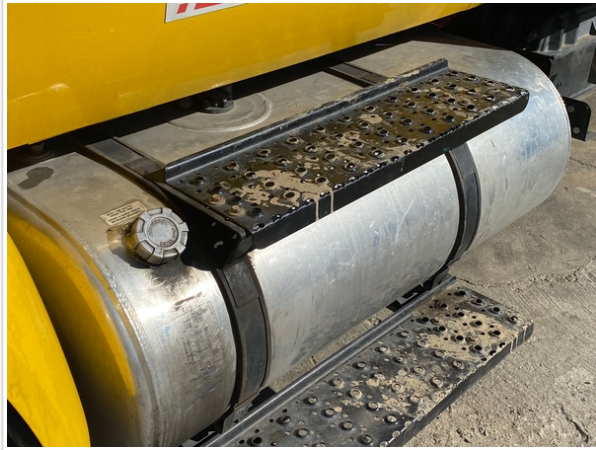
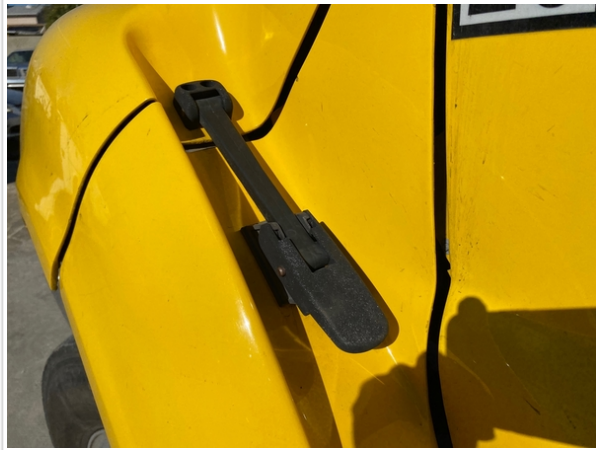
<p>Left</p>	<p>3 - Normal Wear & Tear</p>
<p>Left Condition</p>	<p>No visible damage</p>
<p>Left Photos</p>

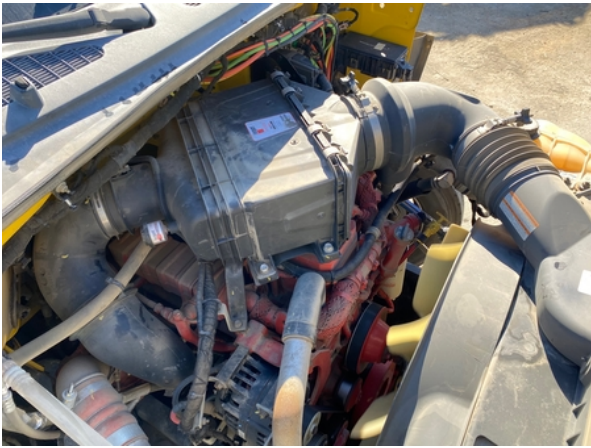
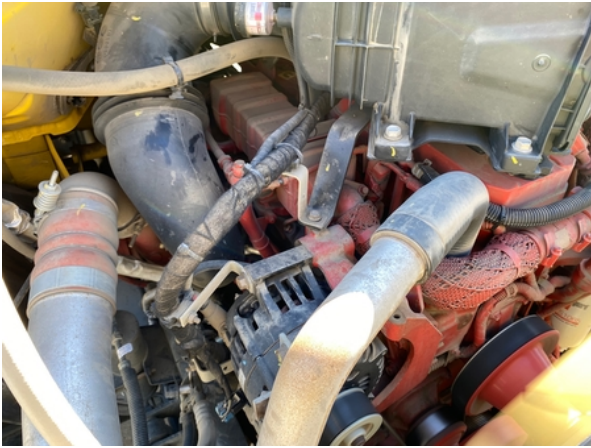
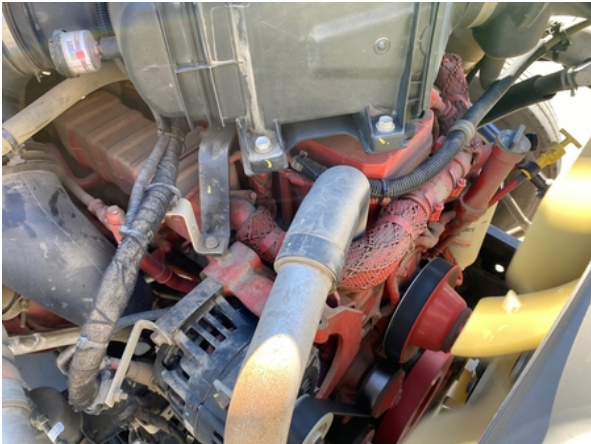
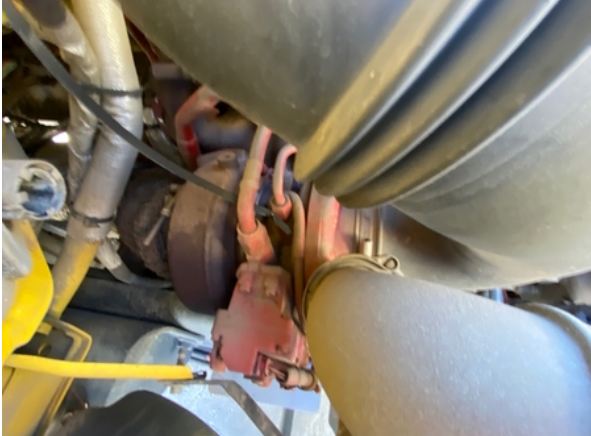
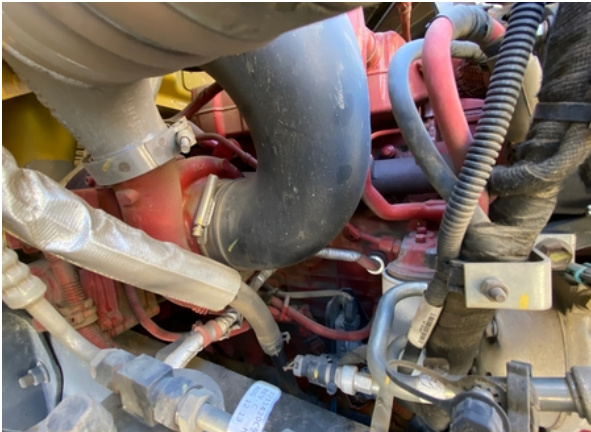
Engine Type (Make, Model, Cylinders, Hp)	Cummins - ISB 6.7L - 6CYL. - 325HP
Emissions Tier	Tier 4F
Engine Serial Number	73579781
Engine Fuel Type	Diesel
Engine Photos

Overall Engine Appearance	Clean & dry	
Overall Engine Comments	Overall engine well maintained, sounds healthy and no obvious major problems seen.

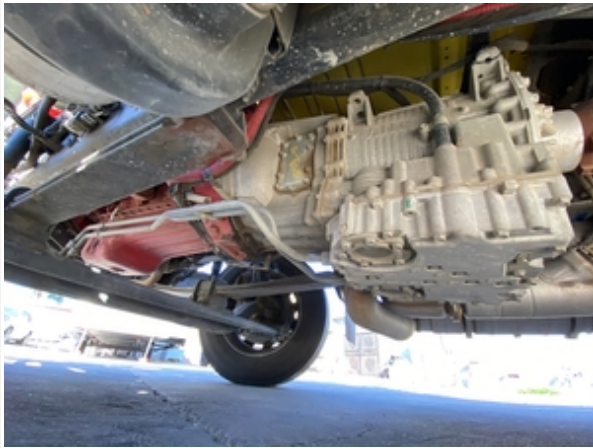
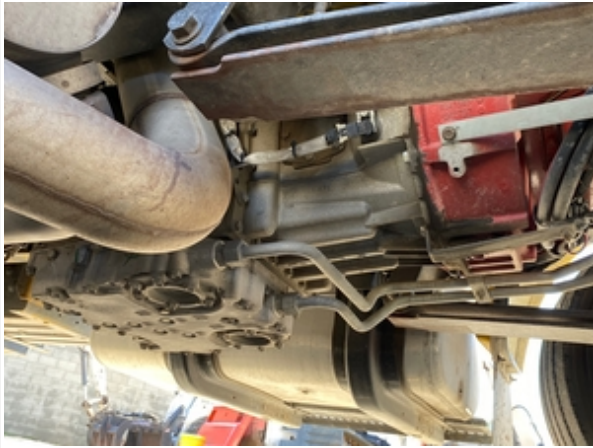
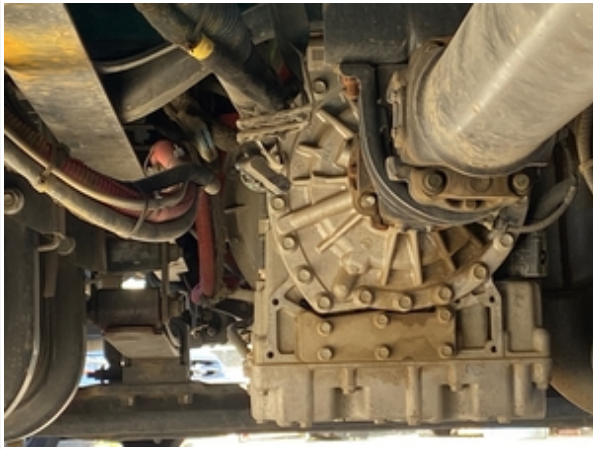
Transmission Info (Make/Model)	Allison- 6 Speed - Auto Trans.	
Drive Type	4X2	
Overdrive	Yes	
Transmission	3 - Normal Wear & Tear	
Transmission Condition	No unusual noises or vibrations	
Transmission Condition Photos

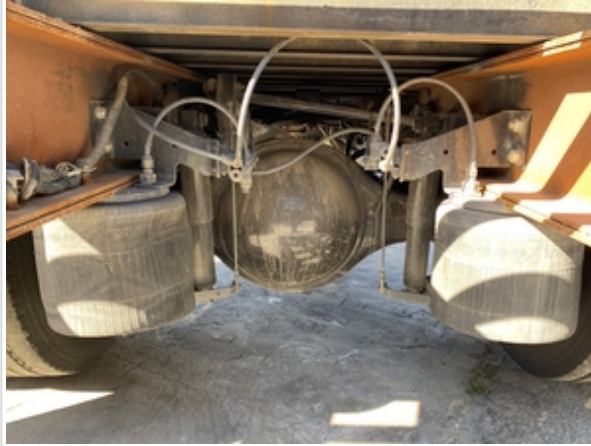
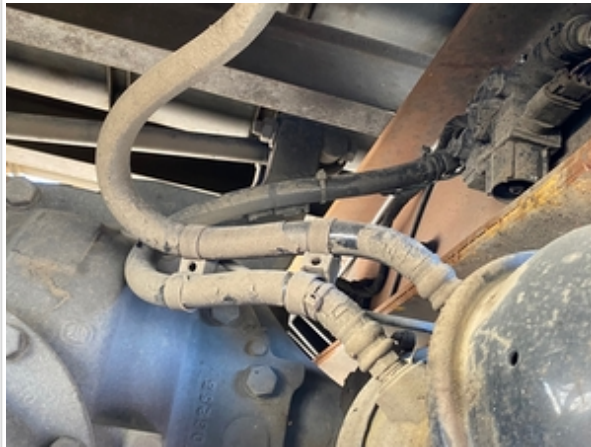
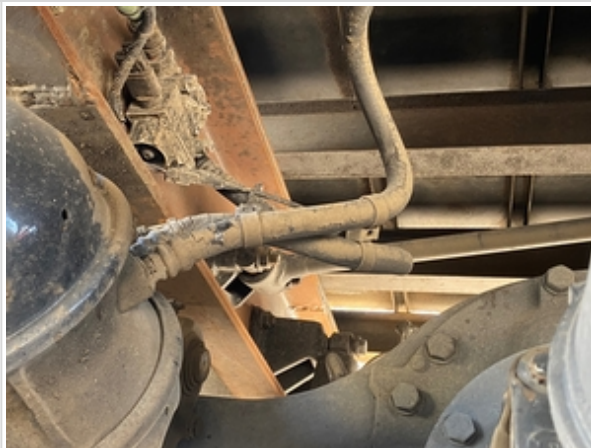
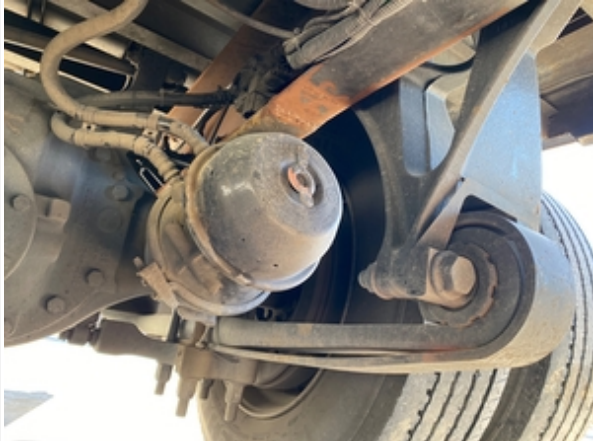
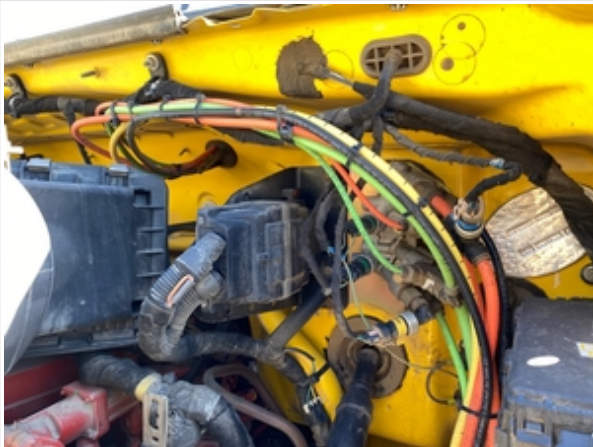
Air Brake System Photos

Front Differential	0
Brake System Type	Air Brakes
Air Brakes Build Correct Pressure	Yes
Air Brake System Leaks	Yes
Comments	Major air leak at seat suspension
Air Brake Hose Condition	3 - Normal Wear & Tear

Engine Brake Configuration	2 Position
Engine Brake	3 - Normal Wear & Tear
Parking Brake	3 - Normal Wear & Tear
Parking Brake Condition	Good brake function
Overall Drivetrain Comments	Overall drivetrain looks solid. No issues seen with major components. Air leak under driver seat observed.

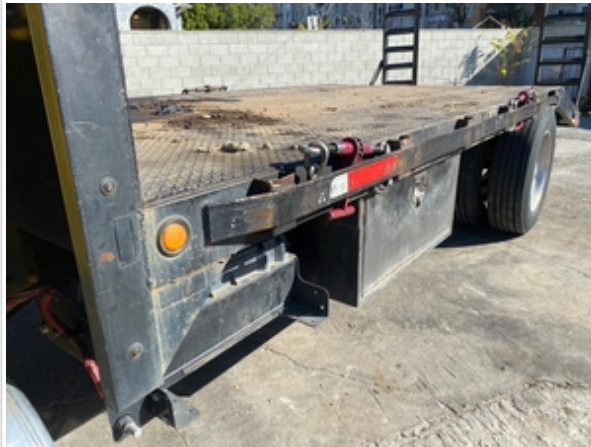
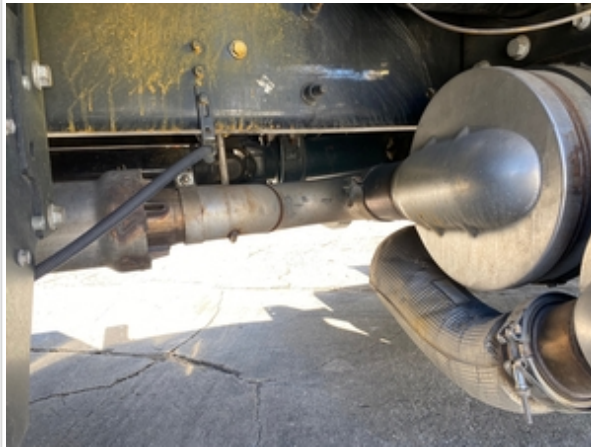
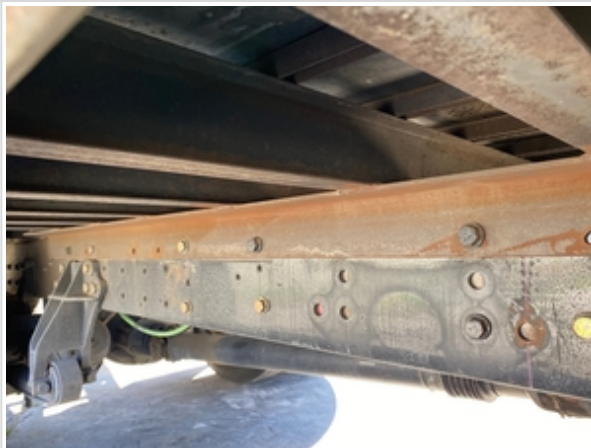
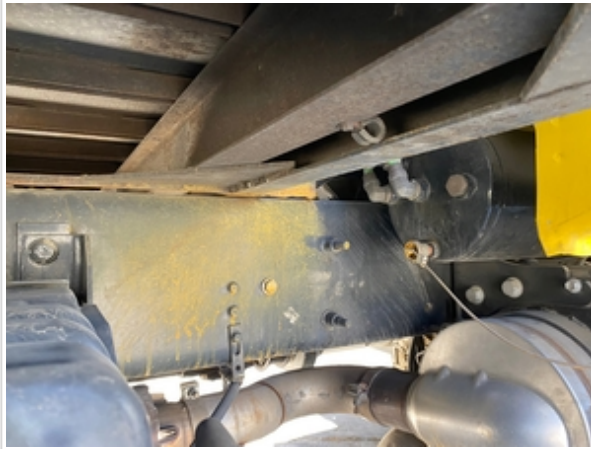
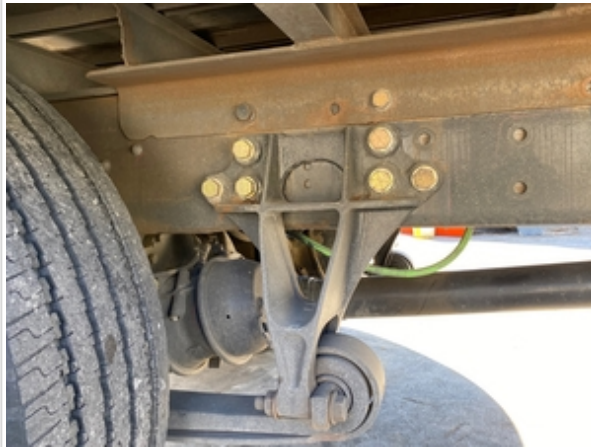
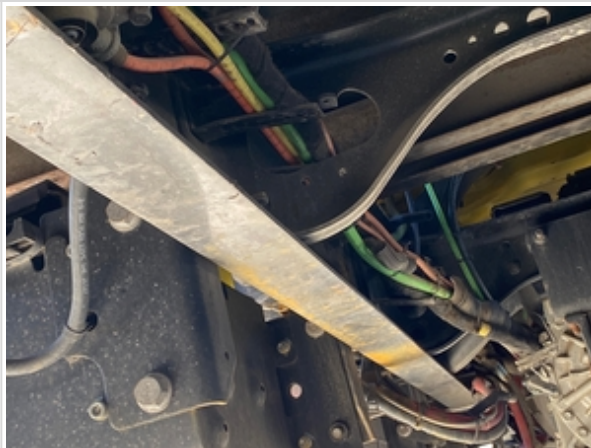
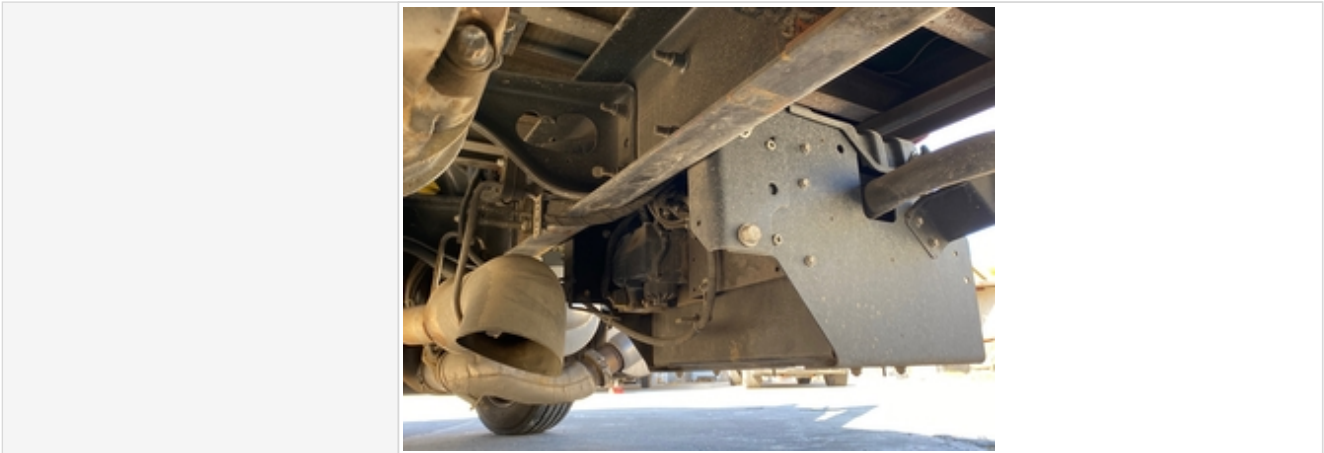
Frame Condition	3
Comments	Frame extended and double layered for extra strength .
Frame Photos

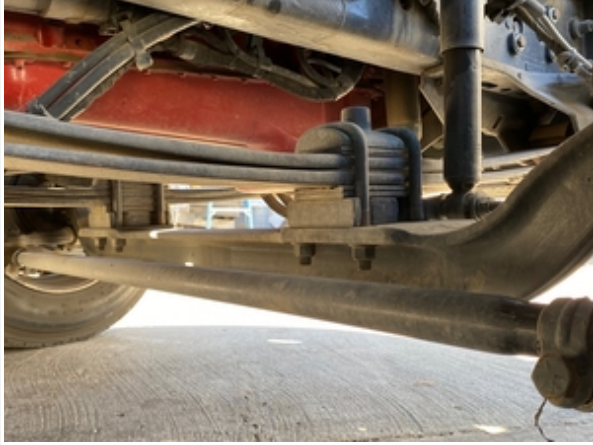
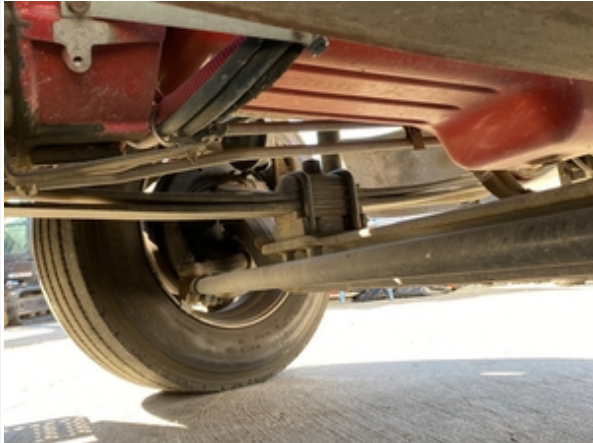
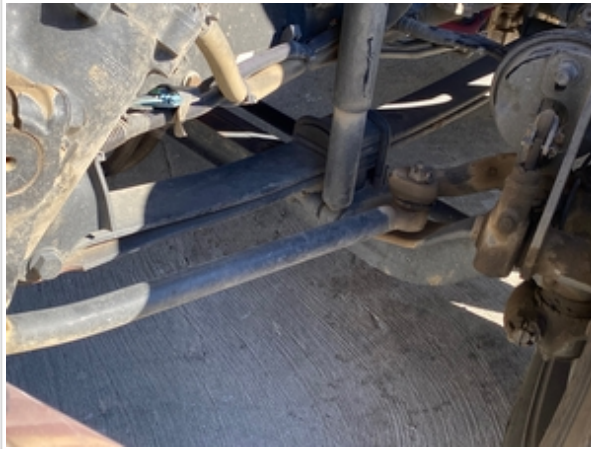
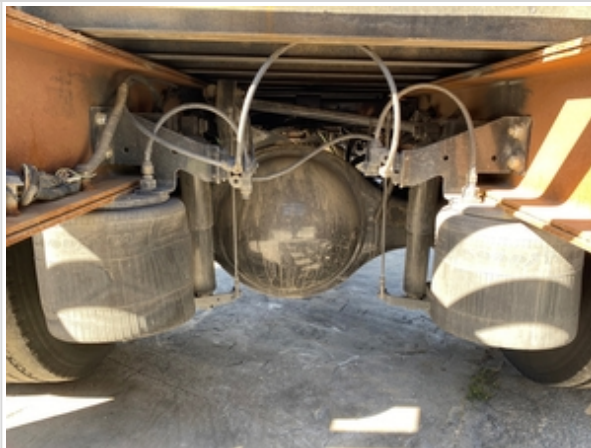
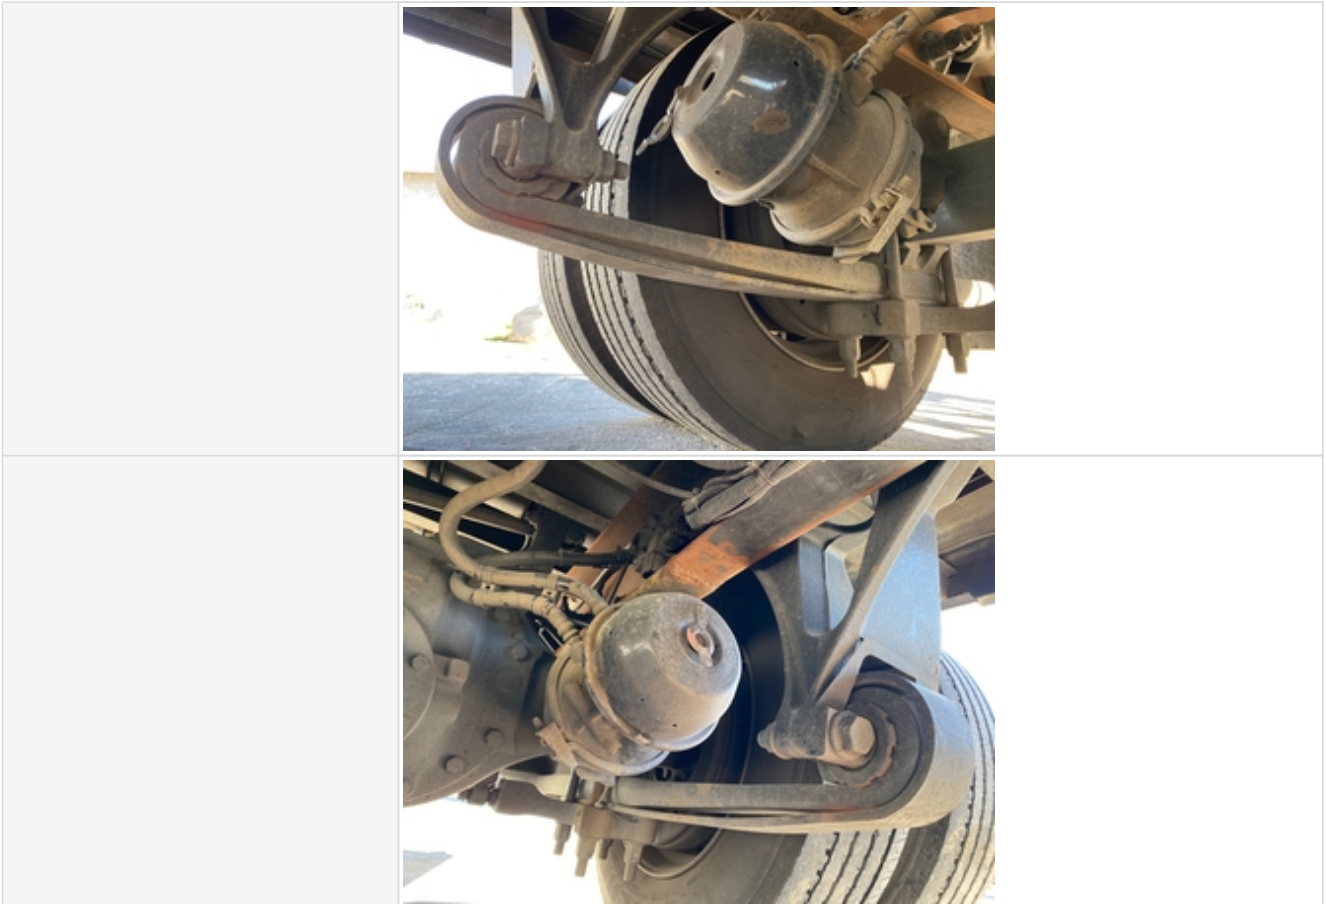
Suspension	3
Suspension Photos

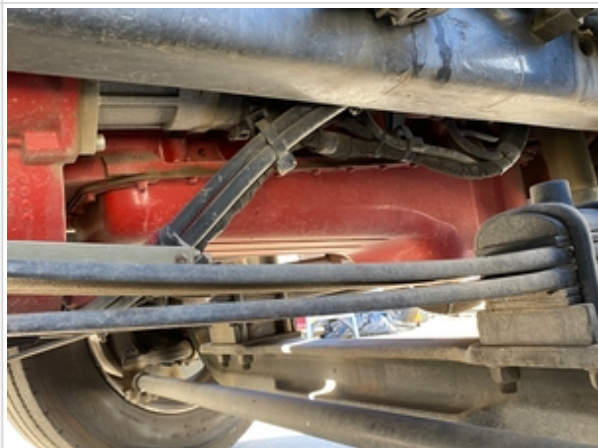
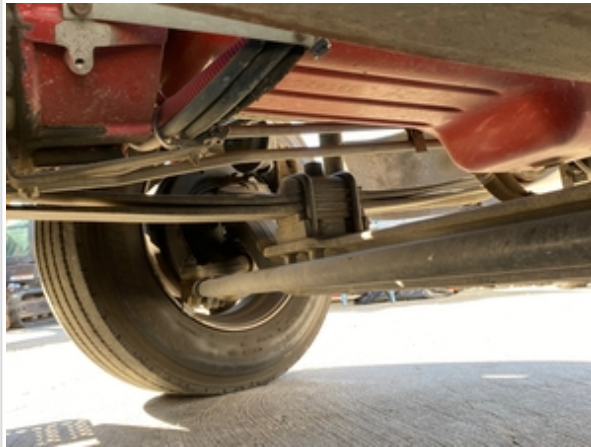
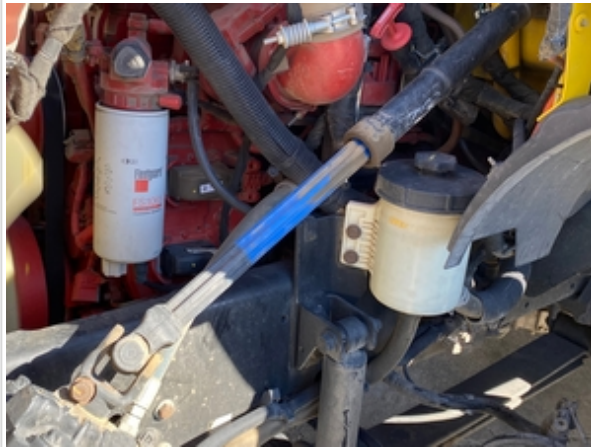
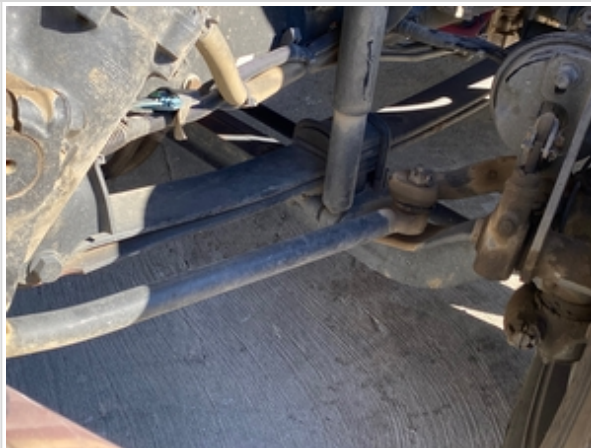
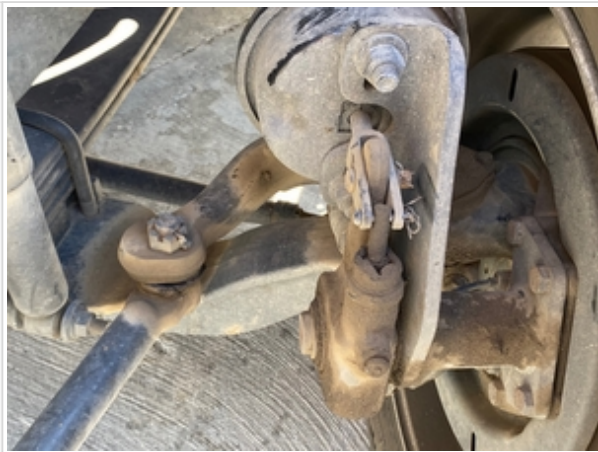
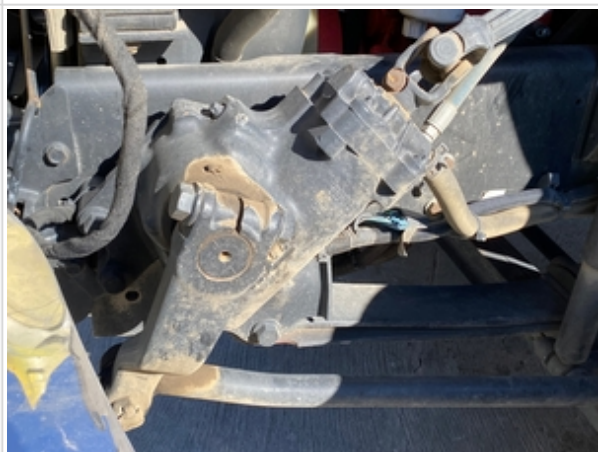
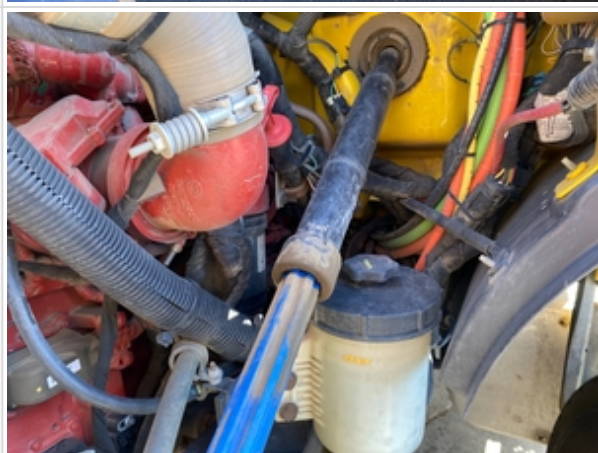
Steering Components	3
Steering Components Photos

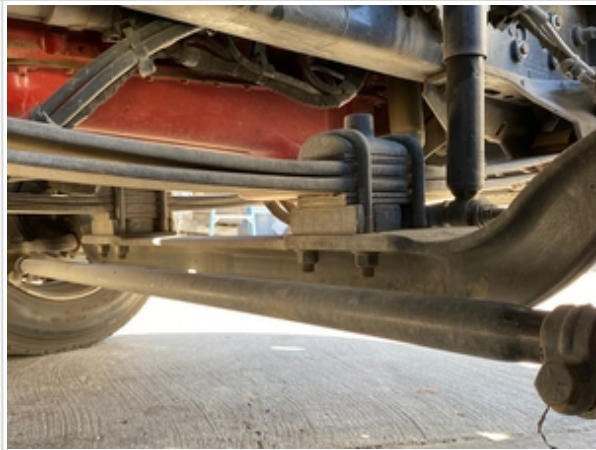
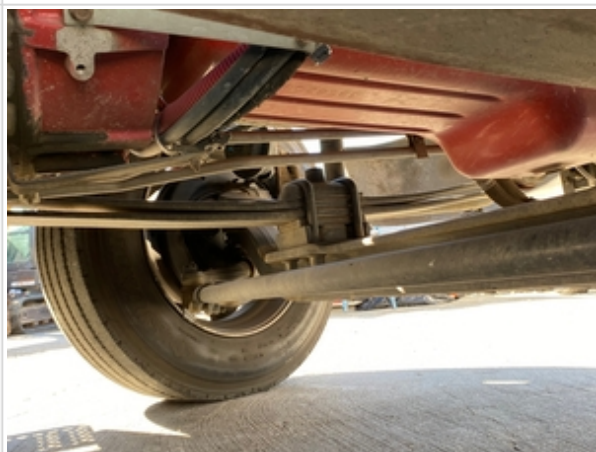
Steer Axle Photos

Steer Axle Condition	3

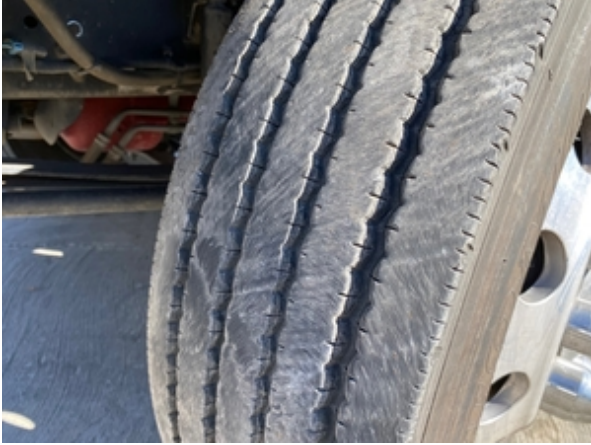
Wheels & Hub Condition	3
Comments	No oil seal leaks observed from inside rim area
Wheel Seal Leaks	No
Tire Brand	Sumitomo (Front) Michelin (Rear)
Tire Size	275/70R/22.5 (Front & Rear)
Front Left Tire - Ratio Remaining	70%
Front Left Tire Photos

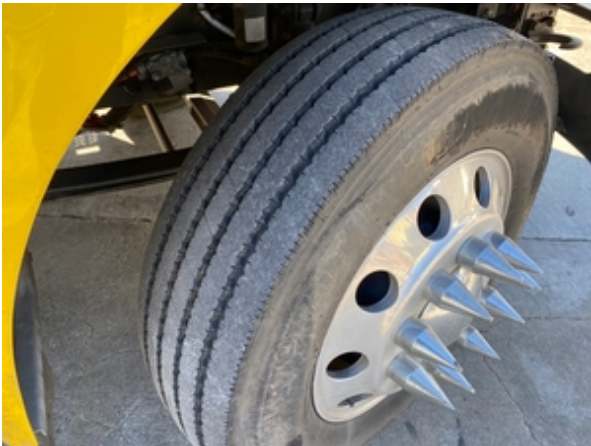
Front Right Tire - Ratio Remaining	70%
Front Right Tire Photos

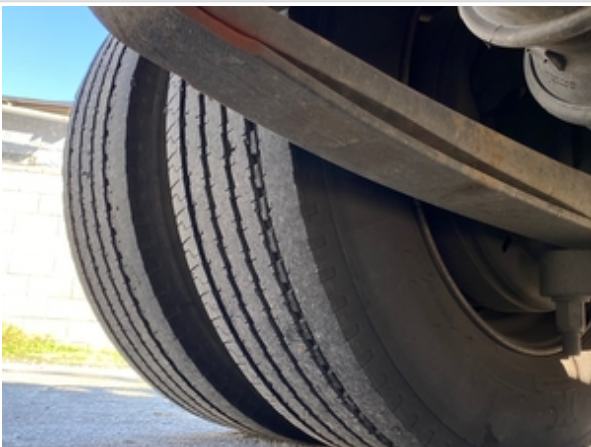
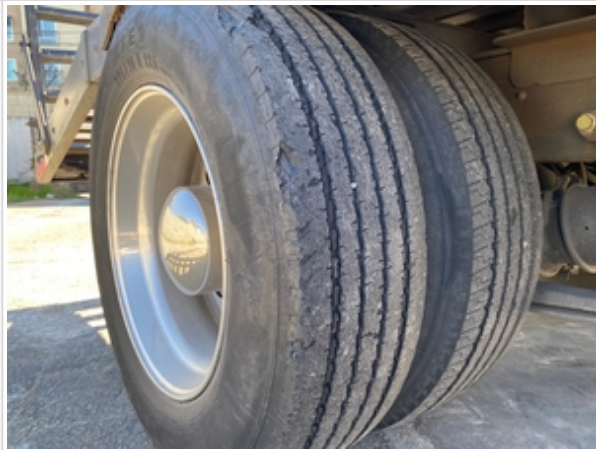
Rear Right Tire - Ratio Remaining	70%
Rear Right Tire Photos

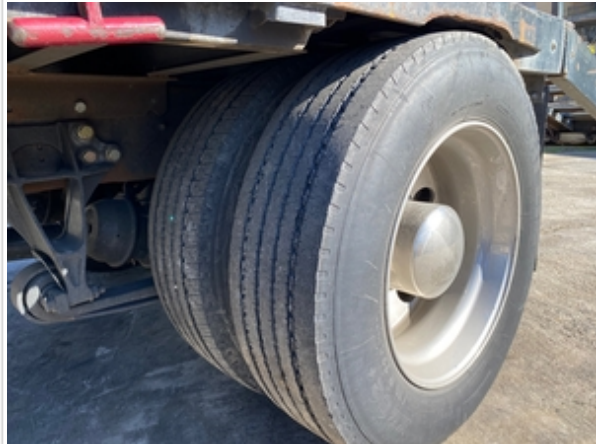
Rear Left Tire - Ratio Remaining	70%	
Rear Left Tire Photos

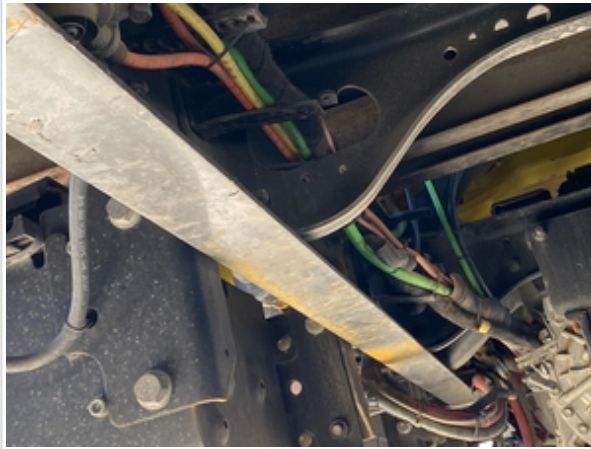
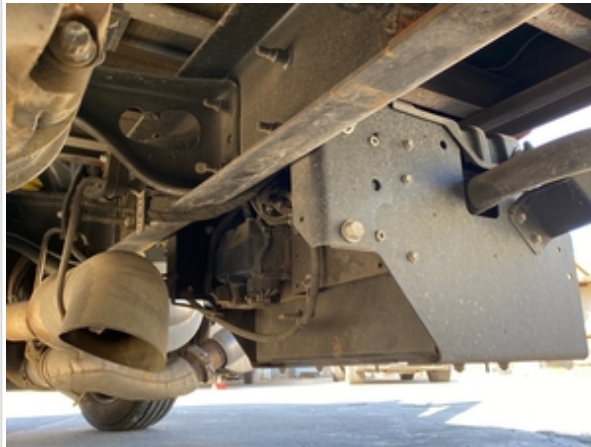
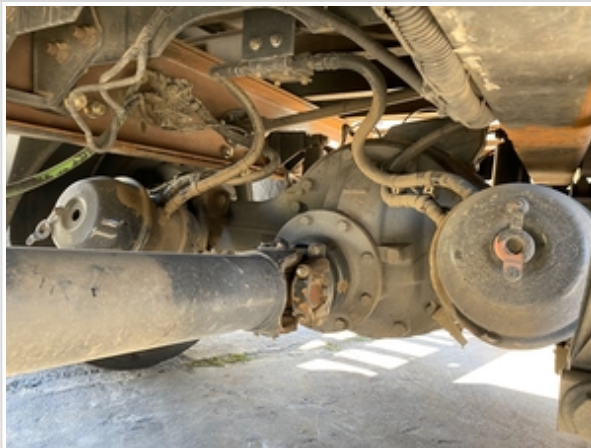
Overall Chassis	3	
Overall Chassis Comments	Overall chassis in solid condition with no major issues observed.	
Overall Chassis & Undercarriage Photos

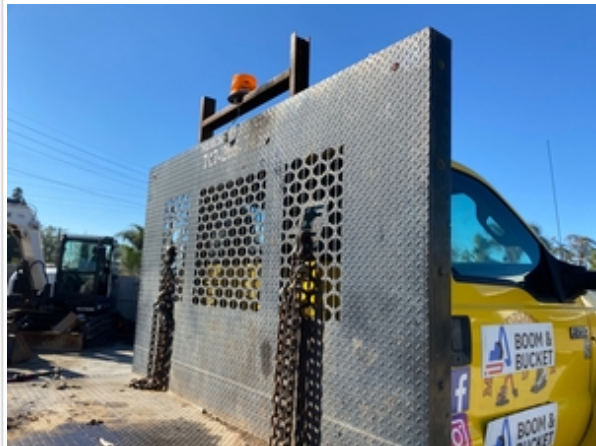
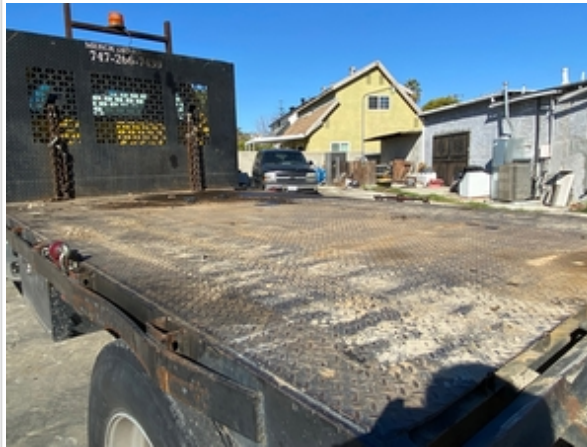
Flatbed Body	Check the condition of the flat bed body. Note any damage or wear. Take photos.
Bed Details (Deck Type, Additional Features)	Bed make N/A
Flatbed Length (ft and inches)	N/A
Flatbed Width (ft and inches)	N/A
Flatbed Body	3
Flatbed Body Photos
