## Inspection Report (On-Highway Truck Cab + Chassis)

Year	2012
Make	Kenworth
Model	T800
Serial Number	1XKDDP9X5CJ335272
Truck Odometer Reading	551,326
Current Inspection / State Cert / DOT	Last inspection 05/2022 (In accordance with 49CFR,Part396,FMCSR)
Previous Application (e.g., earth moving, mining, demolition, etc)	Equipment Rental Hauler

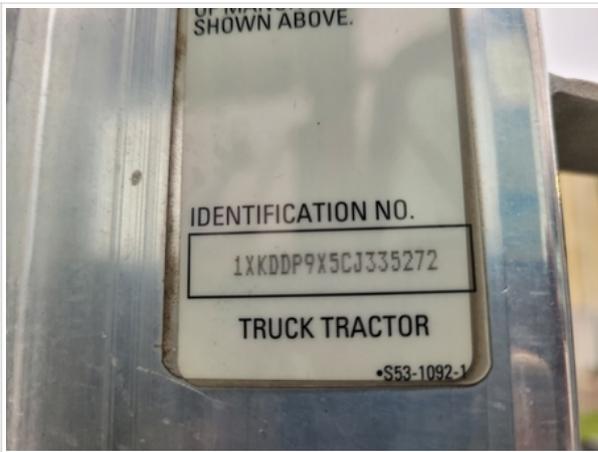
<p>VIN/Serial Number Plate Photo</p>

<p>UP FROM SHOWN ABOVE.</p> <p>IDENTIFICATION NO. 1XKDDP9X5CJ335272</p> <p>TRUCK TRACTOR</p> <p>•S53-1092-1</p>	
<p>Odometer Photo</p>

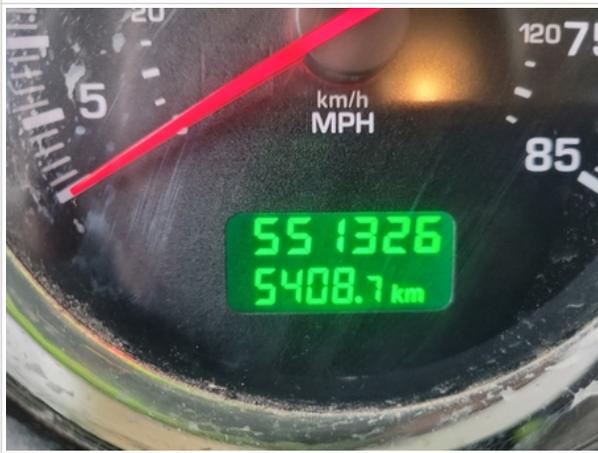
<p>20 120 75 5 km/h MPH 85</p> <p>55 1326 5408.7 km</p>	
<p>Cab Interior Photos</p>

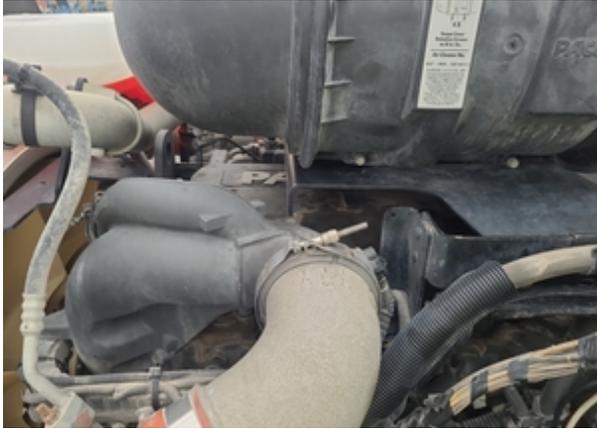
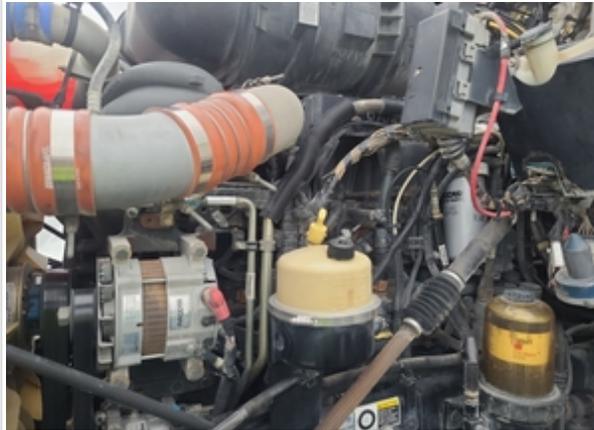
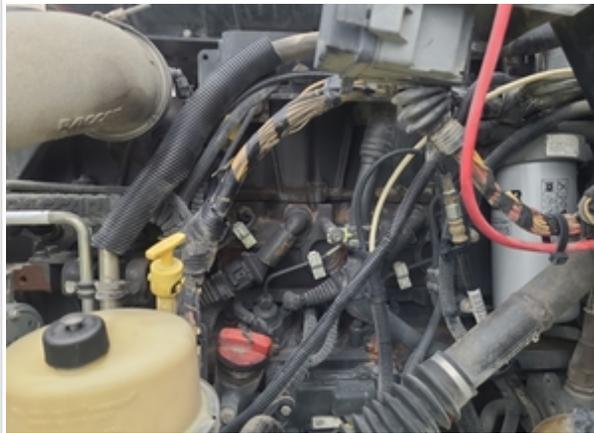
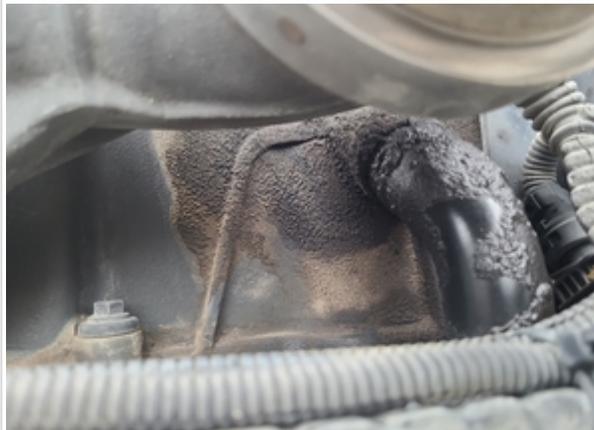
Engine Type (Make, Model, Cylinders, Hp)	PACCAR - 6Cyl. - 430HP - 12.9L
Emissions Tier	Tier 4F
Engine Serial Number	Y008680
Engine Fuel Type	Diesel
Engine Photos

Overall Engine Appearance	Clean & dry
Overall Engine Comments	Overall, engine looks to be in great condition with no major problems seen.

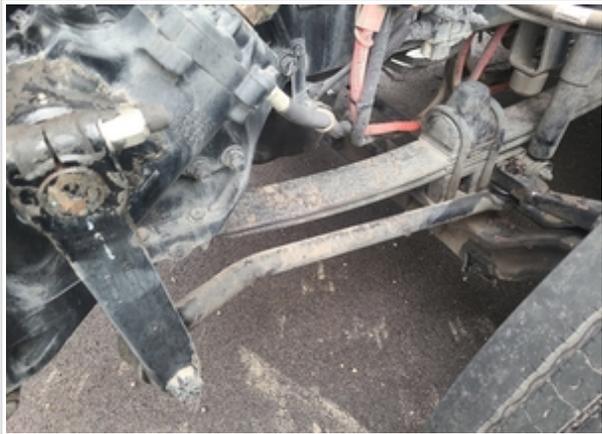
Steering Components	3
Steering Components Photos

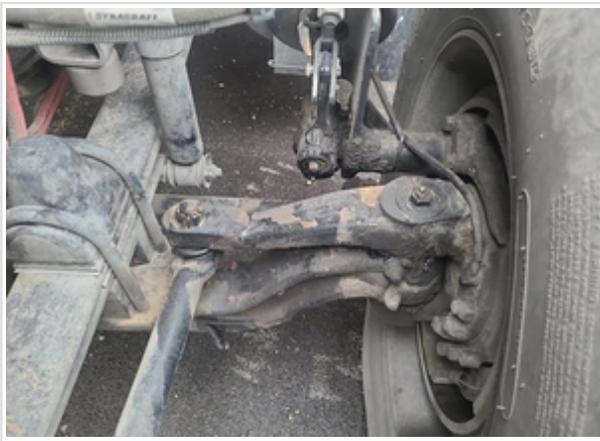
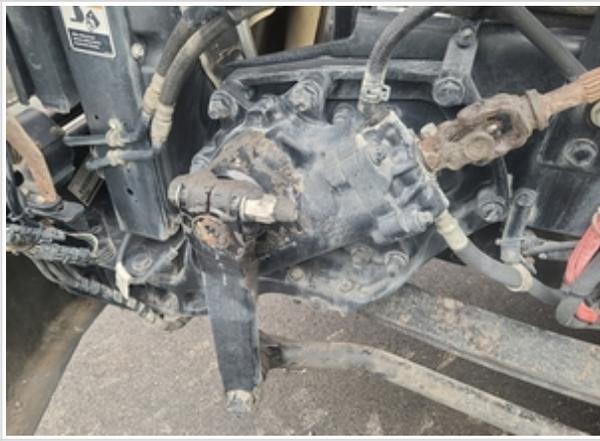
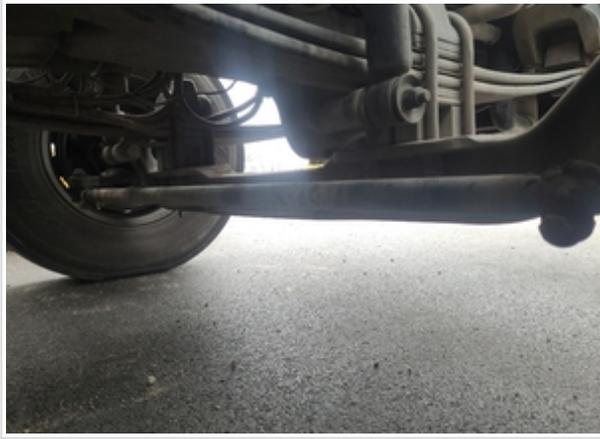
Steer Axle Condition	3

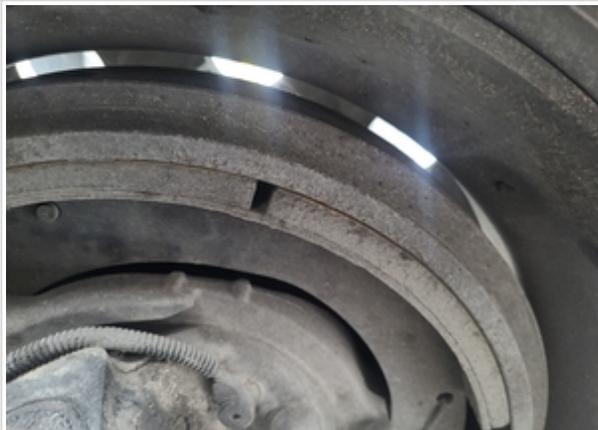
Brake Shoe Thickness	30%
Comments	most brakes above 70% of brake shoe material left
Brake Shoe Photos

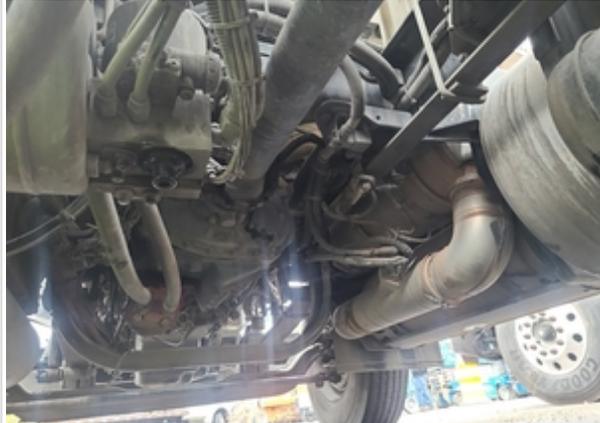
Overall Chassis	3
Overall Chassis Comments	Overall Chassis in Great condition
Overall Chassis & Undercarriage Photos
