Inspection Report (Mini Excavator)

Year	2007
Make	CAT
Model	305C cr
Serial Number	HWJ02087
Hour Meter Reading	252Hrs.
Previous Application (e.g., earth moving, mining, demolition, etc)	General Construction

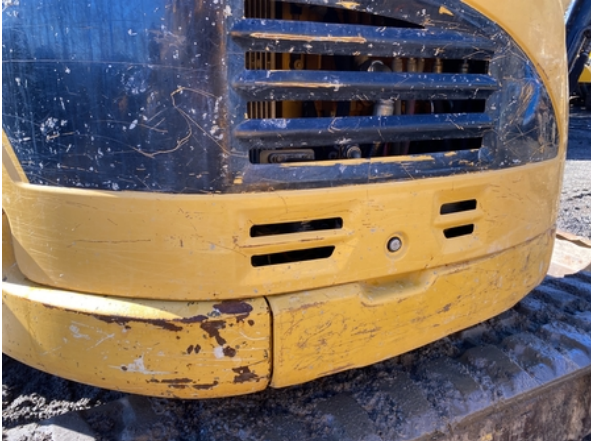
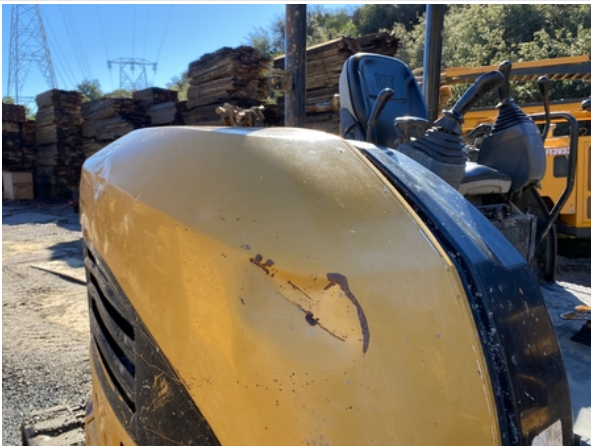
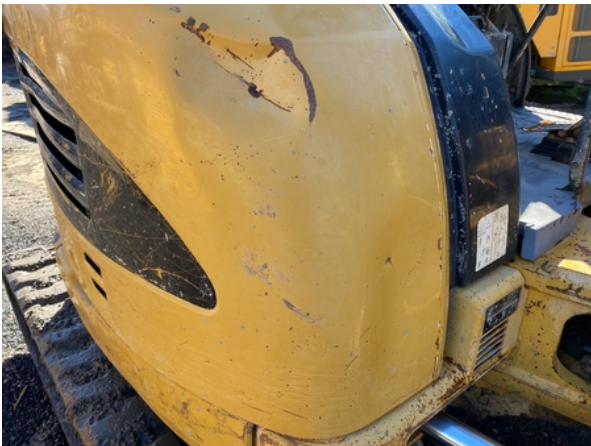
Body Panels	3 - Normal Wear & Tear
Body Panel Condition	Some panel misalignment observed, Visible chipped paint or dents, Other (see comments)
Comments	Normal wear and tear

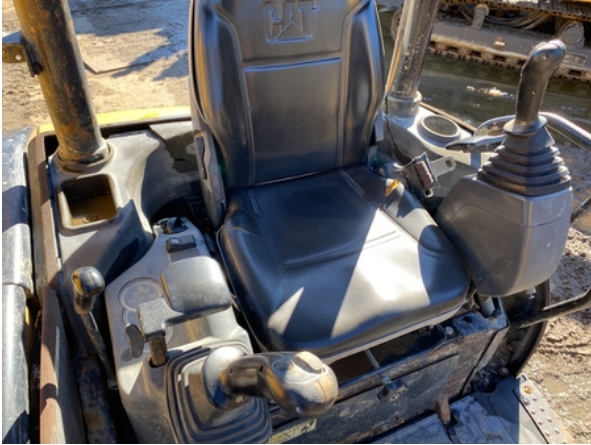
Operator Cabin Overall	3 - Normal Wear & Tear
Operator Cabin Overall Condition	Good cabin appearance, solid floors, panels, and ceiling, Minor cosmetic wear to cabin surfaces, floors, panels, and ceiling
Operator Seat	3 - Normal Wear & Tear
Operator Seat Condition	Seat(s) in good condition, no stains or tears in upholstery, Seat(s) have minor surface staining or small tears
Cabin Lights	0
Safety Lock Out / Stop	3 - Normal Wear & Tear

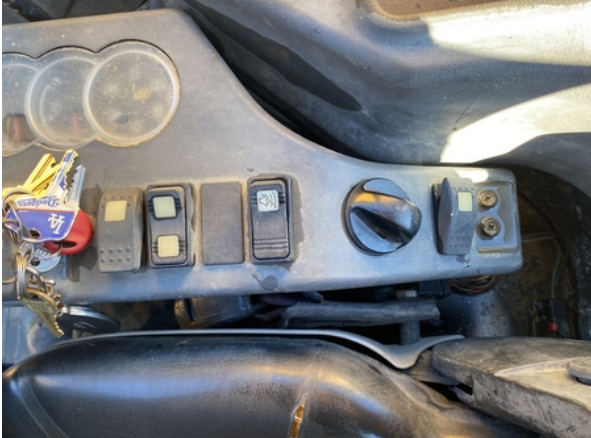
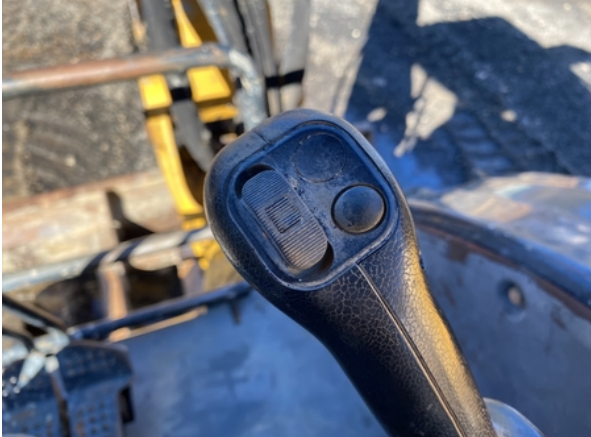
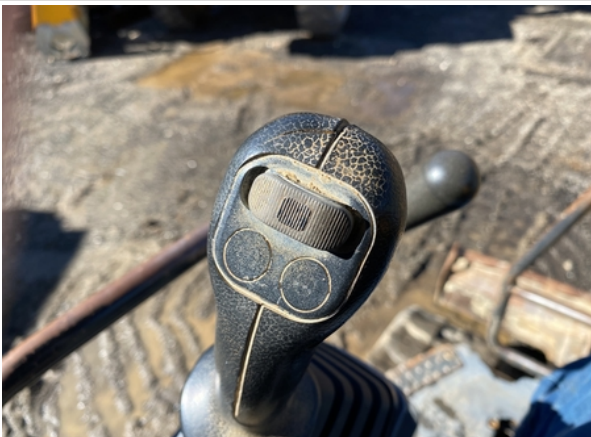
Safety Lock Out / Stop Condition	Safety lock out device is present, in good condition, and functional
Controls & Switches	3 - Normal Wear & Tear
Controls & Switches Condition	All switches are installed and functional, Switches have good functionality, minor cosmetic damage observed, Other (see comments)
Comments	Switch decals worn
Controls & Switches Photos

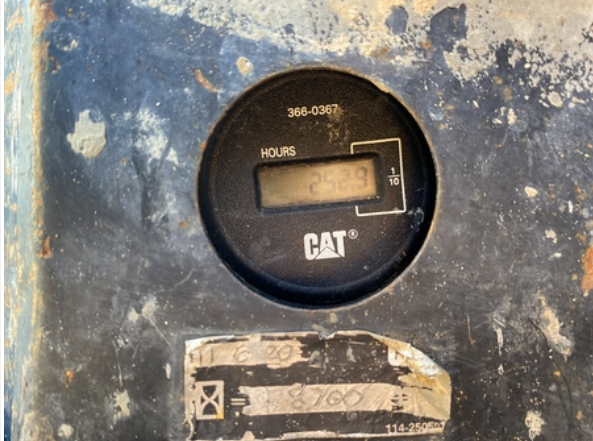
Hour Meter Activity Photos

Hour Meter Activity	3 - Normal Wear & Tear
Hour Meter Condition	Hour meter is functional and in good condition

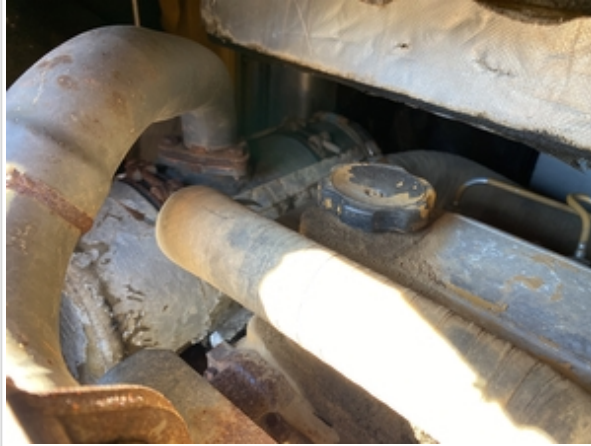
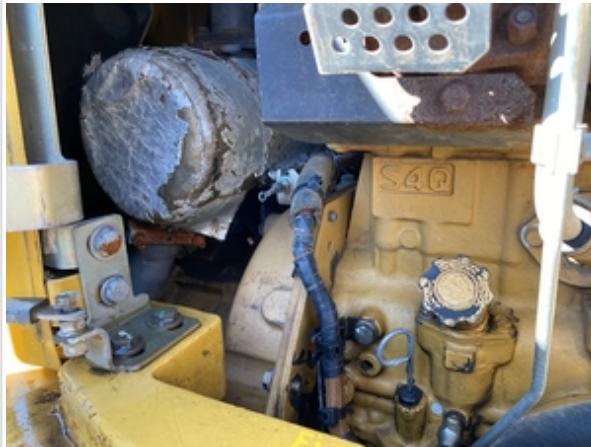
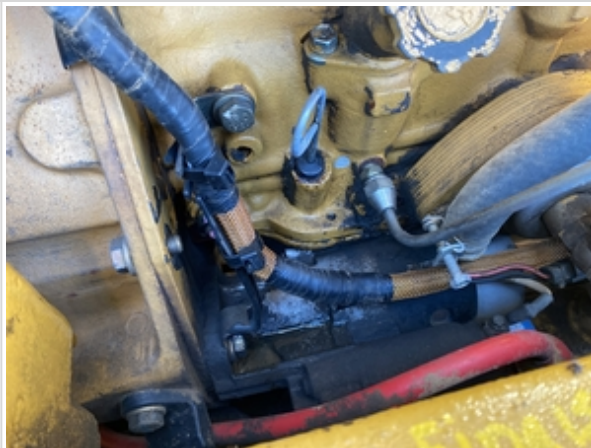
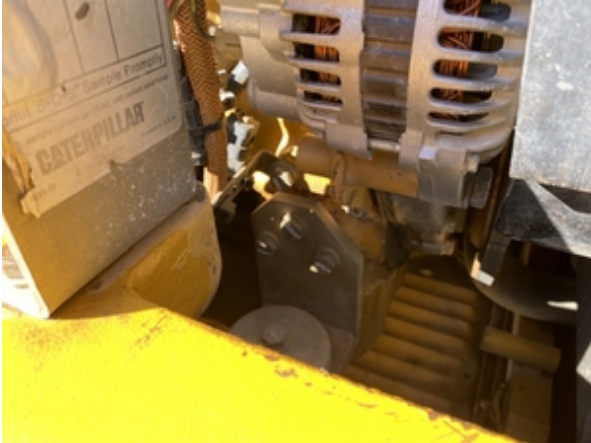
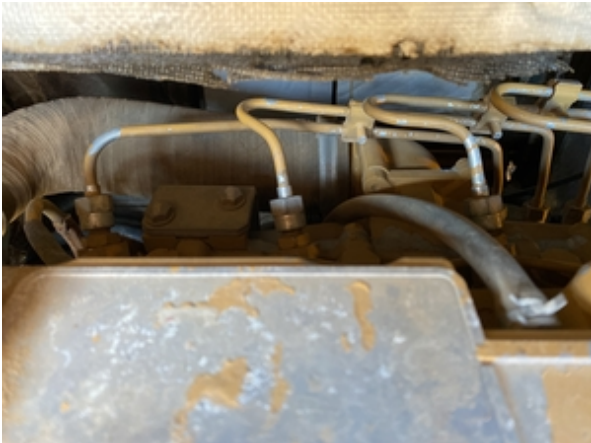
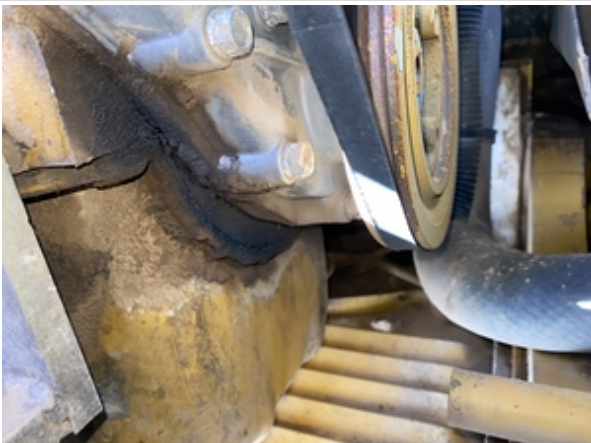
Blow-by (Visual Observation Check)	Yes
Comments	Blowby seen at breather hose
Unusual Noises (Upon Start-up, Idle, Shutdown)	No
Unusual Noise Notes	No unusual noises heard, Other (see comments)
Comments	Minor rattle sound at turbo heat shield (loose hardware, nothing major)
Engine Smoke (Upon Start-up, Idle, Shutdown)	Yes

Engine Smoke Notes	Engine smoke observed upon start up, Other (see comments)
Comments	Small amount of engine smoke seen ONLY at startup
Engine Exhaust Color	Clear
Battery	3 - Normal Wear & Tear
Battery Condition	Clean & dry appearance, tight connections, Other (see comments)
Comments	Battery stamped 2/2021
Battery Condition Photos	 
Radiator	3 - Normal Wear & Tear
Radiator Condition	Radiator fins & components appear to be in good working order, no signs of damage or leaks

Oil Color / Appearance	3 - Normal Wear & Tear
Oil Color / Appearance Notes	Appropriate oil level, Other (see comments)
Comments	Engine service recommended
Fuel Leaks	No
Equipped with DPF (Diesel Particulate Filter)	No
Requires DEF (Diesel Exhaust Fluid)	No
Overall Engine Appearance	Clean & dry
Overall Engine Comments	Overall, engine well maintained with. I major problems observed.

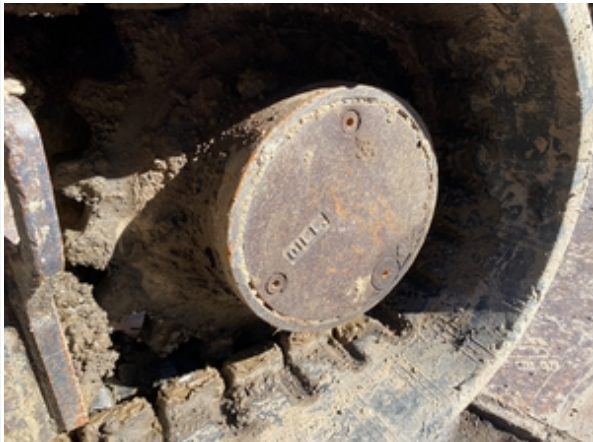
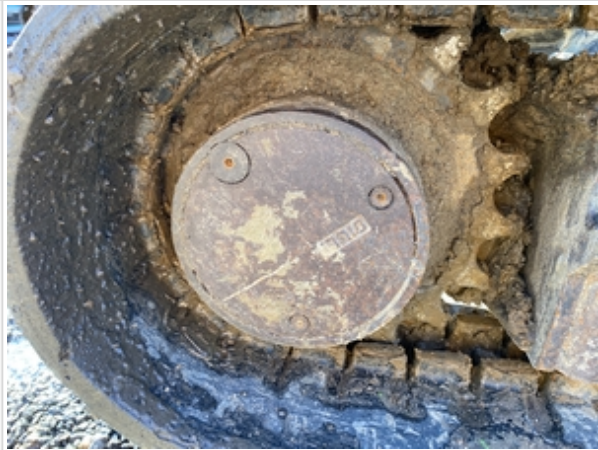
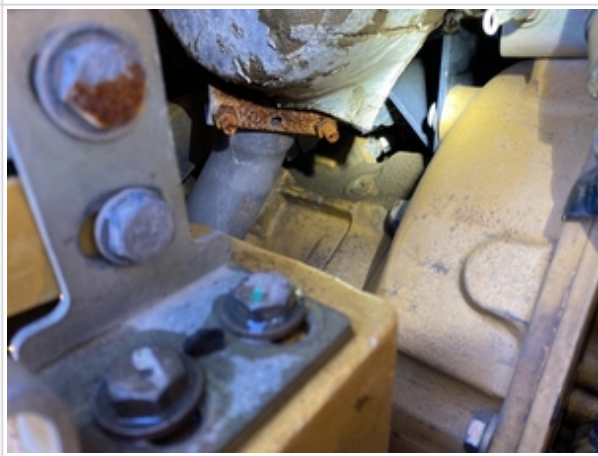
Drivetrain	Take close-up photos of the drivetrain components including transmission housing, drive shaft, drive motors, fittings, and hoses. Note any damage or wear.
Drivetrain Photos

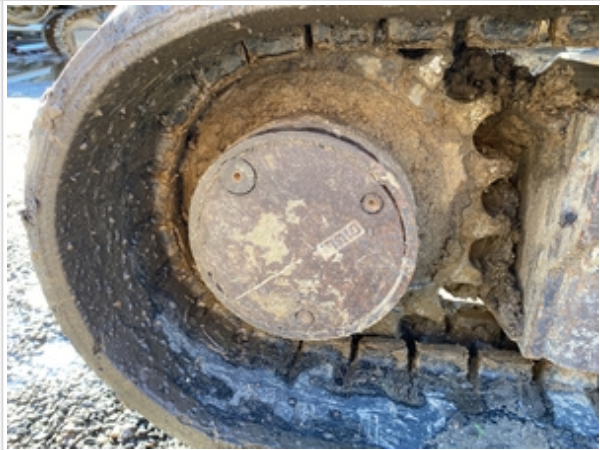
Hydrostatic Transmission?	Yes	
2 Speed?	Yes	
Hydrostatic Drive Configuration	Split Transmission	
Drive Motors	2 - Above Average Wear	
Drive Motor Photos

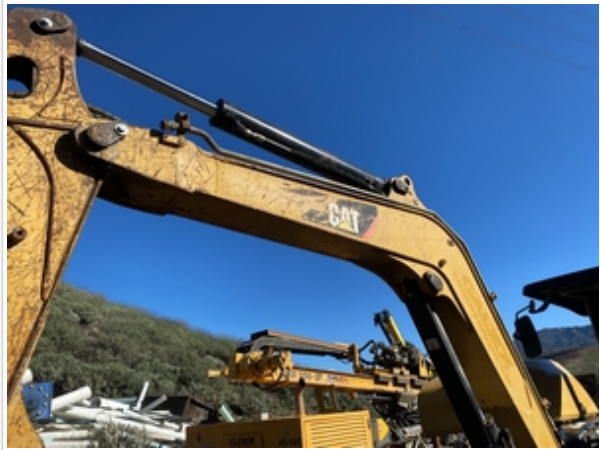
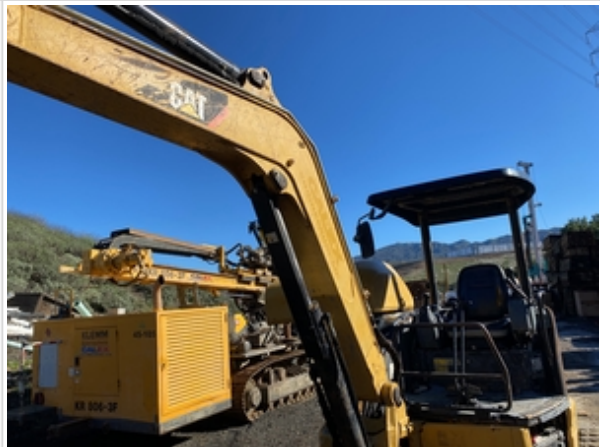
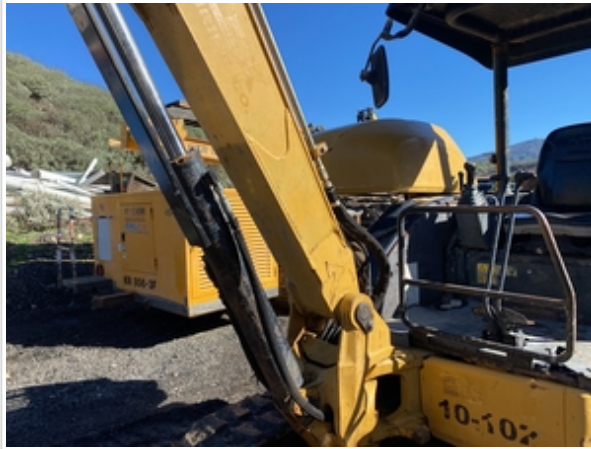
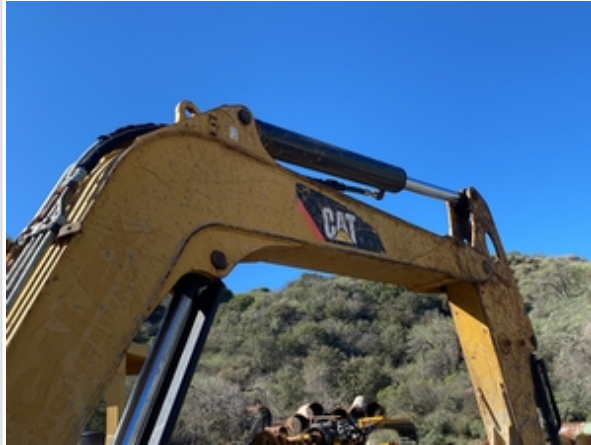
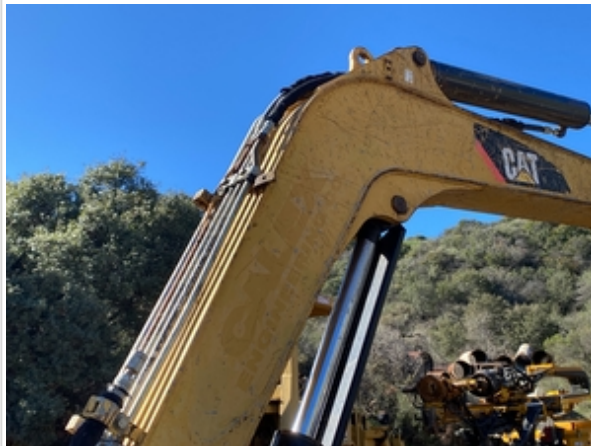
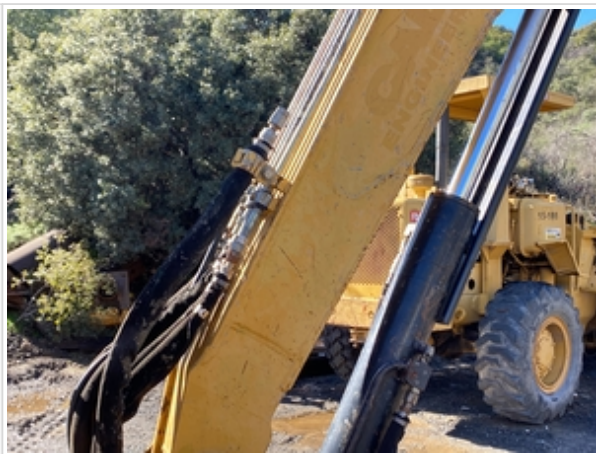
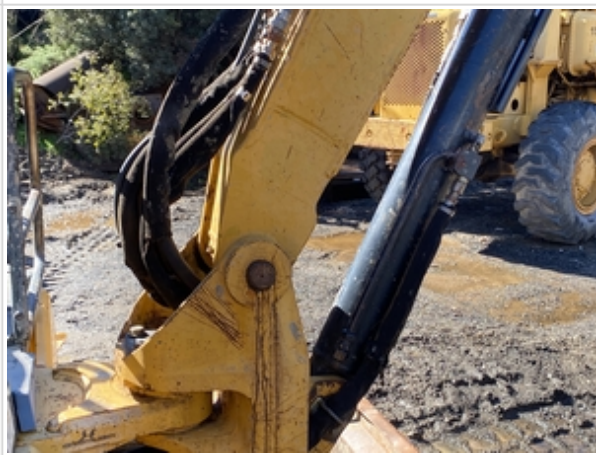
Boom Condition	3 - Normal Wear & Tear	
Boom Photos

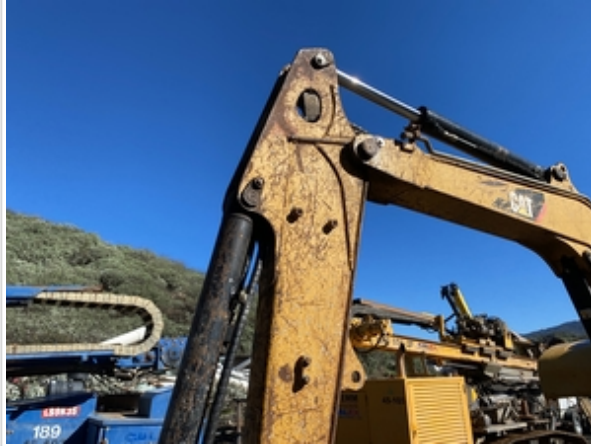
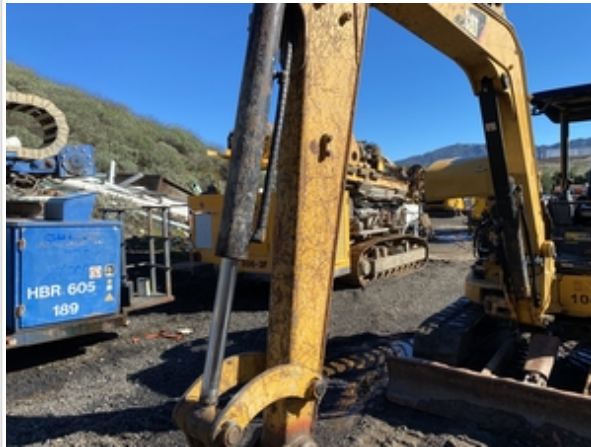
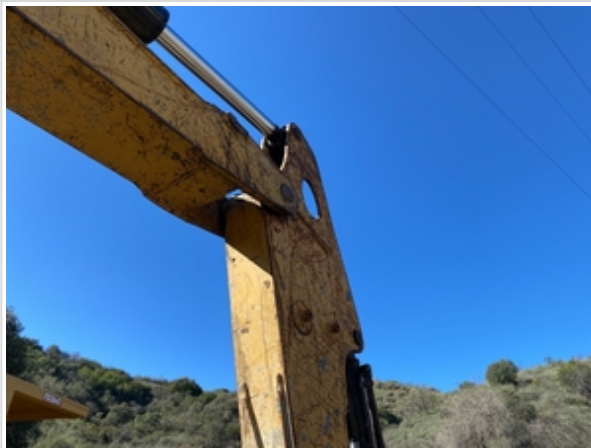
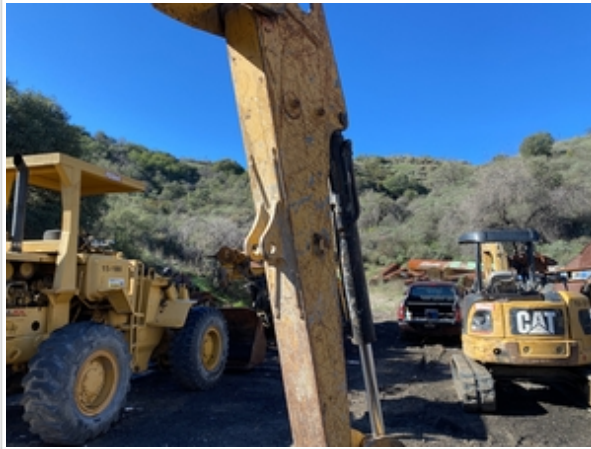
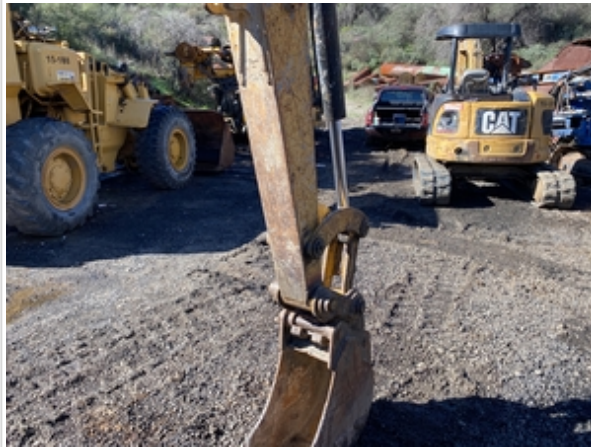
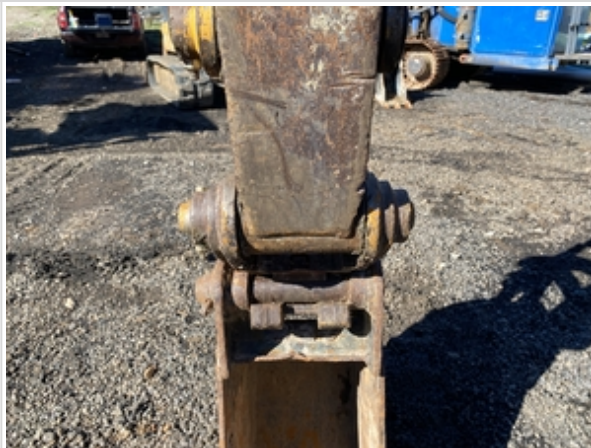
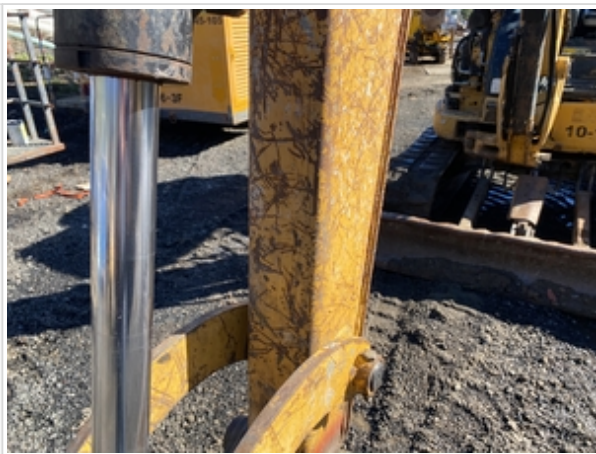
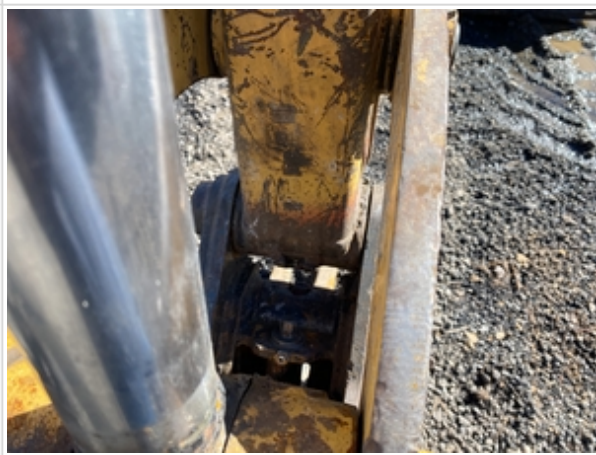
<p>Stick Condition</p>	<p>3 - Normal Wear & Tear</p>
<p>Stick Photos</p>

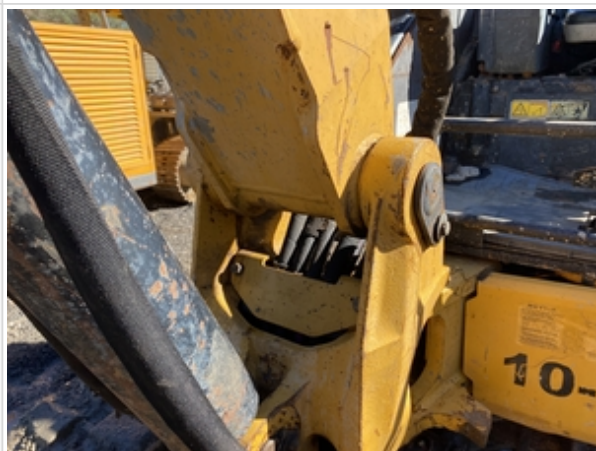
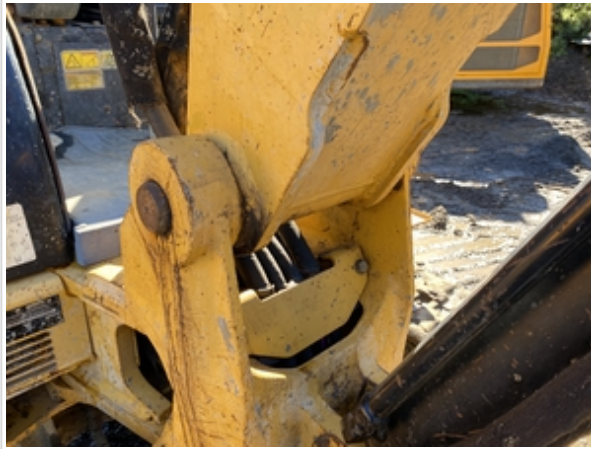
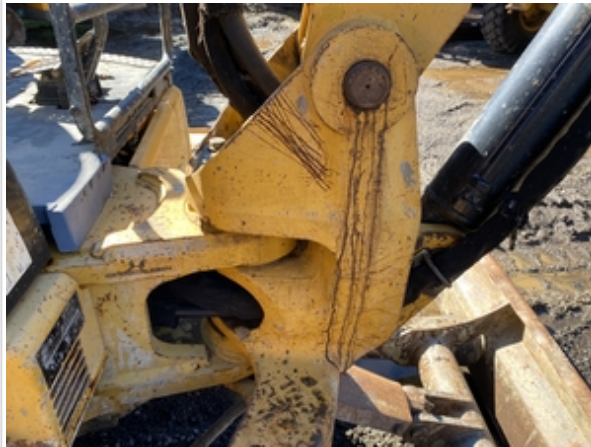
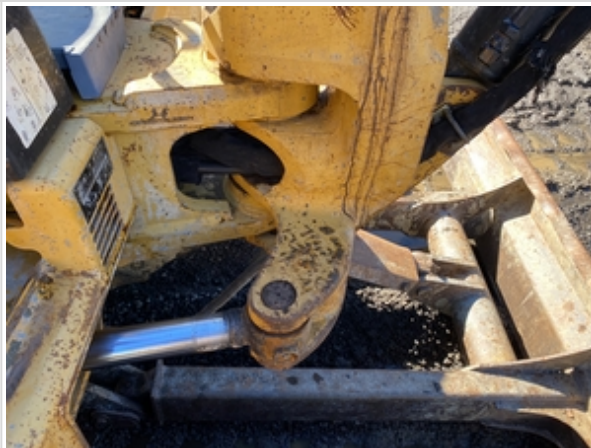
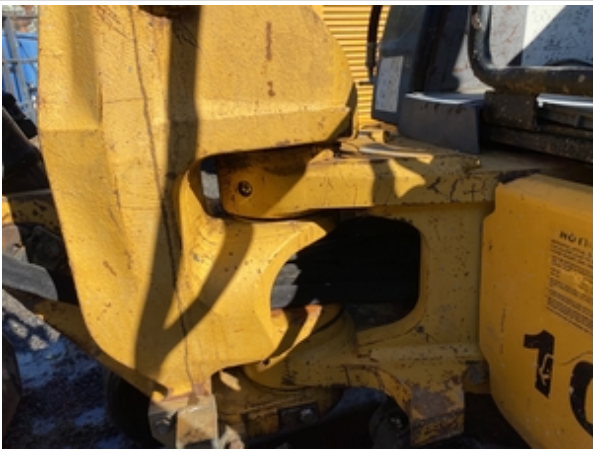
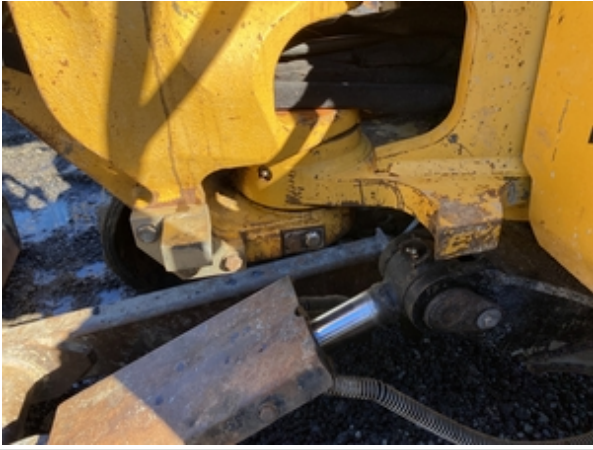
<p>Boom Base Pin & Bushings</p>	<p>3 - Normal Wear & Tear</p>	
<p>Boom Base Pin & Bushings Photos</p>

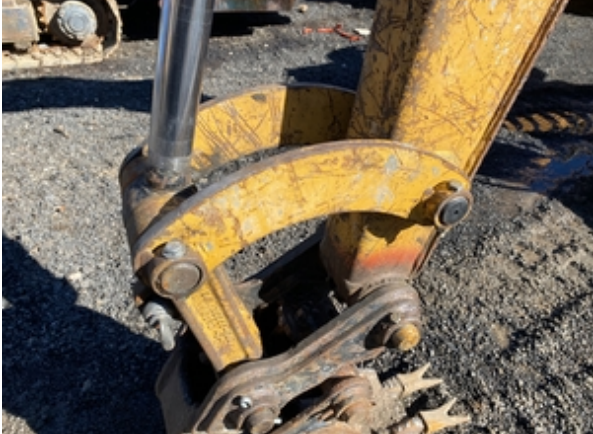
Boom to Stick Pin & Bushings	3 - Normal Wear & Tear	
Stick to Bucket Pin & Bushings	3 - Normal Wear & Tear	
Comments	Minor play in stick to bucket linkage pins	
Stick to Bucket Pin & Bushings Photos

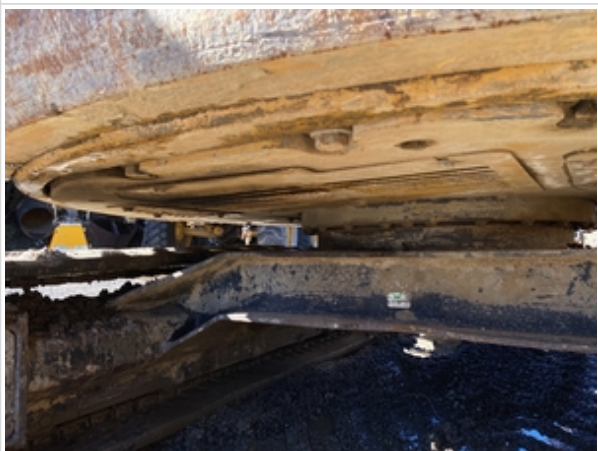
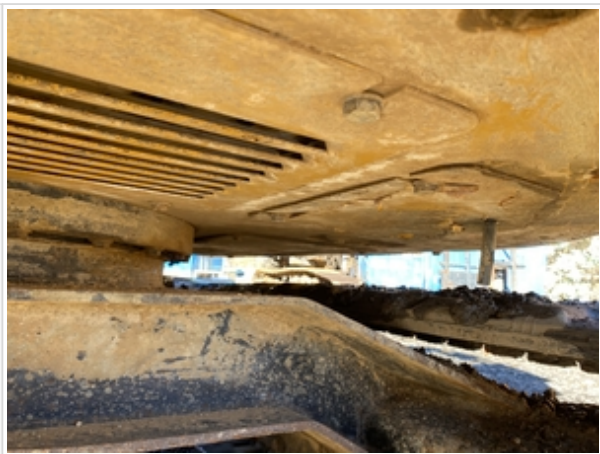
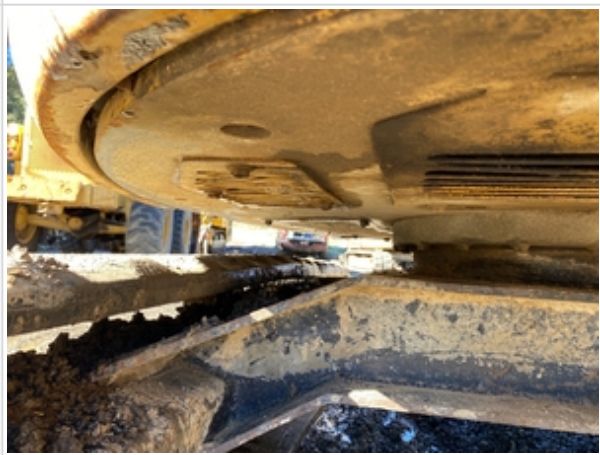
<p>Bottom Covers</p>	<p>3 - Normal Wear & Tear</p>	
<p>Bottom Covers Photos</p>

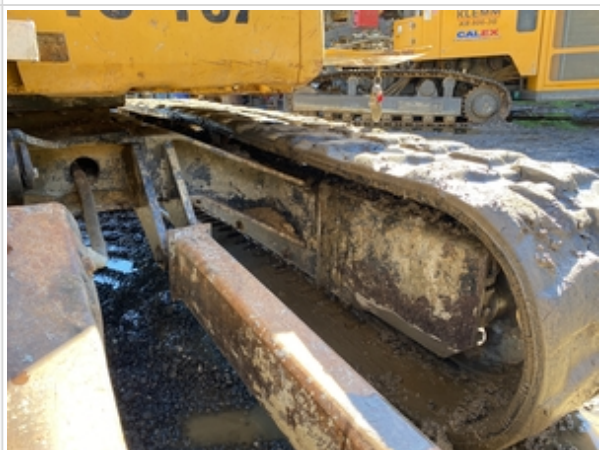
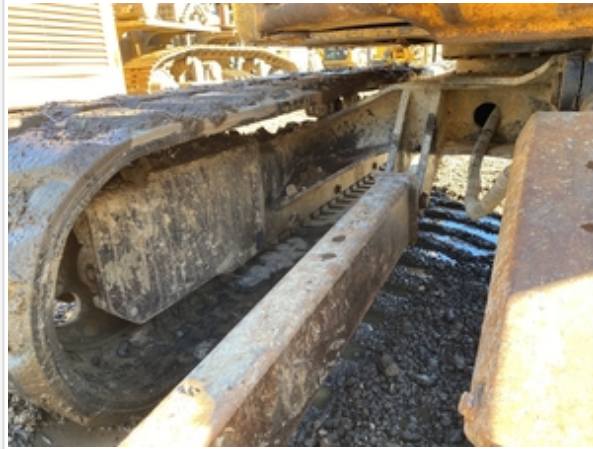
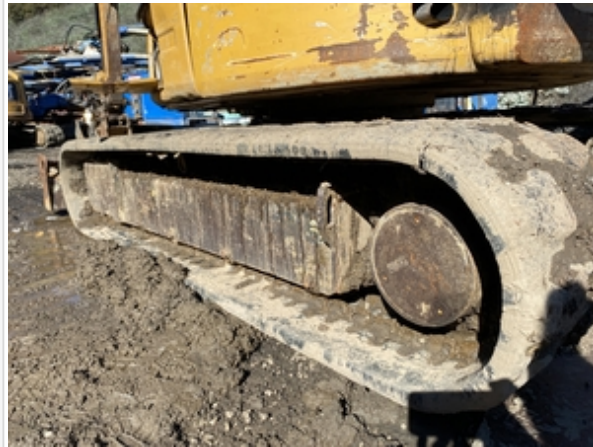
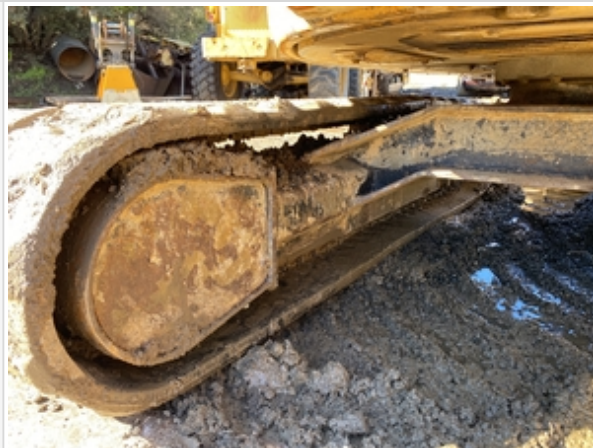
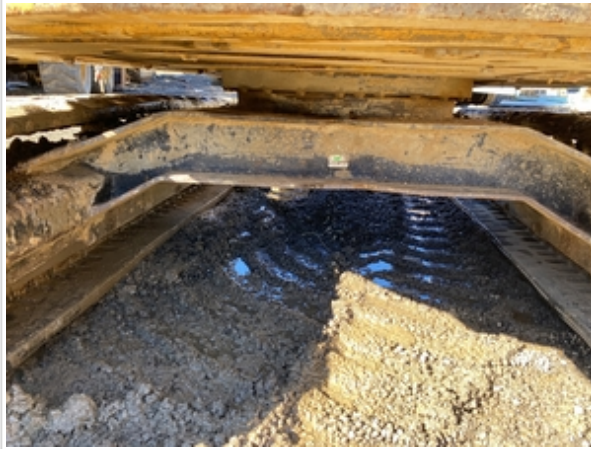
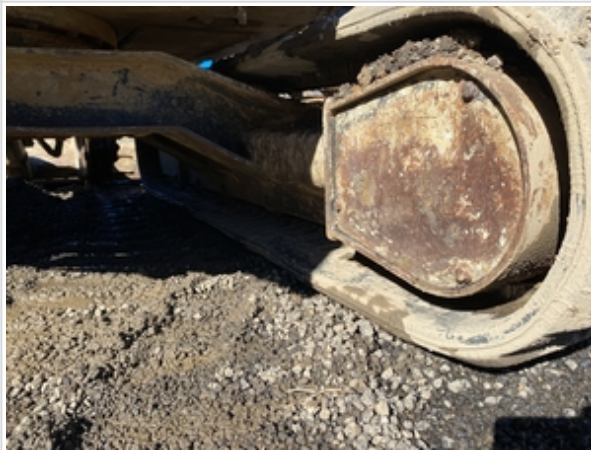
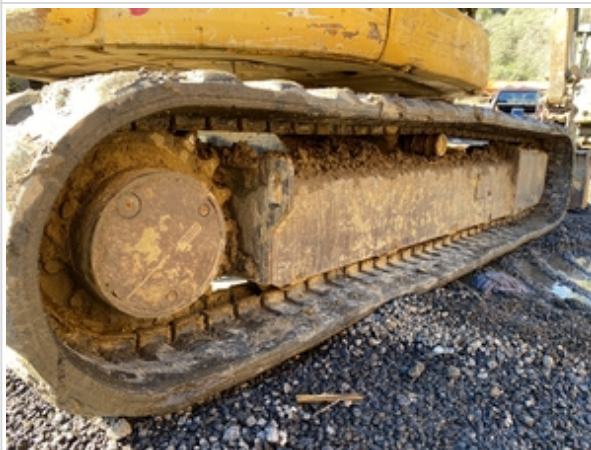
Roller Frames	3 - Normal Wear & Tear	
Roller Frames Photos

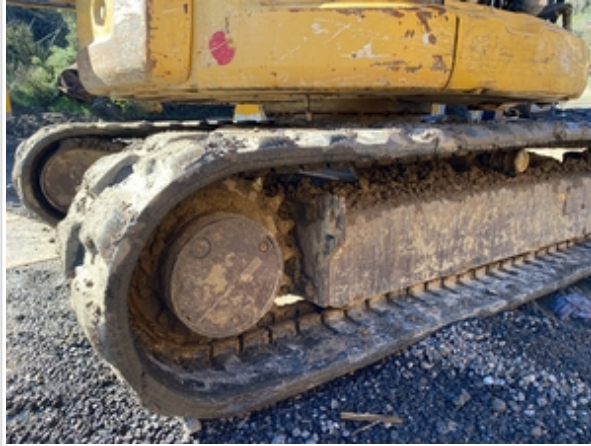
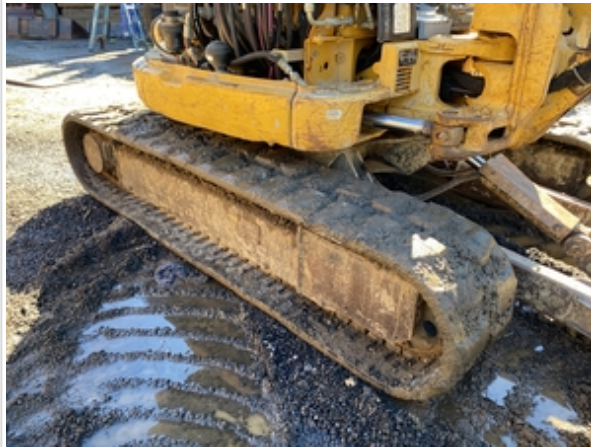
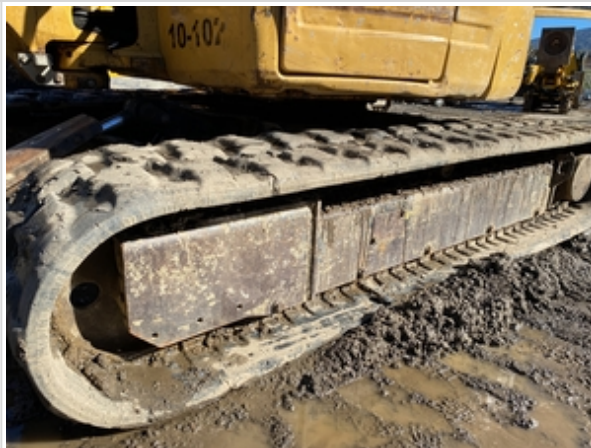
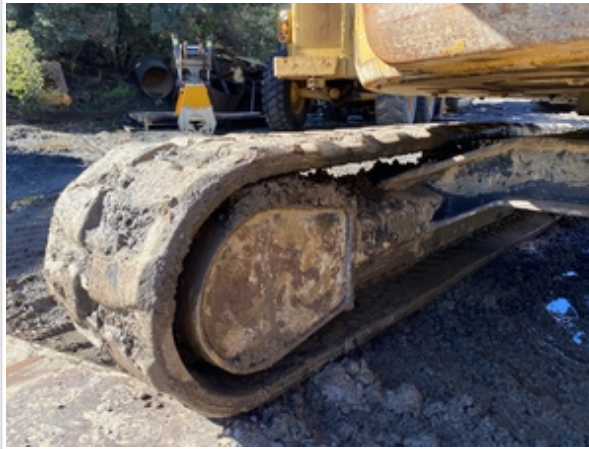
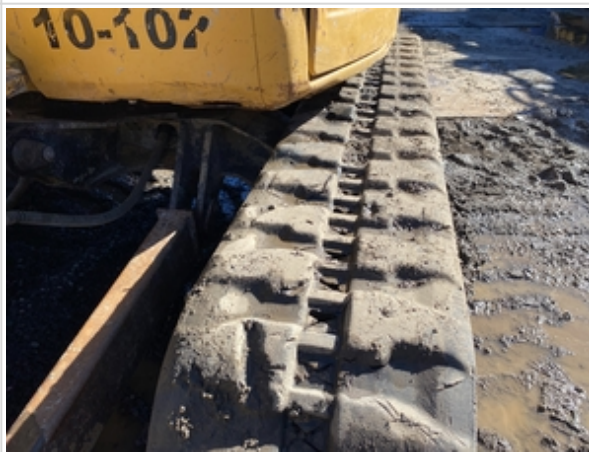
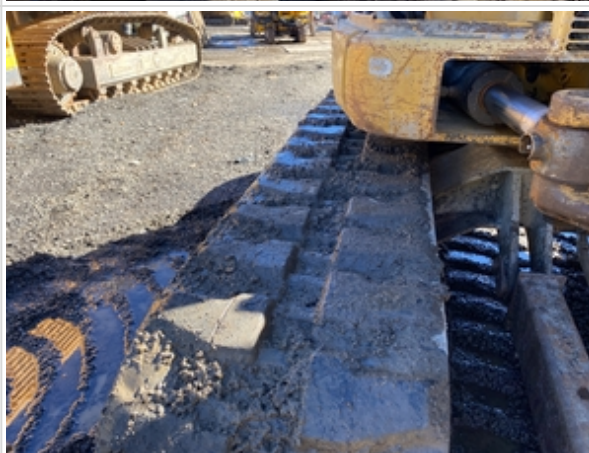
Track Belt

3 - Normal Wear & Tear

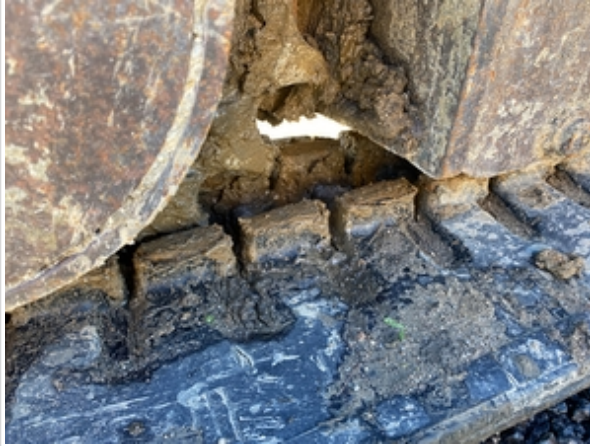
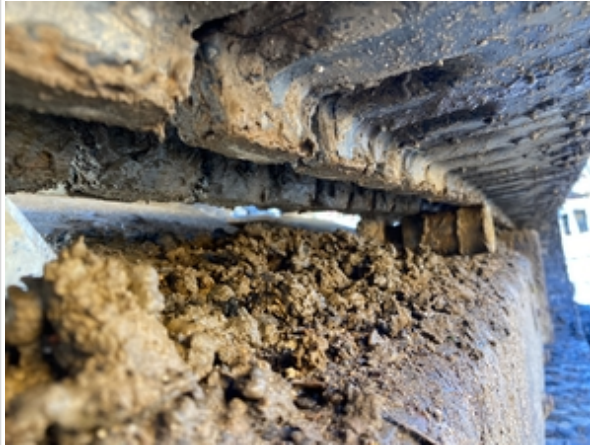
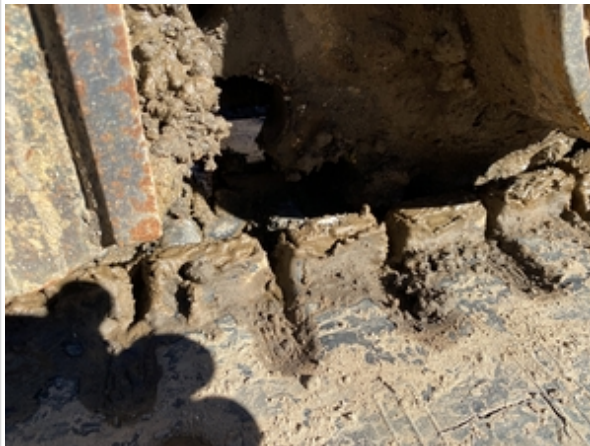
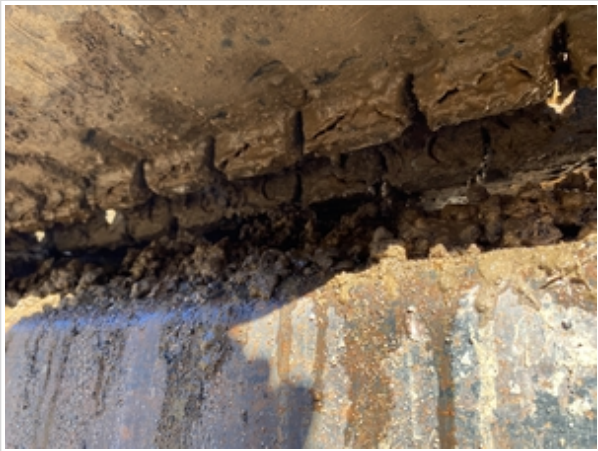
Rubber Belt Drive Lugs

3 - Normal Wear & Tear

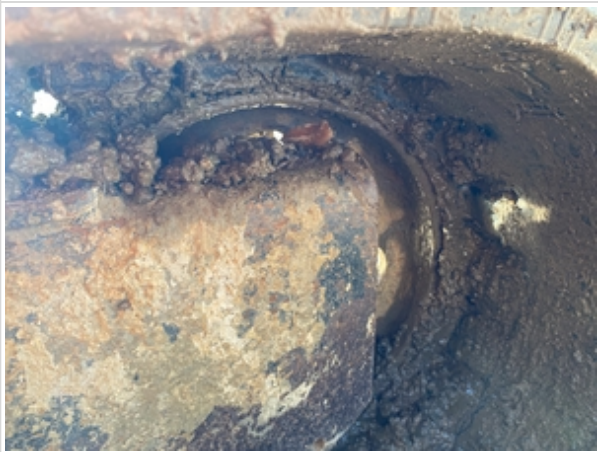
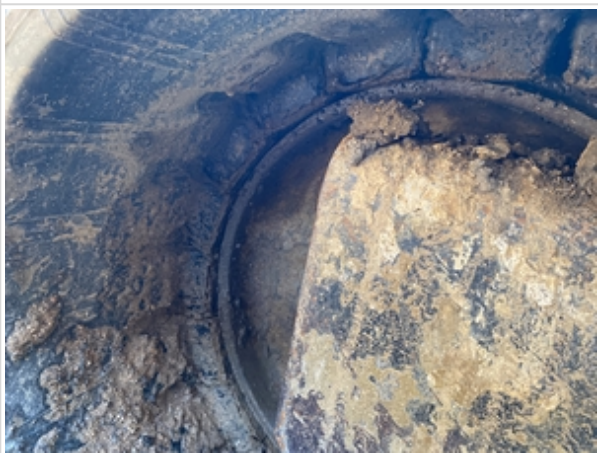
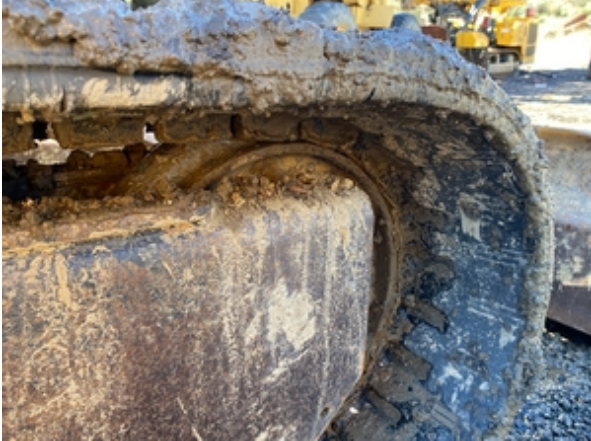
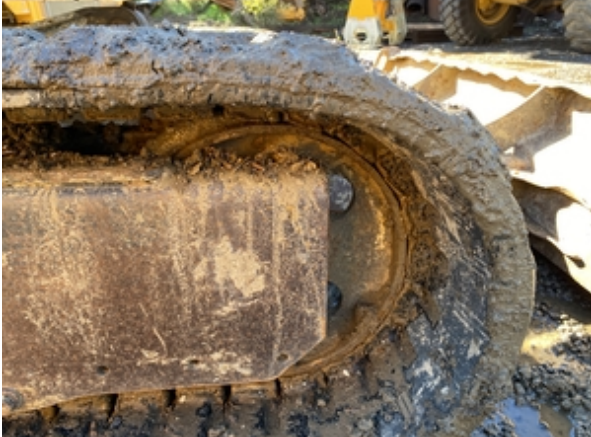
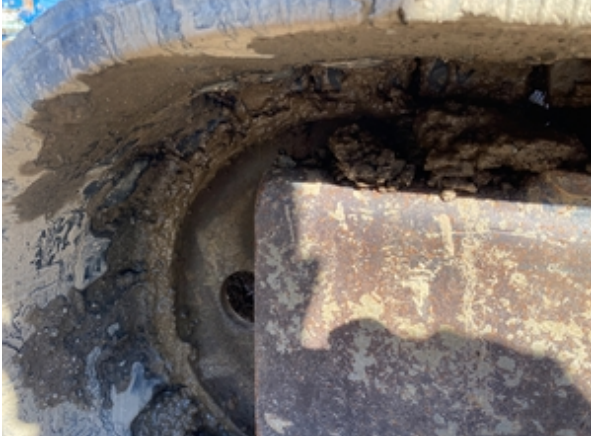
Track Tensioners	3 - Normal Wear & Tear	
Front Idlers	3 - Normal Wear & Tear	
Front Idlers Photos

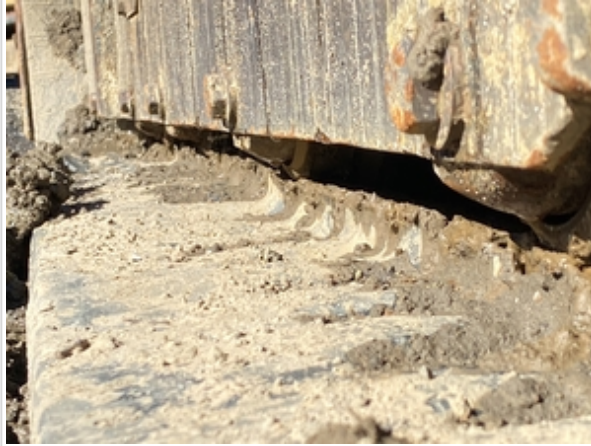
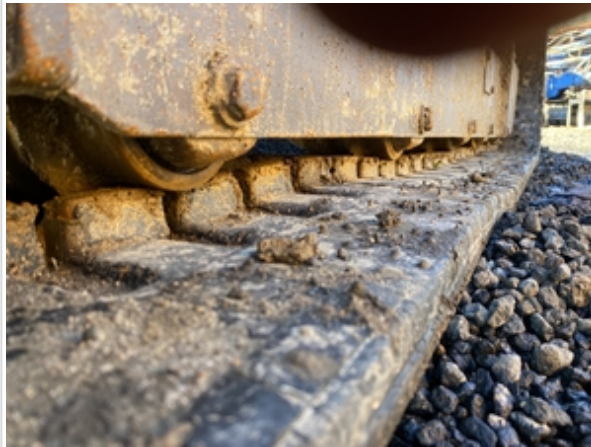
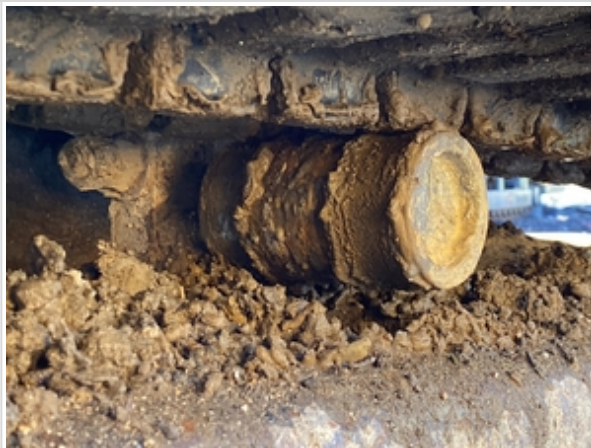
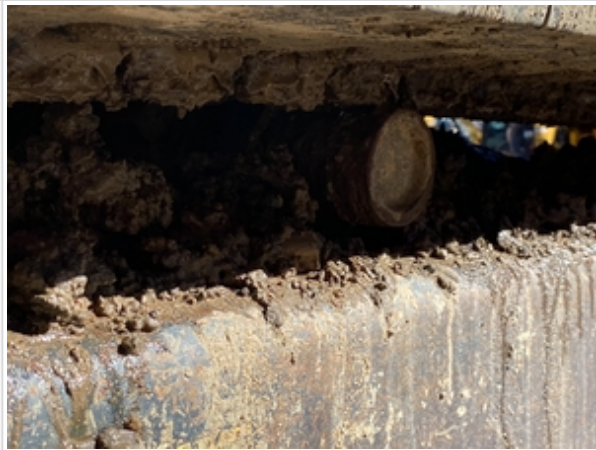
Rear Idlers	0
Track Rollers	3 - Normal Wear & Tear

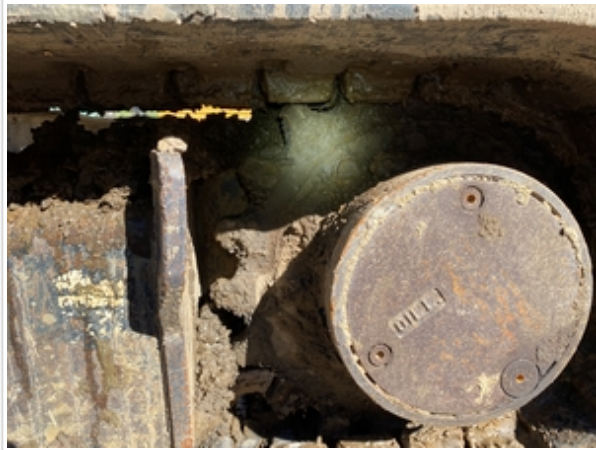
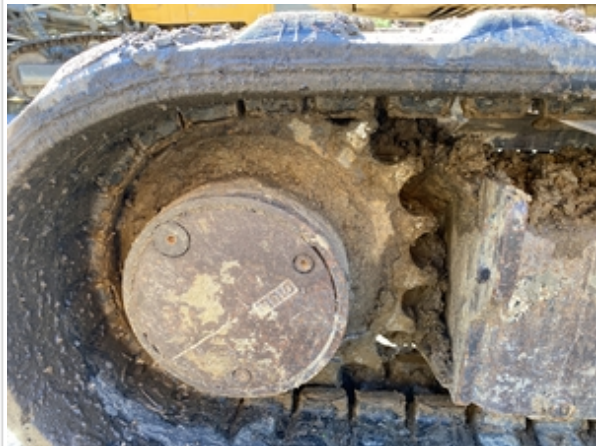
Sprockets	3 - Normal Wear & Tear	
Sprockets Photos

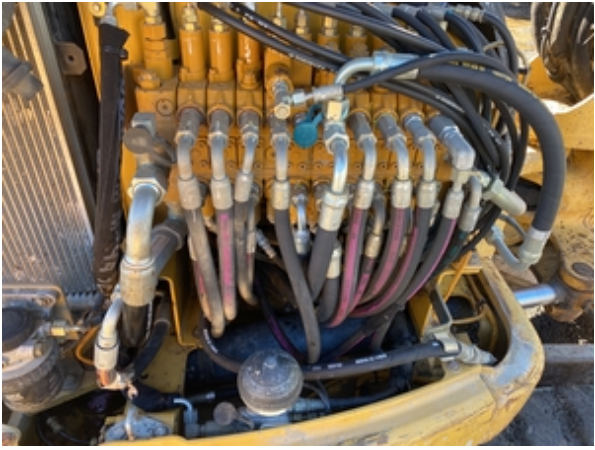
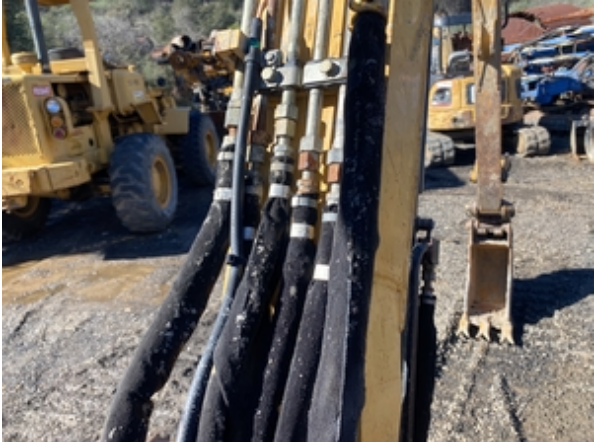
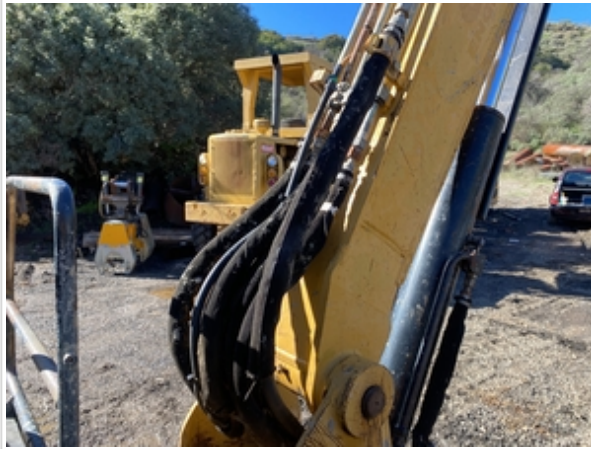
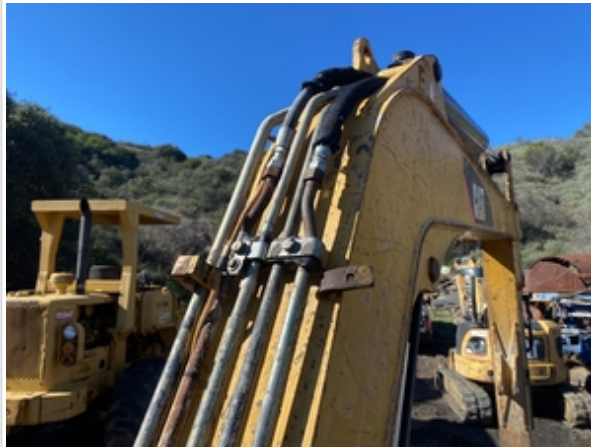
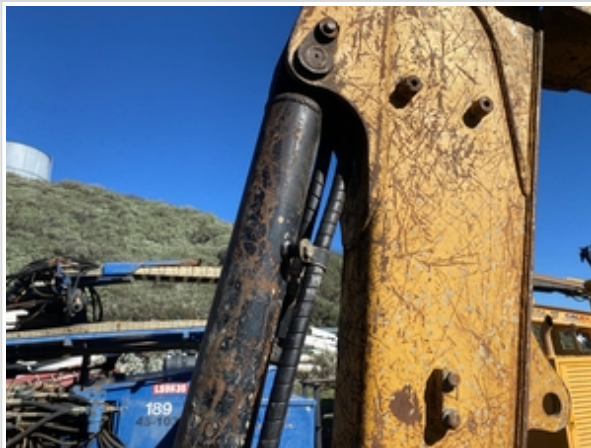
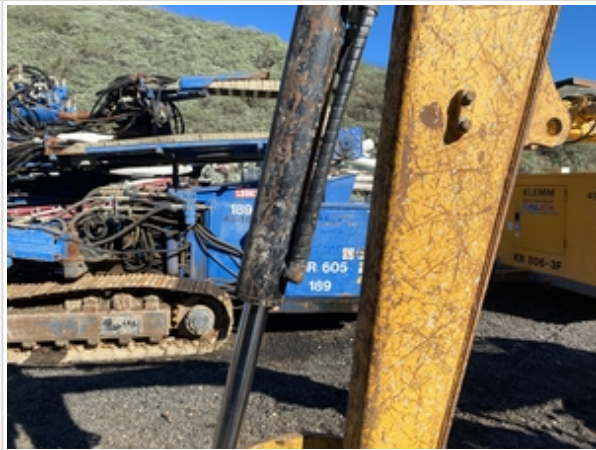
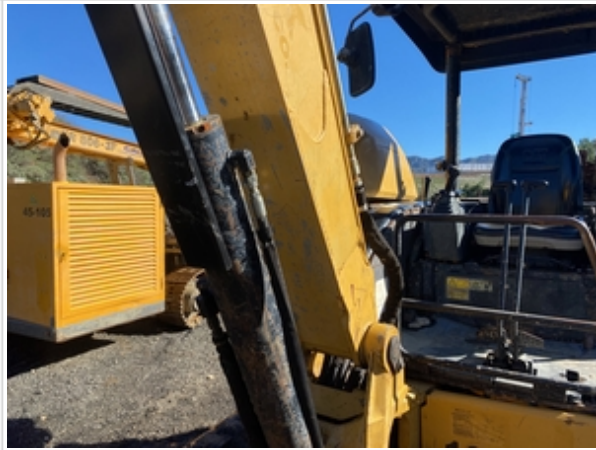
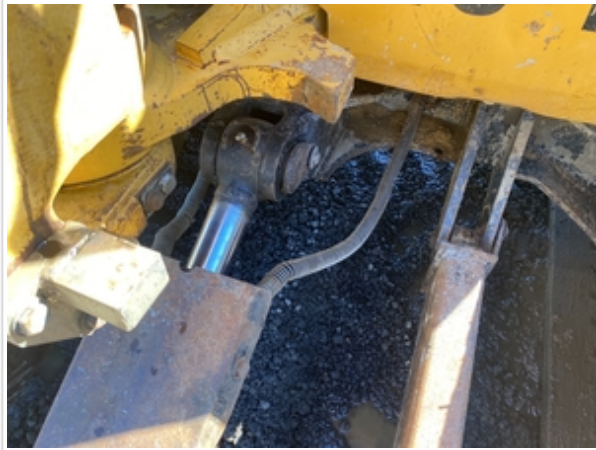
Wet or Damp Hydraulic Lines / Fittings	No	
Appearance of Hydraulic Lines / Fittings	3 - Normal Wear & Tear	
Hydraulic Lines / Fittings Condition	Hydraulic lines & fittings are clean and in good condition	
Appearance of Hydraulic Lines / Fittings Photos

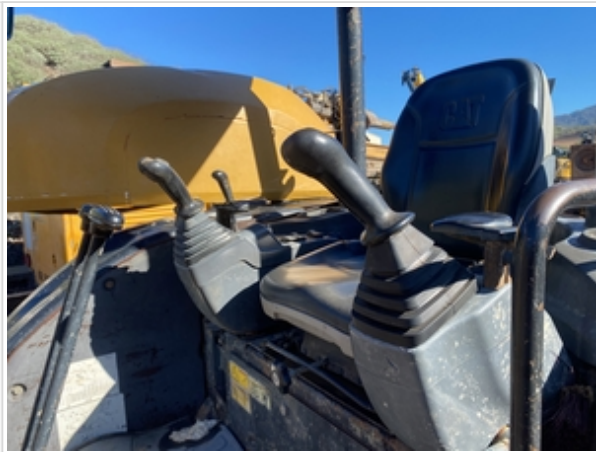
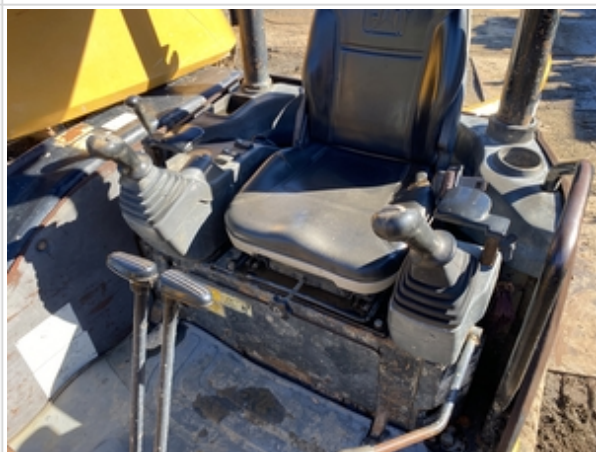
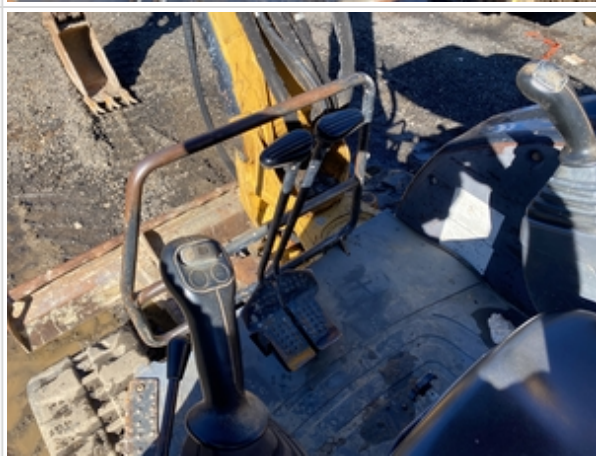
External Controls / Levers Photos

Unusual Noises (Hydraulic Pump)	No
Hydraulic Pump Notes	No unusual noises heard during operation
External Controls / Levers	3 - Normal Wear & Tear
External Controls / Levers Condition	Good function & condition of hydraulic controls
