Inspection Report (Mini Excavator)

Year	2007
Make	CAT
Model	305C cr
Serial Number	HWJ02087
Hour Meter Reading	252Hrs.
Previous Application (e.g., earth moving, mining, demolition, etc)	General Construction

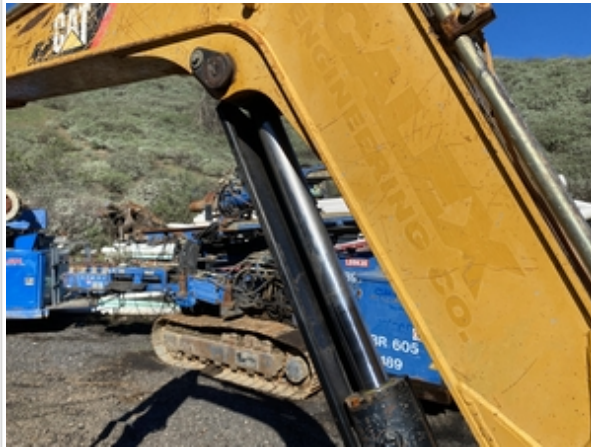
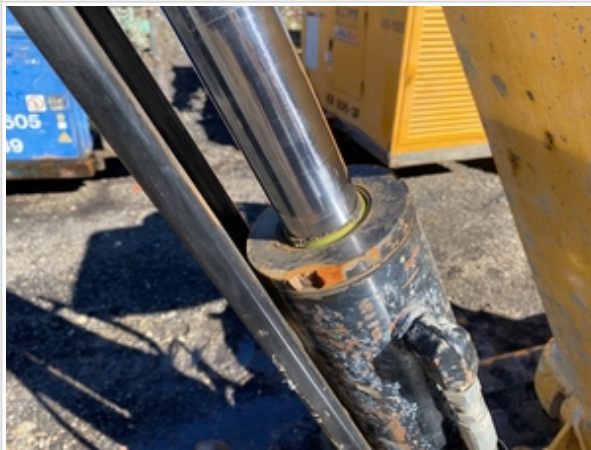
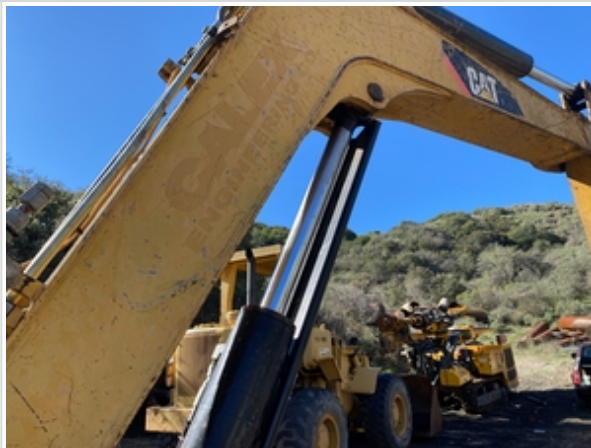
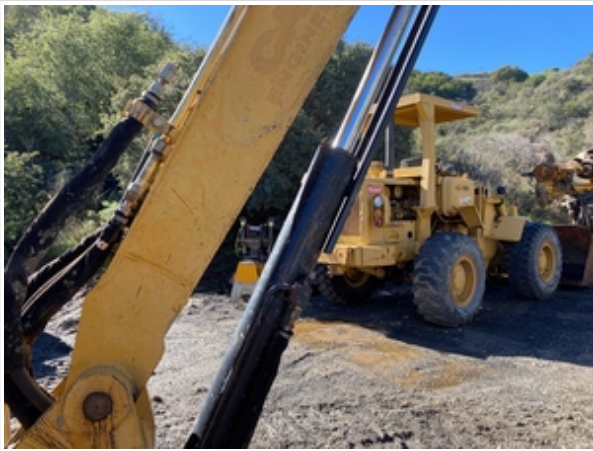
Boom Cylinder Photos

Boom Cylinder: Mounting Pin	3 - Normal Wear & Tear
Boom Cylinder: Oil Leaks	No

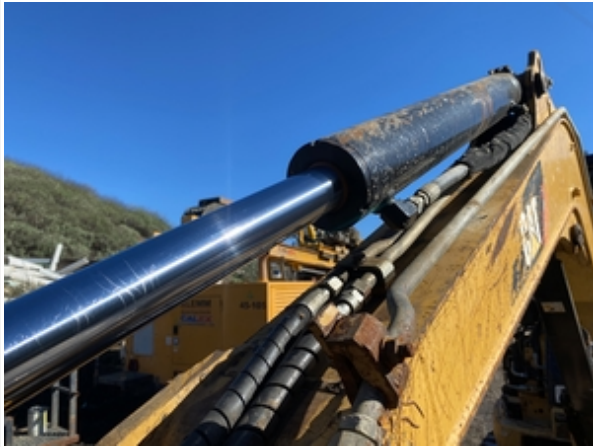
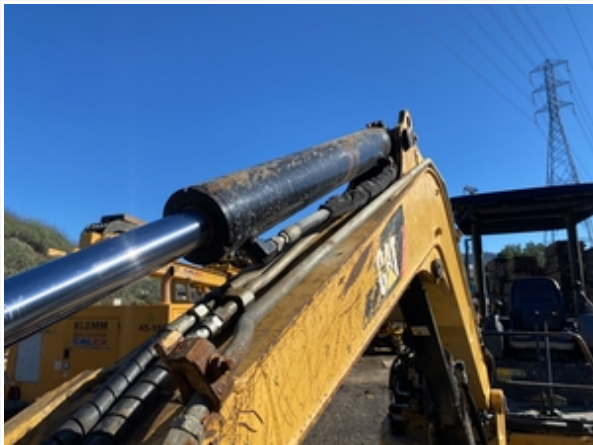
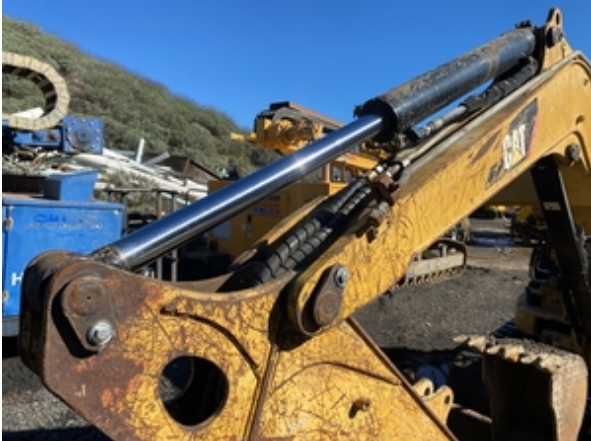
Stick Cylinder: Mounting Pin	3 - Normal Wear & Tear	
Stick Cylinder: Oil Leaks	No	
Stick Cylinder Photos

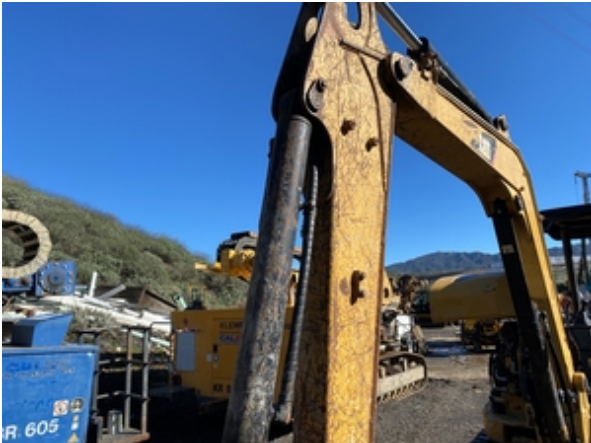
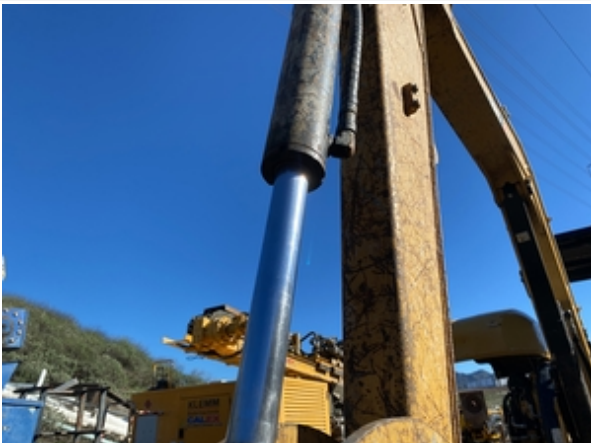
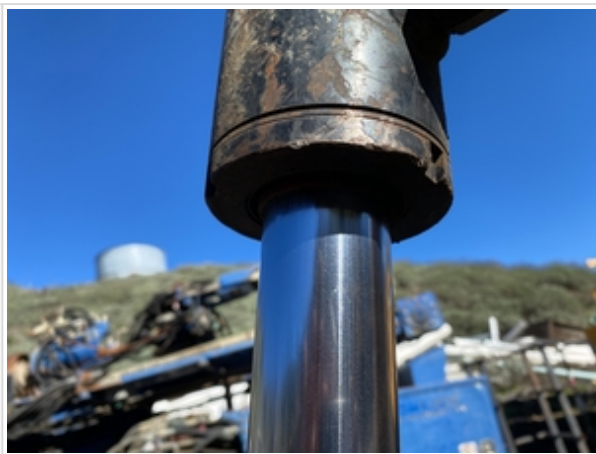
Bucket Cylinder: Mounting Pin	3 - Normal Wear & Tear	
Bucket Cylinder: Oil Leaks	No	
Bucket Cylinder Photos

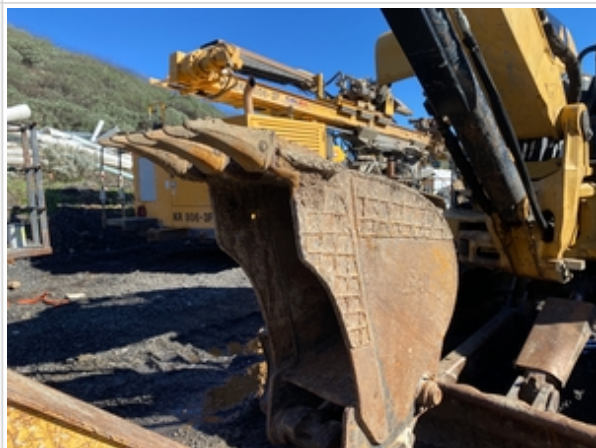
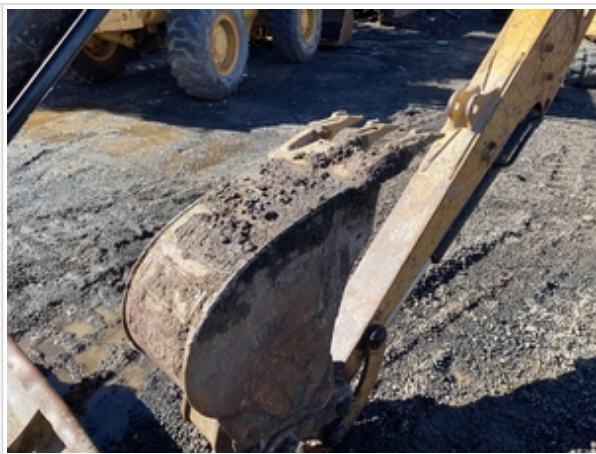
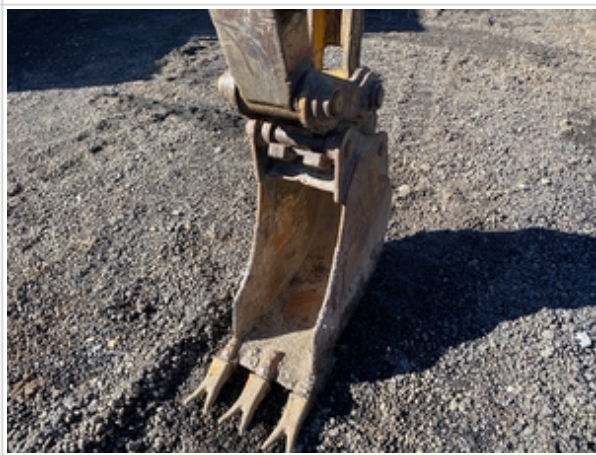
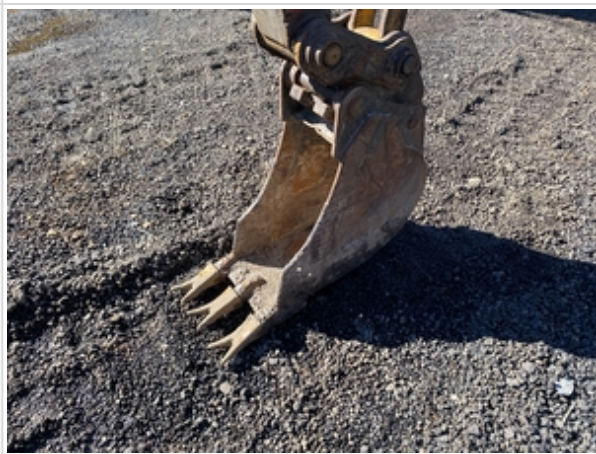
<p>Bucket Condition</p>	<p>3 - Normal Wear & Tear</p>
<p>Bucket Photos</p>

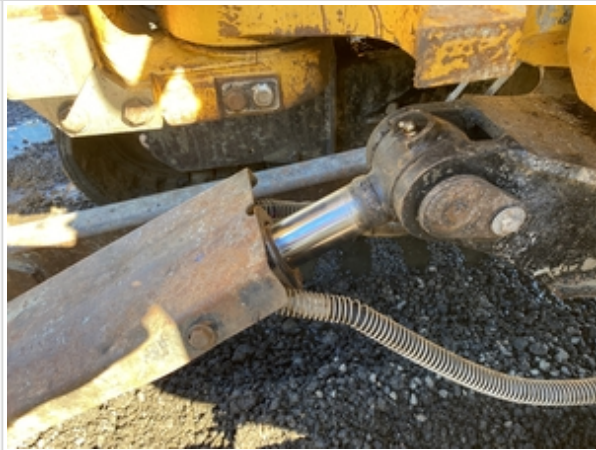
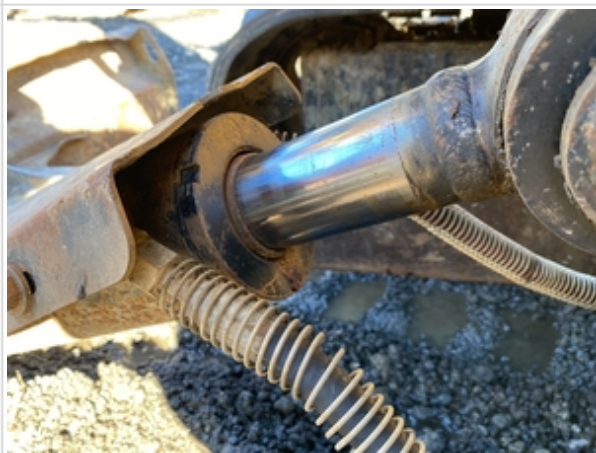
Blade Cylinder Photos

Blade Condition	3 - Normal Wear & Tear	
Blade Edge	3 - Normal Wear & Tear	
Blade Hose & Fittings	3 - Normal Wear & Tear	
Blade Cylinder	3 - Normal Wear & Tear
