## Inspection Report (Mini Excavator)

Year	2016
Make	John Deere
Model	50G
Serial Number	1FF050GXLGH284069
Hour Meter Reading	2,885
Previous Application (e.g., earth moving, mining, demolition, etc)	General Construction

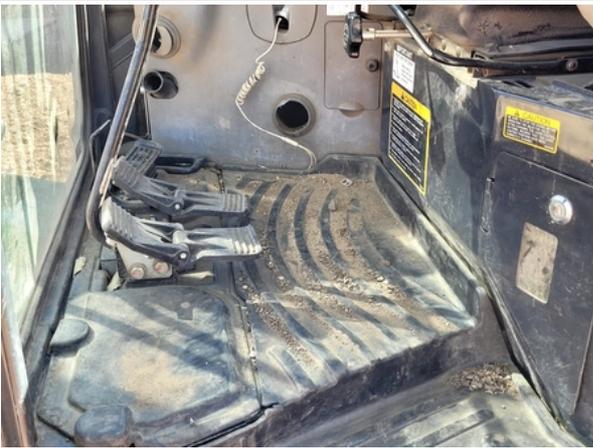
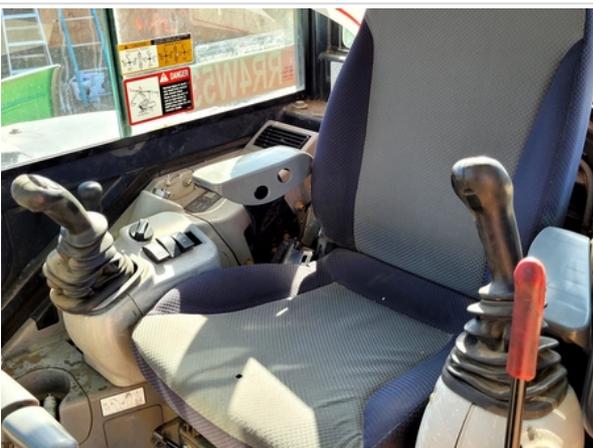
<p>A photograph of a metal serial number plate for a John Deere hydraulic excavator. The plate is mounted on a green surface. It contains the following information:</p> <ul style="list-style-type: none"> <li>Model: 510</li> <li>Product Identification Number: J1FFU50CKL0F2B7069</li> <li>JOHN DEERE</li> <li>DEERE &amp; COMPANY MOLINE, ILLINOIS, USA</li> <li>MADE IN JAPAN</li> </ul>
Operator Cabin Overall	3 - Normal Wear & Tear
Operator Cabin Overall Condition	Good cabin appearance, solid floors, panels, and ceiling
Operator Cabin Photos

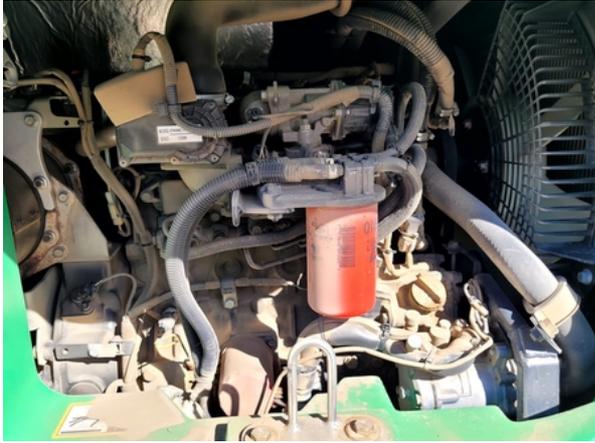
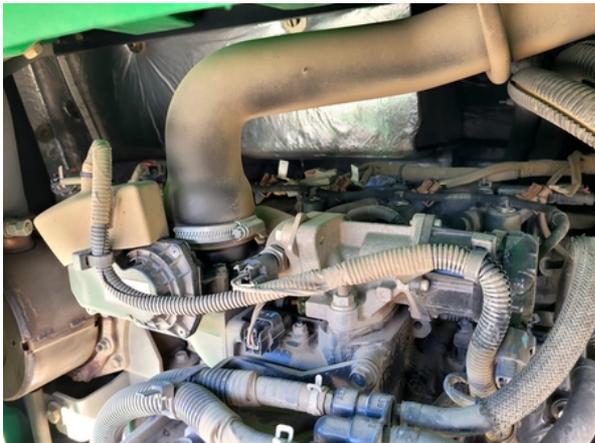
Engine Type (Make, Model, Cylinders, Hp)	Yanmar - 4TNV88C - 4 Cyl - 36HP
Emissions Tier	Tier 4F
Engine Serial Number	N/A
Engine Fuel Type	Diesel
Engine Photos

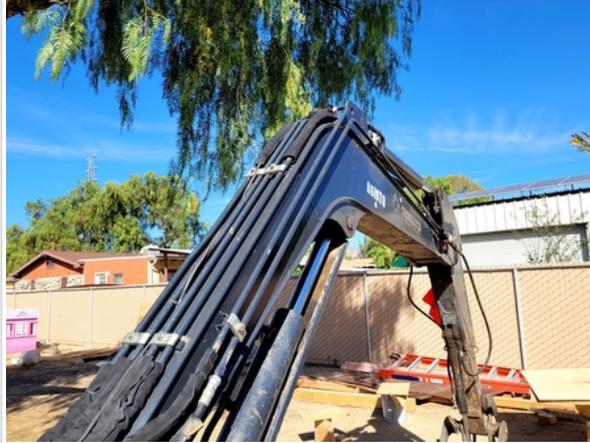
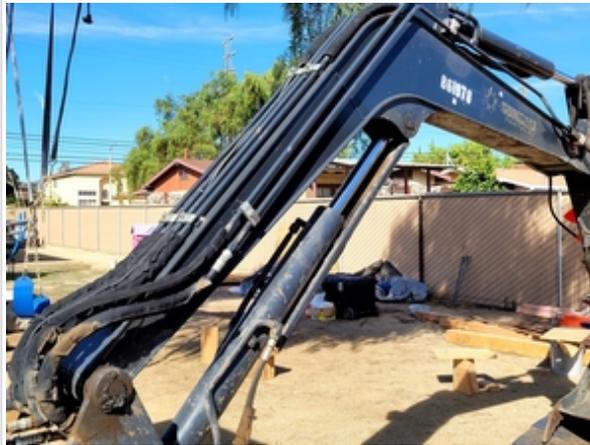
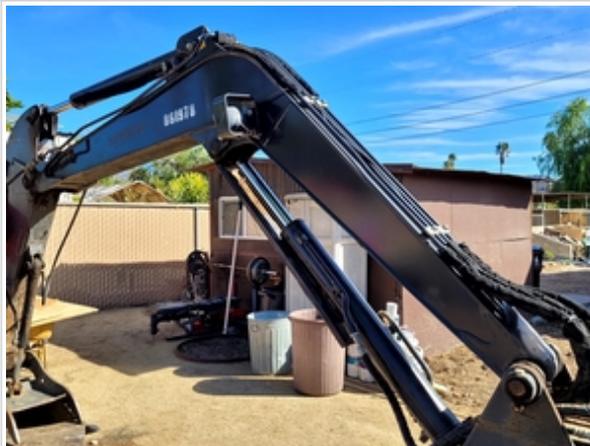
Boom Photos

Boom Condition	3 - Normal Wear & Tear
----------------	------------------------

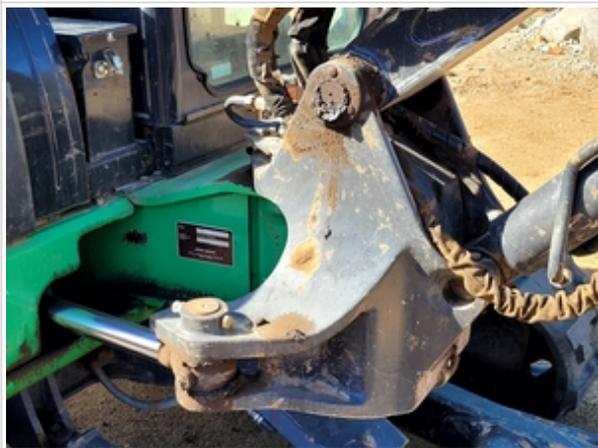
<p><b>Boom Base Pin &amp; Bushings</b></p>	<p>3 - Normal Wear &amp; Tear</p>	
<p><b>Boom Base Pin &amp; Bushings Photos</b></p>

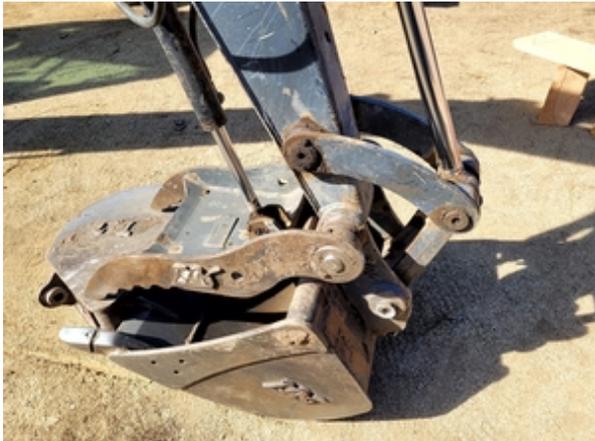
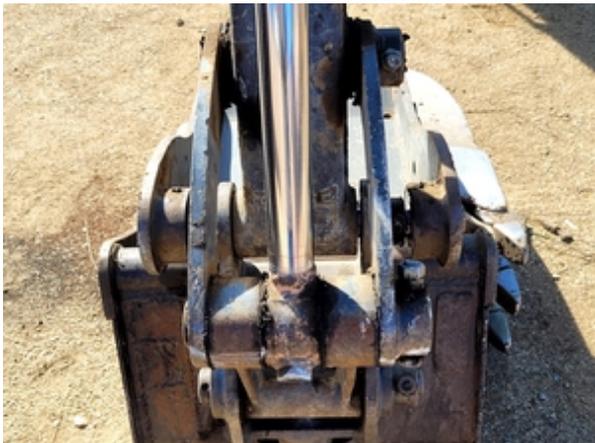
<b>Boom to Stick Pin &amp; Bushings</b>	3 - Normal Wear & Tear
<b>Stick to Bucket Pin &amp; Bushings</b>	3 - Normal Wear & Tear
<b>Stick to Bucket Pin &amp; Bushings Photos</b>

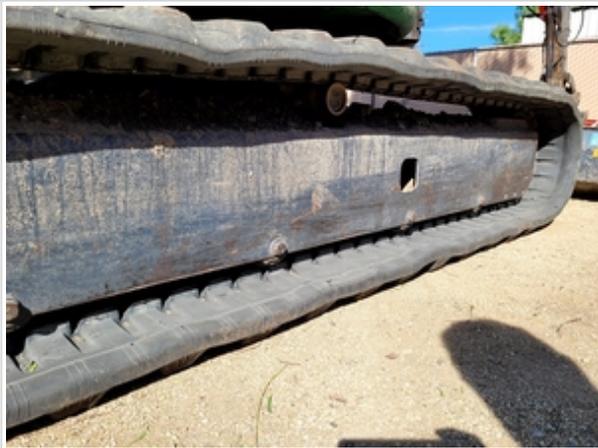
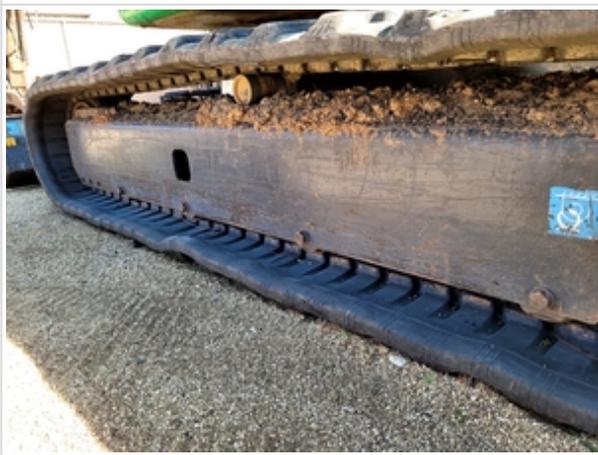
Roller Frames	3 - Normal Wear & Tear
Roller Frames Photos

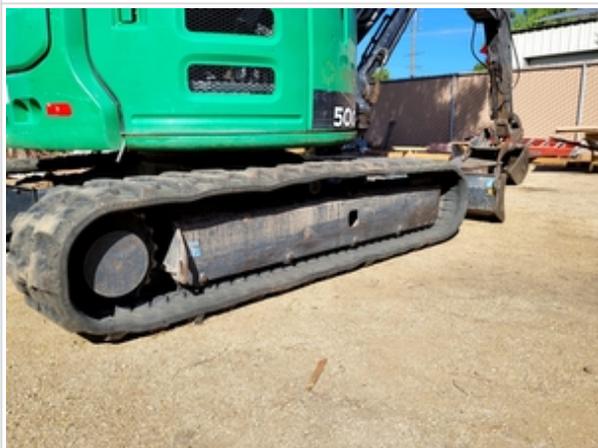
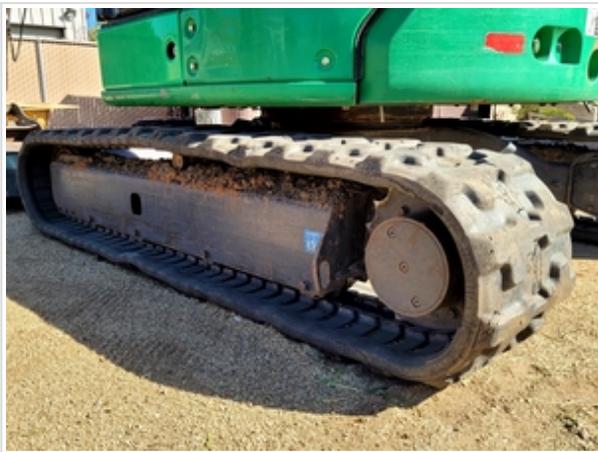
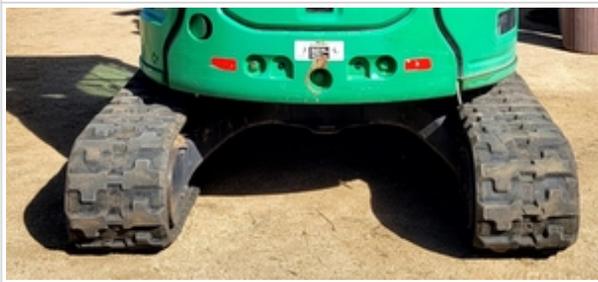
Track Belt	3 - Normal Wear & Tear
Track Belt Photos

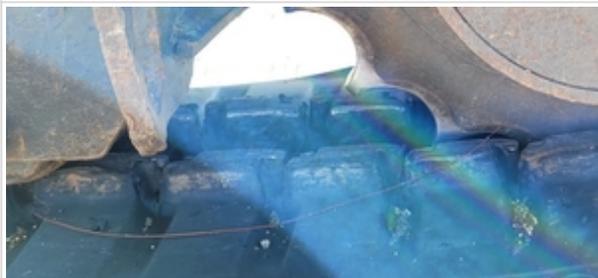
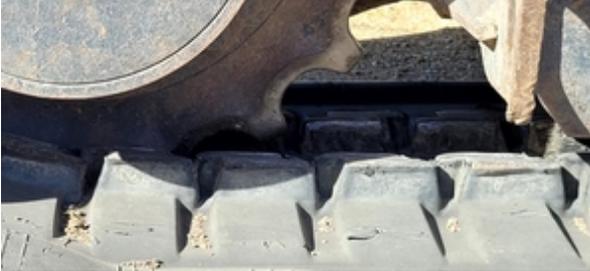
<p><b>Rubber Belt Drive Lugs</b></p>	<p>3 - Normal Wear &amp; Tear</p>	
<p><b>Rubber Belt Drive Lugs Photos</b></p>

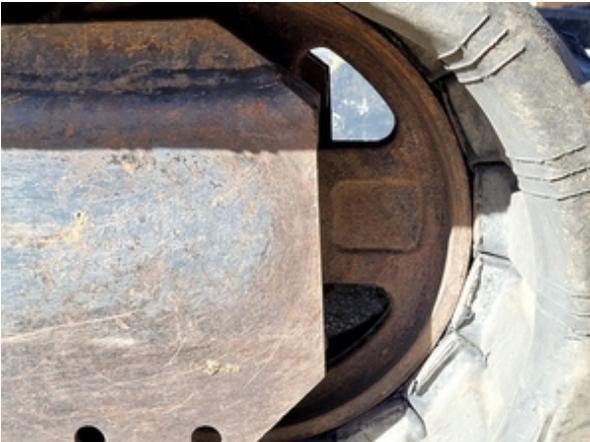
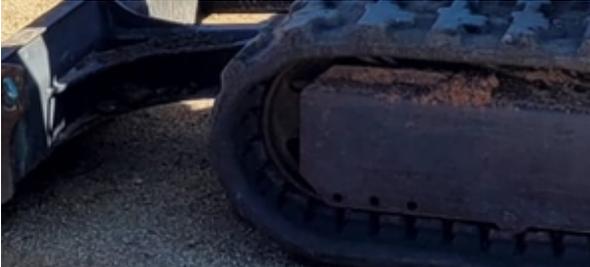
<b>Track Tensioners</b>	3 - Normal Wear & Tear	
<b>Front Idlers</b>	3 - Normal Wear & Tear	
<b>Front Idlers Photos</b>

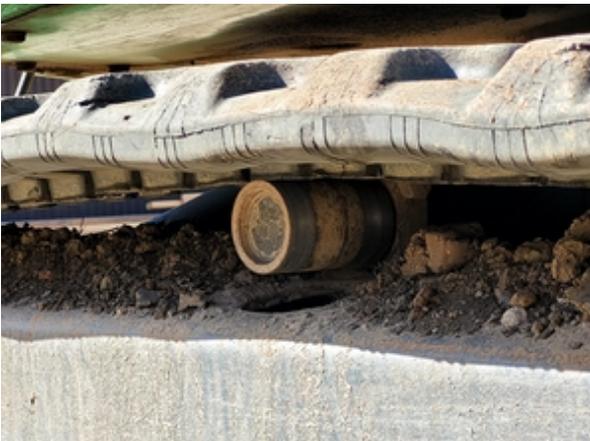
<b>Rear Idlers</b>	0	
<b>Track Rollers</b>	3 - Normal Wear & Tear	
<b>Track Rollers Photos</b>

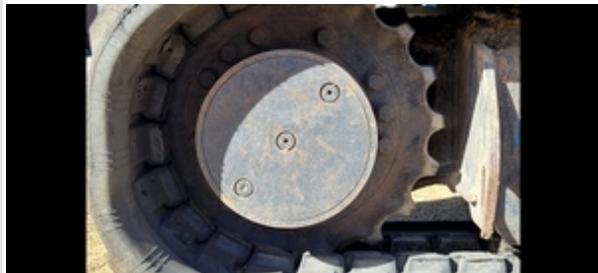
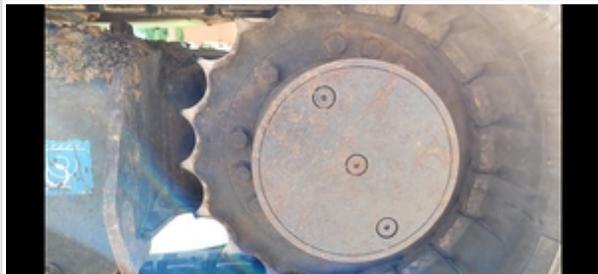
Sprockets Photos

<b>Sprockets</b>	3 - Normal Wear & Tear

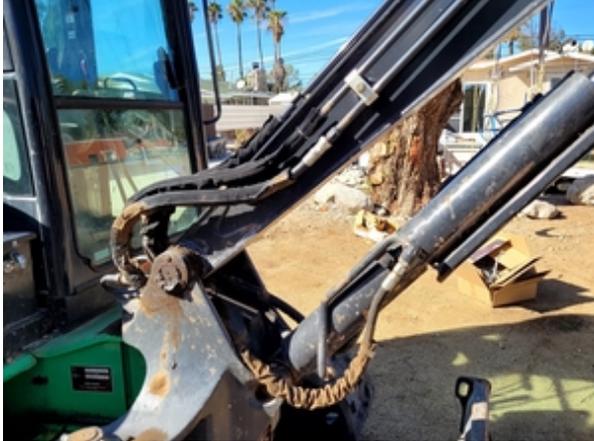
Hydraulics Overall	
Wet or Damp Hydraulic Lines / Fittings	No
Appearance of Hydraulic Lines / Fittings	3
Hydraulic Lines / Fittings Condition	Hydraulic lines & fittings are clean and in good condition
Appearance of Hydraulic Lines / Fittings Photos

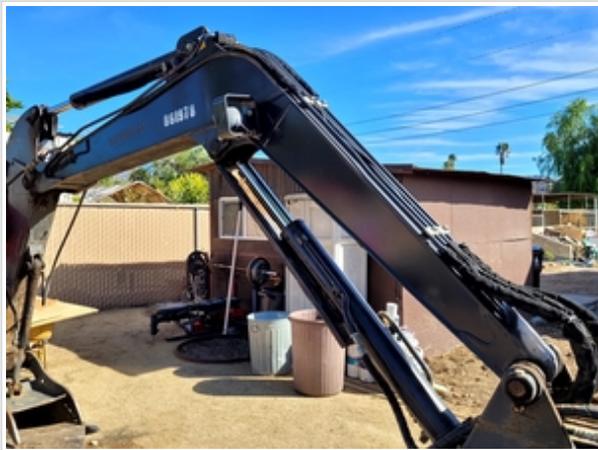
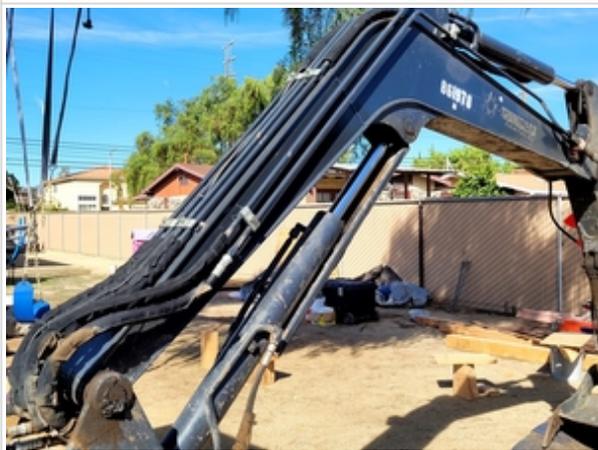
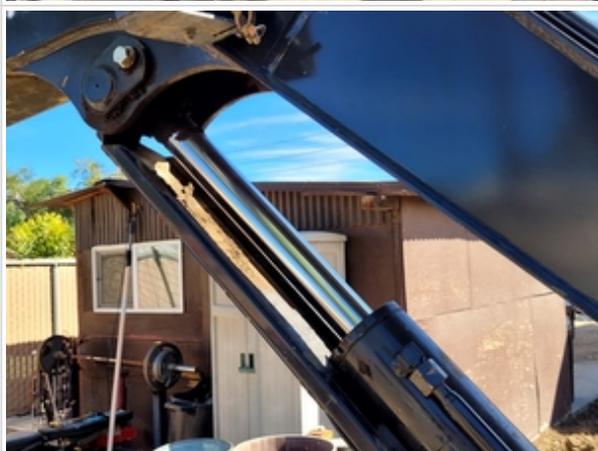
<p>Boom Cylinder Photos</p>

Boom Cylinder	Check the boom cylinder. Note any wear, pitting, discoloration, etc. Take photos.
Boom Cylinder: Mounting Pin	3
Boom Cylinder: Oil Leaks	No

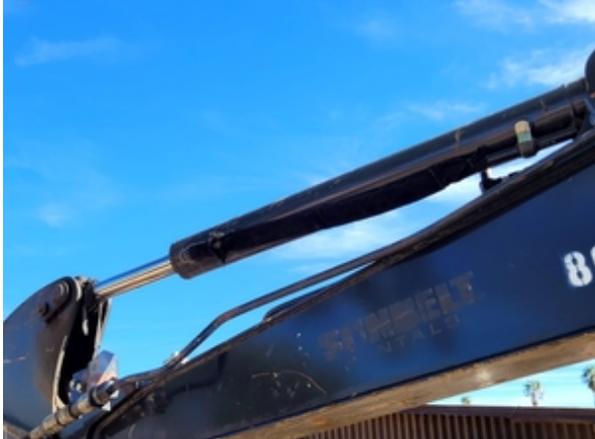
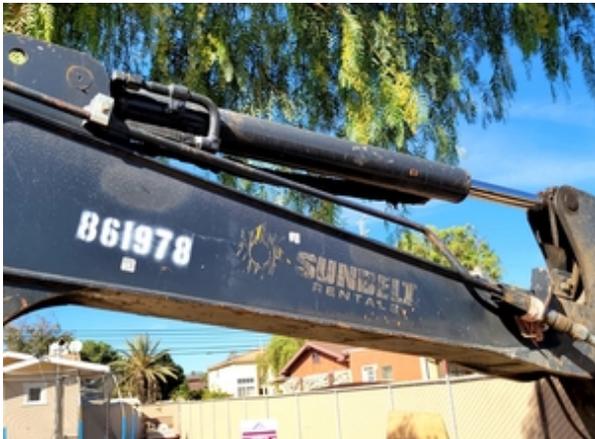
Stick Cylinder Photos

<p>Stick Cylinder</p>	<p>Check the stick cylinder. Note any wear, pitting, discoloration, etc. Take photos.</p>
<p>Stick Cylinder: Mounting Pin</p>	<p>3</p>
<p>Stick Cylinder: Oil Leaks</p>	<p>No</p>

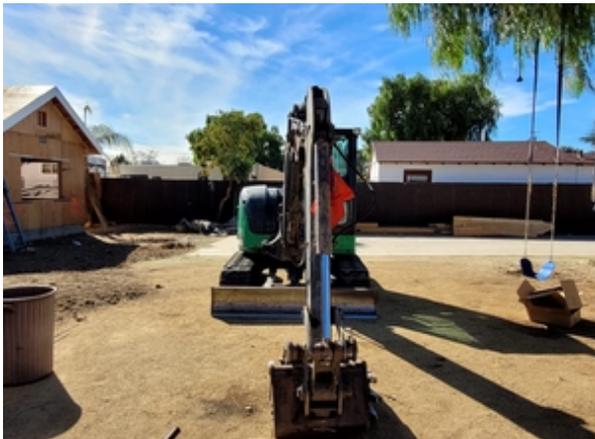
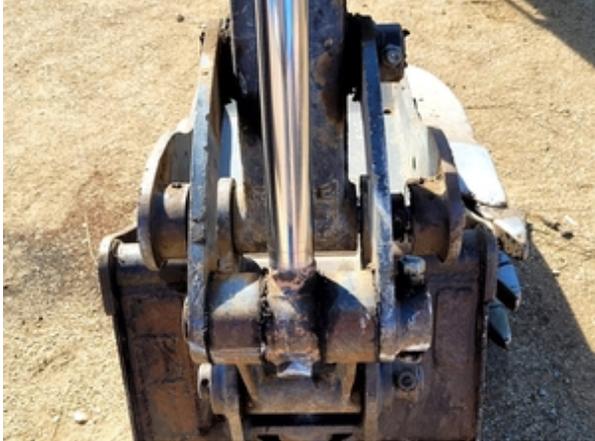
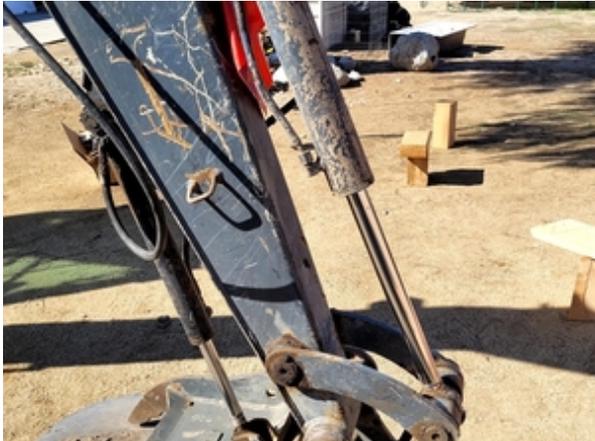
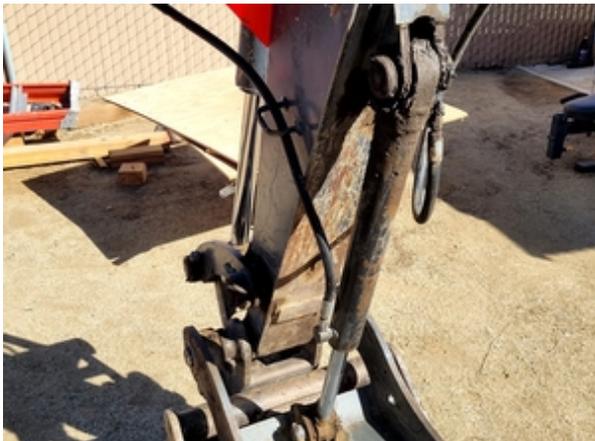
Bucket Cylinder	Check the bucket cylinder. Note any wear, pitting, discoloration, etc. Take photos.
Bucket Cylinder: Mounting Pin	3
Bucket Cylinder: Oil Leaks	No
Bucket Cylinder Photos

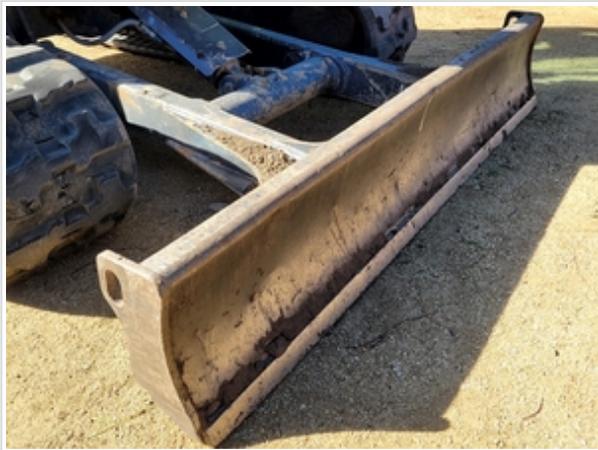
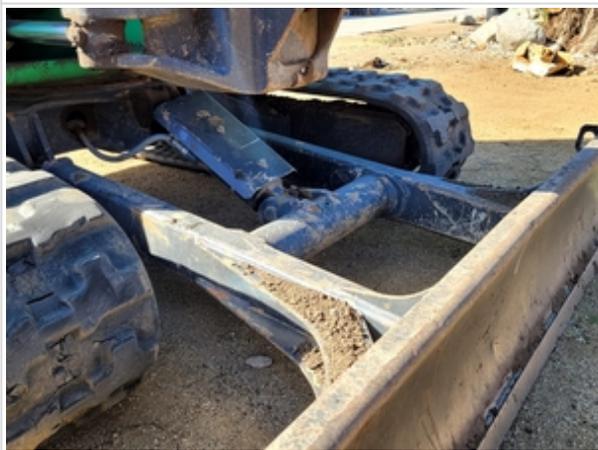
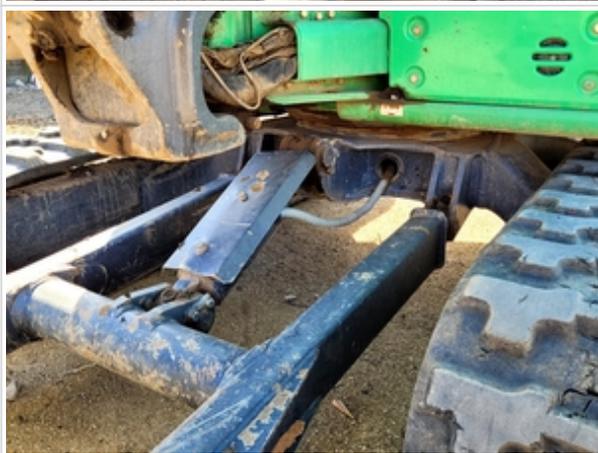
Blade Photos

<b>Blade</b>	Check the blade. Note any wear, pitting, discoloration, etc. Take photos.	
<b>Blade</b>	3

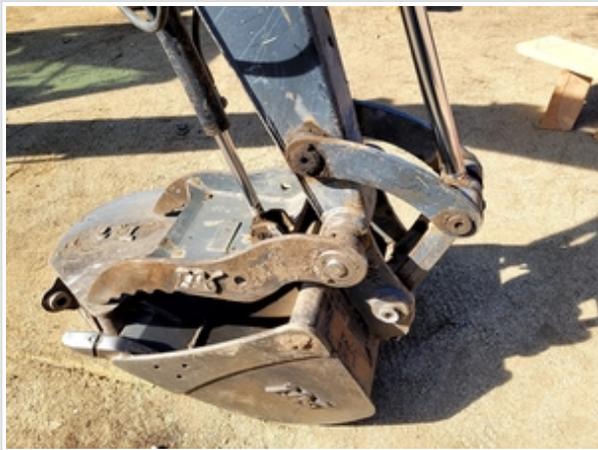
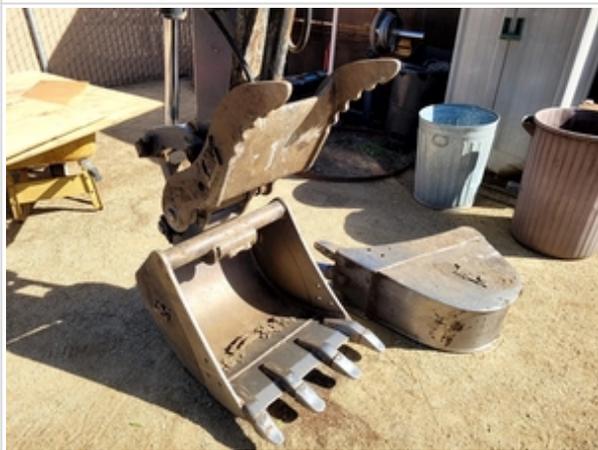
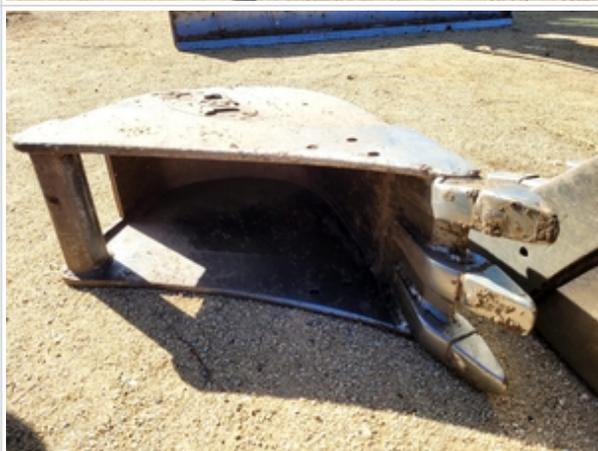
<p>Bucket Photos</p>

Bucket Condition	3 - Normal Wear & Tear
Comments	12" and 24"

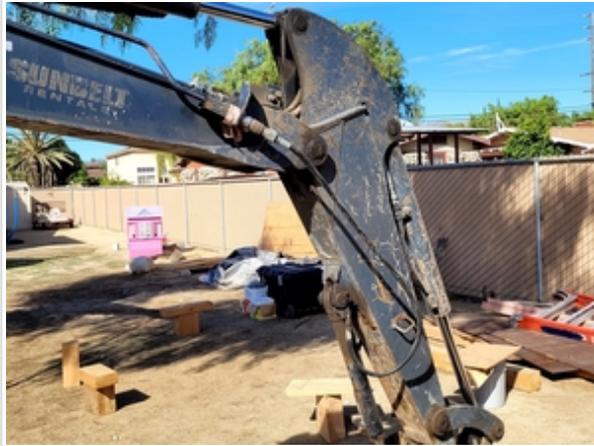
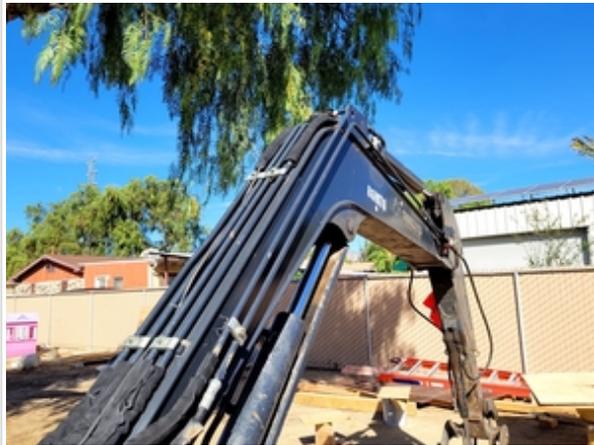
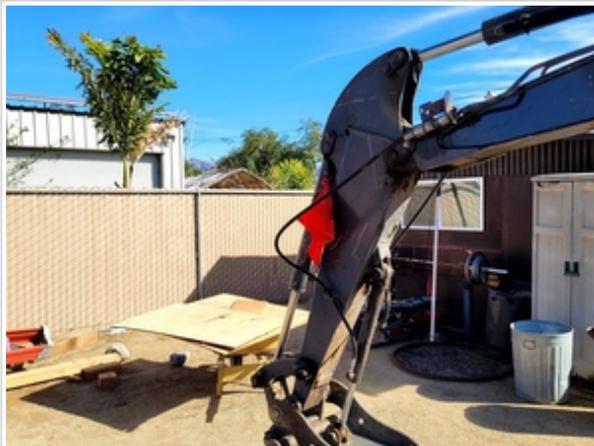
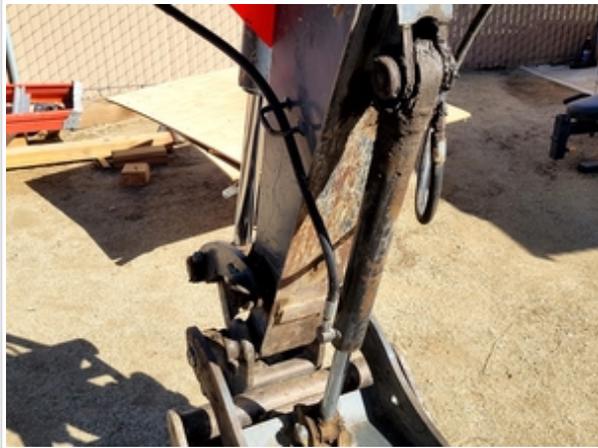
Bucket Hose & Fittings Photos

<p>Bucket Hose &amp; Fittings</p>	<p>3 - Normal Wear &amp; Tear</p>
