Inspection Report (On-Highway Dump Truck)

Year	2011
Make	Peterbilt
Model	367
Serial Number	1NP - TLUOX - 6 - BD127980
Truck Odometer Reading	408,807
Previous Application (e.g., earth moving, mining, demolition, etc)	Asphalt Construction

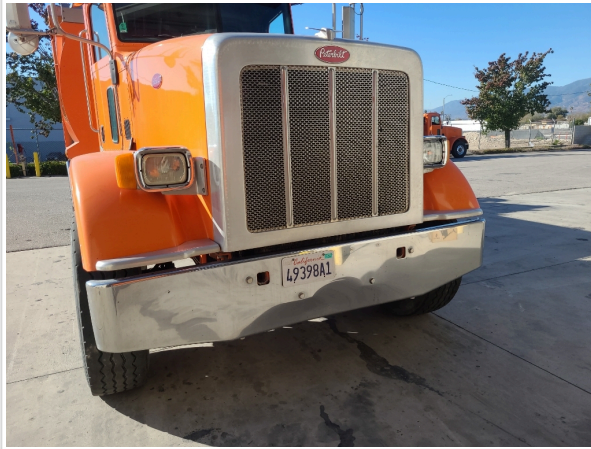
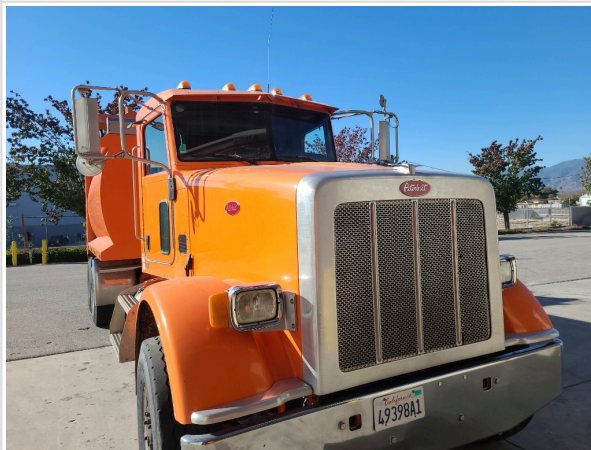
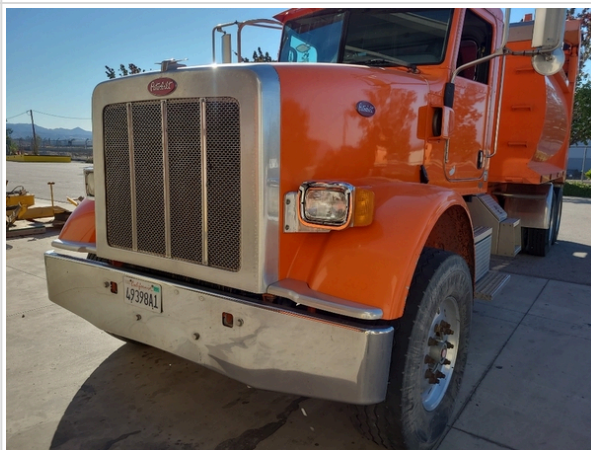
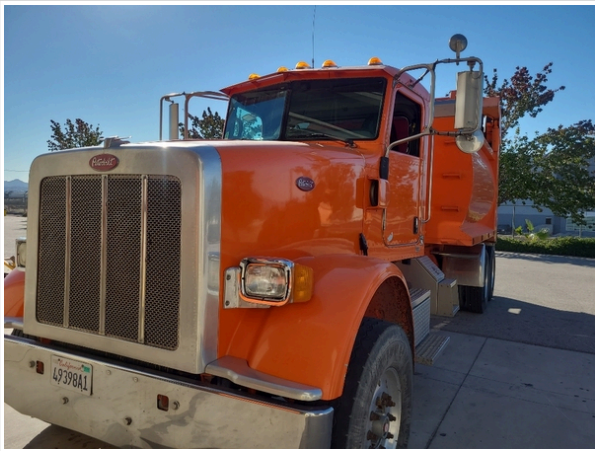
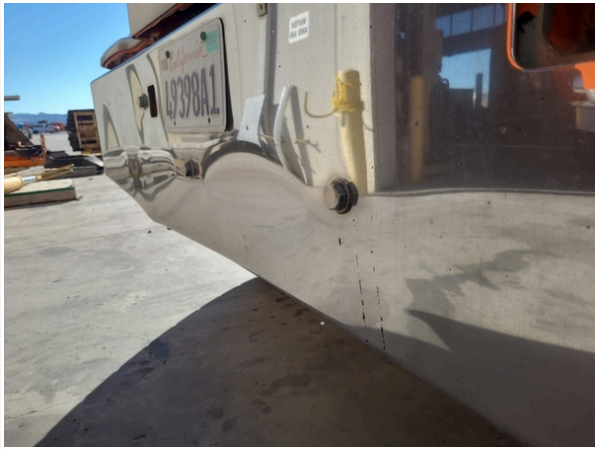
Front Photos

Front	3 - Normal Wear & Tear
Front Condition	No visible damage, Other (see comments)
Comments	Small front bumper dent at center

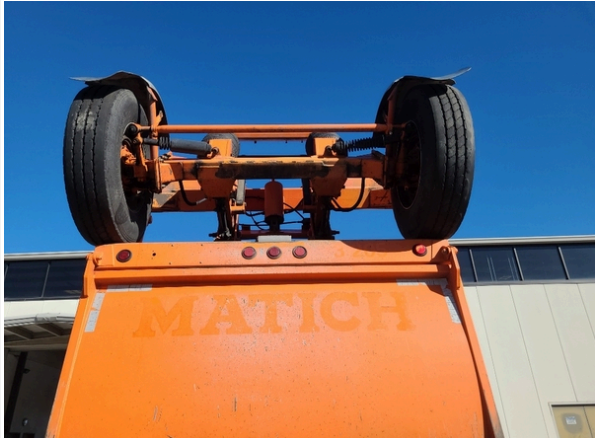
Rear	3 - Normal Wear & Tear	
Rear Condition	No visible damage, Other (see comments)	
Comments	normal wear and tear	
Rear Photos

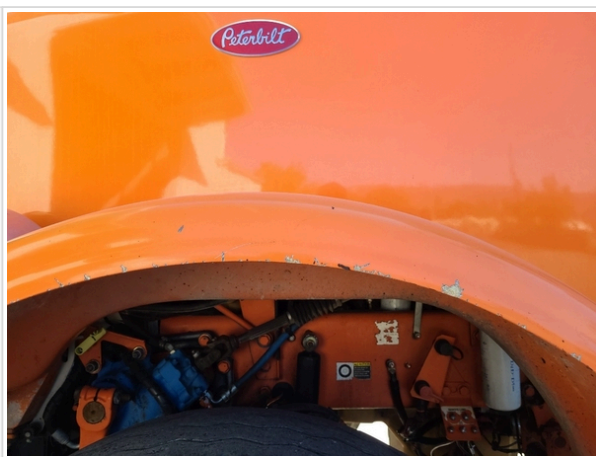
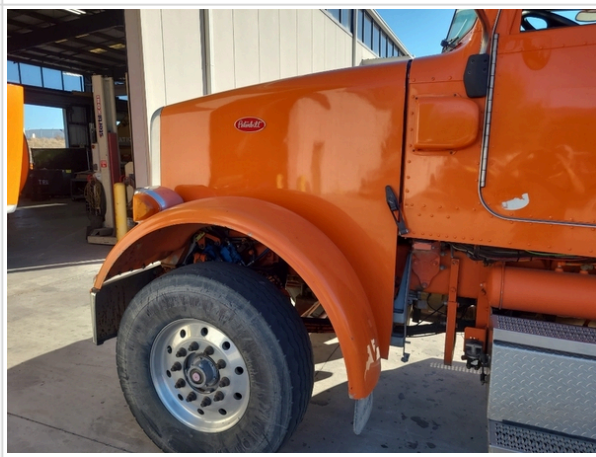
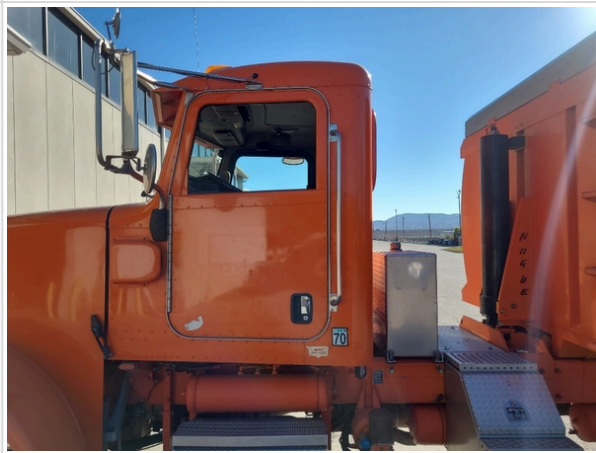
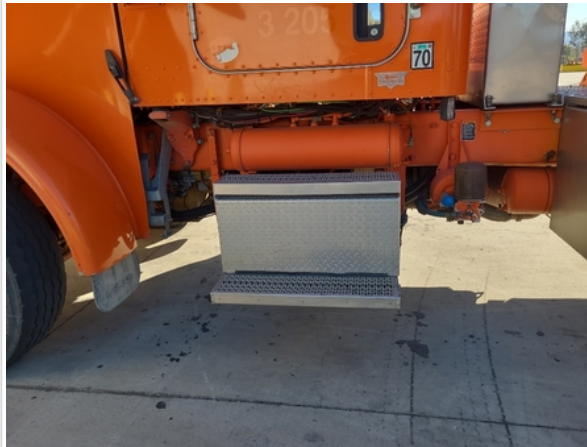
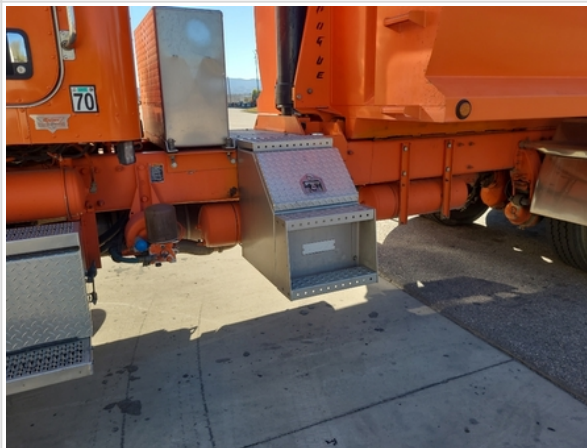
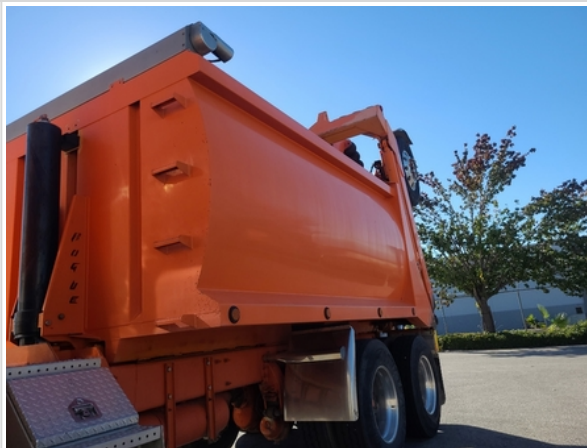
<p>Left Photos</p>

Left	3 - Normal Wear & Tear
Left Condition	No visible damage, Other (see comments)
Comments	a few paint chipping at front fender

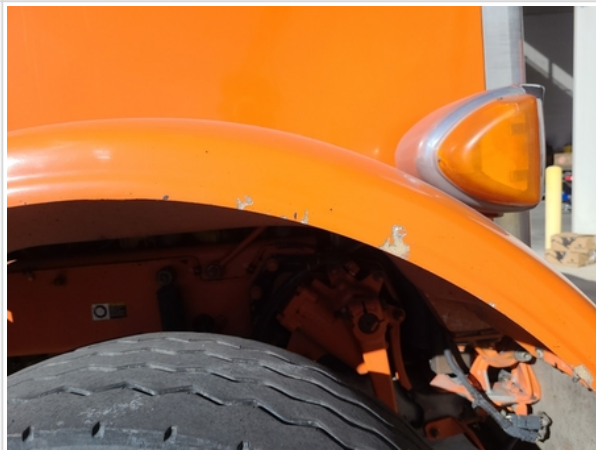
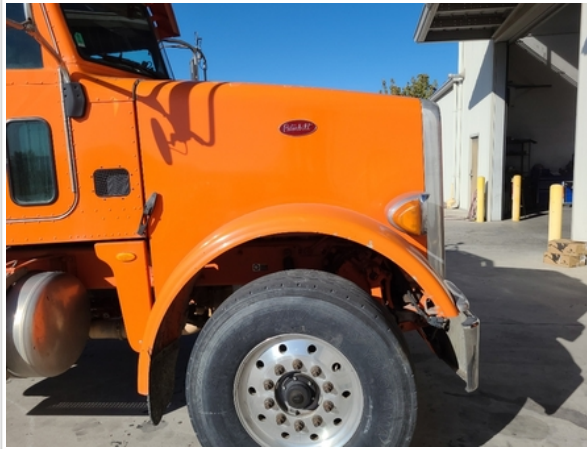
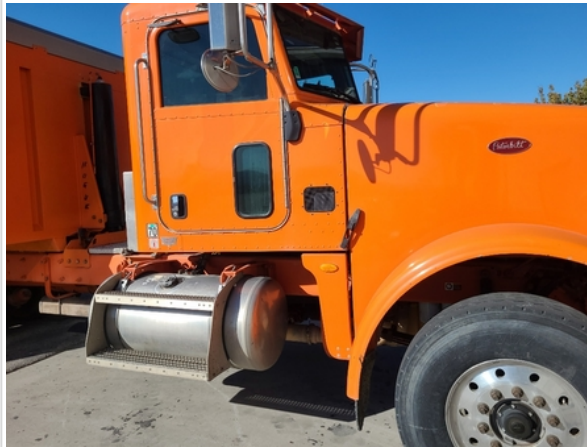
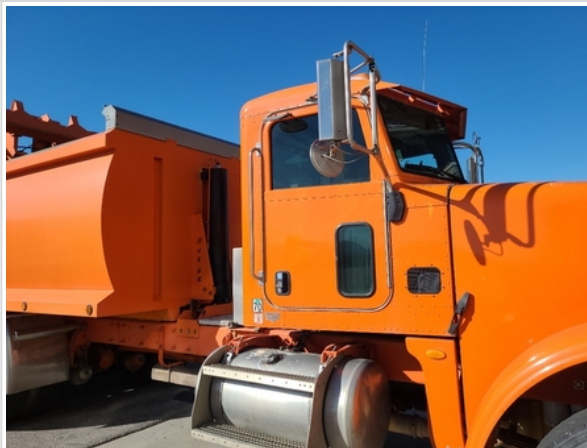
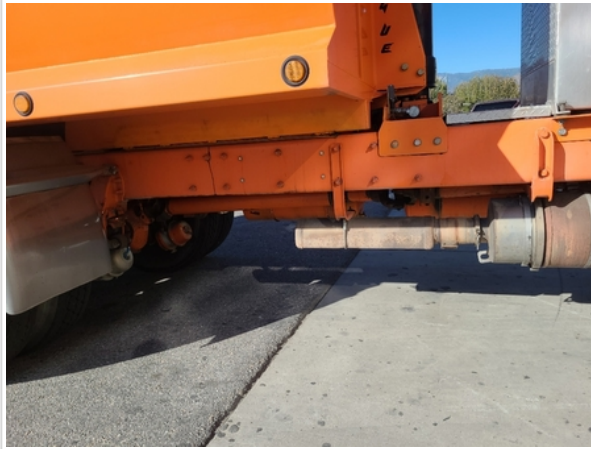
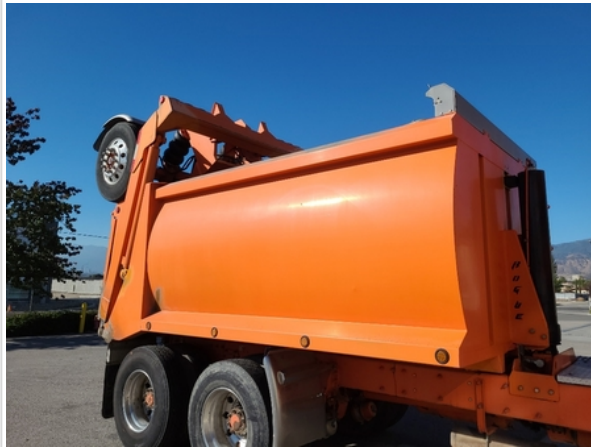
Right	3 - Normal Wear & Tear	
Right Condition	No visible damage, Other (see comments)	
Right Photos

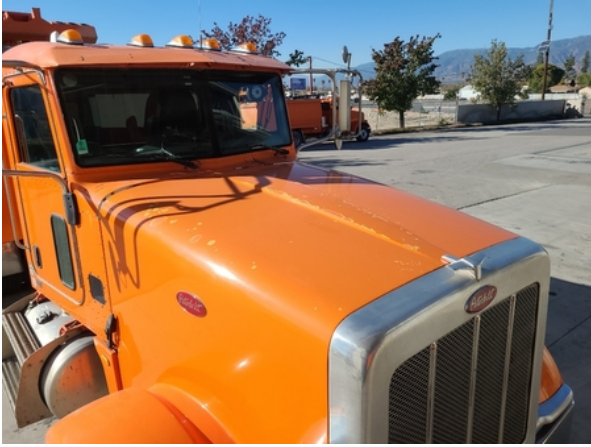
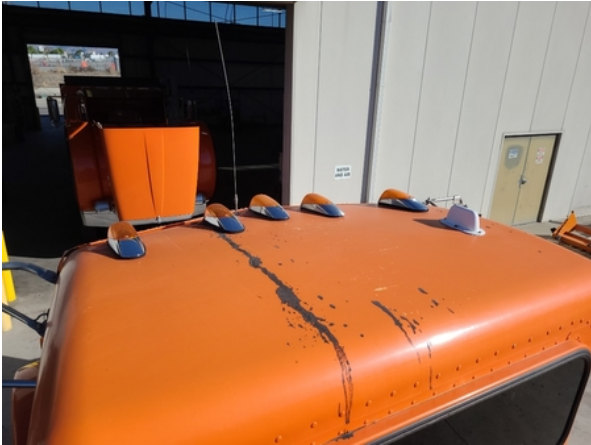
Upper	3 - Normal Wear & Tear	
Upper Condition	No visible damage, Other (see comments)	
Comments	asphalt slurry stained	
Upper Photos

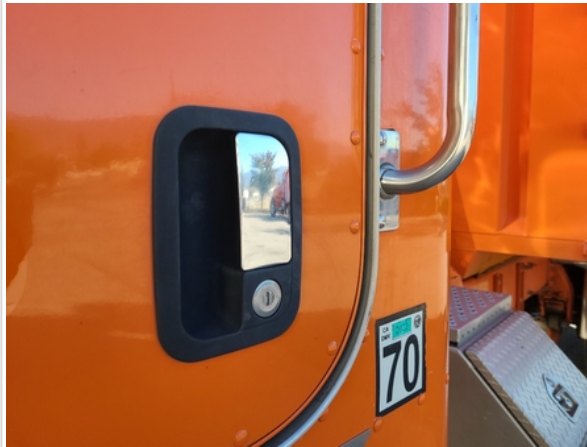
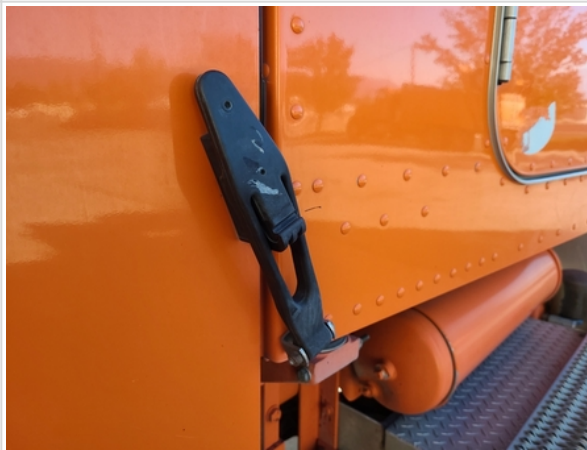
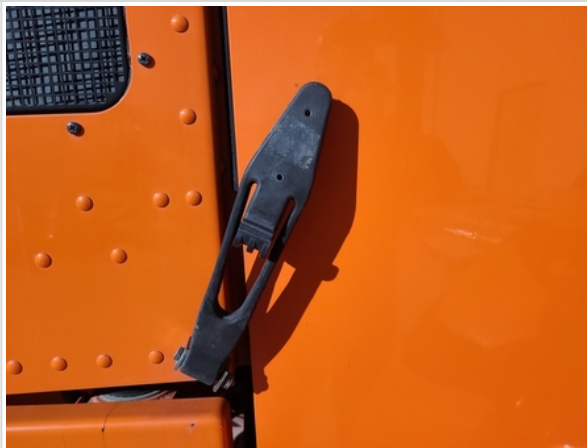
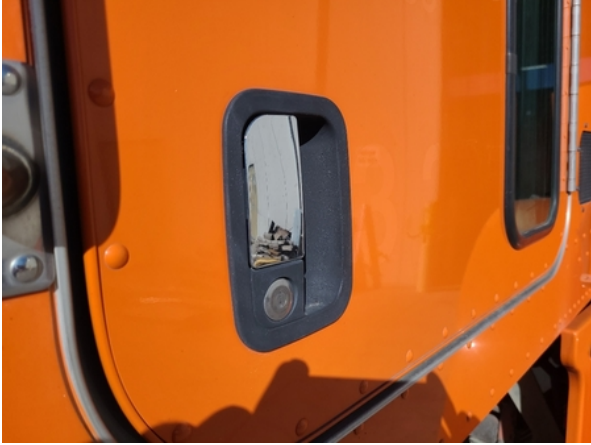
Doors / Canopy Latches Photos

Body Panels (Any Rust Damage?)	3 - Normal Wear & Tear	
Body Panel Condition	No visible damage, good paint condition and panel fitment	
Doors / Canopy Latches	3 - Normal Wear & Tear	
Doors / Canopy Latches Condition	No visible damage

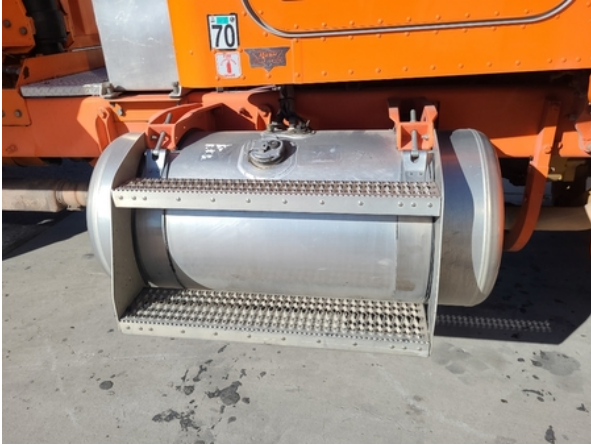
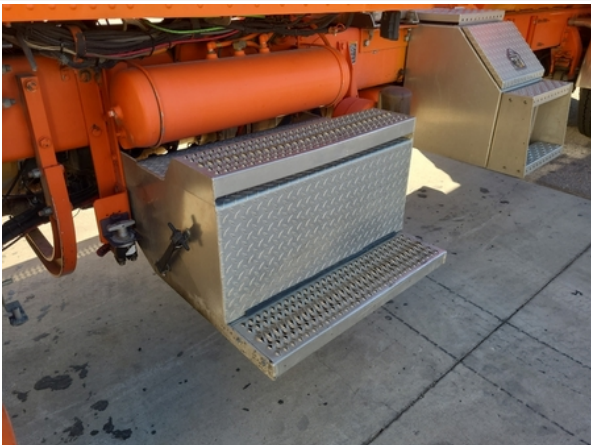
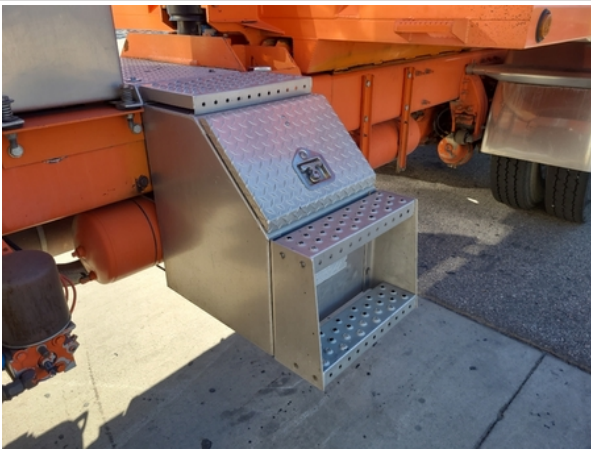
Steps / Ladders	3 - Normal Wear & Tear
Steps / Ladders Condition	Steps/ladders are fully intact and appear structurally sound
Steps / Ladders Photos

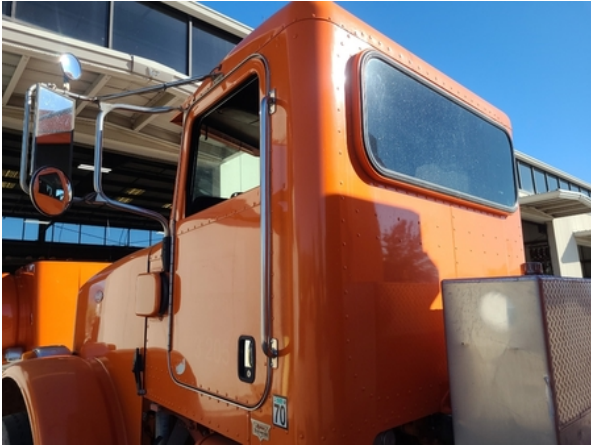
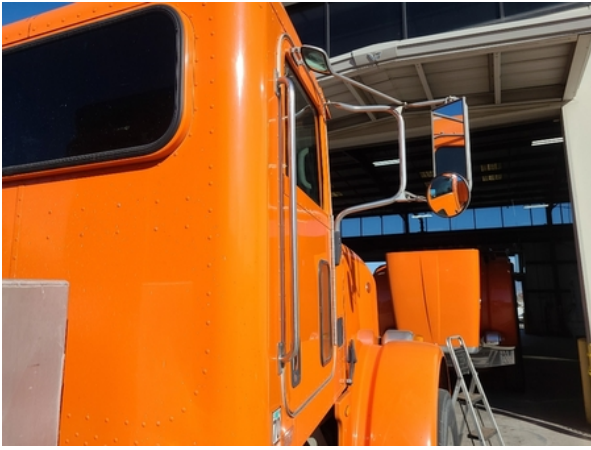
Handrails	3 - Normal Wear & Tear	
Handrails Condition	Handrails are fully intact and appear structurally sound	
Handrail Photos

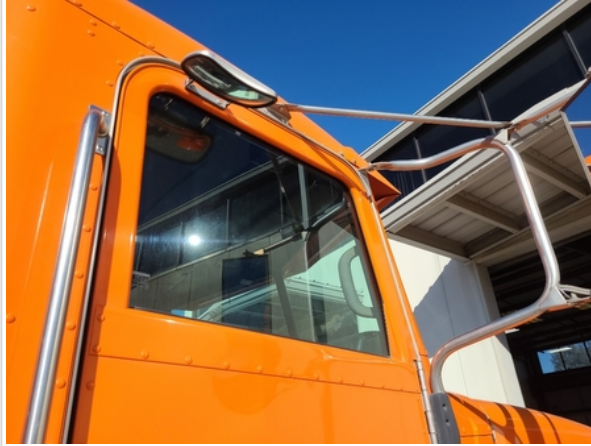
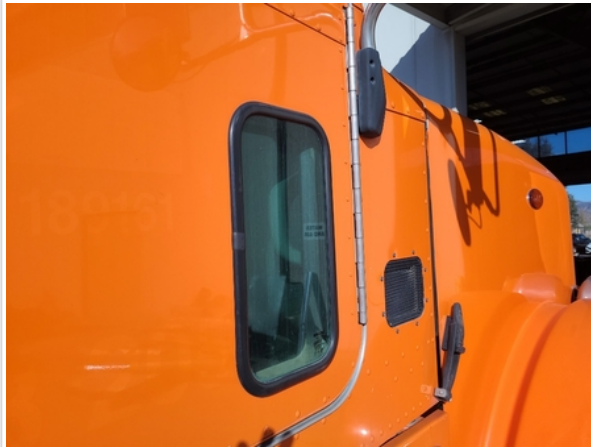
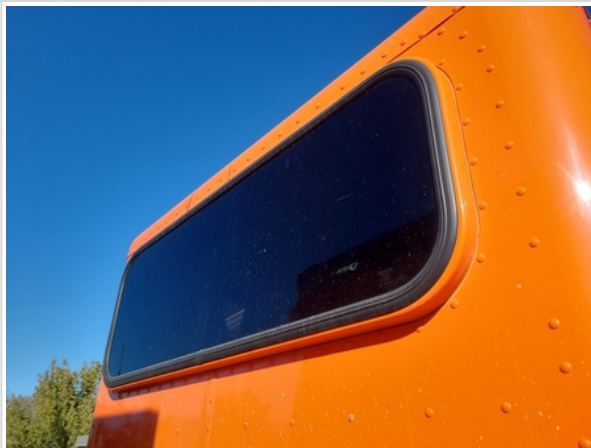
Glass Condition Photos

Glass Condition	3 - Normal Wear & Tear	
Glass Condition Notes	Glass intact, no visible damage

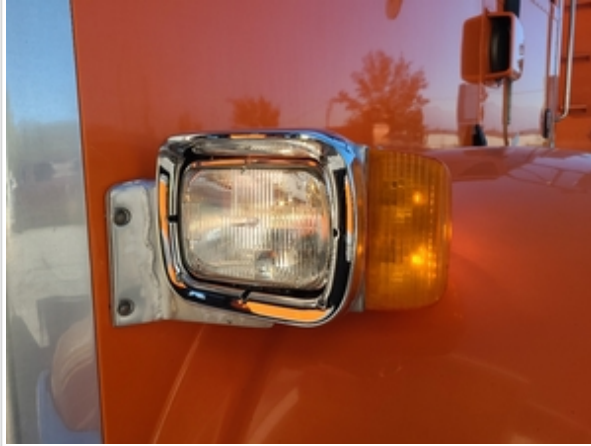
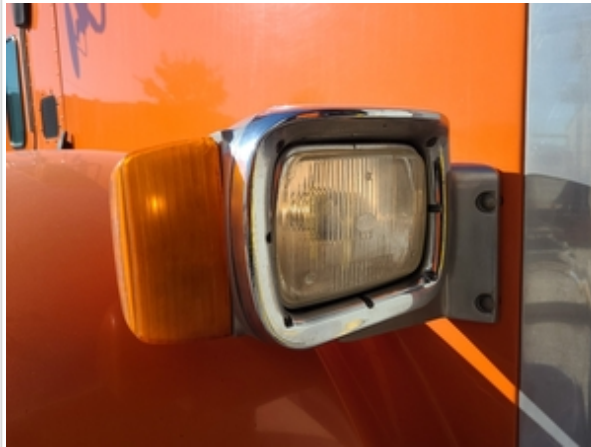
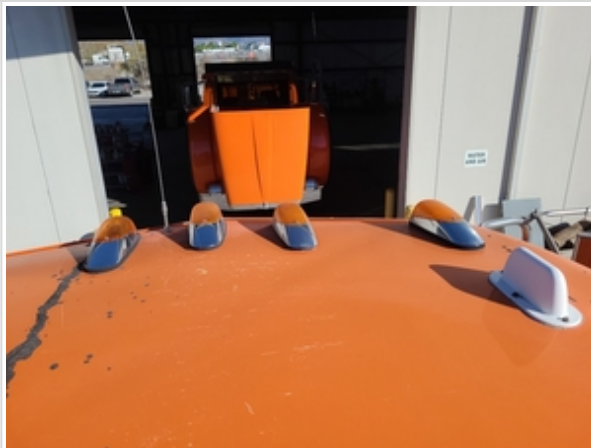
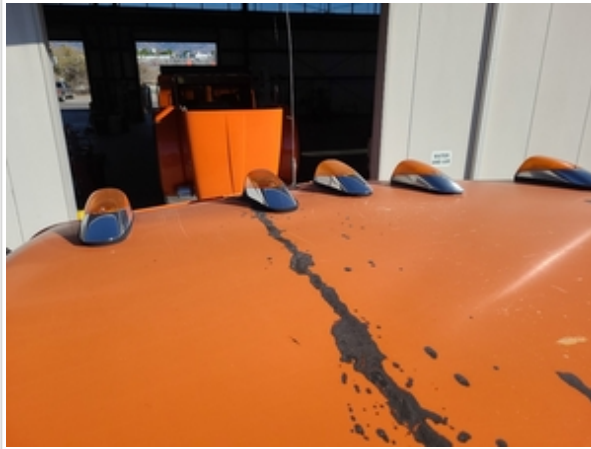
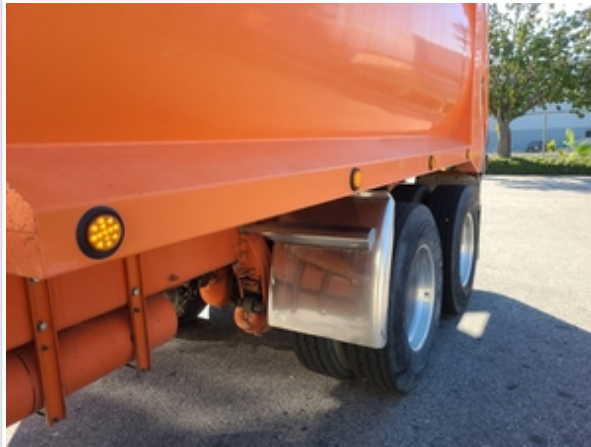
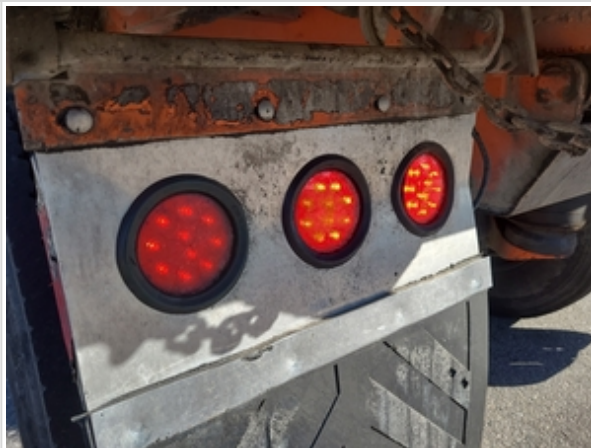
Lighting System Photos

Lighting System	3 - Normal Wear & Tear
Lighting System Condition	No visible damage, lighting system is operational

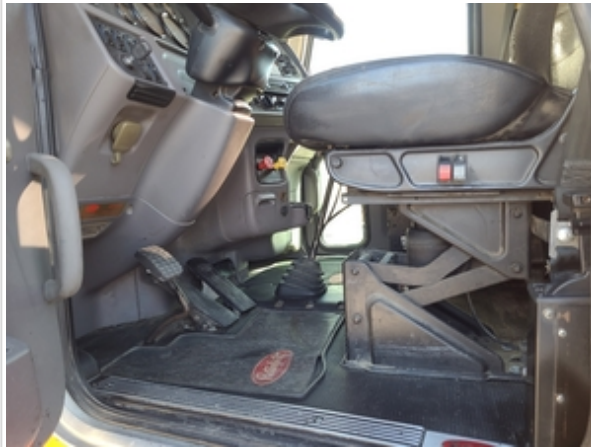
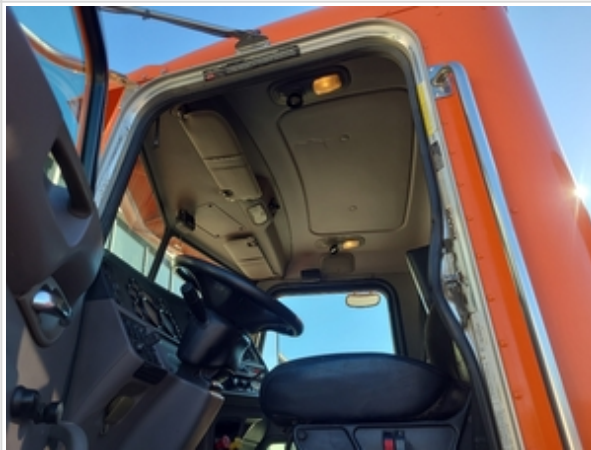
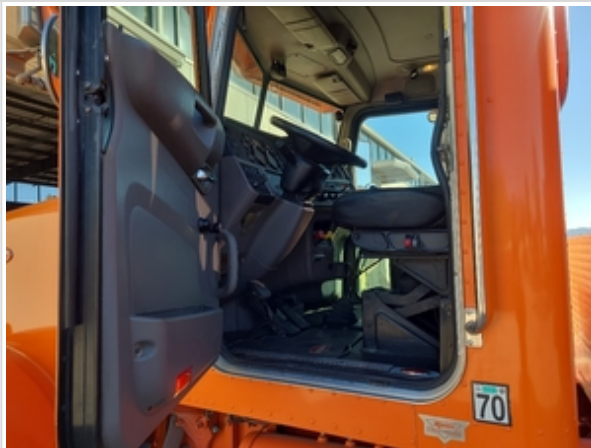
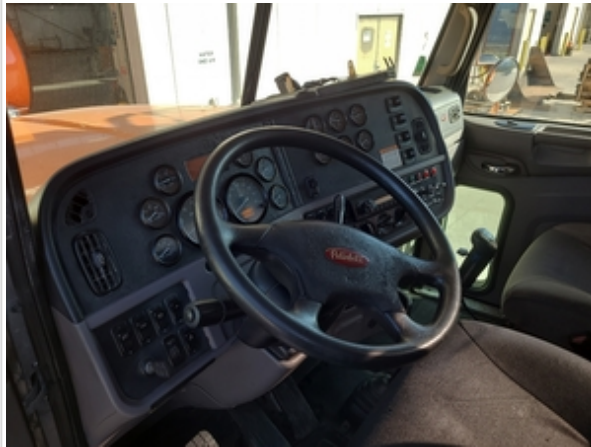
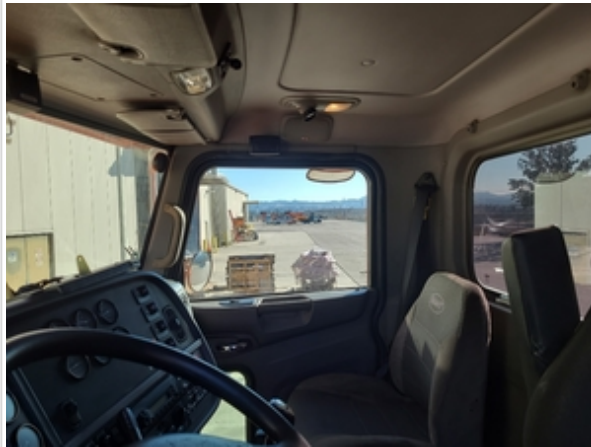
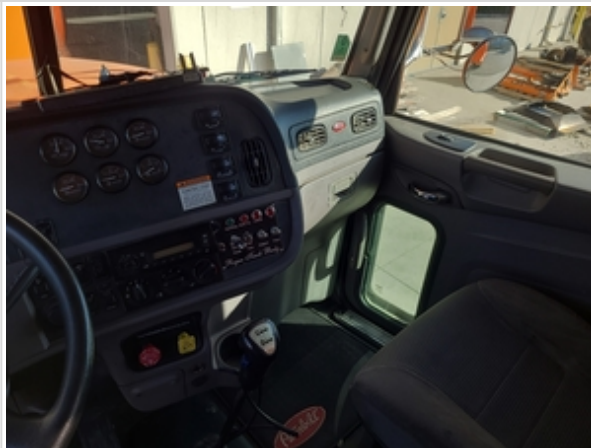
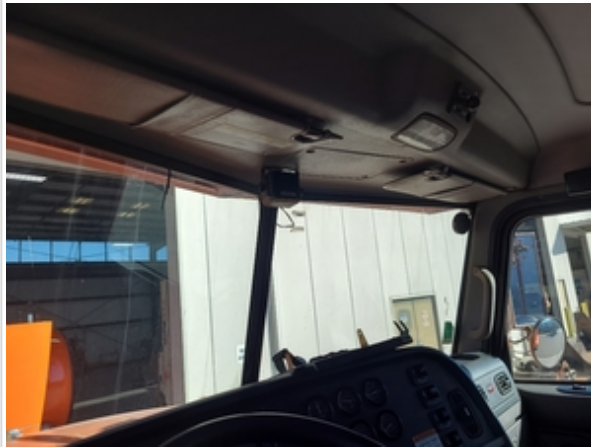
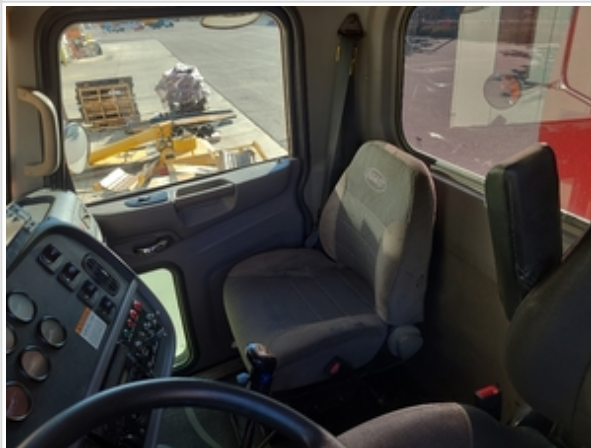
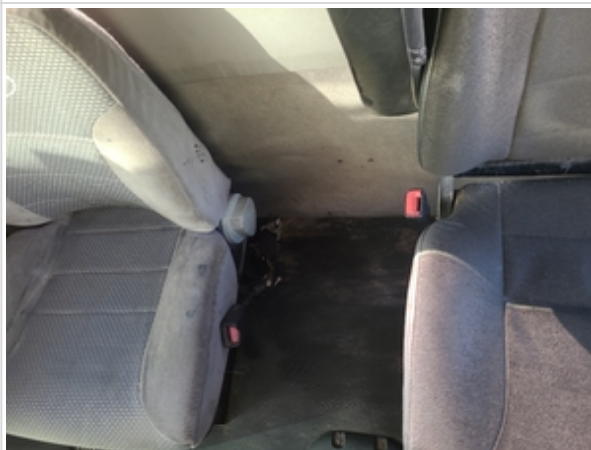
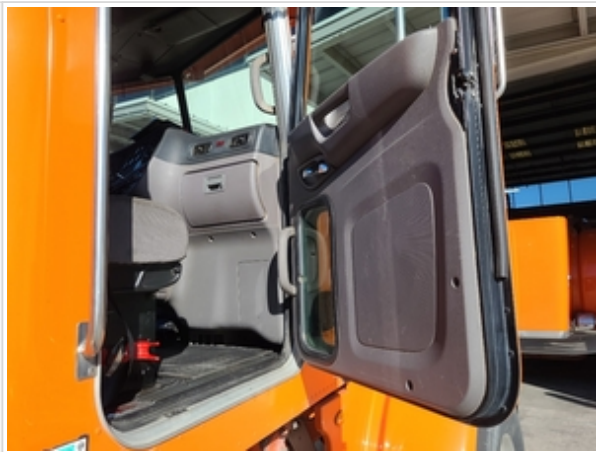
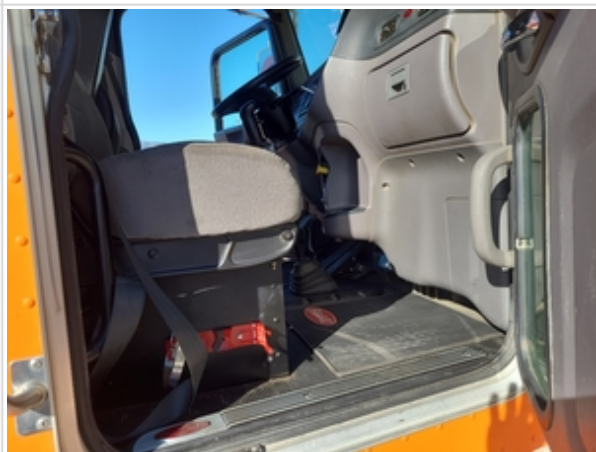
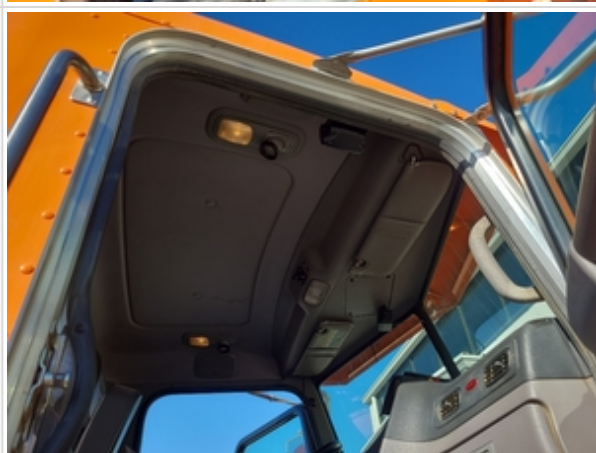
Operator Cabin Photos

<p>Serial Number Plate Photo</p>	 	
<p>Operator Cabin</p>	<p>3 - Normal Wear & Tear</p>

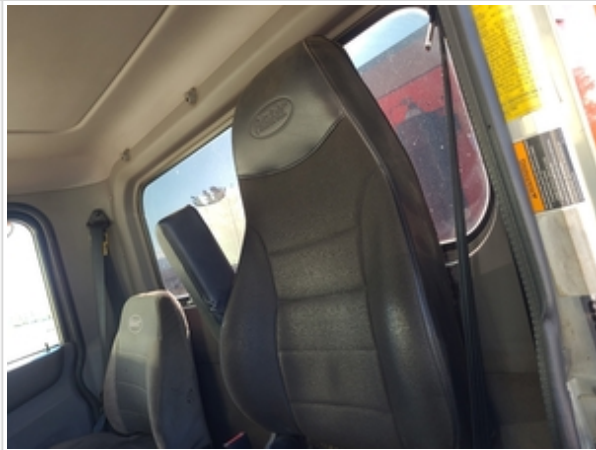
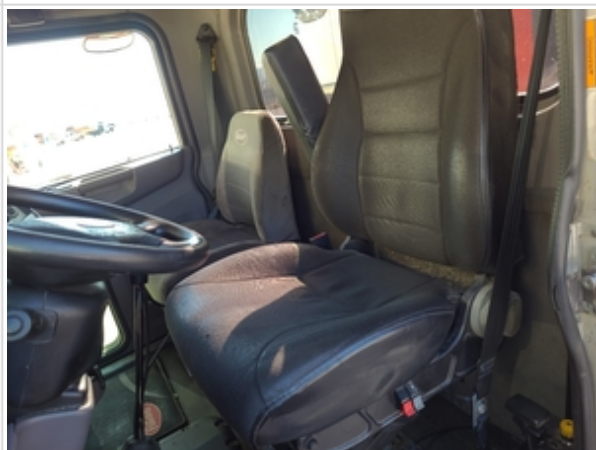
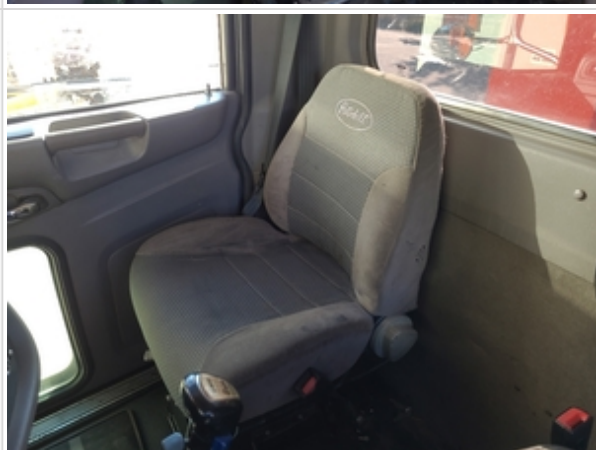
<p>Operator's Seat & Arm Rests Photos</p>

<p>Operator's Seat & Arm Rests</p>	<p>3 - Normal Wear & Tear</p>

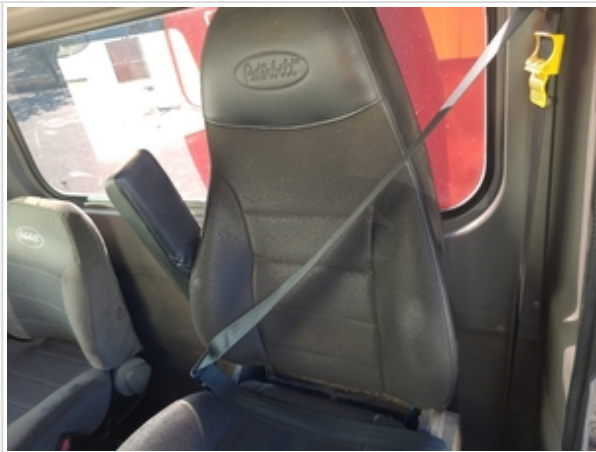
Seat Belt Photos

<p>Seat Belt</p>	<p>3 - Normal Wear & Tear</p>

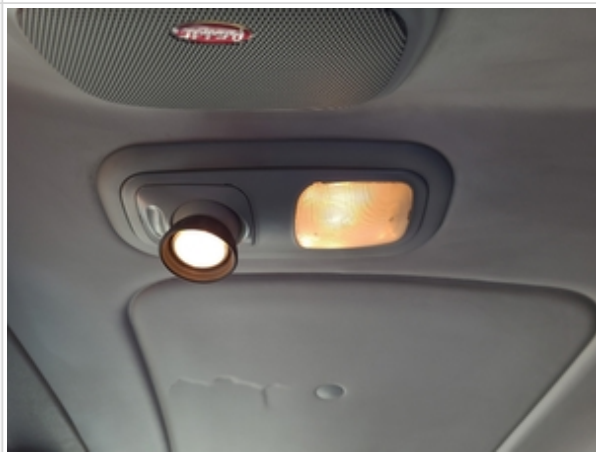
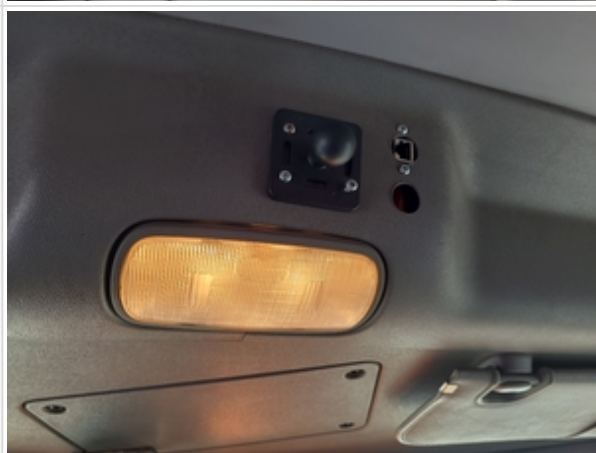
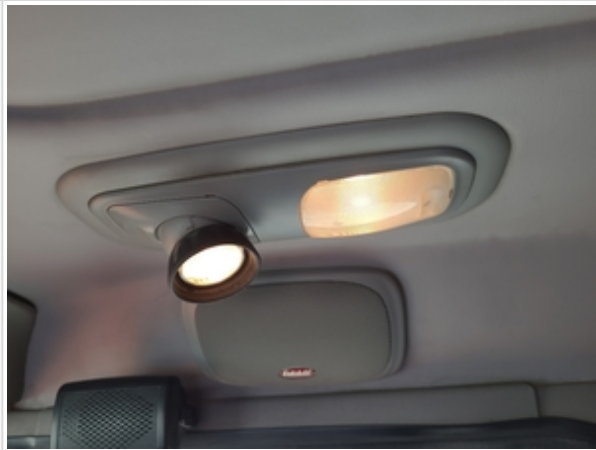
Cabin Lights	3 - Normal Wear & Tear
Cabin Lights Photos

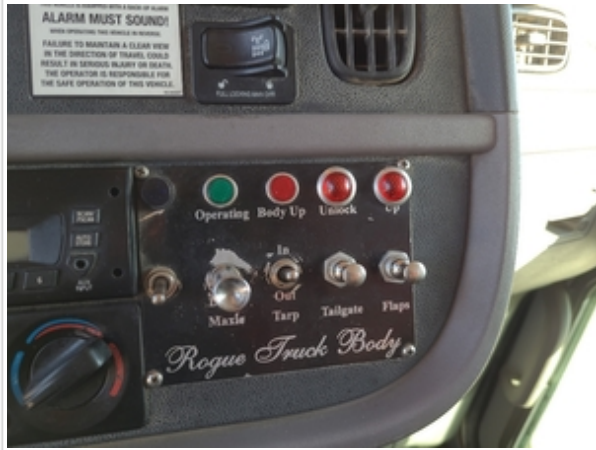
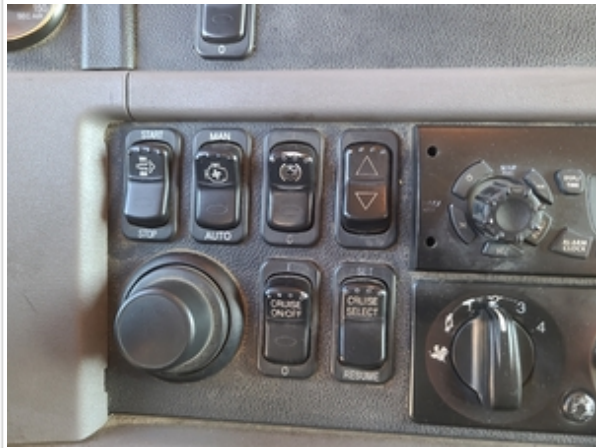
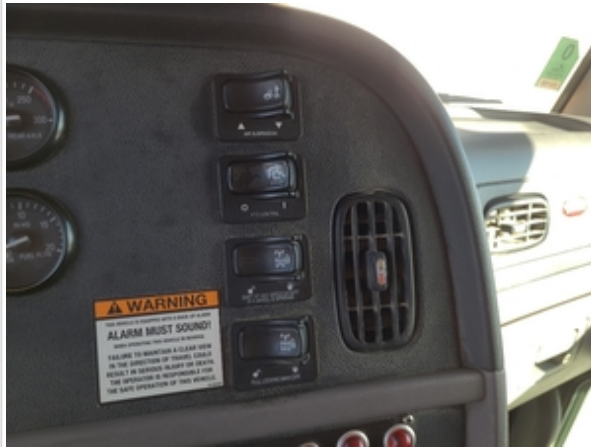
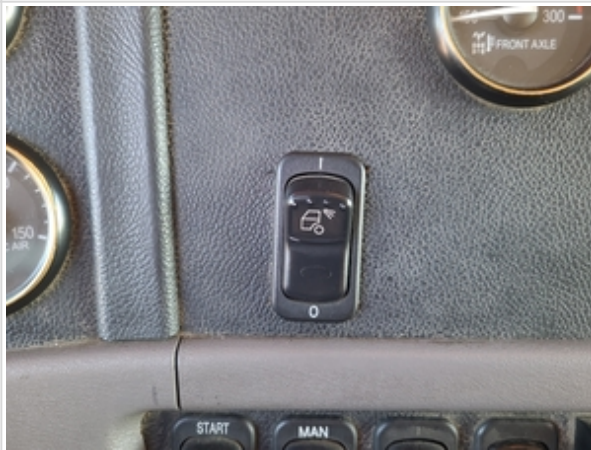
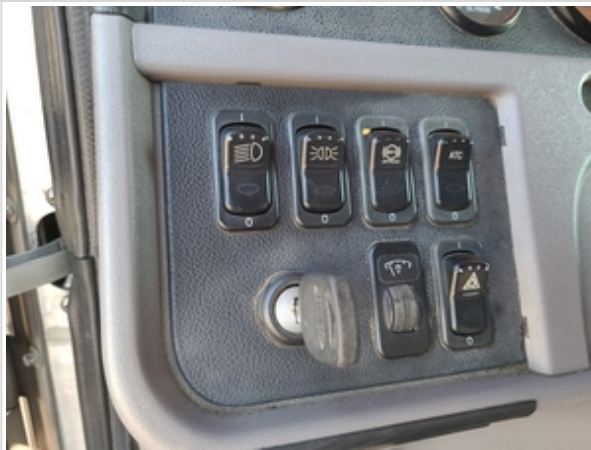
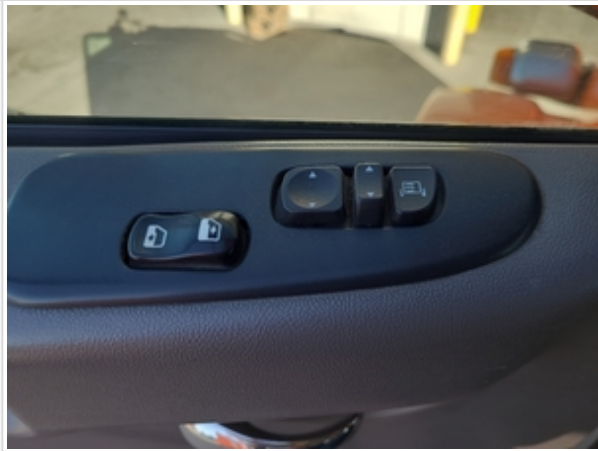
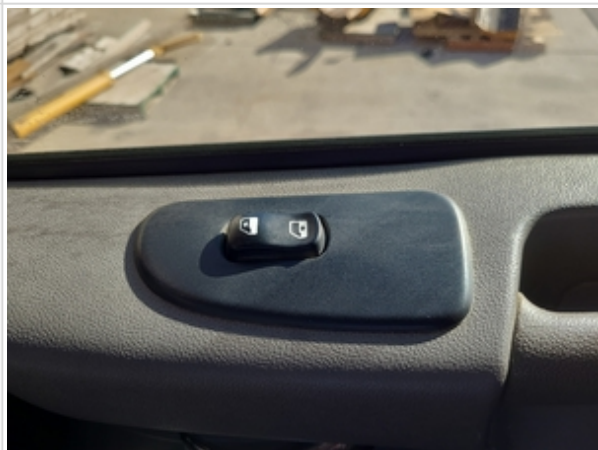
<p>Controls & Switches</p>	<p>3 - Normal Wear & Tear</p>
<p>Controls & Switches Photos</p>

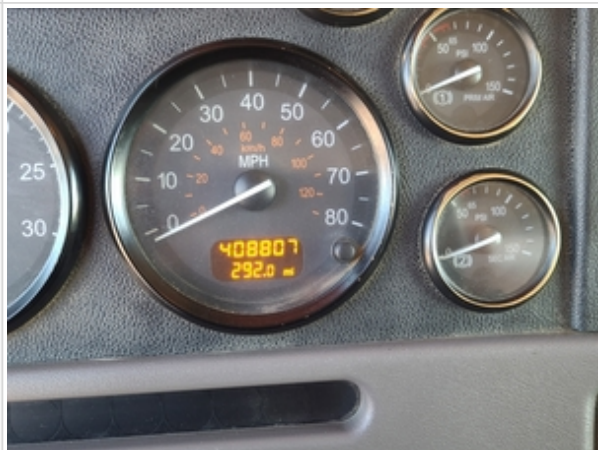
Odometer Activity	3 - Normal Wear & Tear	
Odometer Activity Photos

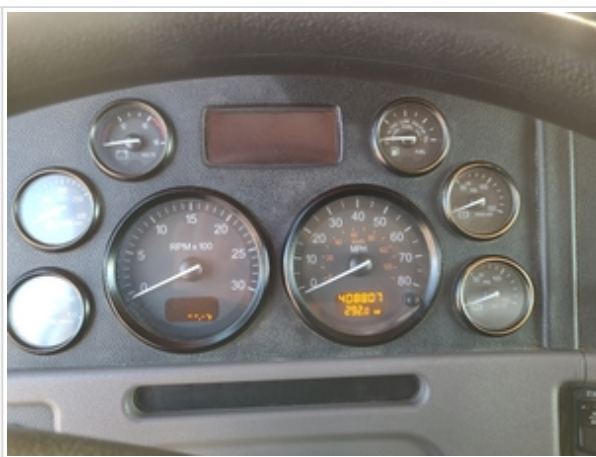
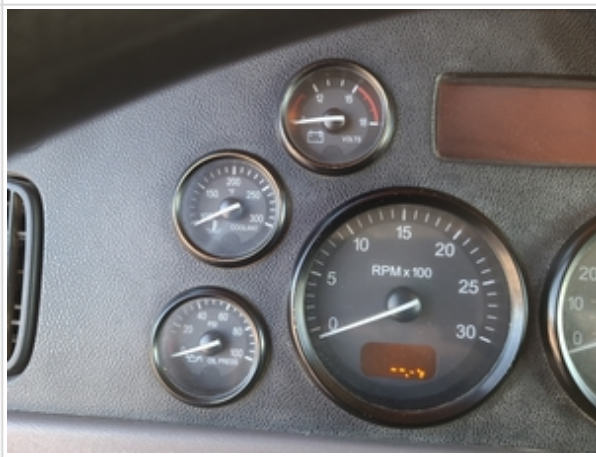
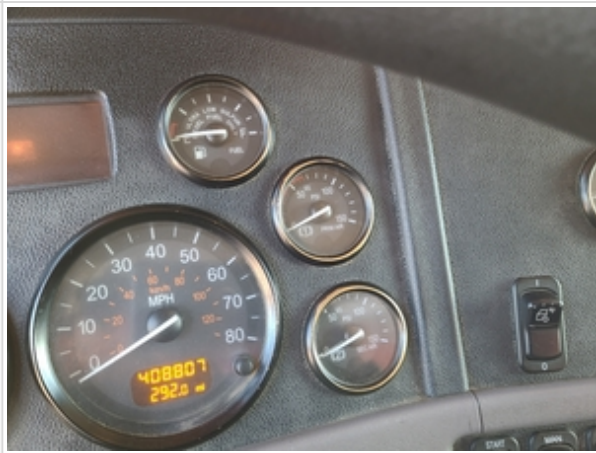
<p>Other Gauge Activity Photos</p>

Other Gauge Activity	3 - Normal Wear & Tear

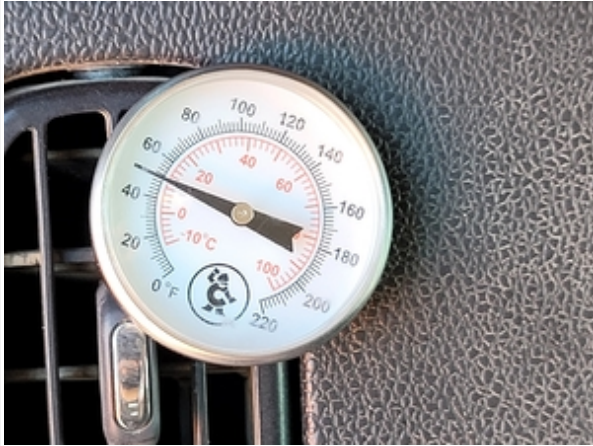
Heater & A/C	3 - Normal Wear & Tear	
Heater & A/C Photos

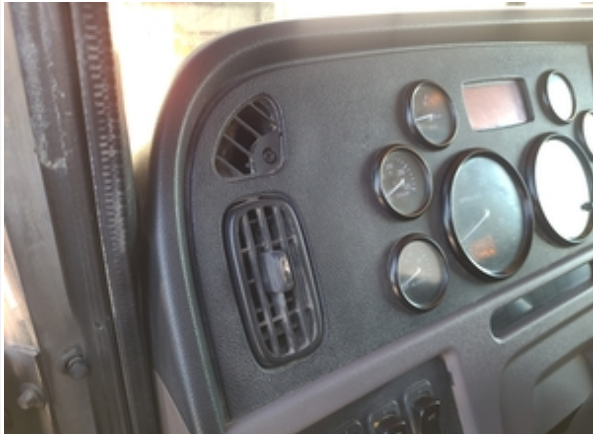
Fans / Vents	3 - Normal Wear & Tear	
Fans / Vents Photos

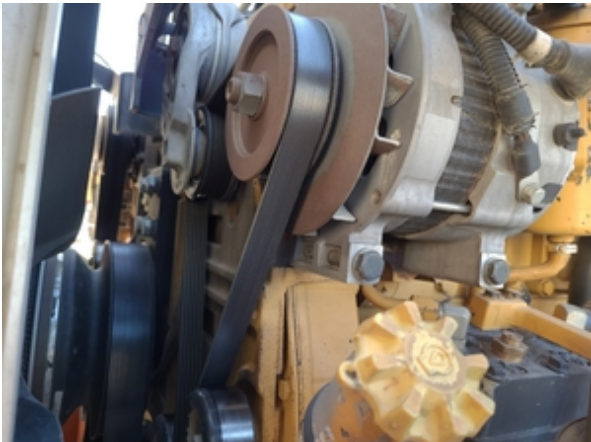
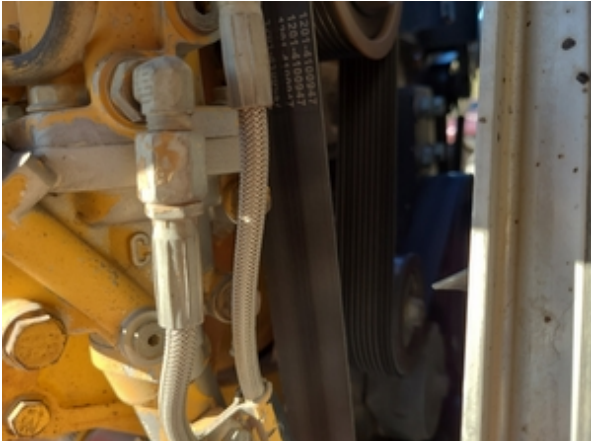
Belt Photos

Belts	3 - Normal Wear & Tear
Belt Condition	Belts appear in good condition & alignment with proper tension

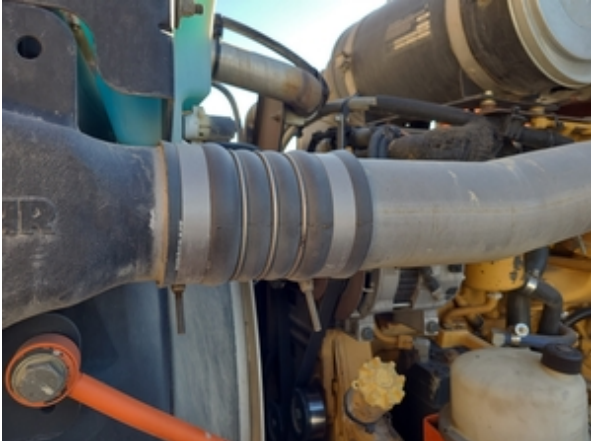
Hoses	3 - Normal Wear & Tear
Hose Condition	Firm, pliant hoses with no signs of wear or leaks
Hose Photos

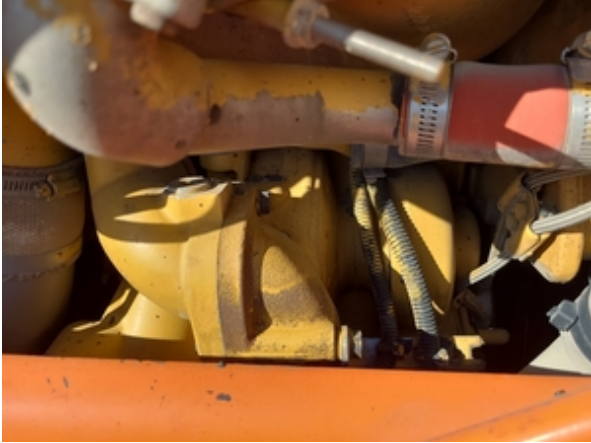
Water Pump Photos

Water Pump	3 - Normal Wear & Tear
Water Pump Condition	No unusual pump noises heard

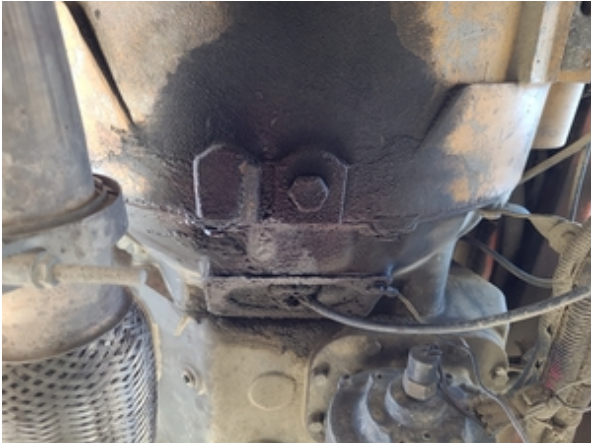
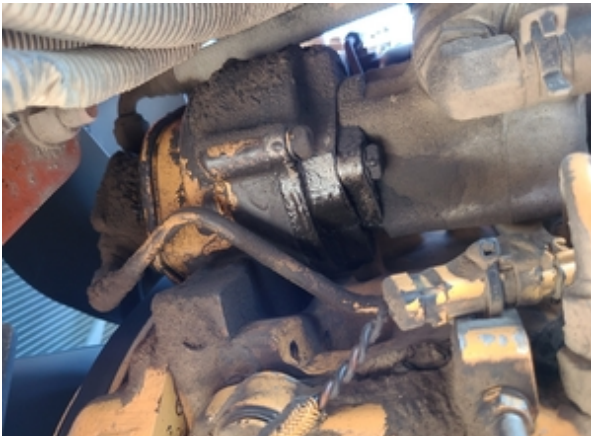
Cooling System Leaks	No	
Coolant Color / Appearance	3 - Normal Wear & Tear	
Coolant Color/Appearance Notes	Normal Translucent appearance, no visual signs of contamination	
Oil Leaks	Yes	
Oil Leak Notes	Wet areas with drops forming due to oil leakage, Other (see comments)	
Comments	small oil leak observed around bell housing & Small oil leak at front left side of engine	
Oil Leak Photos

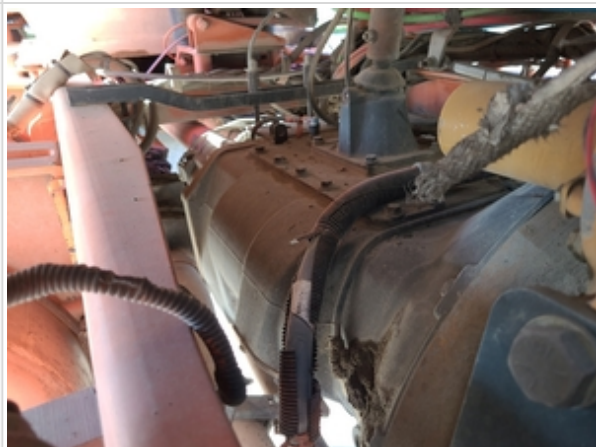
Transmission Info (Make/Model)	Eaton 10 Speed Manual Transmission
Drive Type	6X4
Overdrive	N/A
Transmission	3 - Normal Wear & Tear
Transmission Condition	No unusual noises or vibrations
Transmission Condition Photos

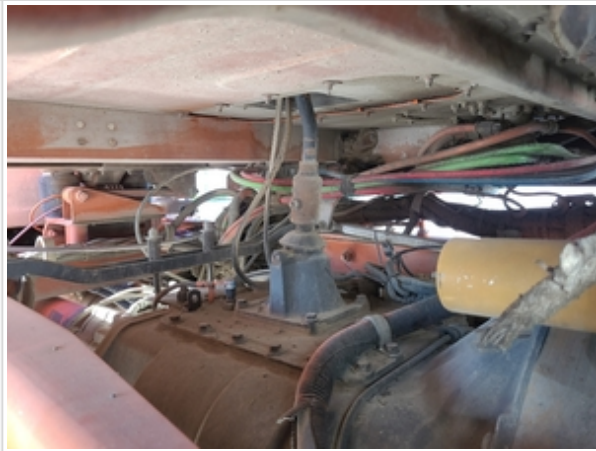
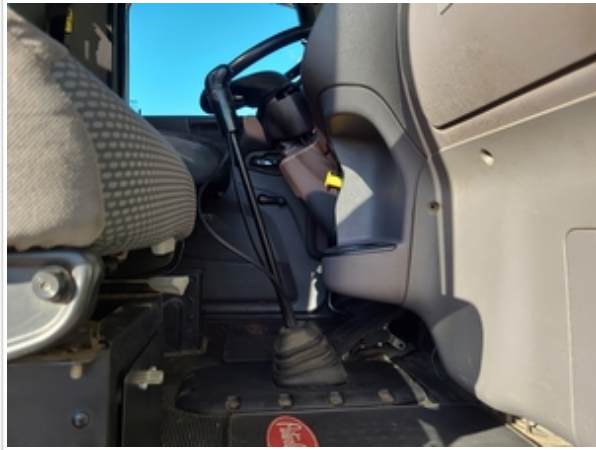
Shift Lever Photos

Clutch	3 - Normal Wear & Tear
Clutch Condition	Clutch is functioning as expected
Shift Lever	3 - Normal Wear & Tear
Shift Lever Condition	Good forward and reverse function

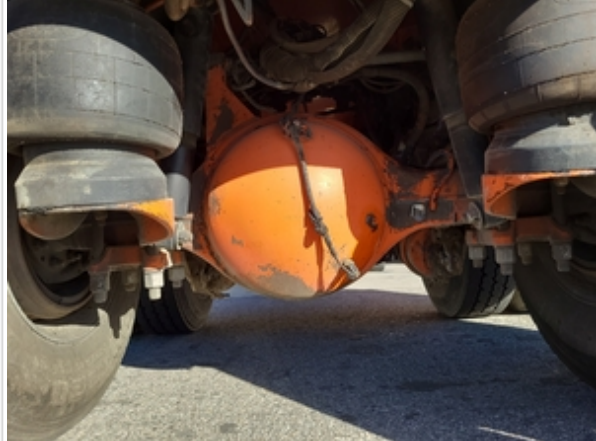
Differential	Check condition of the differential(s). Take photos and notes as relevant.
Rear Differential	3 - Normal Wear & Tear
Rear Differential Condition	Dry housing appearance, no unusual noises heard during operation
Rear Differential Photos

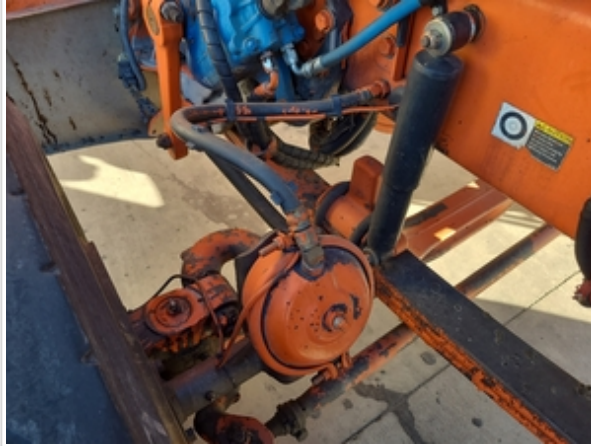
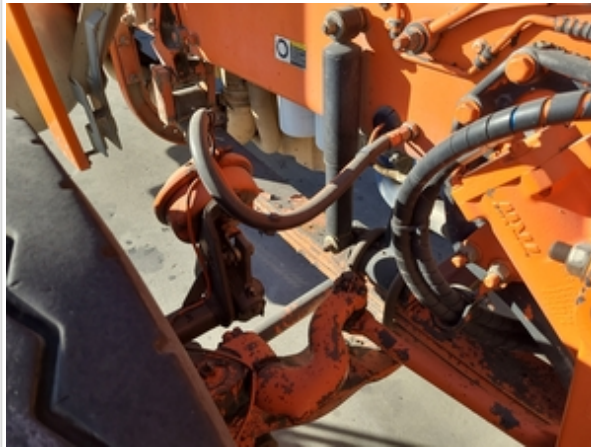
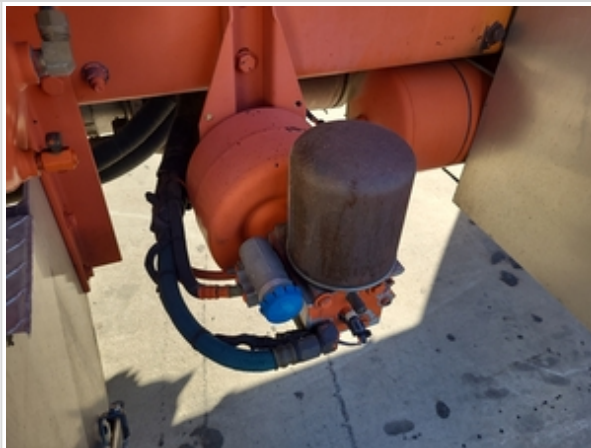
Air Brake System Photos

Brake System Type	Air Brakes	
Air Brakes Build Correct Pressure	Yes	
Air Brake System Leaks	No	
Air Brake Hose Condition	3 - Normal Wear & Tear
