Inspection Report (On-Highway Dump Truck)

Year	2011
Make	Peterbilt
Model	367
Serial Number	1NP - TLUOX - 6 - BD127980
Truck Odometer Reading	408,807
Previous Application (e.g., earth moving, mining, demolition, etc)	Asphalt Construction

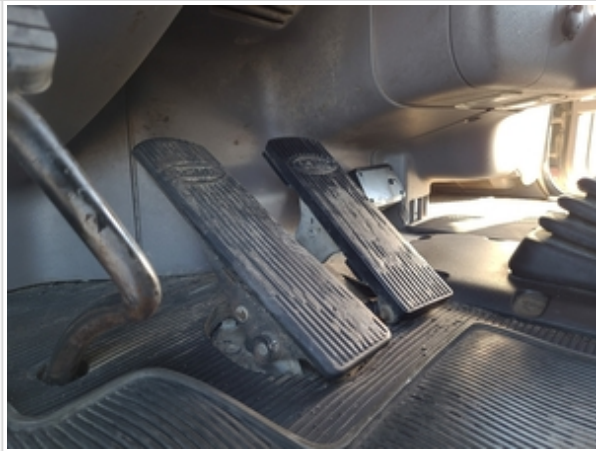
Foot Brake Photos

Foot Brake	3 - Normal Wear & Tear	
Foot Brake Condition	Good brake function

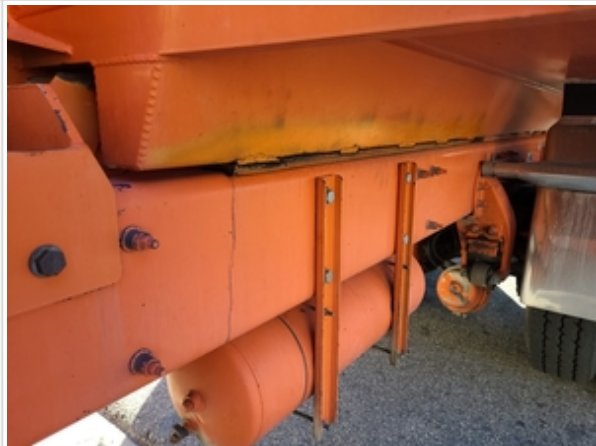
Frame Condition	3
Frame Photos

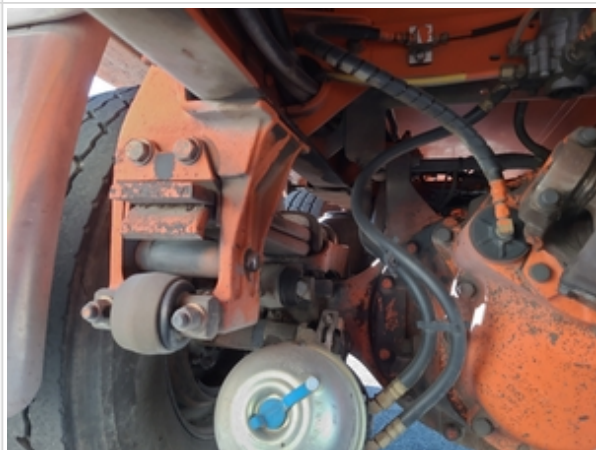
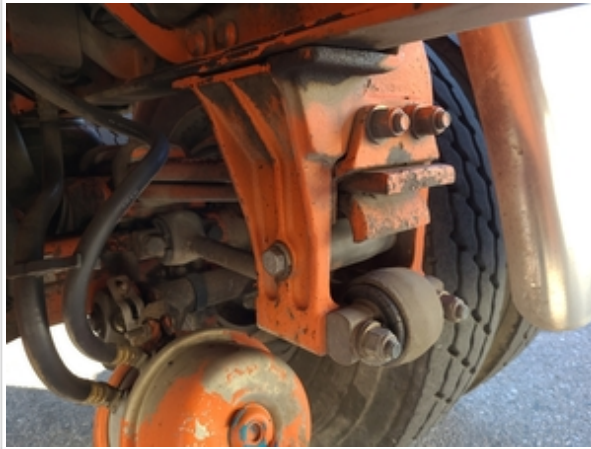
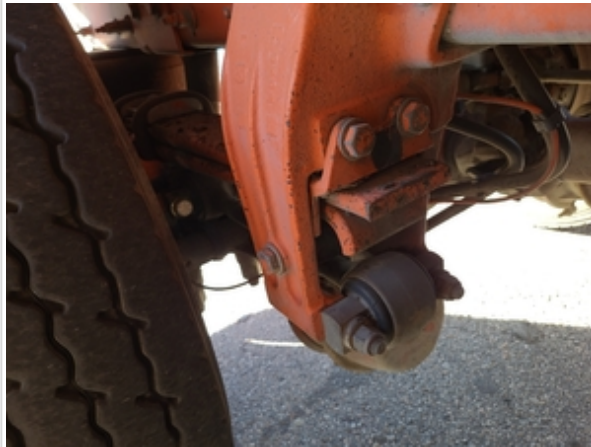
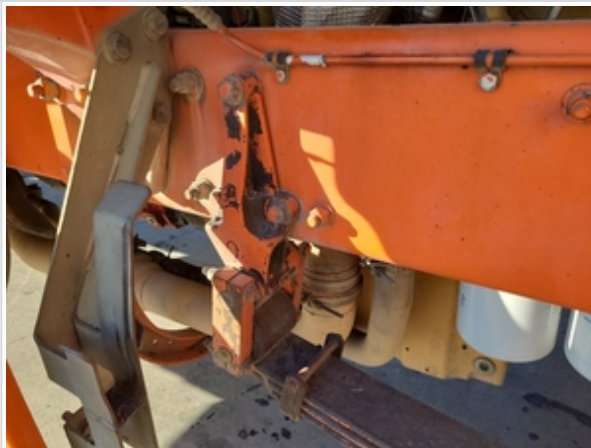
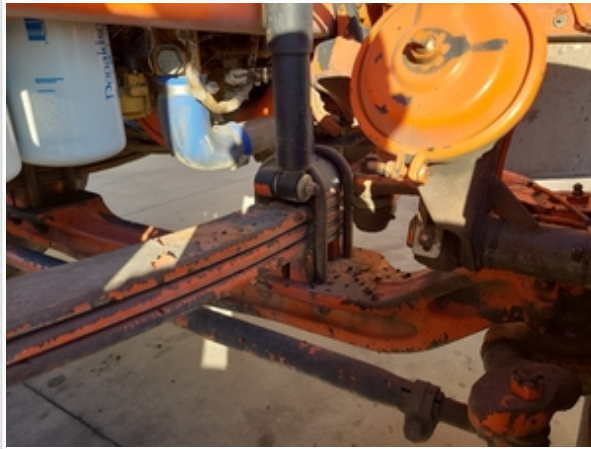
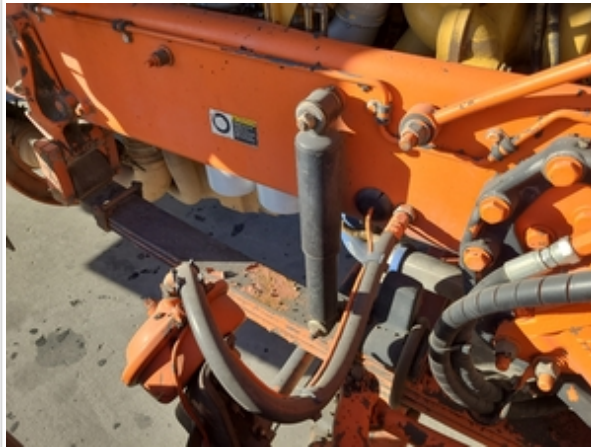
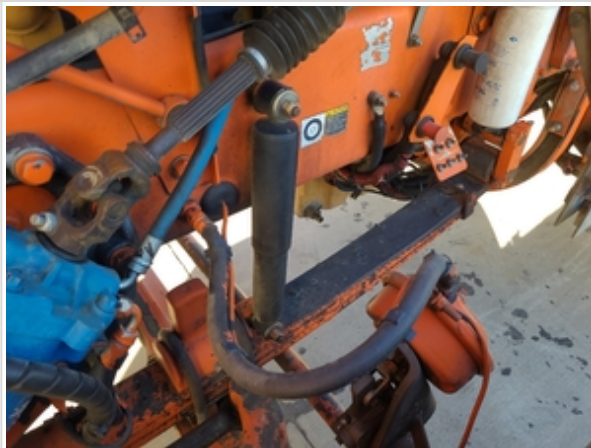
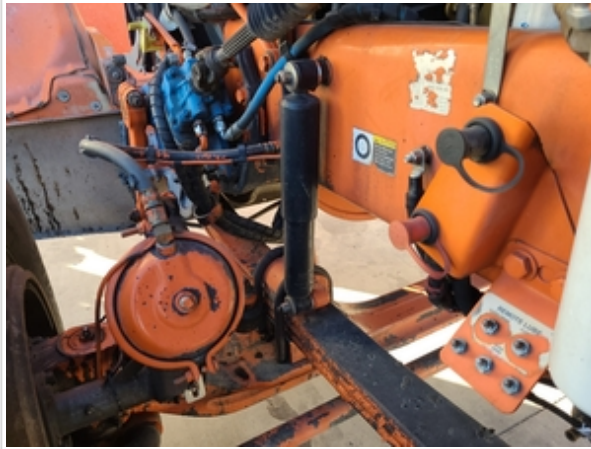
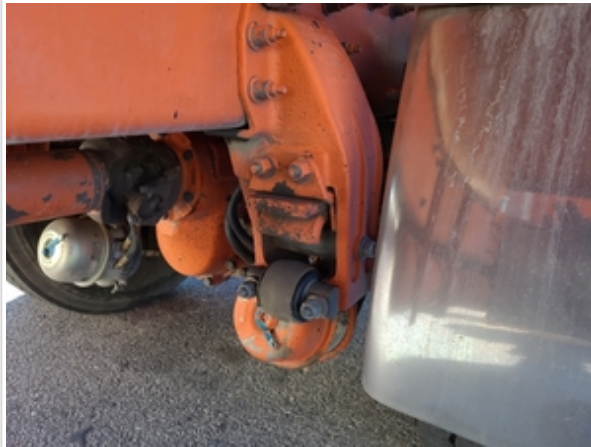
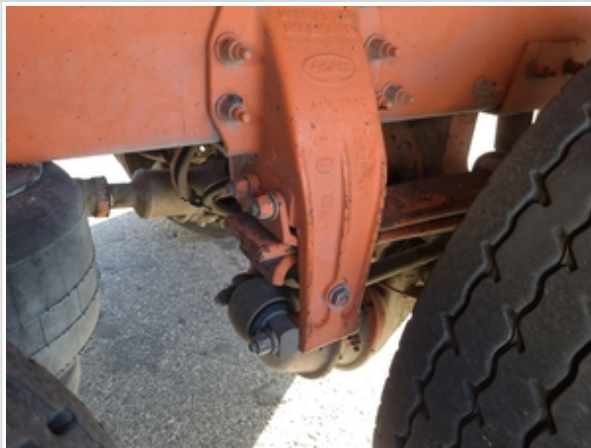
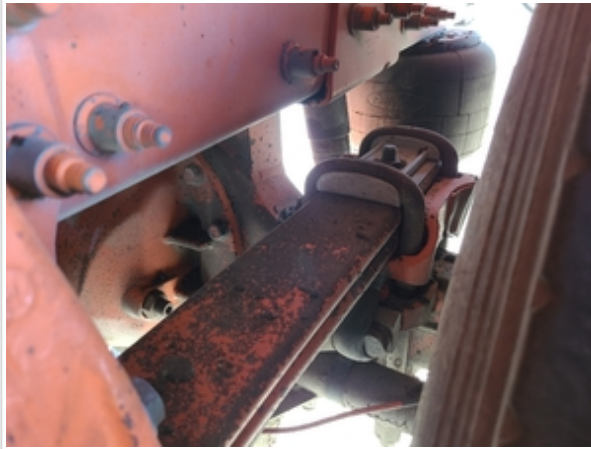
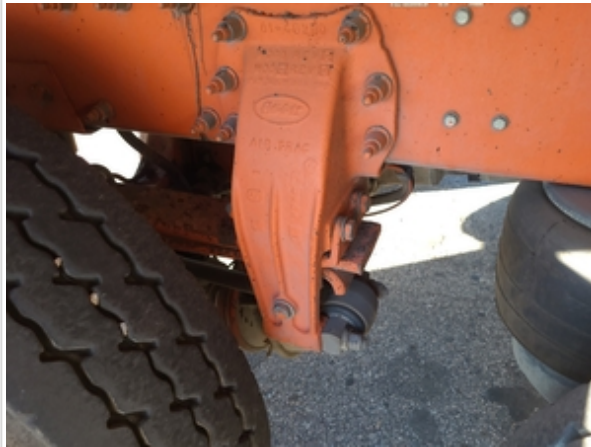
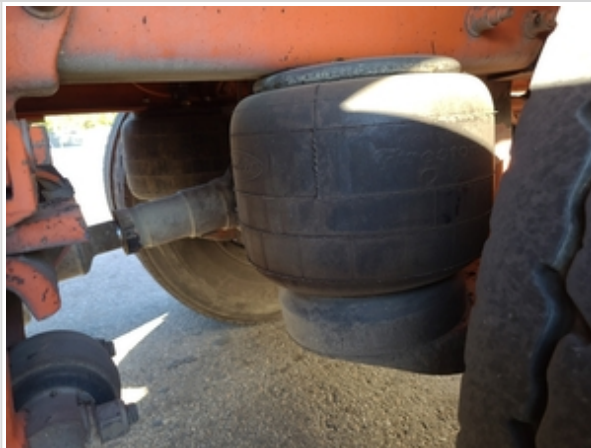
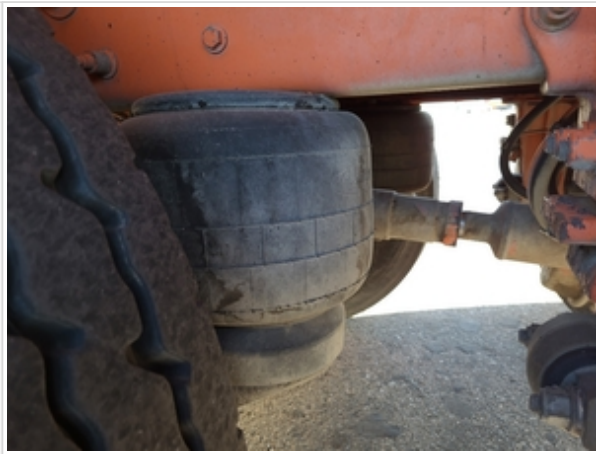
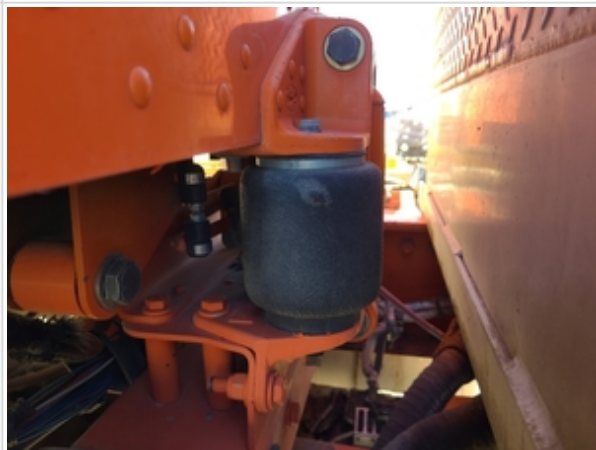
Suspension	3
Suspension Photos

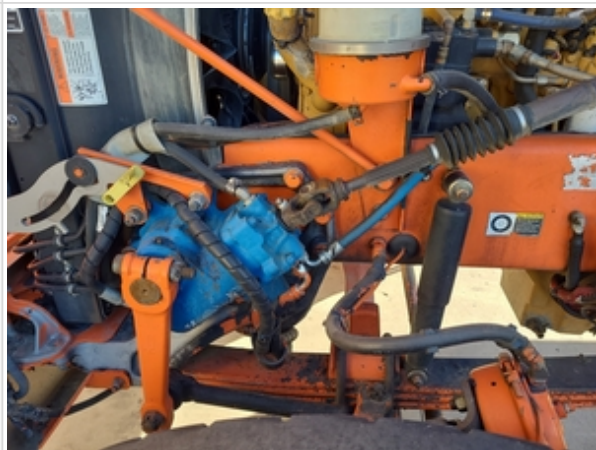
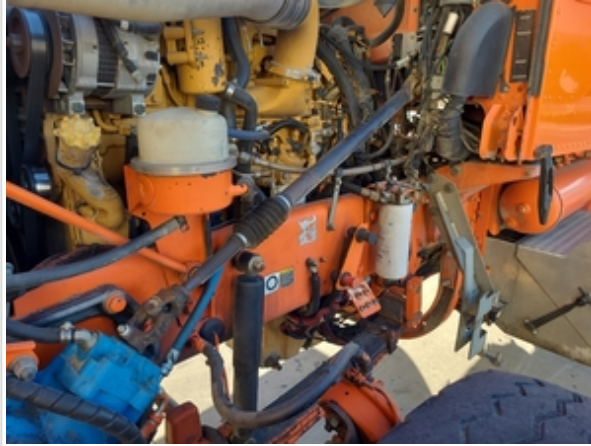
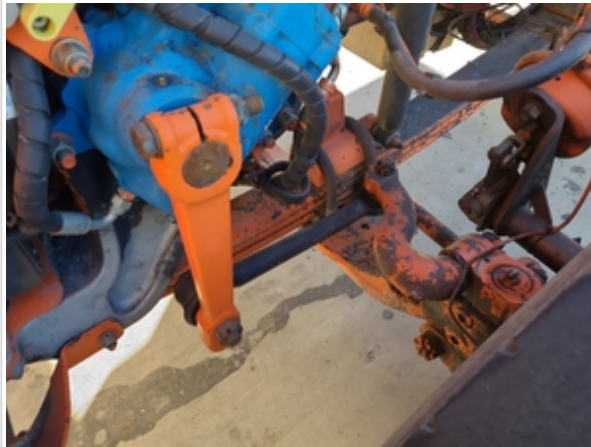
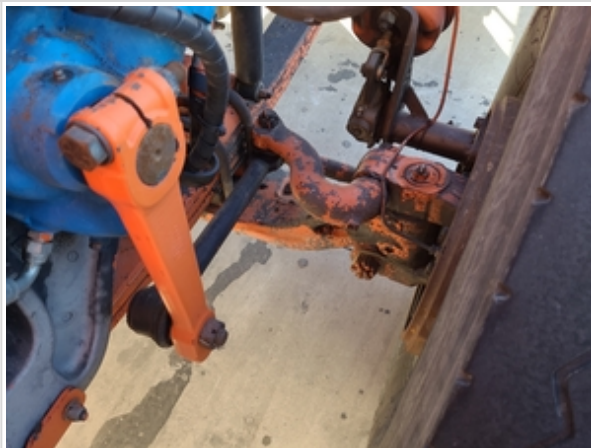
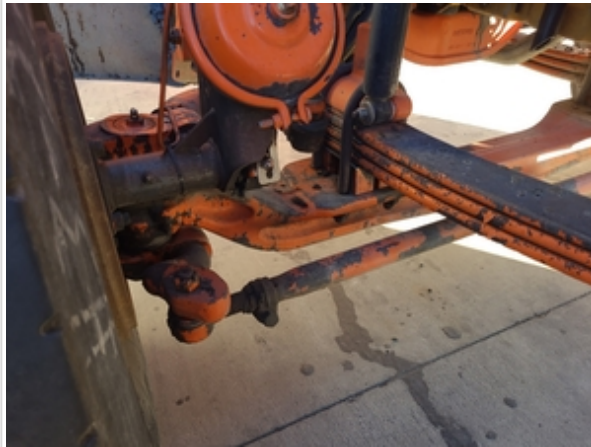
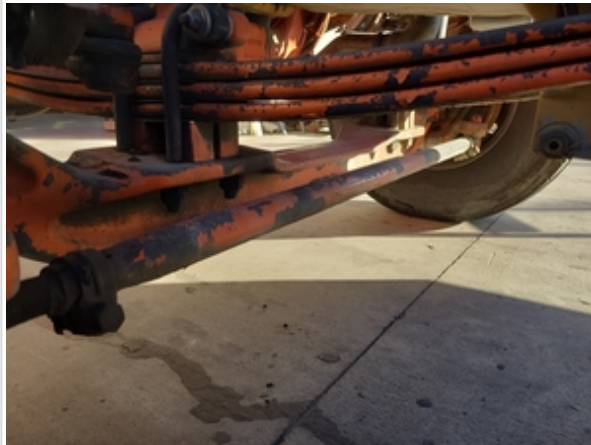
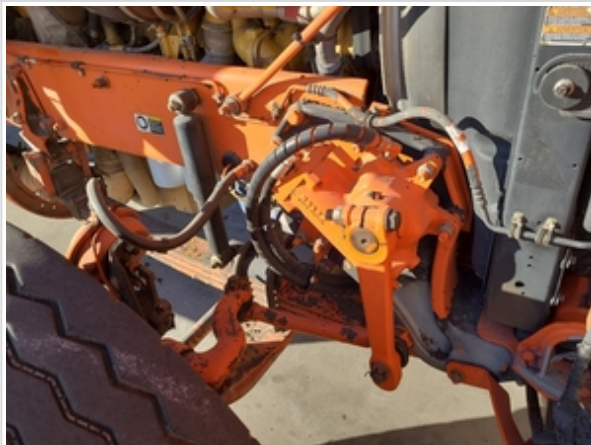
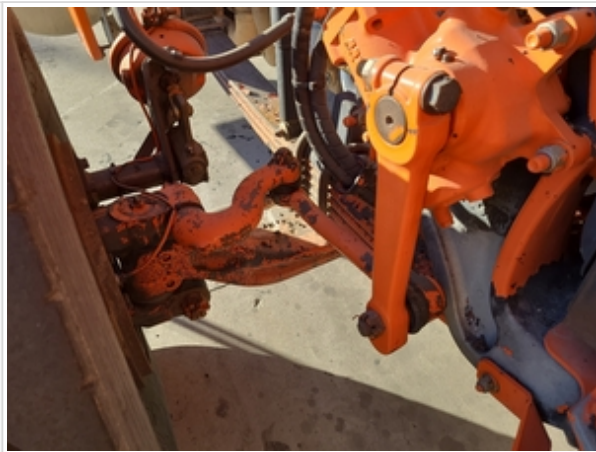
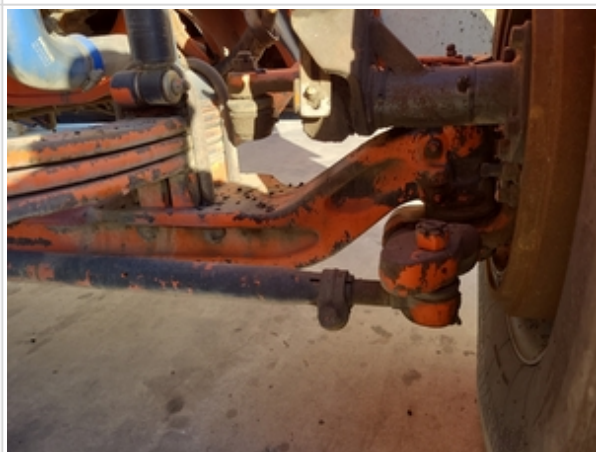
Steering Components	3
Steering Components Photos

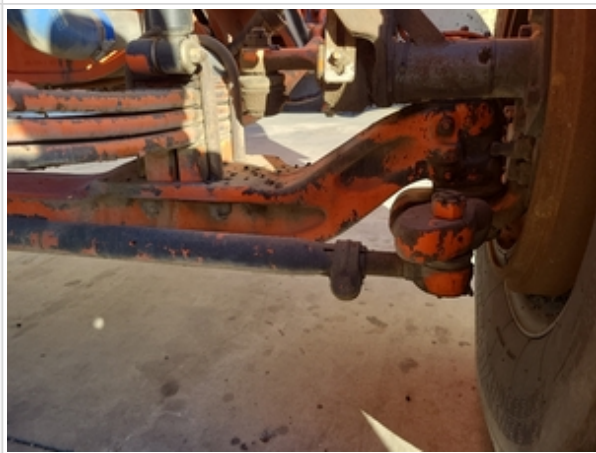
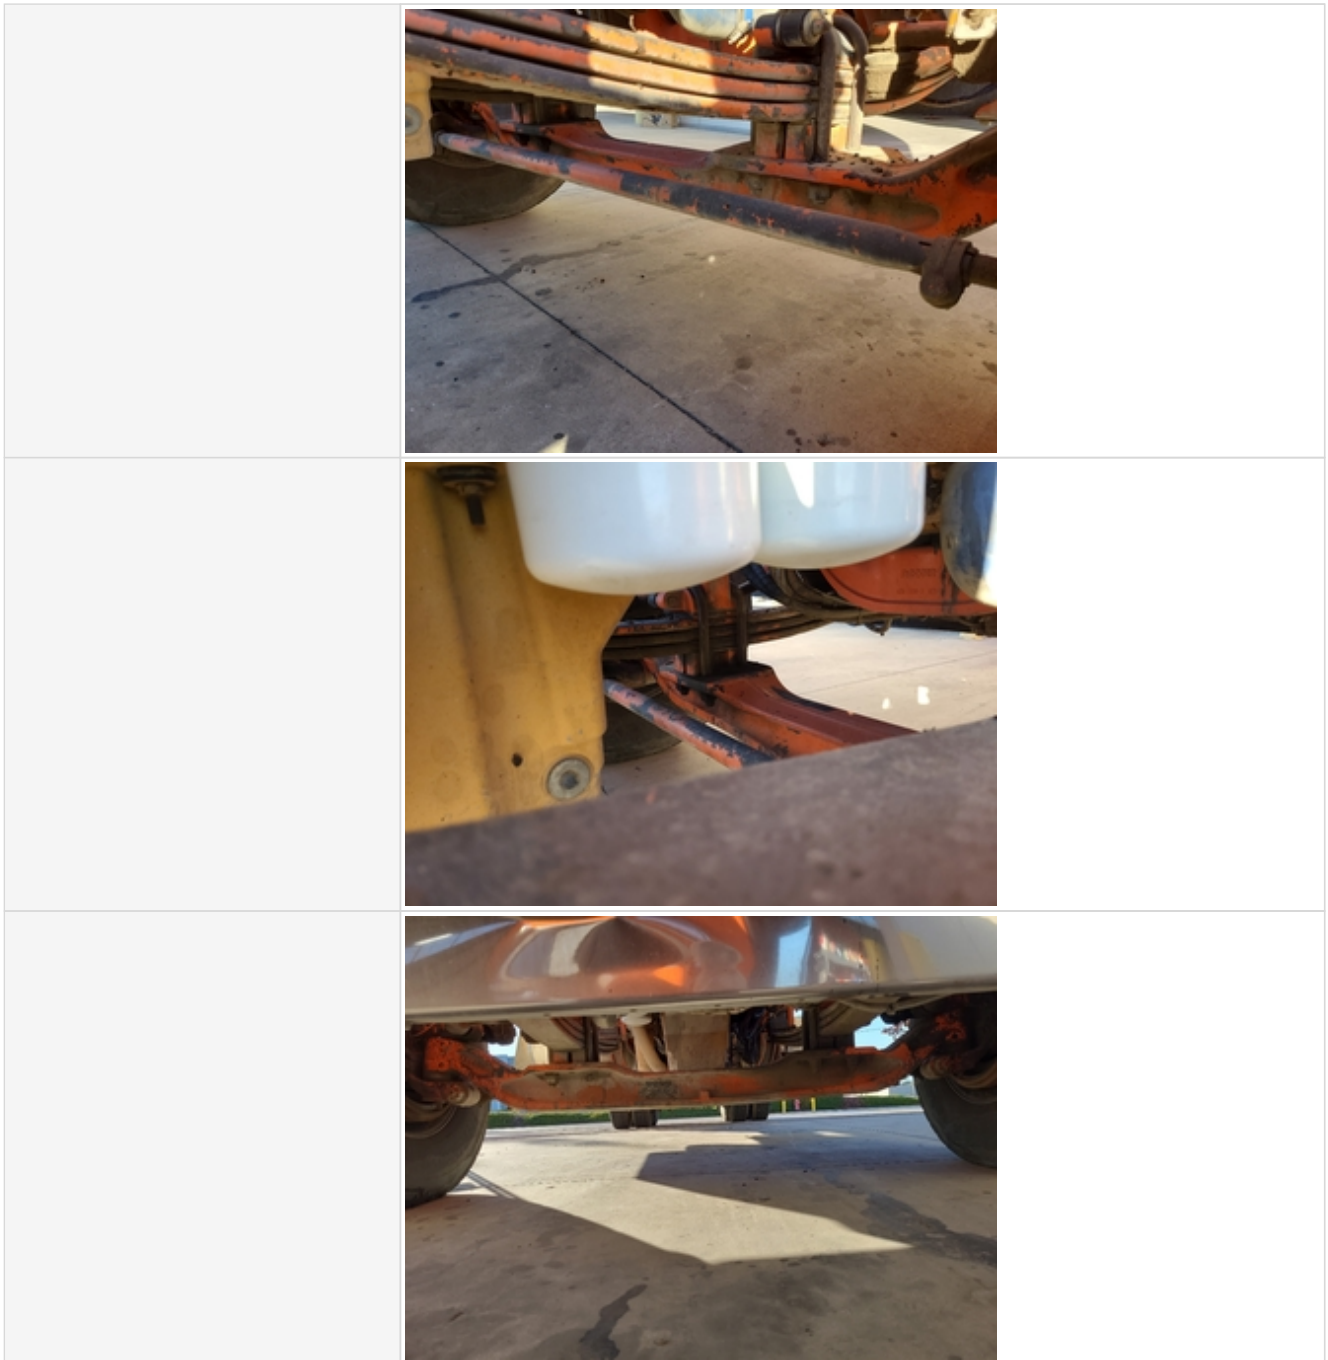
<p>Steer Axle Condition</p>	<p>3</p>
<p>Steer Axle Photos</p>

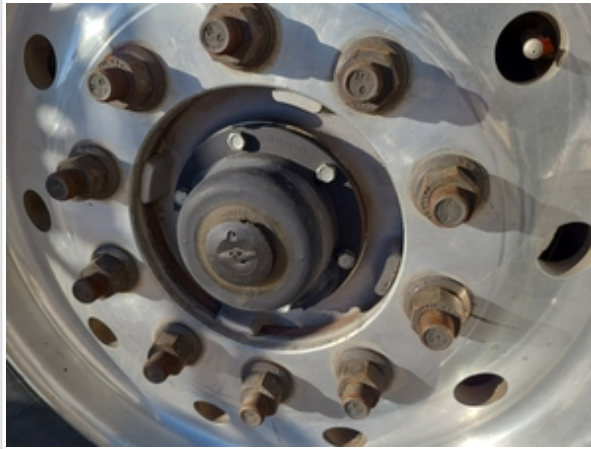
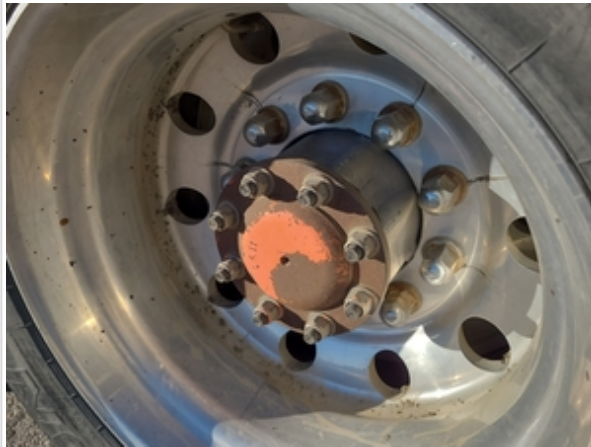
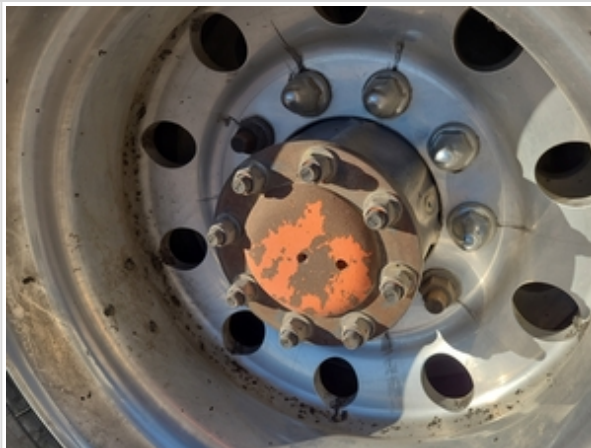
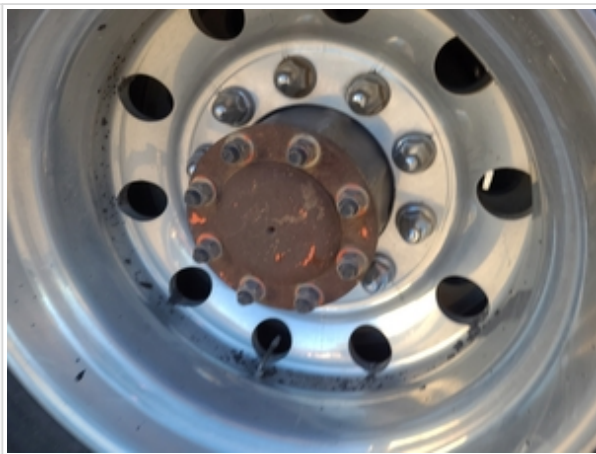
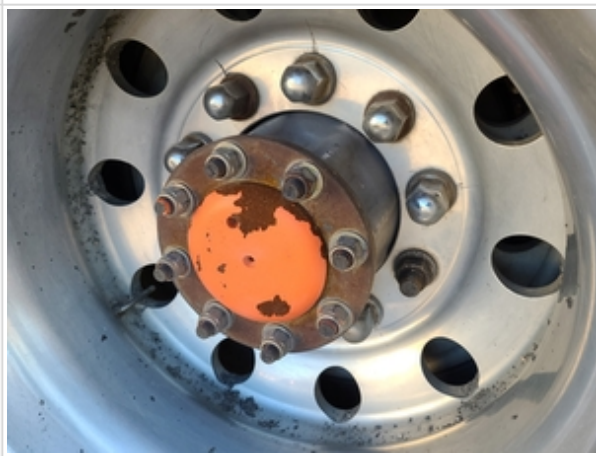
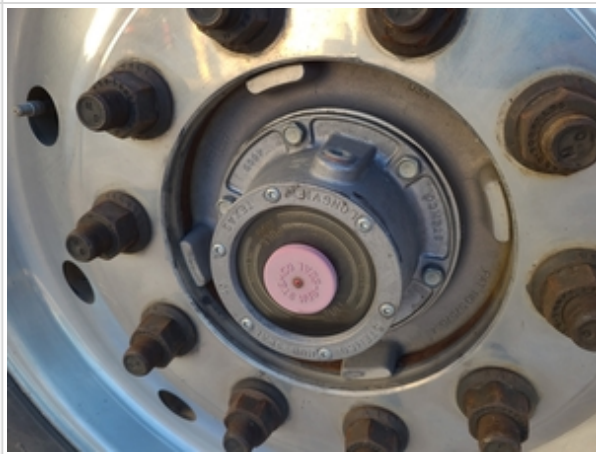
Wheels & Hub Photos

Wheels & Hub Condition	3
------------------------	---

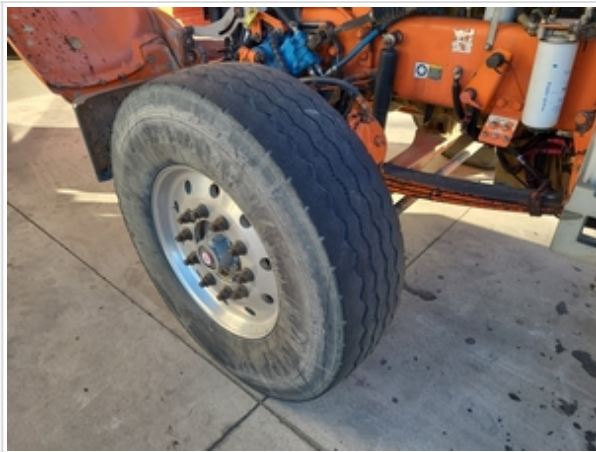
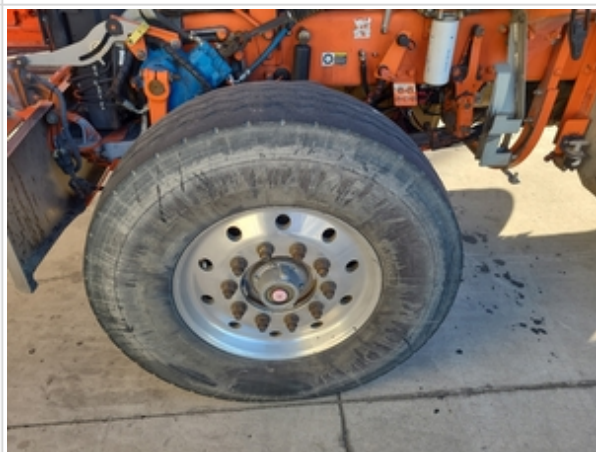
<p>Front Left Tire Photos</p>

Wheel Seal Leaks	No	
Tire Brand	(Front) Yokohama (Rear) generic recaps	
Tire Size	(Front) 315/80R/22.5 (Rear) 11R22.5	
Front Left Tire - Ratio Remaining	10%

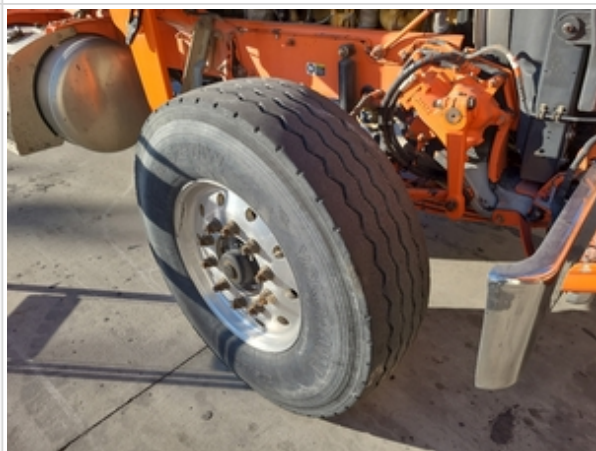
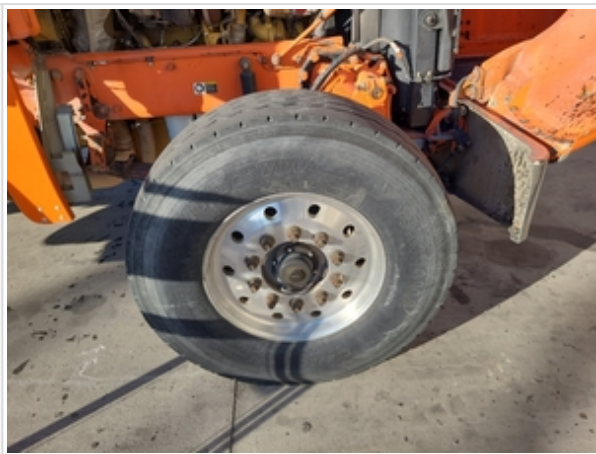
<p>Front Right Tire - Ratio Remaining</p>	<p>30%</p>
<p>Front Right Tire Photos</p>

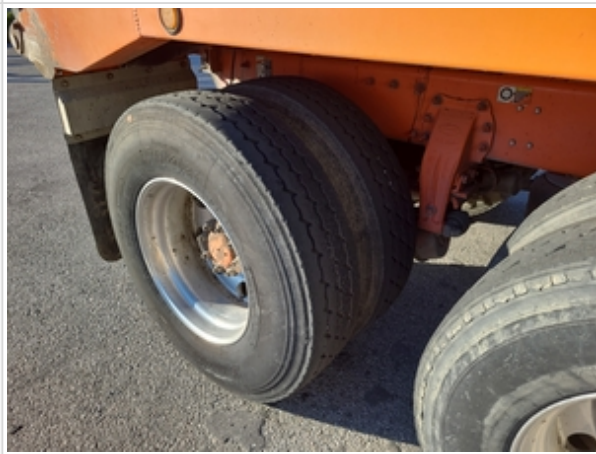
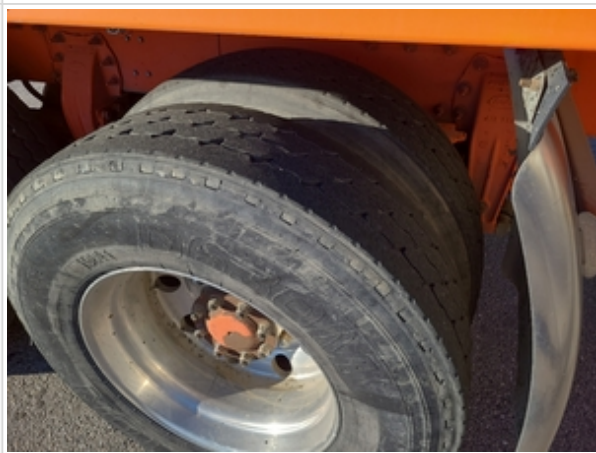
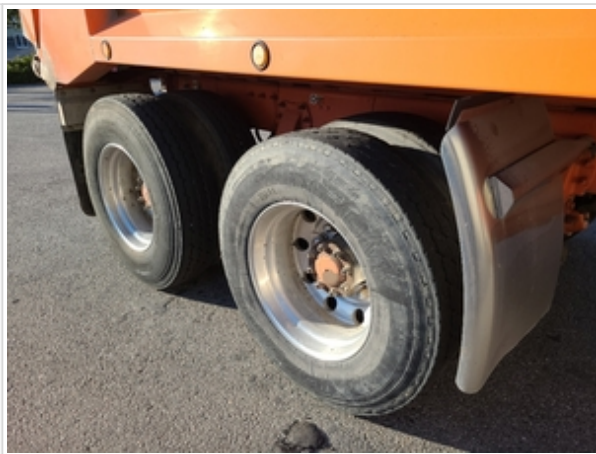
Rear Right Tire - Ratio Remaining	50%	
Rear Right Tire Photos

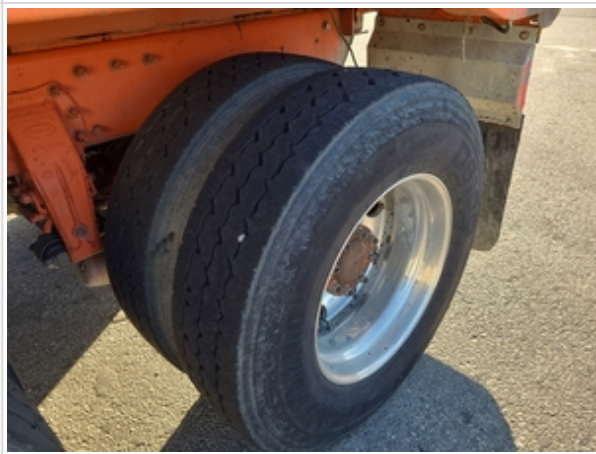
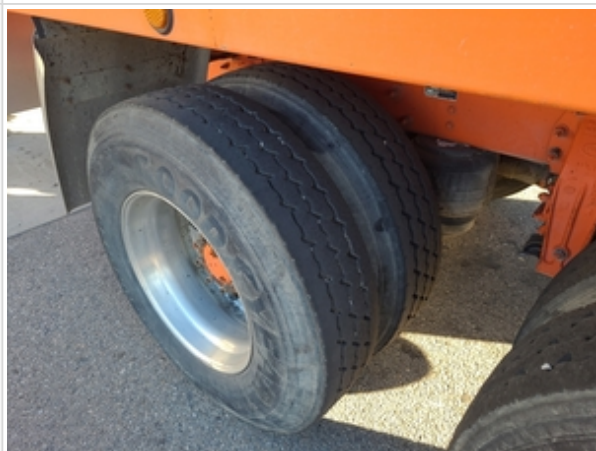
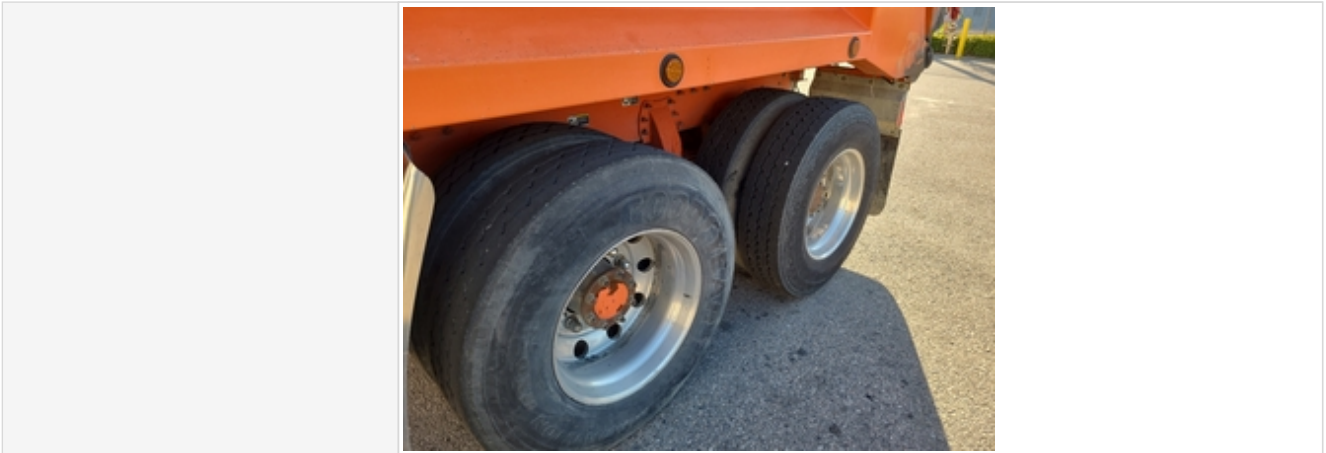
Rear Left Tire - Ratio Remaining	50%	
Rear Left Tire Photos

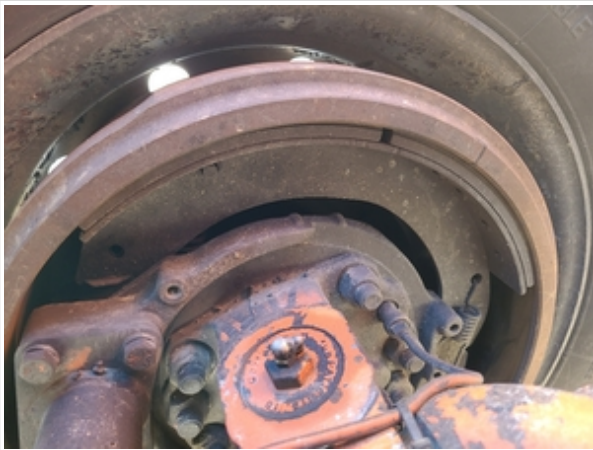
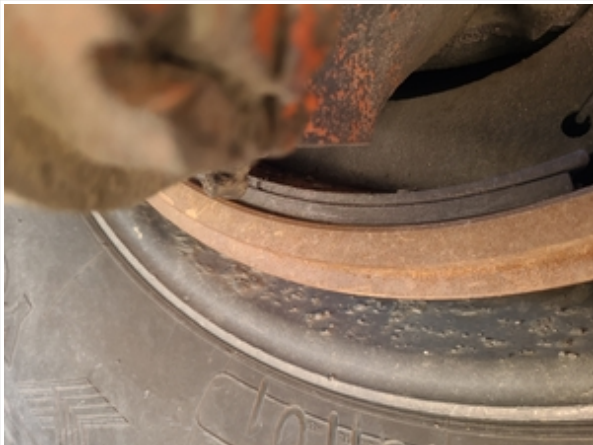
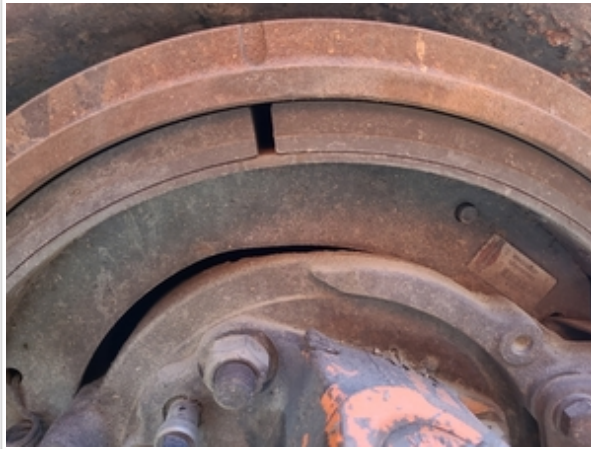
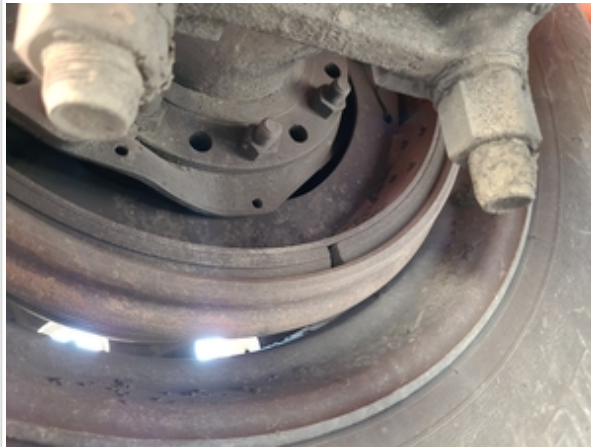
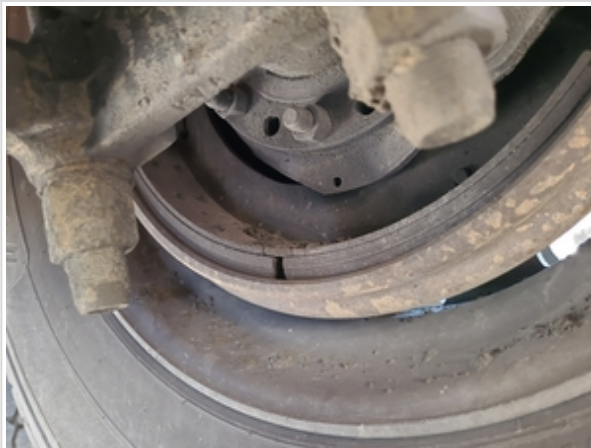
Brake Shoe Thickness	50%
Comments	front left side low rest okay
Brake Shoe Photos

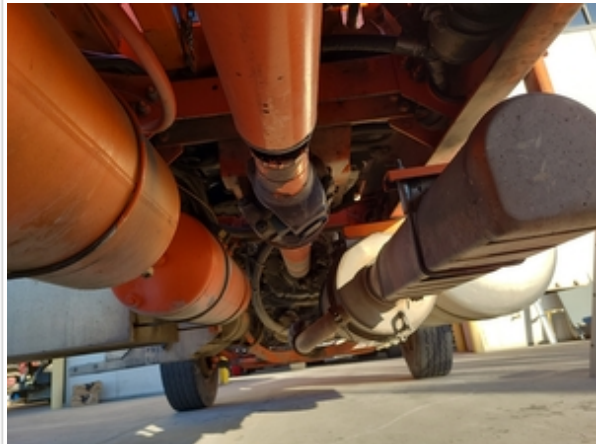
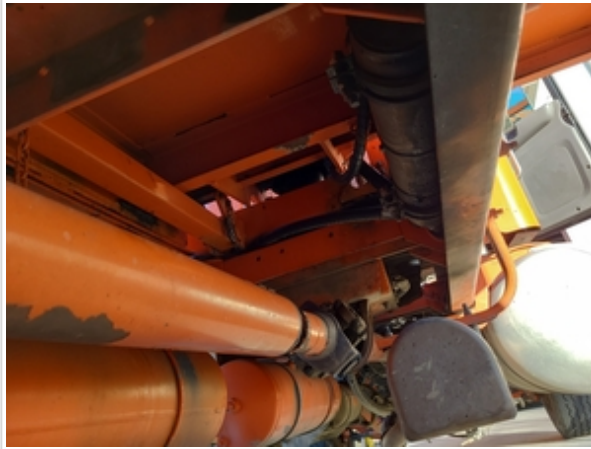
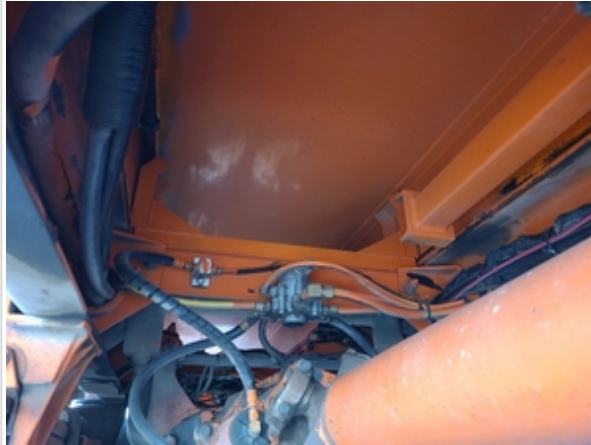
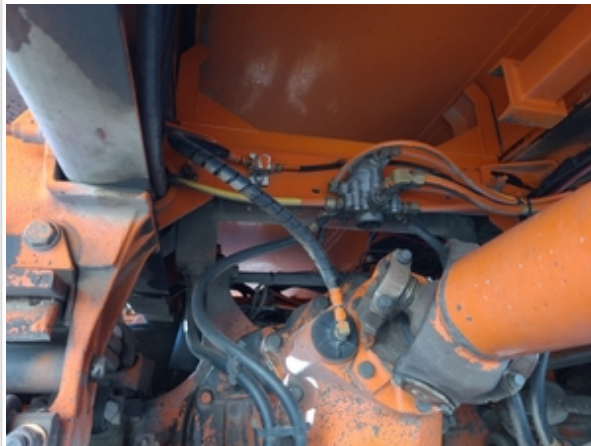
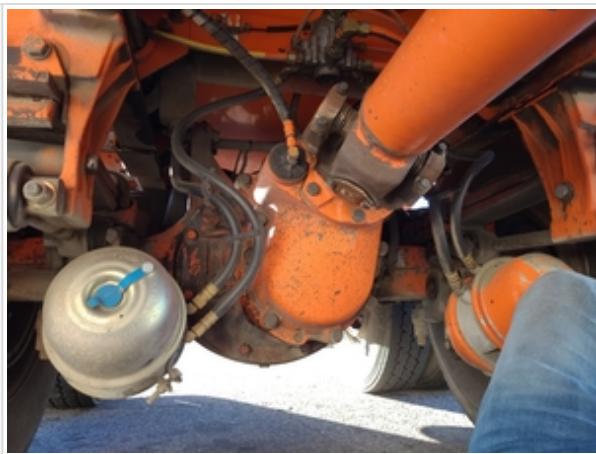
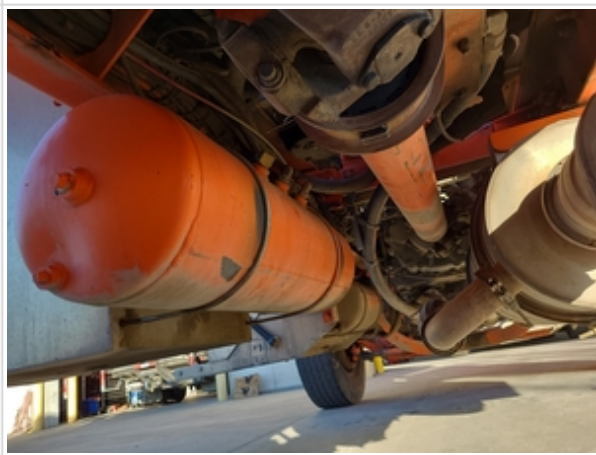
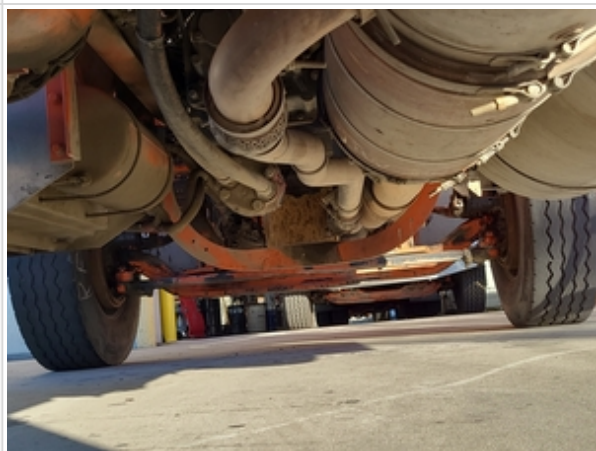
Overall Chassis	3
Overall Chassis Comments	Overall all in good condition
Overall Chassis & Undercarriage Photos

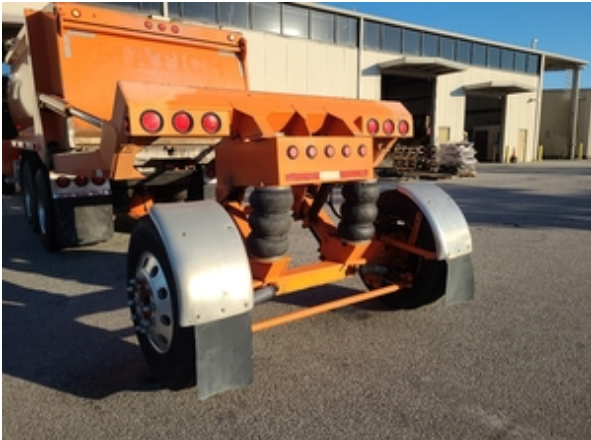
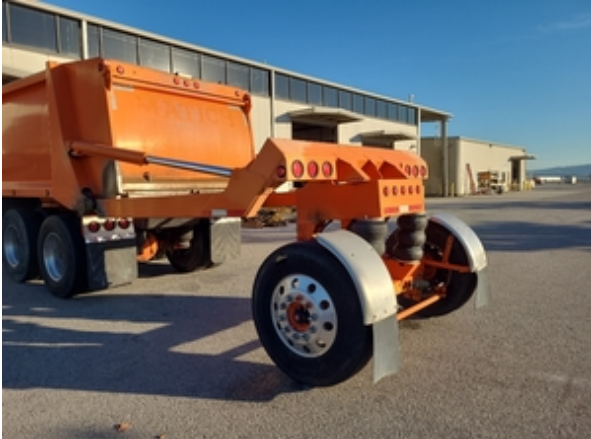
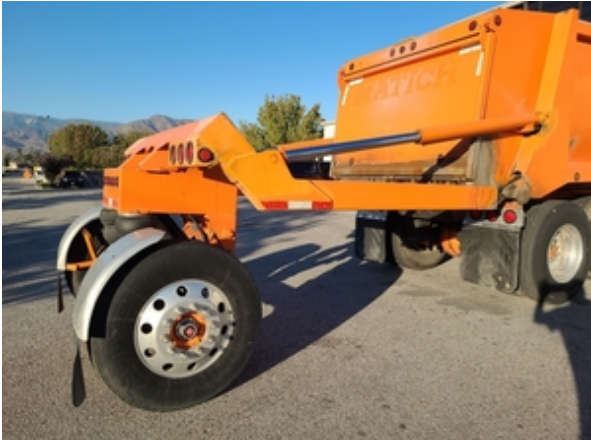
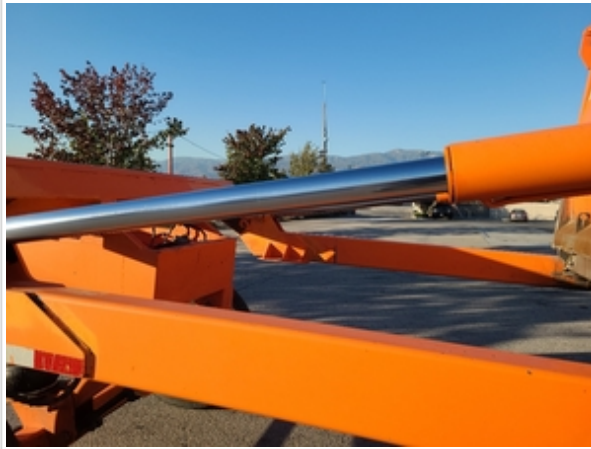
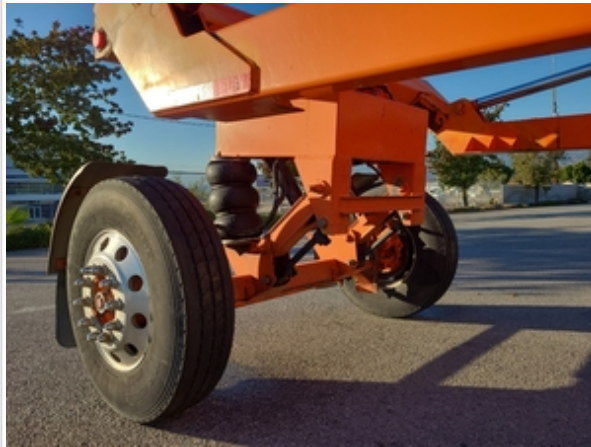
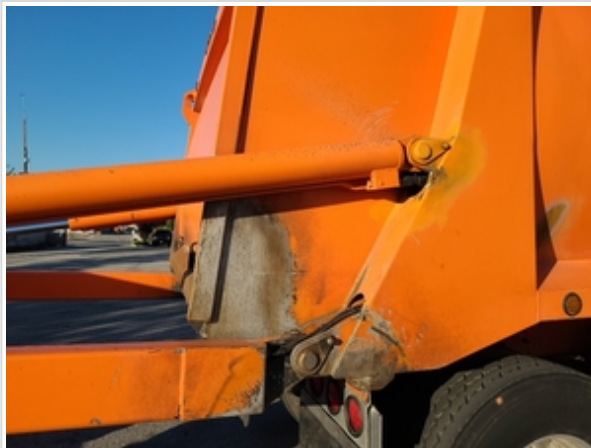
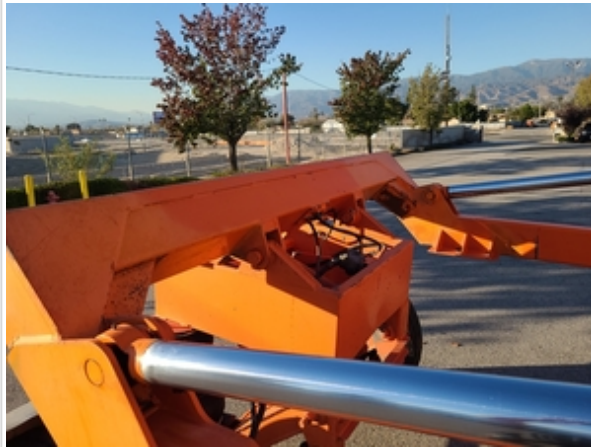
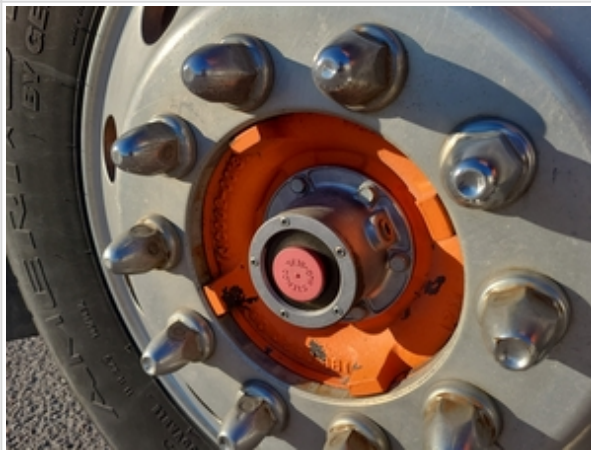
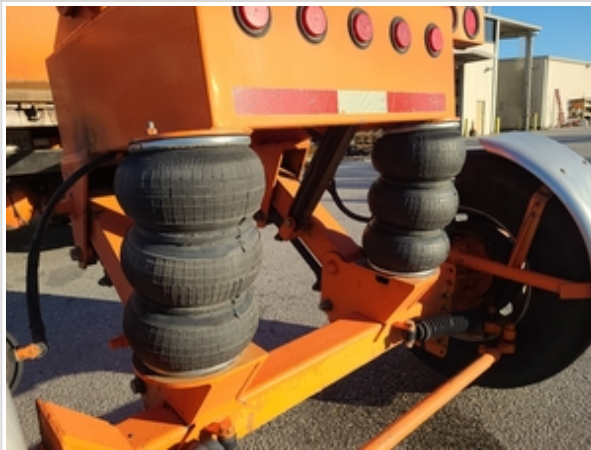
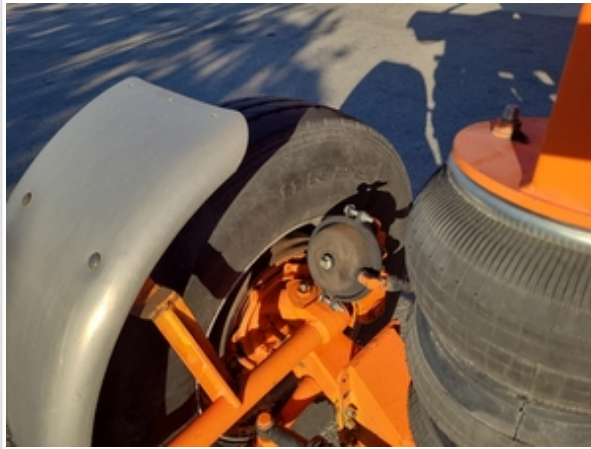
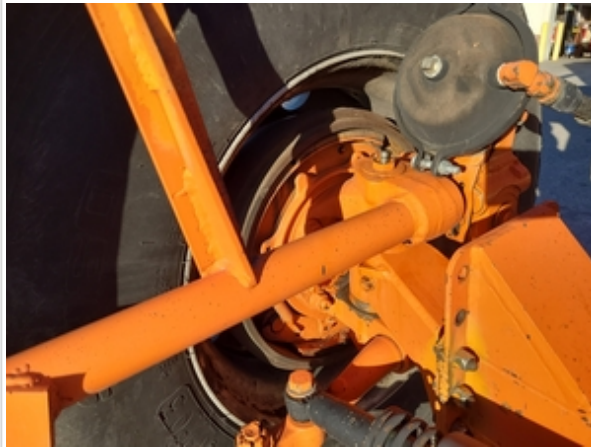
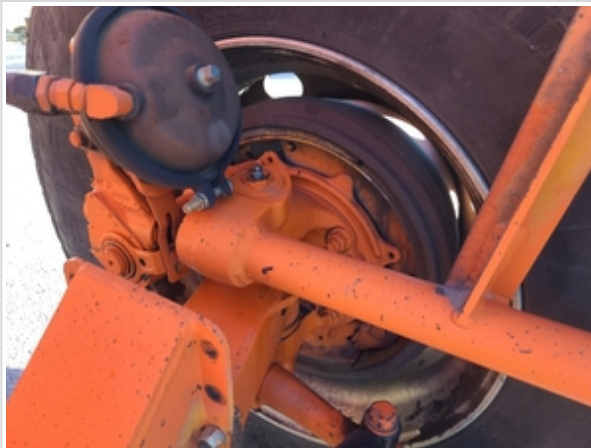
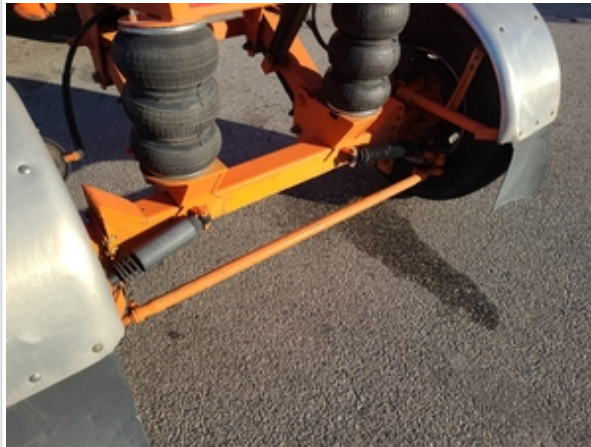
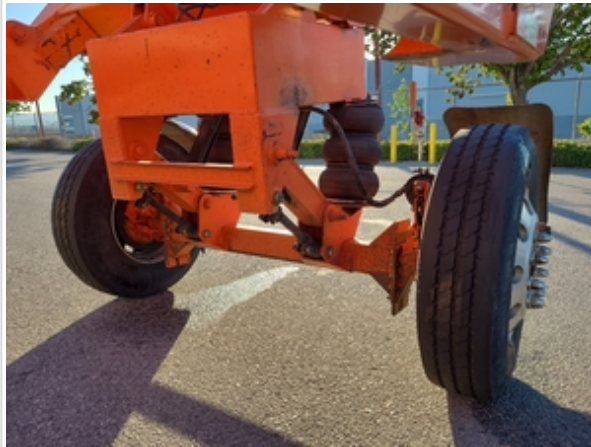
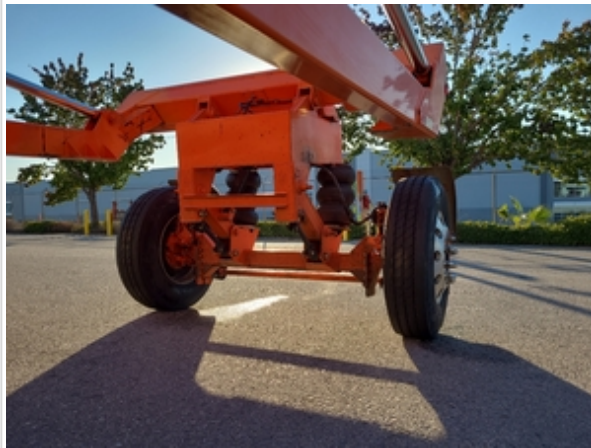
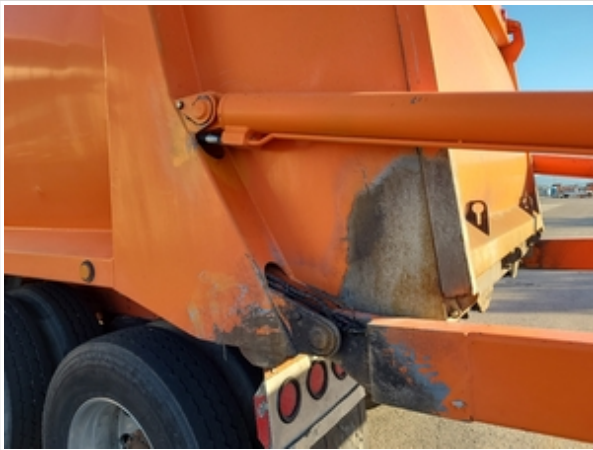
Drop Axle?	Yes
Super Dump?	Yes
Weight Rating	12,000Lbs
Axle Condition	3 - Normal Wear & Tear
Axle Condition Photos

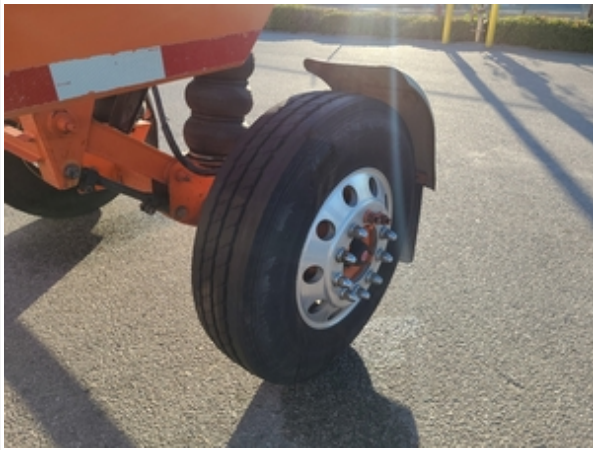
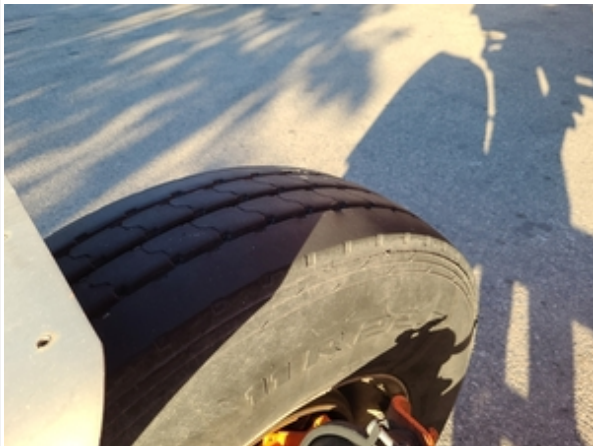
<p>Wheels & Tires</p>	<p>3 - Normal Wear & Tear</p>	
<p>Wheels & Tires Photos</p>

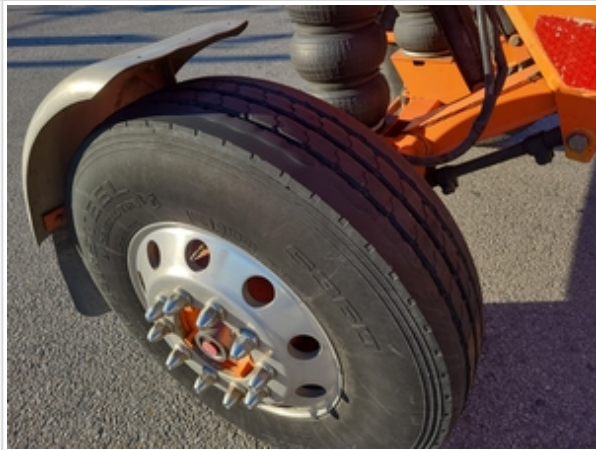
Tire Brand	AmeriSteel
Tire Size	11R22.5
Left Tire(s) Ratio Remaining	50%
Right Tire(s) Ratio Remaining	50%
