Inspection Report (On-Highway Dump Truck)

Year	2011
Make	Peterbilt
Model	367
Serial Number	1NP - TLUOX - 6 - BD127980
Truck Odometer Reading	408,807
Previous Application (e.g., earth moving, mining, demolition, etc)	Asphalt Construction

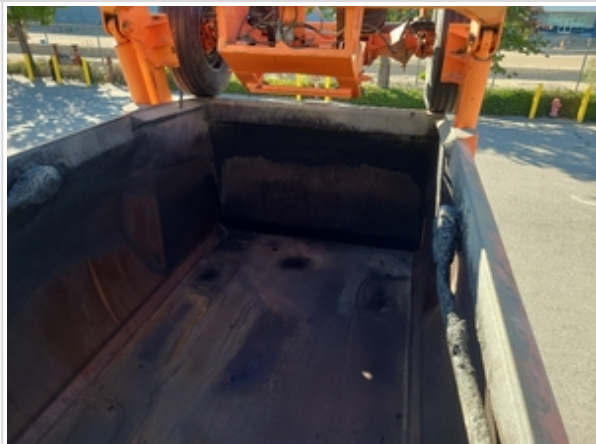
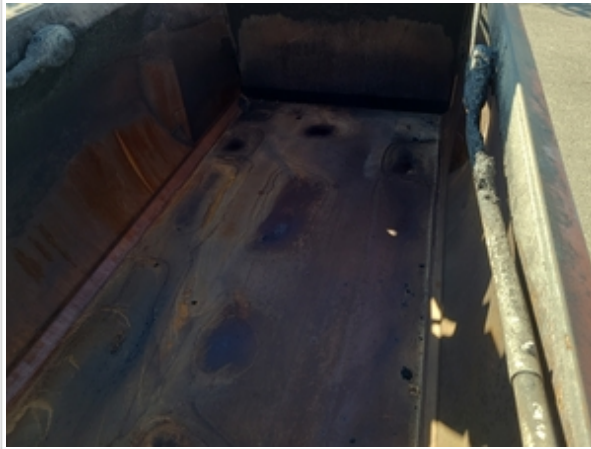
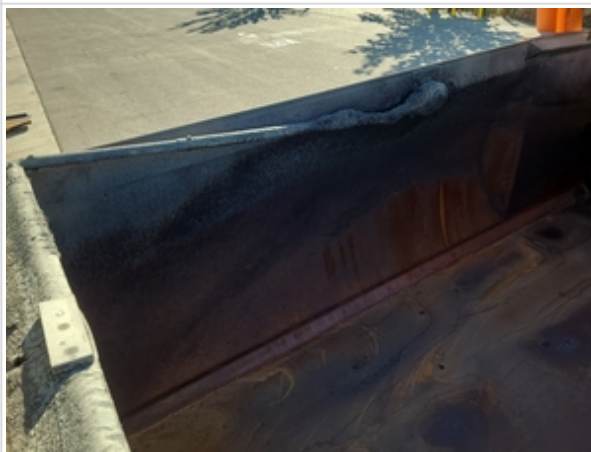
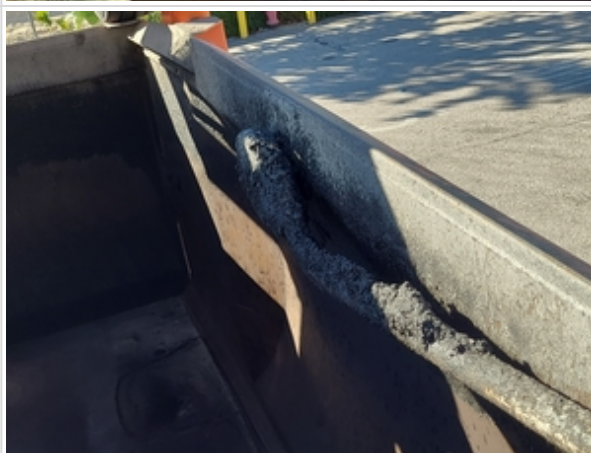
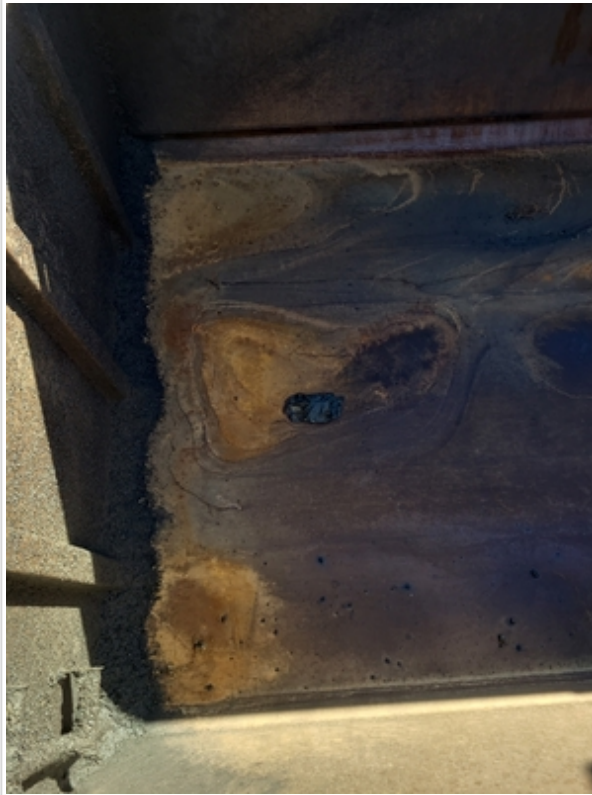
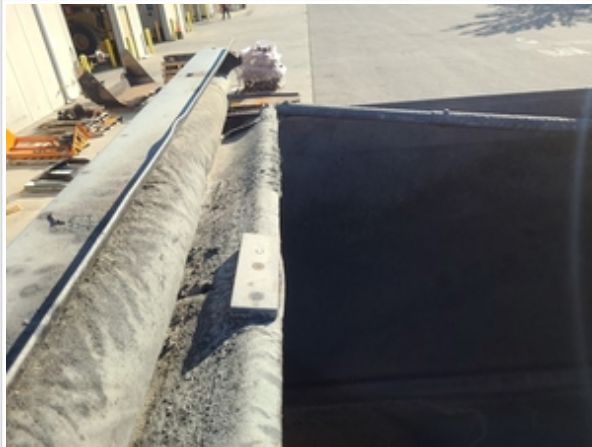
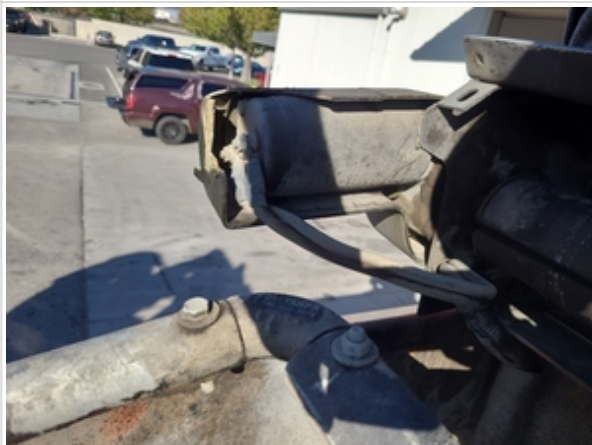
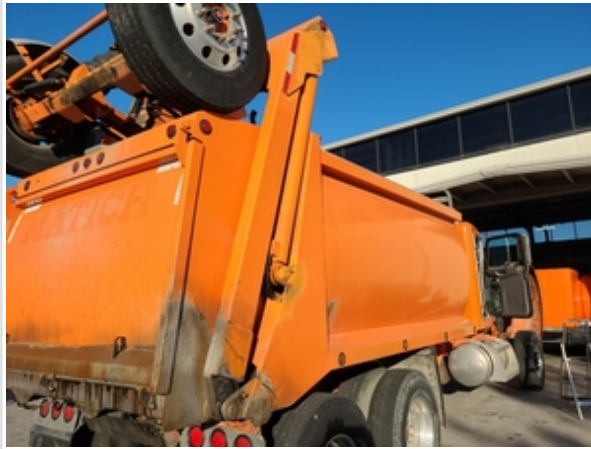
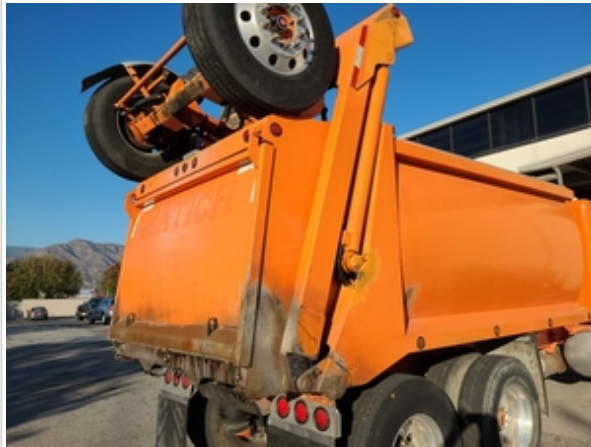
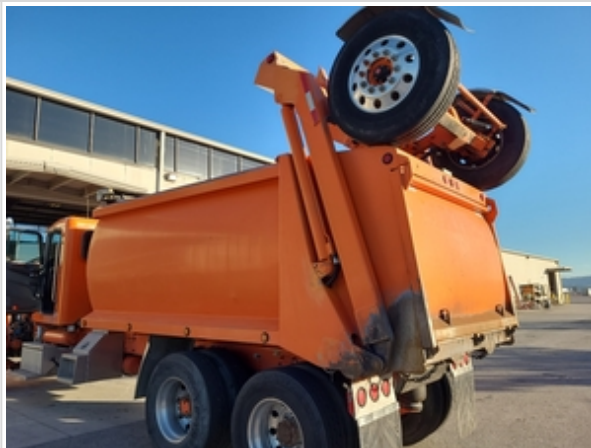
Dump Body Make & Material	Rogue
Dump Body Length (ft and inches)	15'
Dump Body Height (ft and inches)	5'3"
Bed Body	3 - Normal Wear & Tear
Bed Body Photos

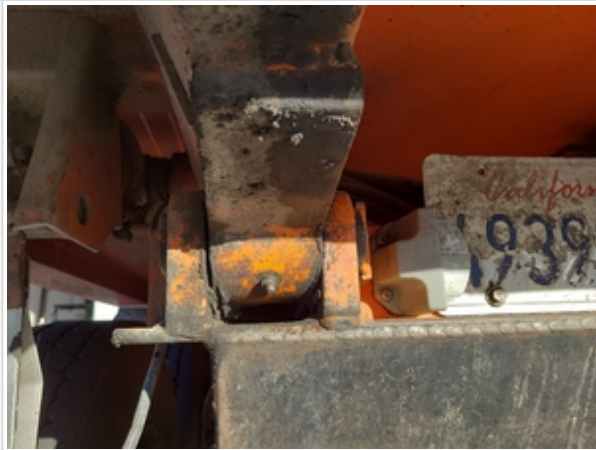
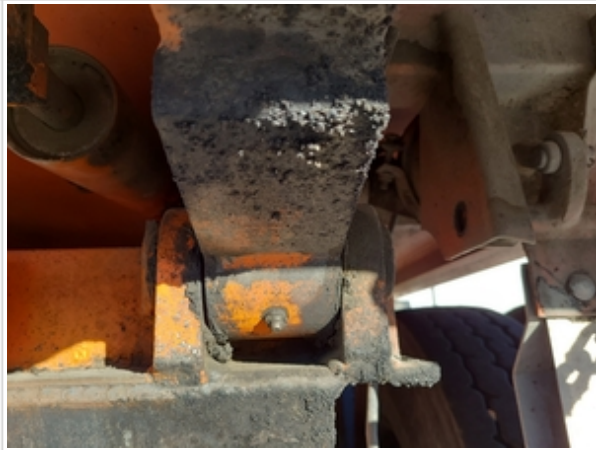
Hinge Point Photos

Tailgate Latch	3 - Normal Wear & Tear	
Support Frame	3 - Normal Wear & Tear	
Hinge Points	3 - Normal Wear & Tear

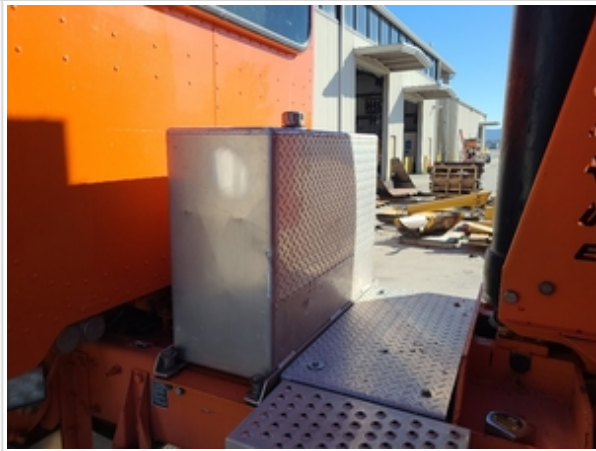
Hydraulics	Check the condition of the hydraulics. Check lines, hoses, fittings, leaks, function, etc. Note any damage or wear. Take photos.
Hydraulic Tank	3 - Normal Wear & Tear
Hydraulic Tank Photos

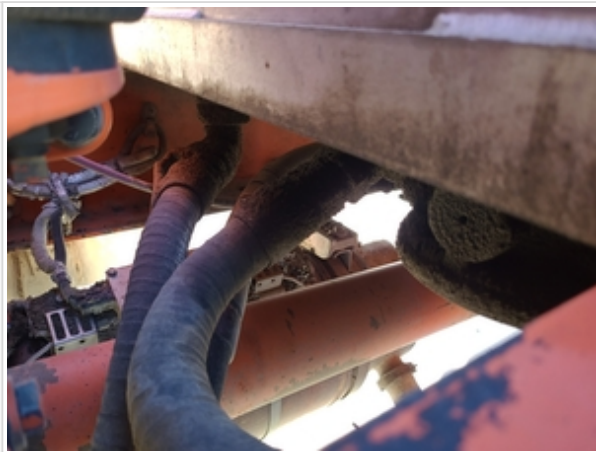
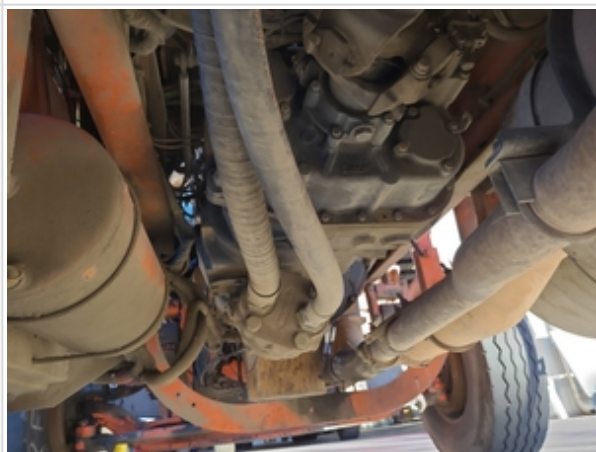
Hose Photos

Hoses	3 - Normal Wear & Tear

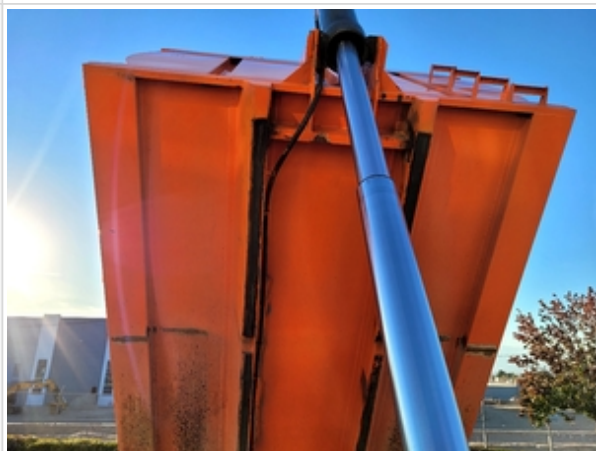
Hydraulic Cylinders	3 - Normal Wear & Tear	
Hydraulic Cylinder Photos

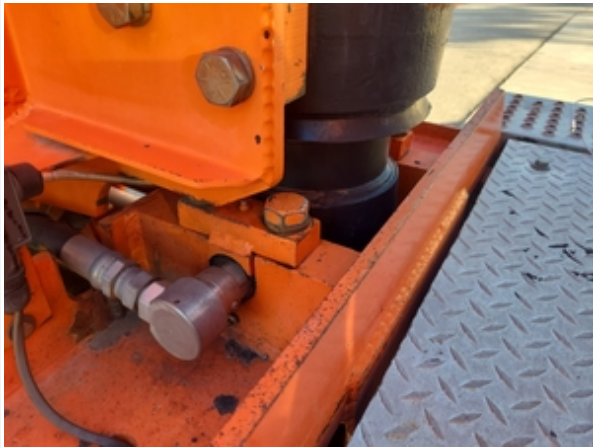
Hydraulic Function	3 - Normal Wear & Tear
Comments	Dump bed lift cylinder retract abnormal

Exterior Rating	3
Interior Rating	3
Safety Rating	3
Quality Rating	3
Functionality Rating	3
Overall Rating	3
What's Great About the Machine	This truck is in excellent condition simply because it has been well maintained bumper to bumper. No obvious major repairs found in powertrain or suspension. The interior is super clean and the exterior looks great.
What Needs Work	Most tires need to be replaced soon. Front brake shoes need to be replaced soon. Dump body lift cylinder should be further inspected to determine possible hydraulic retract problem.
Date/Time	11-14-2022
