Inspection Report (On-Highway Dump Truck)

Year	2011
Make	Peterbilt
Model	367
Serial Number	1NP - TLUOX - 6 - BD127977
Truck Odometer Reading	443,015
Previous Application (e.g., earth moving, mining, demolition, etc)	Asphalt Construction

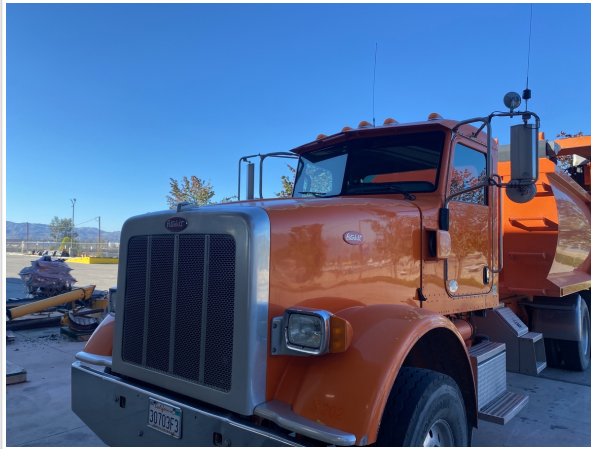
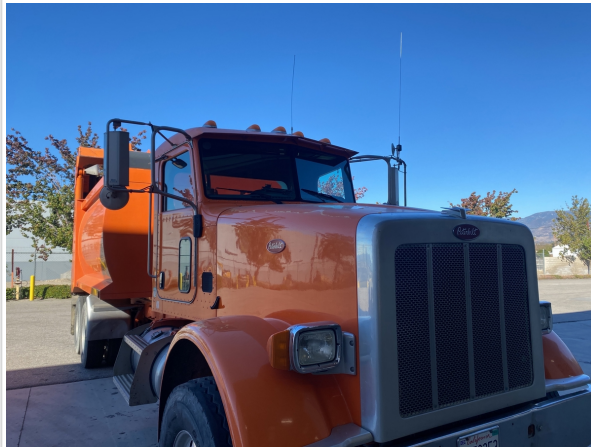
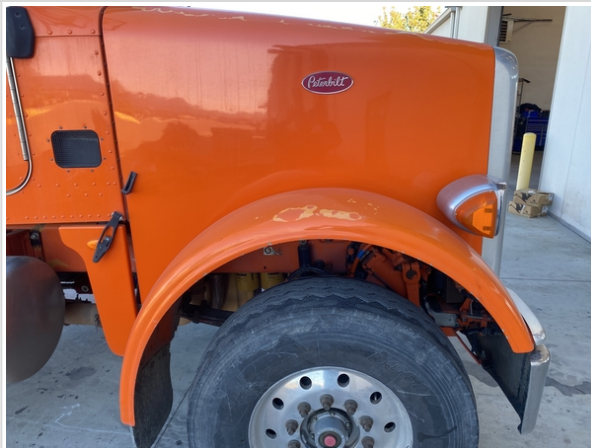
Front	3 - Normal Wear & Tear
Front Condition	No visible damage

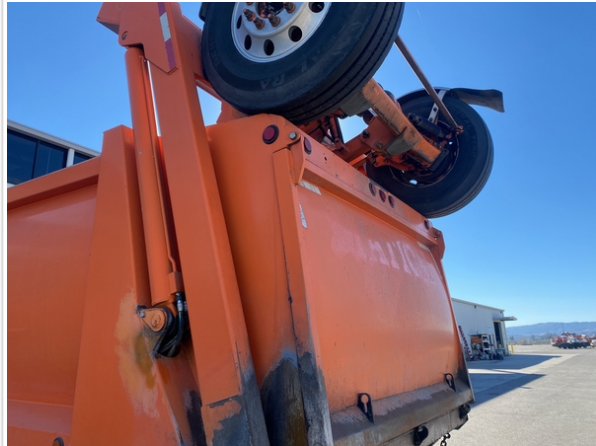
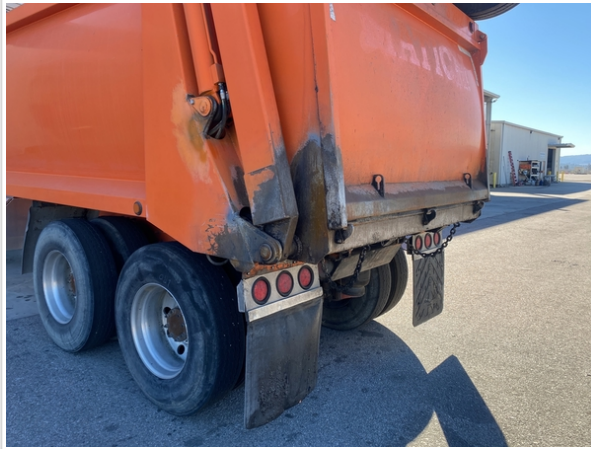
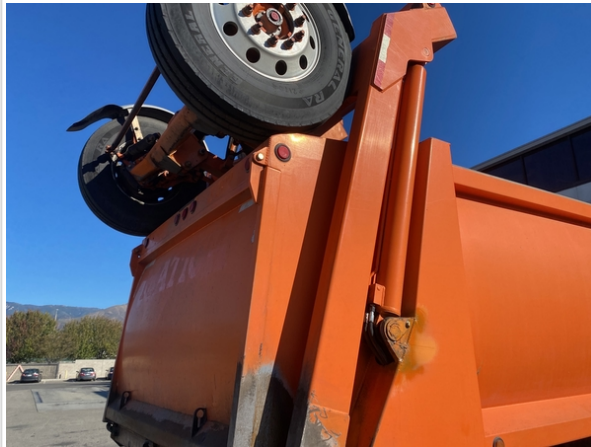
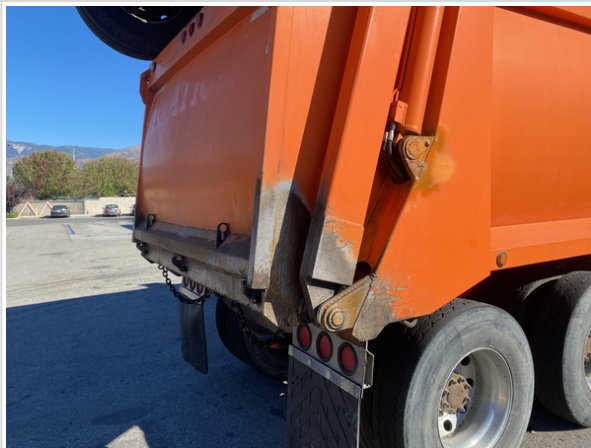
Rear	3 - Normal Wear & Tear
Rear Condition	No visible damage, Other (see comments)
Rear Photos

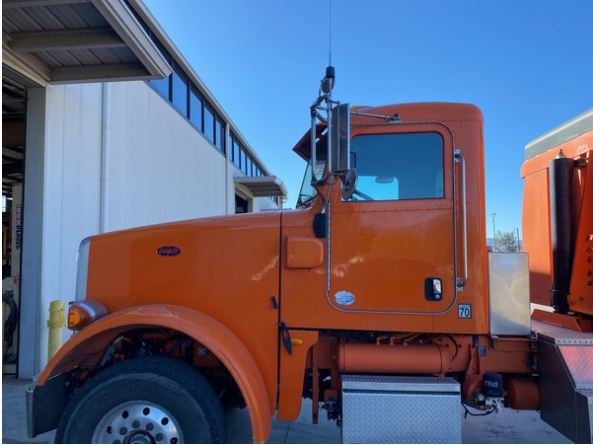
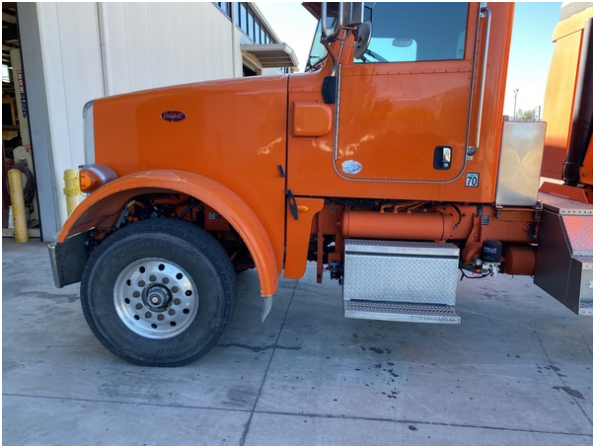
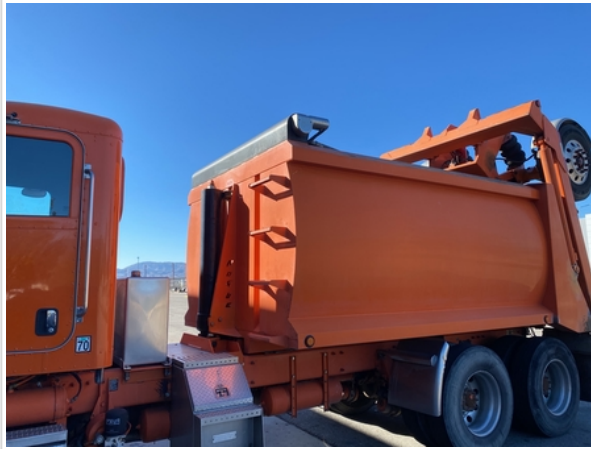
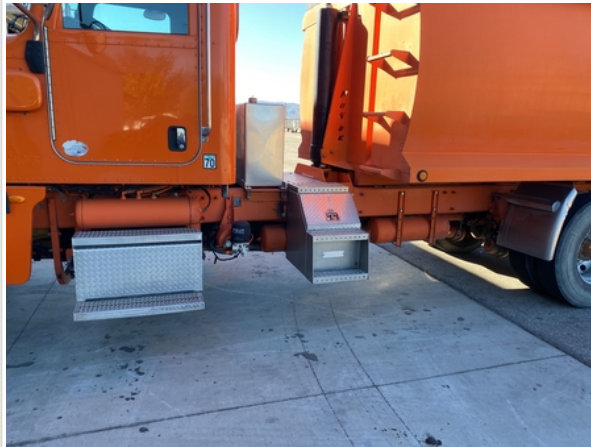
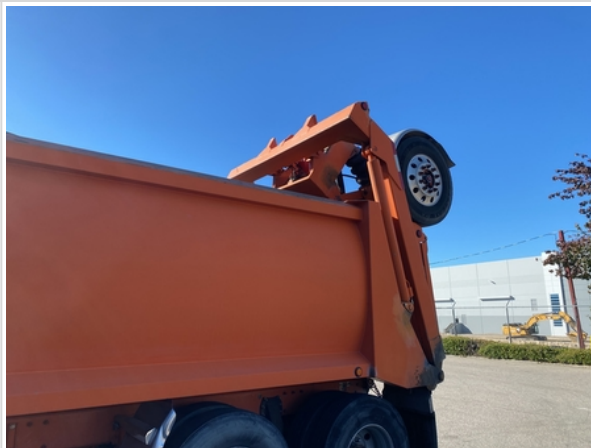
Left	3 - Normal Wear & Tear	
Left Condition	No visible damage	
Left Photos

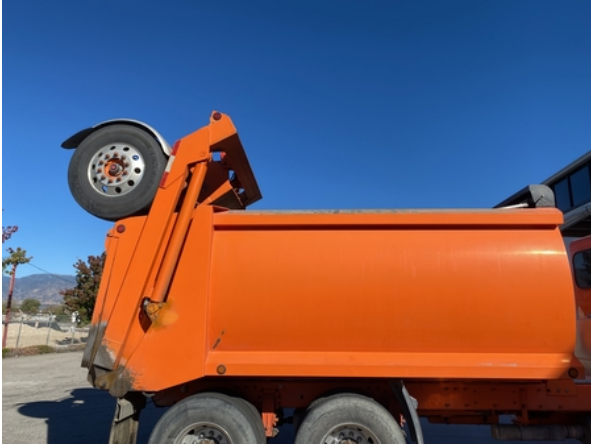
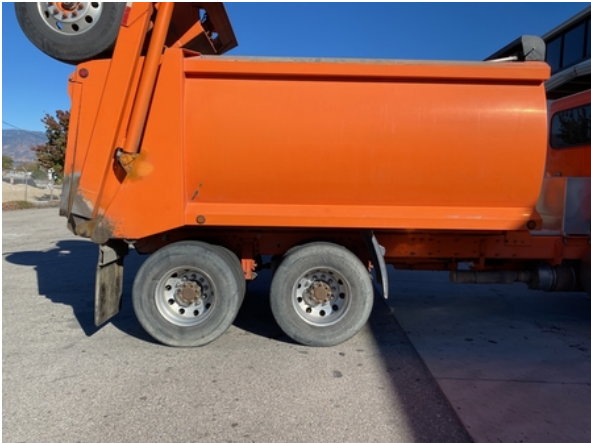
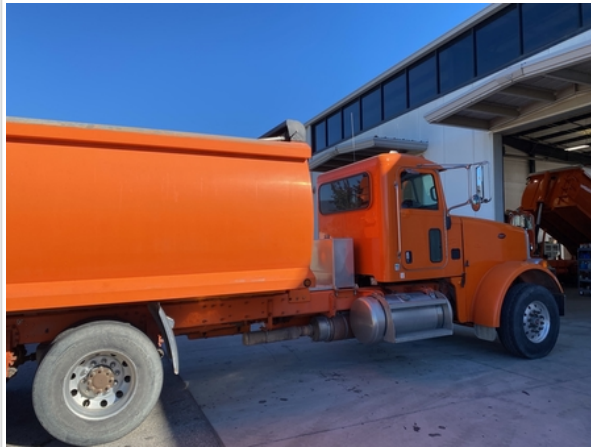
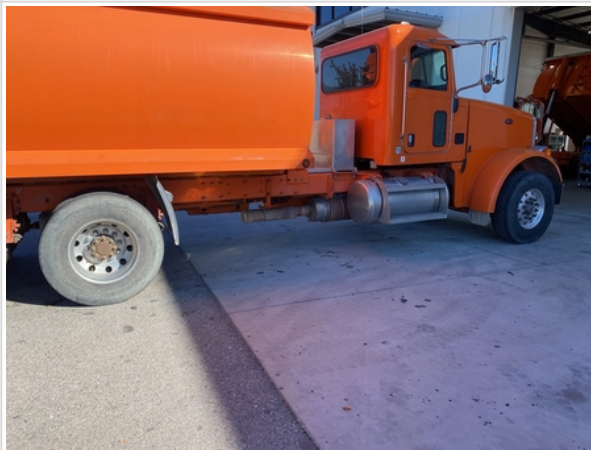
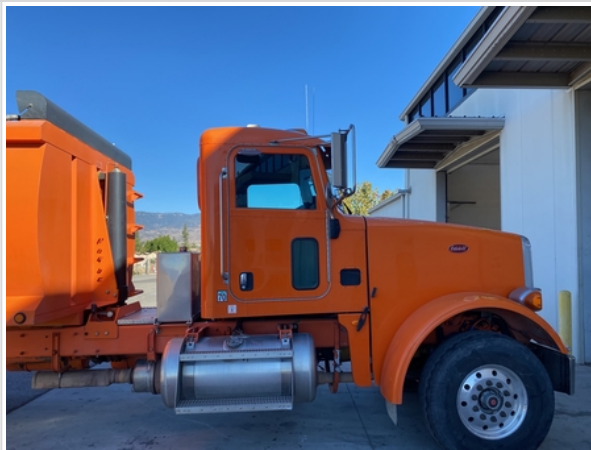
Right	3 - Normal Wear & Tear	
Right Condition	No visible damage	
Right Photos

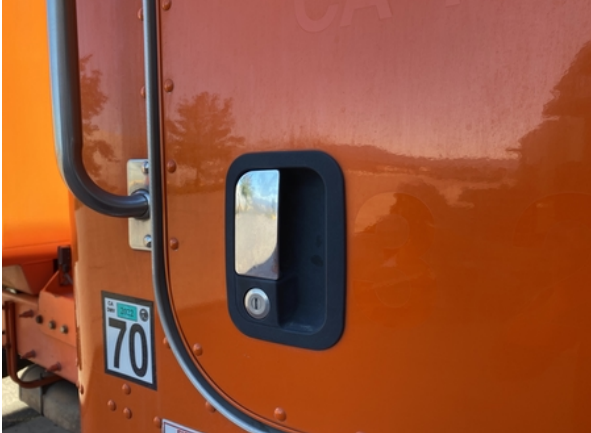
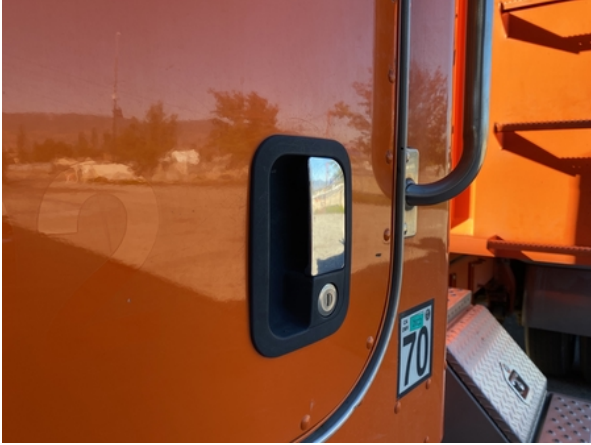
Body Panels (Any Rust Damage?)	3 - Normal Wear & Tear	
Body Panel Condition	No visible damage, good paint condition and panel fitment	
Doors / Canopy Latches	3 - Normal Wear & Tear	
Doors / Canopy Latches Condition	No visible damage	
Doors / Canopy Latches Photos

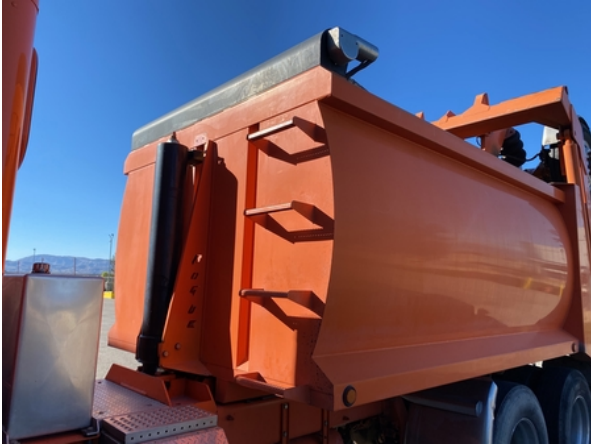
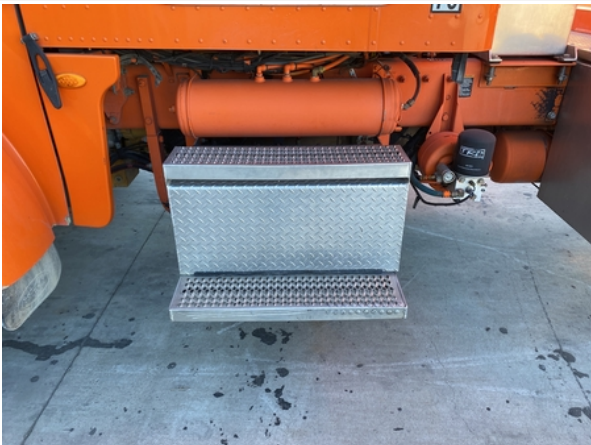
Steps / Ladders	3 - Normal Wear & Tear
Steps / Ladders Condition	Steps/ladders are fully intact and appear structurally sound
Steps / Ladders Photos

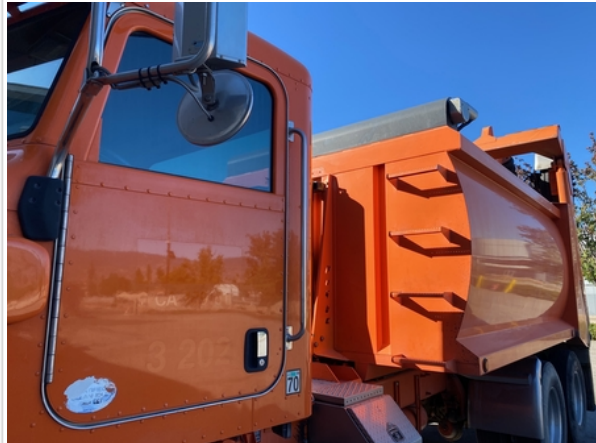
Handrails	3 - Normal Wear & Tear
Handrails Condition	Handrails are fully intact and appear structurally sound
Handrail Photos

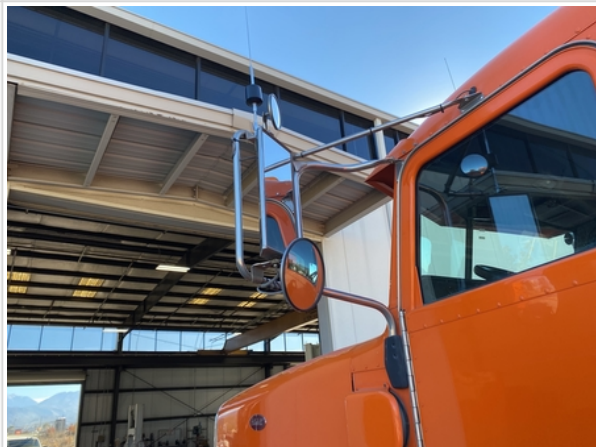
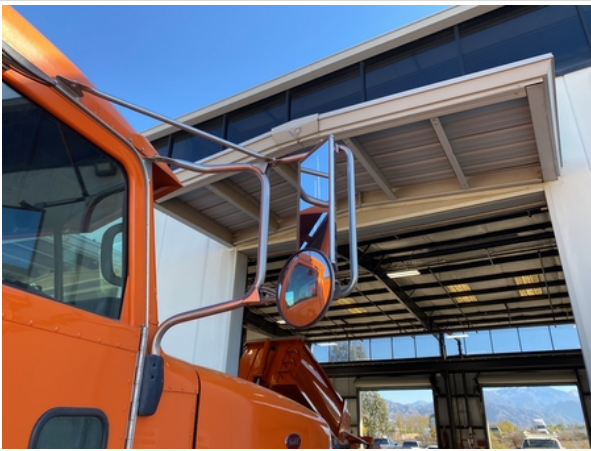
Mirrors	3 - Normal Wear & Tear
Mirror Condition Notes	Mirrors present and intact, no visible damage
Mirrors Photos

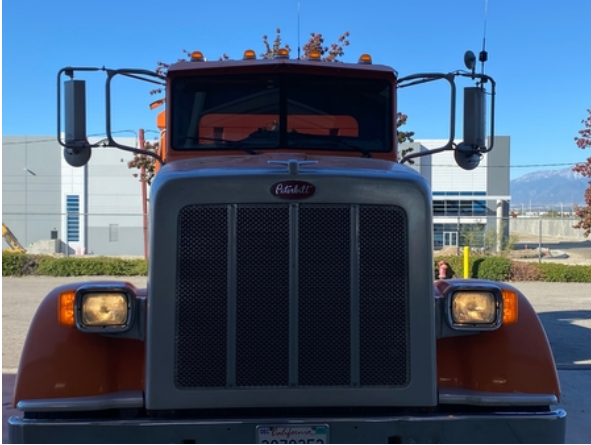
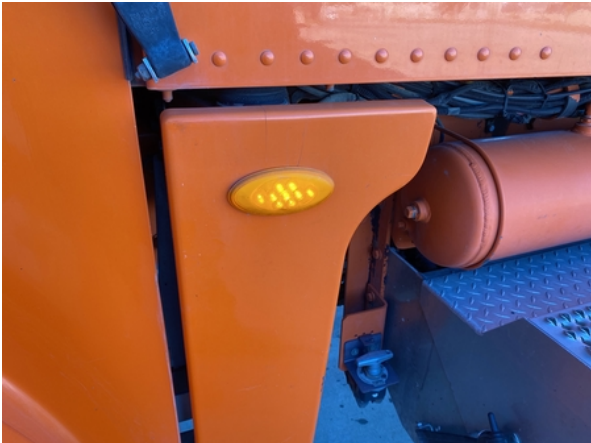
Lighting System	3 - Normal Wear & Tear	
Lighting System Condition	No visible damage, lighting system is operational	
Lighting System Photos

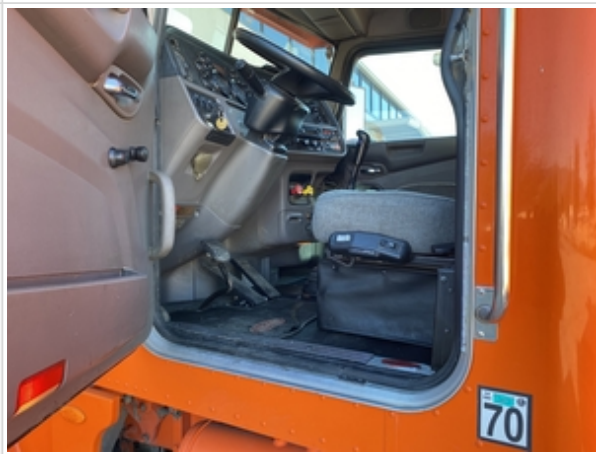
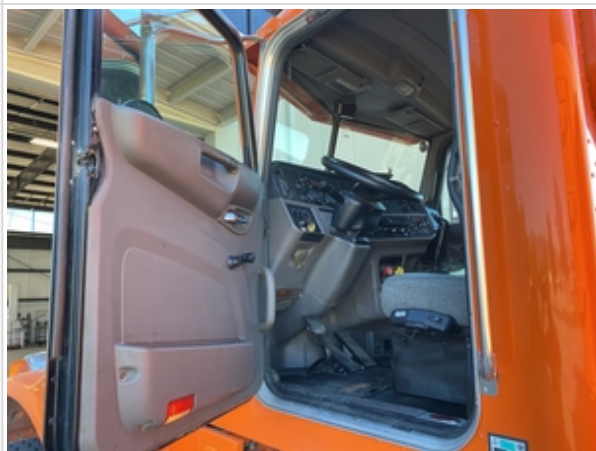
Operator Cabin	3 - Normal Wear & Tear
Operator Cabin Photos

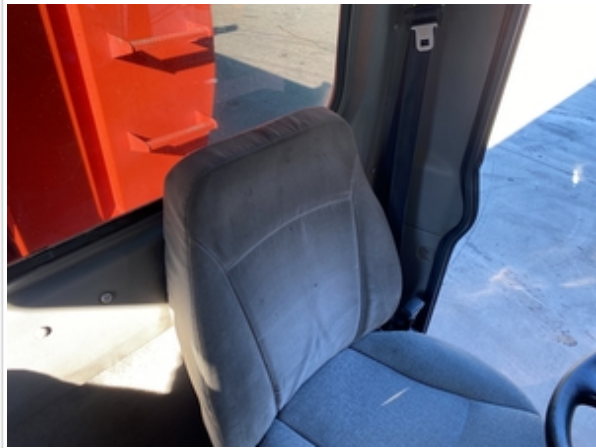
<p>Operator's Seat & Arm Rests</p>	<p>3 - Normal Wear & Tear</p>
<p>Operator's Seat & Arm Rests Photos</p>

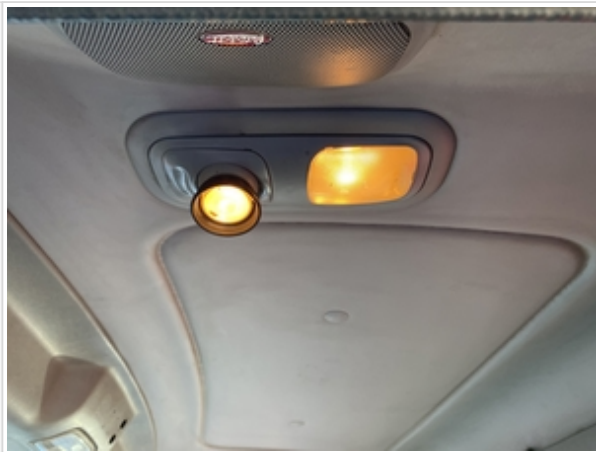
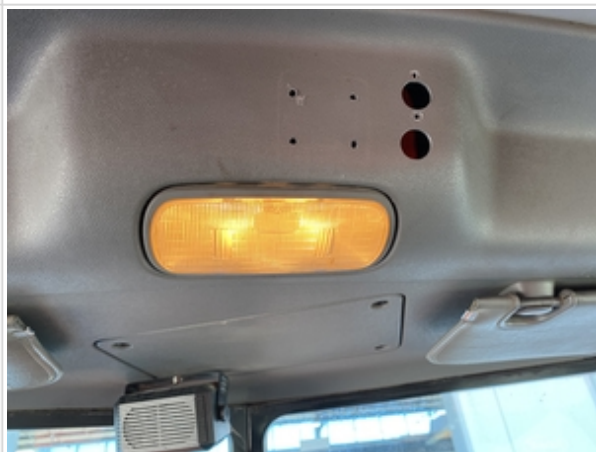
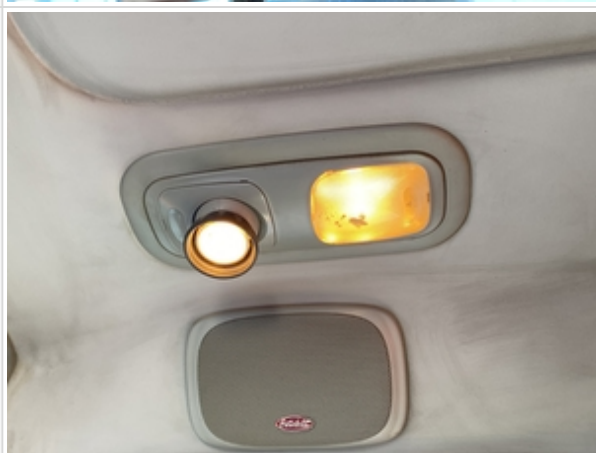
Cabin Lights Photos

Cabin Lights	3 - Normal Wear & Tear

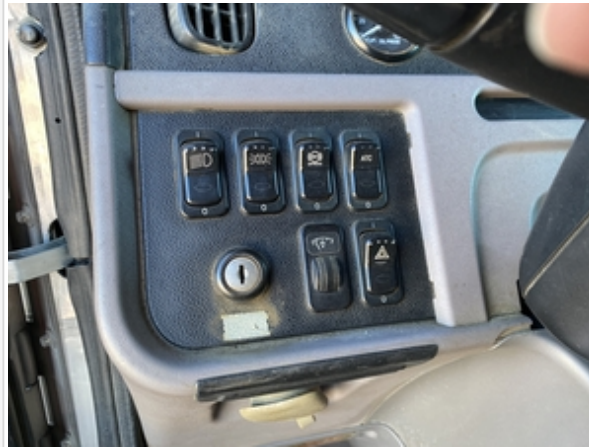
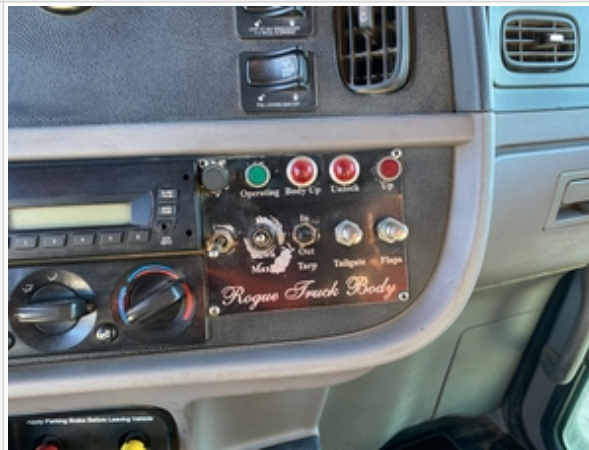
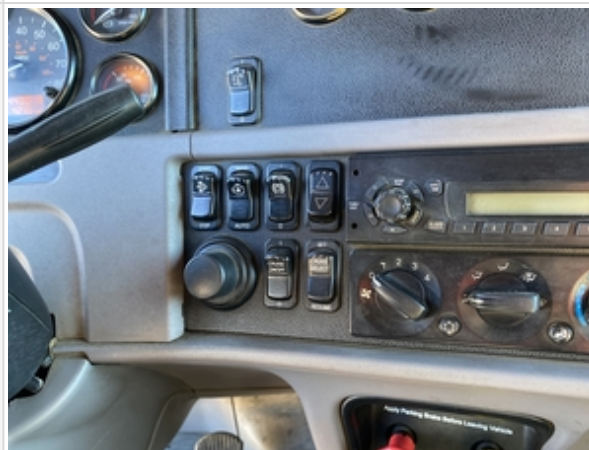
Controls & Switches Photos

Controls & Switches	3 - Normal Wear & Tear

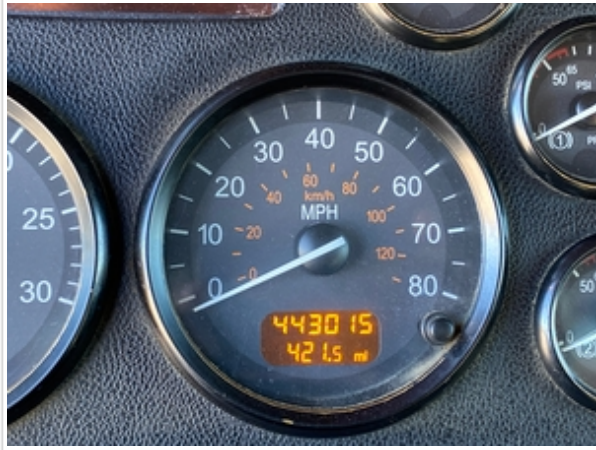
Odometer Activity	3 - Normal Wear & Tear
Odometer Activity Photos

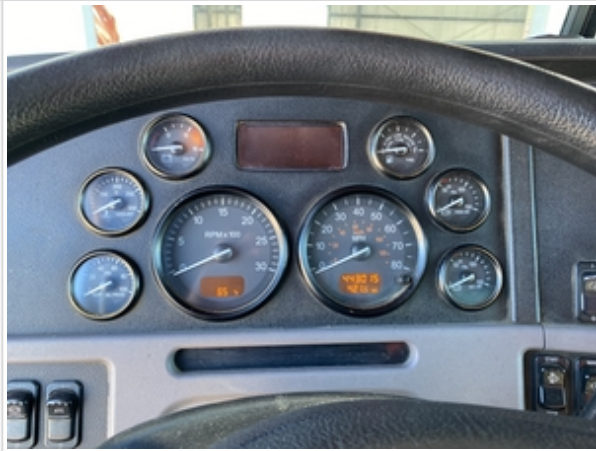
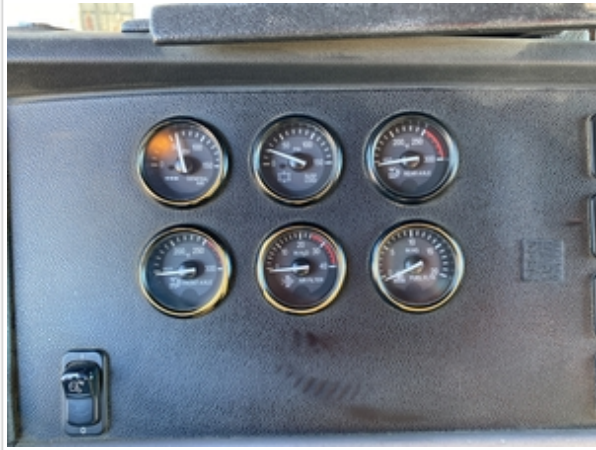
<p>Other Gauge Activity Photos</p>

Other Gauge Activity	3 - Normal Wear & Tear

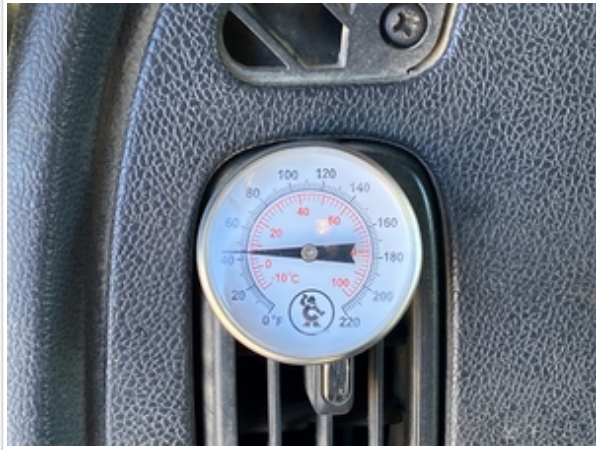
<p>Heater & A/C</p>	<p>3 - Normal Wear & Tear</p>
<p>Heater & A/C Photos</p>

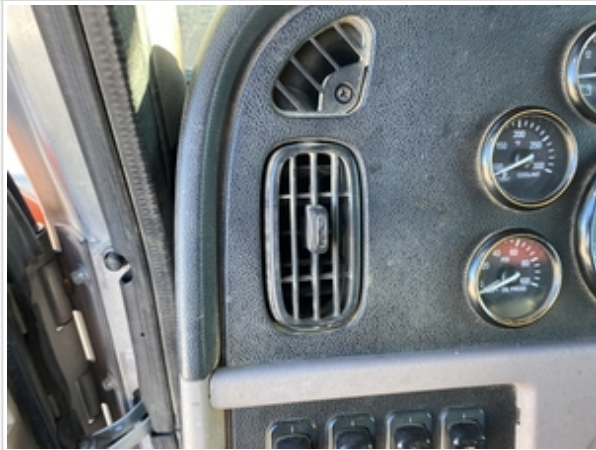
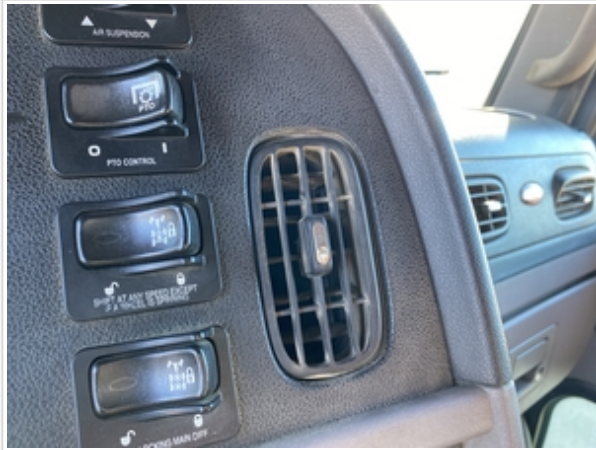
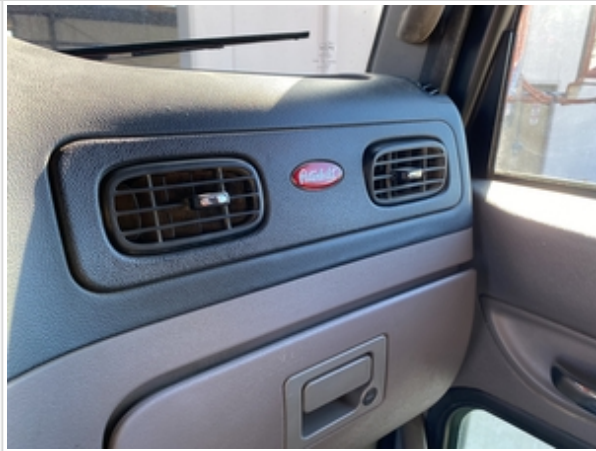
Fans / Vents Photos

<p>Fans / Vents</p>	<p>3 - Normal Wear & Tear</p>

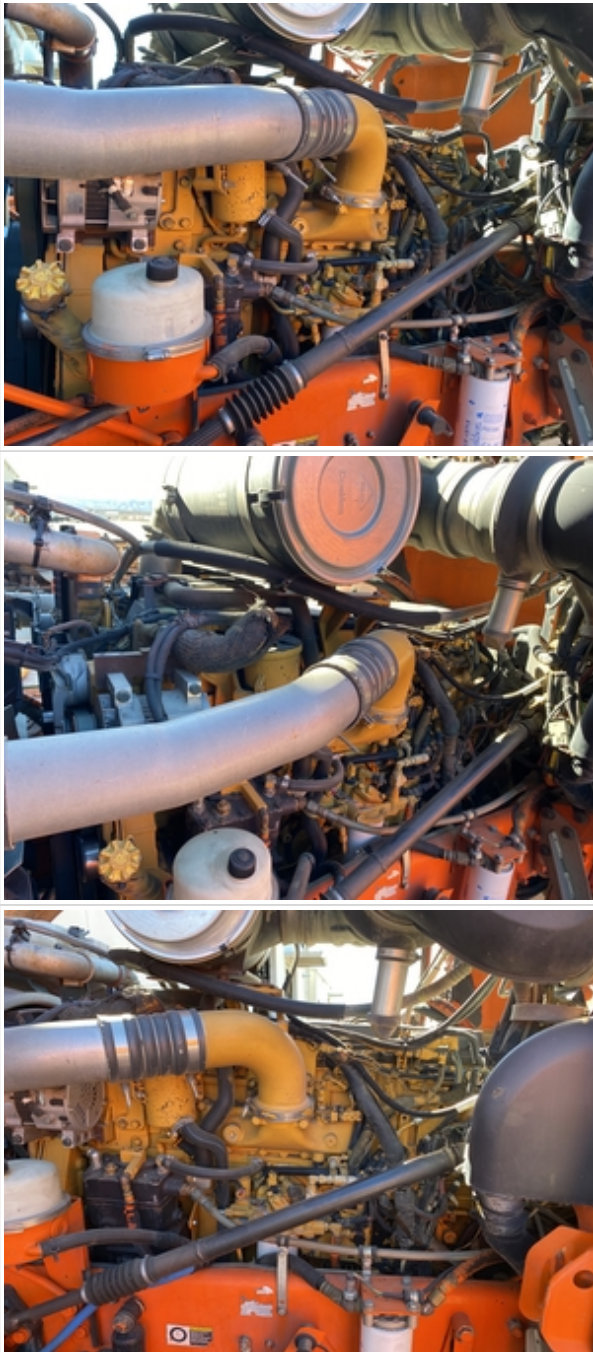
Engine	
Engine Type (Make, Model, Cylinders, Hp)	CAT - C13 - 470HP - 6CYL -12.5L
Emissions Tier	Tier 4i
Engine Serial Number	N/A
Engine Fuel Type	Diesel
Engine Photos

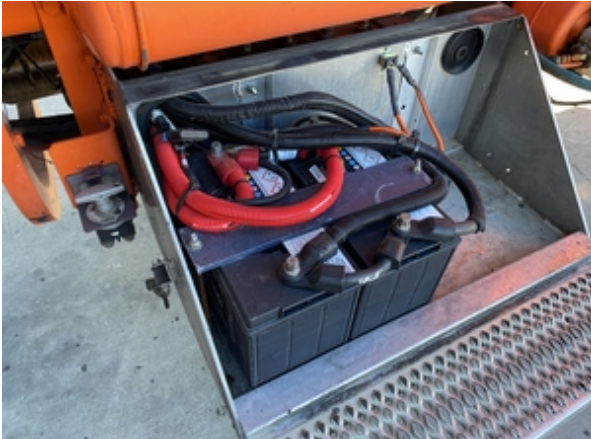
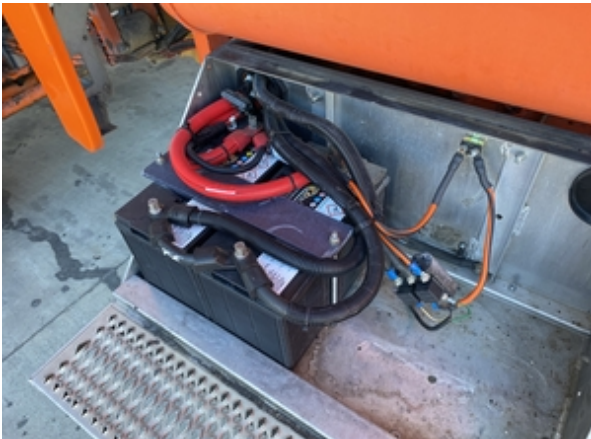
Battery	3 - Normal Wear & Tear
Battery Condition	Like new, recently replaced
Battery Condition Photos

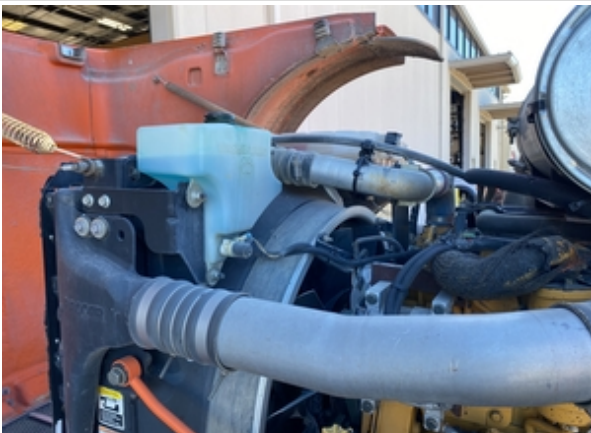
Radiator	3 - Normal Wear & Tear
Radiator Condition	Radiator fins & components appear to be in good working order, no signs of damage or leaks
Radiator Photos

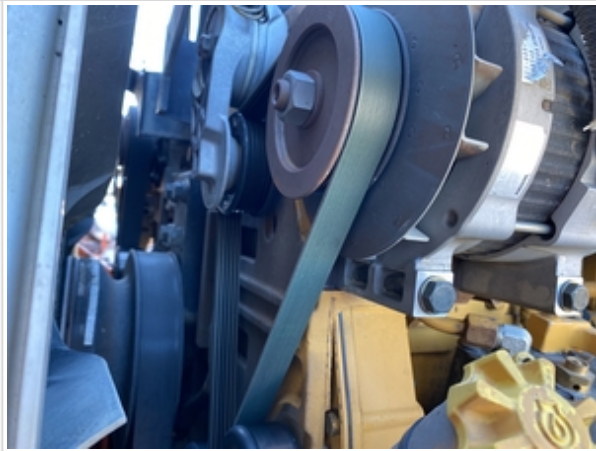
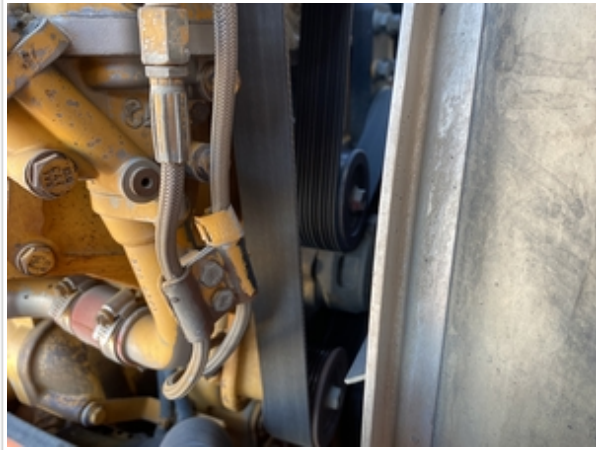
Belt Photos

Belts	3 - Normal Wear & Tear
Belt Condition	Belts appear in good condition & alignment with proper tension

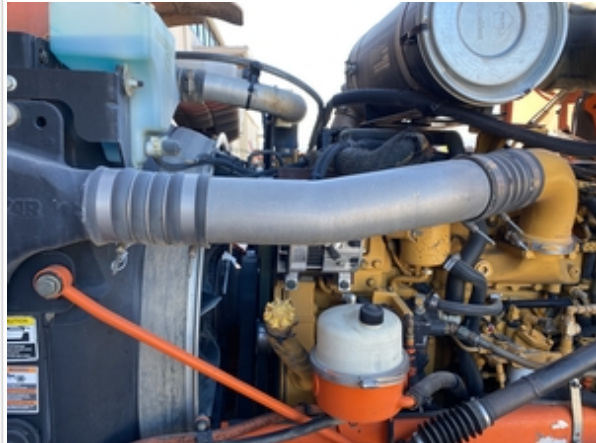
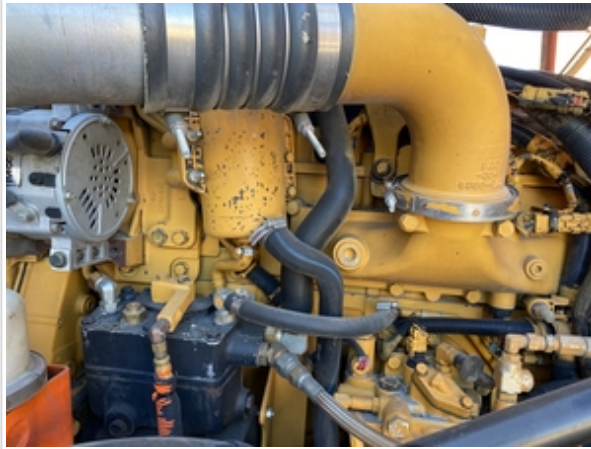
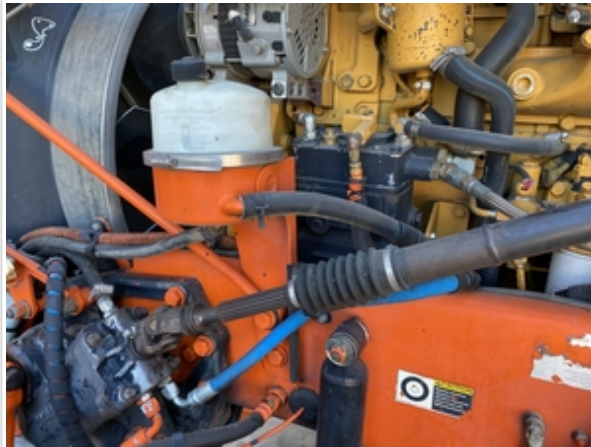
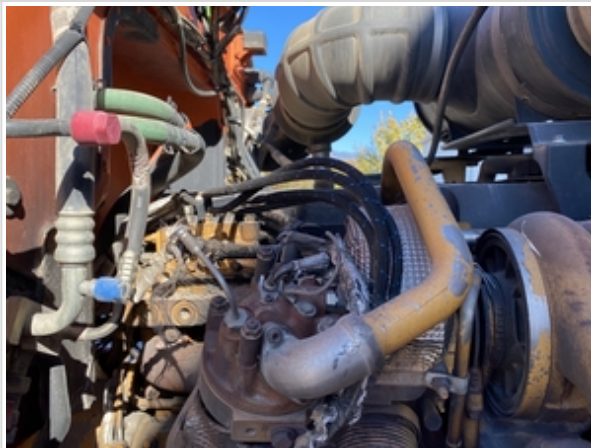
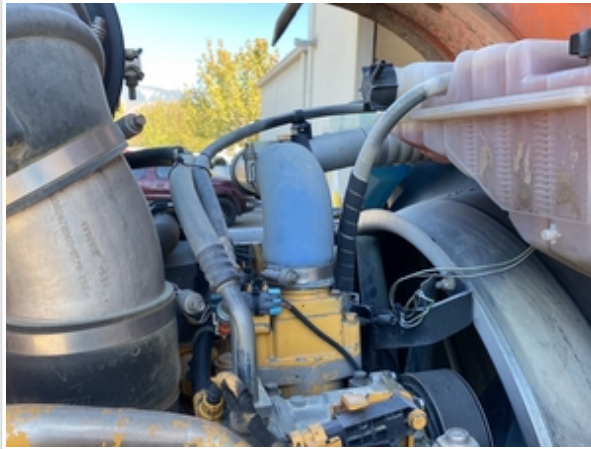
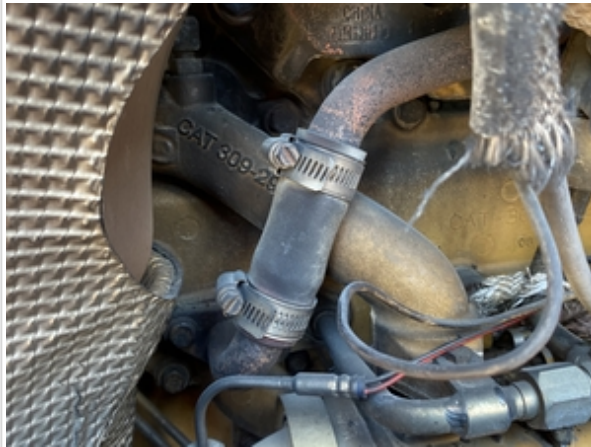
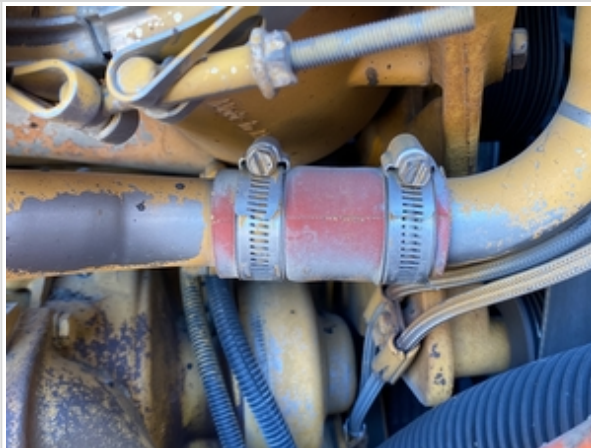
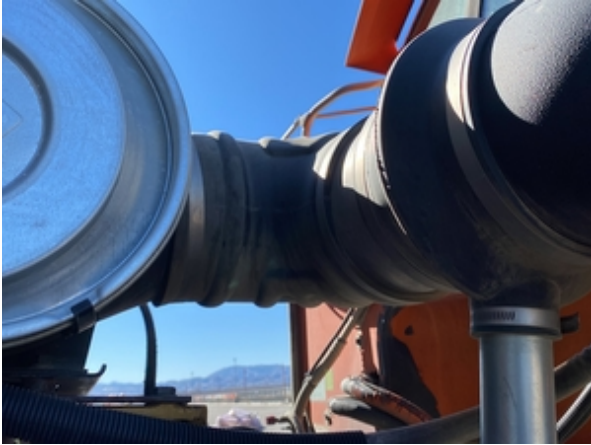
Hoses	3 - Normal Wear & Tear
Hose Condition	Firm, pliant hoses with no signs of wear or leaks
Hose Photos

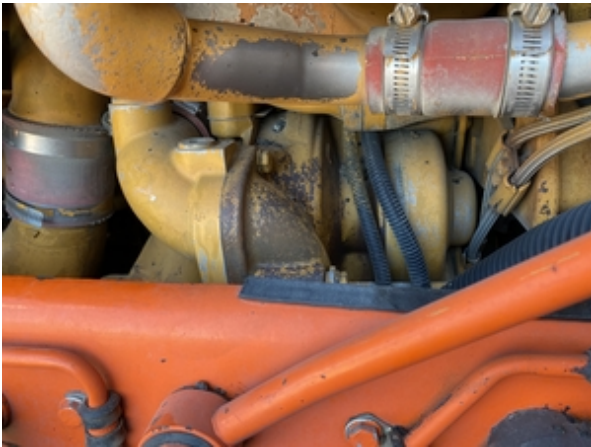
Water Pump	3 - Normal Wear & Tear
Water Pump Condition	No unusual pump noises heard
Water Pump Photos

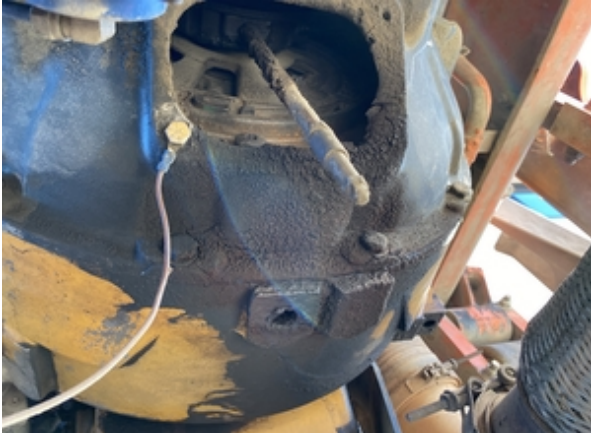
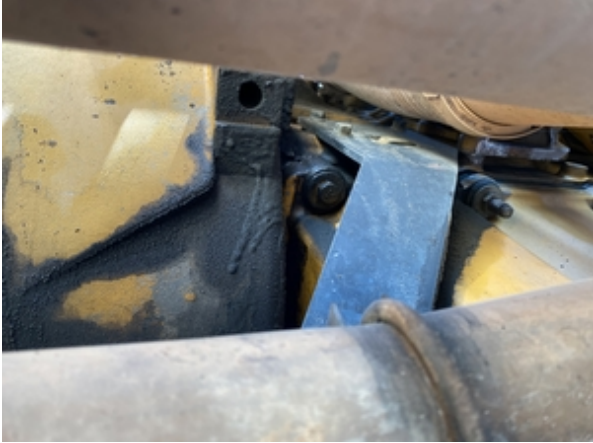
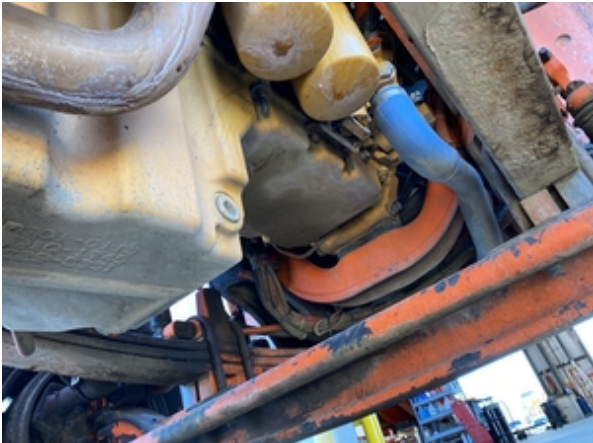
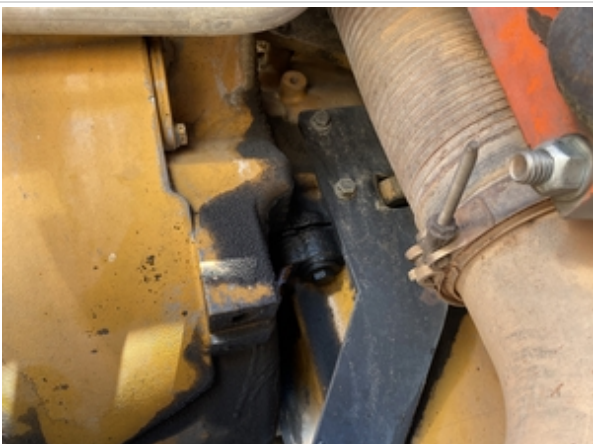
Cooling System Leaks	No
Coolant Color / Appearance	3 - Normal Wear & Tear
Coolant Color/Appearance Notes	Normal Translucent appearance, no visual signs of contamination
Oil Leaks	Yes
Oil Leak Notes	No oil leaks seen, Dried oil seepages seen
Oil Leak Photos

Requires DEF (Diesel Exhaust Fluid)	No
Overall Engine Appearance	Clean & dry, Areas of dried seepage seen on engine hoses & components
Overall Engine Comments	Engine clean, minor leakage at oil pan, rear housing area

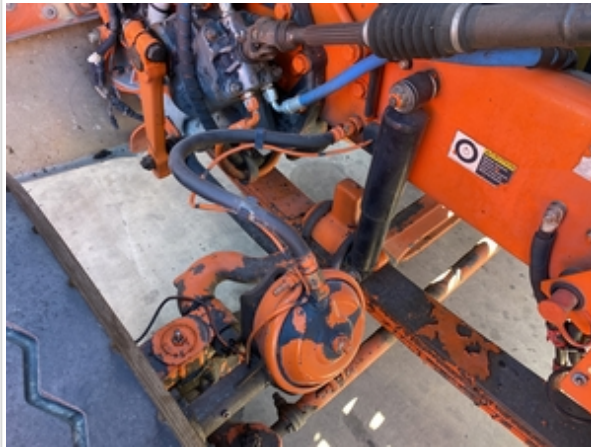
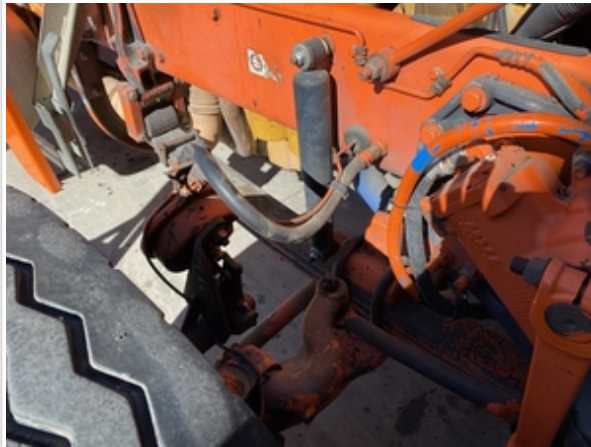
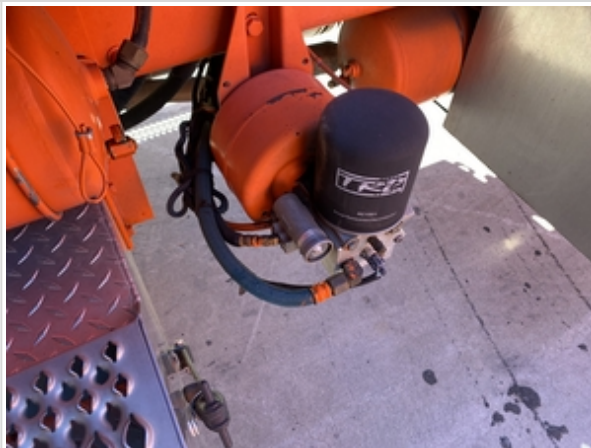
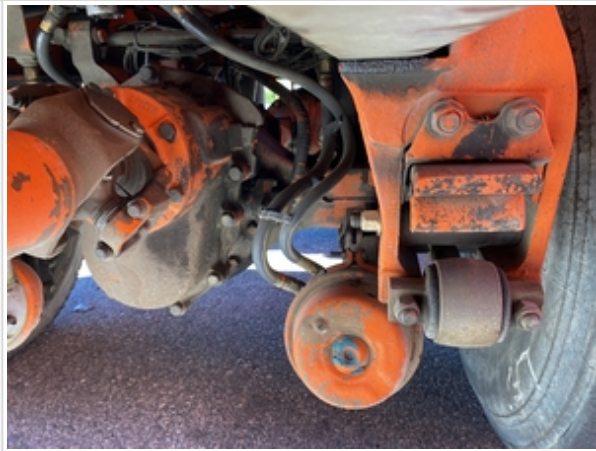
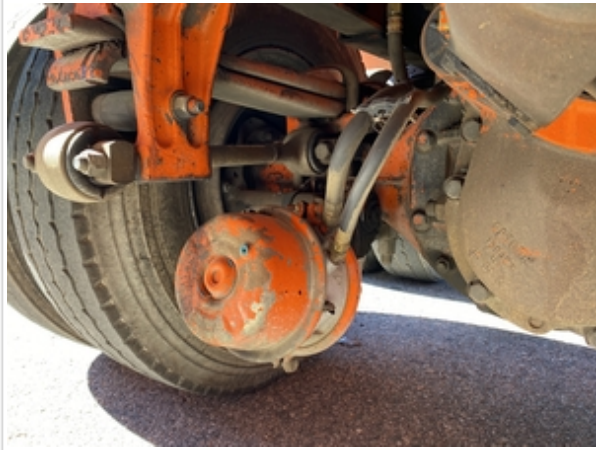
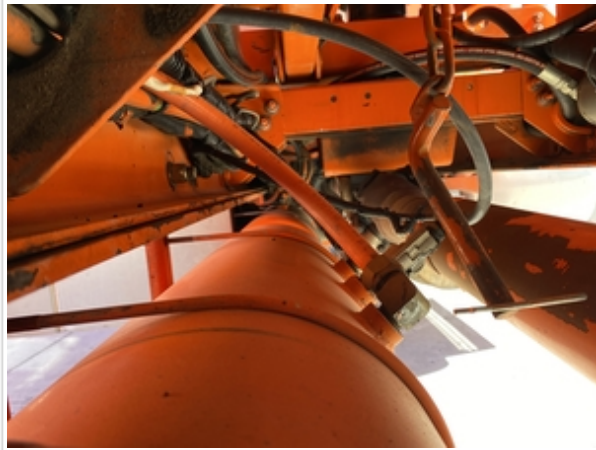
Air Brake System Photos

Brake System Type	Air Brakes
Air Brakes Build Correct Pressure	Yes
Air Brake System Leaks	No
Air Brake Hose Condition	3 - Normal Wear & Tear

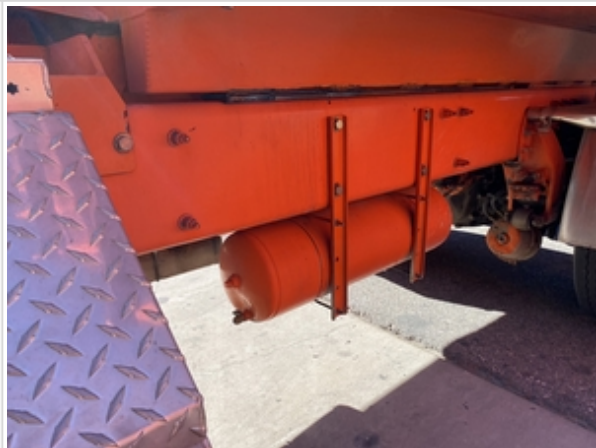
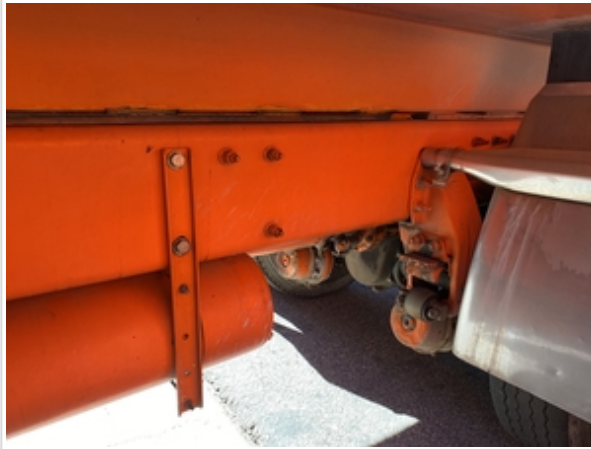
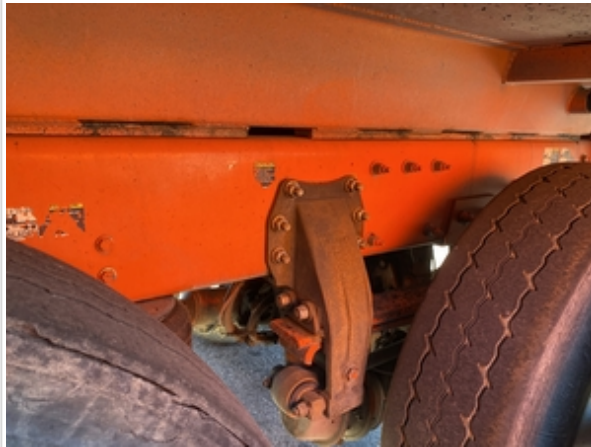
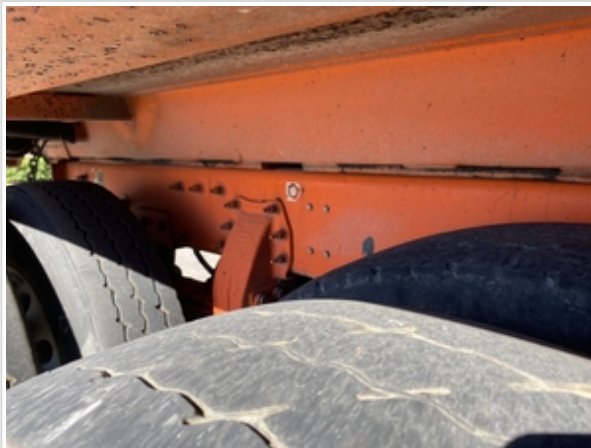
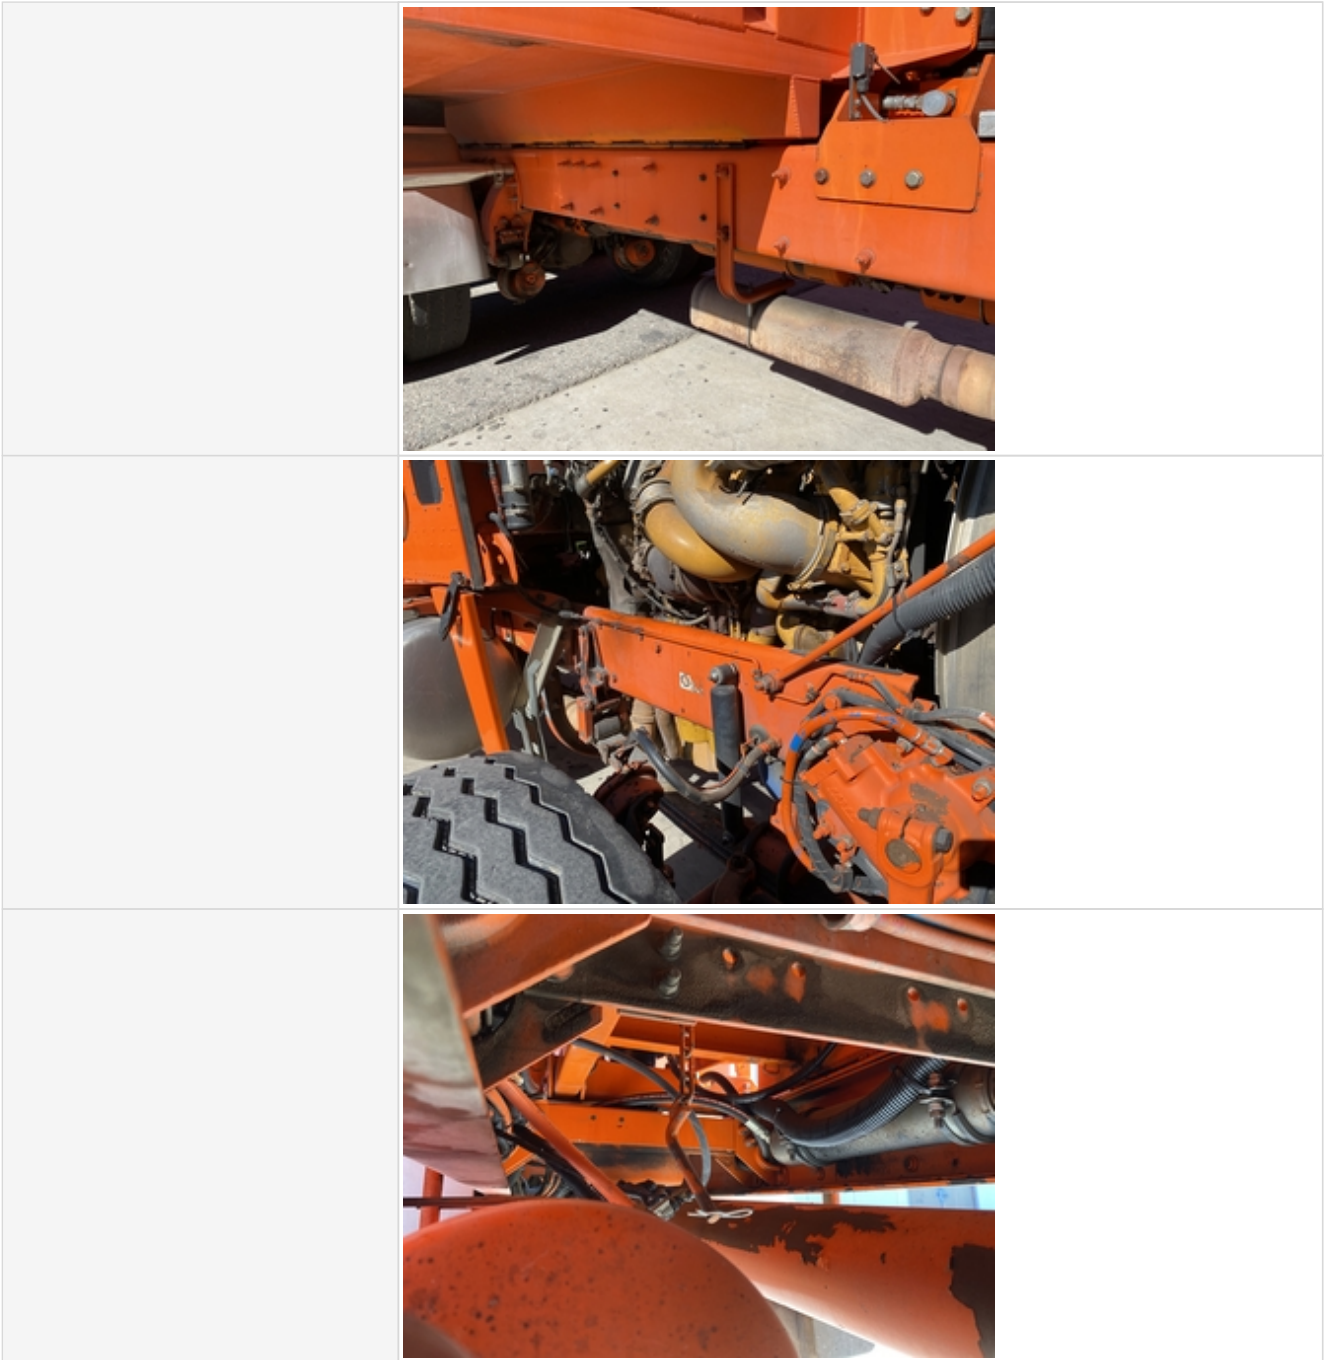
Frame Condition	3
Frame Photos
