Inspection Report (On-Highway Dump Truck)

Year	2011
Make	Peterbilt
Model	367
Serial Number	1NP - TLUOX - 6 - BD127977
Truck Odometer Reading	443,015
Previous Application (e.g., earth moving, mining, demolition, etc)	Asphalt Construction

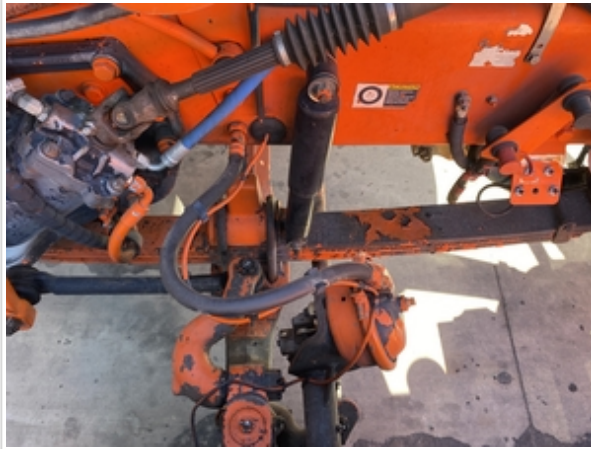
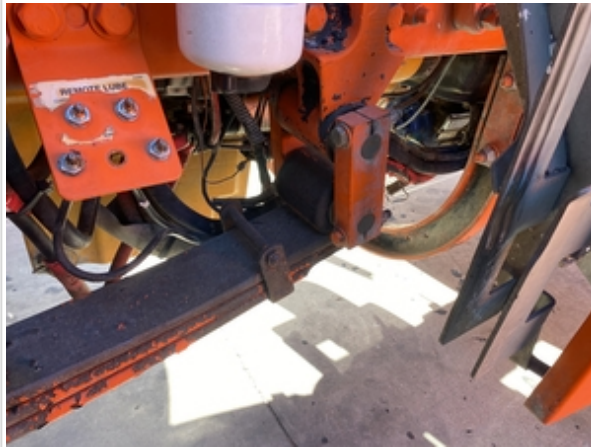
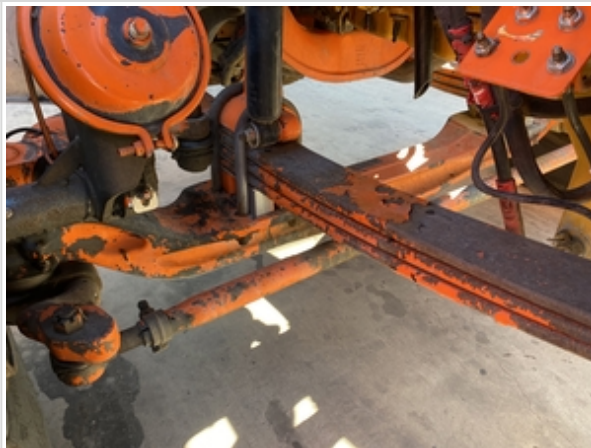
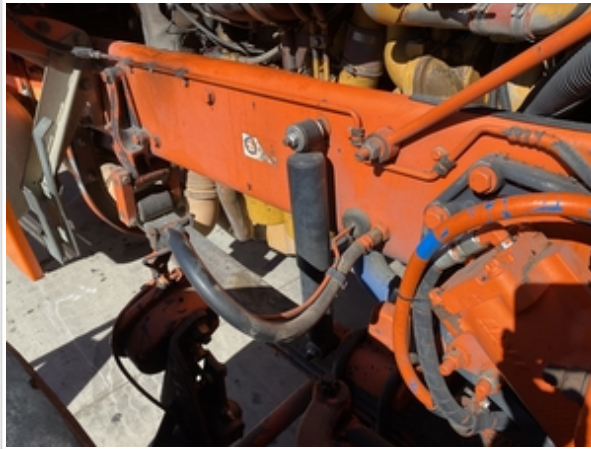
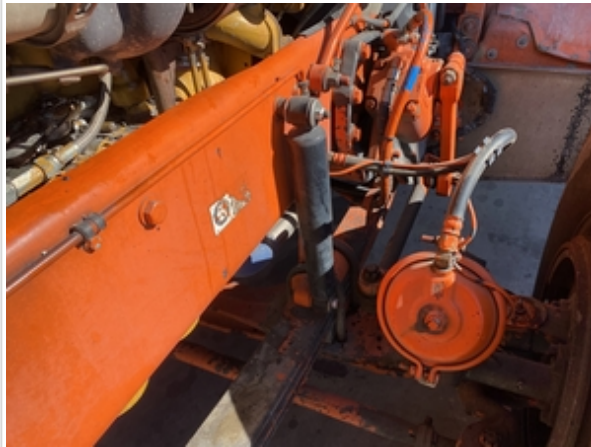
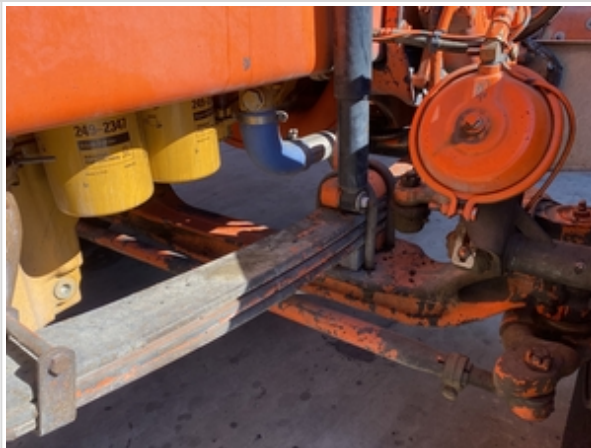
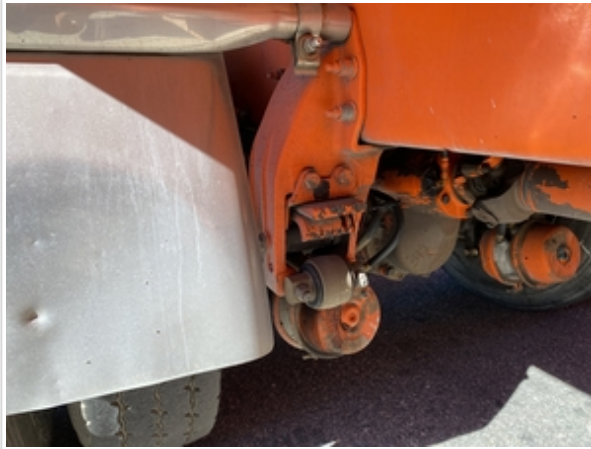
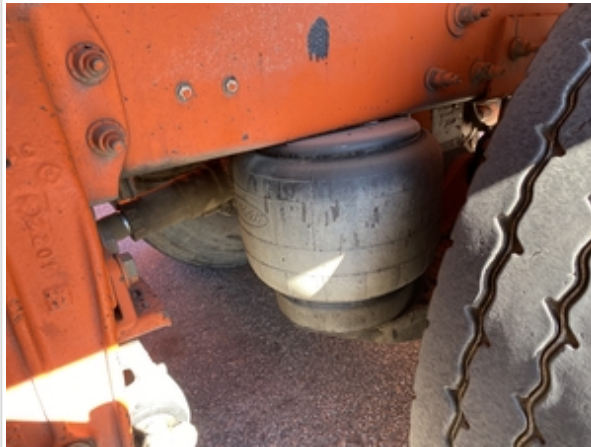
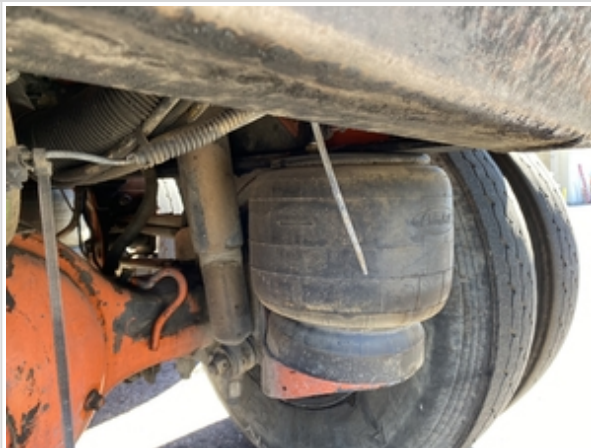
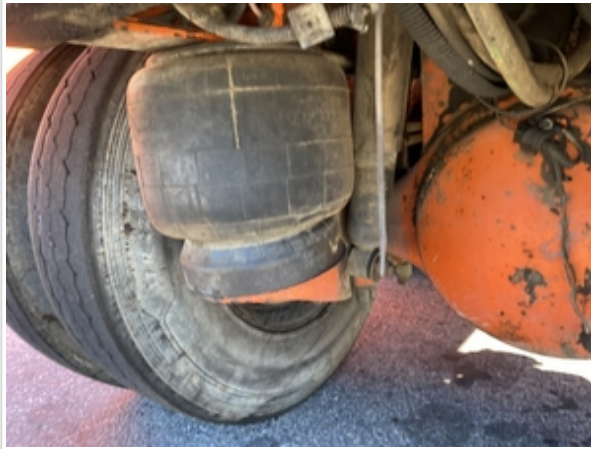
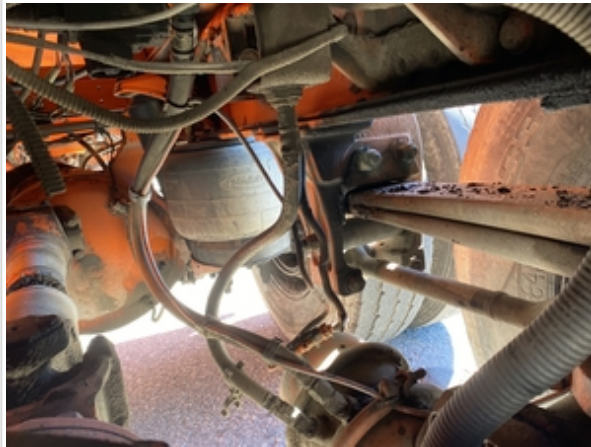
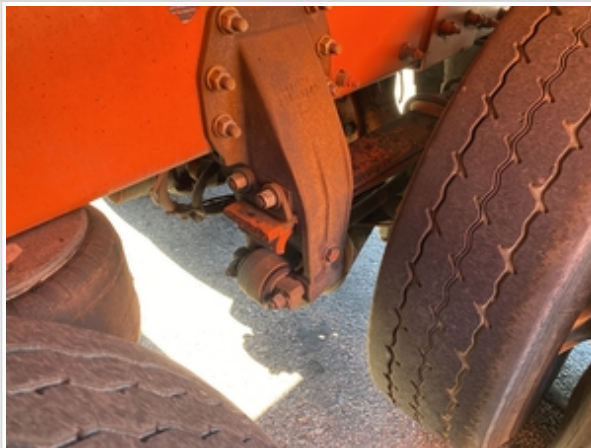
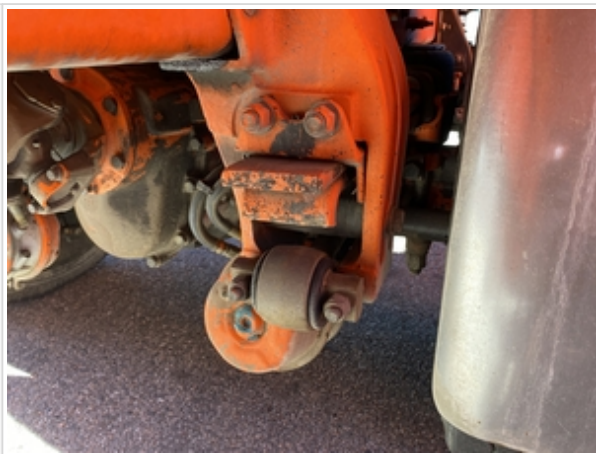
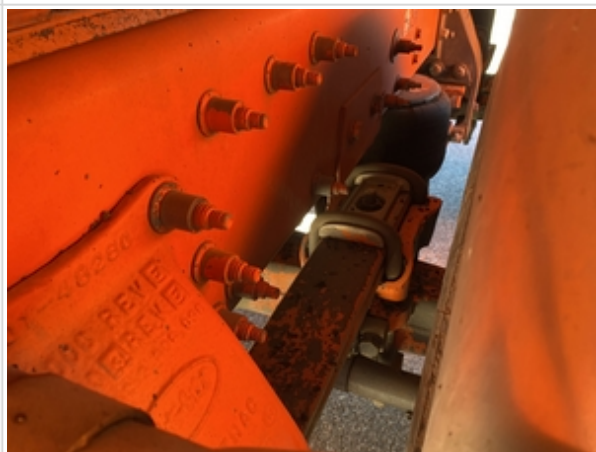
Suspension Photos

Suspension	3
------------	---

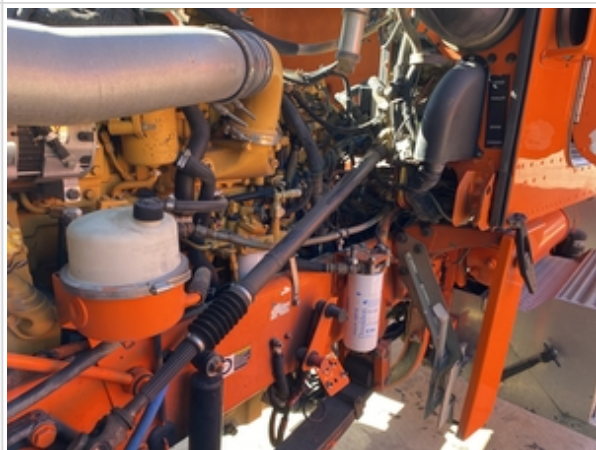
Steering Components	3
Steering Components Photos

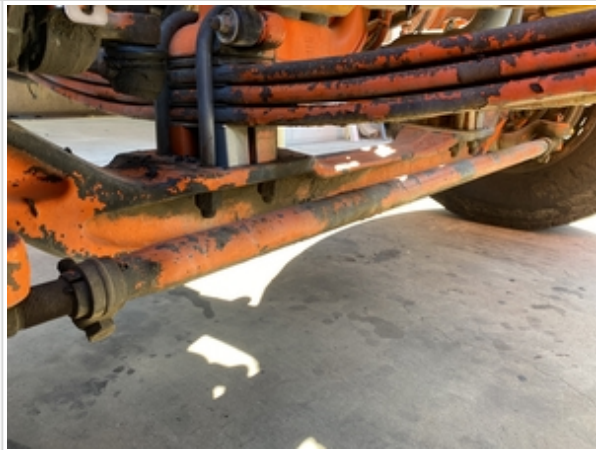
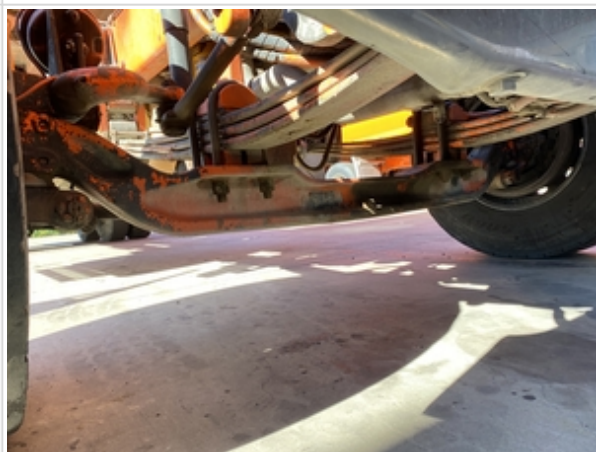
Steer Axle Photos

Steer Axle Condition	3

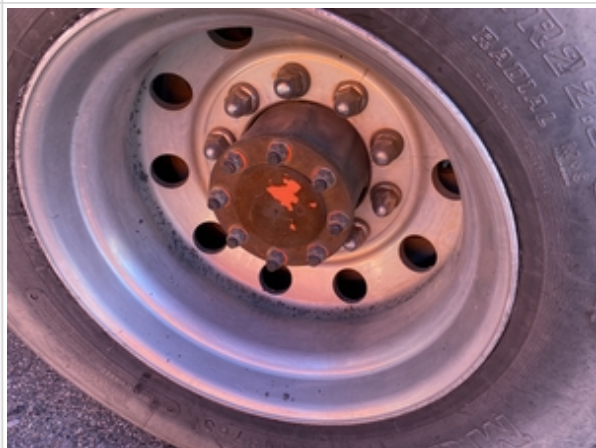
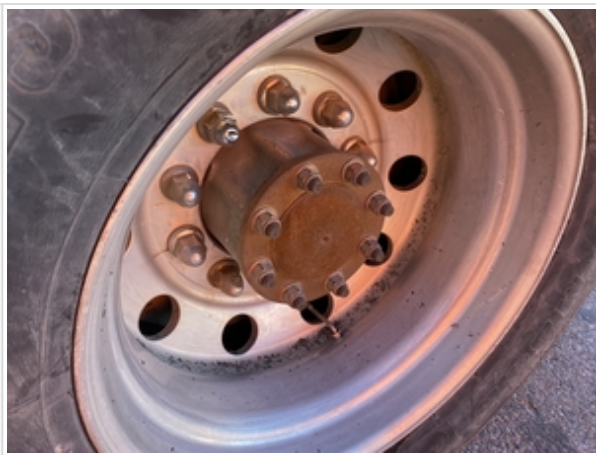
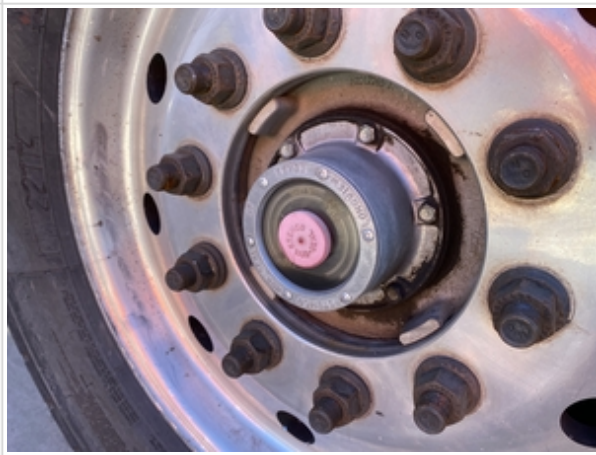
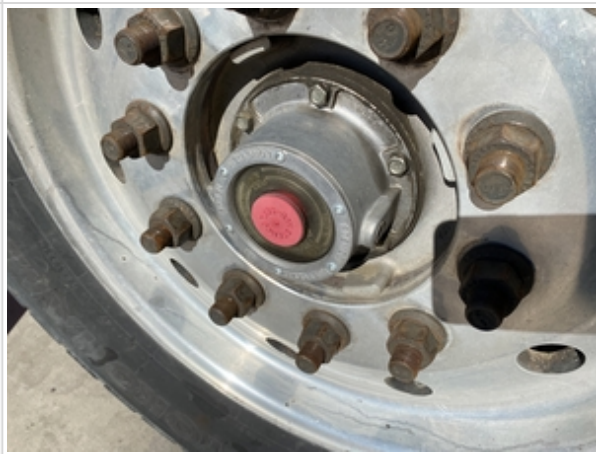
Wheels & Hub Condition	3
Wheels & Hub Photos

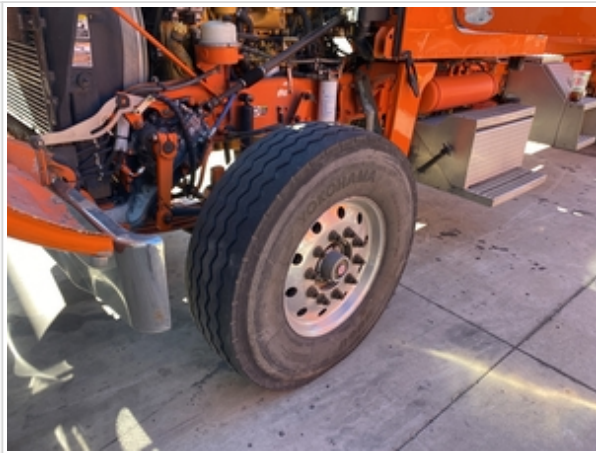
<p>Front Left Tire Photos</p>

Tire Brand	(Front) Yokohama (Rear) generic recap
Tire Size	(Front) 315/80R/22.5 (Rear) 11R22.5
Front Left Tire - Ratio Remaining	30%

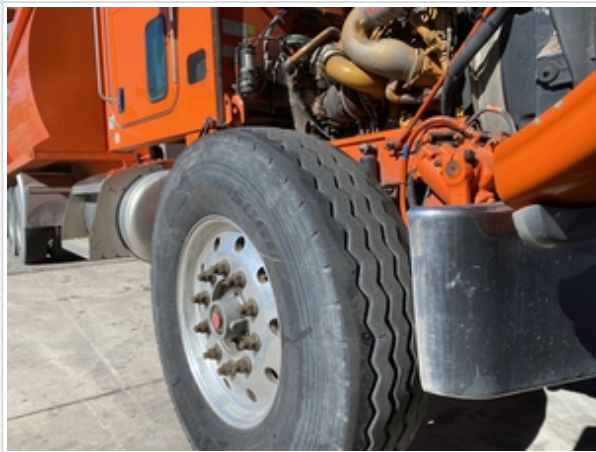
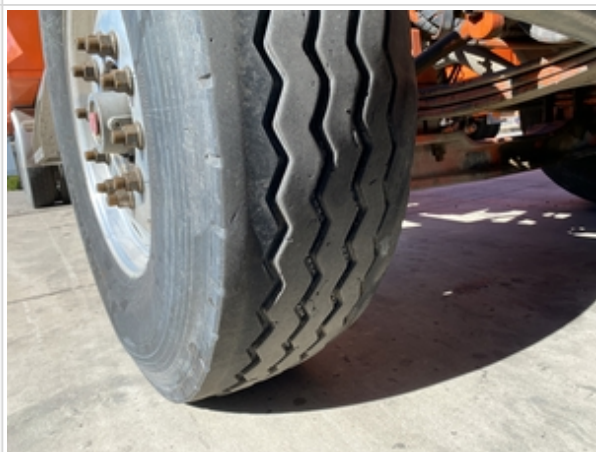
<p>Front Right Tire - Ratio Remaining</p>	<p>30%</p>
<p>Front Right Tire Photos</p>

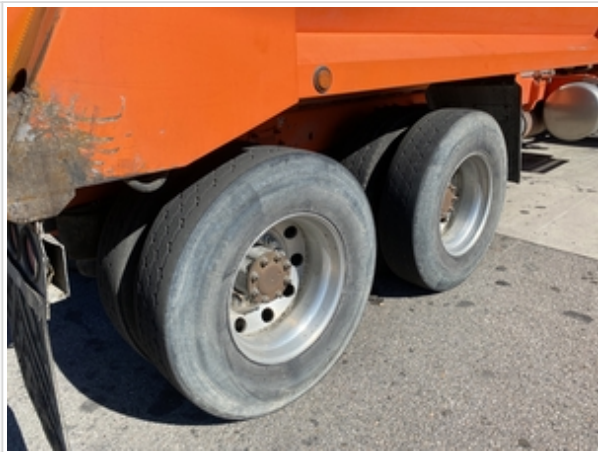
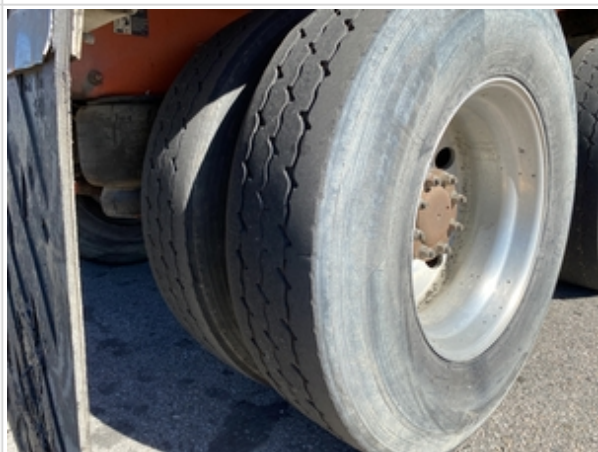
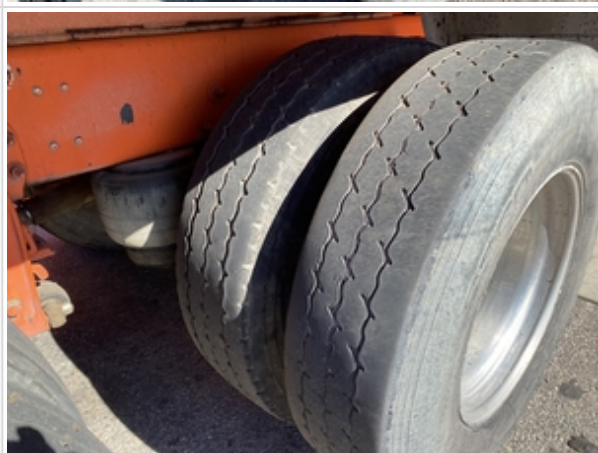
<p>Rear Right Tire Photos</p>

<p>Rear Right Tire - Ratio Remaining</p>	<p>30%</p>

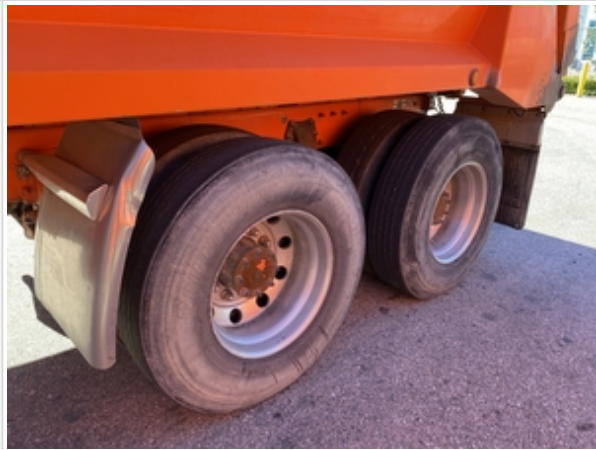
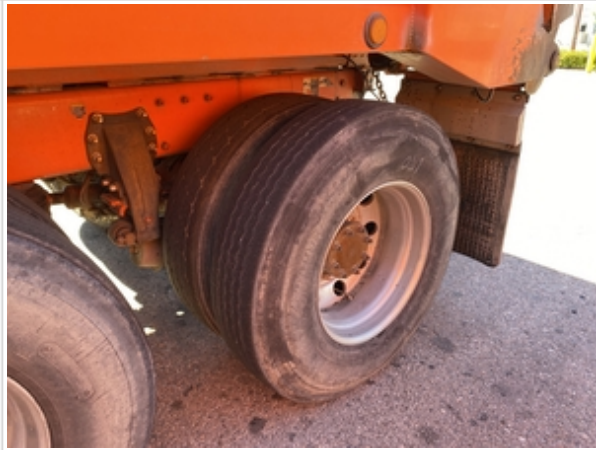
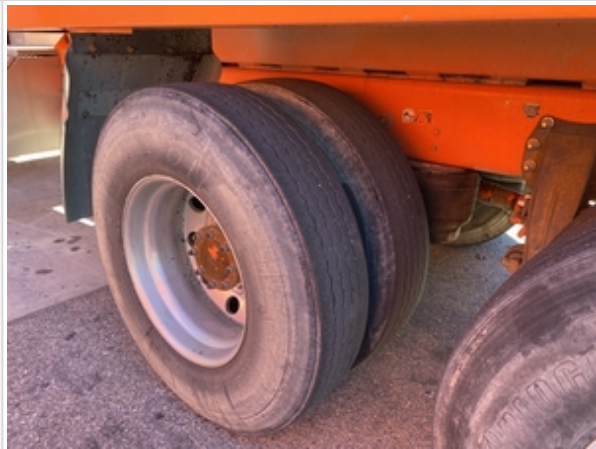
<p>Rear Left Tire Photos</p>

<p>Rear Left Tire - Ratio Remaining</p>	<p>10%</p>

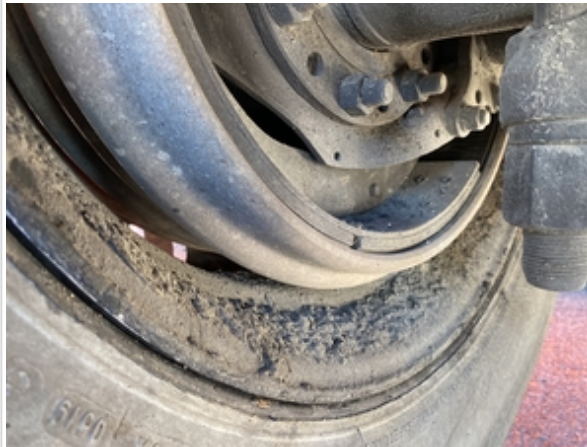
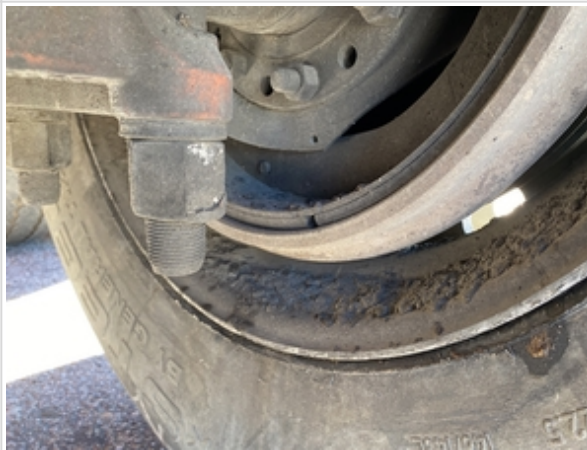
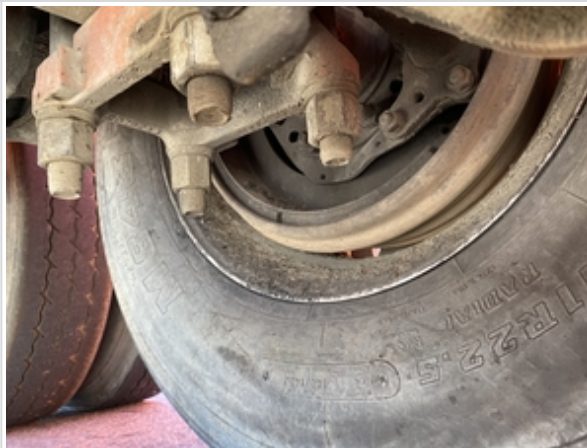
Brake Shoe Photos

<p>Brake Shoe Thickness</p>	<p>10%</p>
-----------------------------	------------

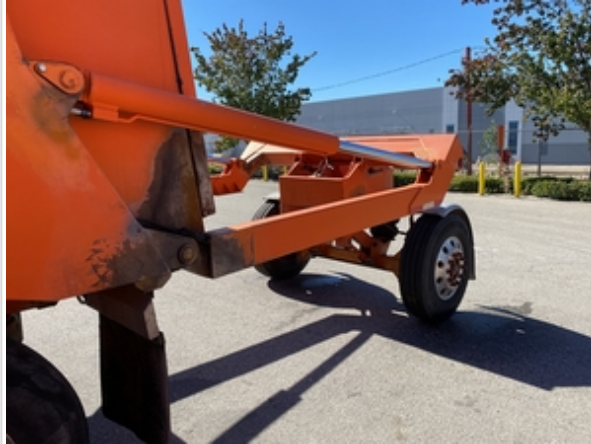
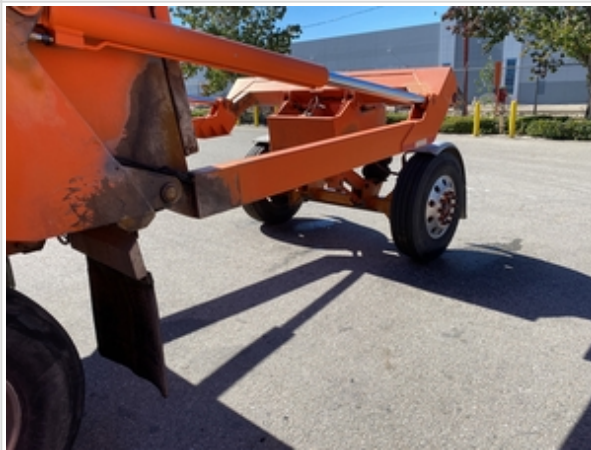
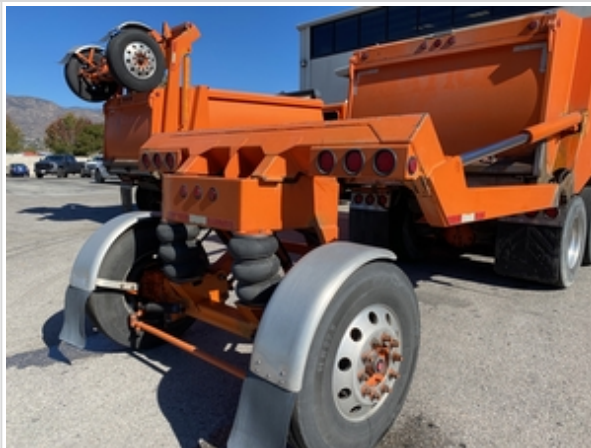
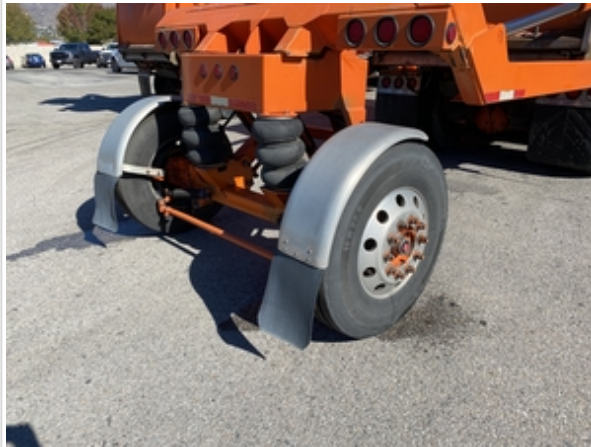
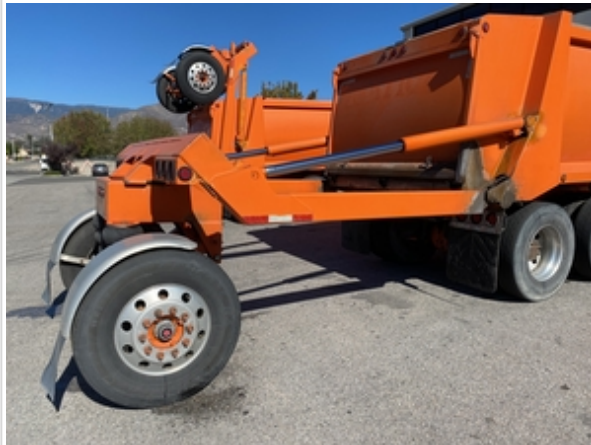
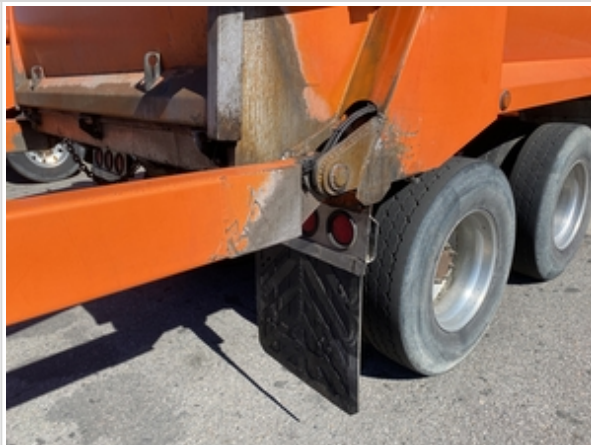
Axle Condition Photos

Instructions	Check the condition of additional axle(s), wheels & tires. Note any damage or wear. Take photos.
Axle Description & Position	Rear Dump Body Mounted Drop Down
Steerable?	No
Drop Axle?	Yes
Super Dump?	Yes
Weight Rating	12,000 Lbs.
Axle Condition	3 - Normal Wear & Tear

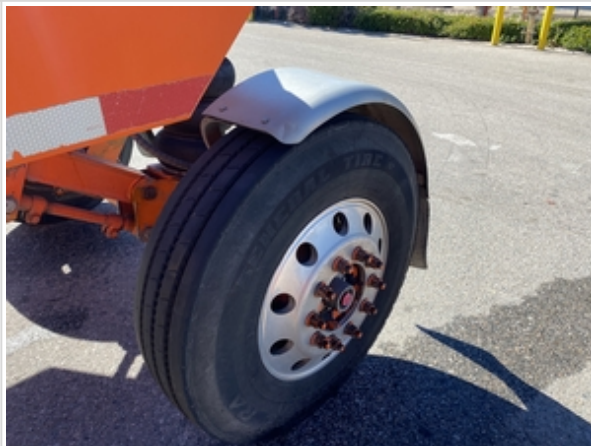
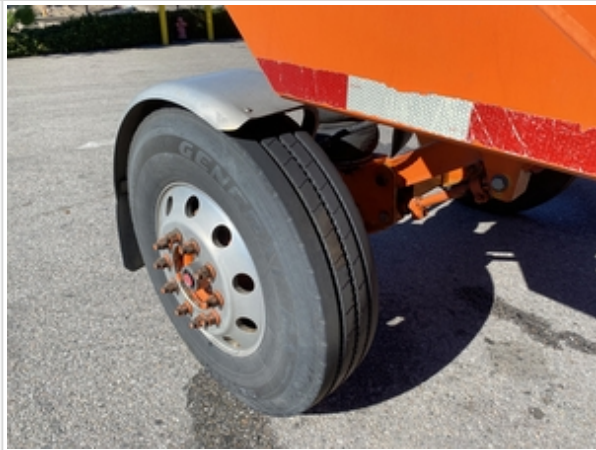
Wheels & Tires Photos

Wheels & Tires

3 - Normal Wear & Tear

Tire Brand	Maxisteel	
Tire Size	11R22.5	
Left Tire(s) Ratio Remaining	70%	
Right Tire(s) Ratio Remaining	70%

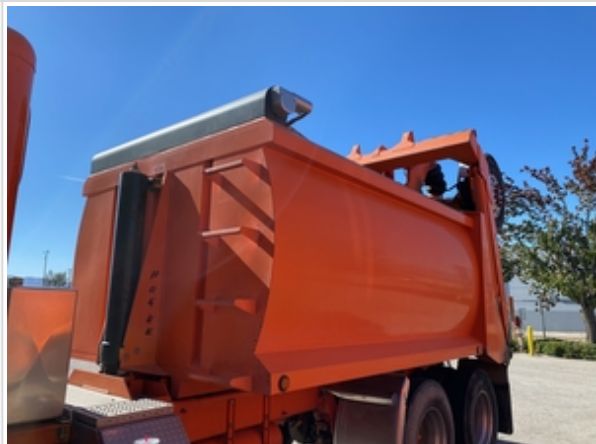
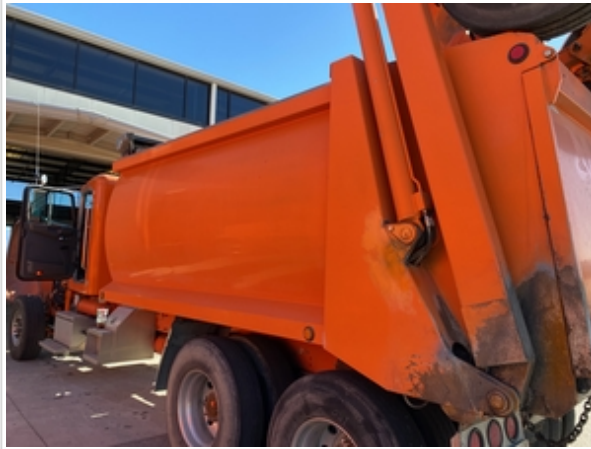
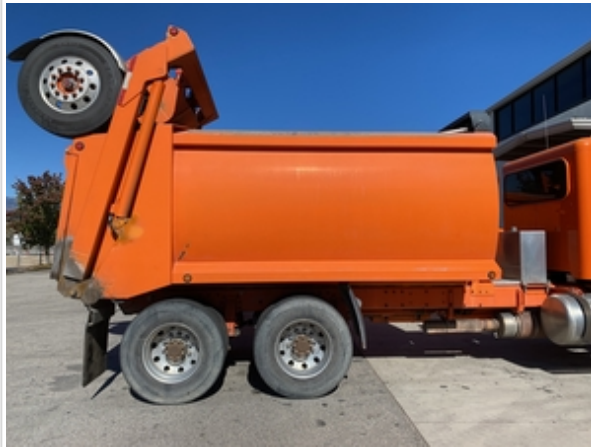
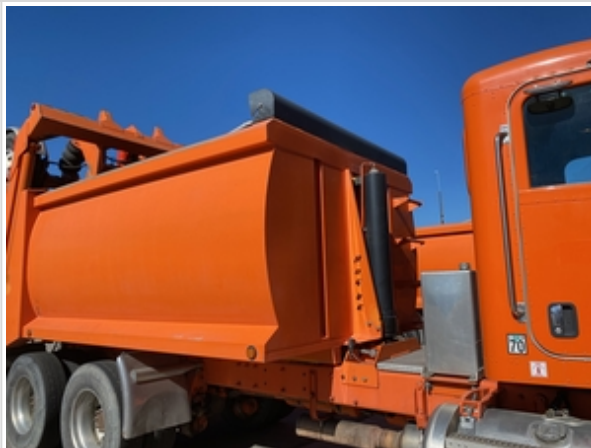
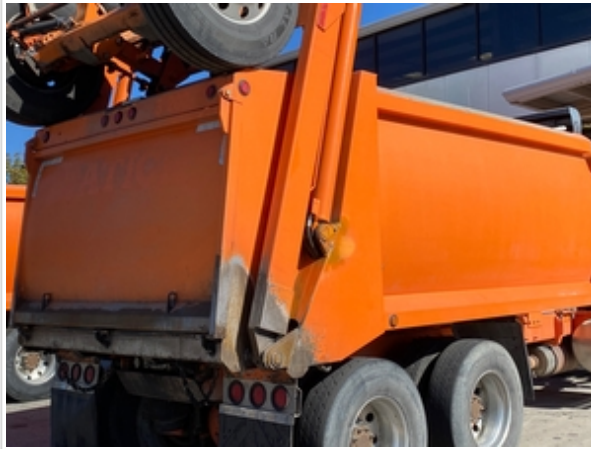
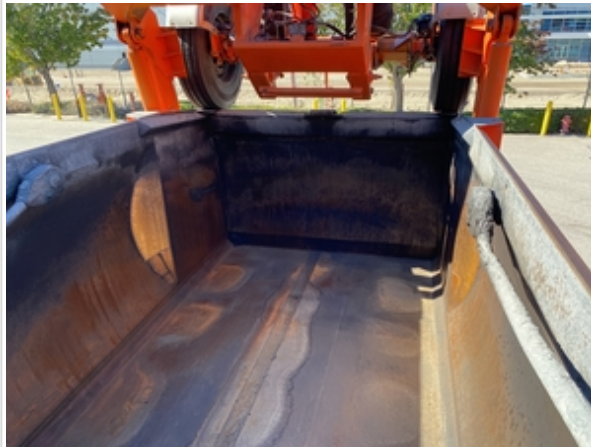
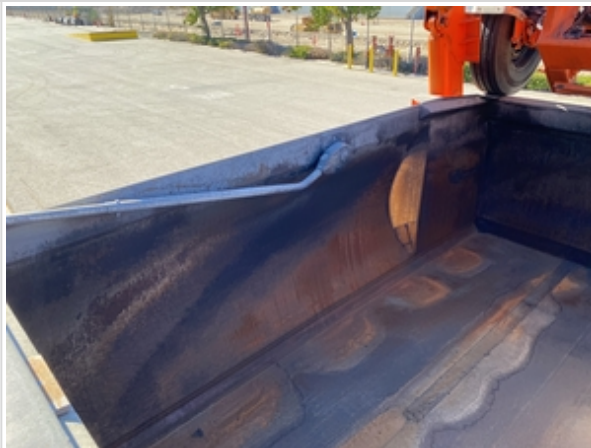
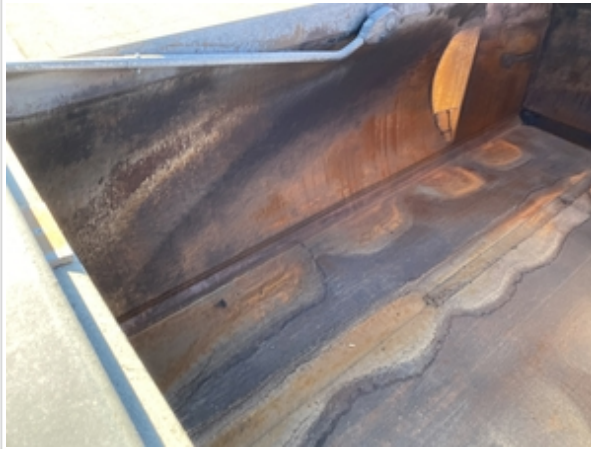
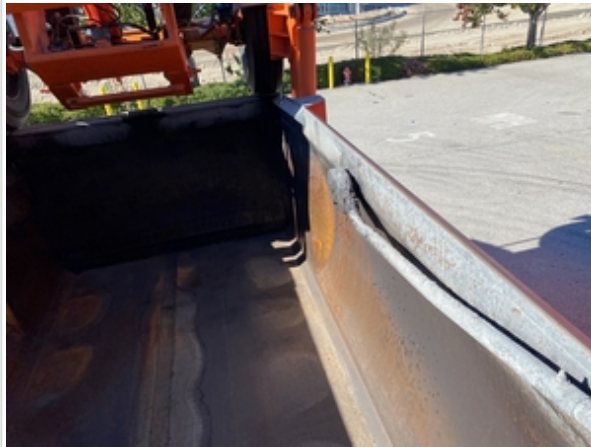
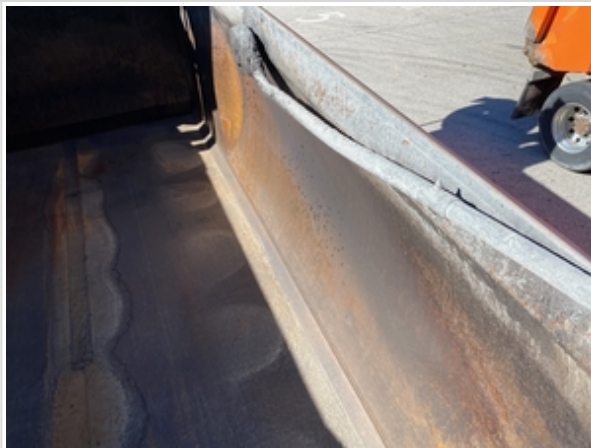
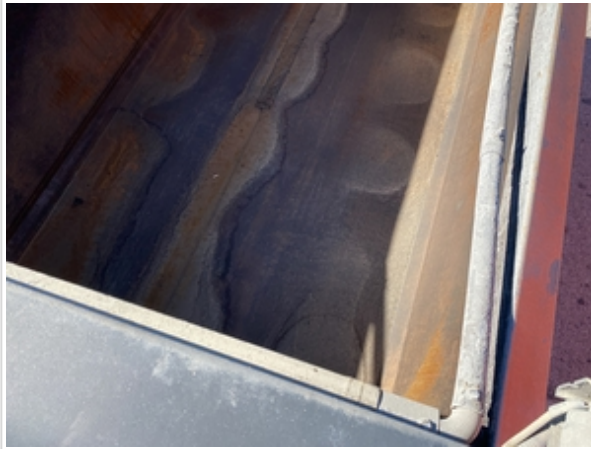
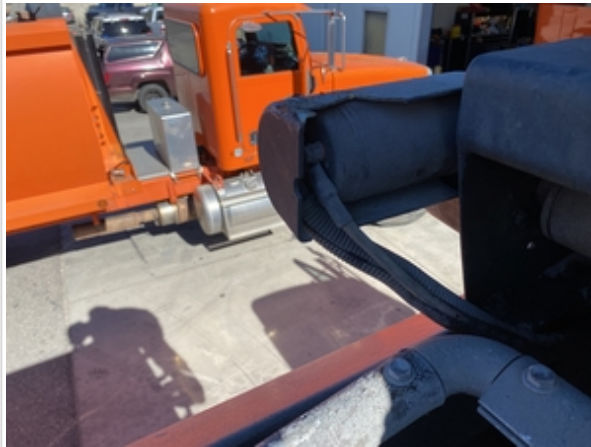
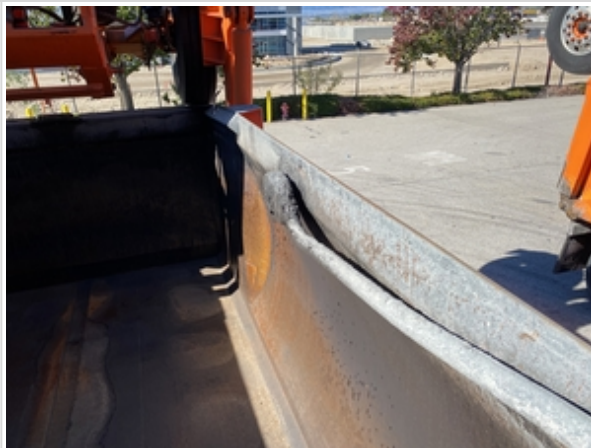
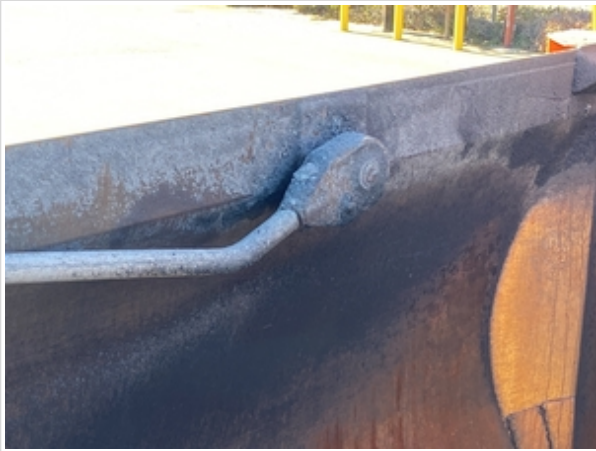
Dump Body Make & Material	Rogue	
Dump Body Length (ft and inches)	15'	
Dump Body Height (ft and inches)	5'3	
Bed Body	3 - Normal Wear & Tear	
Bed Body Photos

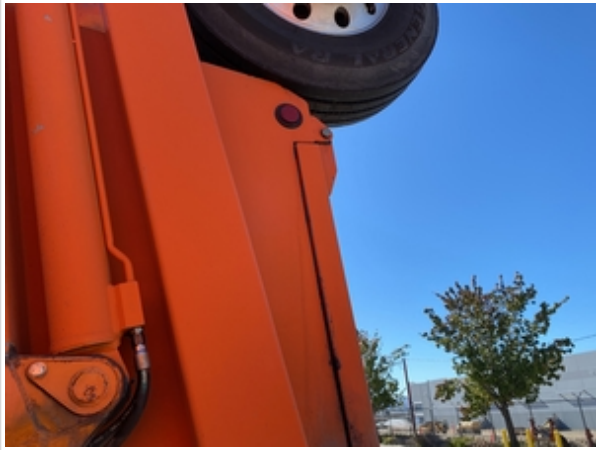
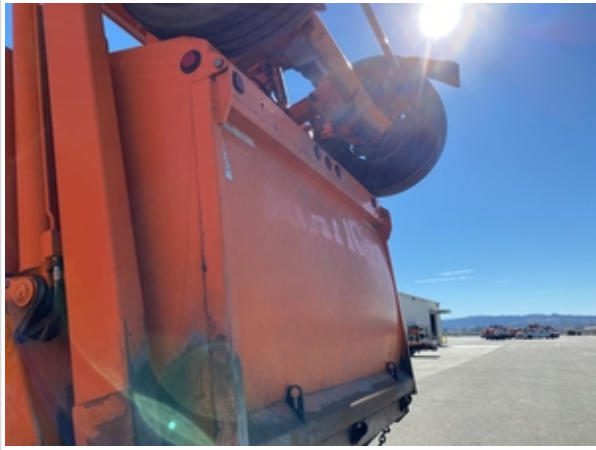
Tailgate	3 - Normal Wear & Tear	
Tailgate Photos

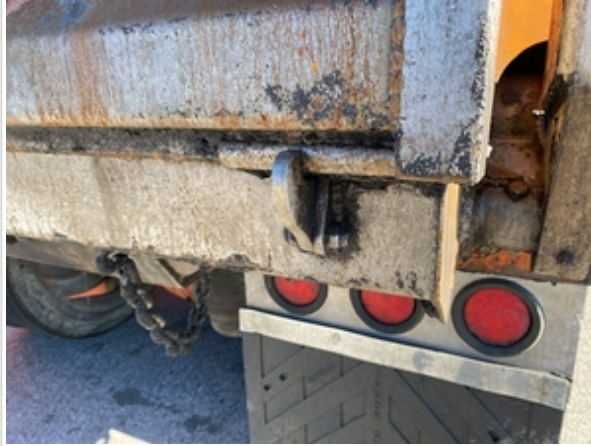
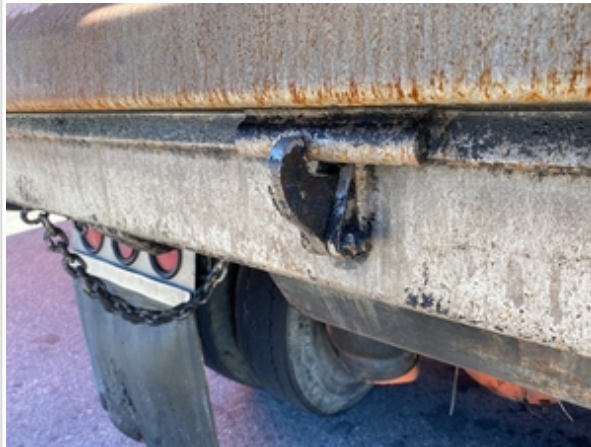
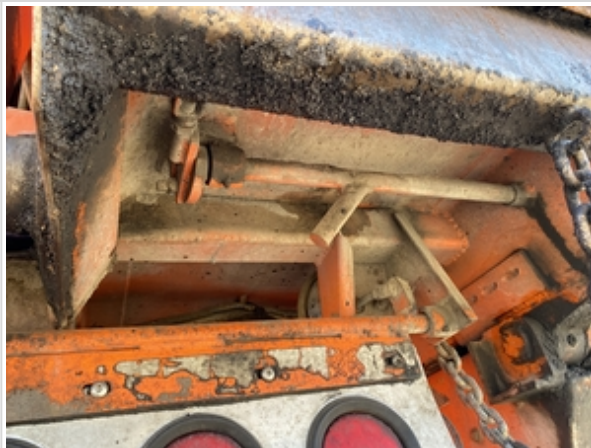
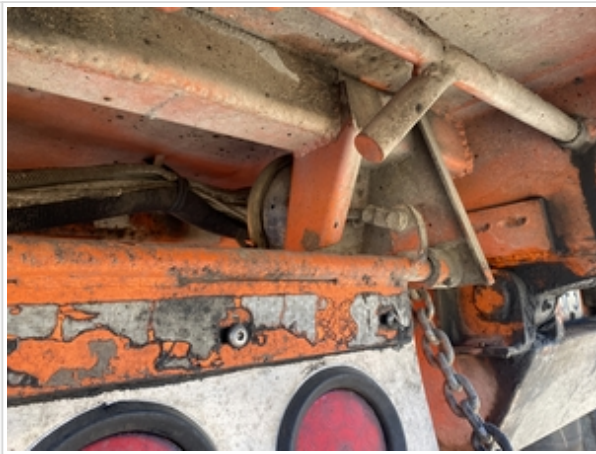
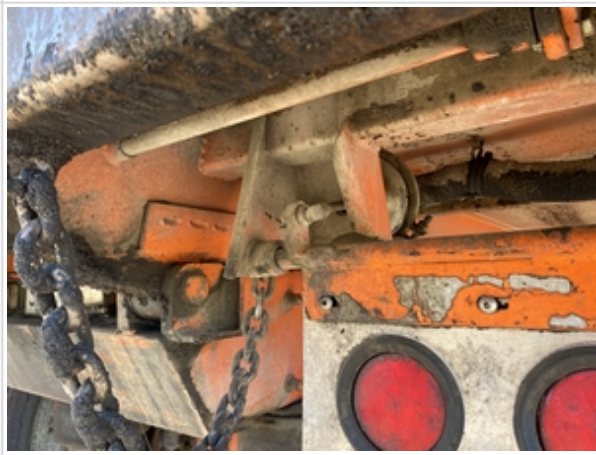
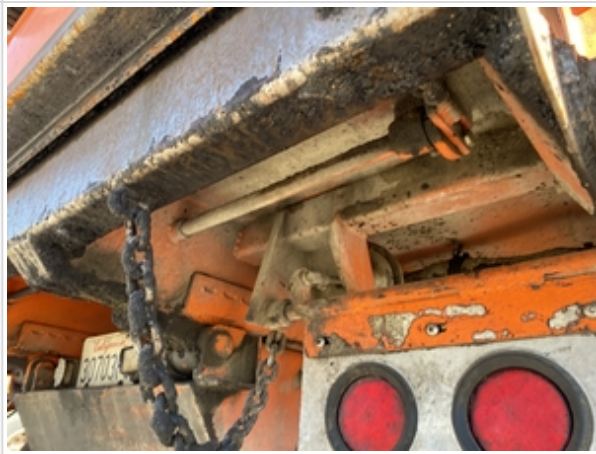
Tailgate Latch Photos

Tailgate Latch	3 - Normal Wear & Tear

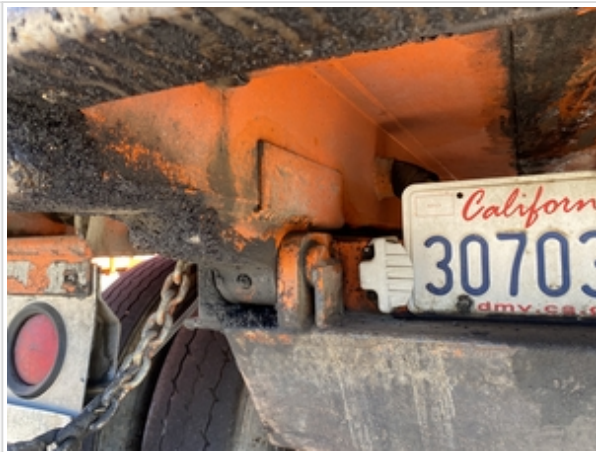
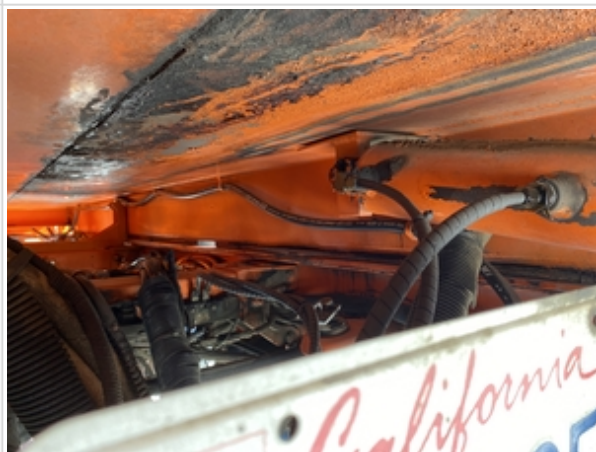
Support Frame Photos

<p>Support Frame</p>	<p>3 - Normal Wear & Tear</p>

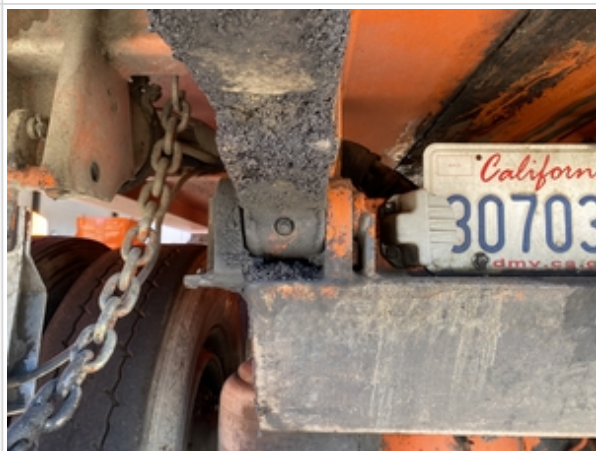
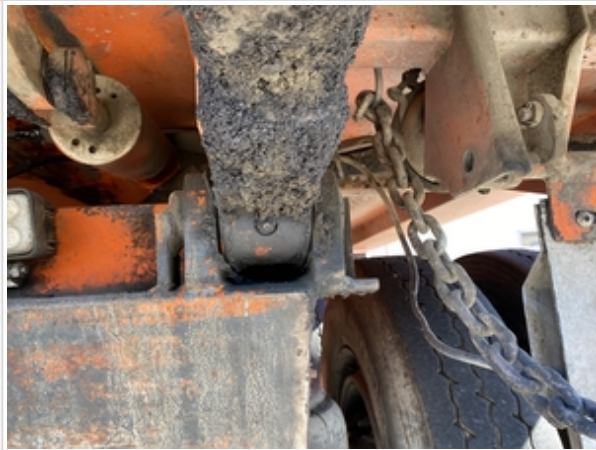
Hinge Points	3 - Normal Wear & Tear
Hinge Point Photos

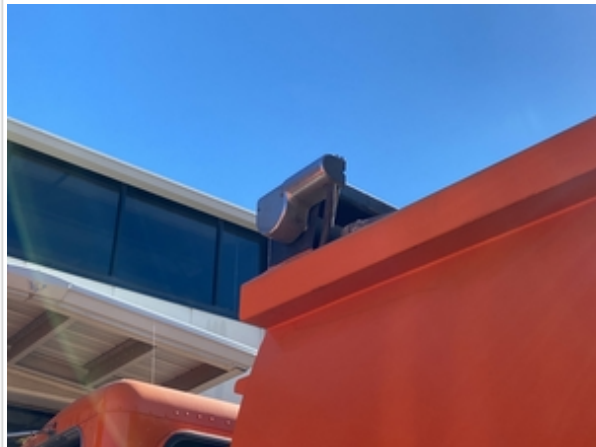
Tarp	3 - Normal Wear & Tear
Tarp Photos
