Inspection Report (Boom Lift)

Year	2003
Make	JLG
Model	450 AJ
Serial Number	03000720160
Hour Meter Reading	3,336 Hours
Previous Application (e.g., earth moving, mining, demolition, etc)	Masonry General Construction

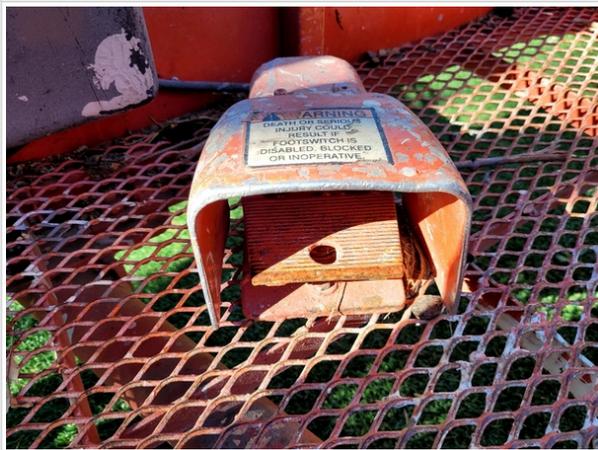
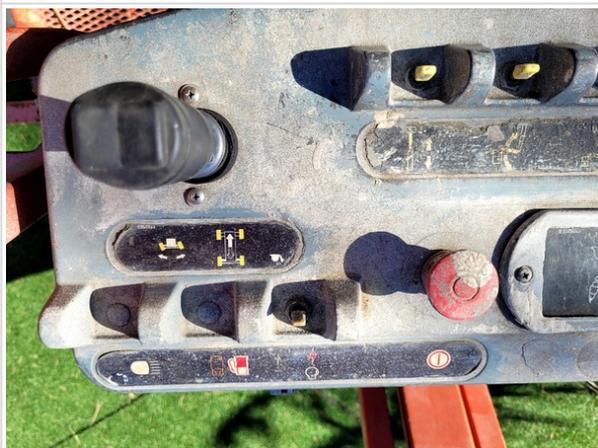
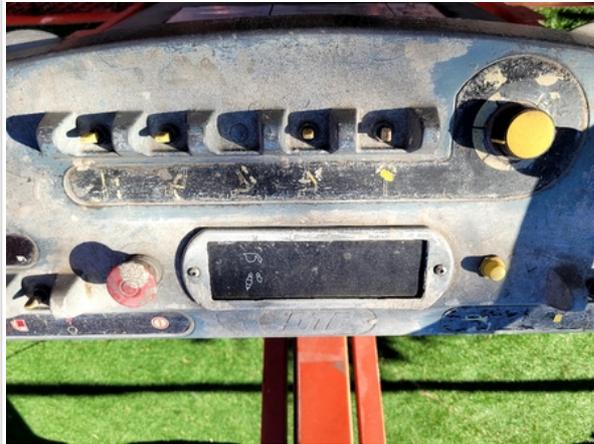
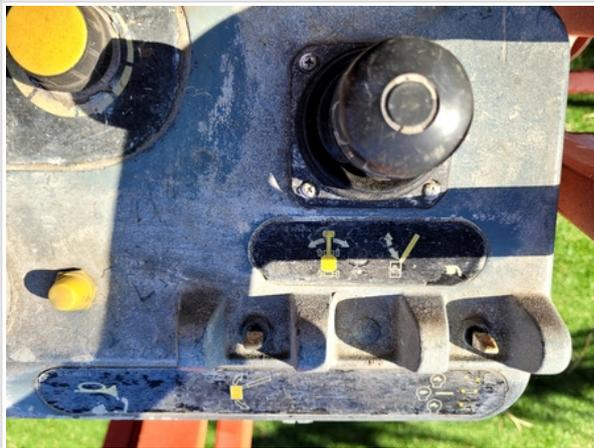
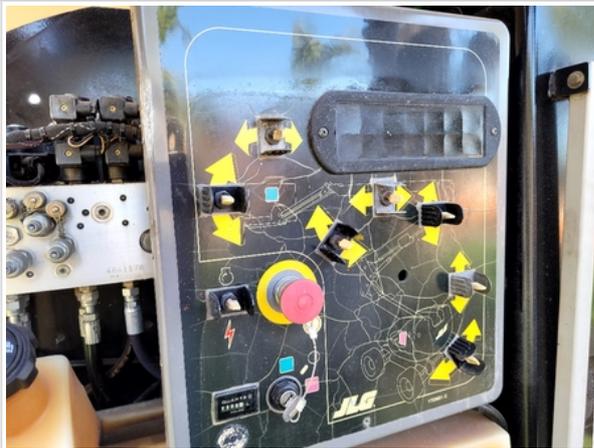
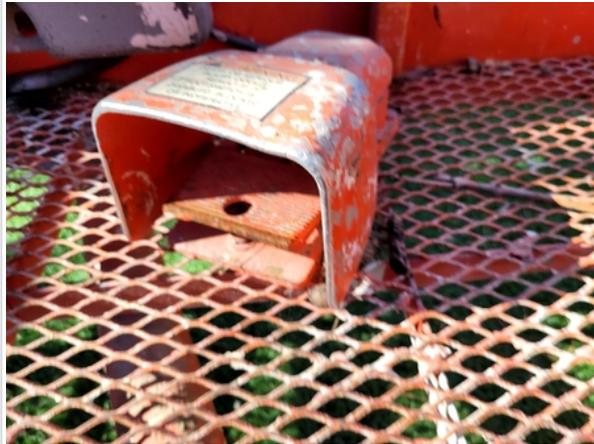
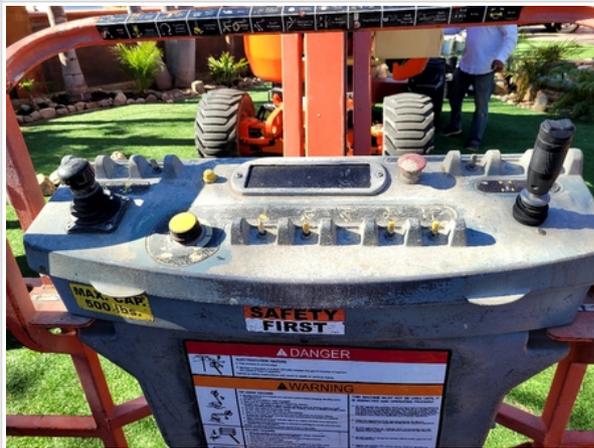
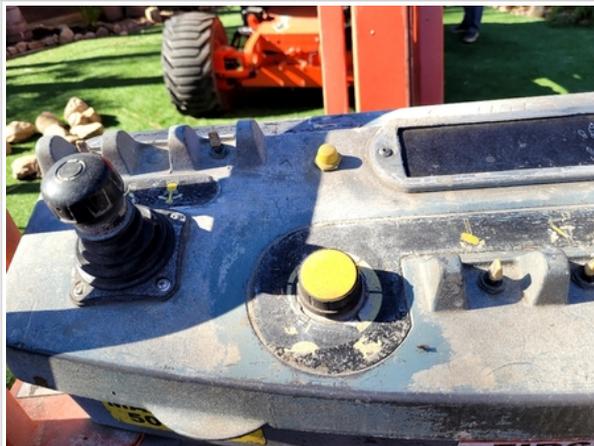
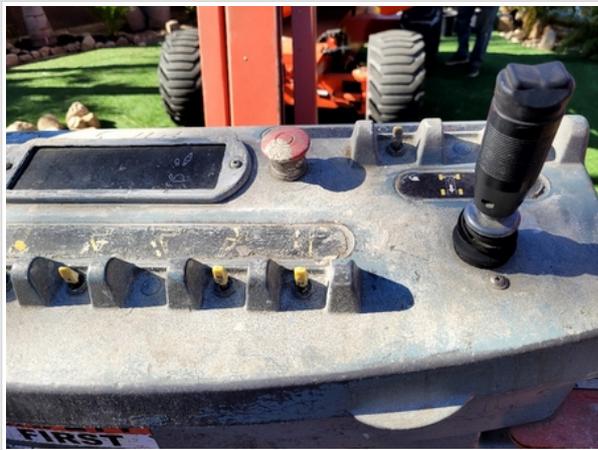
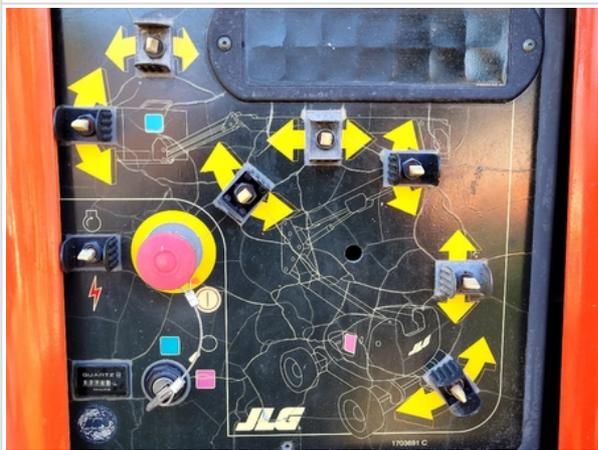
Other Gauge Activity	3 - Normal Wear & Tear
Controls & Switches	3 - Normal Wear & Tear
Controls & Switches Photos

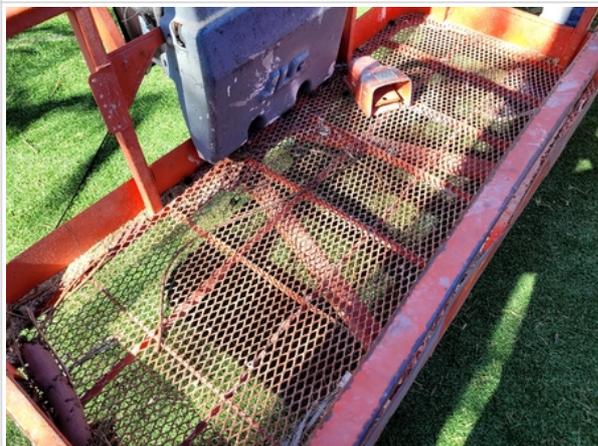
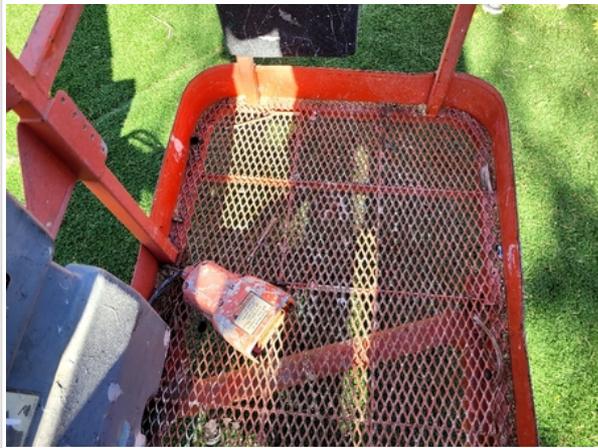
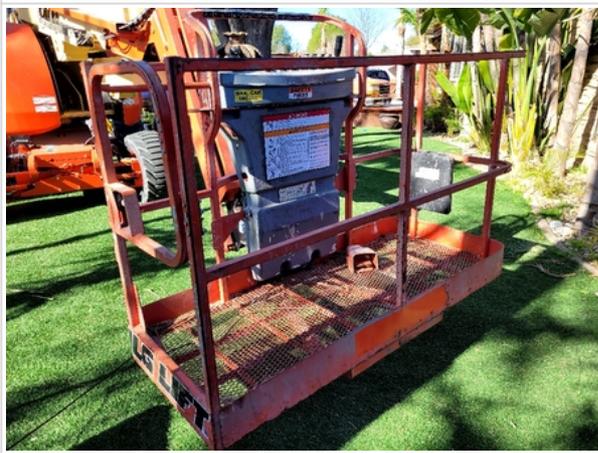
Horn	3 - Normal Wear & Tear	
Travel Alarm	3 - Normal Wear & Tear	
Swing Brake	3 - Normal Wear & Tear	
Safety Lock Out / Stop	3 - Normal Wear & Tear	
Platform Safety Rails & Appearance	3 - Normal Wear & Tear	
Platform Safety Rails & Appearance Photos

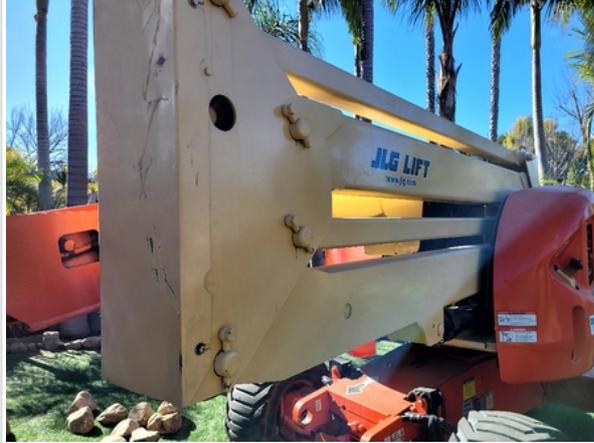
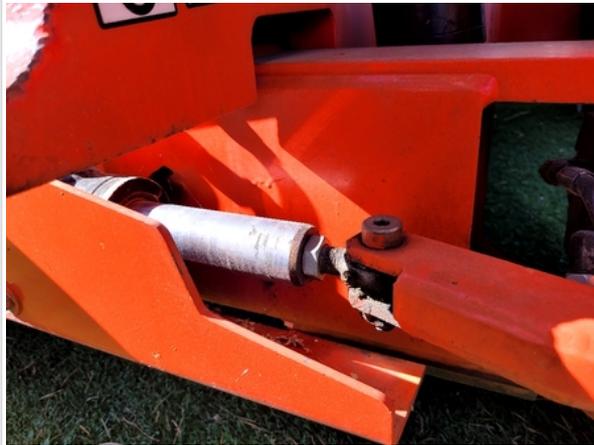
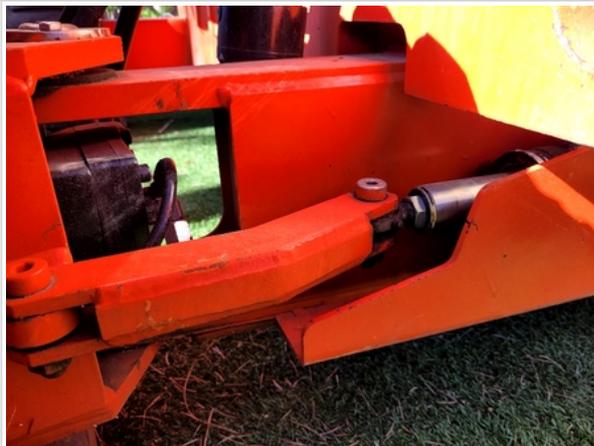
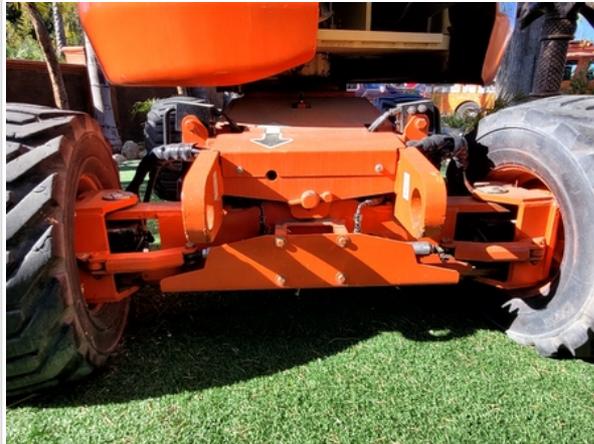
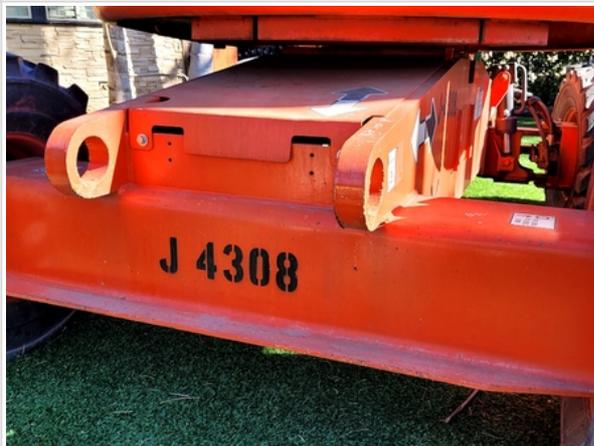
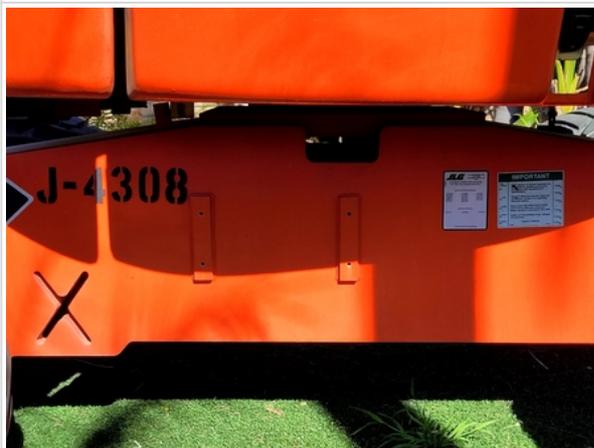
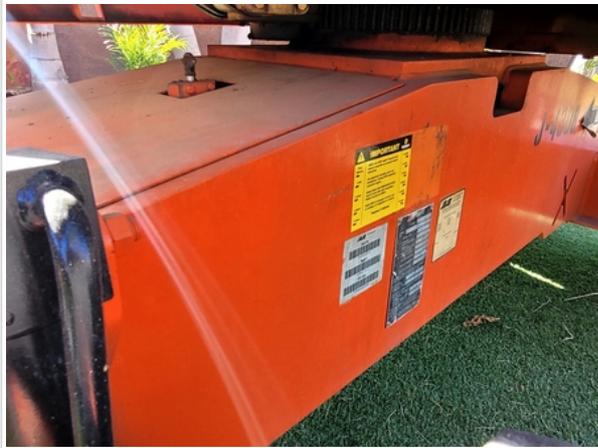
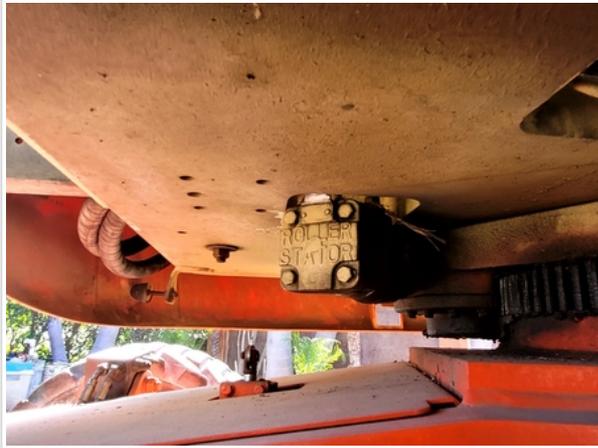
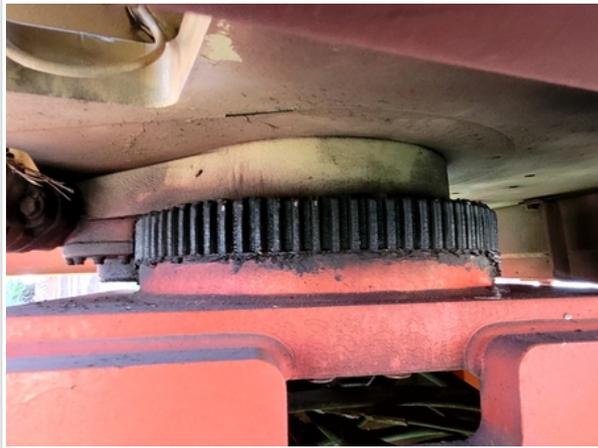
Frame Photos

Frame	3 - Normal Wear & Tear
--------------	------------------------

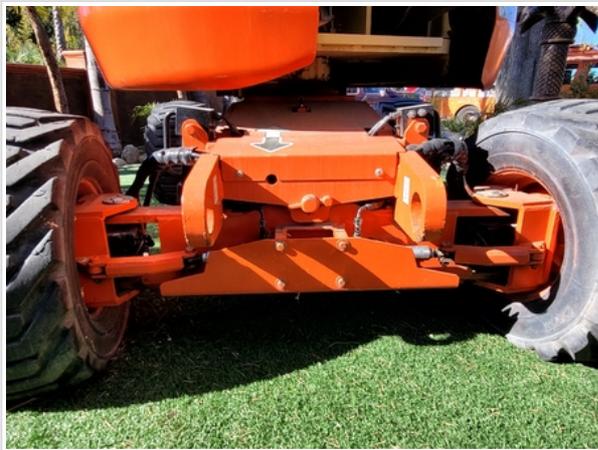
Front Axle Appearance Photos

Stance	3 - Normal Wear & Tear
Front Axle Appearance	3 - Normal Wear & Tear
