Inspection Report (Excavator)

| Year | 2013 |
| Make | John Deere |
| Model | 210G |

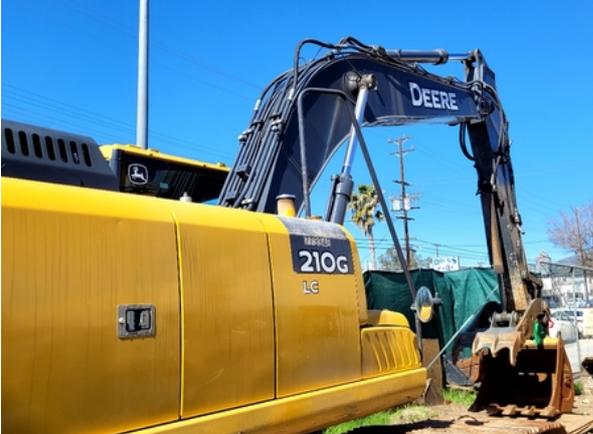
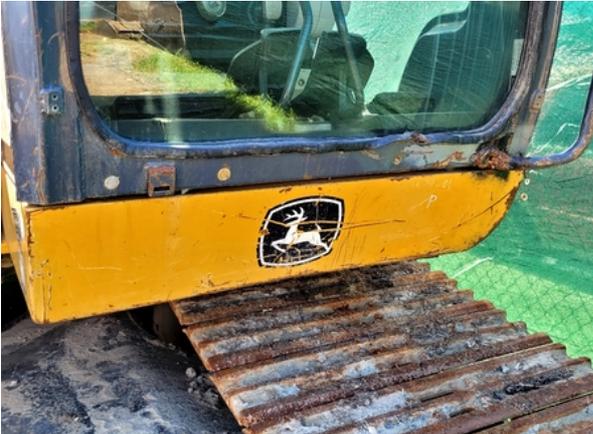
| Body Panels | 3 - Normal Wear & Tear |
| Body Panel Condition | Visible chipped paint or dents, Some panel misalignment observed, Large dents or cracks, Other (see comments) |
| Comments | Rear left side and right side body damage at compartment door and bottom part of counter weight dented |

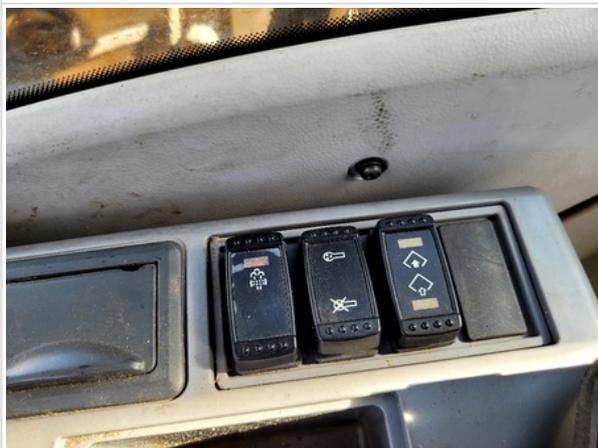
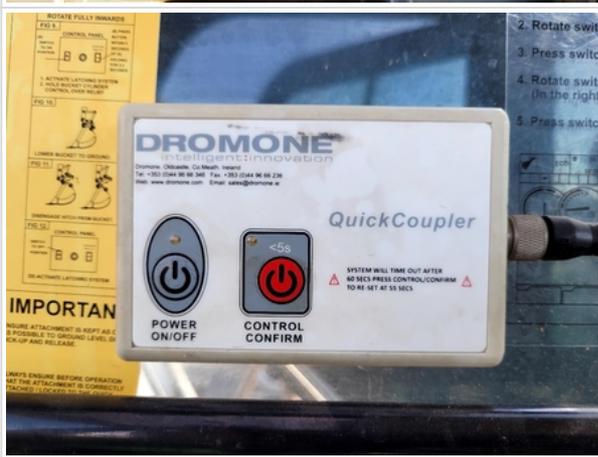
| <p>Operator Cabin Photos</p> | | |

| Operator Cabin Overall | 3 - Normal Wear & Tear |
| Operator Cabin Overall Condition | Good cabin appearance, solid floors, panels, and ceiling |

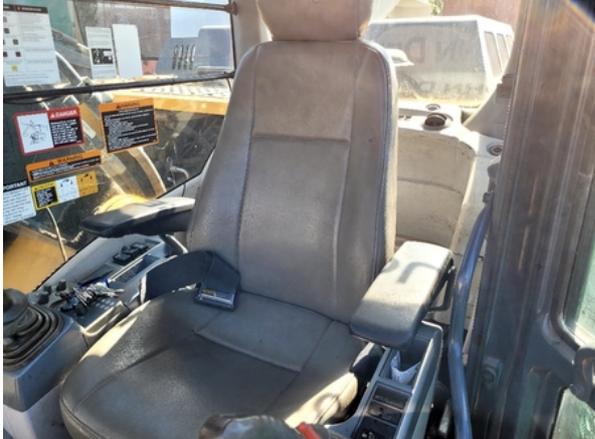
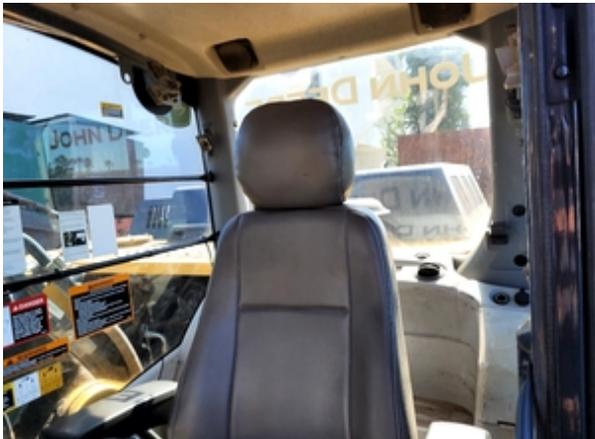
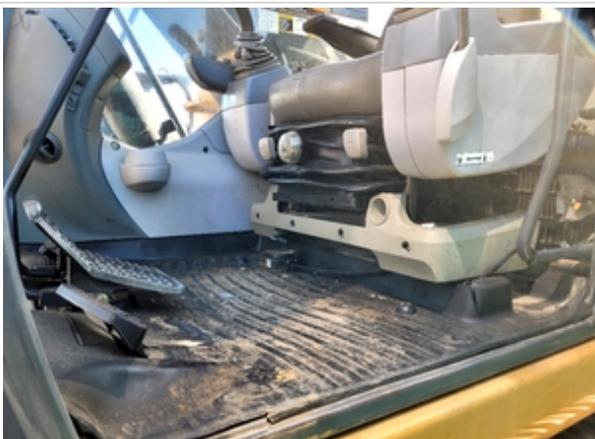
| Operator Seat | 3 - Normal Wear & Tear |
| Operator Seat Condition | Seat(s) have minor surface staining or small tears |
| Cabin Lights | 3 - Normal Wear & Tear |
| Cabin Lights Condition | Cabin lights are installed with all light covers in place, bulbs are installed and working properly |

| Safety Lock Out / Stop Condition | Safety lock out device is present, in good condition, and functional |
| Controls & Switches Condition | All switches are installed and functional |
| Other Gauge Condition | All cockpit gauges are functional and in good condition |
| Heater & A/C Condition | Heater and A/C work as expected |

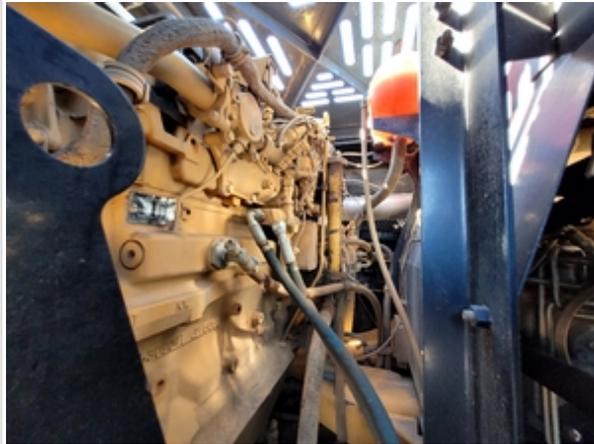
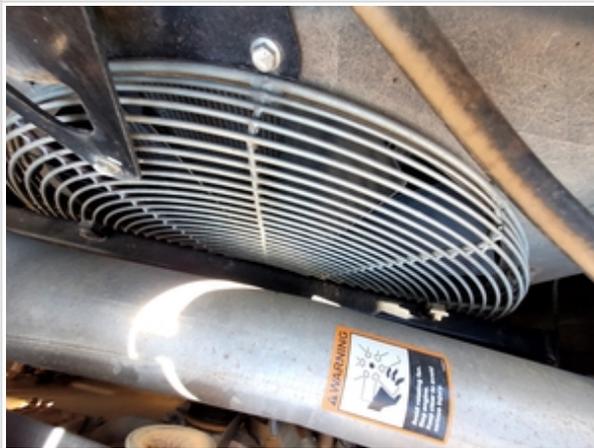
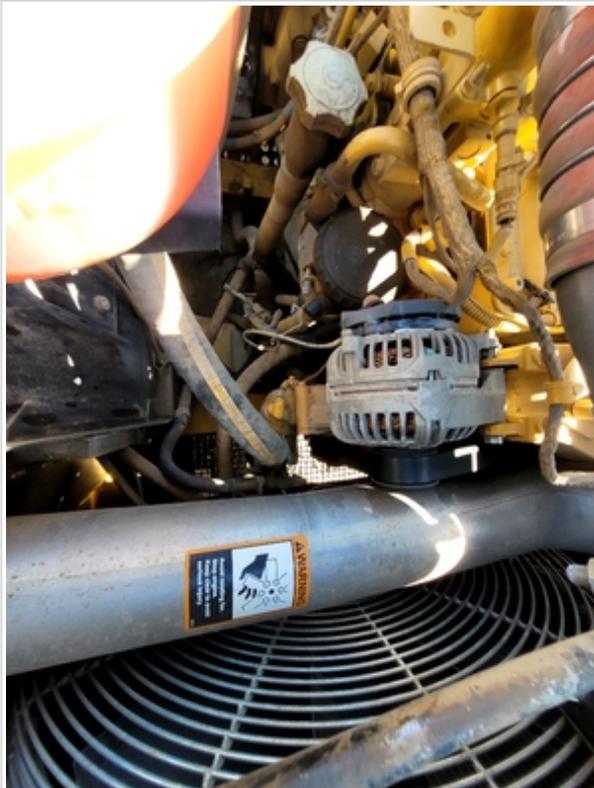
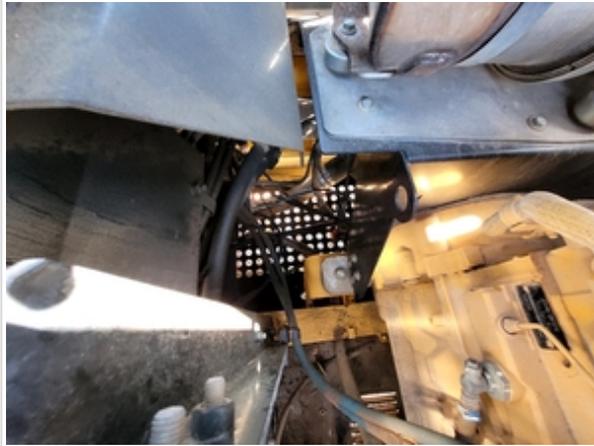
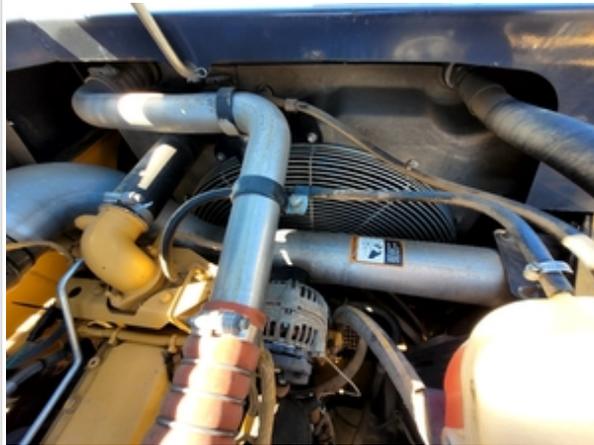
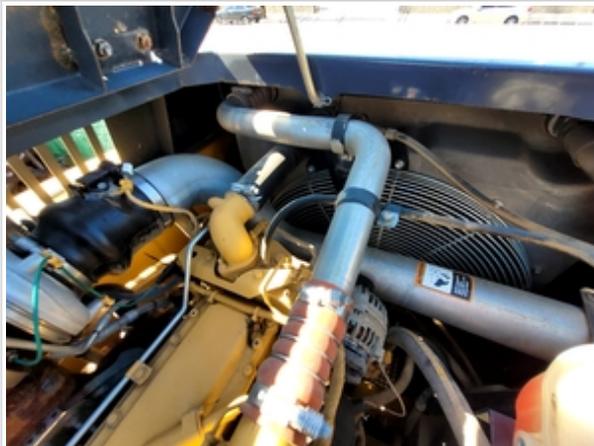
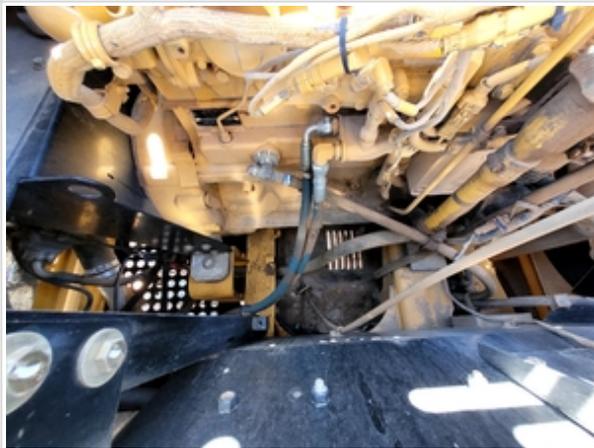
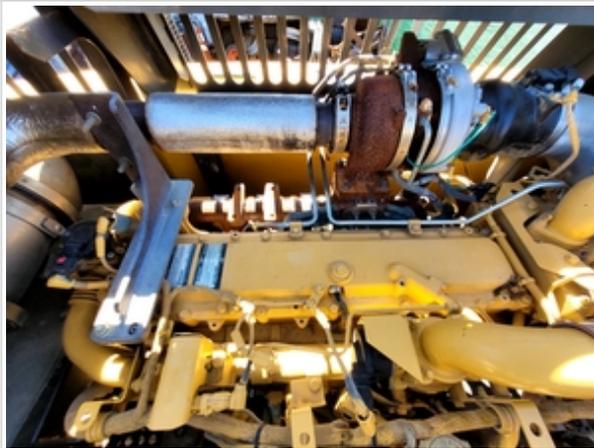
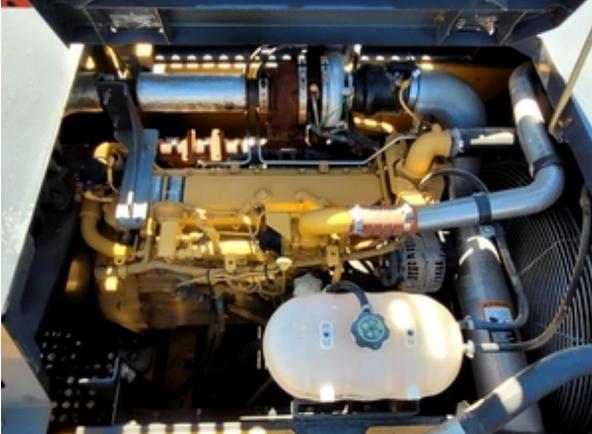
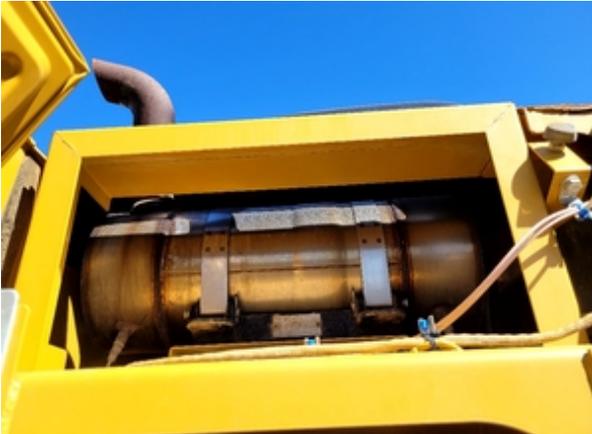
Engine Photos

| Engine Smoke Notes | No engine smoke issues observed | |
| Battery Condition | Like new, recently replaced | |
| Radiator Condition | Radiator fins & components appear to be in good working order, no signs of damage or leaks | |
| Belt Condition | Belts appear in good condition & alignment with proper tension | |
| Hose Condition | Firm, pliant hoses with no signs of wear or leaks | |

| Overall Engine Comments | Overall engine in good condition with no active leaks seen or obvious issues observed during operation. |

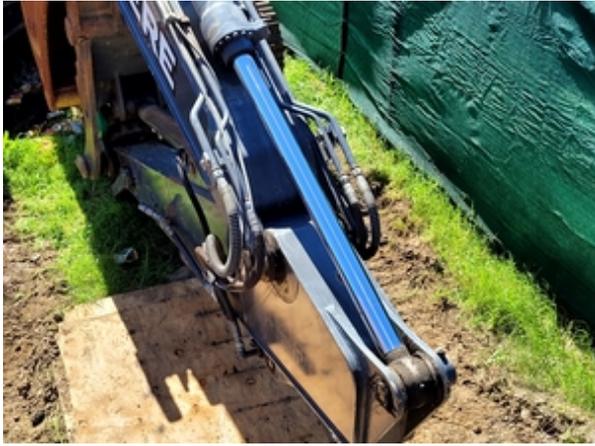
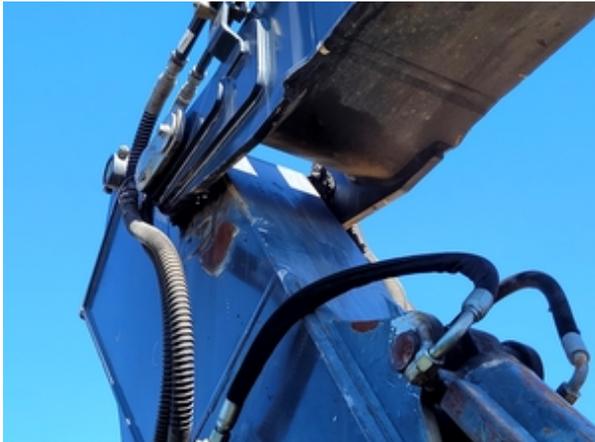
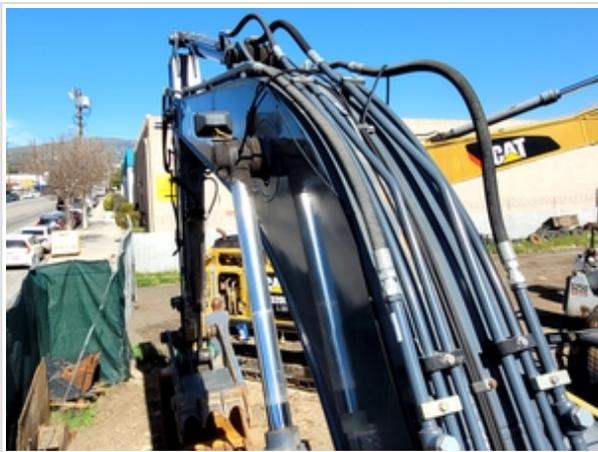
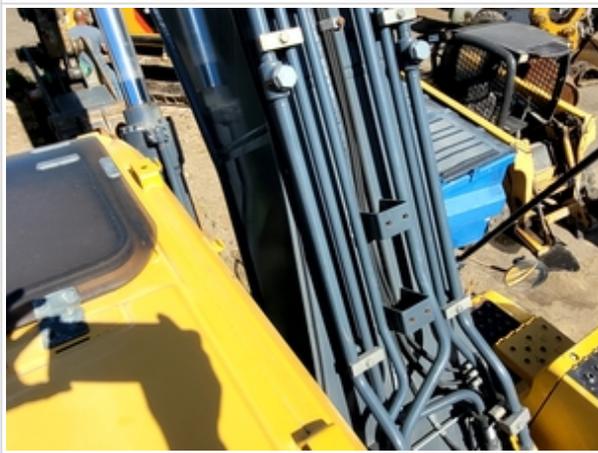
| Boom Photos | |

| Boom Condition | 3 - Normal Wear & Tear |

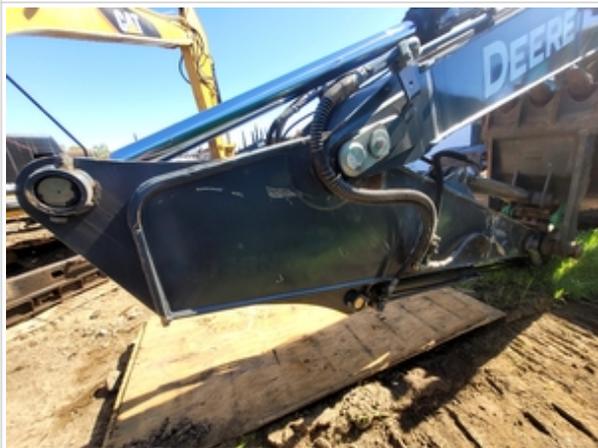
| <p>Stick Photos</p> | |

| <p>Stick Condition</p> | <p>3 - Normal Wear & Tear</p> |

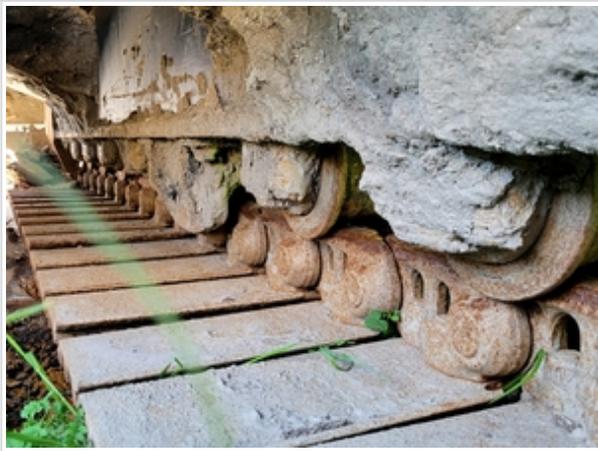
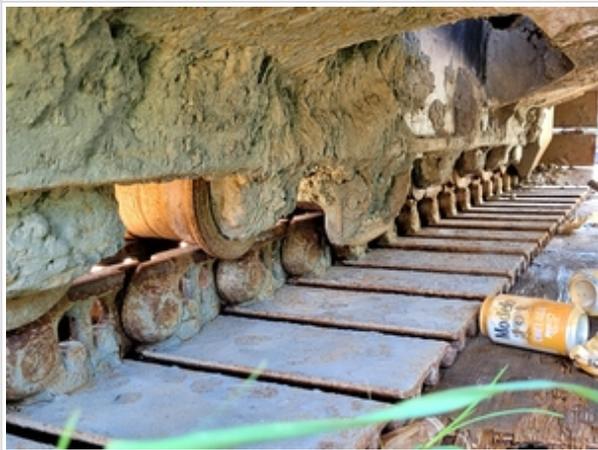
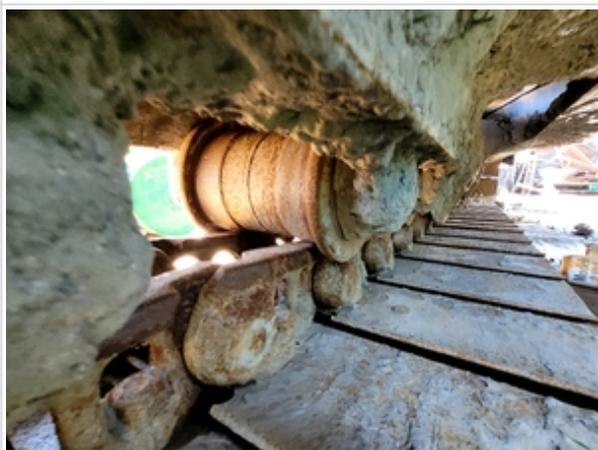
| Undercarriage Overall Photos | |

| Undercarriage Overall Condition | 3 - Normal Wear & Tear |

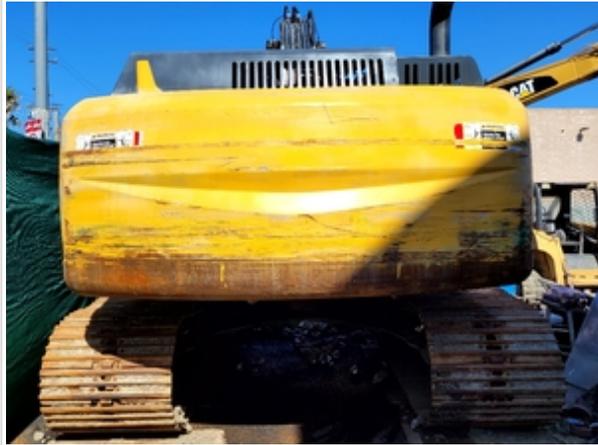
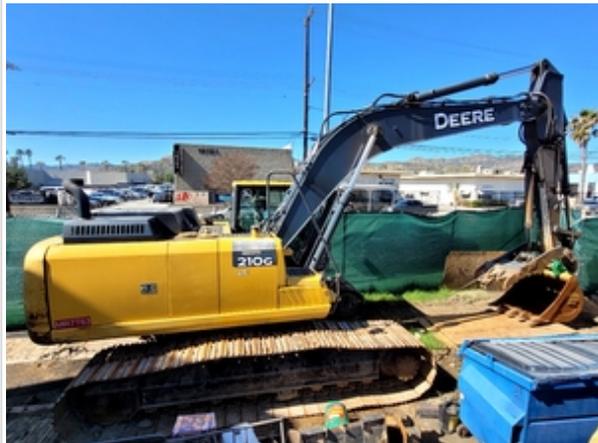
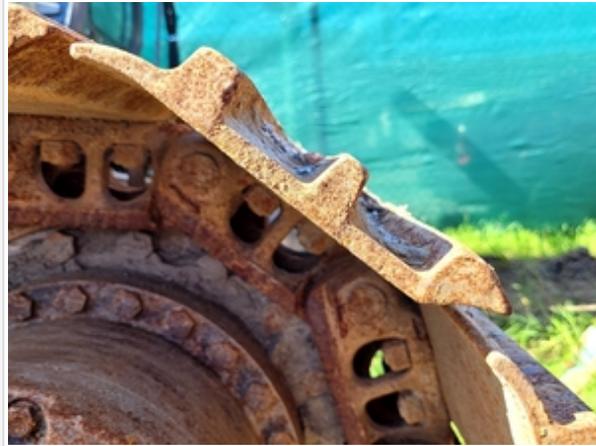
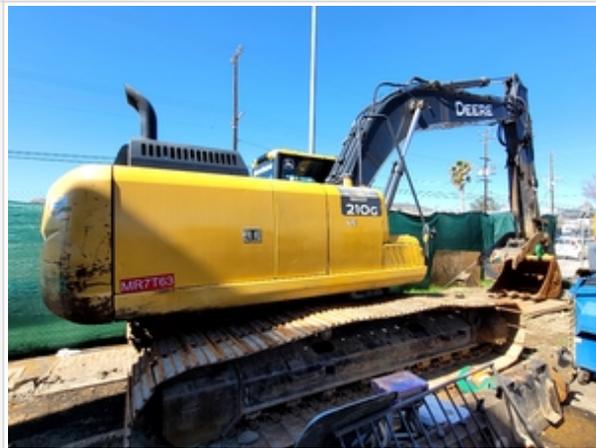
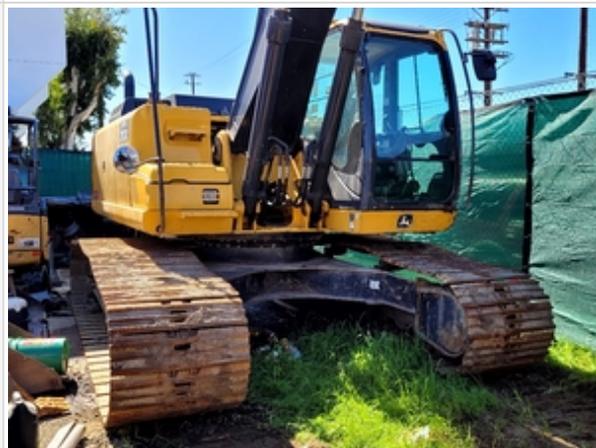
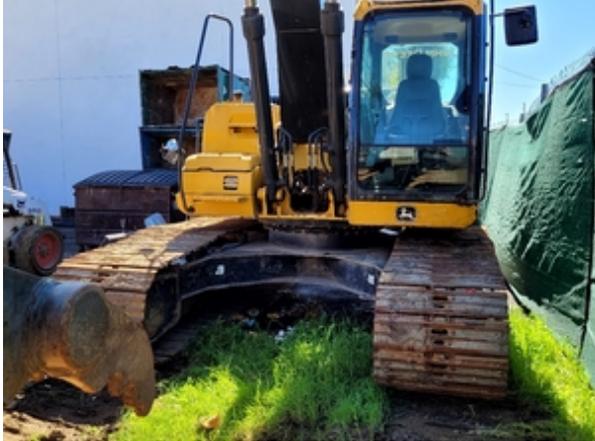
| Tracks Photos | |

| Tracks | 3 - Normal Wear & Tear |

| Left Side: Link Bushings / Drive Sprocket / Shoe Condition | 3 - Normal Wear & Tear |
| Left Side: Upper & Lower Roller / Front Idler Condition | 3 - Normal Wear & Tear |
| Track Condition: Left Front | 50% |
| Track Condition: Left Rear | 50% |
| Right Side: Link Bushings / Drive Sprocket / Shoe Condition | 3 - Normal Wear & Tear |
| Right Side: Upper & Lower Roller / Front Idler Condition | 3 - Normal Wear & Tear |
| Track Condition: Right Front | 50% |
| Track Condition: Right Rear | 50% |

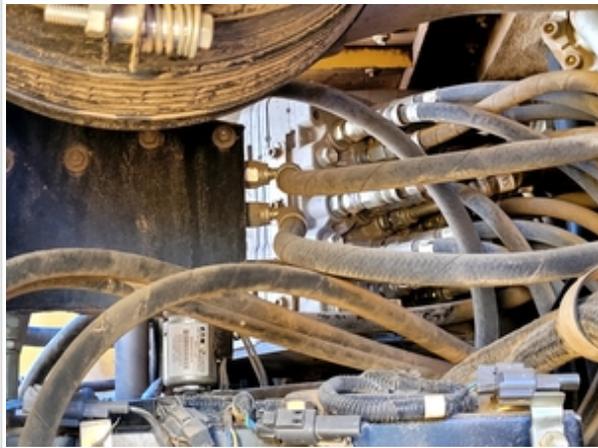
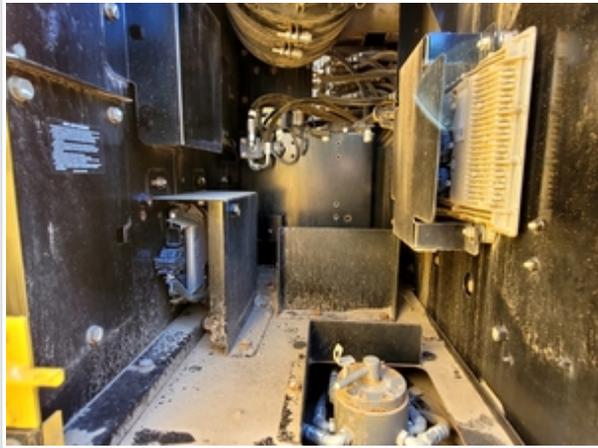
| Wet or Damp Hydraulic Lines / Fittings | No |
| Appearance of Hydraulic Lines / Fittings | 3 - Normal Wear & Tear |
| Hydraulic Lines / Fittings Condition | Hydraulic lines & fittings are clean and in good condition |
| Comments | hydraulics in great working condition with no active leaks observed |

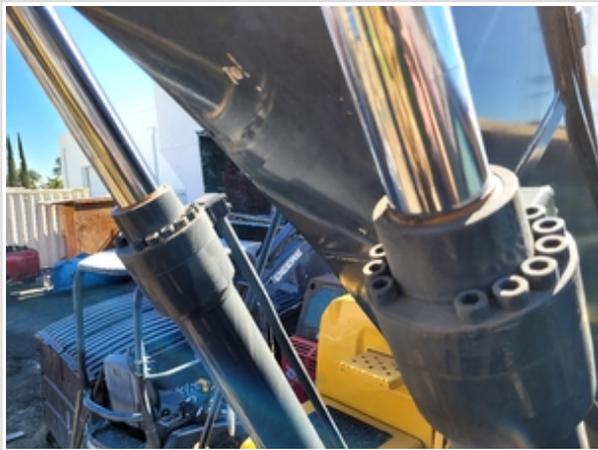
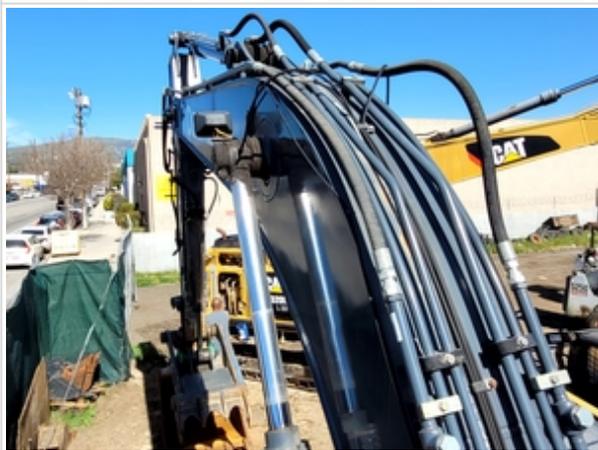
| Boom Cylinder Photos | |

| Boom Cylinder: Oil Leaks | No |

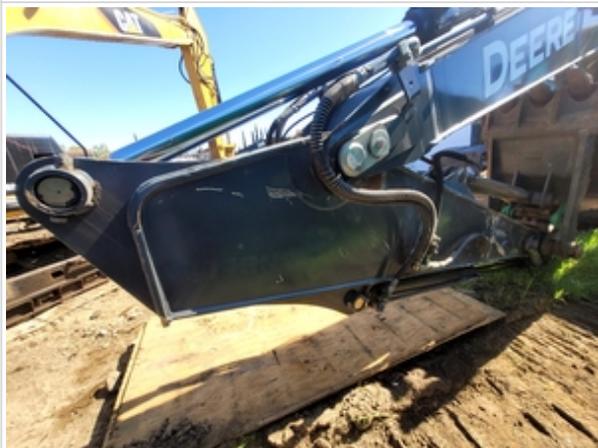
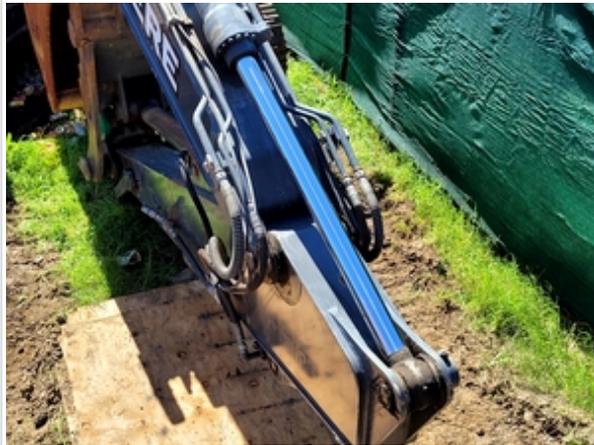
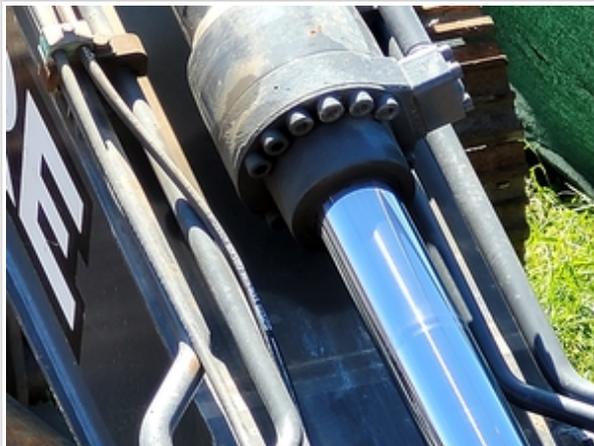
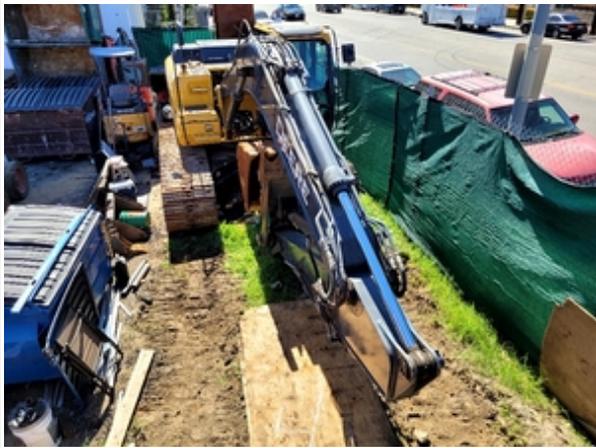
| Stick Cylinder Photos | |

| Stick Cylinder: Mounting Pin | 3 |
| Stick Cylinder: Oil Leaks | No |

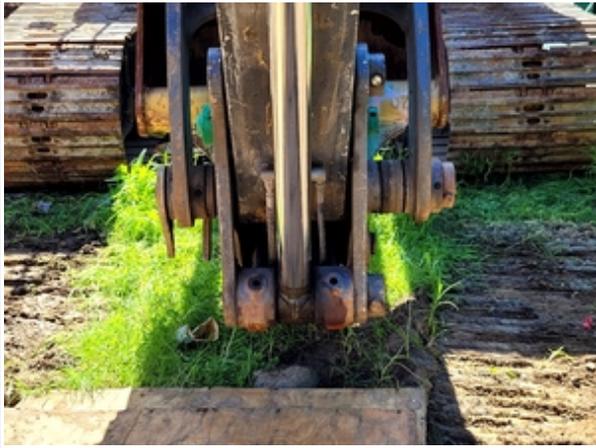
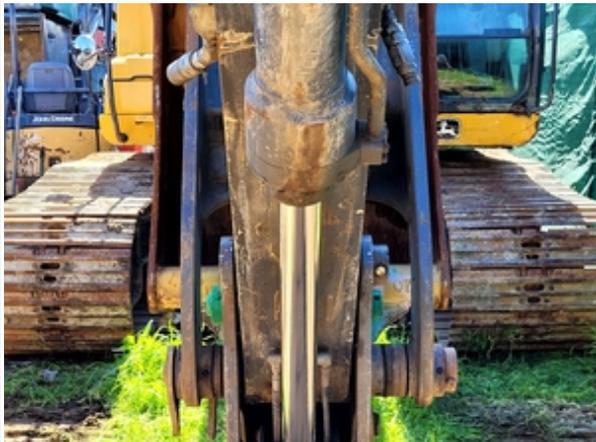
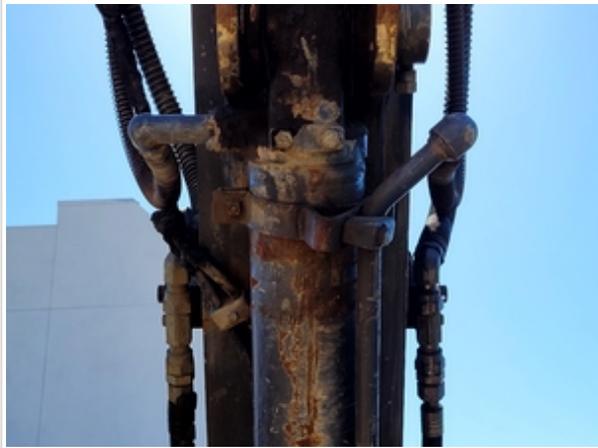
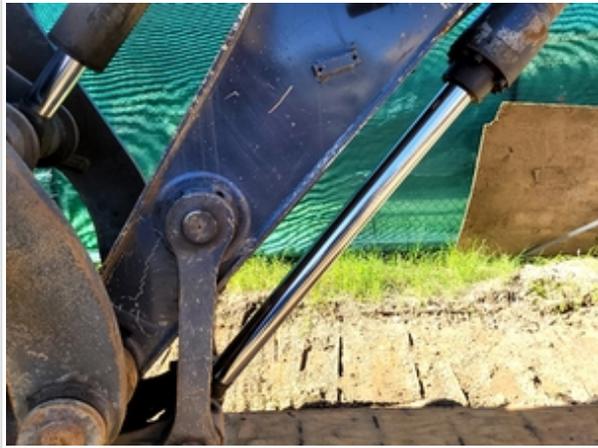
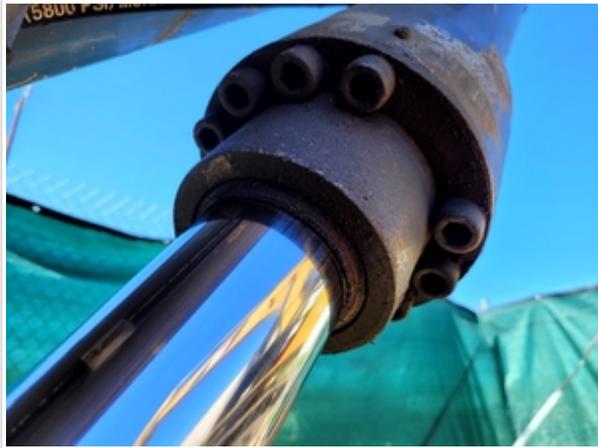
| Bucket Cylinder Photos | |

| Bucket Cylinder: Mounting Pin | 3 |
| Bucket Cylinder: Oil Leaks | No |

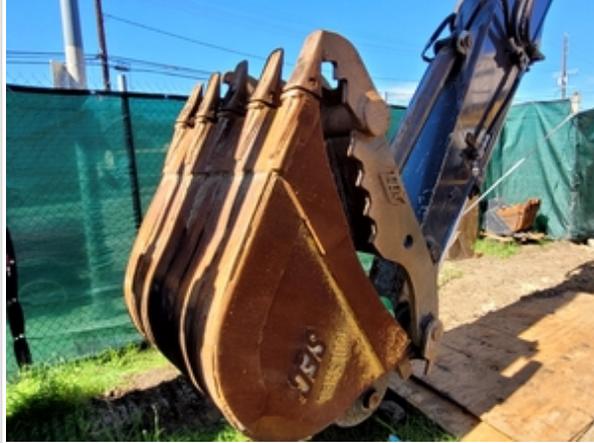
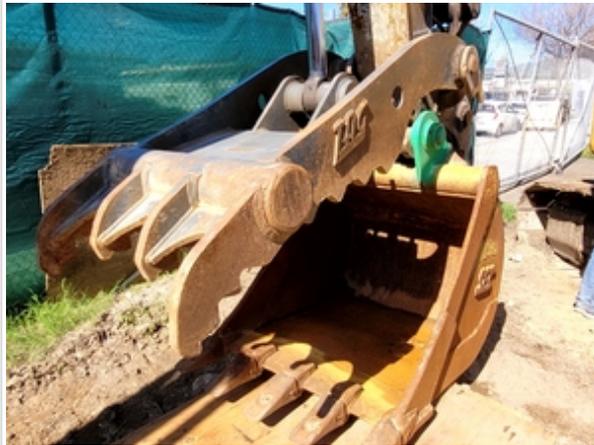
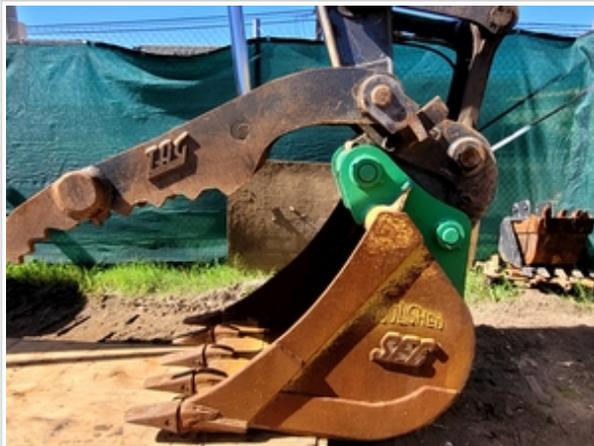
Bucket Photos

| Bucket Condition | 3 - Normal Wear & Tear |
