Inspection Report (Scissor Lift)

Year	2012
Make	Genie
Model	GS-2669
Serial Number	GS6912-793
Hour Meter Reading	1,796 Hrs.
Previous Application (e.g., earth moving, mining, demolition, etc)	Equipment Rental

Max Lift Height	26'
Max Lift Capacity	1,500Lbs.
Electric Powertrain	No
Hydraulic Leveling	Yes
Power to Platform	Yes
Deck Extensions	Yes
Deck Extension Measurements	N/A
Outriggers	No
Additional Attachment(s)?	No
OMM (Operator & Maintenance Manual)	Yes

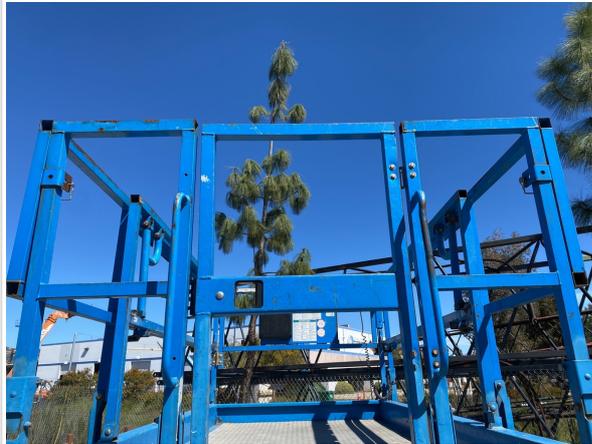
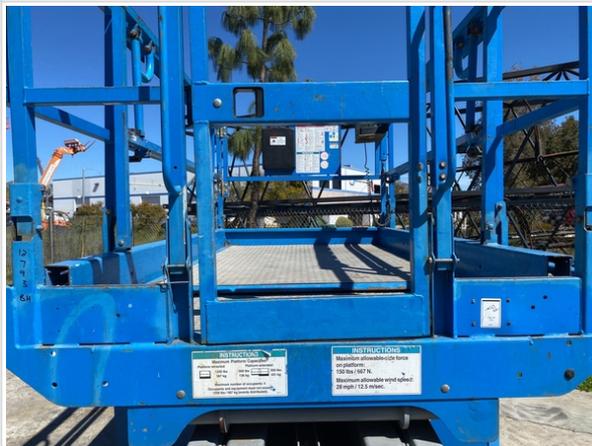
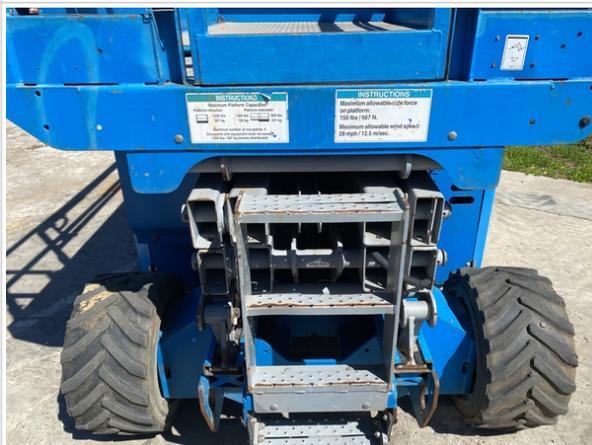
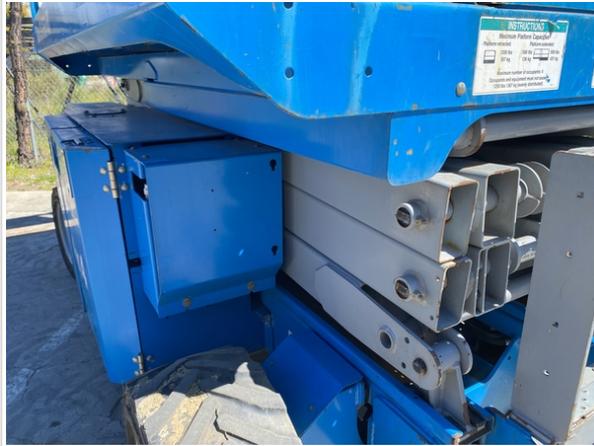
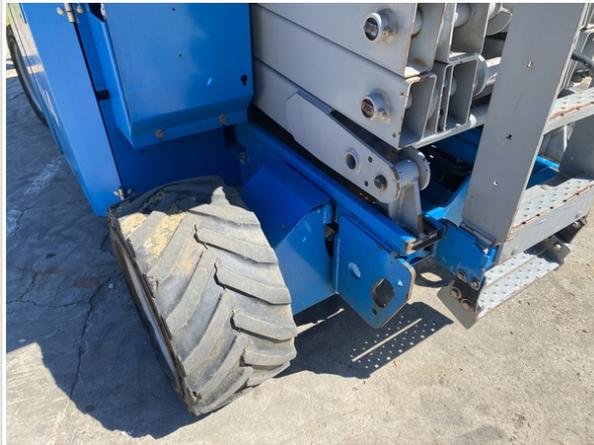
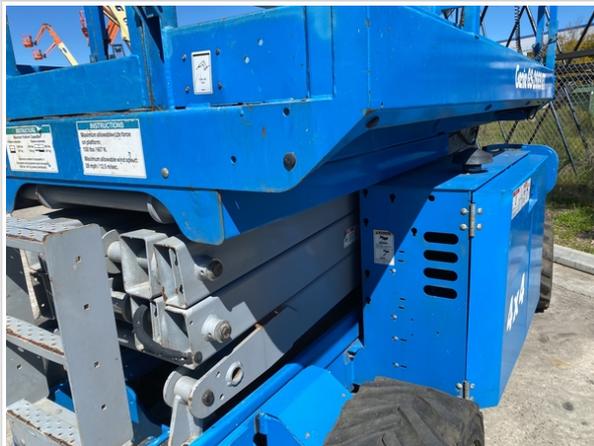
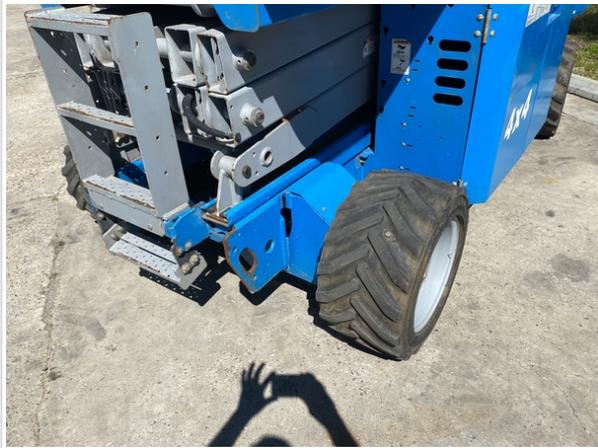
Front Photos

Front	3 - Normal Wear & Tear
-------	------------------------

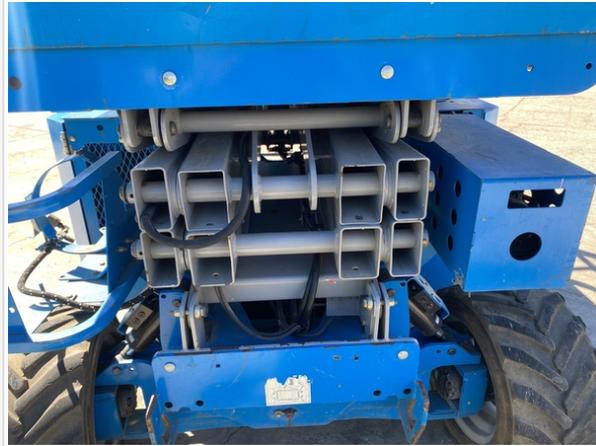
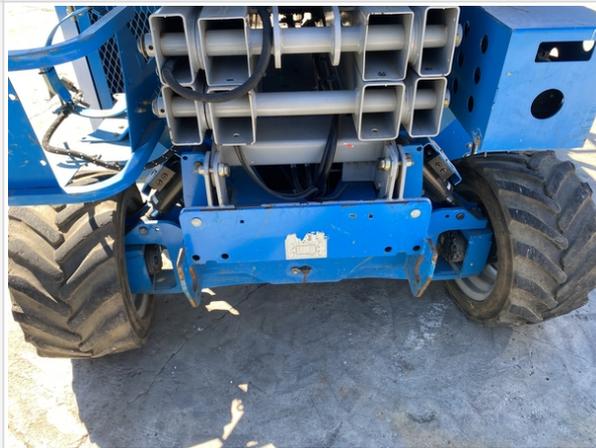
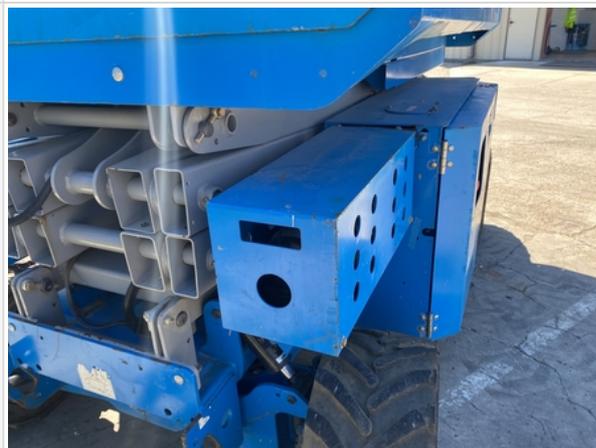
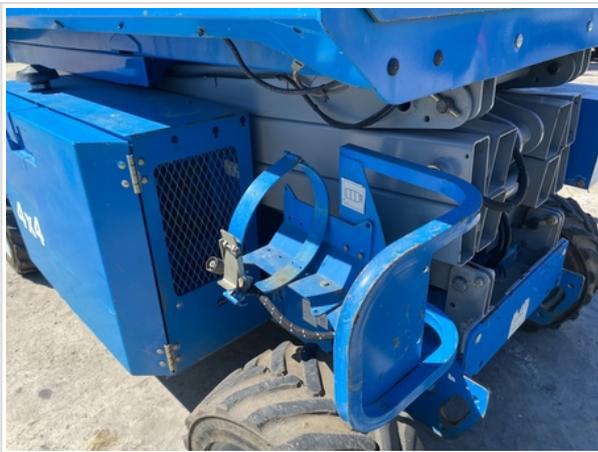
<p>Rear</p>	<p>3 - Normal Wear & Tear</p>
<p>Rear Photos</p>

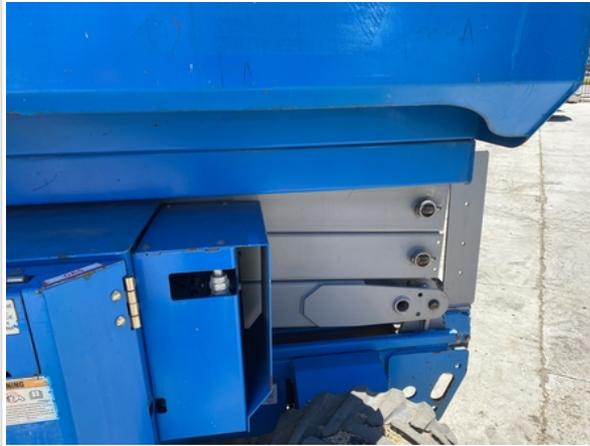
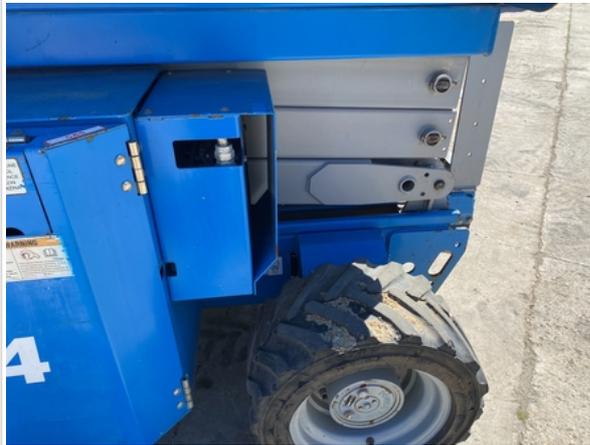
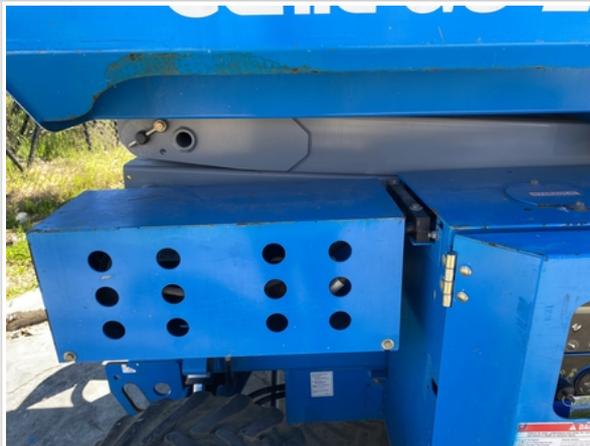
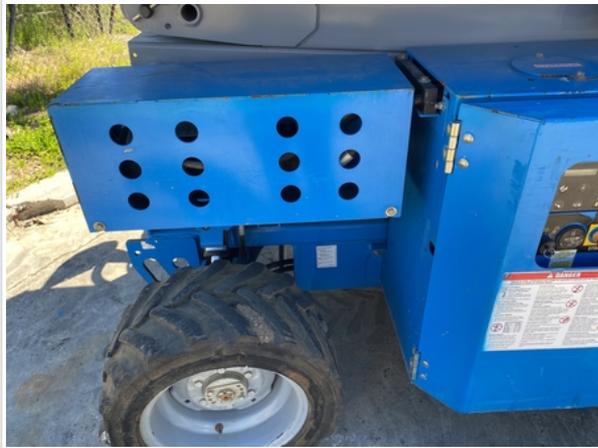
<p>Left</p>	<p>3 - Normal Wear & Tear</p>	
<p>Left Photos</p>

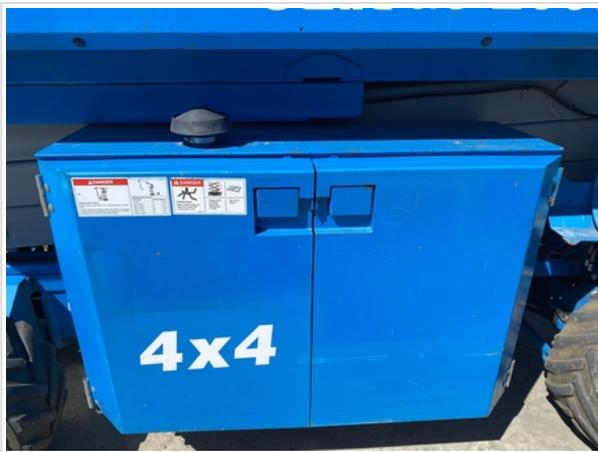
<p>Right</p>	<p>3 - Normal Wear & Tear</p>	
<p>Right Photos</p>

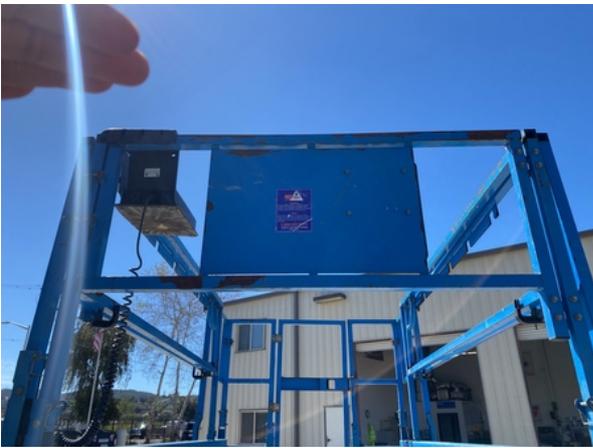
Upper	3 - Normal Wear & Tear
Upper Photos

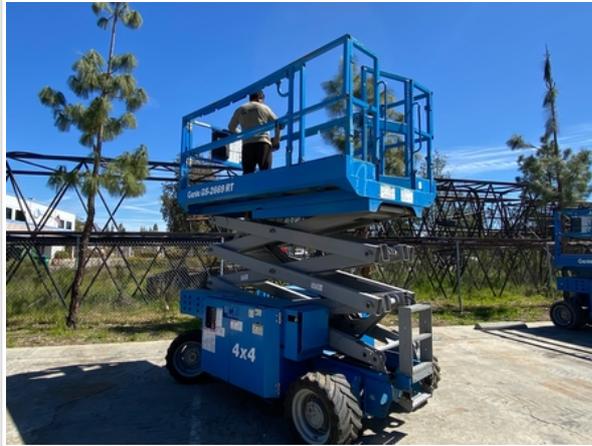
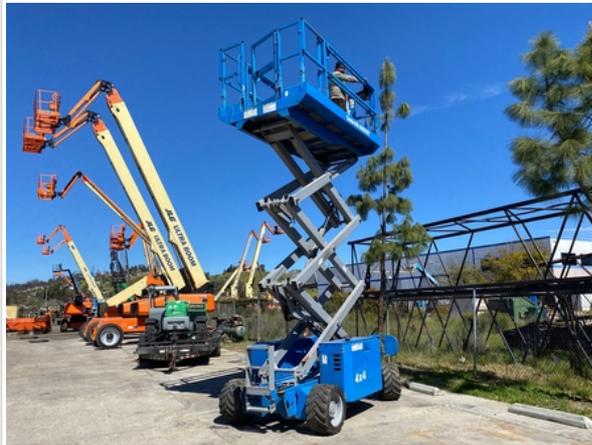
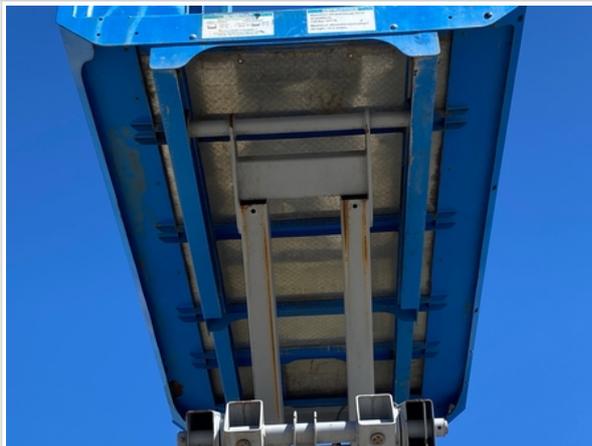
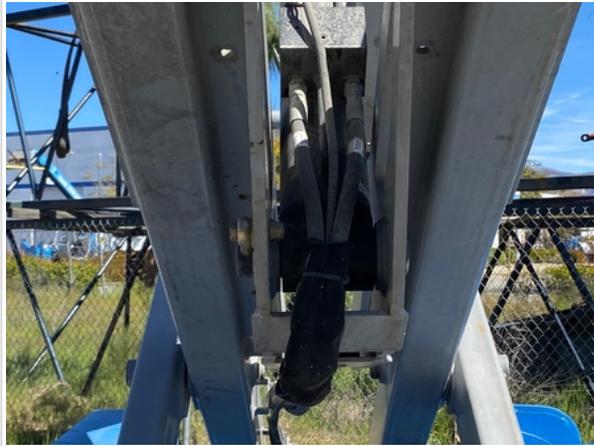
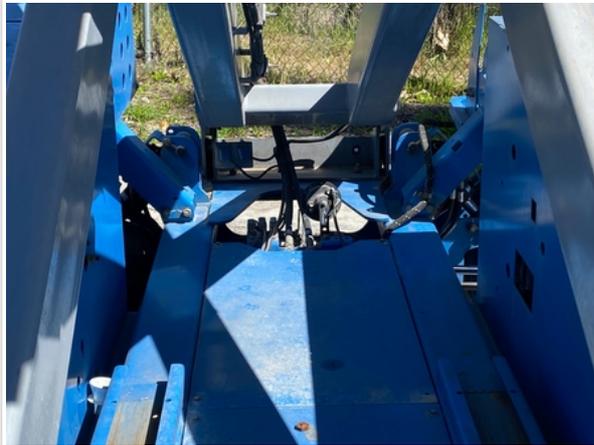
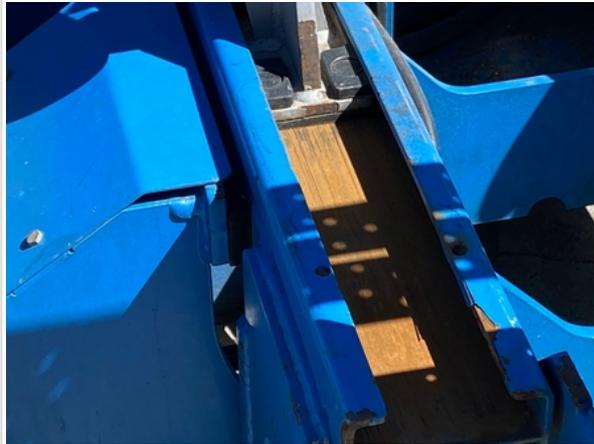
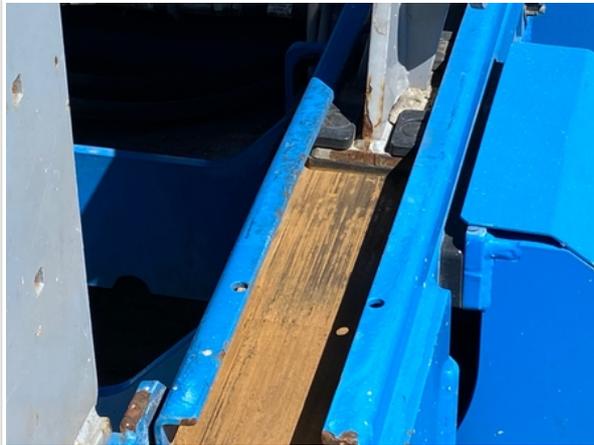
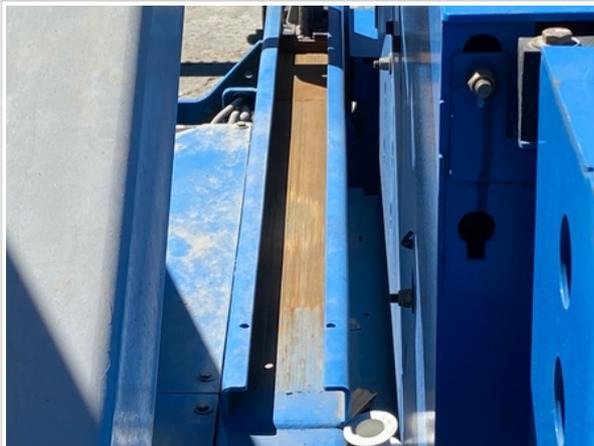
Body Panels (Any Damage?)	3 - Normal Wear & Tear	
Scissor Linkage	3 - Normal Wear & Tear	
Scissor Linkage Photos

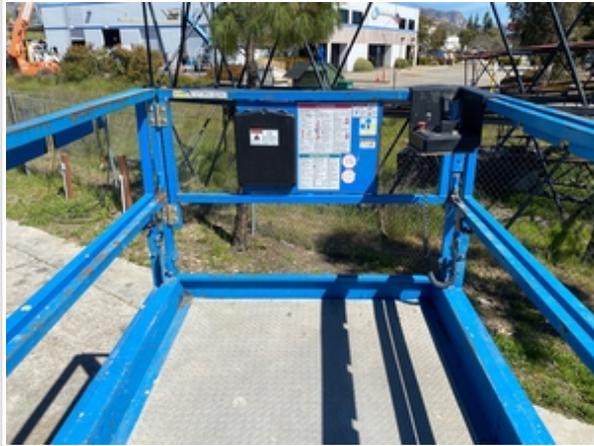
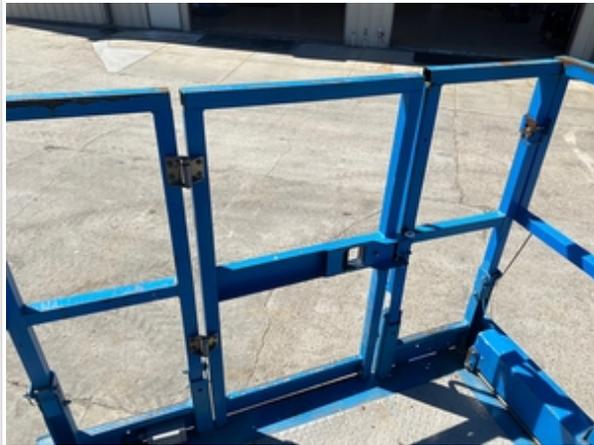
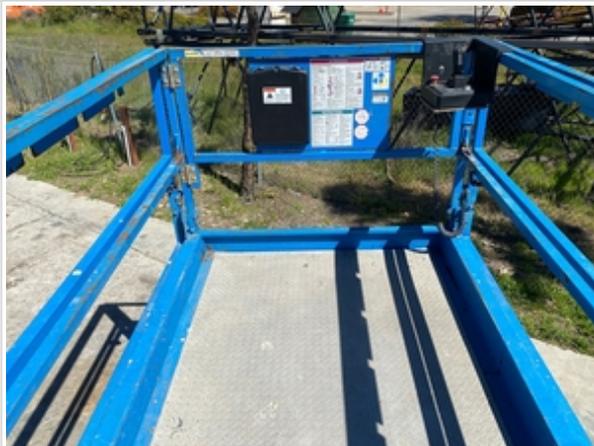
<p>Hand Rails</p>	<p>3 - Normal Wear & Tear</p>
<p>Hand Rails Photos</p>

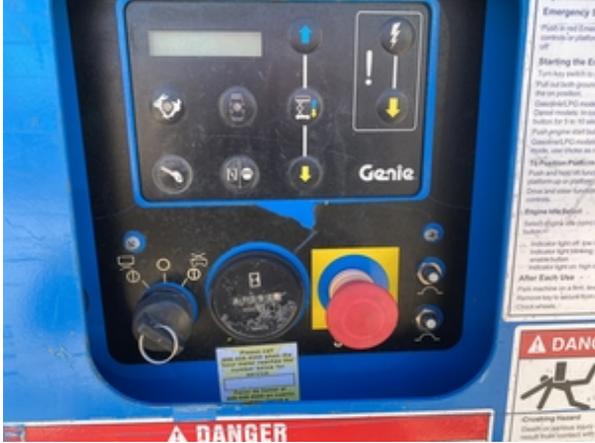
Other Gauge Activity	3 - Normal Wear & Tear
Controls & Switches	3 - Normal Wear & Tear
Controls & Switches Photos

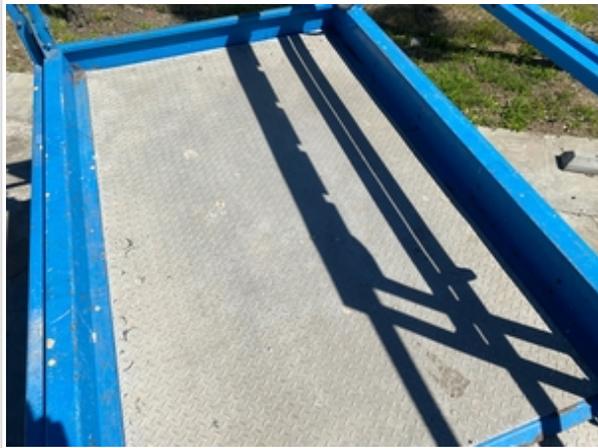
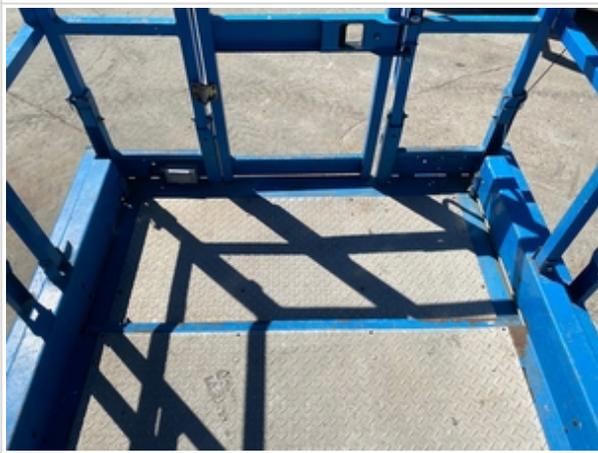
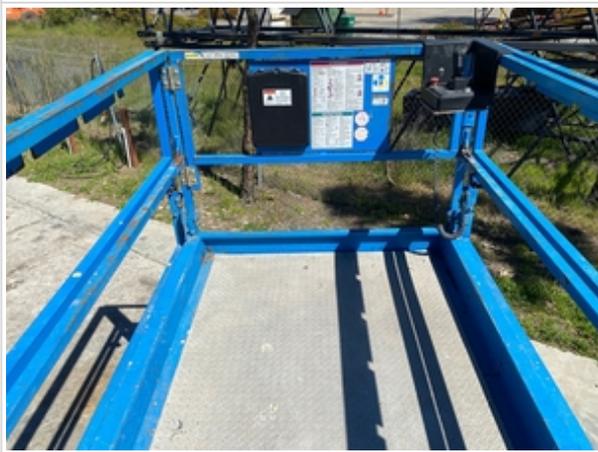
Horn	3 - Normal Wear & Tear
Travel Alarm	3 - Normal Wear & Tear
Safety Lock Out / Stop	3 - Normal Wear & Tear
Platform Safety Rails & Appearance	3 - Normal Wear & Tear
Platform Safety Rails & Appearance Photos

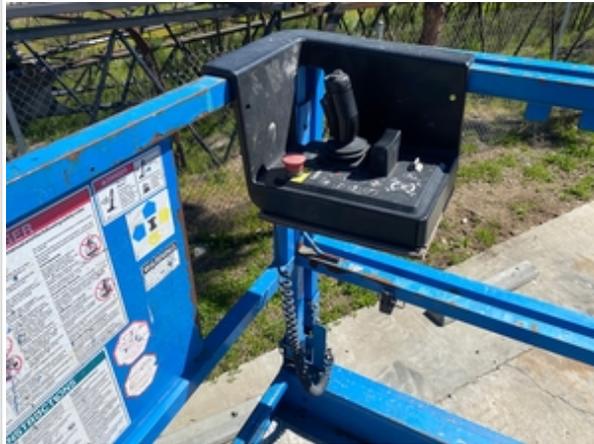
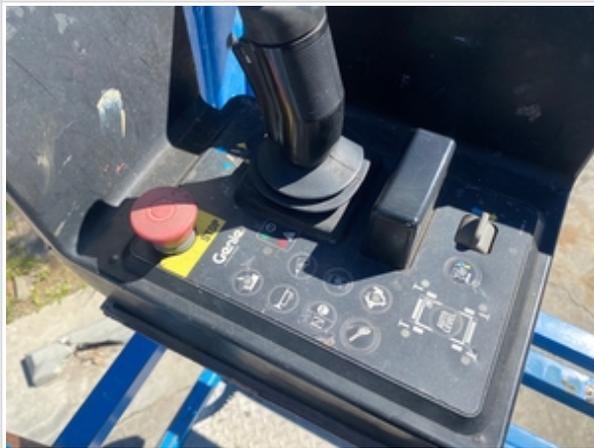
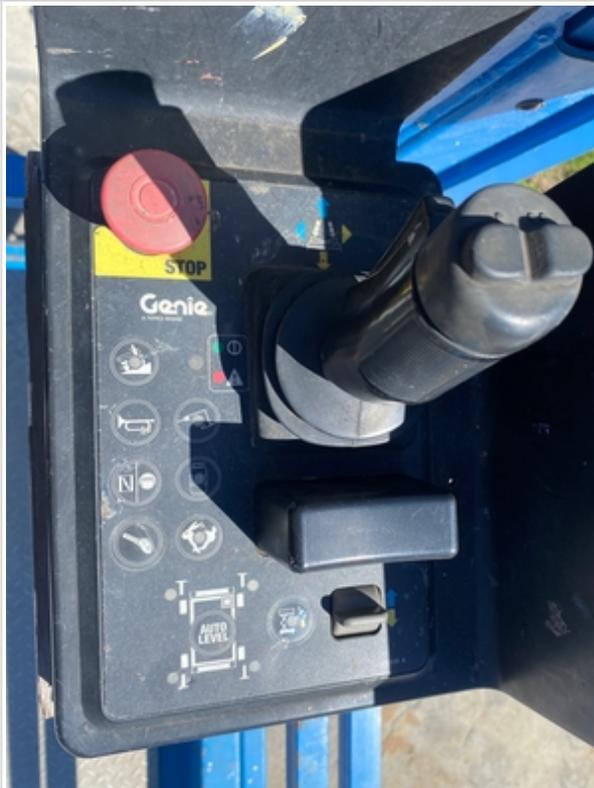
Platform Controls Photos

Platform Floor	3 - Normal Wear & Tear	
Platform Controls	3 - Normal Wear & Tear

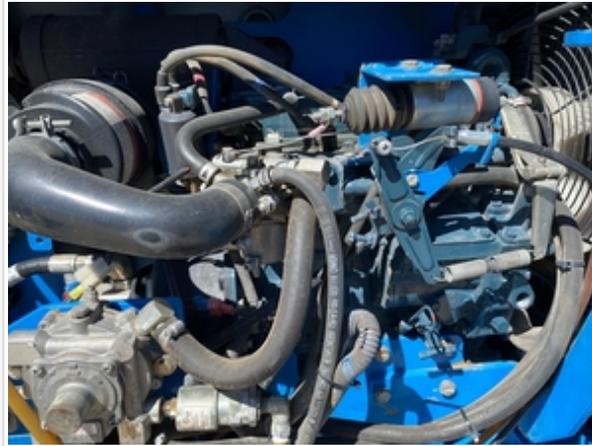
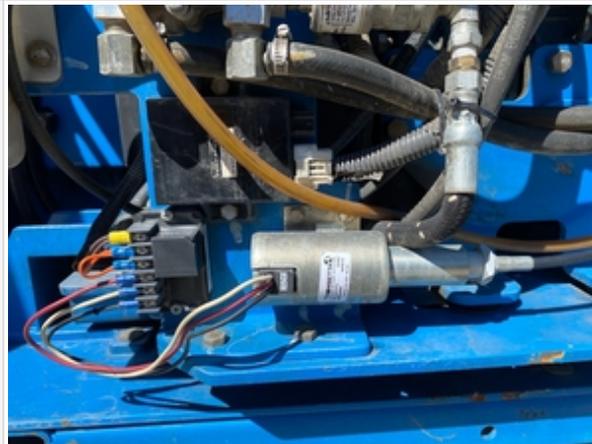
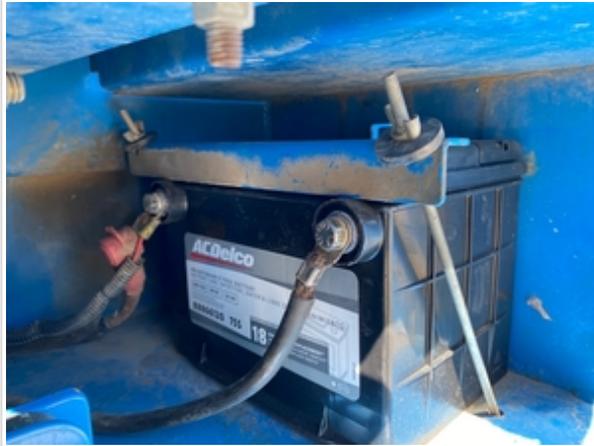
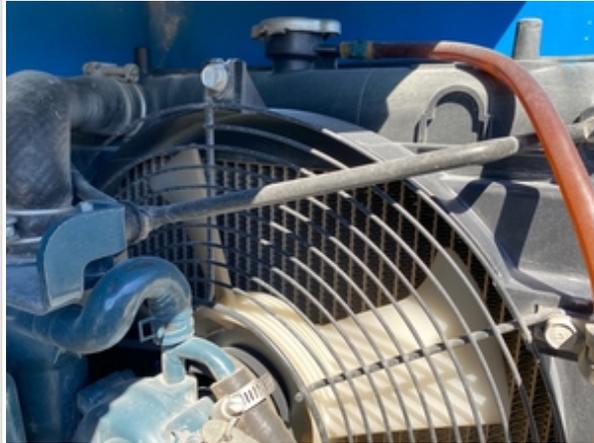
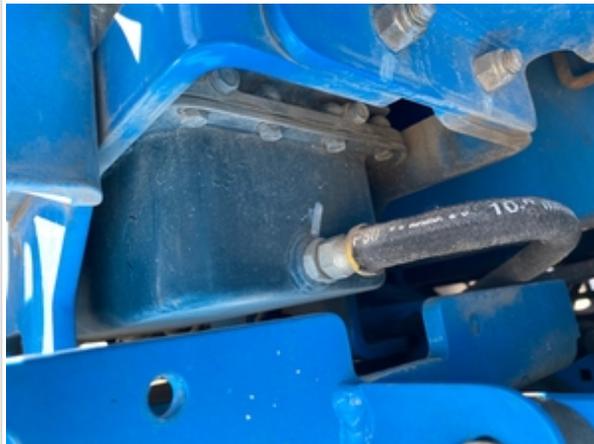
Engine	
Engine Type (Make, Model, Cylinders, Hp)	Kubota - 3Cyl. - 58.7 CU.IN - 32HP
Emissions Tier	Tier 4F
Engine Serial Number	N/A
Engine Fuel Type	Dual-Fuel (Gas, LPG)
Engine Photos

Radiator	3 - Normal Wear & Tear
Radiator Condition	Radiator fins & components appear to be in good working order, no signs of damage or leaks
Belts	3 - Normal Wear & Tear
Belt Condition	Belts appear in good condition & alignment with proper tension
Hoses	3 - Normal Wear & Tear
Hose Condition	Firm, pliant hoses with no signs of wear or leaks
Water Pump	3 - Normal Wear & Tear
Water Pump Condition	No unusual pump noises heard
Cooling System Leaks	No
Coolant Color / Appearance	3 - Normal Wear & Tear
Coolant Color/Appearance Notes	Normal Translucent appearance, no visual signs of contamination
Oil Leaks	Yes
Oil Leak Notes	Wetness & discoloration observed
Oil Color / Appearance	3 - Normal Wear & Tear
Oil Color / Appearance Notes	Clean oil appearance, no signs of cross contamination, Appropriate oil level
Fuel Leaks	No
Requires DEF (Diesel Exhaust Fluid)	No
Overall Engine Appearance	Clean & dry
Overall Engine Comments	Possible Minor oil leak at valve cover. (Highlighted in valve cover photo)

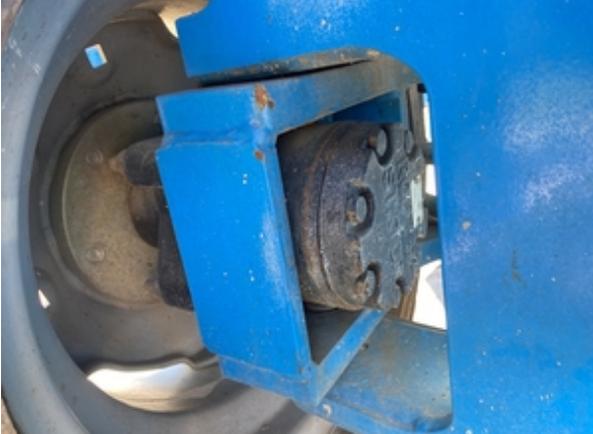
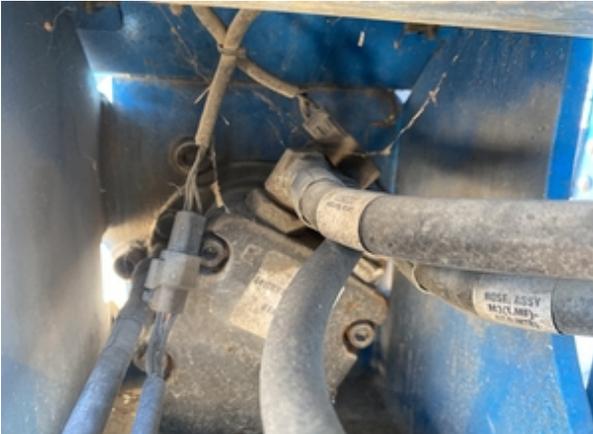
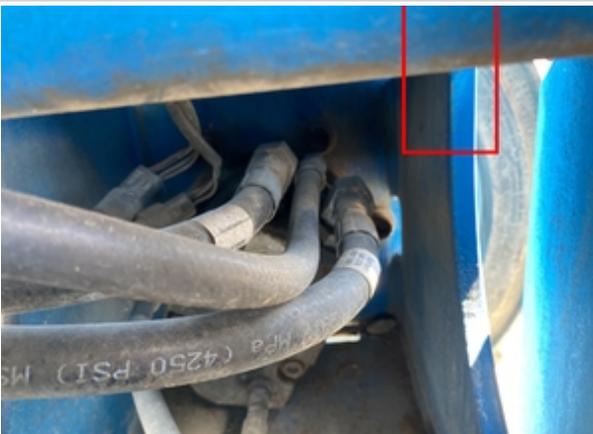
Hydrostatic Transmission?	Yes
2 Speed?	N/A
Hydrostatic Drive Configuration	Split Transmission
Drive Motors	4 - Like New, Recently Replaced
Hydrostatic Parking Brake	3 - Normal Wear & Tear
Hydrostatic Parking Brake Condition	Good brake function
Overall Drivetrain Comments	Drive train functions with no operational issues.

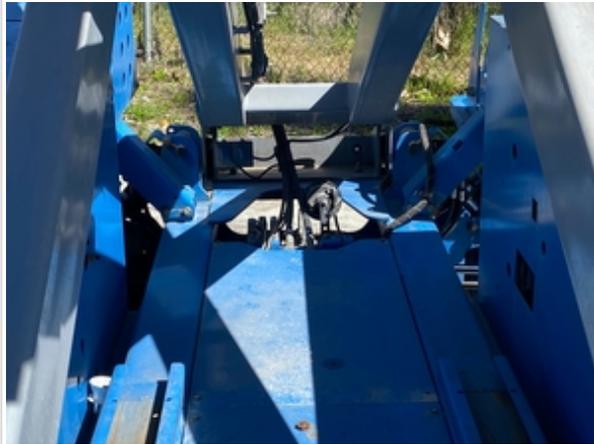
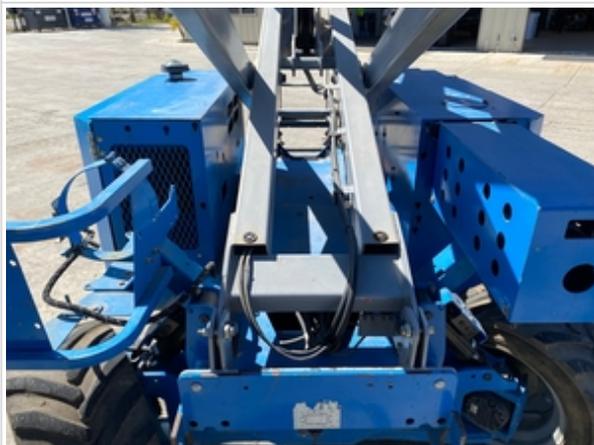
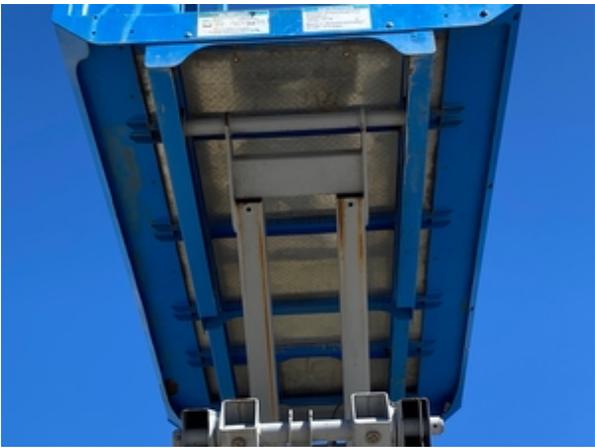
Frame	3 - Normal Wear & Tear
Frame Photos

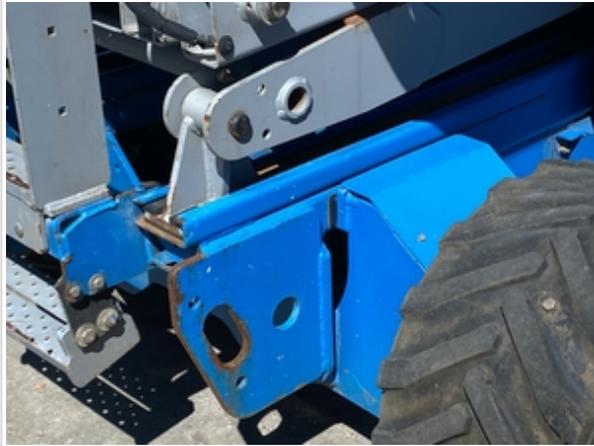
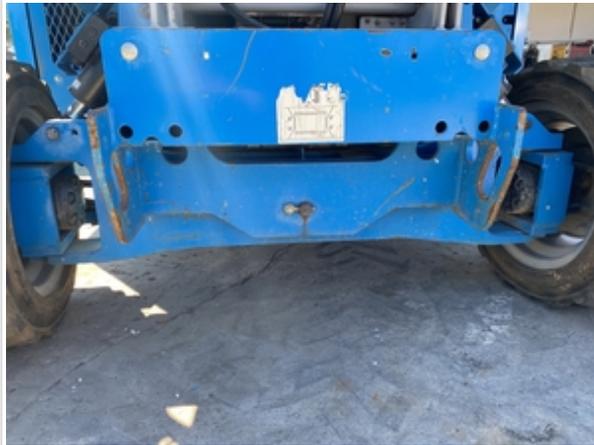
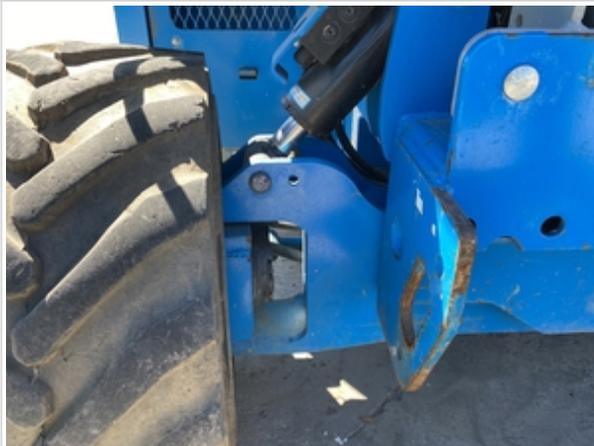
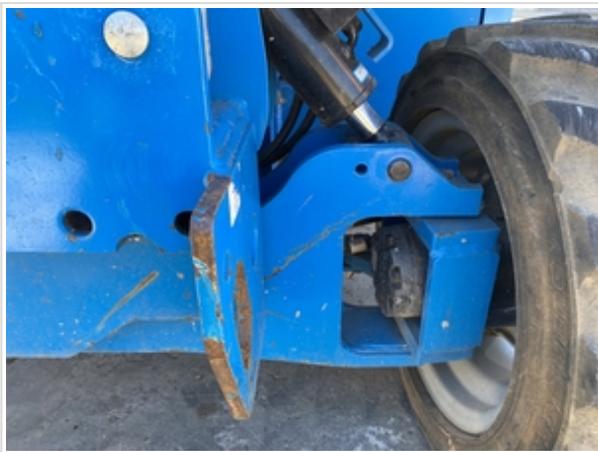
Drive Motors	3 - Normal Wear & Tear	
Front Axle Appearance	3 - Normal Wear & Tear	
Front Axle Appearance Photos

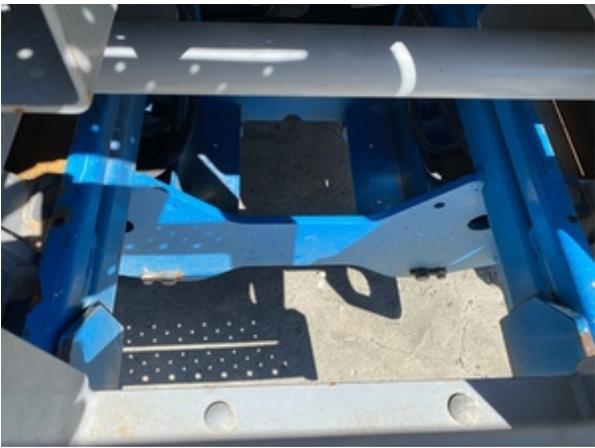
<p>Rear Axle Appearance</p>	<p>3 - Normal Wear & Tear</p>
<p>Rear Axle Appearance Photos</p>

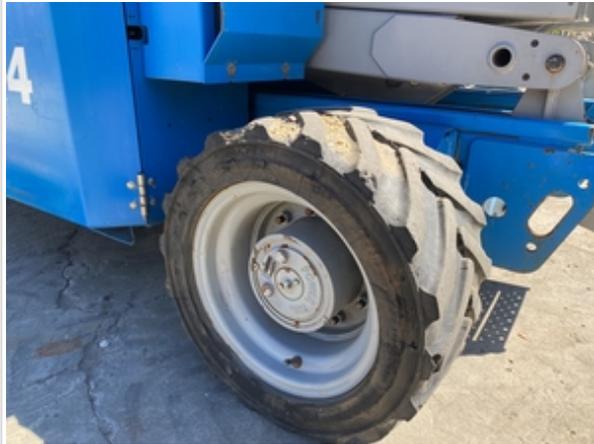
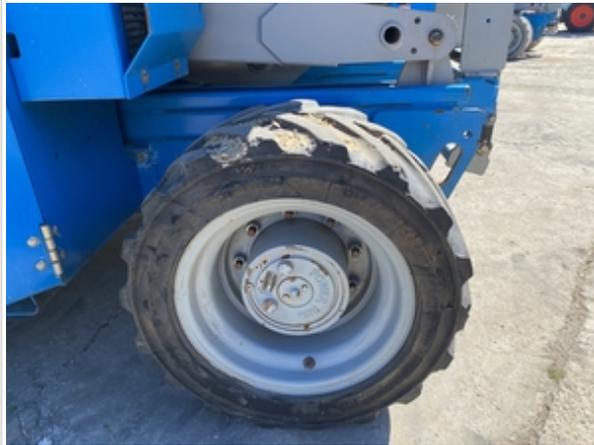
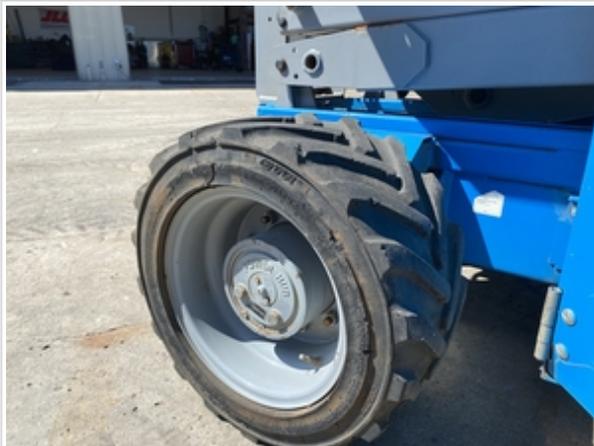
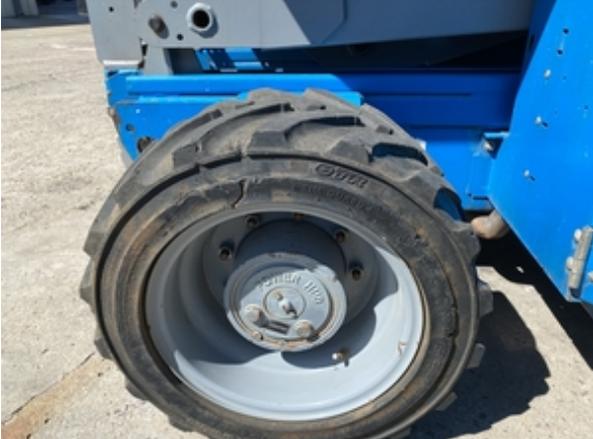
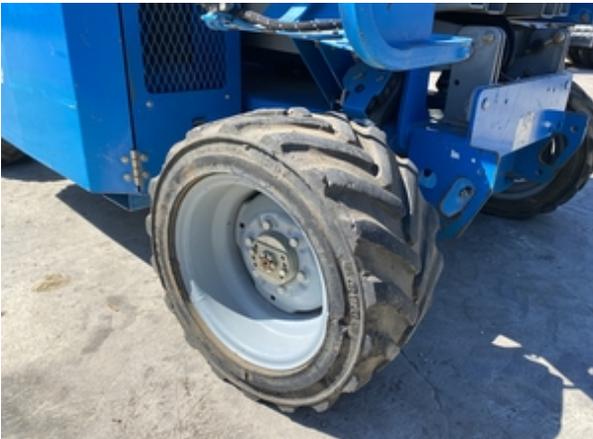
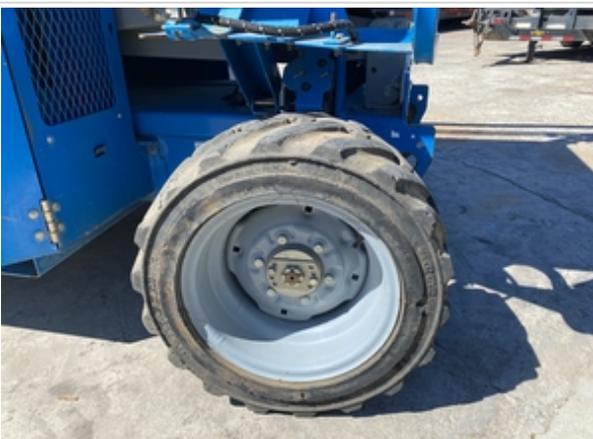
Wheels & Tires	3 - Normal Wear & Tear	
Comments	Tires are foam filled	
Wheels & Tires Photos

Tire Brand	OTR Outrigger
Tire Size	26x12x380
Front Left Tire - Ratio Remaining	30%
Rear Left Tire - Ratio Remaining	30%
Front Right Tire - Ratio Remaining	30%
Rear Right Tire - Ratio Remaining	30%
Overall Chassis	3 - Normal Wear & Tear

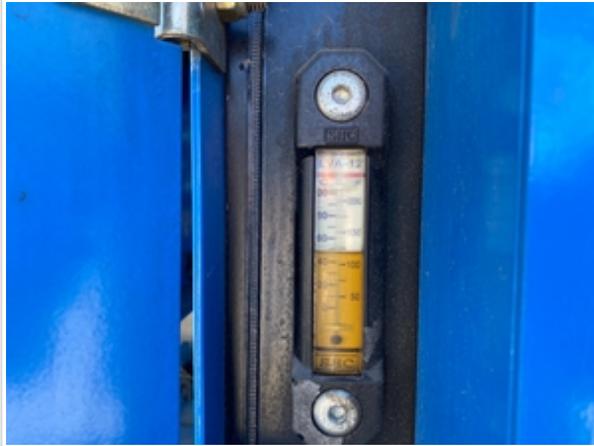
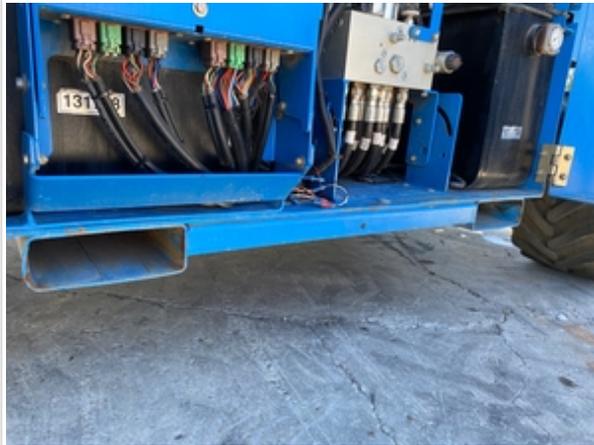
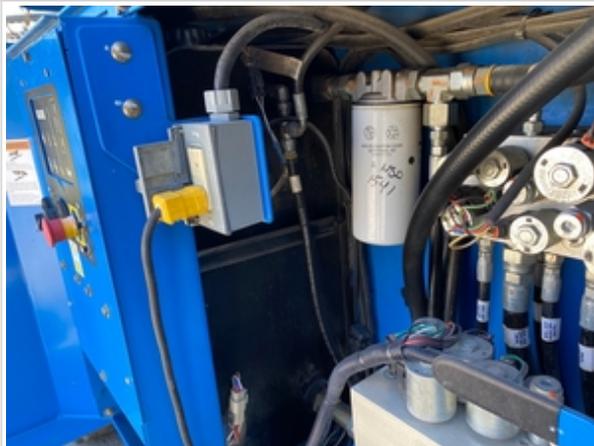
Hydraulic System Photos

Wet or Damp Hydraulic Lines / Fittings	No
Appearance of Hydraulic Lines / Fittings	3 - Normal Wear & Tear
Hydraulic Lines / Fittings Condition	Hydraulic lines & fittings are clean and in good condition
Unusual Noises (Hydraulic Pump)	No
Hydraulic Pump Notes	No unusual noises heard during operation

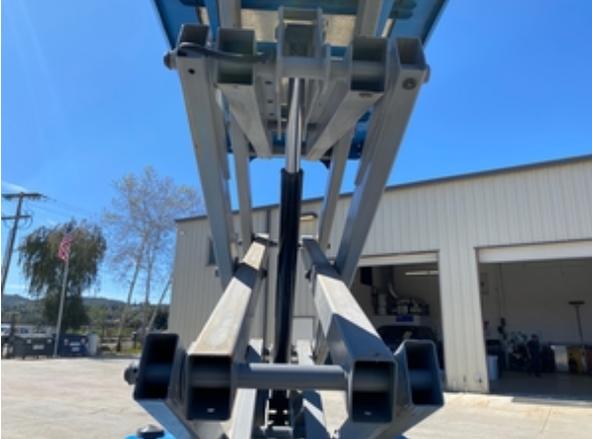
Lift Cylinders	Check the lift cylinders. Note any wear, pitting, discoloration, etc. Take photos.
Lift Cylinders: Mounting Pin	3
Lift Cylinders: Oil Leaks	No
Lift Cylinders Photos
