## Inspection Report (Boom Lift)

Year	2010
Make	Genie
Model	Z-40/23NRJ
Serial Number	Z40N10-924
Hour Meter Reading	1,075 Hrs.
Previous Application (e.g., earth moving, mining, demolition, etc)	Rental Equipment

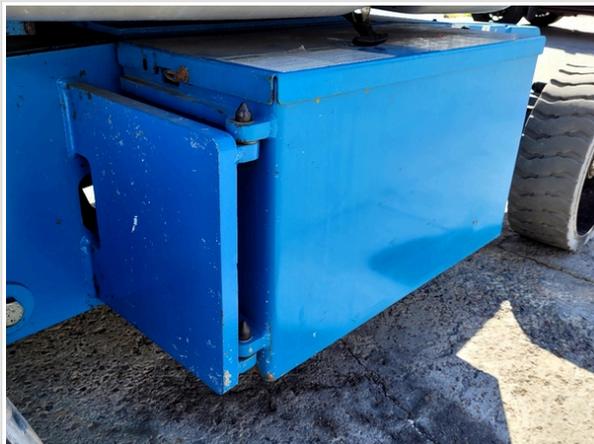
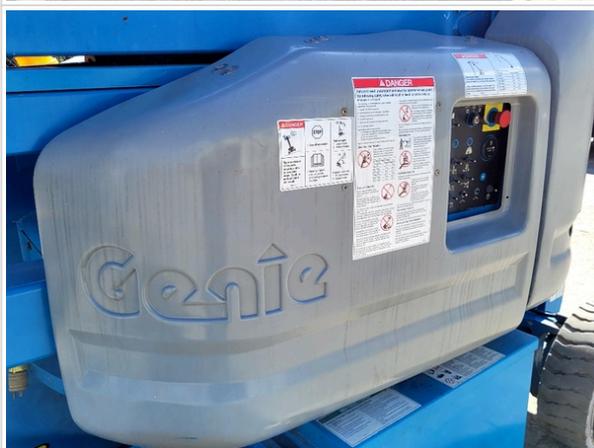
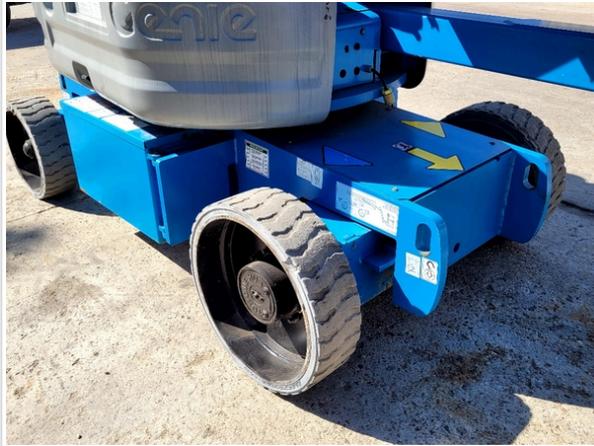
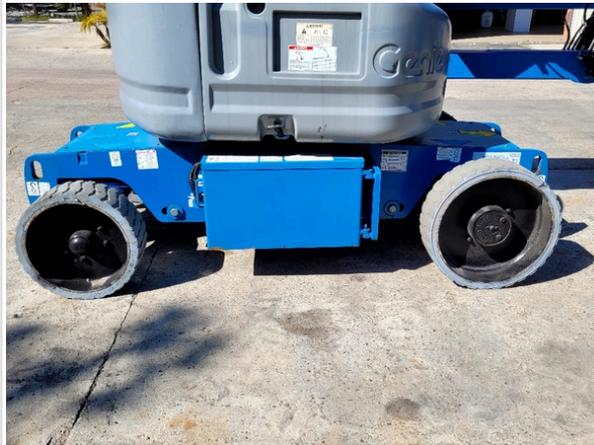
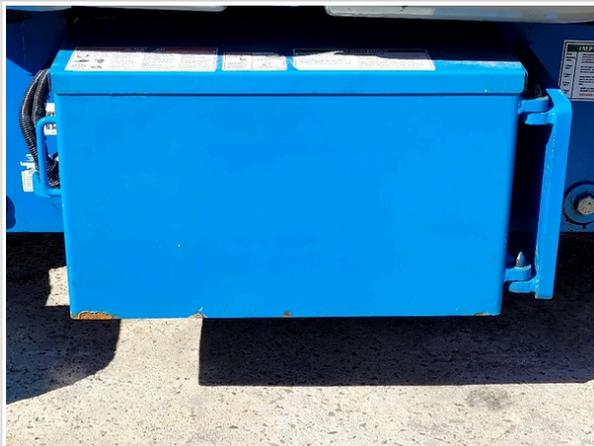
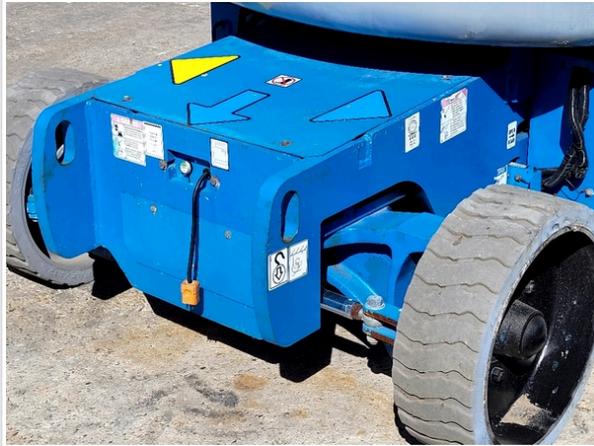
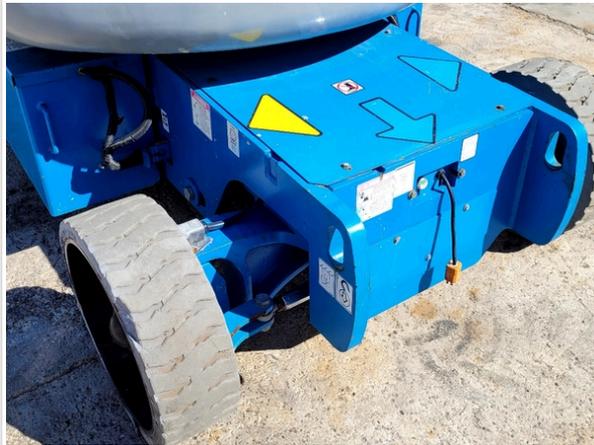
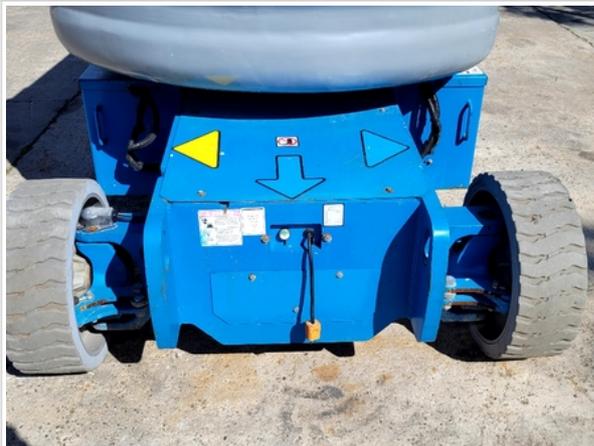
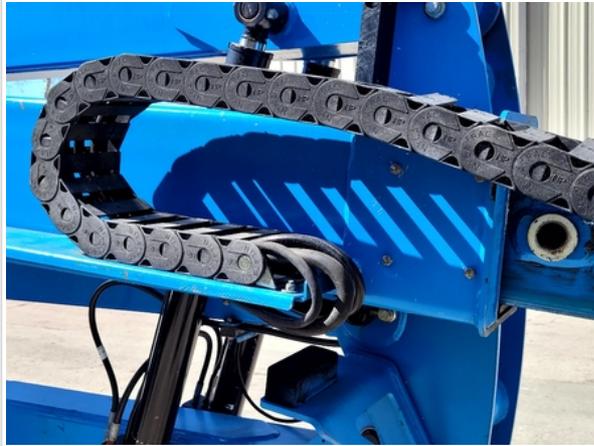
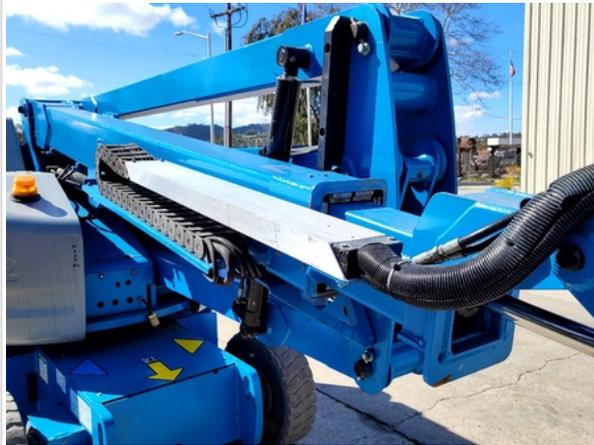
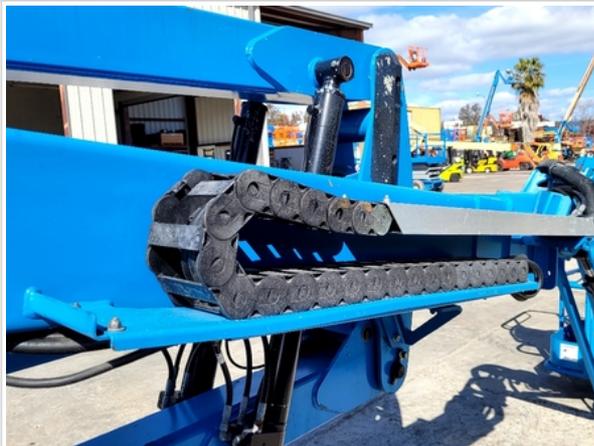
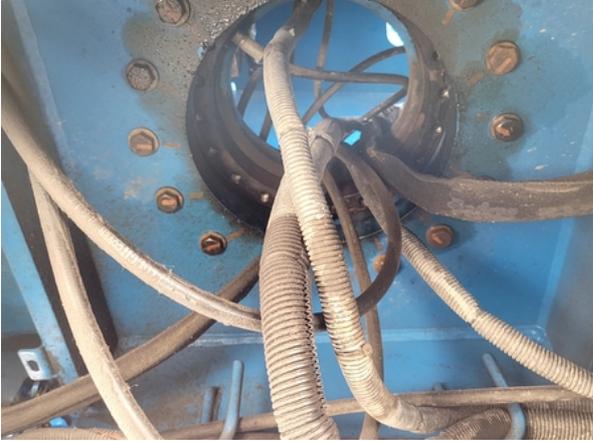
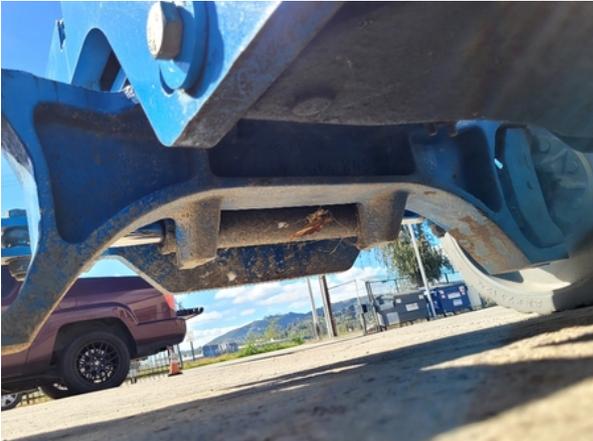
Close-up Exterior Photos

<b>Body Panels</b>	3 - Normal Wear & Tear
<b>Body Panel Condition</b>	No visible damage, good paint condition and panel fitment
<b>Doors / Canopy Latches</b>	3 - Normal Wear & Tear
<b>Doors / Canopy Latches Condition</b>	No visible damage
<b>Steps / Ladders</b>	3 - Normal Wear & Tear
<b>Steps / Ladders Condition</b>	Steps/ladders are fully intact and appear structurally sound
<b>Handrails</b>	3 - Normal Wear & Tear
<b>Handrails Condition</b>	Handrails are fully intact and appear structurally sound
<b>Glass</b>	0
<b>Mirrors</b>	0
<b>Exterior Lights</b>	0

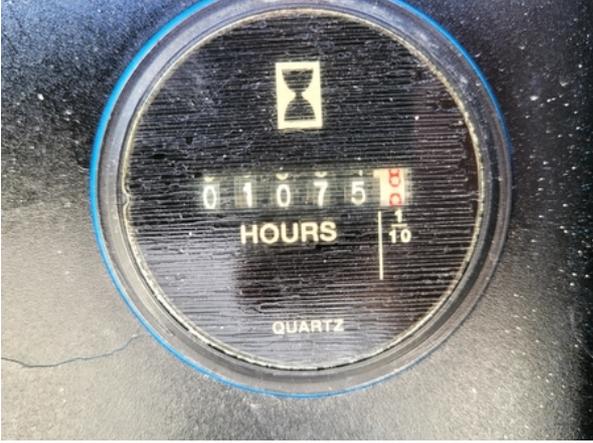
Hour Meter Activity	3 - Normal Wear & Tear
Hour Meter Activity Photos

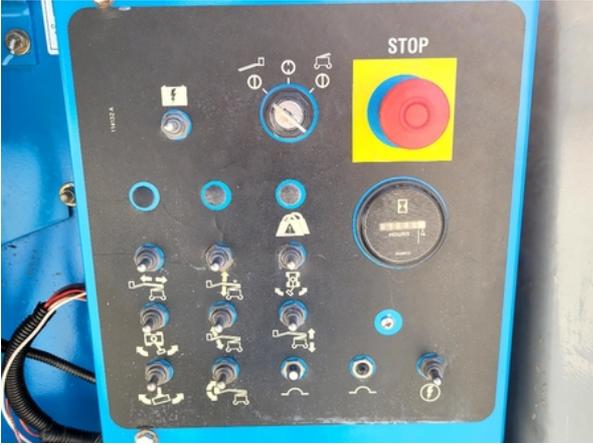
Other Gauge Activity	3 - Normal Wear & Tear
Controls & Switches	3 - Normal Wear & Tear
Controls & Switches Photos

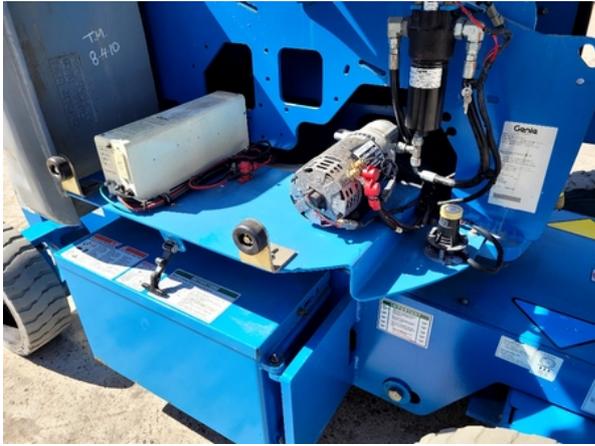
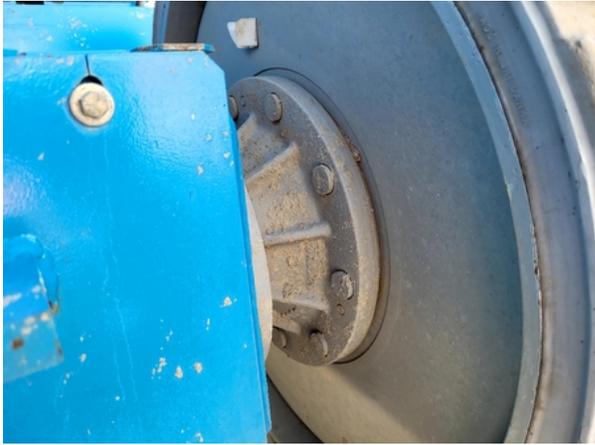
Drivetrain	Take close-up photos of the drivetrain components including transmission housing, drive shaft, drive motors, fittings, and hoses. Note any damage or wear.
Drivetrain Photos

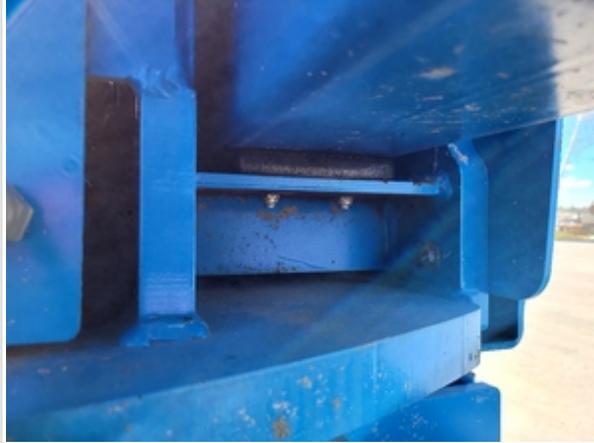
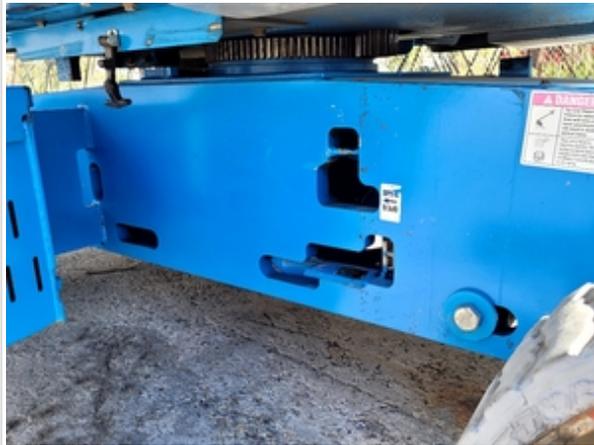
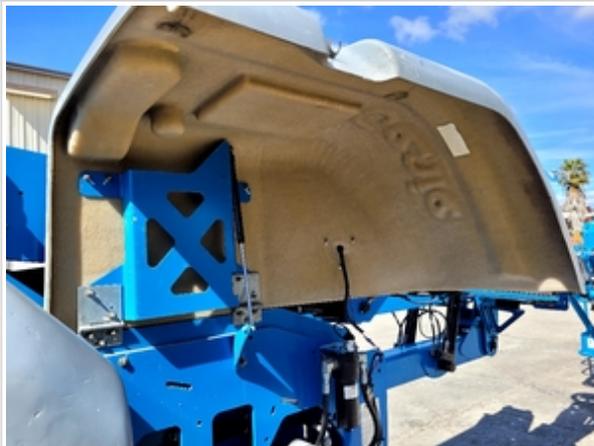
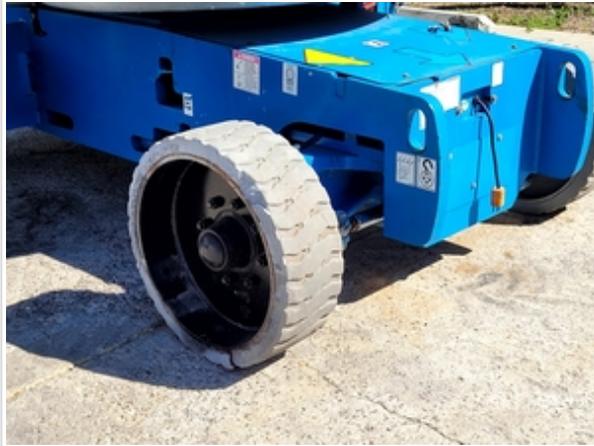
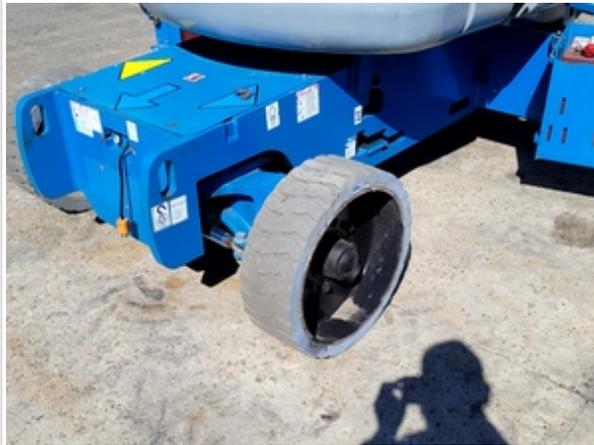
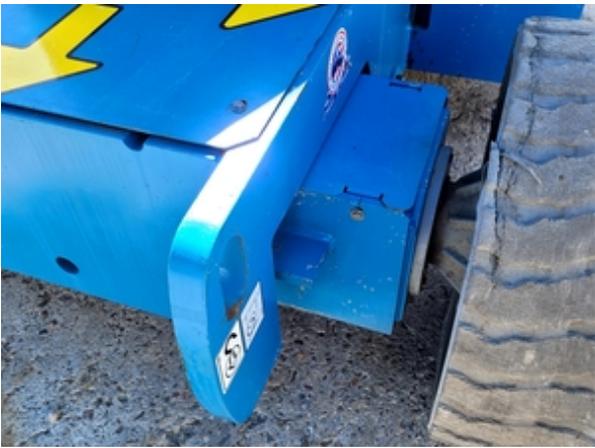
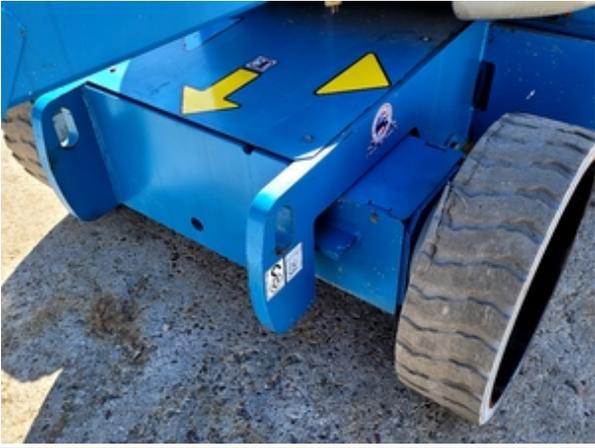
Frame Photos

Frame	3 - Normal Wear & Tear
-------	------------------------

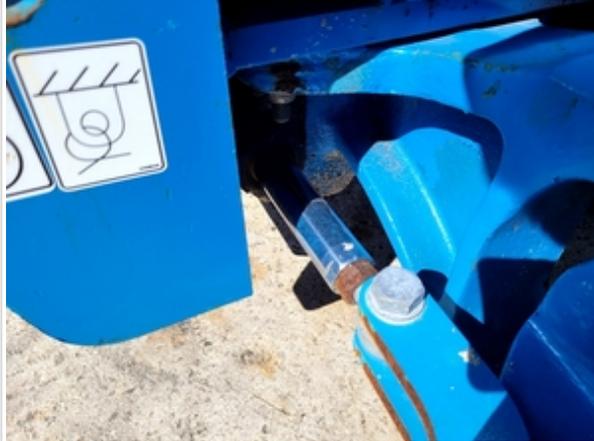
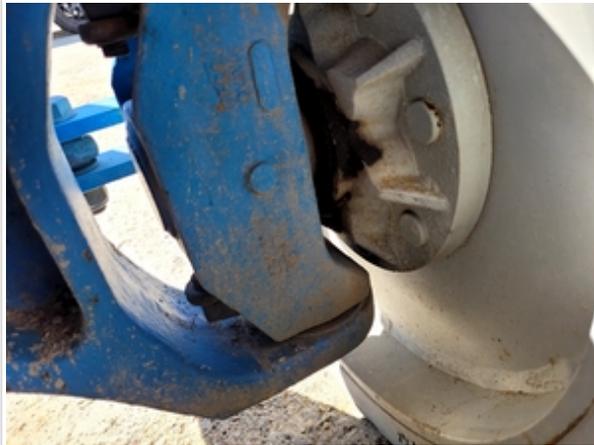
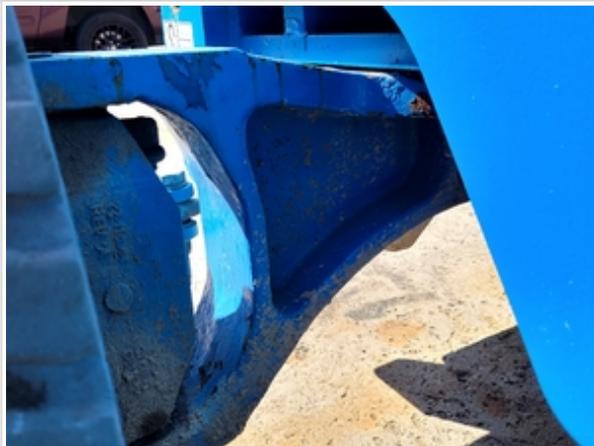
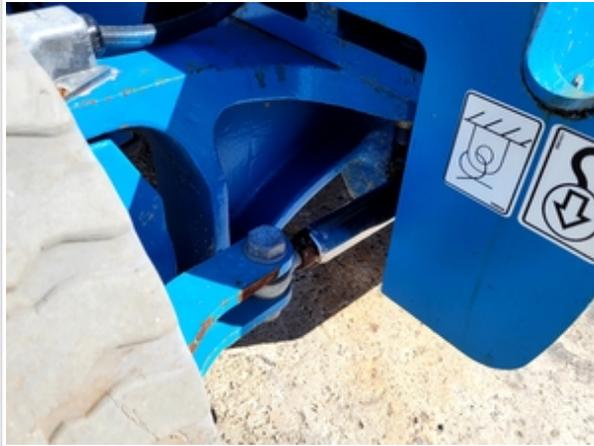
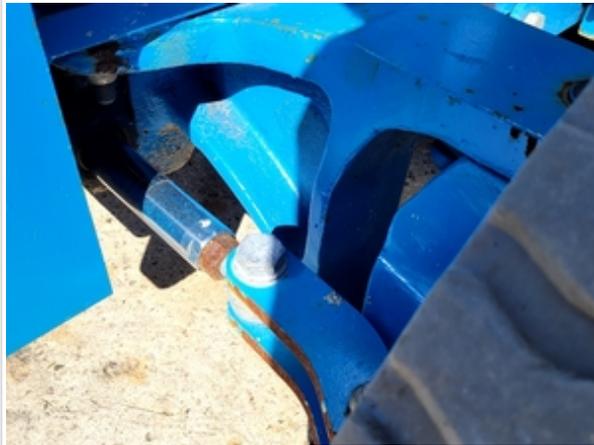
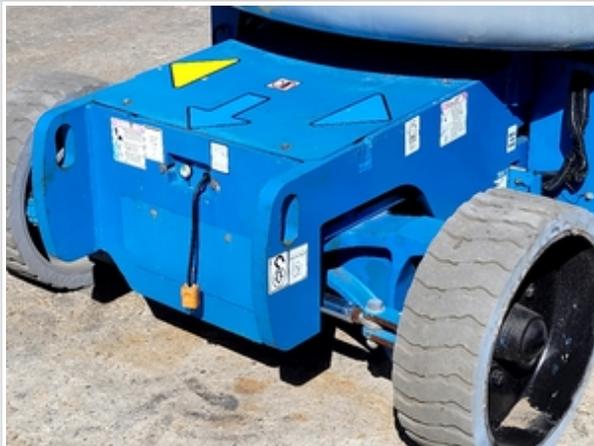
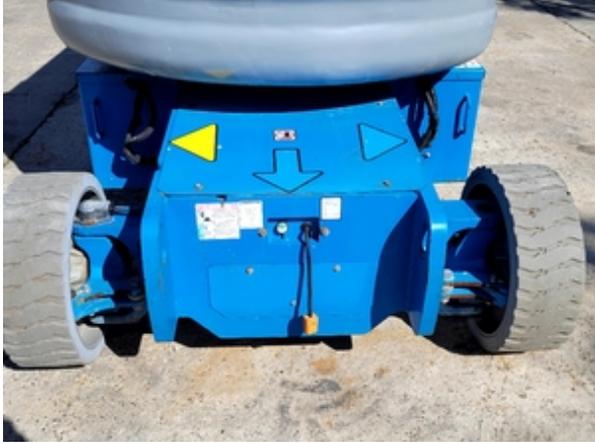
Front Axle Appearance Photos

<b>Front Axle Appearance</b>	3 - Normal Wear & Tear

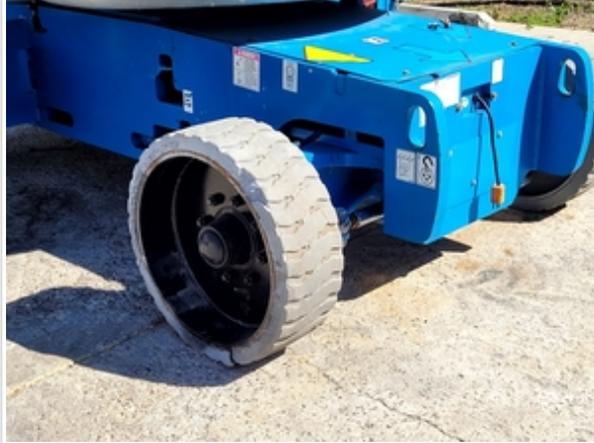
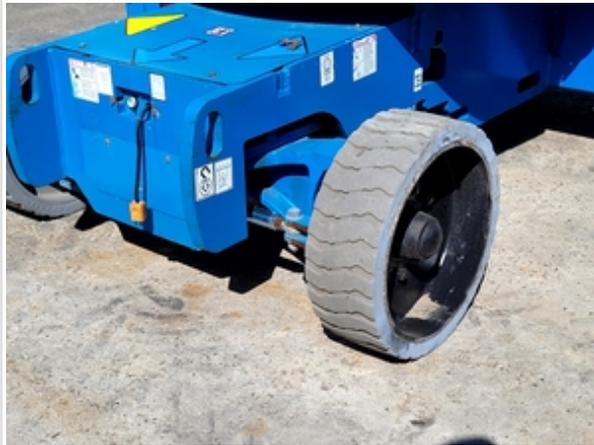
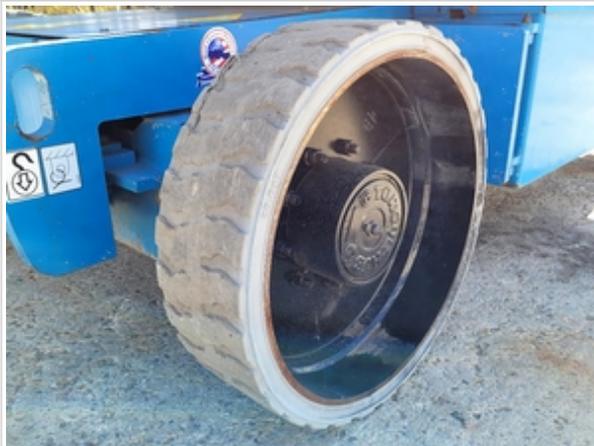
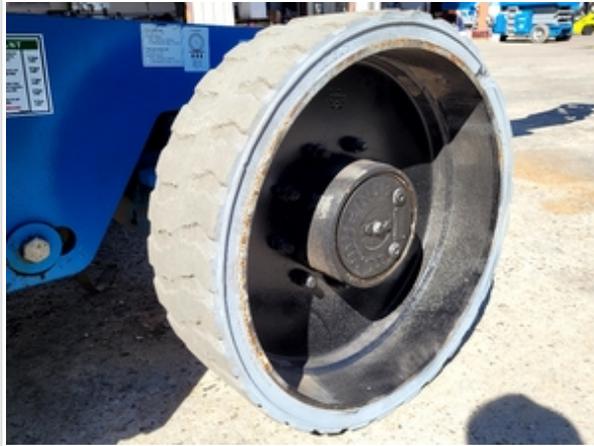
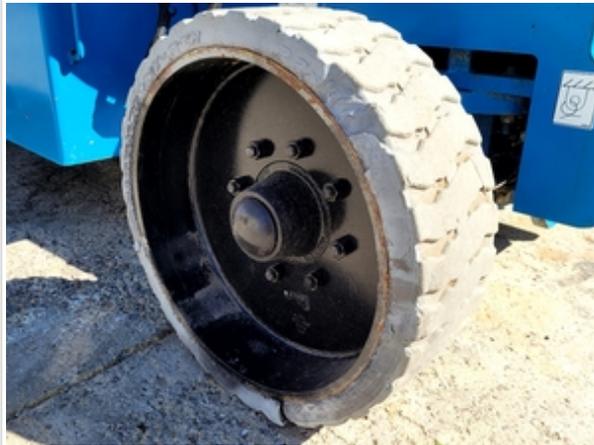
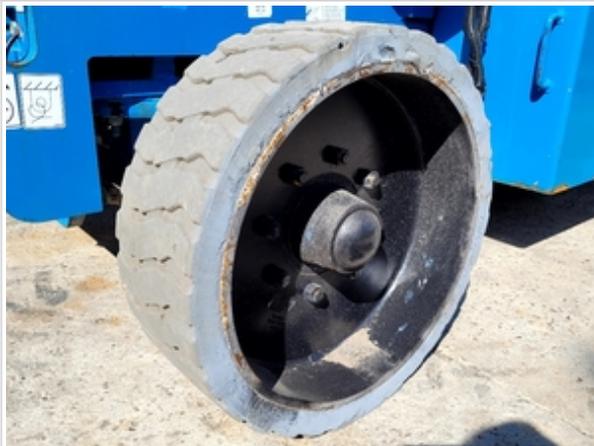
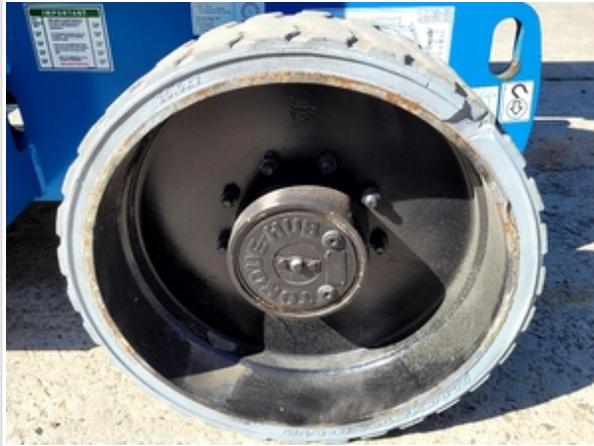
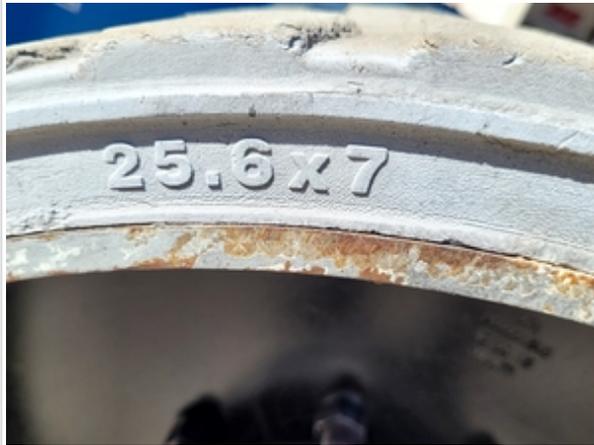
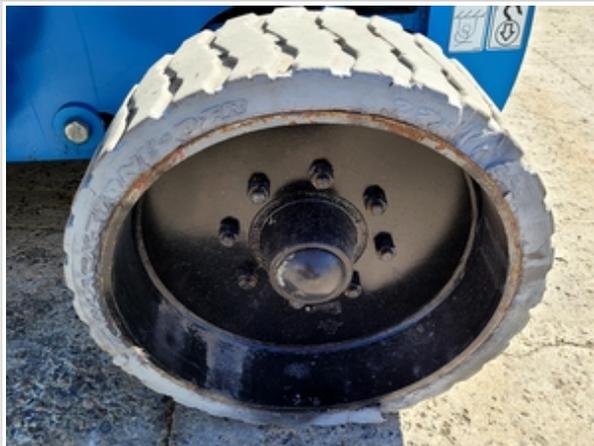
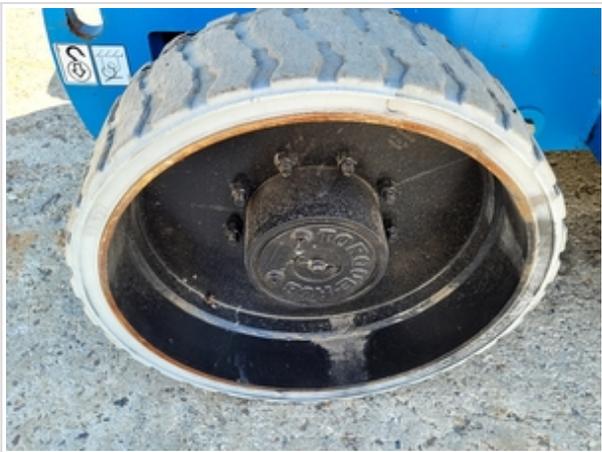
Wheels & Tires Photos

<b>Wheels &amp; Tires</b>	3 - Normal Wear & Tear

Tire Brand	OTR - Outrigger	
Tire Size	25.6x7	
Front Left Tire - Ratio Remaining	10%	
Rear Left Tire - Ratio Remaining	10%	
Front Right Tire - Ratio Remaining	10%	
Rear Right Tire - Ratio Remaining	10%	
Swivel Bearing	3 - Normal Wear & Tear	
Swivel Bearing Photos

Overall Assessment	
Exterior Rating	3 - Normal Wear & Tear
Interior Rating	3 - Normal Wear & Tear
Safety Rating	3 - Normal Wear & Tear
Quality Rating	3 - Normal Wear & Tear
Functionality Rating	3 - Normal, Operating as Expected
Overall Rating	3 - Normal Wear & Tear
What's Great About the Machine	Machine has been well maintained and most functions work great. No active leaks observed and batteries have healthy appearance.
What Needs Work	Main boom lift function faulty and customer already working to get it repaired. Tires will need to be replaced soon.
Date/Time	03-08-2023

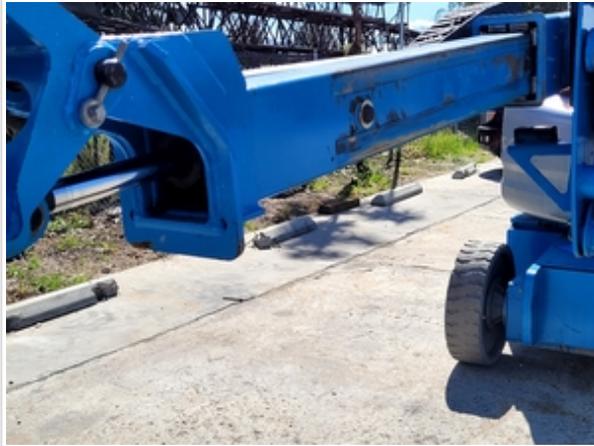
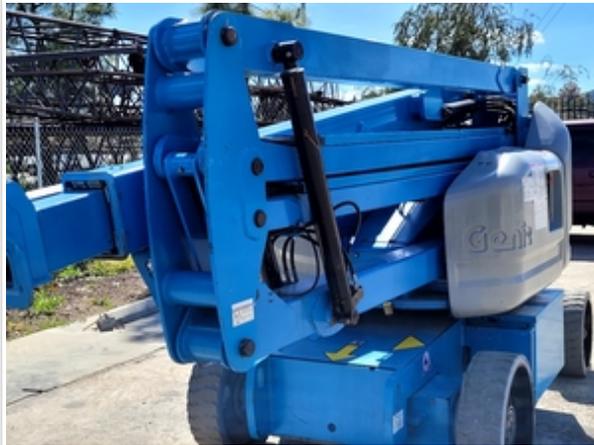
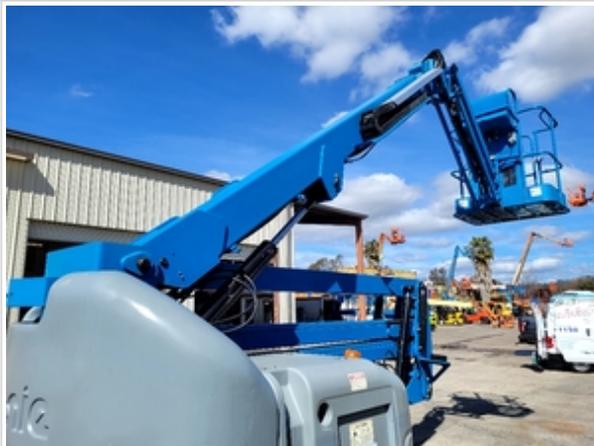
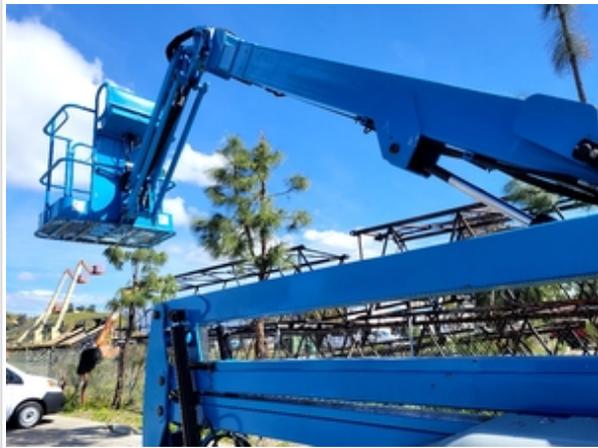
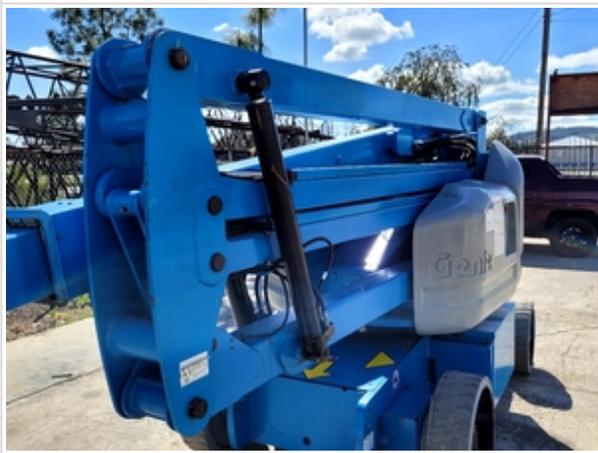
<b>Swivel Joint</b>	3 - Normal Wear & Tear	
<b>Boom Condition</b>	3 - Normal Wear & Tear	
<b>Boom Condition Photos</b>

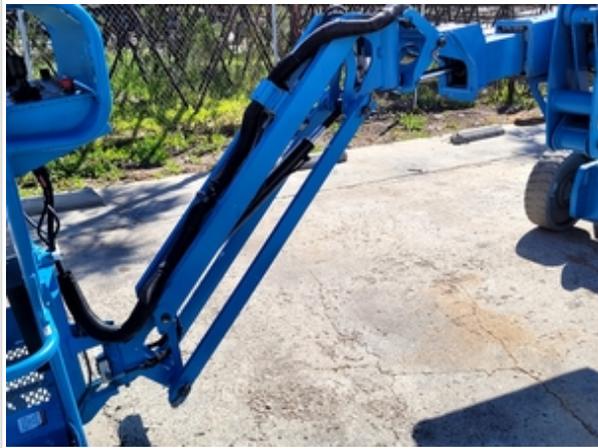
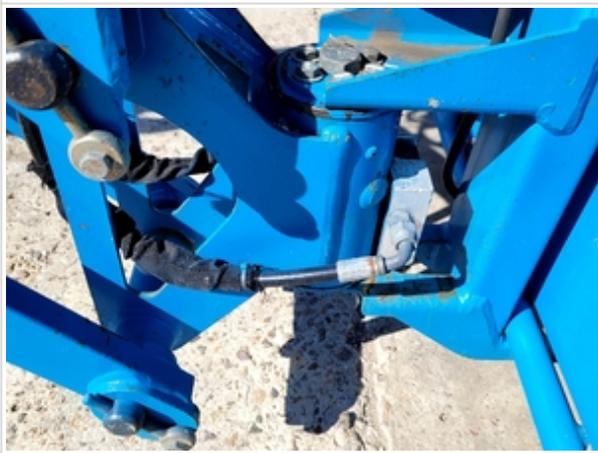
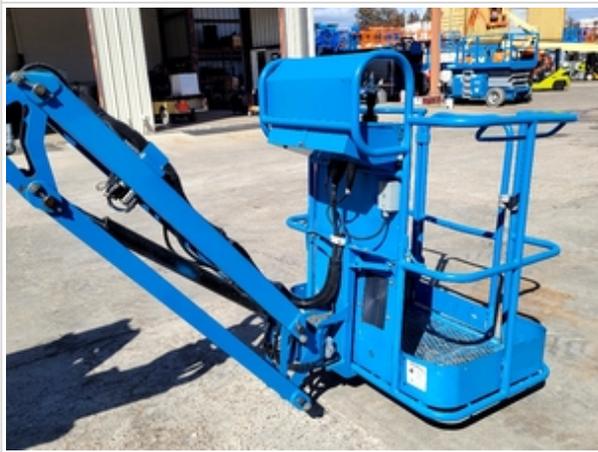
<p>Jib Condition</p>	<p>3 - Normal Wear &amp; Tear</p>	
<p>Jib Condition Photos</p>

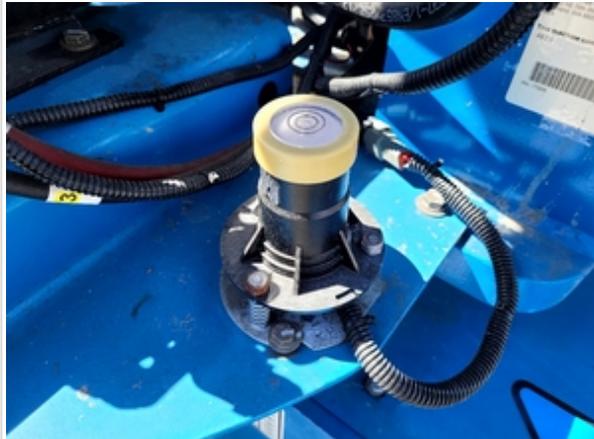
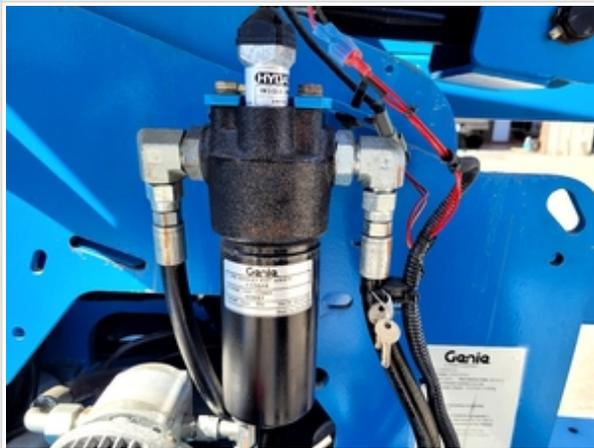
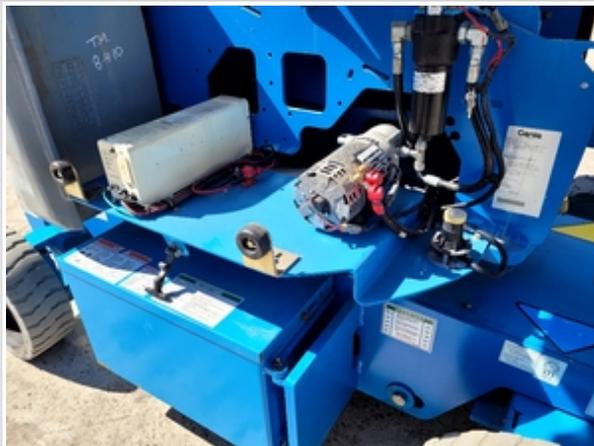
Hydraulic System Photos

Wet or Damp Hydraulic Lines / Fittings	No
Appearance of Hydraulic Lines / Fittings	3 - Normal Wear & Tear
Hydraulic Lines / Fittings Condition	Hydraulic lines & fittings are clean and in good condition
Unusual Noises (Hydraulic Pump)	No
Hydraulic Pump Notes	No unusual noises heard during operation

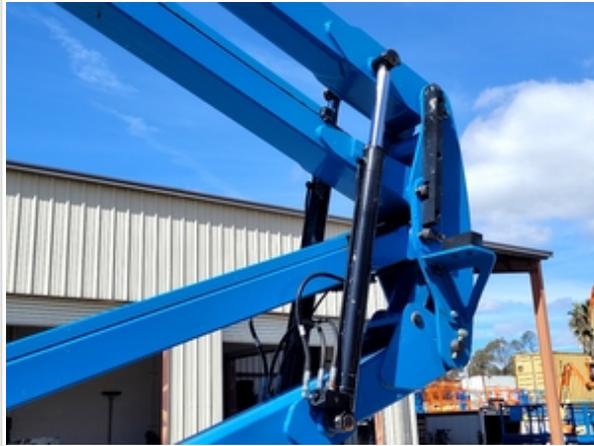
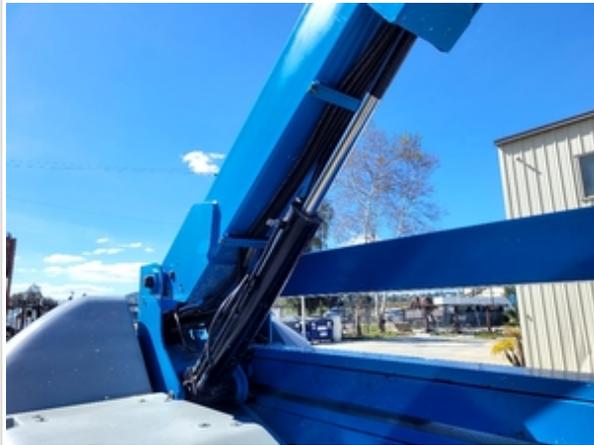
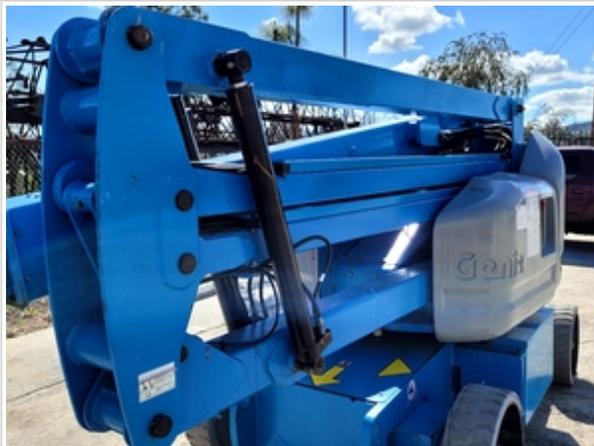
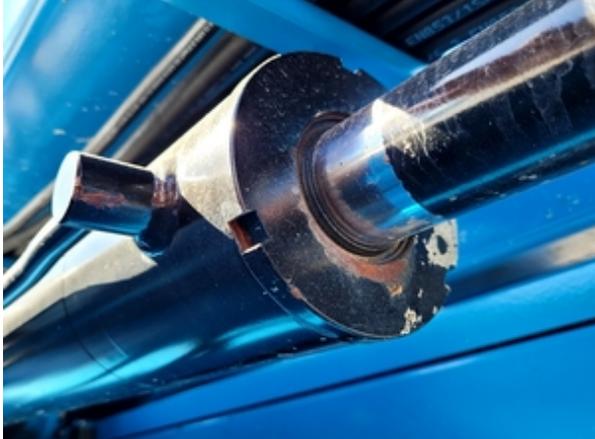
Boom Lift Cylinders	Check the boom lift cylinders. Note any wear, pitting, discoloration, etc. Take photos.
Boom Lift Cylinders: Mounting Pin	3
Boom Lift Cylinders: Oil Leaks	No
Boom Lift Cylinders Photos
