## Inspection Report (Boom Lift)

Year	2012
Make	Genie
Model	S60x
Serial Number	S60X12-23903
Hour Meter Reading	3881.5
Previous Application (e.g., earth moving, mining, demolition, etc)	General Construction Rental

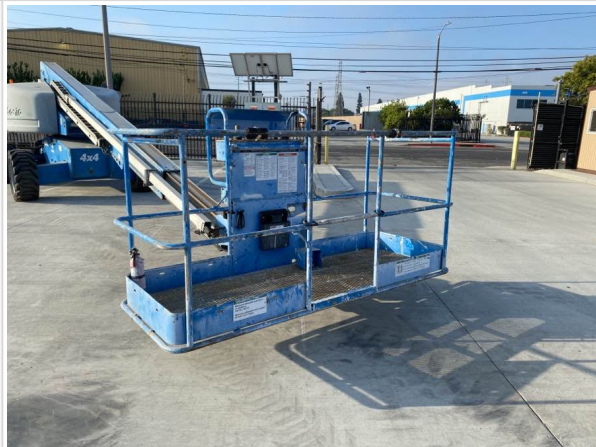
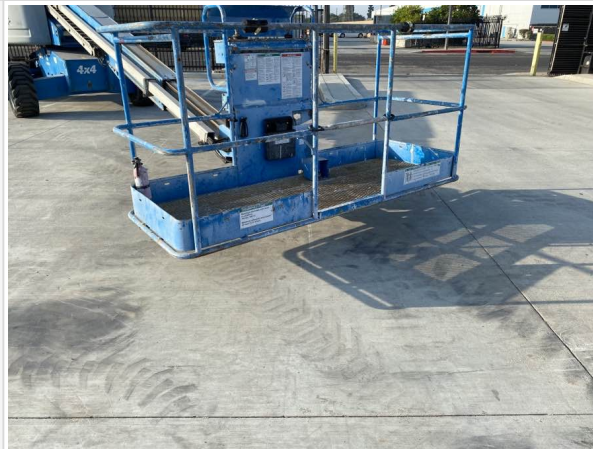
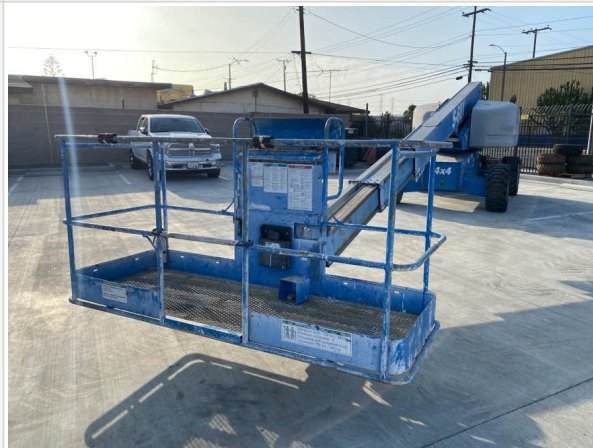
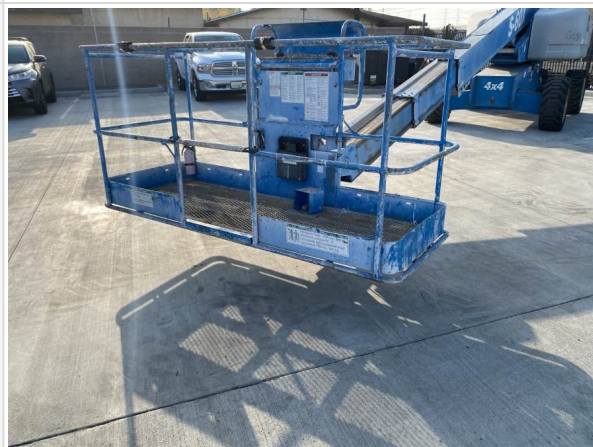
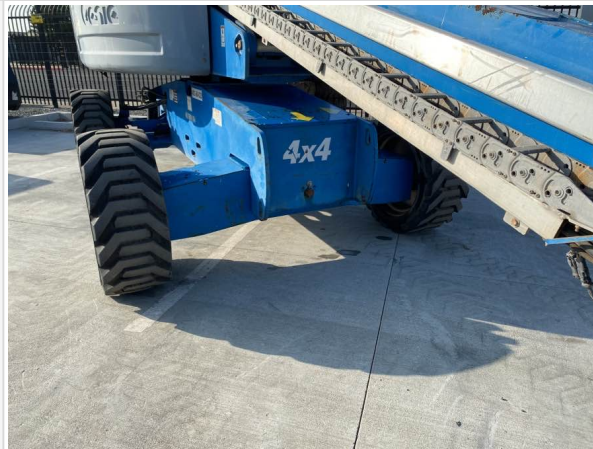
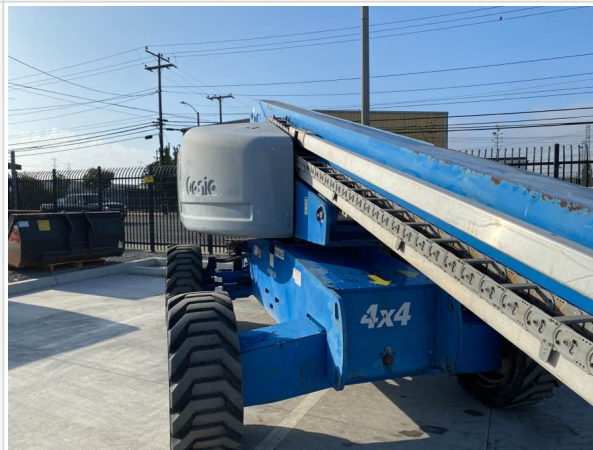
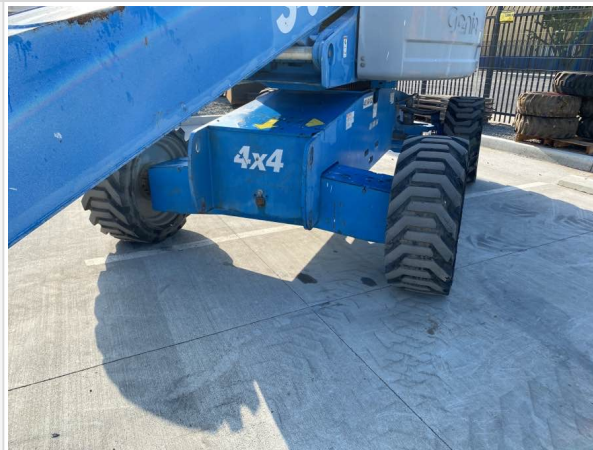
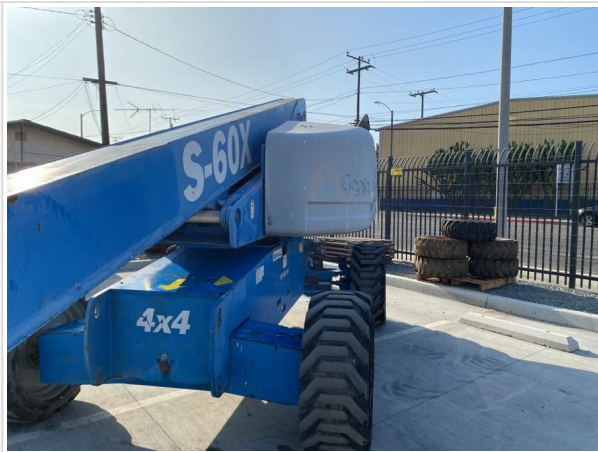
<b>Instructions</b>	<p>Evaluate the following on a 4 point scale (leave comments where an explanation is appropriate):</p> <p>4 = Like New, Recently Replaced        3 = Normal Wear &amp; Tear        2 = Above Average Wear        1 = Service Required</p> <p>Things to look for:</p> <ul style="list-style-type: none"> <li>- cosmetic damage</li> <li>- minor surface rust</li> <li>- repaint (and overspray)</li> <li>- cracked or damaged glass</li> <li>- major rust (cancer)</li> <li>- cracks / visible welds</li> </ul>
<b>Front</b>	3 - Normal Wear & Tear
<b>Front Photos</b>

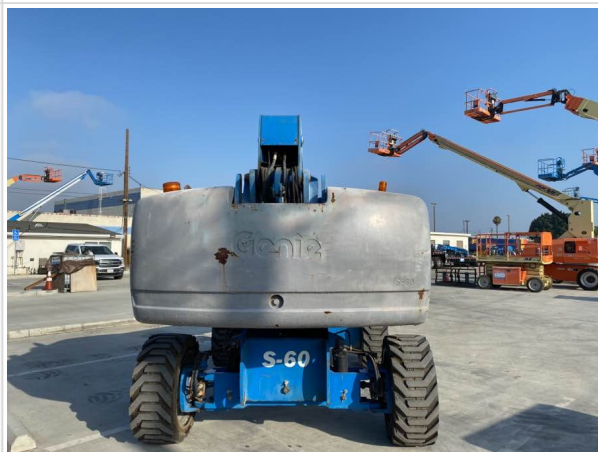
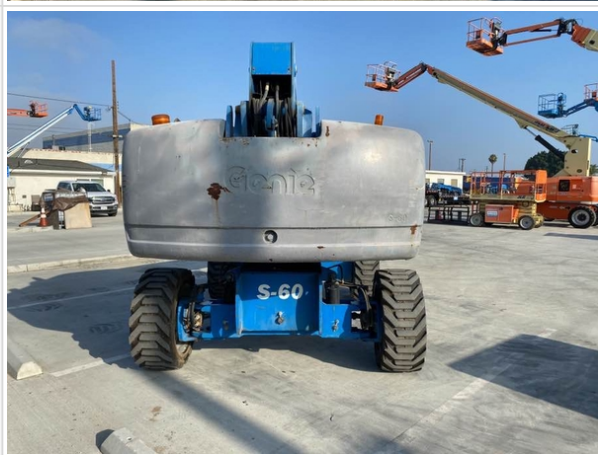
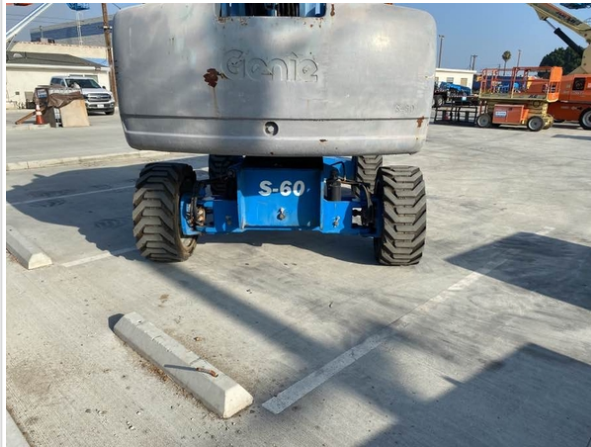
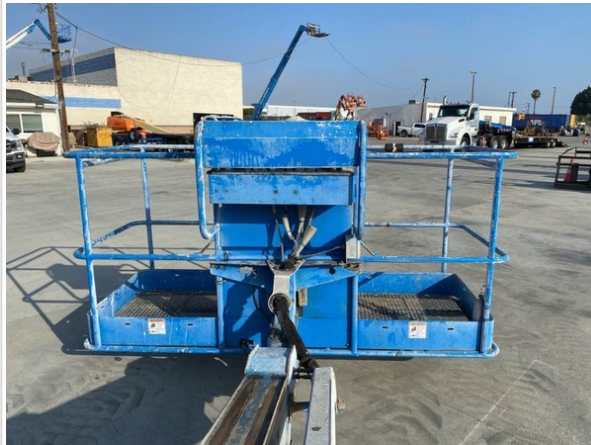
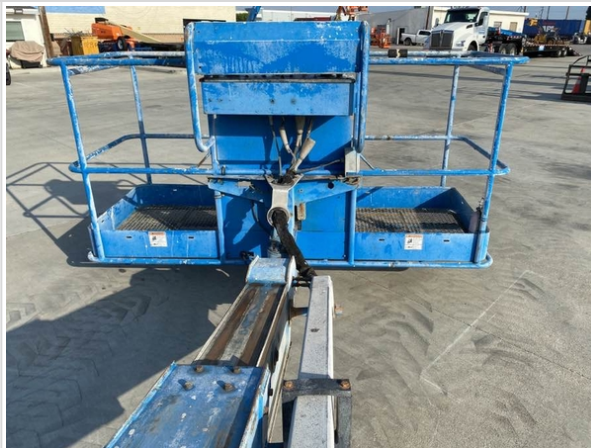
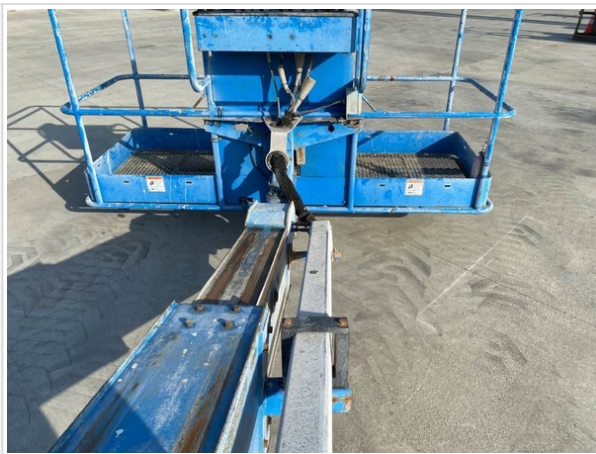
<p>Rear</p>	<p>3 - Normal Wear &amp; Tear</p>	
<p>Rear Photos</p>

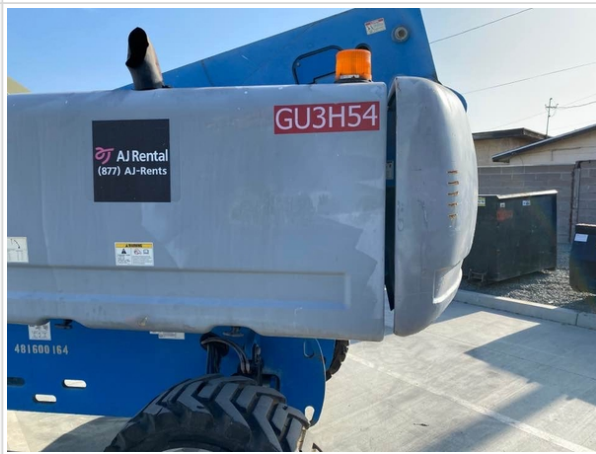
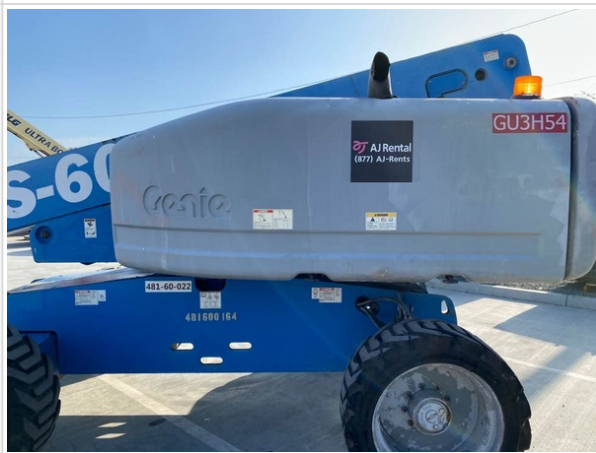
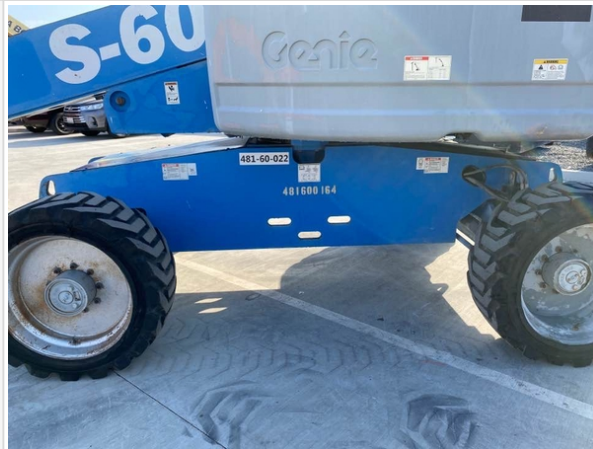
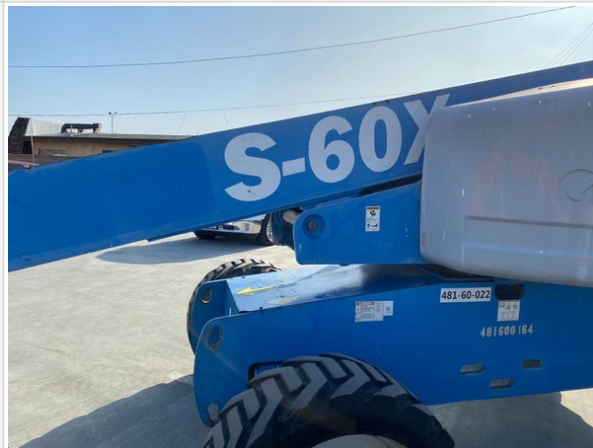
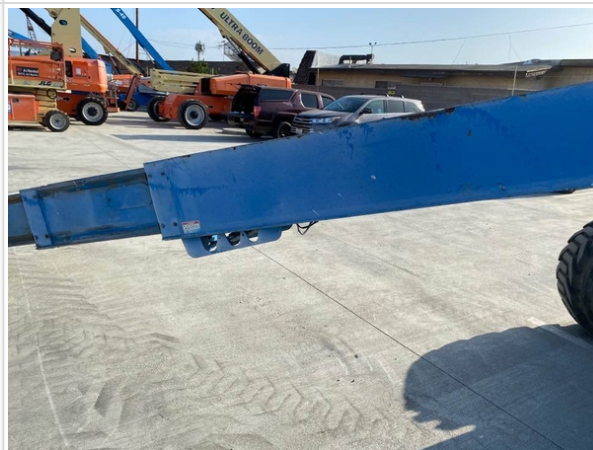
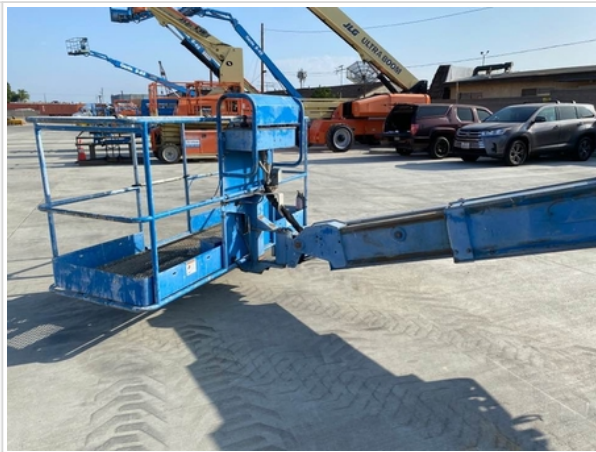
<p>Left</p>	<p>3 - Normal Wear &amp; Tear</p>
<p>Left Photos</p>

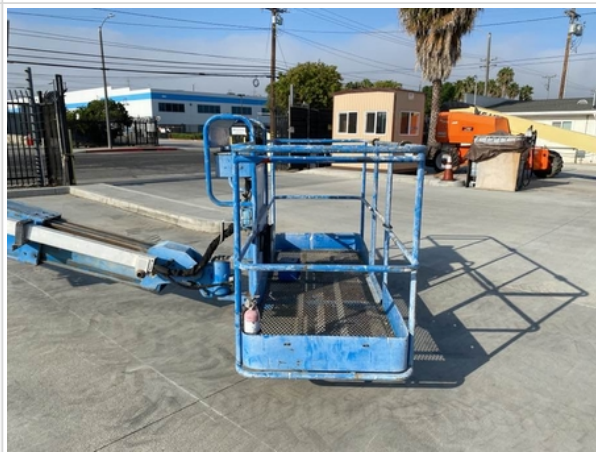
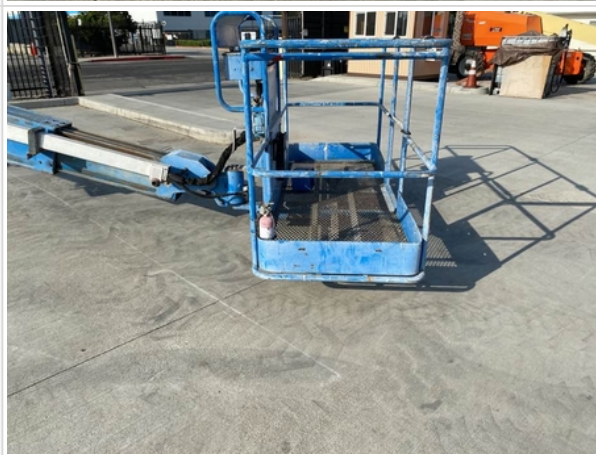
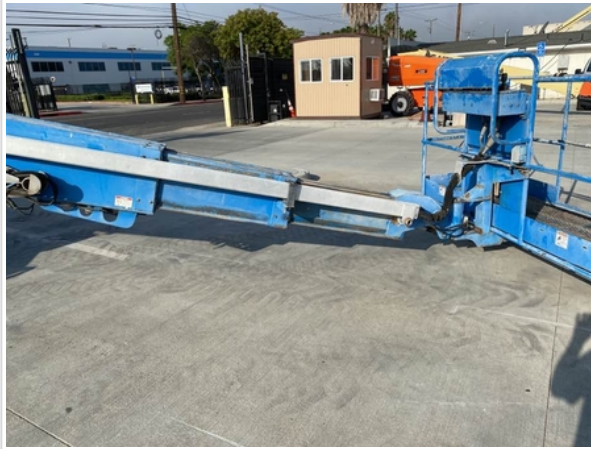
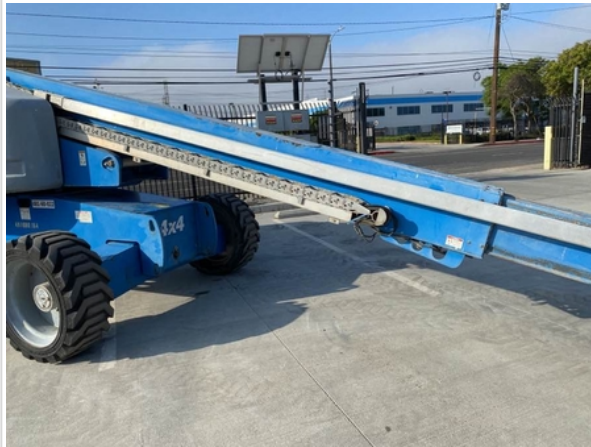
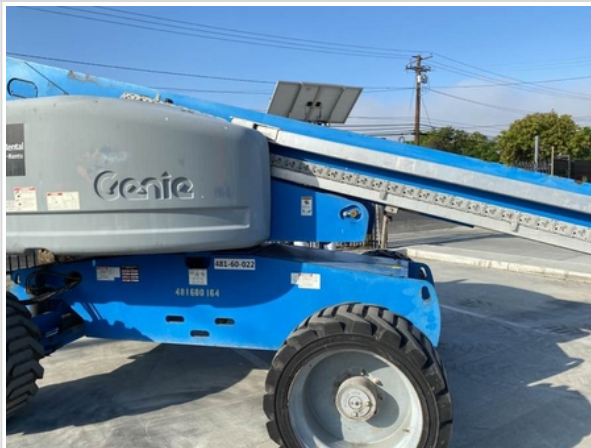
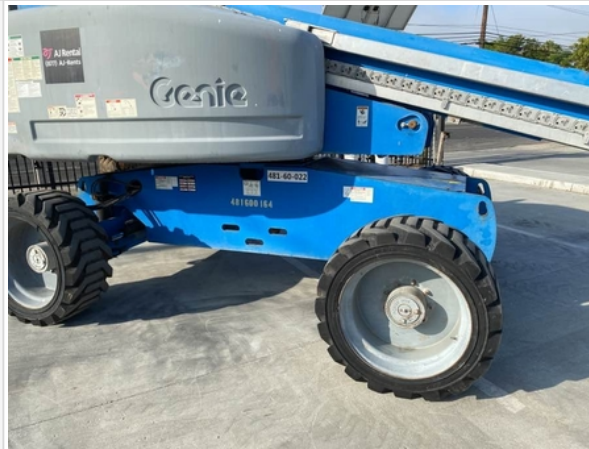
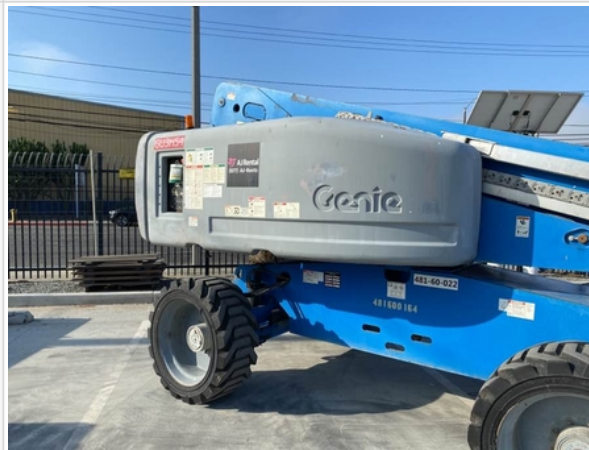
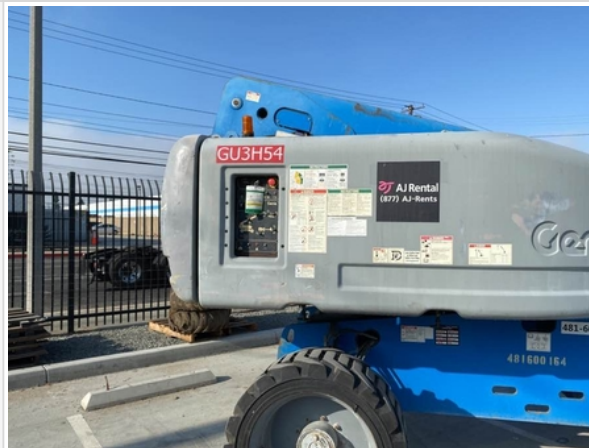
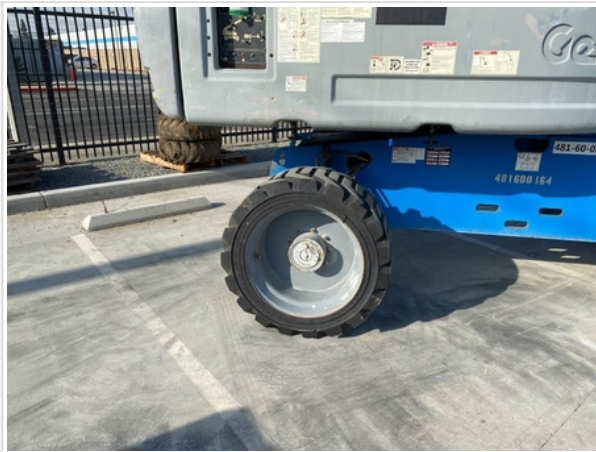
<p>Right</p>	<p>3 - Normal Wear &amp; Tear</p>	
<p>Right Photos</p>

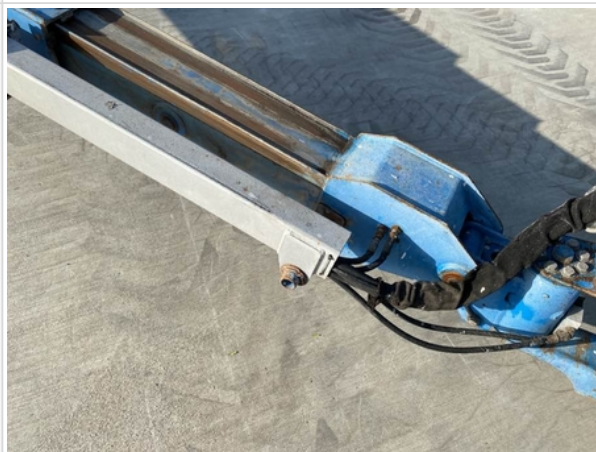
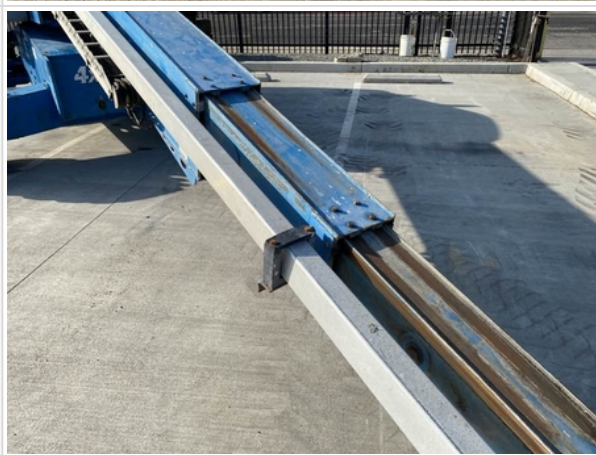
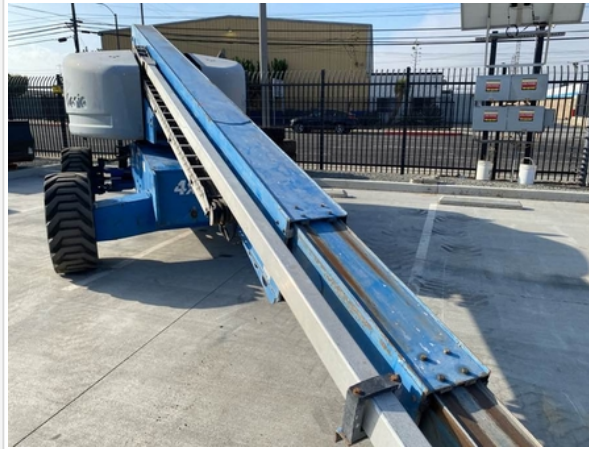
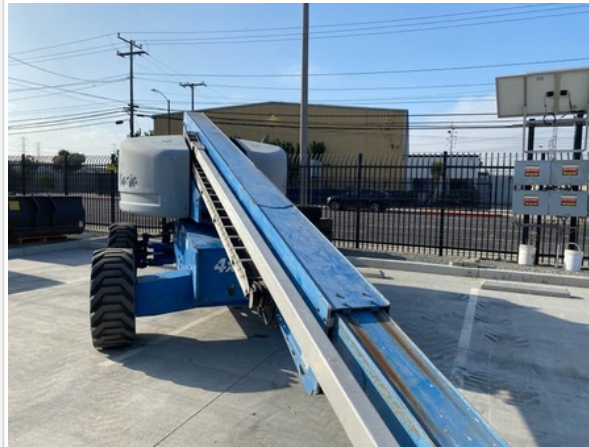
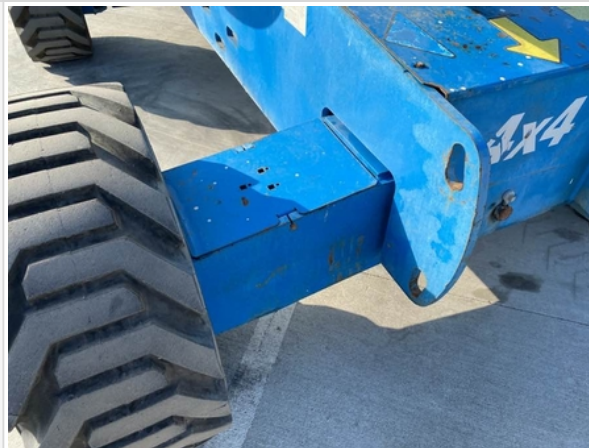
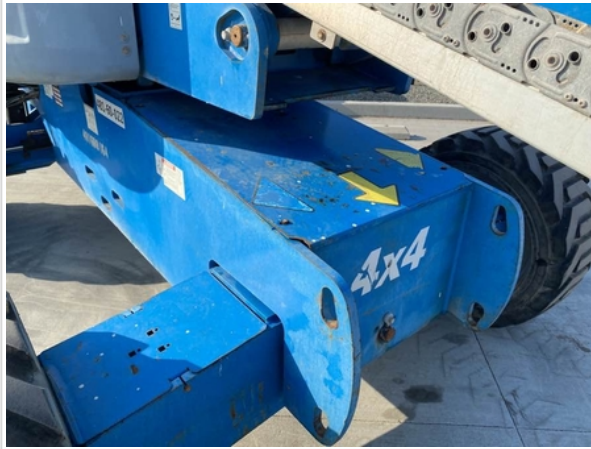
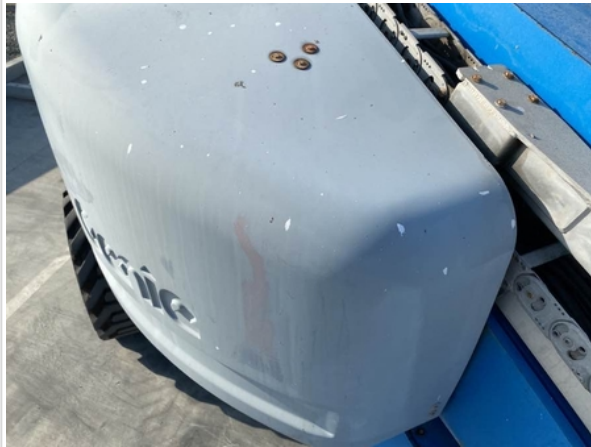
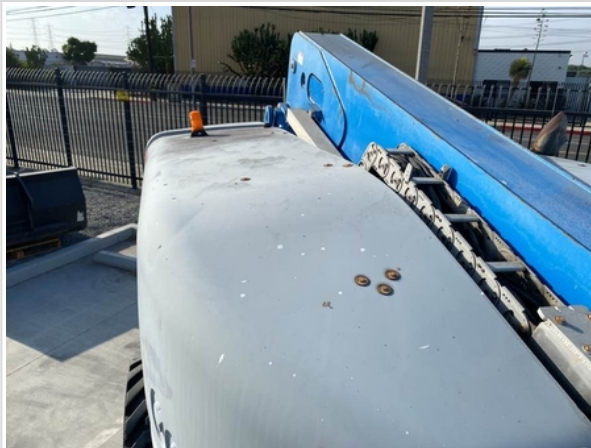
<p>Upper</p>	<p>3 - Normal Wear &amp; Tear</p>	
<p>Upper Photos</p>

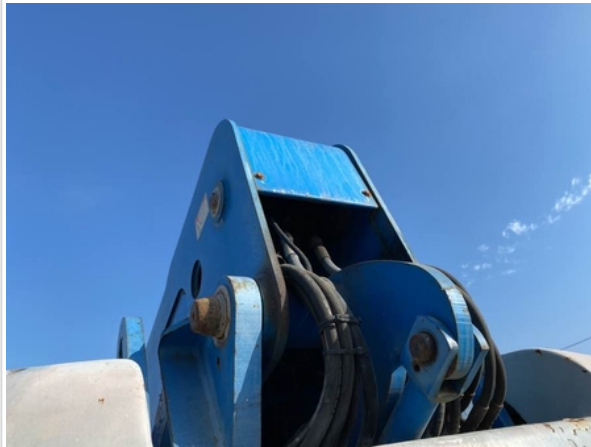
<p>Body Panels Photos</p>

<b>Body Panels (Any Damage?)</b>	3 - Normal Wear & Tear
<b>Comments</b>	Minor fiberglass damage on l/s & r/s, Minor paint chips off of counterweight

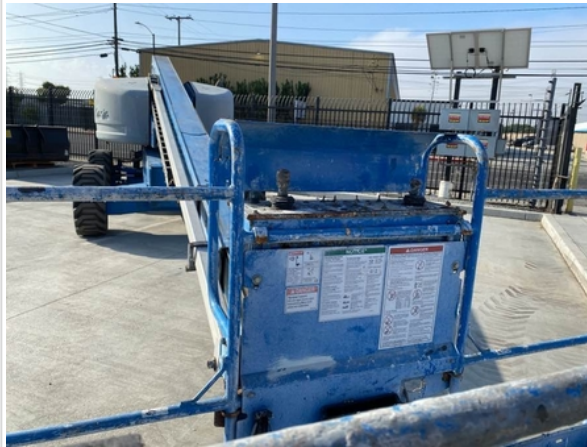
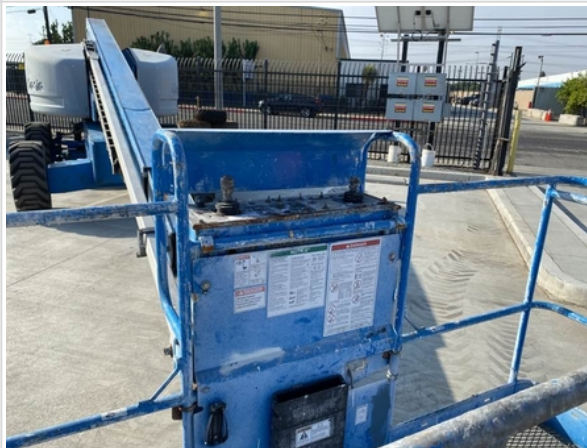
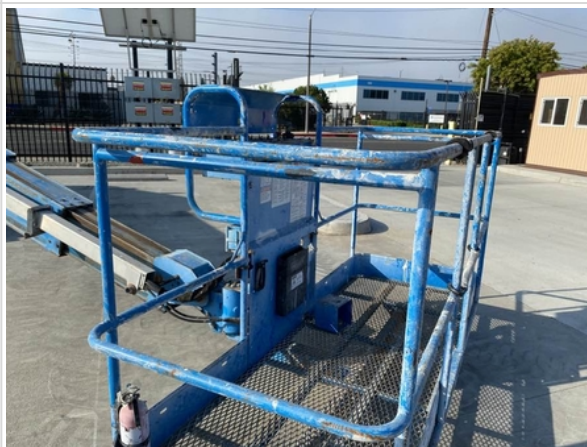
Hand Rails Photos

3 - Normal Wear & Tear

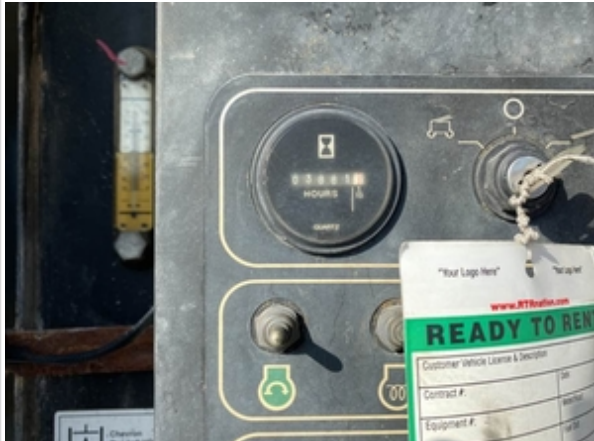
<b>Hour Meter Activity</b>	3 - Normal Wear & Tear
<b>Hour Meter Activity Photos</b>

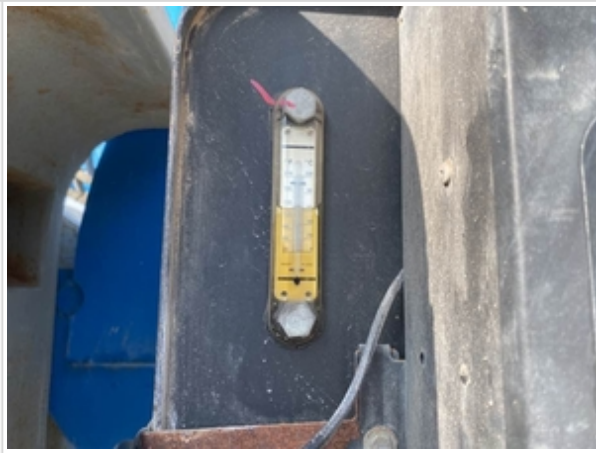
Other Gauge Activity	3 - Normal Wear & Tear
Other Gauge Activity Photos

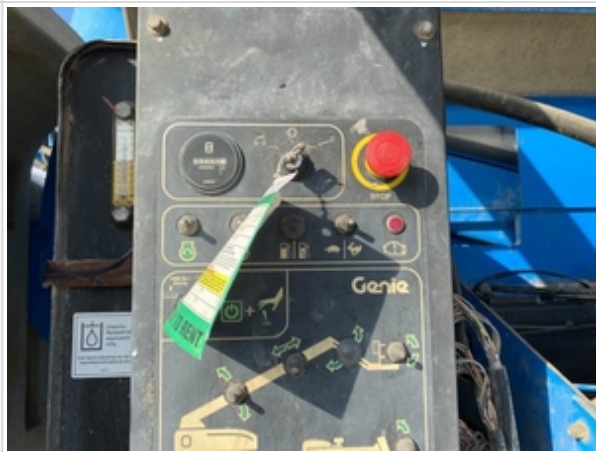
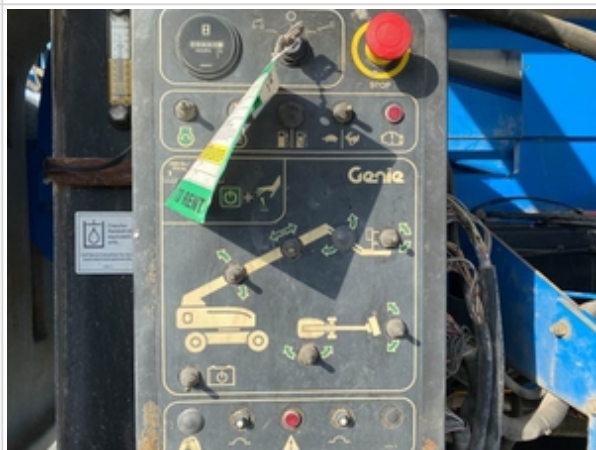
Controls & Switches	3 - Normal Wear & Tear
Controls & Switches Photos

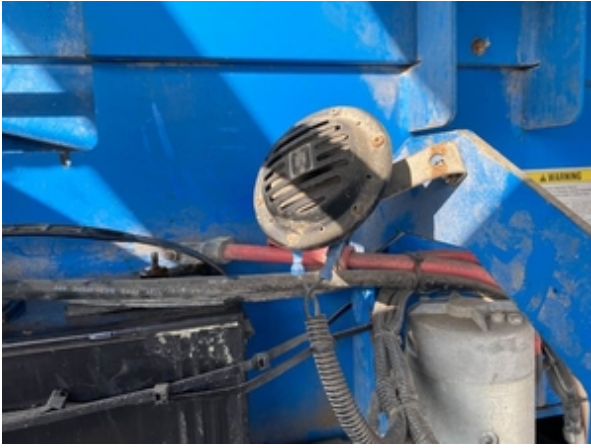
<b>Horn</b>	3 - Normal Wear & Tear
<b>Horn Photos</b>

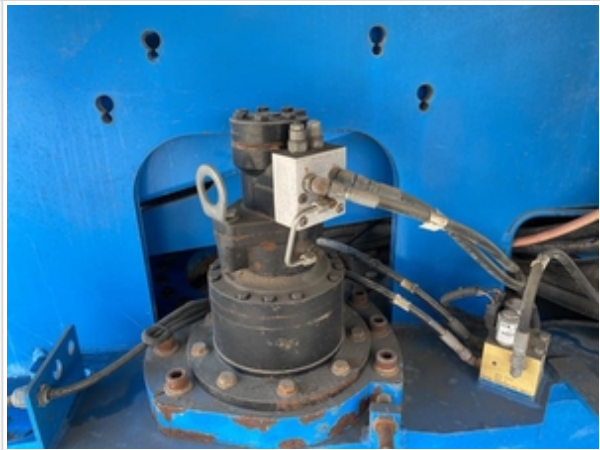
Swing Break Photos

<b>Travel Alarm</b>	3 - Normal Wear & Tear
<b>Swing Brake</b>	3 - Normal Wear & Tear

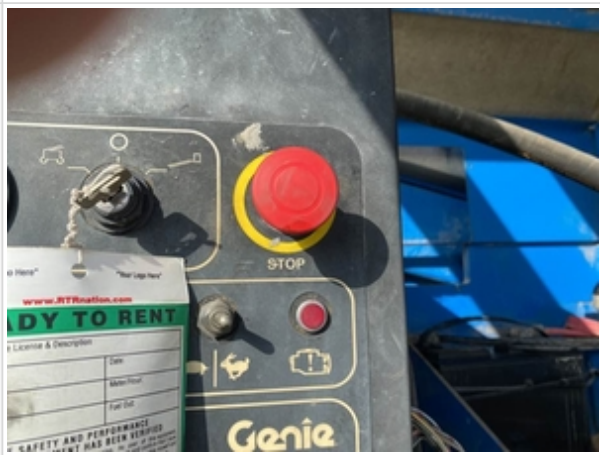
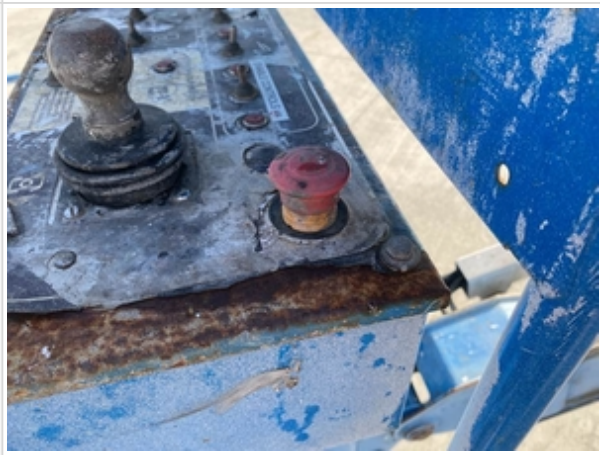
Safety Lock Out / Stop	3 - Normal Wear & Tear	
Safety Lock Out / Stop Photos

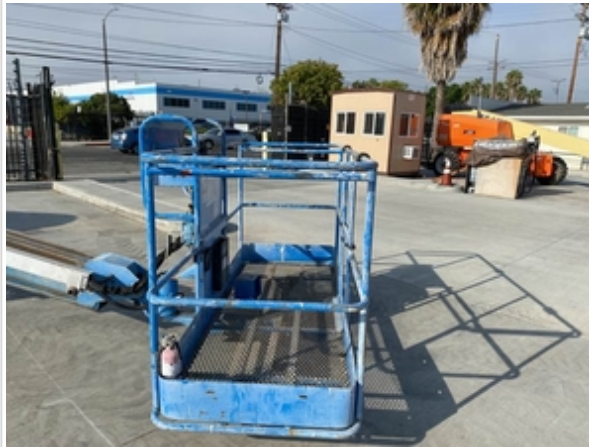
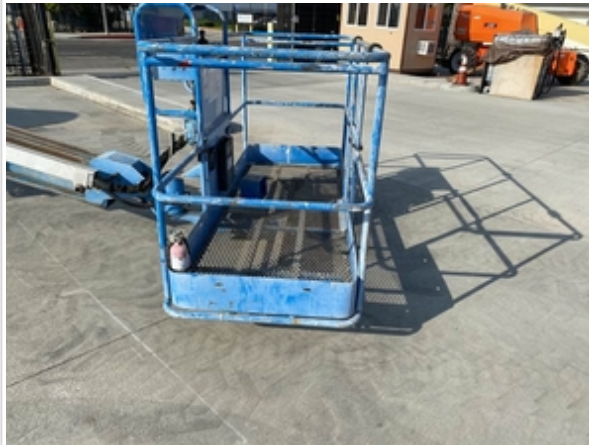
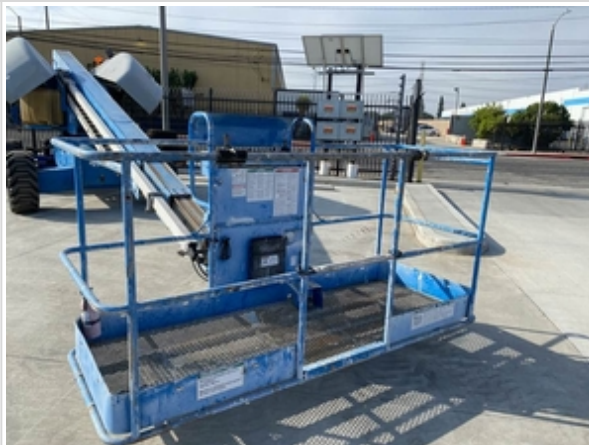
Platform Safety Rails & Appearance Photos

Platform Safety Rails & Appearance	3 - Normal Wear & Tear	
Comments	All around straight !

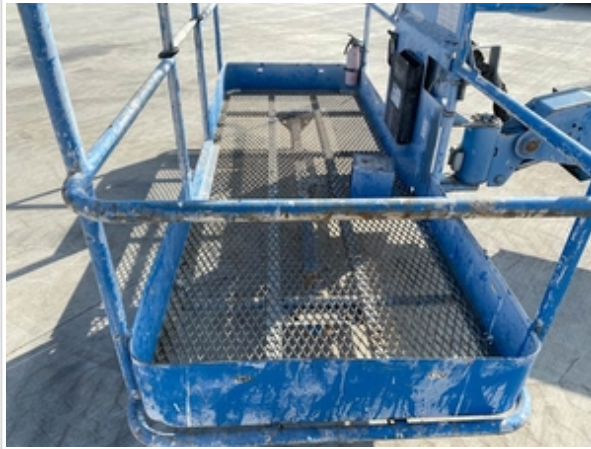
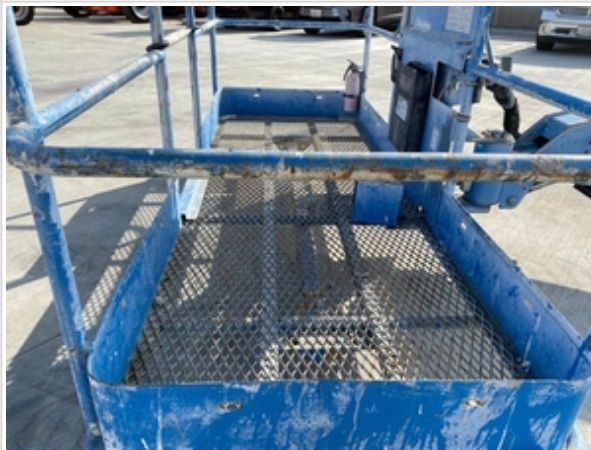
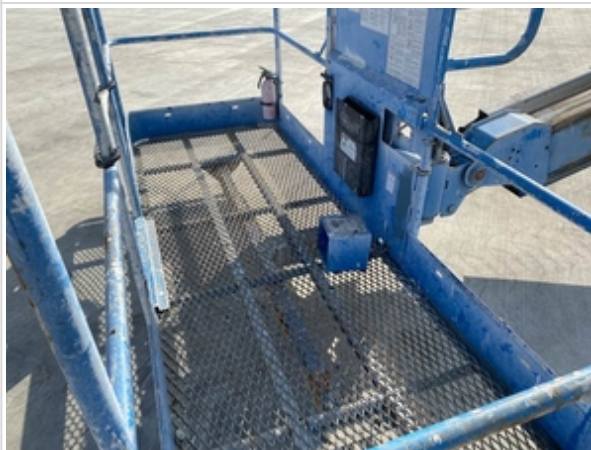
Platform Floor Photos

3 - Normal Wear & Tear

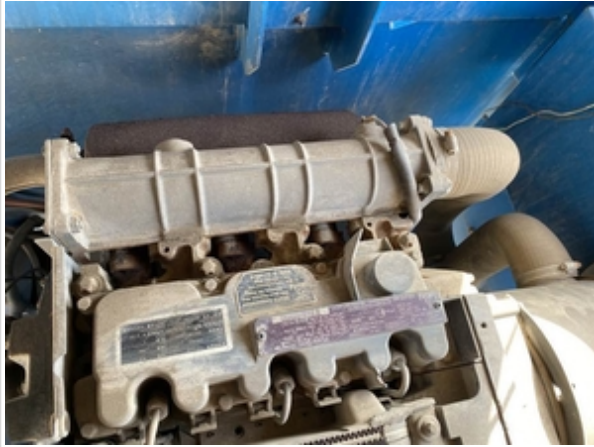
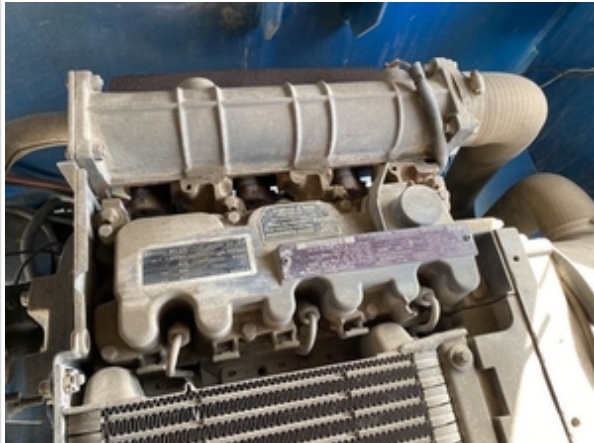
Engine Type (Make, Model, Cylinders, Hp)	Deutz - 4cyl. - 2.3L - 49HP
Engine Serial Number	11250092
Engine Fuel Type	Diesel
Engine Photos

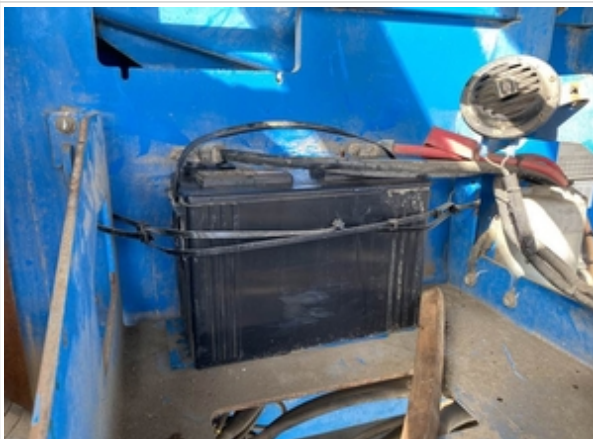
<b>Blow-by (Visual Observation Check)</b>	No
<b>Unusual Noises (Upon Start-up, Idle, Shutdown)</b>	No
<b>Unusual Noise Notes</b>	No unusual noises heard
<b>Engine Smoke (Upon Start-up, Idle, Shutdown)</b>	No
<b>Engine Smoke Notes</b>	No engine smoke issues observed
<b>Engine Exhaust Color</b>	Clear
<b>Battery</b>	3 - Normal Wear & Tear
<b>Battery Condition</b>	Stains & signs of corrosion seen, Other (see comments)
<b>Comments</b>	Missing factory installed battery hold down bracket
<b>Battery Condition Photos</b>

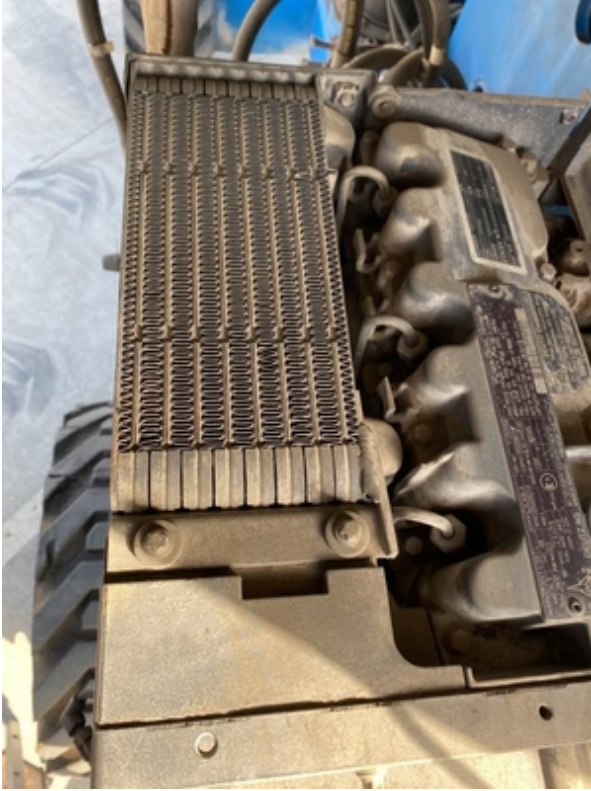
<b>Radiator</b>	3 - Normal Wear & Tear
<b>Radiator Condition</b>	Radiator fins & components appear to be in good working order, no signs of damage or leaks
<b>Radiator Photos</b>

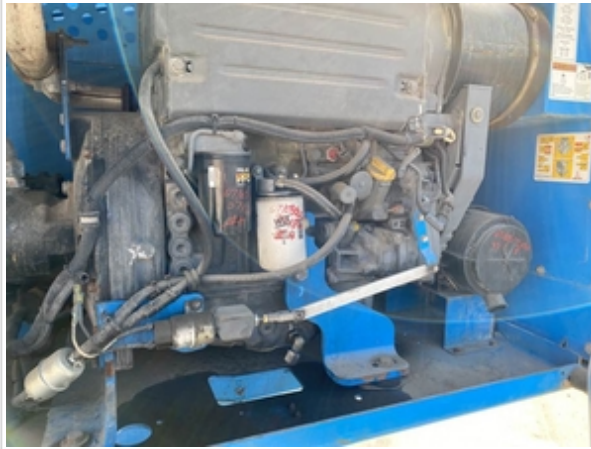
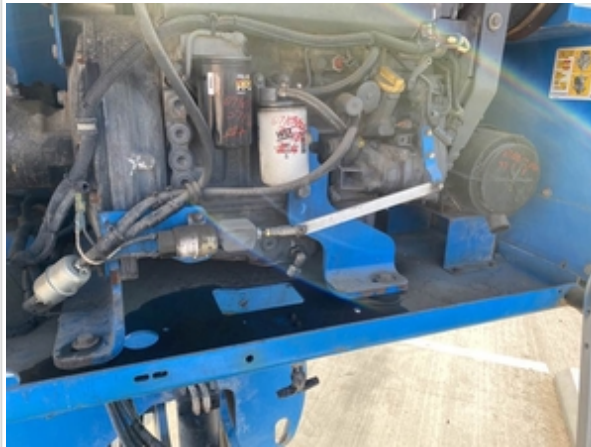
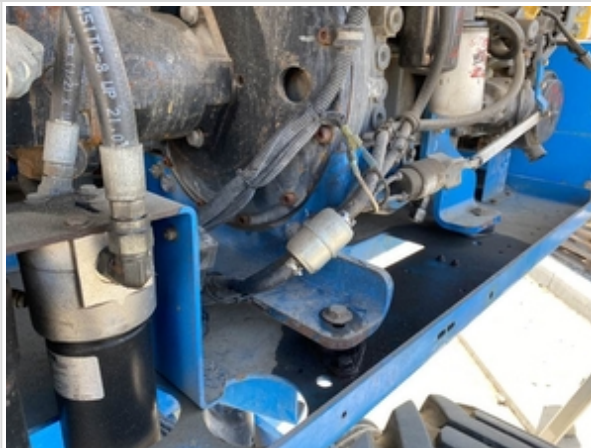
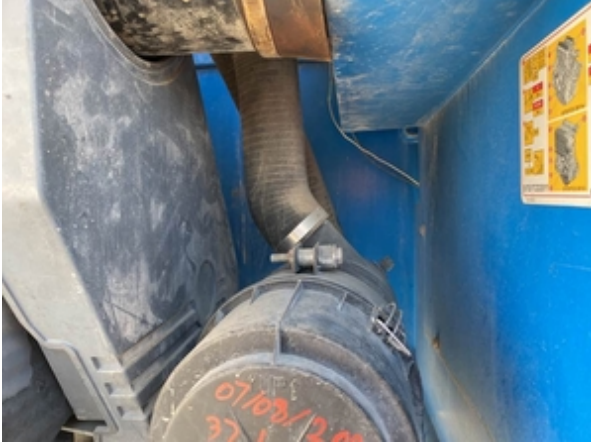
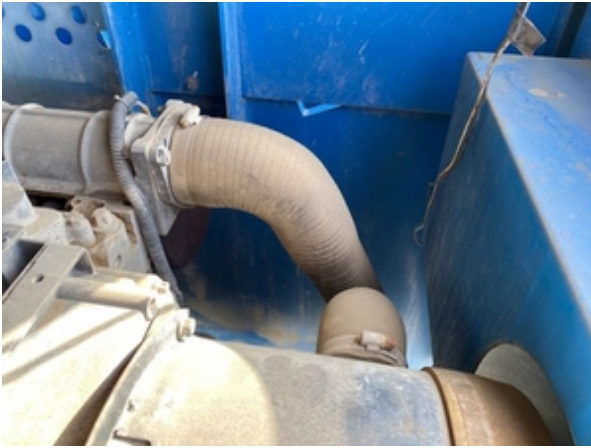
Hose Photos

<p>Hoses</p>	<p>3 - Normal Wear &amp; Tear</p>
<p>Hose Condition</p>	<p>Firm, pliant hoses with no signs of wear or leaks</p>

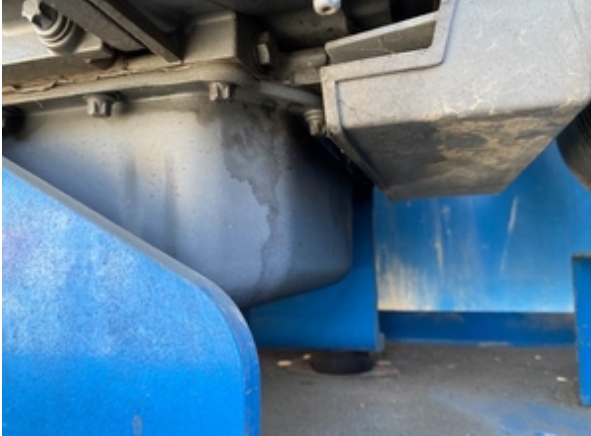
Water Pump	0
Cooling System Leaks	No
Coolant Color / Appearance	0
Oil Leaks	Yes
Oil Leak Notes	Dried oil seepages seen, Other (see comments)
Comments	Minor oil seepage from top side behind engine (no drips or puddles)
Oil Leak Photos

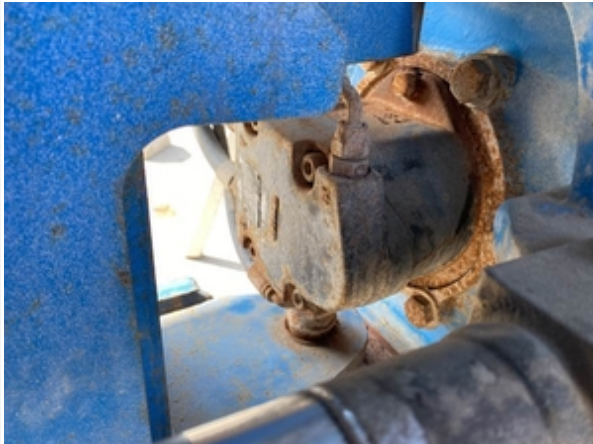
Drivetrain	
Transmission	0
Clutch	0
Shift Lever	0
Foot Brake	0
Inching Brake	0
Parking Brake	3 - Normal Wear & Tear
Parking Brake Condition	Good brake function
Parking Brake Photos

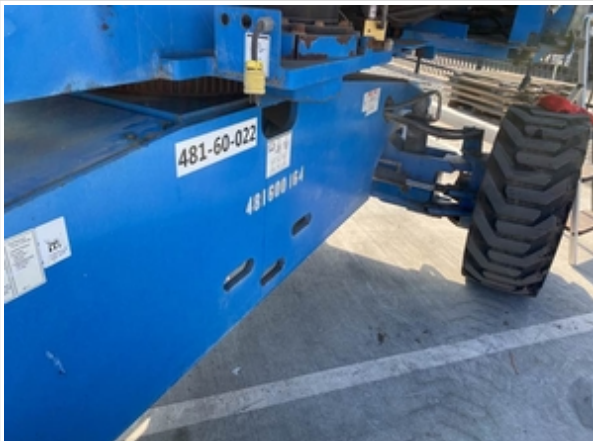
Instructions	<p>Evaluate the following on a 4 point scale (leave comments where an explanation is appropriate):</p> <p>4 = Like New, Recently Replaced            3 = Normal Wear &amp; Tear            2 = Above Average Wear            1 = Service Required</p>
Frame	3 - Normal Wear & Tear
Frame Photos

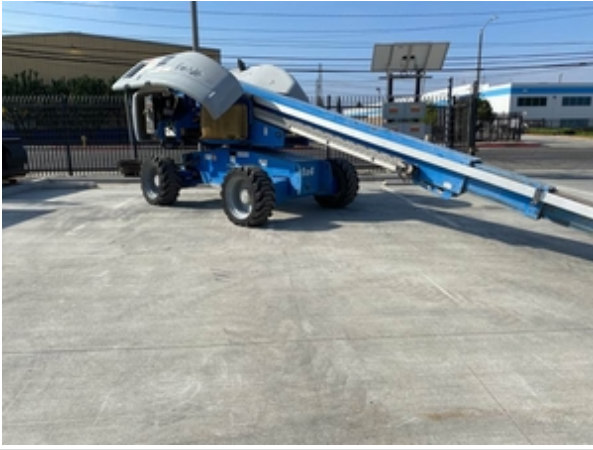
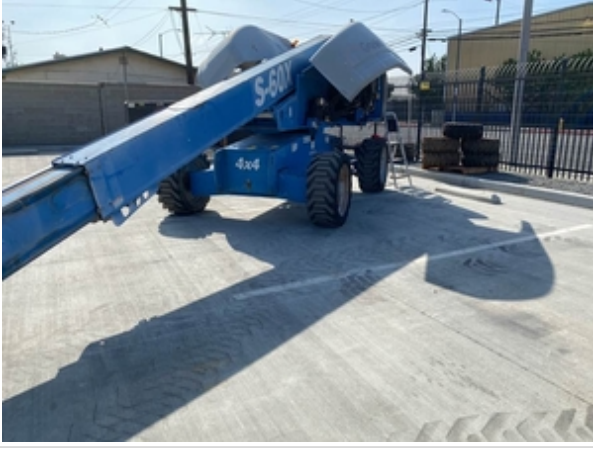
<b>Stance</b>	3 - Normal Wear & Tear	
<b>Stance Photos</b>

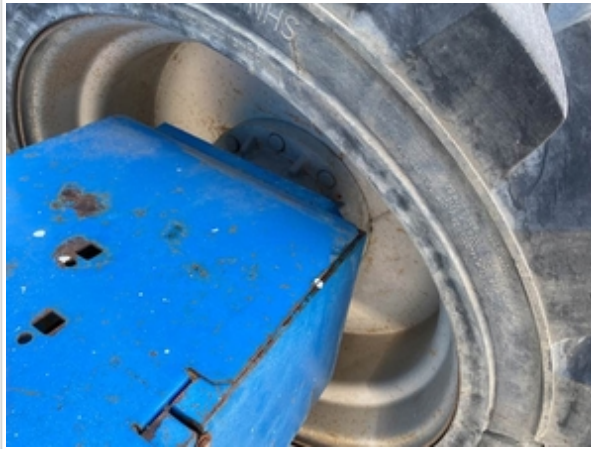
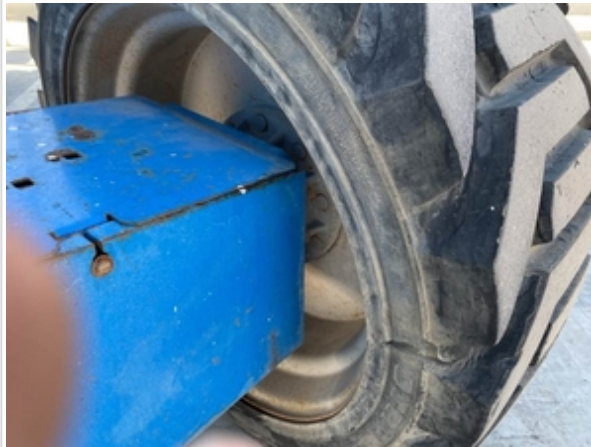
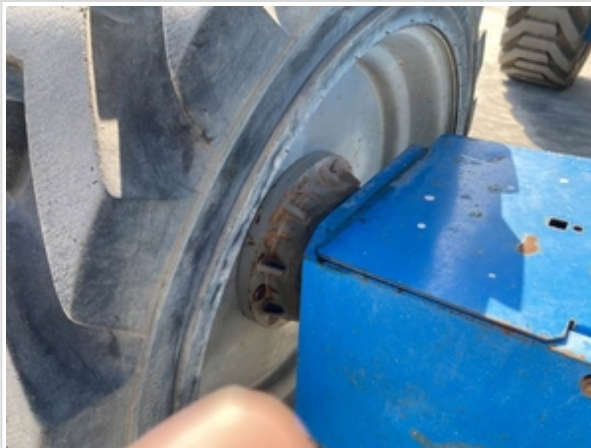
Front Axle Appearance Photos

<b>Front Axle Appearance</b>	3 - Normal Wear & Tear

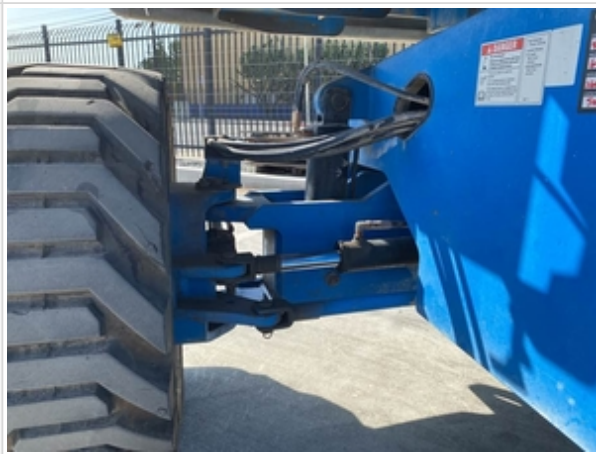
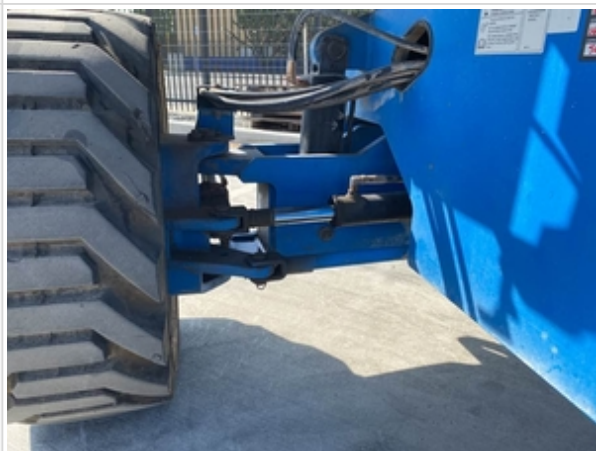
<p>Rear Axle Appearance</p>	<p>3 - Normal Wear &amp; Tear</p>
<p>Rear Axle Appearance Photos</p>

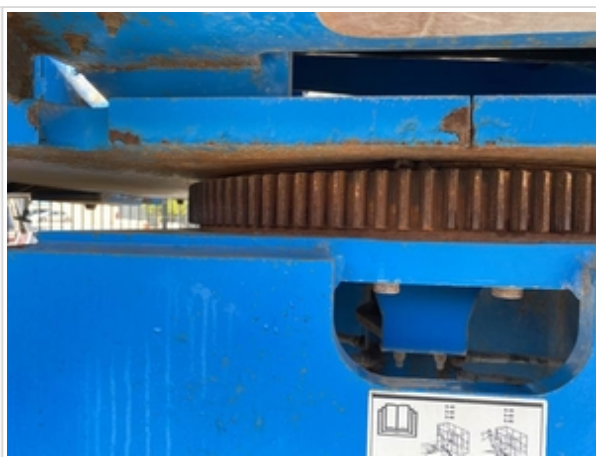
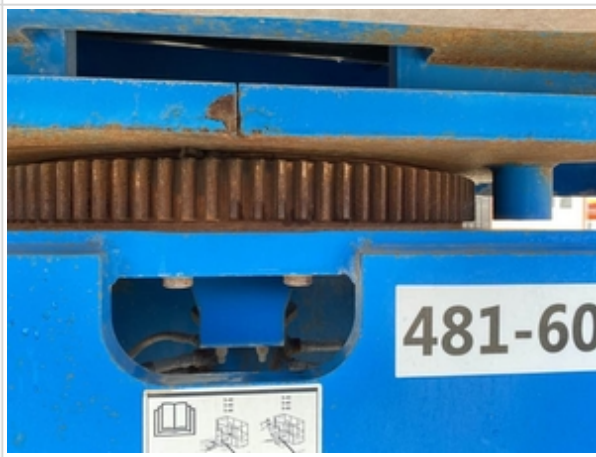
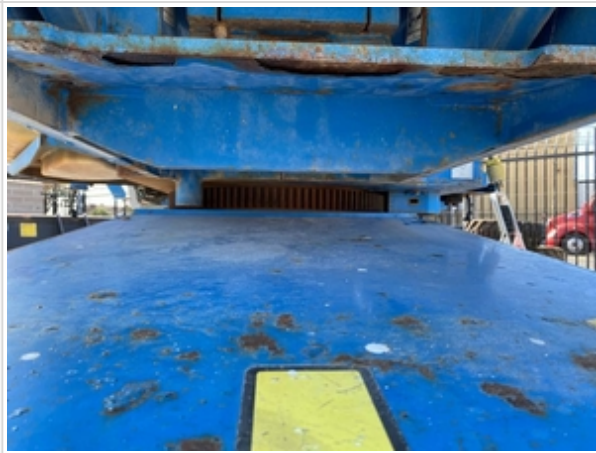
<p>Swivel Bearing Photos</p>

Tire Brand	OTR Outrigger
Tire Size	355/55D625
Front Left Tire - Ratio Remaining	70%
Rear Left Tire - Ratio Remaining	70%
Front Right Tire - Ratio Remaining	90%
Rear Right Tire - Ratio Remaining	90%
Swivel Bearing	3 - Normal Wear & Tear

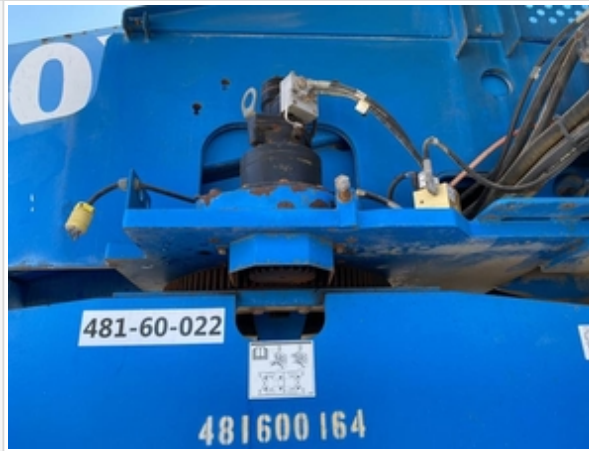
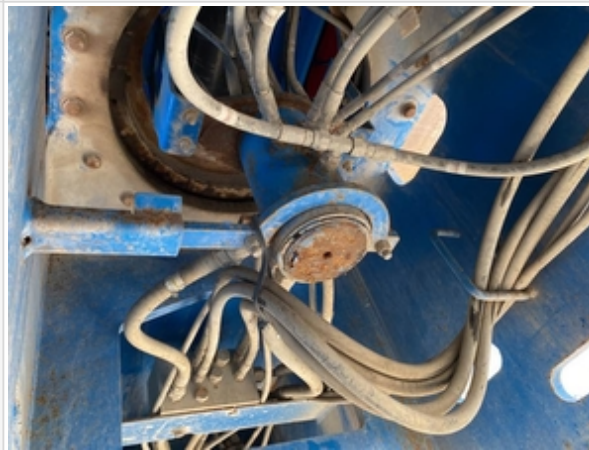
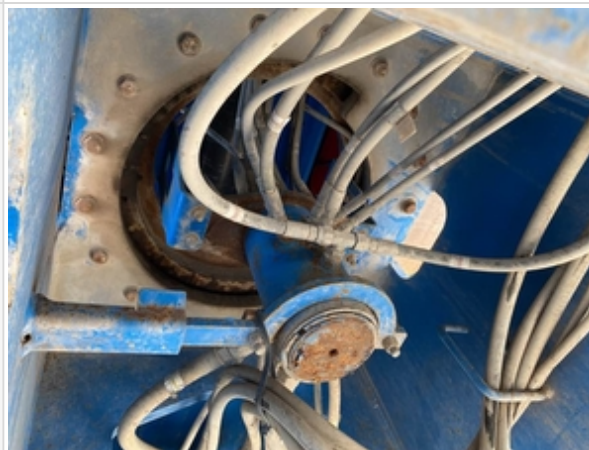
<p>Swivel Motor</p>	<p>3 - Normal Wear &amp; Tear</p>
<p>Swivel Bearing Photos</p>

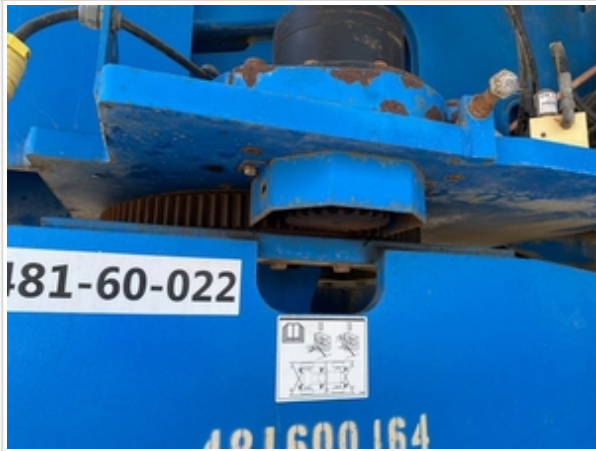
Swivel Joint Photos

Swivel Joint

3 - Normal Wear & Tear
