## Inspection Report (Boom Lift)

Year	2012
Make	Genie
Model	S60x
Serial Number	S60X12-23903
Hour Meter Reading	3881.5
Previous Application (e.g., earth moving, mining, demolition, etc)	General Construction Rental

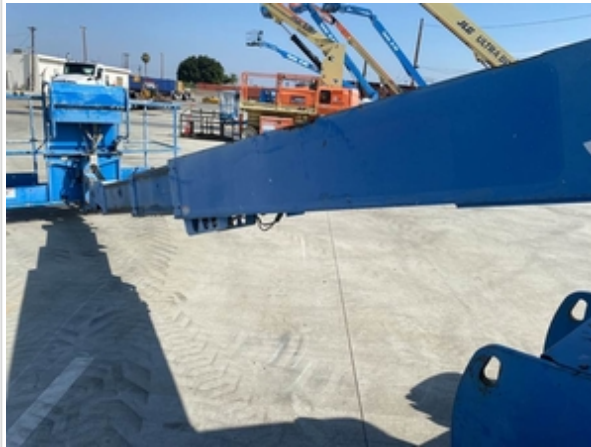
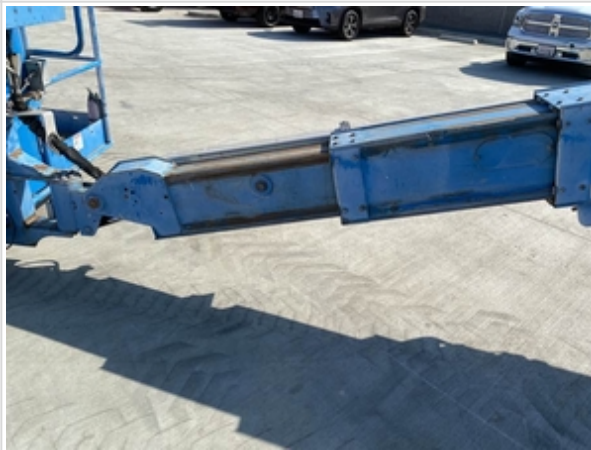
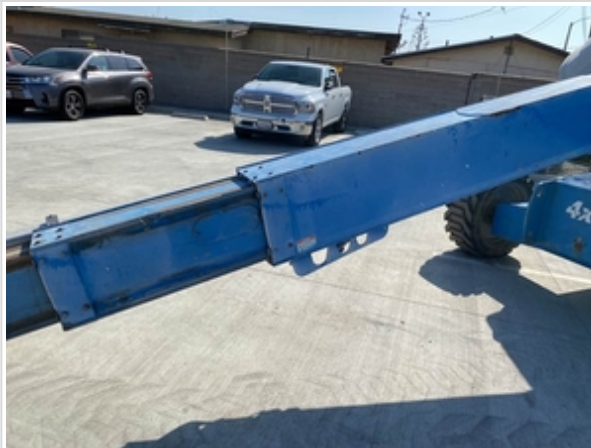
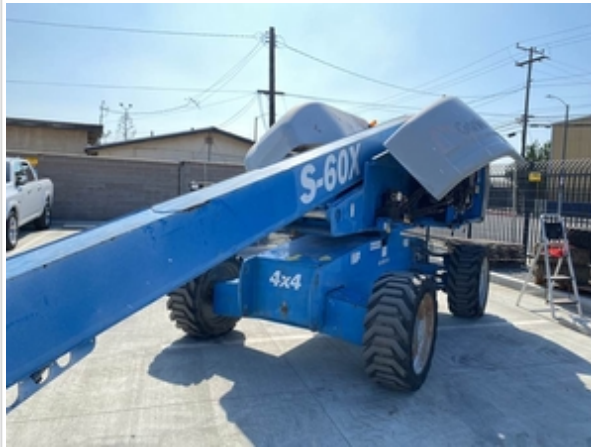
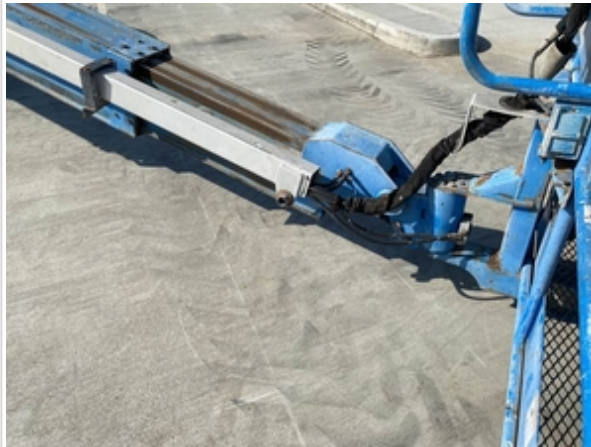
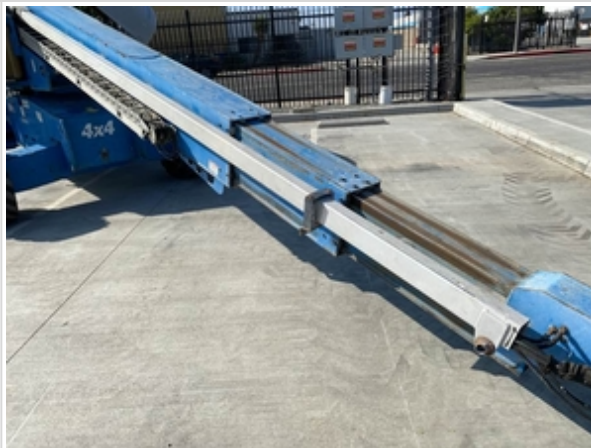
Boom Condition	3 - Normal Wear & Tear	
Comments	Inner boom section slightly bent at r/s end	
Boom Condition Photos

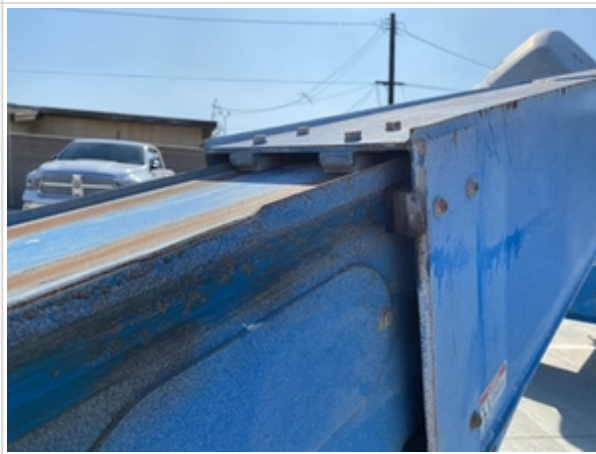
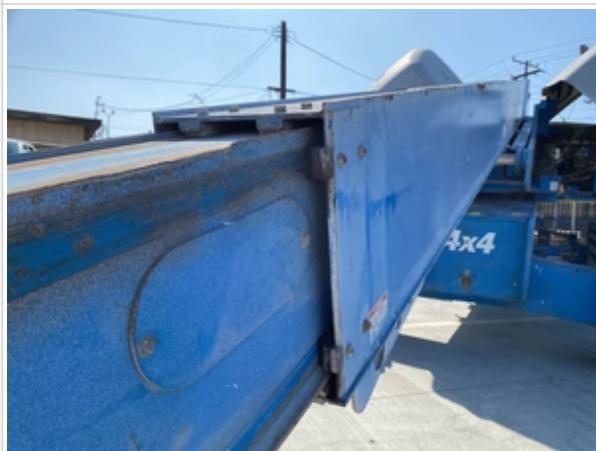
<p><b>Boom Wear Guides</b></p>	<p>3 - Normal Wear &amp; Tear</p>	
<p><b>Boom Wear Guides Photos</b></p>

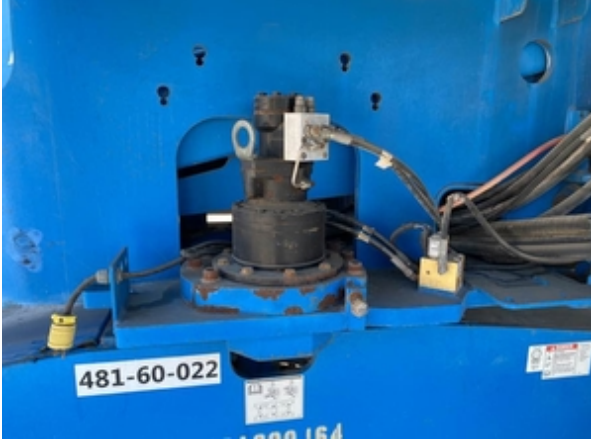
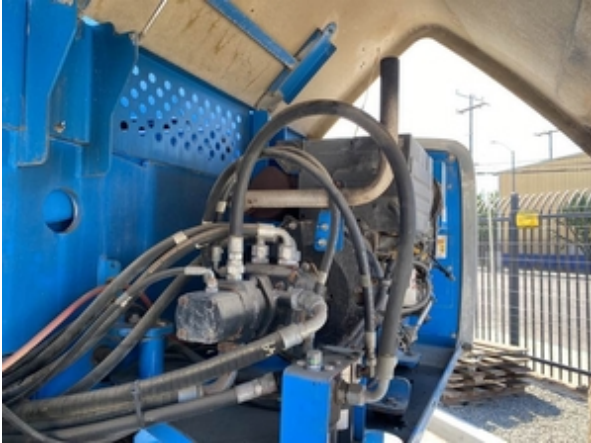
<b>Hydraulic Lines / Fittings Condition</b>	Hydraulic lines & fittings are clean and in good condition, Cracking, stiff, or charred hydraulic hoses, Dried seepages observed
<b>Appearance of Hydraulic Lines / Fittings Photos</b>

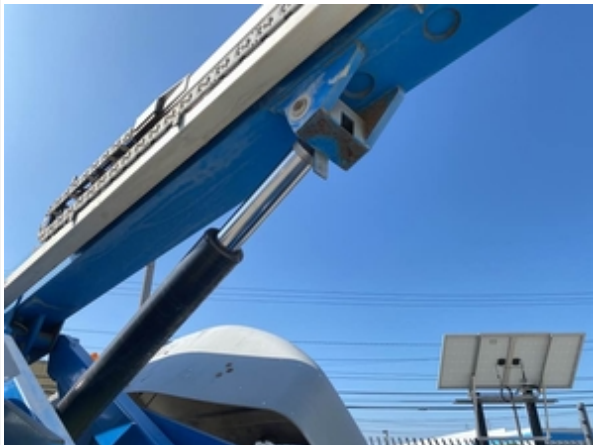
Boom Lift Cylinders	Check the boom lift cylinders. Note any wear, pitting, discoloration, etc. Take photos.
Boom Lift Cylinders: Mounting Pin	4
Boom Lift Cylinders: Oil Leaks	No
Boom Lift Cylinders Photos

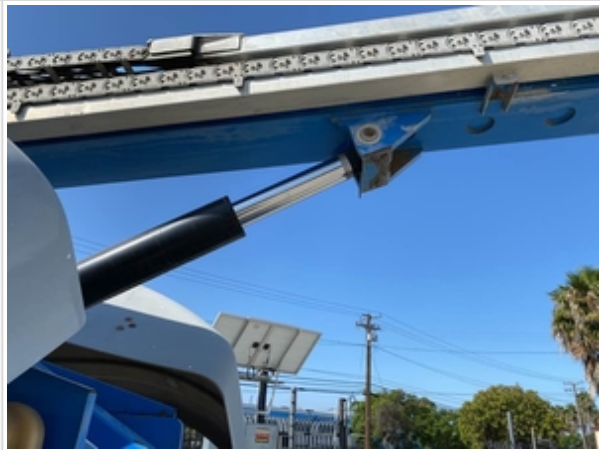
<b>Boom Extension Cylinder</b>	Check the boom extension cylinder. Note any wear, pitting, discoloration, etc. Take photos.	
<b>Boom Extension Cylinder: Mounting Pin</b>	4	
<b>Boom Extension Cylinder: Oil Leaks</b>	No	
<b>Comments</b>	Boom hose track slightly bent	
<b>Boom Extension Cylinder Photos</b>

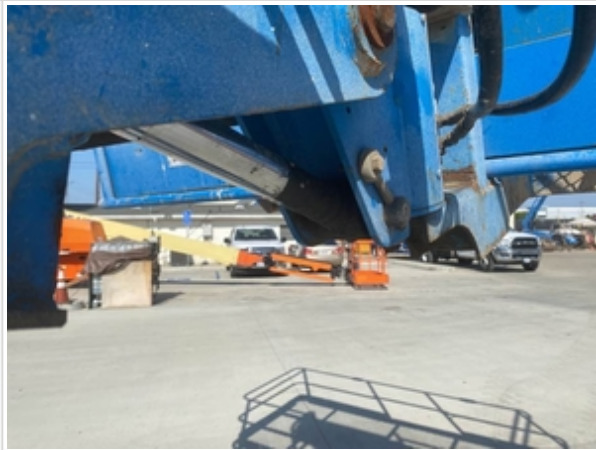
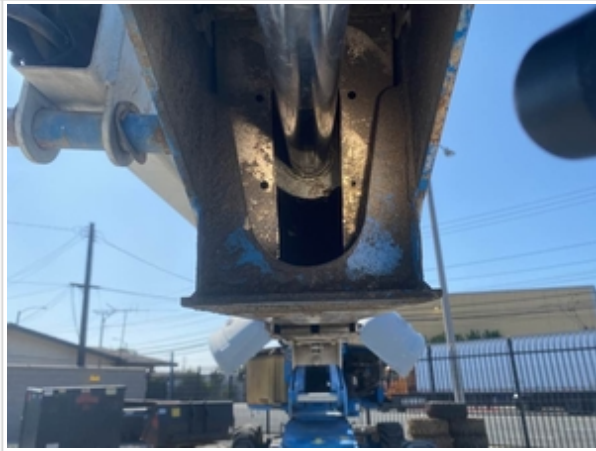
<b>Basket Tilt Cylinder Photos</b>

<b>Jib Cylinder</b>	Check the jib cylinder. Note any wear, pitting, discoloration, etc. Take photos.	
<b>Basket Tilt Cylinder</b>	Check the basket tilt cylinders. Note any wear, pitting, discoloration, etc. Take photos.	
<b>Basket Tilt Cylinder: Mounting Pin</b>	4	
<b>Basket Tilt Cylinder: Oil Leaks</b>	No

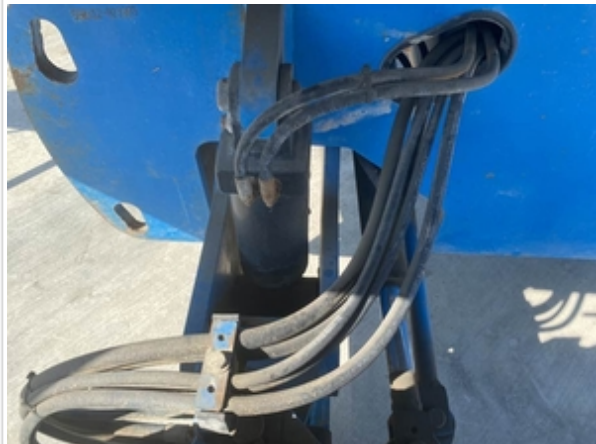
<b>Frame Leveling Cylinders</b>	Check the frame leveling cylinders. Note any wear, pitting, discoloration, etc. Take photos.
<b>Frame Leveling Cylinders: Mounting Pin</b>	4
<b>Frame Leveling Cylinders: Oil Leaks</b>	No
<b>Frame Leveling Cylinders Photos</b>

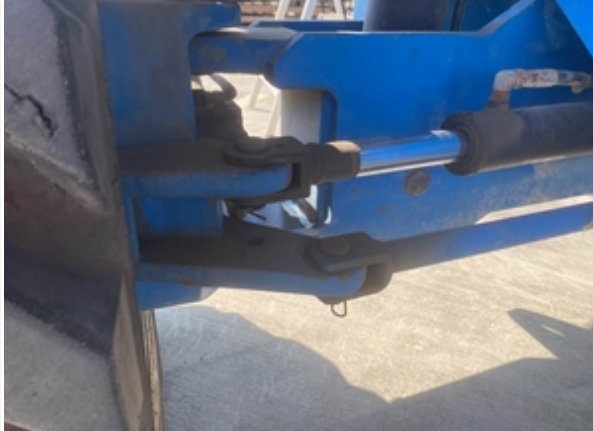
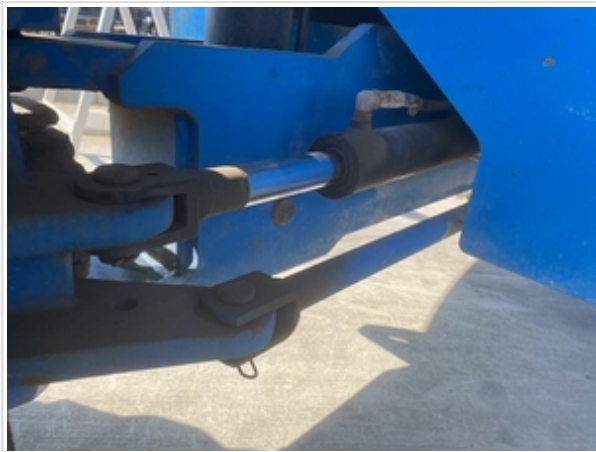
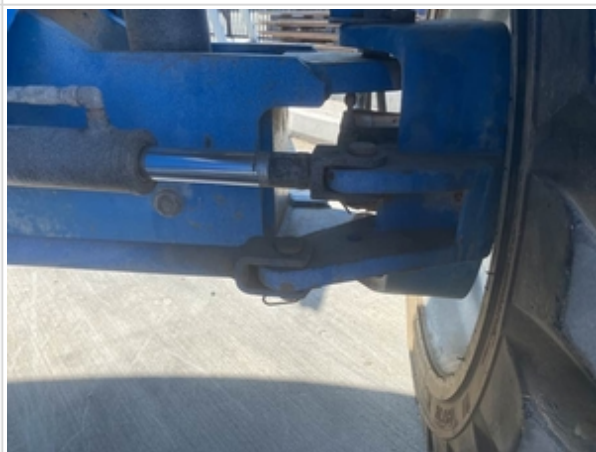
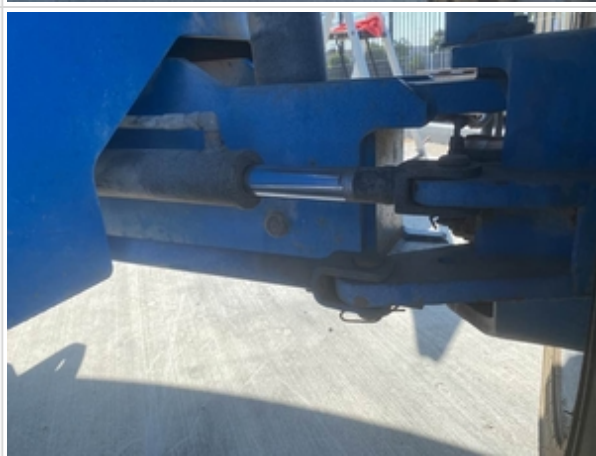
<b>Outrigger Cylinders</b>	Check the outrigger cylinders. Note any wear, pitting, discoloration, etc. Take photos.
<b>Steering Cylinders</b>	Check the steering cylinders. Note any wear, pitting, discoloration, etc. Take photos.
<b>Steering Cylinders: Mounting Pin</b>	4
<b>Steering Cylinders: Oil Leaks</b>	No
<b>Steering Cylinders Photos</b>
