General Info

| General into | | | |
|---|---|--|--|
| Make | Genie | | |
| Model | S40 | | |
| Serial Number | S4013-18140 | | |

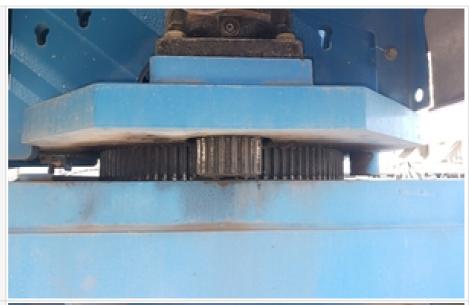
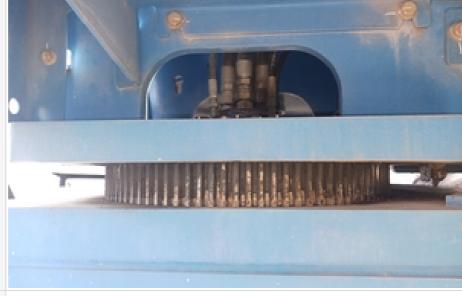
Chassis Photos

| Chassis Rating | 3 - Normal Wear & Tear |
| Comments | The chassis is in good working condition |

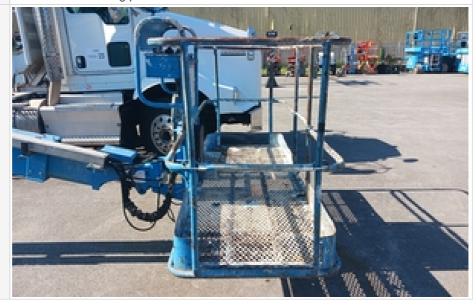
areas of rust/missing paint

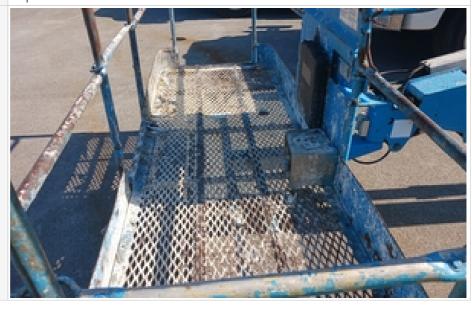
exposed wires
